**TOWN BARTON
BEAWORTHY
WEST DEVON
DEVON**

Historic Building Recording

South West Archaeology Ltd. report no. 190620

01.07.2019

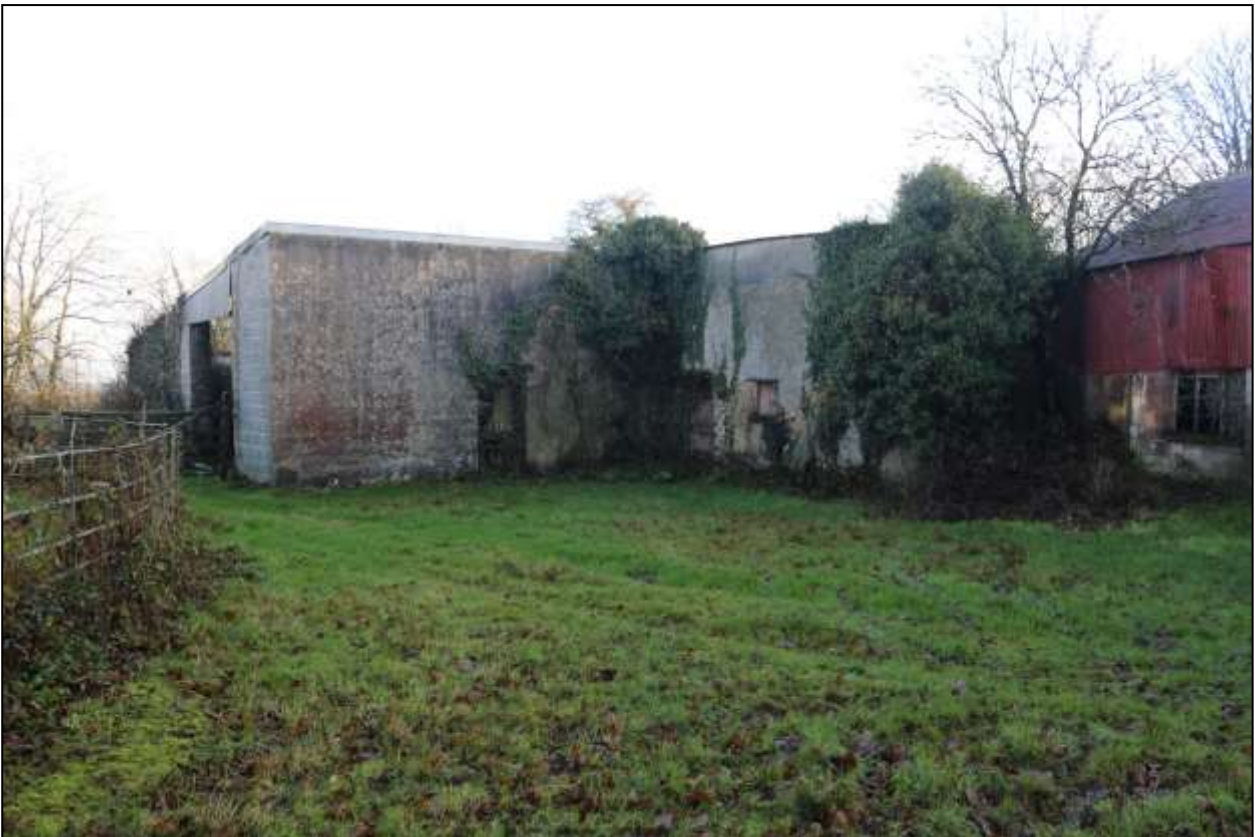
131. L-PLAN BUILDINGS AT EASTERN CORNER OF FARMYARD. FORMER COTTAGE WITH COB CONSTRUCTION TO CENTRE. VIEWED FROM THE WEST.

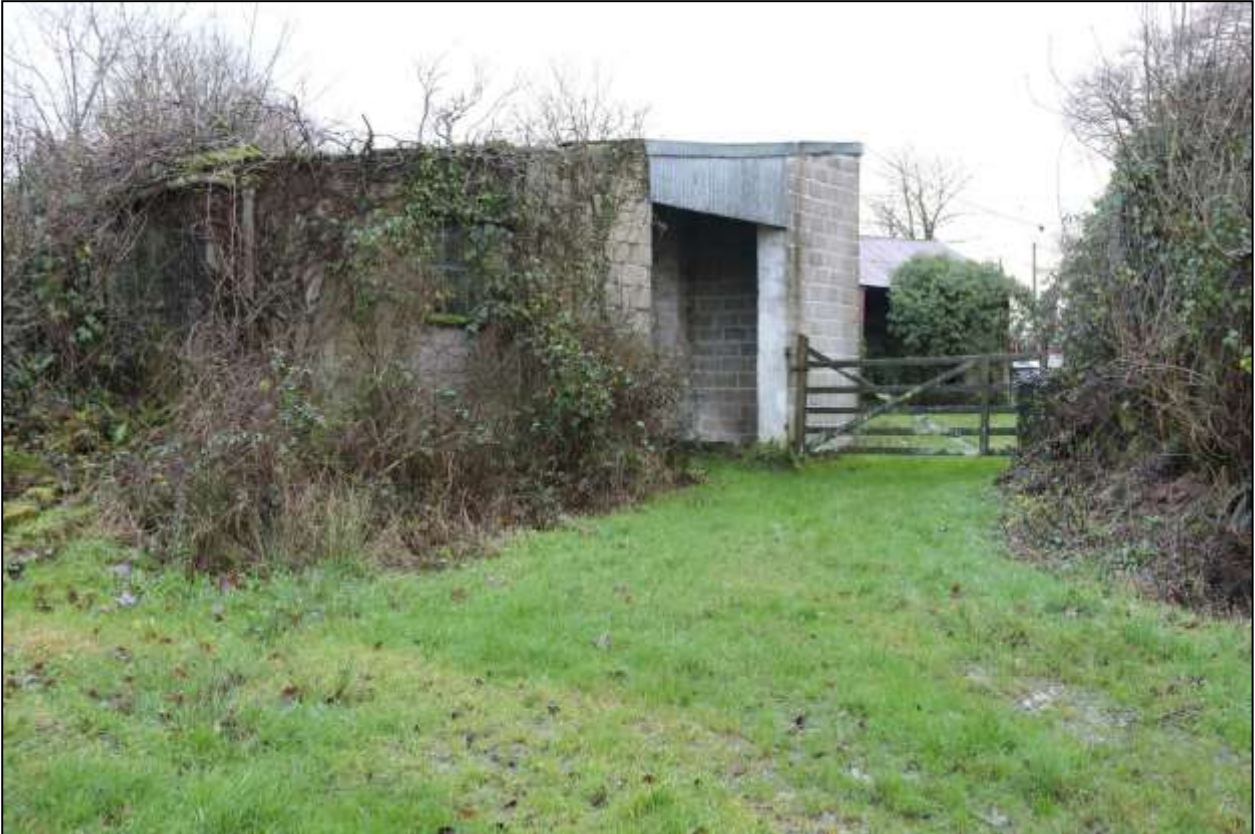
132. NORTH END OF LINHAY WING; MOSTLY MID-20TH CENTURY CONSTRUCTION, NEAR BLOCKWORK FACING RUBBLE. VIEWED FROM THE NORTH.

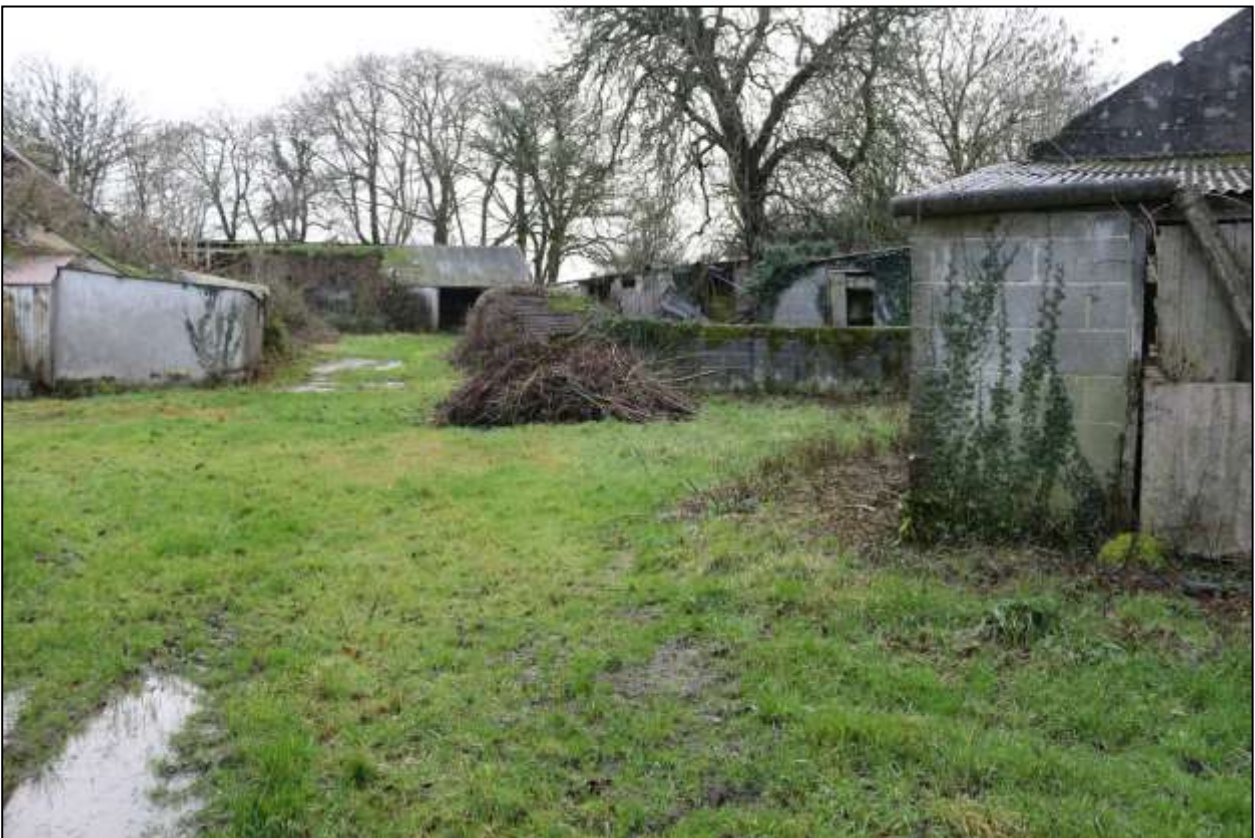
133. GENERAL VIEW OF FARMYARD BEHIND HOUSE; HOUSE ON EXTREME LEFT. VIEWED FROM THE NORTH-EAST.

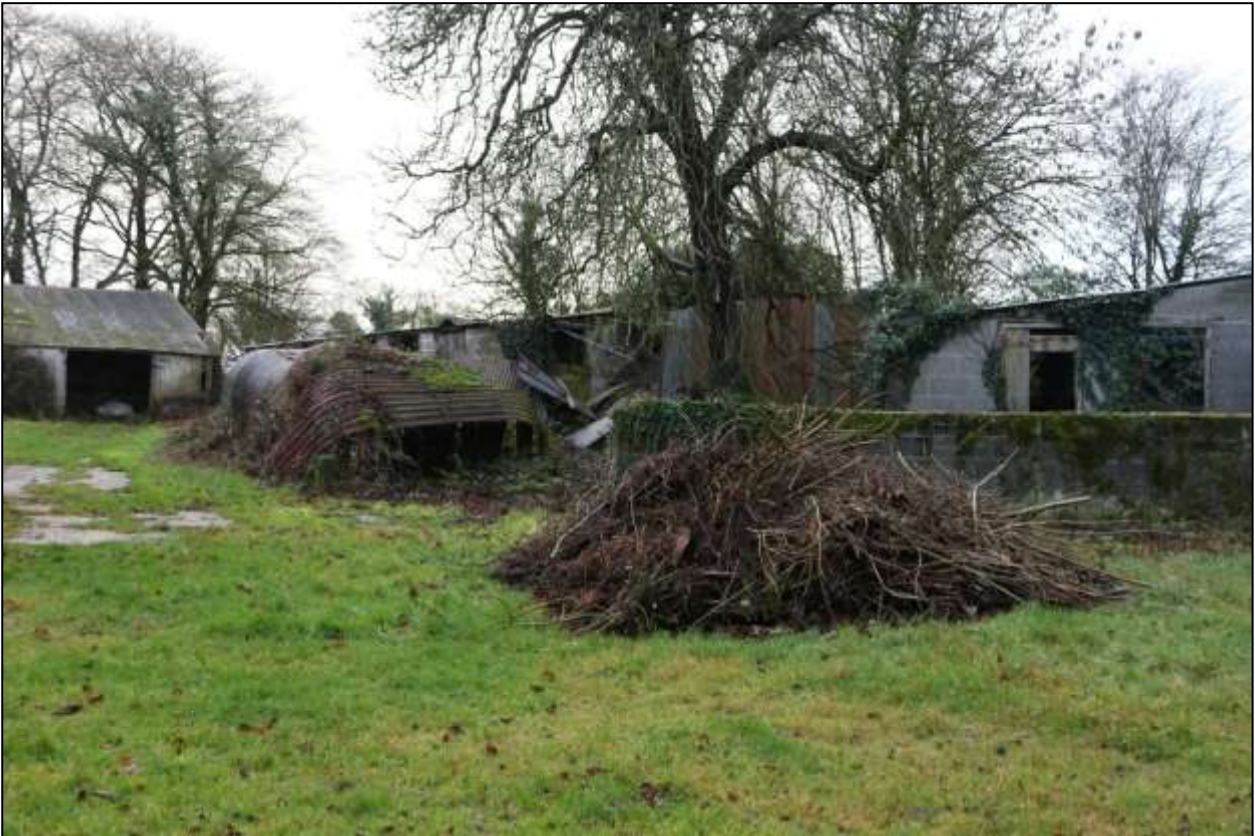
134. GROUP OF 20TH CENTURY BUILDINGS ON NORTH SIDE OF REAR FARMYARD. OLDER STONE RUBBLE AND COB BUILDING TO LEFT OF LARGE TREE IS SHOWN ON THE 1840 TITHE MAP AND 1885 OS MAP. VIEWED FROM THE EAST.

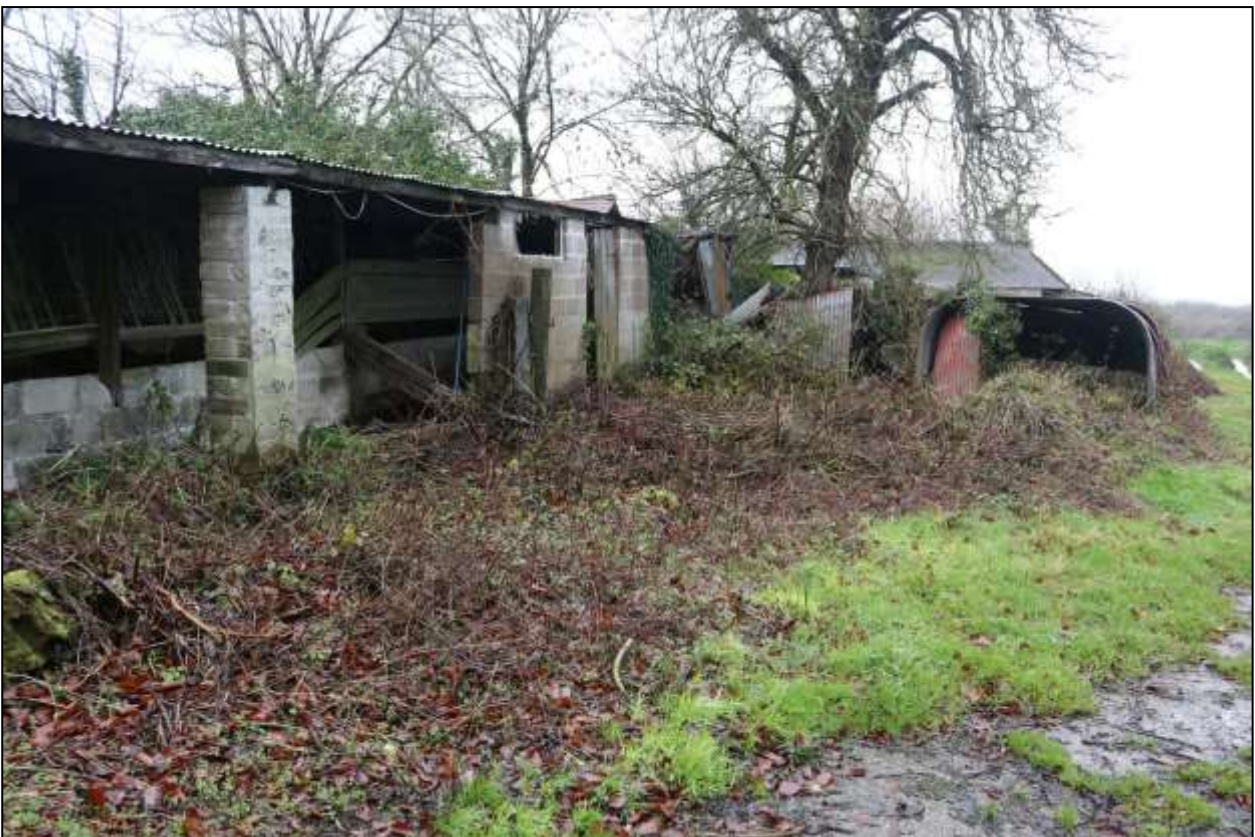
135. THE 20TH CENTURY AGRICULTURAL BUILDINGS BEHIND THE HOUSE; VIEWED FROM THE NORTH-WEST.

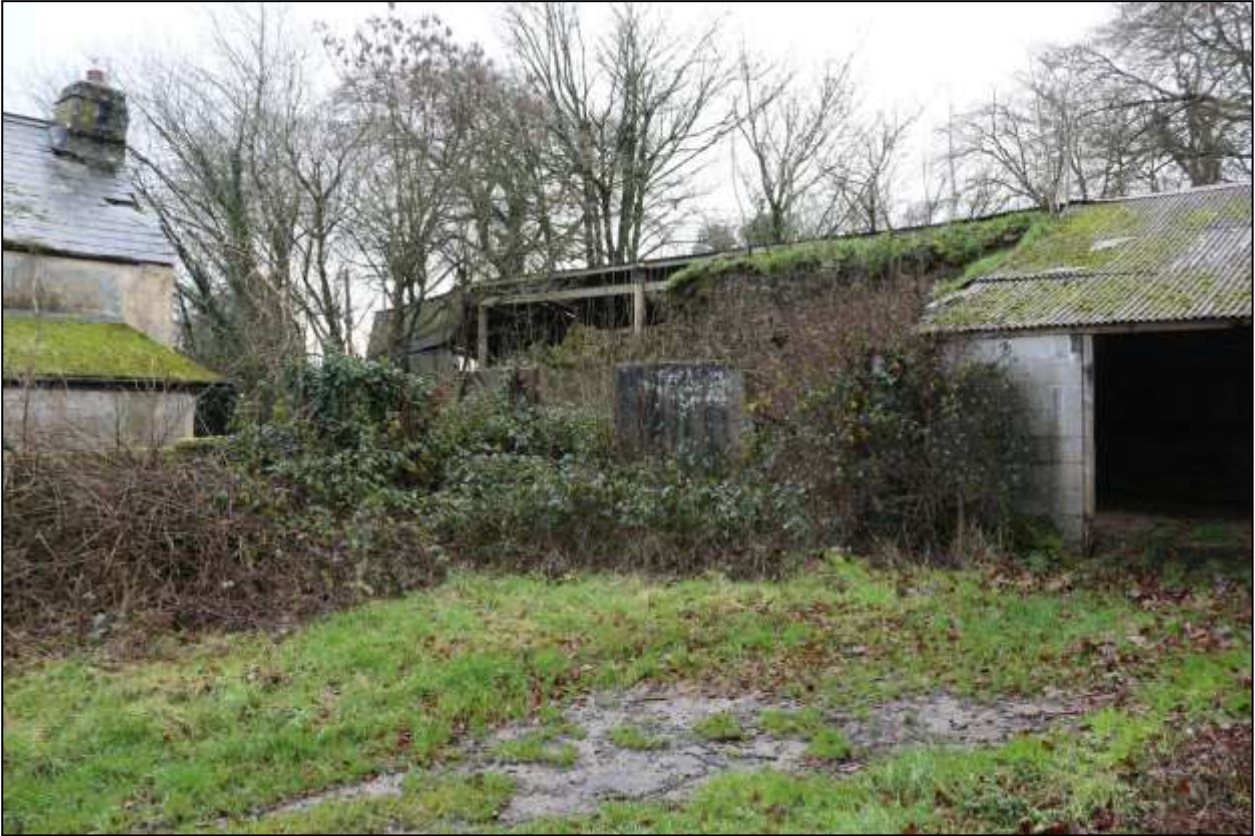
136. REMAINS OF WESTERN LINHAY RANGE ON THE SOUTH-WEST SIDE OF THE FARMYARD. RUBBLE WALL TO REAR OF LINHAY, THE REST LARGELY REBUILT IN THE MID-20TH CENTURY. HOUSE TO LEFT. VIEWED FROM THE NORTH.

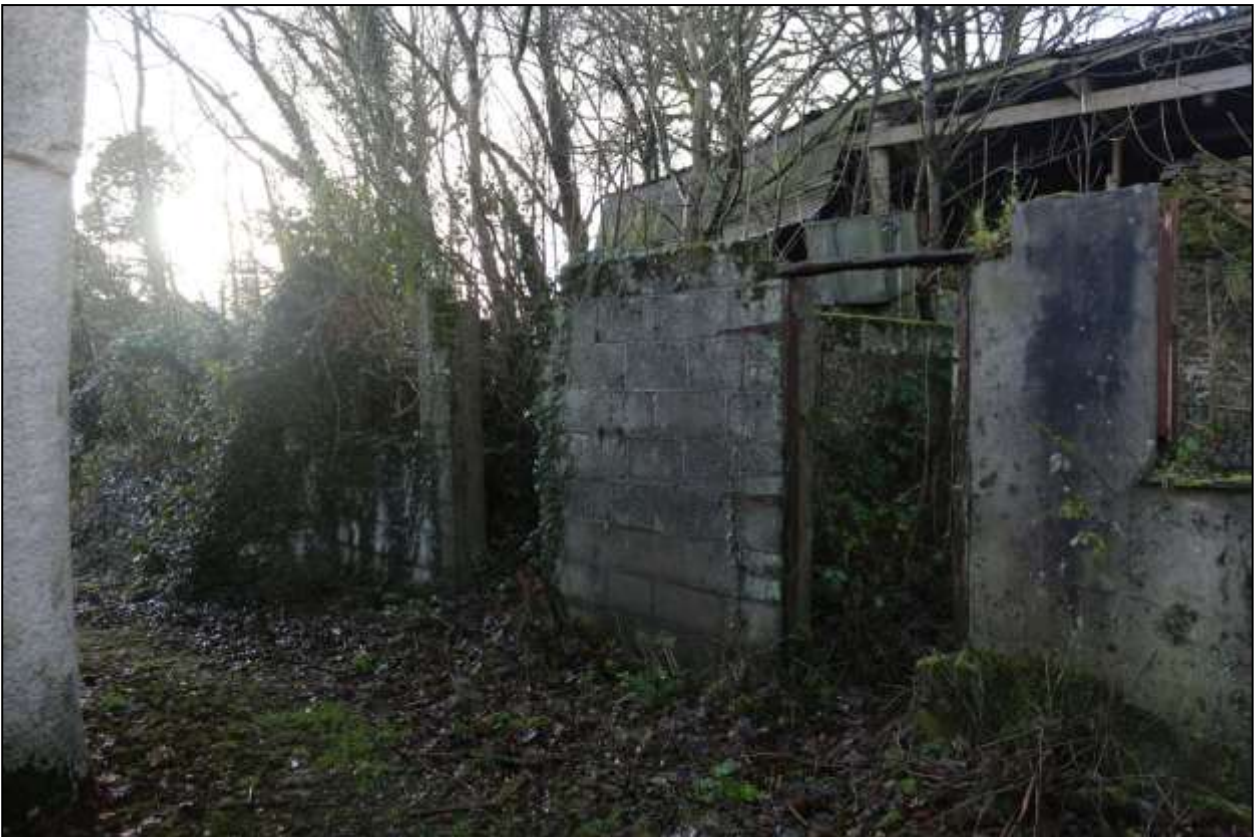
137. SOUTH-WEST END OF LINHAY RANGE WITH LOW OVERGROWN REMAINS OF THRESHING BARN BEHIND. THE NORTH-WEST CORNER OF HOUSE IS ON THE EXTREME LEFT. VIEWED FROM THE NORTH.
