**BELLHAY COTTAGE
CHURCH ROAD
CARDINHAM
CORNWALL**

Historic Building Recording & Archaeological Monitoring

South West Archaeology Ltd. report no. 191129

By E. Wapshott & A. Allen
Report Version: FINAL
Issued: 29th November 2019
Finalised: 9th December 2019

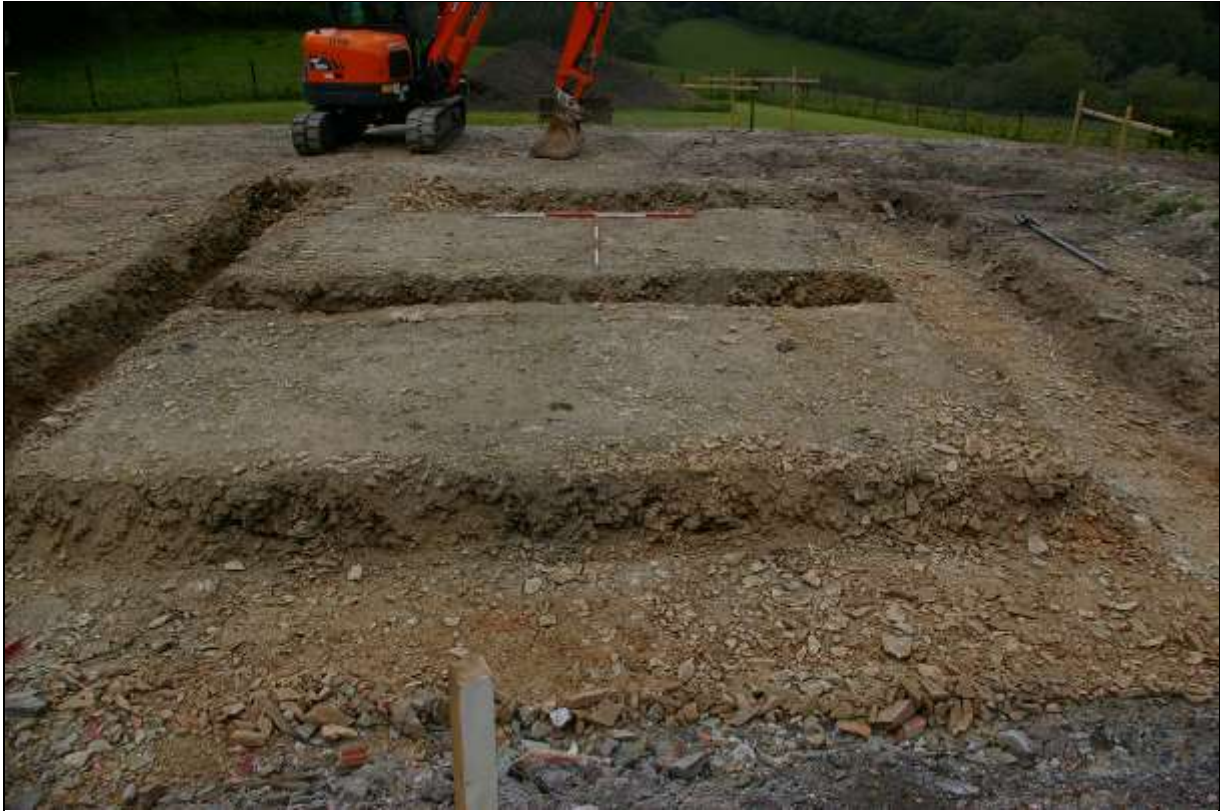
The deep cut which framed Bellhay on its western side, upon which it seems some 19th century outbuilding had been built would suggest this site had already been significantly terraced when building the first house. This likely removed any older archaeological features and deposits. Despite the previous works removing the house and its foundations, no conclusive evidence was seen of any features cut into the subsoil layers or bedrock also seemingly ruling out any earlier archaeology on the site.

FIGURE 7: MONITORING THE NEW FOUNDATIONS OF THE HOUSE, WITH 2 X 2M SCALES; FROM THE EAST.

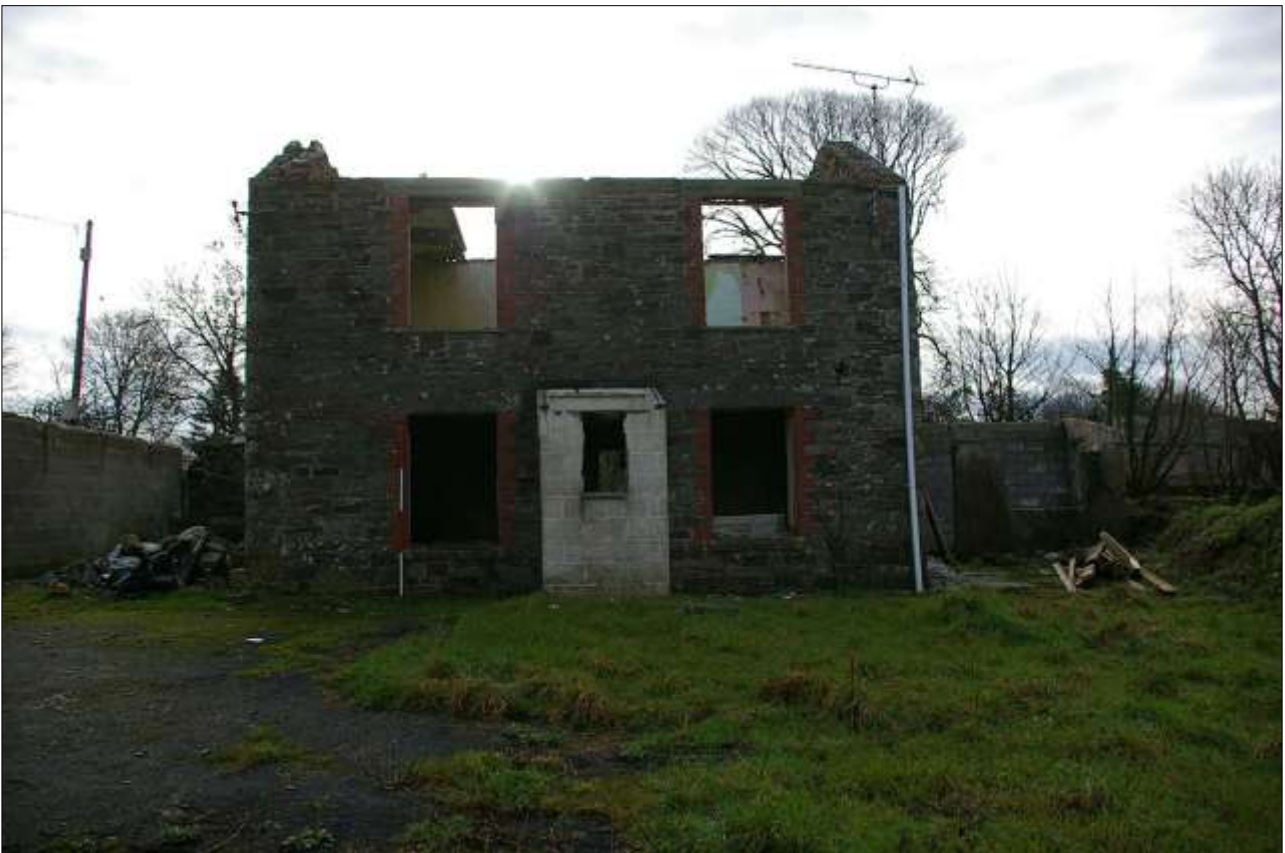
The north elevation presents as a symmetrical two window range elevation, of looser-style slatestone rubble, with granite quoins and brick detailing to windows, with granite lintels. It has a central door between the two ground floor windows, which is now obscured by a small modern concrete block porch.

6. THE NORTH ELEVATION, WITH 2M SCALE, 19TH CENTURY EXTENSION; FROM THE NORTH.

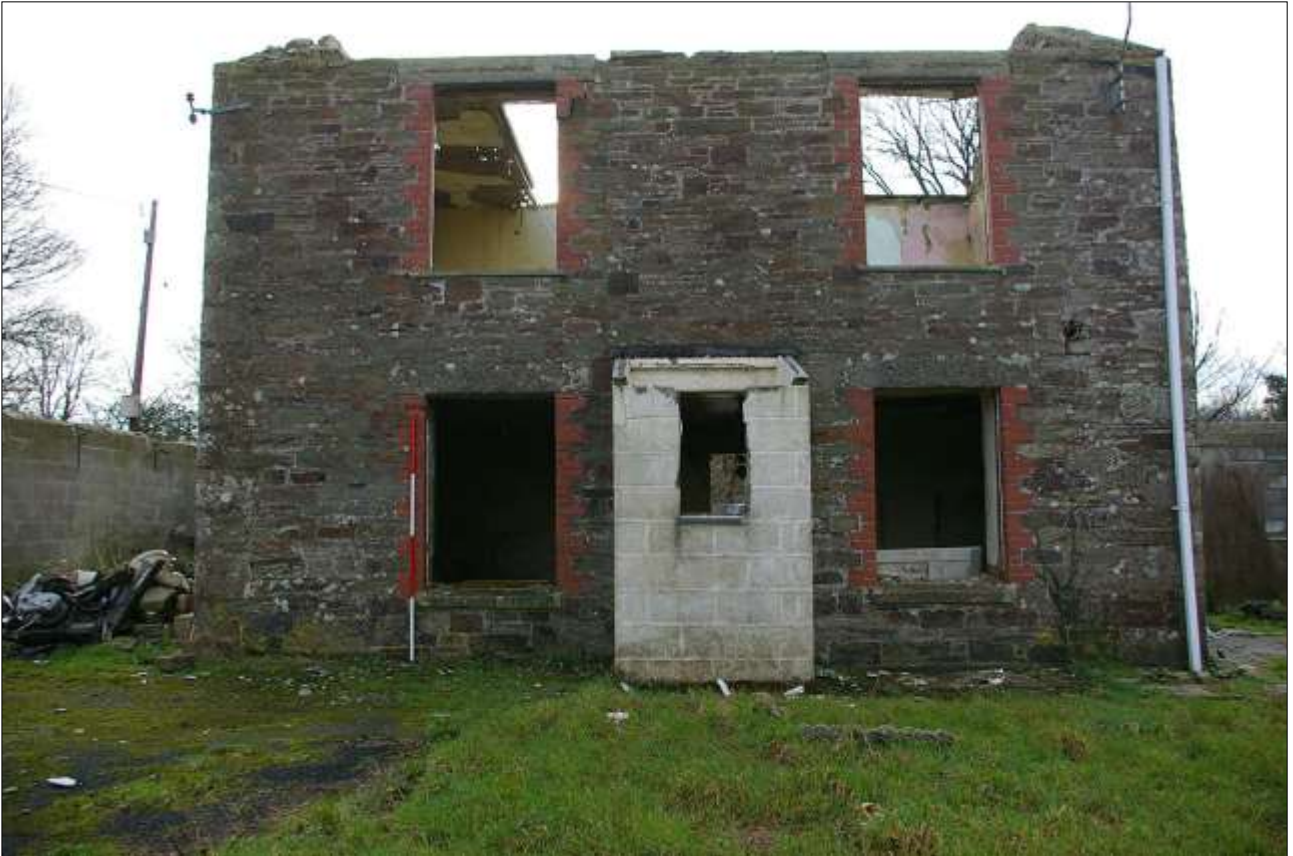
7. MORE DETAILED VIEW OF THE NORTH ELEVATION; FROM THE NORTH, 2M SCALE.

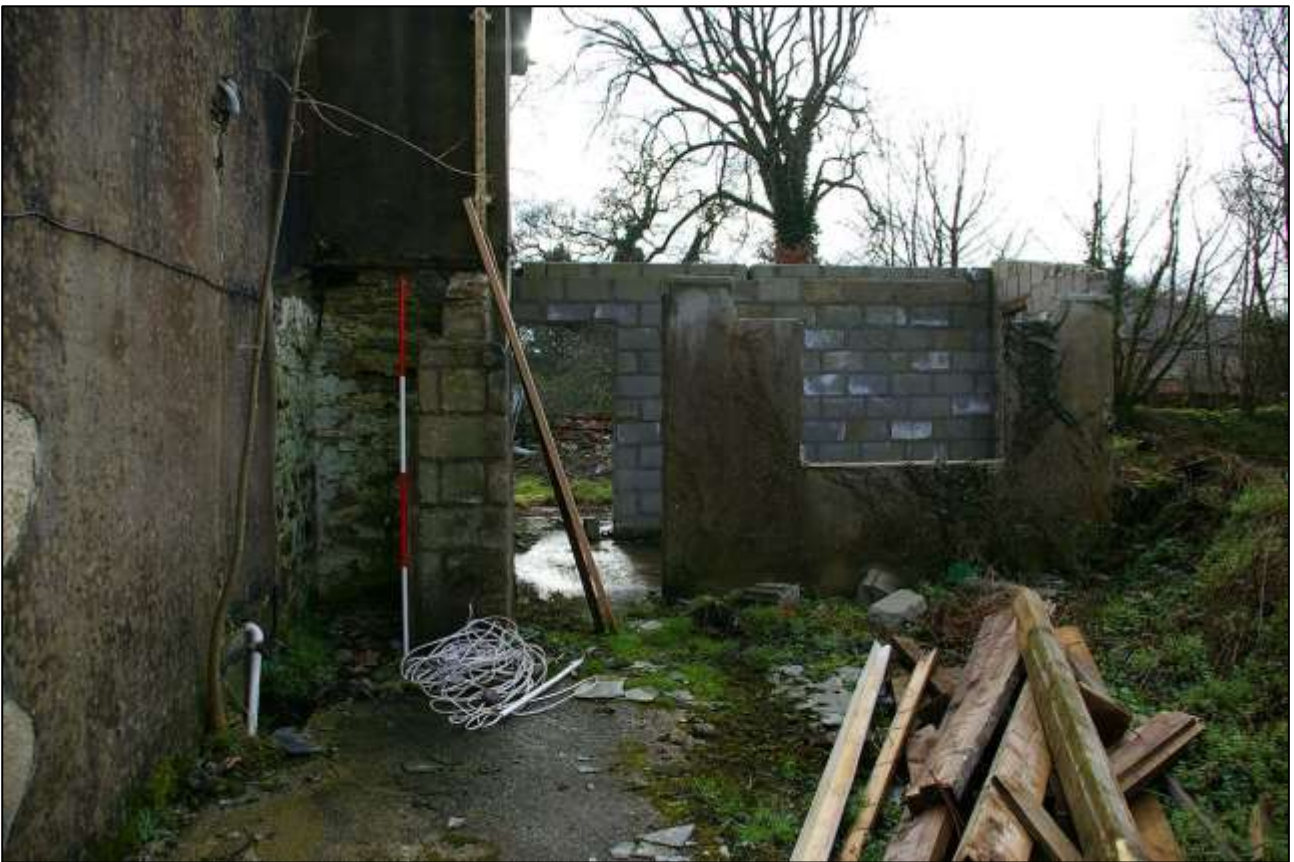
The concrete block single storey extension to the west and the enlargement of that to the east are clearly modern additions and attempts to expand the accommodation or services at the site. Their construction appears never to have been completed.

11. THE CONCRETE BLOCK EXTENSIONS TO THE WEST, WITH 2M SCALE; FROM THE NORTH.

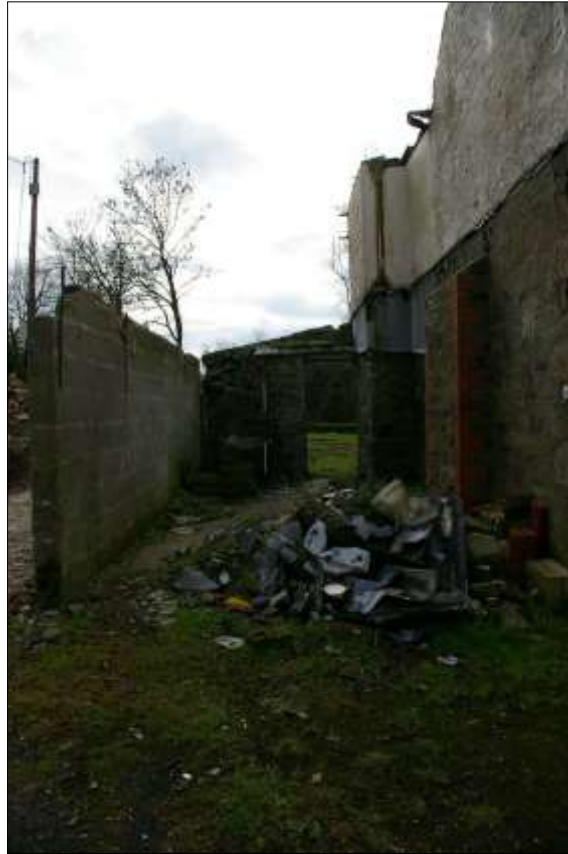
The lean-to to the east side has one rubble-built wall, which is very heavily built, of a loose vernacular rubble, using the same mix of local stones as the house. This abuts the original cottage and a small set of flashings wrap around the large kitchen stack. This lean-to has been later extended

16. LEAN-TO ON THE EAST ELEVATION, STONE RUBBLE TO THE SOUTH END, CONCRETE BLOCK TO THE EAST WALL, CONCRETE FLOOR, 2M SCALE; FROM THE NORTH.

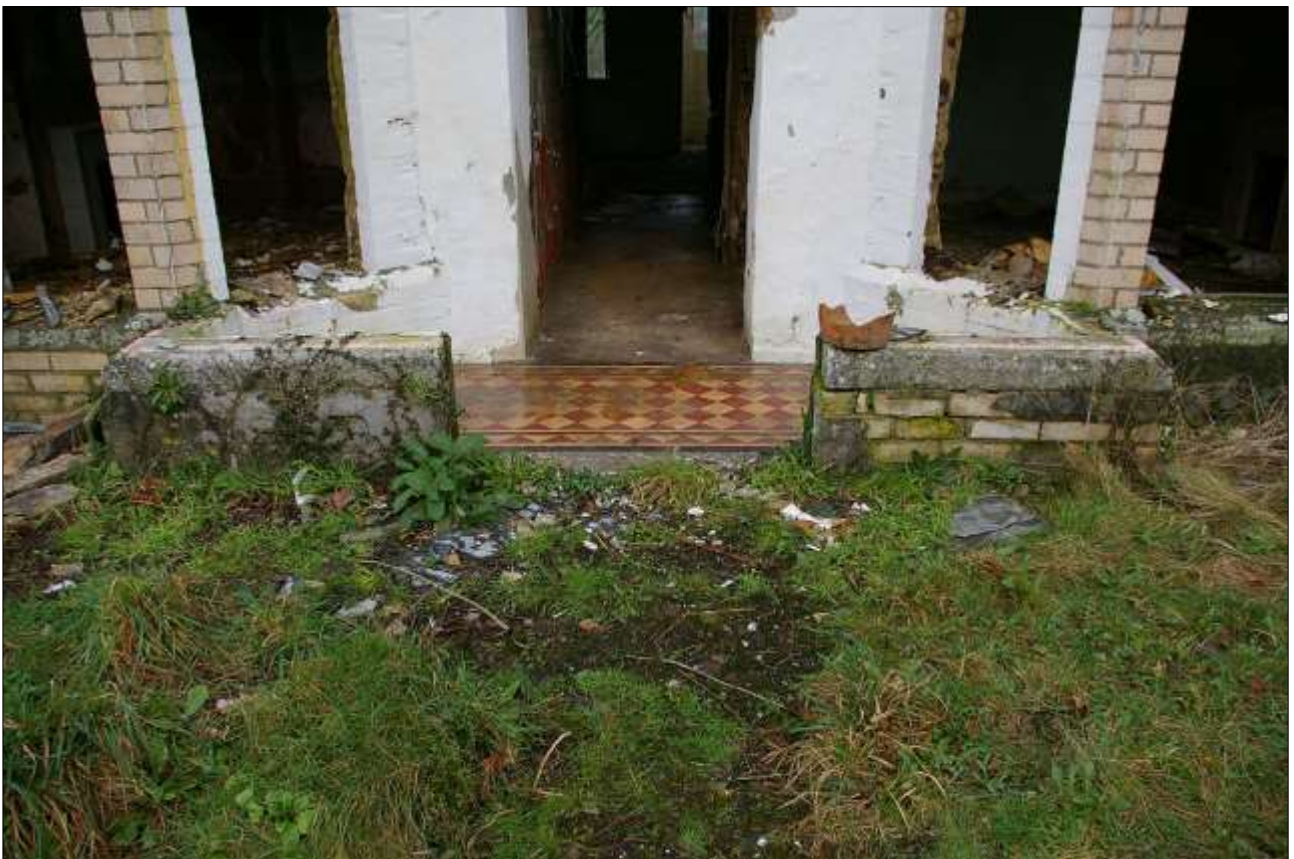
26. THE REMAINS OF THE FORMER FRONT PORCH, A 19TH CENTURY ADDITION, WITH GRANITE AND CERAMIC BRICK STRUCTURE, LIKE THE BAY WINDOWS; FROM THE SOUTH.

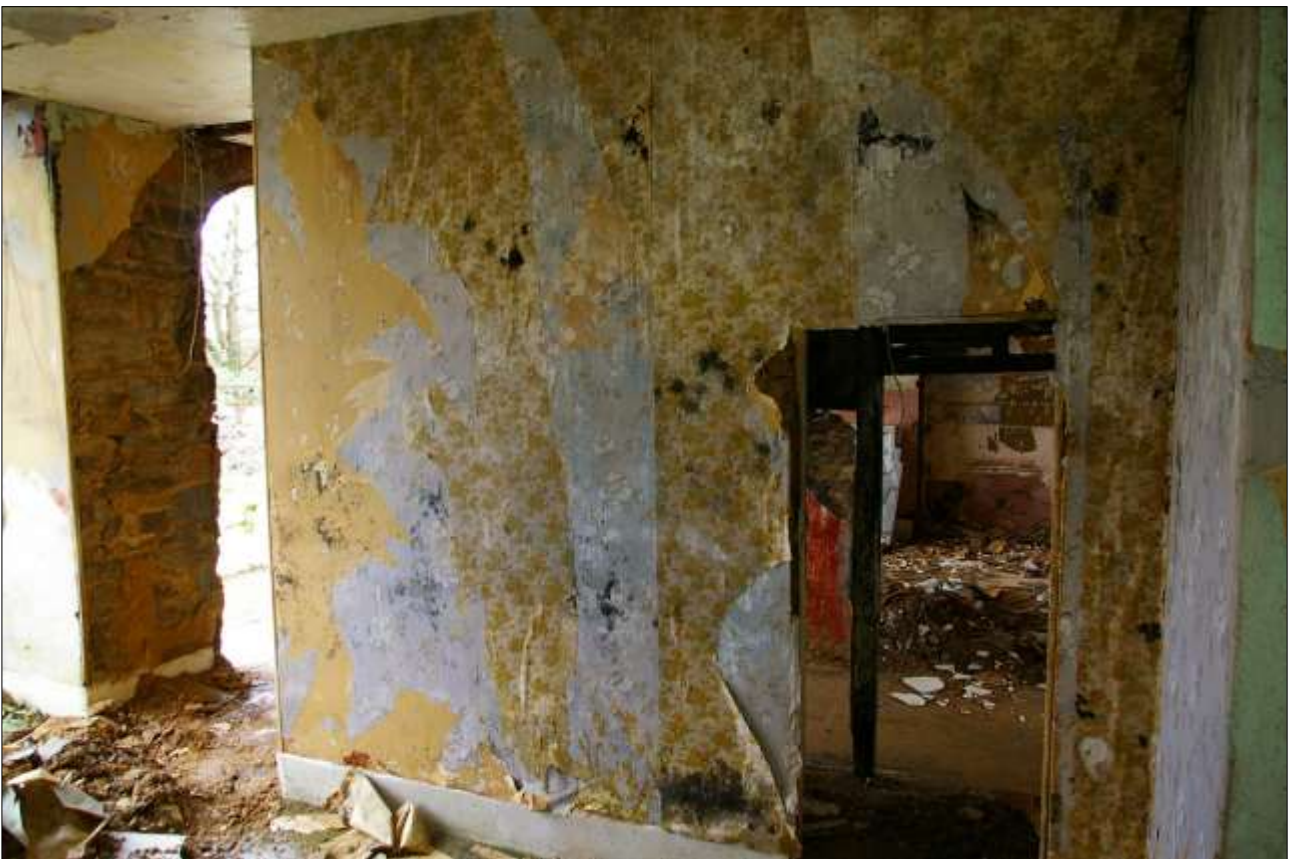
41. THE WEST PARTITION WALL OF ROOM 3, WHICH WRAPS AROUND THE STAIRS; FROM THE NORTH-EAST.

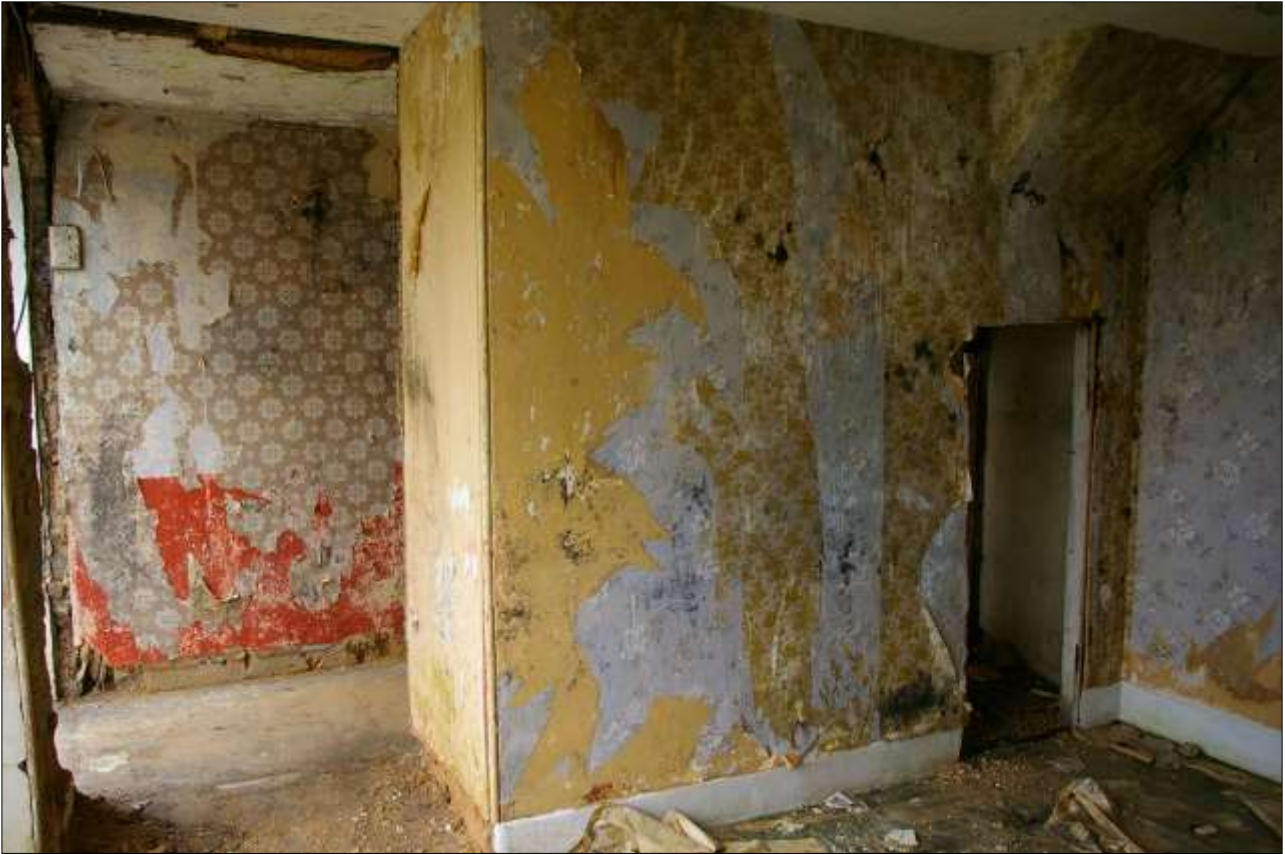
44. THE OPENING TO THE ENTRANCE HALLWAY FROM ROOM 3 AND THE EAST PARTITION WALL; FROM THE SOUTH-WEST..

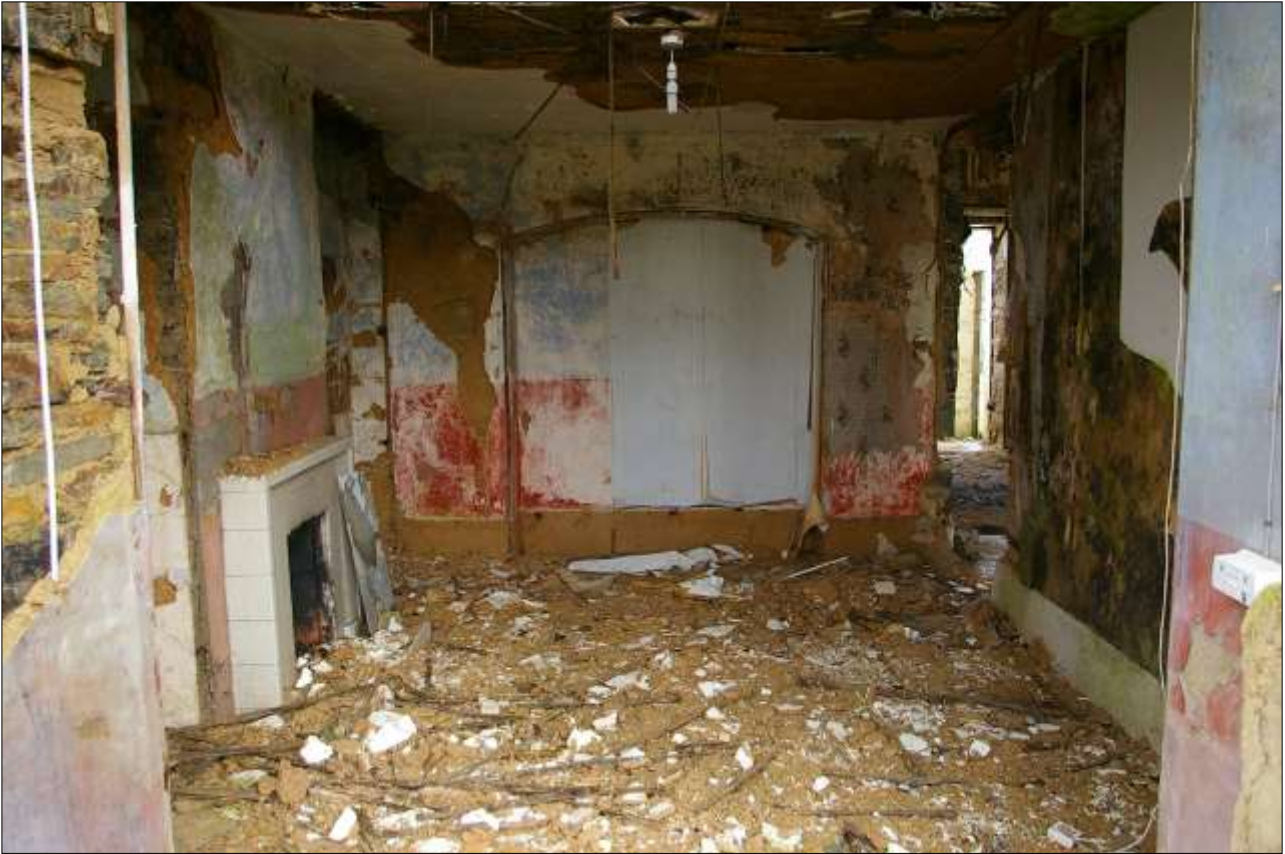
46. ROOM 4, THE PARLOUR, WITH ALTERED FIREPLACE, VIEWED FROM OUTSIDE, FROM THE BAY WINDOW, THE SOUTH.

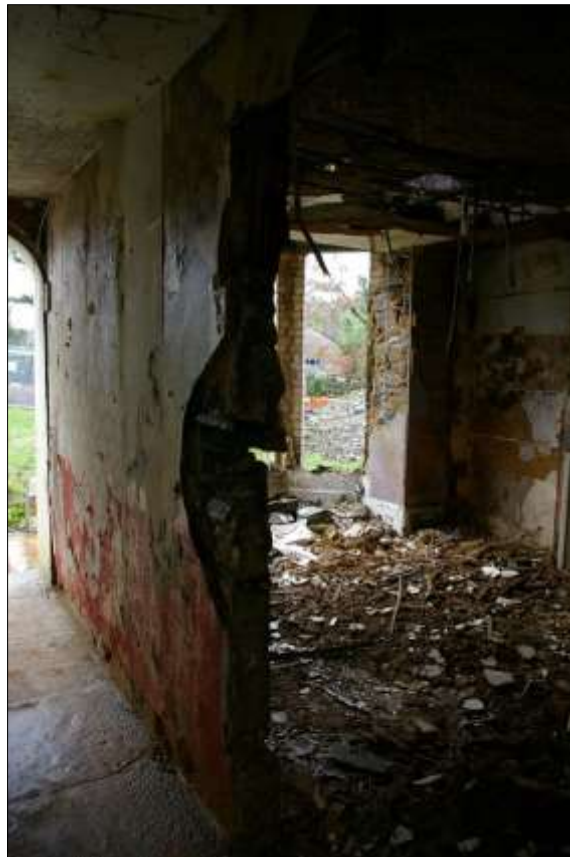
47. THE TIMBER FRAMED AND STONE RUBBLE NOGGIN PARTITION BETWEEN THE ENTRANCE HALLWAY AND ROOM 4; FROM THE NORTH-EAST.

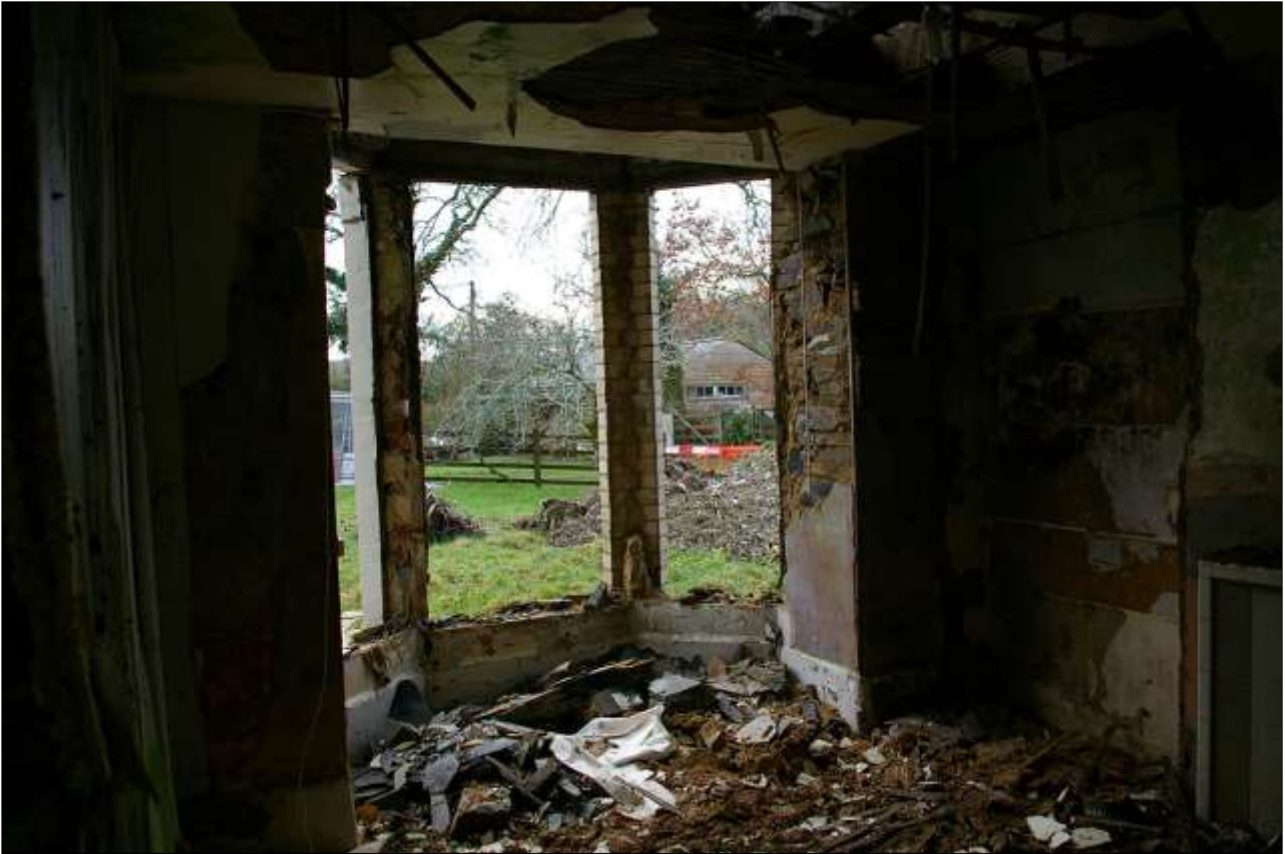
48. ROOM 4, THE PARLOUR, THE ADDED BRICK BAY WINDOW TO THE SOUTH WALL; FROM THE NORTH-EAST.

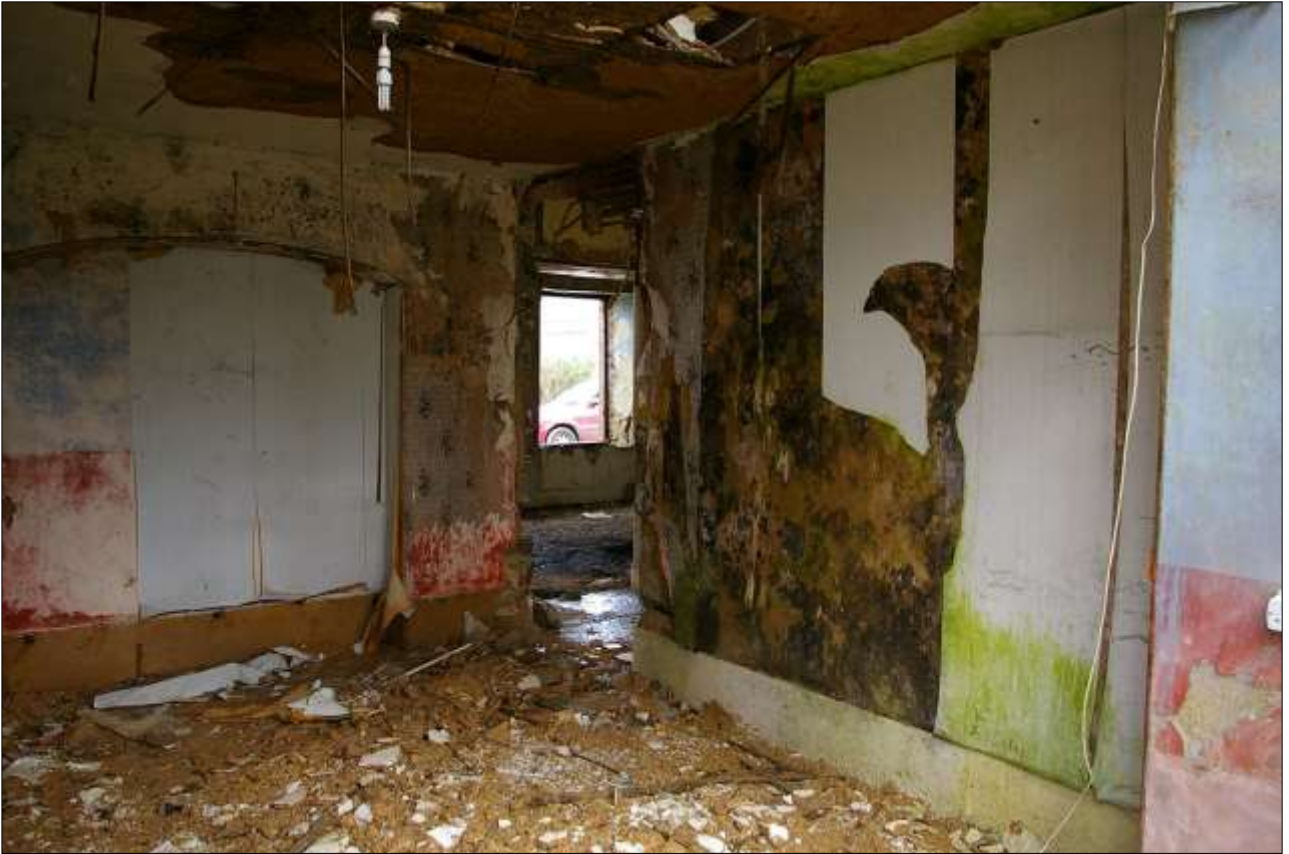
50. ROOM 4, THE NORTH WALL WITH SHALLOW BASKET ARCHED ALCOVE WITH BEAD MOULDING AND EAST PARTITION; FROM THE SOUTH-WEST.

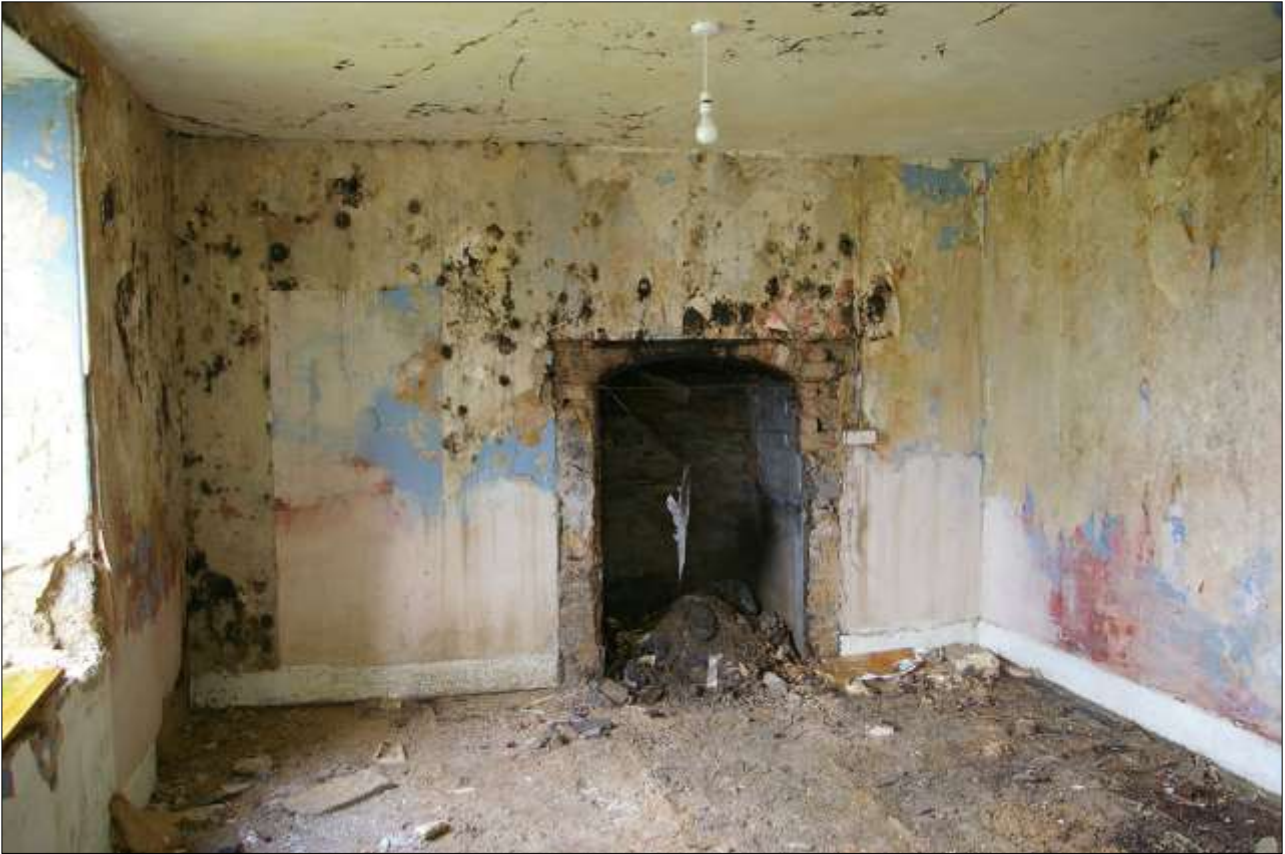
54. THE EAST END OF THE ROOM 6, WITH TALL SHALLOW BASKET ARCHED OPEN HEARTH; FROM THE WEST, NORTH-WEST.

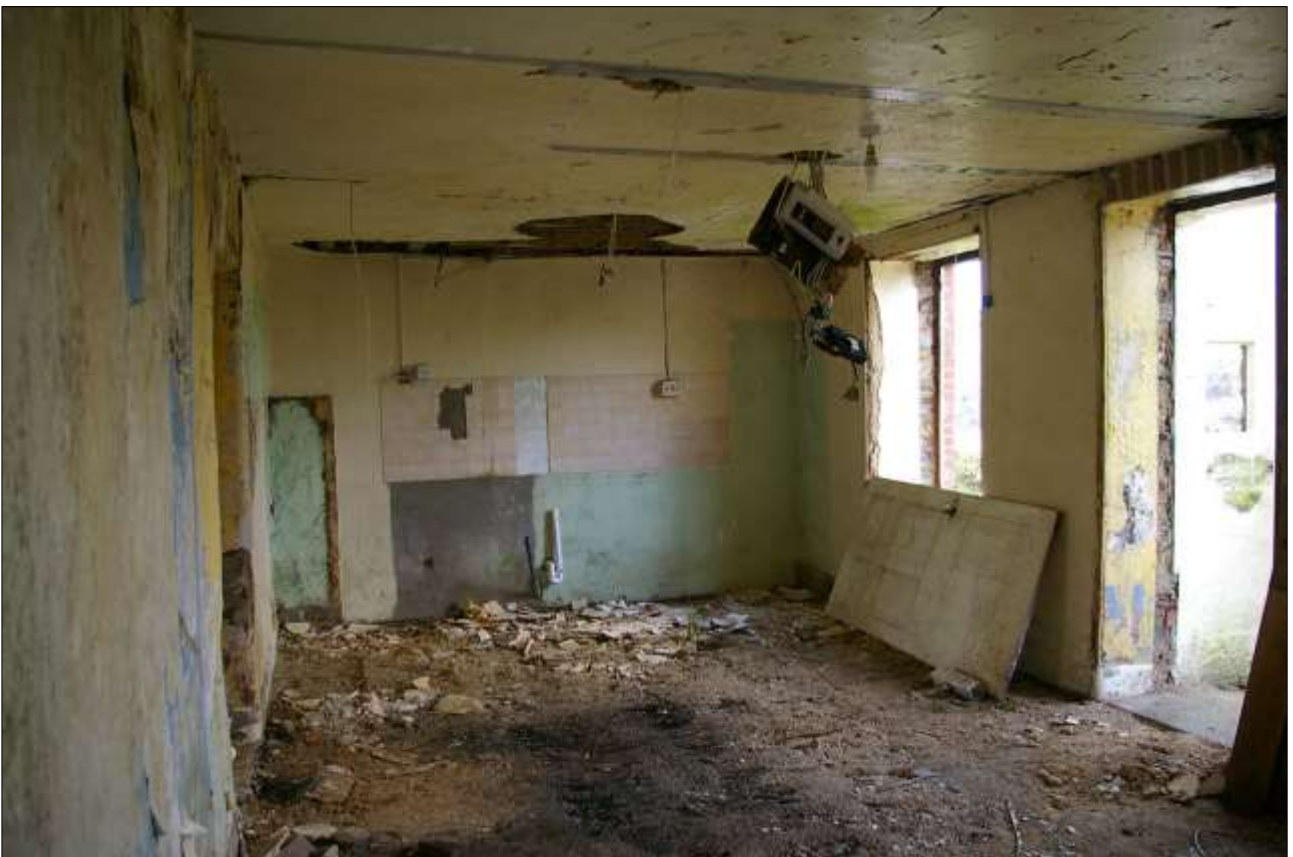
57. ROOM 6 FROM THE SOUTH-EAST, WITH TILED KITCHEN REMAINS VISIBLE ON THE WEST WALL.

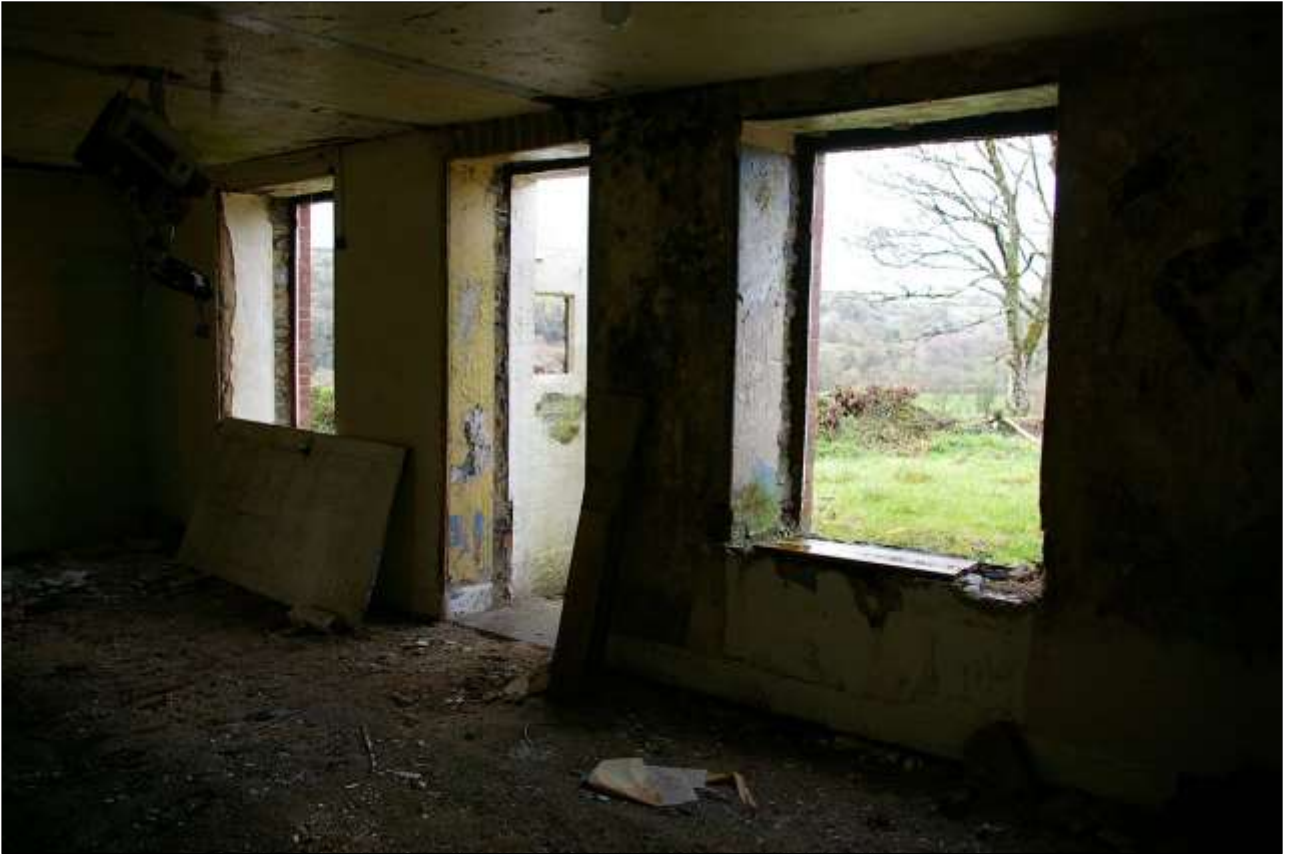
58. THE NORTH WALL OF ROOM 6, WITH TWO WINDOWS, BEAD MOULDED STRAIGHT EDGED OPENINGS, THE CENTRAL DOORWAY IS ALSO BEAD MOULDED TO EDGE; FROM THE SOUTH-EAST.

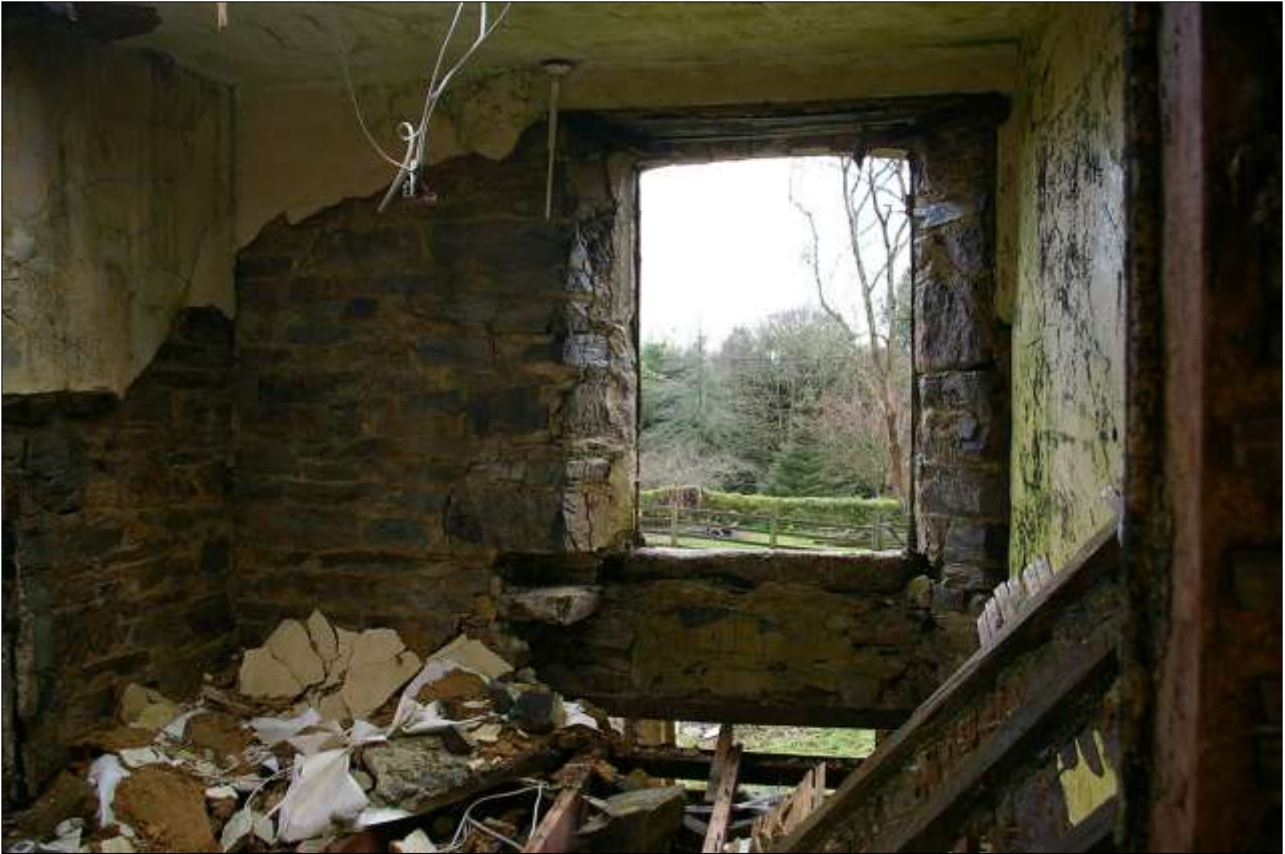
66. ROOM 8, THE SOUTH WALL, WITH INTERNAL TIMBER LINTEL AND OUTER STONE SEGMENTAL LINTEL; FROM THE NORTH.

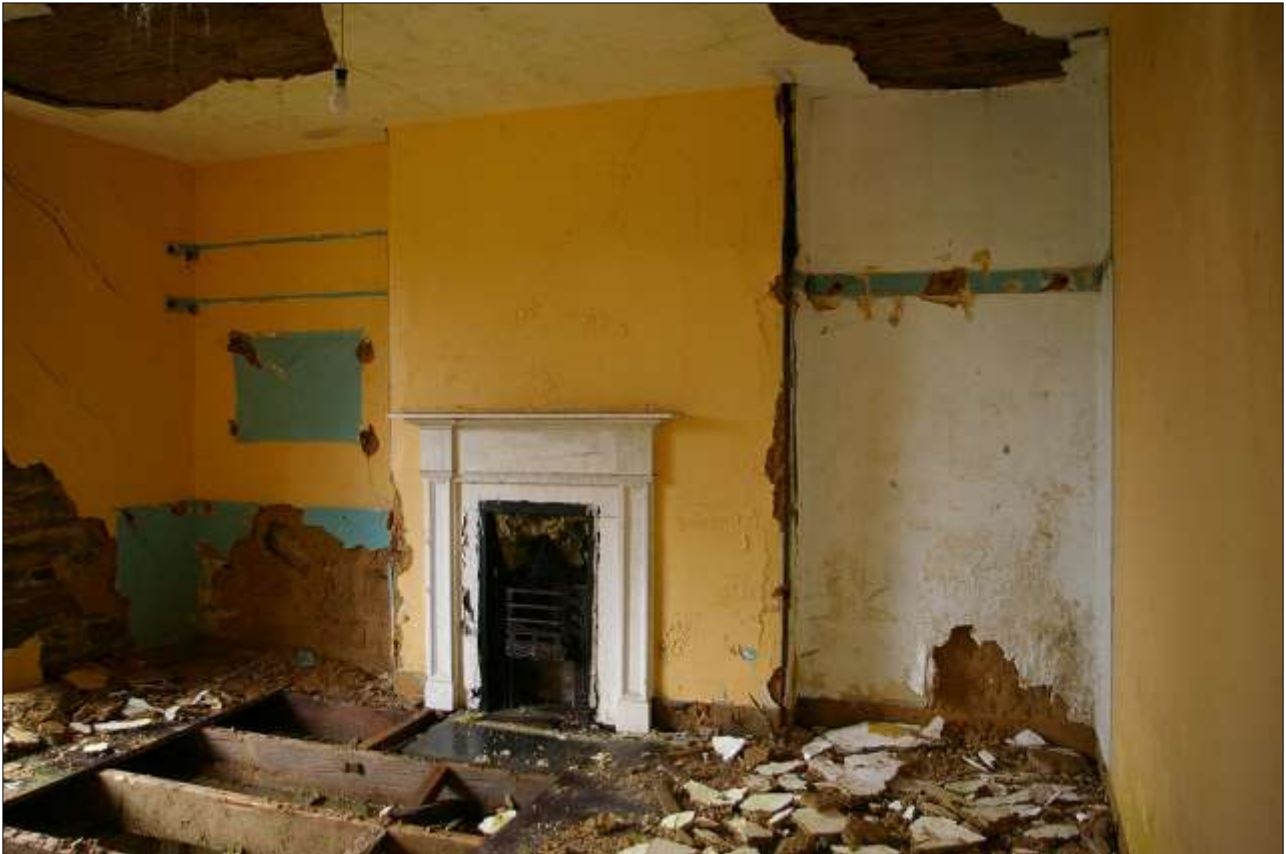
70. ROOM 10, THE SHALLOW STACK ON THE WEST WALL, WITH FINE LATE GEORGIAN OR EARLY 1800S, CAST IRON FOLIATE MOULDED HOB GRATE, TWO SHALLOW ALCOVES, SHELVES TO SOUTH, SCAR FROM ROW OF CLOTHING HOOKS TO NORTH; FROM THE EAST, NORTH-EAST.

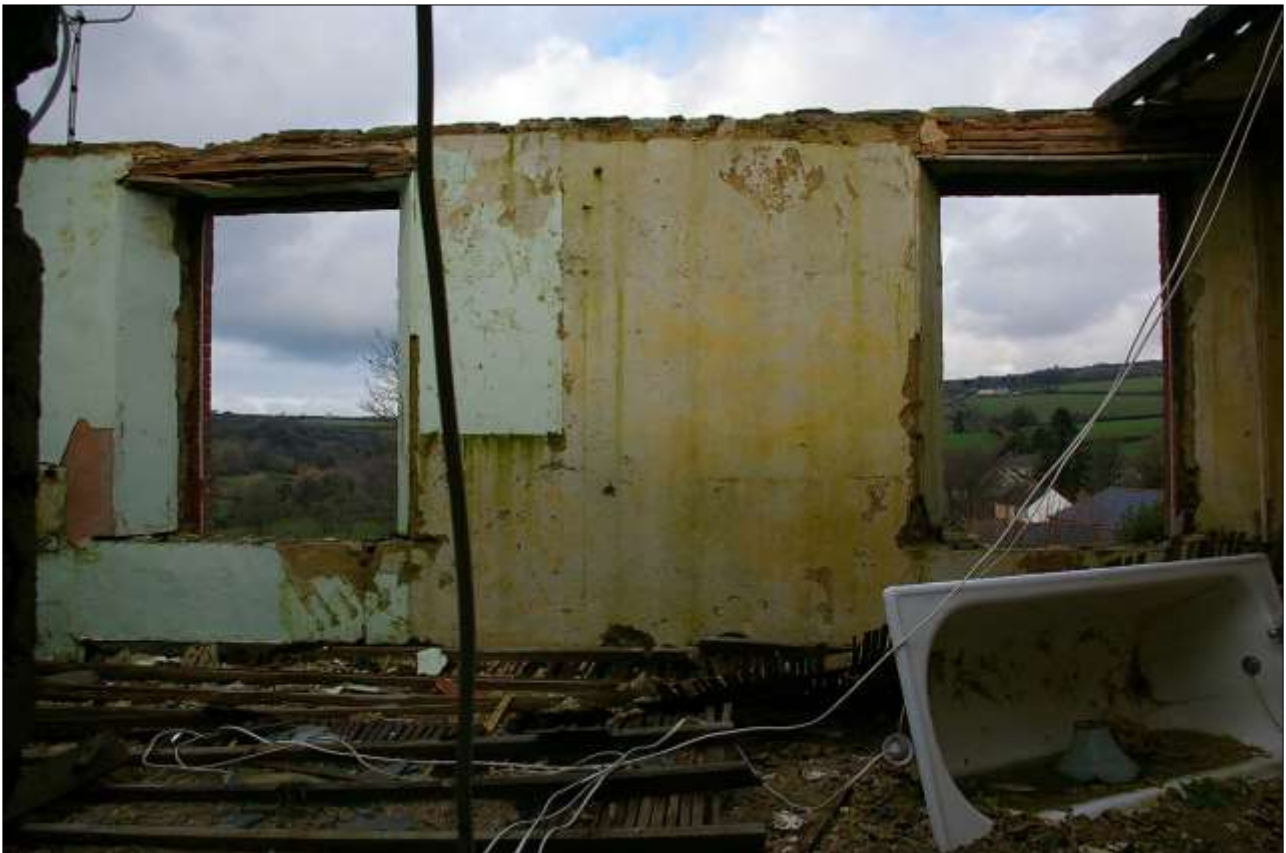
74. THE NORTH WALL OF ROOM 11, WITH TWO FIRST FLOOR WINDOWS AND SCARS OF PARTITIONS DIVIDING THE SPACE; FROM THE SOUTH.

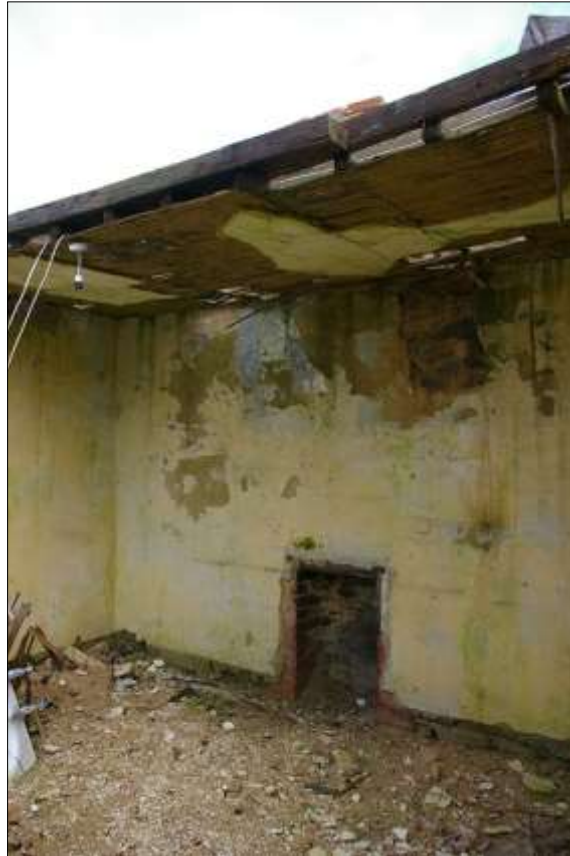
75. THE EAST WALL OF ROOM 11, WITH BRICK LINED HEARTH WITH ROUNDED FIREBACK, QUITE INDICATIVE OF THE 19TH CENTURY; FROM THE SOUTH-WEST.

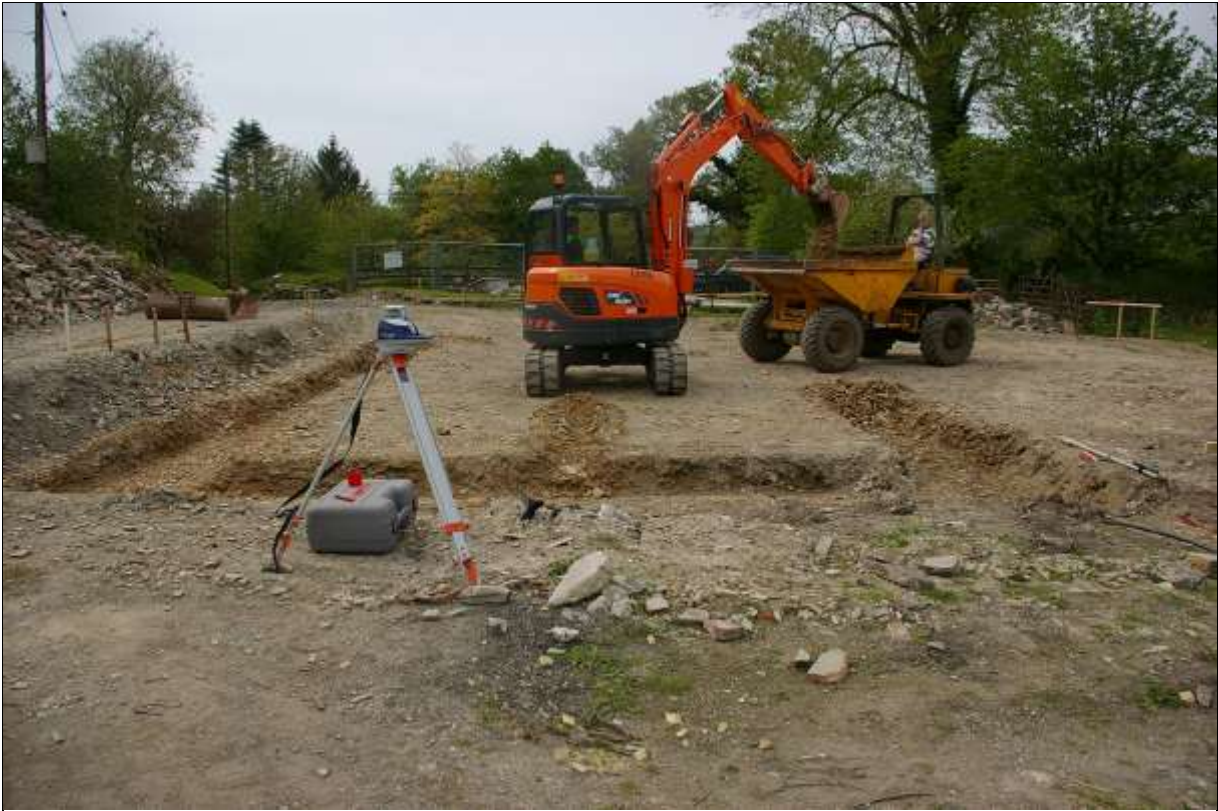
1. THE SITE; FROM THE NORTH DURING MONITORING OF THE FOUNDATION TRENCHES.
