WEEK
BERRY POMEROY
SOUTH HAMS
DEVON

Historic Building Recording and Archaeological Evaluation Trenching

South West Archaeology Ltd. report no. 190902

By E. Wapshott & P. Webb

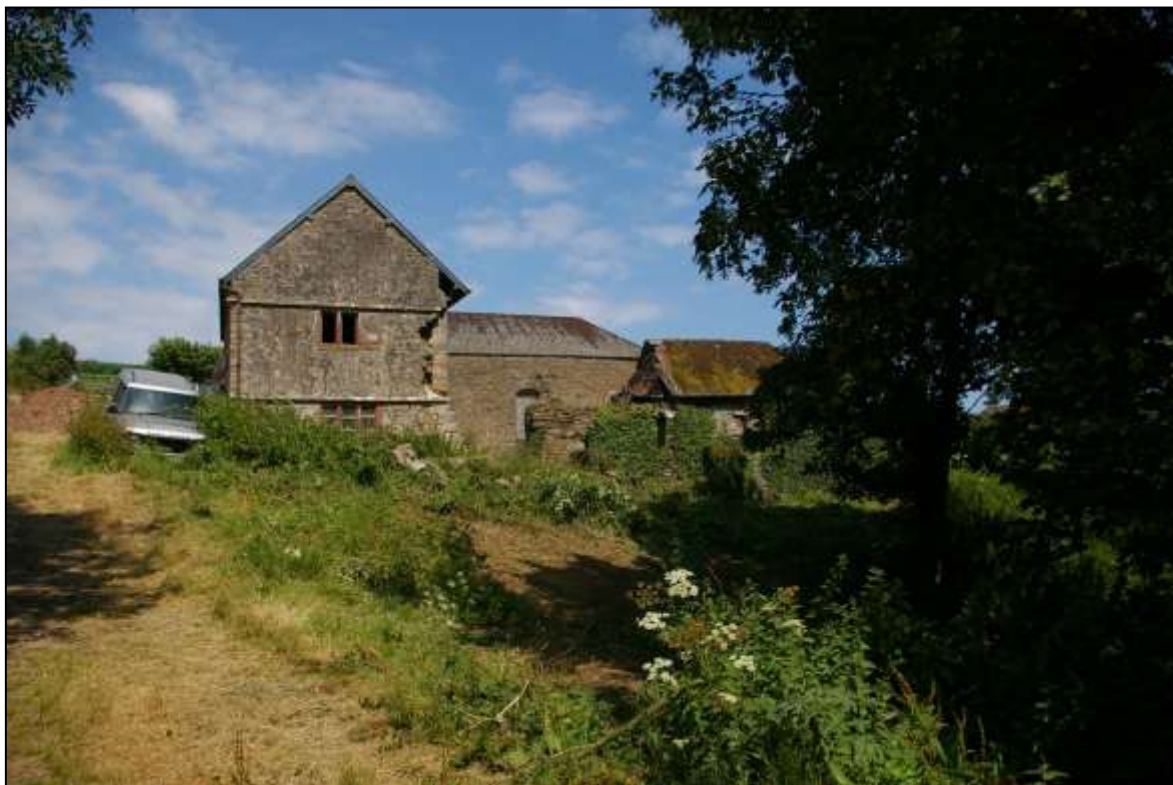
FIGURE 2: VIEW OF THE BUILDINGS AT WEEK, WITH B1 (LEFT), B2 (REAR CENTRE) AND B3 (RIGHT); VIEWED FROM THE SOUTH-WEST.

All three surviving structures may have similar origins, the upstanding structures all containing evidence of earlier construction; though only B1 and B3 suggest evidence of possible medieval remains. However, whilst B1 sits broadly at right angles at the north-western end of B3, any direct relationship between the early phases of the structures has been lost when both were rebuilt in the 16th century, B3 abutting B1. B2, meanwhile, stands isolated and whilst its construction appears to match that of the remodelling of B1, suggesting that the earlier phase may indeed match, this is not definitive.

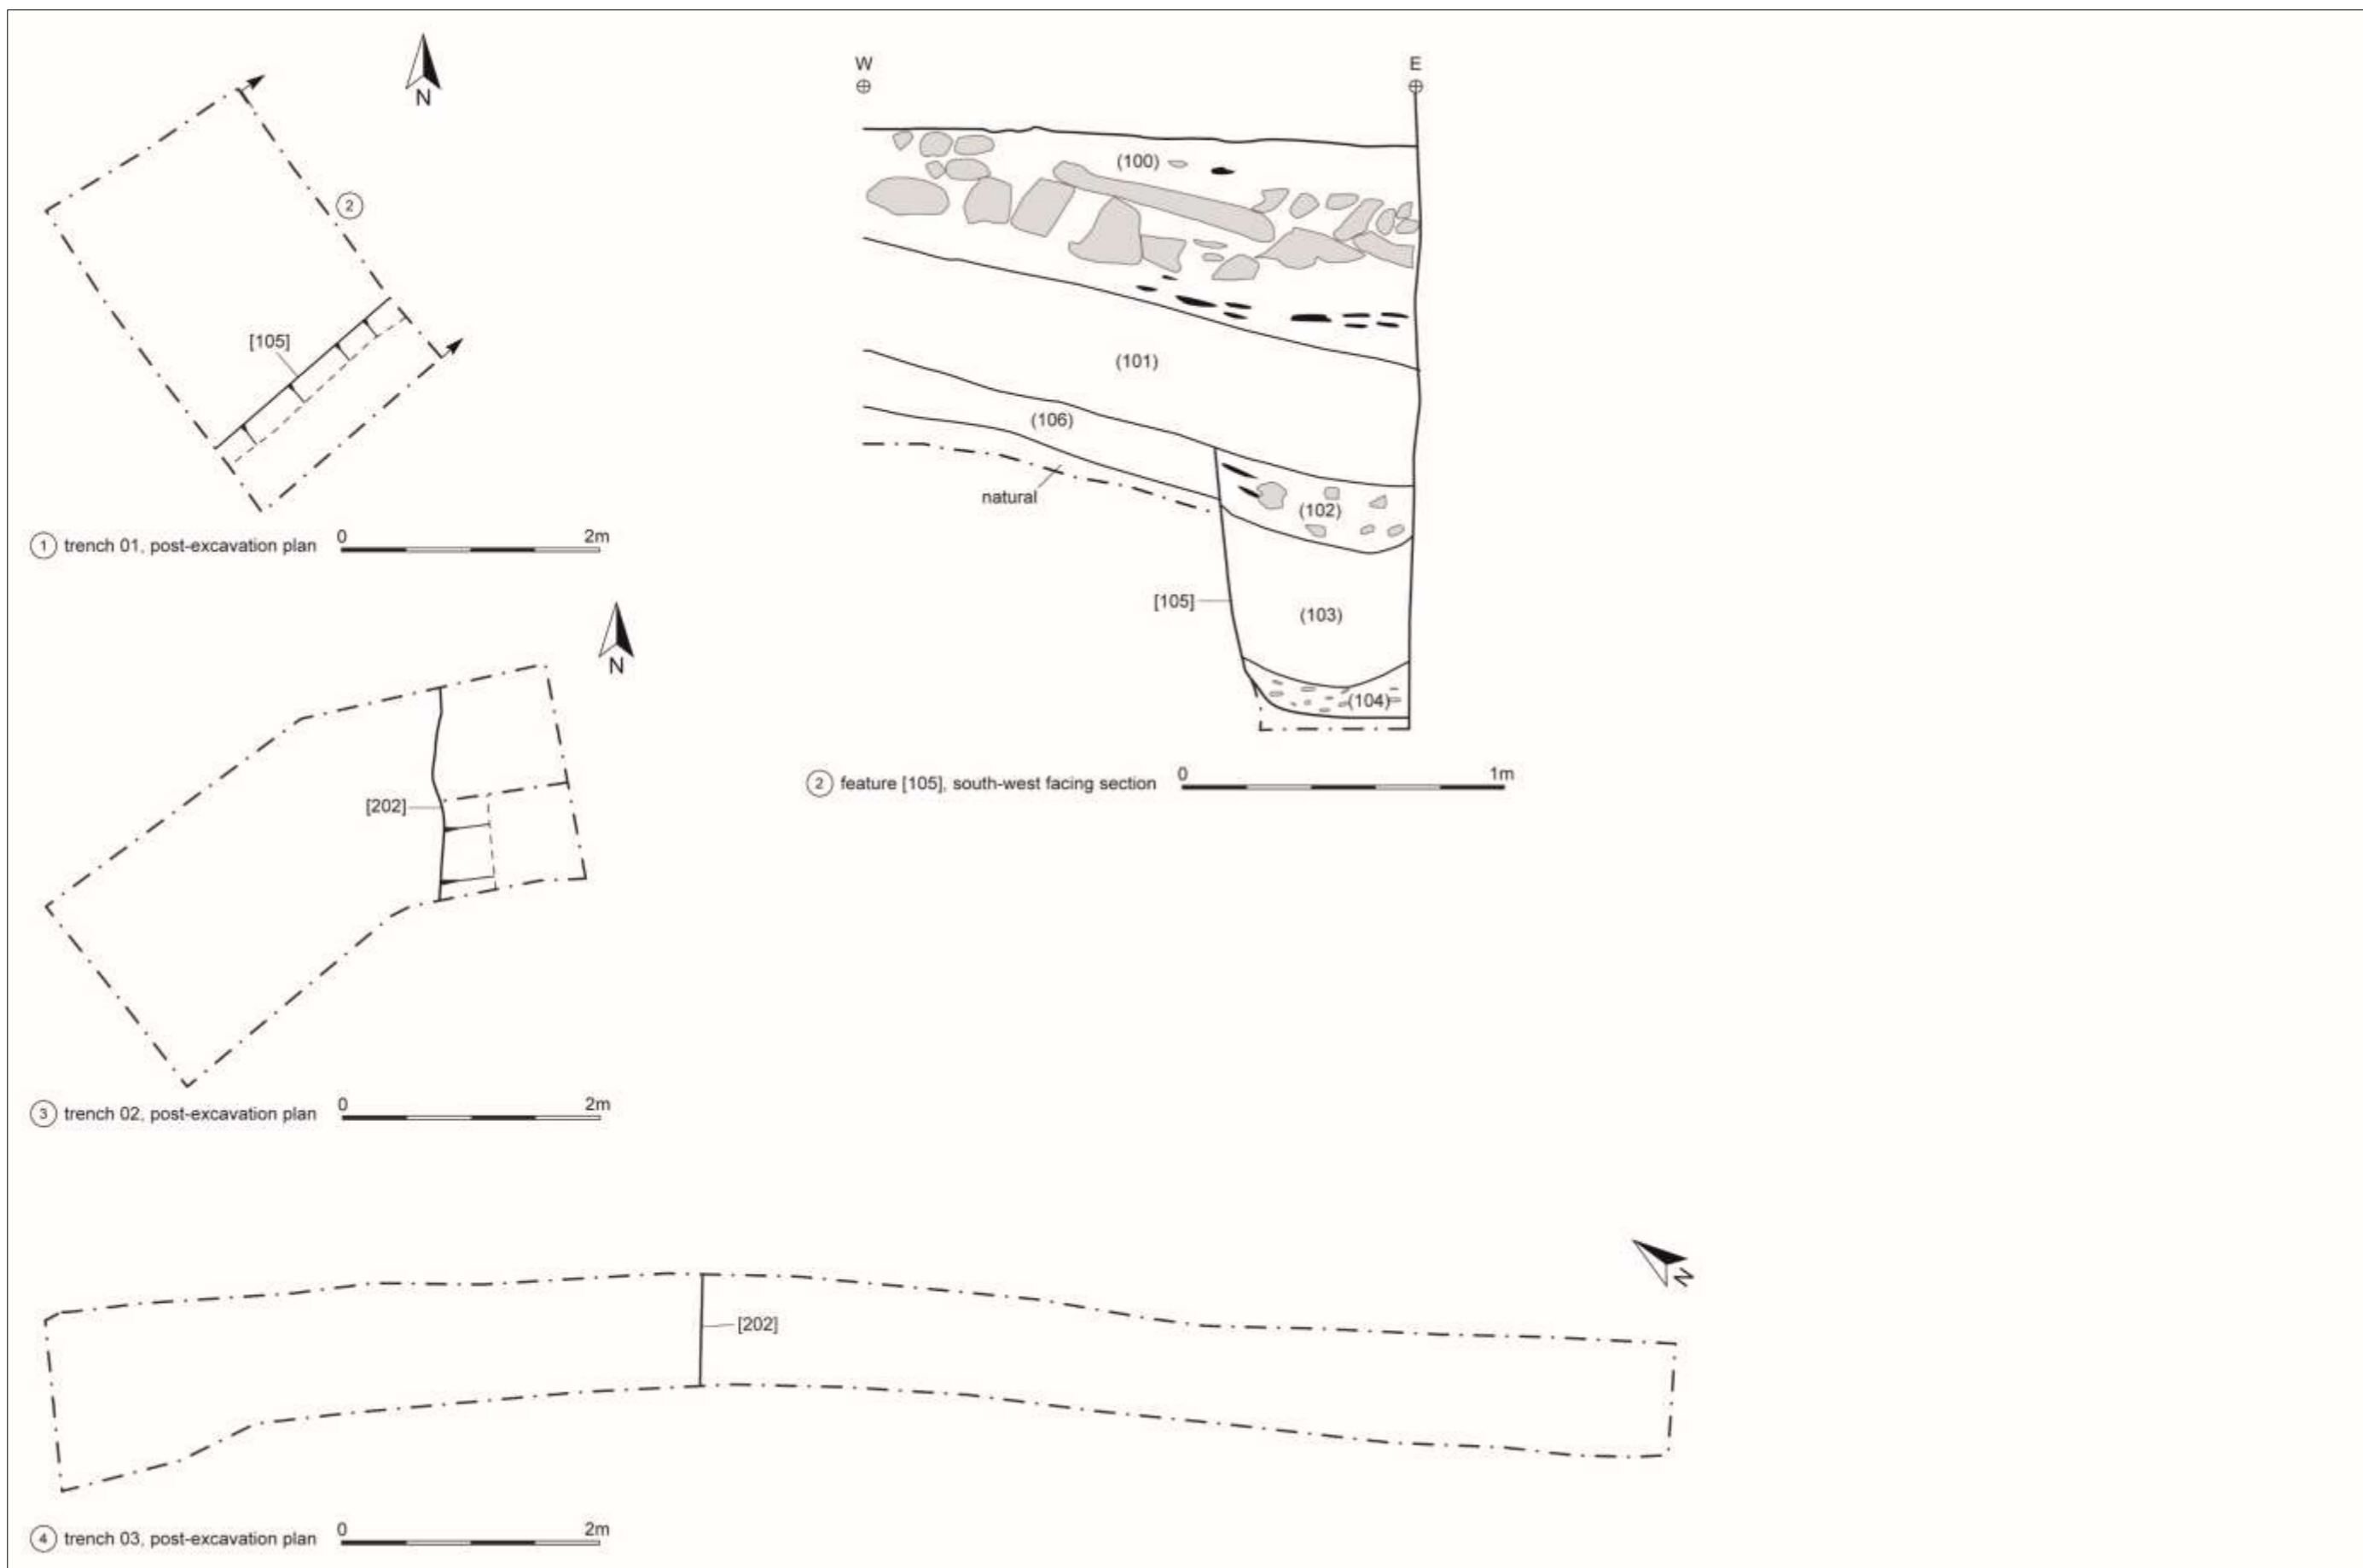
FIGURE 13: TRENCH PLANS AND SECTIONS.

Trench 02 was located approximately centrally between buildings B2 and B3, and to the south-east of B1. It was 4.40m long on an approximate north-east to south-west alignment, measuring 1.80m wide and 0.25m deep. A single feature, surface [202], was identified within the trench (Figure 13).

Surface cut [202] was oriented approximately north-west to south-east, measuring 1+m wide and c.0.30m deep with a gradual south-western edge, clear break of slope and flat base. It contained a single fill: (203), dark brown-grey silt-clay with angular and sub-angular stone and tarmac inclusions. This feature forms part of a modern farmyard surface.

Trench 03 was located to the south-east of the corner of B3. It was 12.60m long on an approximate north-west to south-east orientation, measuring 1m-1.50m wide and 0.25m deep. A single feature, surface [302], was identified within the trench (Figure 13).

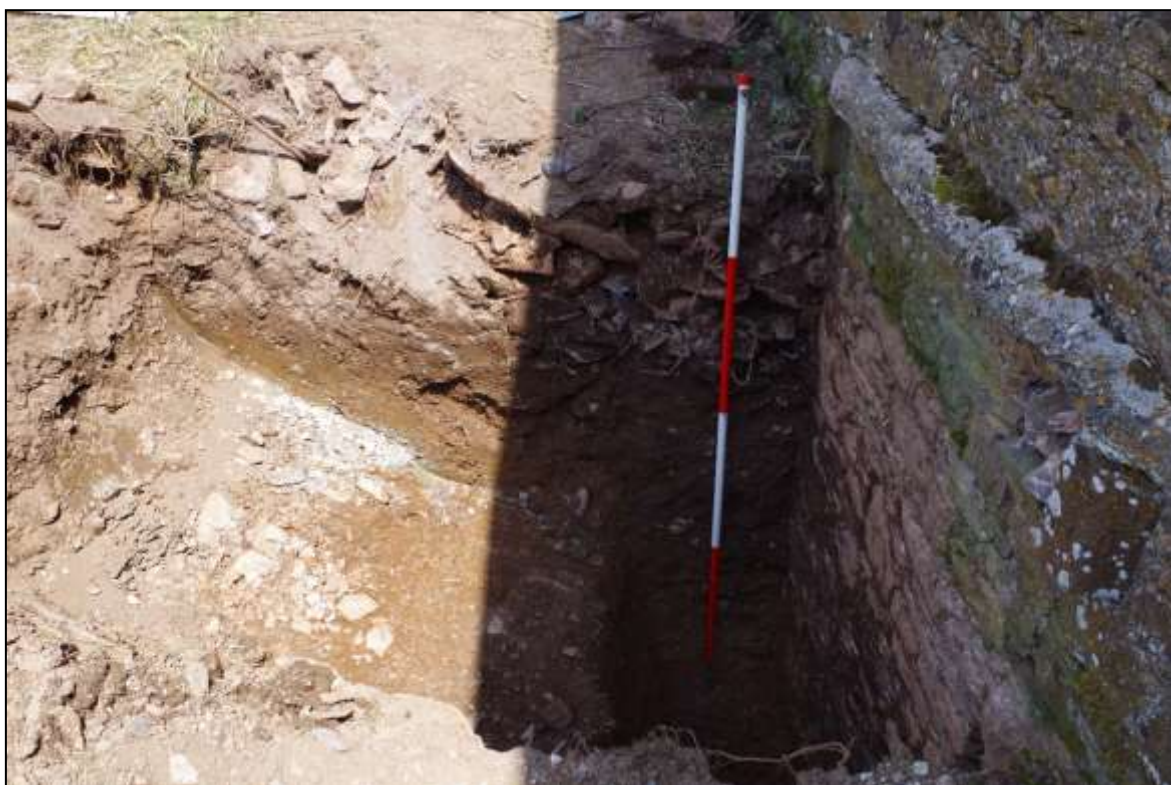
FIGURE 14: CONSTRUCTION CUT [105], SOUTH-WEST FACING SECTION; VIEWED FROM THE SOUTH-WEST (2M SCALE).

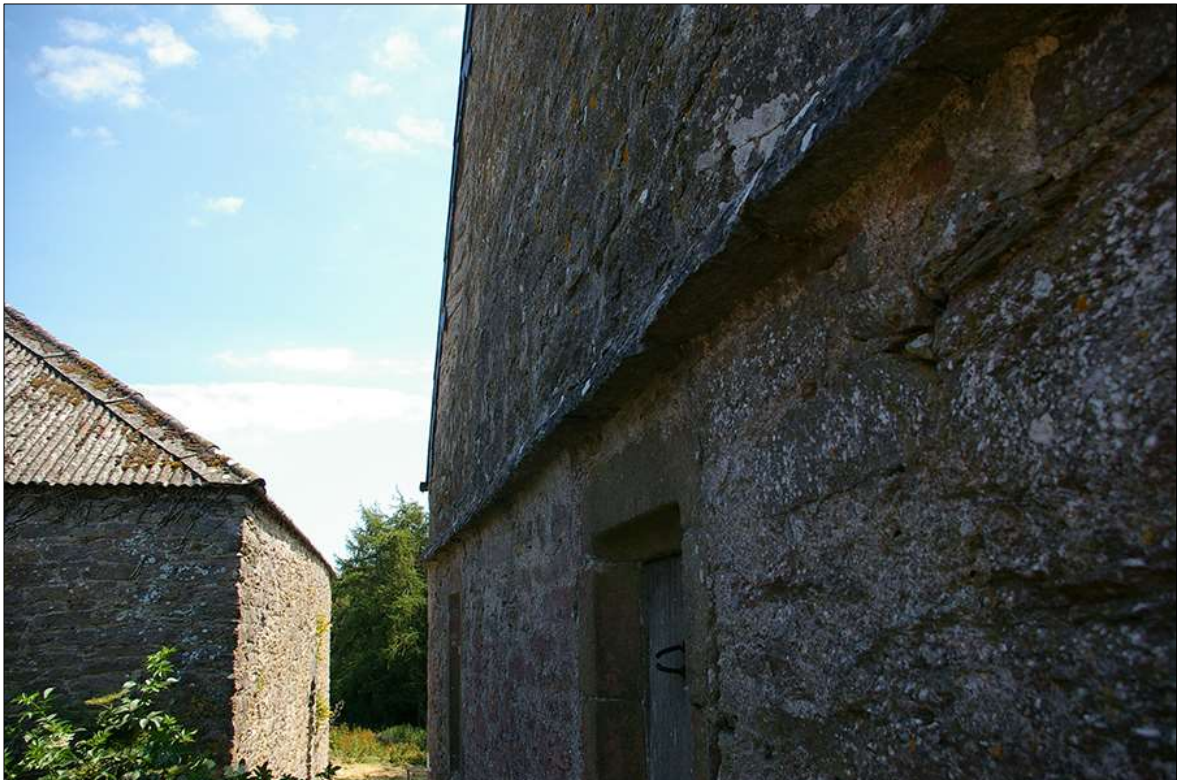
The application of crudely shaped rounded projecting string courses appears quite eccentric as they often do not wrap around corners or continue across whole elevations; eaves string courses, used for weathering purposes are also useless cutting across the apex of a gable at eaves height. It is also noted that in the case of W5 and W7 the string course truncates and disrupts the lower stones of the heavy relieving arches over these openings. It is also to be noted that despite their location on the building, where the weather-load would be different these exhibit an oddly crude 'finish' with clear chisel marks, no attempt having been made to 'face' the stonework.

9. DETAIL OF THE CRUDE STRING COURSE ON THE NORTH-EAST GABLE WALL OF B1; VIEWED FROM THE NORTH-WEST.

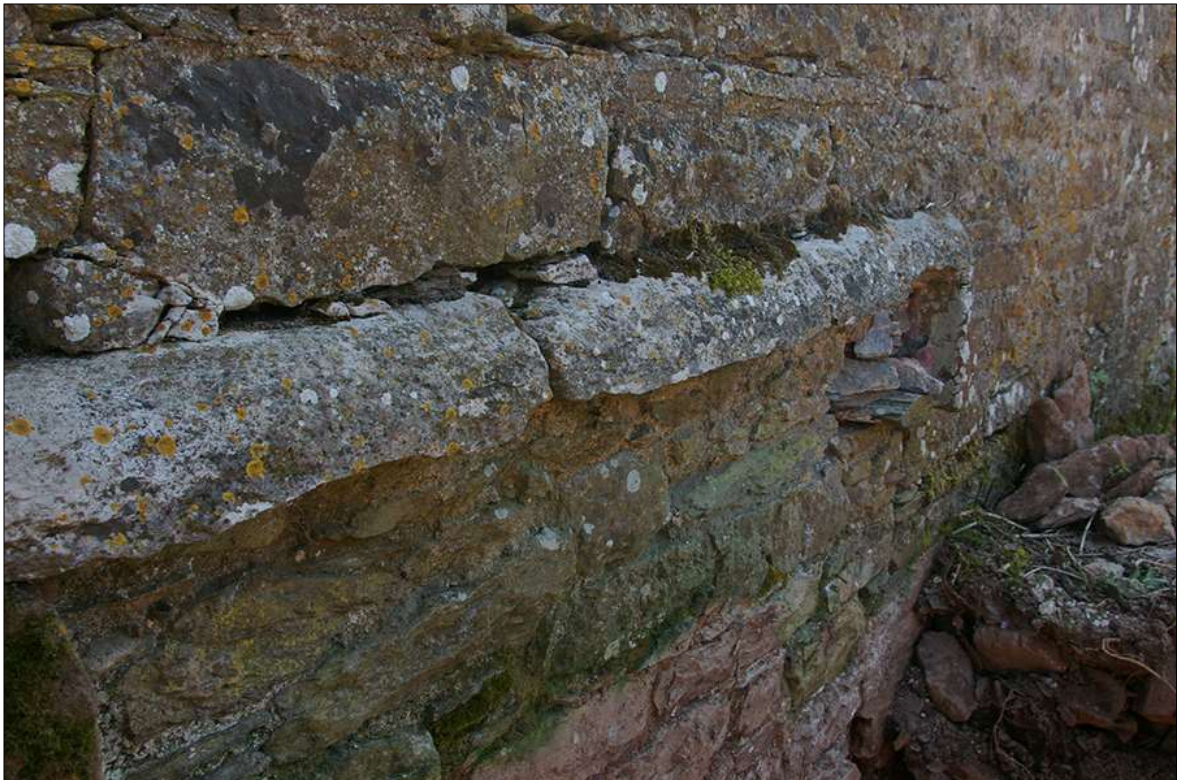
17. DETAIL OF THE CRUDE HOODMOULD OVER W3 WHICH MATCHES THE STRING COURSES TO THE NORTH-EAST AND SOUTH-WEST ELEVATIONS; VIEWED FROM THE NORTH.

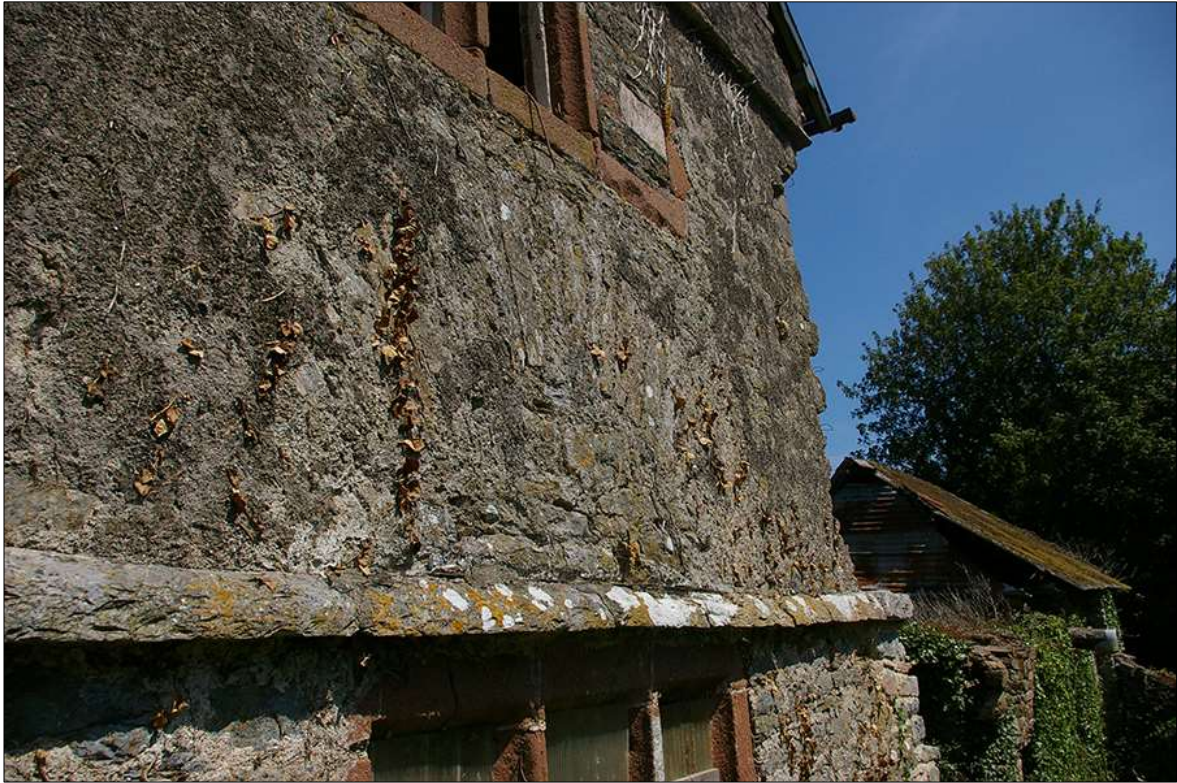
The massive slatestone slab segmental pointed relieving arches present in both the south-east and south-west elevations of B1 suggest that there were originally large arched openings in this phase of the construction, and that these were the presentation front and yard elevations. It is likely that B1 and B3 formed contiguous linked ranges at this time, much as they would do today if not for the storm damage. Whilst not surviving, photographic evidence from an RCHME survey in the 1950s (Lane 2018) shows an additional gable end at the south elevation of B1 with chimney, which is interpreted as belonging to a lost southern range dating to this period. Storm damage from the 1990s means that this relationship cannot be established, though it is possible that earlier surviving aspects of B3 reflect this range.

20. DETAIL OF THE SLATESTONE SLAB SEGMENTAL POINTED ARCH OVER W5 IN THE SOUTH-WEST ELEVATION OF B1; VIEWED FROM THE WEST.

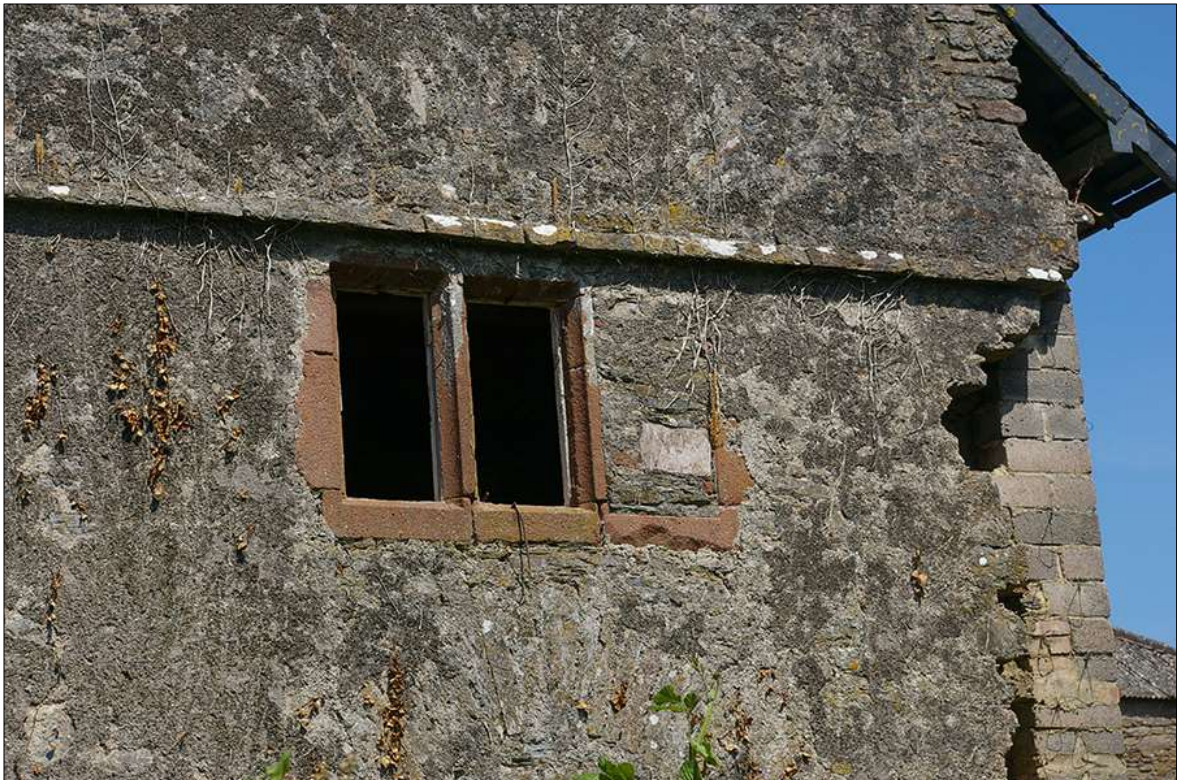
21. DETAIL OF WINDOW W6 IN THE SOUTH-WEST ELEVATION OF B1, DEMONSTRATING THE SINGLE BLOCKED LIGHT; VIEWED FROM THE SOUTH-WEST.

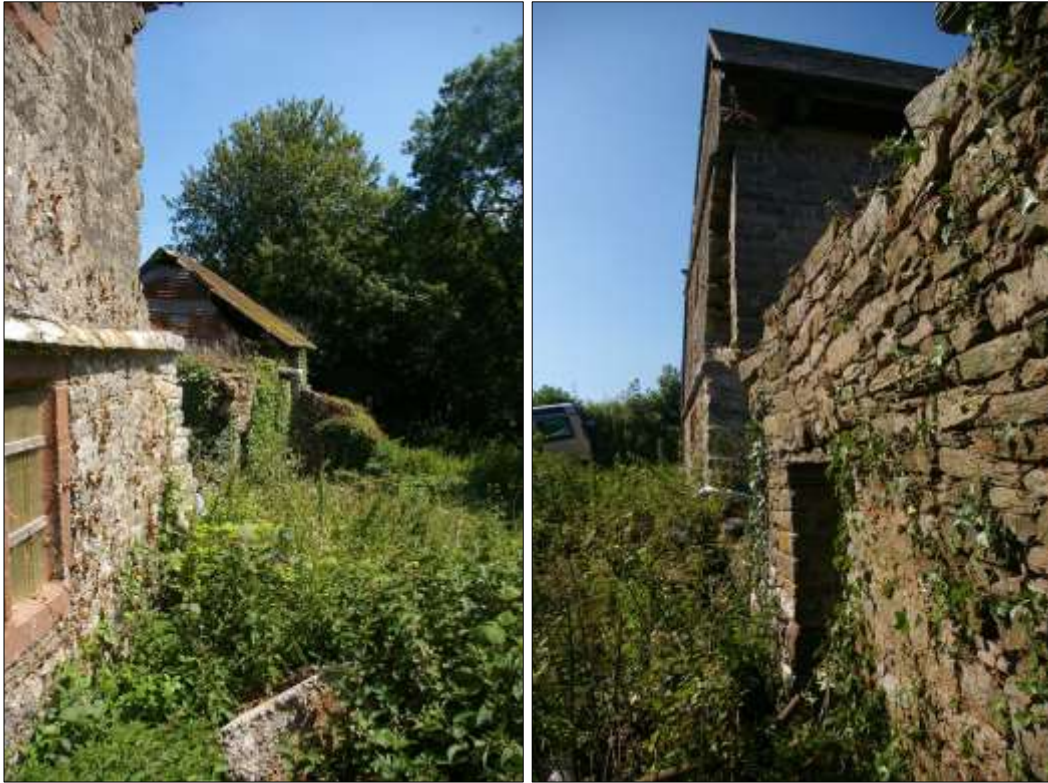
22. (LEFT) VIEW ALONG THE FULL SOUTH-WEST ELEVATION OF B1 AND B3 DEMONSTRATING THE PARTIALLY COLLAPSED BUT COHESIVE NATURE OF THE WALLS; VIEWED FROM THE WEST.

23. (RIGHT) VIEW ALONG THE FULL SOUTH-WEST ELEVATION OF B1 AND B3; VIEWED FROM THE SOUTH-EAST.

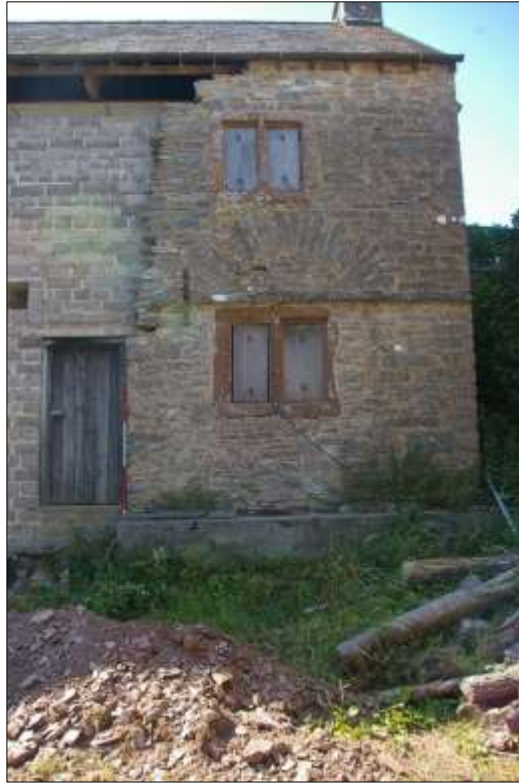
25. DETAIL OF THE SOUTH-EAST ELEVATION OF B1, SHOWING THE SURVIVING HISTORIC FABRIC; VIEWED FROM THE SOUTH-EAST (2M SCALE).

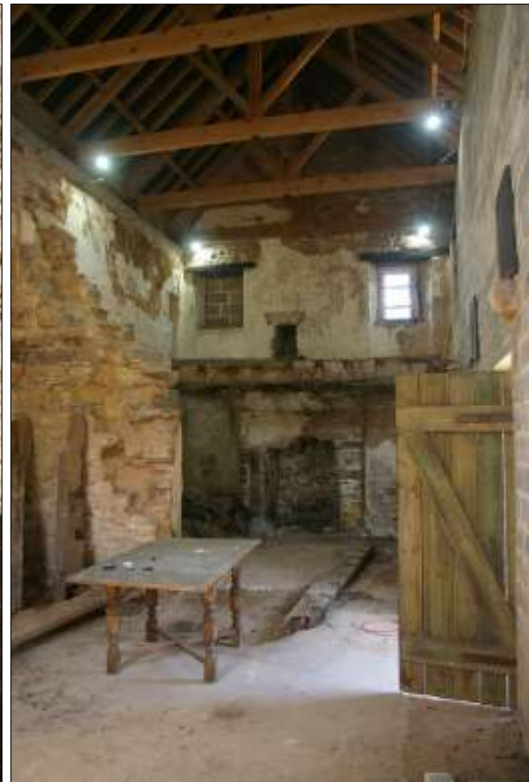
The interior of the building has lain empty for much of the 20th century during which time it has been damaged; leading to internal features not surviving in good condition, and almost all detail being lost. The space is divided unequally by a now ruinous heavy two storey stone rubble partition; there being historically larger ground and first floor rooms to the south-western end compared to those of the north-eastern end.

27. (LEFT) DETAIL OF THE NORTH-EASTERN CORNER OF THE SOUTH-EAST ELEVATION OF B1; VIEWED FROM THE EAST.
28. (RIGHT) INTERIOR OF B1 SHOWING ITS CURRENT STATE OF DISREPAIR; VIEWED FROM THE SOUTH.

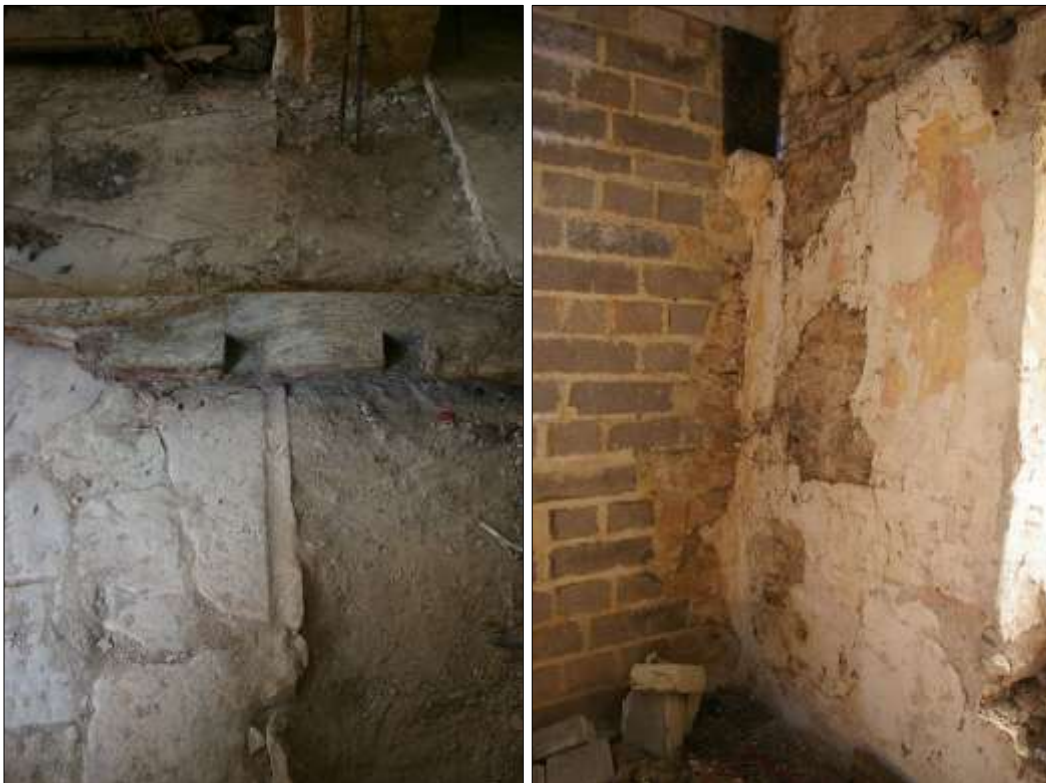
40. (LEFT) DETAIL OF THE REBATE IN THE FLAGSTONE FLOOR OF THE SOUTH-WEST GROUND-FLOOR ROOM OF B1, SUGGESTING THE POSITION OF AN EARLIER SCREEN DIVISION; VIEWED FROM THE SOUTH-EAST.

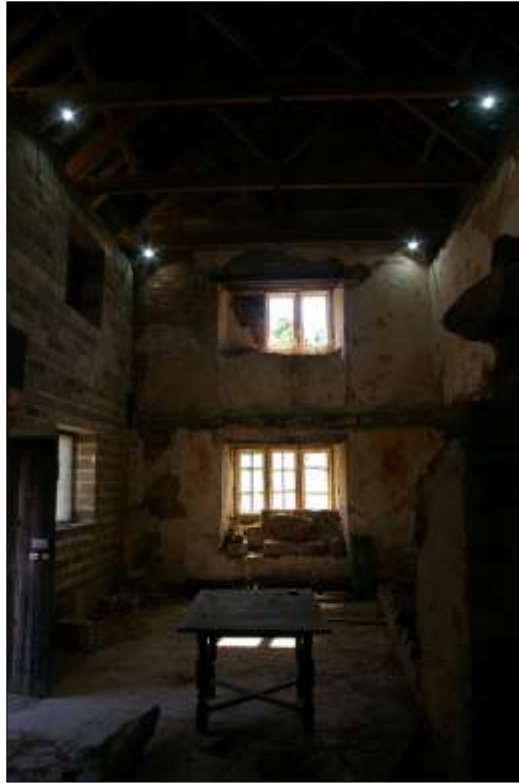
42. THE INTERIOR FACE OF THE SOUTH-WEST WALL WITH WINDOWS W5 AND W6; VIEWED FROM THE NORTH-WEST.

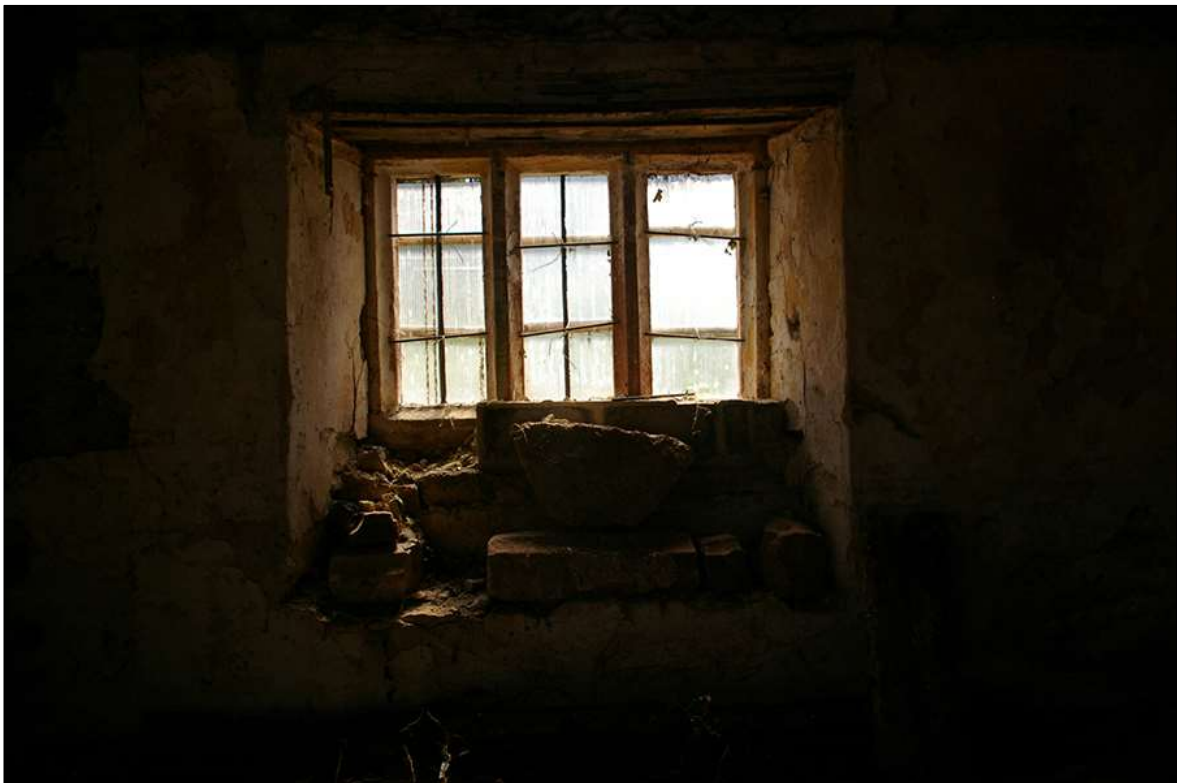
43. DETAIL OF THE INTERIOR FACE OF WINDOW W5 IN THE SOUTH-WEST WALL OF B1; VIEWED FROM THE NORTH-EAST.

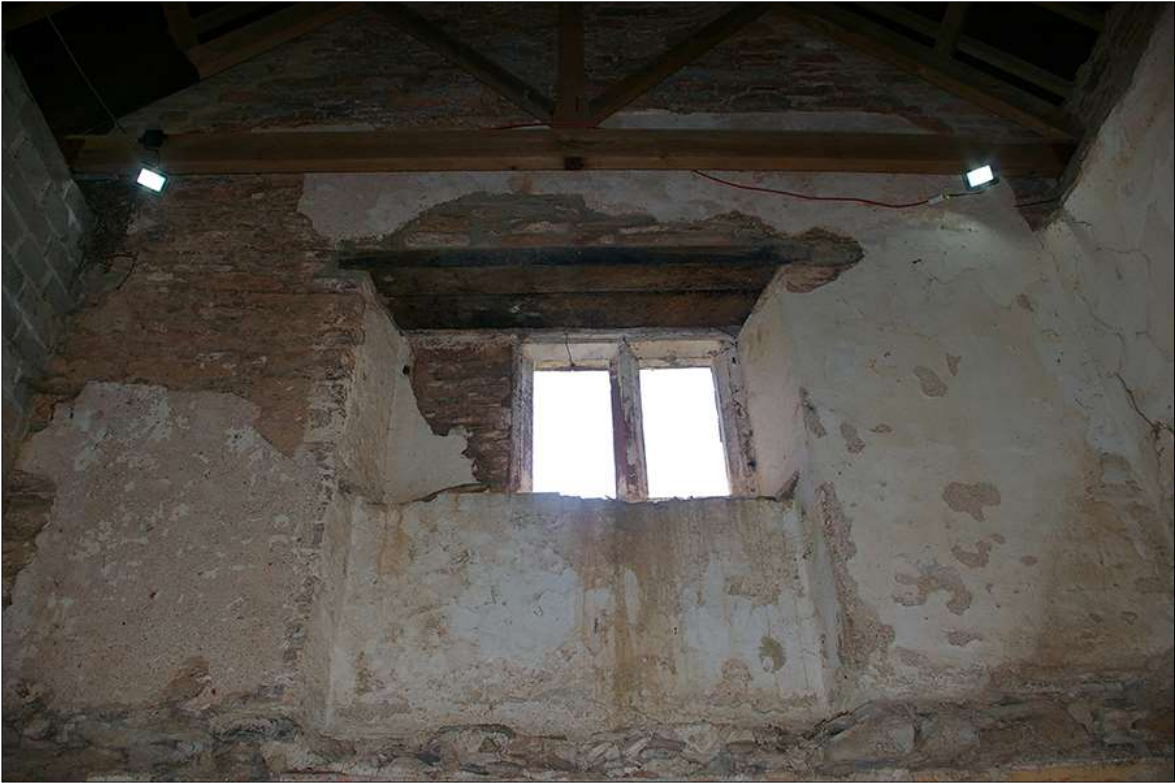
44. DETAIL OF THE INTERIOR FACE OF WINDOW W6 IN THE SOUTH-WEST WALL OF B1; VIEWED FROM THE NORTH-EAST.

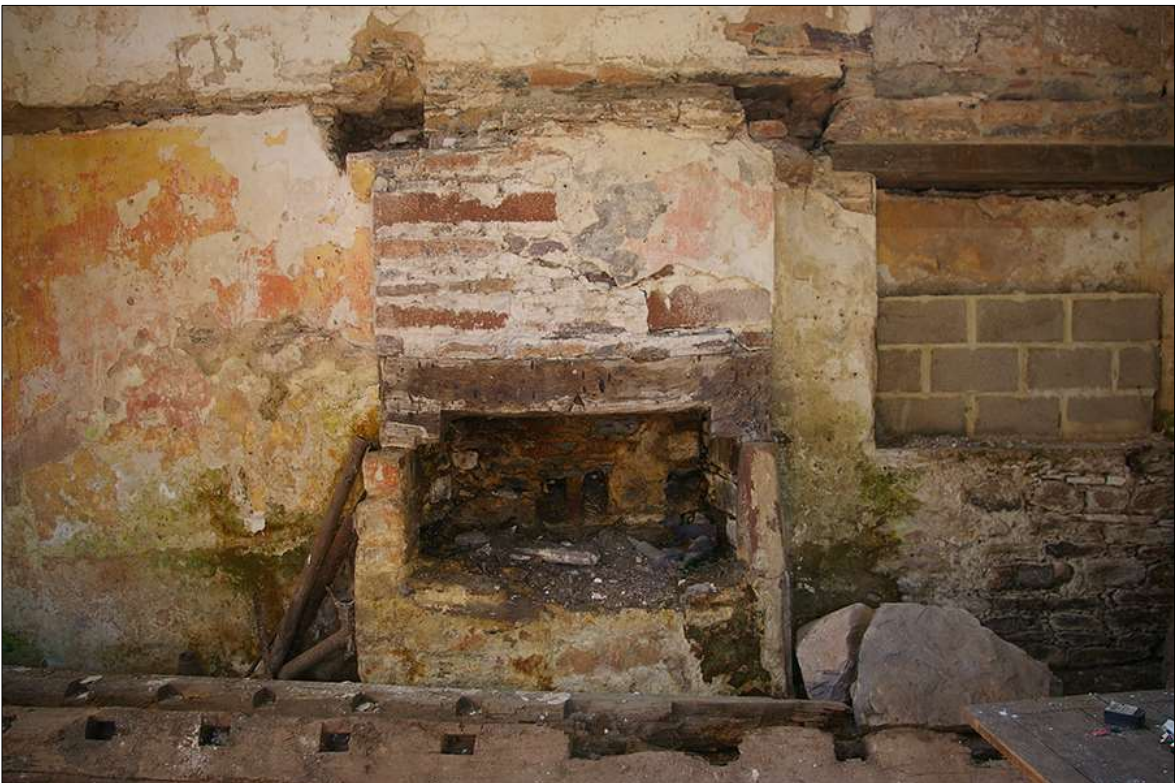
45. DETAIL OF FIREPLACE FP1 IN THE NORTH-WEST WALL OF THE SOUTH-WEST GROUND-FLOOR ROOM OF B1; VIEWED FROM THE SOUTH-EAST.

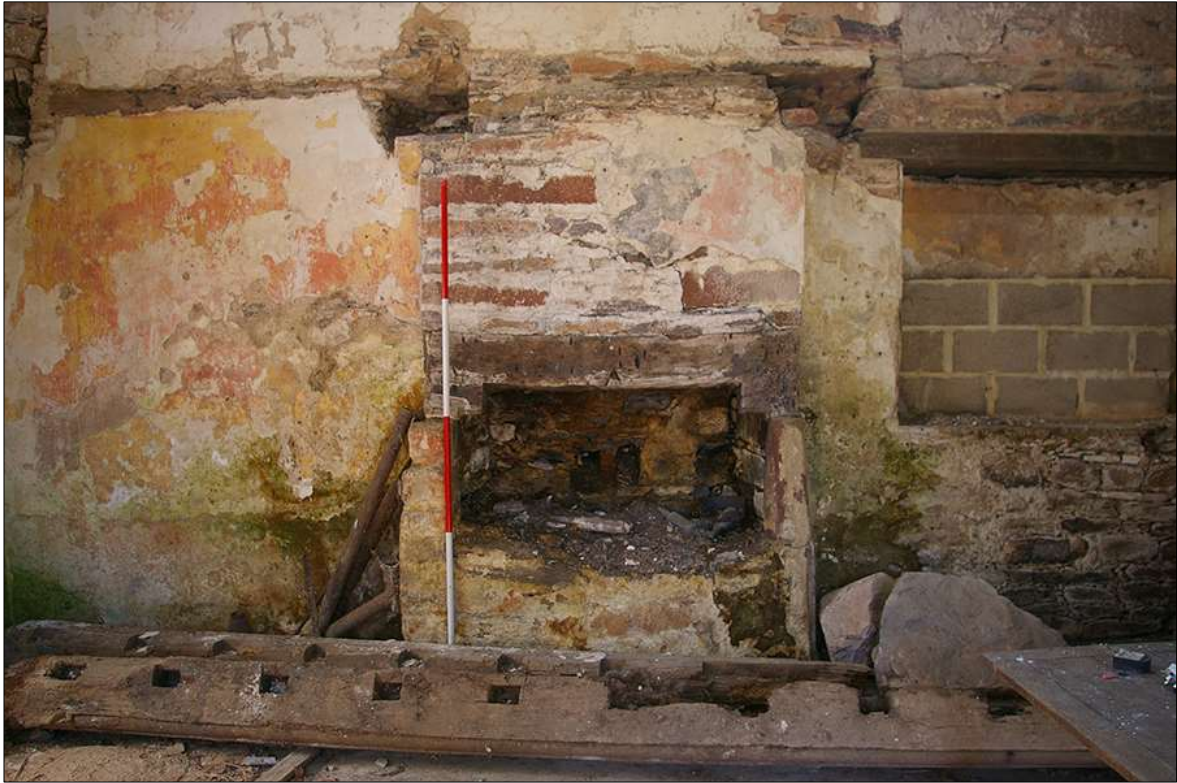
46. DETAIL OF FIREPLACE FP1 IN THE NORTH-WEST WALL OF THE SOUTH-WEST GROUND-FLOOR ROOM OF B1; VIEWED FROM THE SOUTH-EAST (2M SCALE).

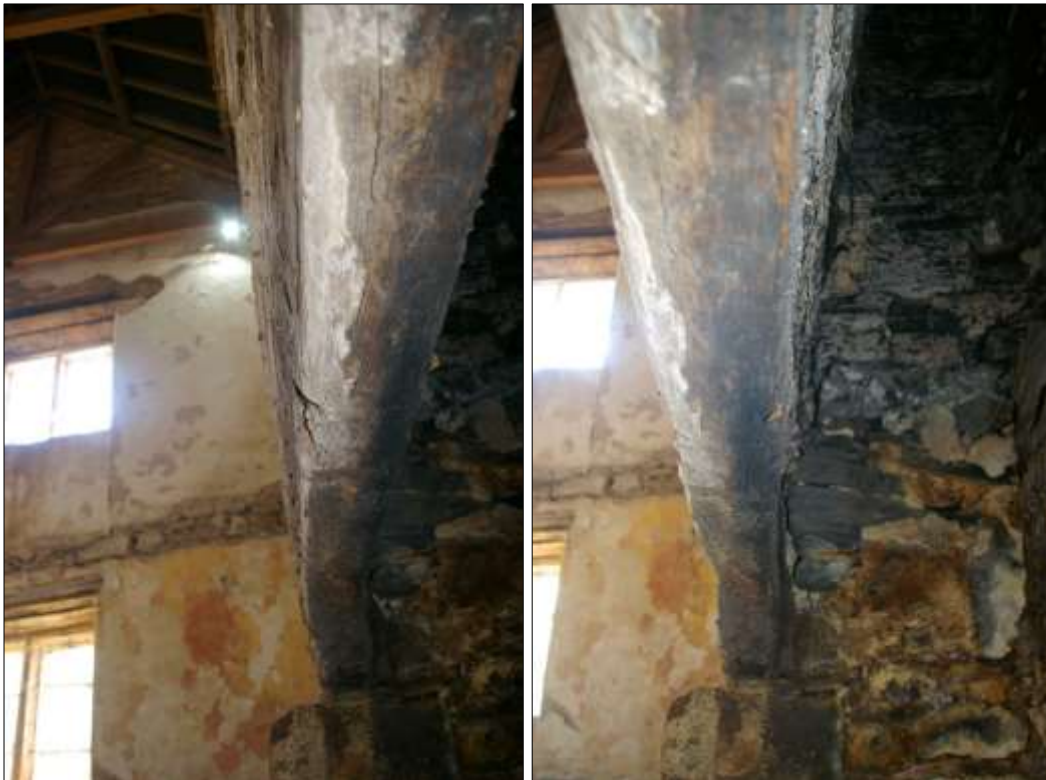
49. (LEFT) DETAIL OF RE-USED TIMBER LINTEL OVER FIREPLACE FP1; VIEWED FROM THE NORTH-EAST.

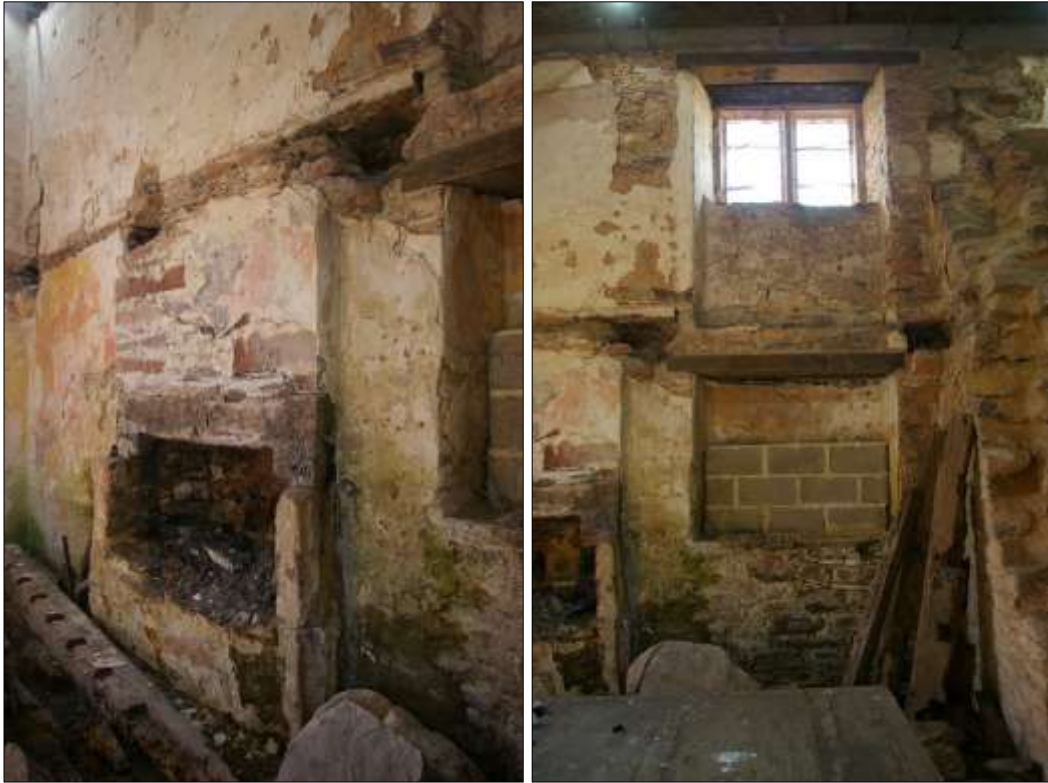
51. (LEFT) DETAIL OF FIREPLACE FP1 IN THE NORTH-WEST WALL OF THE SOUTH-WEST ROOM WITHIN B1, SHOWING ITS RE-USE OF RED SANDSTONE WINDOW JAMBS; VIEWED FROM THE EAST.
52. (RIGHT) DETAIL OF THE SOUTH-WEST ROOMS OF B1, SHOWING THE BLOCKED WINDOW W3 AND PARTIALLY BLOCKED LOADING DOOR ABOVE, NOW WINDOW W4; VIEWED FROM THE SOUTH-WEST.

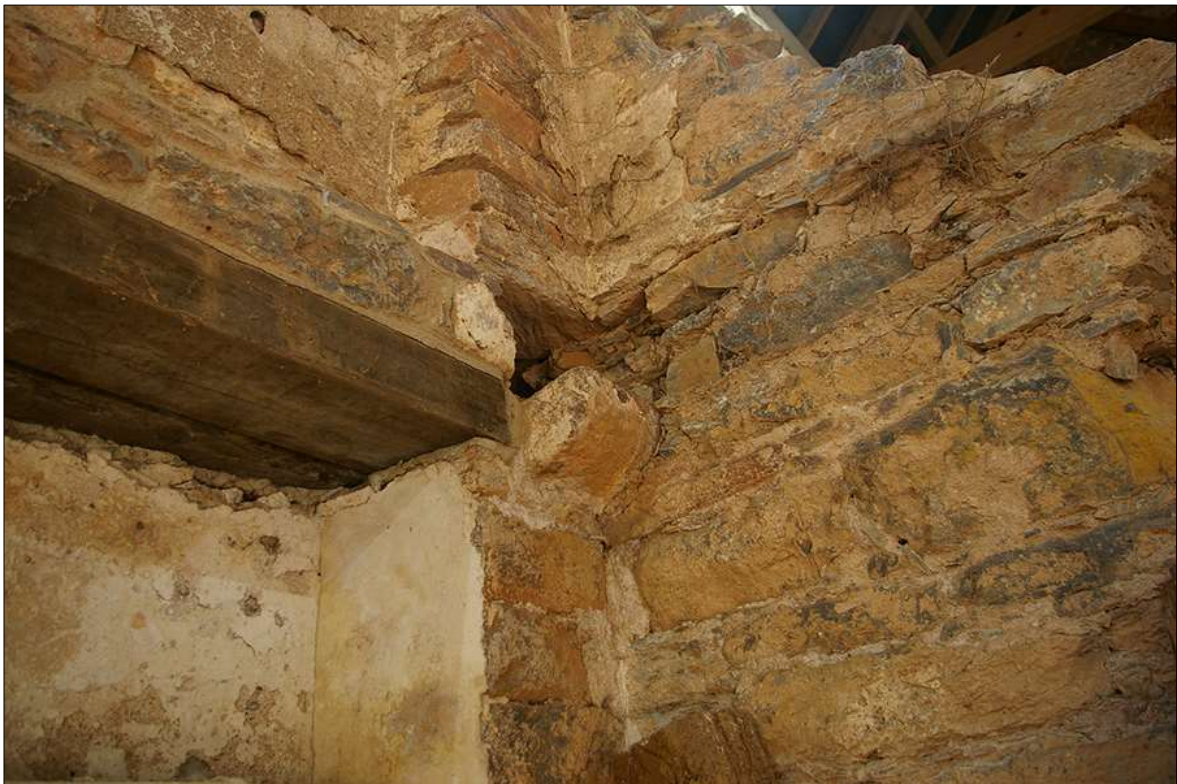
53. DETAIL OF THE CROSS-WALL WITHIN B1, SHOWING HOW IT IS BUILT AROUND THE CORBEL ADJACENT TO WINDOW W3; VIEWED FROM THE SOUTH.

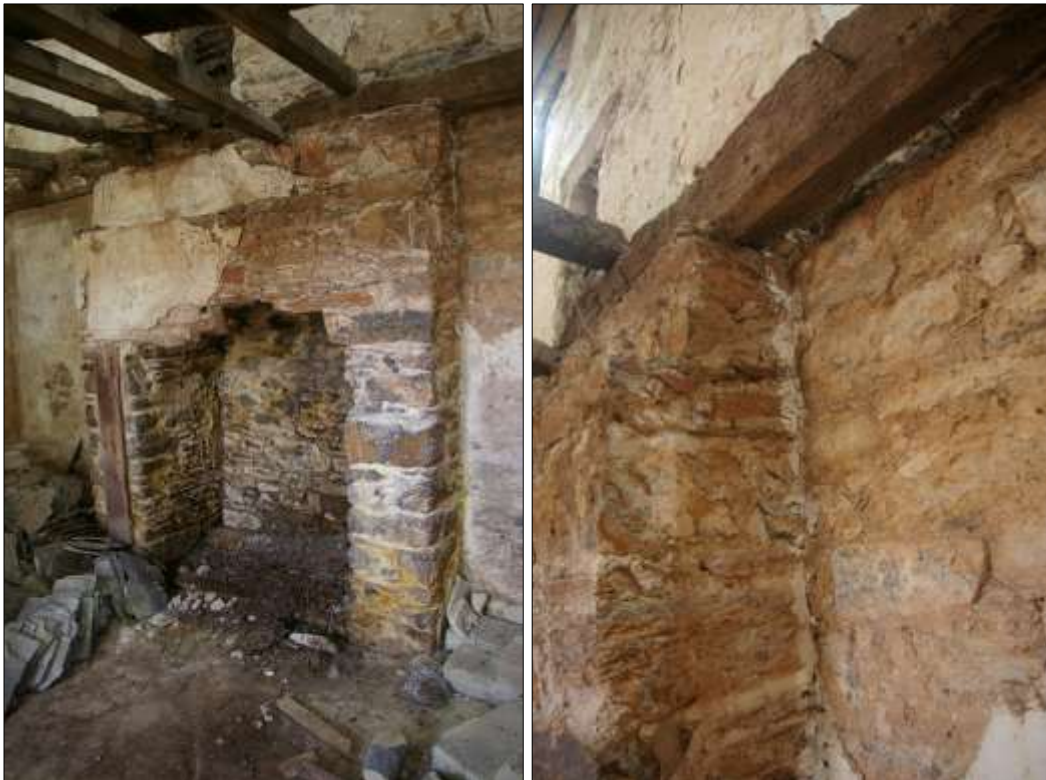
63. (LEFT) DETAIL OF FIREPLACE FP2, SHOWING ITS ABUTTING AND PARTIALLY FORCED RELATIONSHIP WITH THE NORTH-EAST WALL OF B1; VIEWED FROM THE SOUTH.

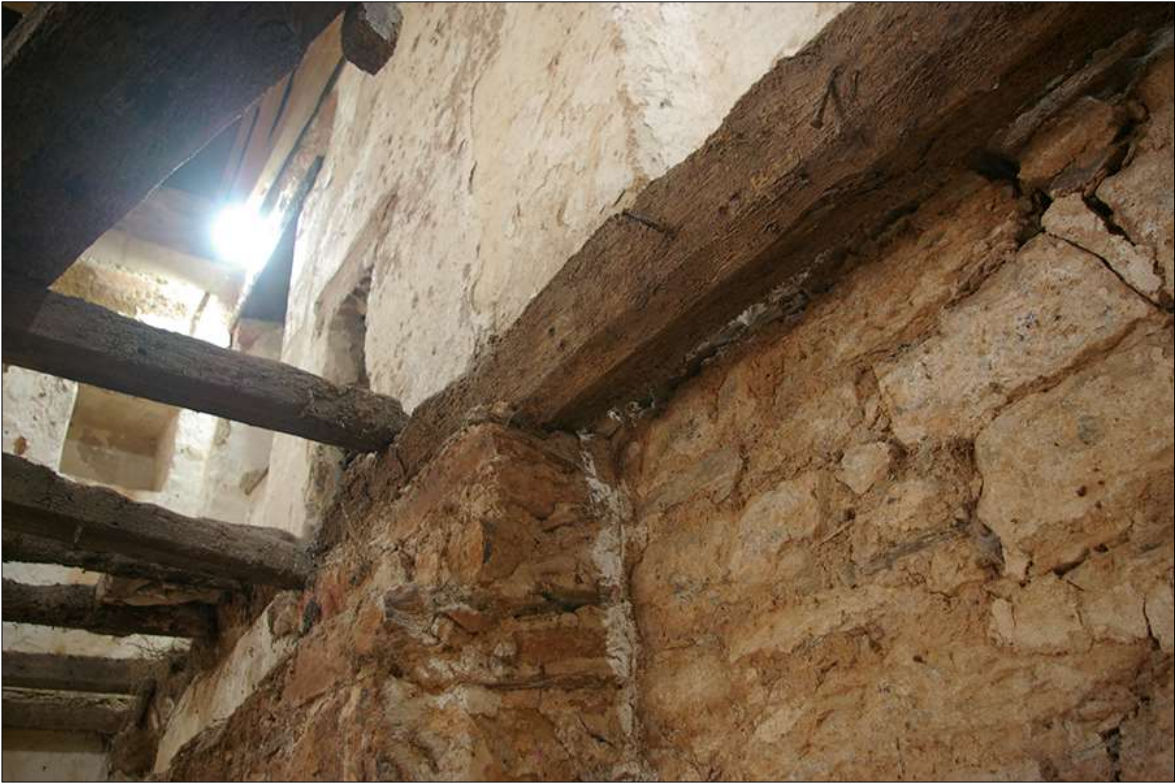
65. DETAIL OF FIREPLACE FP2, SHOWING THE CRUDE BUILD TO FIT IT AROUND THE CHAMFERED CEILING BEAM; VIEWED FROM THE SOUTH.

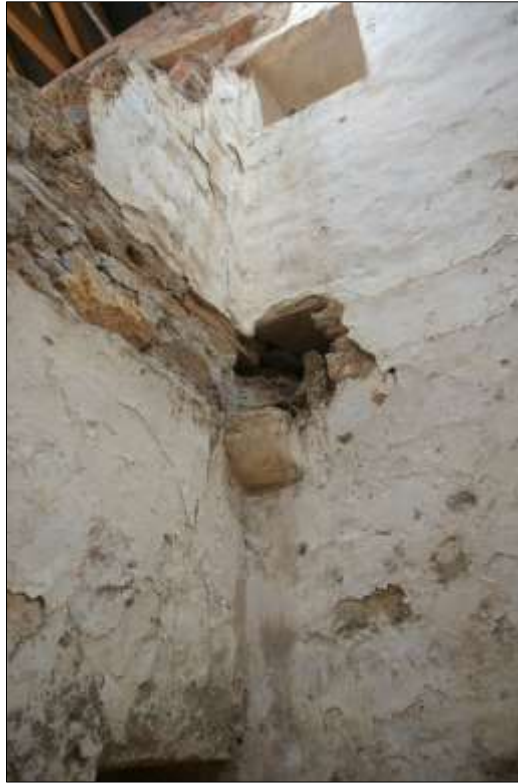
74. (LEFT) DETAIL OF THE CROSS-WALL, SHOWING HOW IT IS CRUDELY BUILT OVER THE CORBEL AND NOT WELL TIED INTO THE NORTH-WEST WALL OF B1; VIEWED FROM THE EAST.

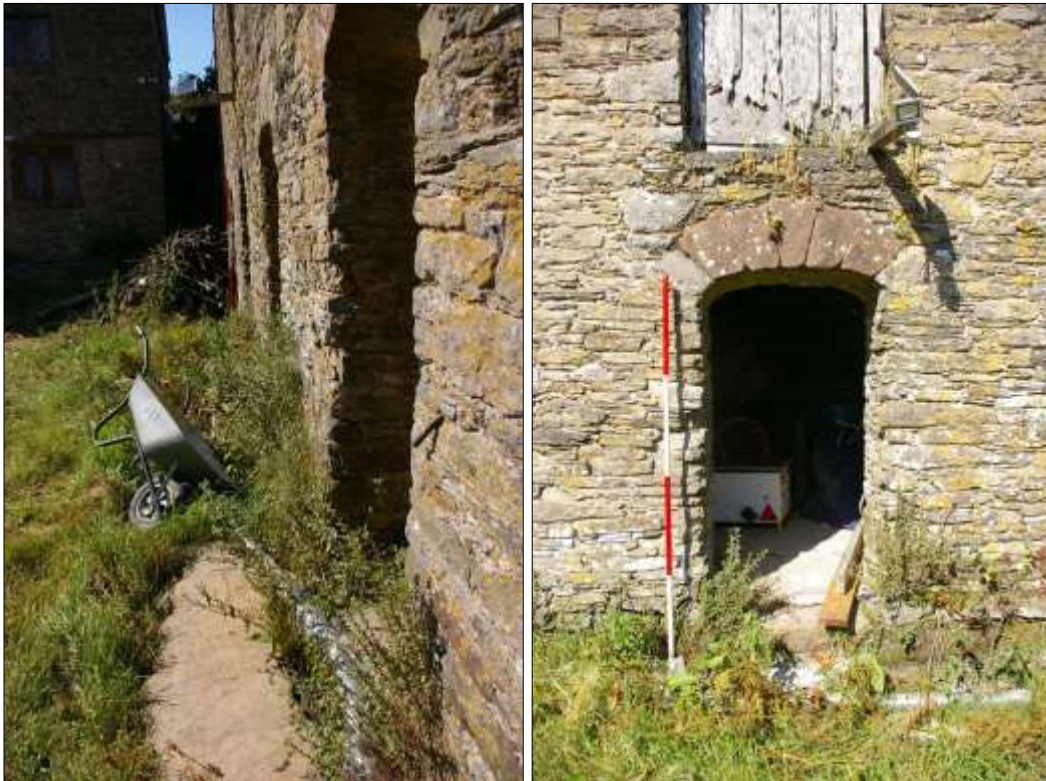
87. (LEFT) DETAIL OF THE SOUTH-WEST ELEVATION OF B2 DETAILING THE SLIGHTLY BATTERED ANGLE OF THE LOWER, HEAVIER STONEMWORK; VIEWED FROM THE SOUTH-SOUTH-EAST.
