WEEK
BERRY POMEROY
SOUTH HAMS
DEVON

Historic Building Recording and Archaeological Evaluation Trenching

South West Archaeology Ltd. report no. 190902

By E. Wapshott & P. Webb

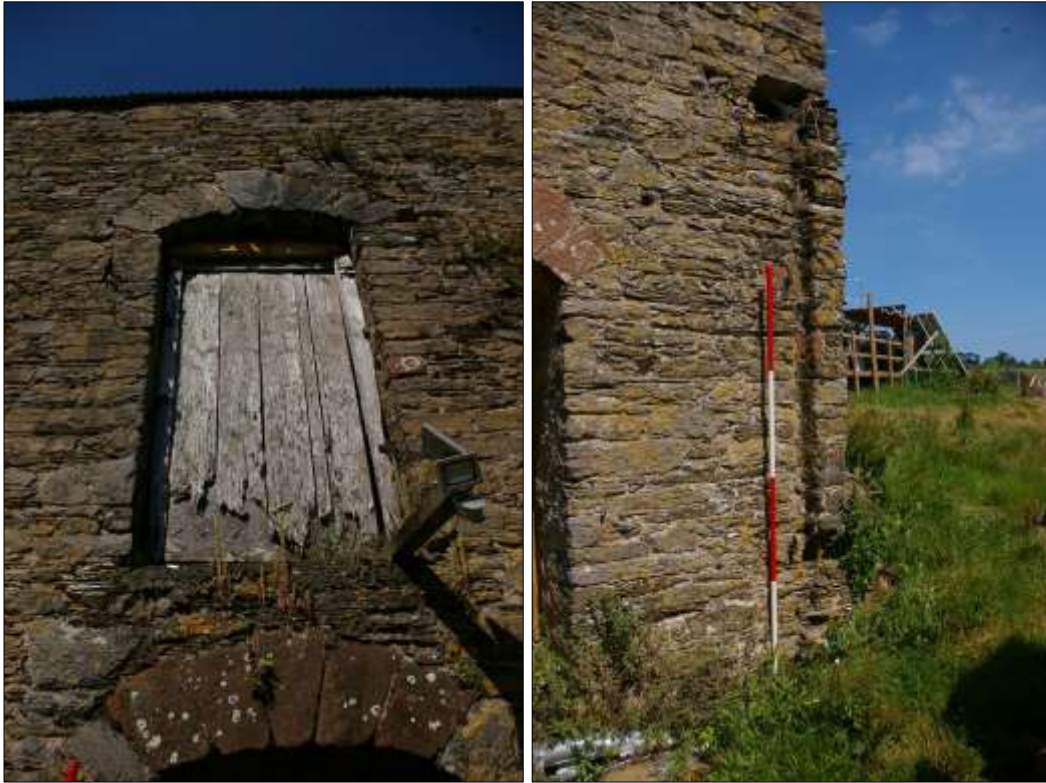
91. (LEFT) DETAIL OF THE LOADING DOORWAY D9 IN THE SOUTH-WEST ELEVATION OF B2; VIEWED FROM THE SOUTH-WEST.
92. (RIGHT) DETAIL OF THE REBATE AT THE SOUTH-EASTERN CORNER OF THE SOUTH-WEST ELEVATION OF B2 SUGGESTING THE PRESENCE OF AN EARLIER RANGE; VIEWED FROM THE WEST-SOUTH-WEST (2M SCALE).

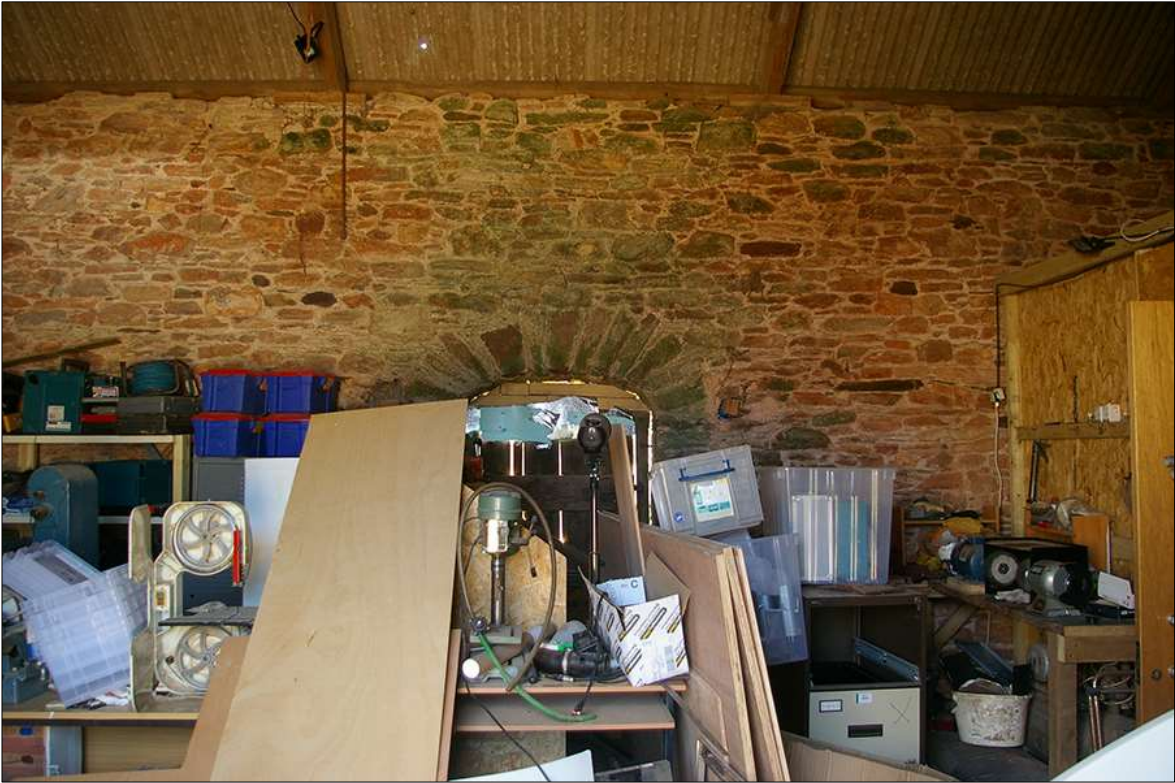
98. THE INTERIOR FACE OF THE SOUTH-WEST WALL OF B2 SHOWING THE FINE SEGMENTAL ARCH, VOISSIORS AND KEYSTONE OVER LOADING DOOR D9; VIEWED FROM THE NORTH-EAST.

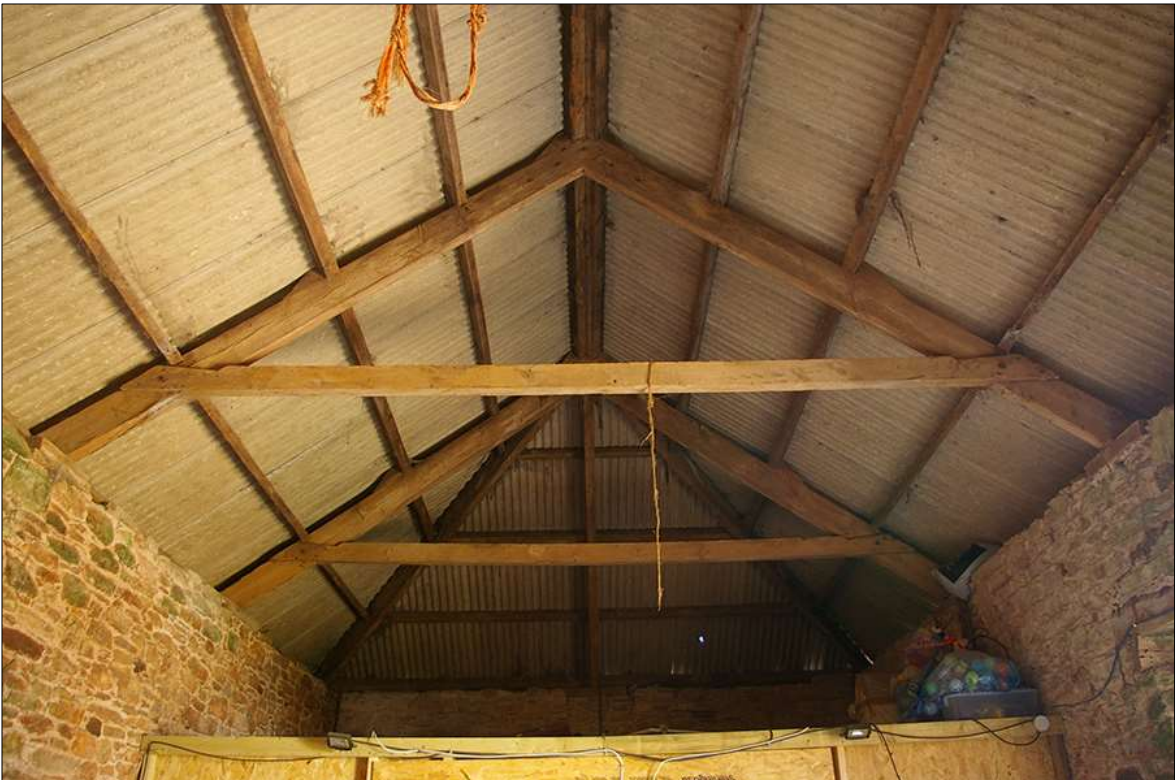
99. THE A-FRAME TRUSS ROOF STRUCTURE OF B2; VIEWED FROM THE SOUTH-EAST.

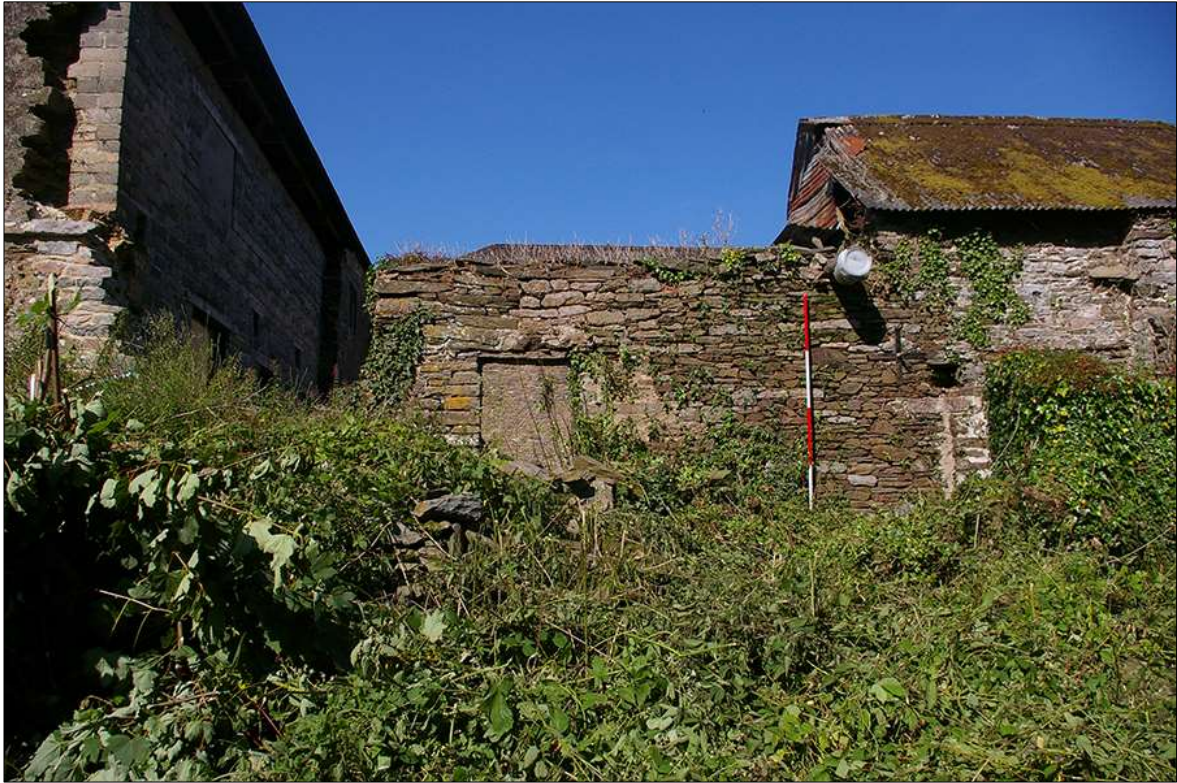
102. DETAIL OF THE DIFFERING BUILDS WITHIN THE SOUTH-WEST ELEVATION OF B3; VIEWED FROM THE SOUTH-WEST (2M SCALE).

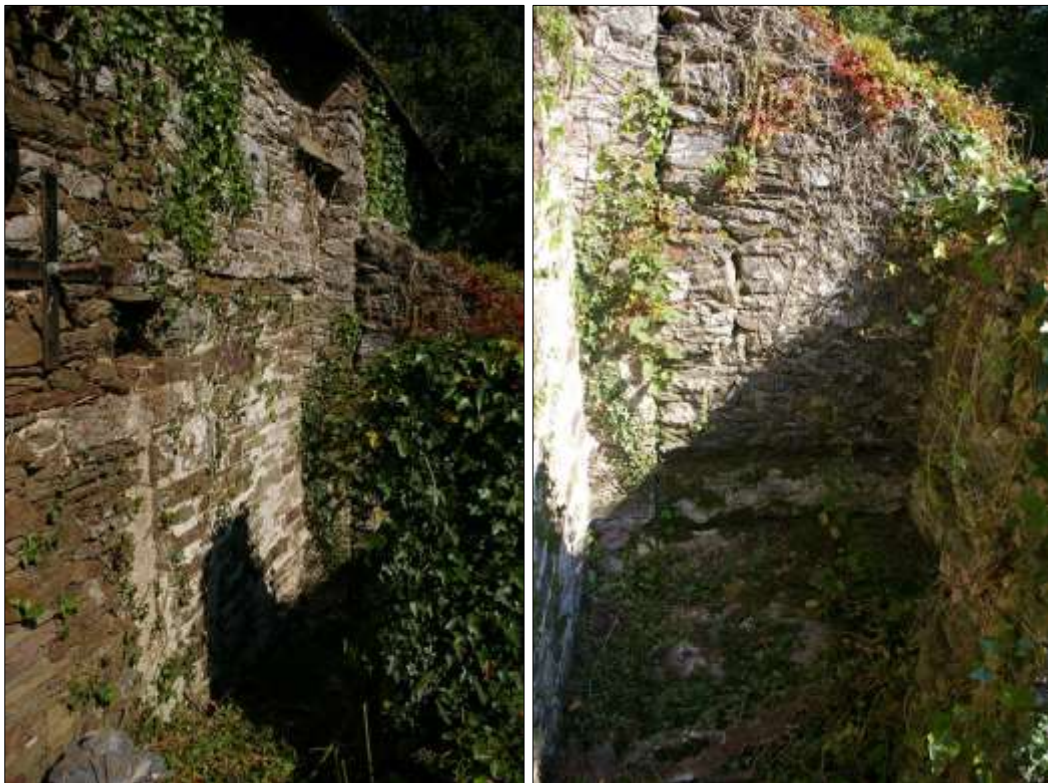
D2	There is a wide low blocked doorway set further 'east' on this wall. This has a heavy timber reused lintel, with an empty socket, set unevenly. The doorway is loosely blocked in rubble, in lime mortar. It appears on the exterior face that the doorway has been set up against a corner, with projecting quoins, sitting on a different build line. The internal cheek to the doorway may in fact be a return of wall for a once detached range. This doorway once served a small square projecting block, which abuts this wall, possibly a garderobe, or stair turret, now roofless and partially roofless.
Openings – Windows:		N/A
Significant Details:		A small three walled block has been built half-way along the range, clearly abutting it. This is built of heavy slatestone slab rubble. It only survives to one storey, it is terraced into the bank above the slope leading to the pond. This has an exterior opening on the north-west wall. The floor of this block is obscured by debris, but there is a rebate in the south-east, south-west and north-west walls, offset to the exterior side, as if for a privy bench. This is partially cleared but still obscured by ivy and foliage at its base. Colloquially this is known as 'the privy' and is expected to be a garderobe block.

103. (LEFT) DETAIL OF BLOCKED DOOR D11 TO THE 'GARDEROBE' THROUGH THE SOUTH-WEST ELEVATION OF B3; VIEWED FROM THE WEST.

104. (RIGHT) DETAIL OF POSSIBLE 'GARDEROBE' ABUTTING THE EARLIER RANGE AND DEMONSTRATING THE REBATE FOR A POSSIBLE PRIVY SEAT; VIEWED FROM THE NORTH-WEST.

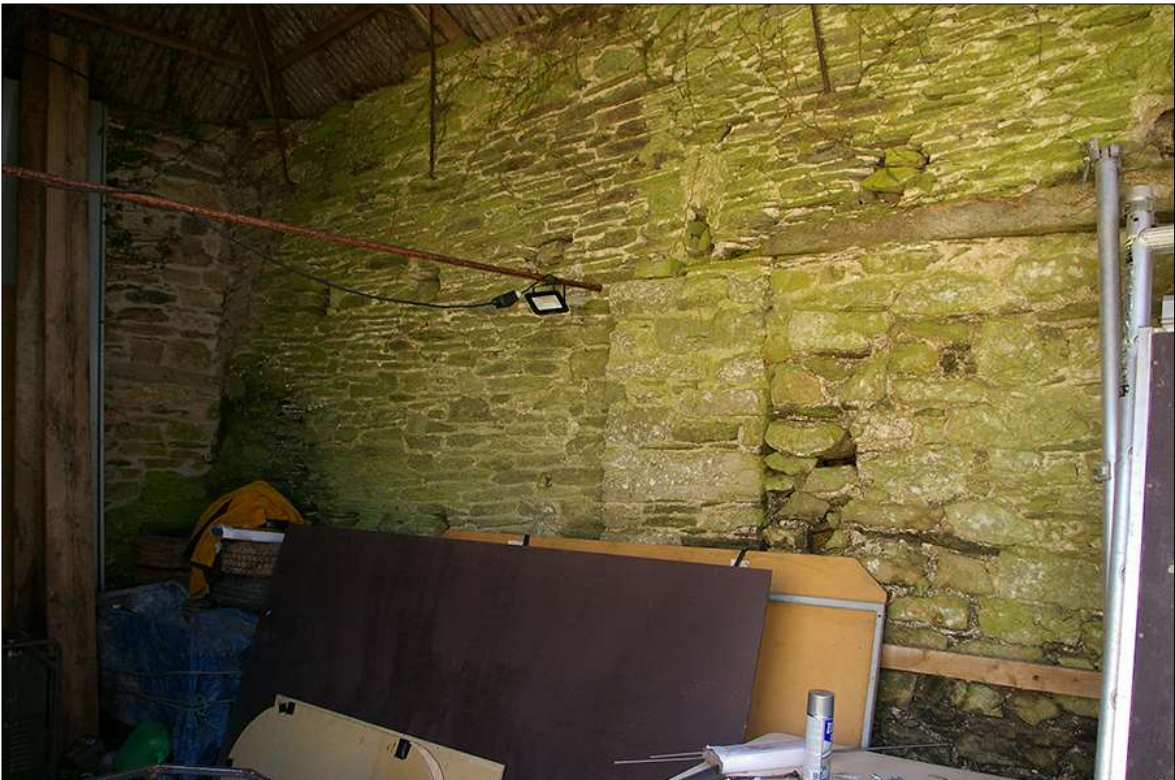
113. INTERIOR FACE OF THE SOUTH-WEST ELEVATION (NORTH-WEST END) OF B3 SHOWING THE EXTENT OF STORM DAMAGE; VIEWED FROM THE NORTH-EAST.

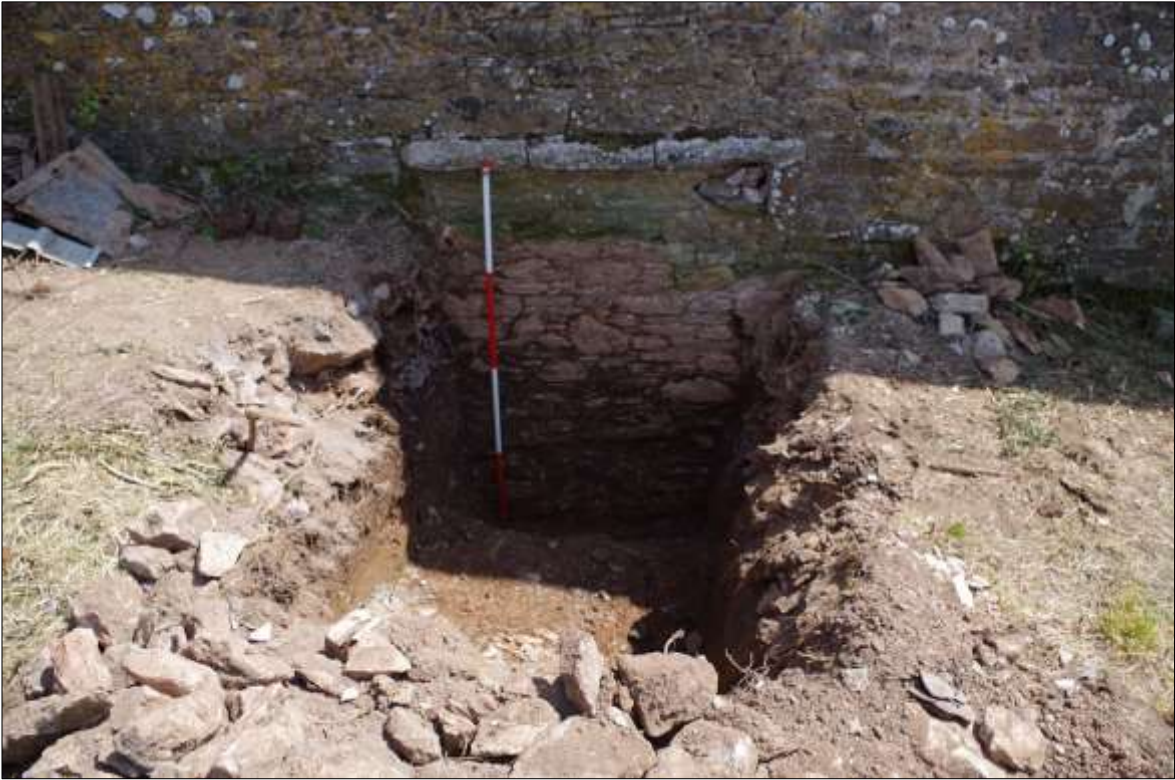
3. BLOCKING OF WINDOW W3 IN THE NORTH-WEST ELEVATION OF B1, AS SEEN WITHIN TRENCH 01; VIEWED FROM THE NORTH-WEST (2M SCALE).

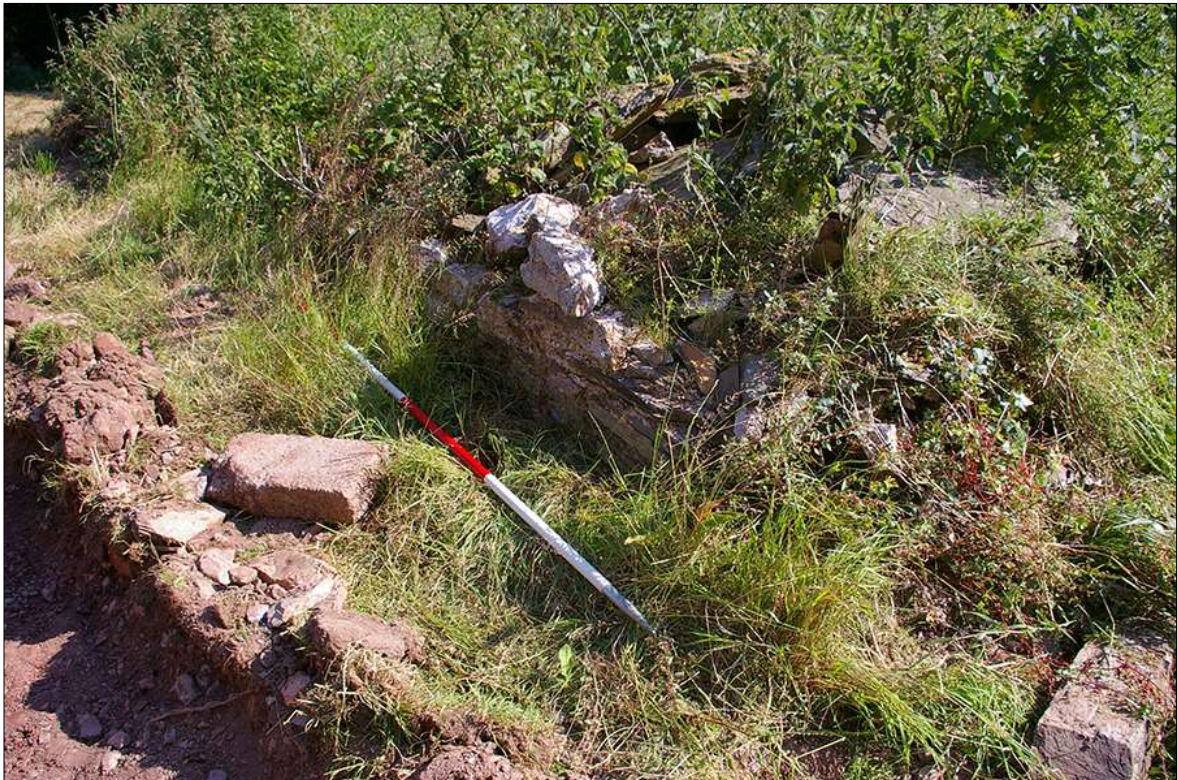
10. DETAIL OF THE LOW-LYING STRUCTURAL REMAINS IDENTIFIED ALONG THE SOUTH-EASTERN EDGE OF THE COURTYARD; VIEWED FROM THE NORTH-WEST (2M SCALE).
