# ASH HOUSE HENSTRIDGE SOMERSET

Historic Building Recording

South West Archaeology Ltd. report no. 190326

## Ash House, Henstridge, Somerset Historic Building Recording

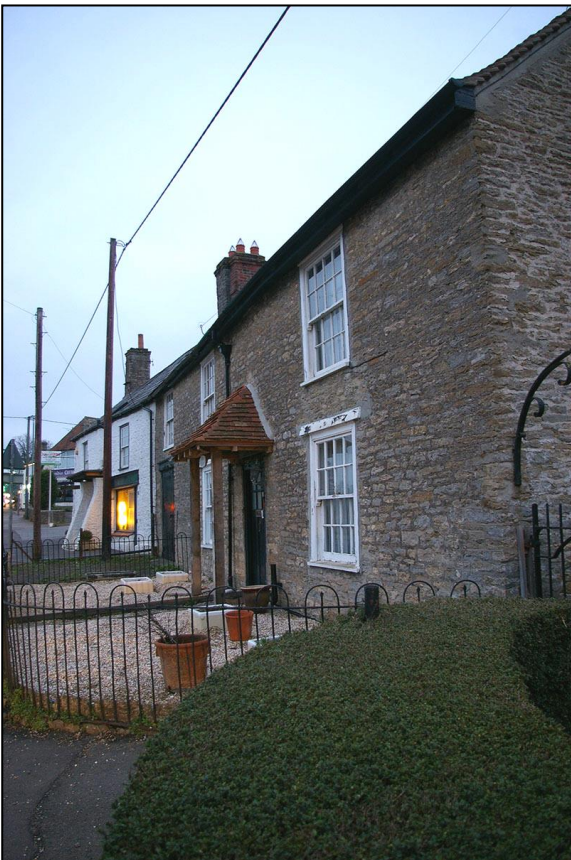
VIEW ALONG THE FRONT ELEVATION OF THE LONG RANGE, SHOWING THE DIFFERENCE IN ALIGNMENT THAT IDENTIFIES THESE AS SEPARATE STRUCTURES; VIEWED FROM THE EAST.

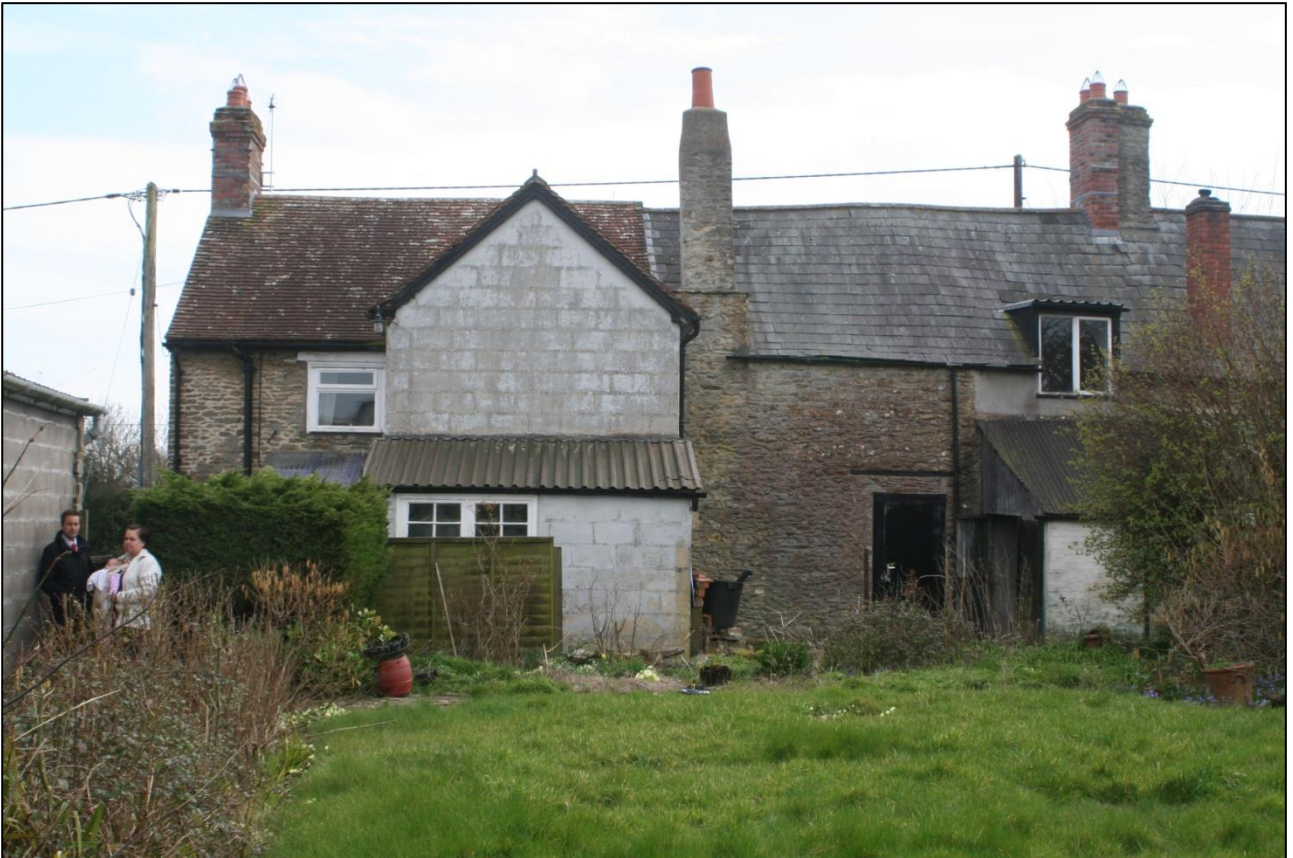
THE NORTH ELEVATION OF ASH HOUSE TO THE WEST OF THE CONCRETE BLOCK EXTENSION; VIEWED FROM THE NORTH; SUPPLIED BY CLIENT.

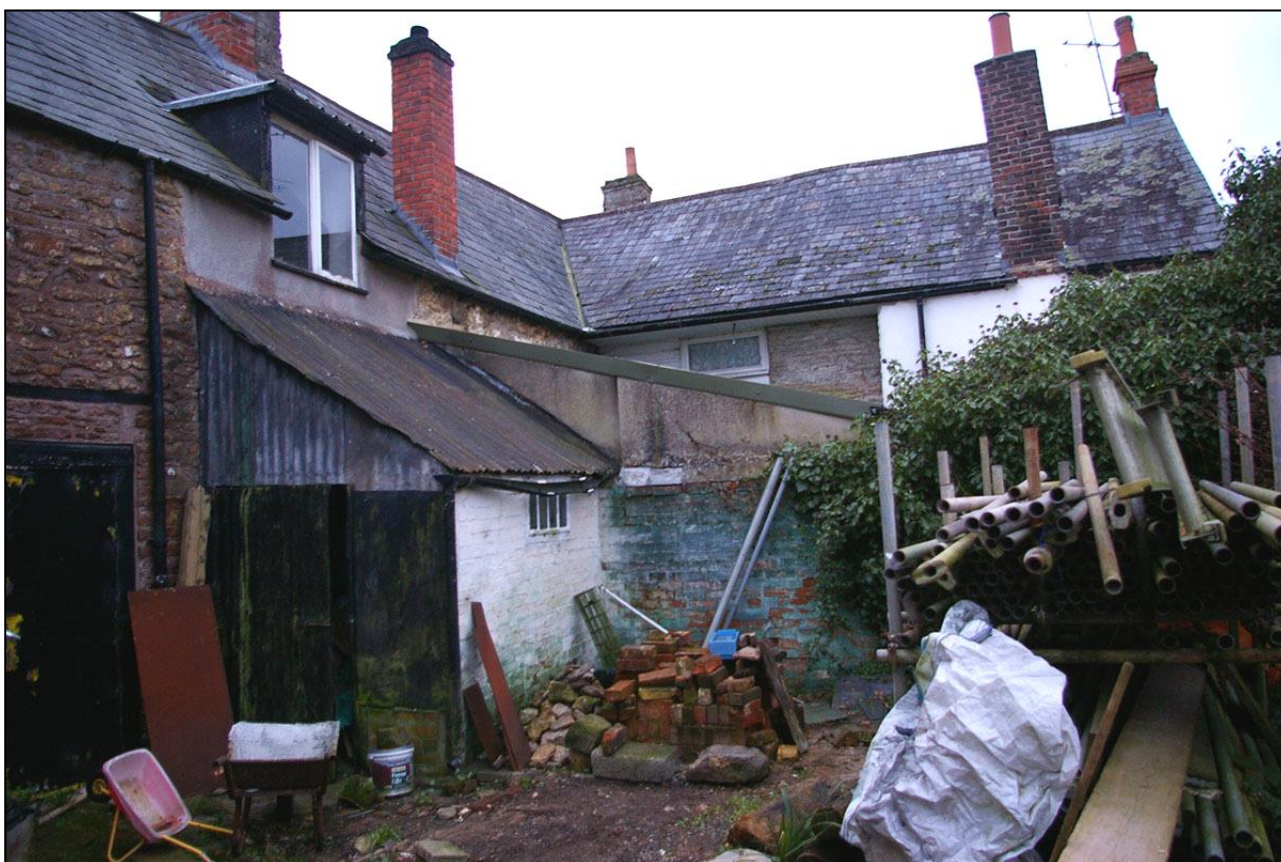
THE SMALL 19<sup>TH</sup> CENTURY BRICK SHED BUILT UP AGAINST THE RENDERED CONCRETE BLOCK INFILL THAT LINKS THE TWO BUILDINGS; VIEWED FROM THE EAST-NORTH-EAST.

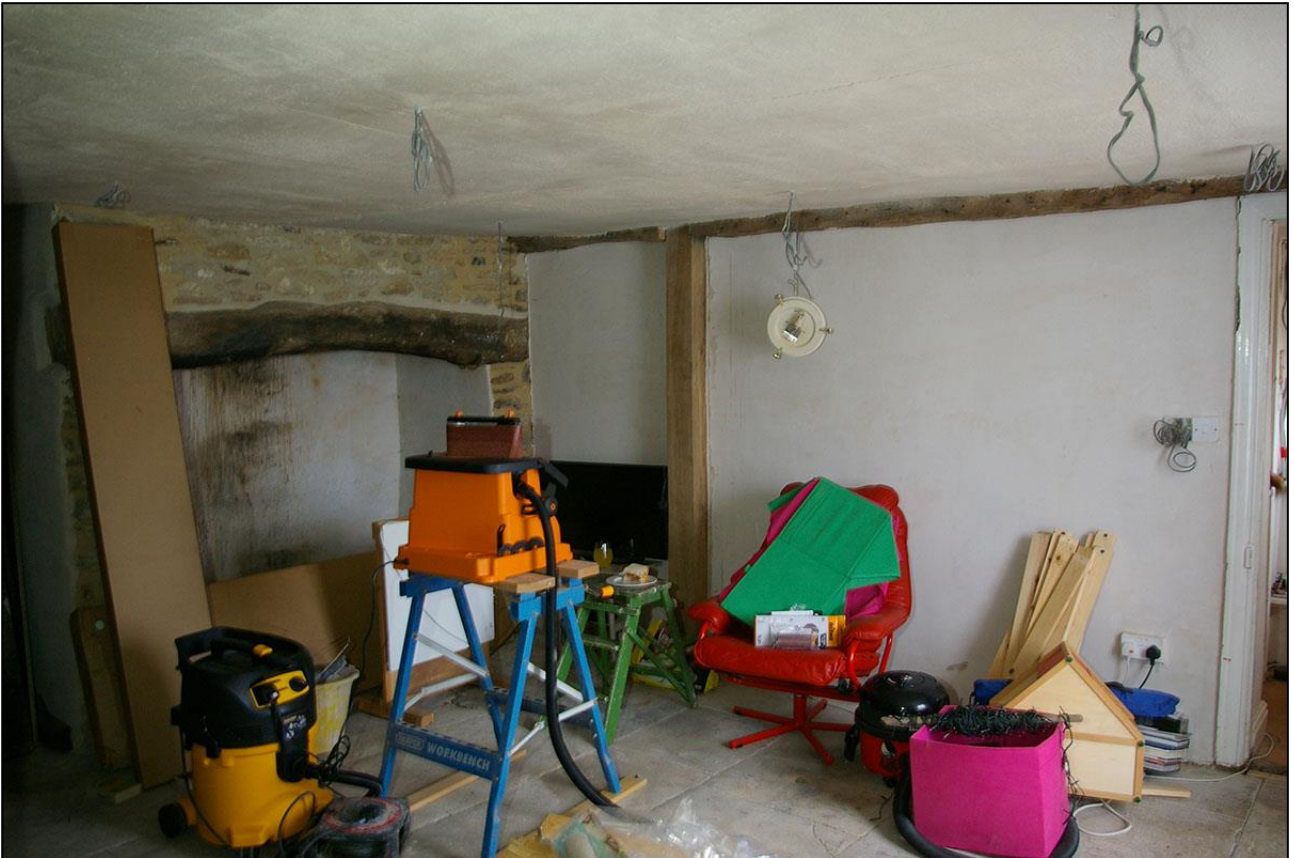
R2 FROM THE SOUTH-WEST CORNER, SHOWING THE LARGE STONE STACK WITH OPEN HEARTH; VIEWED FROM THE SOUTH-WEST.

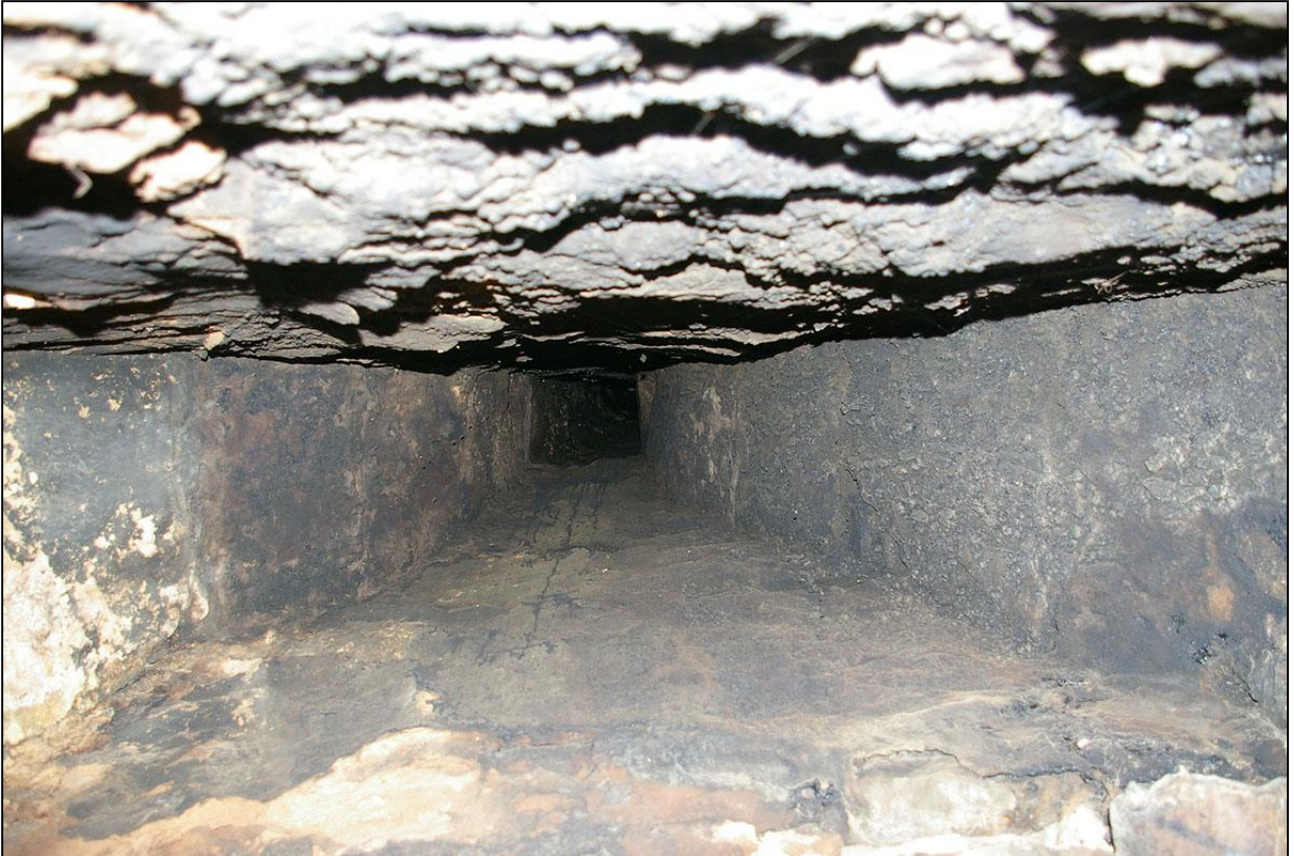
R2, VIEW UP THE FLUE; VIEWED FROM BELOW.

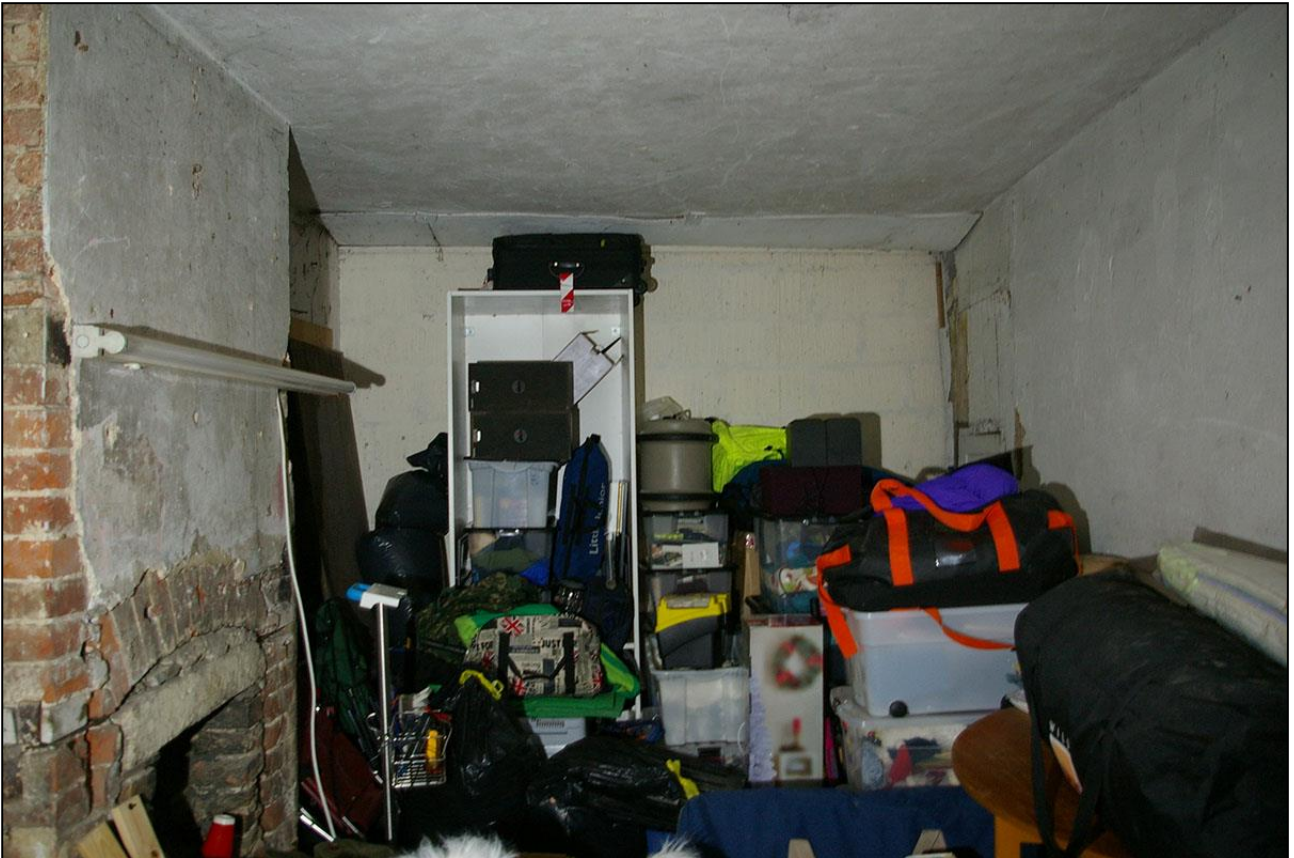
R3, SHOWING THE BRICK STACK BUILT AGAINST THE GABLE WALL OF THE OLD BAKEHOUSE; VIEWED FROM THE SOUTH.

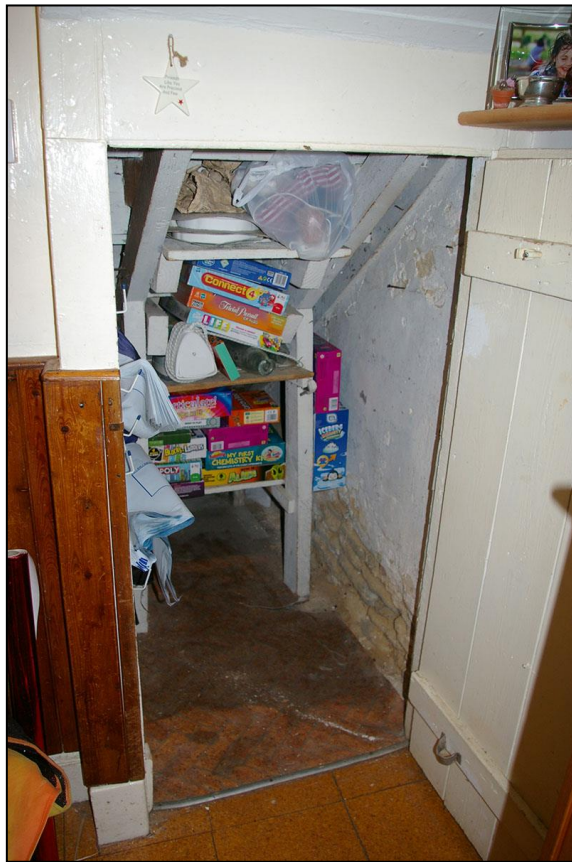
RIGHT: R5, THE UNDERSTAIR CUPBOARD, SHOWING THE CHUNKY PLANK AND TREAD RISERS CARRIED ON CARRIAGE BRACES, A TYPICAL 18<sup>TH</sup> CENTURY FORM OF STAIR CONSTRUCTION; VIEWED FROM THE NORTH-NORTH-EAST.

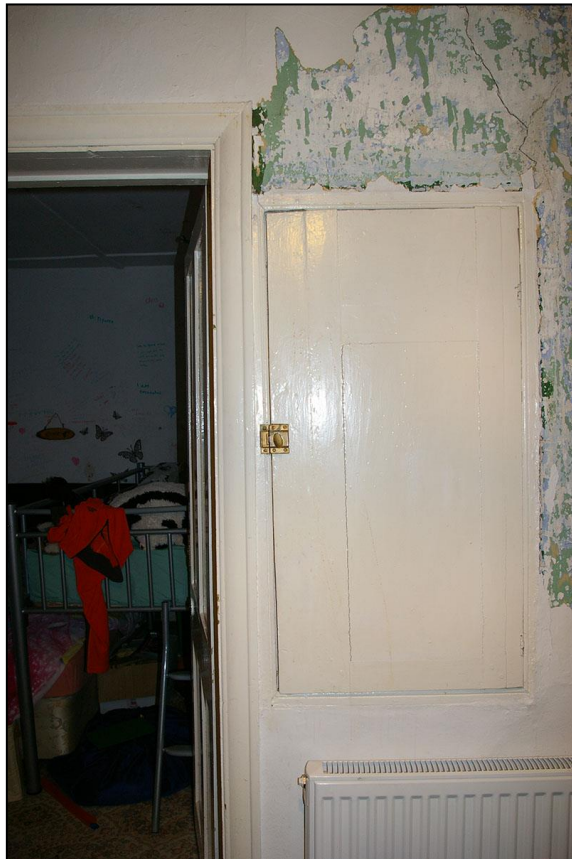
RIGHT: R9, THE SMALL CUPBOARD WITH MOULDED FRAME AND UNEVEN PLANK DOOR SET INTO THE SIDE OF THE LATERAL STACK; VIEWED FROM THE EAST.

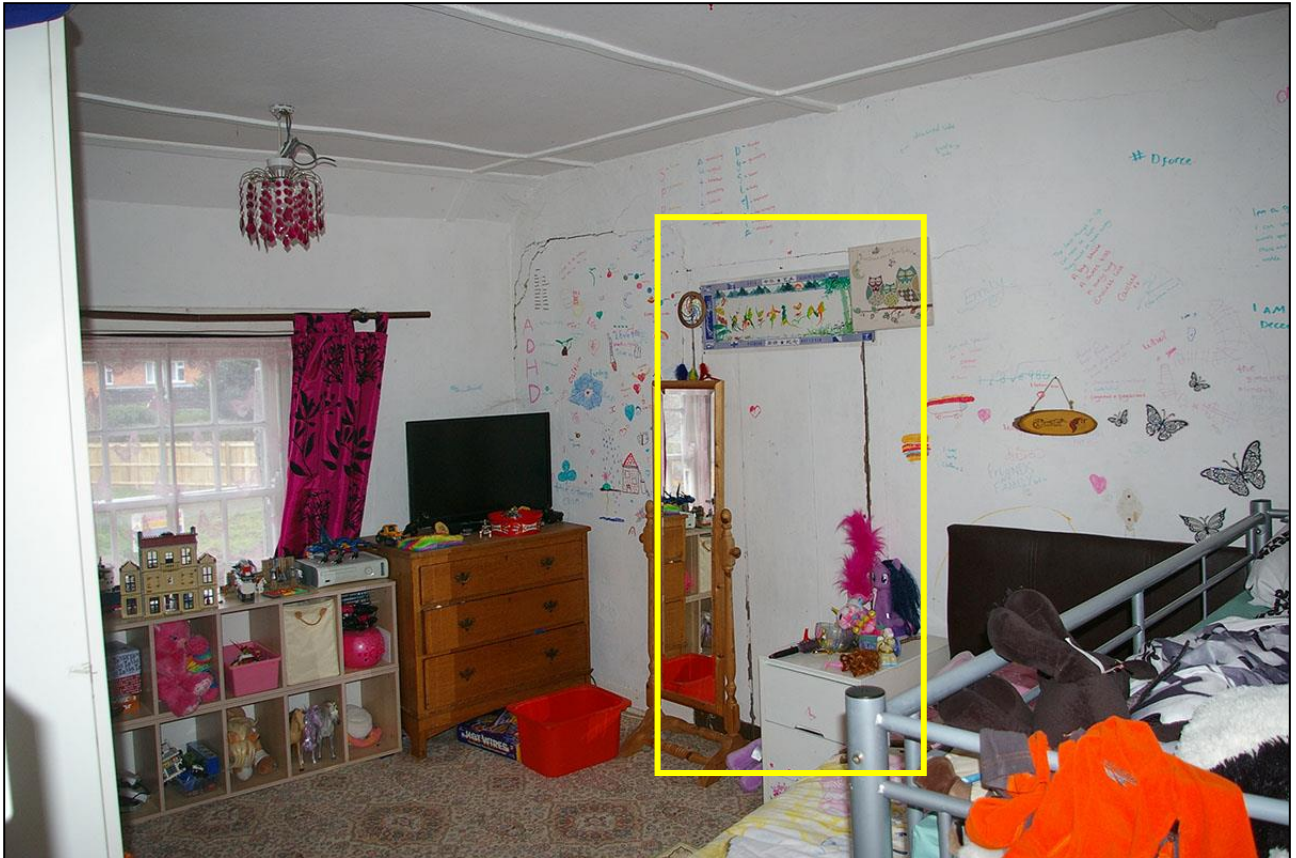
R10, SHOWING THE DOOR TO R14 (INDICATED); VIEWED FROM THE NORTH-EAST.

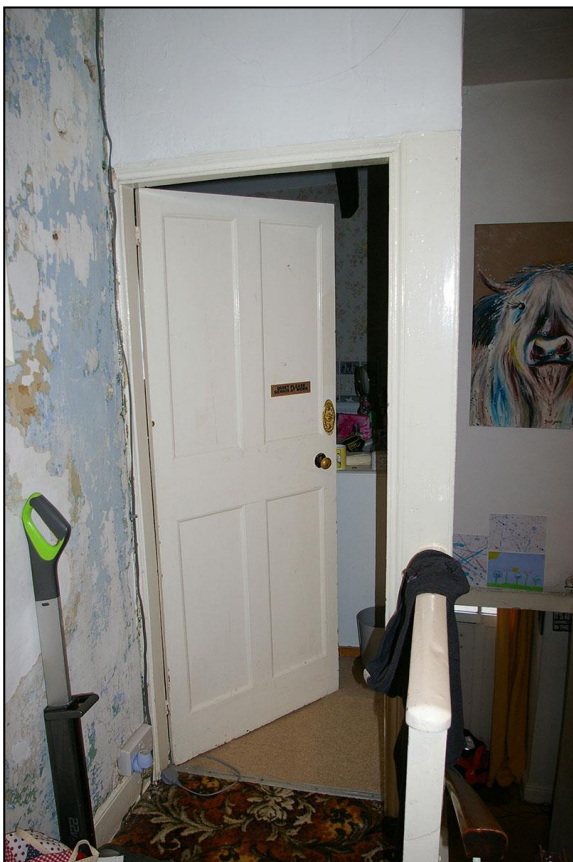
R9, THE 19<sup>TH</sup> CENTURY MOULDED FOUR-PANEL DOOR TO R11; VIEWED FROM THE NORTH-WEST.

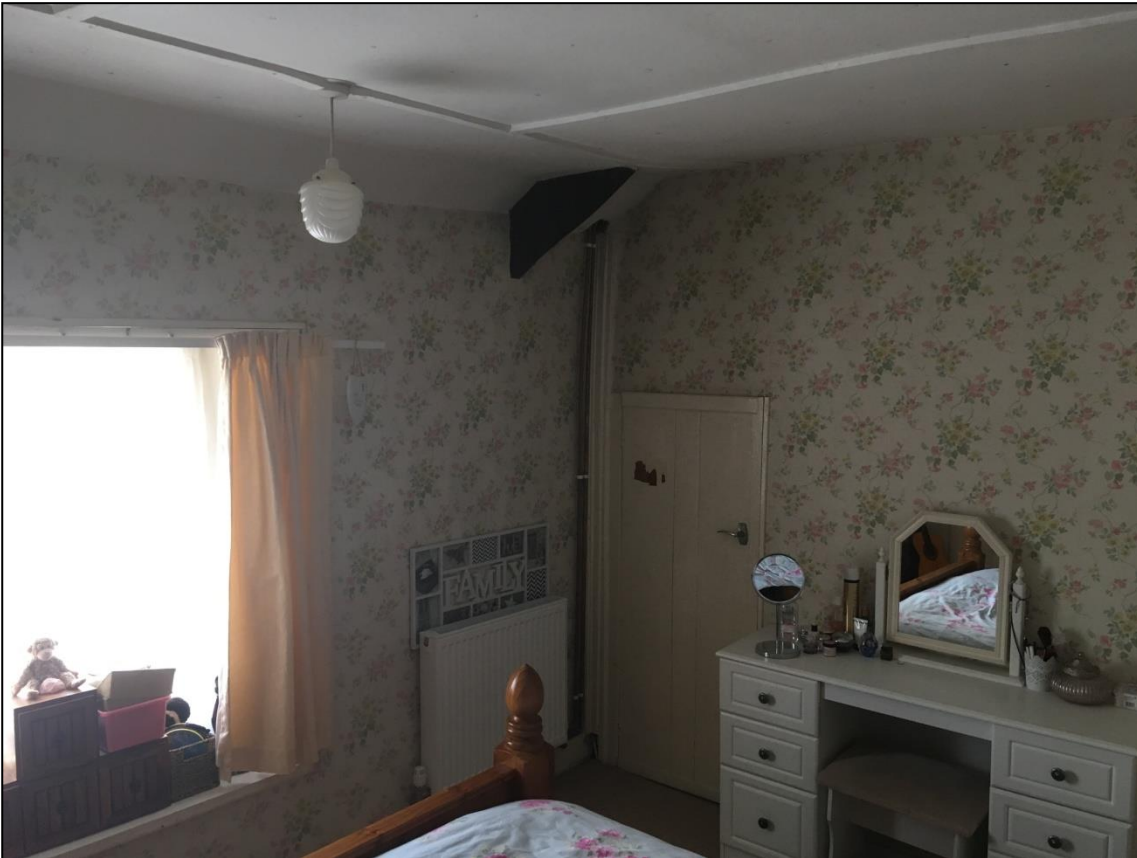
R11, SHOWING THE LOW PLANK DOOR (LEFT) TO THE DEEP CUPBOARD THAT FORMERLY PROVIDED ACCESS TO R10; VIEWED FROM THE NORTH-EAST (SUPPLIED BY CLIENT).

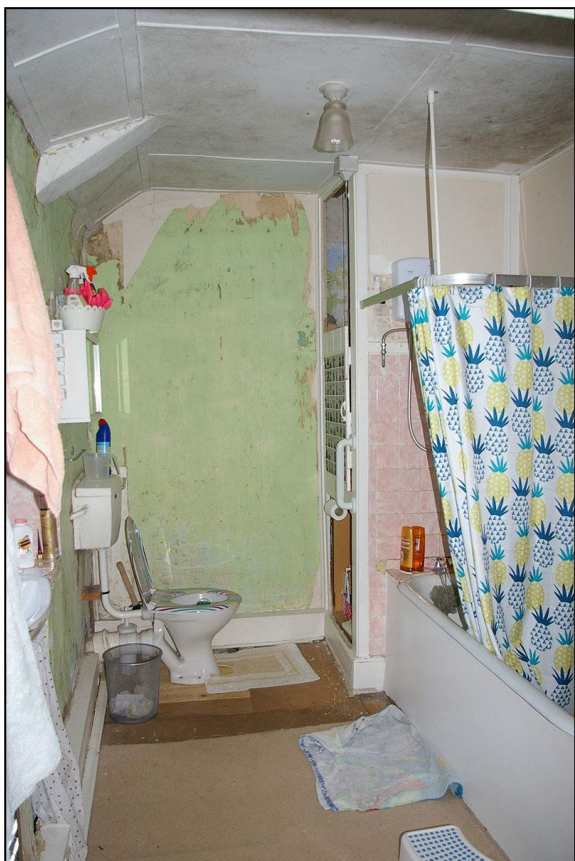
LEFT: R12; VIEWED FROM THE WEST.

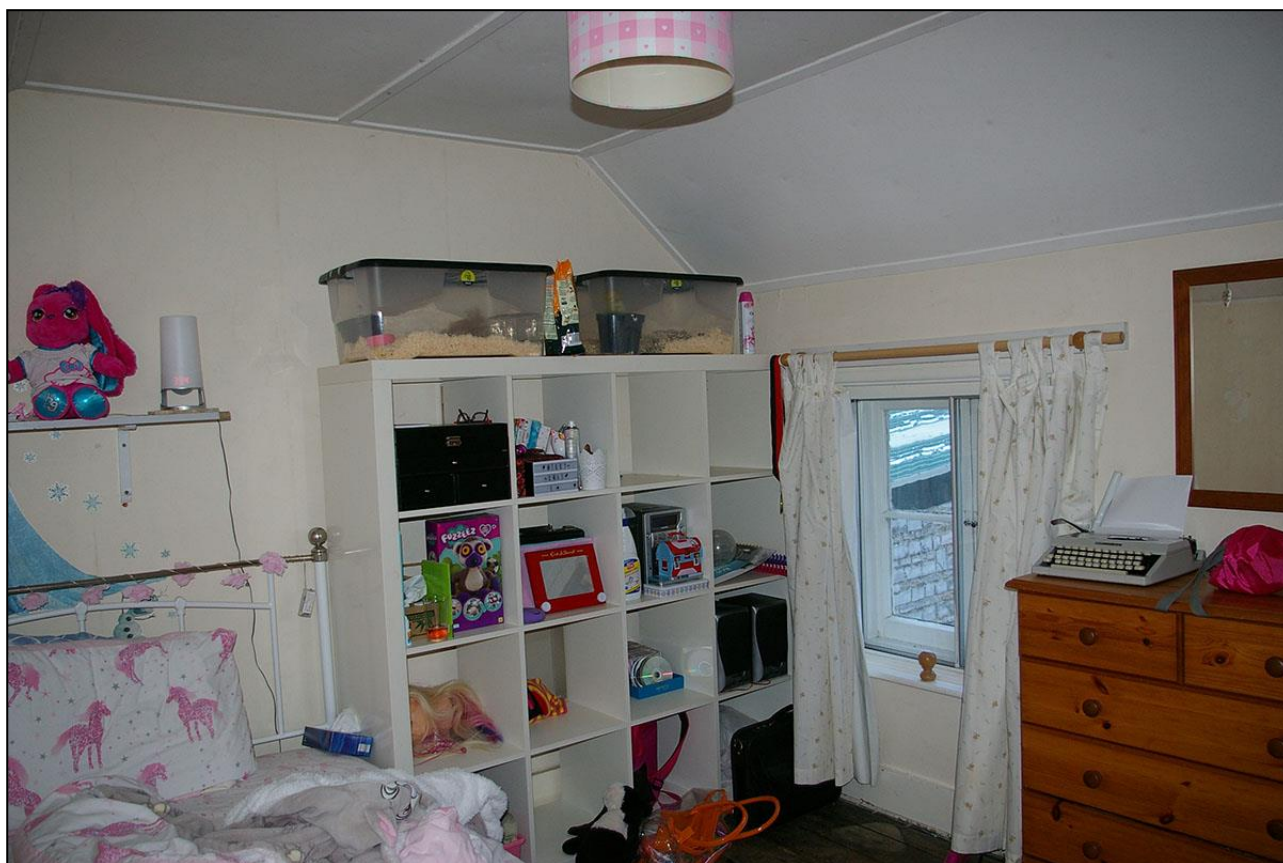
R13, THE BEDROOM OVER THE KITCHEN; VIEWED FROM THE SOUTH-WEST.

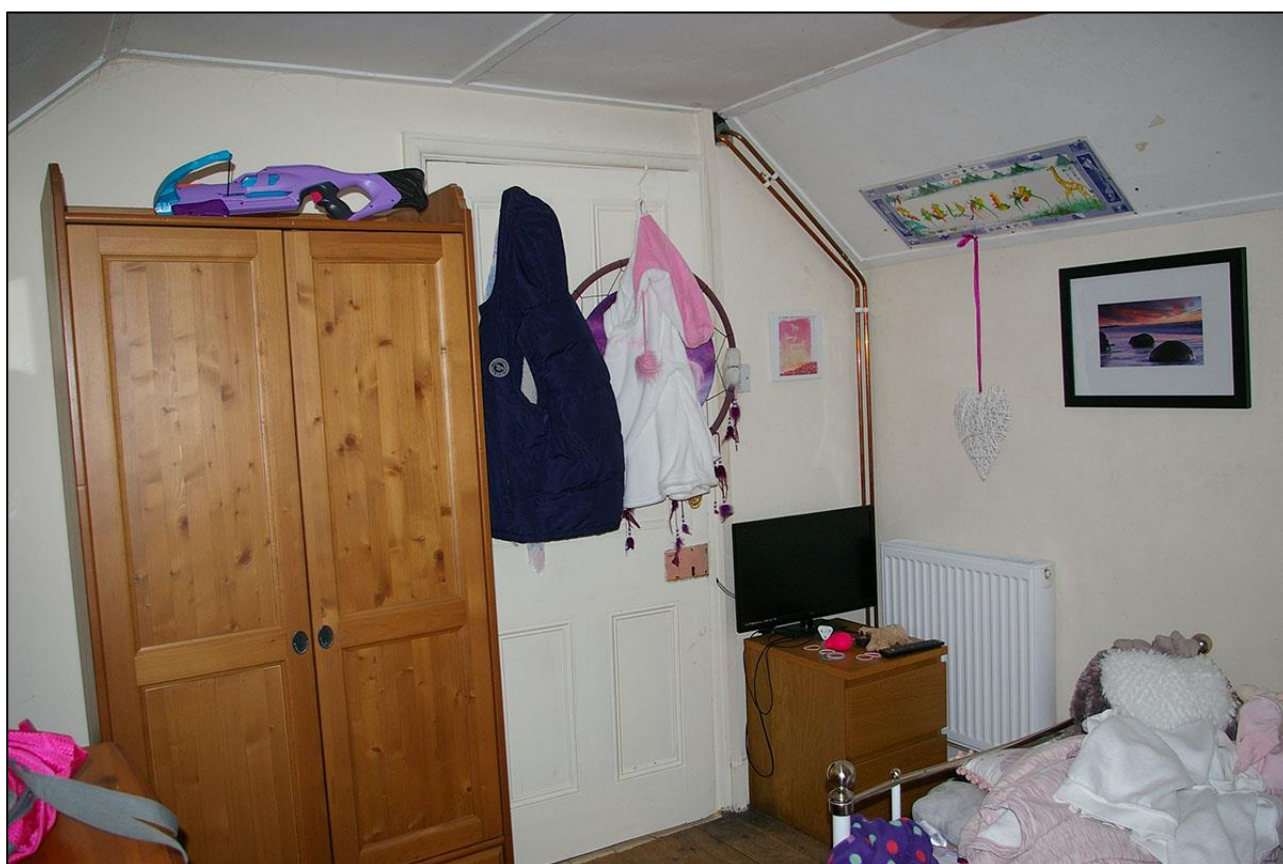
R13; VIEWED FROM THE NORTH-EAST.

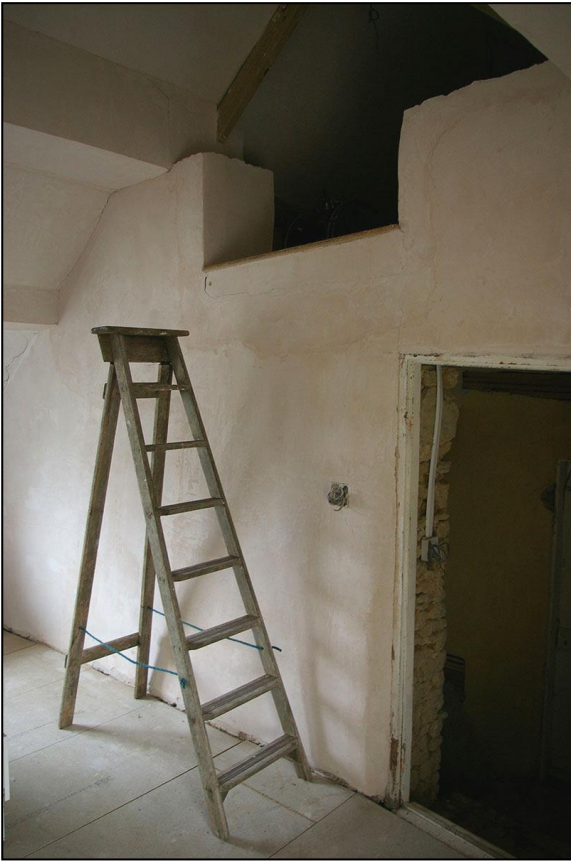
R15, THE FORMER GABLE END WALL OF THE ORIGINAL COTTAGE, FORCED TO PROVIDE WIDER ACCESS TO THE LOFT SPACE ADJACENT; FROM THE SOUTH-WEST.

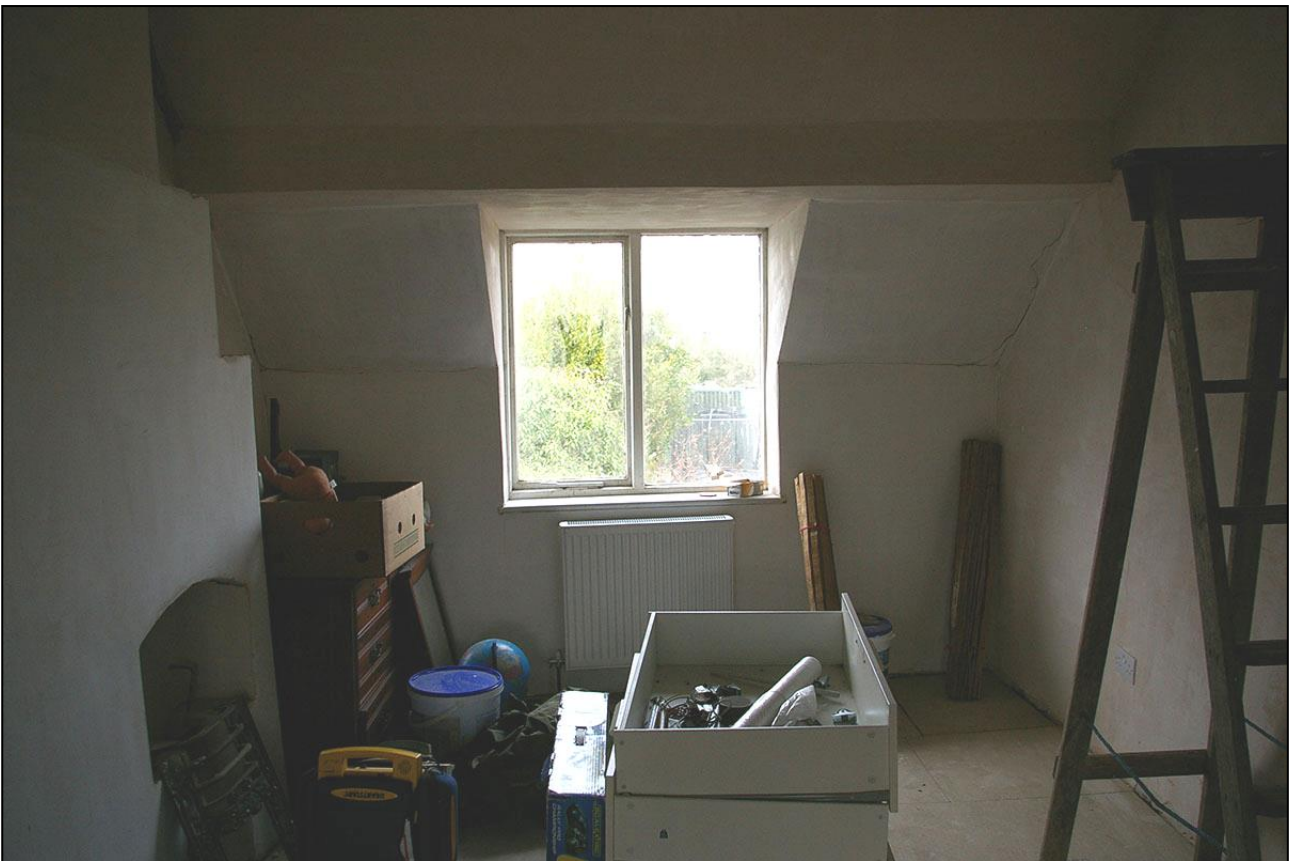
R15, THE NORTH WALL WITH MID 20<sup>TH</sup> CENTURY WINDOW IN LOW WALL; VIEWED FROM THE SOUTH.

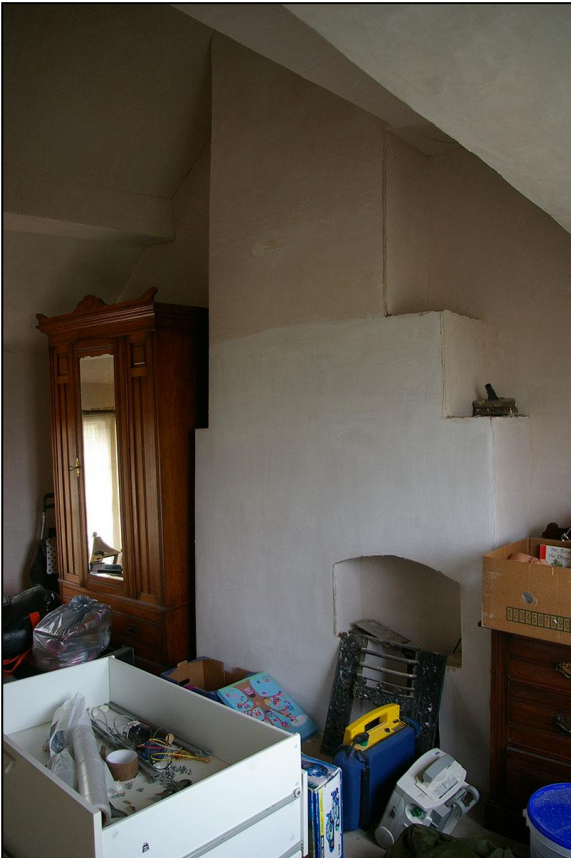
R15, THE BRICK STACK, BUILT UP AGAINST THE WALL OF THE OLD BAKEHOUSE; VIEWED FROM THE NORTH-EAST.

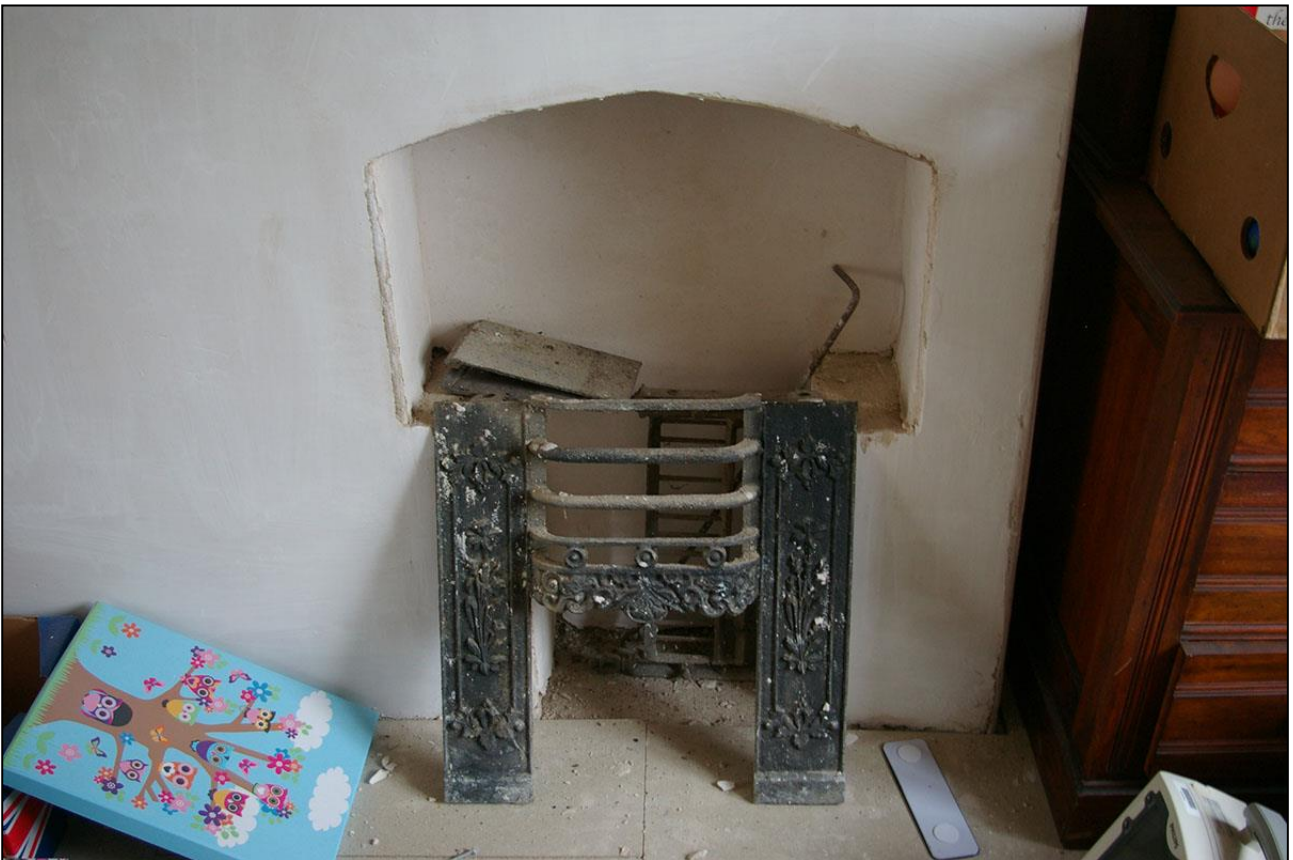
R15, THE FINE SMALL LATE 18<sup>TH</sup> CENTURY OR EARLY 19<sup>TH</sup> CENTURY HOB GRATE; VIEWED FROM THE EAST.

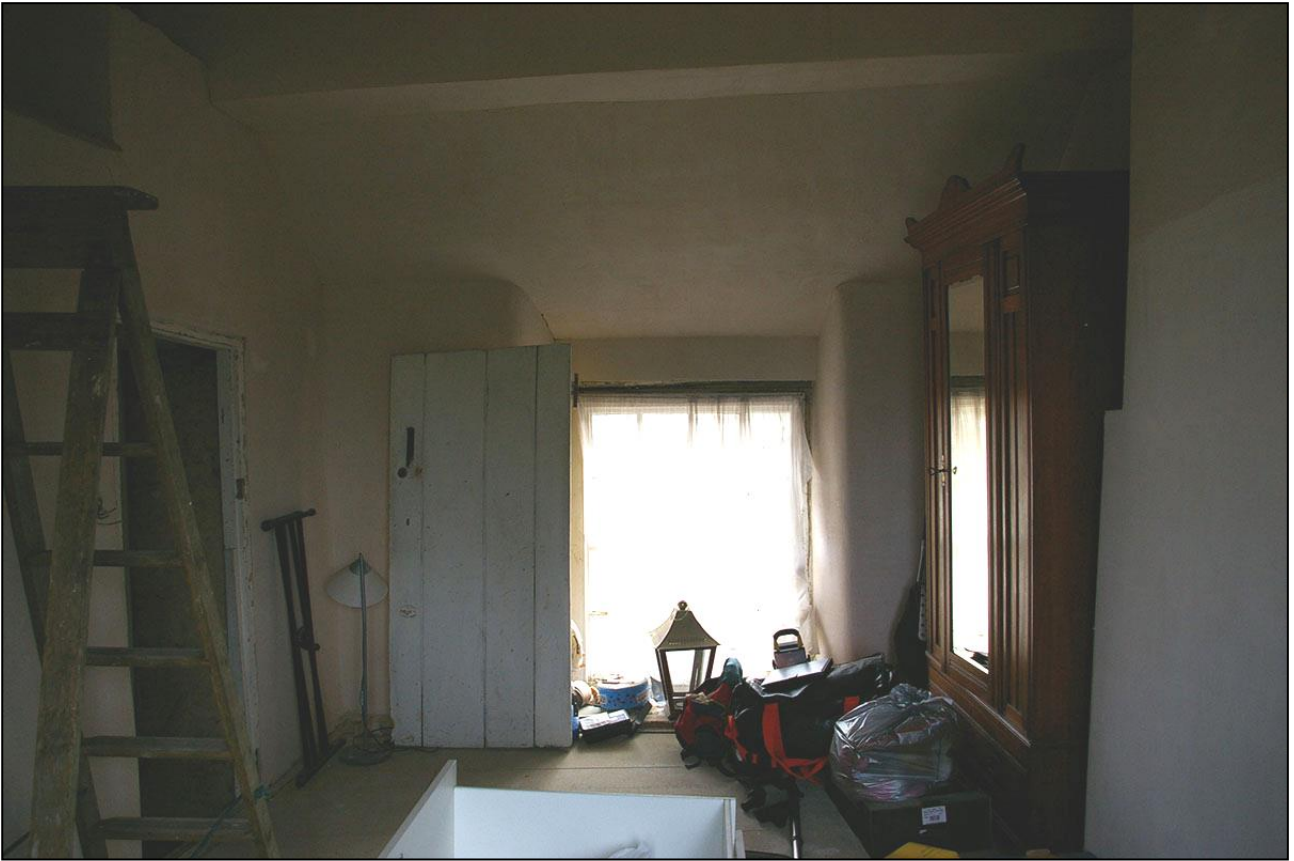
R15, THE SOUTH WALL; VIEWED FROM THE NORTH.

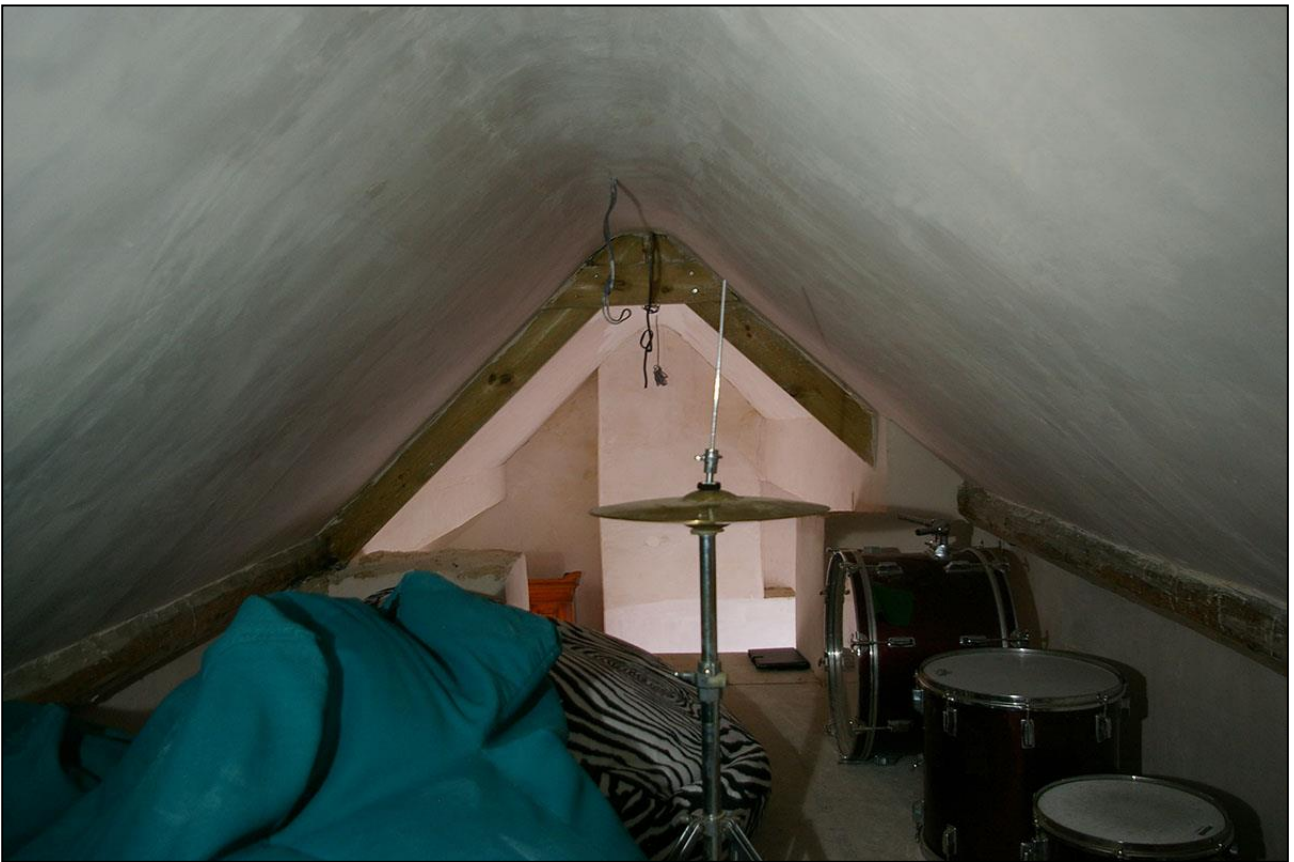
R16, THE CONVERTED LOFT SPACE R14 AND R10; VIEWED FROM THE EAST.

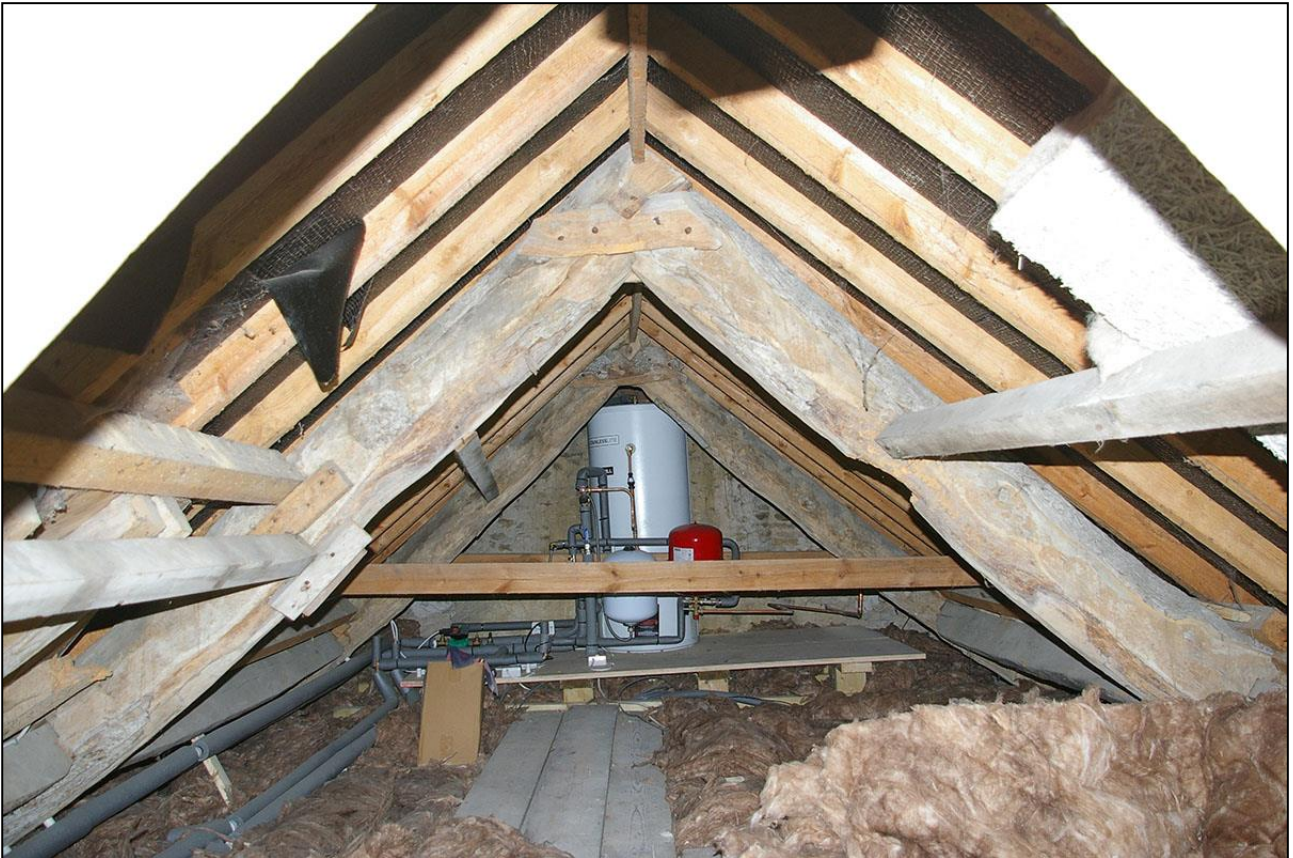
R17, THE LOFT SPACE SHOWING TWO TRUSSES AND LOOKING THROUGH THE THIRD; VIEWED FROM THE WEST.

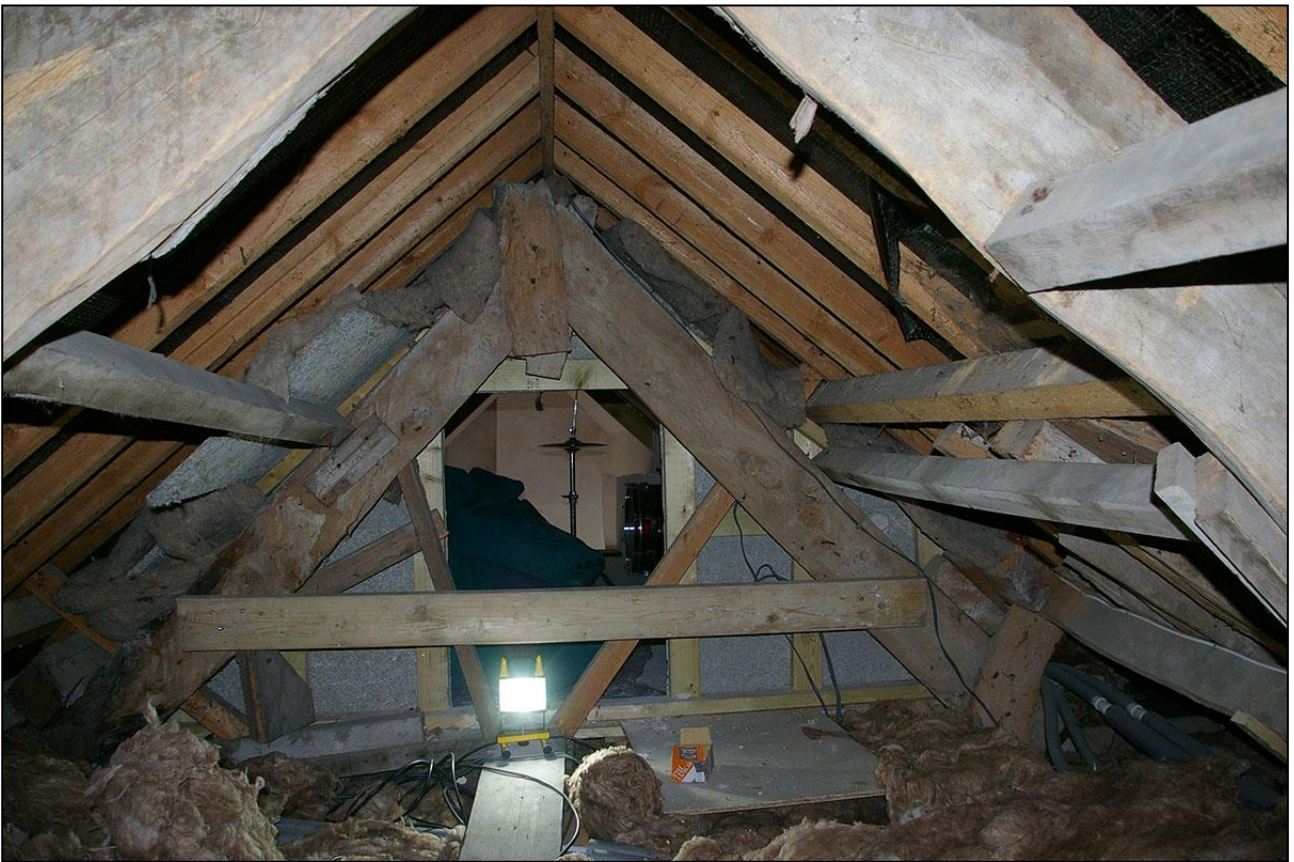
R17, VIEW BACK TO THE TRUSS BETWEEN R16 AND R17; VIEWED FROM THE EAST.
