THE SYNAGOGUE NEW STREET PENZANCE CORNWALL

Updated - Historic Building Assessment

South West Archaeology Ltd. report no. 190402

By N. Boyd & E. Wapshott
Report Version: **FINAL**

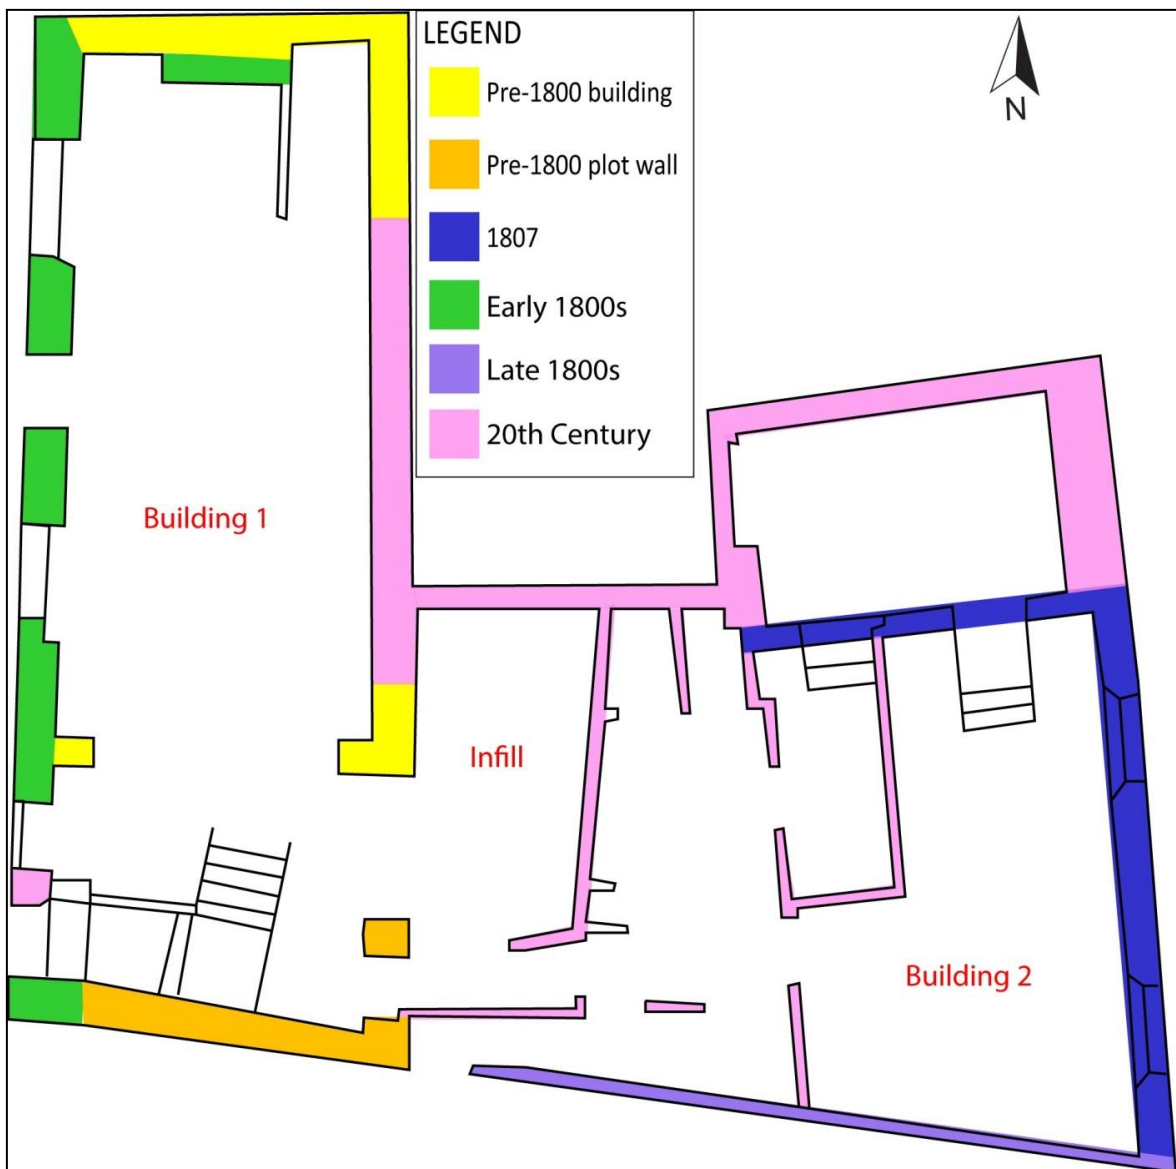
A later 19th or early 1900s phase of studwork repaired and further raised the building in the last years of synagogue usage or when the Plymouth Brethren took over in 1907. This non-conformist evangelical group continued to use the building as a prayer house, but we have no defined evidence of their impact on the building and 1908 photographs of the interior show much of the synagogue furniture and layout remained until the building was stripped and converted.

FIGURE 7: PROVISIONAL PHASE DIAGRAM (GROUND FLOOR).

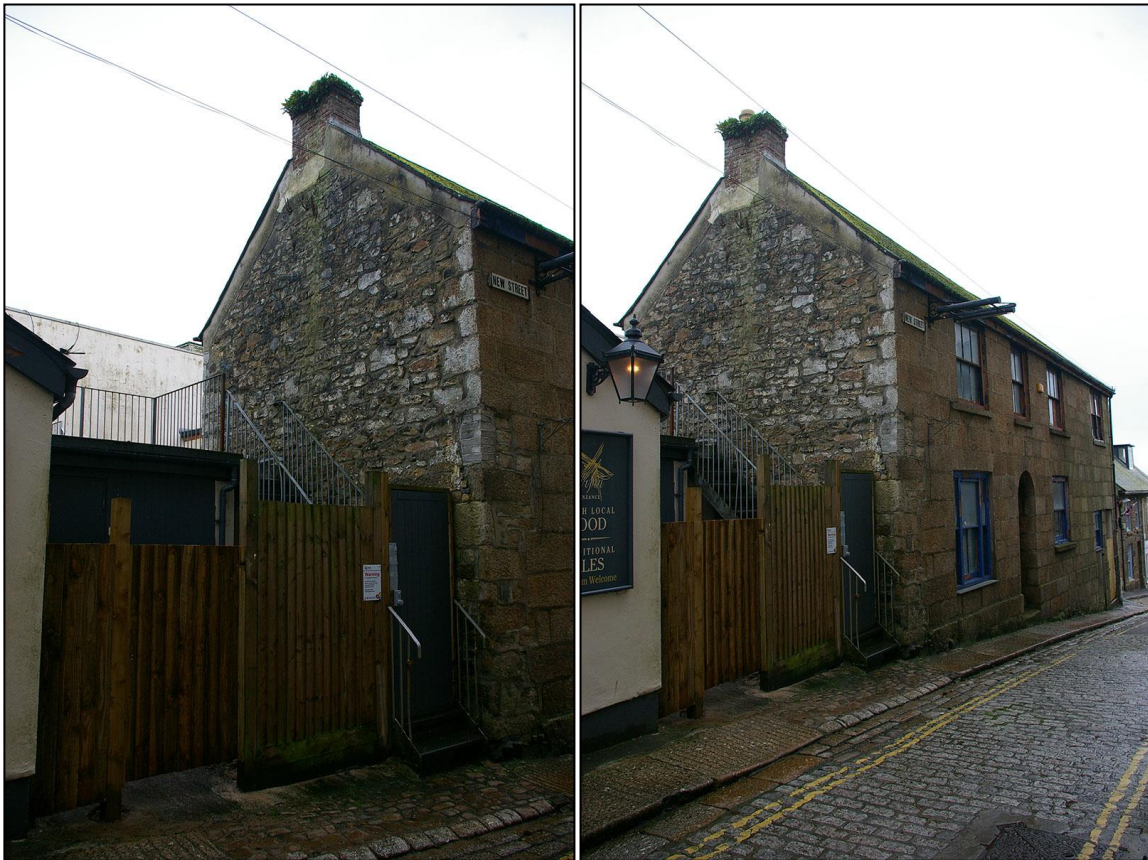
The north gable elevation is steeply pitched, the roofline has been raised, having been even sharper before, patched with brick and rendered at the eaves. There is a large, brick, box stack, in lime mortar, rising from the apex, with lead flashings. The long, rear, east wall has been largely replaced with concrete block for much of the ground floor, surviving best to the north-east, but appears intact to the first floor. It presents as blind on the ground floor but has a blocked loading door set high into the eaves on the first floor. Several later access points have been forced into this wall at the south end on both ground and first floors, linking it to Building 2, the former synagogue. The south end of the building has been truncated and then extended; internal stubs of rubble walling survive on the ground floor, indicating the former gable. The current south gable of the extension has been built up and over a former town plot boundary wall and is of regularised build, built up with studwork and brick noggin, over a low section of earlier granite, pebble and killas rubble. The west wall, which fronts onto the street, has been re-faced with granite ashlar. This presentation facade can clearly be seen to cut into the earlier wall and, whilst it looks correct on the exterior, it is clear on the interior face that the windows sit in partially blocked openings, and that the doorway has been forced in the earlier stonework, to create a sense of symmetry. The current windows are Victorian in style, but relatively recent copies, and due to the dereliction of the building are in poor condition.

LEFT: THE NORTH GABLE END WALL OF NO.1, A HEAVY GRANITE RUBBLE WALL, WITH ADDED LATER BRICK STACK; FROM THE NORTH-WEST.
RIGHT: THE WEST ELEVATION WITH GRANITE ASHLAR RE-FACING, MOST EVIDENT ON THE NORTH-WEST CORNER; FROM THE NORTH-WEST.

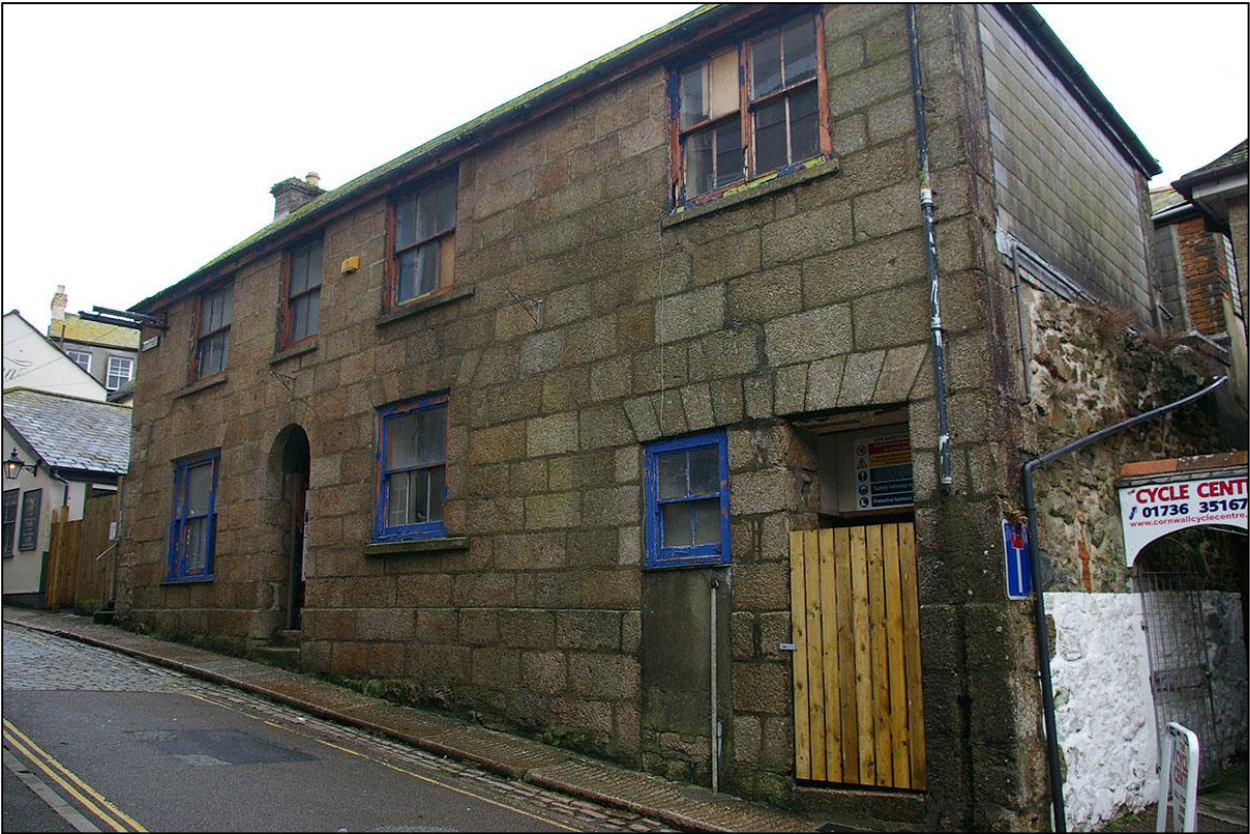
NO.1 NEW STREET, WITH SYMMETRICAL DOOR AND WINDOW TO THE NORTH AND WINDOW AND BLOCKED CARRIAGE ARCH TO THE SOUTH END; FROM THE WEST, SOUTH-WEST.

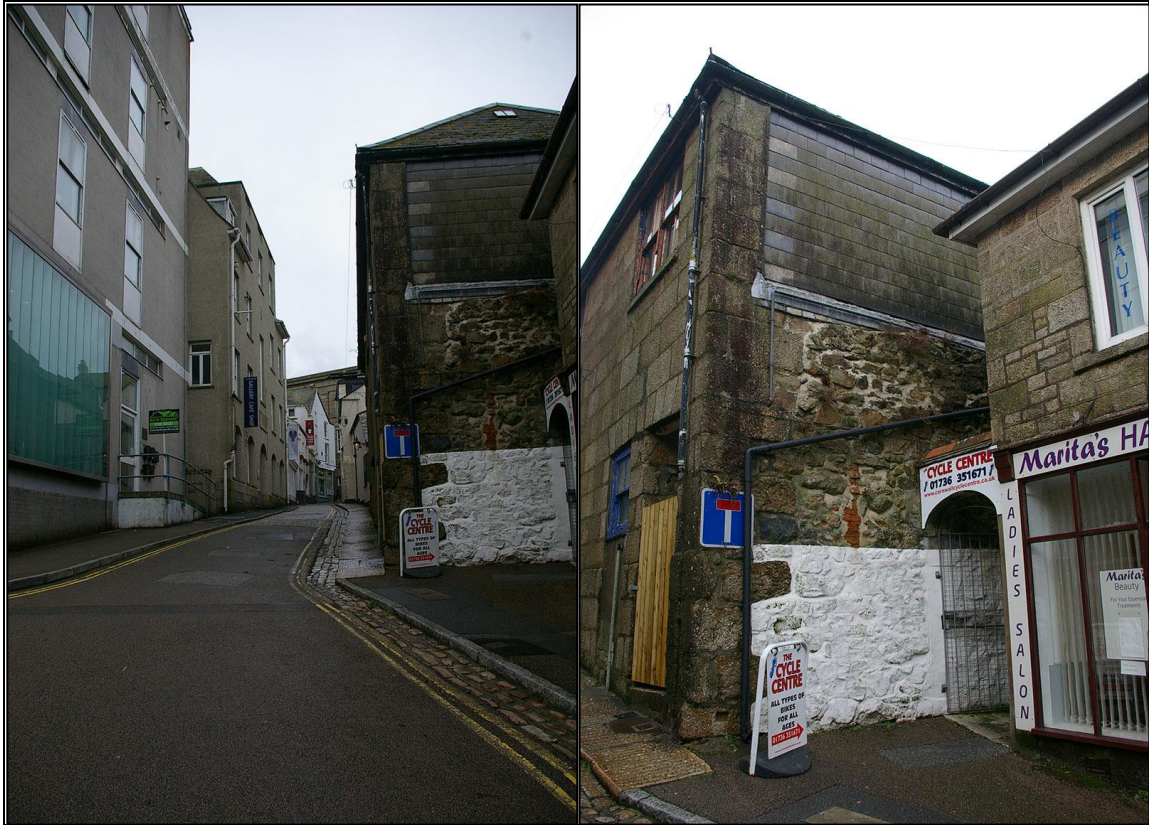
RIGHT: THE TRUNCATED SOUTH GABLE END OF NO.1 NEW STREET, HEAVY GRANITE RUBBLE WALLING AT THE BASE, STUDWORK AND SLATE HANGING ABOVE; FROM THE SOUTH, SOUTH-WEST.

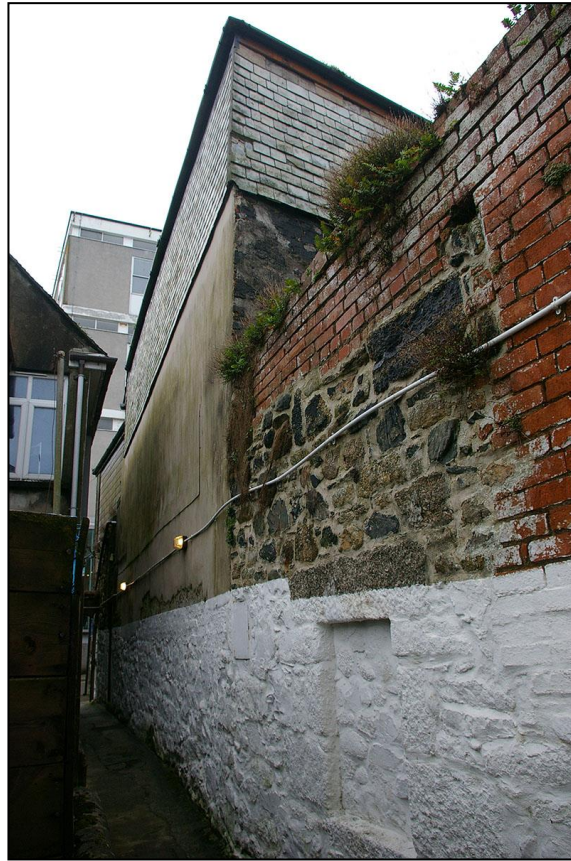
THE SOUTH GABLE END OF THE FORMER SYNAGOGUE, ADJACENT WALL AND BLOCKED WINDOW; FROM THE SOUTH-EAST.

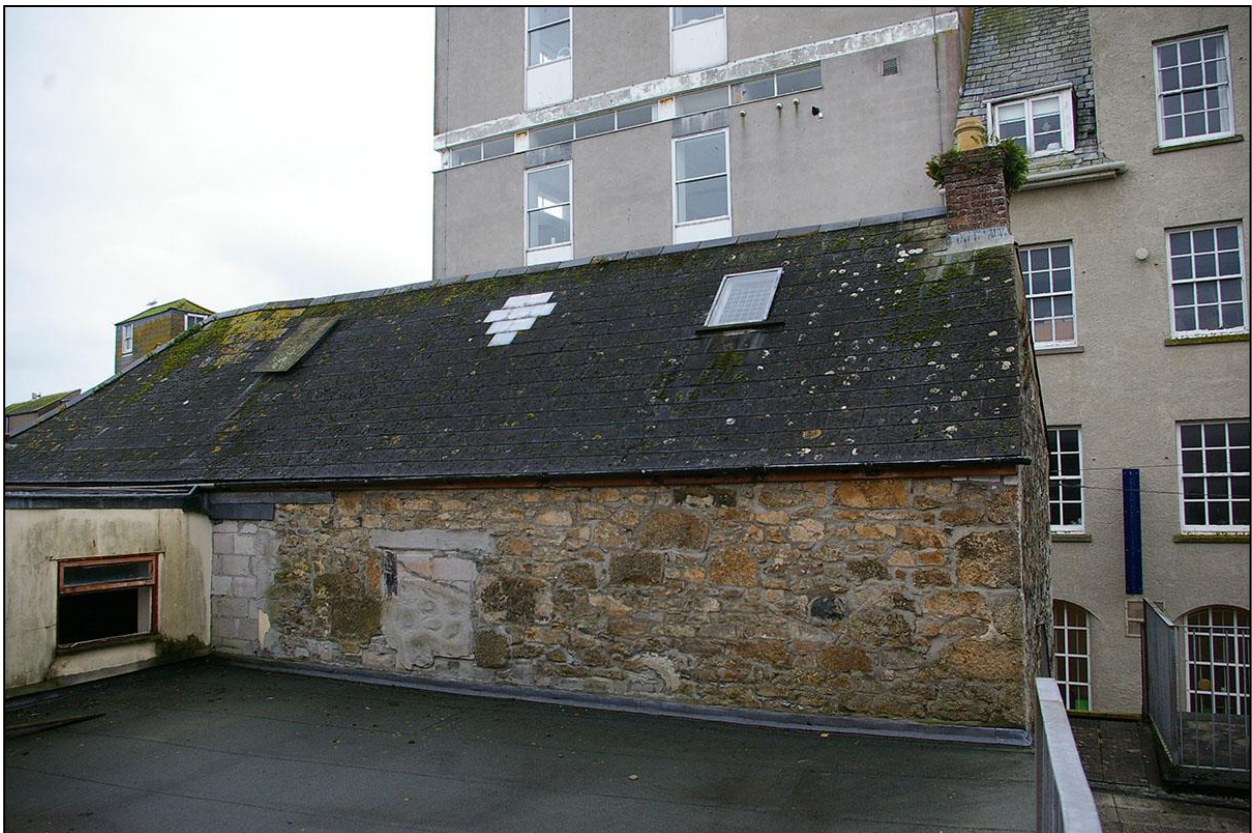
THE EAST WALL OF NO.1 NEW STREET, WITH BLOCKED LOADING DOOR; FROM THE NORTH-EAST.

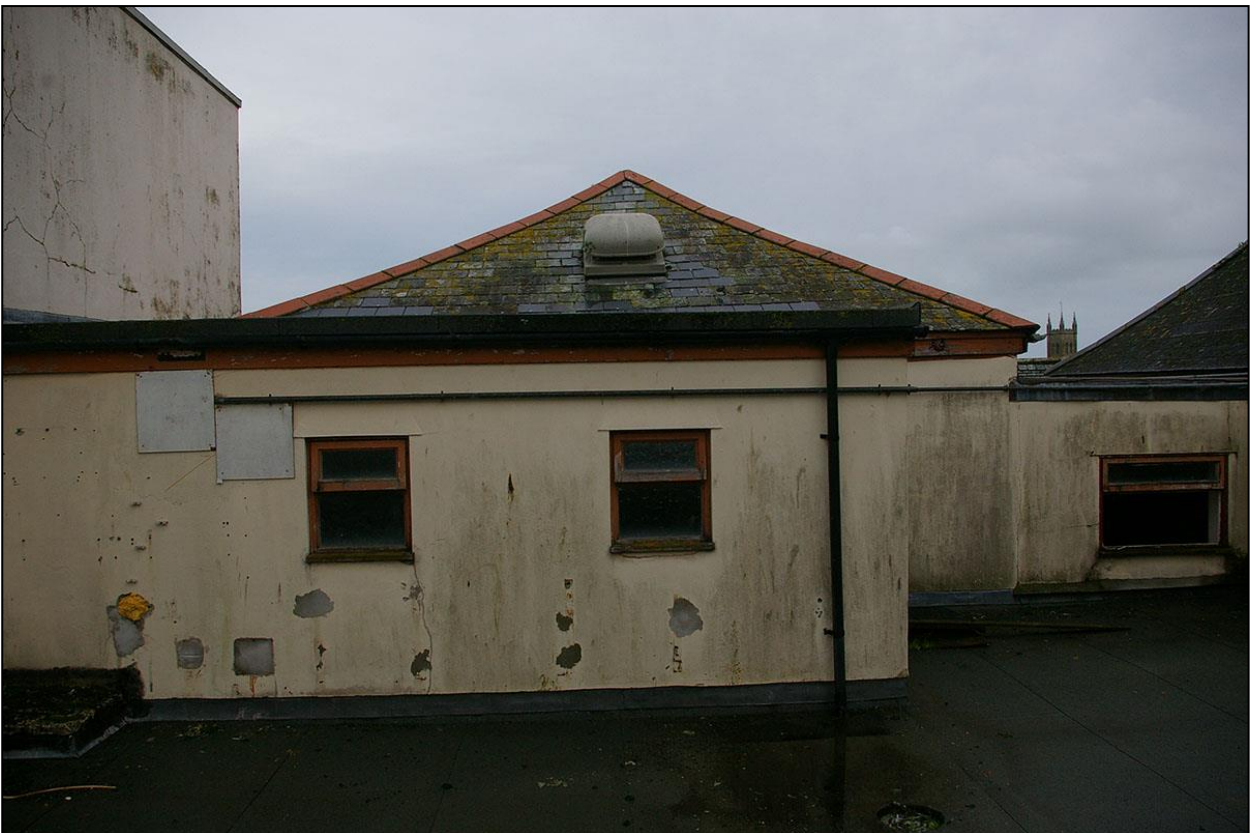
THE HISTORIC COMPOSITE PITCHED ROOF OVER THE SYNAGOGUE, SLATED WITH TERRACOTTA RIDGE TILES; FROM THE NORTH.

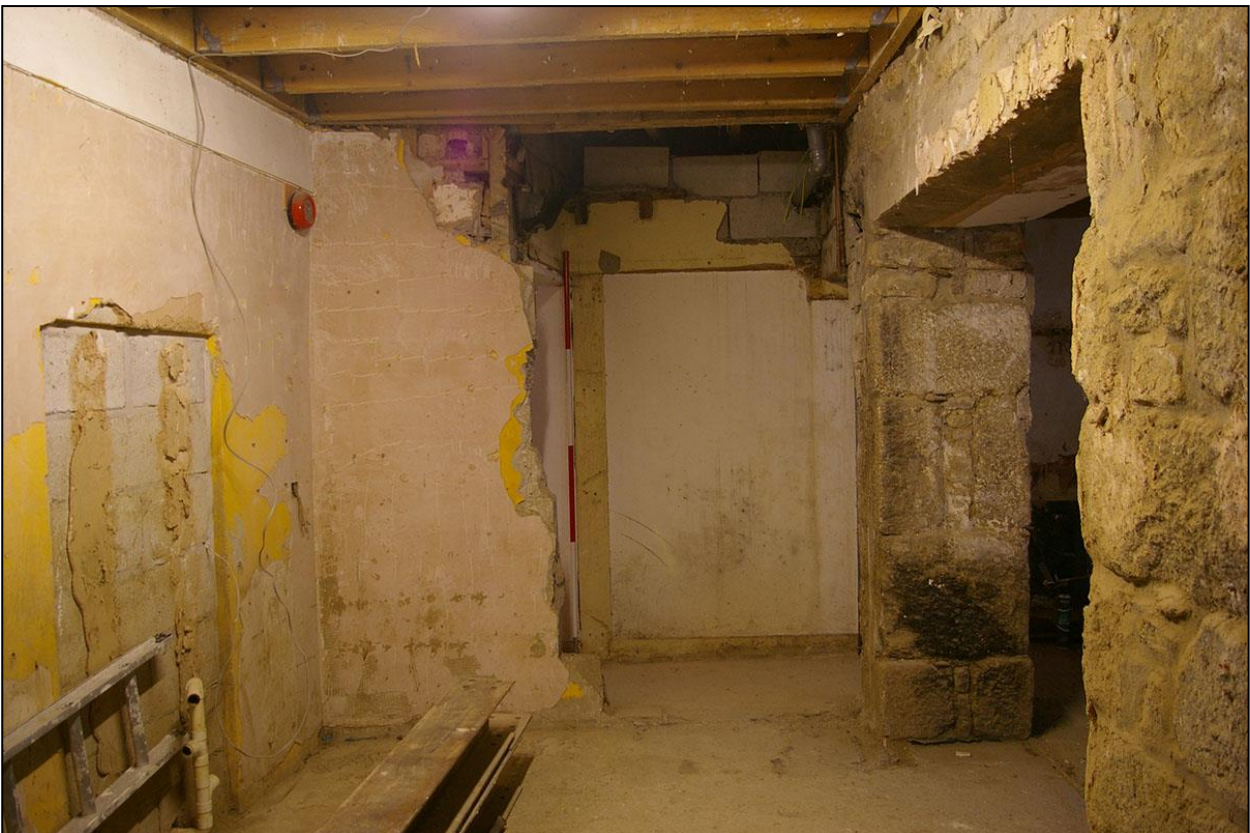
ROOM 2, BEHIND NO.1 NEW STREET, INFILL OF A FORMER OPEN YARD, BUILT OF CONCRETE BLOCK AND BRICK; FROM THE NORTH.

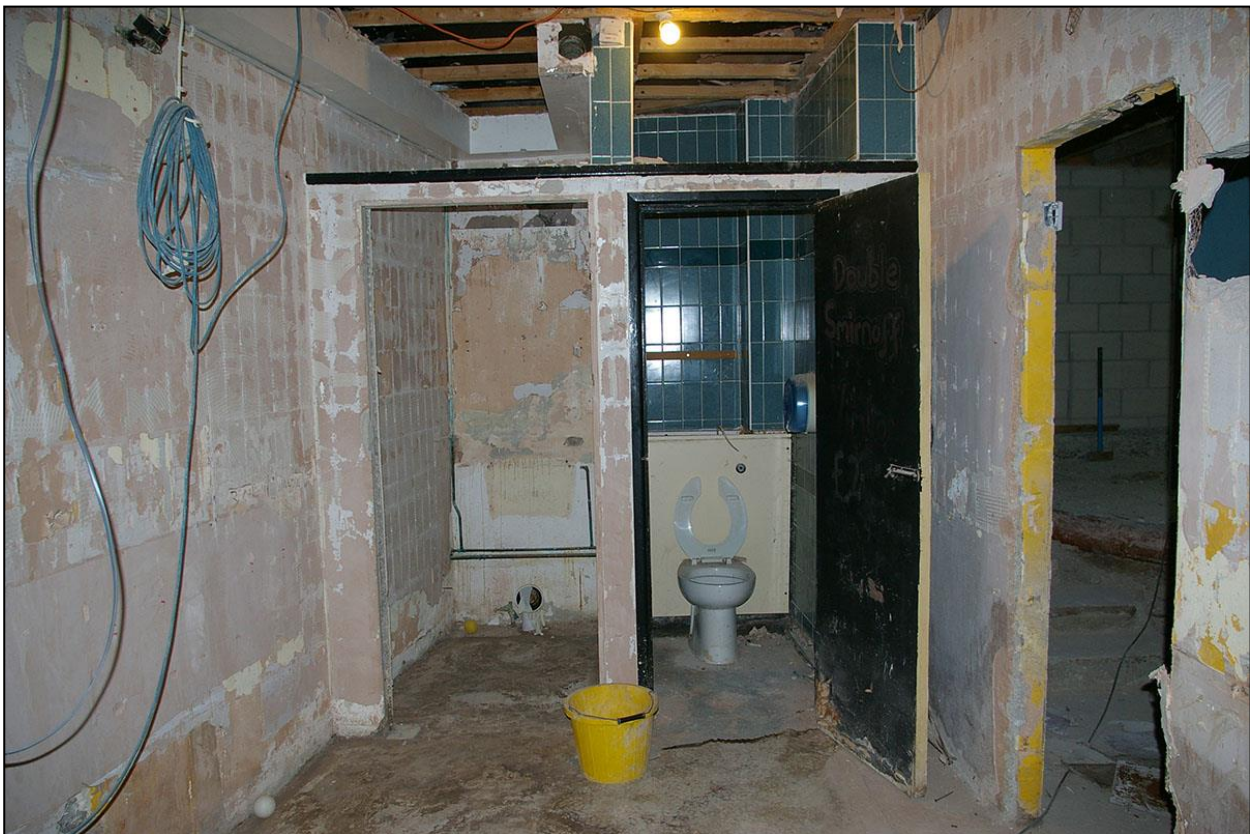
ROOM 3A, A MODERN CONCRETE TOILET BLOCK BUILT IN THE REAR YARD BEHIND NO.1 NEW STREET; FROM THE SOUTH.

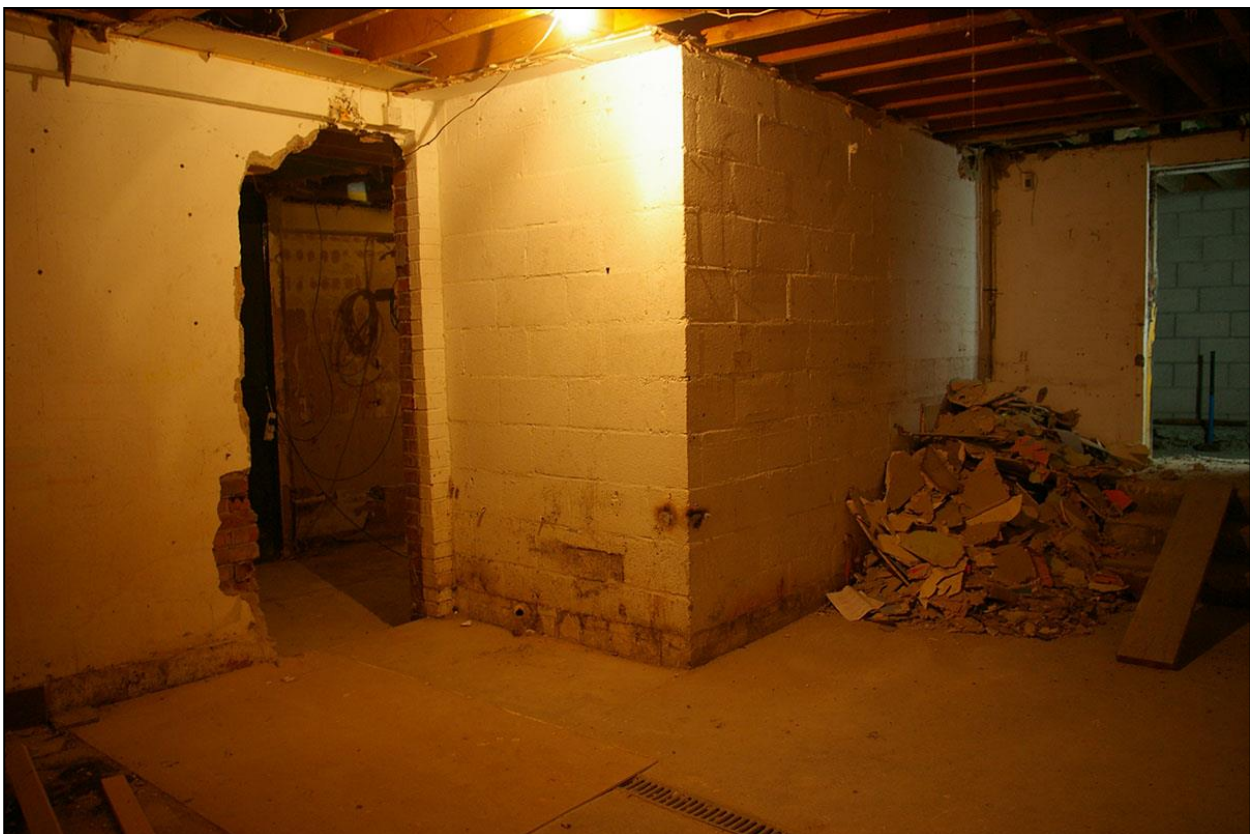
THE CONCRETE INSERTION OF ROOM 3B WITHIN THE FORMER SYNAGOGUE; FROM THE SOUTH-EAST.

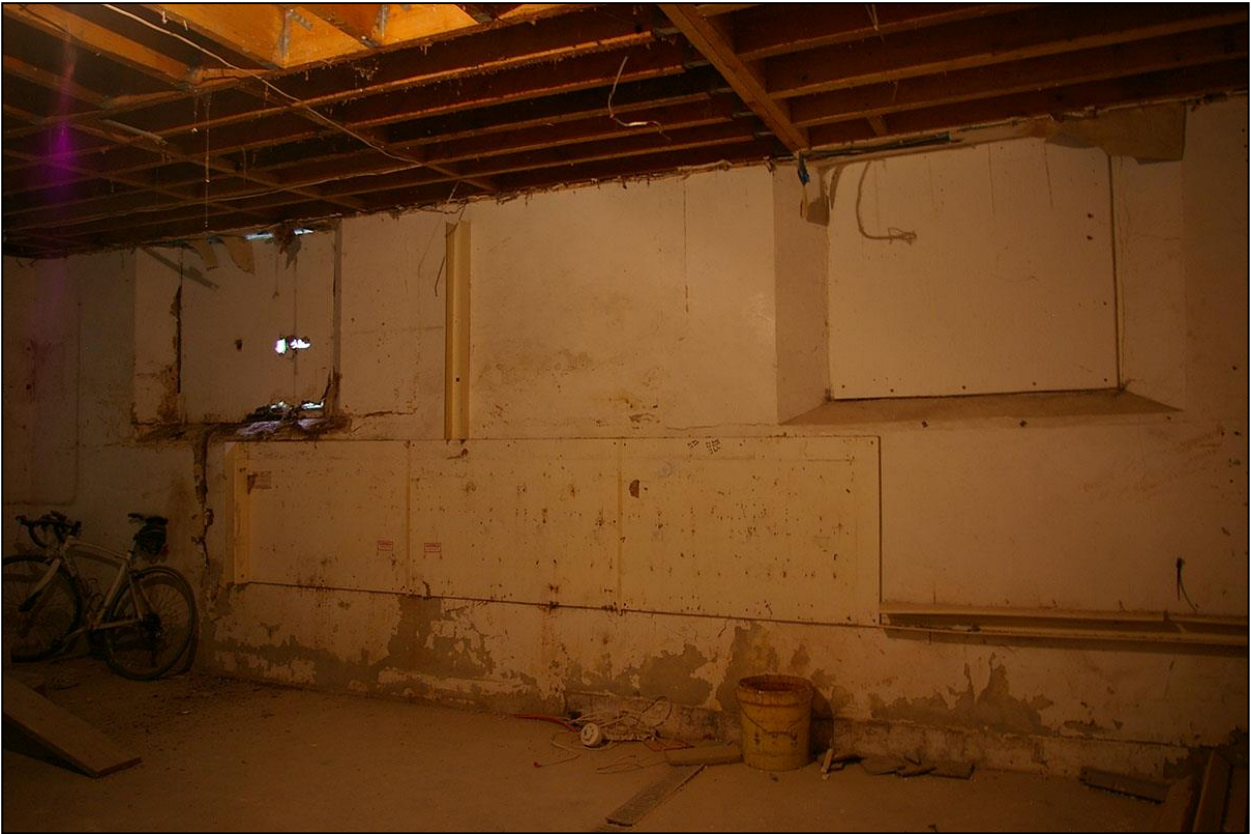
THE IMPORTANT 'EAST' WALL OF THE SYNAGOGUE, WITH TWO WINDOWS, INTENDED TO FACE JERUSALEM; FROM THE WEST, SOUTH-WEST.

The former synagogue windows were heavily altered in the 19th century, poorly repaired in the 20th century and are in very poor condition; however, these windows should be retained and conserved, as they are a vital indicator of this being an 18th/19th century nonconformist religious building. A specific design element to consider is how the floor levels within the synagogue meet

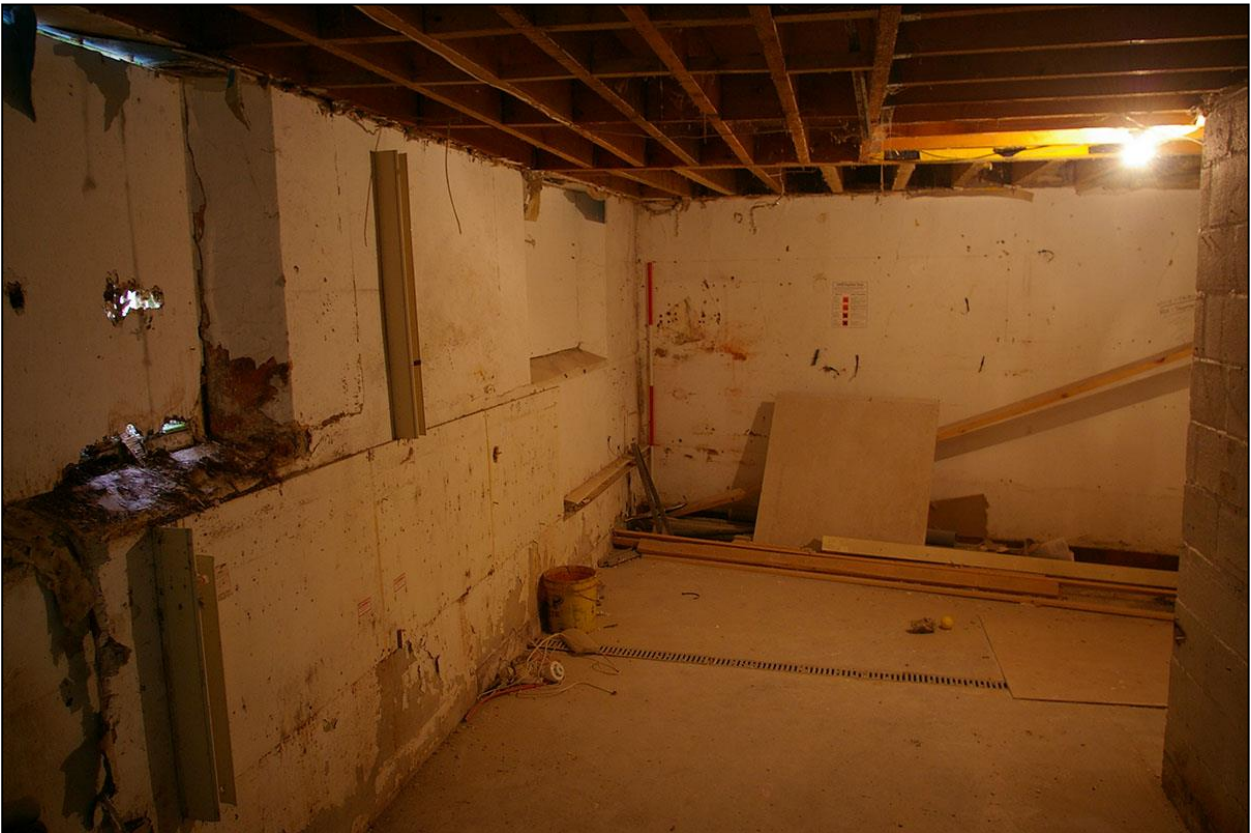
THE EAST AND SOUTH PLASTERED BRICKWORK WALLS OF THE SYNAGOGUE, THE ONLY ELEMENTS WHICH SURVIVE; FROM THE NORTH (2M SCALE).

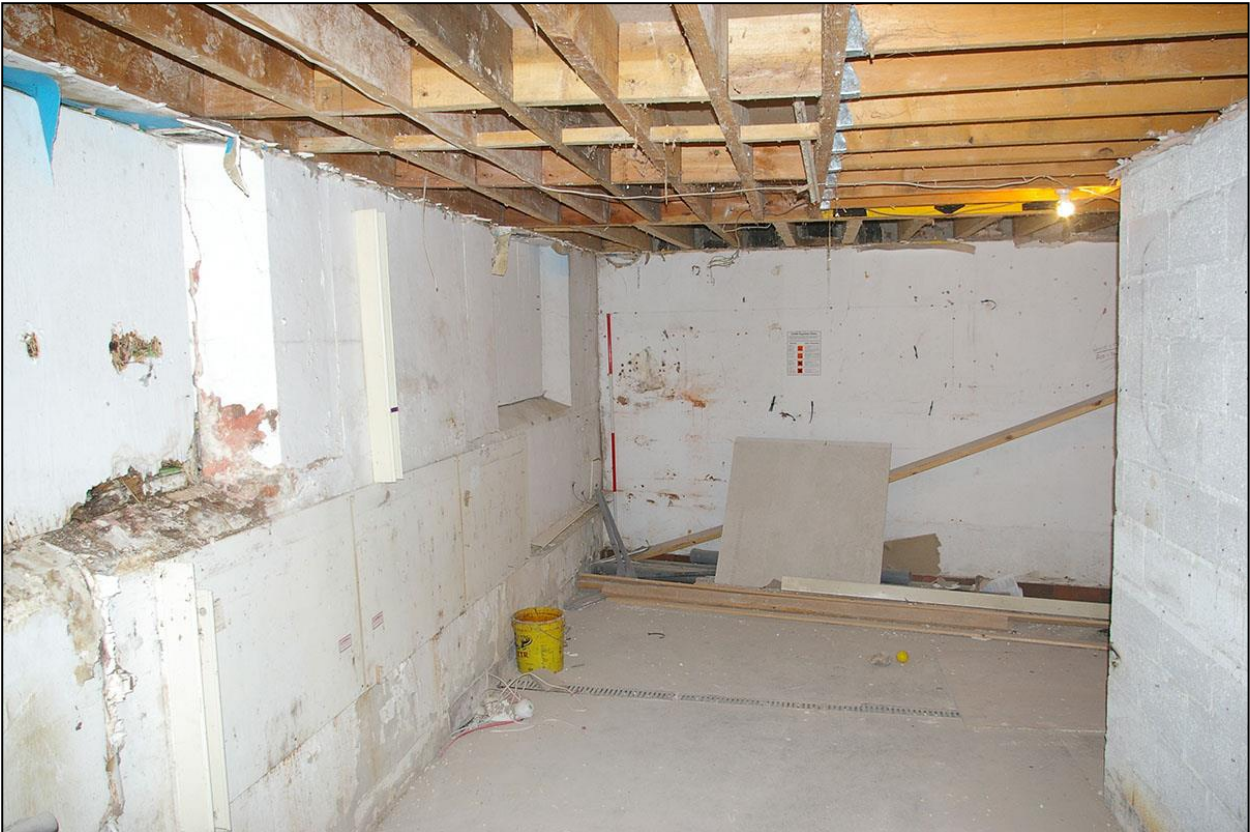
THE EAST AND SOUTH PLASTERED BRICKWORK WALLS OF THE SYNAGOGUE, WITH FLASH; FROM THE NORTH (2M SCALE).

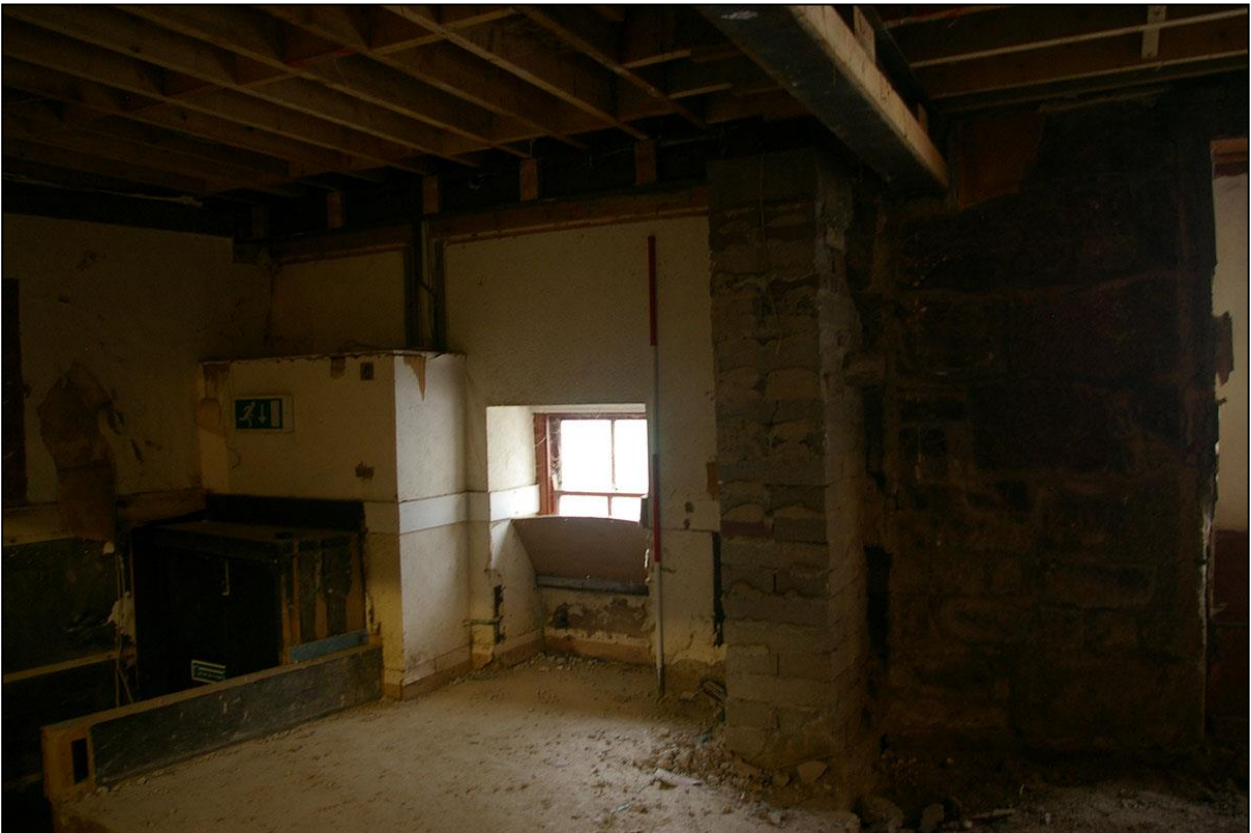
VIEW FROM THE TRUNCATED SOUTH END OF ROOM 6, BACK INTO ROOM 1; FROM THE EAST (2M SCALE).

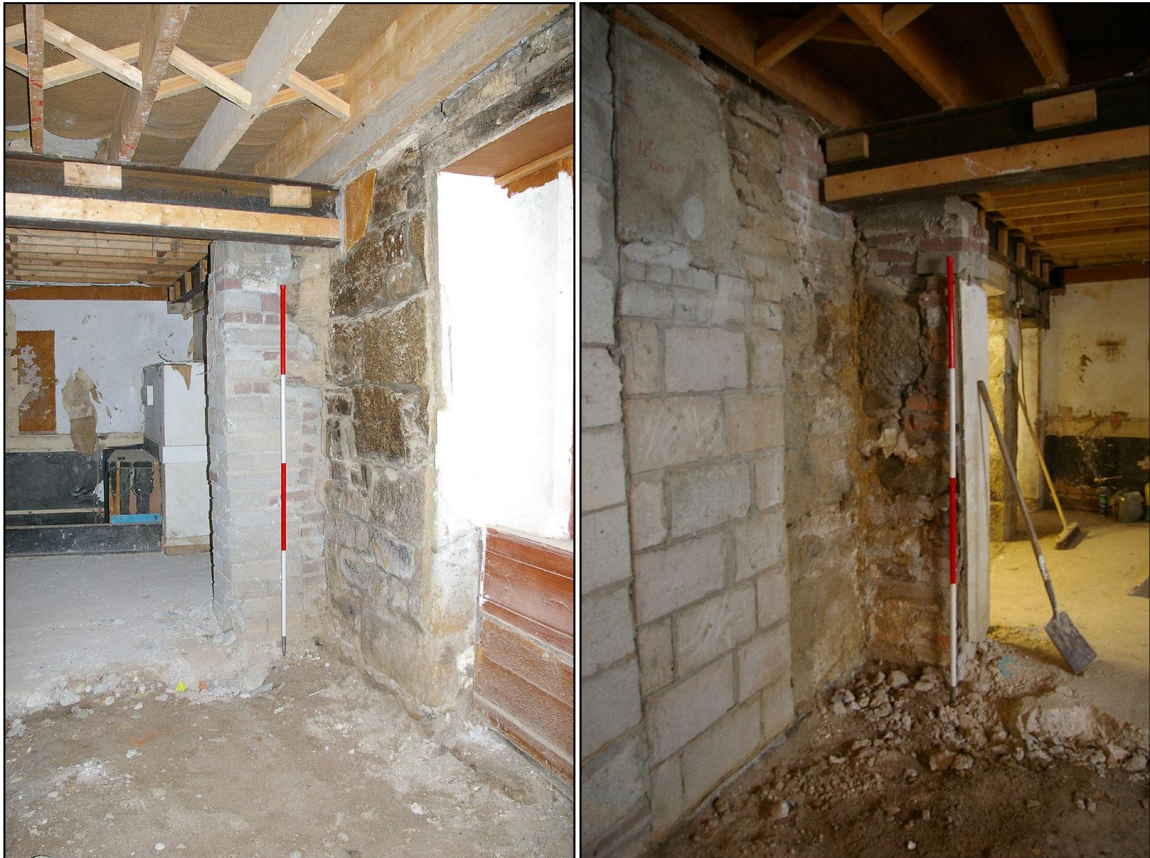
LEFT: THE SOUTH-WEST CORNER OF THE EARLIER BUILDING WITHIN NO.1 NEW STREET, SHOWING THE STUB OF THE ORIGINAL GABLE END WALL; FROM THE NORTH-EAST (2M SCALE).

RIGHT: THE SOUTH-EAST CORNER OF THE EARLIER BUILDING WITHIN NO.1 NEW STREET, SHOWING THE STUB OF THE ORIGINAL GABLE END WALL; FROM THE NORTH-WEST (2M SCALE).

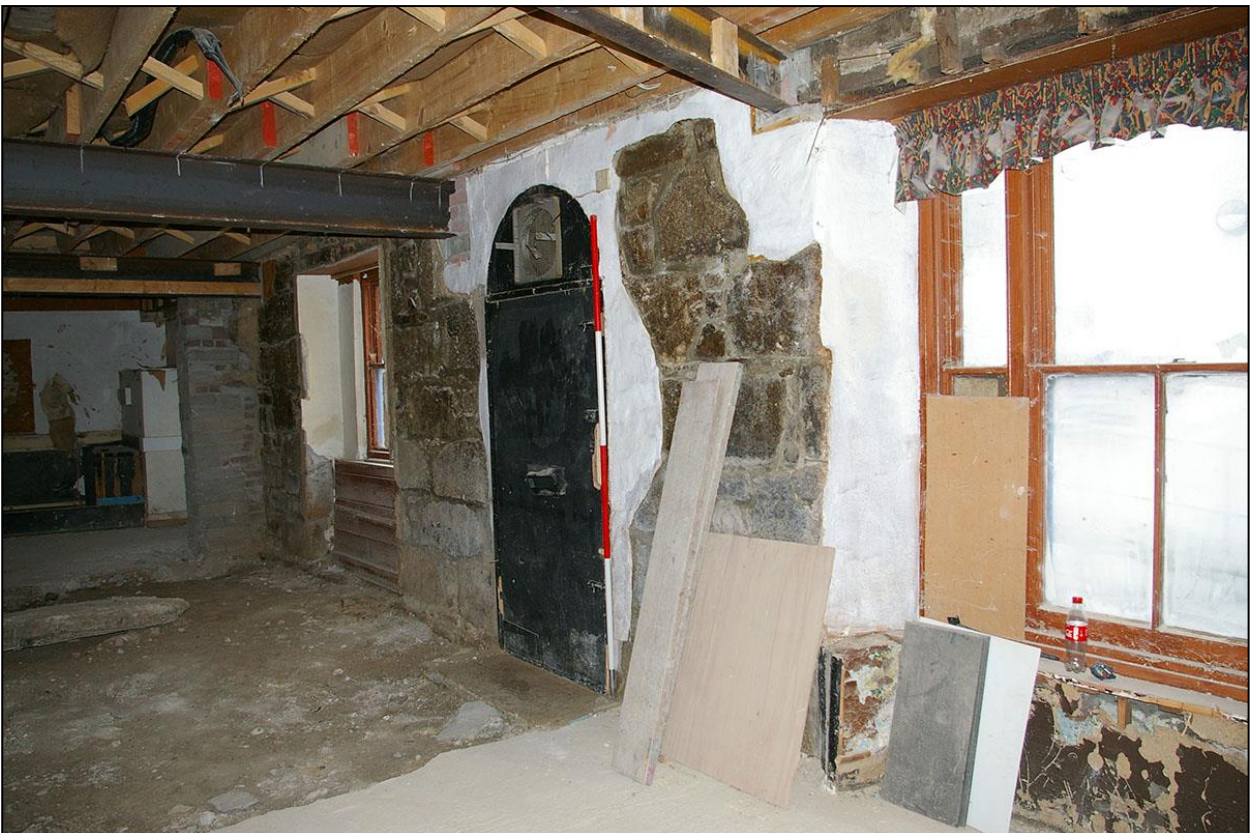
THE WEST WALL OF NO.1 NEW STREET, ROOM 6, WITH TWO WINDOWS AND A CENTRAL DOOR; FROM THE NORTH, NORTH-EAST (2M SCALE).

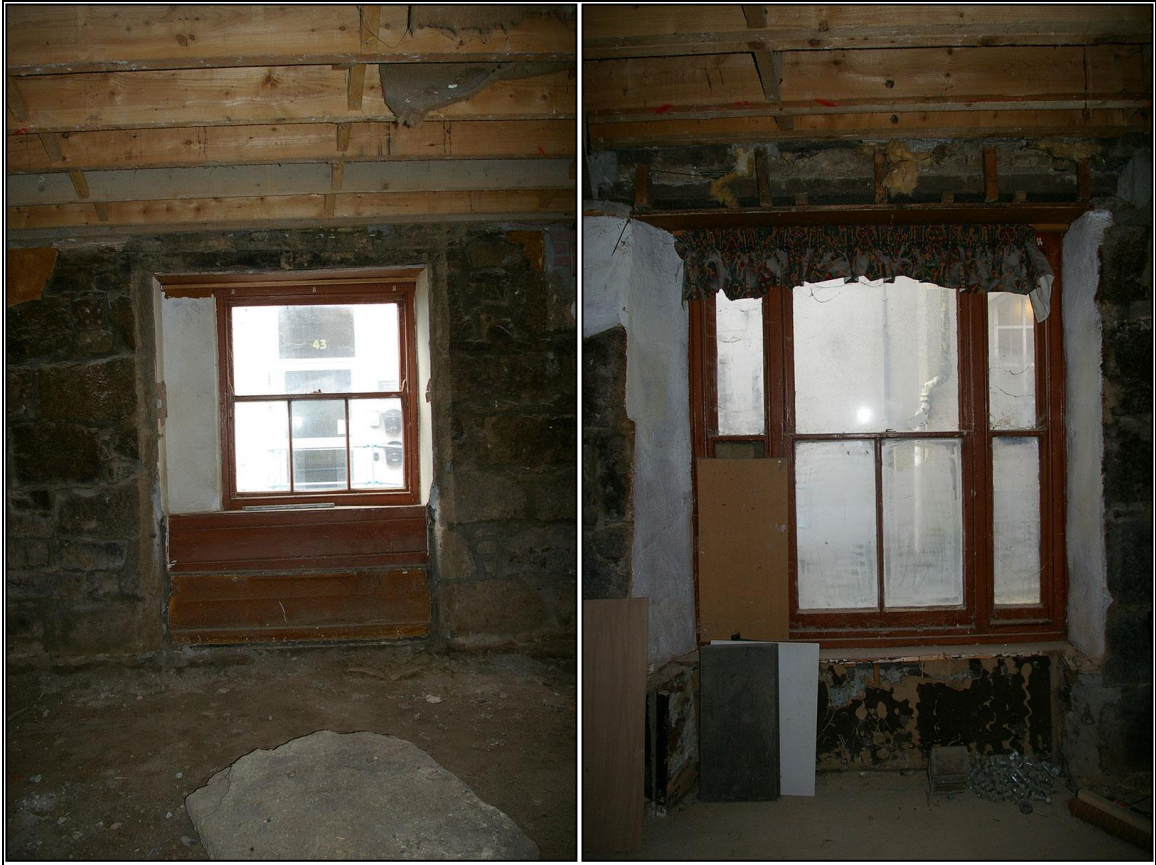
LEFT: THE WINDOW TO THE SOUTH, SET WITHIN A PARTIALLY BLOCKED OPENING, THIS PHASING NOT VISIBLE ON THE ASHLAR FRONTAGE;
FROM THE EAST.

RIGHT: THE WINDOW TO THE NORTH, SET WITHIN A PARTIALLY BLOCKED OPENING, THIS PHASING NOT VISIBLE ON THE ASHLAR FRONTAGE;
FROM THE EAST.

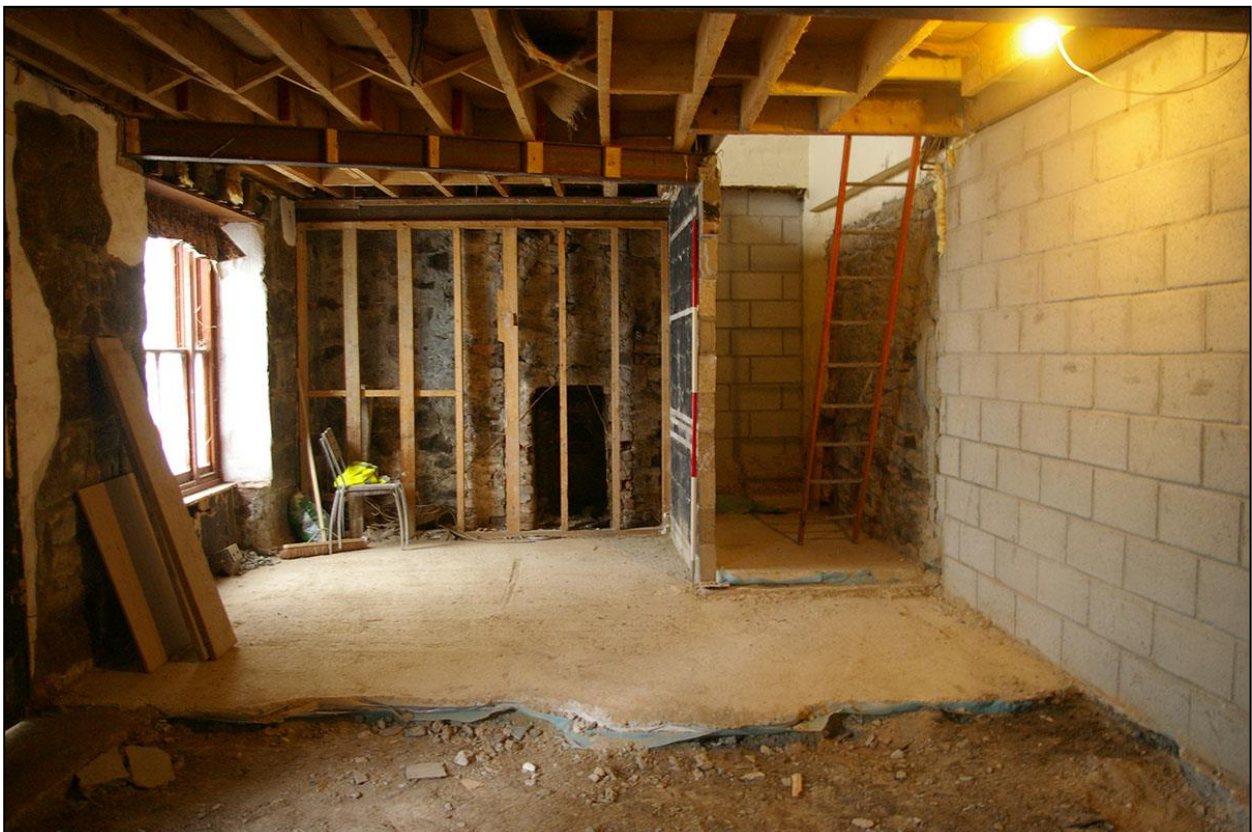
THE NORTH GABLE OF ROOM 1, WITH STONE RUBBLE AND BRICK STACK; FROM THE SOUTH (2M SCALE).

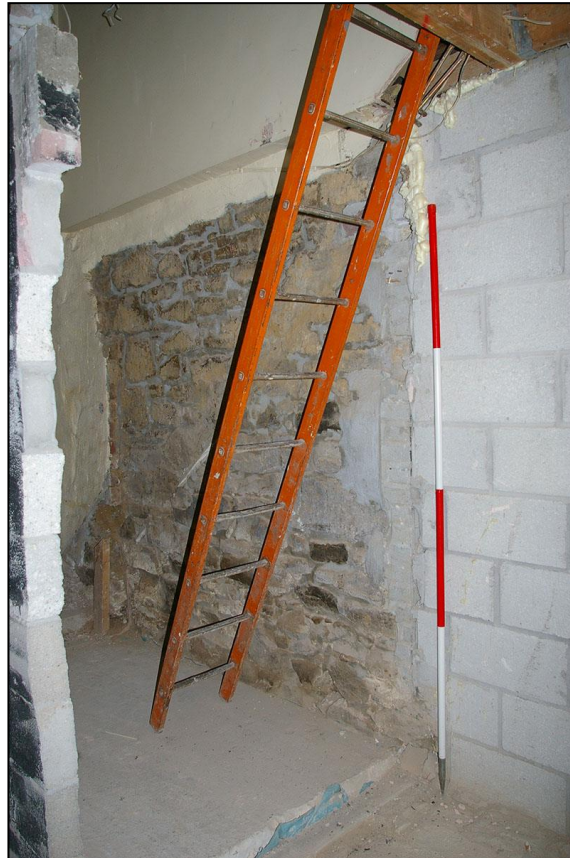
THE SHORT SECTION OF SURVIVING GRANITE RUBBLE IN THE NORTH-EAST CORNER OF ROOM 6, WITH LADDER ACCESS TO THE FIRST FLOOR; FROM THE SOUTH-WEST (2M SCALE).

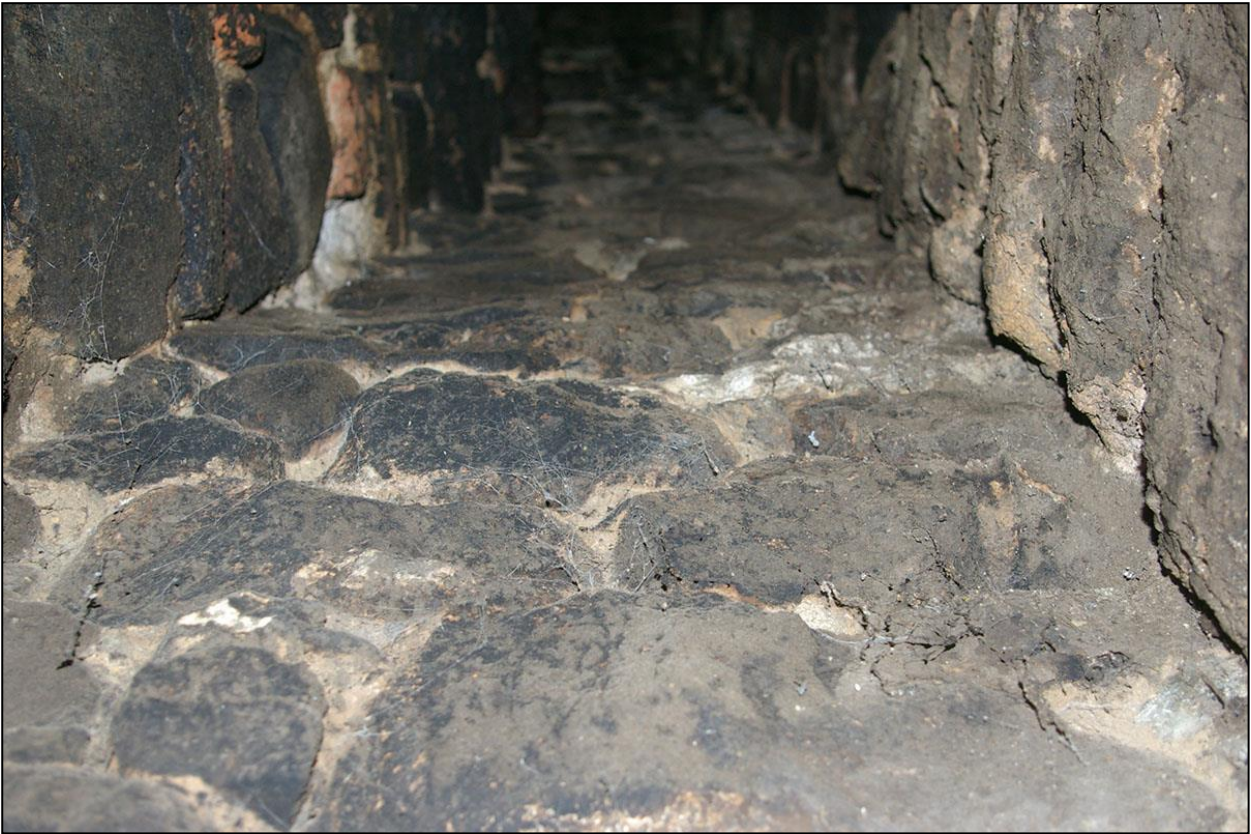
VIEW UP THE SMOKE-BLACKENED, TAPERED STACK; FROM BELOW.

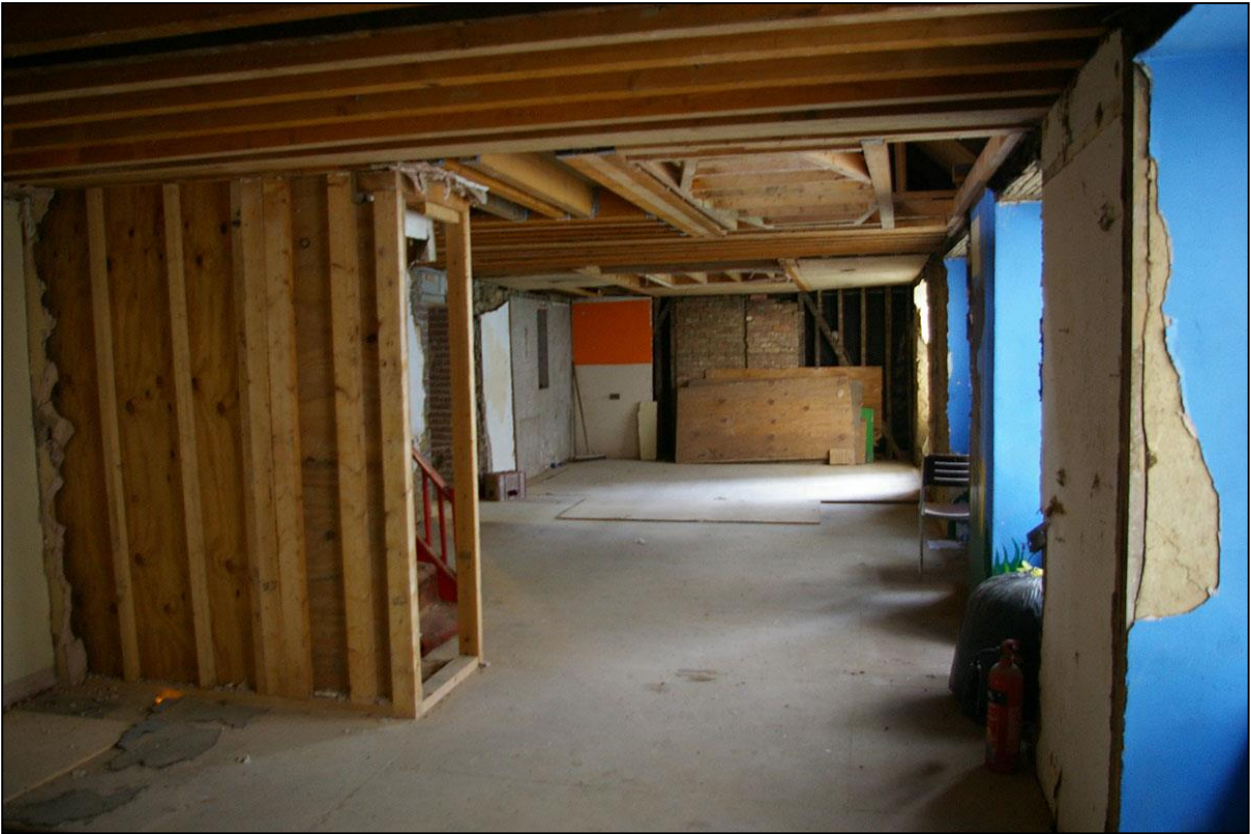
ROOM 7; FROM THE NORTH-WEST.
