THE SYNAGOGUE NEW STREET PENZANCE CORNWALL

Updated - Historic Building Assessment

South West Archaeology Ltd. report no. 190402

By N. Boyd & E. Wapshott
Report Version: **FINAL**

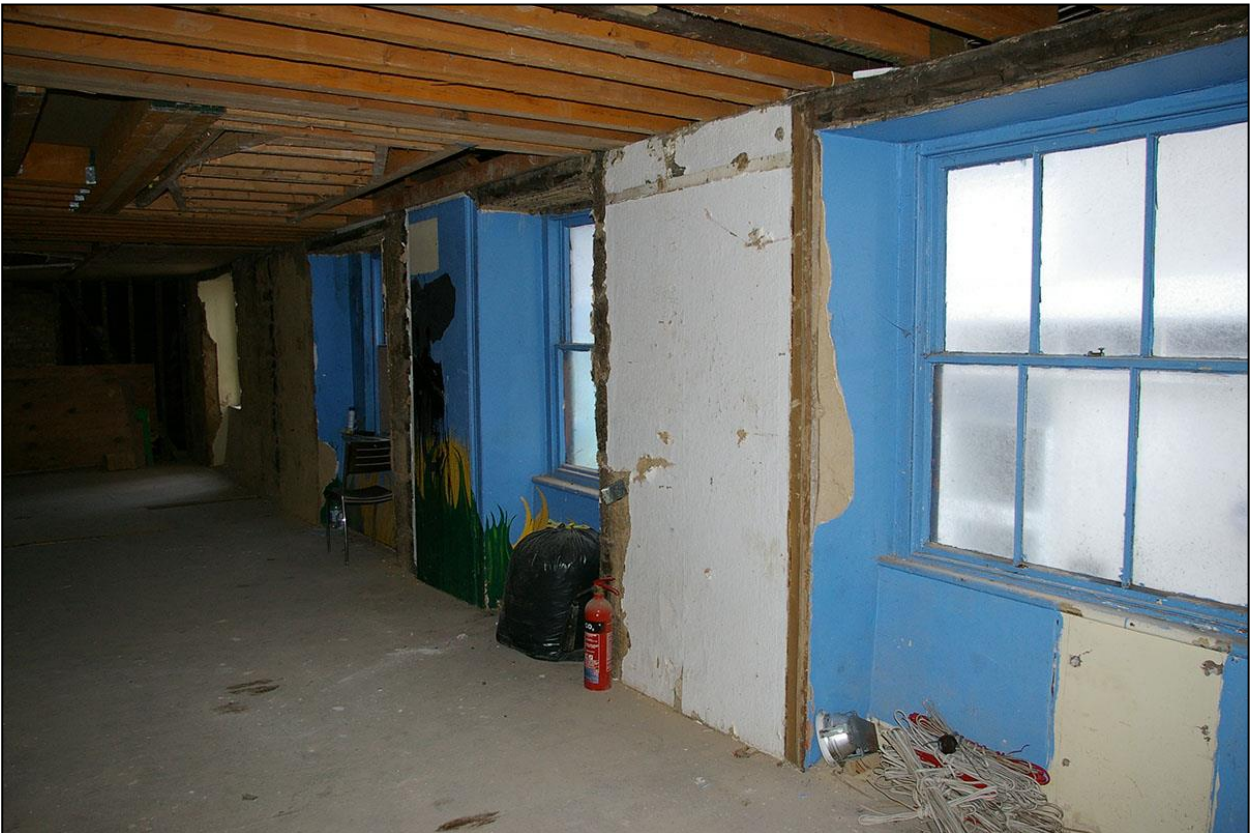
ROOM 7, THE WEST WALL; FROM THE NORTH, NORTH-EAST.

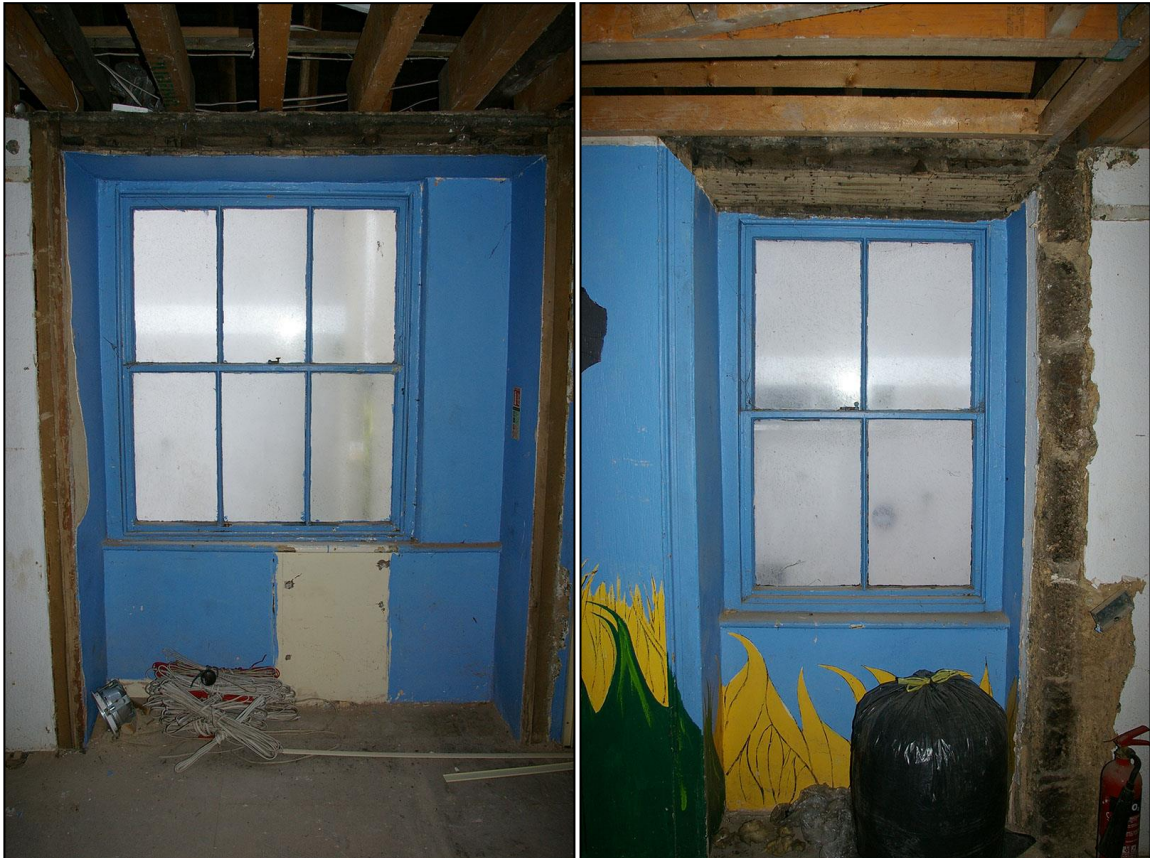
LEFT: ROOM 7, THE WINDOW TO THE NORTH, SET WITHIN A PARTIALLY BLOCKED OPENING, THIS PHASING NOT VISIBLE ON THE ASHLAR FRONTAGE; FROM THE EAST.

RIGHT: ROOM 7, THE WEST WALL, THE SYMMETRICALLY PLACED NARROW WINDOW OVER THE DOORWAY; FROM THE EAST.

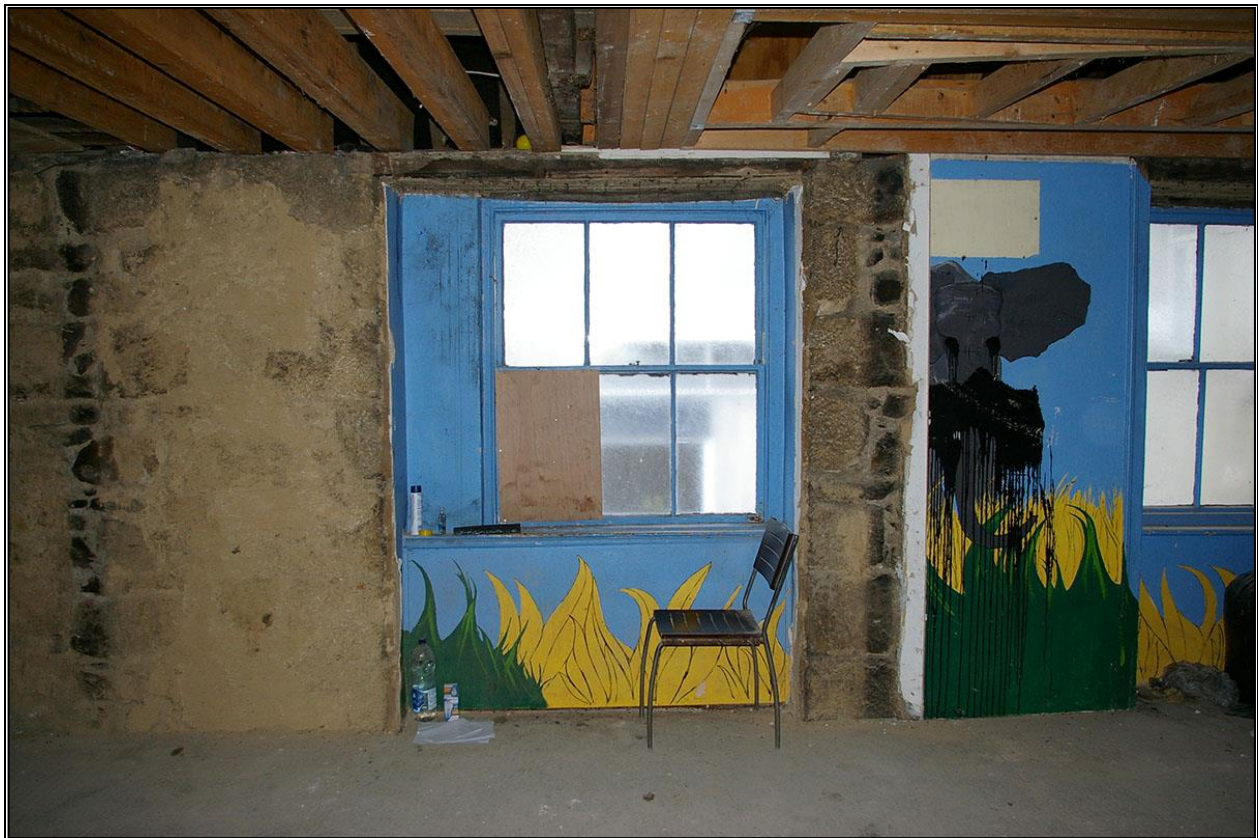
ROOM 7, THE WINDOW TO THE SOUTH, SET WITHIN A PARTIALLY BLOCKED OPENING, THIS PHASING NOT VISIBLE ON THE ASHLAR FRONTAGE; FROM THE EAST.

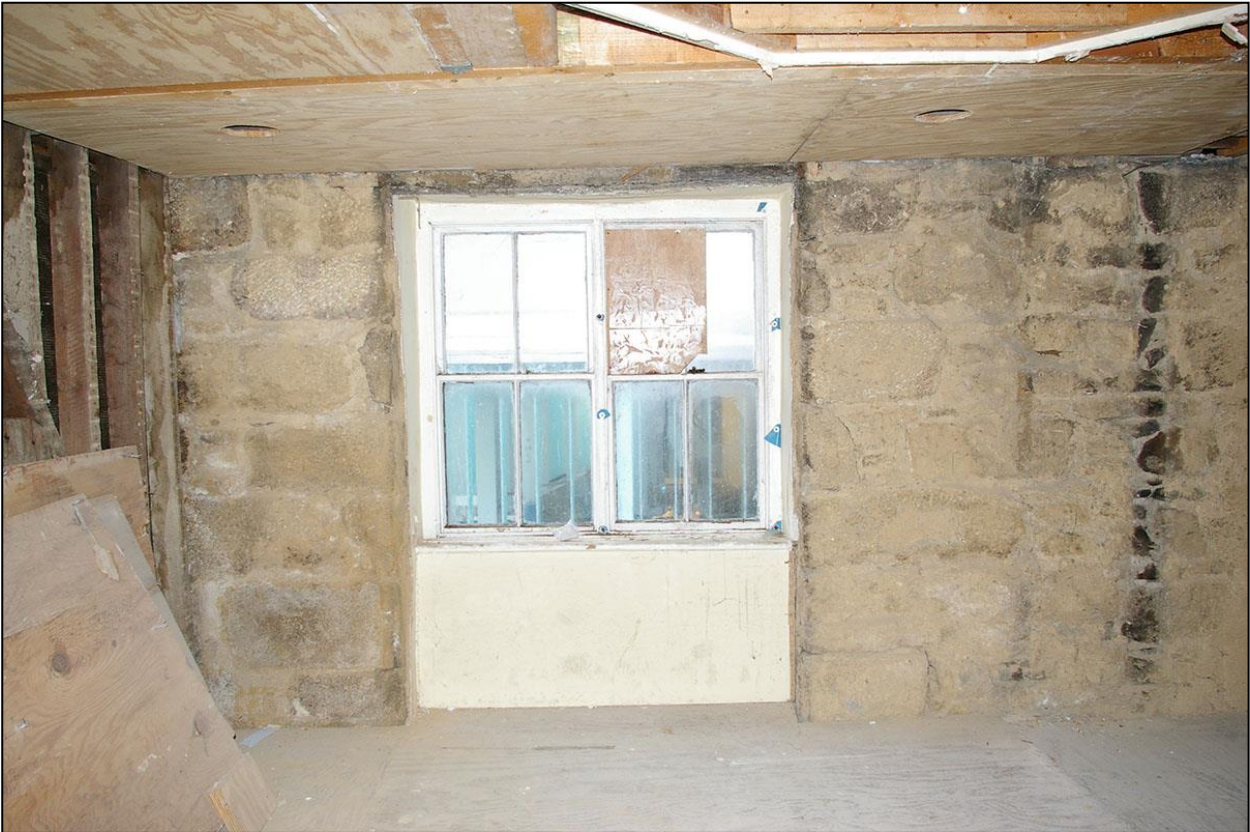
THE DEEP WINDOW ABOVE THE CARRIAGE ARCH IN THE EXTENSION OF NO.1 NEW STREET; FROM THE EAST.

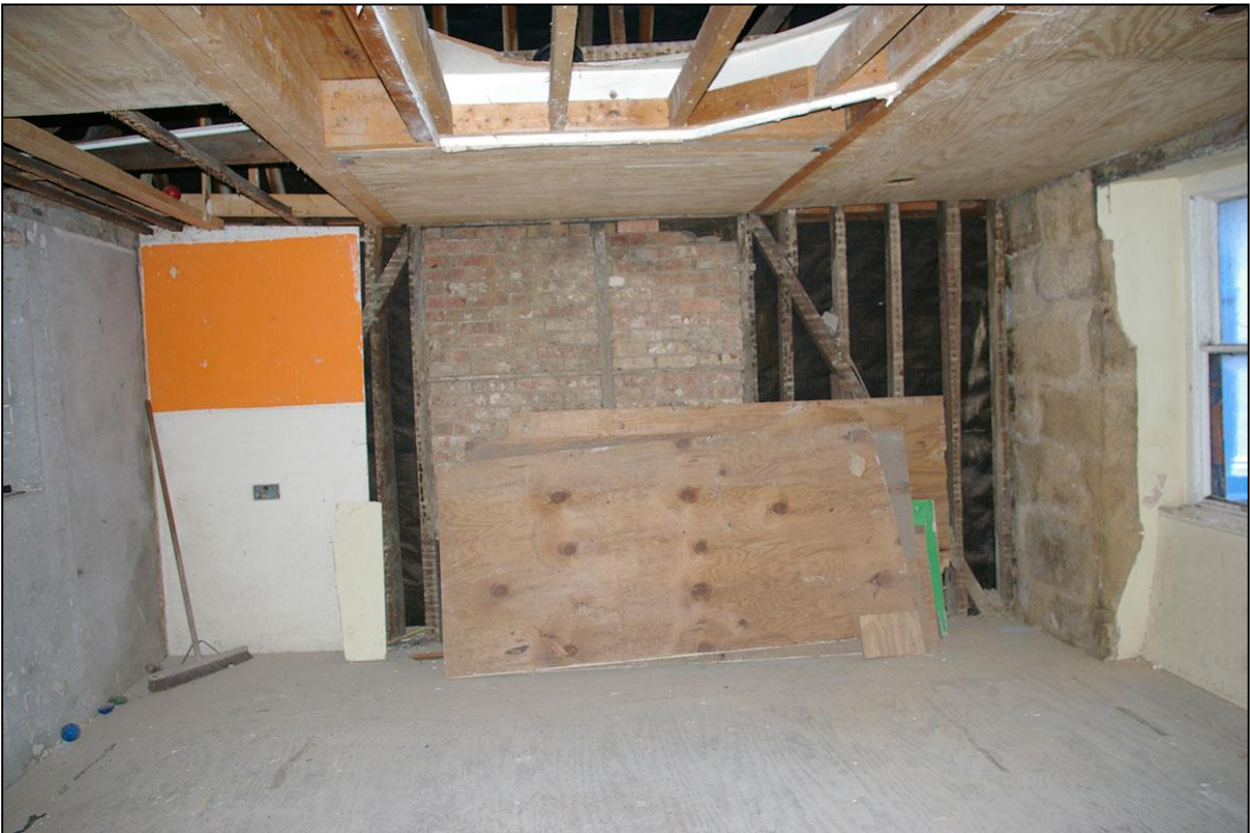
THE STUDWORK SOUTH GABLE END WITH OUTER LAYER OF FELT AND WATERPROOFING AND SMALL SECTION OF BRICK NOGGIN; FROM THE NORTH.

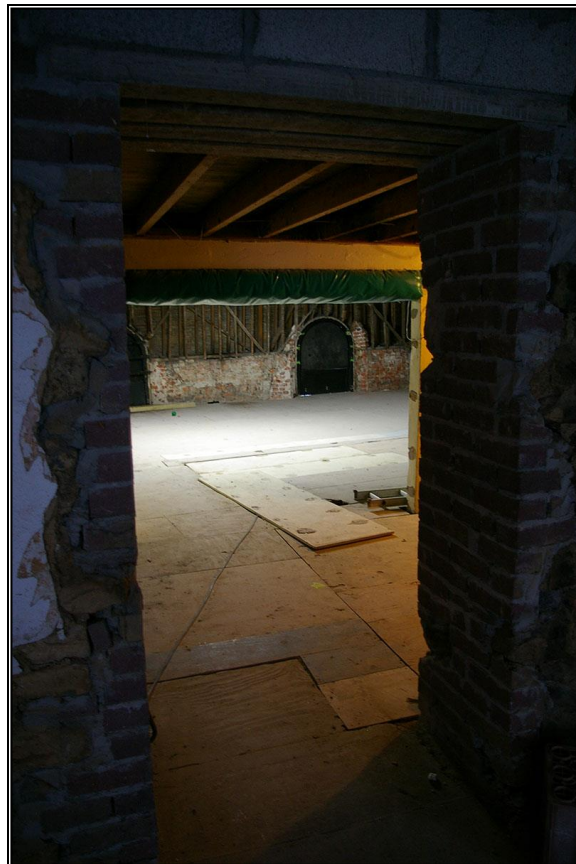
VIEW THROUGH THE OPENING IN THE EAST WALL OF ROOM 7, THROUGH ROOM 8 TO ROOM 9, THE FORMER SYNAGOGUE; FROM THE WEST.

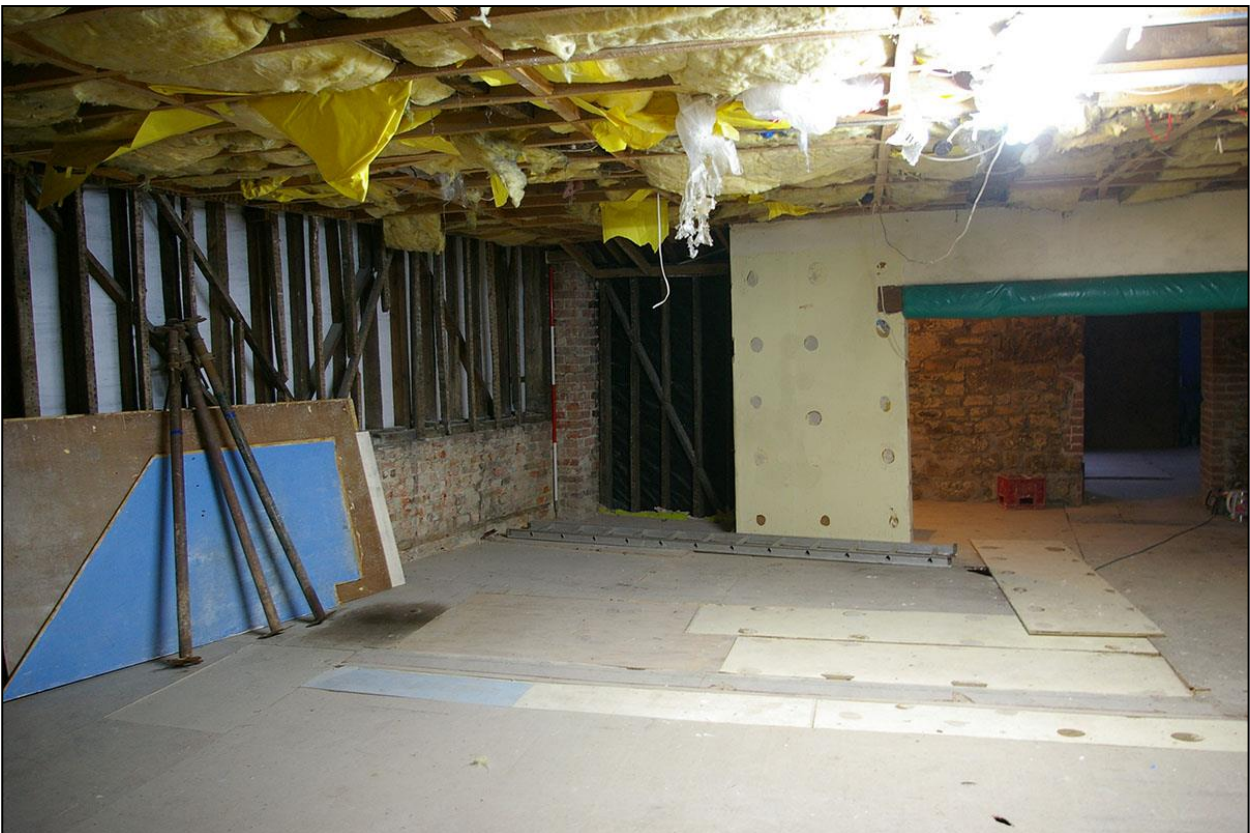
THE SOUTH-WEST CORNER OF THE FORMER SYNAGOGUE, WHERE THE STEPS ONCE ROSE TO THE WOMEN'S GALLERY; FROM THE EAST, NORTH-EAST (2M SCALE).

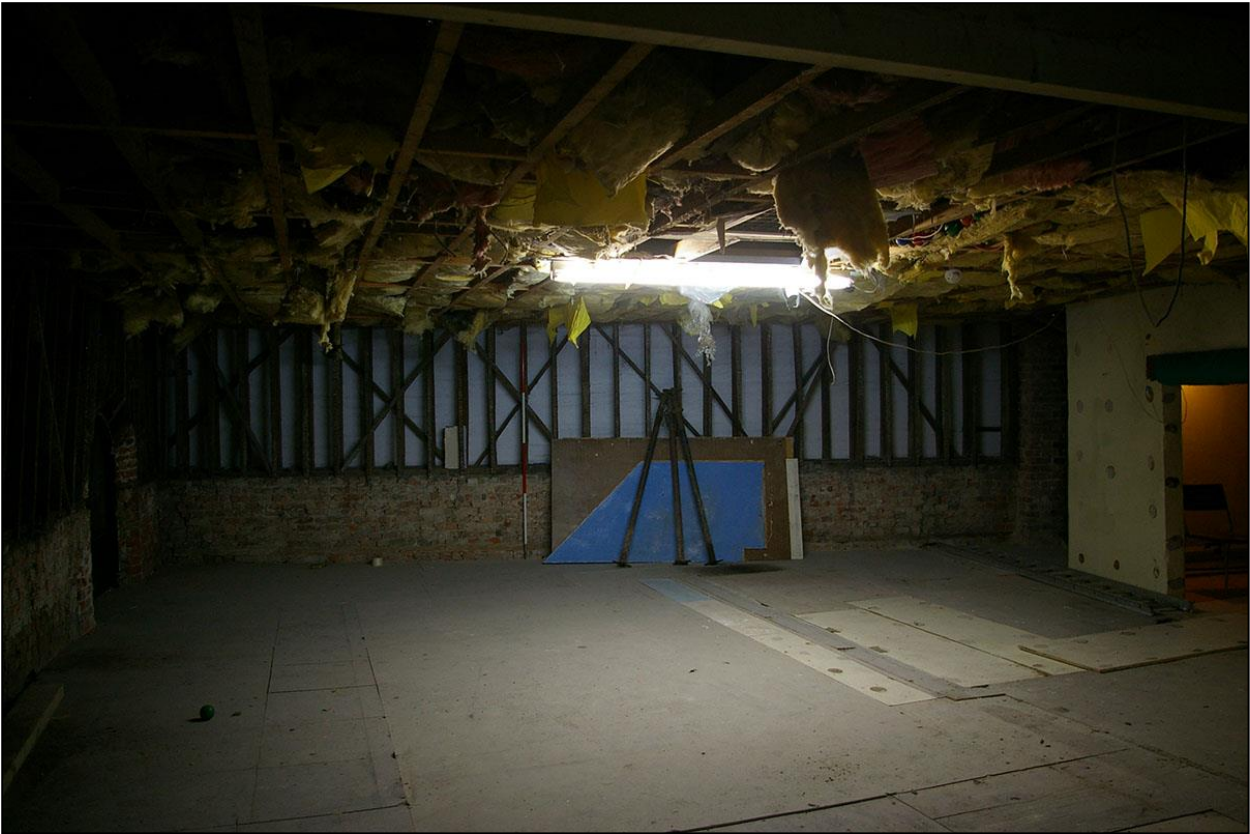
THE ANGLED SOUTH WALL OF THE FORMER SYNAGOGUE, SHOWING THE RAISE IN STUDWORK ABOVE THE BRICKWORK; FROM THE NORTH (2M SCALE).

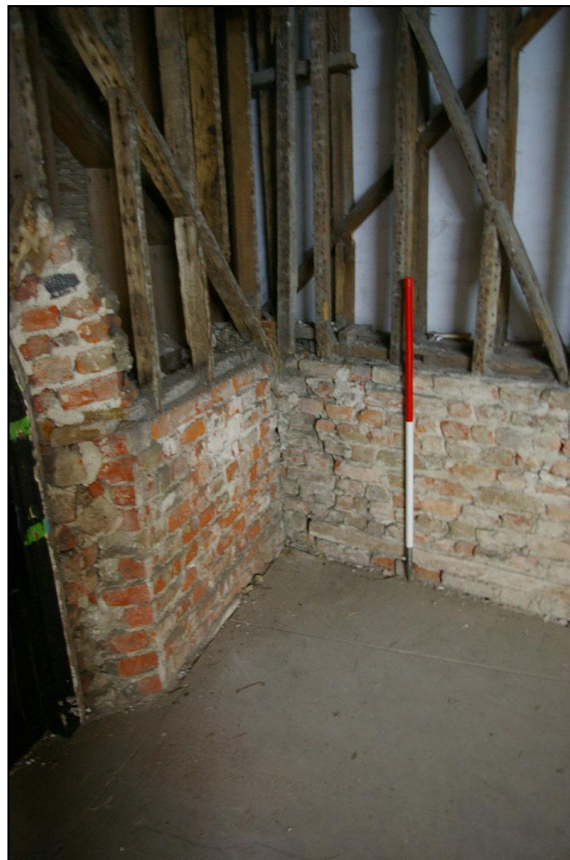
THE SOUTH-EAST CORNER OF THE FORMER SYNAGOGUE, ON THE FIRST FLOOR, ROOM 9, WHERE THE PLASTER HAS BEEN REMOVED, SHOWING DIFFERENT PHASING, THE SOUTH WALL SEEMINGLY ABUTTING THE EAST WALL; FROM THE NORTH (1M SCALE).

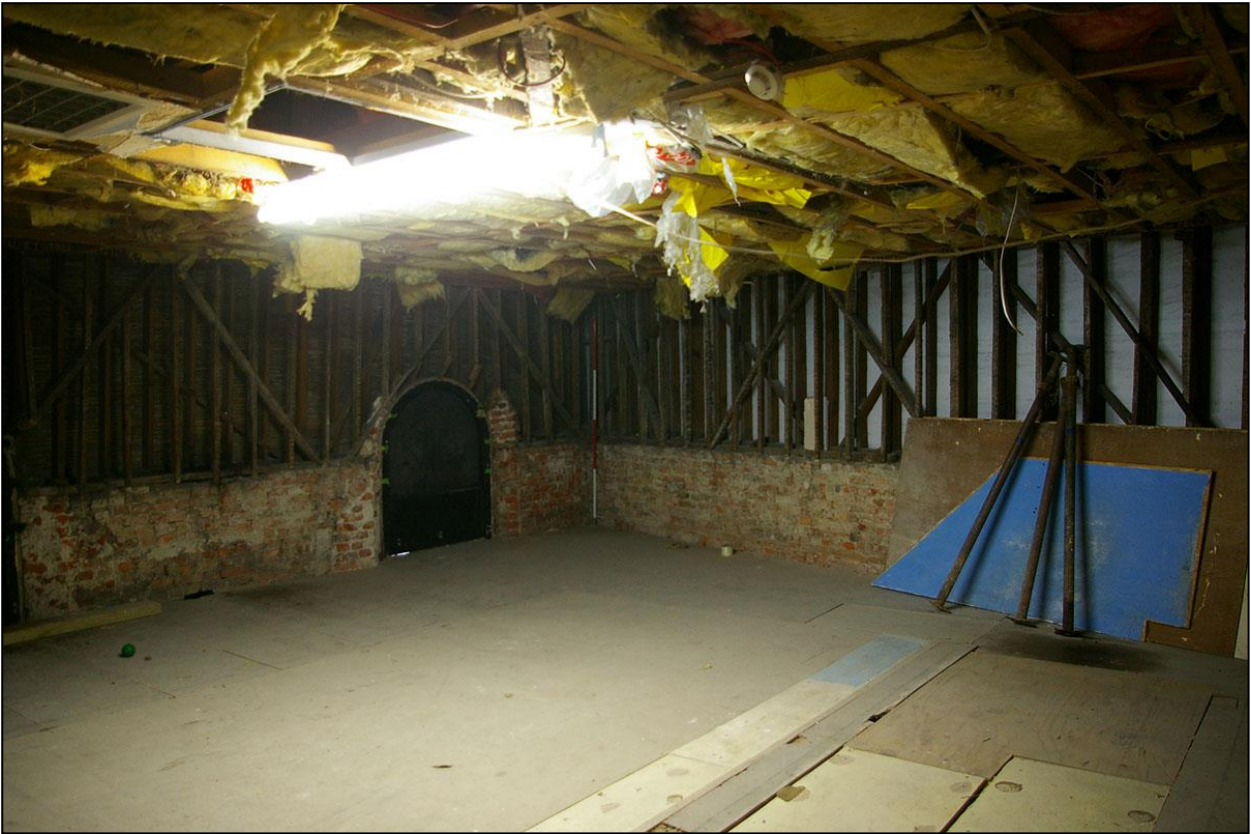
The former synagogue windows were heavily altered in the 19th century, poorly repaired in the 20th century and are in very poor condition; however, these windows should be retained and conserved, as they are a vital indicator of this being an 18th/19th century nonconformist religious building. A specific design element to consider is how the floor levels within the synagogue meet

THE SOUTH AND EAST WALL OF THE SYNAGOGUE; FROM THE NORTH-WEST.

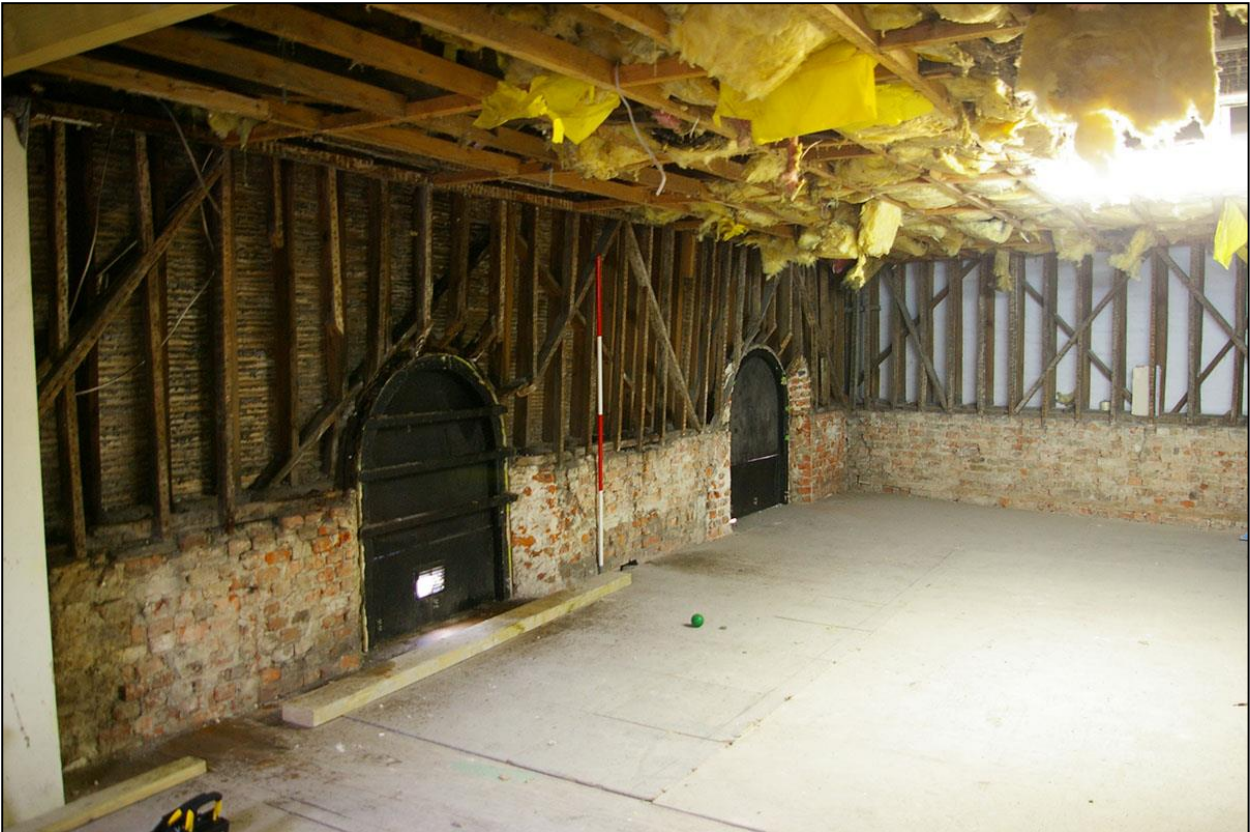
LONG VIEW DOWN THE EAST WALL OF THE SYNAGOGUE, SHOWING THE CLEAR STUDWORK RAISE TO THE BUILDING; FROM THE NORTH-WEST (2M SCALE).

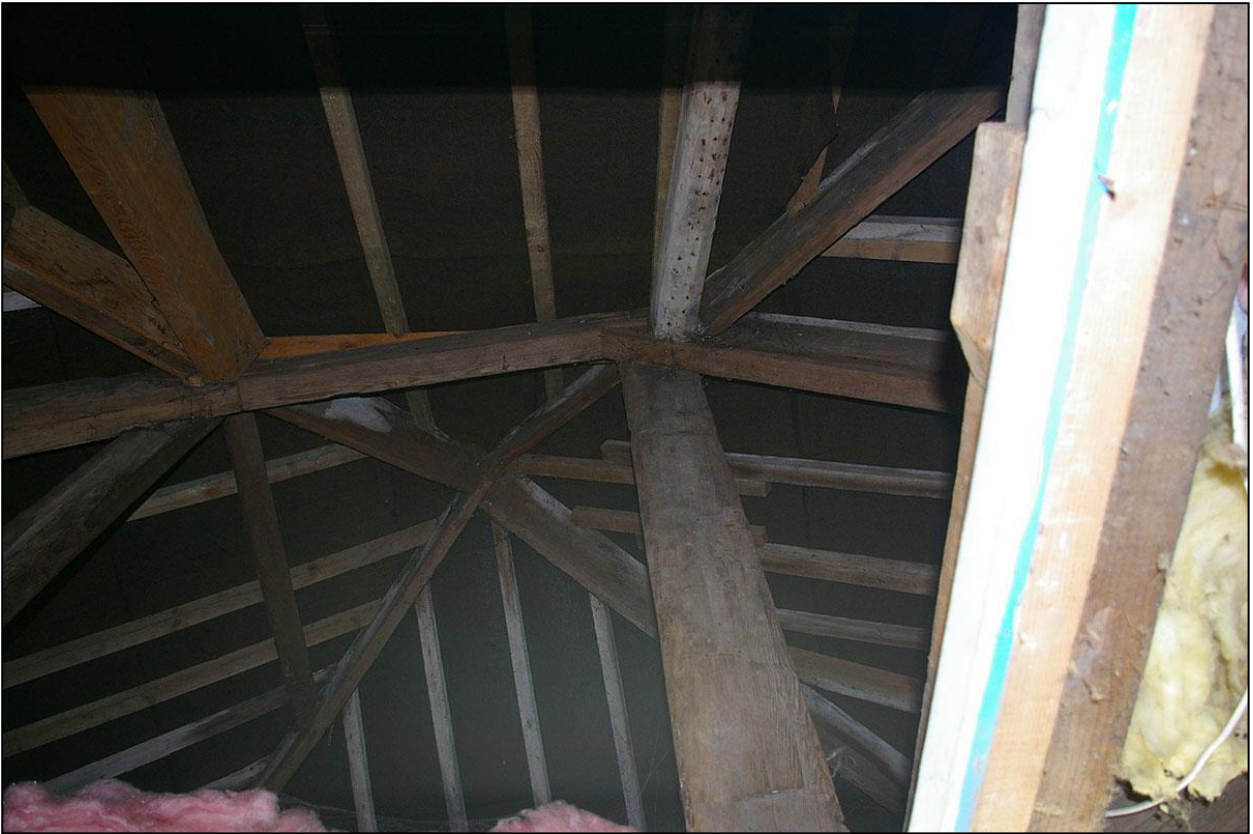
THE COMPOSITE TIMBER ROOF STRUCTURE ABOVE THE SYNAGOGUE.

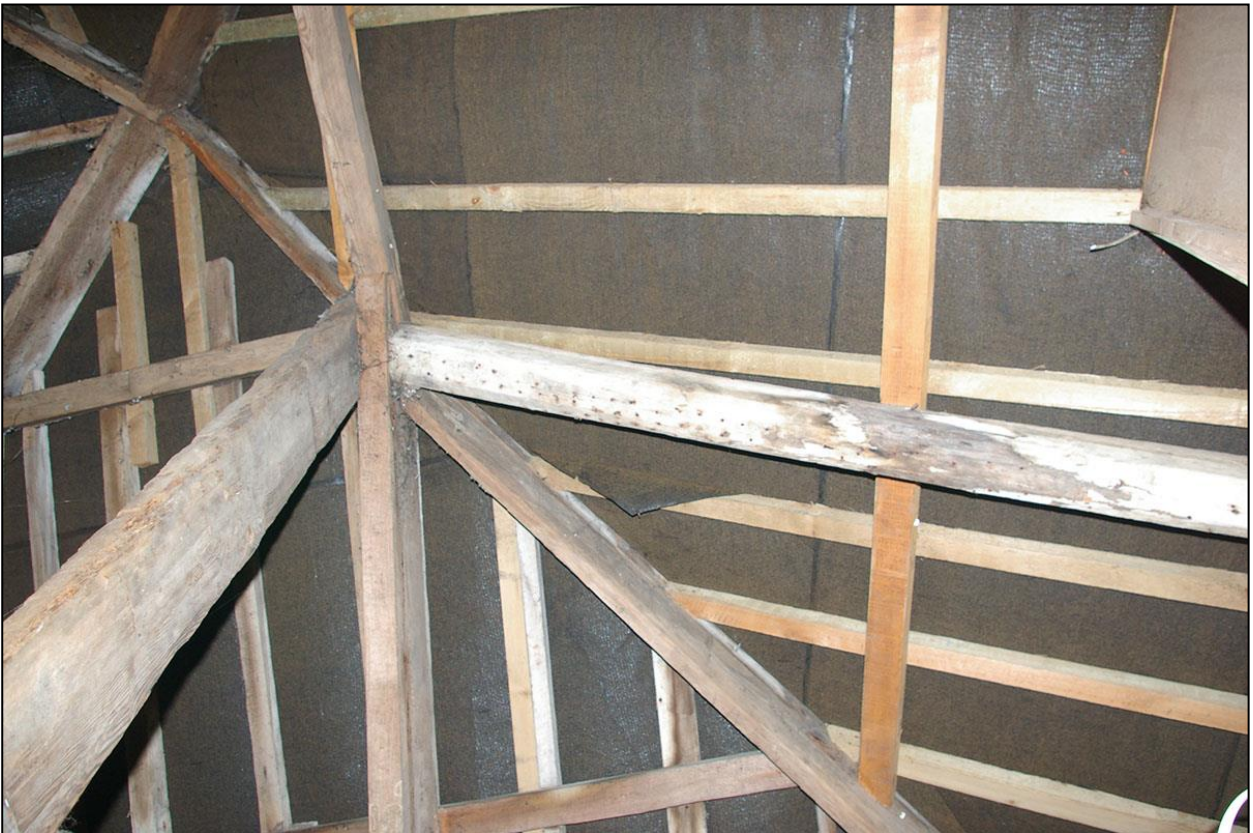
THE COMPOSITE TIMBER ROOF STRUCTURE ABOVE THE SYNAGOGUE.

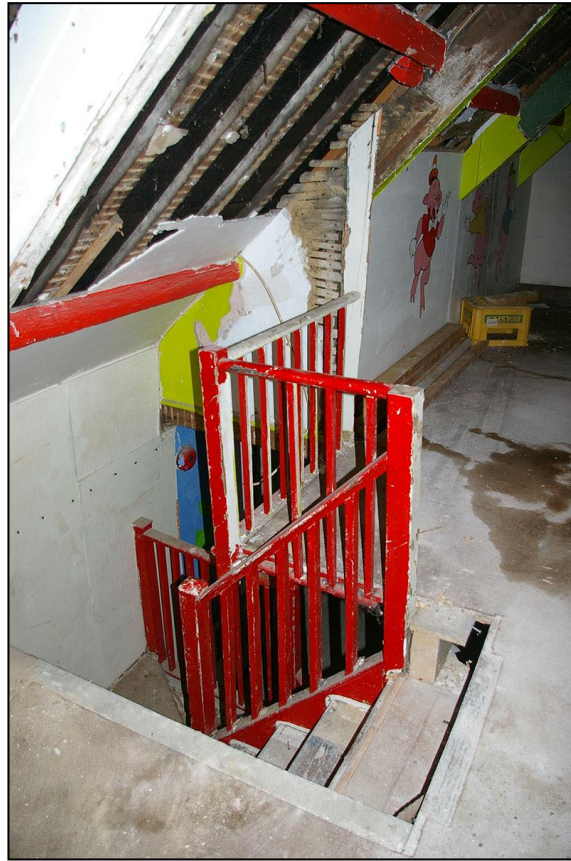
THE STAIRCASE TO THE ATTIC; FROM ROOM 7.

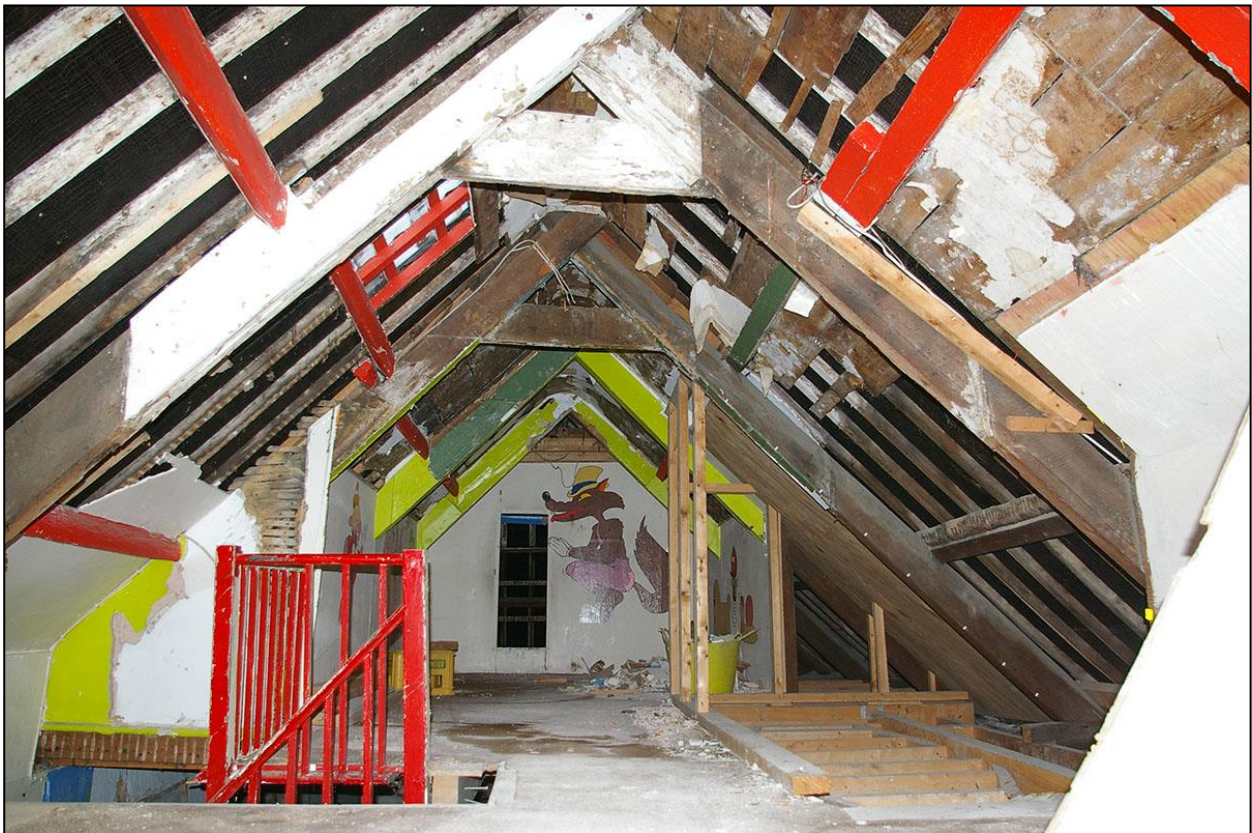
- Roof extended and several trusses from original roof also replaced, three older trusses survived.
- Stack added to north gable.
- Stair to attic installed and attic converted for accommodation.

ROOM 10, THE ATTIC, WITH ROOF TRUSSES OF TWO DIFFERENT PHASES; FROM THE NORTH.

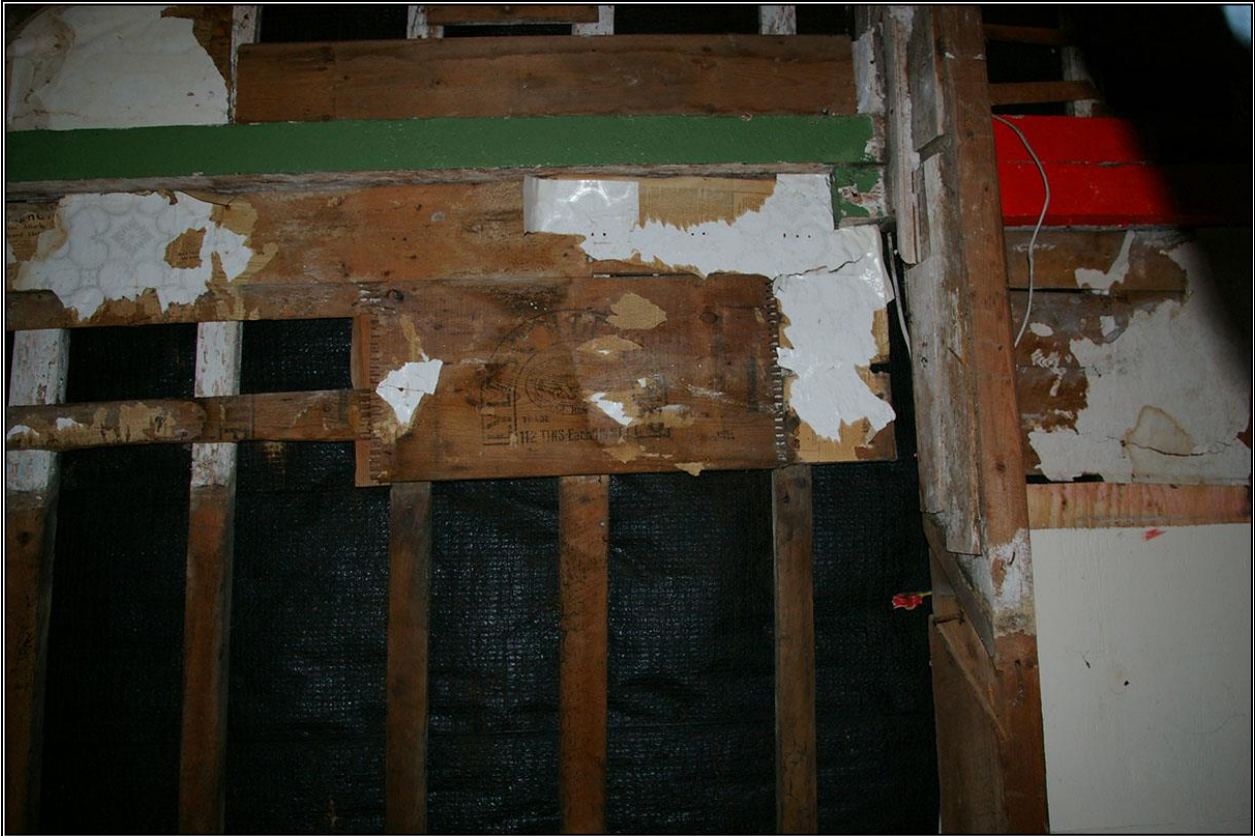
19TH CENTURY LYLES SUGAR BOX, NAILED TO THE ROOF TIMBERS, FORMING SARK BOARDING; FROM THE EAST.

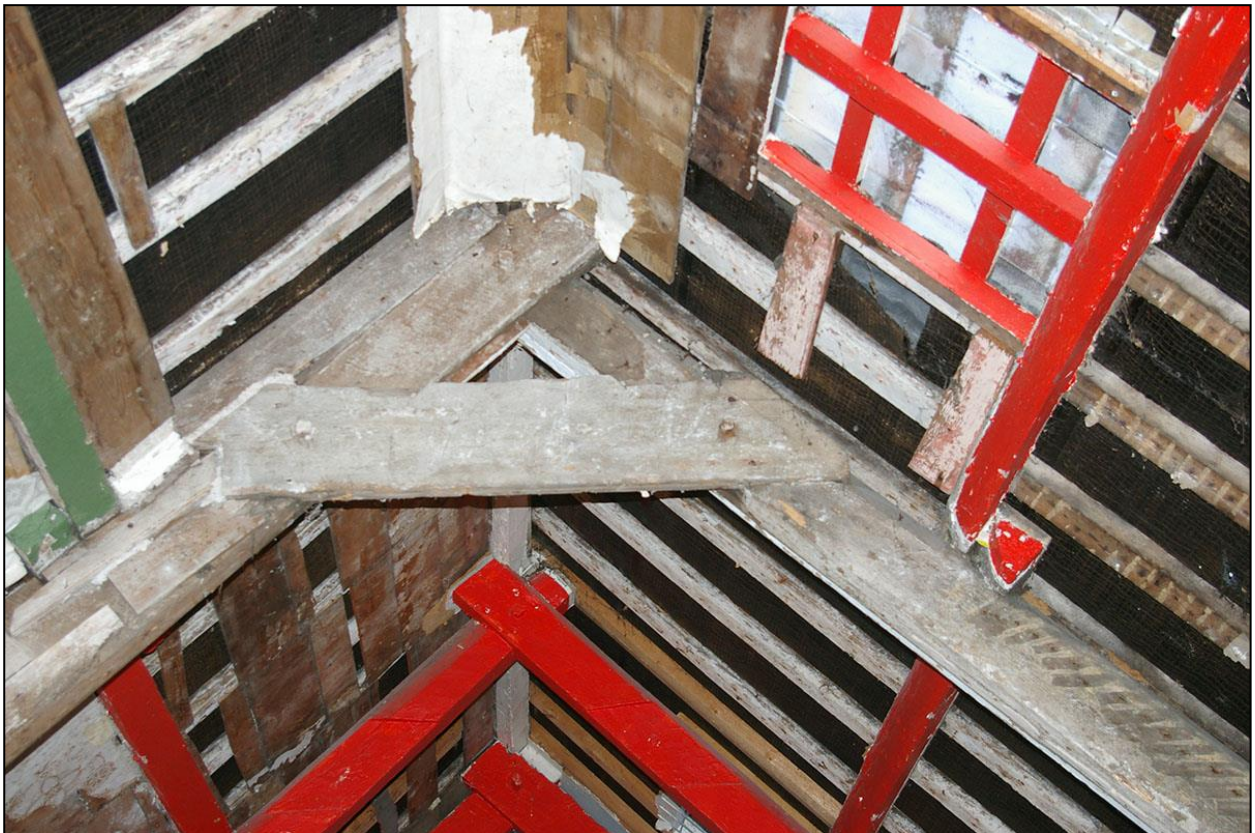
PEGGED COLLAR AND RIDGE, AS WELL AS PEGGED RIDGES BEYOND TO THE EARLIER TRUSSES TO THE NORTH END OF NO.1 NEW STREET; FROM THE SOUTH.

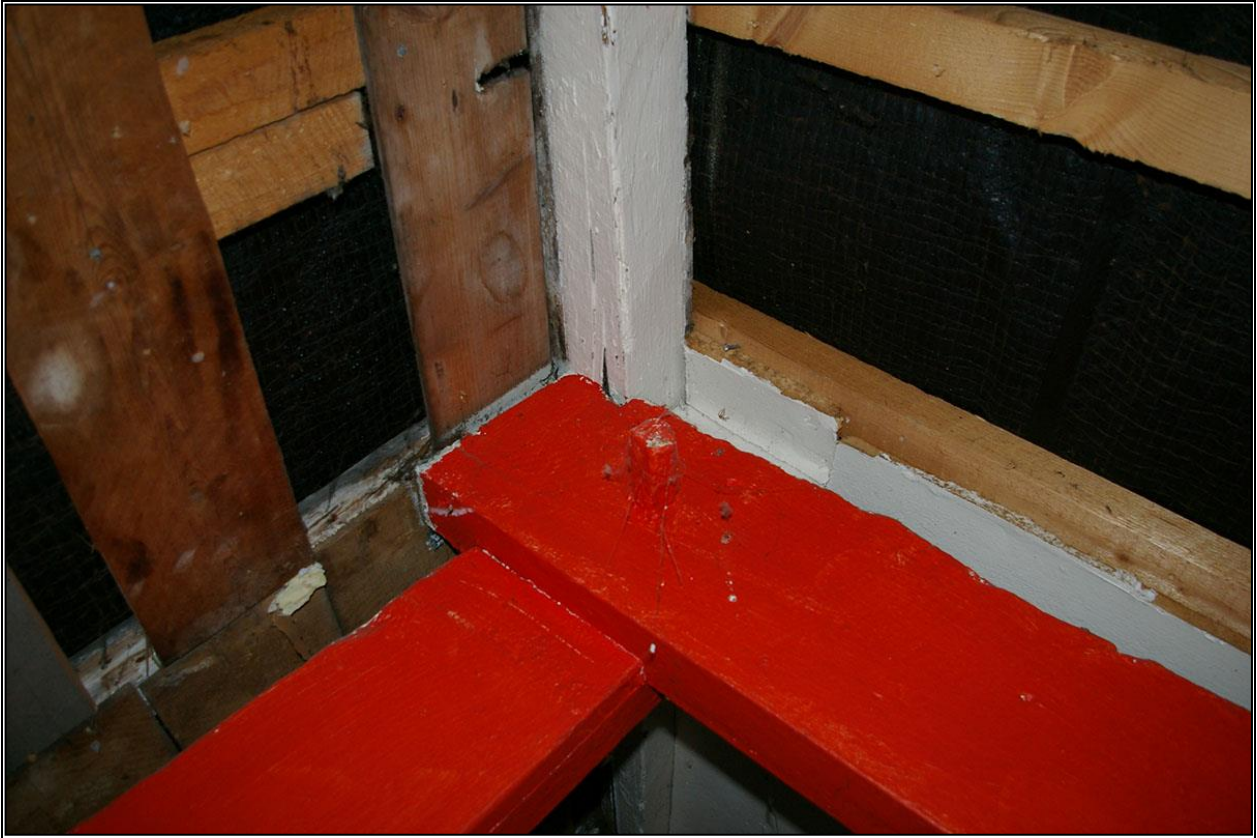
DETAIL OF ONE OF THE PEGGED RIDGES ON THE OLDER 18TH CENTURY TRUSSES; FROM THE SOUTH.

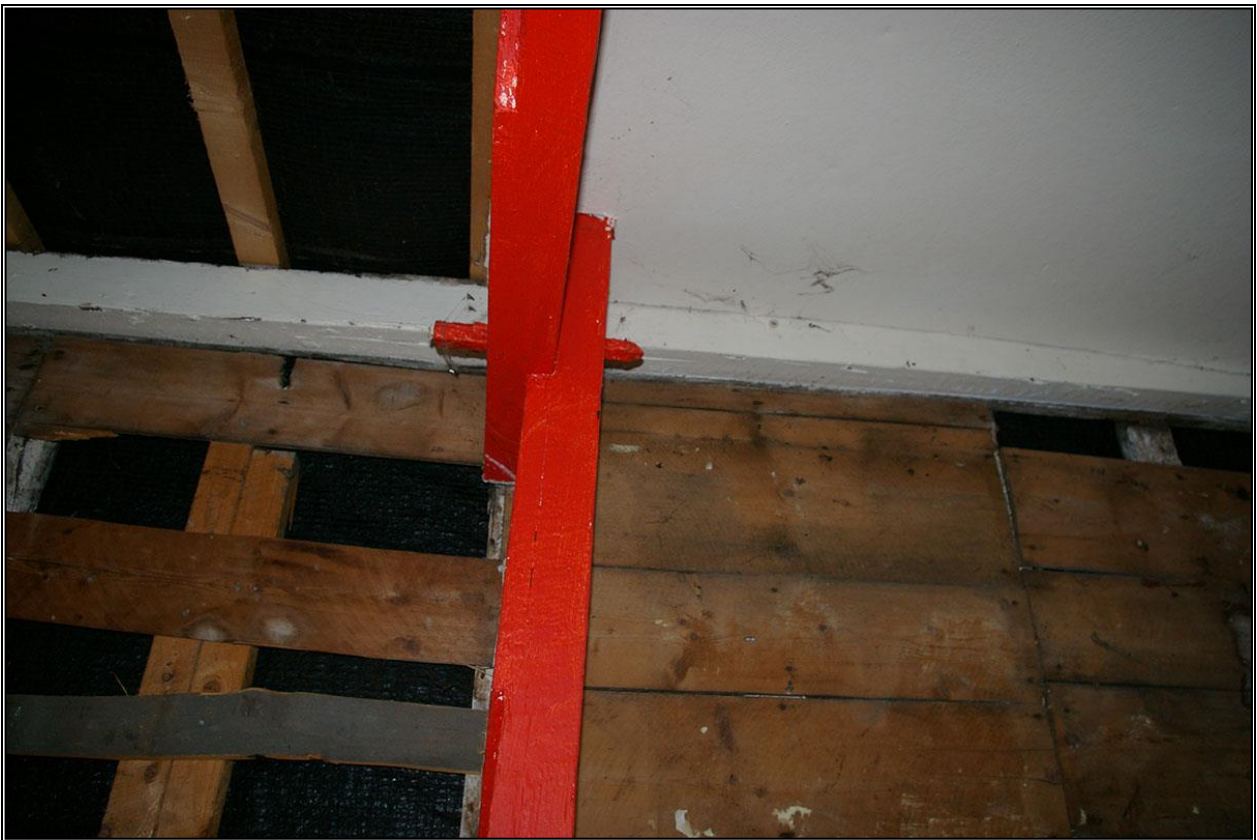
DETAIL OF THE SHALLOW HALF-LAPPING OF THE TRUSS BLADES ON THE PEGGED 18TH CENTURY TRUSSES TO THE NORTH END OF NO.1 NEW STREET; FROM BELOW.

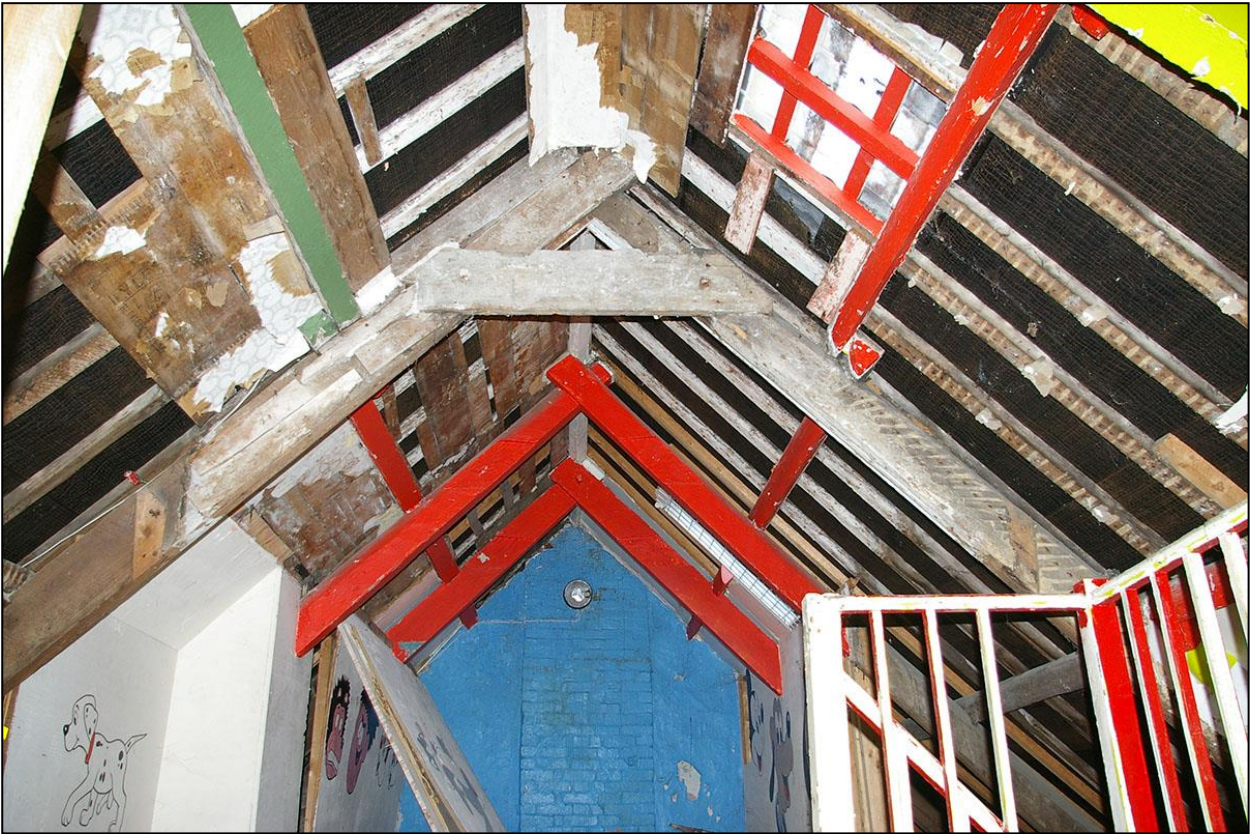
THE THREE HISTORIC PEGGED TRUSSES TO THE NORTH OF NO.1 NEW STREET, IN ROOM 10; FROM THE SOUTH.

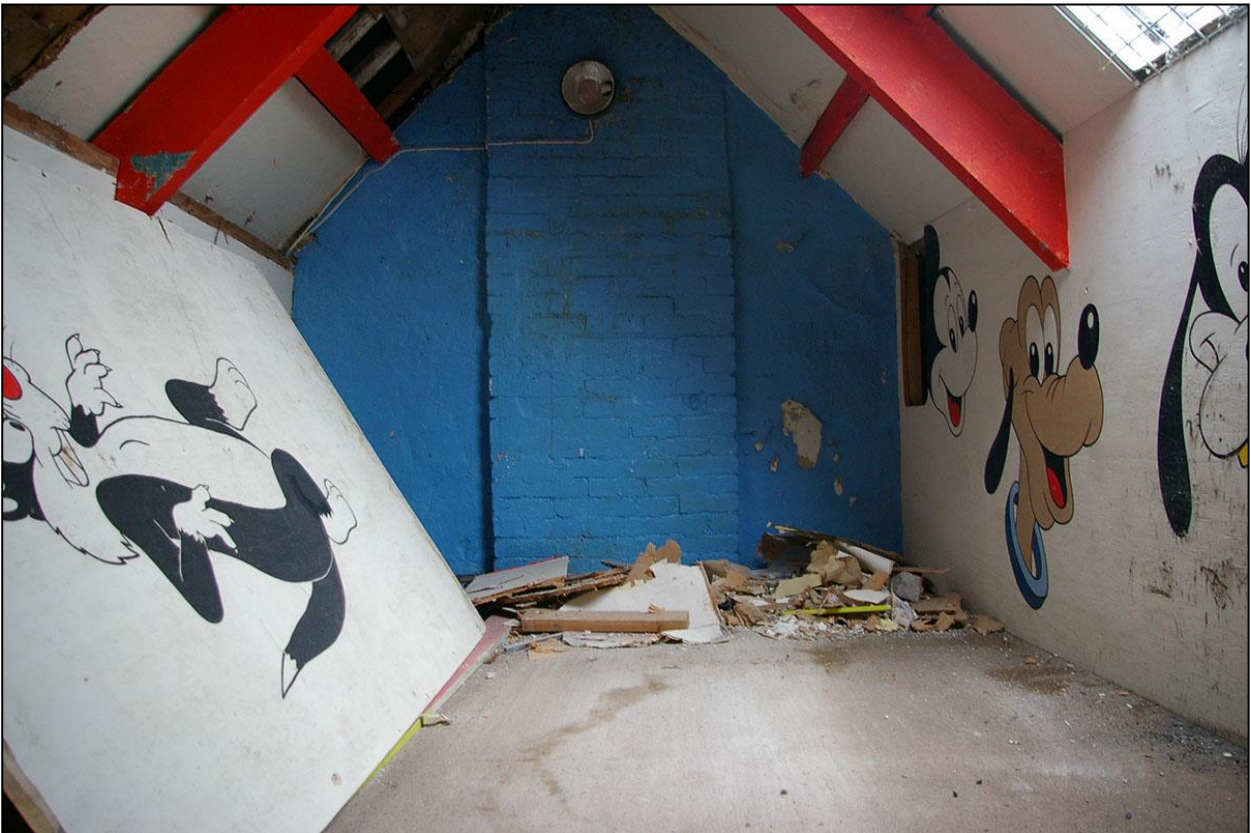
THE UPPER SHALLOW BRICK STACK BUILT ONTO THE NORTH GABLE OF NO.1 NEW STREET; FROM THE SOUTH.
