**GLYNN WEIR  
CARDINHAM  
BODMIN  
CORNWALL**

Updated Heritage Statement and Statement of Significance

South West Archaeology Ltd. report no. 191108

By N. Boyd & E. Wapshott  
Report Version FINAL  
8<sup>th</sup> November 2019

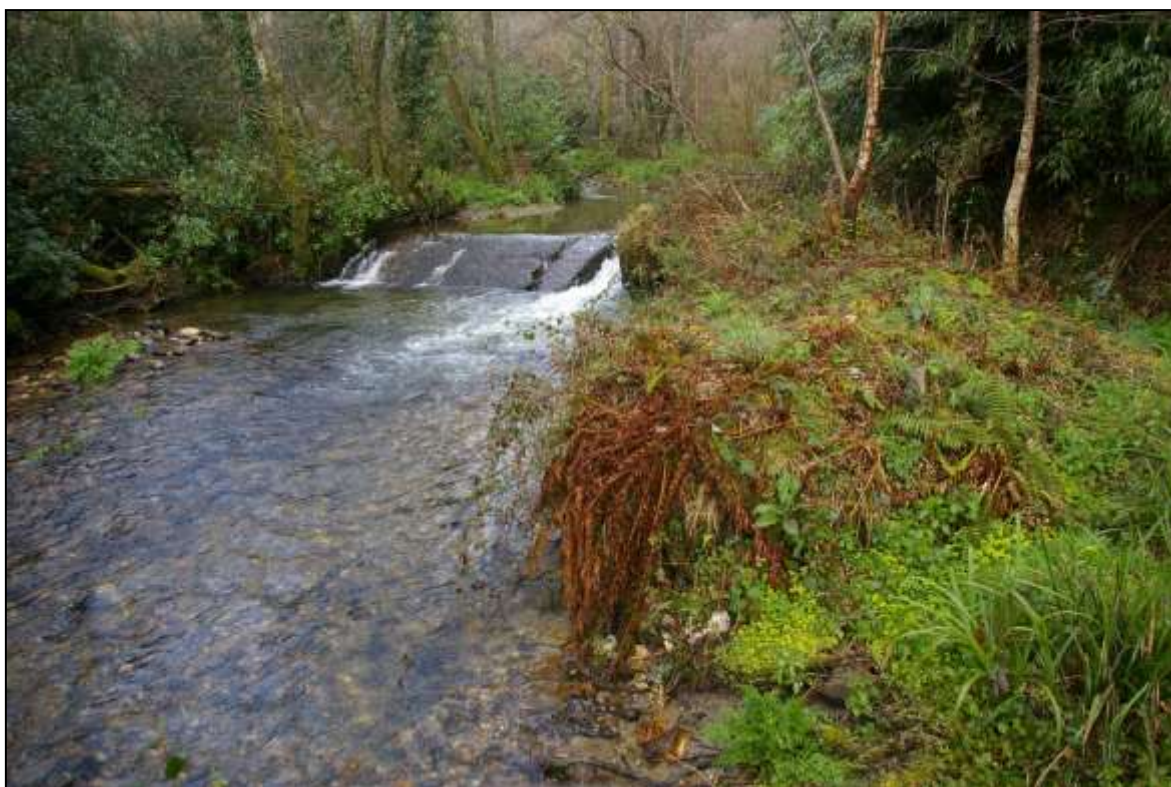
FIGURE 5: THE WEIR IN ITS SETTING, AS VIEWED FROM THE SOUTH-SOUTH-EAST (NO SCALES).

One chunky, relatively short weir has been built across the river, where it narrows in a shallow curving bend. Further back from the weir, upstream to the north, on the east banks, a small section of chunky shaped stones mortared together can be seen eroding out of the bank, suggestive of the riverbanks here having once been retained, either for strength or for aesthetics, framing the weir. To the east side, closer to the weir retaining banks become more consolidated as built flank walls, of large shaped and faced slate slab blocks, in coursed build, capped with concrete but mortared, where it survives in a hard grey lime mix; these have been formed framing a leat and sluice system. The weir is built at a very slight oblique angle to the flow, intended to maximise its effect on water flow; this is referred to as a 'diagonal' weir. The current shape of the weir, (the upper layer of which is of a coarse mix concrete with pebble inclusions), is of 'Ogee' form, with a prescribed curve to the profile, c.4-5m long and c.1.75m wide. The angle is gradual and shallow, the water running smoothly over the weir for most of the channel (Figure 5). There is a step to the base, with a straight drop beyond. A narrow fish pass has been cut into the east side, framed by slate slabs.

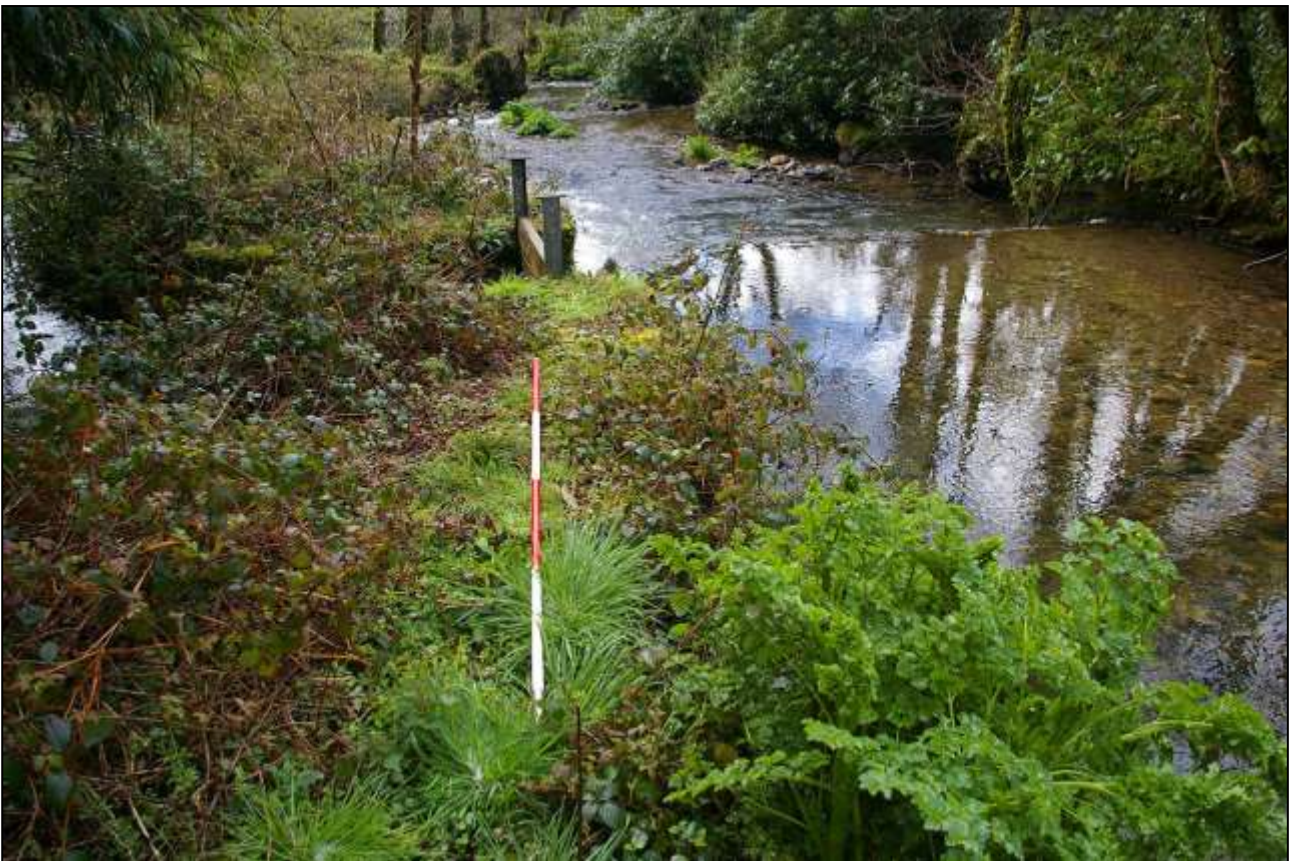
6. THE EASTERN ABUTMENT OF THE LEAT, JUST ABOVE THE WEIR, WITH 2M SCALE; FROM THE NORTH-EAST.

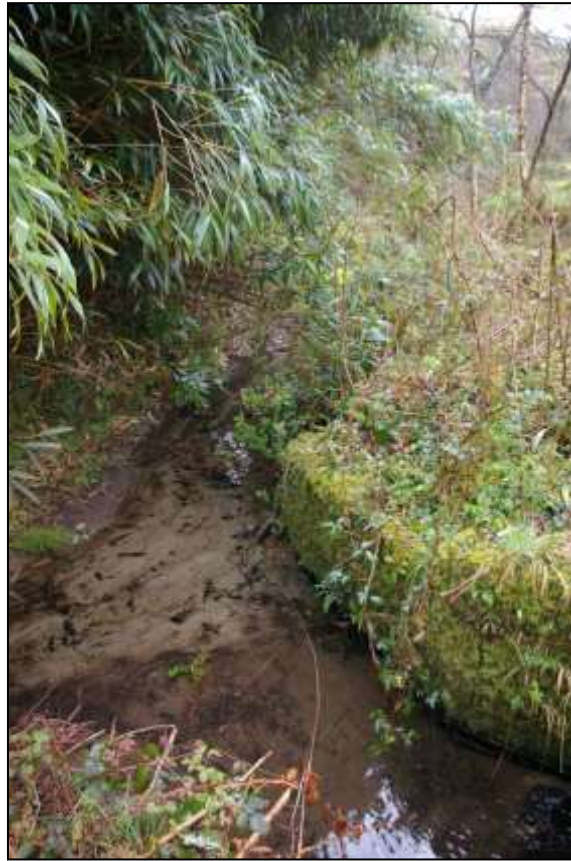
11. THE ANGLED CURVE WHICH CARRIES THE LEAT AWAY FROM THE RIVER AND THEN CORRECTS TO RUN SOUTH WITHIN THE VALLEY, SHOWING DEEP BUILT UP OF SANDY SILT IN THE BASE OF THE LEAT; FROM THE NORTH, NORTH-WEST.

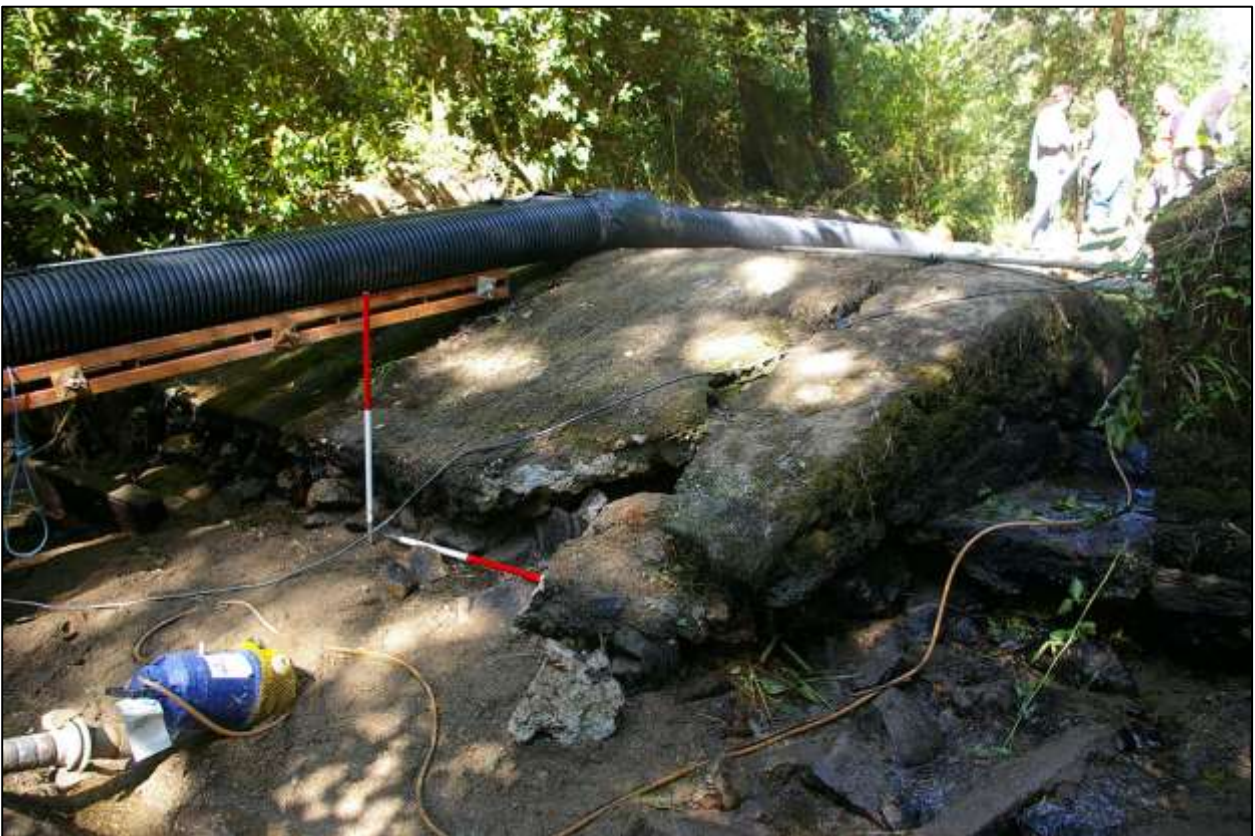
There is a large visible crack in the weir, approximately 0.5-0.6m into the weir from the eastern abutment, approximately 0.2m from the fish pass. The slight oblique angle of the weir to the water flow and the fish pass have created an effect where an eddy of water gathers and pours over the side of the fish pass, as well as down its vertical line. This eddy has caught what was likely a slight lip in the thin concrete capping layer and worked at it. This has now burst open, forcing water into a narrow channel and into the looser limecrete build of the second phase of construction, washing out stones from under the concrete cap, leaving it hollow beneath. The crack is now as much as 10-15cm or so wide in places, weakening the weir and disrupting the flow of the water.

The weir, possibly due to its significant change in height and shape, is moving the water in such a way across its form that it is scouring and undermining its own structure. The riverbed, once drained, is significantly washed away under the east wing wall and weir, hence the collapse at the front end, the front rectangular upright concrete kerbs, which likely framed the vertical drop, are now loose, lying away on a bed of scoured stones. The east bank below the weir has suffered from being blown out by the river, making a very thin spit of riverbank between the river and leat. The west wing wall is being damaged by the roots of a large tree and is slowly tipping into the river.

31. THE EXPOSED WEIR DURING DRAINAGE WORKS; FROM THE NORTH-EAST (1M SCALES).

If works adapting the fish pass move forward in the future monitoring of the feature may be required to ensure adequate recording of the structure beneath the concrete capping can take place. A comprehensive photographic record has been made of the weir in its current state, both with the water and following drainage. Further drawings of the weir could be recorded if works are to take place and it will change from its current form, recording the various layers of repair and alteration.

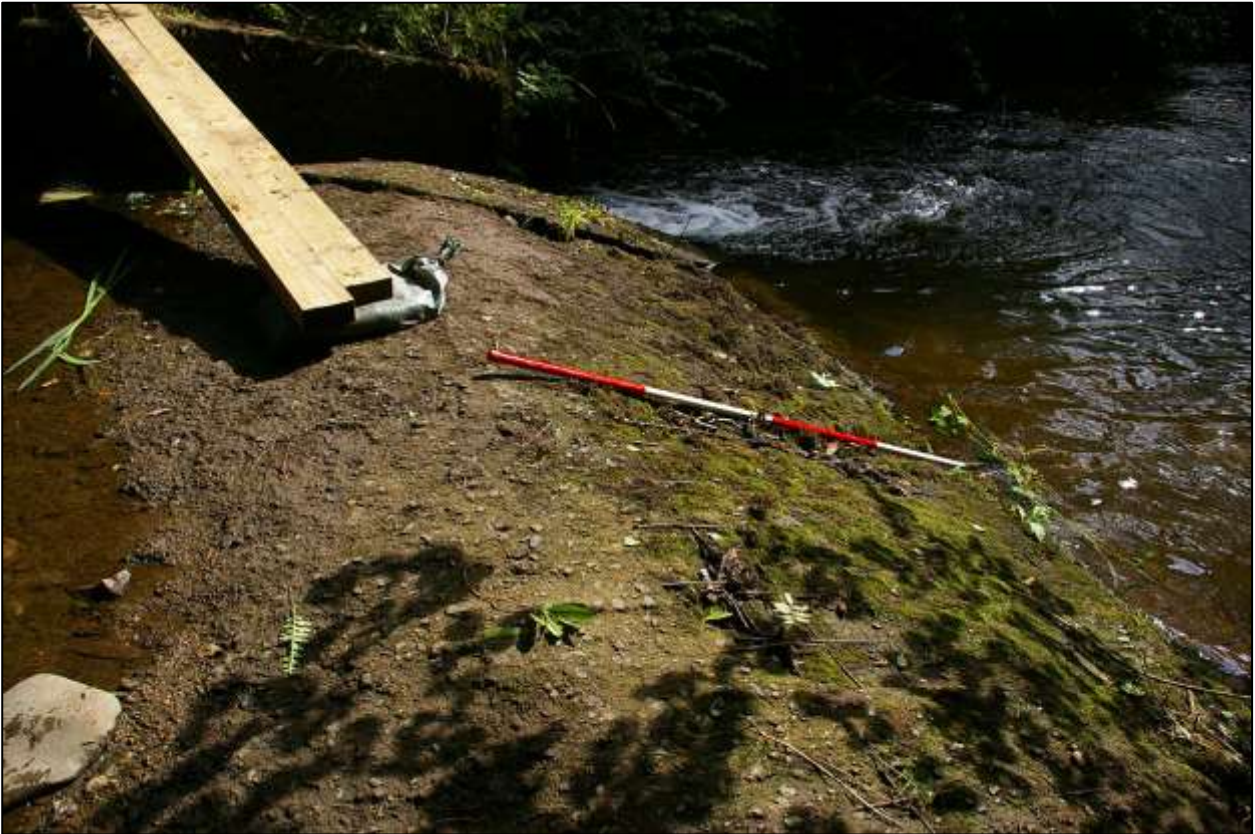
Beneath these two upper layers is a lower, much shallower elongated sloping weir; of 'crump' weir form (102). The first phase clearly needed to be adapted quite quickly after construction, but the quality of build is quite different from the later repairs. Aesthetics have been considered in this build, in the wing walls and leat flanking walls. This phase is of blocky shaped stones, like the wing walls, mixed and capped by a much more solid and smooth textured harder concrete, without obvious inclusions of stones or pebbles. Massive timbers brace the weir, wing walls and fish pass, which is framed in large flat slates. Further back from the weir, upstream to the north, a small section of more chunky shaped stones can be seen eroding out of the bank, suggestive of the riverbanks here having once been retained, either for strength or for aesthetics, framing the weir and leat. The weir appeared on the historic mapping between the 1st and 2nd Edition OS

36. PROFILE OF THE LONG-ANGLED SLOPE OF THE WEIR, WITH 2M SCALE; FROM THE WEST.

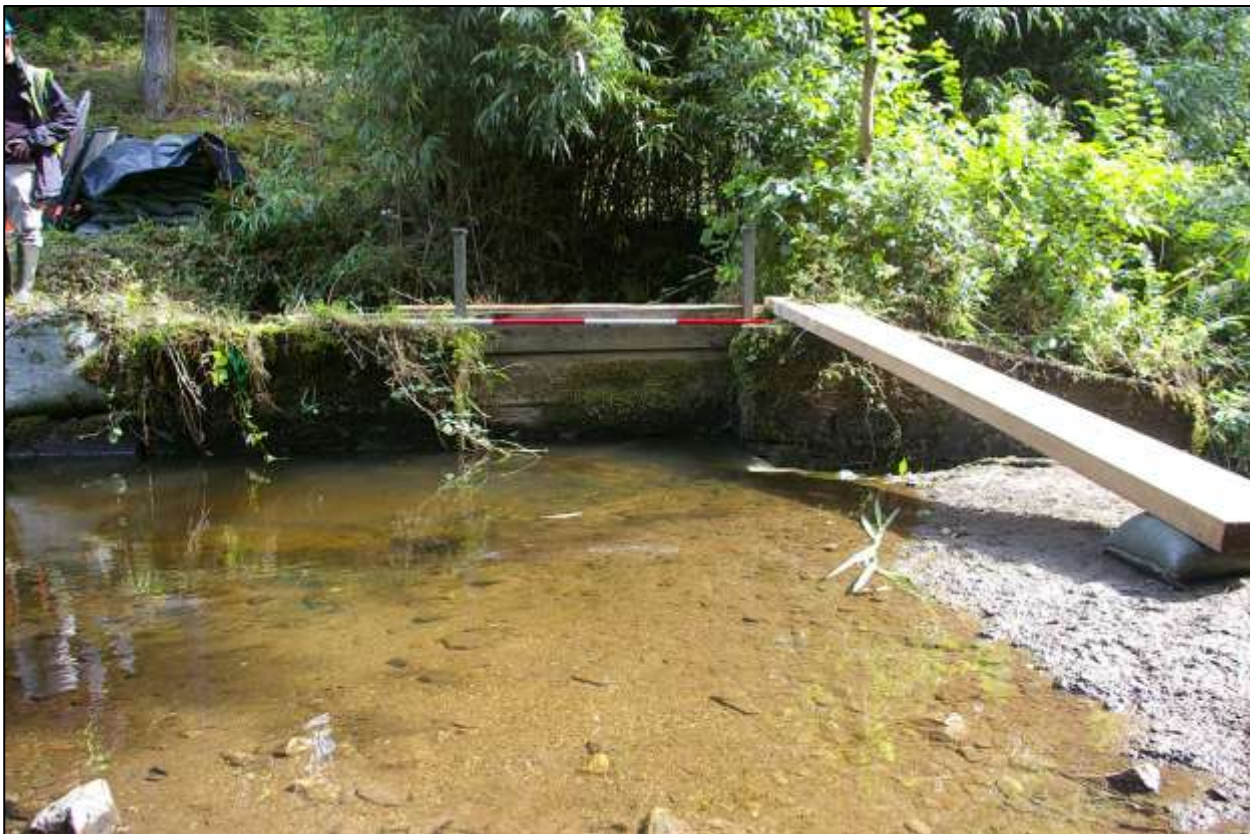
The weir's integrity is quite high, although its abutment banks and the sluice gates have been quite heavily repaired with modern materials. The significant modern changes are considered to build in some natural flexibility for further adaptation. The continual alterations of the past provide precedence for this.

41. THE MODERNISED SLUICE GATE, WITH 2M SCALE; FROM THE WEST-SOUTH-WEST.

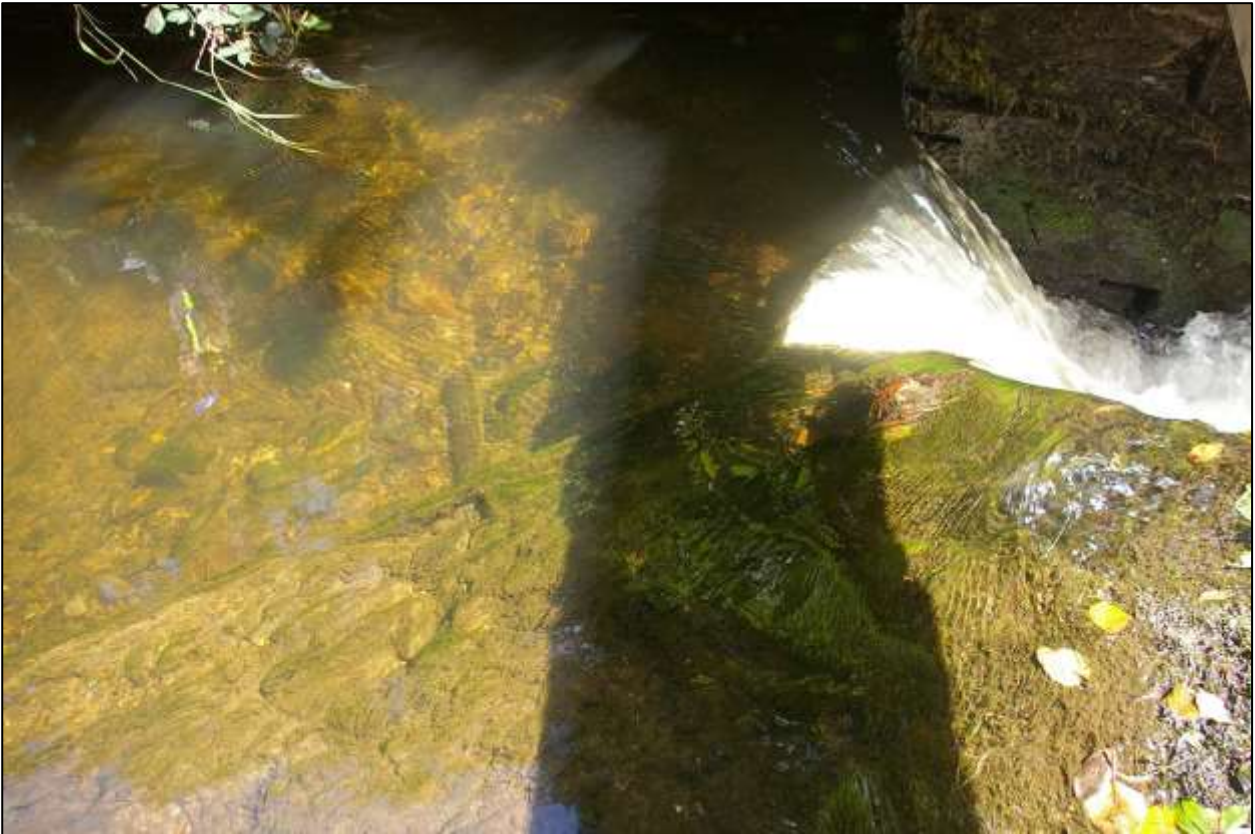
42. DETAIL OF THE SLATE SLAB EDGING TO THE CHANNEL ABOVE THE FISH PASS; FROM THE SOUTH-WEST.

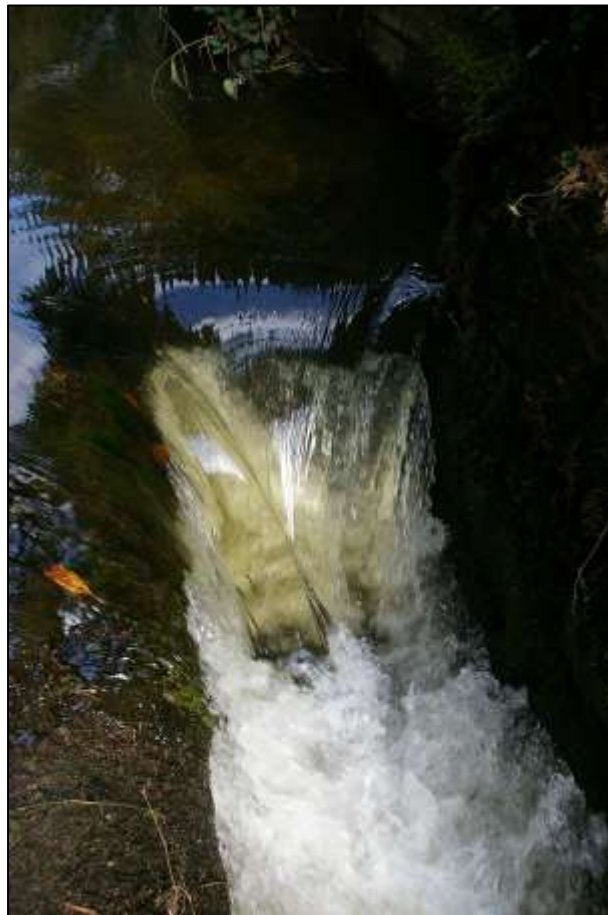
There is a fish pass cut into the weir at the east end, c.0.2m wide; once the water was drained it best exposed the profiles of the different phases of alteration and repair. The fish pass is a narrow rectangular cut in the weir with a straight drop, which is currently not working to the benefit of the fish stocks in the river. The slight oblique angle of the weir to the water flow and the fish pass have created an effect where an eddy of water gathers and pours over the side of the fish pass, as well as down its vertical line. This eddy has caught what was likely a slight lip in the concrete and worked at it, pushing a large chunk of the weir apart. The weir, possibly due to its significant change in height and shape, is moving the water in such a way across its form that it is scouring and undermining its own structure. The riverbed, once drained, is significantly washed away under the east wing wall and weir, hence the collapse at the front end.

43. THE FISH PASS IN DETAIL; FROM THE SOUTH.
