**TRAVIS PERKINS  
MAYOR'S AVENUE  
DARTMOUTH  
DEVON**

Desk-Based Assessment & Updated Historic Building Recording

South West Archaeology Ltd. report no. 190906

By E. Wapshott & B. Morris  
Report Version 03  
6<sup>th</sup> September 2019

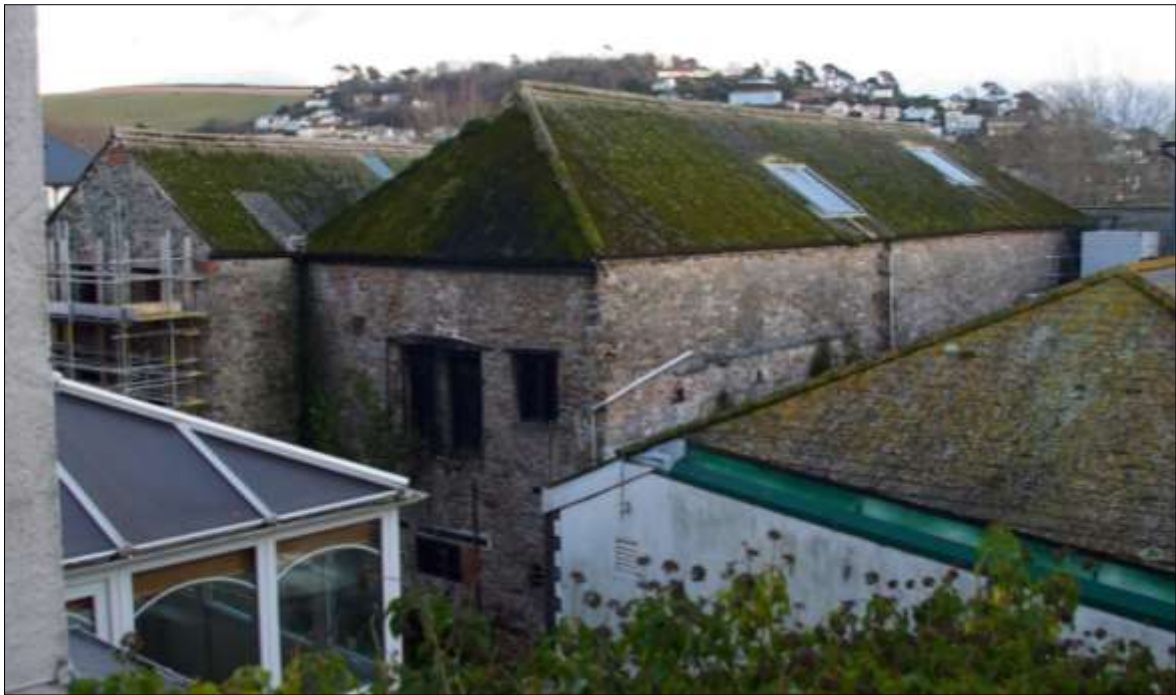
FIGURE 19: THE NORTH AND WEST WALLS OF B1, VIEWED FROM THE NORTH-WEST.

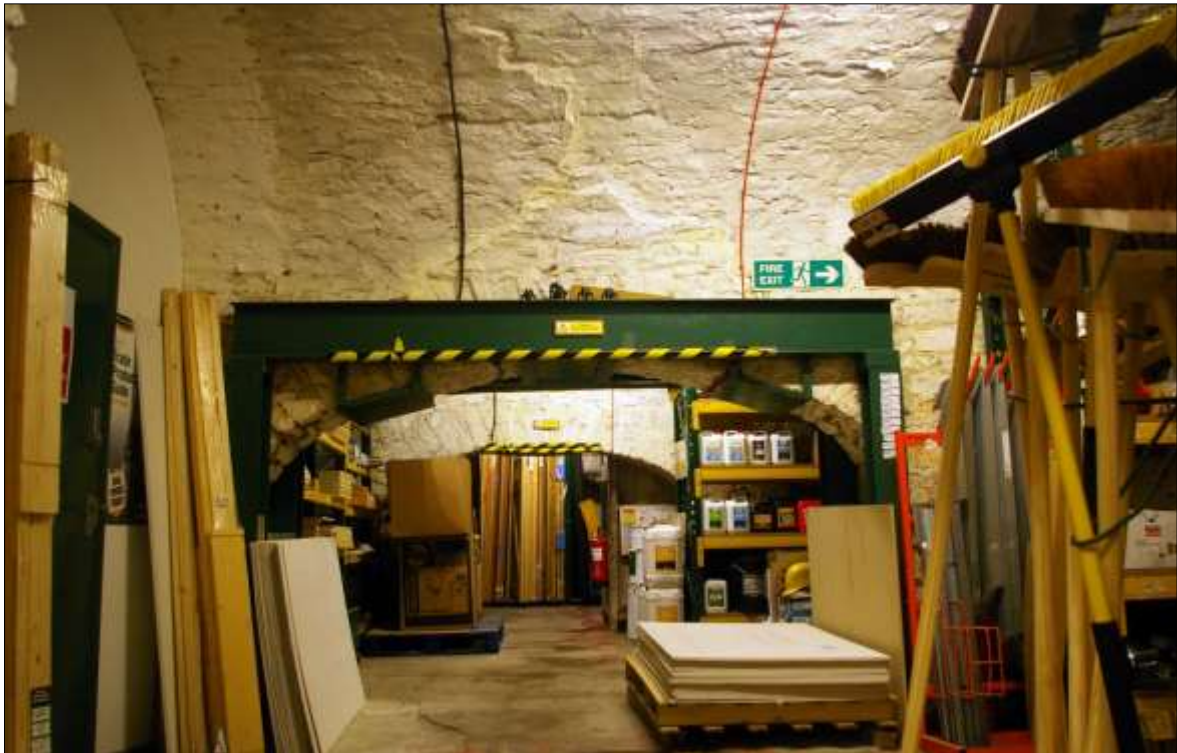
FIGURE 20: THE VAULTS ON THE GROUND-FLOOR LEVEL OF B1, LOOKING THROUGH ARCHWAY D4 TO D7, IN VAULTS V3-V5; VIEWED FROM THE SOUTH.

From the internal walls spring round-arched vaults of narrow mortared slatestone; these have deformed over time and now appear as flattened arches, with the western end of V1 supported by a brick pier. The northernmost vault (V6) is divided by narrow concrete-block walls into toilets, shower room and additional storage/welfare. This vault features a wide blocked forced opening in the north wall (BO23), probably a double-doorway matching the one above on the first floor. The entire east wall of B1 has been rebuilt at an angle to the original structure, with narrow (0.5m) mortared walls of stone rubble; this wall leans out to the east, opening large (up to 50mm) gaps between it and the roof of the vaults. V1 is currently accessed by a forced door (D1) with reset chamfered architrave (lintel re-set upside down) in the south wall from B6. V3 is accessed by a widened opening (D5) in the east wall from B2. Four of the other vaults (V1, V2, V4 and V6) have slightly-offset doorways in the east wall, but these are now blocked. When B1 was built each vault was accessed via a doorway in the west wall. These doorways are all now blocked, but feature heavy curved timber lintels and shaped quoins, with iron pintles, loops catches, spikes and sockets indicating secure door fittings. The small arched window above each door is set into the apex of the vault and was designed to throw light into the chamber; each deeply-splayed window sports *ferramenta* (chunky iron bar with saddlebar). When the bus depot was redeveloped, these blocked openings were revealed (see Figure 23). There are two similar windows in the north wall of V6, though the *ferramenta* have been lost.

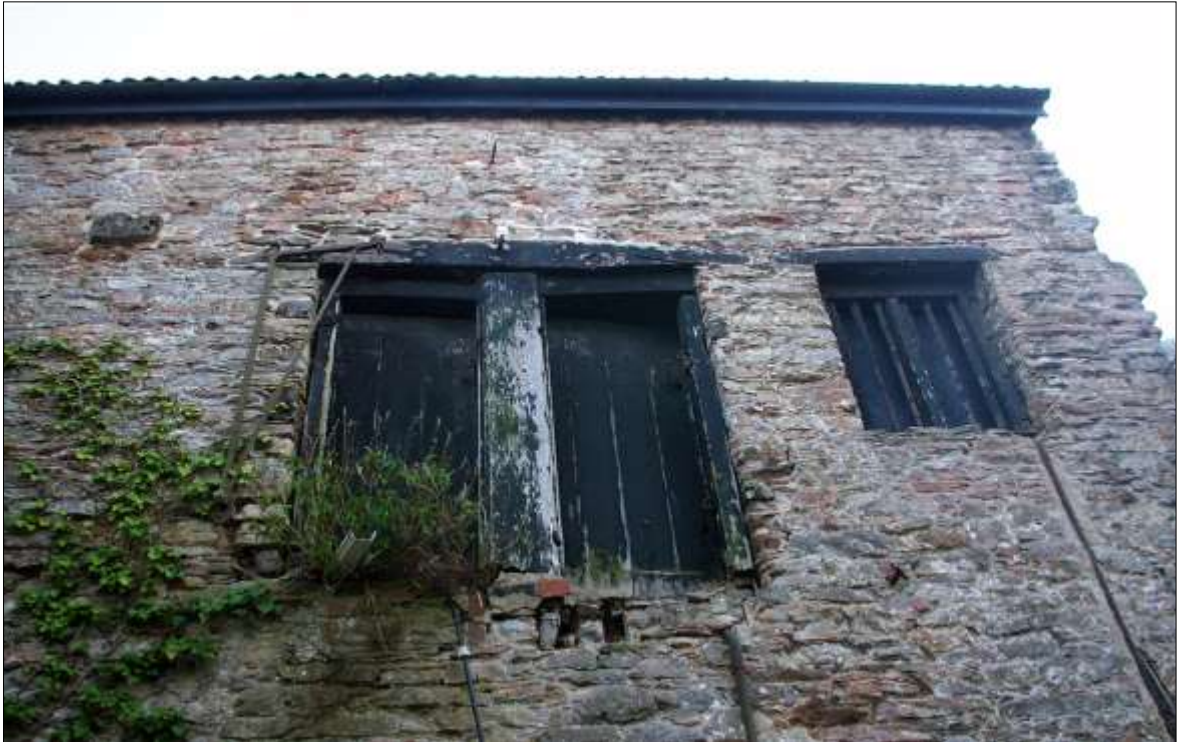
FIGURE 24: THE NORTH ELEVATION OF B1, SHOWING W11 AND DOUBLE-DOOR D21/D22; VIEWED FROM THE NORTH.

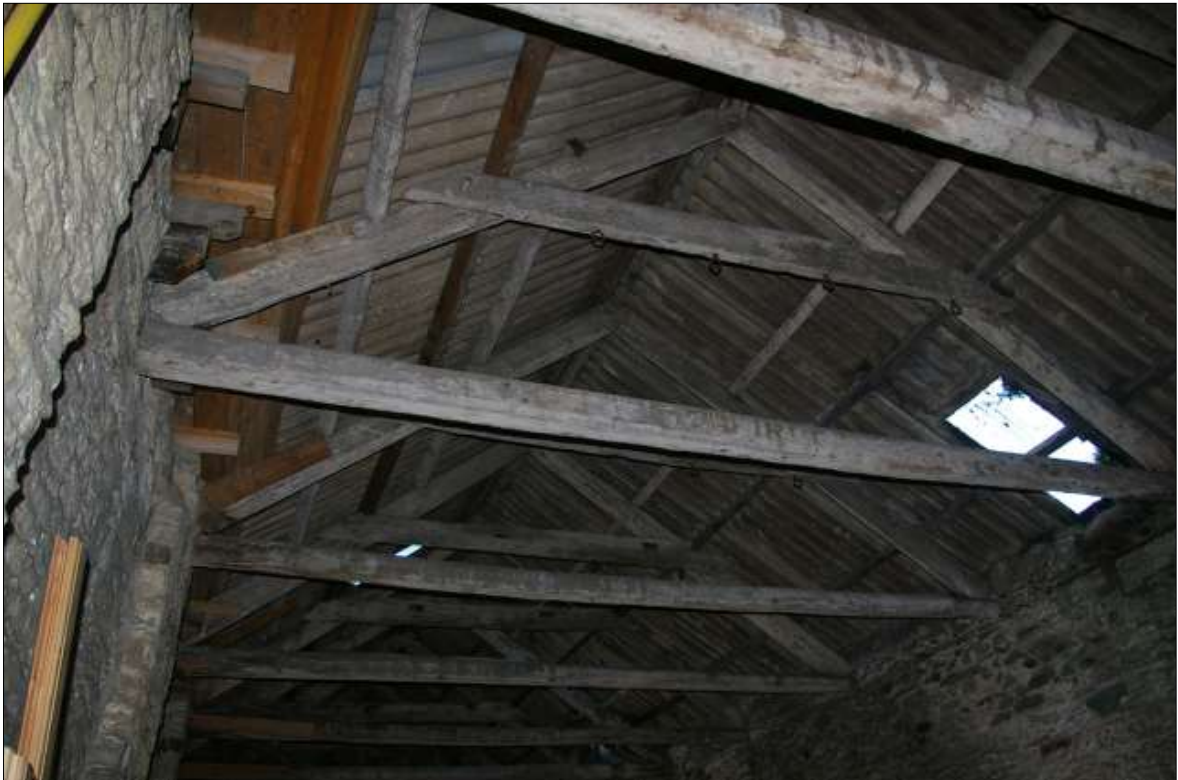
FIGURE 28: THE ROOF STRUCTURE IN B2; VIEWED FROM THE SOUTH.

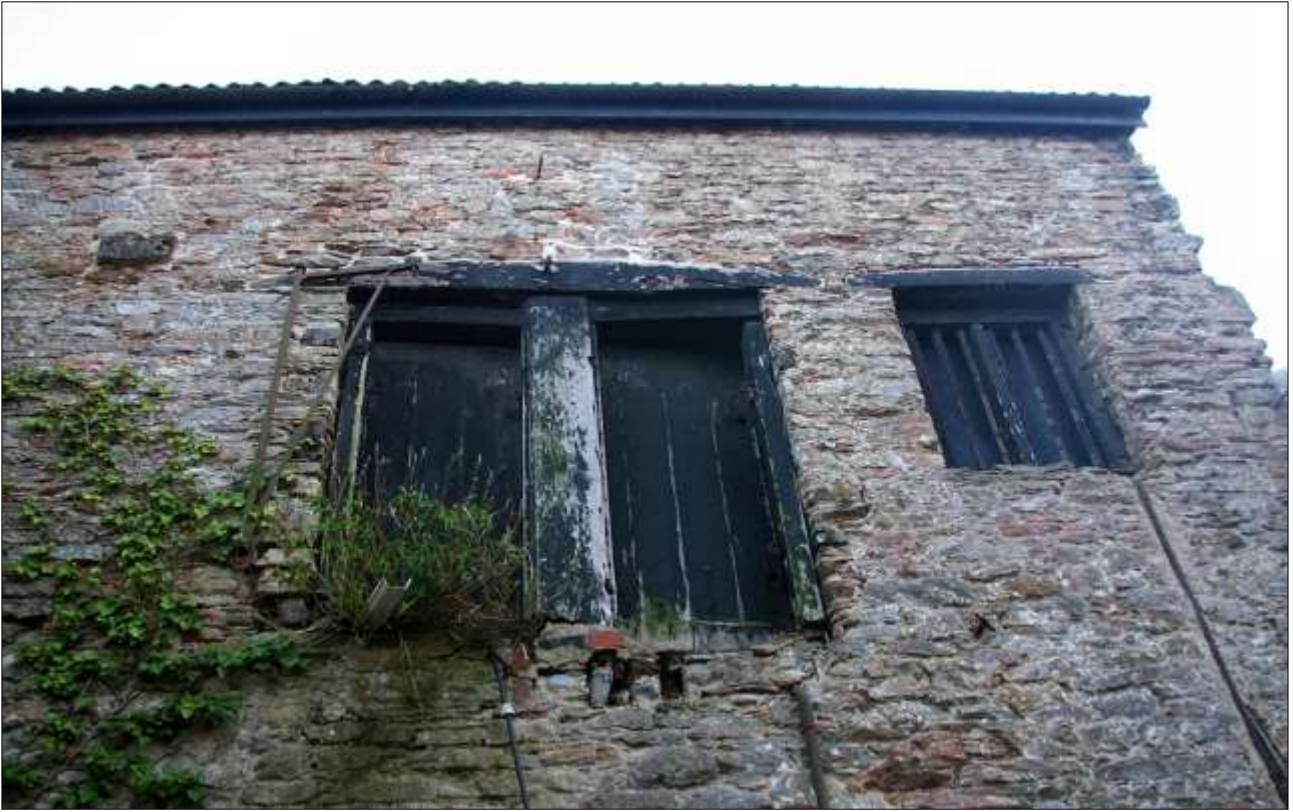
4. THE NORTH ELEVATION OF B1, SHOWING W11 AND FF DOOR 21 (D21) AND DOOR 22 (D22); VIEWED FROM THE NORTH.

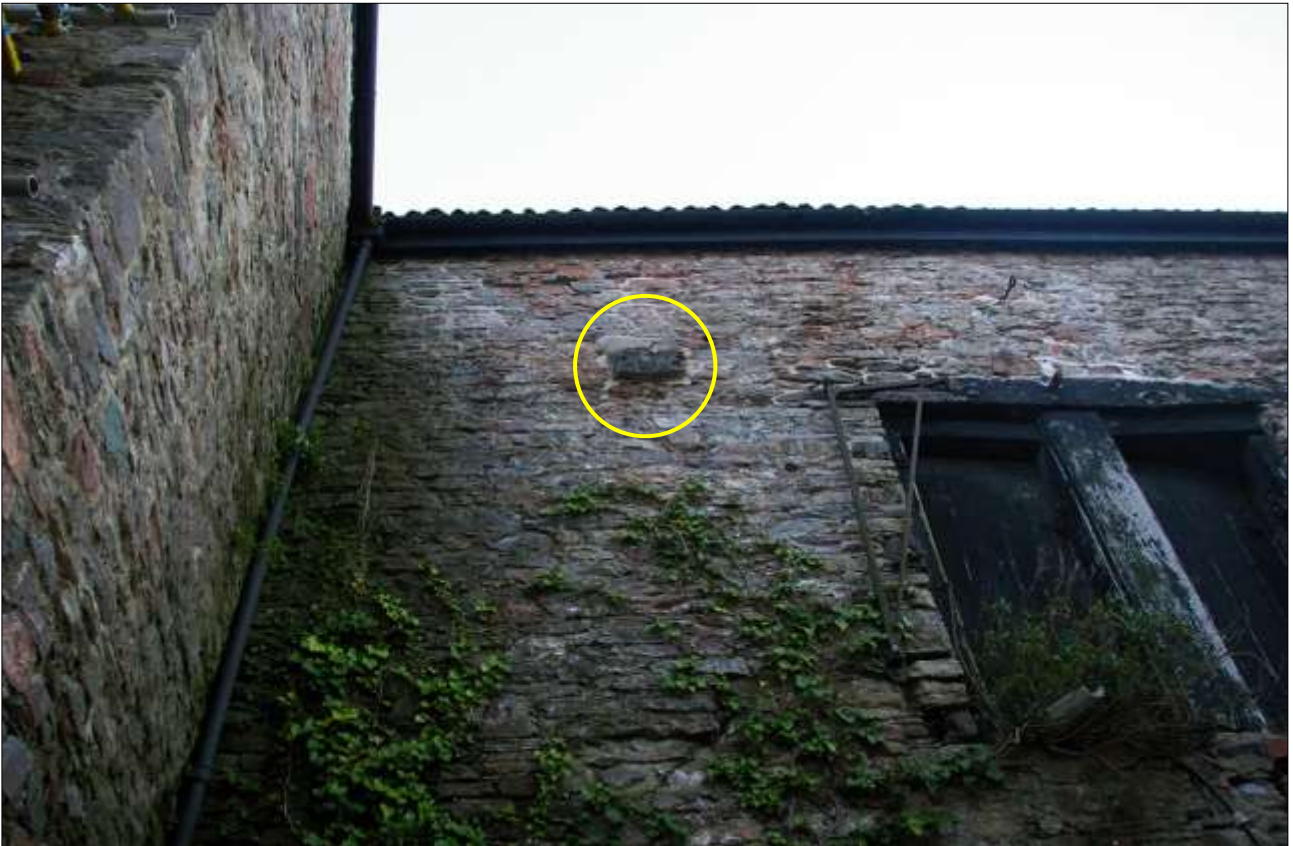
S11	A dragon tie projects into the room from the north elevation; the dragon tie has been sawn off, but features a number of pegged holes on its south-western side.
<b>Room 3</b>		
Function:		Sail-loft, then grain loft, then commercial warehousing.
Walls:		The west and east walls feature a deep structural crack. The late C19 south wall features a wide tall relieving arch of slatestone, and abuts the west wall.
Floor:		Boards over lime and soil, the boards are a mix of wide oak, and elm, and later even-width pine; these date to the C17-C20. As S4 and S9.
Openings – Windows:	W11	FF rectangular window opening with timber lintels. Plains chunky pegged frame with central mullion; the side timbers feature a series of sloping sockets to carry weather boarding (therefore reused from a weather-boarded bay?). Diamond set iron security bars. Thick black paint.
Openings – Doors:	D20	FF narrow doorway to R1, with a chamfered frame and a late C19 heavy framed braced and ledged plank door with heavy strap hinges and a large wooden lock.

5. THE NORTH WALL OF B1, SHOWING THE SHEERLEGS AND THE PROJECTING STUB OF THE DRAGON TIE S11 (INDICATED); VIEWED FROM THE NORTH.

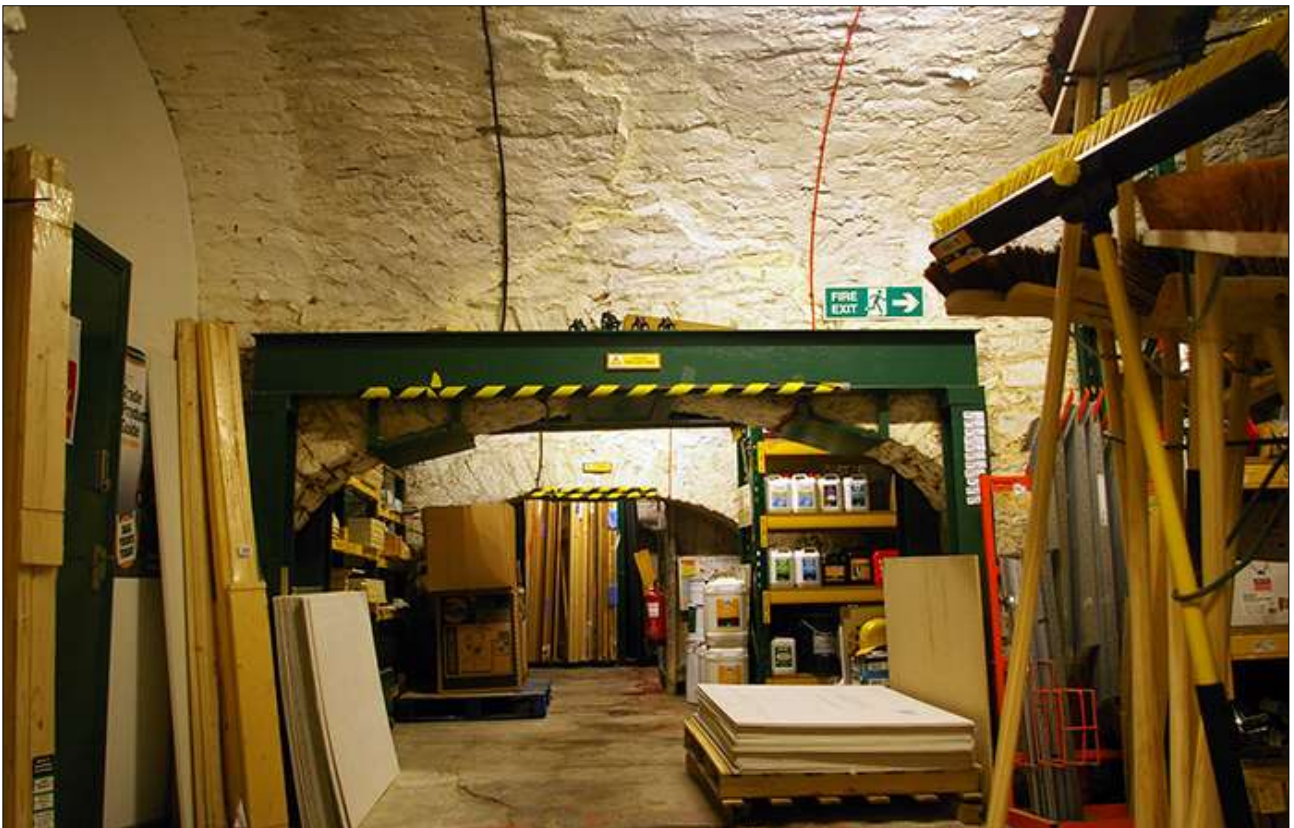
39. B1 GF, LOOKING THROUGH STEEL REINFORCED D4 FROM V3 INTO V4; VIEWED FROM THE SOUTH.

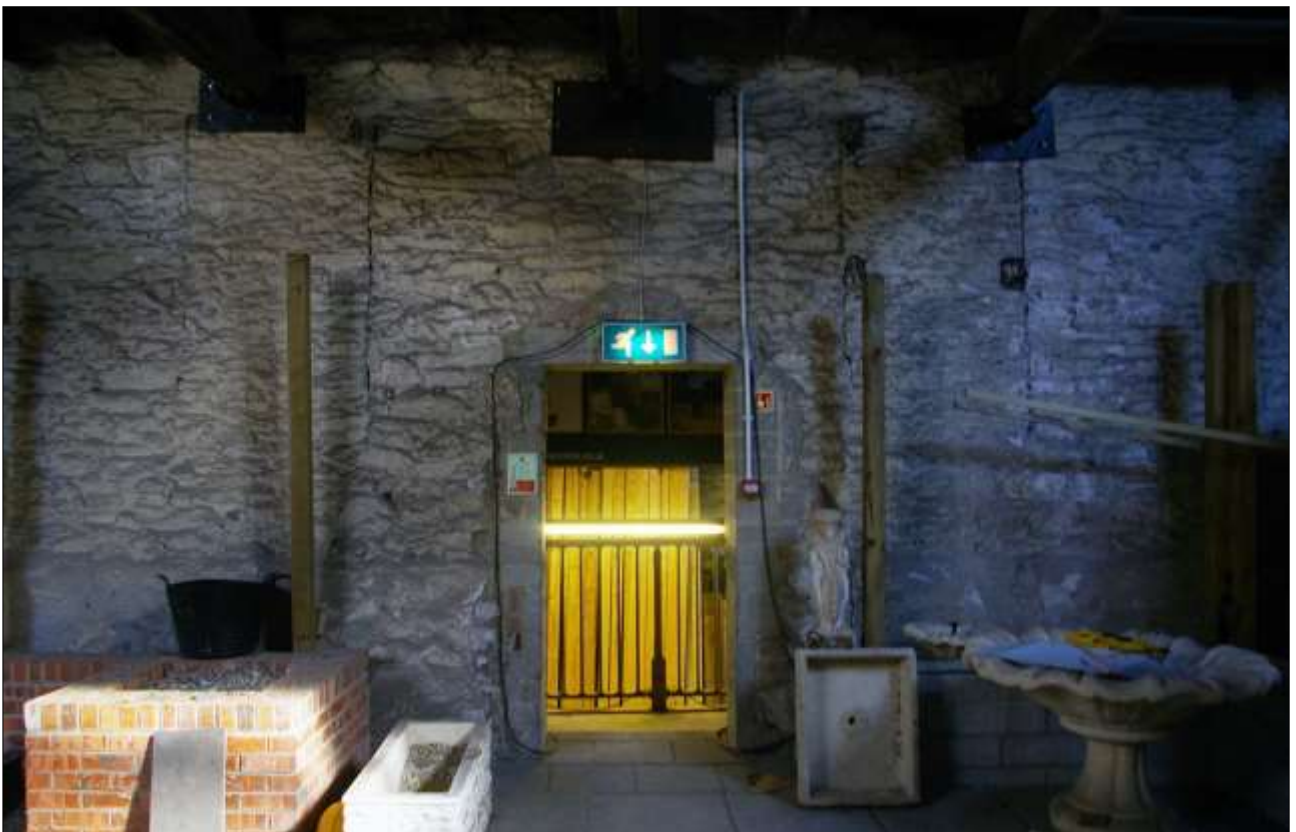
44. B1 FF ROOM 1 (R1), SHOWING FORCED DOORWAY D18 IN BO37; VIEWED FROM THE WEST.

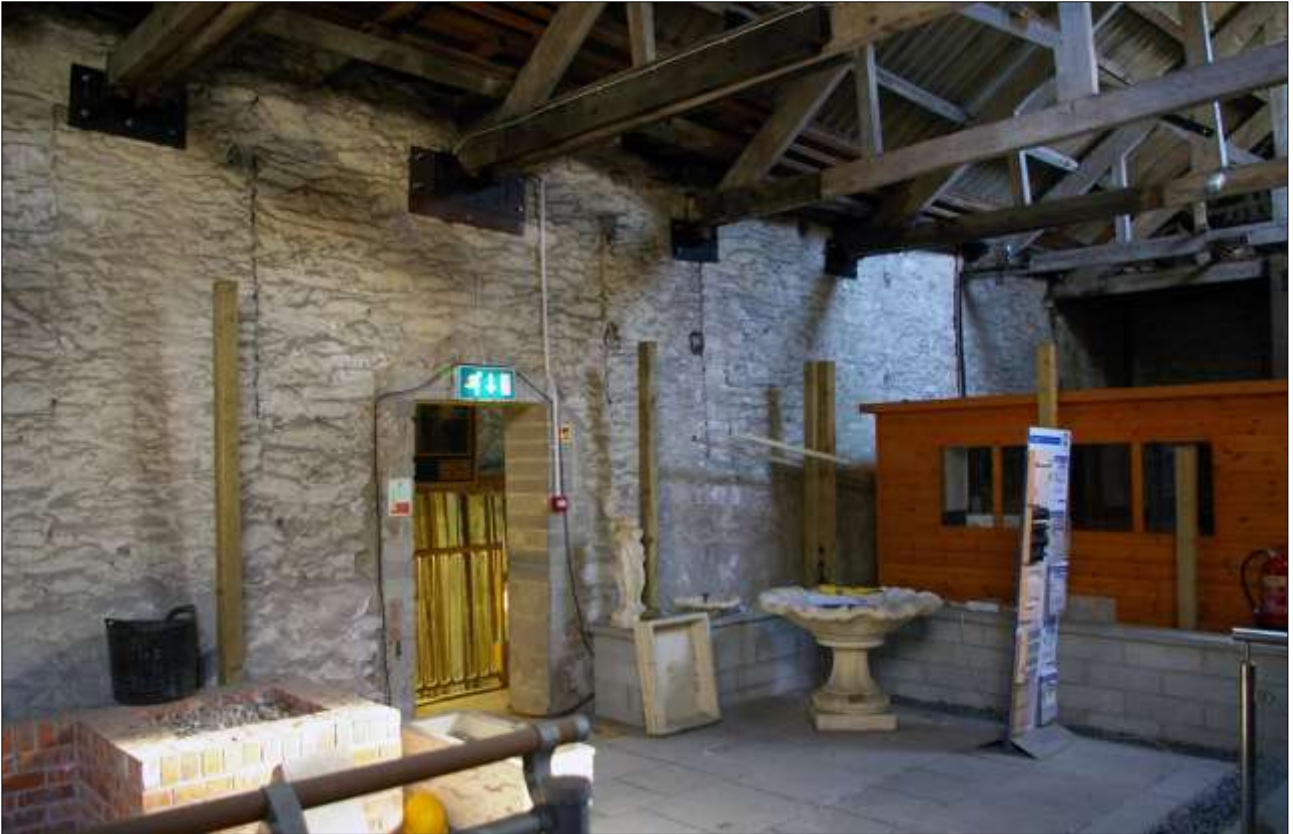
45. AS ABOVE, SHOWING THE STEEL REINFORCED TIE BEAMS ABOVE; VIEWED FROM THE NORTH-WEST.

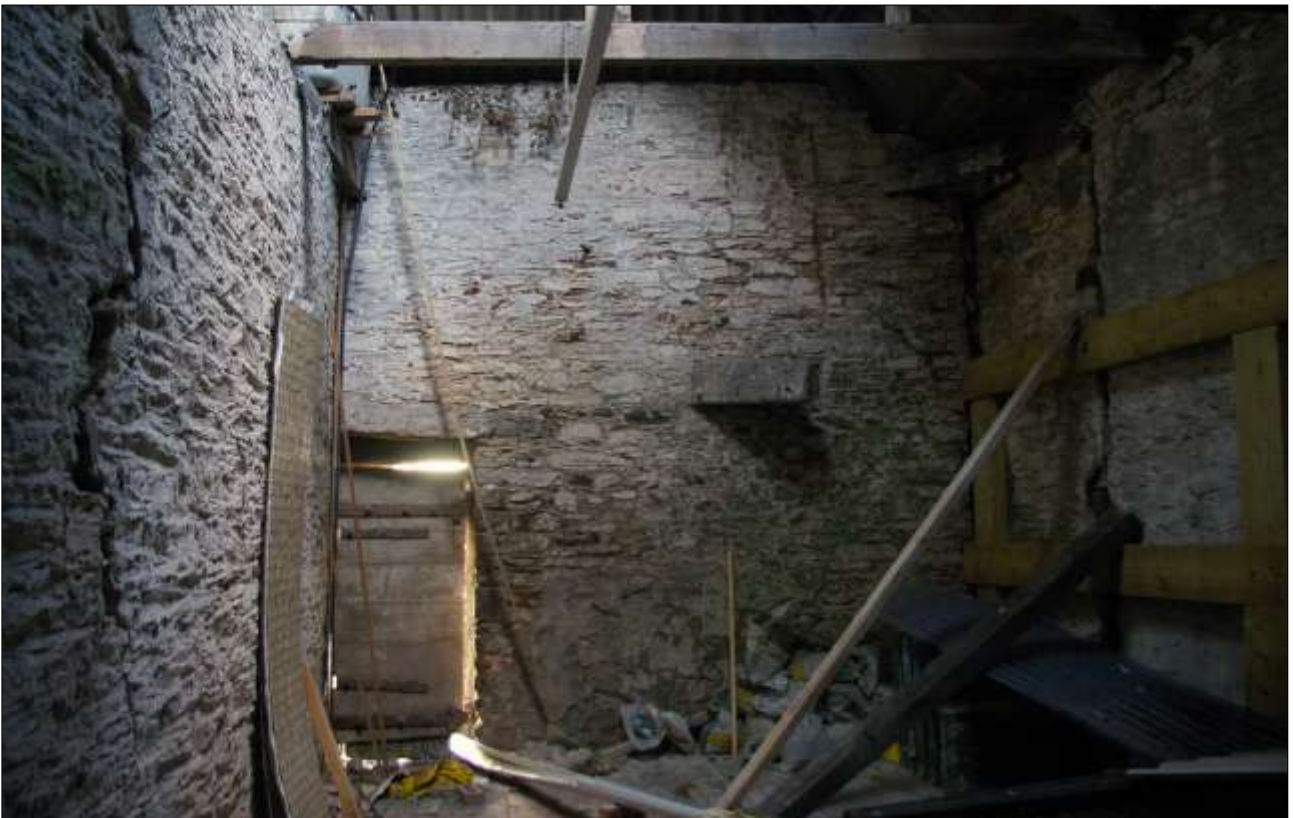
74. B1 FF R2, VIEW OF THE STRUCTURAL CRACK IN THE WEST WALL, AND D22 IN THE NORTH WALL; VIEWED FROM THE SSE.

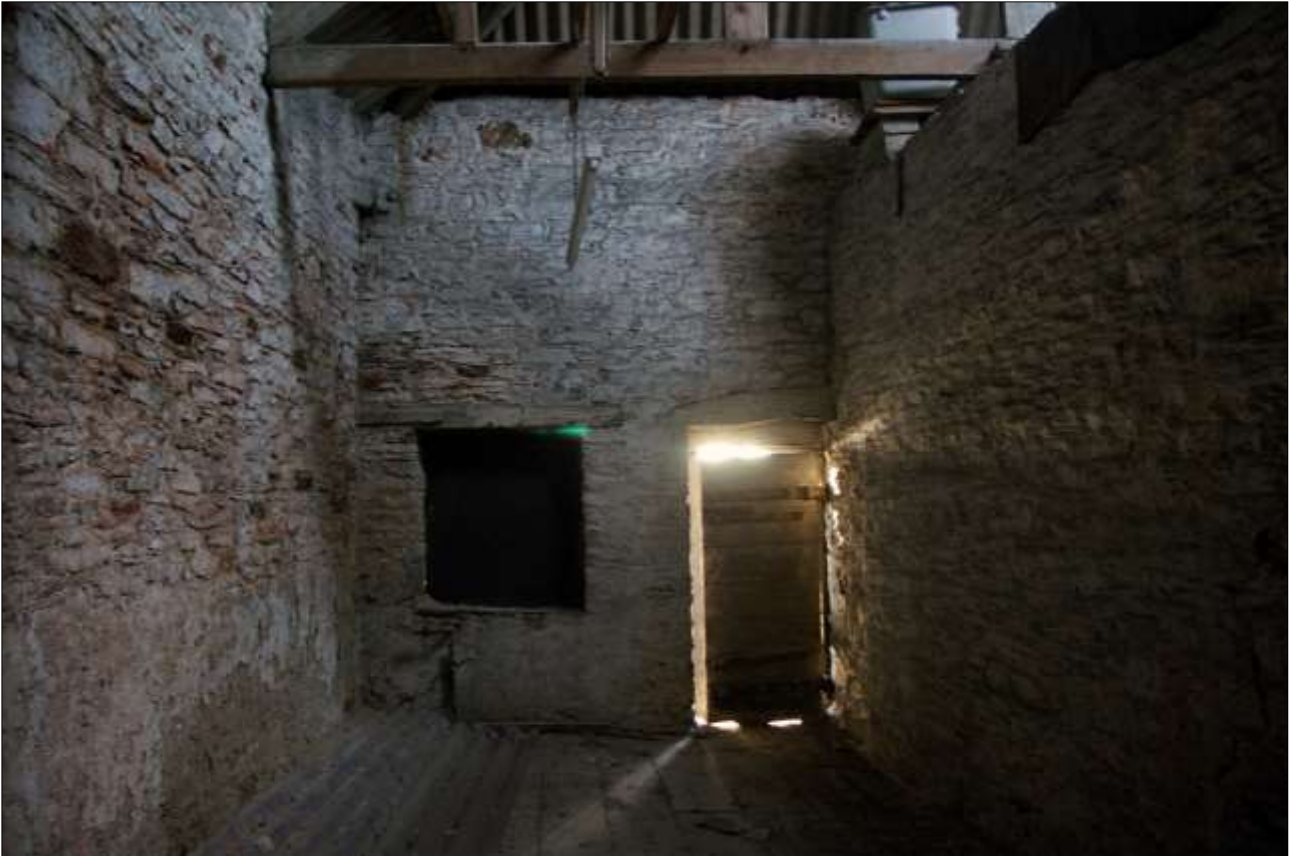
83. B1 FF R3, THE WEST WALL OF R3 SHOWING ITS STRUCTURAL CRACKS; VIEWED FROM THE SOUTH-EAST.

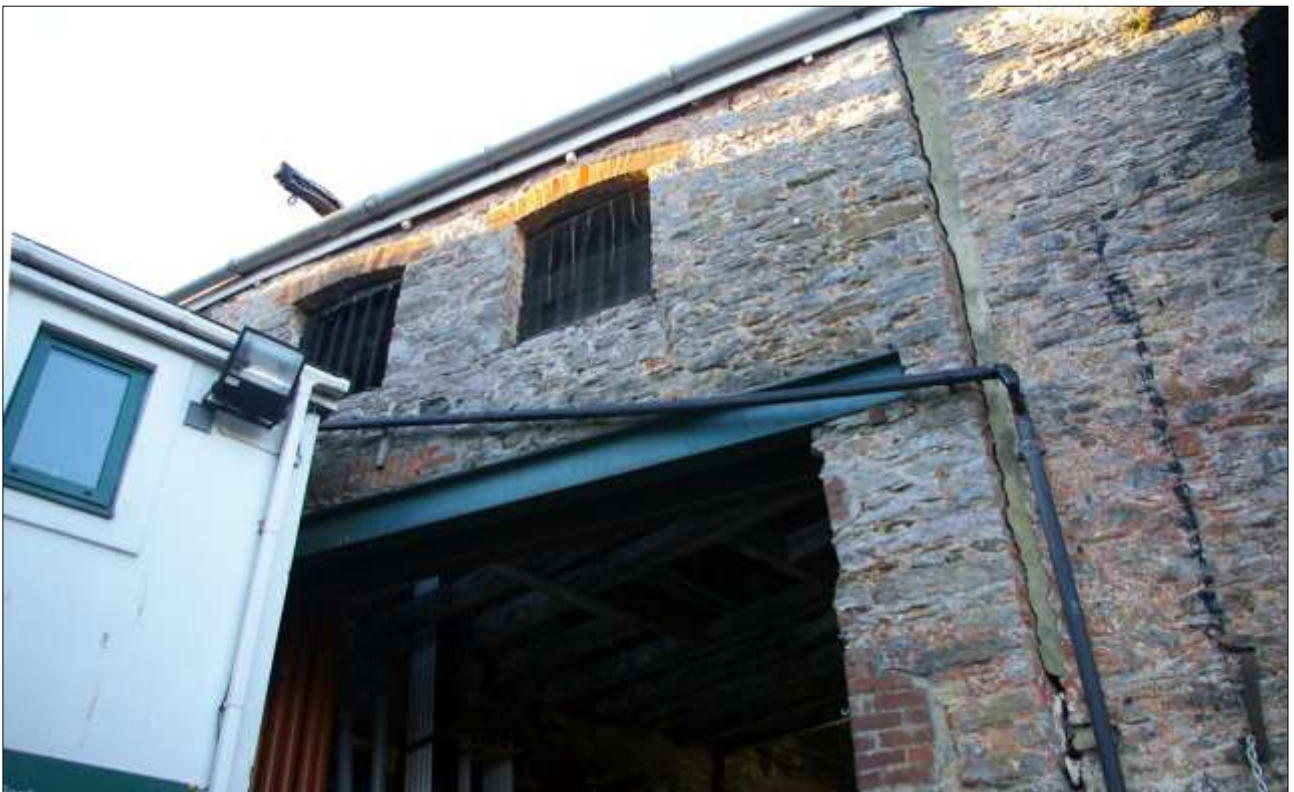
Openings – Doors:	D5	GF forced doorway to B1, repaired in concrete block with a concrete lintel. Probably an opening like BO7-BO8 but much enlarged.
	D12	GF and FF tall wide modern forced opening in the south wall, heavy RSJ lintel, with reveals patched with cement and brick.
Openings – windows:	W12	FF square window opening. Forced or widened, with west reveal rebuilt in brick. Thin timber lintel, pegged frame with central mullion, pintles for shutters, set with thin modern iron bars.
	W13	FF square window opening. Forced or widened, cutting the blocked fireplace FP2. Plains chunky pegged frame with central mullion. Diamond-set iron security bars, pintles for shutters. Thick black paint. Similar to W11 and W21.
	W18	SF square window opening in south wall, paired with W19. Brick segmental arch. The window has a heavy plain frame with pegged joints, six wooden diamond-set security bars, painted black. Covered with modern mesh to prevent pigeons.

94. THE SOUTH ELEVATION OF B2, WITH LARGE FORCED GF OPENING D12 WITH W18 AND W19 ABOVE; VIEWED FROM THE SSE.

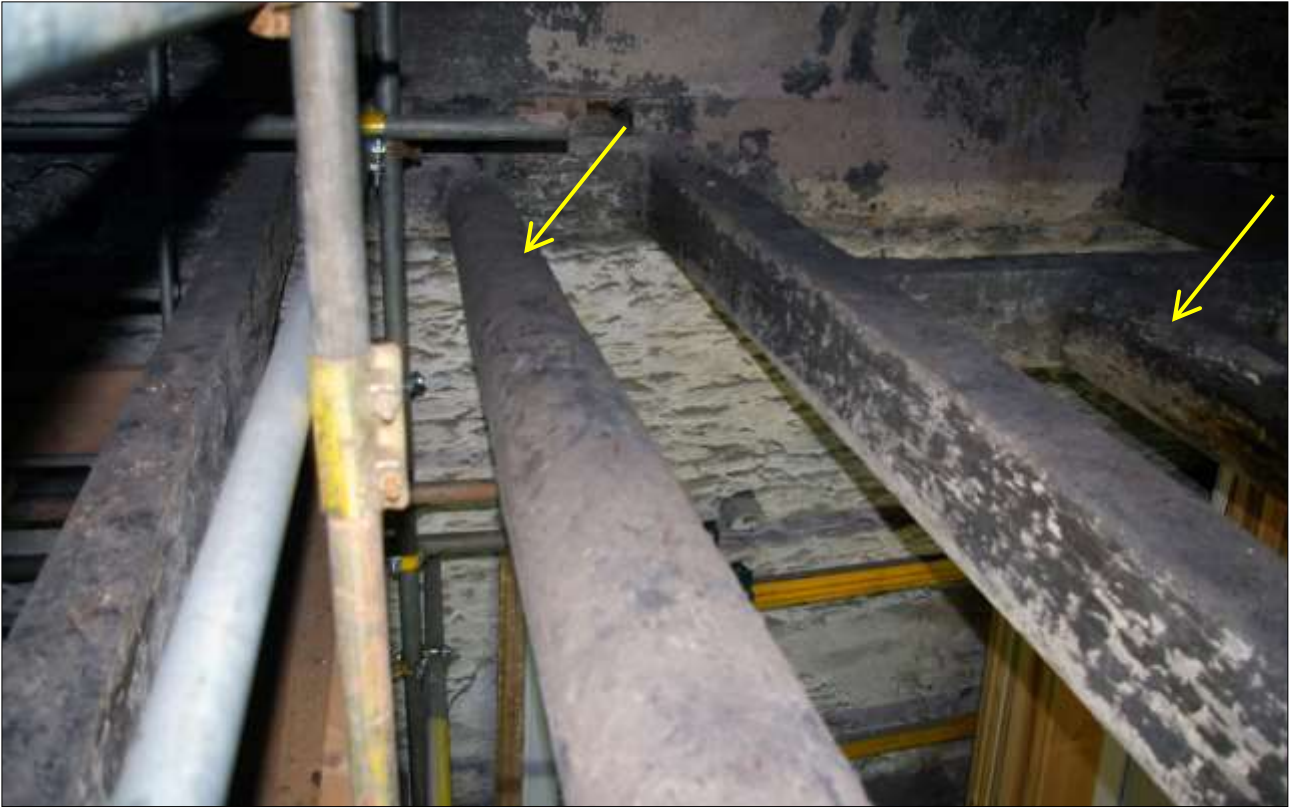
127. B2 SF INTERIOR, SHOWING THE BEAMS AND RE-USED SHIPS TIMBERS S22 (INDICATED); VIEWED FROM THE WEST.

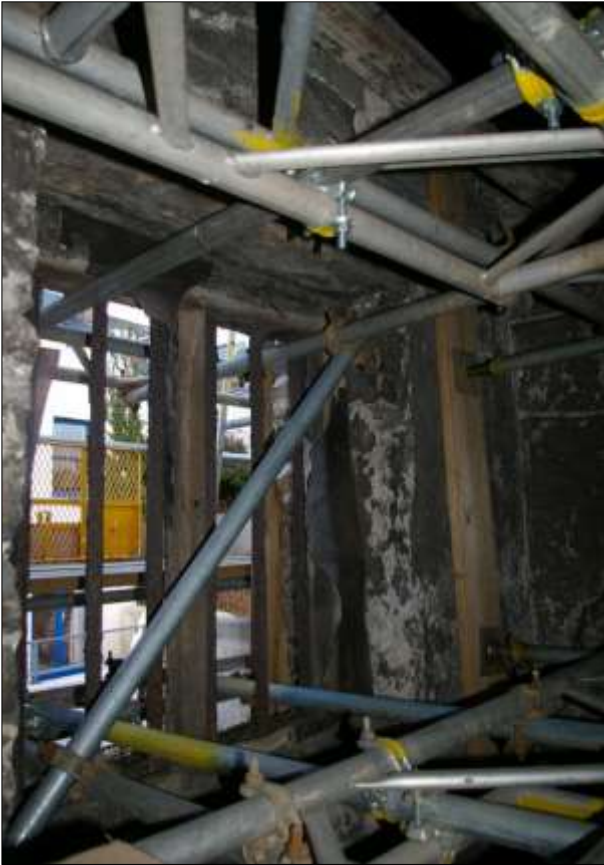
130. B2 SF INTERIOR, NORTH WALL, SHOWING W21; VIEWED FROM THE SOUTH-WEST.

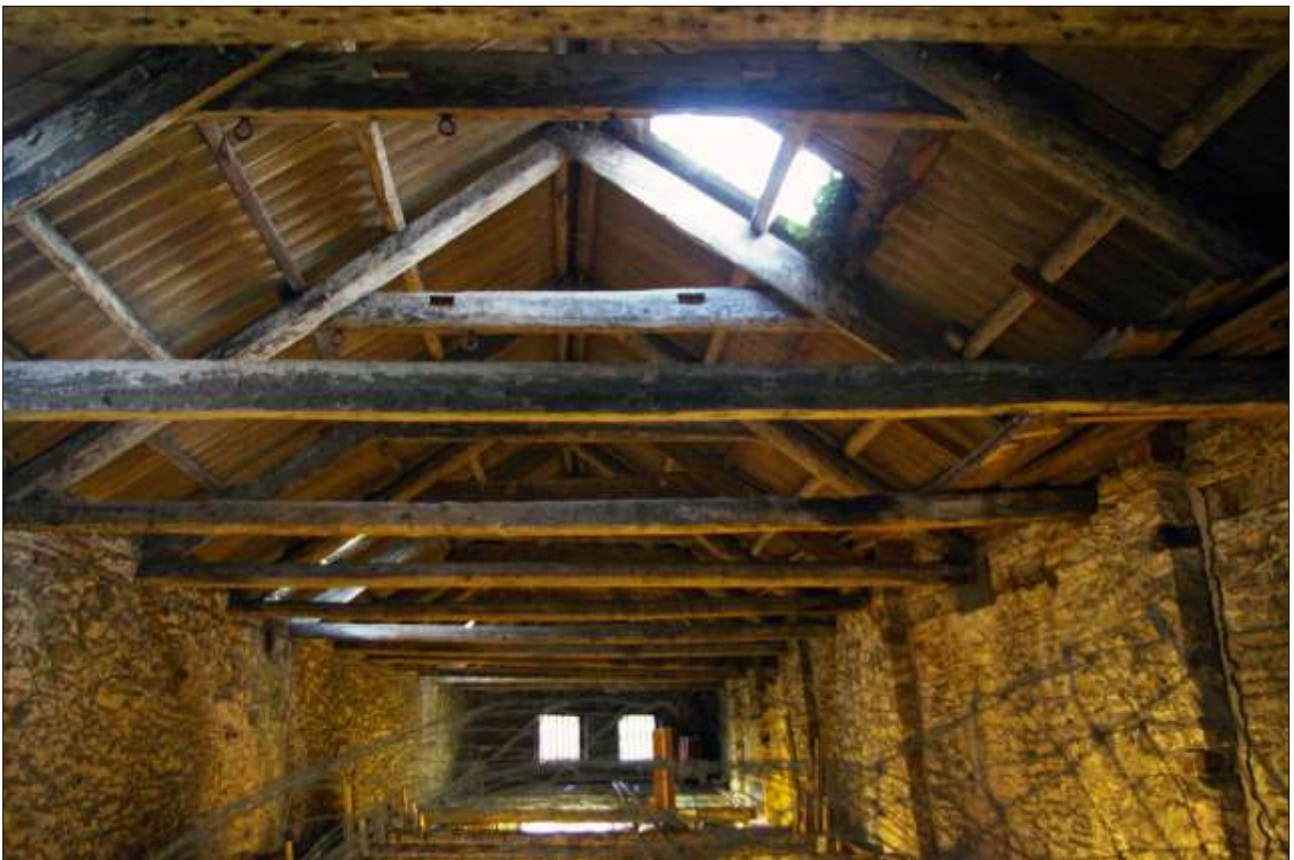
131. B2 SF INTERIOR, DETAIL OF THE ROOF STRUCTURE; VIEWED FROM THE NORTH.

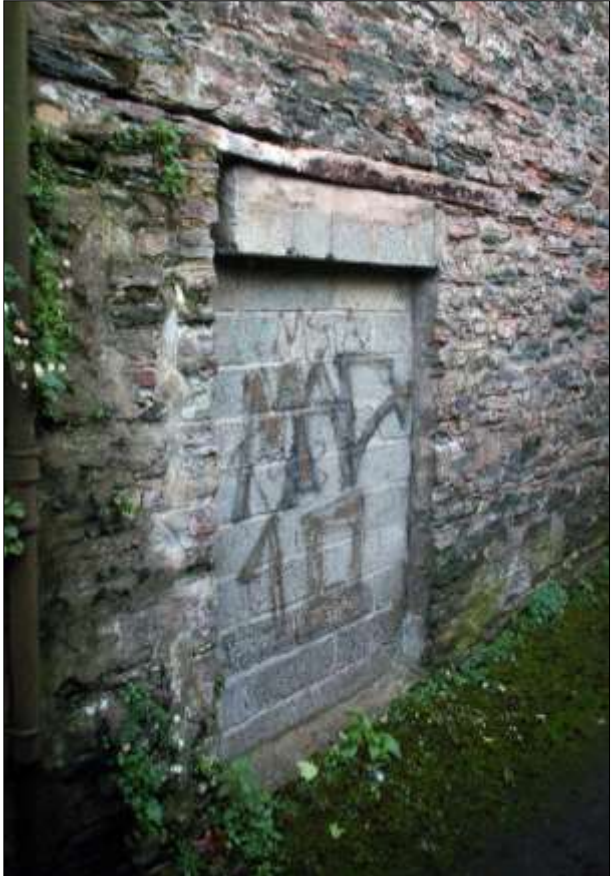
piers have failed through water damage the core build seems to be with a brownish-beige clay bond, possibly mixed with some lime. The north and south walls are of inferior mixed slatestone rubble set in a lime mortar. The bays between each pier are infilled with stone rubble, concrete block, with framed timber weather-boarding to the two northern bays (W16 and W17). The south wall features a forced or widened opening ground-floor level carried on a reused timber lintel (D13) with a slightly narrower loading door above (D19); above the loading door is a projecting gabled pentice of corrugated sheet steel covering a flywheel (S23); the timbers carrying the flywheel extend back to the first roof truss. The north wall has blocked doorways at ground- and first-floor level, with 17<sup>th</sup> century yoked timber lintels reused upside down (BO34 and BO46).

136. THE NORTH WALL OF B3 SHOWING FF BO46; VIEWED FROM THE NORTH-EAST.  
137. THE NORTH WALL OF B3 SHOWING BO34; VIEWED FROM THE NORTH-EAST.

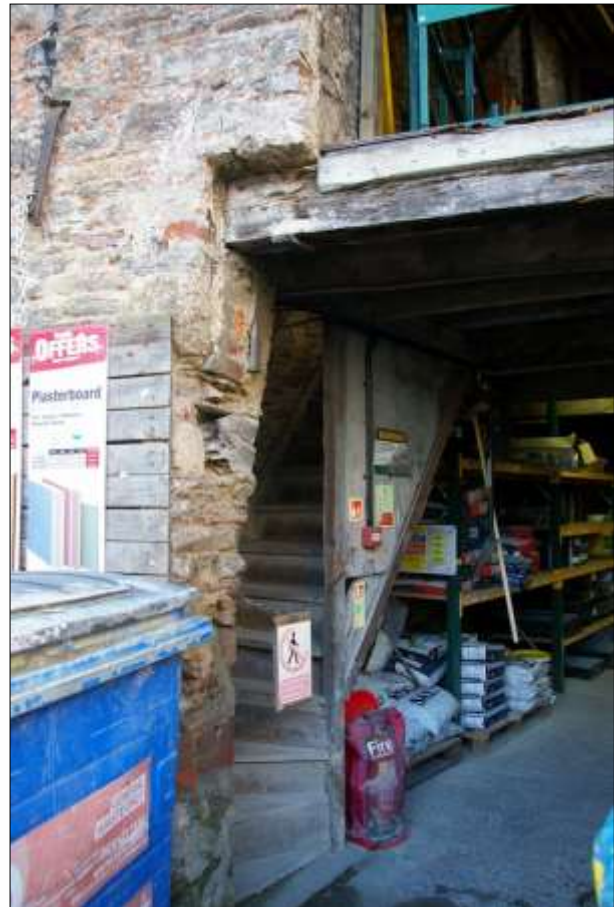
140. RIGHT: THE SOUTH ELEVATION OF B3 SHOWING THE WIDENED DOORWAY D13 WITH STAIRS (S3) BEHIND; VIEWED FROM THE SSE.

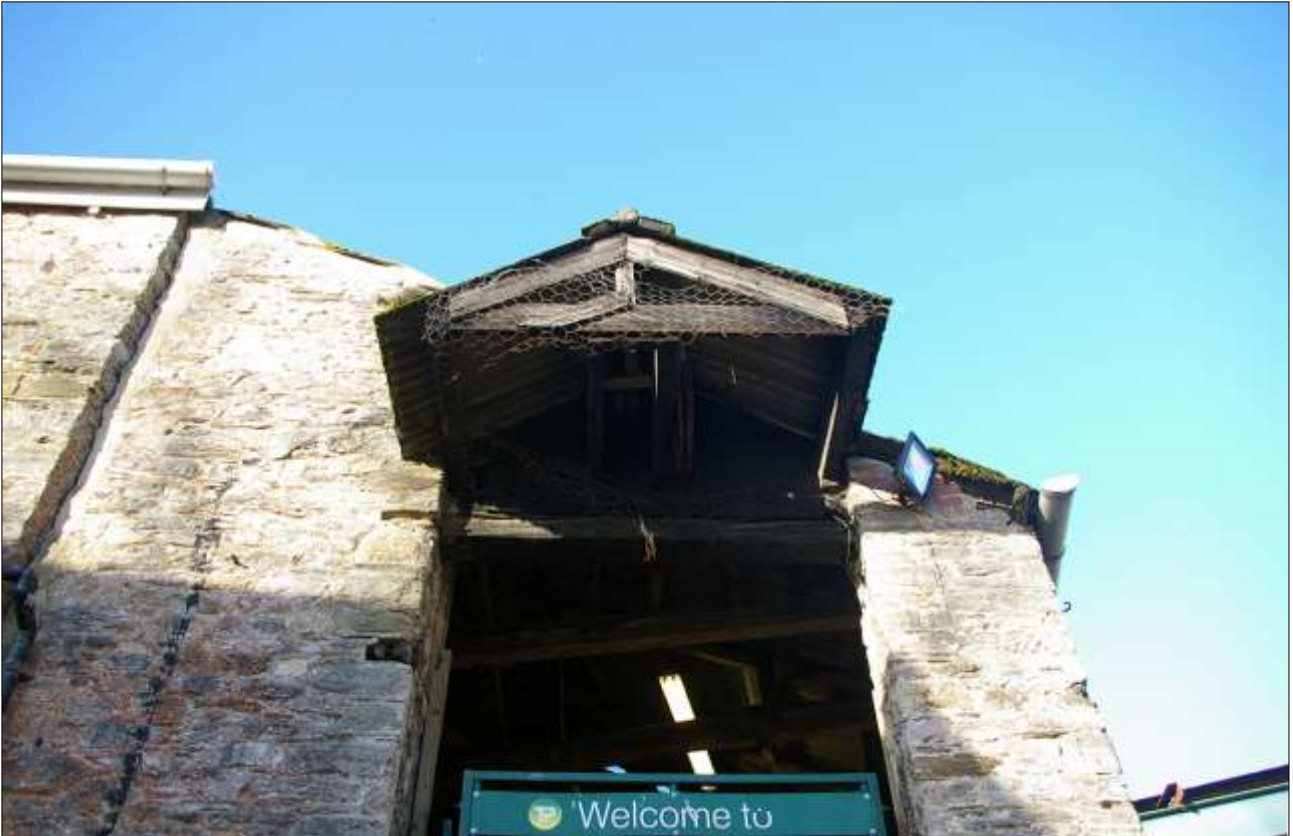
141. THE SOUTH ELEVATION OF B3, WITH FF LOADING DOOR D19 WITH PENTICE AND FLYWHEEL (S23) ABOVE; VIEWED FROM THE SOUTH.

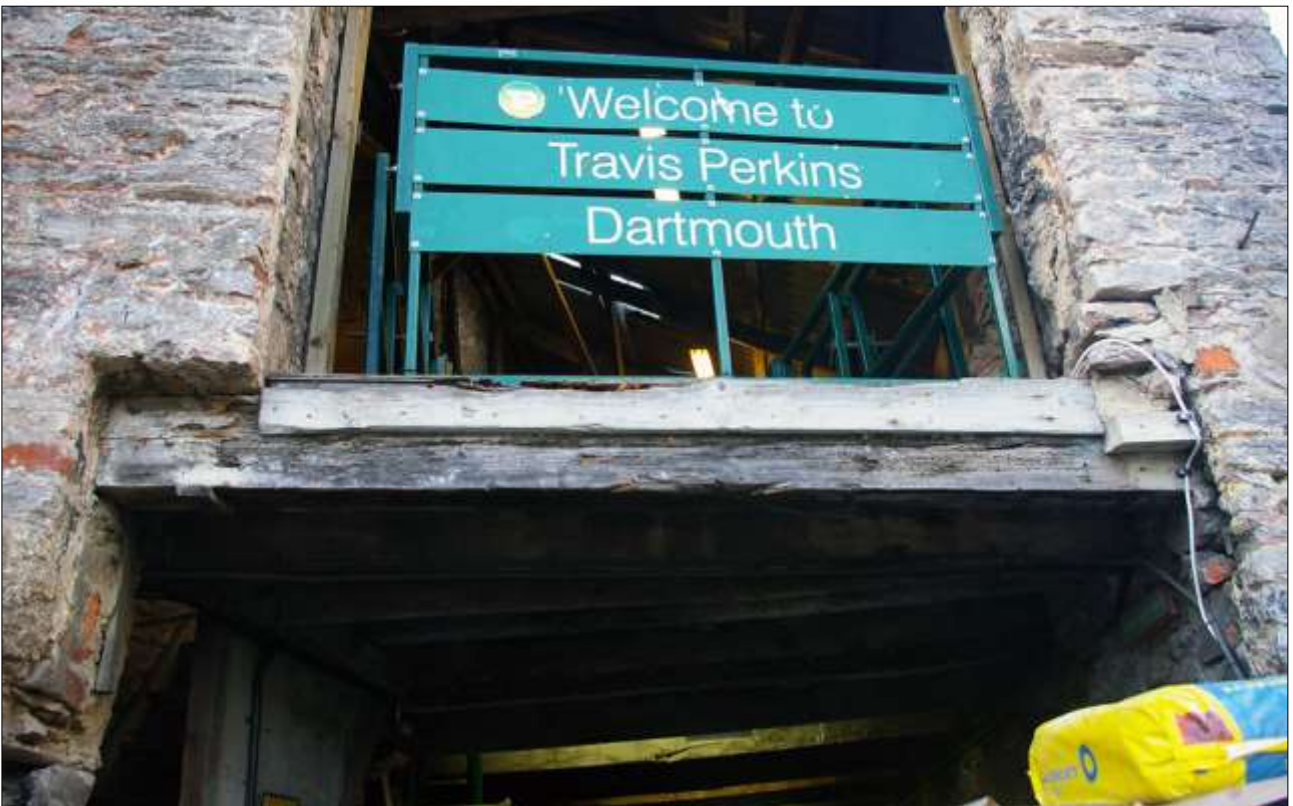
142. THE SOUTH ELEVATION OF B3, SHOWING THE LINTEL OVER D13; VIEWED FROM THE SOUTH.

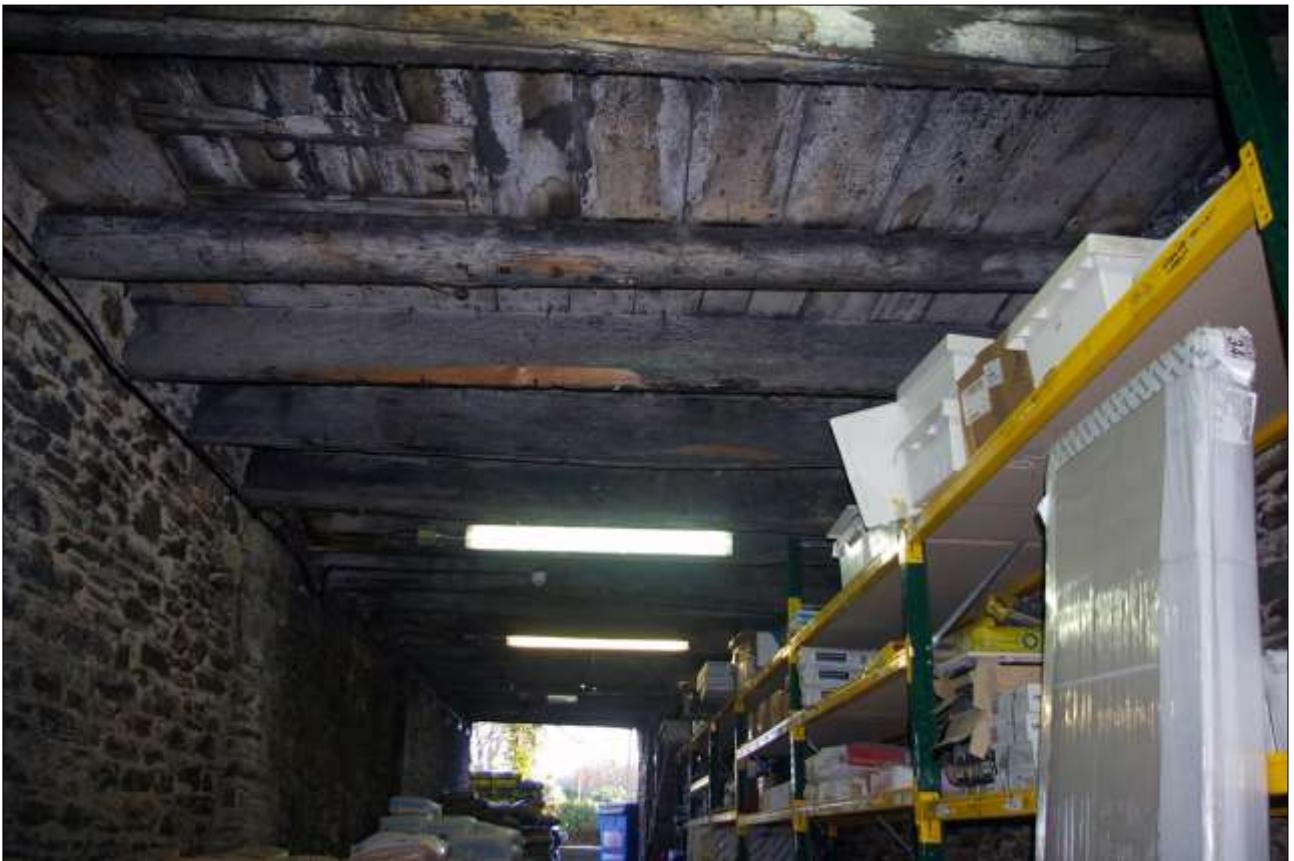
154. B3 GF INTERIOR, DETAIL OF THE MANY RE-USED BEAMS, INCLUDING SHIPS TIMBERS; VIEWED FROM THE NORTH.

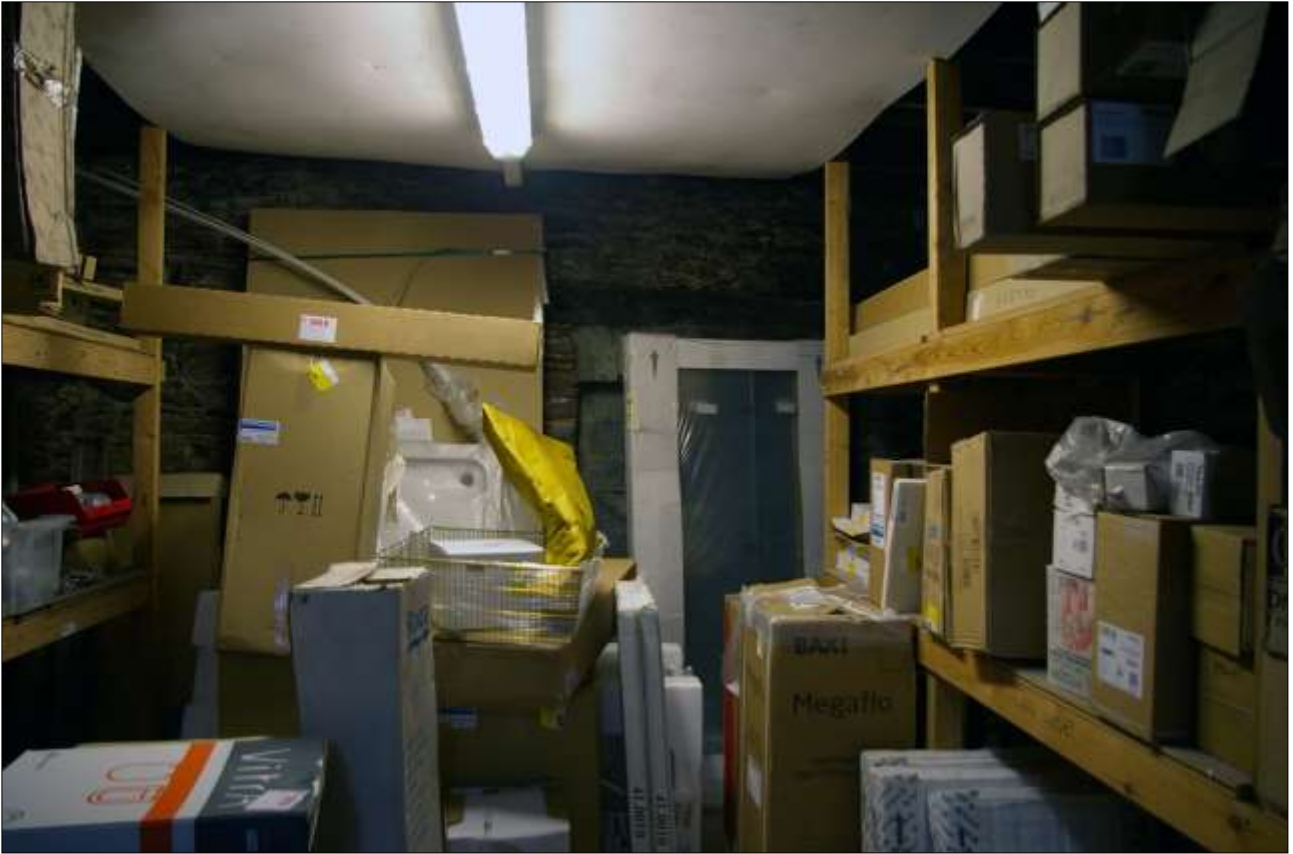
165. B3 GF INTERIOR, THE NORTH WALL WITH BO34; VIEWED FROM THE SOUTH.
