THE BARNs
CHELFHAM BARTON
BRATTON FLEMING
NORTH DEVON

Historic Building Recording and Archaeological Monitoring

South West Archaeology Ltd. report no. 201013

By Dr S. Walls, E. Wapshott & A. Allen
Report Version: FINAL
Issued: 13th October 2020
Finalised: 22nd July 2021

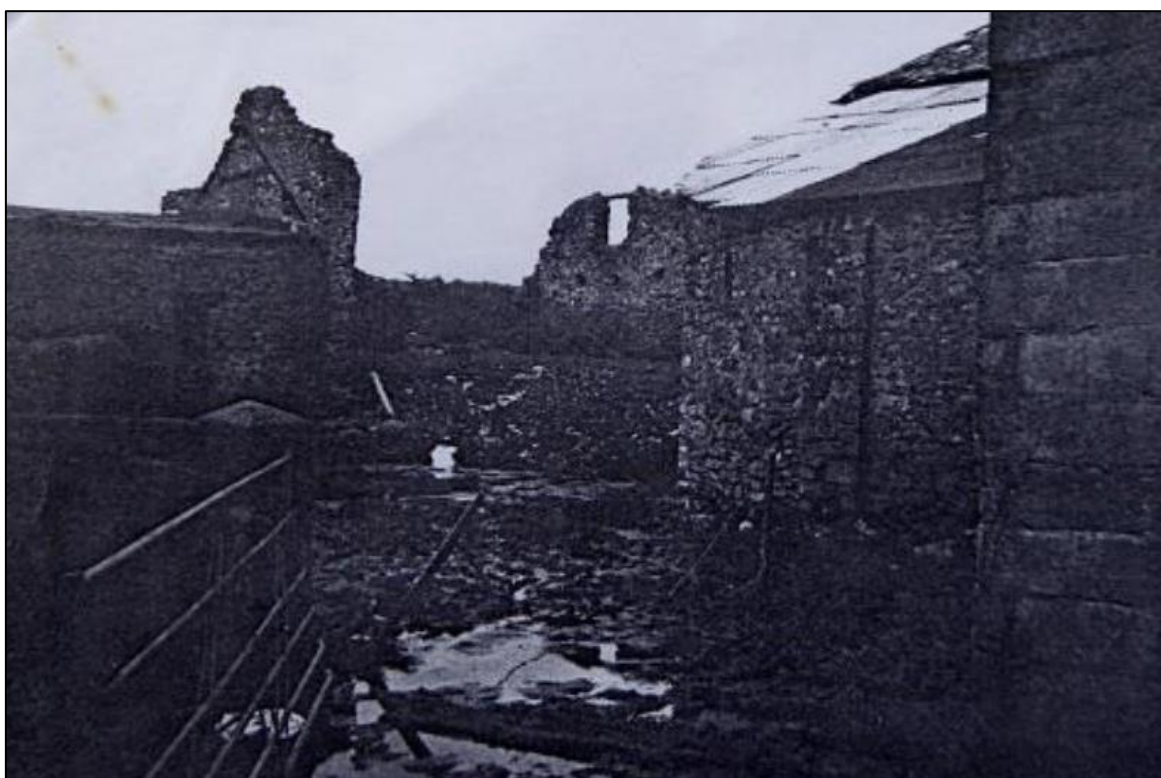
FIGURE 10: 1989 PHOTOGRAPH OF BUILDING 1, WITH ROOFED ROUNDHOUSE (B3) TO THE RIGHT. (FROM: NIMROD RESEARCH, 2017).

Old photographs of Building 1 (Figures 10 & 11) show a small, two storey structure, to the north end of a range of buildings with a loading door set high in the north gable. Previous work suggested a 'bank barn' due to the position of the loading door, which is a valid interpretation. The pair of low blocked windows (Figure 12) at ground floor, are however more unusual in agricultural animal housing, slit vents are more common, except in stabling; however it is unusual for horses to be kept in shippens, stables being a specific and separate form of farm building. The presence of windows of different sizes serving small interior spaces indicate both a need for light and differing functions of spaces within the range and therefore suggests mixed or even semi-domestic function in an earlier phase.

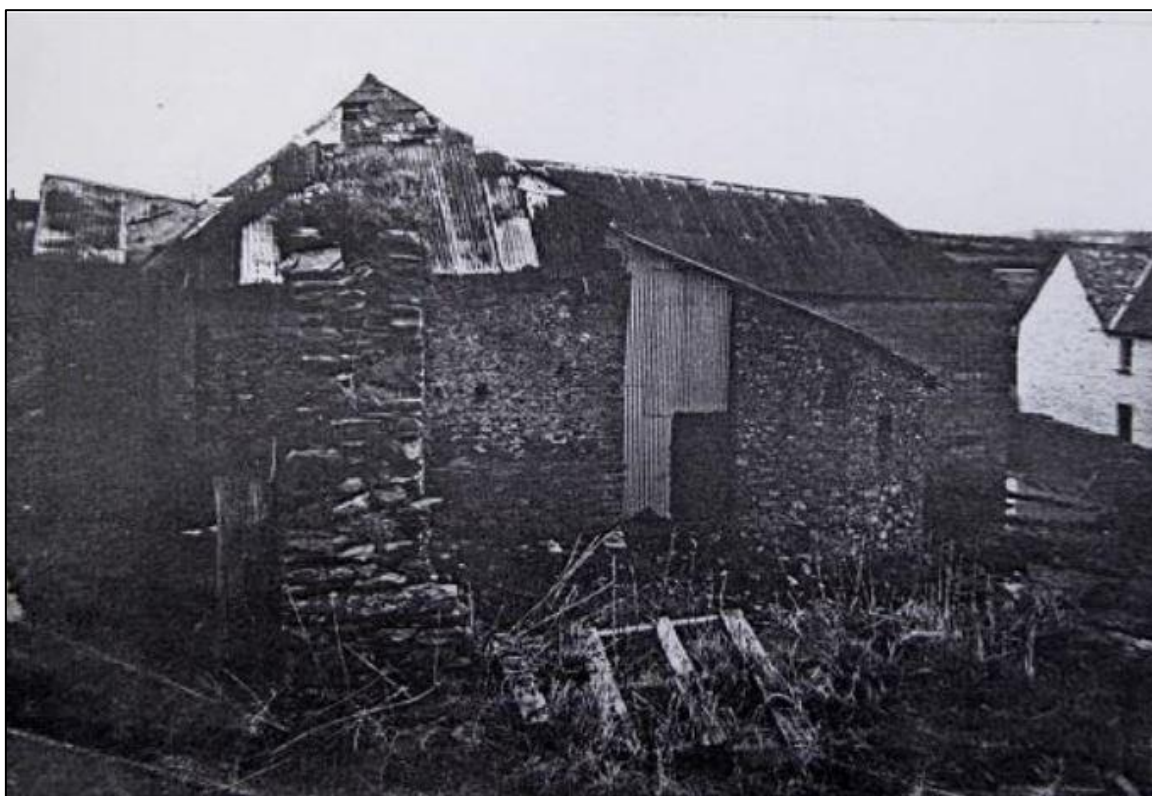
FIGURE 11: 1989 PHOTOGRAPH TAKEN FROM THE WESTERN EDGES OF THE SITE. B2A VISIBLE ON THE LEFT, WITH B3 VISIBLE TO THE RIGHT AND THE WHITE RENDERED FARMHOUSE IN THE BACKGROUND (FROM: NIMROD RESEARCH, 2017).

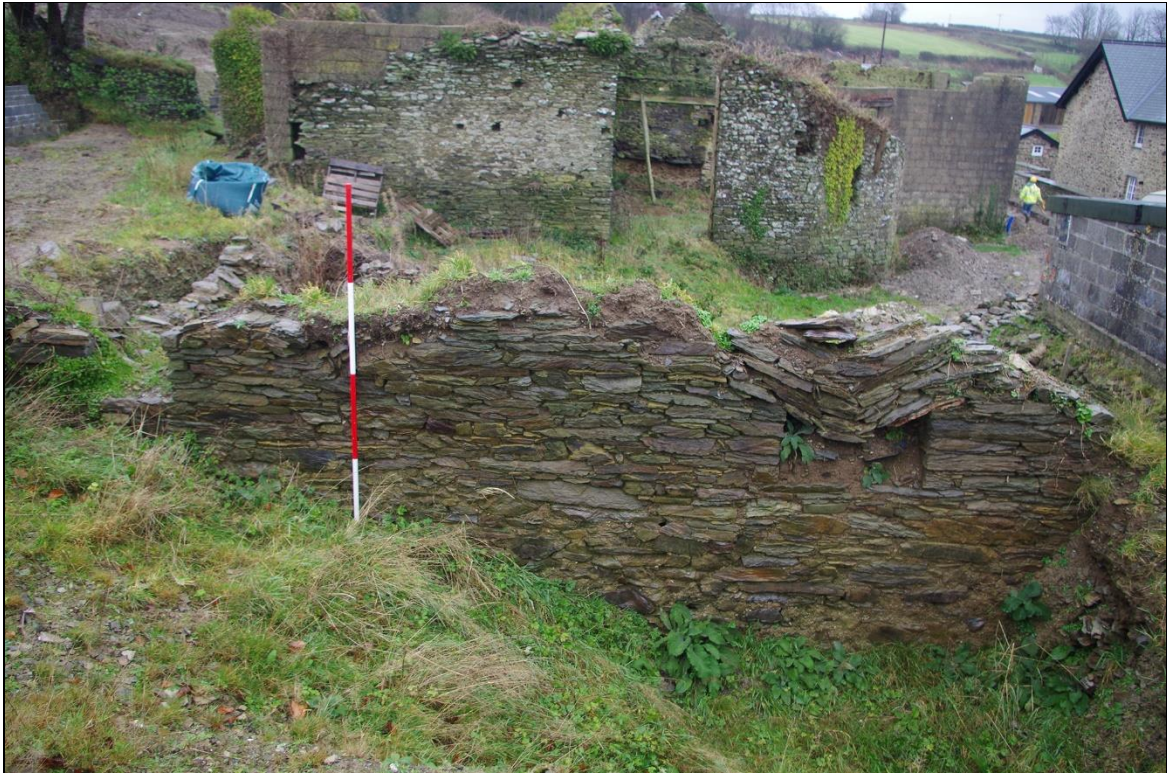
Surviving as low walls to the north and west, forming the remains of an L-shaped range, B1 rises at its tallest to only c.1.5m high. The west wall is of heavy slate slab build, slightly battered with graduating stonework, in an earth/clay bond. It contains the bases of two irregularly positioned and sized window openings which had previously been blocked with loose rubble, as the ground surface has raised over time on the west side. The stonework here is of good vernacular quality, regularised, semi-coursed, with some shaping to larger slate slabs, with sills to the windows and crude quoins. The wall varies between 0.55-0.65m in width. The north wall after a short return from the west, beyond a build line, is thinner, c.0.4-0.45m in width and is of looser rubble, with some further blocked openings, the details obscured by its demolished/damaged condition. This wall runs out towards B2 to the east, having been demolished for access at the east end.

FIGURE 12: B1, WEST WALL, SHOWING WINDOW OPENINGS AND HEAVY SLATESTONE BUILD; FROM THE WEST (2M SCALE).

- A pair of small square window openings, slate slab sills; larger window to south, set lower on wall, smaller narrower window, deep embrasures to north on corner, raised higher on wall.
- Evidence of an earlier phase; vernacular, regularised, semi-coursed west wall on battered foundations

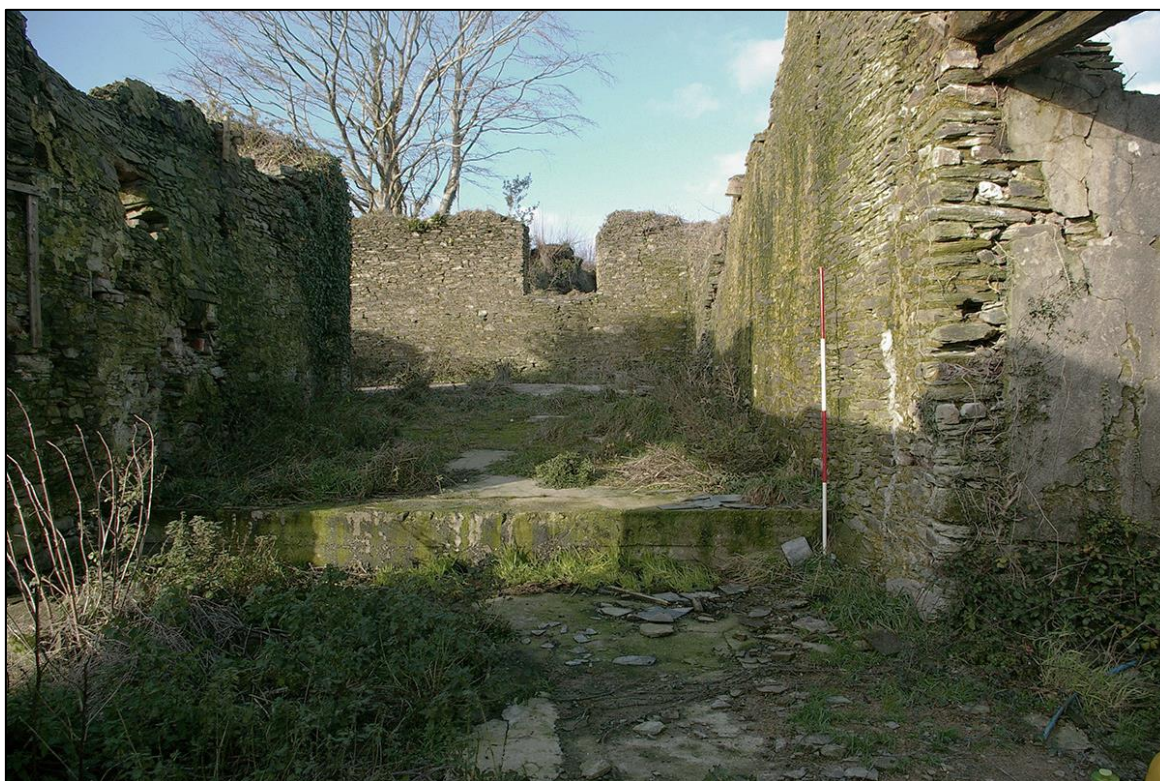
FIGURE 14: B2B INTERIOR, SHOWING HOW IT ADJOINS B2A, TO THE NORTH; FROM THE SOUTH (2M SCALE).

This building is of an irregular rectangular plan on an oblique north-south alignment (Figure 14), only its east and west walls survive, to one and a half storeys height. The west wall is of heavy, slate slab build, the stonework graduated with a batter; with a slate slab string course or weathering course. This wall was built directly onto the bedrock, which has since been exposed by terracing on the outer face. The inner face of the wall has been patched with cob and concrete block in places and there are a number of blocked window openings and forced openings for machine shafts and belts. A keeping-place alcove for a candle or lamp has been created at the south end, where a threshing door has been formed within an extension against the earlier wall, the lower part of this barn has been rebuilt in concrete blocks.

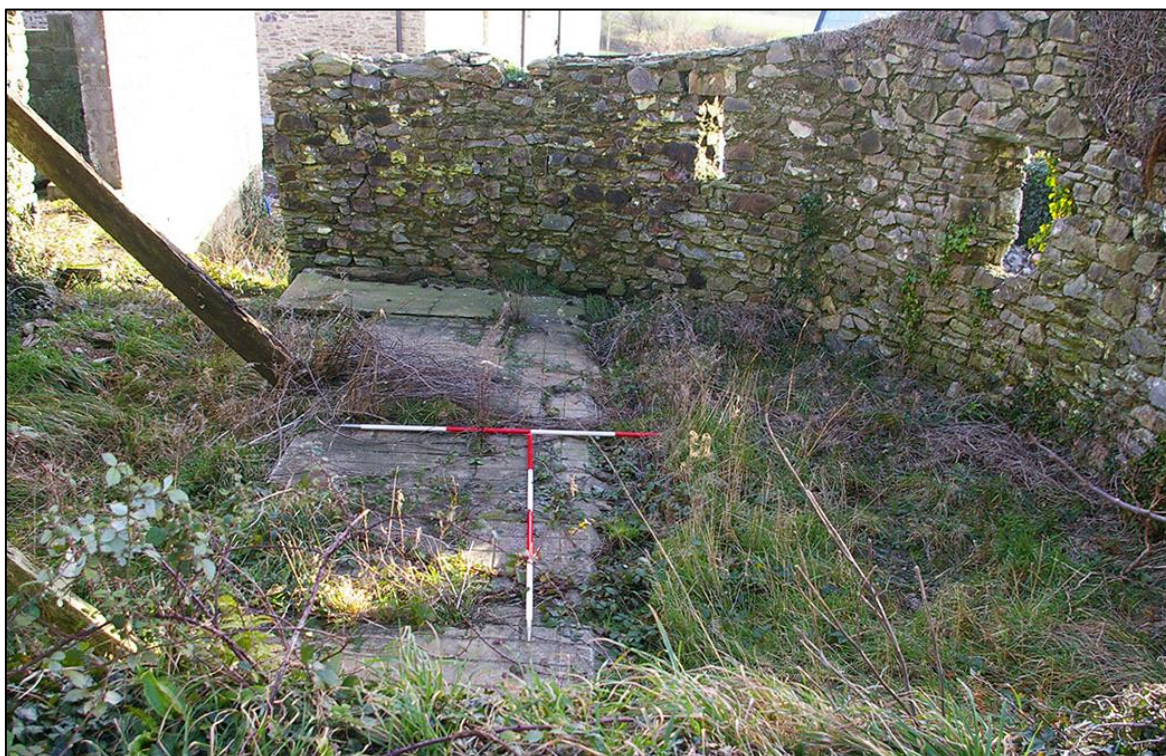
This structure survives as a roofless single storey, multifaceted, multi-phase wall, infilling the corner between B2B and B2A. It is of slate-rubble build, with a slight plinth to base and contains one stone-built drain hole and has a slit vent in its southern wall and two later forced window openings (Figure 15). Two large openings provide access, against B2A and B2B respectively and the stone around these suggests significant rebuilding. The floor is concreted in part and laid with pre-fabricated moulded concrete panels in the other half, but there is a drain, running roughly north-south through the building, and a large concrete plinth with iron bolt fixings is evidence of the position of a former engine.

This building presents as an altered horse engine house, later housing a threshing machine engine

as agricultural technology developed. The forced openings for this are evident in adjacent B2B.

FIGURE 15: B3, VIEWED FROM ABOVE, FROM THE THRESHING DOOR OF B2A, SHOWING THE CURVING OUTER SOUTH WALL; FORM THE NORTH (WITH 2M SCALES).

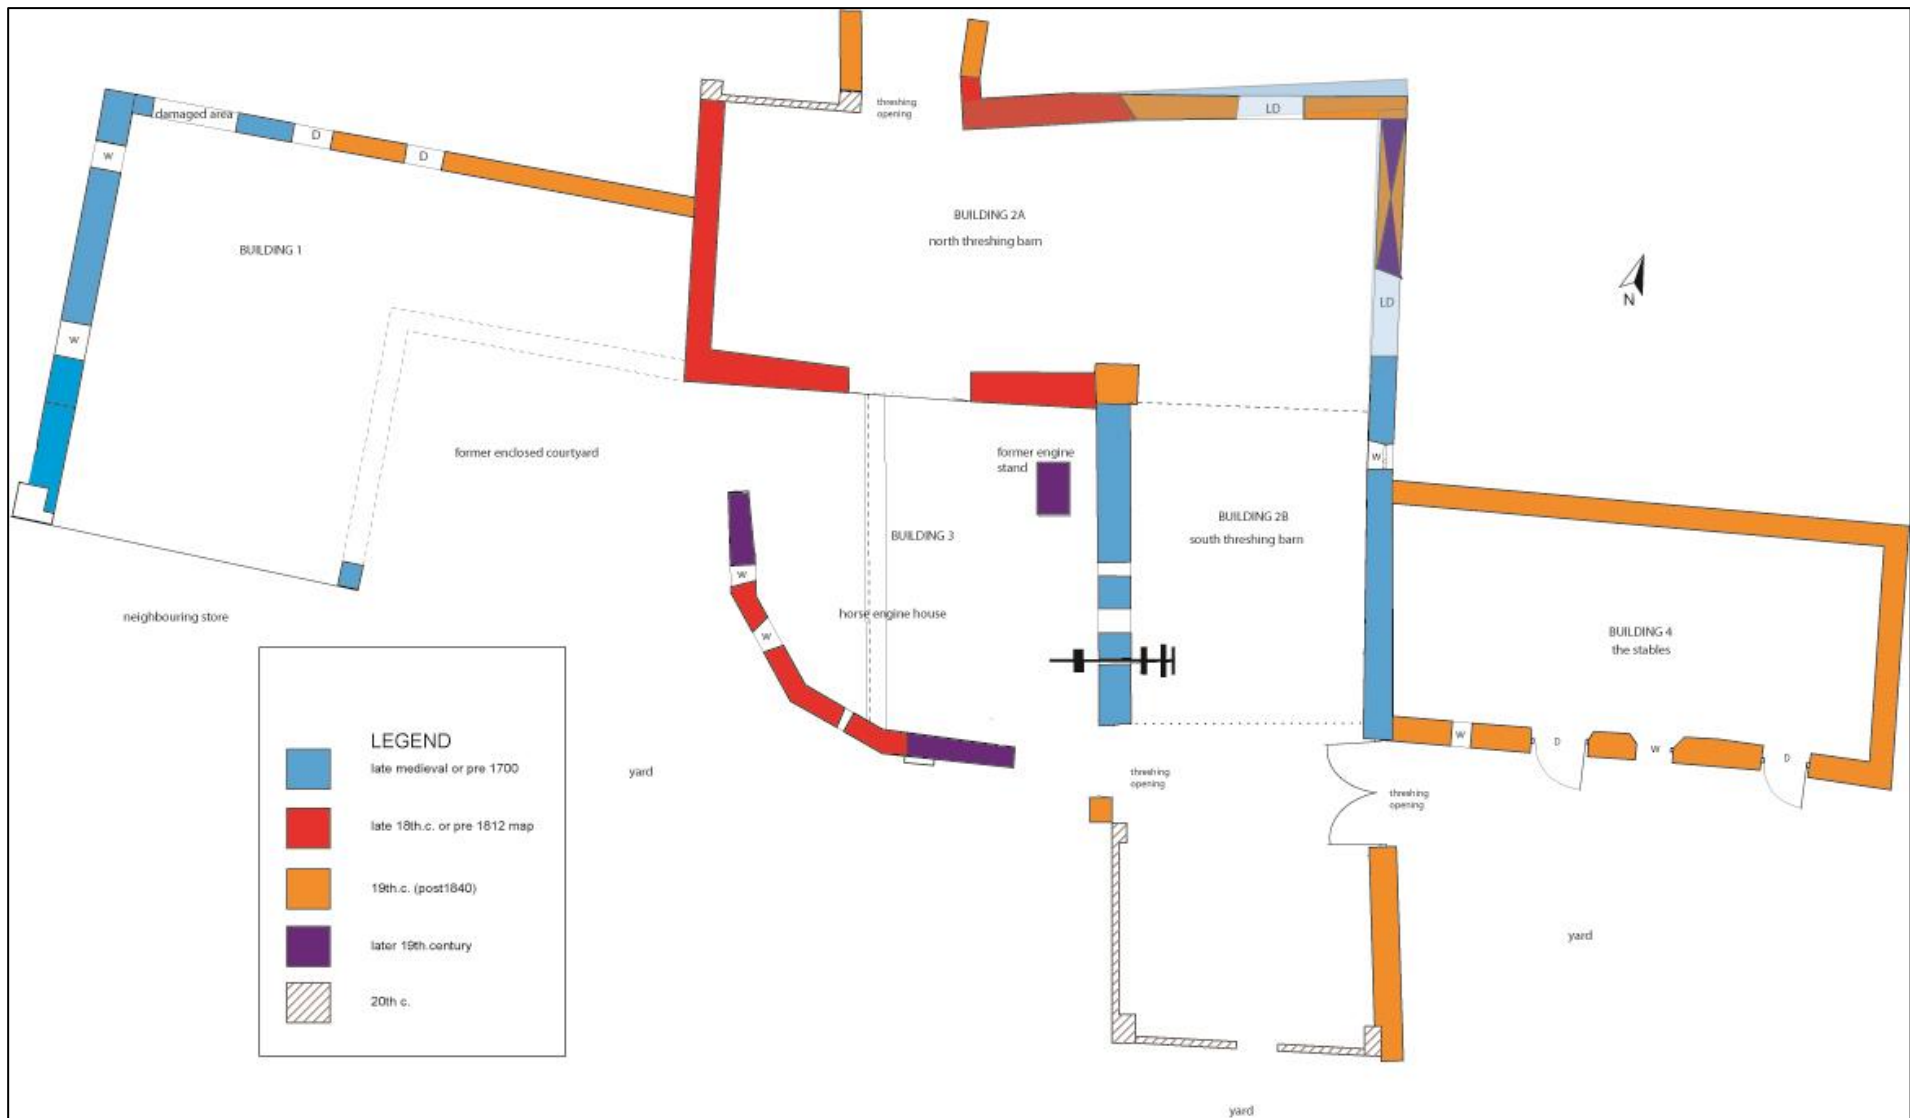
B2A represents a later 18th century or very early 19th century threshing barn, incorporating earlier walls and abutting B2B, with clear build line between (Figure 17). B3's building footprint, or elements of its outer wall, certainly at the base and central section, may also be from this phase. B2B would have been remodelled at this stage, losing at least its northern gable to fit with the new use of the structures. A supporting pier was built to brace the adjoining structures of B2A and B2B on their newly linked corner.

FIGURE 17: PHASED PLAN.

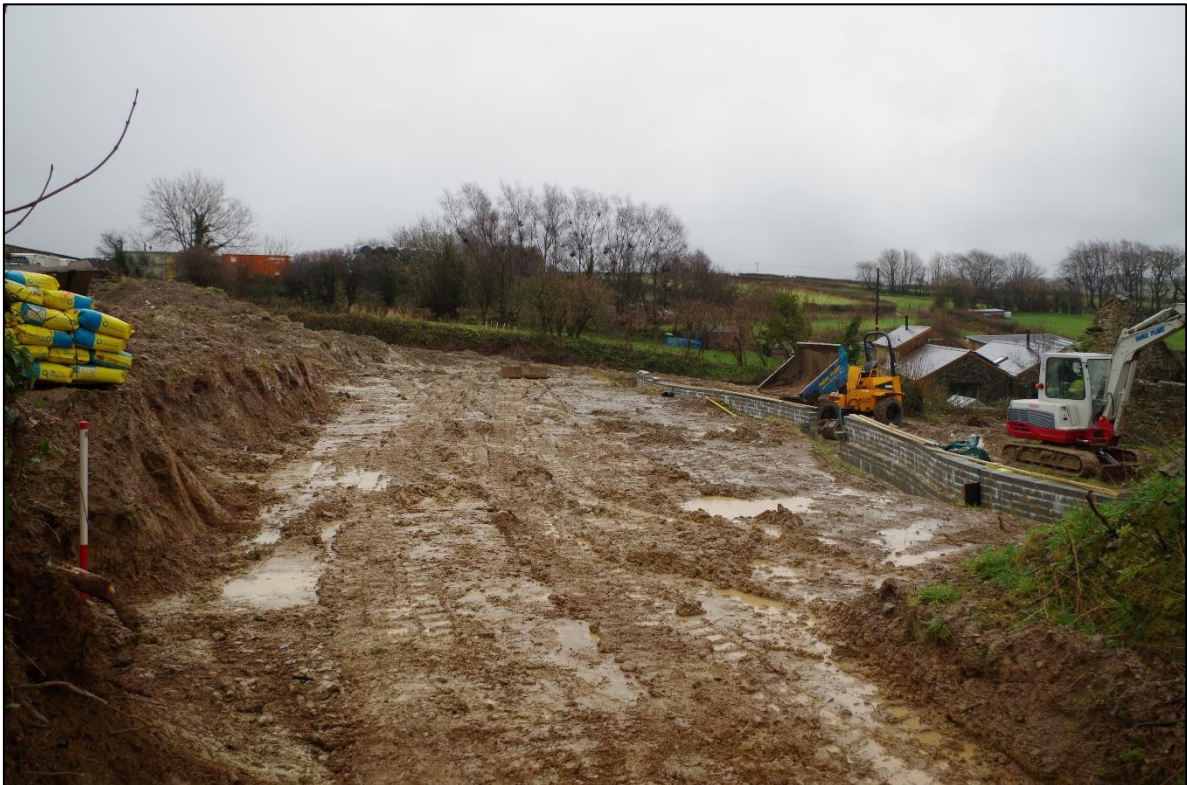
Area 2 (Figure 20) was recorded on a separate occasion alongside the demolition of the north eastern walls of B2a. The area had been stripped by machine using a toothless bucket and tracked over. The area comprised a c.6m wide and 36m long strip and was located to the north of the barn complex, on an east to west alignment. The thin (0.1m thick) mid-brown silt-clay topsoil, overlaid a natural of yellow-brown clay with common and abundant shillet.

Two features were evident in the exposed south facing section, with a c.5m wide and 1m deep cut against the western field boundary, which is likely the remains of a backfilled pond or sheep dip, concrete block and modern debris were contained within the fills. To the east c. 15m from the boundary there was evidence of this area having been cut away slightly (a terrace), presumably reflecting previous landscaping, perhaps associated with a lost (and not archaeologically evident) north-south boundary having once divided this field, or as modern landscaping. A large c.3m wide modern drainage cut ran along the edge of the eastern hedge boundary. No finds were found from recovered.

FIGURE 20: AREA 2; VIEWED FROM THE WEST (1M SCALE).

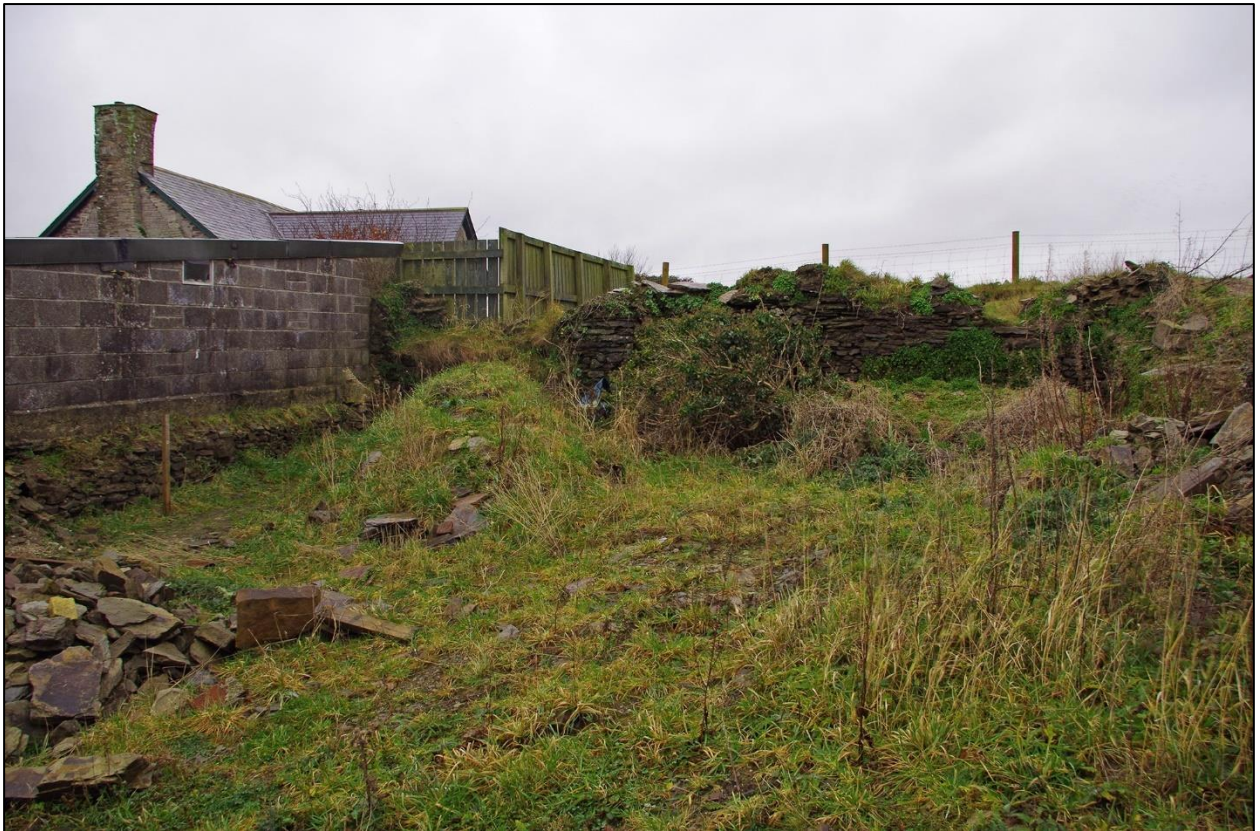
1. BUILDING 1; LOOKING TOWARDS THE EASTERN CORNER. (WITH 2M SCALES). TAKEN FROM THE EAST.

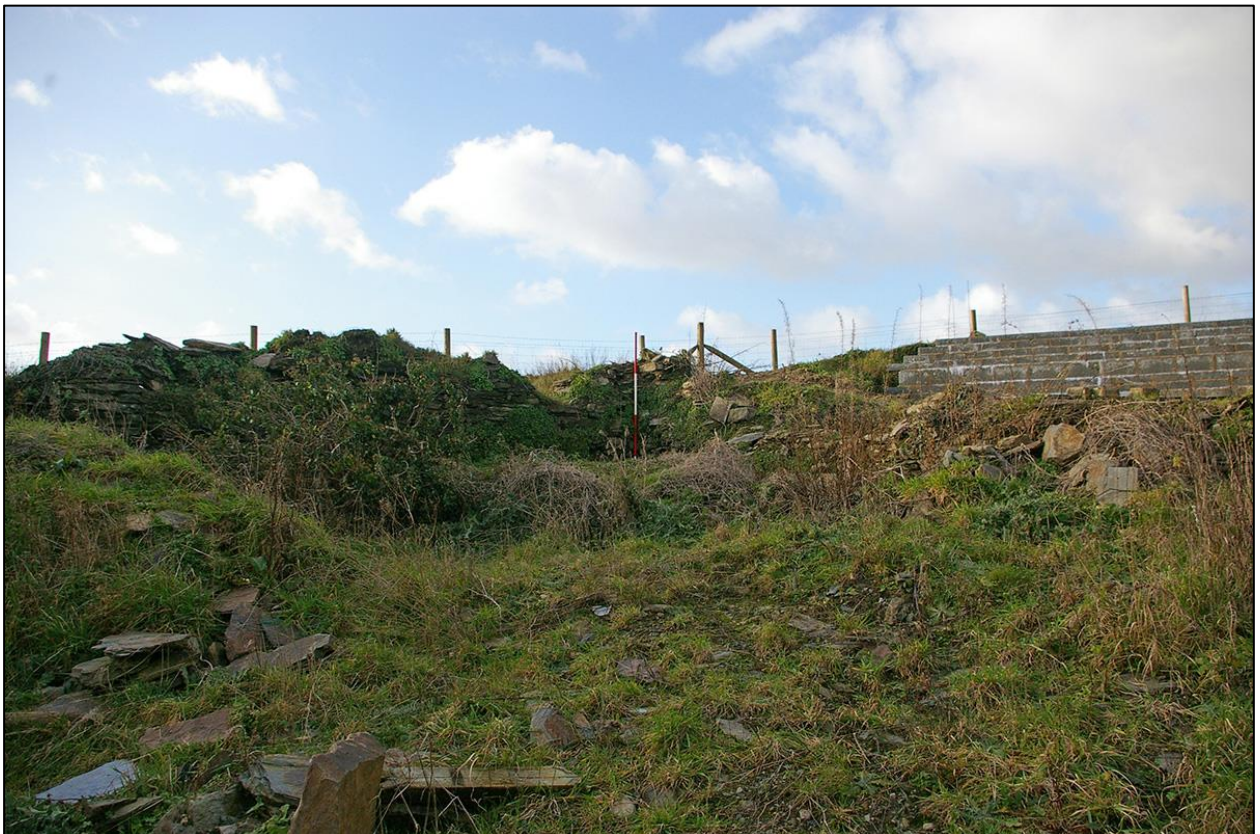
2. BUILDING 1 OUTER RUINOUS WALL. (WITH 2M SCALES) TAKEN FROM THE SOUTH EAST.

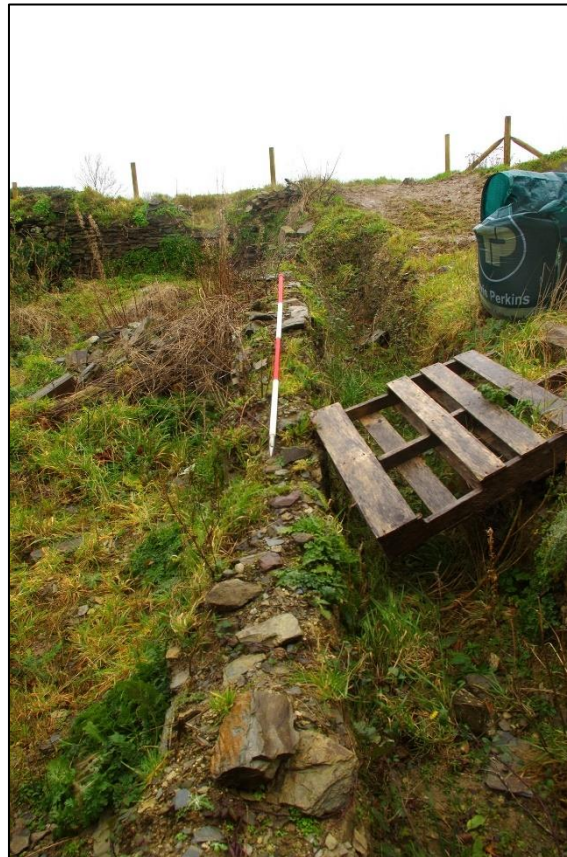
4. BUILDING 1 IN CONTEXT WITH BARN AND HOUSE COMPLEX, COLLAPSED WINDOW OPENING VISIBLE. (WITH 2M SCALES). TAKEN FROM THE EAST.

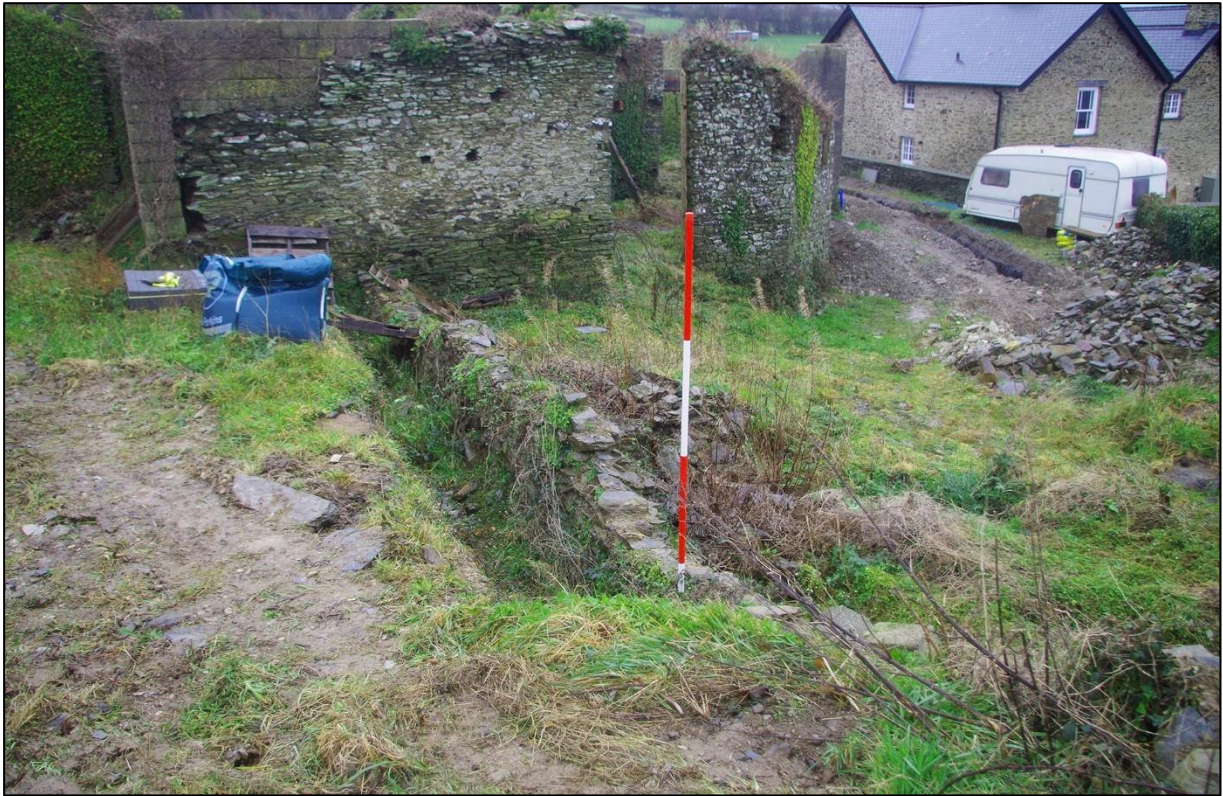
5. BUILDING 1; LOOKING DOWN ON TO THE FARM COMPLEX, WITH BUILDINGS B2A AND B3 VISIBLE. (WITH 2M SCALES). TAKEN FROM THE NORTH EAST.

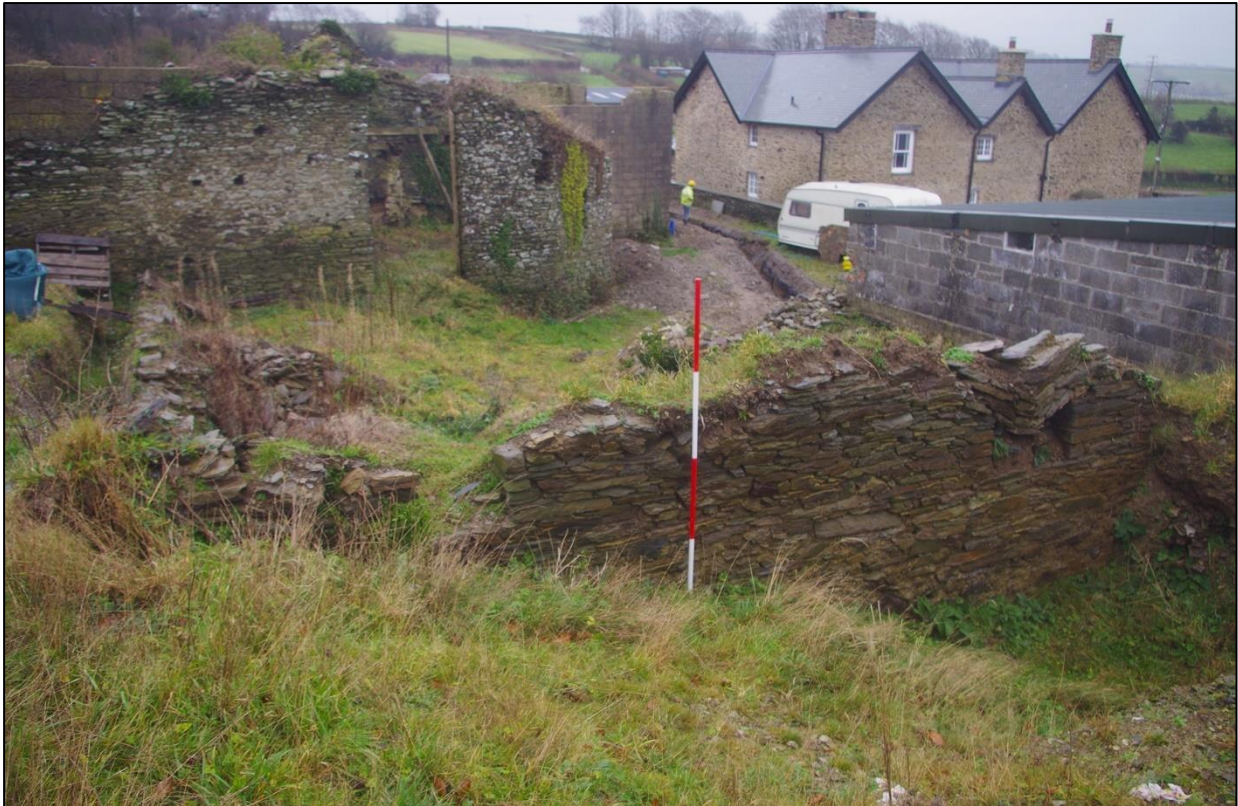
6. BUILDING 1; SOUTHERN CORNER, LOOKING DOWN ONTO B3 (WITH 2M SCALES). FROM THE NORTH WEST.

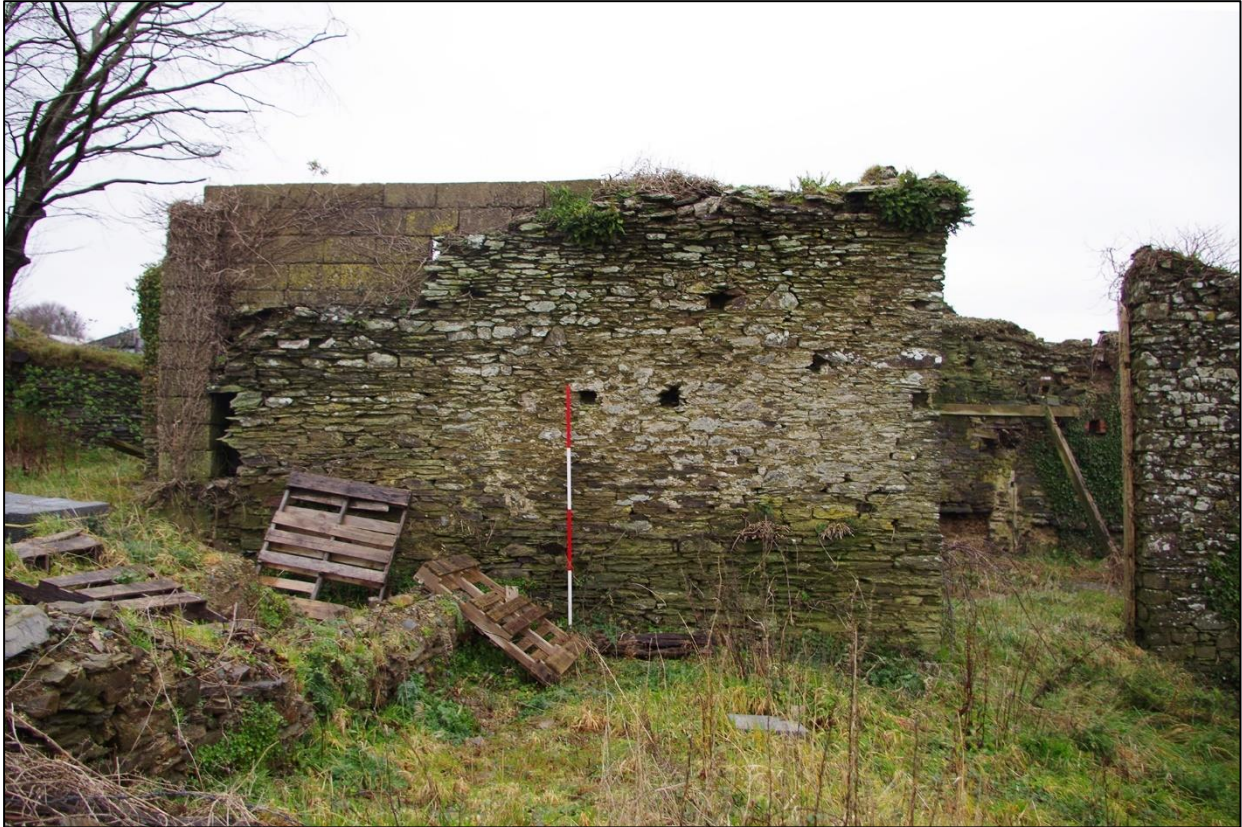
8. BUILDING 2A; WESTERN WALL, LOOKING TOWARD BUILDING 3 (WITH 2M SCALES). TAKEN FROM THE WEST.

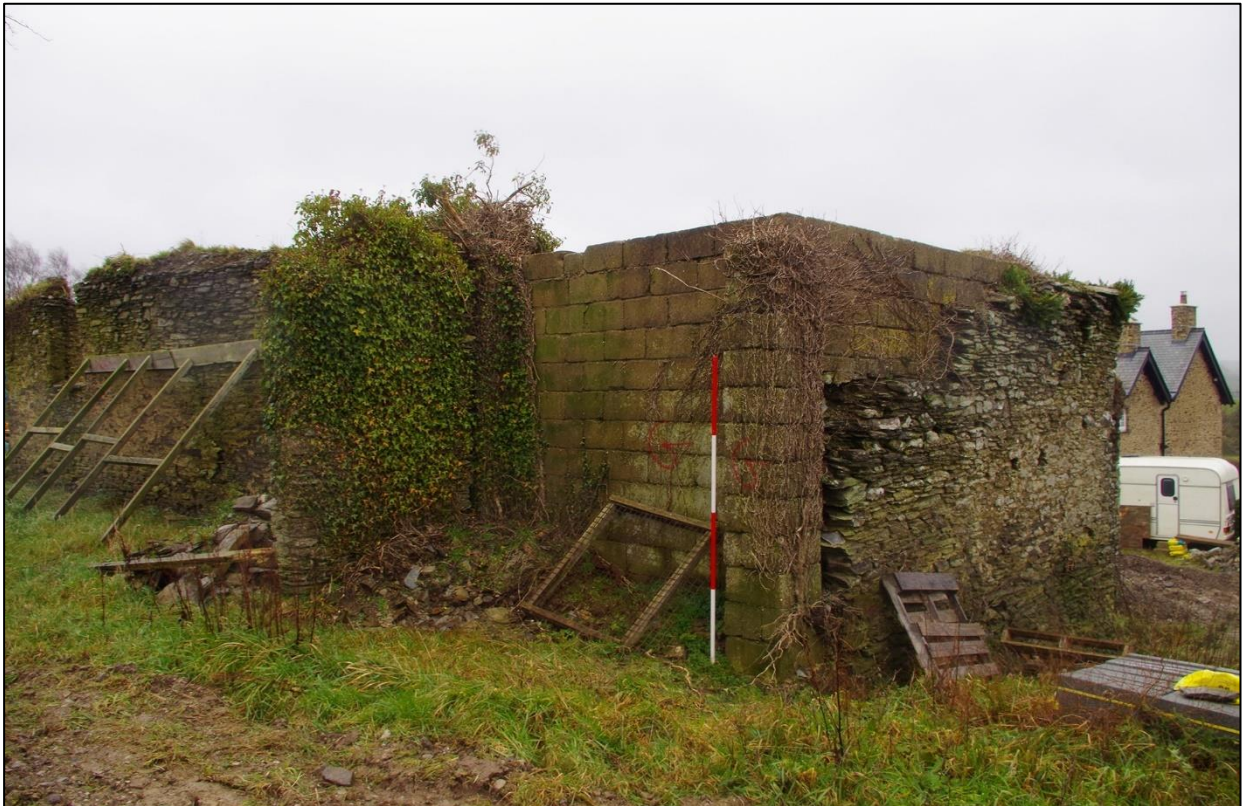
9. BUILDING 2A; WESTERN CORNER CONCRETE REBUILD (WITH 2M SCALES). TAKEN FROM THE NORTH WEST.

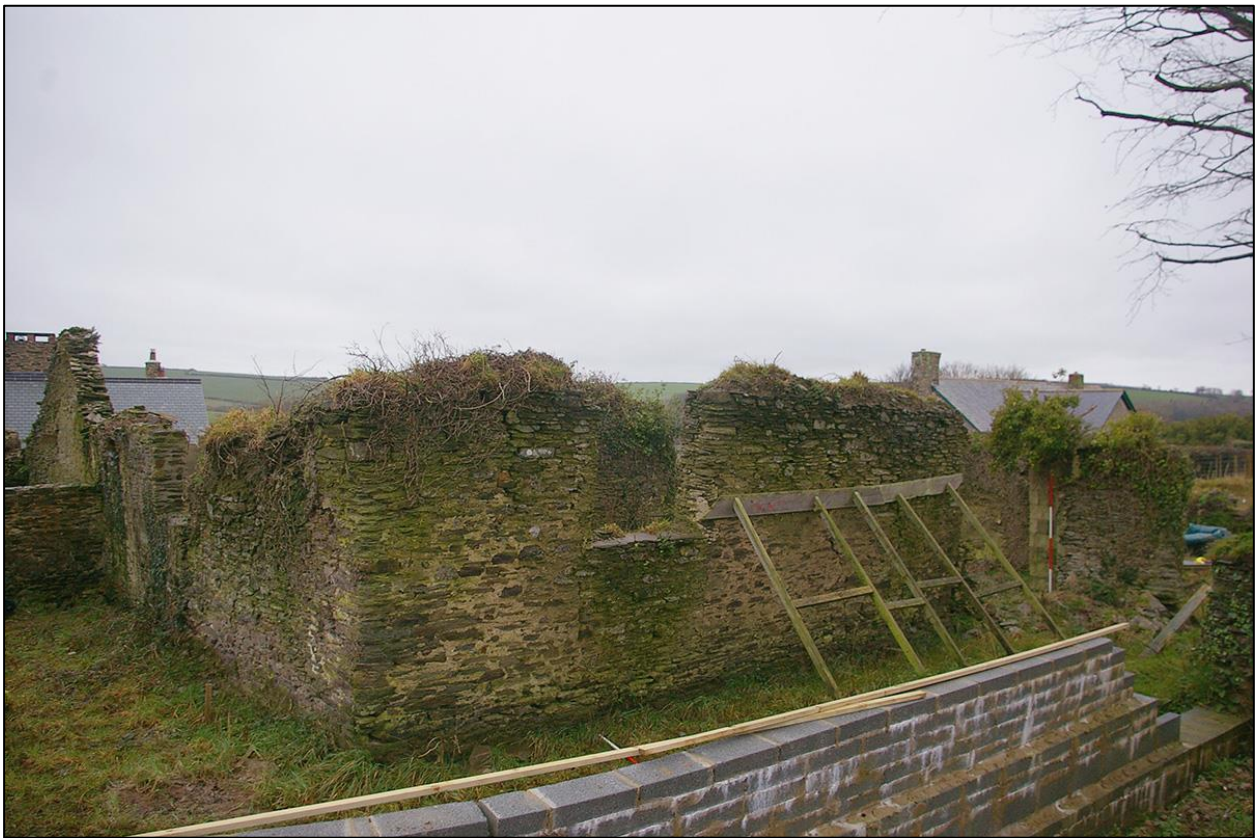
11. LOOKING SOUTH IN BUILDING 2A (WITH 2M SCALES). TAKEN FROM THE NORTH.

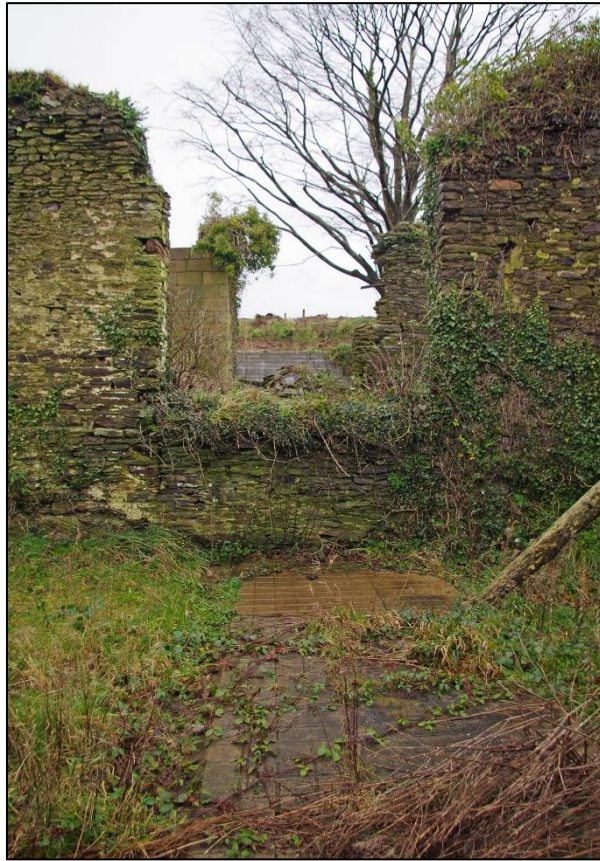
17. LOOKING INTO BUILDING 2A FROM B3. FROM THE SOUTH.

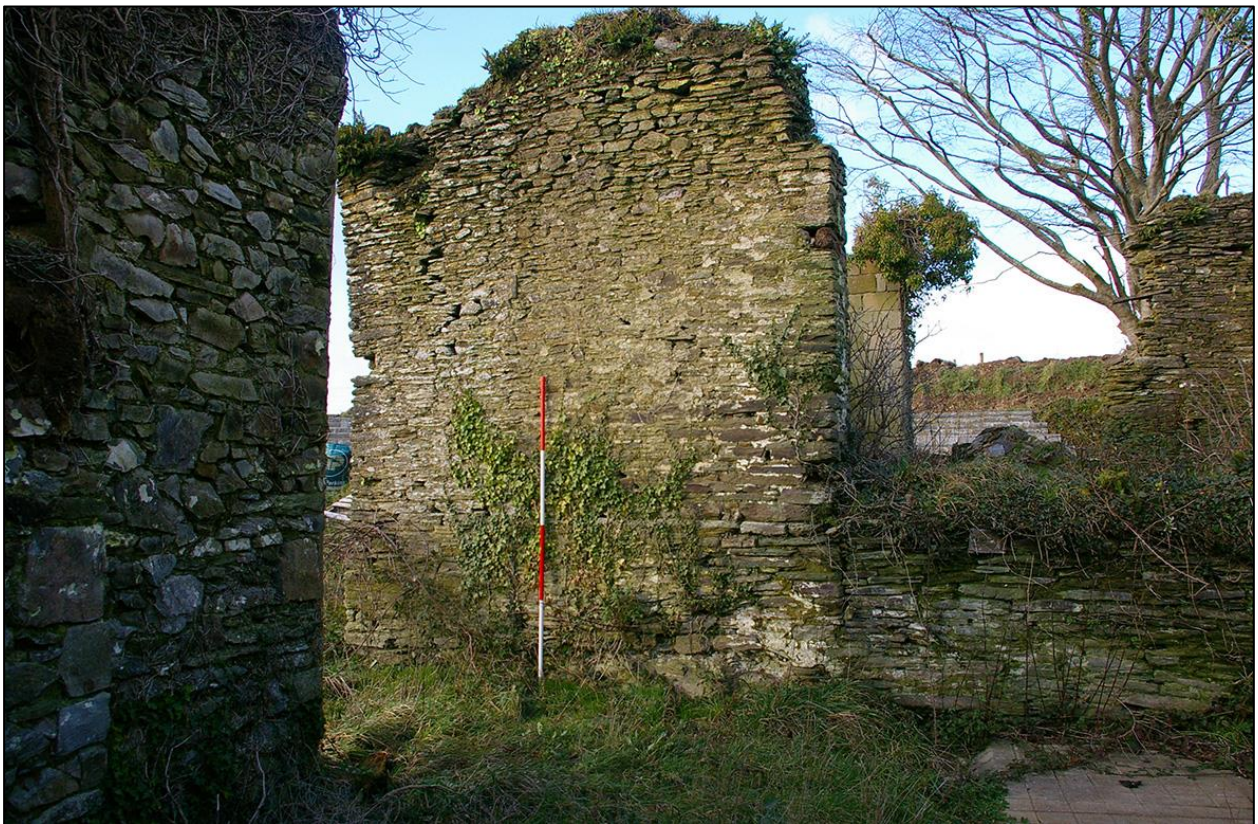
18. LOOKING INTO BUILDING 2A FROM B3; SHOWING THE WESTERN OPENING AND PARALLEL FORCED OPENINGS IN B2A. (WITH 2M SCALES). TAKEN FROM THE WEST.

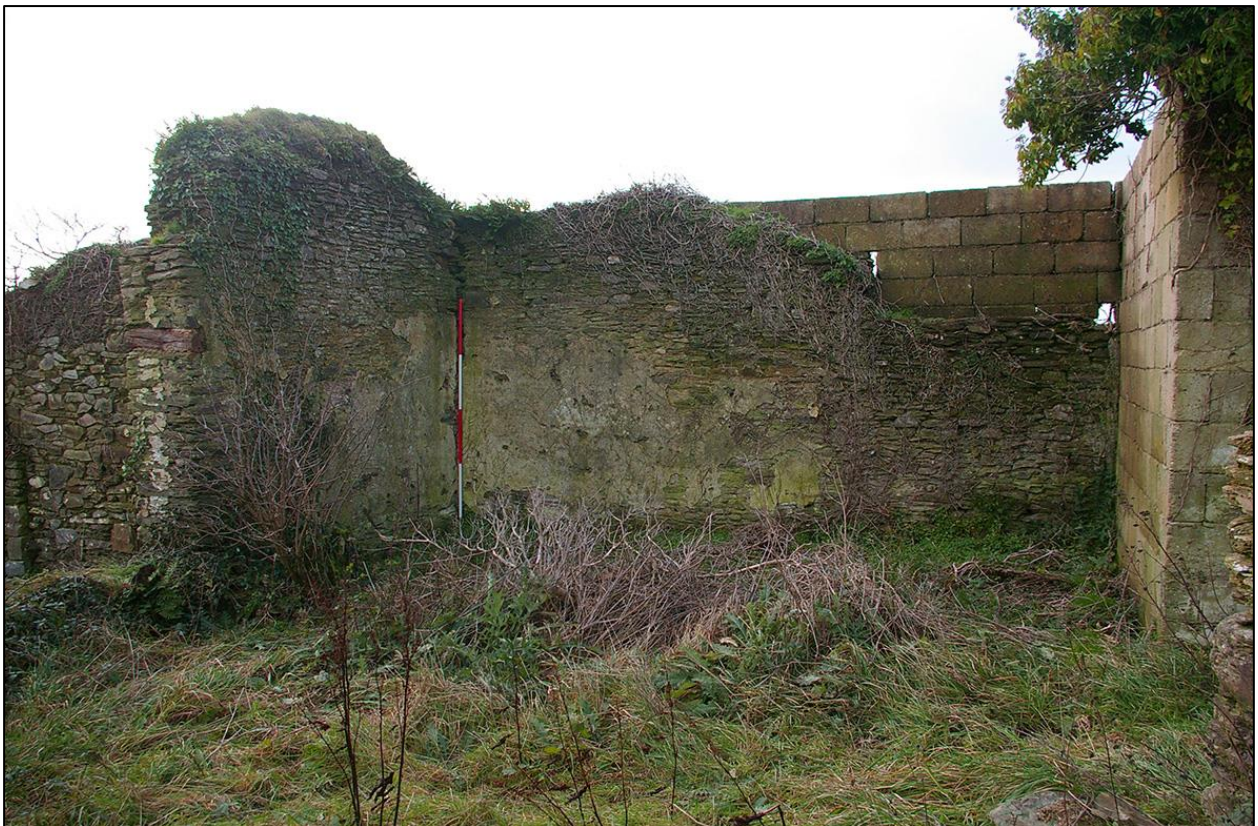
22. BUILDING 2A SOUTH WESTERN CORNER, LOOKING INTO B3 TO THE LEFT. PLASTER IS STILL VISIBLE ON SOME OF THE WALLS (WITH 2M SCALES). TAKEN FROM THE EAST.

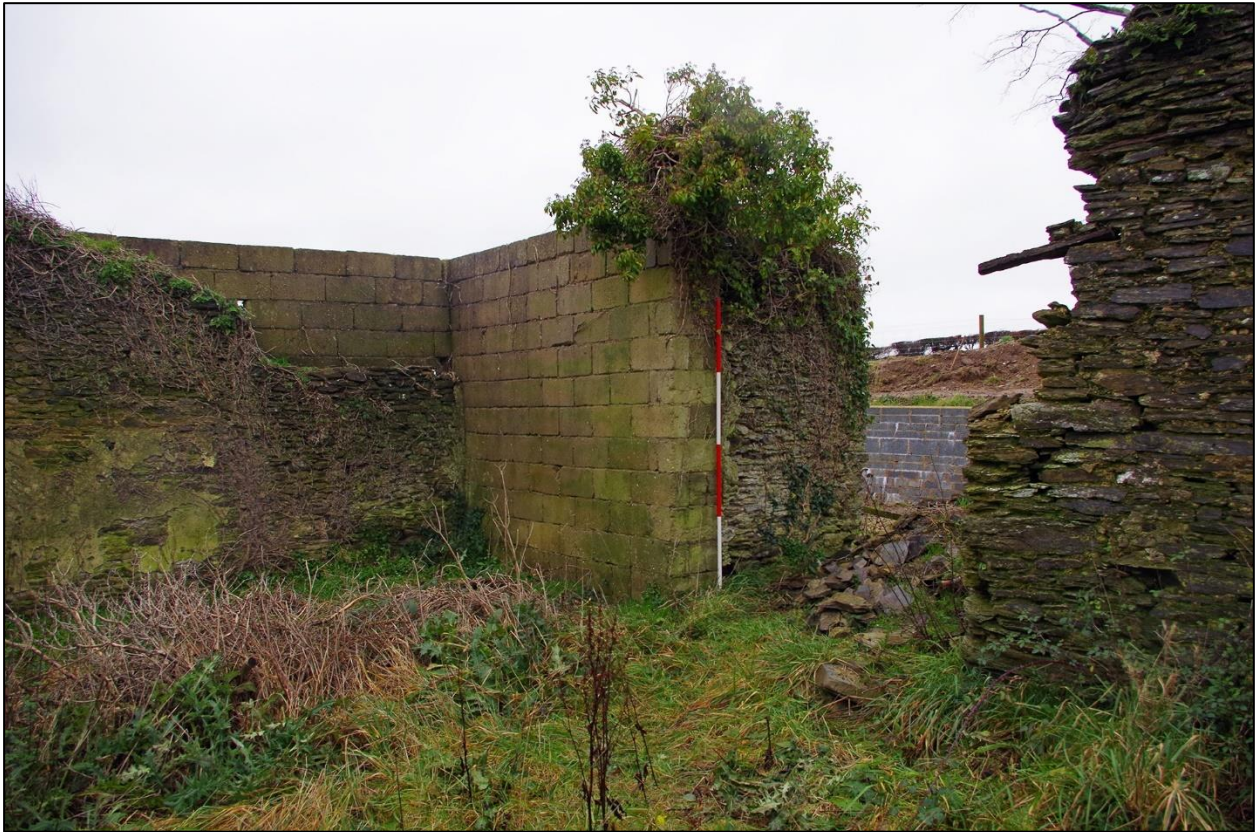
23. BUILDING 2A; SHOWING THE LATER FORCED NORTHERN OPENING TO AID THE DEVELOPMENT OF THE MACHINE HOUSE IN B3. (WITH 2M SCALES). TAKEN FROM THE SOUTH EAST.

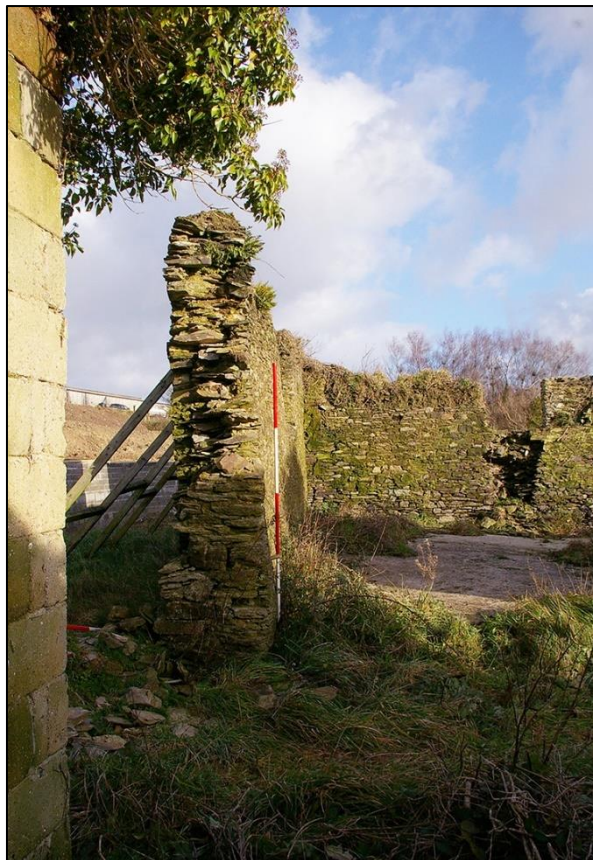
Relationships		Contiguous with the west wall of B2A. Abuts B2B to the east end.
B2A Elevation EAST		Description
Fabric Description:		The wall survives to low single storey height and has partially collapsed on its inner face, failing structurally. To the east of B2A the wall is more irregular, of loose slate and shale build. On the inner face it has been repaired in cob and then patched again in concrete blocks.

24. B2A NORTHERN WALL, SUPPORTED BY TIMBER FRAMES DUE TO ITS INSTABILITY. (WITH 2M SCALES). TAKEN FROM THE WEST.

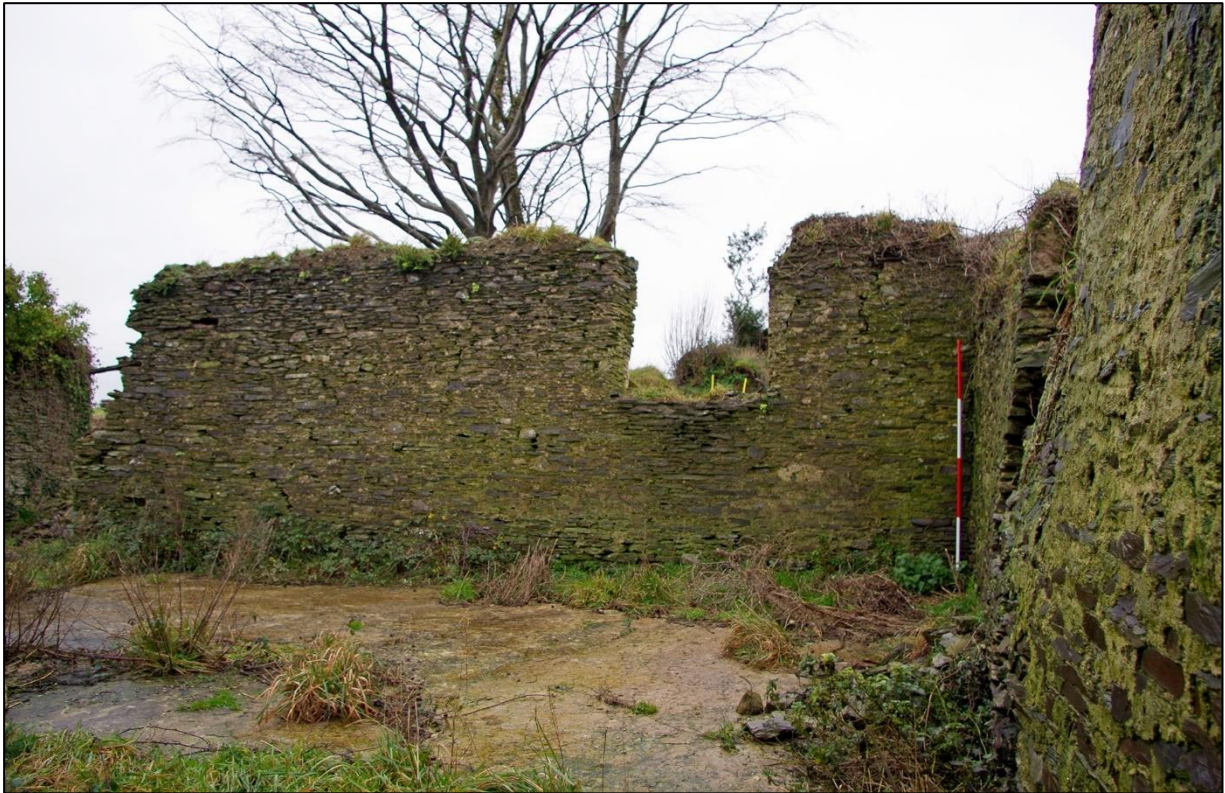
25. B2A AND THE NORTHERN FORCED OPENING. TO THE LEFT THE OLDER BUILDING FABRIC TAPERS (WITH 2M SCALES). TAKEN FROM THE SOUTH EAST.
