THE BARNs
CHELFHAM BARTON
BRATTON FLEMING
NORTH DEVON

Historic Building Recording and Archaeological Monitoring

South West Archaeology Ltd. report no. 201013

By Dr S. Walls, E. Wapshott & A. Allen
Report Version: FINAL
Issued: 13th October 2020
Finalised: 22nd July 2021

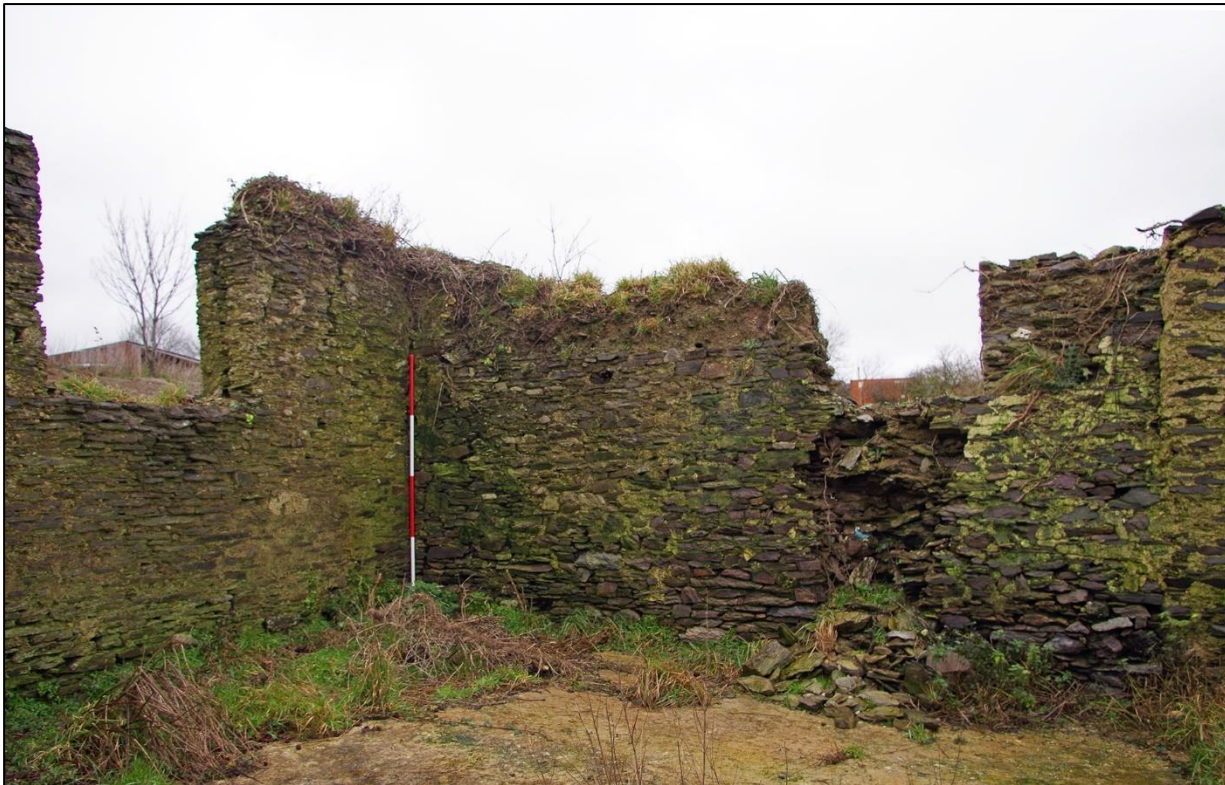
26. B2A WESTERN WALL SHOWING THE COB TOP AND FORCED WINDOW OPENINGS. (WITH 2M SCALES). TAKEN FROM THE WEST.

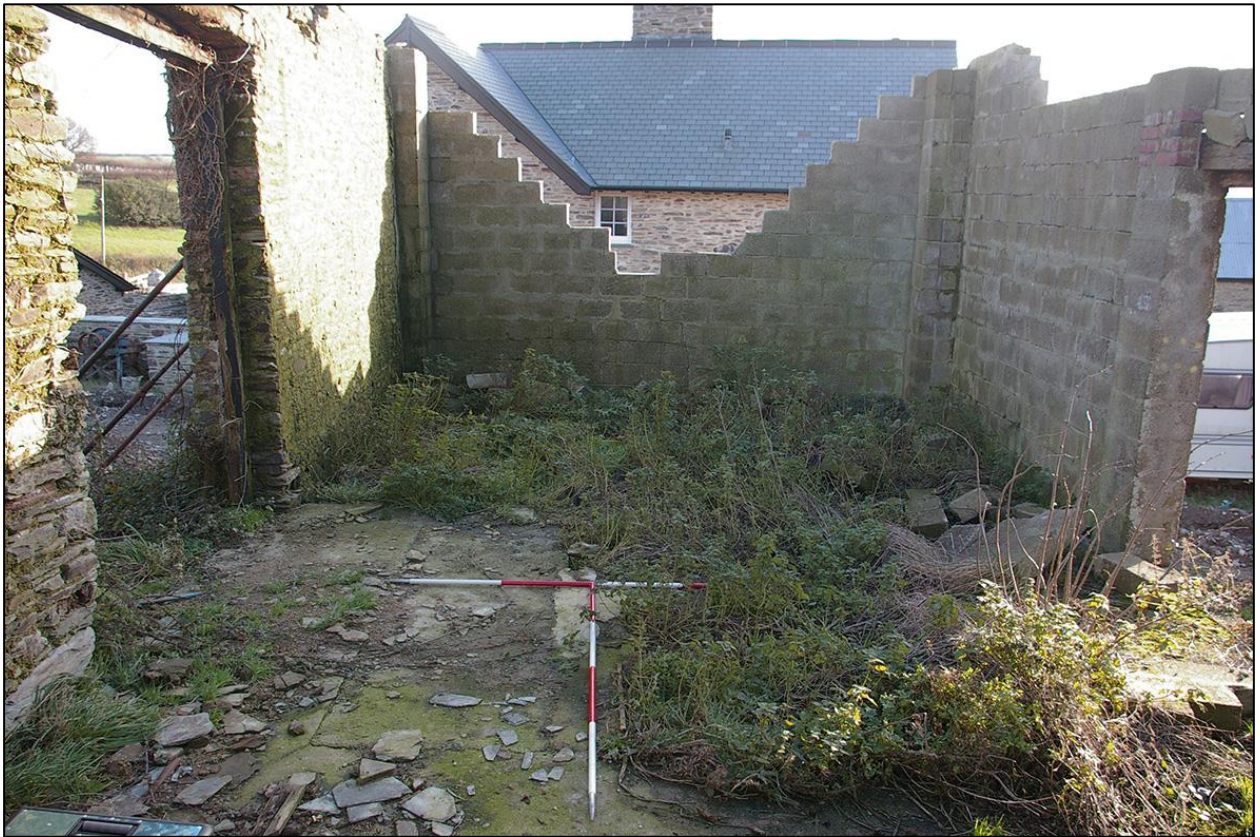
36. BUILDING 04; STONE PLINTH ON INNER NORTHERN WALL. (WITH 2M SCALES). FROM THE NORTH.

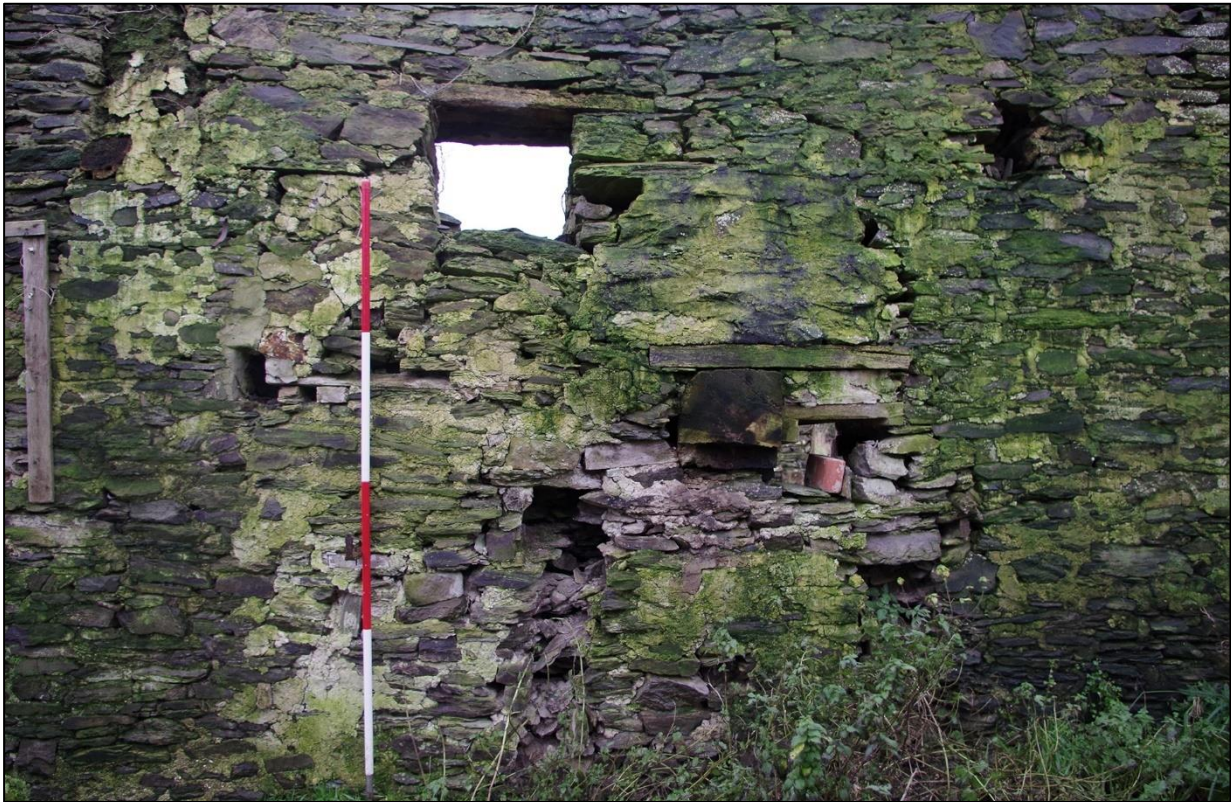
42. THE WESTERN INTERIOR WALL OF B2A & B, SHOWING SEVERAL SMALLER FORCED OPENINGS FOR MACHINE AND TRUSS SUPPORTS FOR B3. (WITH 2M SCALES). TAKEN FROM THE EAST.

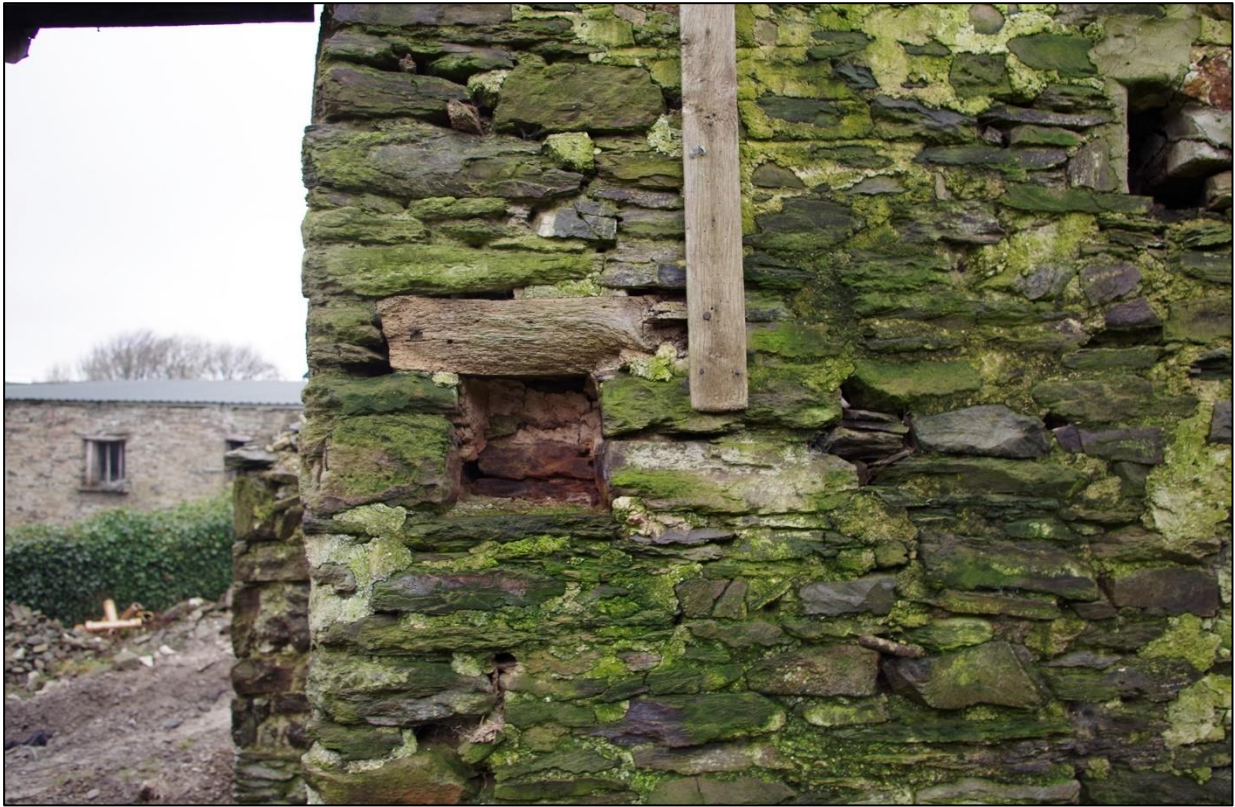
43. THE WESTERN INTERIOR WALL OF B2B SHOWING THE SMALL FORCED OPENING FOR CANDLES. TAKEN FROM THE EAST.

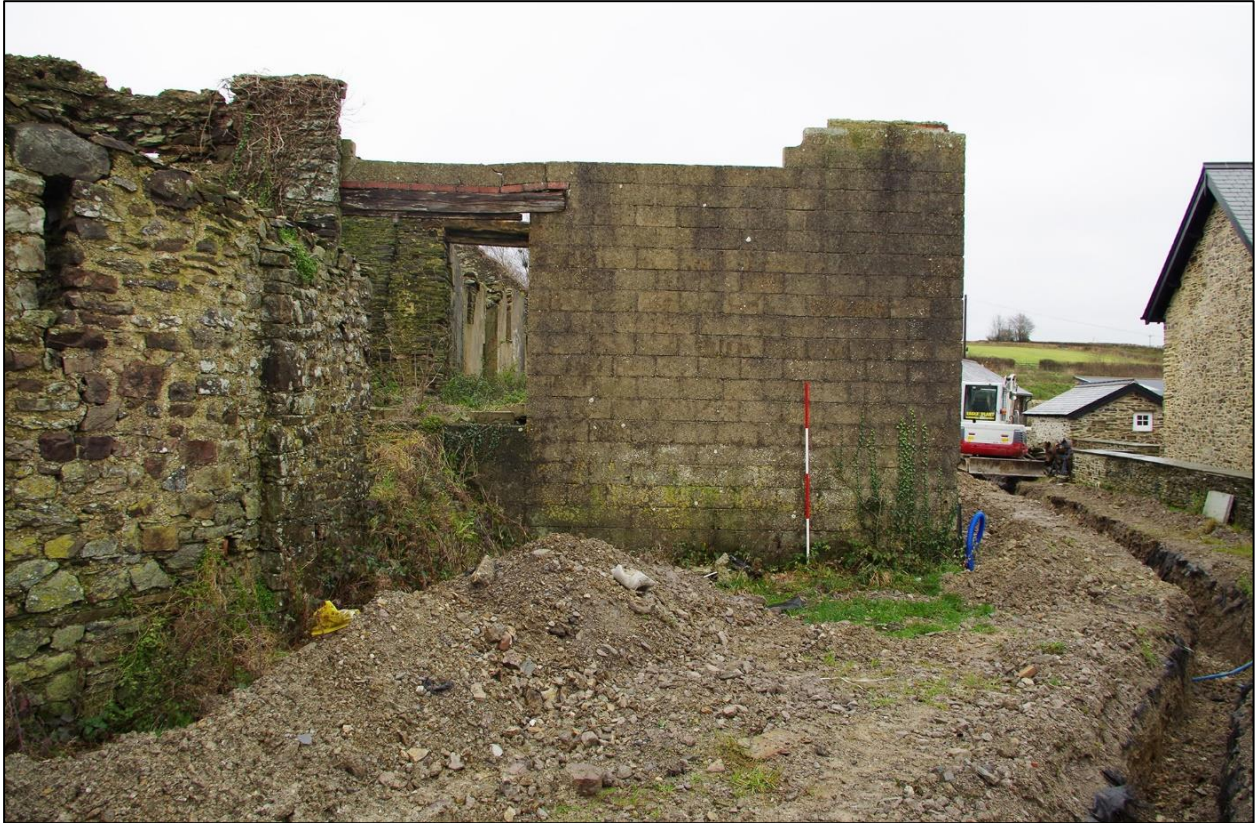
47. THE LATER ADJUSTED WESTERN CONCRETE BLOCK EXTERIOR OF B2B AND OPENED SERVICE TRENCH (TRENCH 1). (WITH 2M SCALES). TAKEN FROM THE WEST.

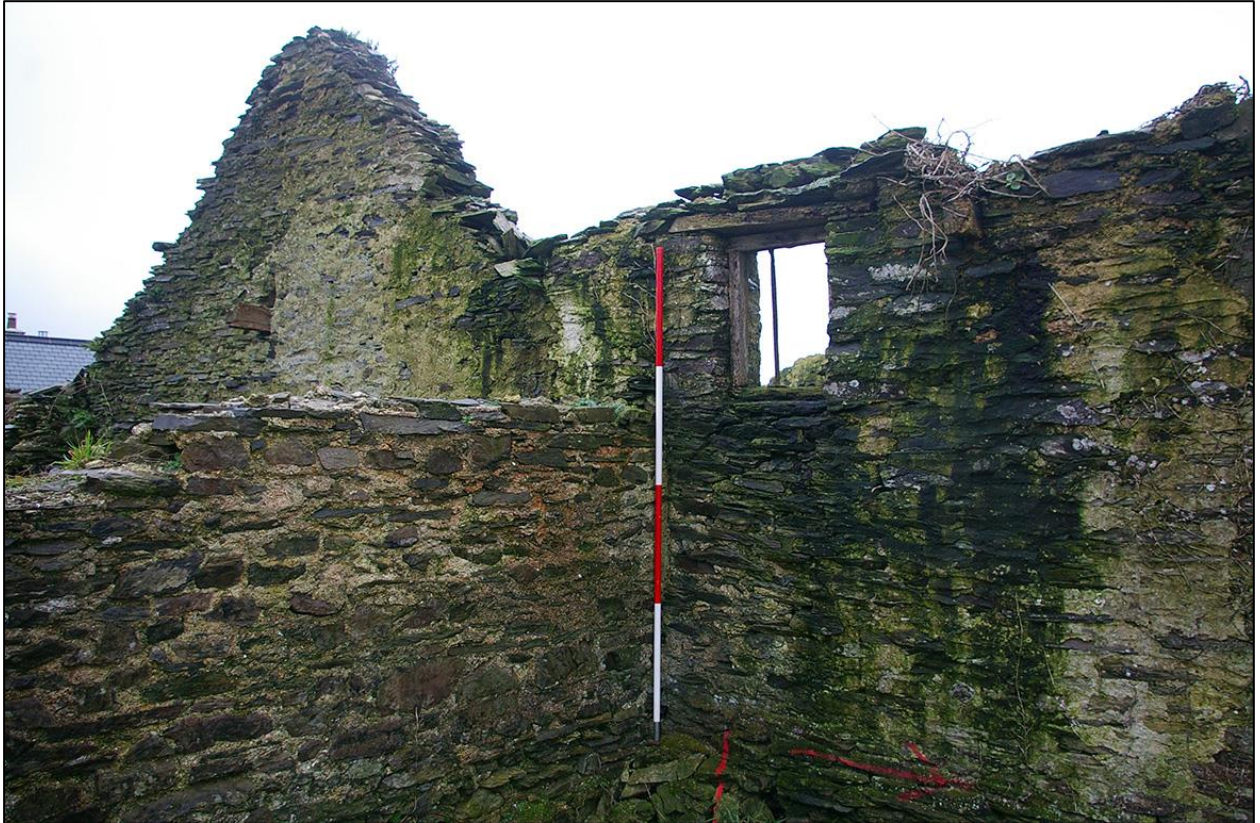
51. THE STABLES BUILDING 4 ABUTTING THE OLDER EASTERN BARN WALLS OF B2A; SHOWING THE EXTERIOR STONE PLINTH. (WITH 2M SCALES). TAKEN FROM THE NORTH.

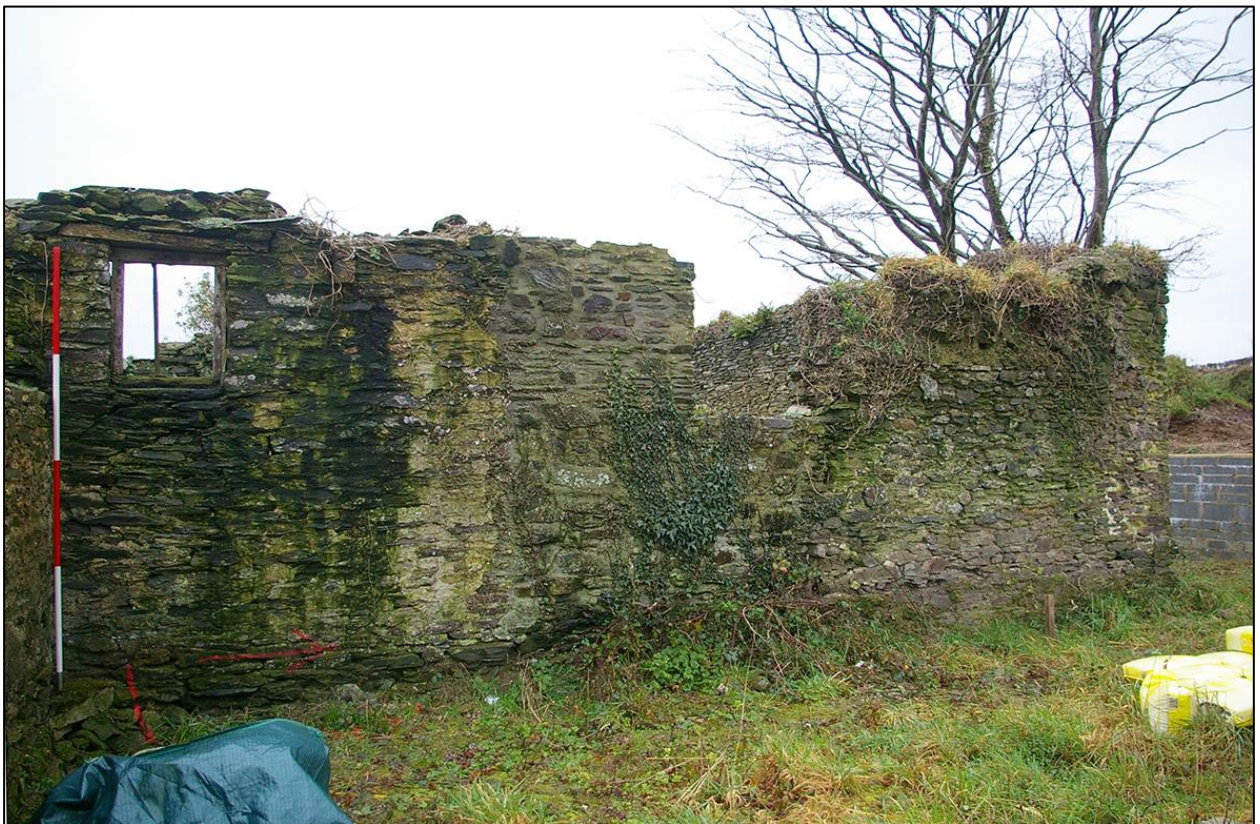
Roof Covering:		Roofless ruin.
Openings – Doors:		N/A
Opening – Windows:	1	Loading door at the top of the collapsed wall, only the base can be seen.
Drainage/Guttering		N/A
Significant Details:		There is a ragged plinth to this wall, especially to the south near B2b, which is actually an earlier wall footing on a slightly different alignment.
Relationships:		There is a ragged build line to the north wall, but this could be result of rebuild phases of repair, there is also a large structural crack. To the south the wall abuts an earlier phase of stonework within B2B.
B2A Interior		Description
Function:		Threshing barn.
Walls:		Exposed stone, some lime plaster to the west and south walls.
Floor:		The floor of this building is covered with weeds and foliage but exhibits a potential threshing floor to the west end, with possible cobbles, replaced in a poor quality concrete/lime mix scree to the east end, where it joins onto B2B.

52. THE OLDER EASTERN BARN WALLS OF B2A; SHOWING THE EXTERIOR STONE PLINTH AND FORCED WINDOW OPENINGS. (WITH 2M SCALES). TAKEN FROM THE EAST.

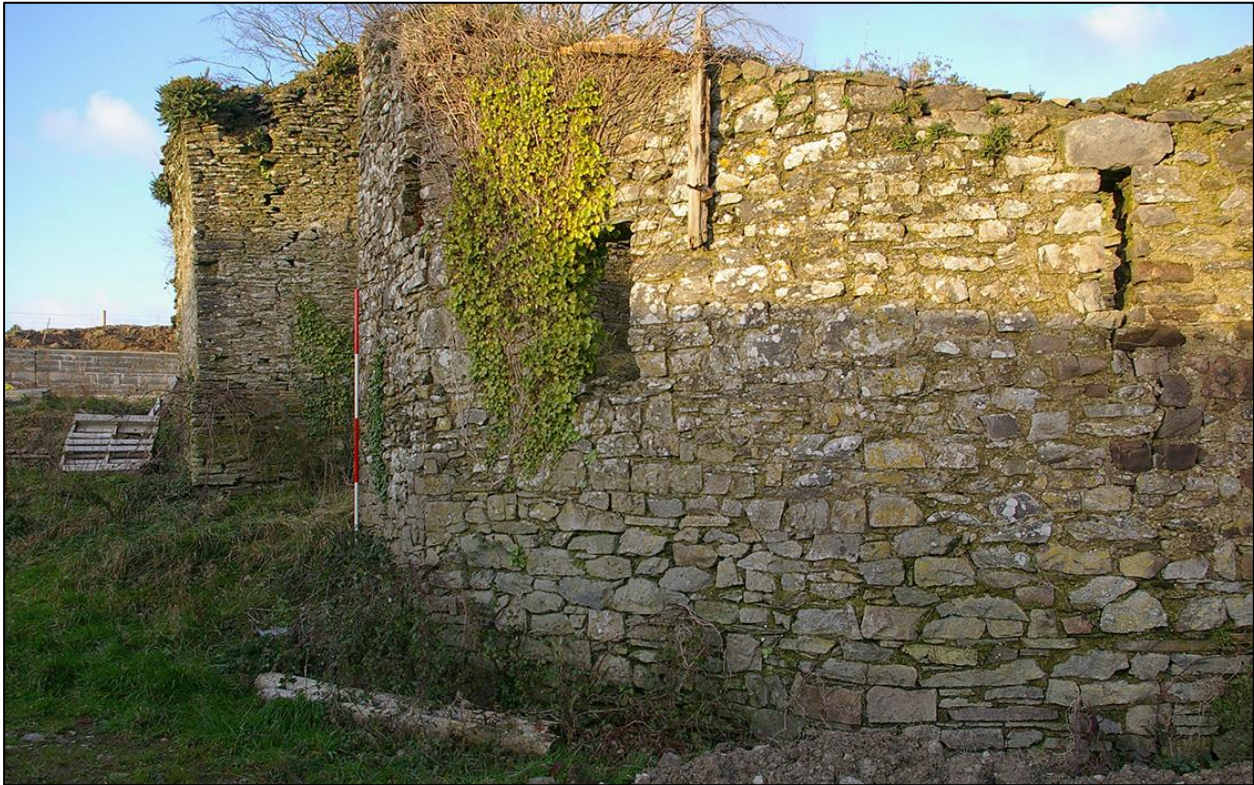
54. EXTERNAL WALLS OF B3 SHOWING THE SMALL WINDOWS. (WITH 2M SCALES). TAKEN FROM THE SOUTH.

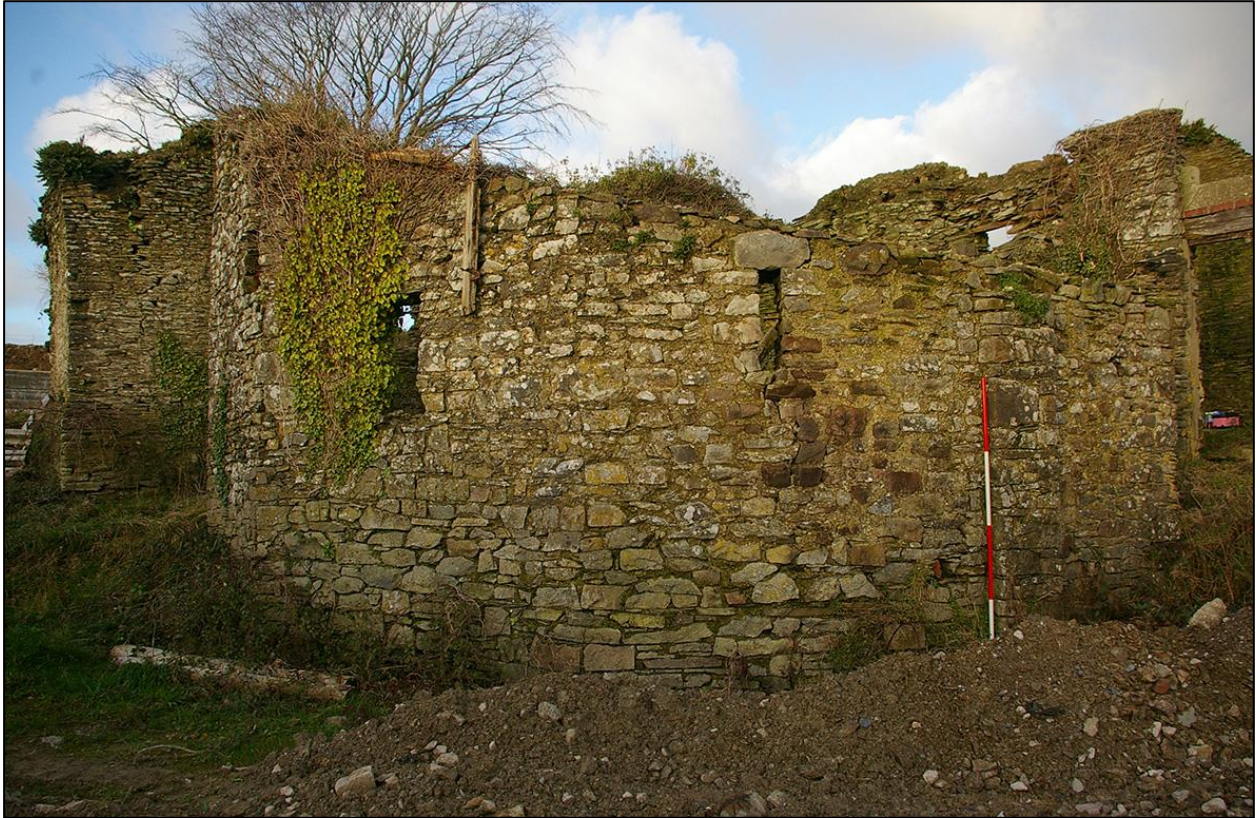
55. EXTERNAL WALL SECTION OF B3 SHOWING THE SMALL WINDOWS. (WITH 2M SCALES). TAKEN FROM THE SOUTH.

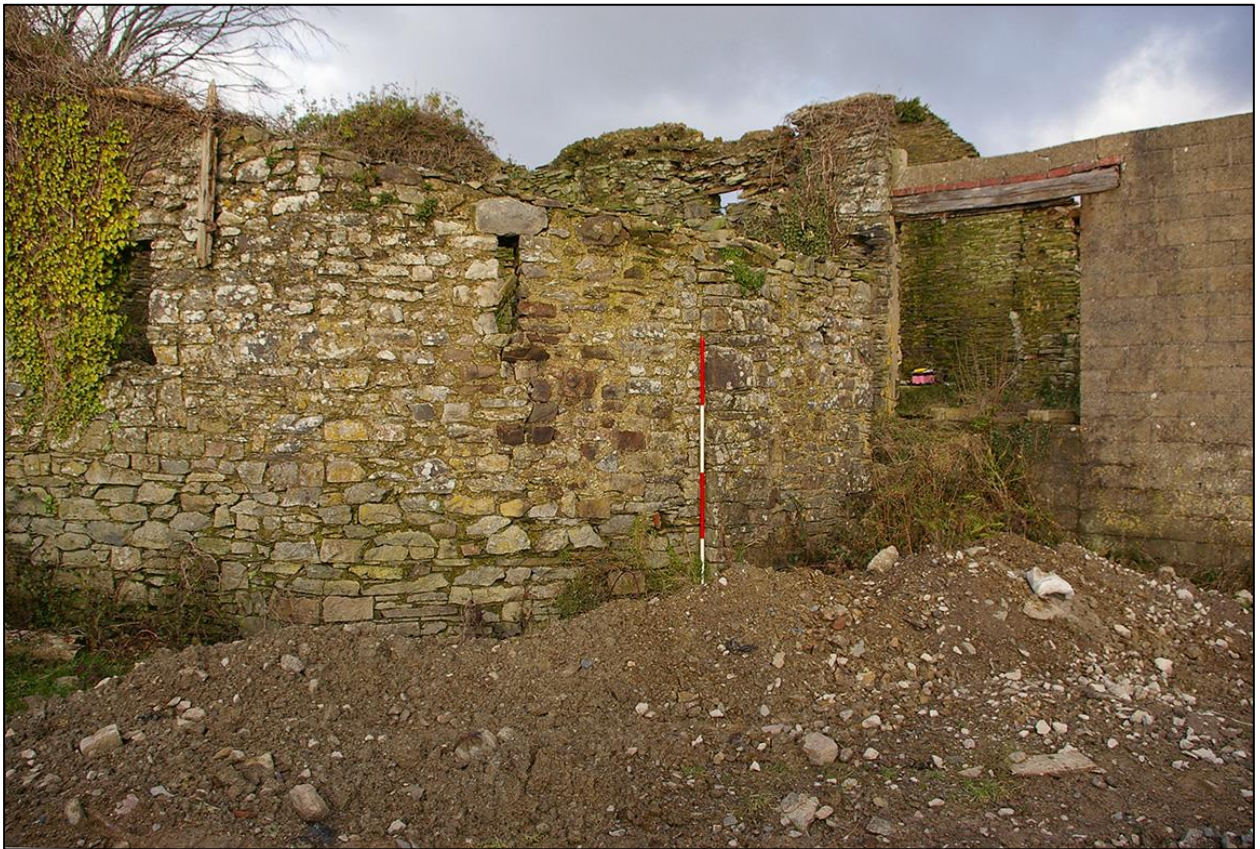
56. EXTERNAL WALLS OF B3 LOOKING IN TO B2B. (WITH 2M SCALES). TAKEN FROM THE SOUTH WEST.

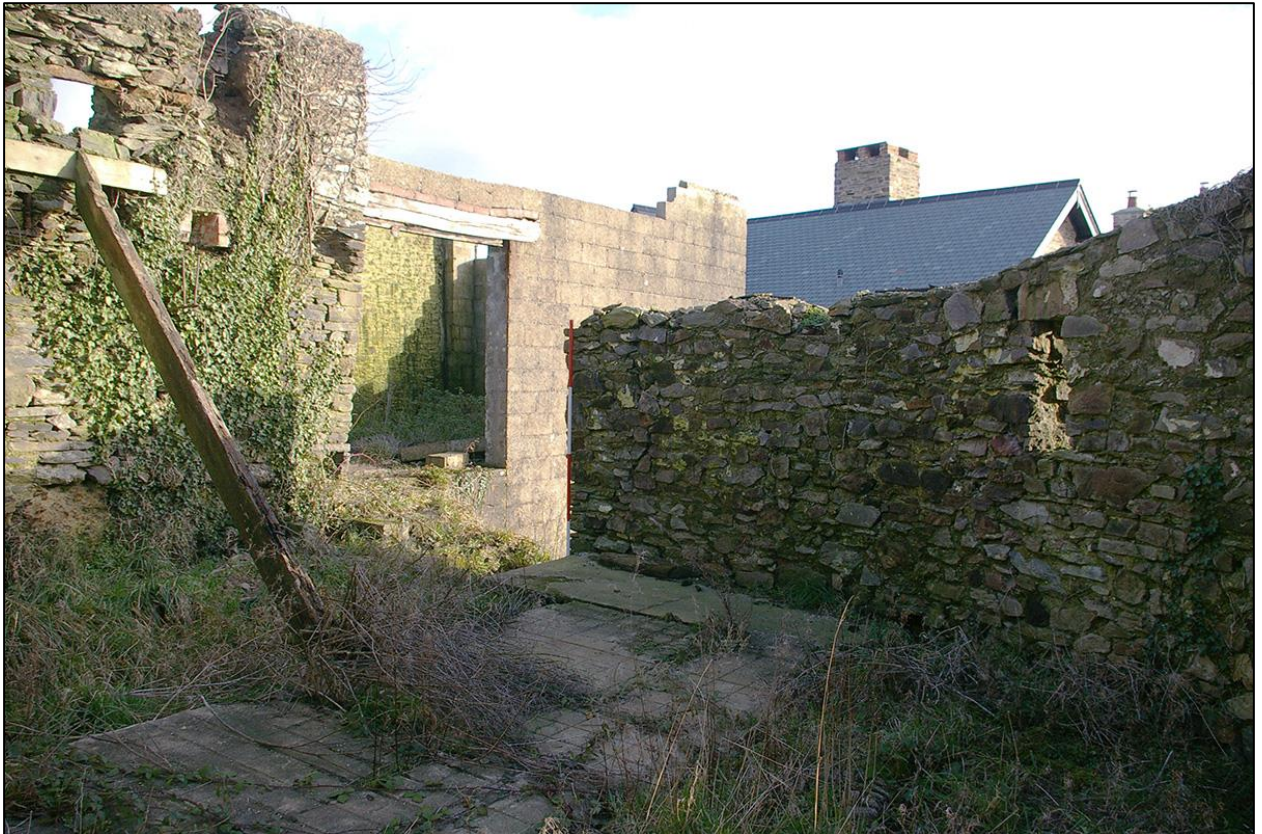
57. INSIDE B3 SHOWING THE MACHINE FLOORS AND GULLEYS; LOOKING INTO B2B. (WITH 2M SCALES). TAKEN FROM THE EAST.

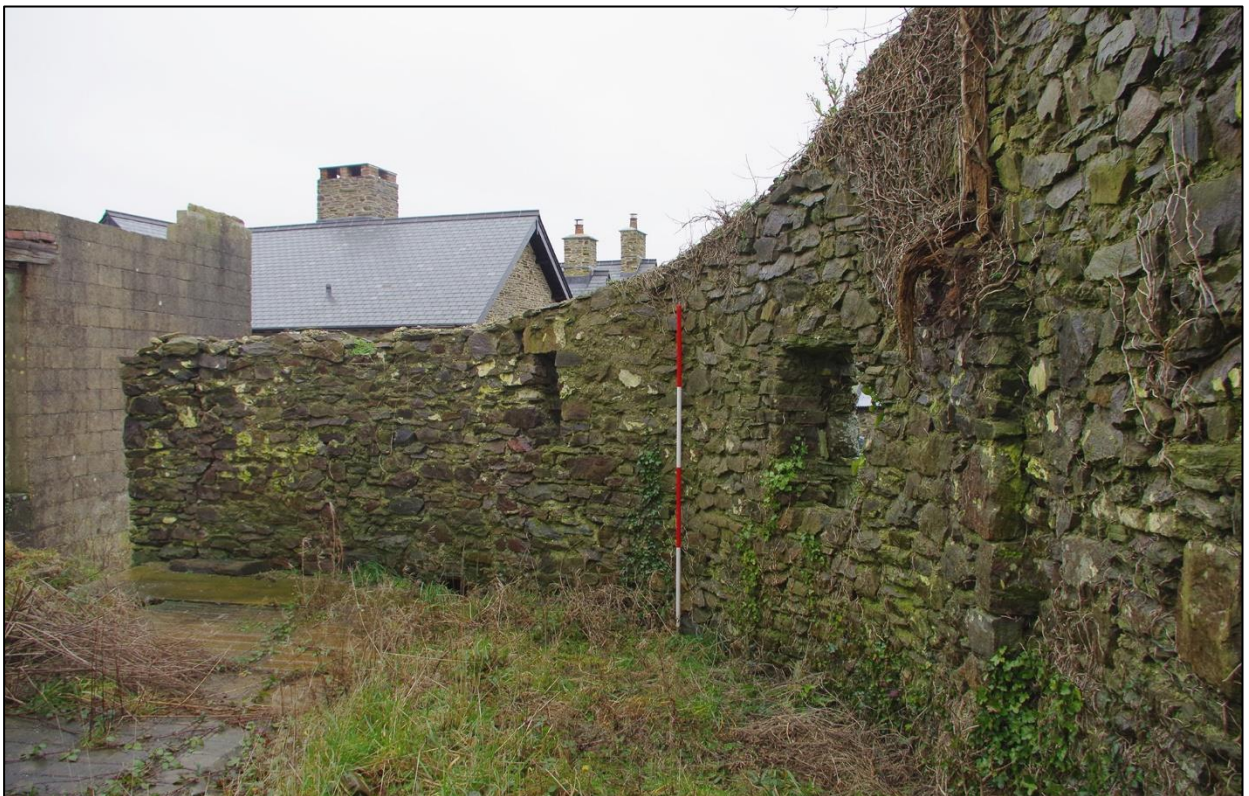
58. INSIDE B3 SHOWING THE CURVED BARN WALLS. (WITH 2M SCALES). TAKEN FROM THE SOUTH.

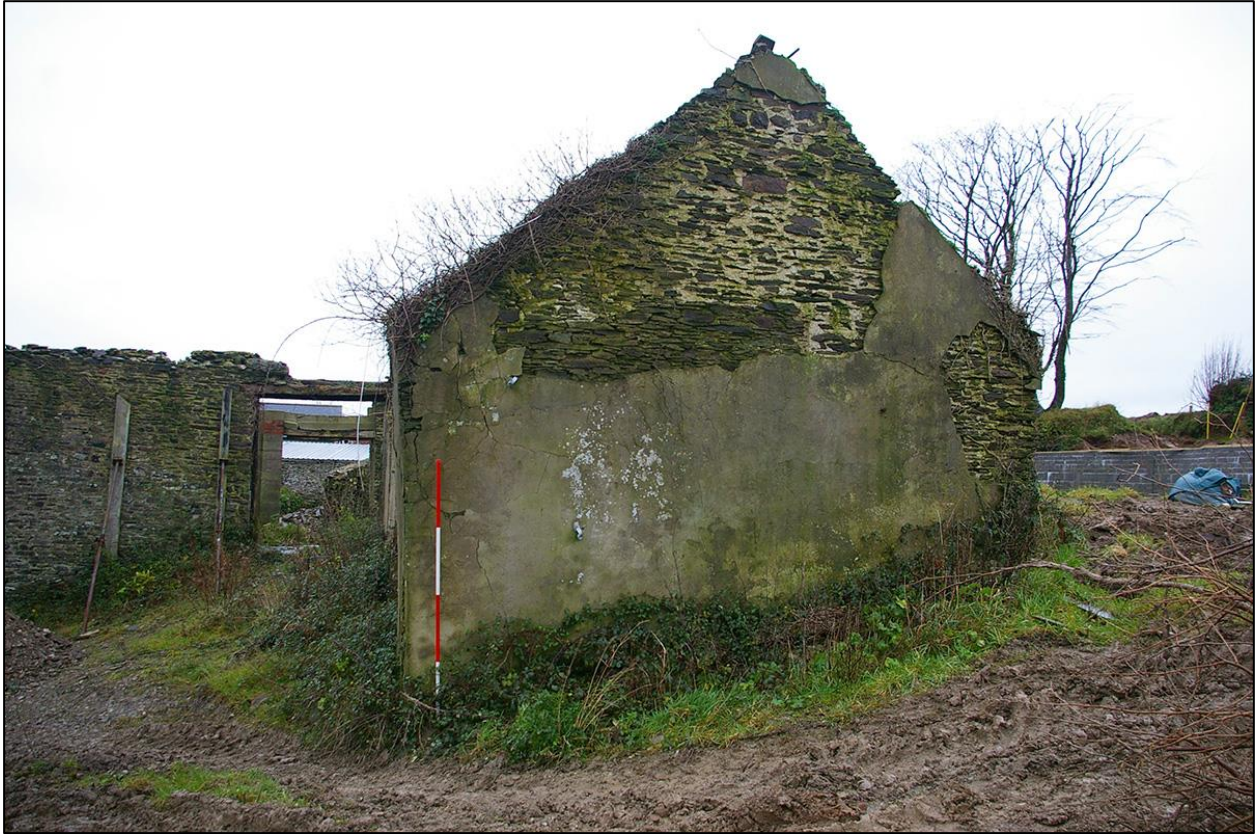
59. THE PLASTERED EASTERN GABLED END OF THE STABLES. (WITH 2M SCALES). TAKEN FROM THE EAST.

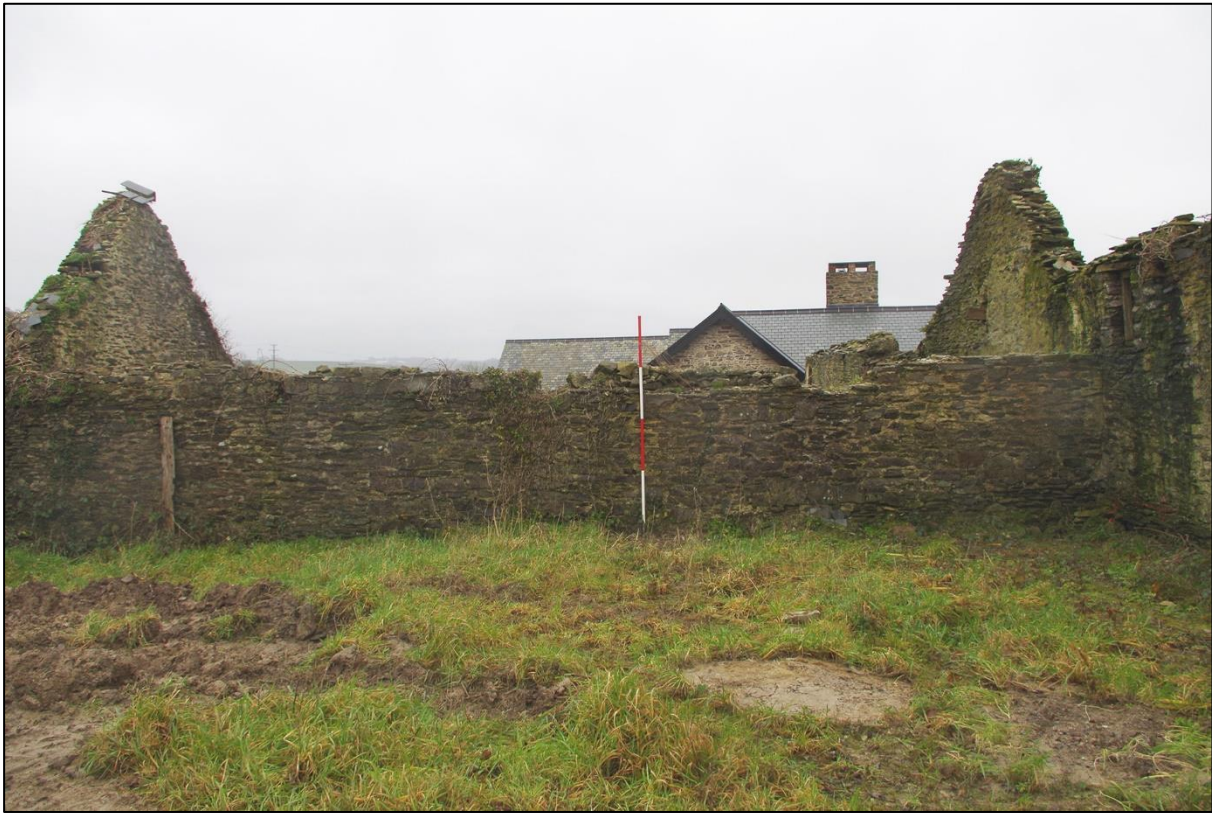
Building 4		General Description
Function/Summary:		Stable block.
Dating Evidence:		The historic mapping and form and build of the buildings all confirm their 19 th century date.
B4 Exterior		
B4 Elevation NORTH		Description
Fabric Description:		Tall single-story wall terraced into the slope to the north. The walls are of loose slate rubble, in a mix of cob and lime bonds and mortars, with a lot of later cement re-pointing. The north wall is blind, built over the remains of an earlier structure to the west end, which appears integral to fragments of walling incorporated in B2B.
Roof Covering		Roofless ruin.
Opening – Windows:		N/A
Openings - Doors		N/A
Drainage/Guttering		N/A
Significant Details:		Built over the remains of an earlier structure to the west end, which appears integral to fragments of walling incorporated in B2B.
Relationships:		The wall is contiguous with the east gable and south wall. The wall is built up against B2B to the west.

60. NORTHERN EXTERNAL WALLS OF B4 SHOWING THE BOTH GABLED ENDS. (WITH 2M SCALES). TAKEN FROM THE NORTH.

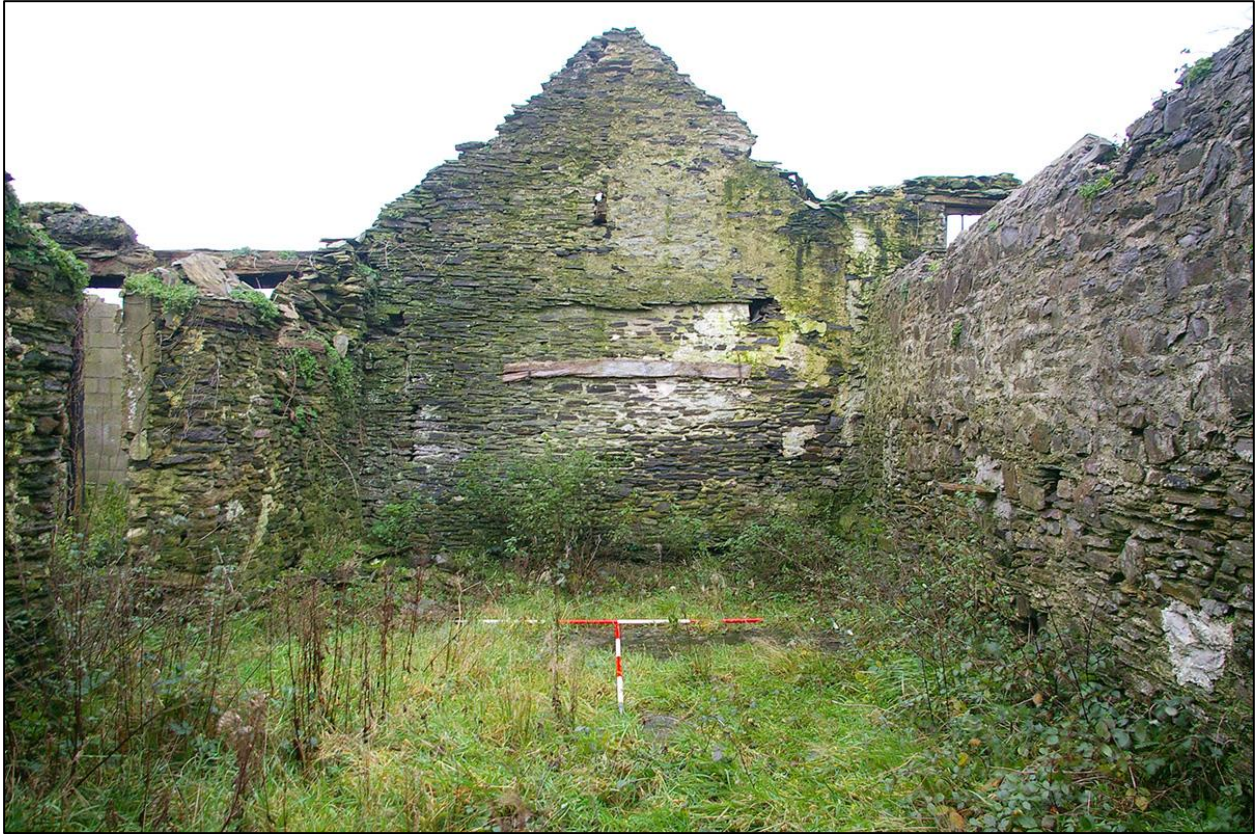
61. WESTERN GABLED END OF B4. (WITH 2M SCALES). TAKEN FROM THE EAST.

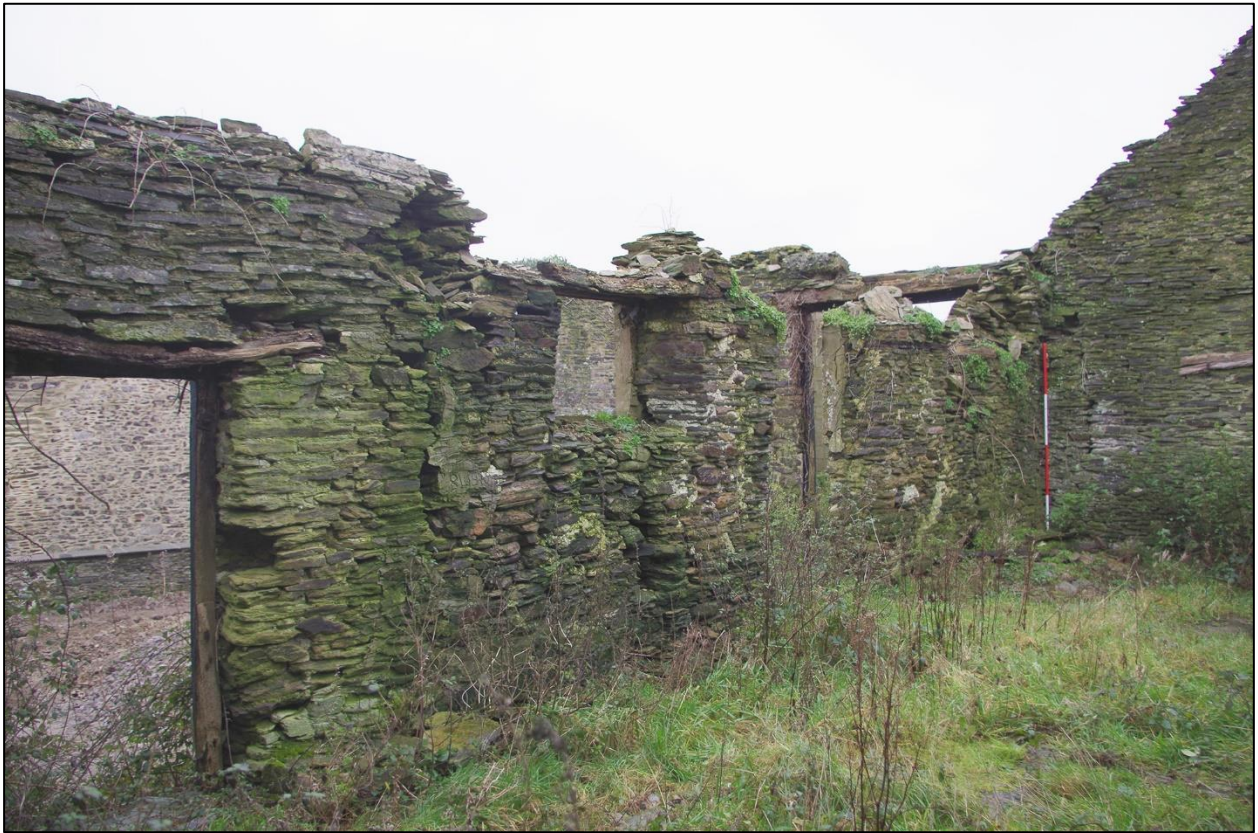
62. SOUTHERN WALL OF B4 SHOWING BOTH DOORWAYS AND WINDOWS. (WITH 2M SCALES). TAKEN FROM THE NORTH EAST.

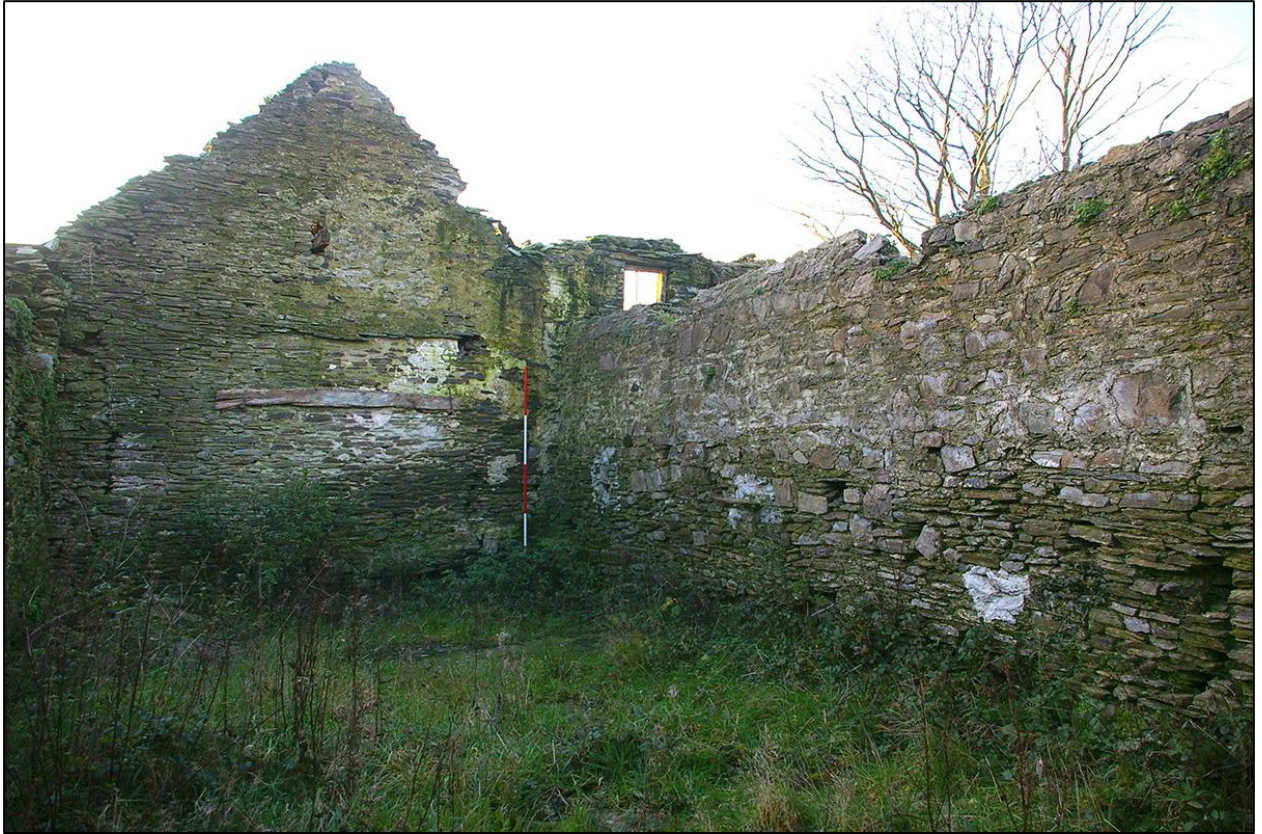
63. WESTERN GABLED END OF B4. (WITH 2M SCALES). TAKEN FROM THE EAST.

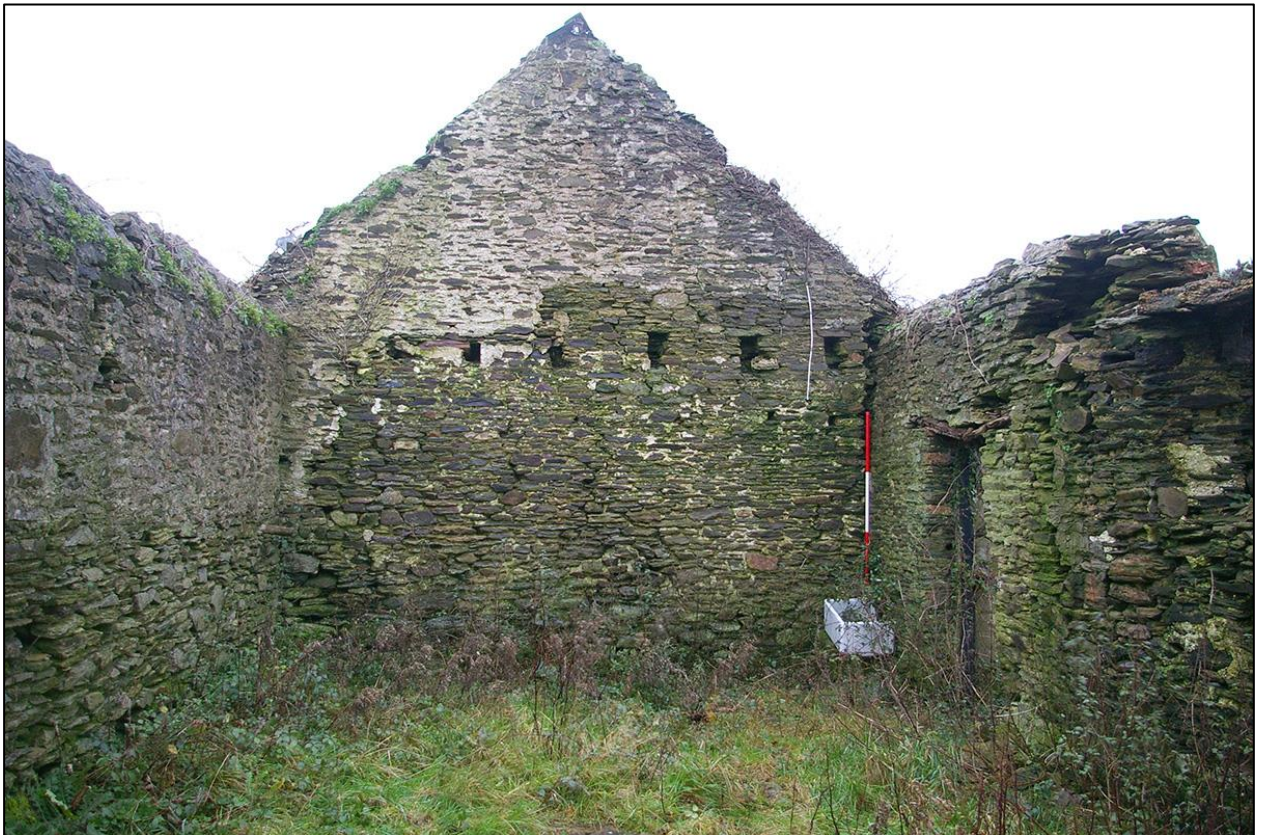
B4 Elevation EAST		Description
Fabric Description:		Tall gables, with joist sockets at first floor, which suggest a fodder loft, in the angle of the roof line. The walls are of loose slate rubble, with a mix of cob and lime bonds and mortars, with a lot of later cement re-pointing.
Roof Covering:		Roofless ruin.
Openings – Doors:		N/A
Opening – Windows:		N/A
Drainage/Guttering		N/A
Significant Details:		Loft joists.
Relationships:		The building comprises a ‘north’ and ‘south’ wall, with an east gable; the building built up against B2B to the west.
B4 Elevation SOUTH		Description
Fabric Description		Single-story wall, of loose slate rubble, with a mix of cob and lime bonds and mortars, with a lot of later cement re-pointing and some area rebuild to the ‘south’ wall.
Roof Covering:		Roofless ruin.
Openings – Doors:	2	D1 – door to the west end. The west door is quite wide with a chunky timber frame and heavy low timber lintel. D2 – door to east end. The door to the east end is narrow, with a plank door, in a beaded frame, with iron door furniture and strap hinges.

64. EASTERN GABLED END OF B4 SHOWING TRUSS HOLES FOR UPPER STORAGE AREA. (WITH 2M SCALES). TAKEN FROM THE WEST.

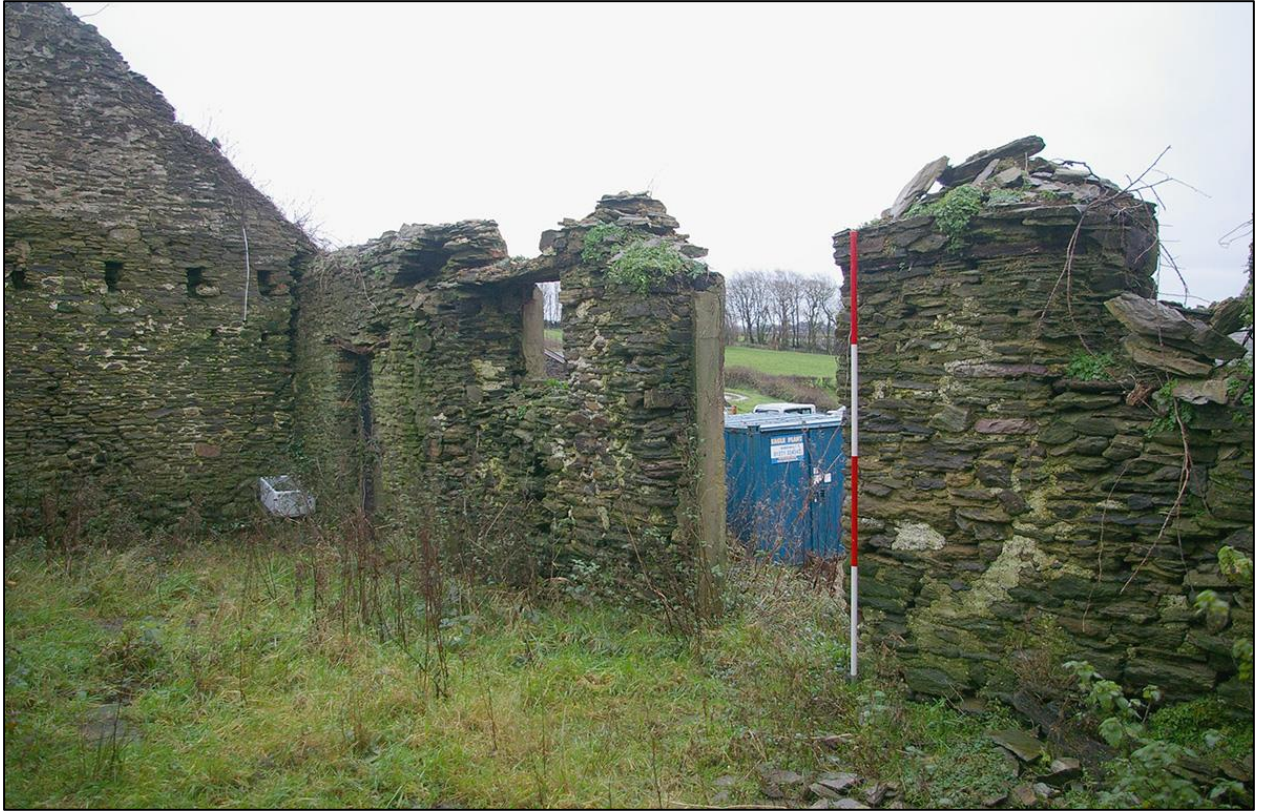
65. EASTERN GABLED END OF B4 SHOWING DOORWAYS AND WINDOW OPENINGS. (WITH 2M SCALES). TAKEN FROM THE WEST.

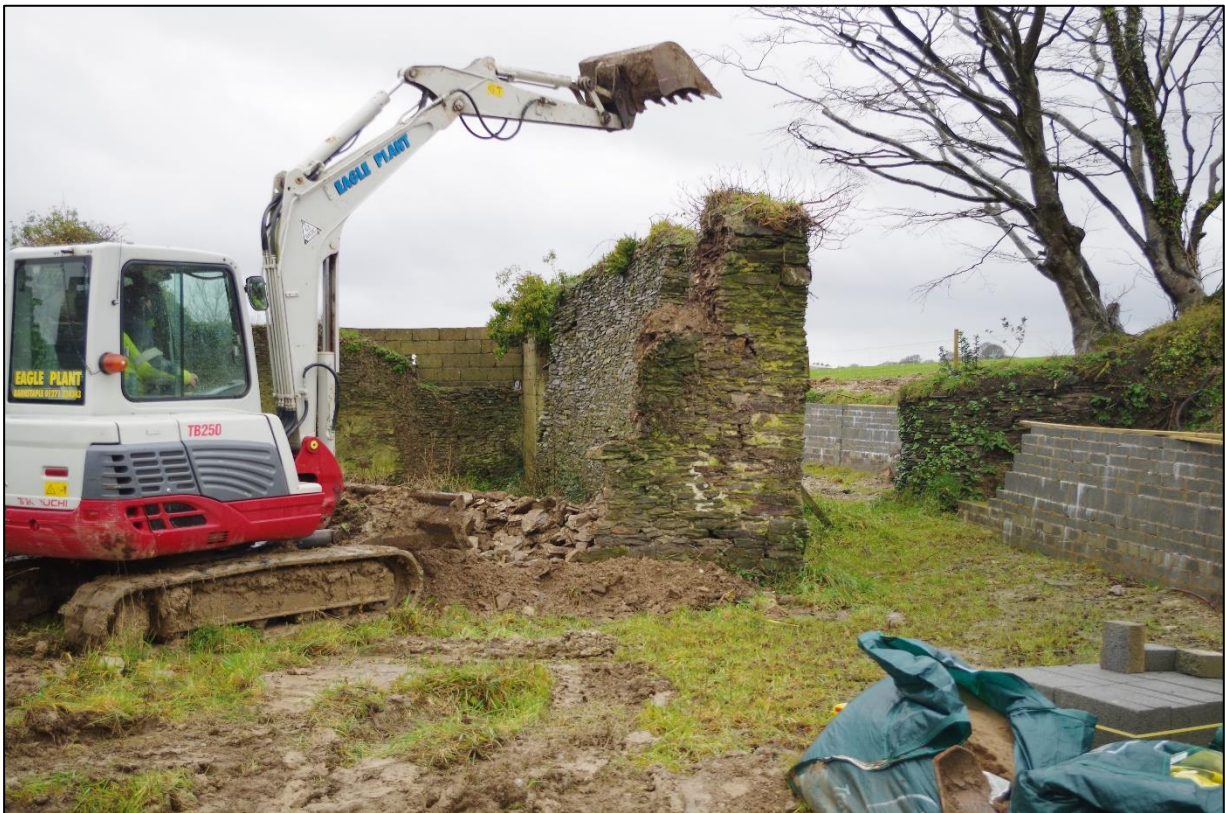
Relationships		Contiguous with the west wall of B2A. Abuts B2B to the east end.
B2A Elevation EAST		Description
Fabric Description:		The wall survives to low single storey height and has partially collapsed on its inner face, failing structurally. To the east of B2A the wall is more irregular, of loose slate and shale build. On the inner face it has been repaired in cob and then patched again in concrete blocks.

5. DEMOLITION OF THE NORTHERN WALL OF B2A.

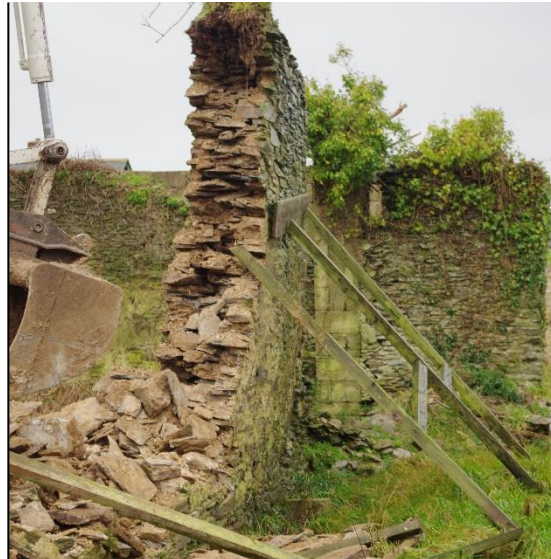
The monitoring confirmed that elements of B2A, within the main L-shaped range, to the north and east, which were demolished due to being unsafe were sat on and incorporated foundations of a heavy well built vernacular wall which had an interior and exterior drain and damp proof course, therefore likely enclosing a courtyard. A broad date range could be confirmed due to the presence of a fragment of medieval pottery within this wall.

6. B2A DEMOLISHED. TAKEN FROM THE WEST.
