THE BARNs
CHELFHAM BARTON
BRATTON FLEMING
NORTH DEVON

Historic Building Recording and Archaeological Monitoring

South West Archaeology Ltd. report no. 201013

By Dr S. Walls, E. Wapshott & A. Allen
Report Version: FINAL
Issued: 13th October 2020
Finalised: 22nd July 2021

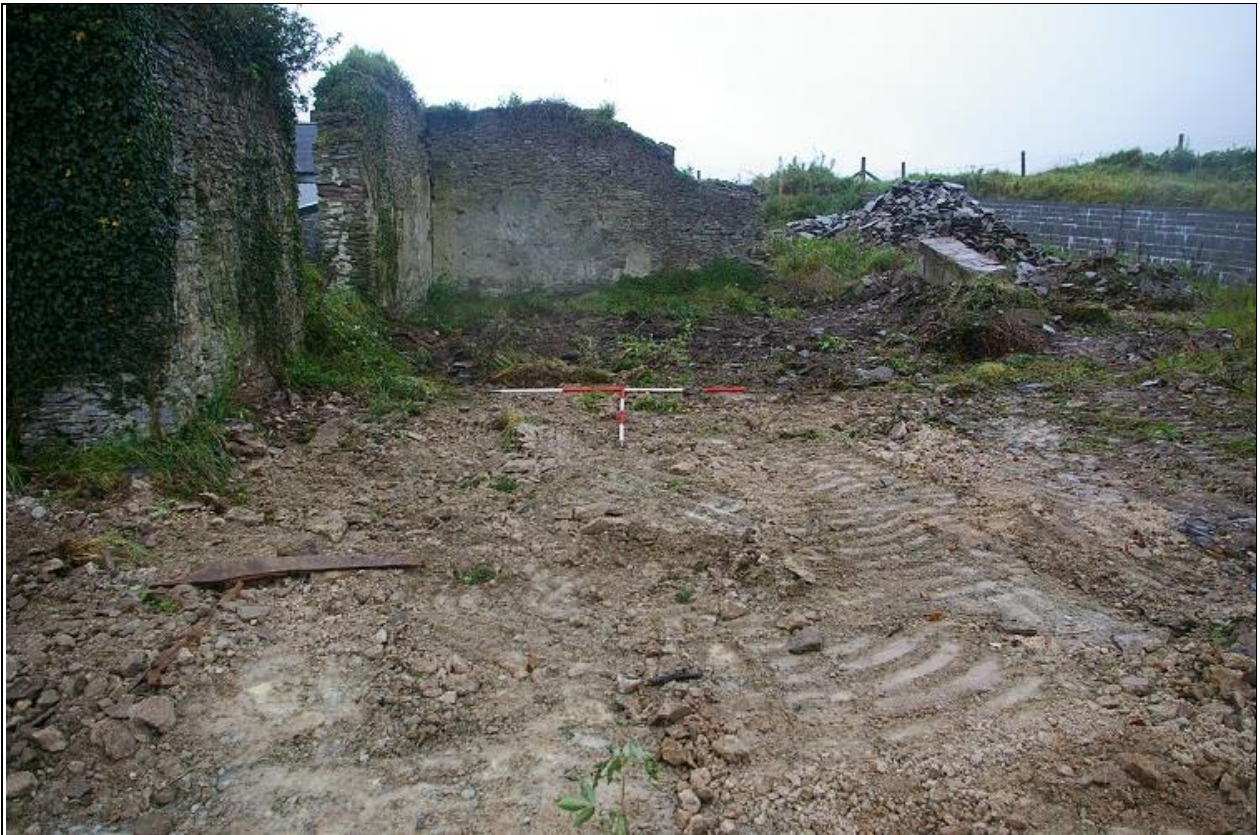
15. THE NORTH AND EAST WALLS OF B2A, DURING FLOOR CLEARANCE, EXHIBITING INTERNAL AND EXTERNAL DRAINS; FROM THE WEST (2X2M SCALES).

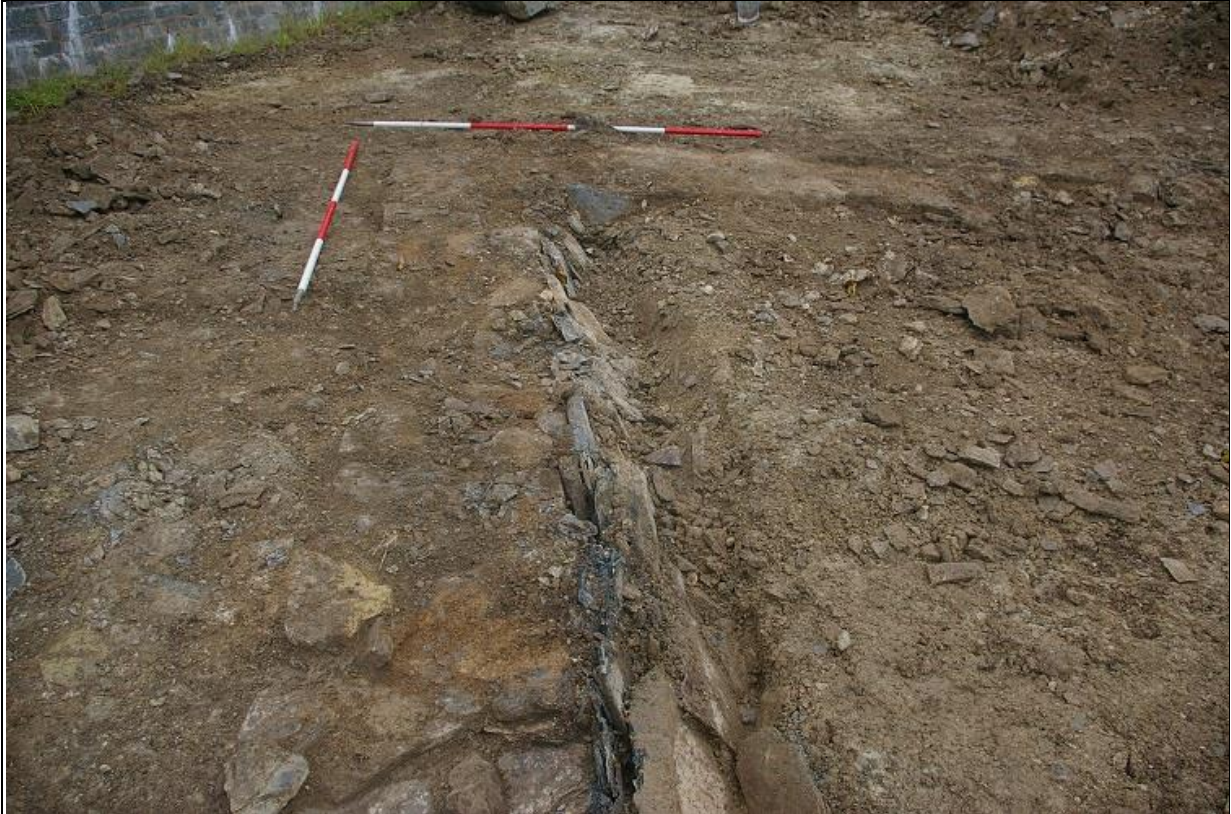
Drainage/Guttering		N/A
Significant Details:		The bottom c.1m of the wall from the threshing opening to the north-east corner and lower in places to the east end is of heavier build and is slightly battered, it appears to be on a slightly different alignment, possibly the reason the upper rebuilt section is failing.
Relationships:		The north wall is of complex phasing, rebuilt in places, there is a build line to the east wall, which has also been repaired. The north-west corner and west wall are contiguous.
B2A Elevation WEST		Description
Fabric Description:		Blind end elevation, of single storey height, of regularised slate and shale rubble build with a plinth to the base to brace the building and correct for the steepness of the ground slope. The stonework is in a clay and lime bond, with a lime mortar.
Roof Covering:		Roofless ruin.
Openings – Doors:		N/A
Opening – Windows:		N/A
Drainage/Guttering		N/A

16. THE NORTH AND EAST WALLS OF B2A, DURING FLOOR CLEARANCE, EXHIBITING THE SLIGHTLY SHARP ANGLE AND INTERNAL AND EXTERNAL DRAINS; FROM THE NORTH (2X2M SCALES).

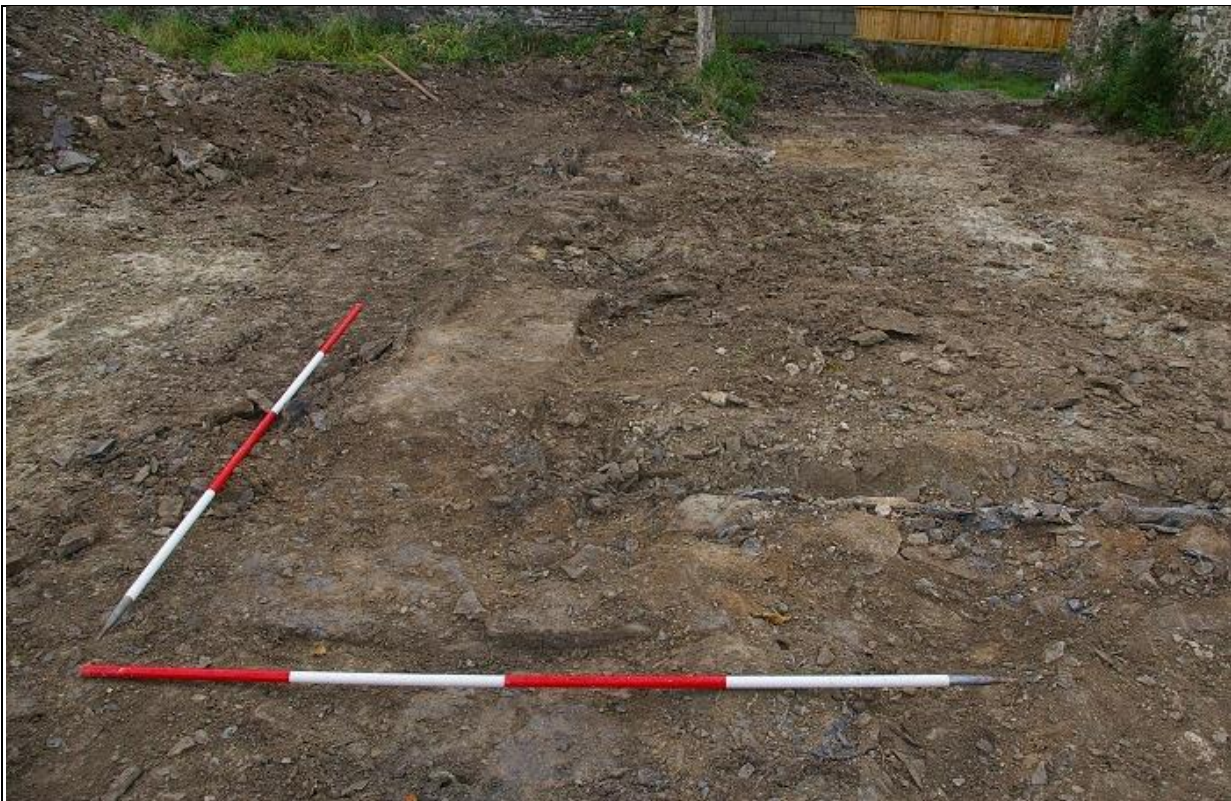
The archaeological monitoring identified an earlier phase of activity in the north-east area of the barn complex, within B2A, seemingly a main exterior boundary wall, only the foundations of which survive and which were then reused to build the upstanding buildings upon. The form of the wall and presence of internal and external drainage alongside it possibly indicates a courtyard or enclosed open area, rather than it being part of a building. This could tentatively be associated with an medieval courtyard-house type enclosure and certainly the section of wall examined in more detail, contained medieval pottery fabric within its structural build.

(105)	Surface	Rotten wood planks of suspended threshing floor	Part of {104} Overlies (100) Overlain by (101)	-	18 th – 19 th century
{106}	Structure	Foundations of north and east wall of B2A, thick coursed slate slabs, in a yellow clay bond	Abutted by (107)		Late medieval?

17. THE DRESSED QUOINS TO THE NORTH-EAST CORNER, WITH 2M X 1M SCALE, SHOWING THE CONTINUITY OF THE FOUNDATIONS;
FROM THE EAST.

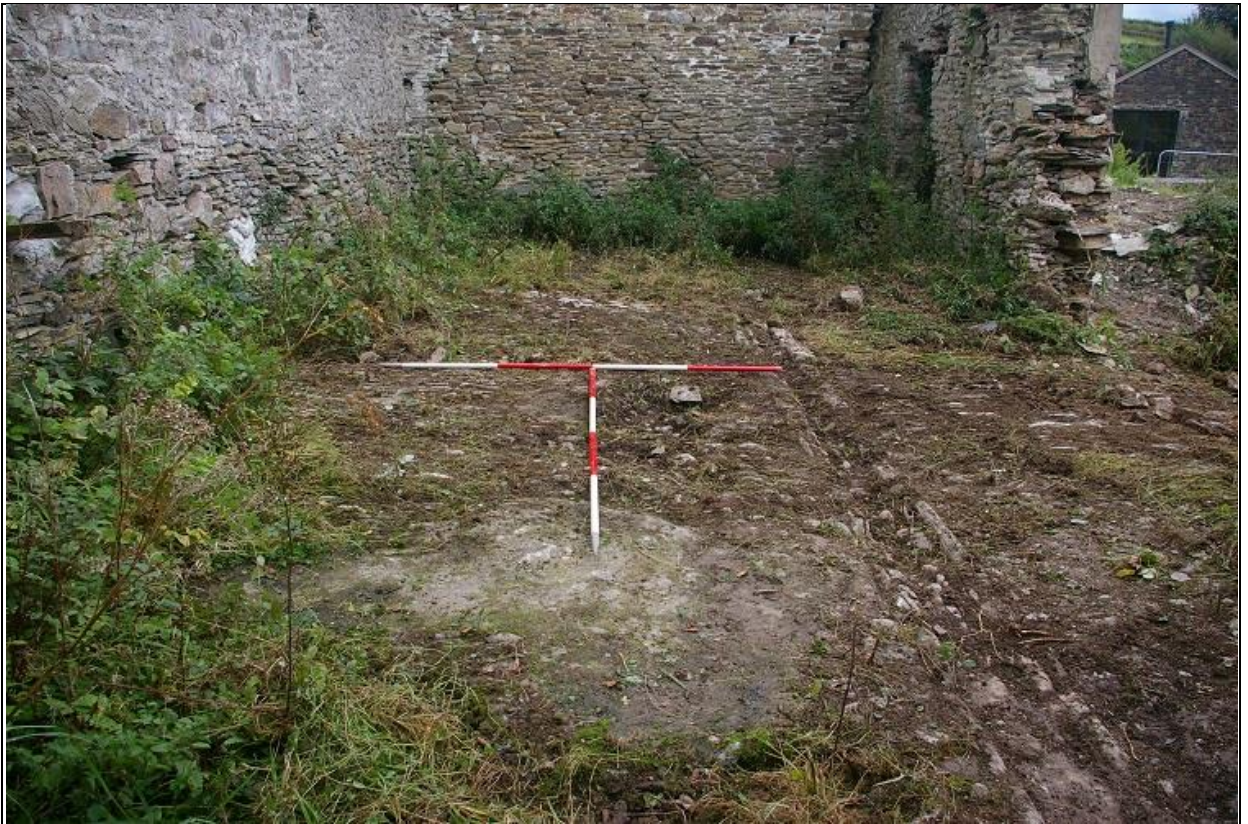
(114)	Surface	Split slate cobbled floor, damaged	Overlies (100)		19 th century
{115}	Structure	Slate-built drain, shallow, flat-bottomed, vertical slate slab sides	Overlies (100) Part of (114)		19 th century

21. DETAIL OF THE SLATE SLAB DRAIN IN B4, WITH 0.3M SCALE; FROM ABOVE.

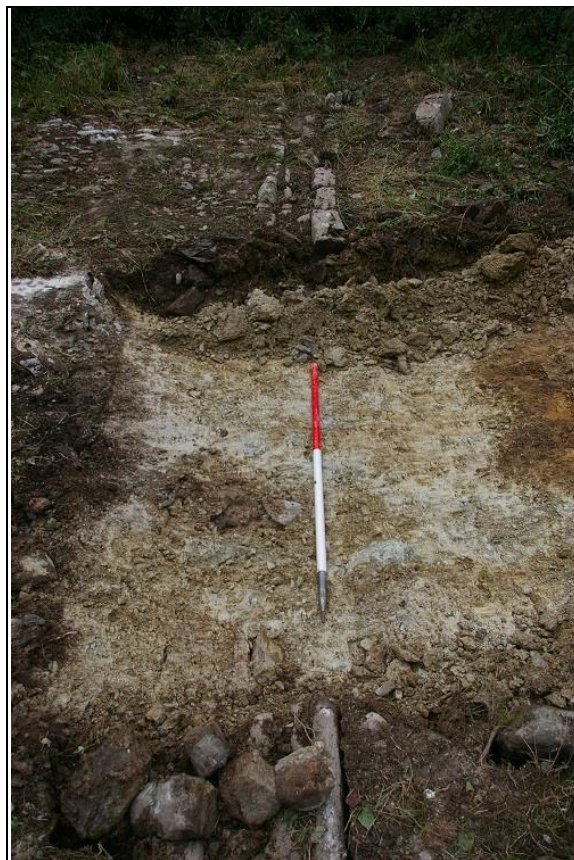
22. EXPLORATORY SECTION THROUGH COBBLES IN B4, CONFIRMED THEY WERE LAID DIRECTLY ONTO THE SUBSOIL OVER CLAY-SILT NATURAL, IN A LIME/SAND MORTAR (1, SCALE); FROM THE 'WEST'.
