**WESTACOMBE COTTAGE  
HEANTON PUNCHARDON  
NORTH DEVON  
DEVON**

Historic Building Recording of the Roof

South West Archaeology Ltd. report no. 200623

By E. Wapshott  
Report Version: **FINAL**  
Assessment issued: 27<sup>th</sup> November 2019  
Reissued with Roof Recording: 23<sup>rd</sup> June 2020

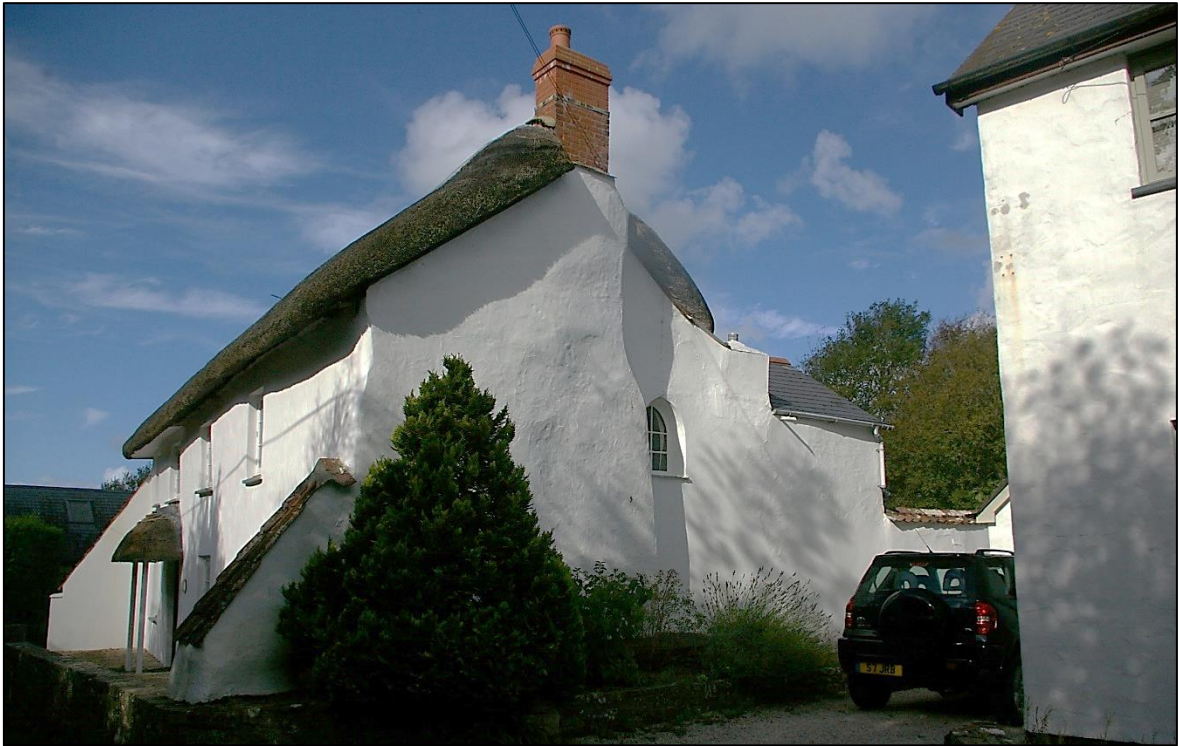
FIGURE 5: THE EAST GABLE OF WESTACOMBE COTTAGE; FROM THE EAST-SOUTH-EAST.

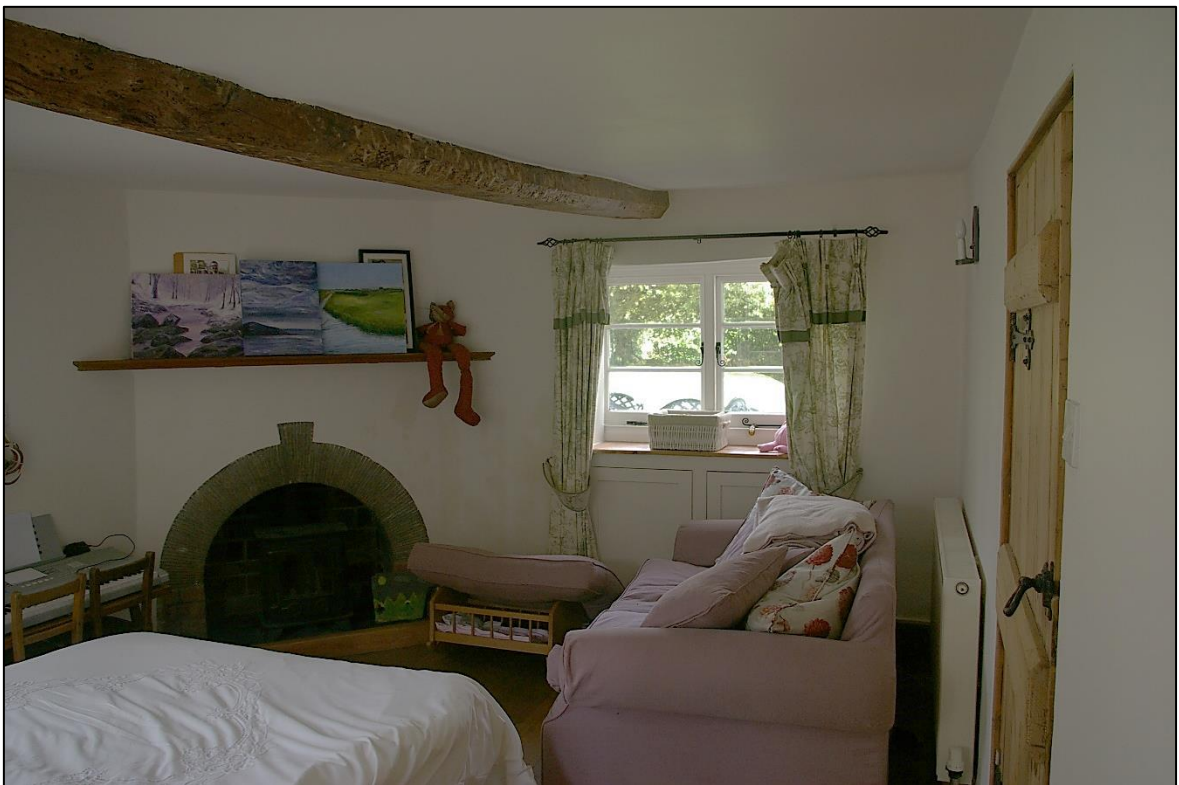
FIGURE 6: ROOM 2, THE FORMER SERVICE END OF THE COTTAGE; FROM THE SOUTH-SOUTH-EAST.

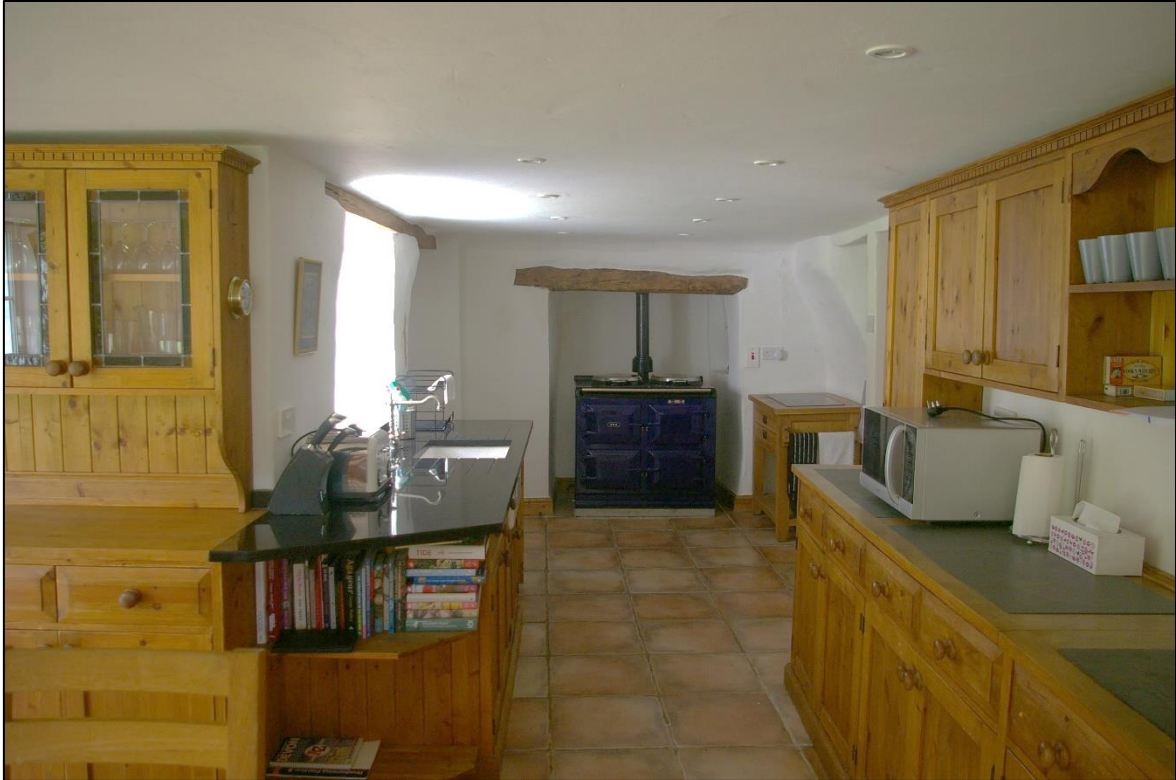
FIGURE 8: THE KITCHEN BLOCK, NOW OPEN TO THE EXTENSION; FROM THE WEST.

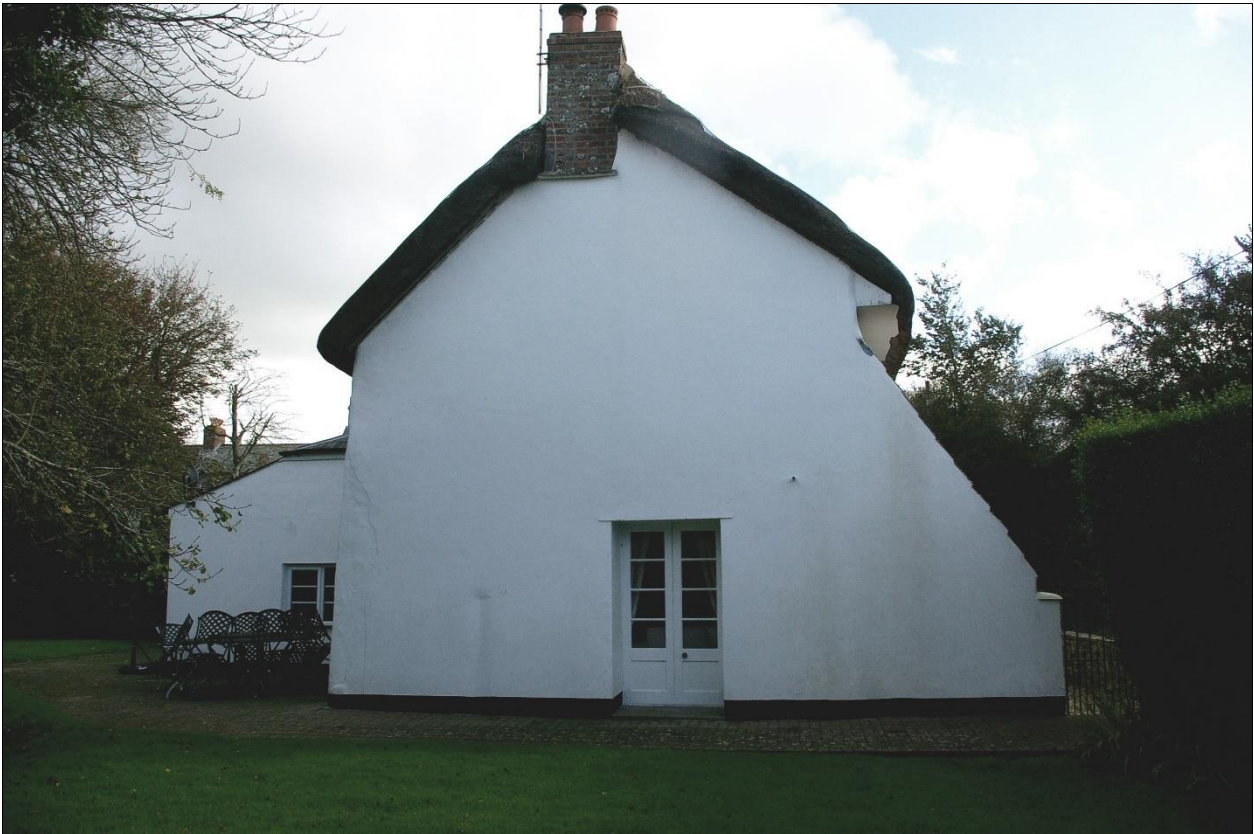
1. THE WEST GABLE, WITH 18<sup>TH</sup> OR 19<sup>TH</sup> CENTURY BRICK STACK AND MODERN FORCED FRENCH WINDOWS; FROM THE WEST.

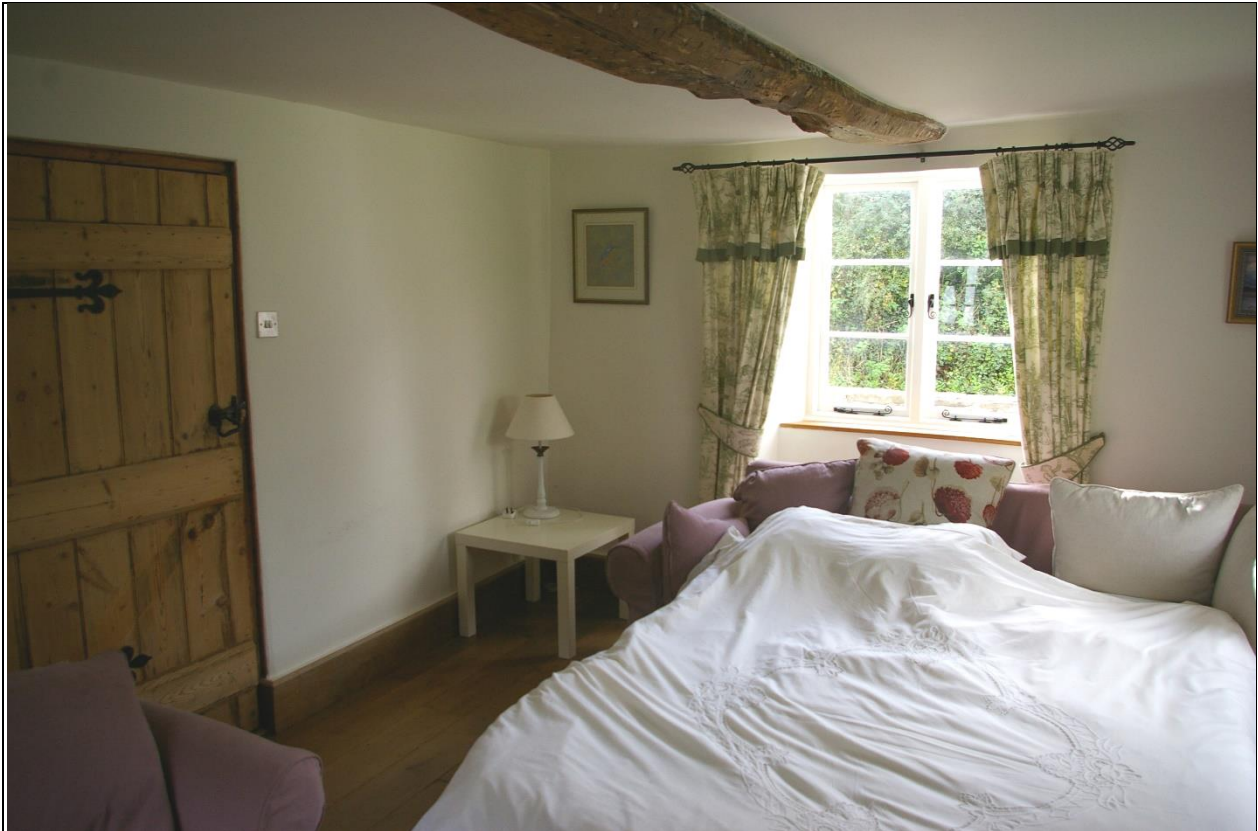
- 5. ROOM 2, SHOWING THE 17<sup>TH</sup> CENTURY CHAMFERED CEILING BEAM; FROM THE NORTH-WEST.

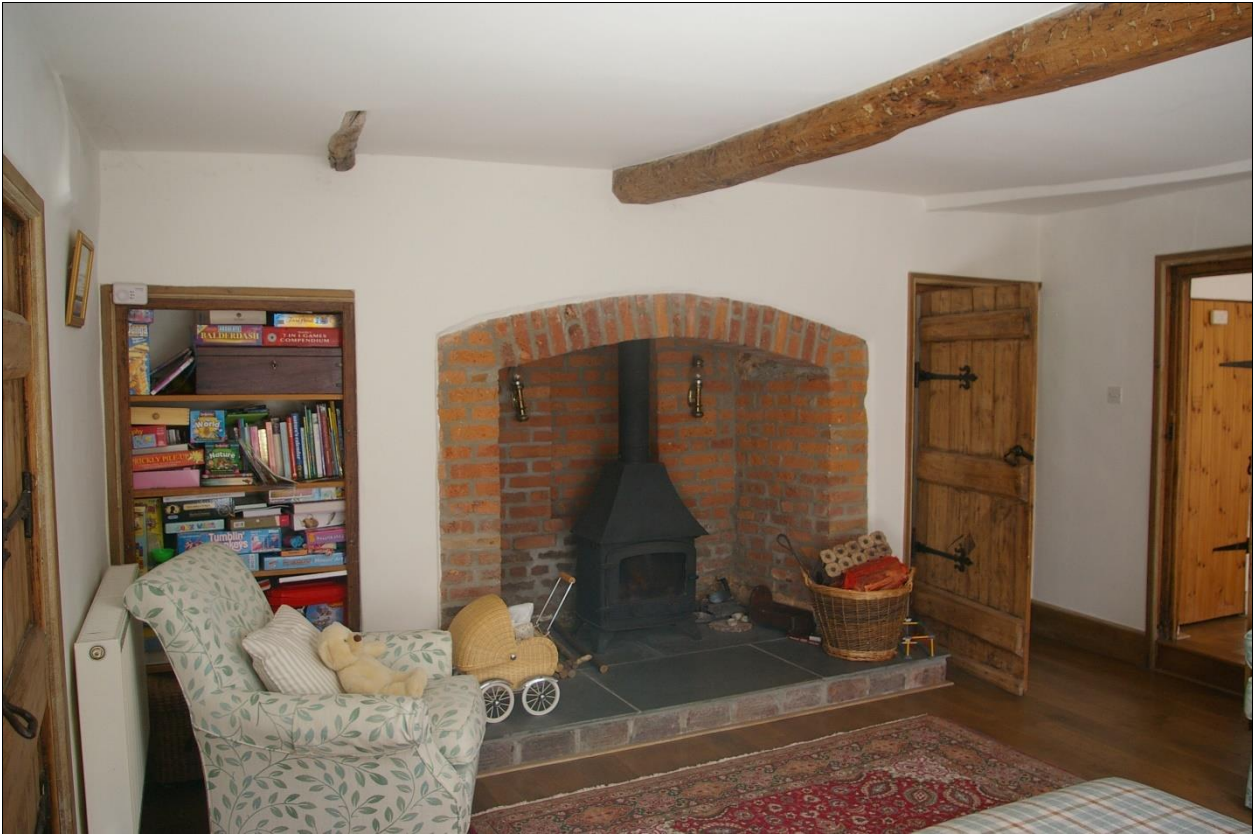
6. THE FORMER HALL, ROOM 3, WITH REMODELLED LATERAL STACK, LATER CEILING BEAM, EARLIER STAIR AND POTENTIAL PLASTERED JETTY; FROM THE SOUTH-WEST.

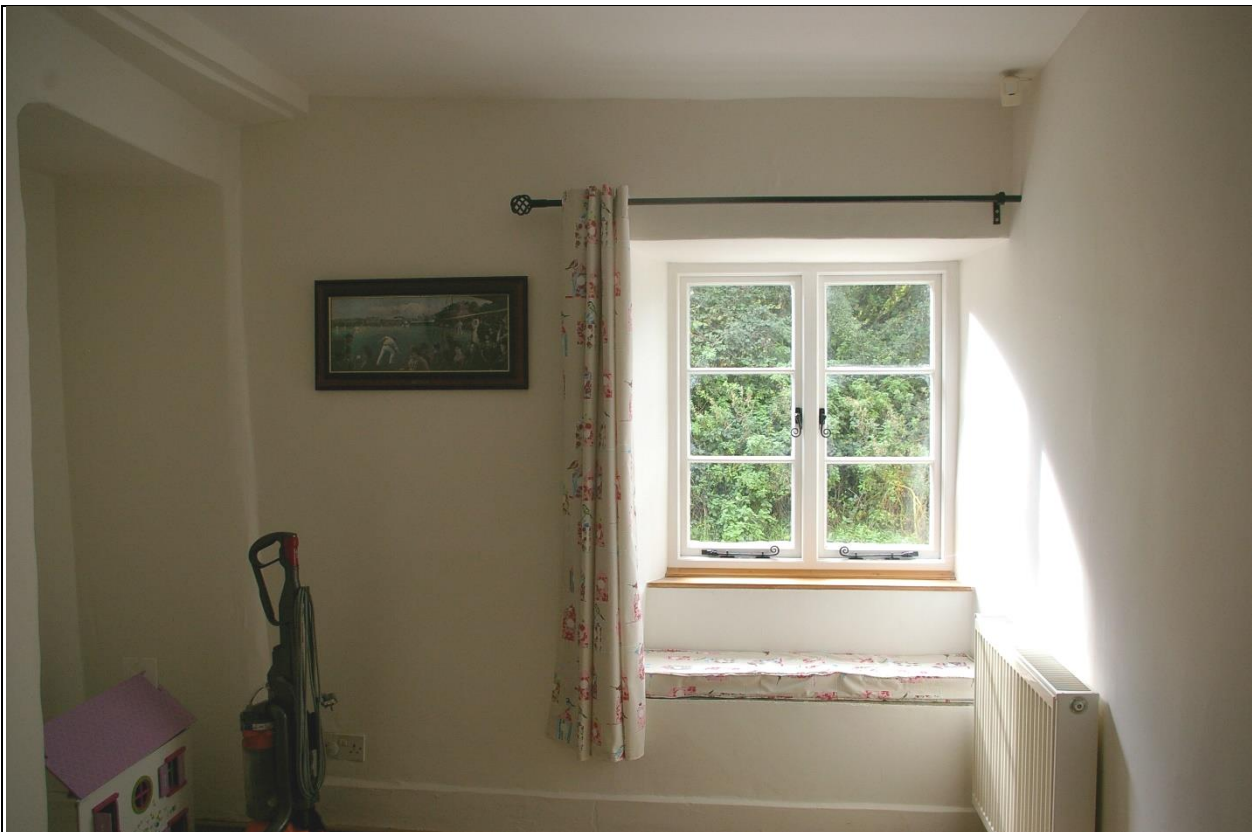
9. ROOM 4, WITH WINDOW WITH SLATE SHELF BELOW AS WINDOW SEAT AND LARGE FORCED/BLOCKED DOORWAY TO THE SOUTH-EAST CORNER; FROM THE NORTH-WEST.

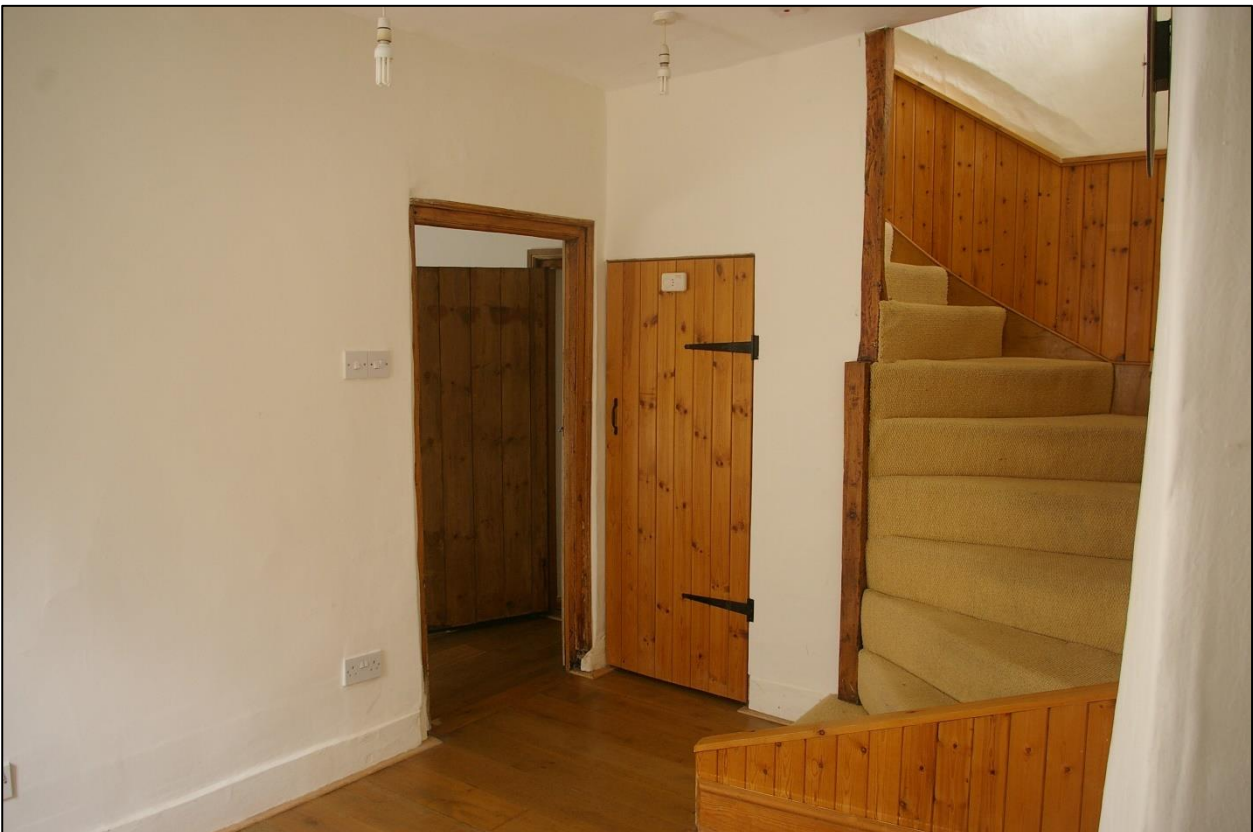
11. ROOM 4, THE THICK COB PARTITION AND WINDER STAIR, WITH BLOCKED DOORWAY BENEATH TO KITCHEN BLOCK; FROM THE SOUTH-EAST.

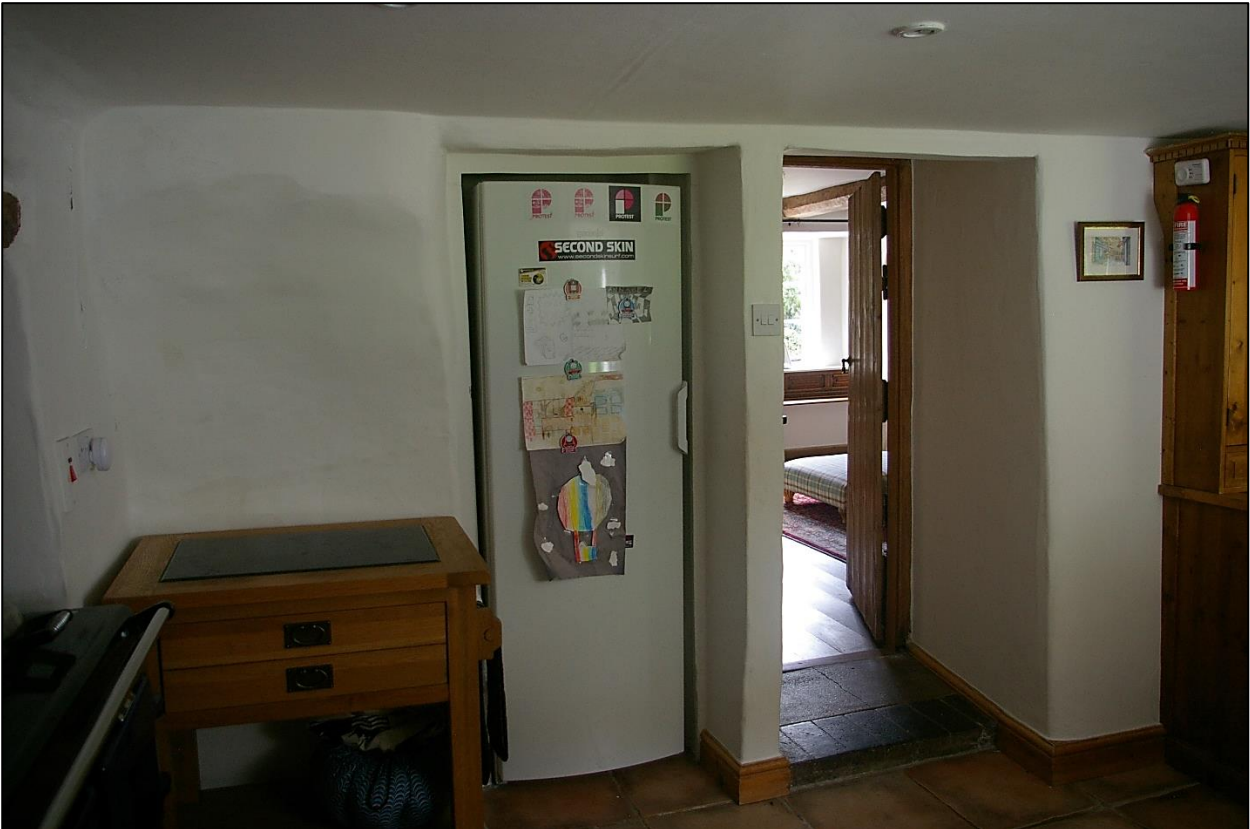
12. THE PAIRED DOORWAYS TO THE MAIN RANGE FORM ROOM 5, THE KITCHEN BLOCK, ONE ORIGINAL DOORWAY, NOW BLOCKED, ONE MORE MODERN FORCED DOORWAY; FROM THE NORTH-NORTH-EAST.

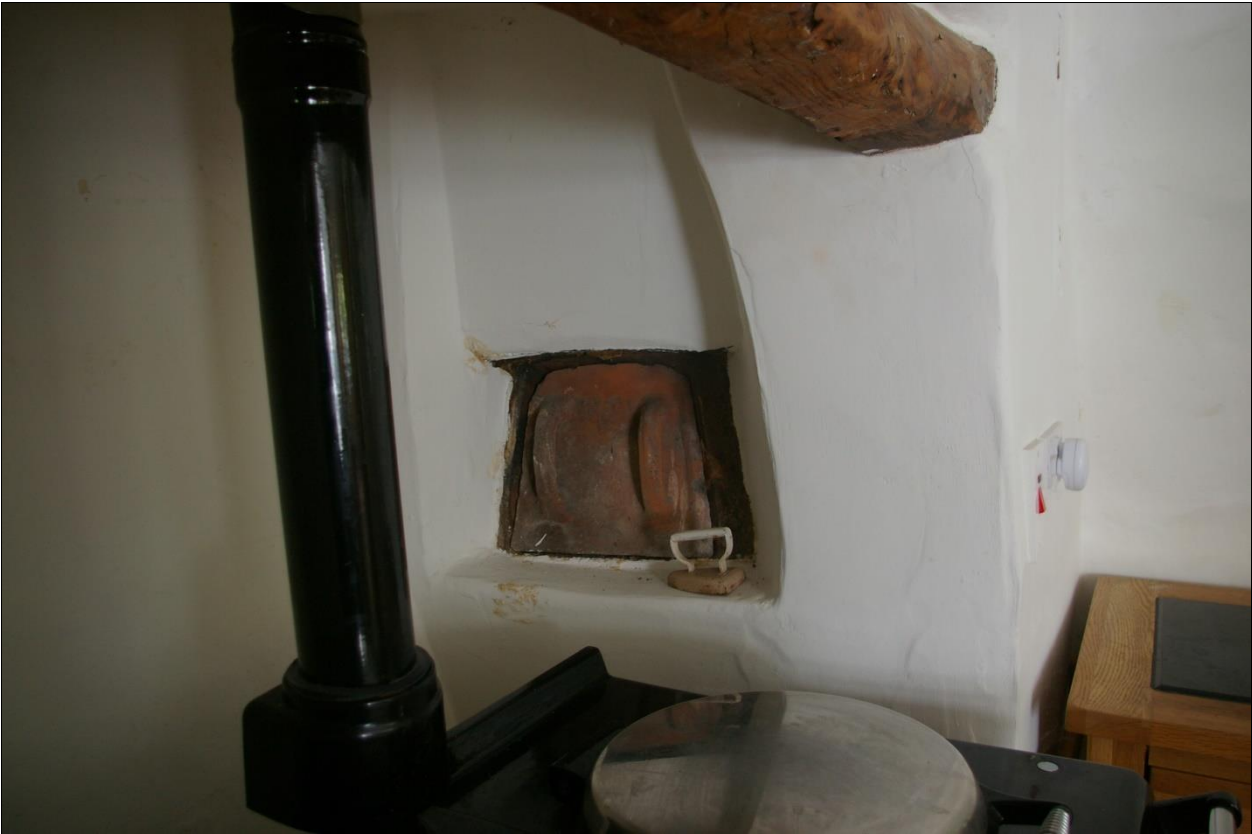
14. THE BREAD OVEN, WITH INFILLED PYRAMIDAL OPENING AND CLAY-CLOAM OVEN WITH CLAY DOOR, ROOM 5; FROM THE NORTH-WEST.

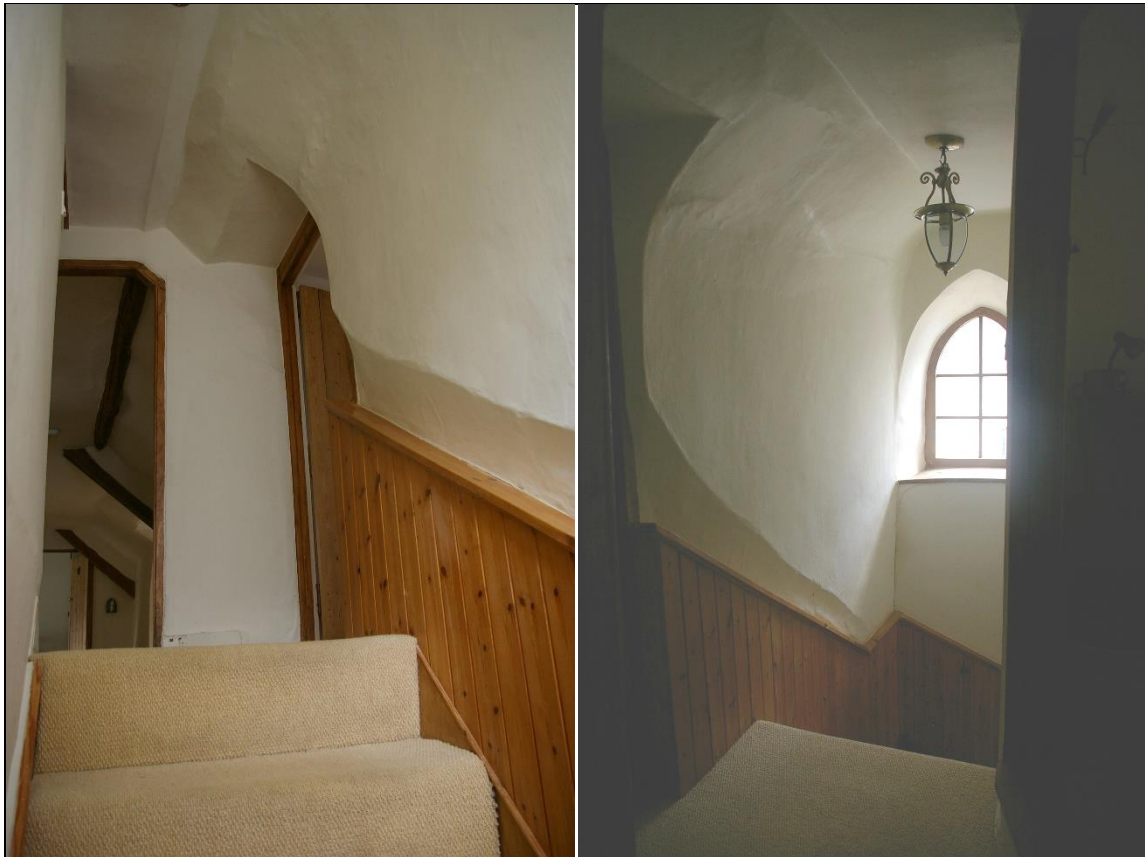
17. LEFT: THE WINDER STAIRS AS THEY RISE TO A SMALL LANDING FORMED BY A COB PARTITION TRUNCATING ROOM 9; FROM THE EAST-SOUTH-EAST.

18. RIGHT: VIEW BACK TO THE POINTED GOTHIC WINDOW INSERTED INTO THE NORTH-EAST CORNER OF THE MAIN RANGE TO LIGHT THE STAIR; FROM THE WEST-SOUTH-WEST.

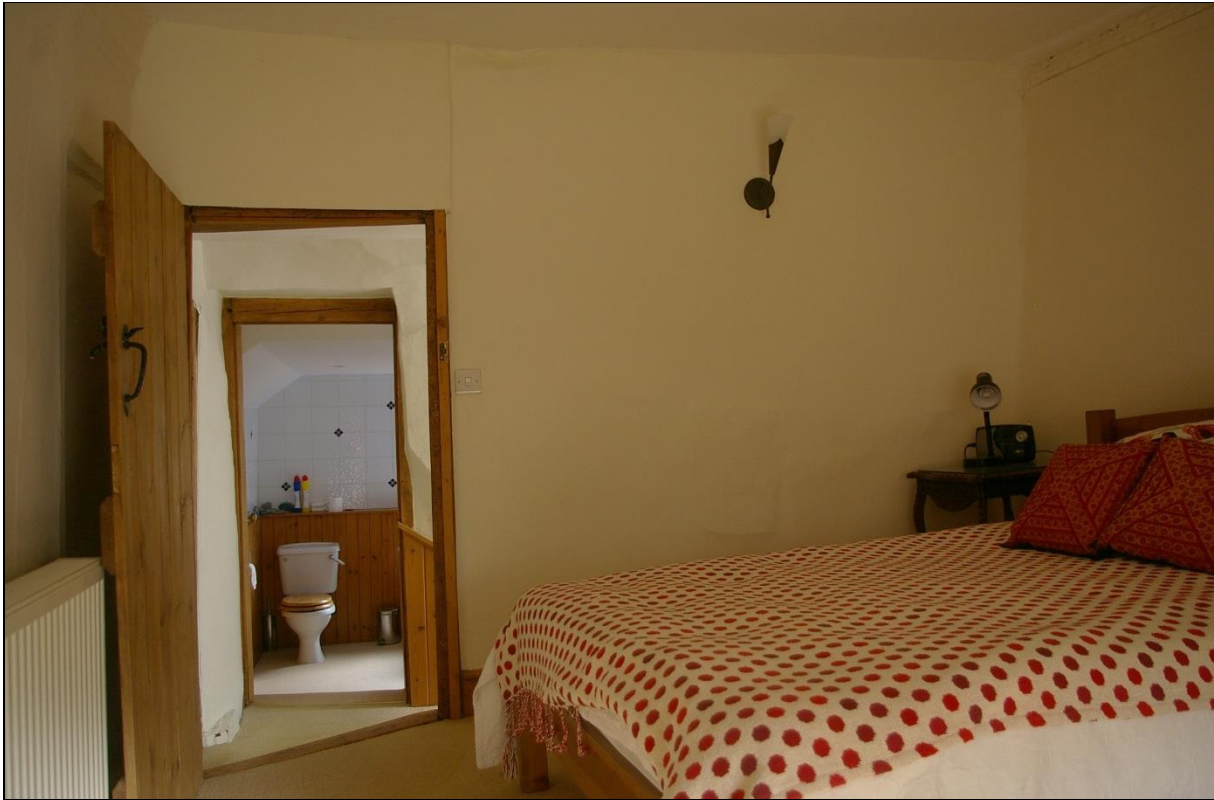
19. THE THICK COB PARTITION WHICH ENCLOSES THE STAIR AND TRUNCATES ROOM 9; FROM THE SOUTH-SOUTH-WEST.

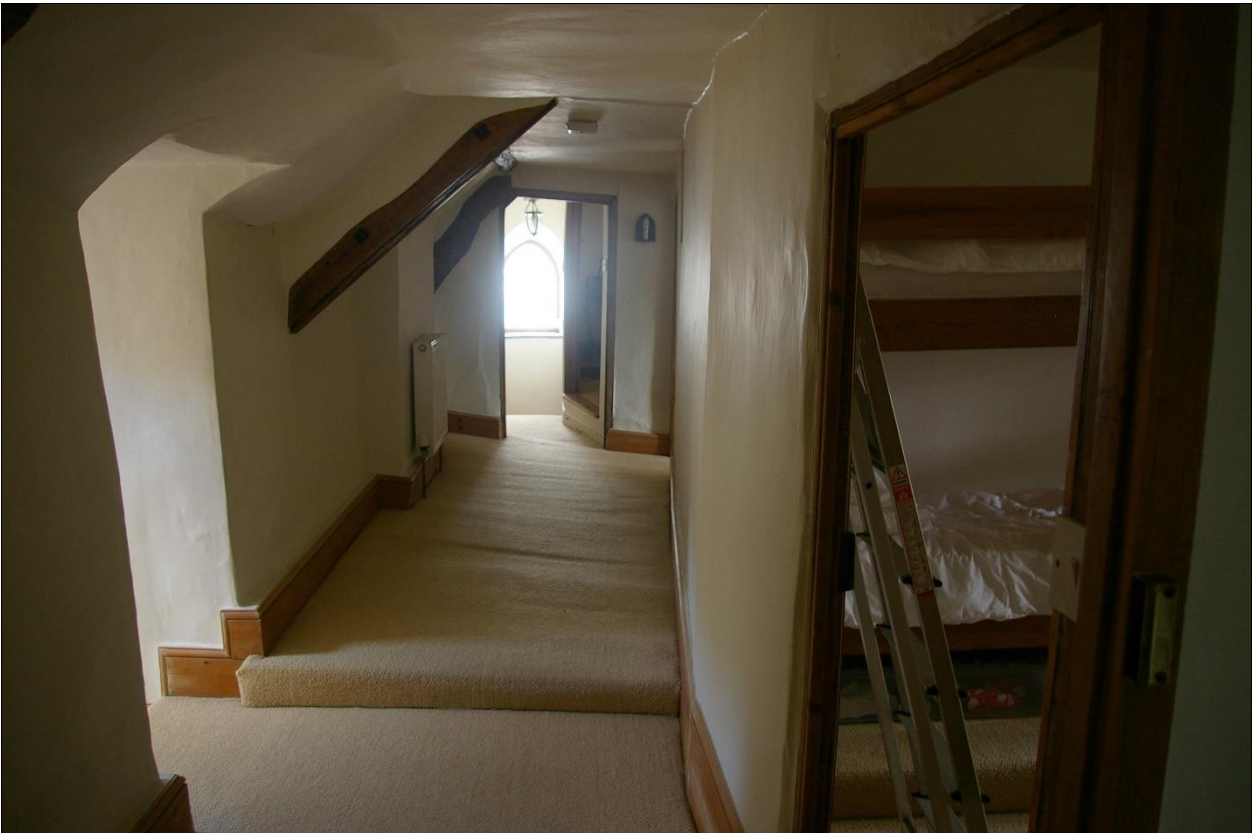
22. ROOM 11, THE CORRIDOR, SHOWING FLOOR LEVEL RAISE OVER FORMER HALL AND ANGLE CHANGE TO INSERTED PARTITIONS; FROM THE WEST.

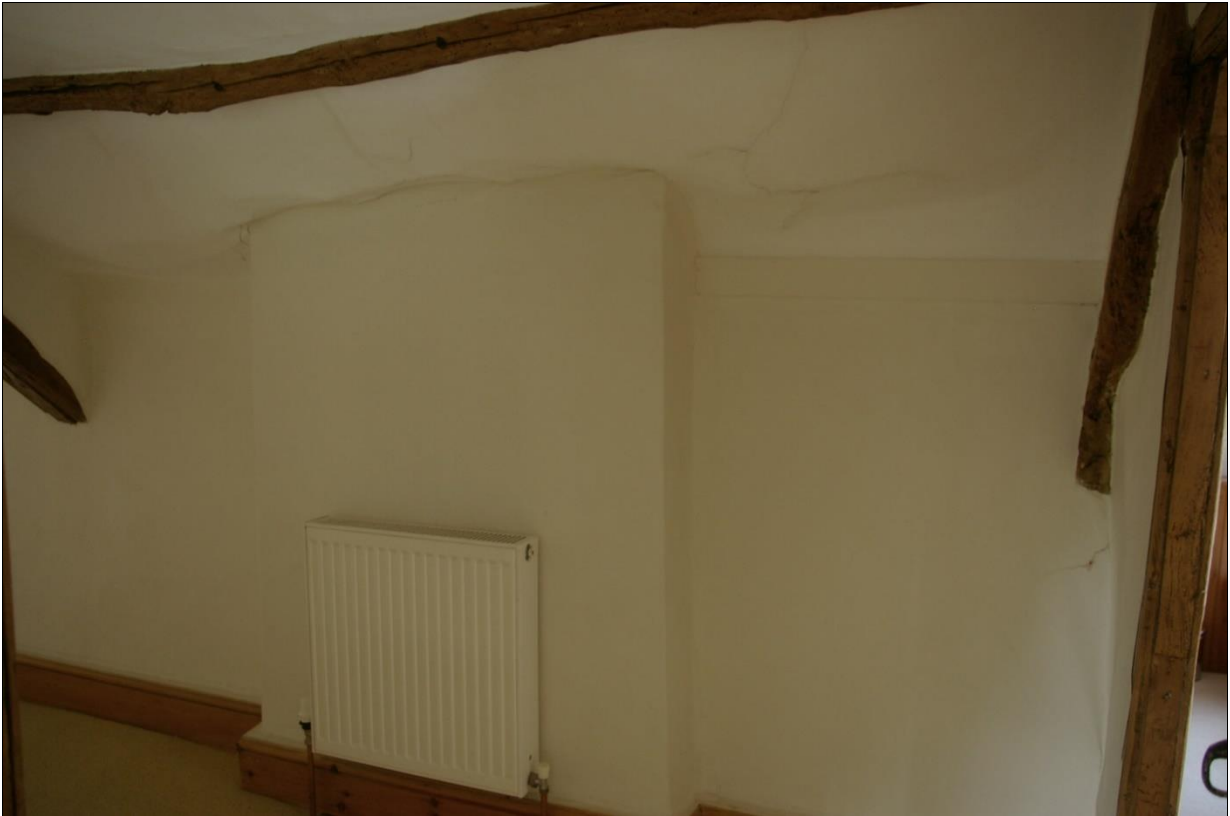
23. ROOM 11, THE NARROWER UPPER PART OF THE LATERAL STACK, SEEN WITHIN THE CORRIDOR BUT DESIGNED TO HEAT THE NEW FLOORED ROOM ON THE FIRST FLOOR; FROM THE SOUTH-EAST.

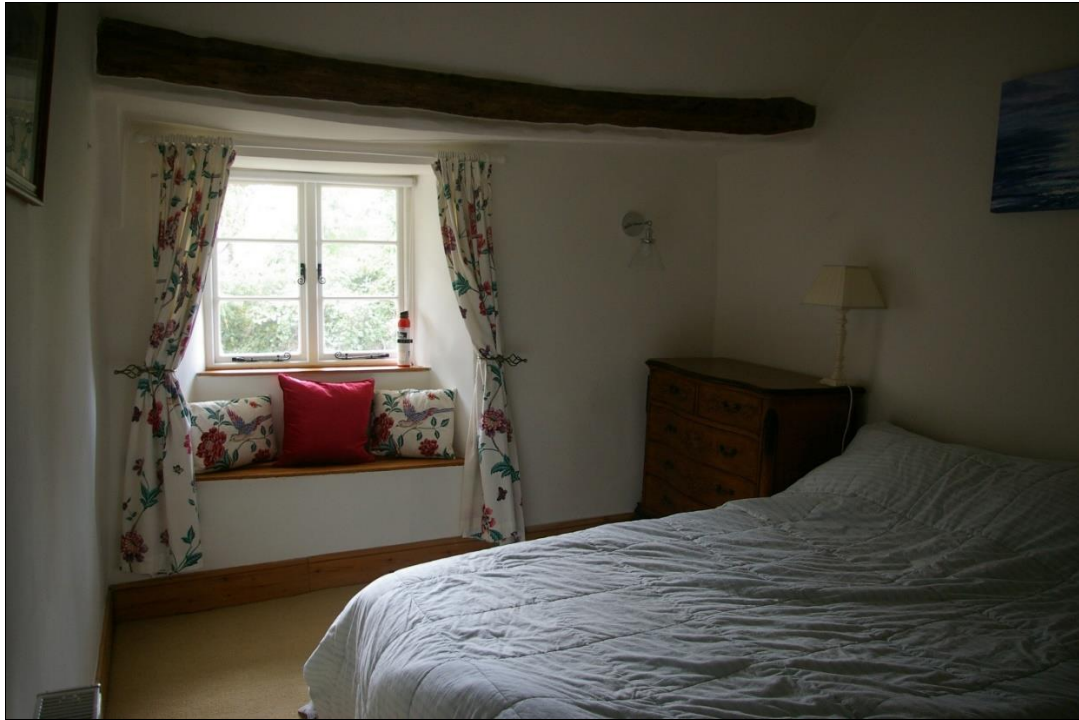
25. ROOM 14, THE GOOD PURLIN AND LOW EAVES TO THE SOUTH; FROM THE NORTH-NORTH-EAST.

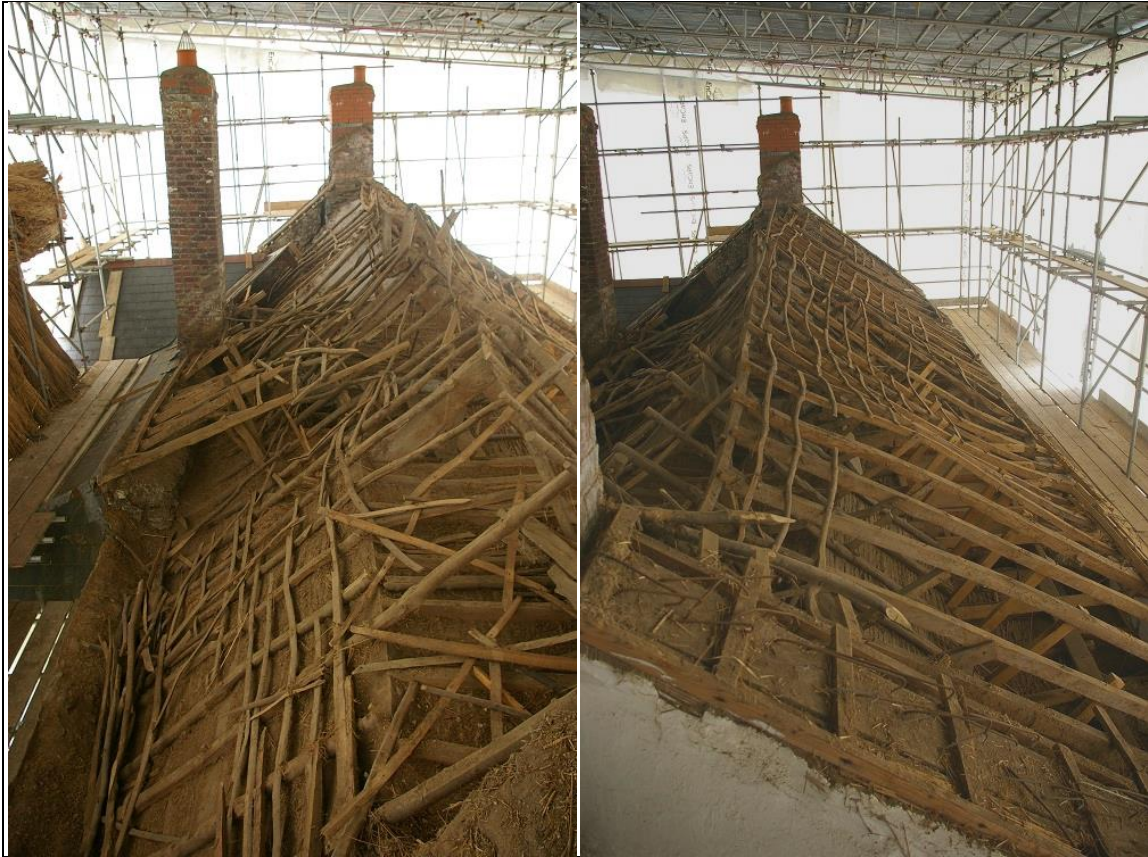
28. LEFT: WESTACOMBE ROOF, STRIPPED OF THATCH FROM THE WEST END, NORTH SIDE.  
29. RIGHT: WESTACOMBE ROOF, STRIPPED OF THATCH FROM THE WEST END, SOUTH SIDE.

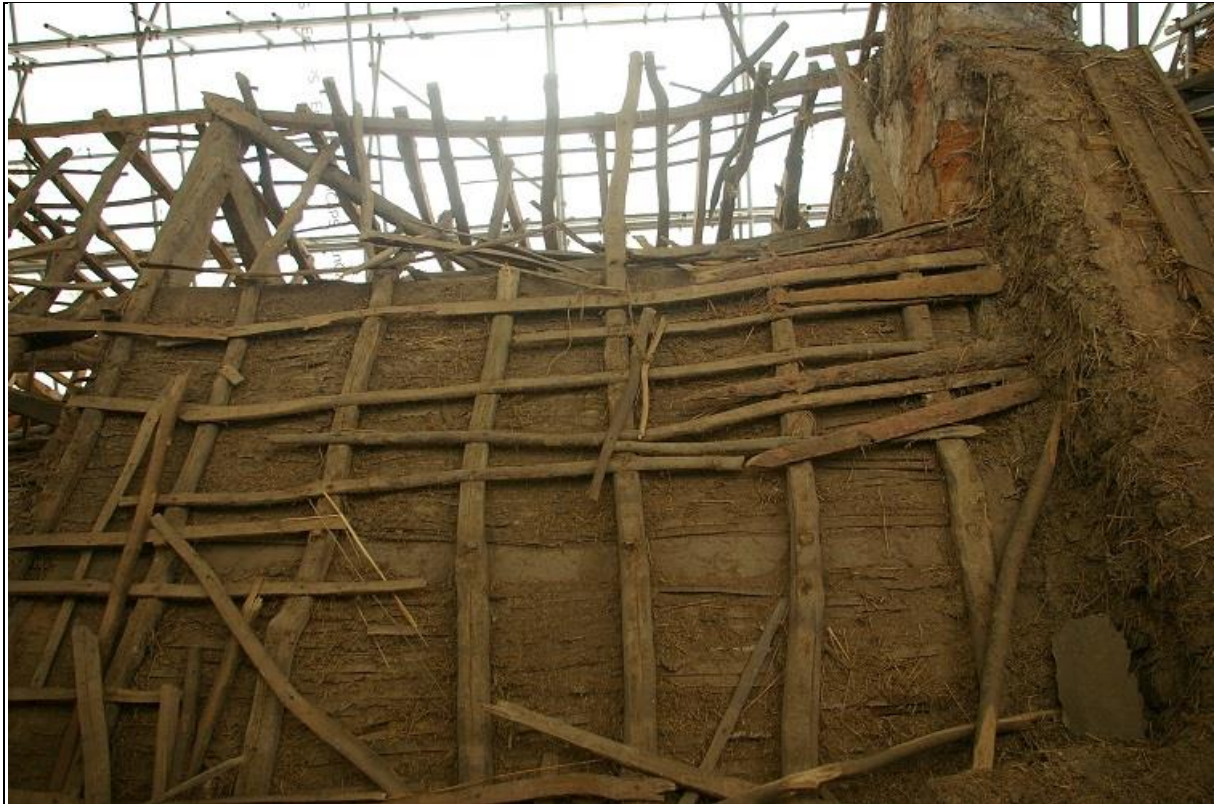
39. THE NORTH SIDE OF BAY 1 OF THE ROOF (AT THE WEST END); FROM THE NORTH.

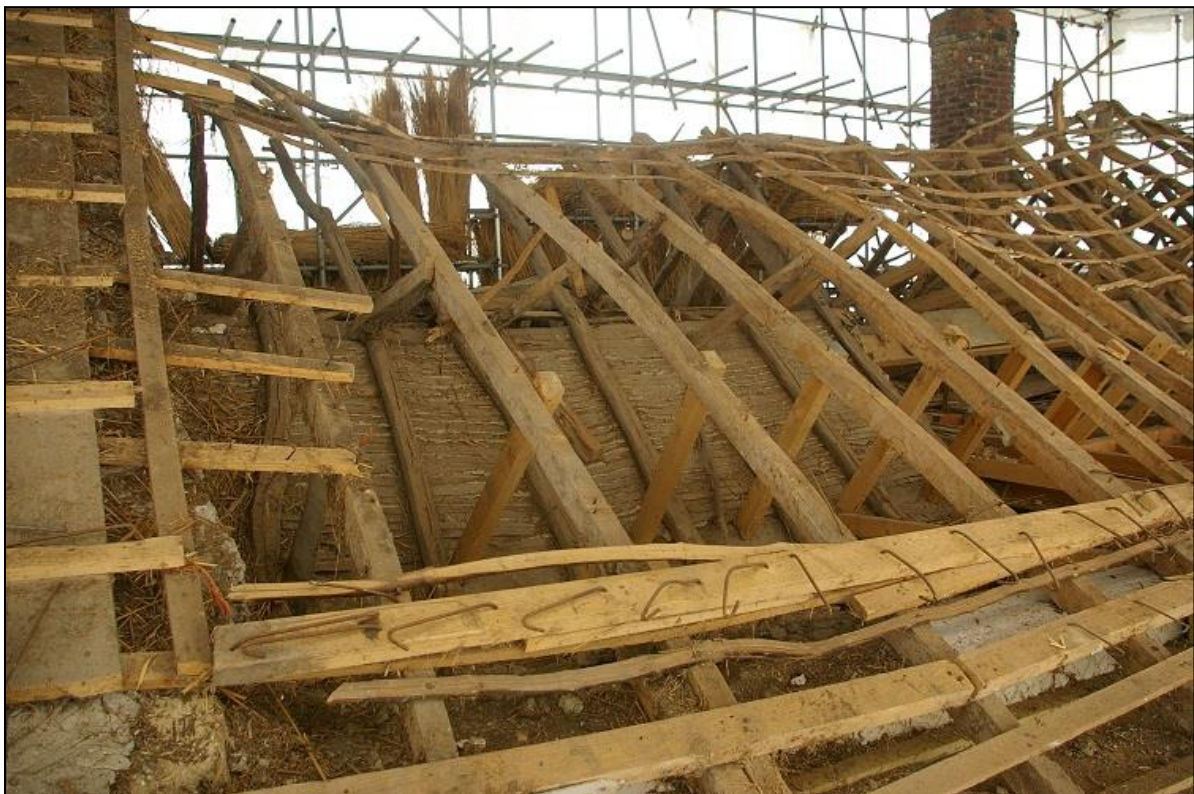
40. THE SOUTH SIDE OF BAY 1 (AT THE WEST END OF THE ROOF); FROM THE SOUTH-WEST.

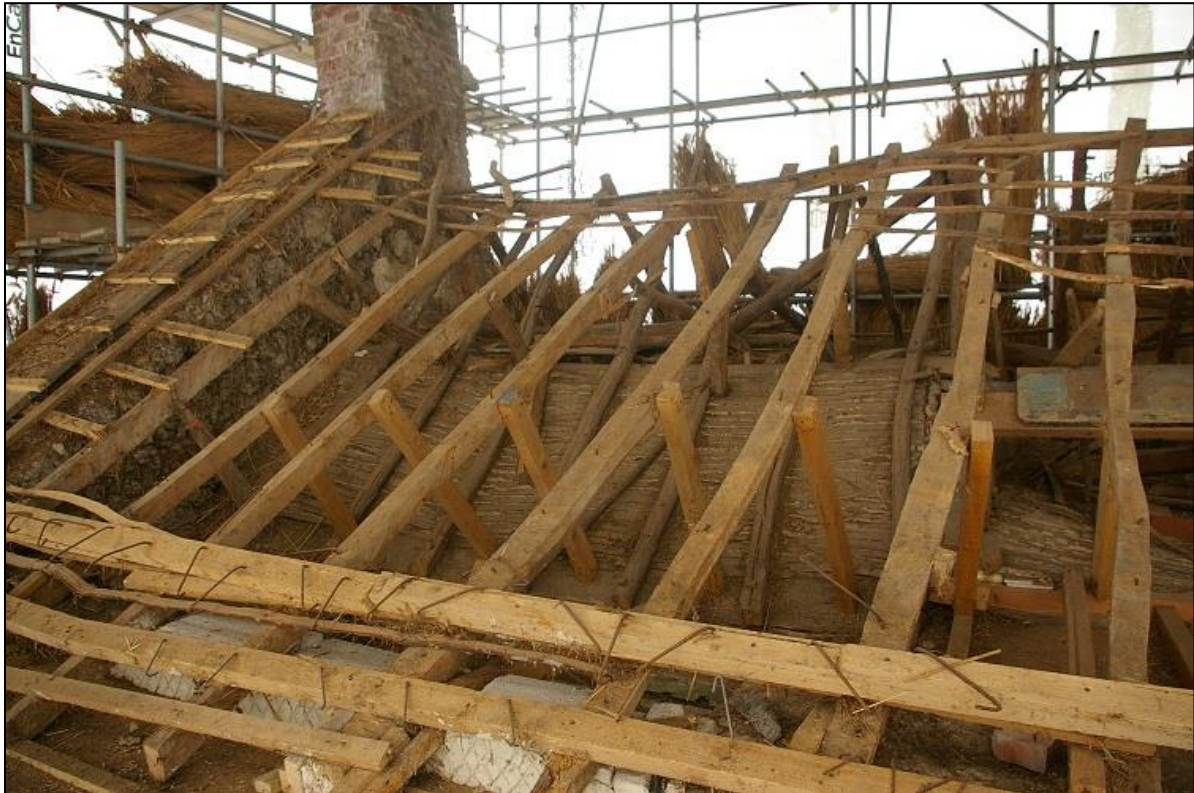
41. BAY 1 OF THE ROOF (FROM THE WEST END); FROM THE SOUTH-EAST.

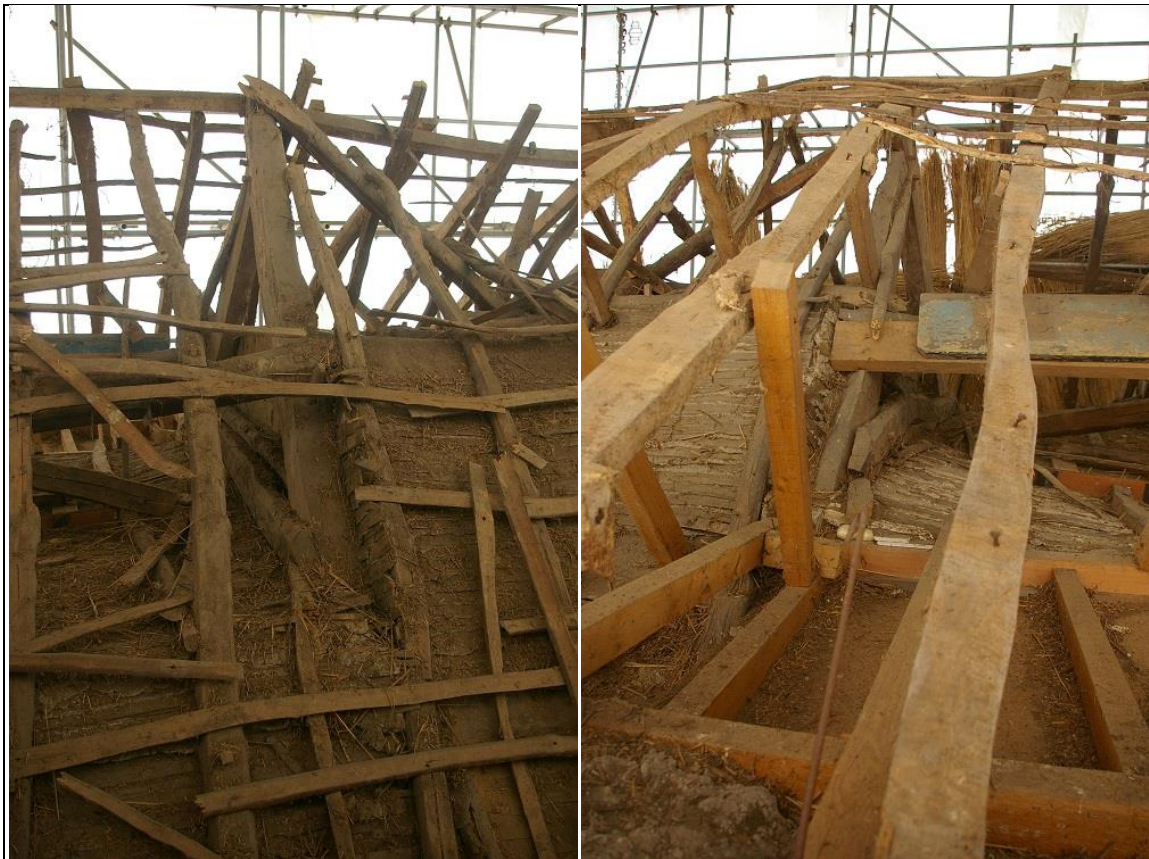
42. LEFT: TRUSS 1 FROM THE NORTH.

43. RIGHT: TRUSS 1 FROM THE SOUTH.

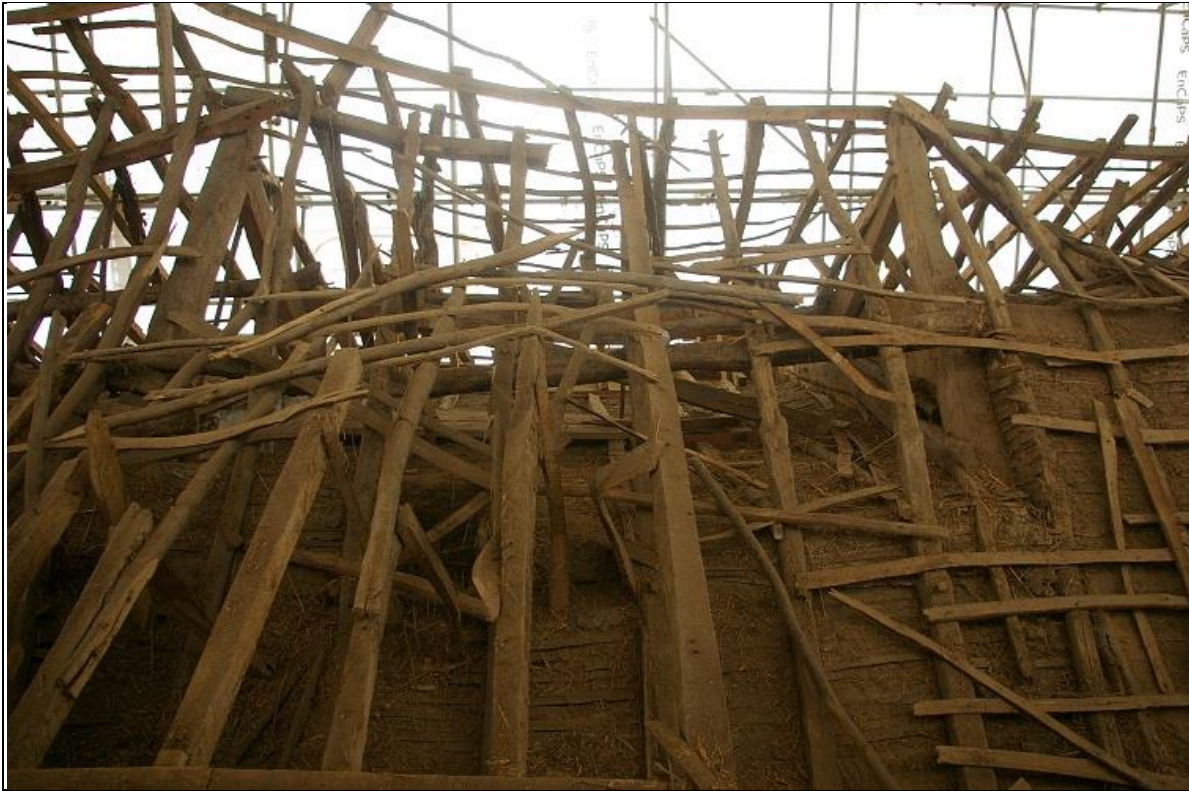
44. BAY 2 OF THE WESTACOMBE ROOF (IN THE CENTRE); FROM THE NORTH SIDE.

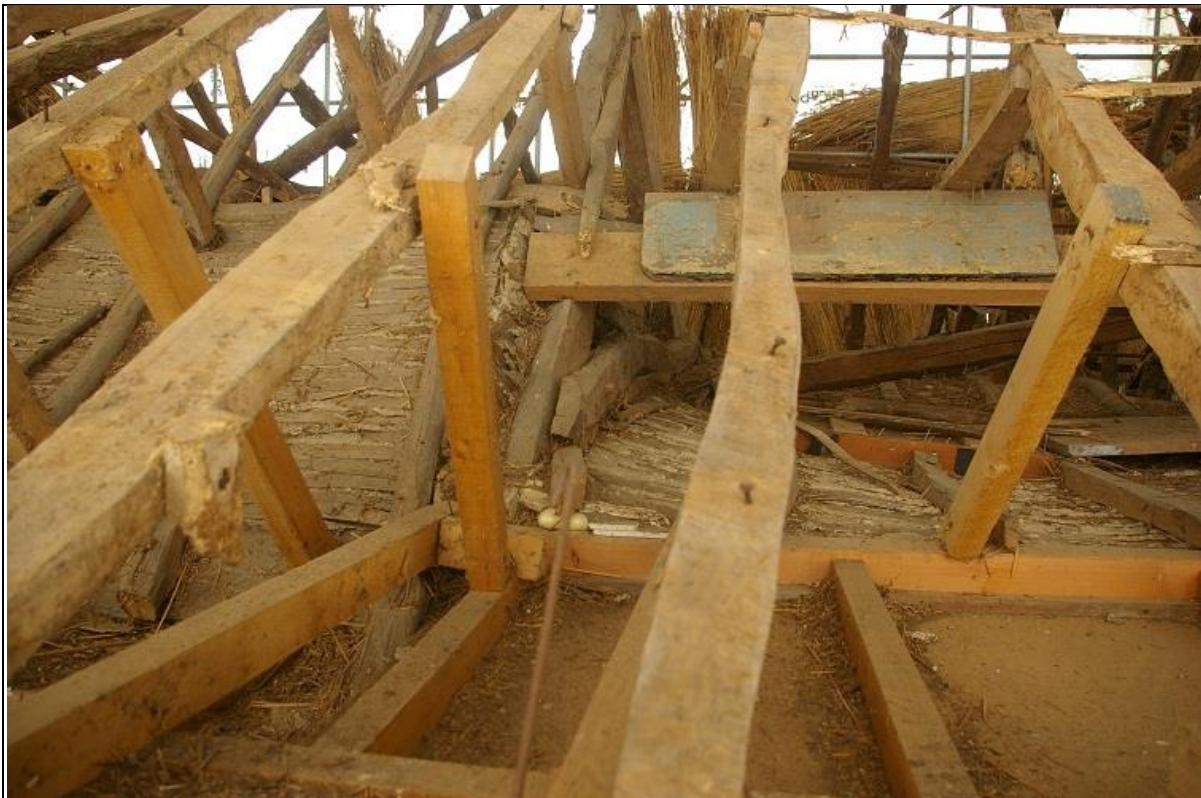
45. TRUSS 1, SHOWING IN DETAIL THE FACE PEGGED COLLARS AND DIFFERENCES IN HEIGHTS BETWEEN THE LATHE CEILINGS OF BAY 1 AND BAY 2: FROM THE SOUTH SIDE.

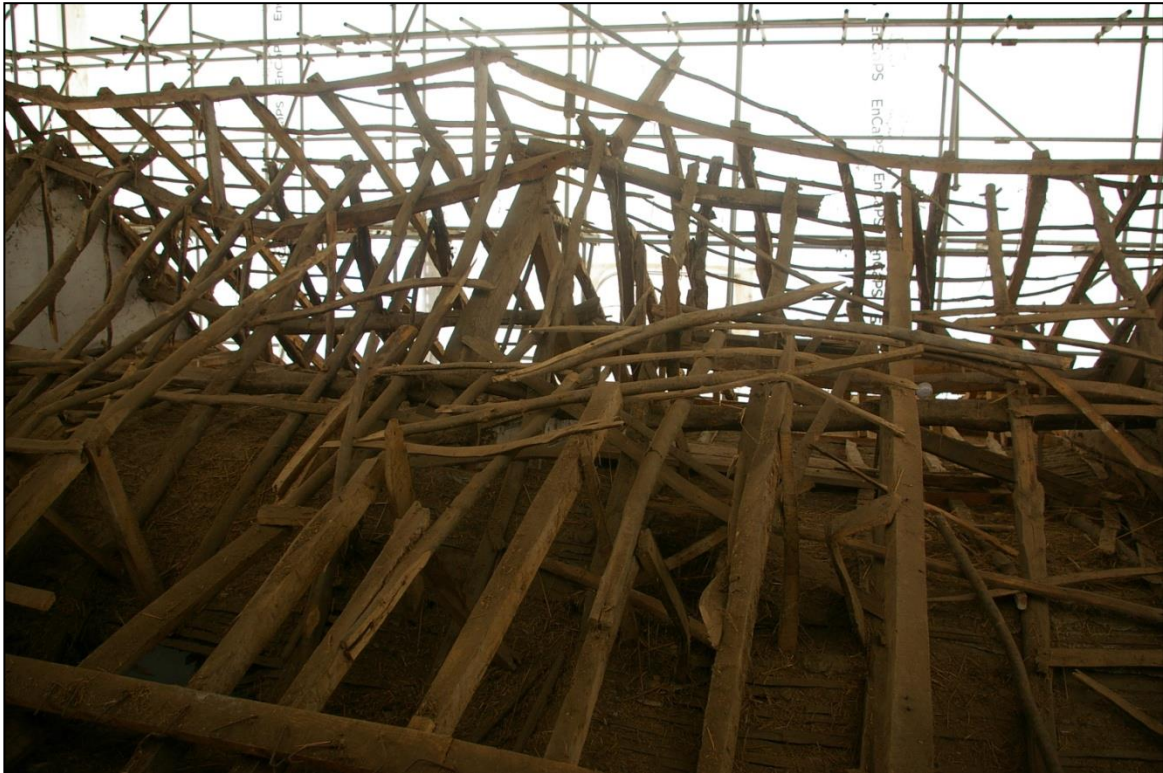
48. TRUSS 2 FROM THE NORTH SIDE OF THE ROOF; FORM THE NORTH-WEST.
