**WESTACOMBE COTTAGE  
HEANTON PUNCHARDON  
NORTH DEVON  
DEVON**

Historic Building Recording of the Roof

South West Archaeology Ltd. report no. 200623

By E. Wapshott  
Report Version: **FINAL**  
Assessment issued: 27<sup>th</sup> November 2019  
Reissued with Roof Recording: 23<sup>rd</sup> June 2020

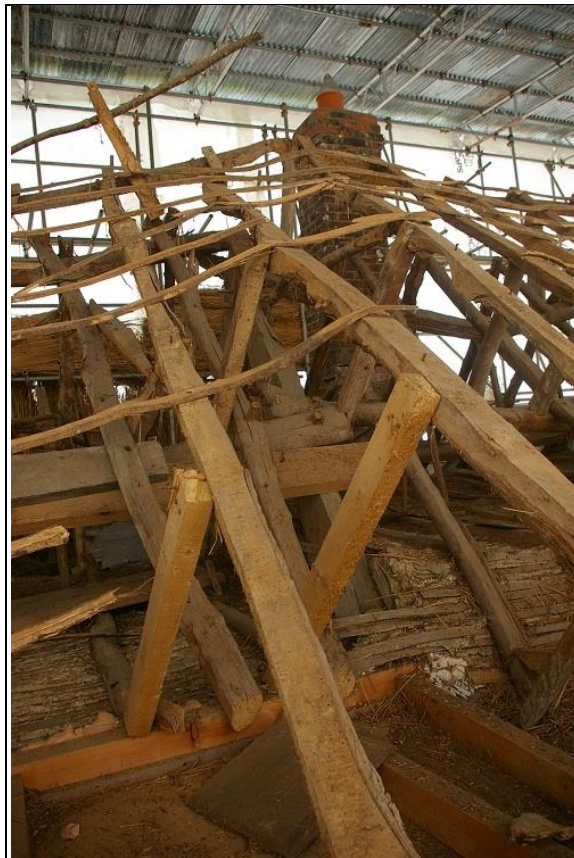
49. TRUSS 2, FROM THE SOUTH SIDE OF THE ROOF; FROM THE SOUTH-WEST.

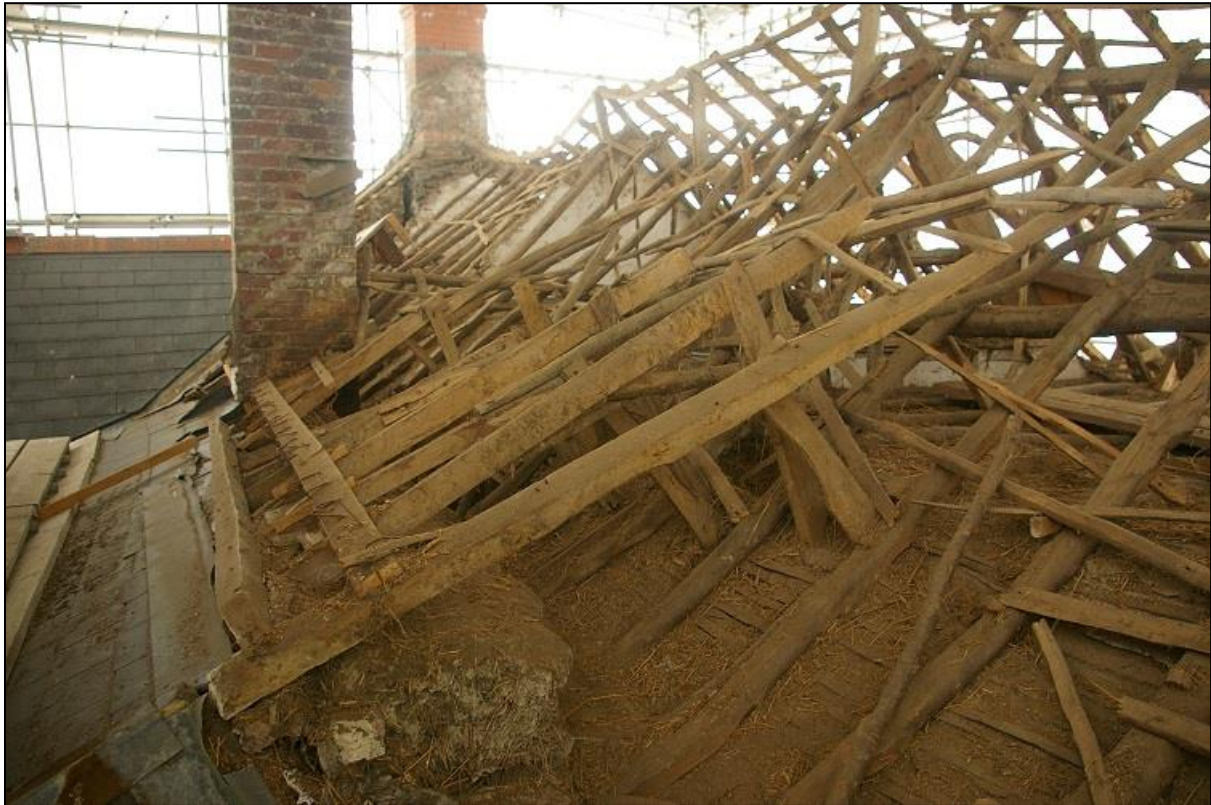
50. THE NORTH SIDE OF BAY 3, WITH THE REAR LATERAL STACK AND A SECTION OF SURVIVING LATER ROOF, PROJECTING OFF THE OLDER STICK RAFTERS; FROM THE WEST-NORTH-WEST.

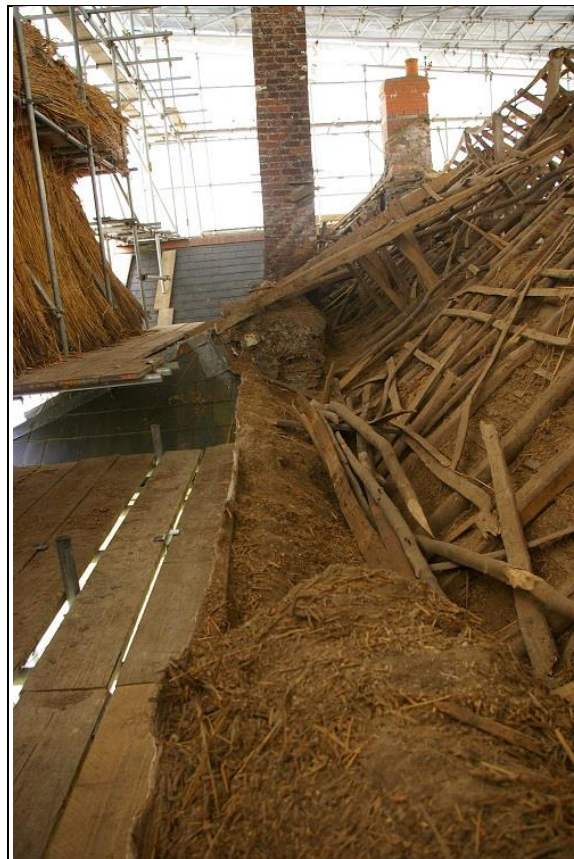
51. LOOKING ALONG THE NORTH SIDE OF THE ROOF, FROM THE WEST GABLE END, SHOWING THE PROFILE OF THE LATERAL STACK AND SMALL SURVIVING SECTION OF SECONDARY ROOF COVERING PROJECTING OVER THE RAISED COB WALL; FROM THE WEST.

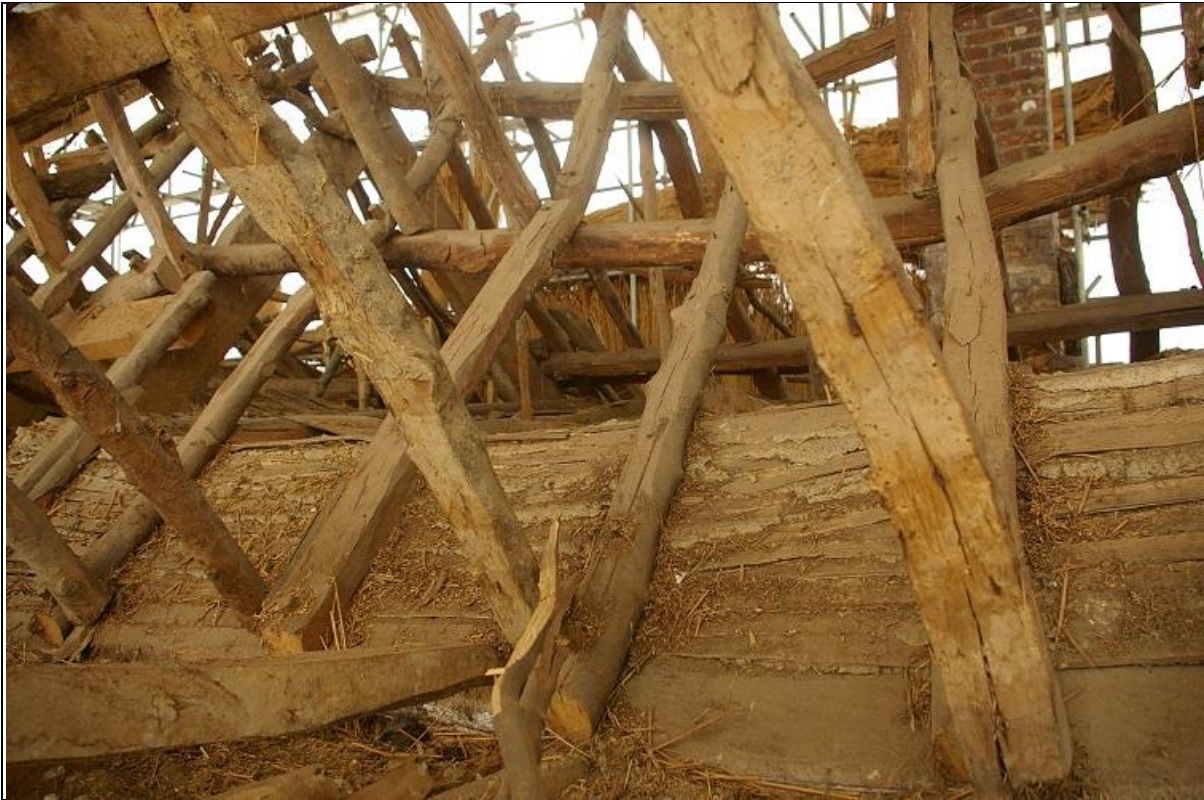
52. BAY 3, FROM THE SOUTH, PHOTO TAKEN FROM WITHIN THE ROOF, SHOWING THE STICK RAFTERS AND ROUGH PURLINS OF THE OLDER, INNER ROOF STRUCTURE; FROM THE SOUTH-EAST.

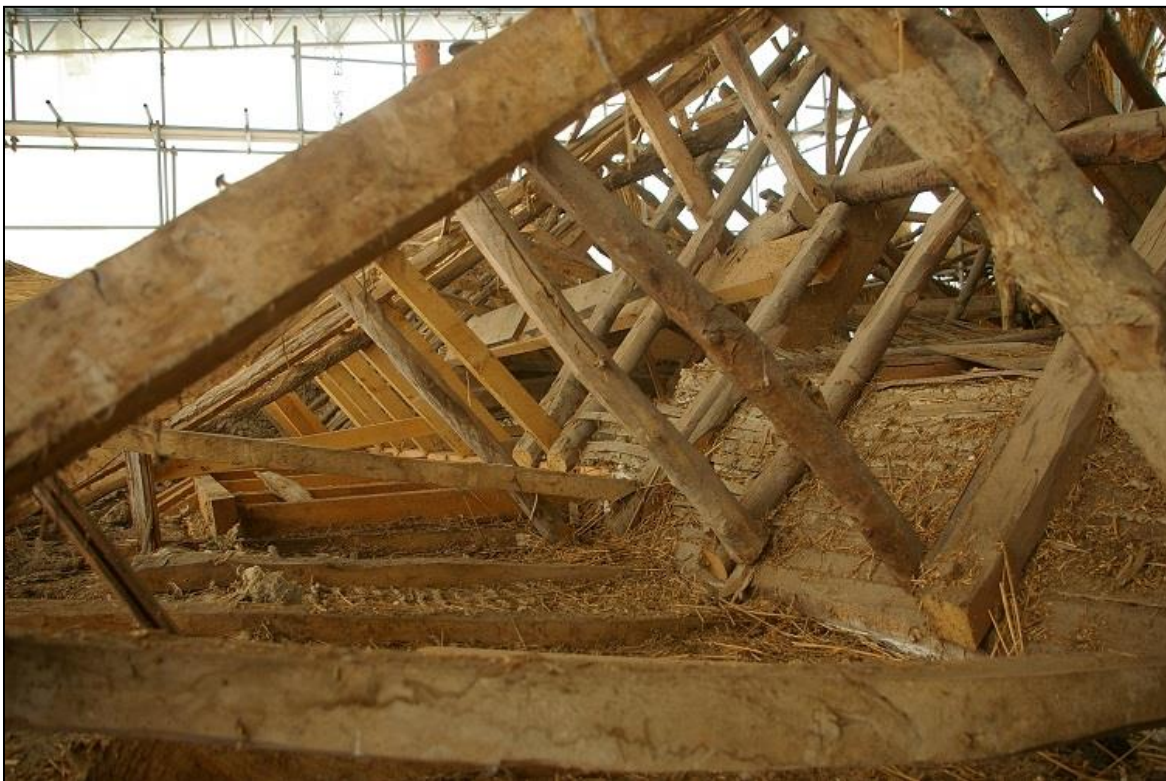
53. VIEW ALONG BAY 3-1 OF THE ROOF, FROM THE EAST END, SHOWING HOW THE LATER ROOF PROJECTS OUT TO THE RAISED FRONT WALL FROM THE OLDER ROOF LINE; FROM THE EAST-SOUTH-EAST.

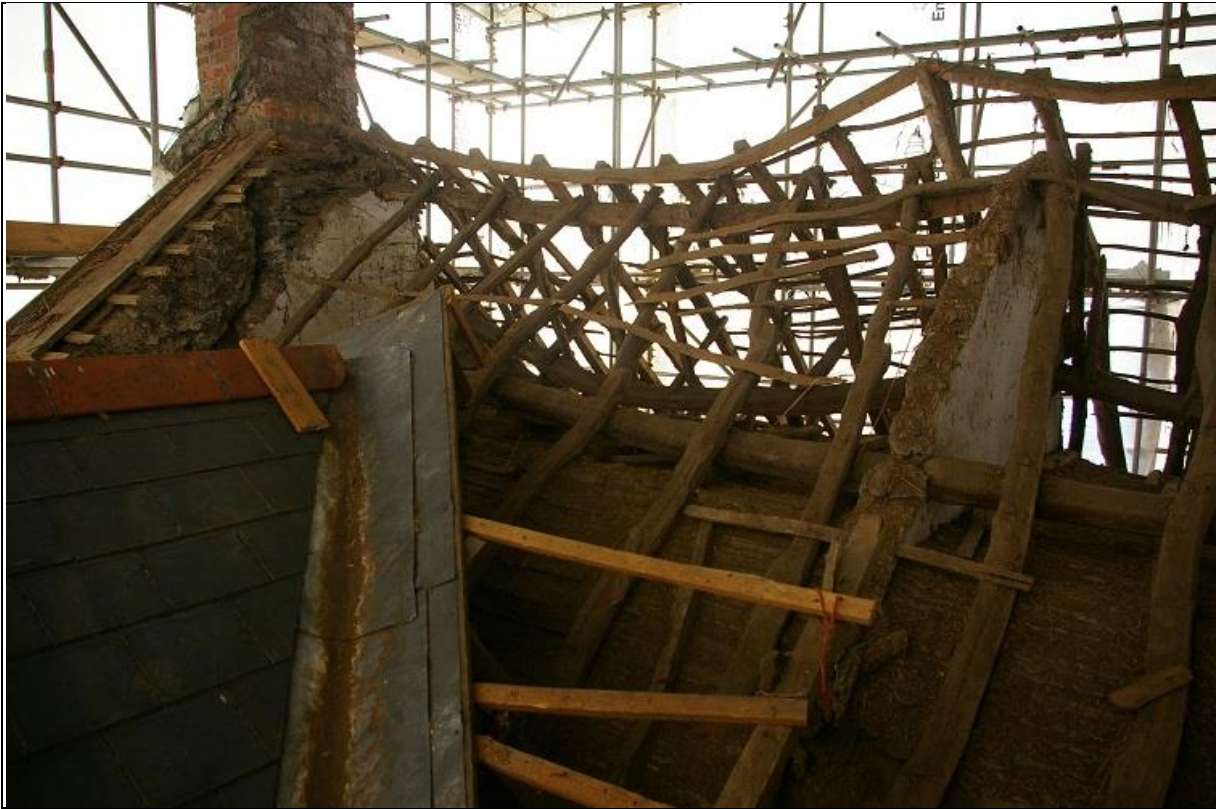
54. BAY 4 OF THE ROOF; FROM THE NORTH SIDE; FROM THE NORTH-WEST.

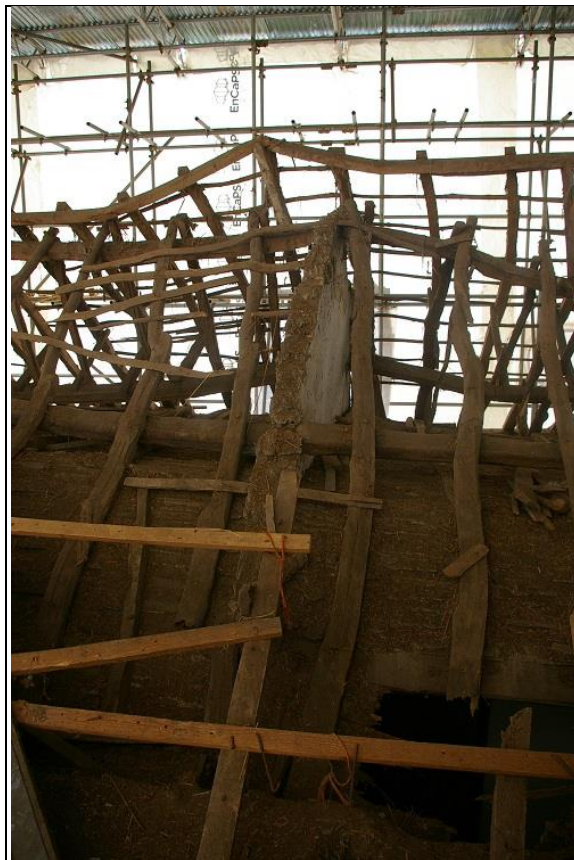
55. TRUSS 3 FROM THE NORTH, SHOWING IT PLASTERED OVER AND SEALED ON THE WEST FACE; FROM THE NORTH-NORTH-WEST.

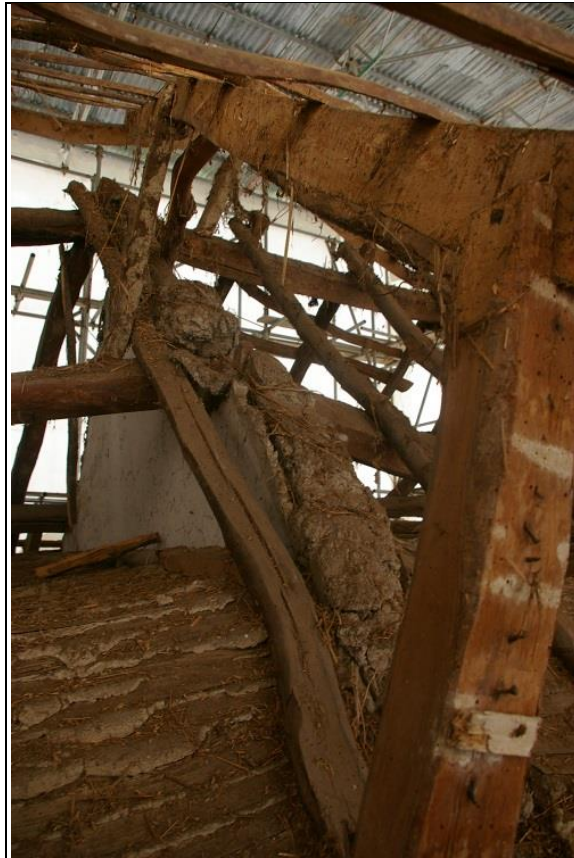
56. TRUSS 3; FROM THE SOUTH SIDE; FORM THE SOUTH-SOUTH-WEST SHOWING THE SEALED SIDE, COVERED BY LIME HAIR PLASTER, WITH COB BENEATH.

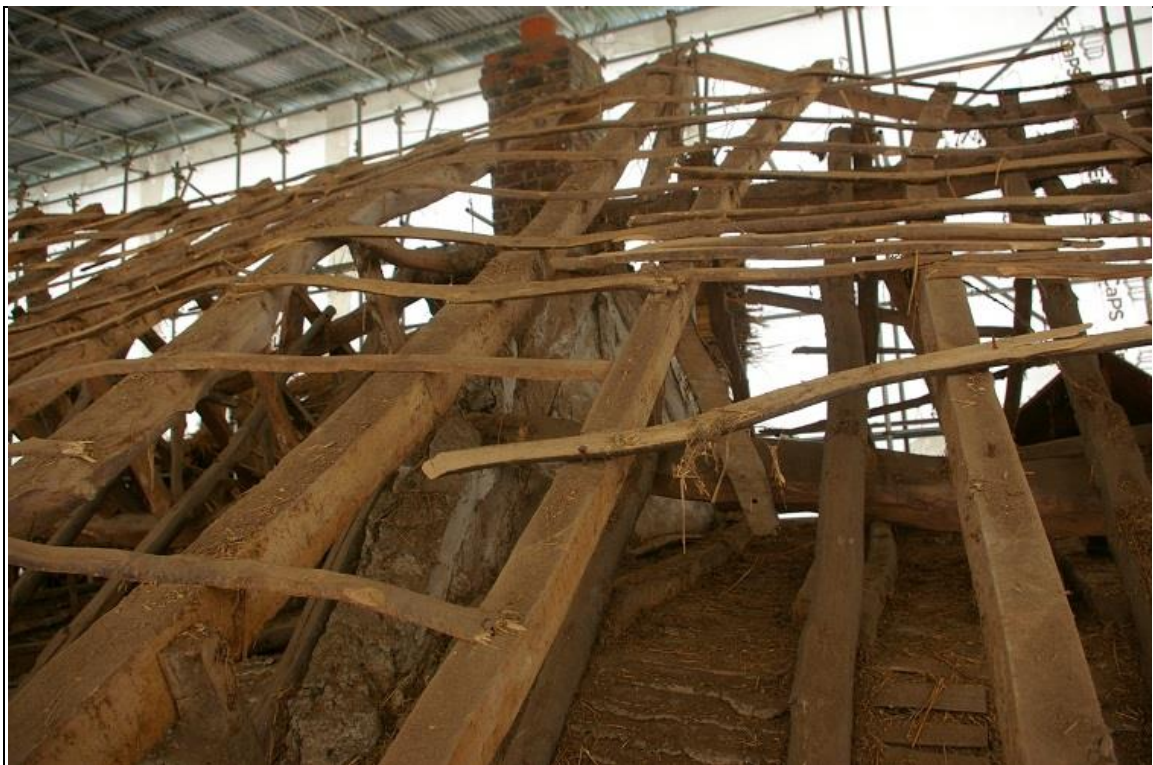
57. TRUSS 3 FROM SOUTH SIDE, THE EAST FACE; FORM THE SOUTH-SOUTH-EAST, SHOWING THE EXPOSED TIMBERS WHITEWASHED AND THE INFILL PARTITION SEALING THE APEX, SUPPORTED ON A KINGPOST CENTRAL POST/BRACE.

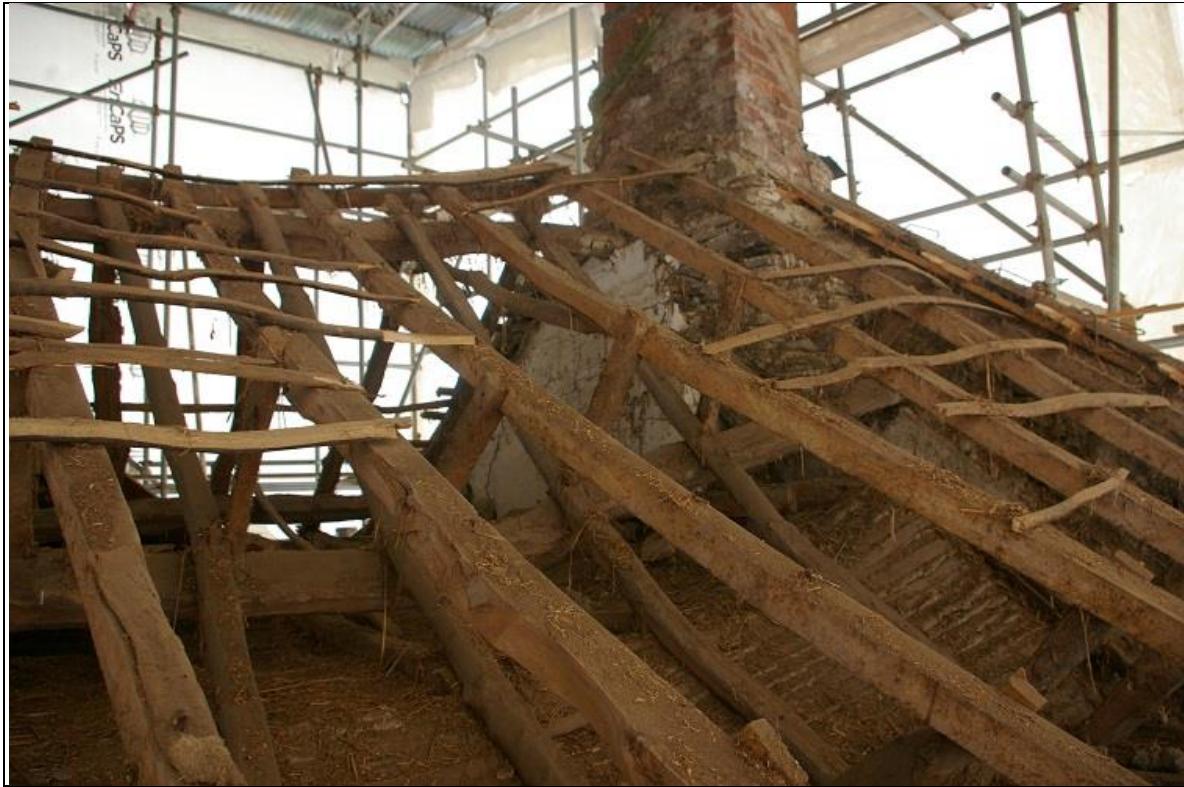
58. THE EAST GABLE STACK ADDED TO THE BUILDING RANGE, WITH PLASTERED APEX OF ORIGINAL TRUSS SURVIVING WITHIN THE BAY; FROM THE SOUTH SIDE OF THE ROOF; FORM THE SOUTH-WEST.

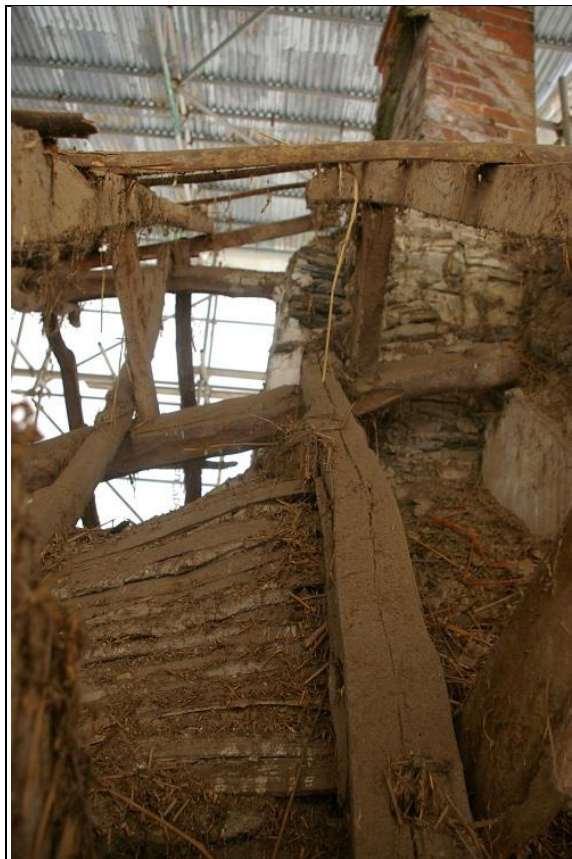
59. THE SOUTHERN TRUSS BLADE PROJECTING OVER A POSSIBLE FORMER WINDER STAIR AND ORIGINAL STONE GABLE OF THE BUILDING, ABUTTED ON ITS EAST SIDE BY THE ADDITION OF THE GABLE END STACK; FROM THE SOUTH.
