# BATSON HALL FARM

Updated - Historic Building Assessment

South West Archaeology Ltd. report no. 200224

## Batson Hall Farm, Batson, Salcombe, Devon Updated - Historic Building Assessment

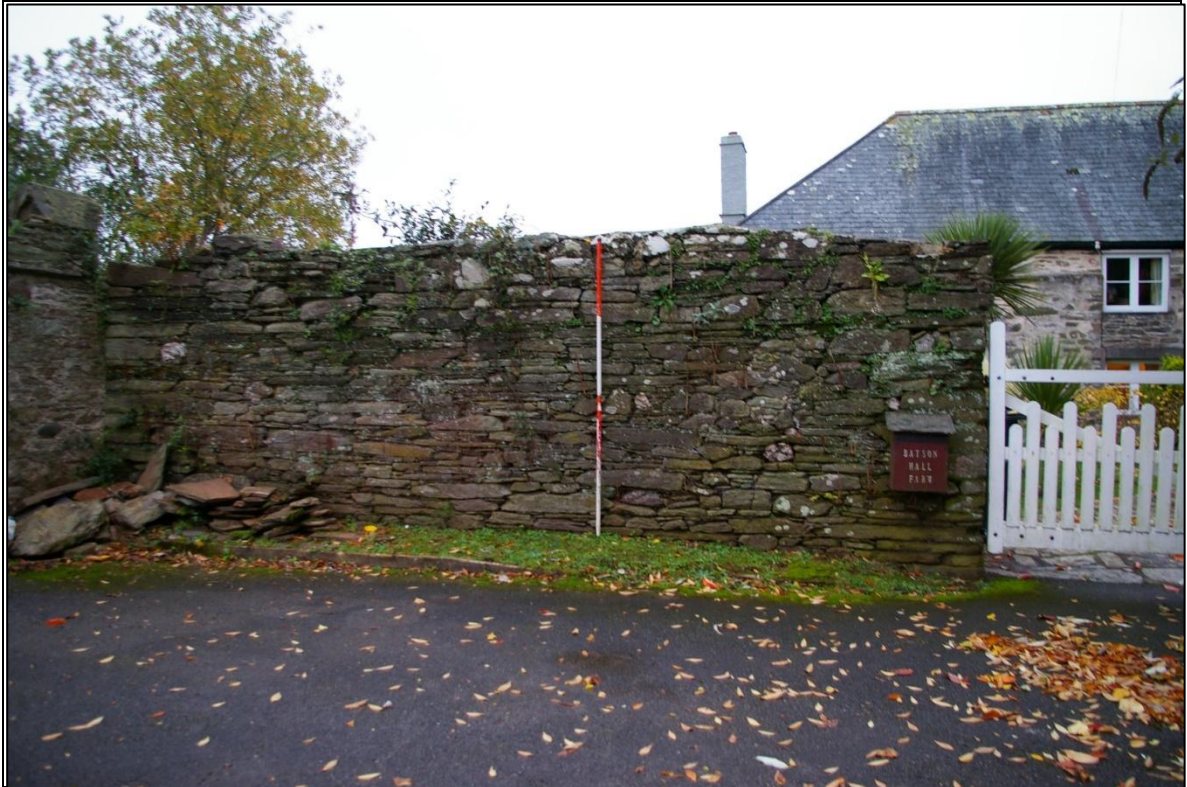
FIGURE 12: THE FRONT GARDEN WALL THE FORMER GABLE END OF A MEDIEVAL BUILDING, 2M SCALE, AUTUMN 2010; FROM THE NORTH-NORTH-WEST.

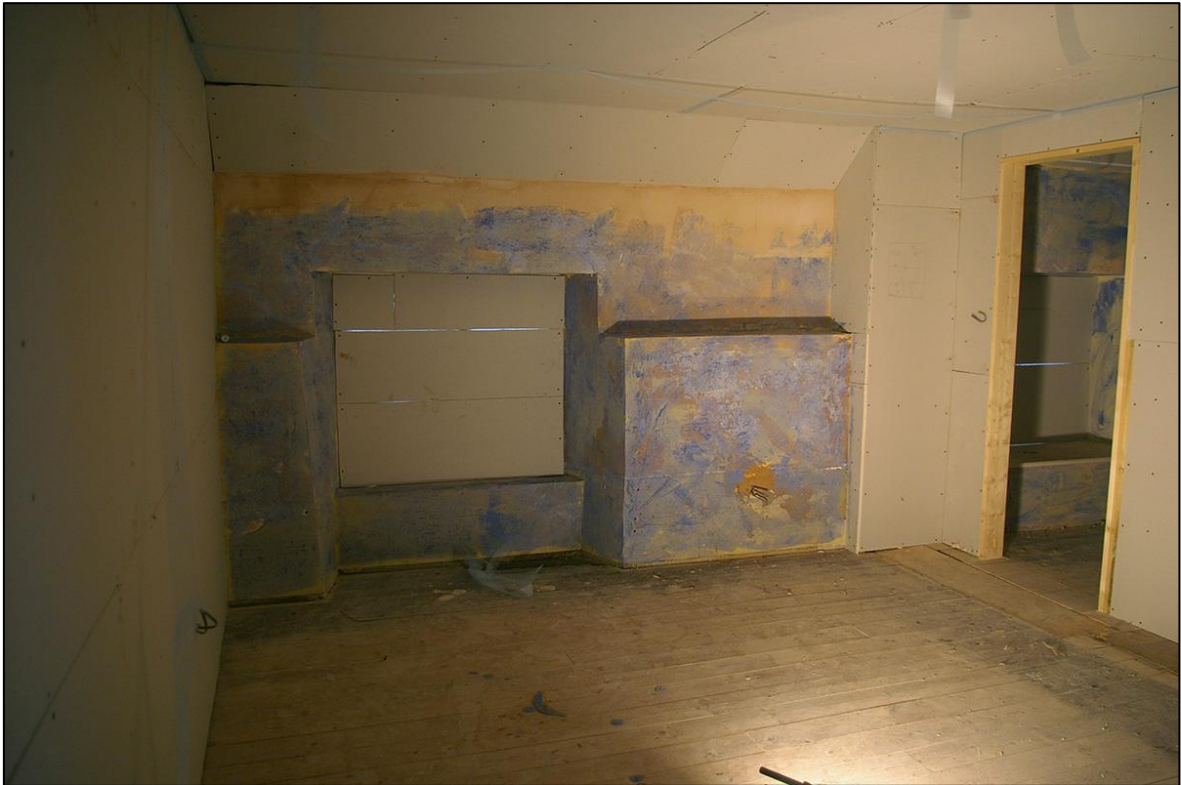
Room 8 also lies to the north of the corridor, east of the bathroom. Both the south and west walls have been heavily repaired or replaced with new plasterboard partitions, the thicker east partition, refaced with newer sections of plasterboard. A small space has been formed via new partitions in the north-east corner. The north wall, as to the south rises to 0.5-0.7m below the eaves here and is a thicker tapering wall, being the medieval remains. There is a wide boxed in area to the north-east corner, where the wall drops back and once again stands at full two storeys height. The floor here is wholly modern narrow floorboards, pine, of c1970s or 1980s date. The window in the north wall can be seen to be infilled below, with wide shallow sloping embrasures to the opening. The window to the east in the narrower taller section of wall merely has a modern plank sill and straight sides. The eaves here are lower than to the east.

FIGURE 18: BEDROOM 2, ROOM 8, SHOWING THE MEDIEVAL WALL FRAGMENT SURVIVING TO THE NORTH WALL; FROM THE SOUTH-WEST.

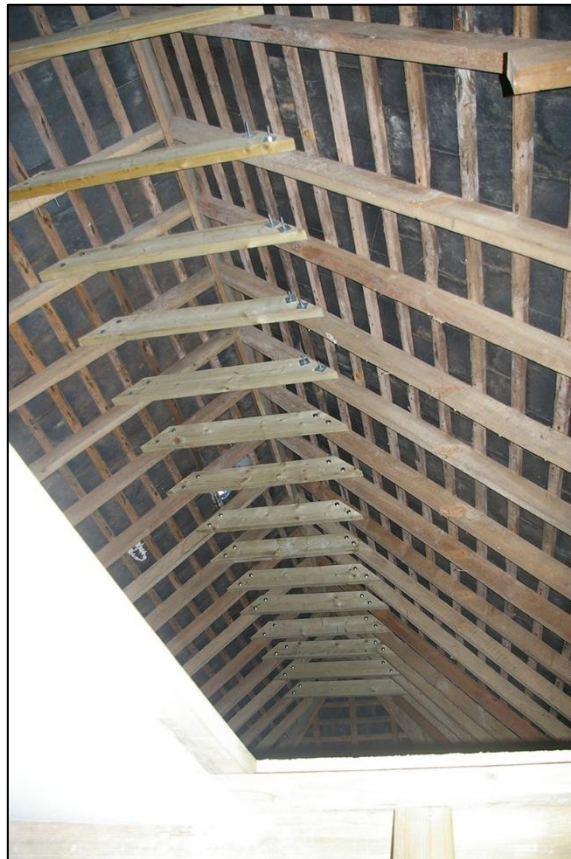
All the ceilings have been repaired with new plasterboard as they had been reputedly damaged and partially collapsed from water ingress. The ceiling joists are relatively modern, c1970s or 1980s. The roof itself has no felting or waterproofing below the slates, being of late 20<sup>th</sup> century common rafter form. The client has braced the upper ridge with new bolted collars for support. There is evidence of water damage, with damp patches and wood mould visible on some of the rafters.

FIGURE 19: VIEW UP INTO THE ROOF SPACE, OVER BATSON HALL FARMHOUSE, SHOWING C.1970S COMMON RAFTER LIGHTWEIGHT ROOF AND NEW BOLTED COLLARS FOR SUPPORT; FROM THE WEST-SOUTH-WEST.

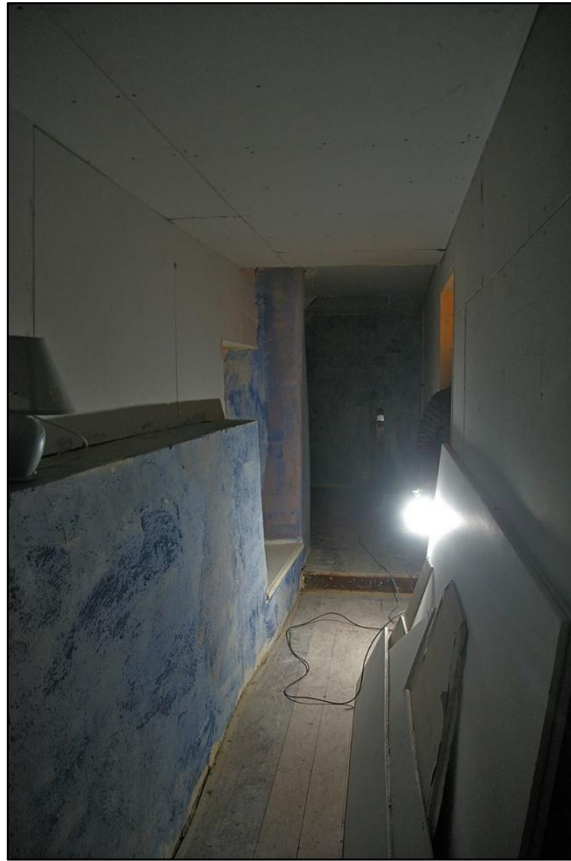
FIGURE 20: VIEW ALONG THE SOUTH CORRIDOR, SHOWING THE MEDIEVAL WALL REMAINS IN THE FOREGROUND, THE TALLER HEAVY BLOCK OF ANGLED MASONRY, WITH CURVING INNER PROFILE IN THE BACKGROUND TO THE PROJECTING BAY; FROM THE EAST.

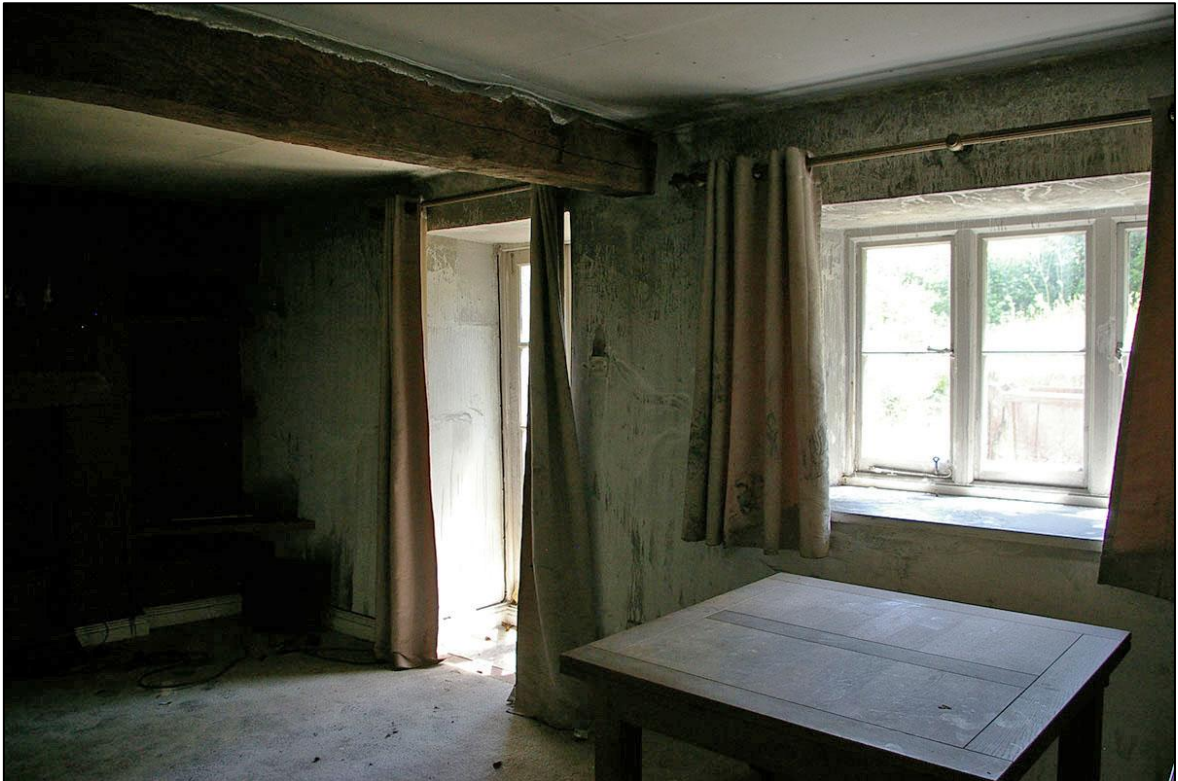
FIGURE 24: THE SITTING ROOM IN THE COTTAGE (CR3), WITH GOOD 19TH CENTURY THREE LIGHT WINDOW; FROM THE NORTH-WEST.

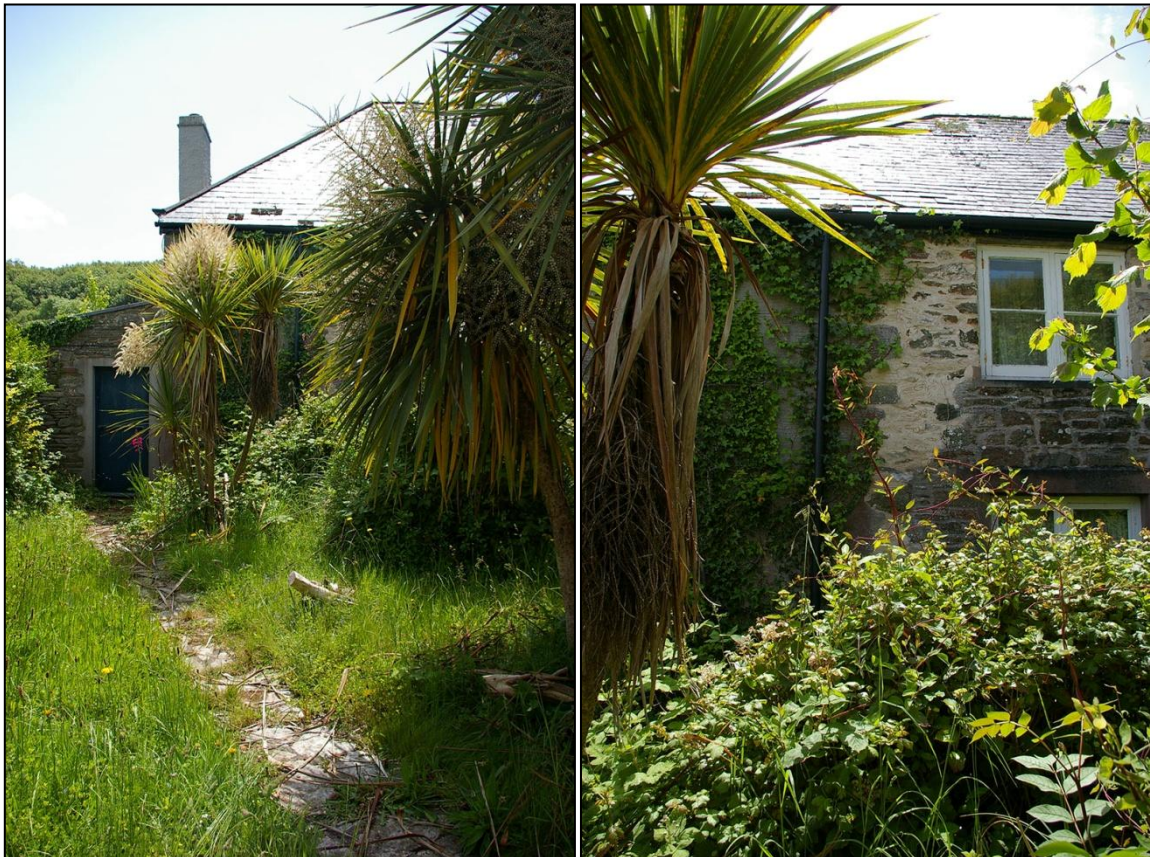
LEFT: THE LEAN-TO WITH AN OLD SECTION OF WALLING WHICH THE CONSERVATORY ABUTS FROM THE SOUTH SIDE; FROM THE NORTH, NORTH-WEST.

RIGHT: THE RENDERED NORTH-EAST CORNER OF BATSON HALL FARM AND THE BADLY REPOINTED STONEMWORK WHICH PARTLY OBSCURES A SET OF QUOINS, AT LEAST 1M INTO THE NORTH ELEVATION; FROM THE NORTH.

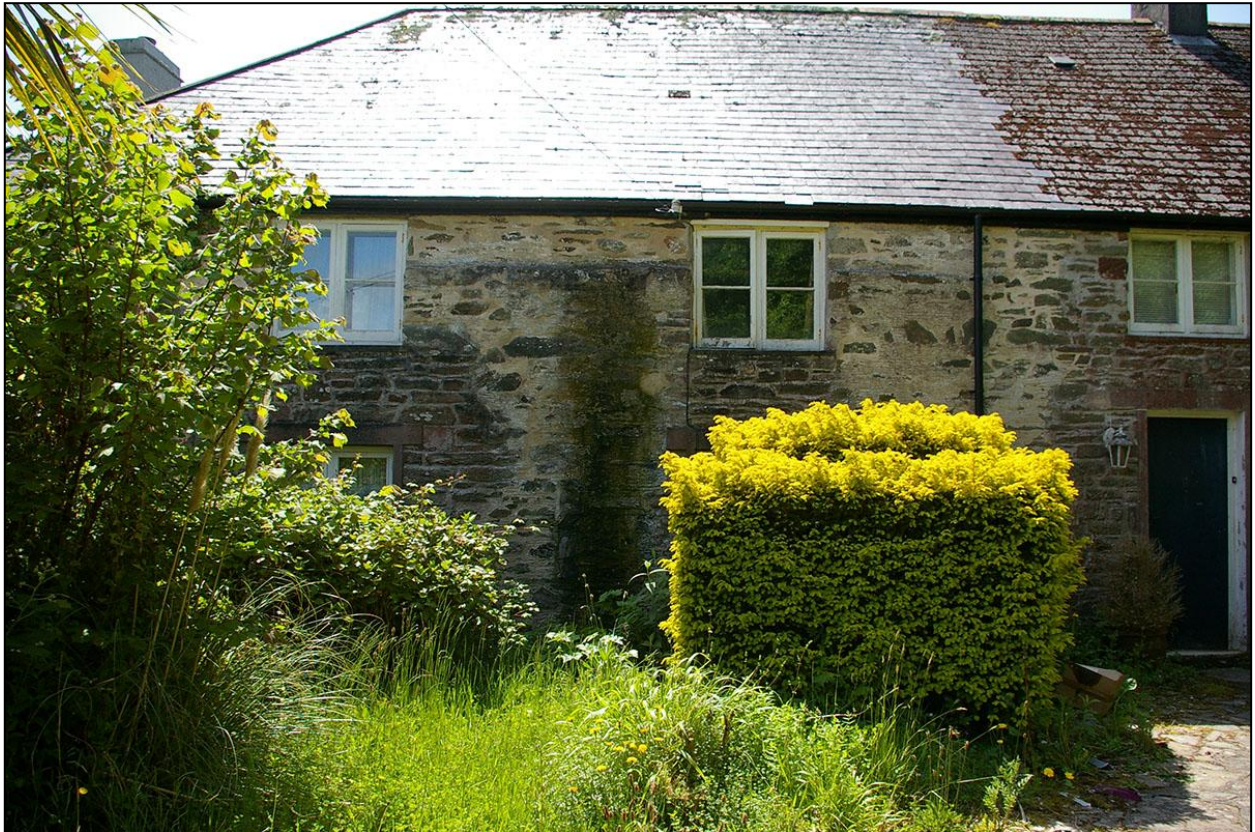
DETAILED VIEW OF THE THICKER LOWER SECTION OF WALLING WHICH DOMINATES THE NORTH FRONT OF THE FARMHOUSE, AT THE EAST END, THE REMAINS OF A RUINED EARLIER BUILDING; FROM THE NORTH.

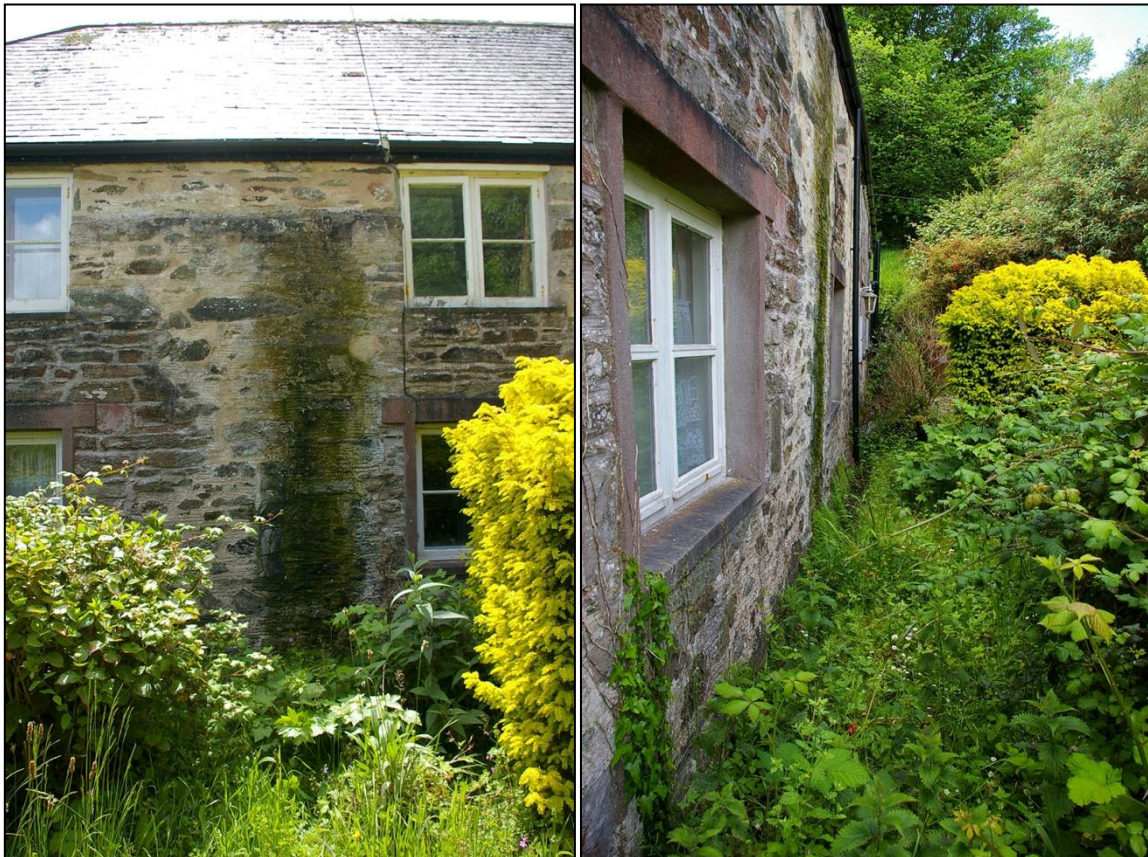
LEFT: DETAIL WITHIN THE RUINED WALL INCORPORATED INTO THE BUILDING SHOWING A POTENTIAL SET OF RAGGED LARGE SLAB QUOINS AND ALSO A POTENTIAL BLOCKED OPENING AT GROUND FLOOR; FROM THE NORTH.

RIGHT: VIEW ALONG THE FRONT OF THE BUILDING, SHOWING HOW THE RUINED SECTION OF WALL IS ANGLING OUTWARDS QUITE CONSIDERABLY AND HOW THE ALIGNMENT OF THE RANGE CHANGES; FROM THE EAST.

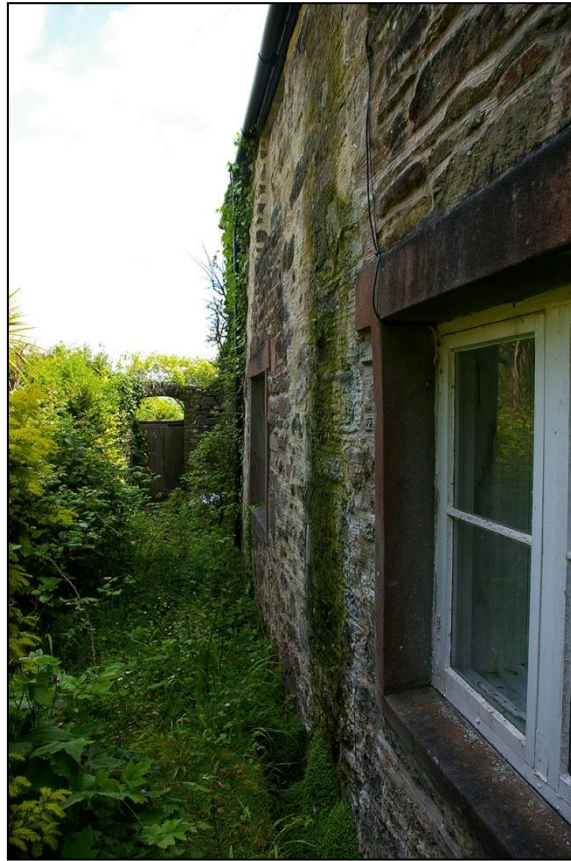
VIEW BACK ALONG THE INCORPORATED RUINED EARLIER BUILDING SHOWING THE SLIGHT BATTER TO THE WALL AND HOW THE WINDOWS AND RAISED EAVES ARE INSET BEHIND THE EARLIER WALLING, FORMING A LEDGE; FROM THE WEST.

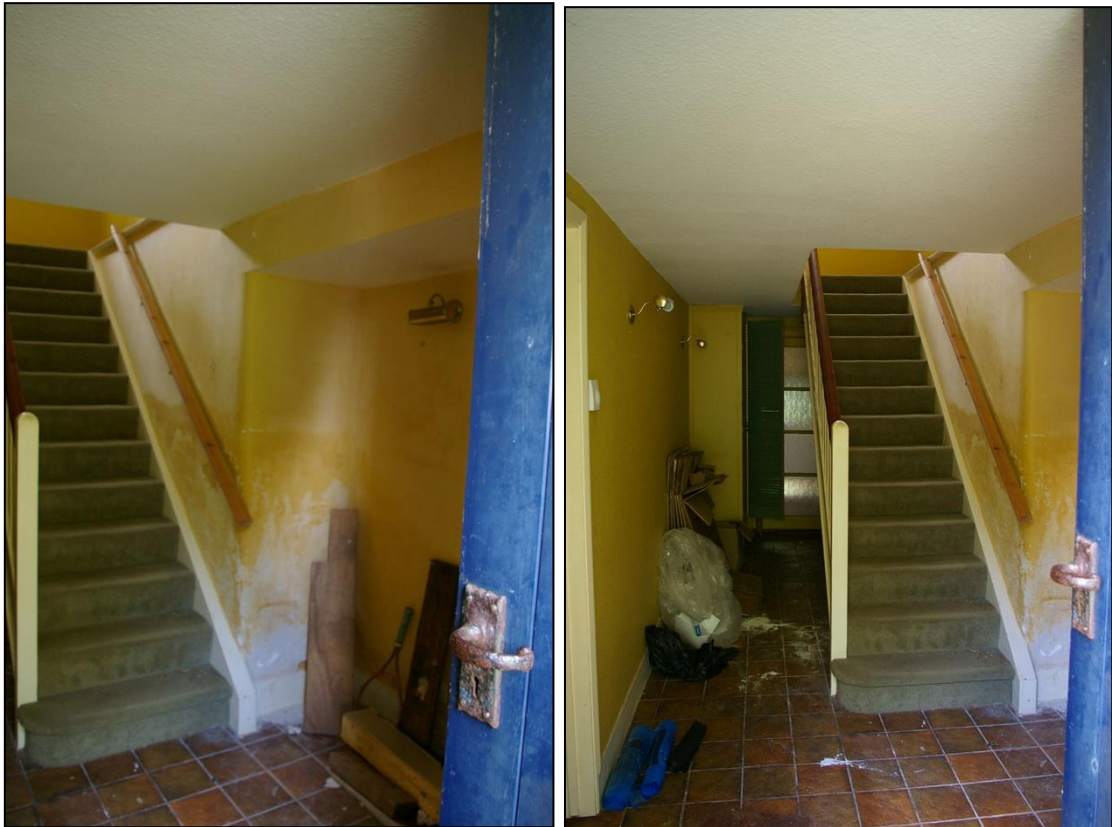
LEFT: INTO THE ENTRANCE HALLWAY AND STAIRS, ROOM 1, SHOWING HOW THIS DOOR HAS BEEN FORCED UP AGAINST THE PARTY WALL TO THE COTTAGE, WHICH HAS A LARGE BLOCKED DOORWAY WITHIN IT; FROM THE NORTH-EAST.

RIGHT: THE HALLWAY, ROOM 1, ENTRANCE AND STAIRS, QUARRY TILED FLOOR, MODERN PARTITIONS DIVIDING THE SPACE AND PLASTER BOARDED CEILING AND MODERN GLAZED DOORS; FROM THE NORTH.

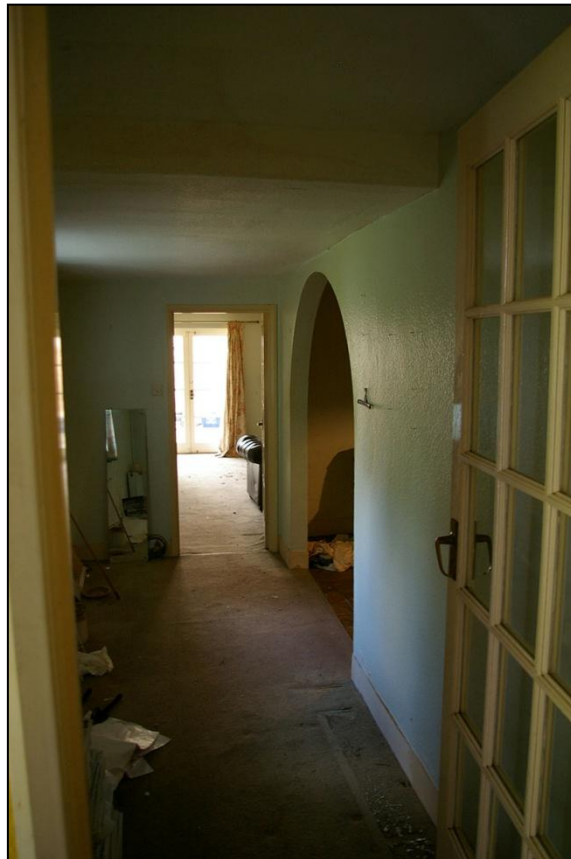
VIEW FROM THE HALLWAY INTO THE LOBBY/CORRIDOR CREATED BY ANOTHER MODERN PARTITION AND ARCHWAY, FORMING A FITTED KITCHEN, ALSO SHOWING FURTHER MODERN GLAZED DOORS AND MODERN FITTINGS; FROM THE WEST.

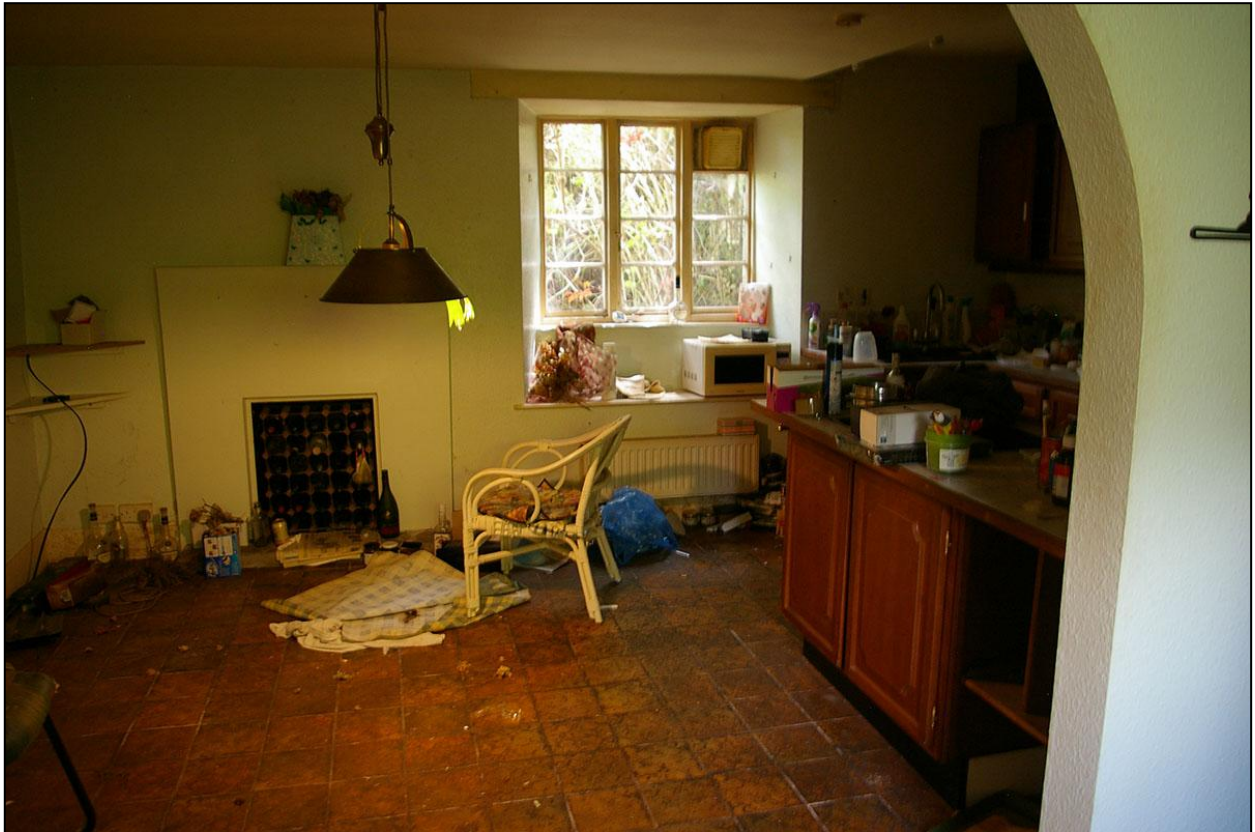
THE FITTED KITCHEN, WITH THE THREE LIGHT 19<sup>TH</sup> CENTURY CASEMENT AND WINDOW SEAT, BLOCKED FIREPLACE ON THE REAR WALL, MODERN QUARRY TILED FLOOR, BOARDED OUT CEILING WHICH OBSCURES A CHANGE IN CEILING HEIGHT; FROM THE NORTH, NORTH-EAST.

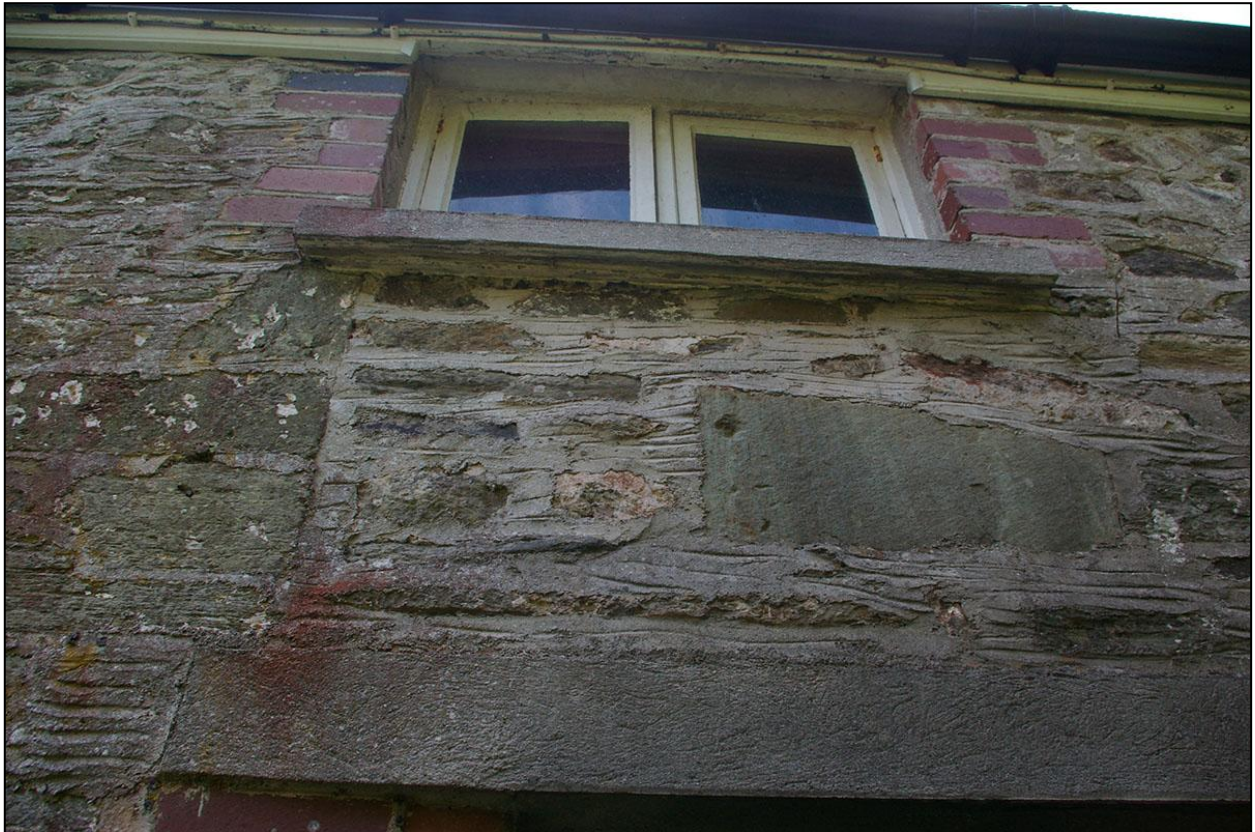
THE SMALL BLOCKED WINDOW WITH BRICK REVEALS SET INTO A LARGER OPENING, A LOADING DOOR ABOVE THE FORCED DOORWAY TO THE FRONT OF THE ATTACHED COTTAGE; FROM BELOW (NORTH-EAST).

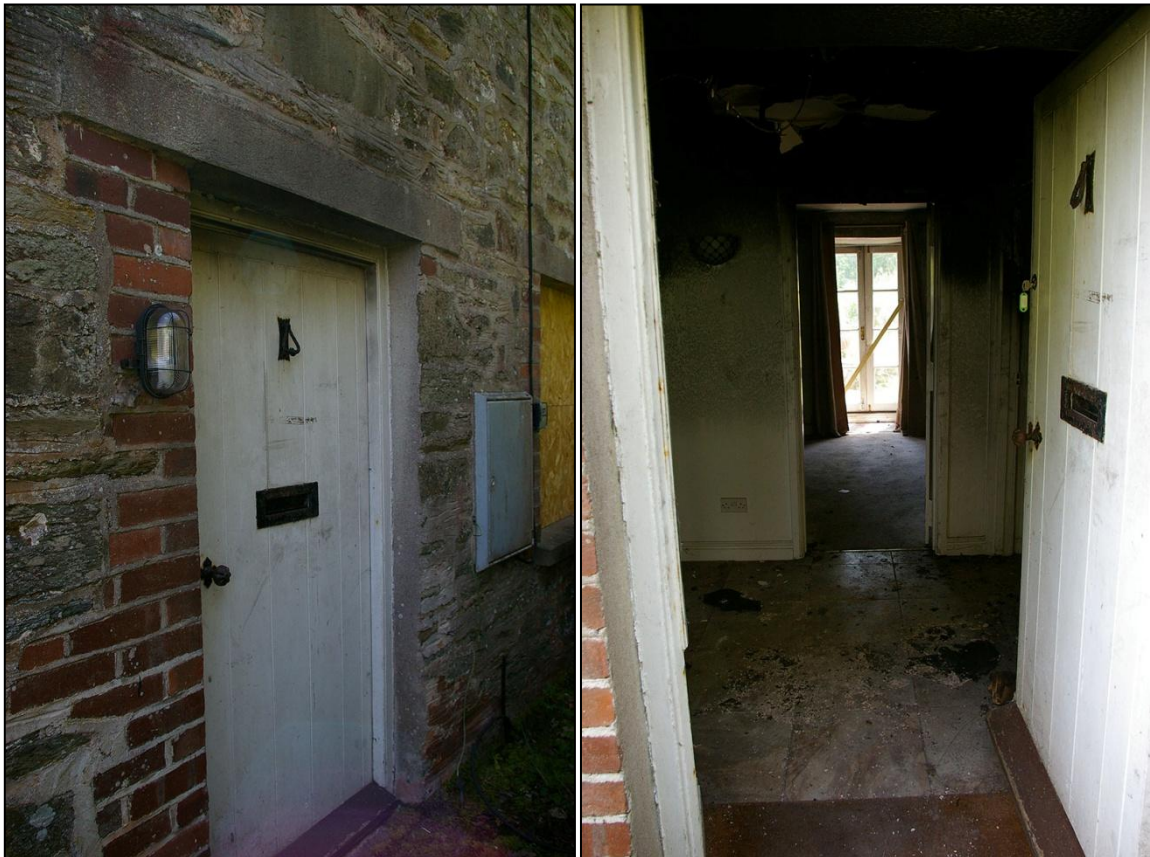
LEFT: THE FRONT DOOR TO THE COTTAGE, BRICK PATCHED REVEALS TO THE EAST, CONCRETE RENDER PATCHING TO THE WEST AND RENDERED LINTEL; FROM THE NORTH-EAST.

RIGHT: VIEW THROUGH THE FRONT DOOR, INTO THE HALLWAY OF THE COTTAGE CR1 AND THROUGH TO THE SITTING ROOM CR3; FROM THE NORTH.

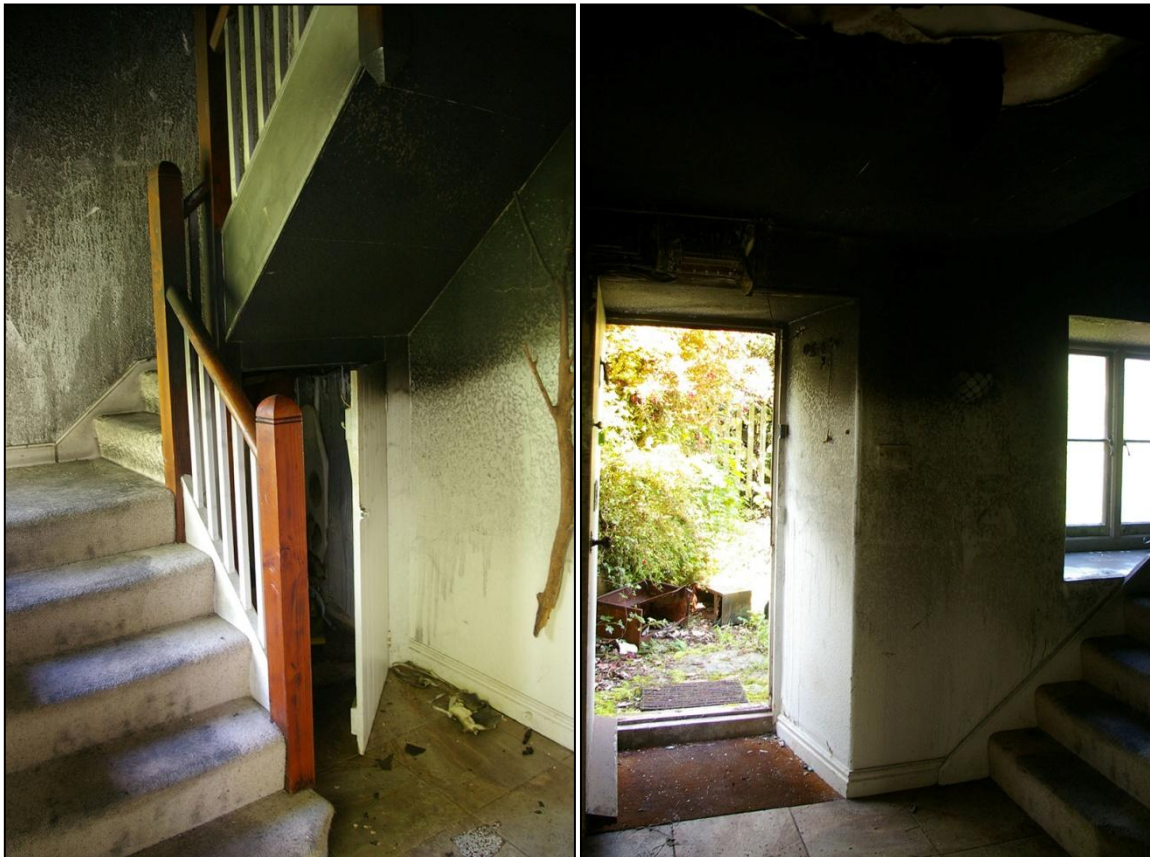
LEFT: VIEW OF THE LATE 20<sup>TH</sup> CENTURY TIMBER STAIRCASE, HEAVILY SMOKE BLACKENED; FROM THE NORTH-WEST.

RIGHT: VIEW OF THE FORCED DOORWAY FROM THE INTERIOR OF CR1, SHOWING THE THICKNESS OF THE WALL HERE; FROM THE SOUTH, SOUTH-WEST.

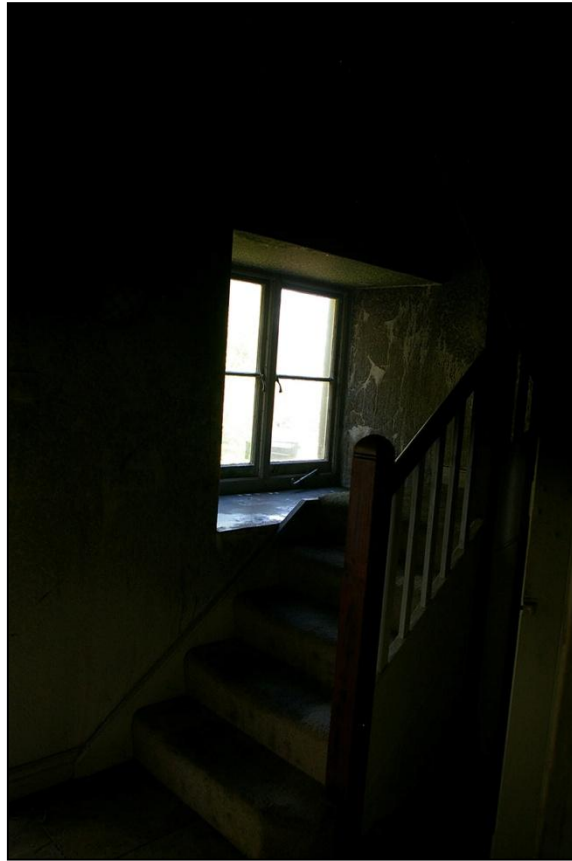
VIEW OF HOW THE STAIRCASE, MODERN CUTS THE HISTORIC WINDOW IN THE FRONT WALL OF THE COTTAGE IN CR1; FROM THE SOUTH-WEST.

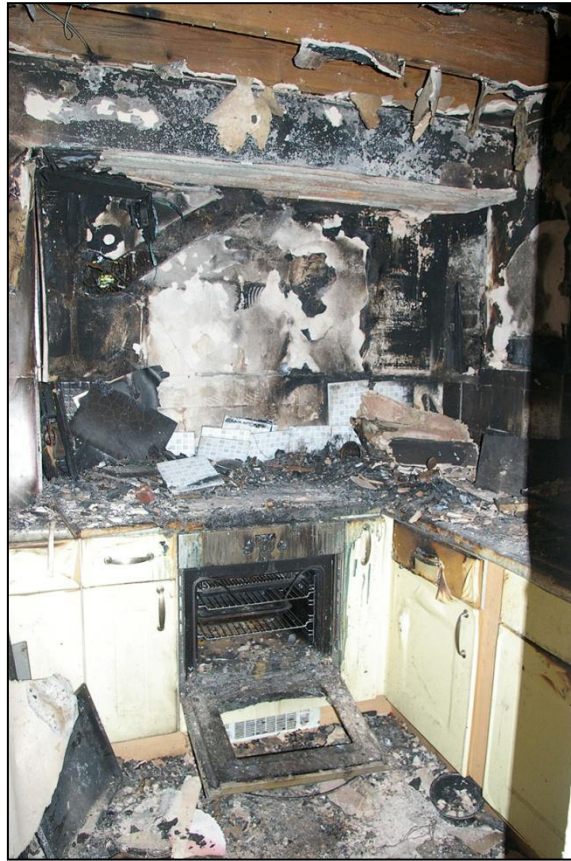
THE RUINED KITCHEN, CR2; FROM THE EAST.

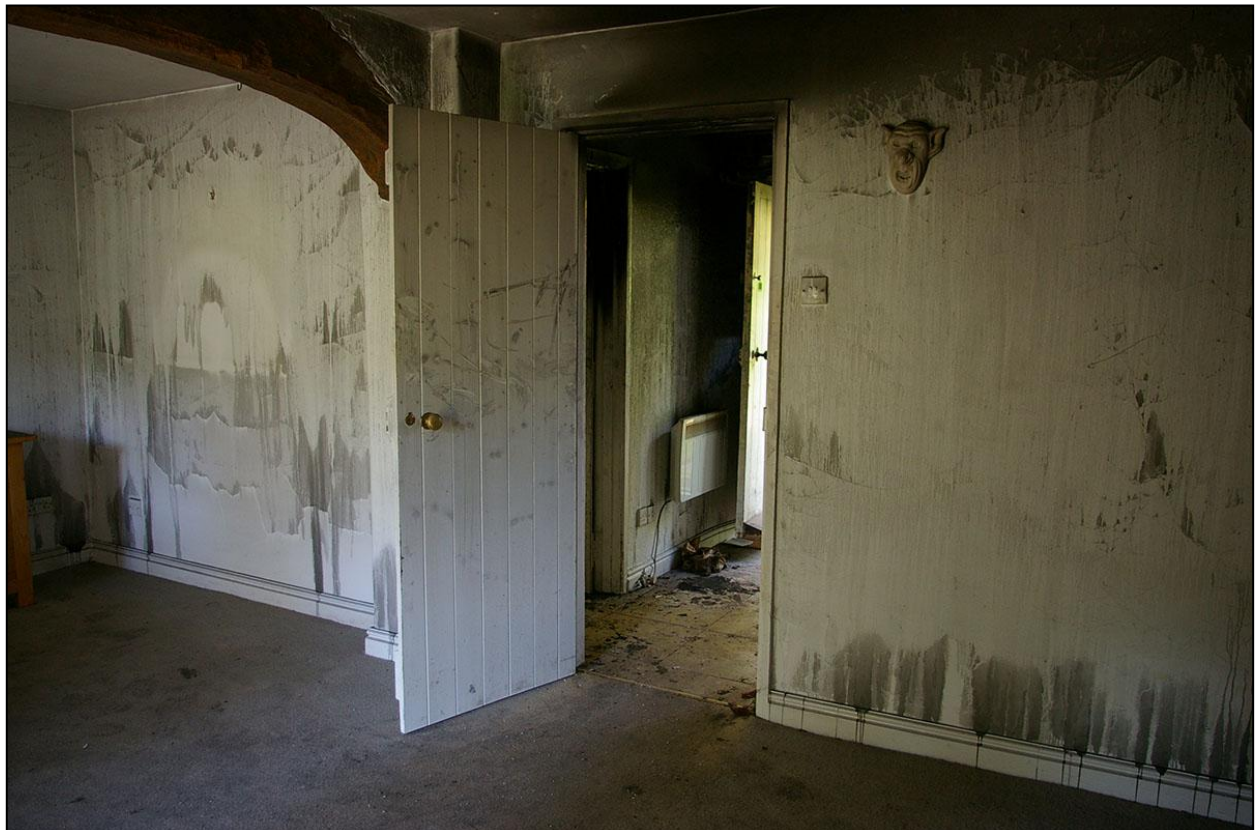
THE MODERN PARTITIONS, WITH A STUD OF EARLIER WALL BRACED BY A HACKED BACK BEAM IN CR3, THE SITTING ROOM, ALSO WITH DOOR BACK TO THE HALLWAY; FROM THE SOUTH-EAST.

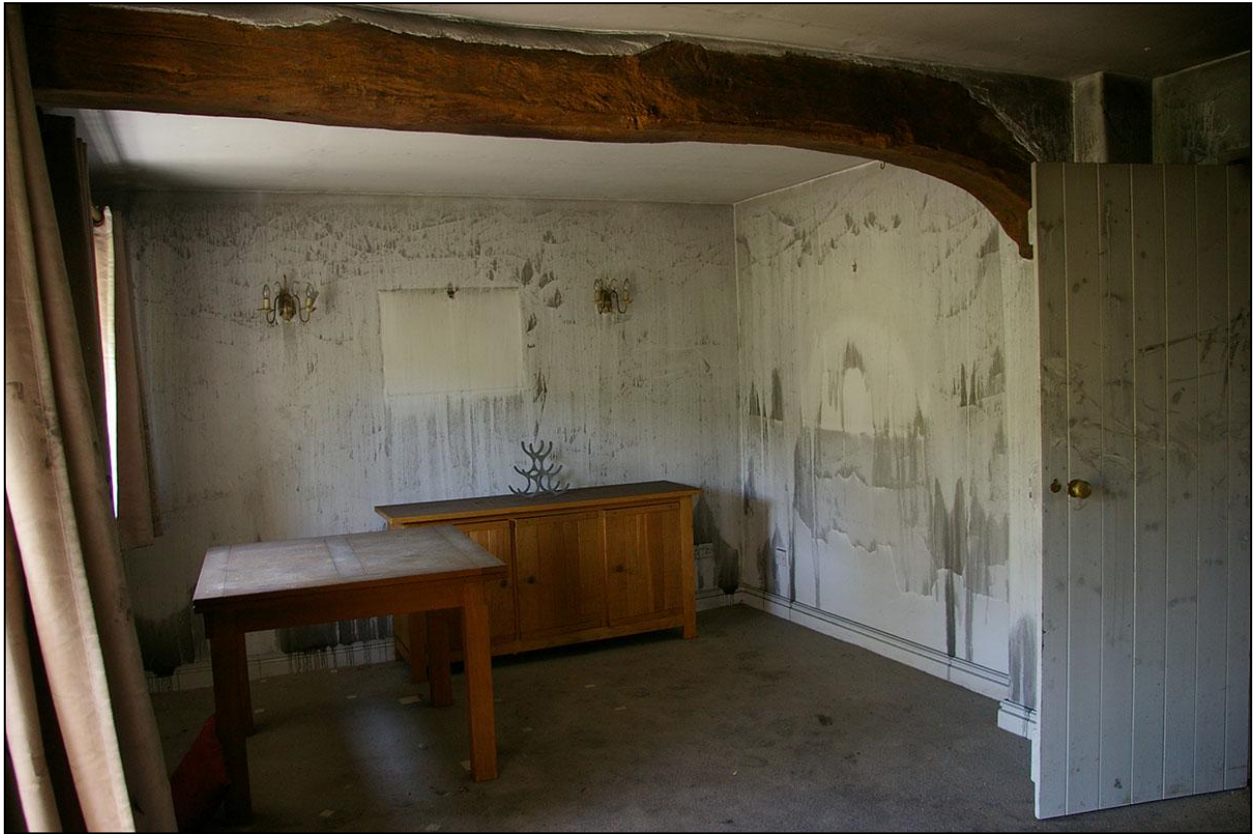
THE BEAM IN MORE DETAIL, BRACING A FORMER PARTITION LINE/WALL LINE; FROM THE SOUTH-EAST.

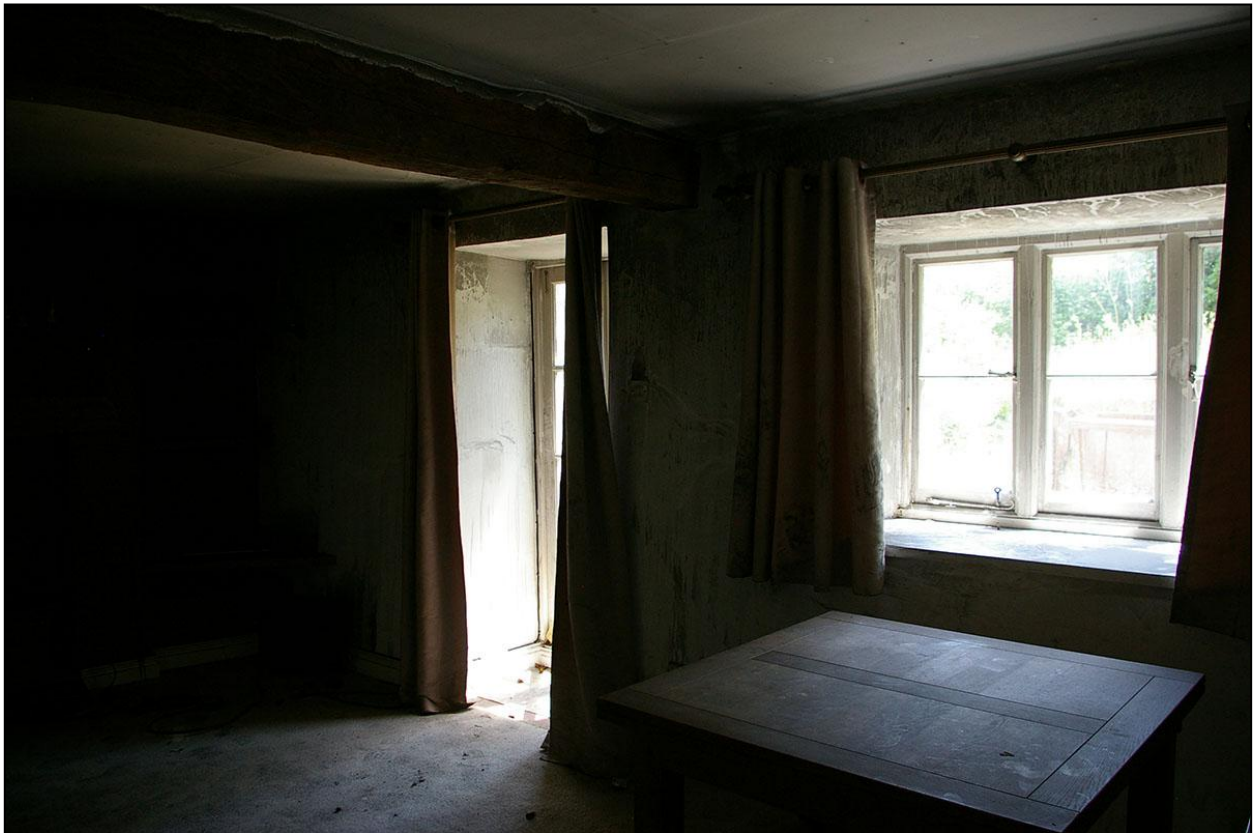
THE SOUTH WALL OF CR3, WITH FORCED PATIO DOORS AND 19<sup>TH</sup> CENTURY WINDOW; FROM THE NORTH-EAST.

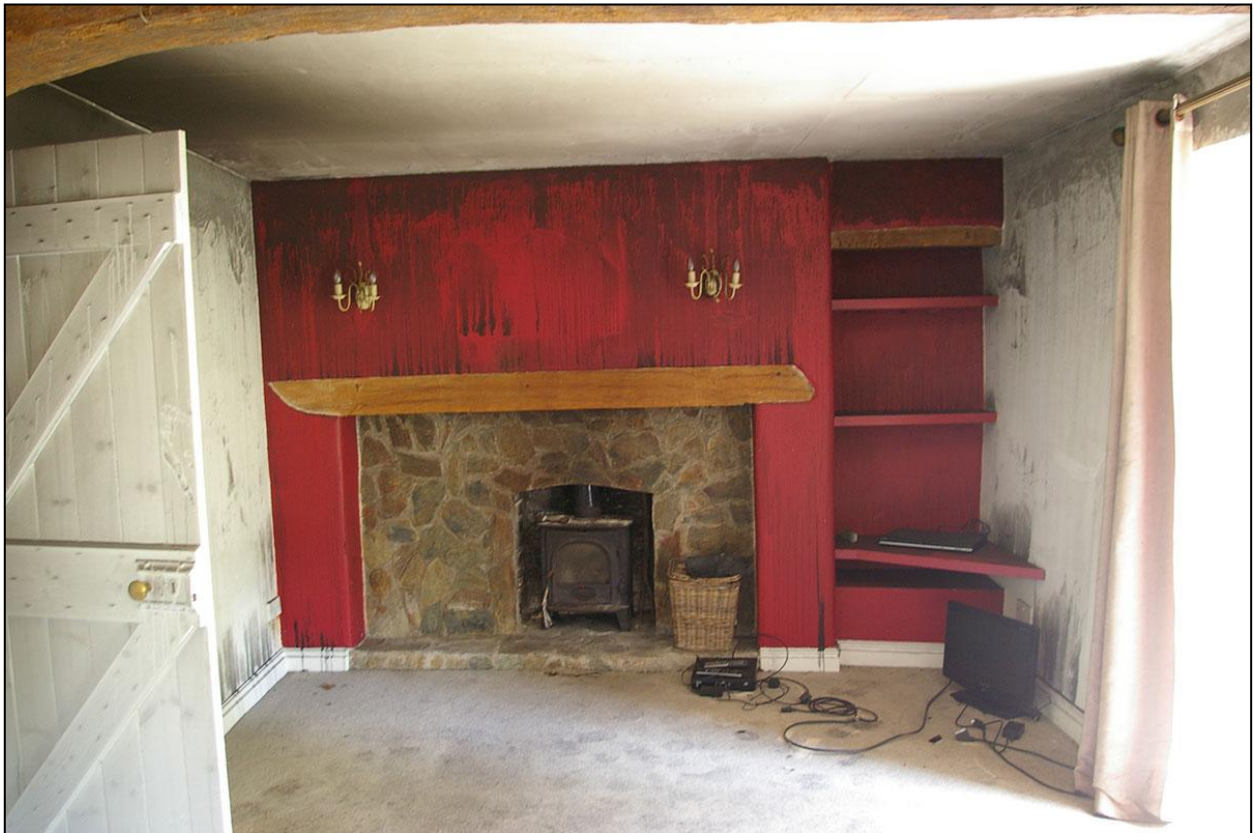
THE SHALLOW STACK AND BLOCKED FIREPLACE, WITH ALCOVE TO THE SOUTH, WITH TIMBER LINTEL; FROM THE WEST.

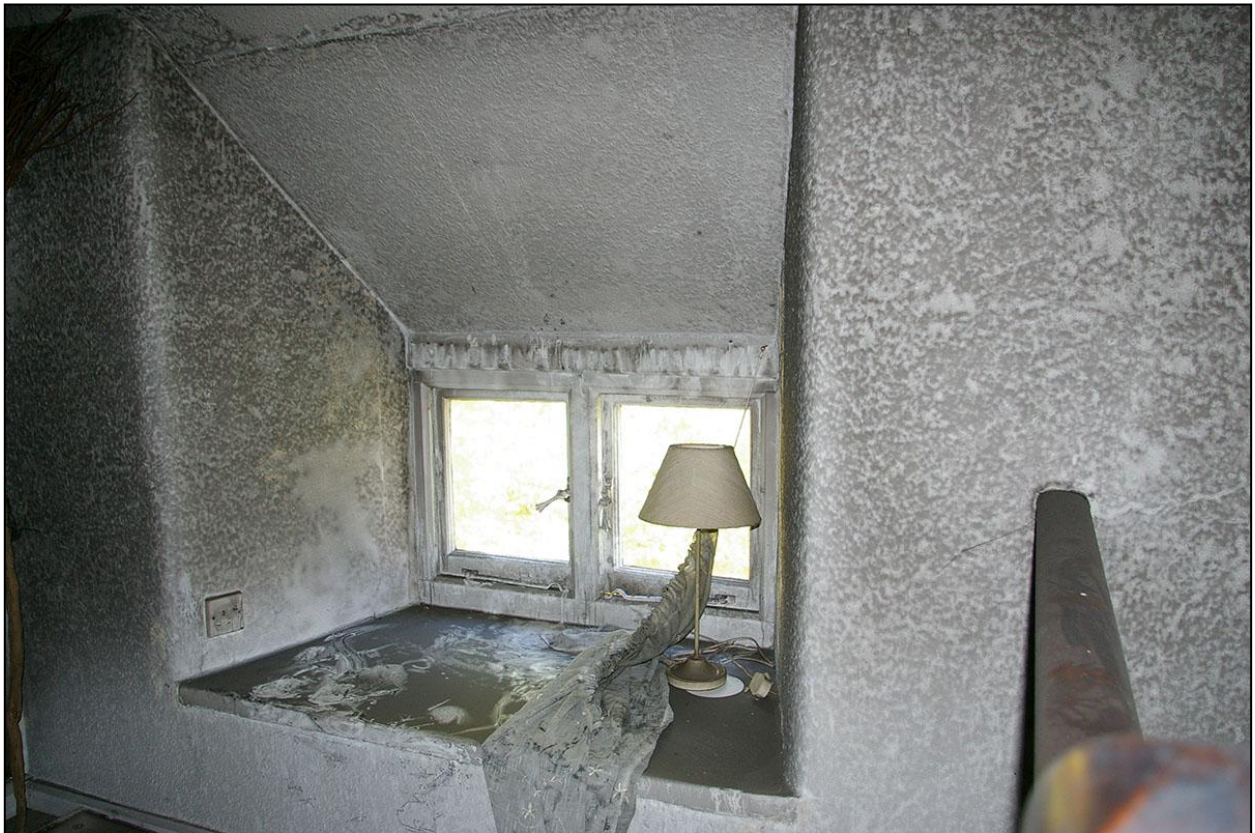
THE TWO LIGHT WINDOW SET INTO A BLOCKED LOADING DOOR IN THE FRONT WALL, CW4; FROM THE SOUTH-EAST.

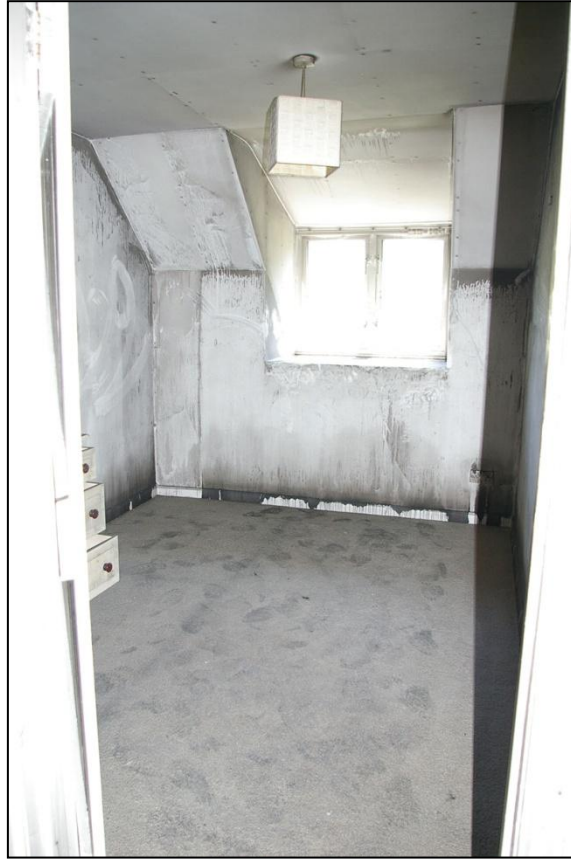
BEDROOM 2 WITH FORCED DORMER WINDOW TO THE REAR; FROM THE NORTH-WEST.

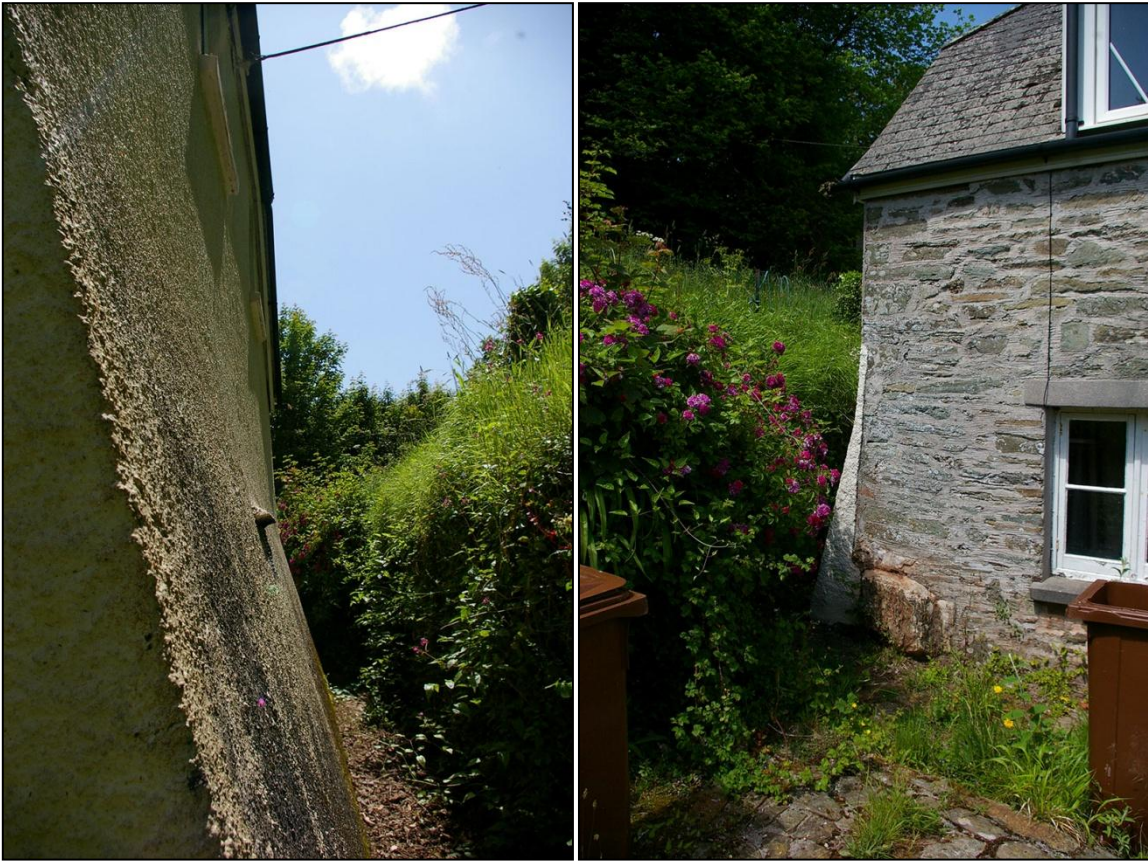
LEFT: THE WEST GABLE END OF THE COTTAGE, SHOWING HEAVY BUTTRESS AND FORCED WINDOWS SET HIGH IN APEX; FROM THE NORTH.  
RIGHT: VIEW OF THE SOUTH-WEST CORNER OF THE COTTAGE, SHOWING BRICK RENDERED BUTTRESS SUPPORTING THE WEST GABLE; FROM THE SOUTH-EAST.

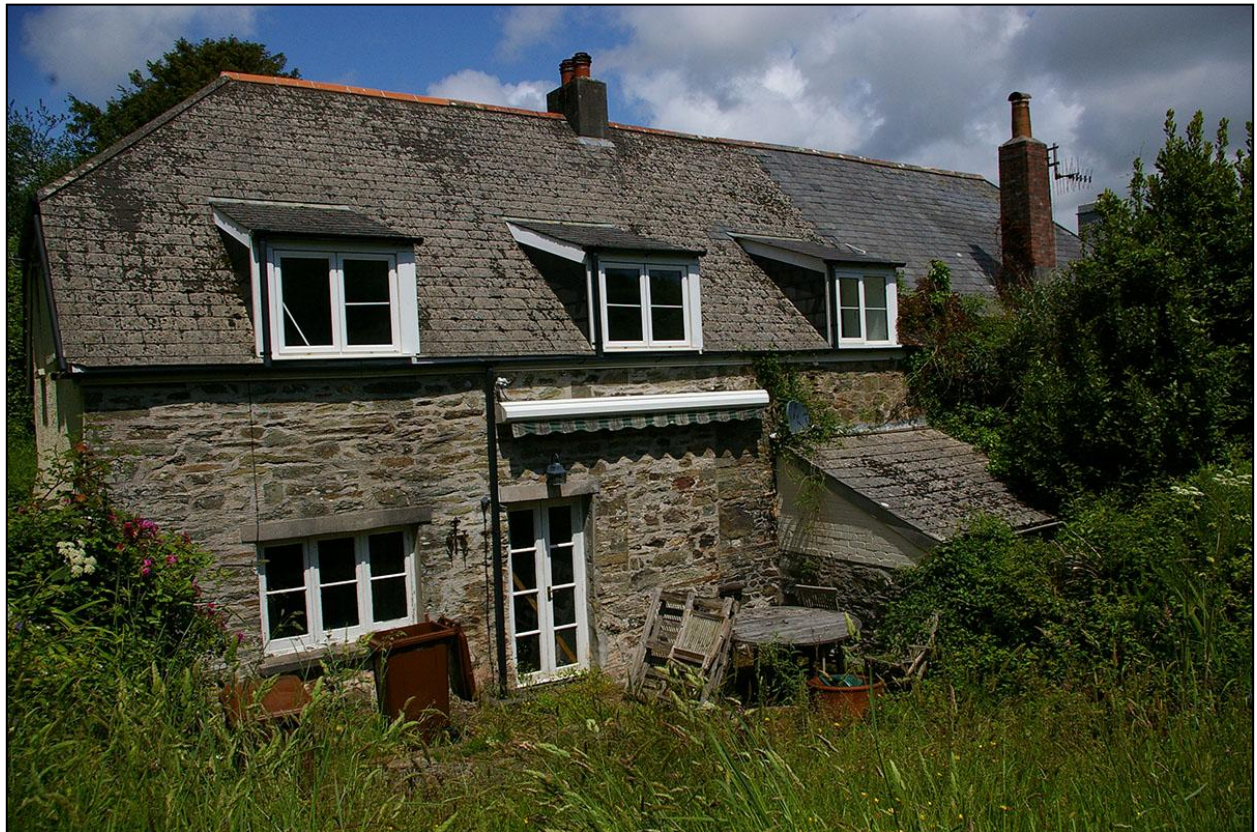
THE COTTAGE AND BATSON HALL FARM SOUTH ELEVATIONS AND ROOFLINE, SHOWING THE OBSCURING FOLIAGE; FROM THE SOUTH-WEST.
