# BATSON HALL FARM

Updated - Historic Building Assessment

South West Archaeology Ltd. report no. 200224

## Batson Hall Farm, Batson, Salcombe, Devon Updated - Historic Building Assessment

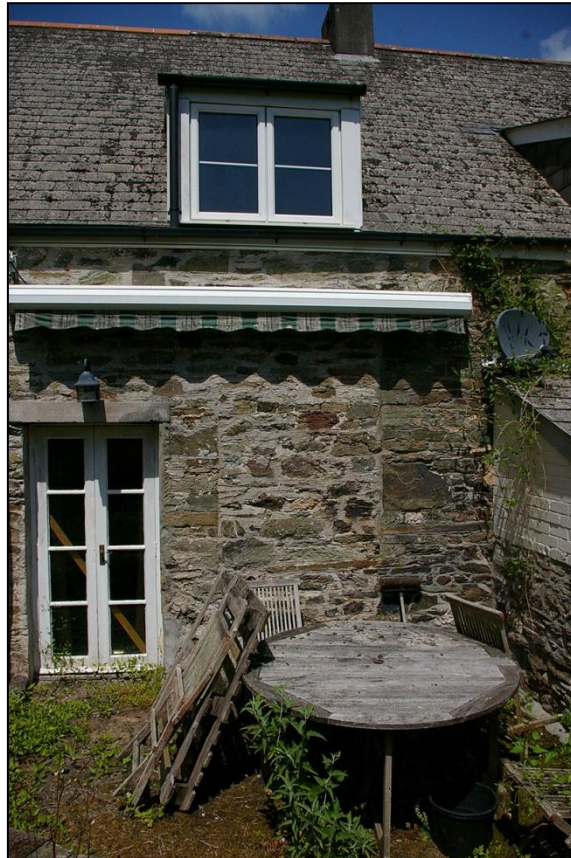
THE BLOCKED DOORWAY IN THE SOUTH ELEVATION OF THE COTTAGE IN THE SOUTH-EAST CORNER, SHOWING GOOD DRESSED REVEALS; FROM THE SOUTH.

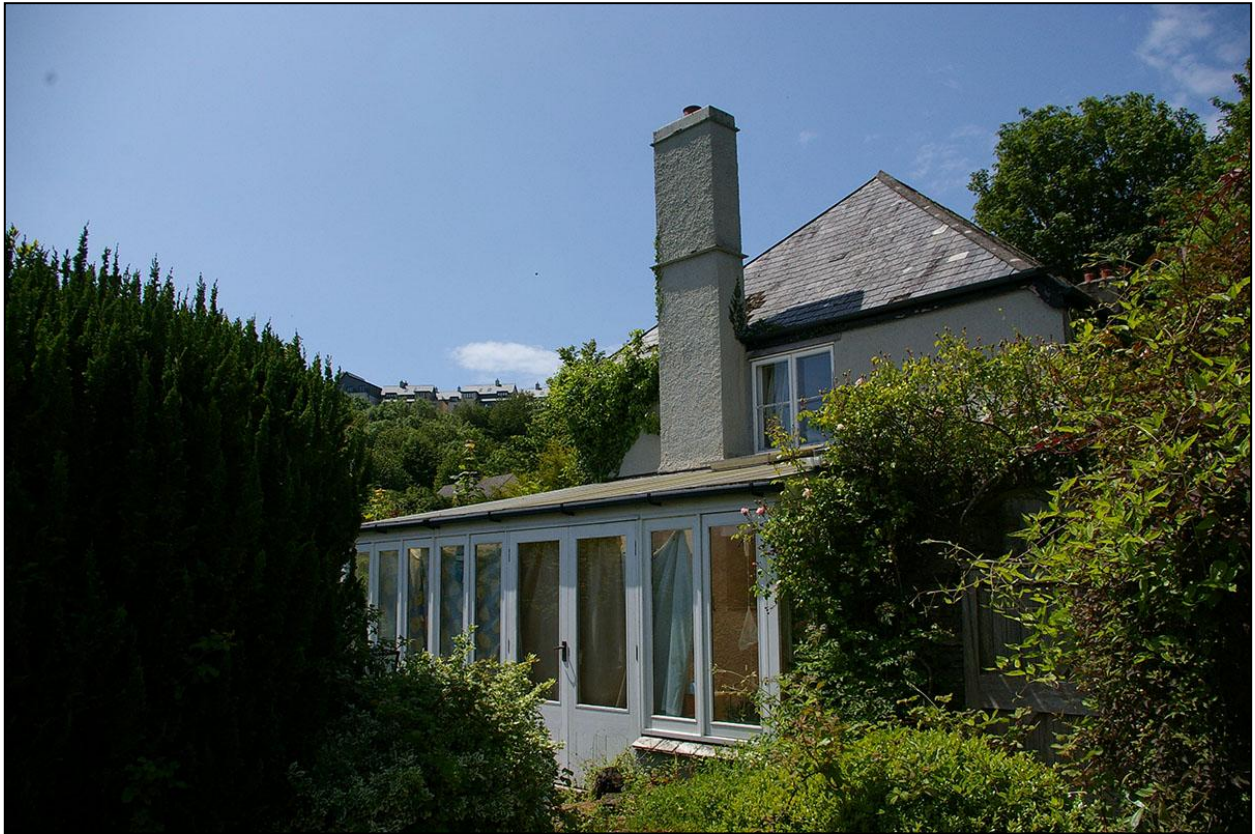
Relationships		
<b>Elevation EAST</b>		<b>Description</b>
Fabric Description:		The two storey east gable is built of post medieval rubble significantly rebuilt and repaired in brickwork and concrete block. It is plastered internally and rendered in pebble dash, painted externally. Unpainted cement render wraps around to both the north and south walls from this elevation, presumably obscuring modern elements of build. The majority of the elevation is obscured by a timber painted and pvc

THE EAST GABLE END OF THE FARMHOUSE, WITH HIPPED ROOF, BOX STACK AND SHAFT AND LARGE MODERN CONSERVATORY; FROM THE NORTH-EAST.

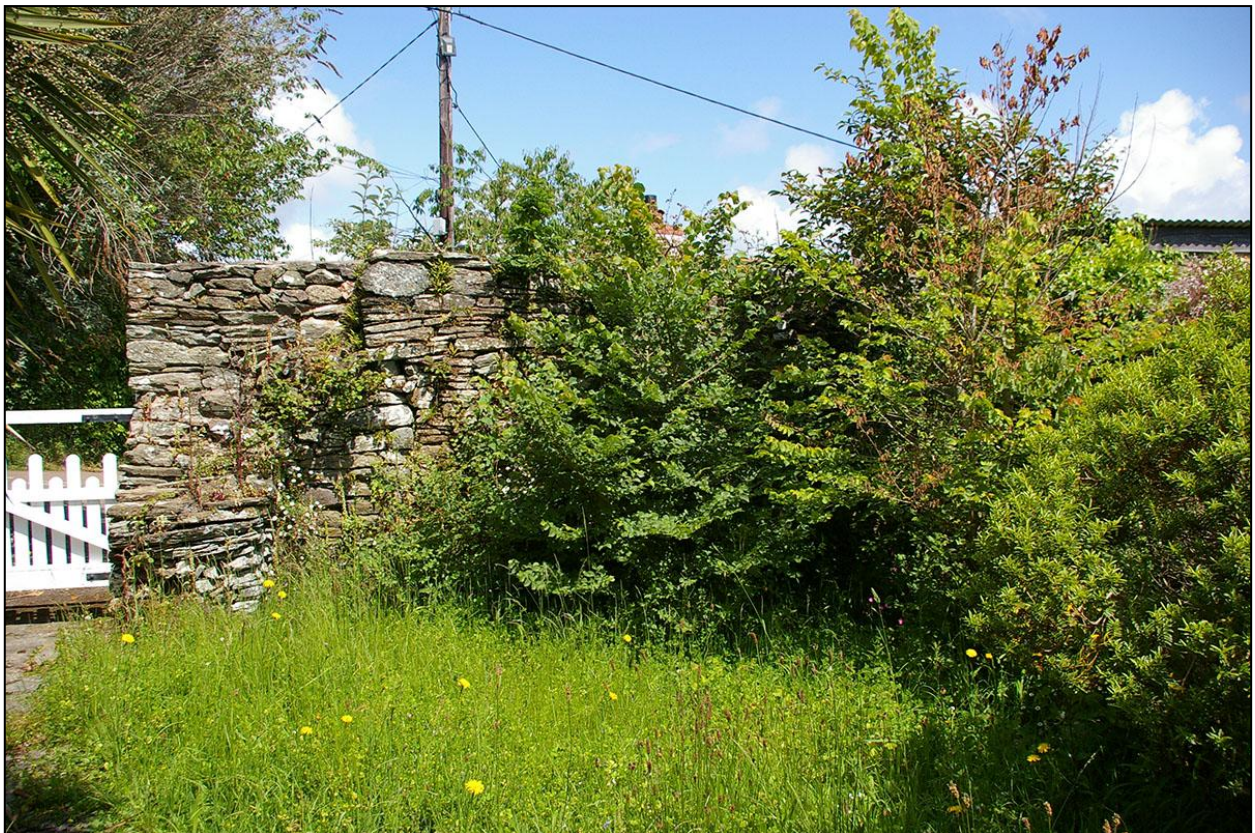
DIRECT VIEW OF THIS WALL, WHICH CONTAINS A RUINED STACK AND FIREPLACE, OBSCURED BY BUSHES; FROM THE SOUTH.

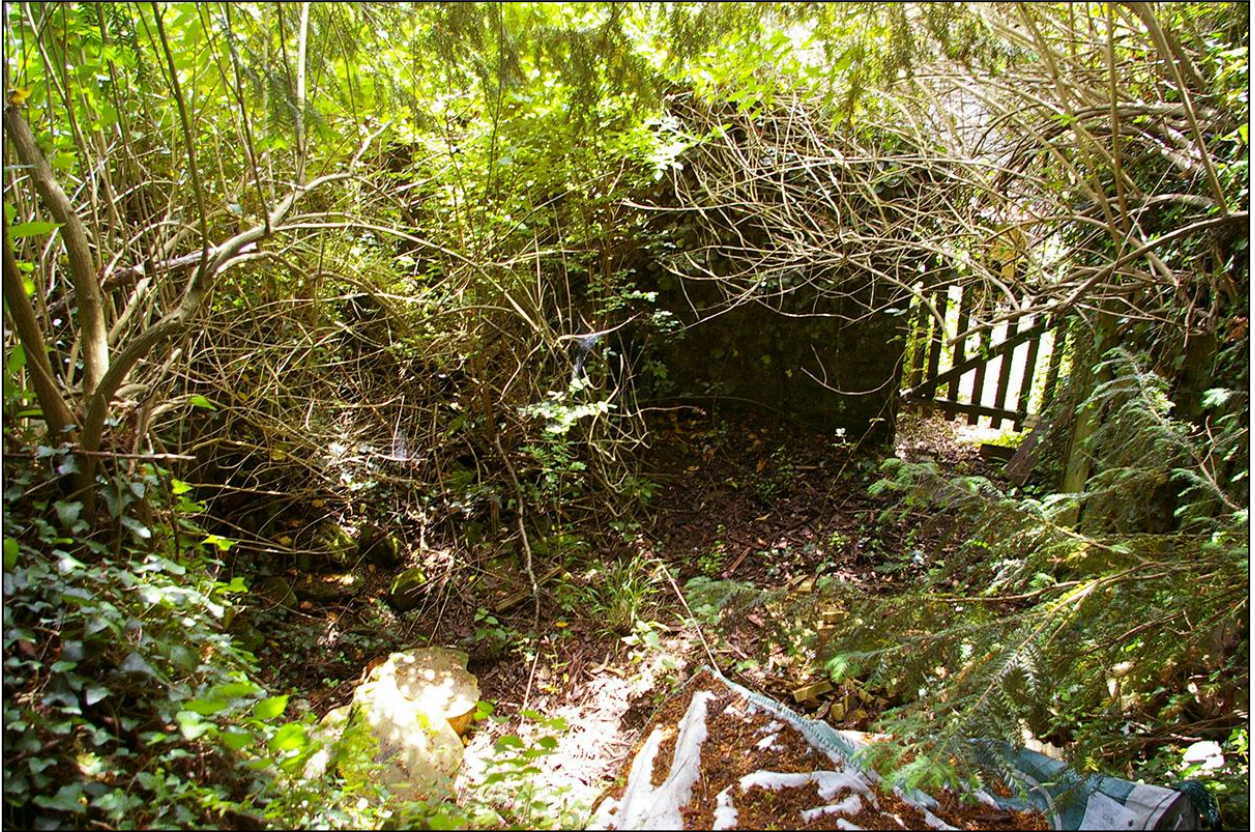
LOOKING DOWN INTO THE SQUARE RUINED BLOCK, SHOWING EARTH FLOOR, LOG STORE FUNCTION AND THE GATE AND WINDOW; FROM THE NORTH (ABOVE).

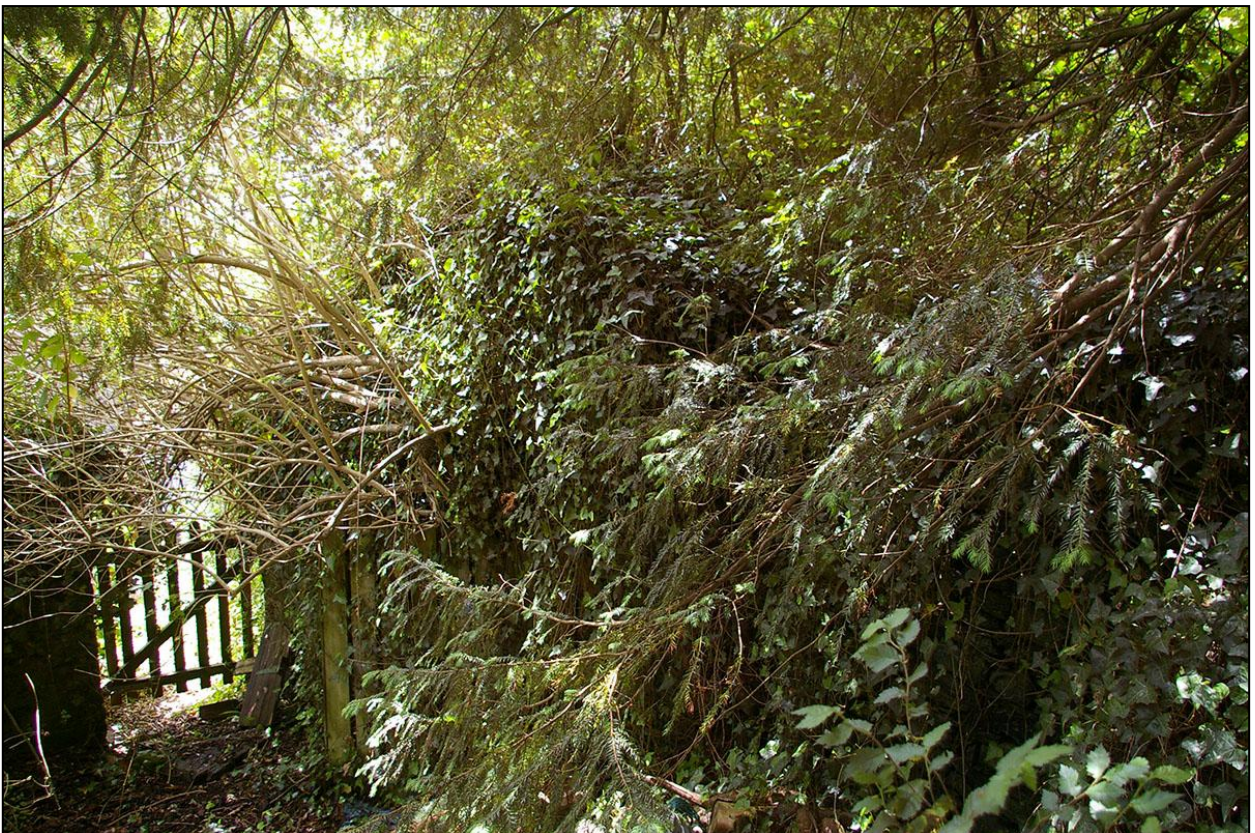
THE TALLER VERY THICK WEST WALL OF THE SQUARE BLOCK, WHICH LOOKS TO CONTAIN FURTHER OBSCURED FEATURES, POSSIBLY A STACK? FROM THE NORTH, NORTH-EAST.

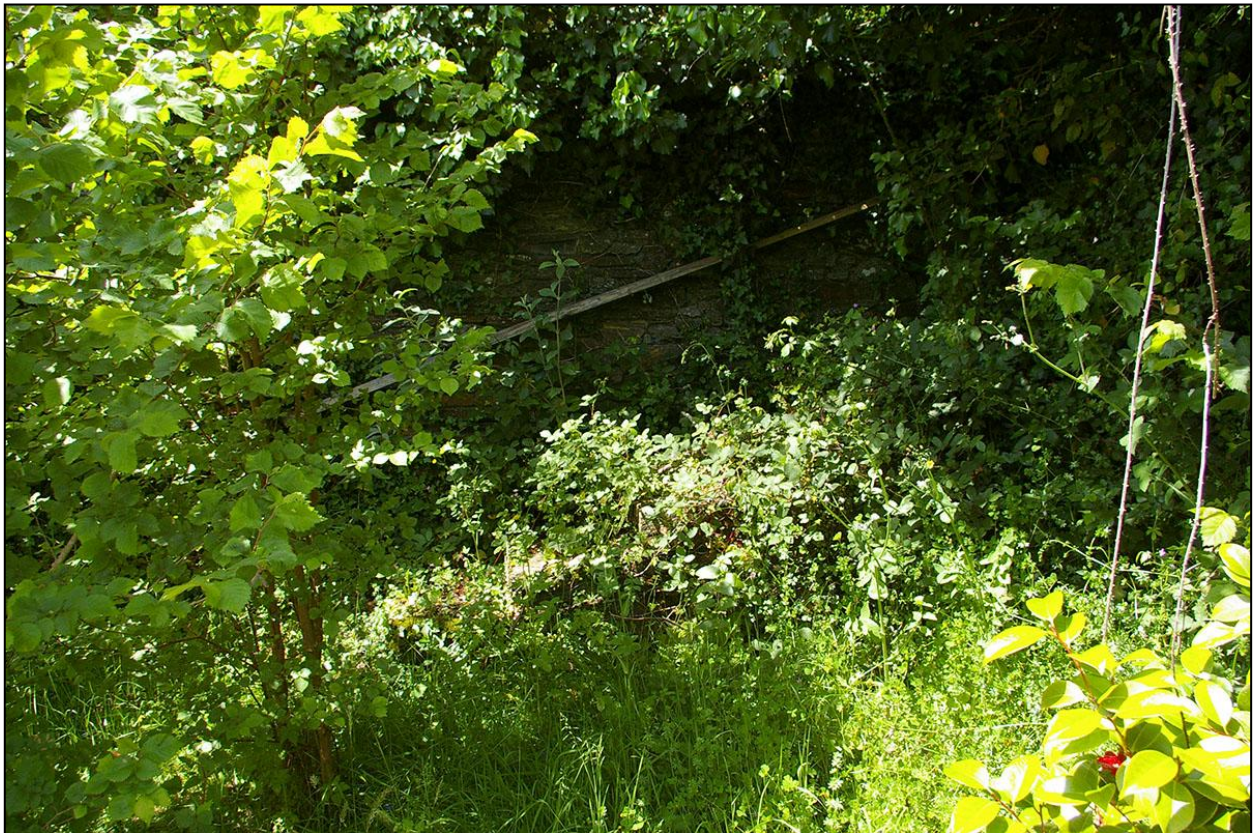
THE EAST WALL OF THE SQUARE BLOCK LARGELY OBSCURED BY IVY BUT ALSO WITH THE SET OF SATE GARDEN STEPS RISING ALONGSIDE IT; FROM THE EAST.

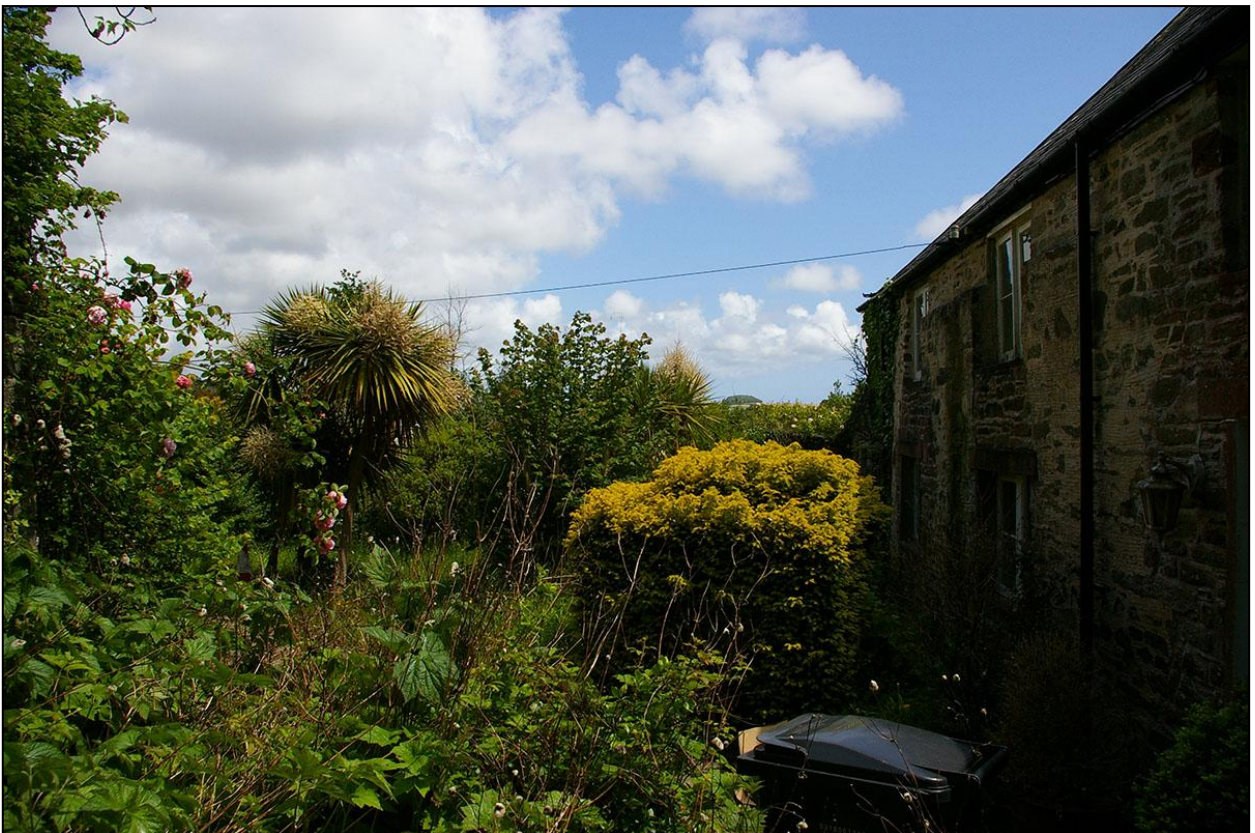
VIEW ALONG AND ACROSS THE ENCLOSED NORTHERN PART OF THE GARDEN, BETWEEN THE BUILDINGS AND THE ROAD; FROM THE WEST, SHOWING HOW ENCLOSED VIEWS ARE.

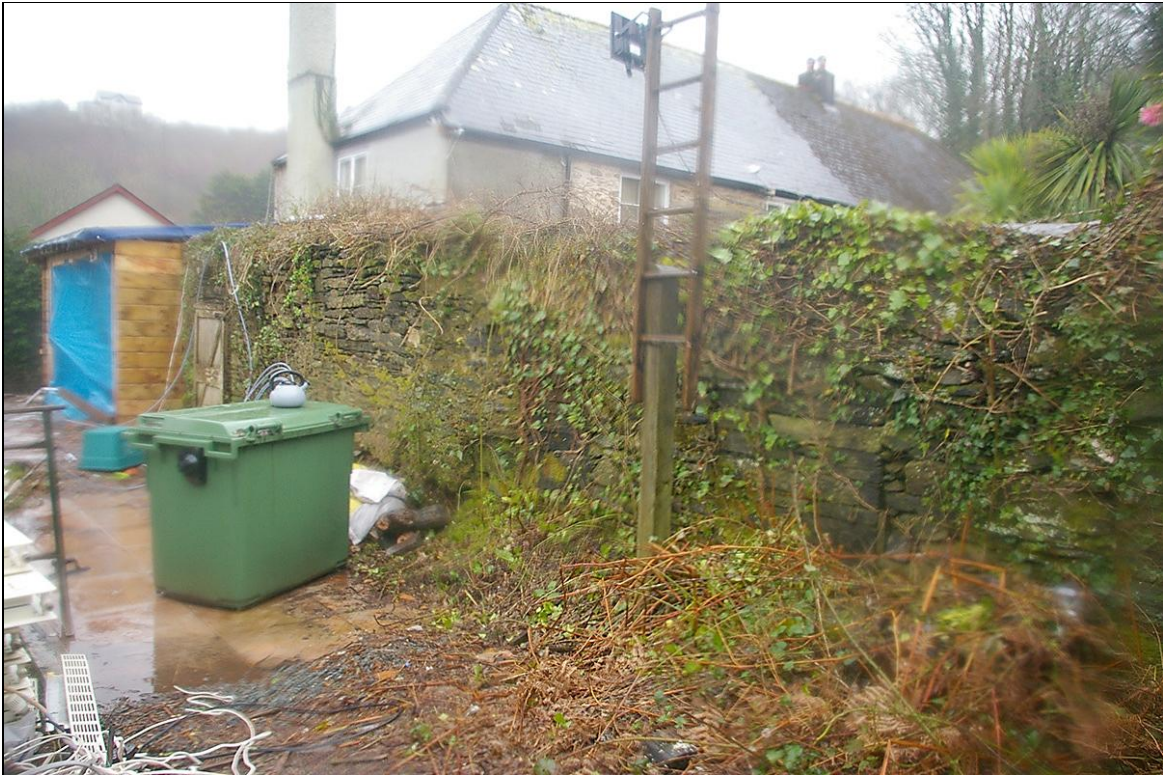
THE EAST WALL OF THE NORTH-EAST RUINED RANGE, SHOWING A NUMBER OF BLOCKED OPENINGS, FACING DOWN TO THE CREEK;  
FROM THE NORTH-EAST.

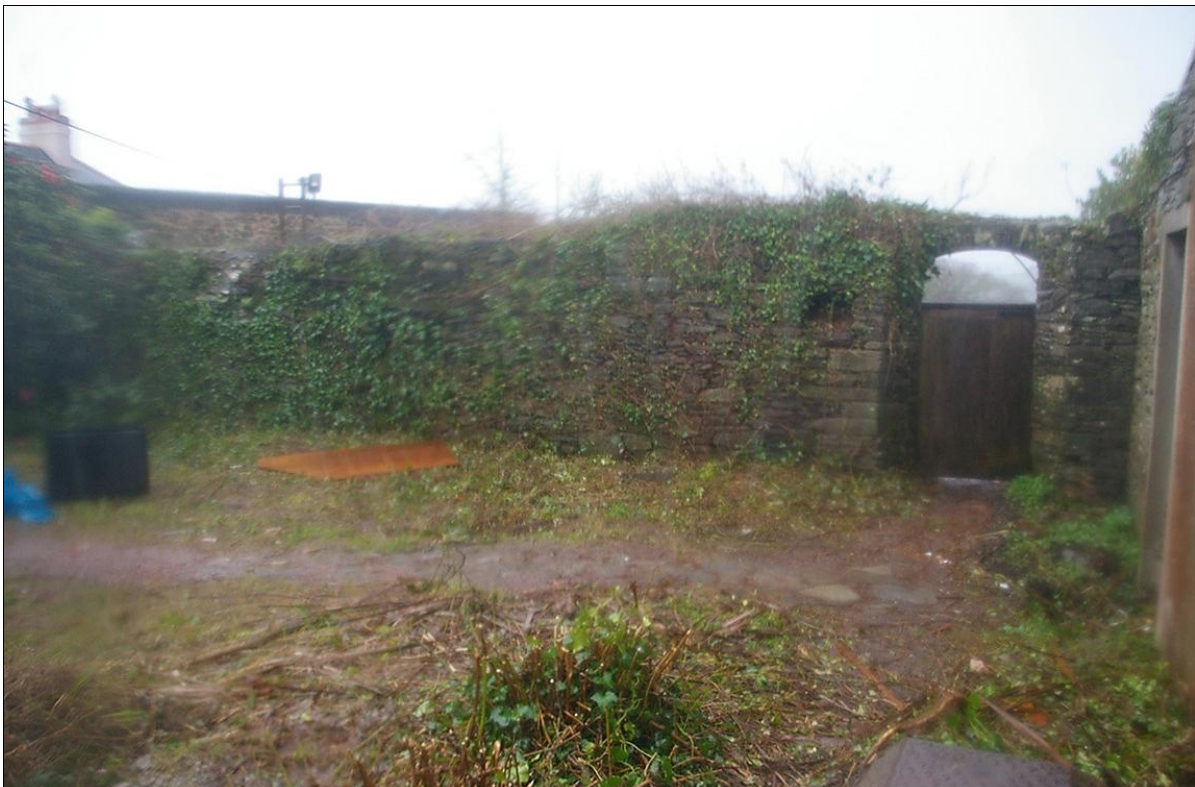
THE EAST WALL OF THE NORTH-EAST RUINED RANGE, INNER FACE, BEING CLEARED OF FOLIAGE; FROM THE WEST-SOUTH-WEST.

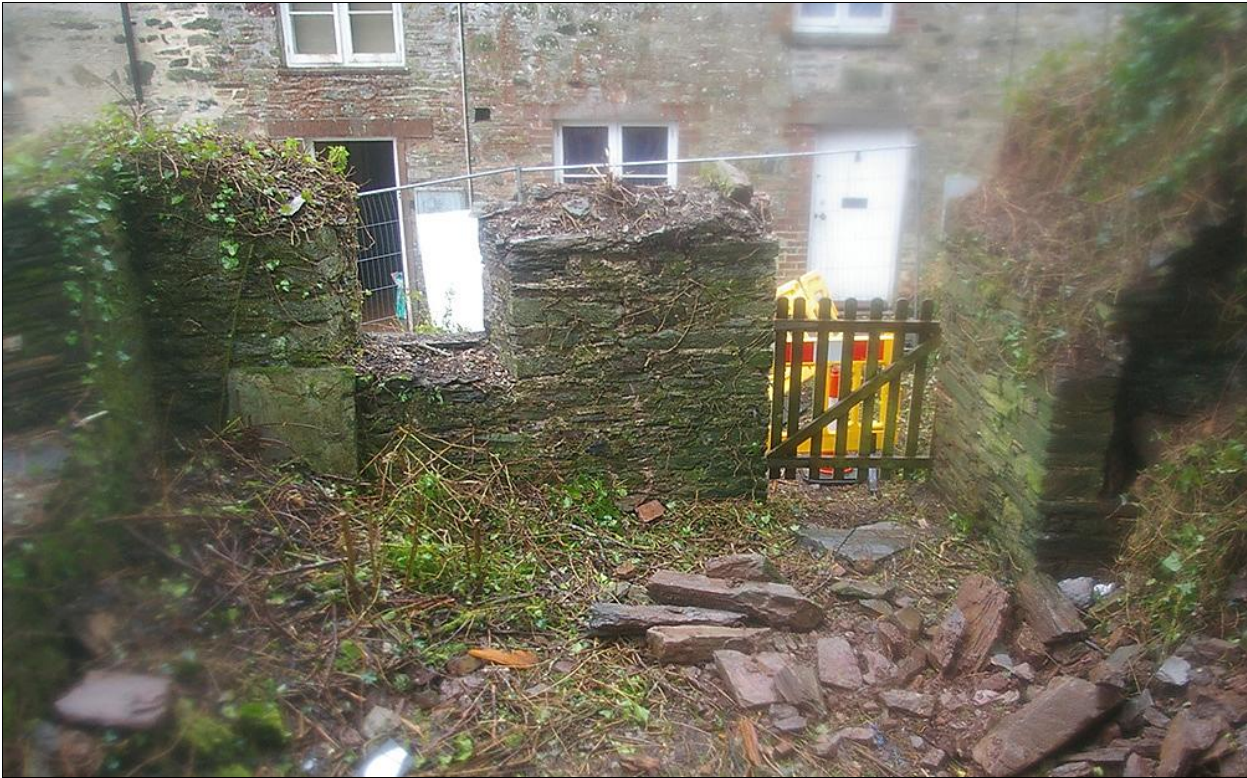
THE SOUTH WALL OF THE DETACHED BLOCK, WITH WINDOW AND DOOR, SHOWING THE INNER VERNACULAR CHARACTER FACE OF THE WALL, SO DIFFERENT FROM THE OUTER DRESSED AND FACED STONEWORK, FROM THE NORTH.

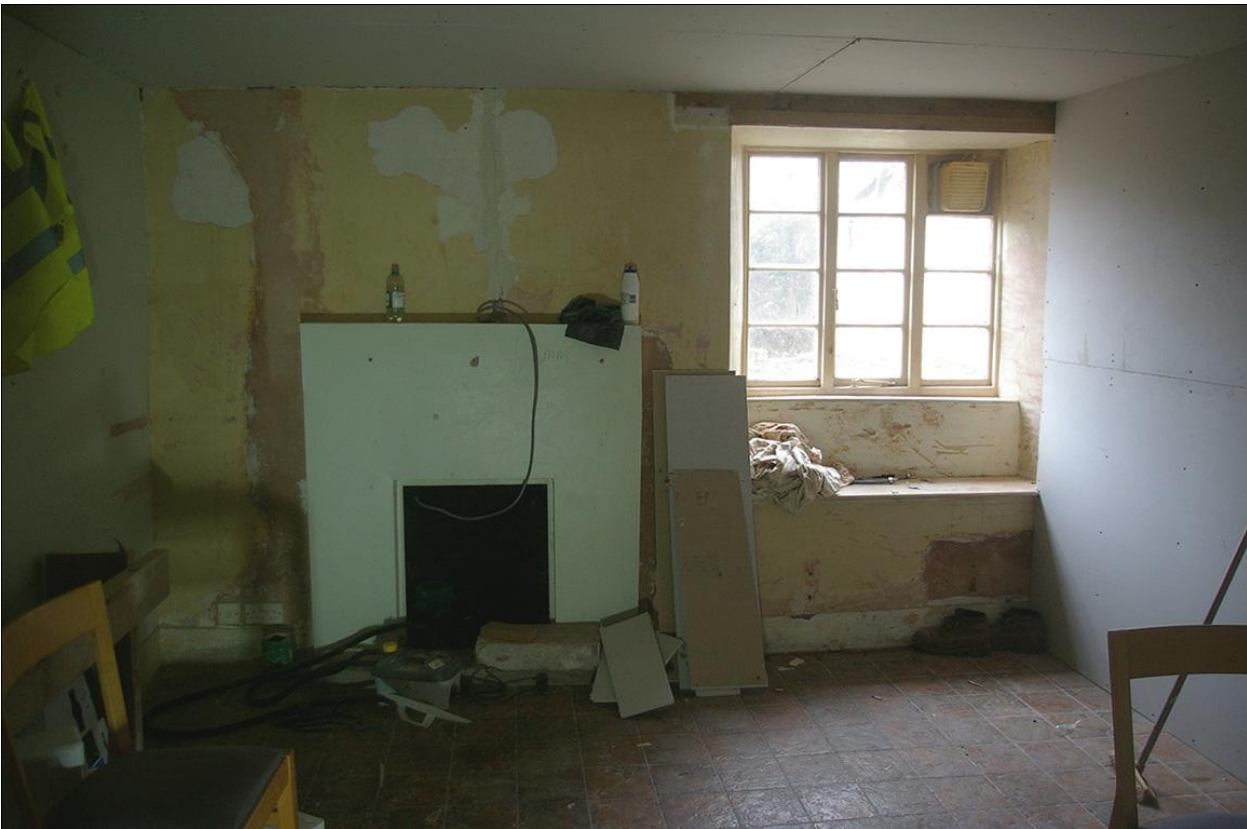
THE MODERNISED KITCHEN FIREPLACE AND GOOD 19<sup>TH</sup> CENTURY WINDOW, ROOM 2B; FROM THE NORTH.

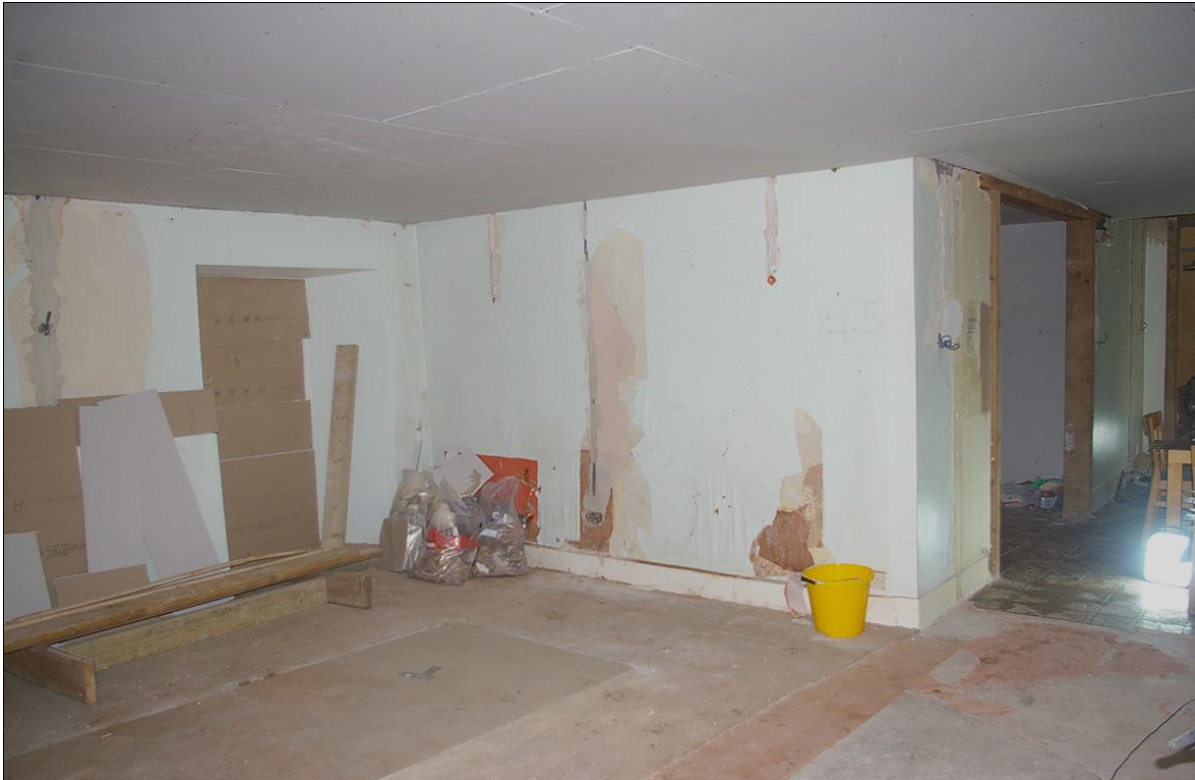
ROOM 3, IN THE FARMHOUSE, THE MAIN SITTING ROOM, WITH BOARDED OVER FRENCH-STYLE PATIO DOORS TO THE GARDEN; FROM THE NORTH-EAST.

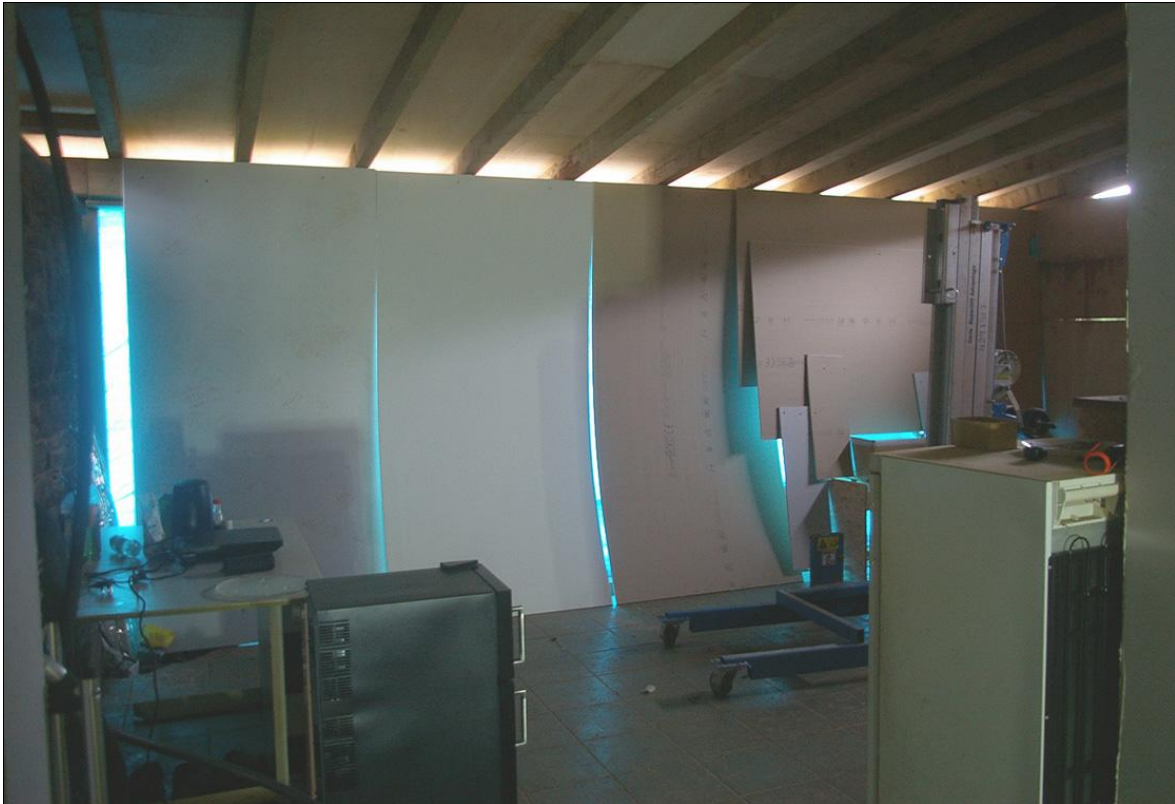
THE CONSERVATORY, WHICH HAS BEEN BOARDED OUT FOR SECURITY AND DUE TO PARTIAL COLLAPSE; FROM THE WEST-NORTH-WEST.

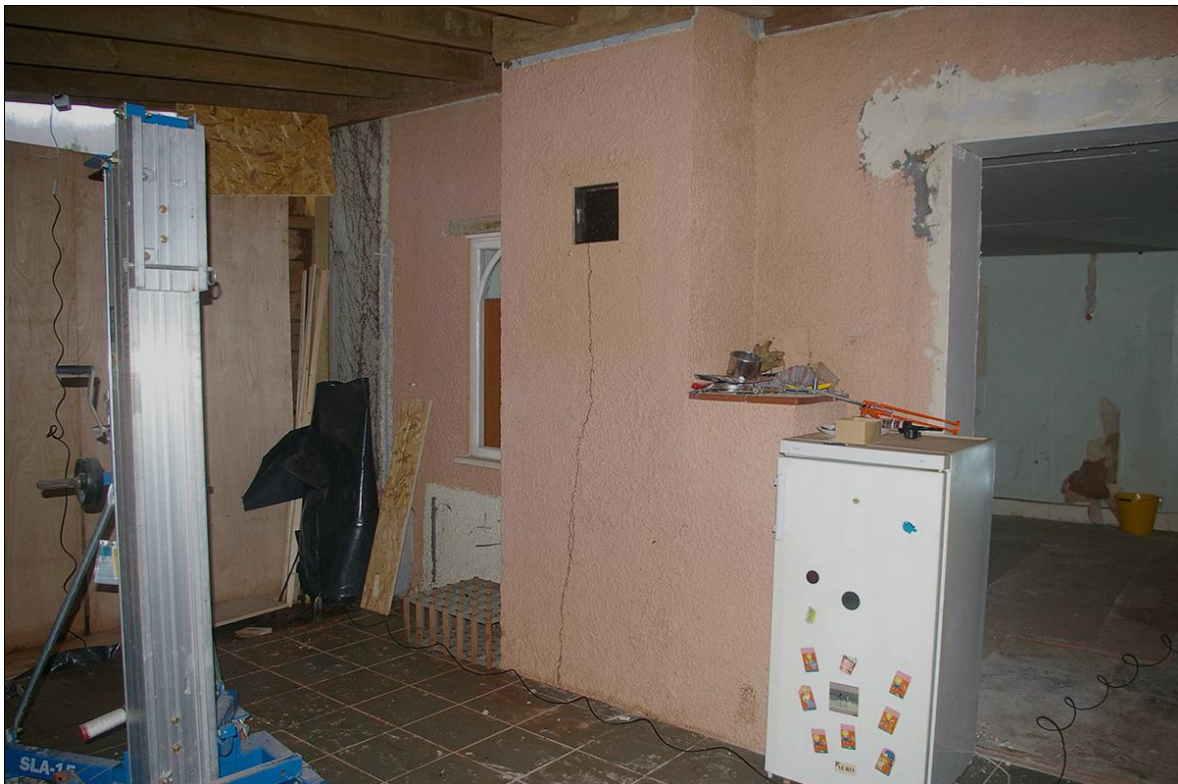
THE MODERN BOXY STACK SERVING THE SITTING ROOM FIREPLACE, ENCLOSED WITHIN THE CONSERVATORY; FROM THE NORTH-EAST.

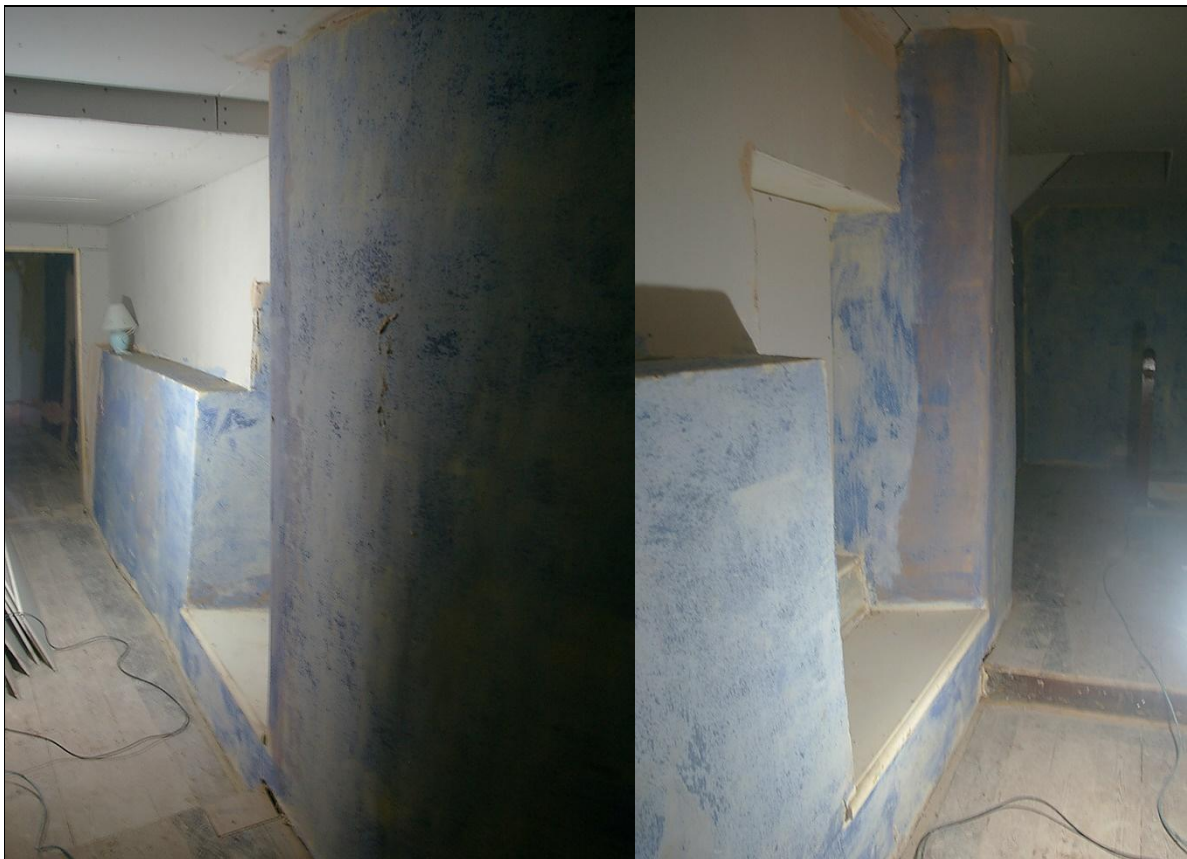
LEFT: THE SOUTH WALL OF THE FARMHOUSE, SHOWING THE BATTERED LOWER EARLIER SECTION OF WALL AND THE TALL ANGLED WEST PROJECTION, WITH DISTINCTIVE CURVE; FROM THE WEST-NORTH-WEST.

RIGHT: THE WEST PROJECTION, ON THE END OF THE MEDIEVAL WALL; FROM THE EAST.

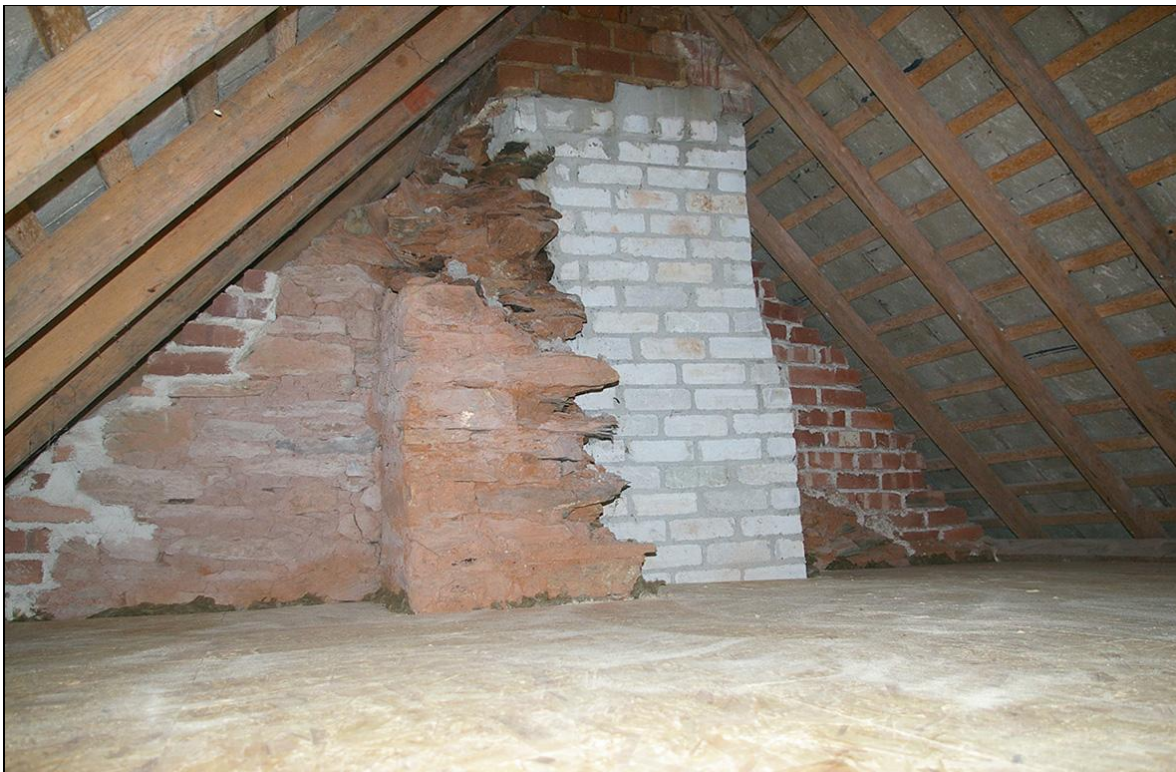
THE STACK TO THE WEST END OF BATSON HALL FARM; WITH FRAGMENTARY REMAINS RISING TO ONE AND A HALF STOREYS, THE STONWORK PATCHED IN BRICKWORK IN LIME MORTAR, THEN IN LATER BRICKWORK IN CEMENT AND IN CONCRETE BLOCK, INDICATING 19<sup>TH</sup> AND SEVERAL PHASES OF 20<sup>TH</sup> CENTURY REMODELLING.
