BARN AT LOWER RIXDALE FARM

Historic Building Recording

Barn at Lower Rixdale Farm, Dawlish, Teignbridge, Devon

Results of historic building recording

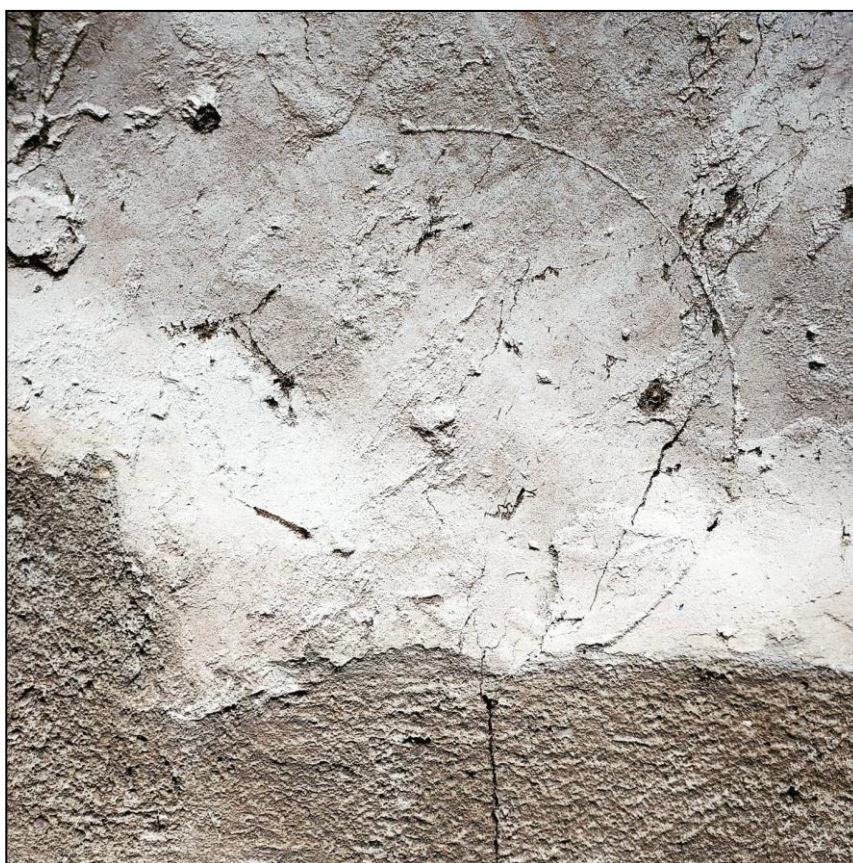
FIGURE 13: THE POTENTIAL DAISY-WHEEL ON THE NORTH WALL OF THE BARN, AT THE WEST END, WEST OF THE WINNOWING DOOR; FROM THE SOUTH.

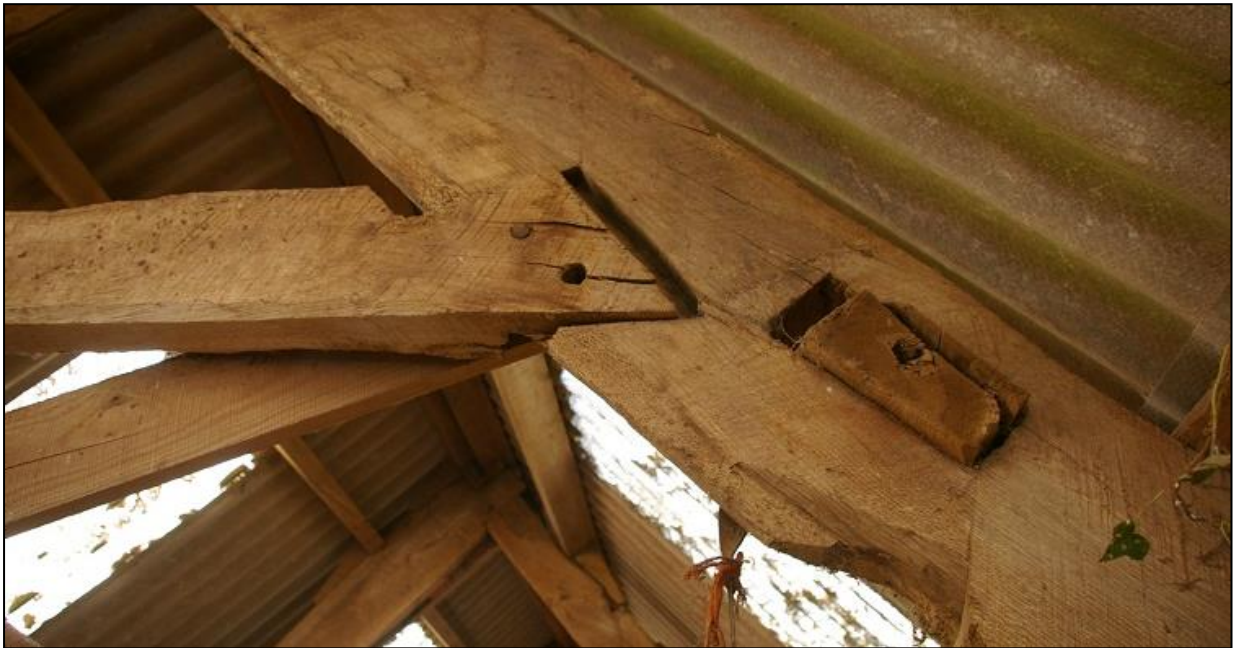
FIGURE 14: DETAIL OF ONE OF THE DOVETAILED COLLAR JOINTS AND THREADED PURLINS SOCKETS; FROM THE EAST.

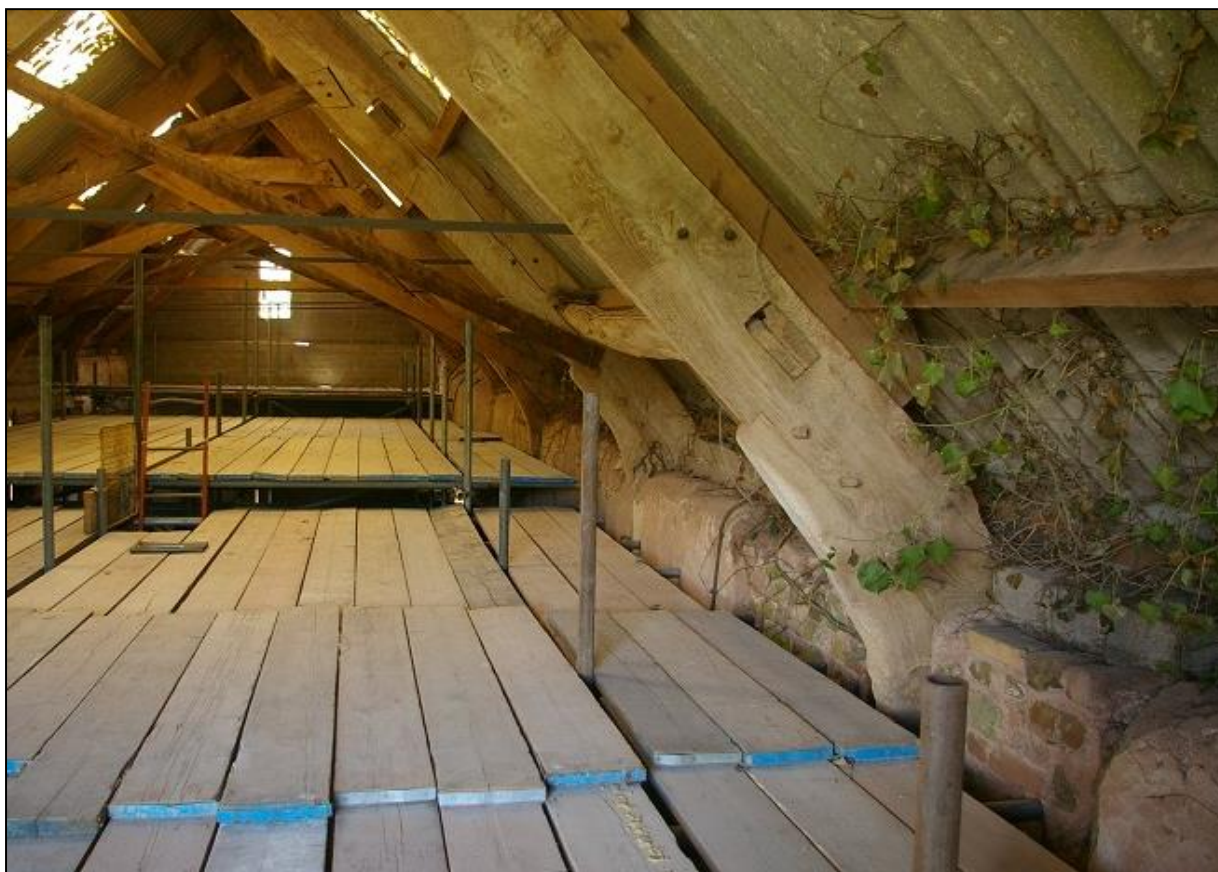
FIGURE 16: DETAIL OF PART OF THE ROOF OVER B1.1, THE JOINTED CRUCKS, SHOWING THE SHAPED FOOT PEGGED TO THE CRUCK BLADE AND ONE OF THE SURVIVING HEAVY PURLINS; FROM THE EAST.

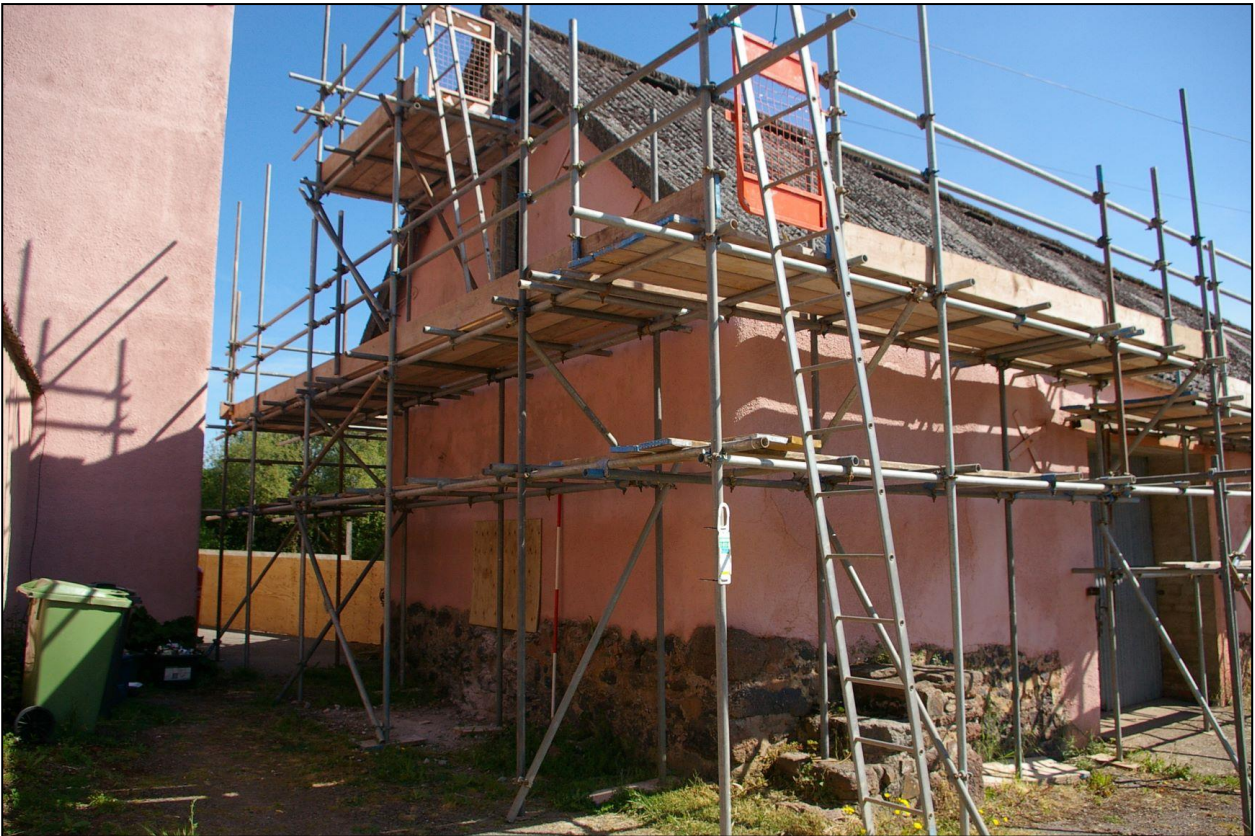
The west gable of the barn has also been rebuilt in concrete block and externally rendered, but its stone base, deeply terraced into the ground remains partly intact to c.0.75m on the exterior and 1.5m on the inside face, although obscured by render. The south-west and north-west corners have also retained their integrity too; it is only the central portion of the elevation which is rebuilt. The north-west corner is now built of stone rubble it is angled and relieved, mortared in lime; this is likely a 19th century repair associated with works to the farmhouse which stands within 2m of the corner of the barn. There is also a loading door cut into the concrete block at loft height here too. This work is contemporary to that undertaken on the east gable and most likely within the time the building was listed. This has led to a damaging loss of historic fabric and integrity, however different from the east end, there is a middle phase of iron braces holding the barn and gable together on the corners; these x-ties come across the south-west and north-west corners, at an angle. Clearly before the rebuild there were significant stresses on the barn structure at this end; bearing in mind how close the house now is and its rebuilding or remodeling in the 19th century after a major fire, this may not be a surprise.

1. THE WEST GABLE ELEVATION OF THE MAIN BARN (B1.1) WITH 2M SCALE; FROM THE SOUTH-WEST.

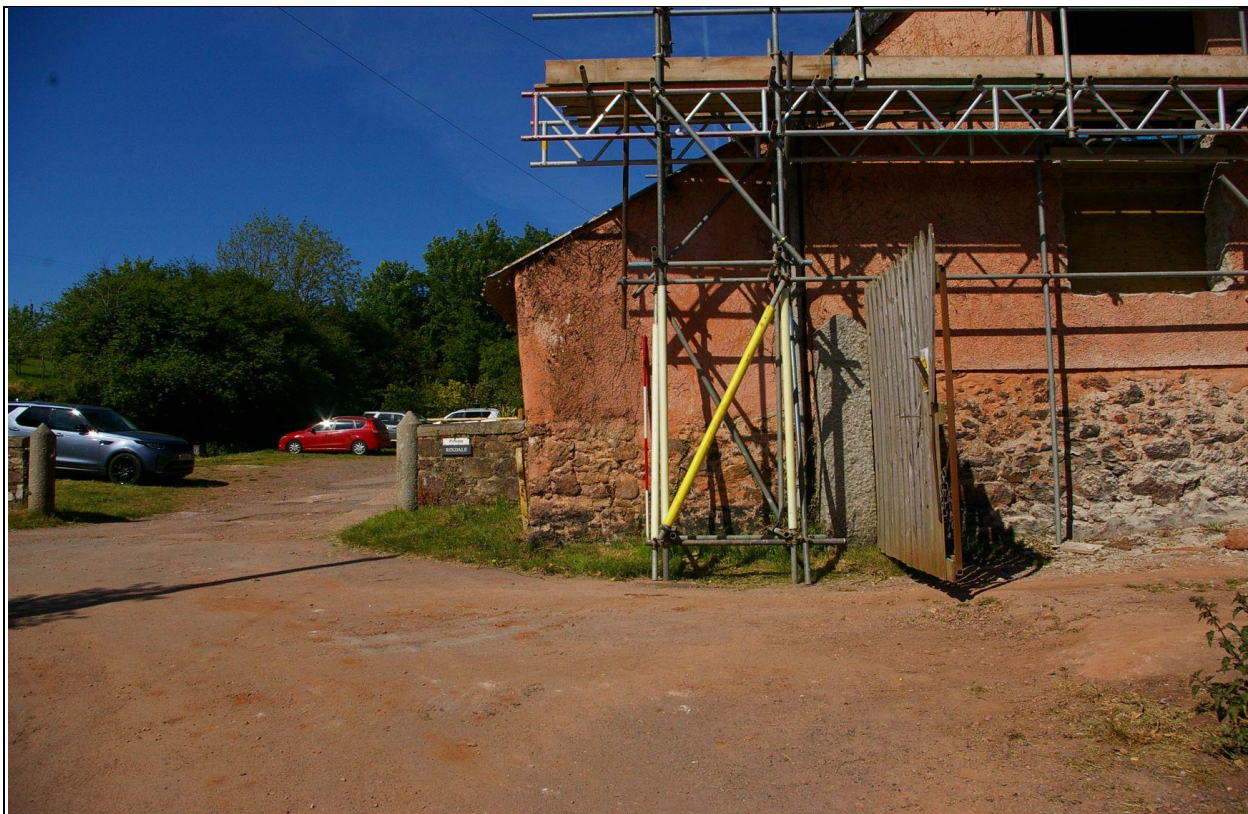
11. THE EQUIPMENT SHED (B1.2), WHERE IT ABUTS THE MAIN BARN (B1.1), WITH 2M SCALE; FROM THE EAST.

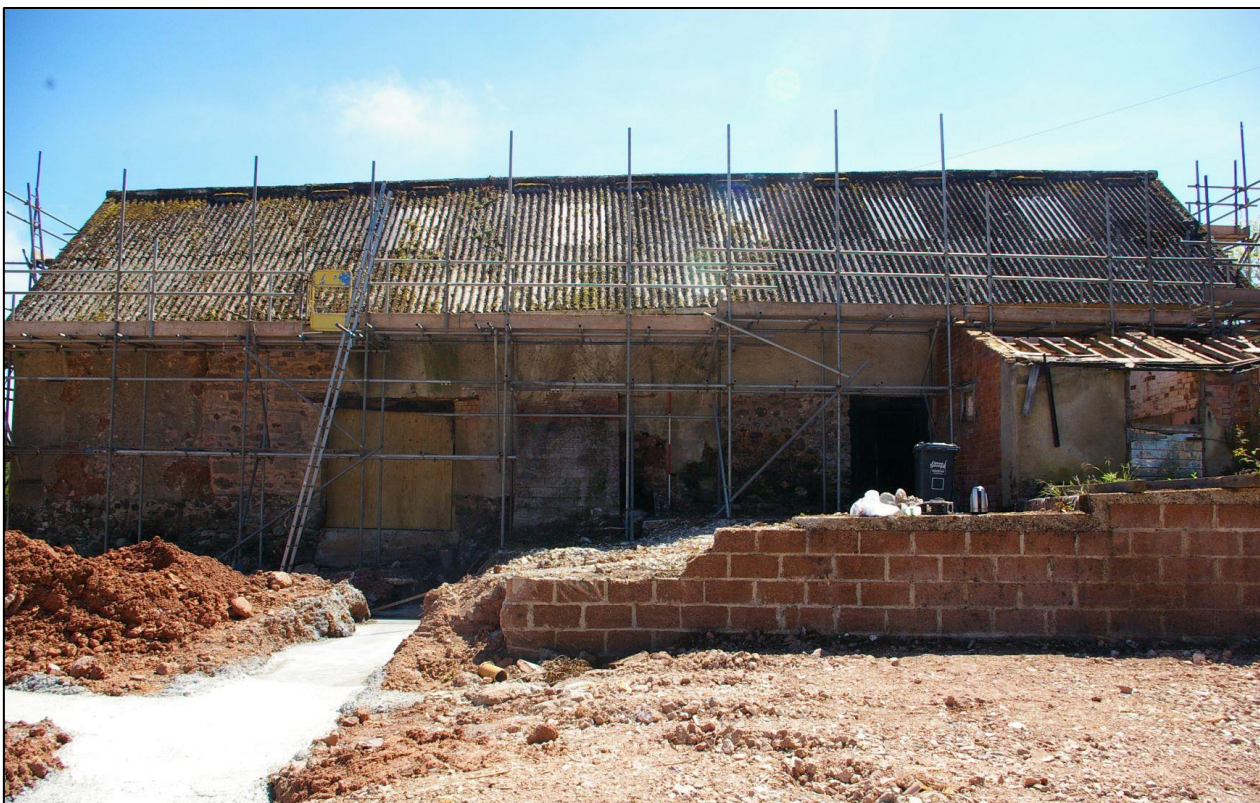
The rear, north elevation, facing the former modern cattle shed (the former north farmyard) is the most interesting from a historical perspective as we can see farm more detail of alteration and repair to the cob. To the east end the stone rubble base is battered, rising 1.3m up the elevation, it is bonded in reddish-brown clay and lime, with a lot of beige cement mortar re-pointing. Bay 5, around the eastern threshing opening, shows considerable under-building and re-facing in rubble stonework in a pale red-brown clay and lime bond. The character of this repair is very clearly post-medieval, including quartz in the build and the cob survives to the interior faces of the wall at this point. There are heavy weathered timber lintels with chamfers and run out stops to the eastern threshing opening, but there is also some patching in cream ceramic brick, which would be 19th or even 20th century in date, as it is a later material. The cob then resumes but is braced by a massive concrete block buttress, where the wall is dropping outward at first floor level.

Bays 3 and 4 have had all cob replaced in under-built rubble, as to bay 5. There is scarring and patching here in concrete block and render which suggests a building has been removed, hence the structural weakness. We know from the mapping that this was the location of the former horse engine house. Interestingly the truss foot between bays 3 and 4 is exposed here, partly rendered over showing it sitting on a horizontal thick pad of wood about 2m above the external ground level. The winnowing door occupies bay 2 of the barn, it has fine shaped oak jambs, with wide chamfers ending in run out stops c.0.3m above the ground; these are undoubtedly medieval and of high quality finish. The lintel is

16. THE NORTH ELEVATION OF B1.1, THE MAIN BARN, WITH THE BRICK OUTSHUT, B1.3, ADDED TO THE NORTH-WEST END; FROM THE NORTH

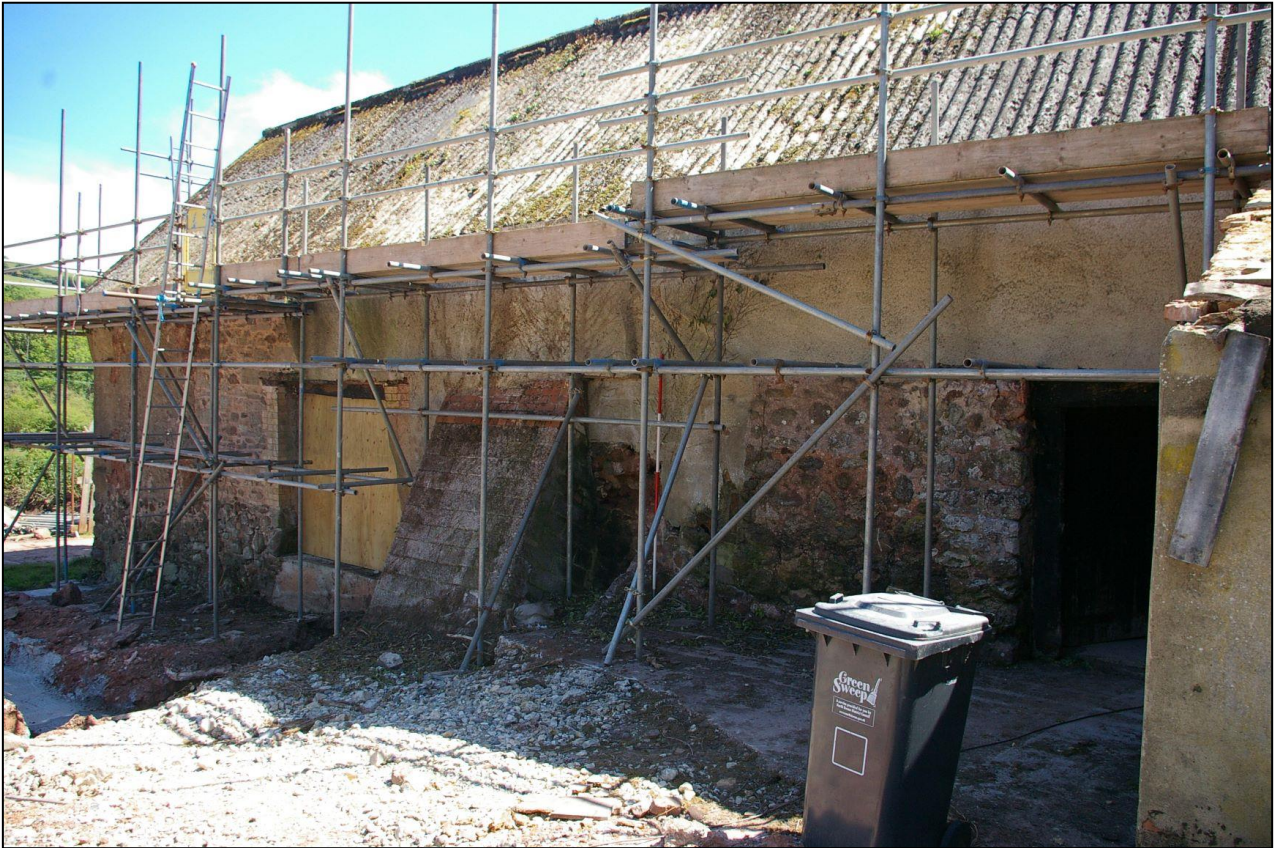
17. THE NORTH ELEVATION OF B1.1, THE MAIN BARN, WITH 2M SCALE; FROM THE NORTH-WEST.

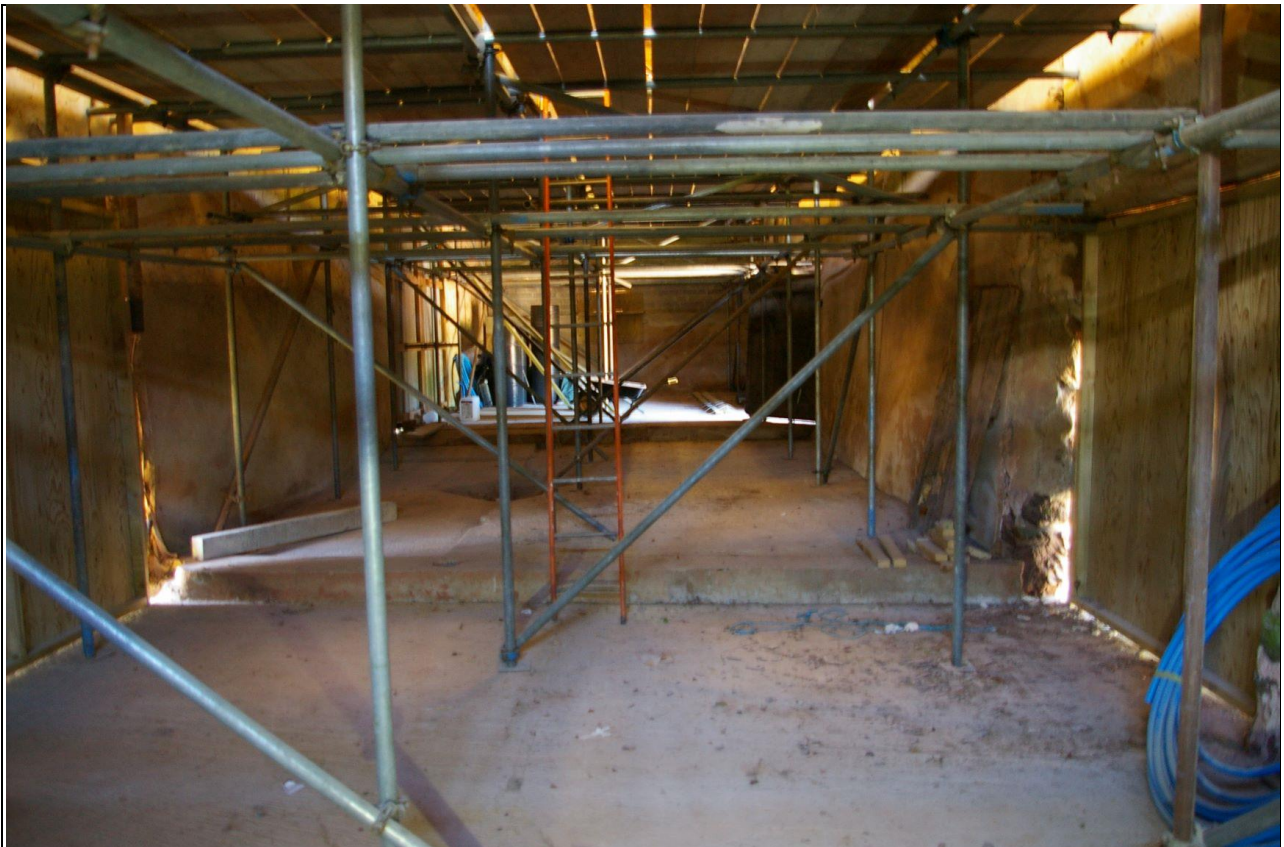
The internal faces of the barn walls have largely been rendered in modern cement, but sections of cob, with lime plaster survive. Where they do, there are distinctive layers, the cob is pale brown, as noted on the outer face of the south elevation, the lime plaster is grey coloured and mixed with horse hair, then topped with a thin coat of white lime and then lime washed. A section survives to the west end, bay 1, to both north and south walls; a section to bays 3 and 4 on the south wall; to bay 4 on the north wall and to bay 6 on the south wall. It is noted that the cob to the east end of the barn, most clear in bays 4-6 is of a slightly darker reddish-brown colour and denser in quality than to the west end. Trusses 3, 4 and 5 to this east end have exposed feet in places, the cement render cut around them; it can be seen that they project at least 2-2.5m down from the wall-plate and finish c.0.65m above the current floor level, where the timber pads have rotted they have been under-built with bricks slotted into the stonework. The end three trusses, 3, 4 and 5 were obviously intended to sit onto the stonework plinth on the inner face. There is some further internal patching in concrete block and brick where cob has fallen out, particularly to the east end of the north wall. There is a small rendered over square hollow in the wall, east of the north-east threshing door, with a chunky rendered lintel; this has been interpreted as a blocked 'keeping place' alcove for light.

25. THE INTERIOR OF THE MAIN BARN B1.1, WITH IN SITU SCAFFOLDING; FROM THE EAST.

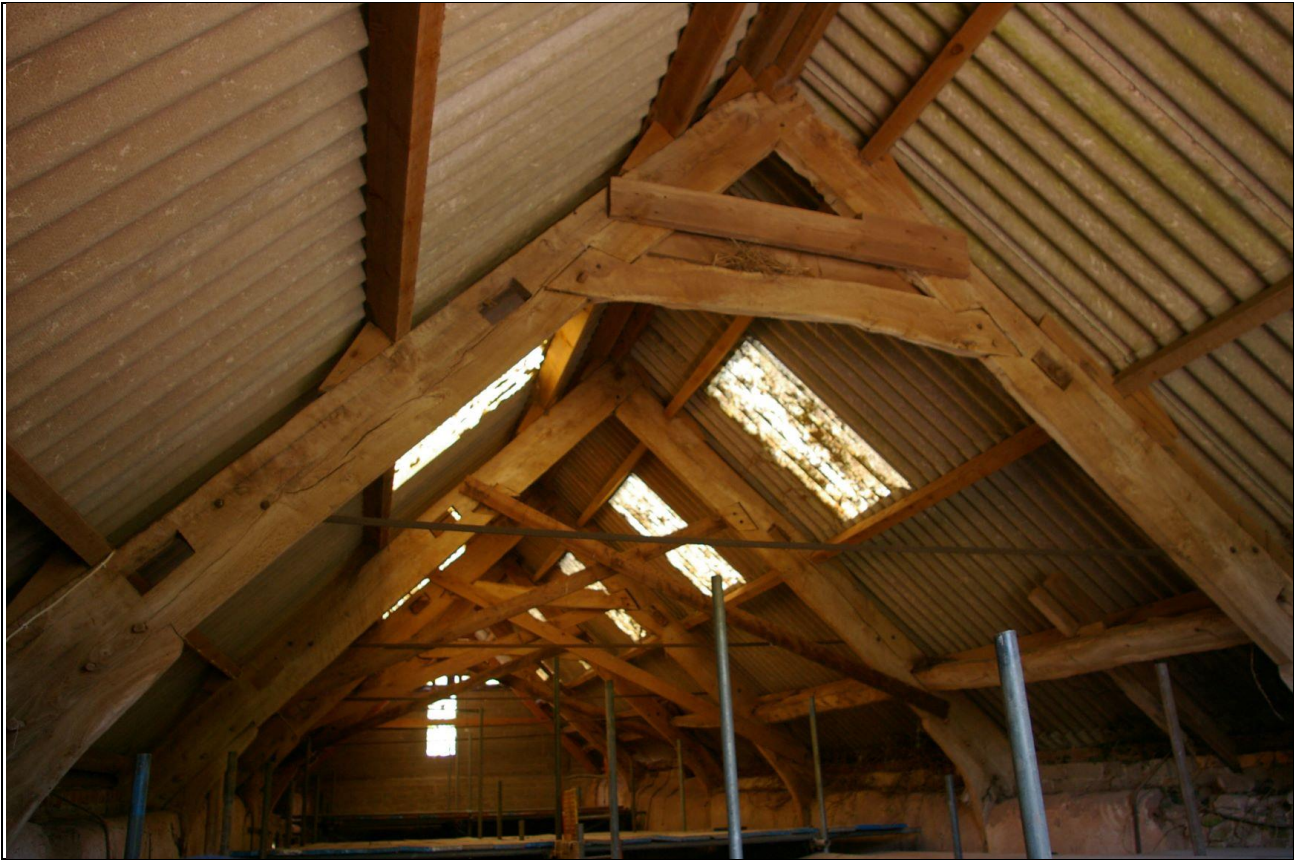
26. THE JOINTED CRUCK ROOF STRUCTURE OF B1.1, THE MAIN BARN; FROM THE SOUTH-EAST CORNER, BAY 6.

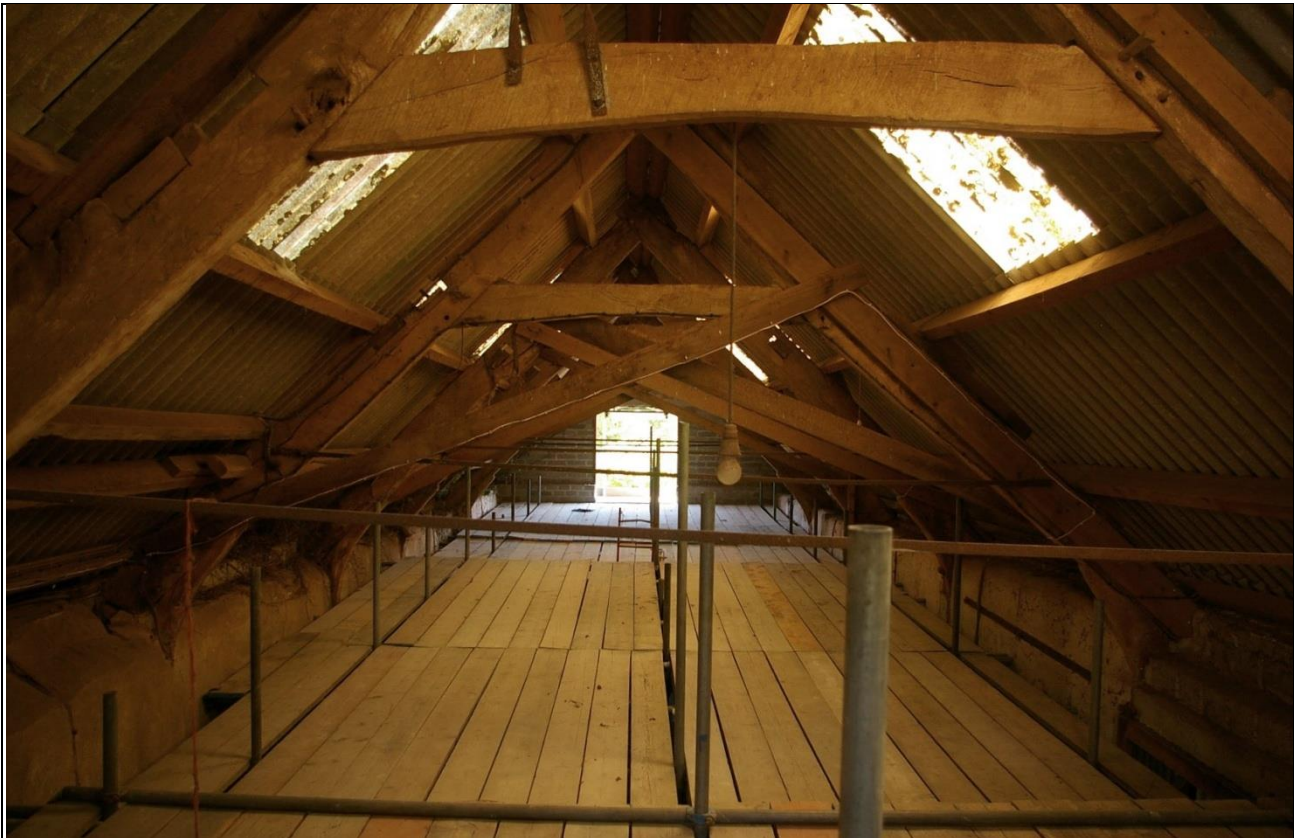
2	Jointed Cruck	Oak Truss. Blades much rougher than the other trusses. Narrower almost square profile blades. Two sets of deeply trenched sockets in the back of the blades. Much smaller shallower sharply curved feet, lightweight scantling, six pegs to north, seven pegs to south. Feet are much shorter only run c.1.5m down the wall, sit on pads set high in the walls. Knotches at different heights of both blades and one to the back side of the oak blade, suggestive of this being a reused timber?
3	Jointed Cruck	Elm Truss. Deep, but narrow tapered blades, very heavy scantling. Wide slightly curved feet, deeply set down into the walls, c2.5m from the wall-plate. Feet rise 0.5m up from the top of the barn walls. Four pegs to either side. Narrow rectangular sockets cut into blades for two threaded purlins to each pitch. Purlins, where they survive, pegged together, tapered to overlap/butt in socket. Knotches to north blade, suggesting this has been propped – associated with an extension of the barn at some stage? The full square socket for treaded ridge survives to the top blade here.

27. THE JOINTED CRUCK ROOF OF THE BARN, B1.1; FROM THE WEST, BAY 1, SHOWING THE DIFFERENT TRUSS TYPE FOR TRUSS 1 AND 2.

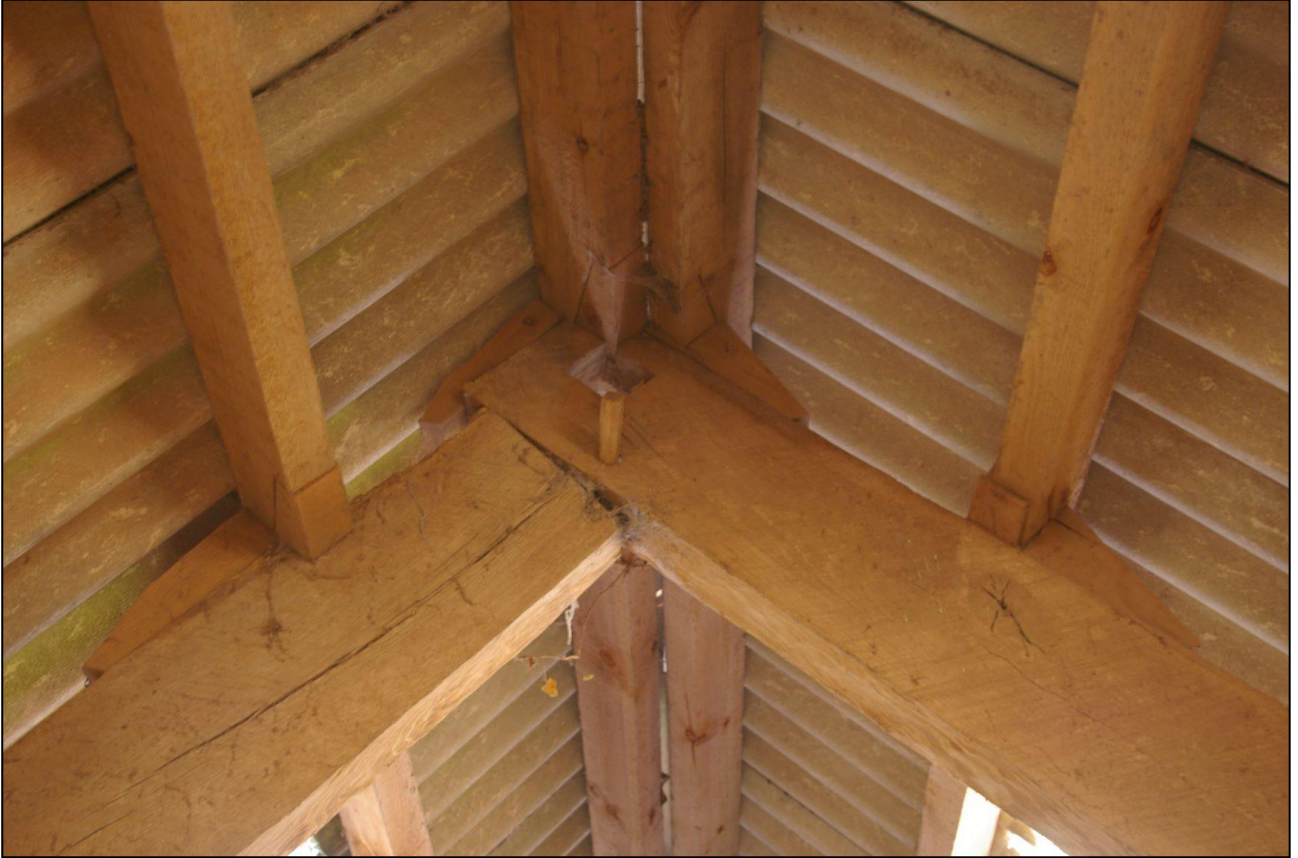
28. UNALTERED RIDGE, SHOWING THE RIDGE POLE WAS ORIGINALLY THREADED; FROM THE WEST, TRUSS 4.

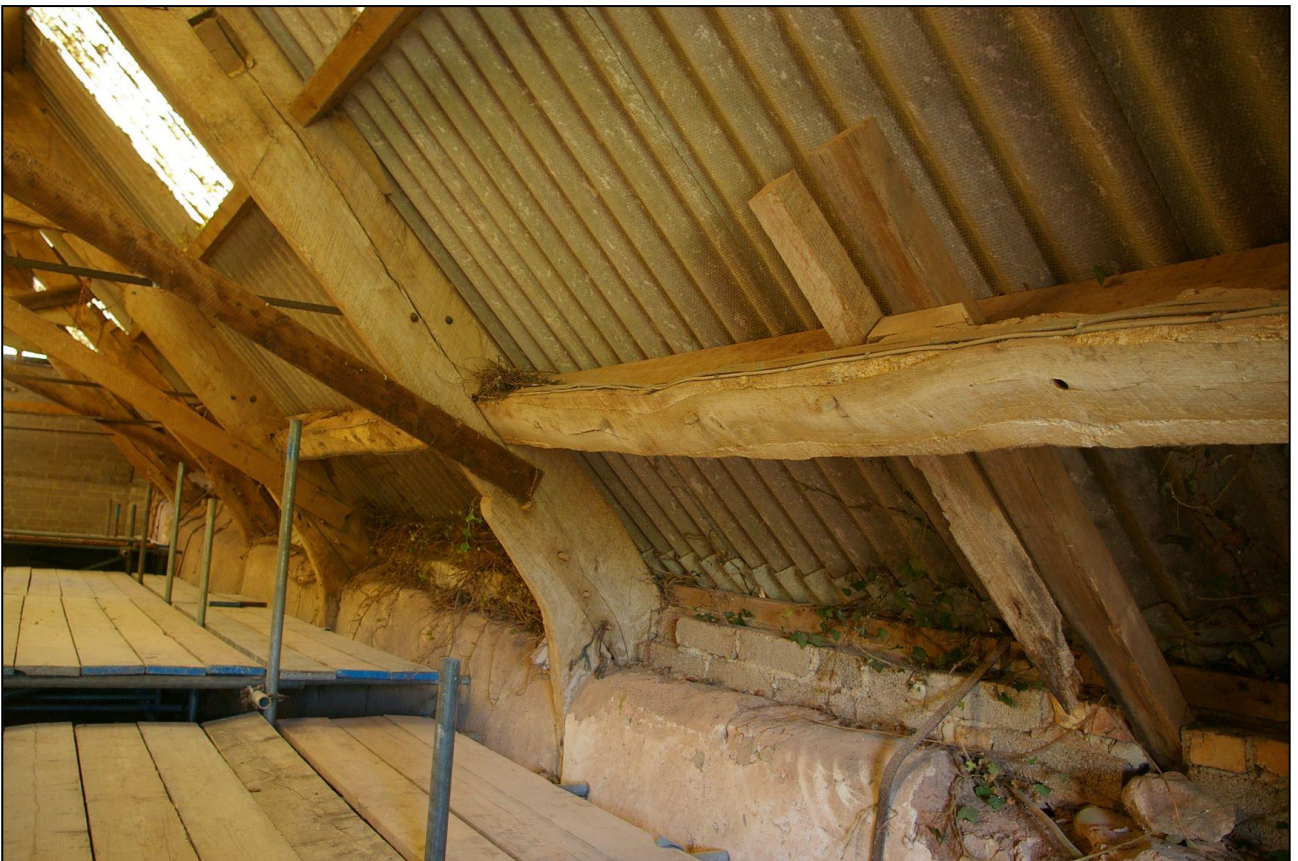
29. DETAIL OF THREADED BUTT PURLINS, FOR TRUSSES 3 AND 4, PEGGED TOGETHER IN THE SOCKET, FOR BAYS 4 AND 5; FROM THE SOUTH-EAST.
