TREVEDDA FARM
LANTEGLOS HIGHWAY
FOWEY
CORNWALL

Heritage Assessment

South West Archaeology Ltd. report no. 200510

Draft issued: 29th May 2020
Finalised: 9th June 2020

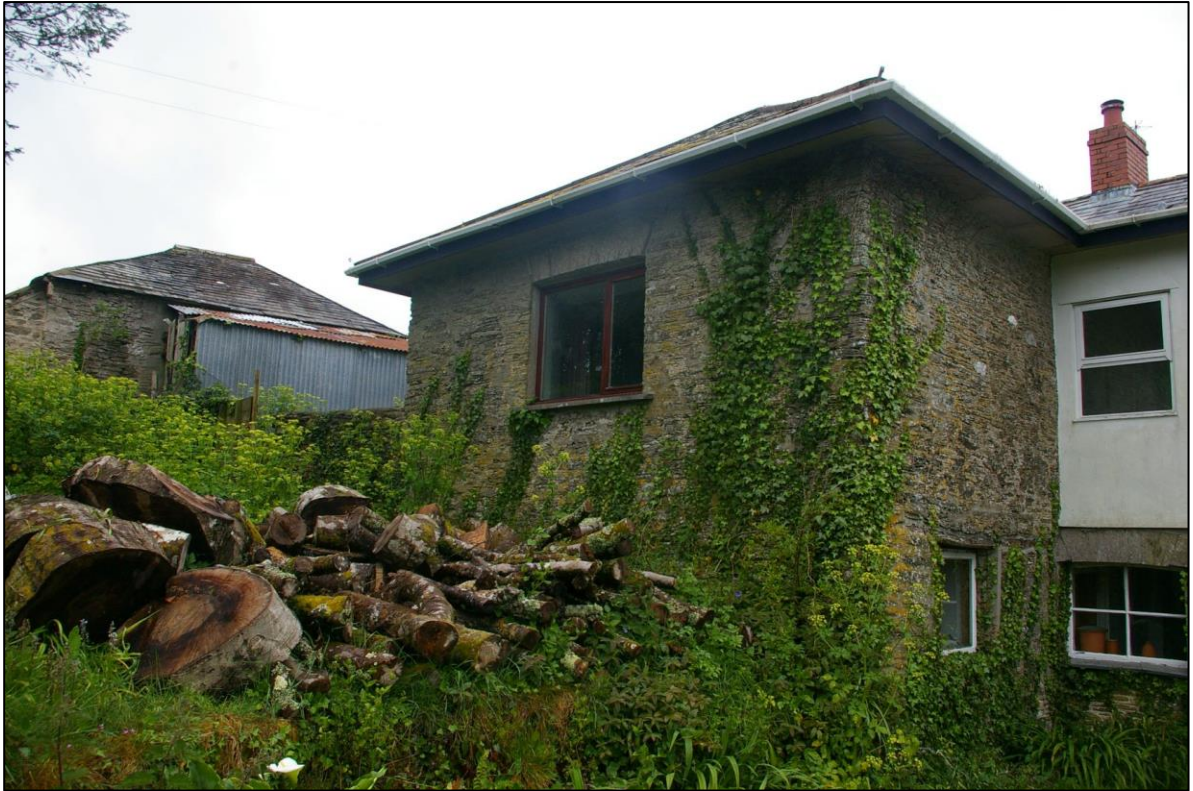
The west flank wall of the west wing is of earlier stonework to the lower one and a half storeys, battered, stopping short of the south wall by 2m, again with a clear build line. There is a raise above at the eaves and with the front south-west corner having been totally rebuilt and the south elevation replaced. It has a lot of interesting detail and phasing, with a small ground floor window offset north of centre, with heavy oak lintel and small 19th century casements, it then has a central first floor window which has been forced into the older stonework, but is correct within the raise, this has a modern casement. At ground floor level within the rebuilt section to the south there is a large doorway, with voussoirs, which is now partly blocked with a modern casement window. The presence of the doorway would suggest levels have been significantly altered here as outside the ground level is at first floor height, blocking any sensible form of access.

1. THE WEST WING AT TREVEDDA; FROM THE SOUTH-WEST.

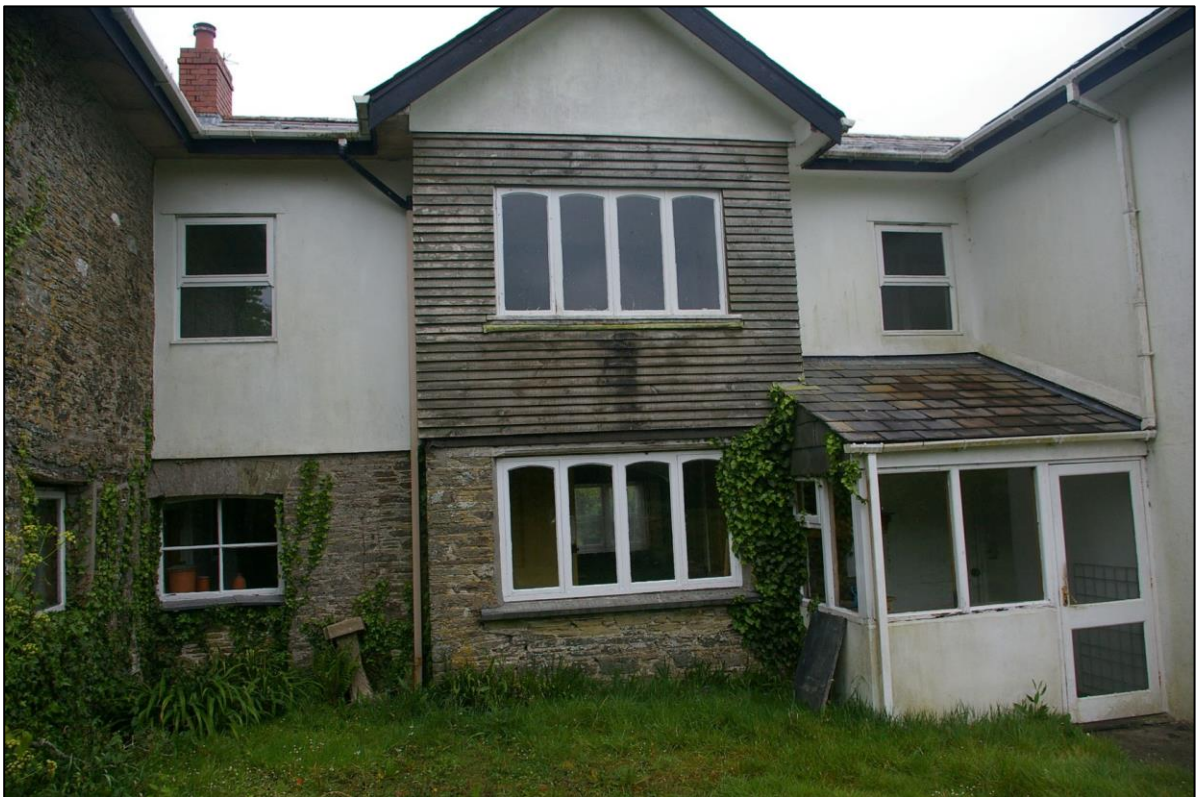
2. THE CENTRAL RANGE OF THE SOUTH ELEVATION, WITH GABLED STAIR PROJECTION; FORM THE SOUTH-SOUTH-WEST.

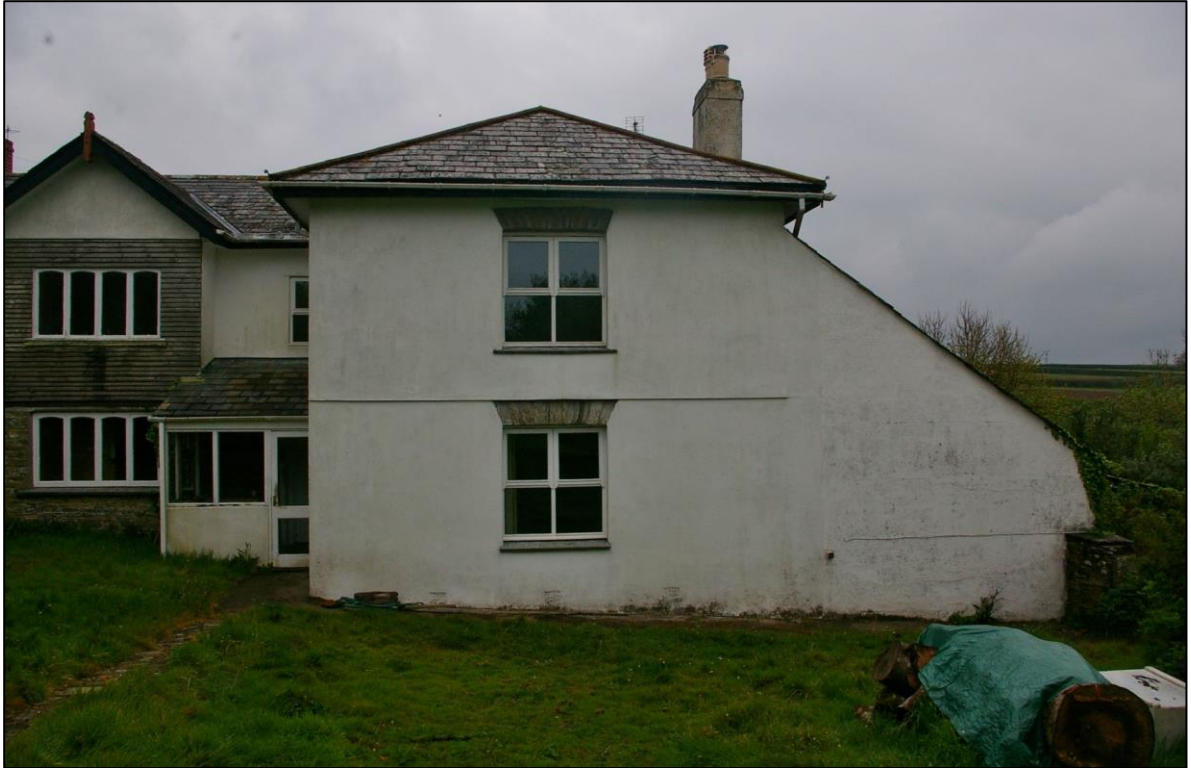
The south elevation has a wide squat projecting east wing, which is rendered and painted, with symmetrically positioned windows, facing south, to ground and first floor, both replaced with mid-20th century timber frames. To the centre the walls are rendered above and exposed repointed stonework below, with a shallow stair projection with gabled detail; this projection was obviously formerly slate hung but is now set with timber boarding, it has two long symmetrically positioned windows, both large four light modern casements. A timber and plastic porch/sunroom has been built into the angle with the east wing, over the front door. To the west is a narrower longer projecting wing, partly set into the slope of the bank, with exposed stonework elevations. There is a large first floor window in its south wall and a ground floor modern window on its east return wall, within a longer blocked opening, under a heavy weathered timber lintel (Figure 4). This wing has received a half storey raise and potentially the whole front south wall has been rebuilt.

3. THE EAST WING AT TREVEDDA; FROM THE SOUTH.

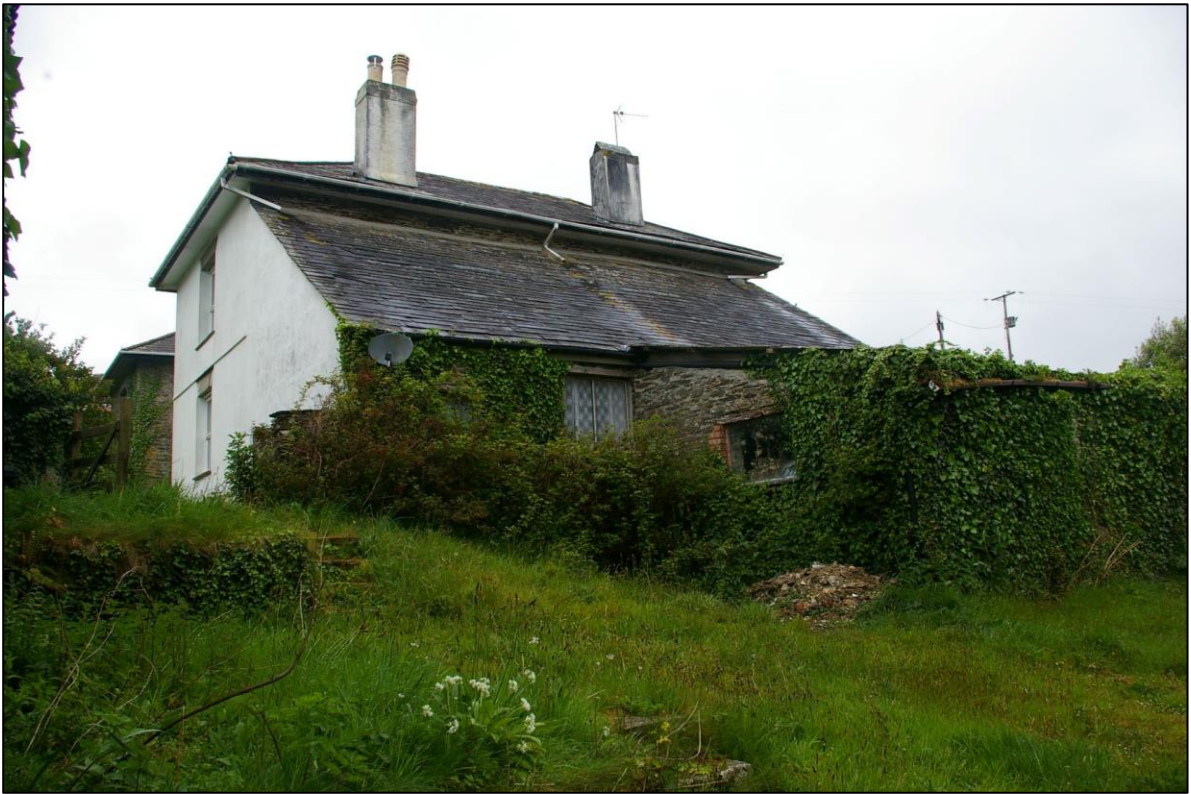
The east flank wall of the east wing is largely obscured by the series of lean-to outbuildings, but within these structures it can be seen that there is a small square block to the north of some considerable age and the southern half of the wing is a more recent extension, with defined build line between. The north end is of much heavier cruder stonework, battered and has a plinth, seemingly with a cob or clay bond, externally re-pointed in lime, with an integral end stack. To the south is a looser build, of semi-coursed stonework, with shallow internal stack, thickly mortared in lime.

4. THE EAST FLANKING WALL OF THE HOUSE, WITH ATTACHED OUTBUILDINGS; FROM THE EAST-SOUTH-EAST.

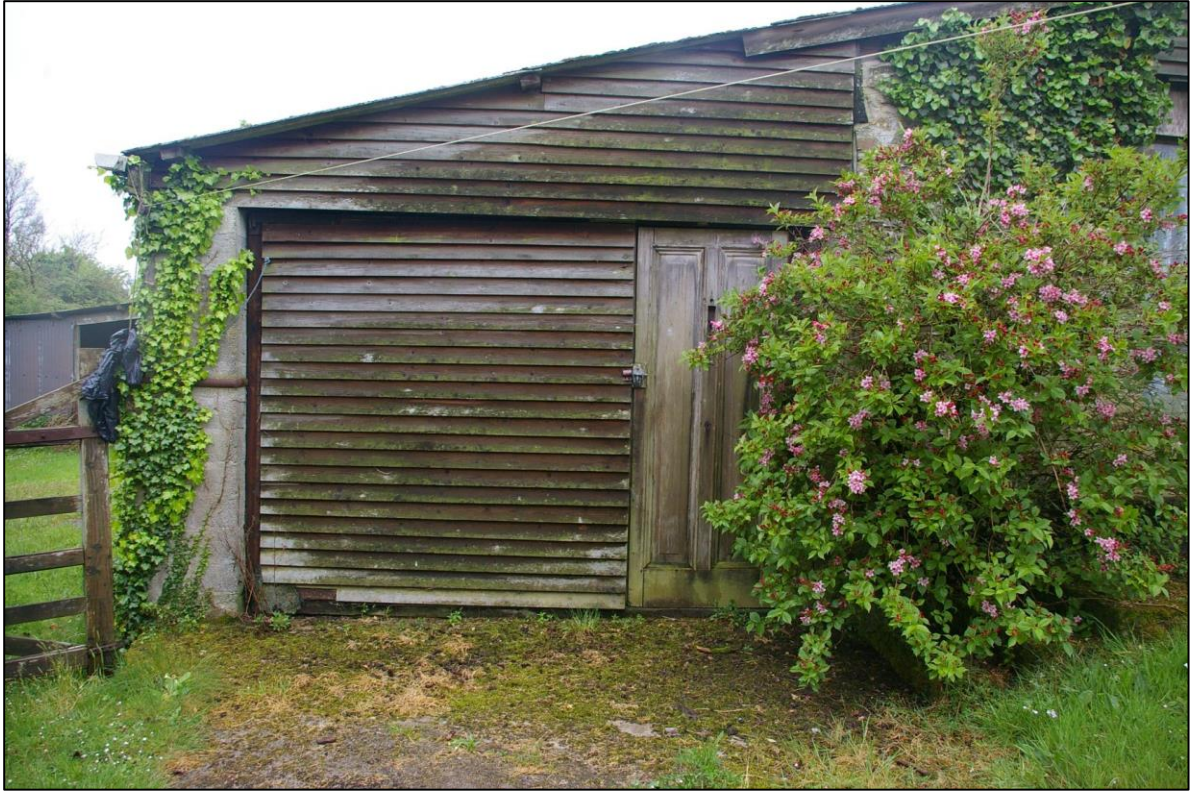
5. OB2, THE NORTH FRONT, SHOWING BOARDING; FORM THE NORTH.

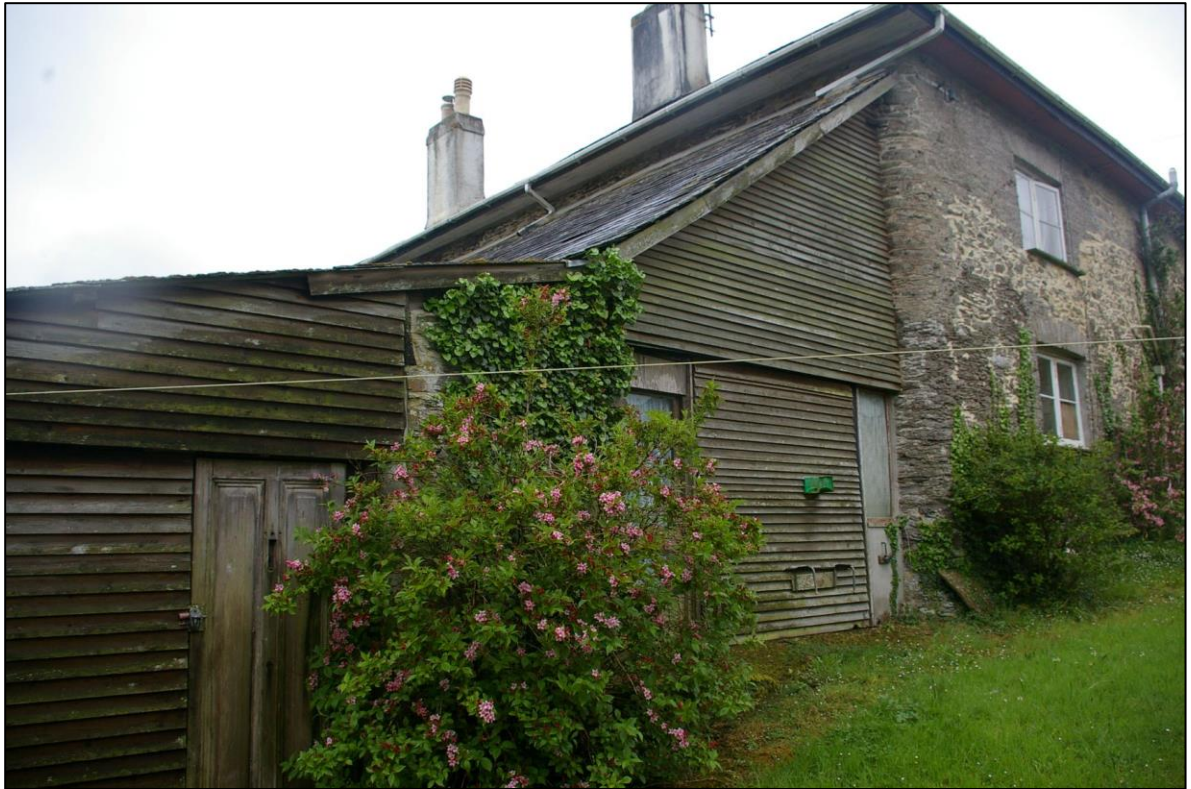
7. OB1, ATTACHED TO THE EAST WALL OF THE HOUSE; FROM THE EAST-NORTH-EAST.

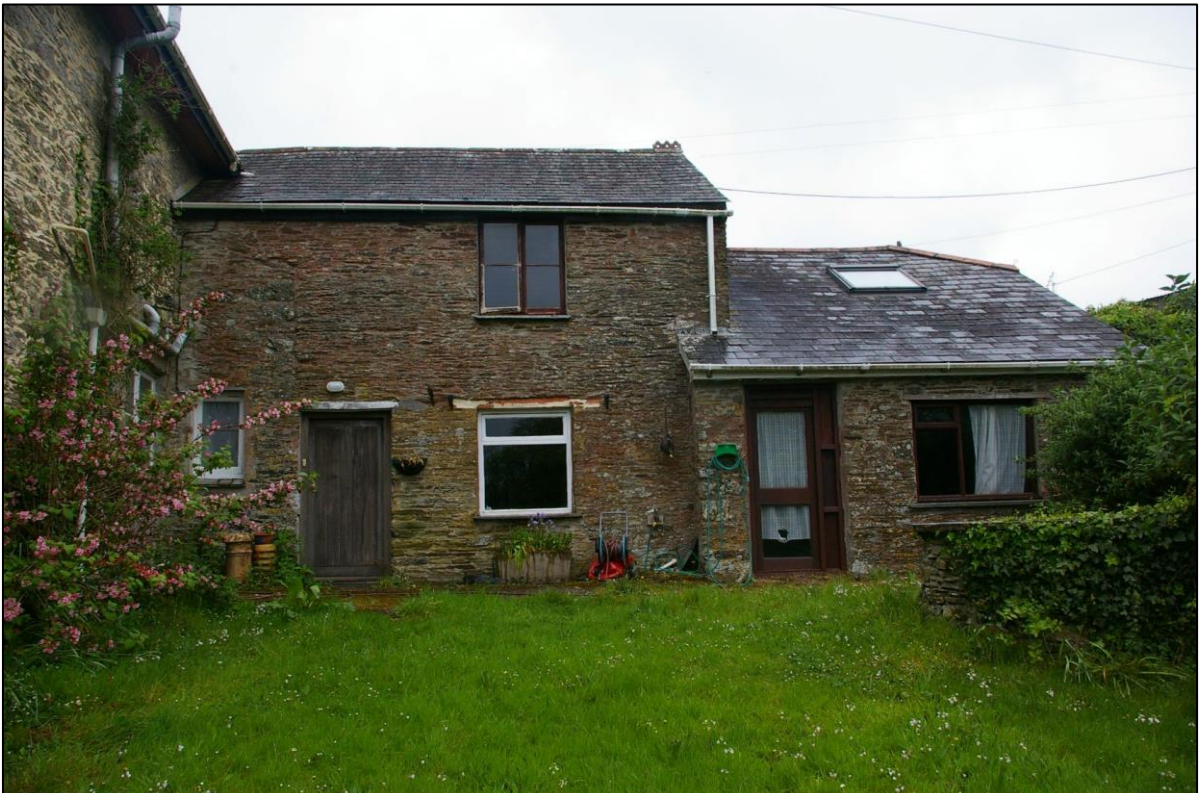
10. THE EAST WALL OF THE REAR SERVICE WING; FROM THE EAST.

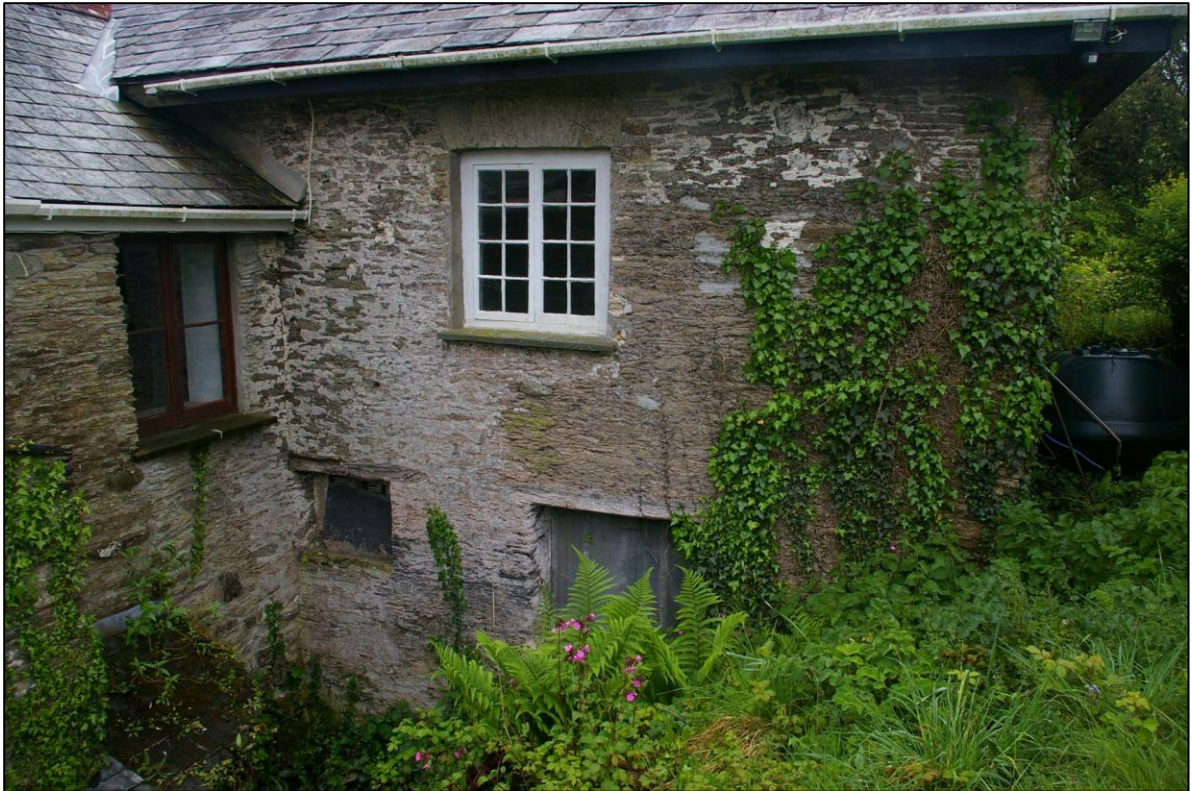
13. THE NORTH WALL OF THE WEST CROSS-WING; FROM THE NORTH-WEST.

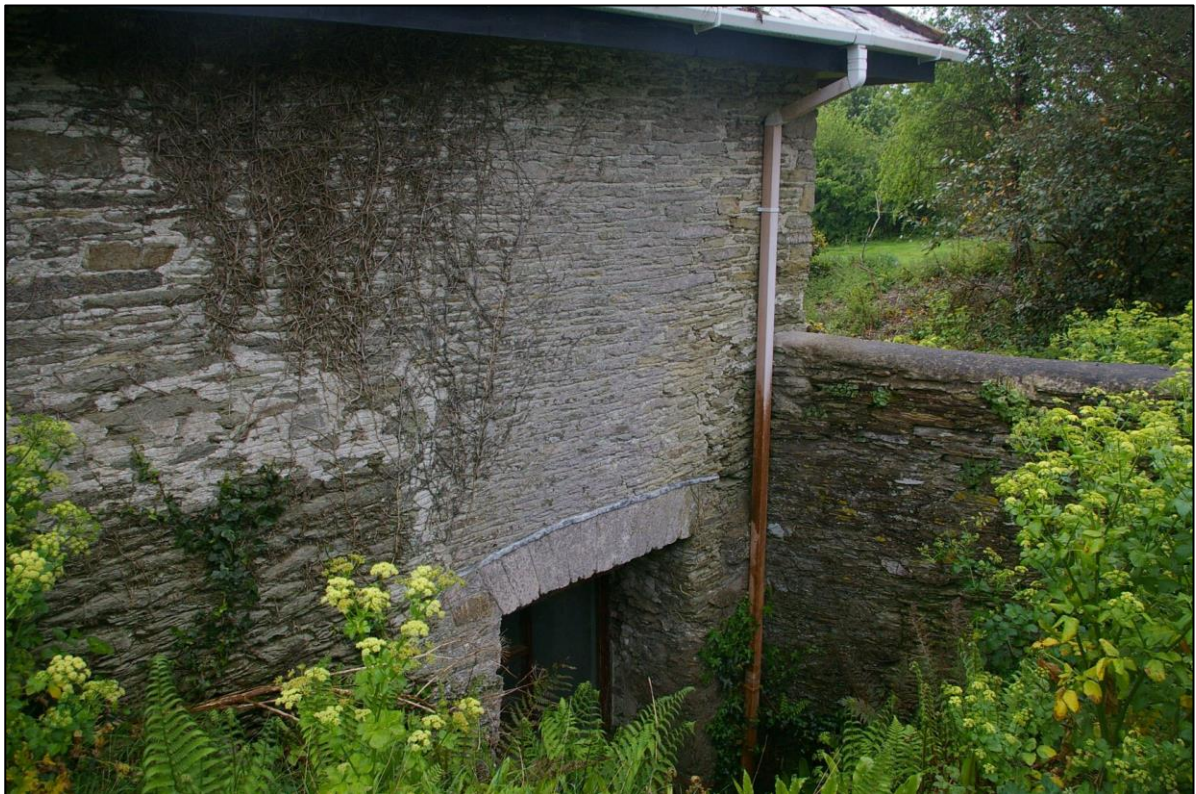
14. THE SOUTH END OF THE WEST WALL OF THE WEST CROSS-WING; FROM THE NORTH-WEST.

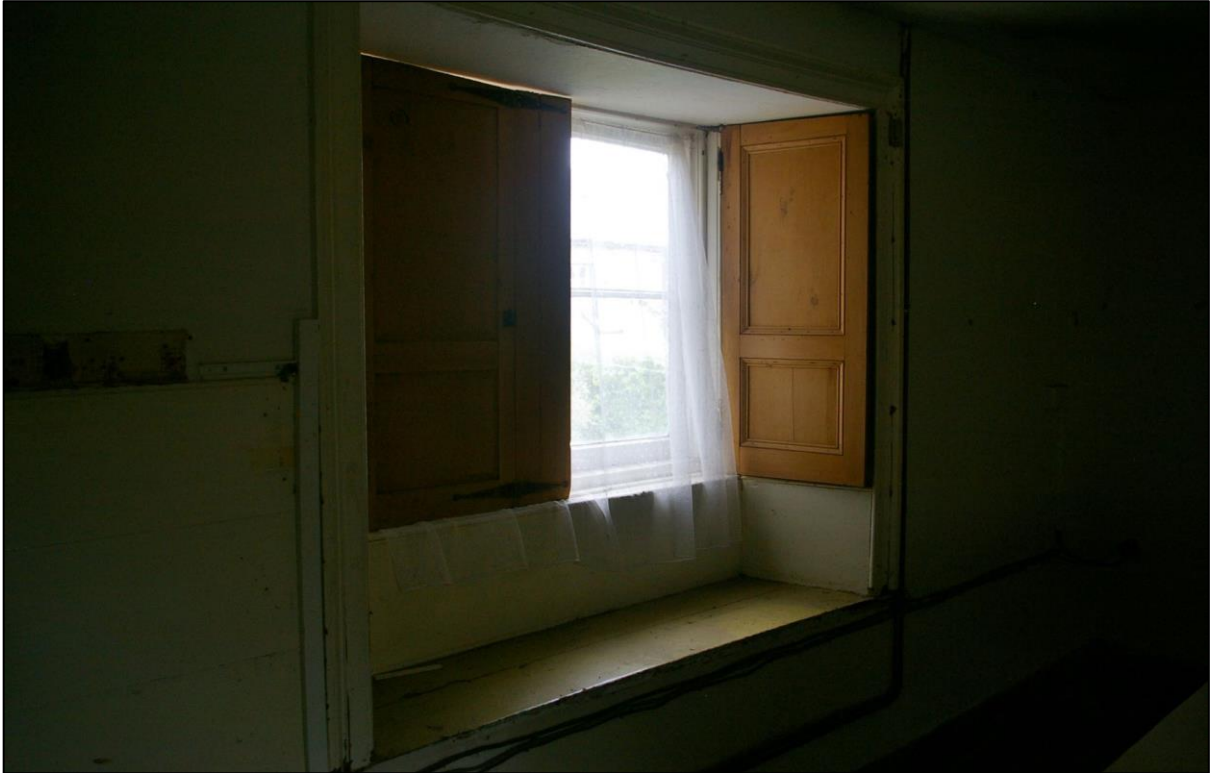
18. THE WINDOW WITH GOOD PANELLED CASEMENT AND WINDOW SEAT AND GOOD WINDOW FRAME, IN R2A; FROM THE SOUTH-WEST.

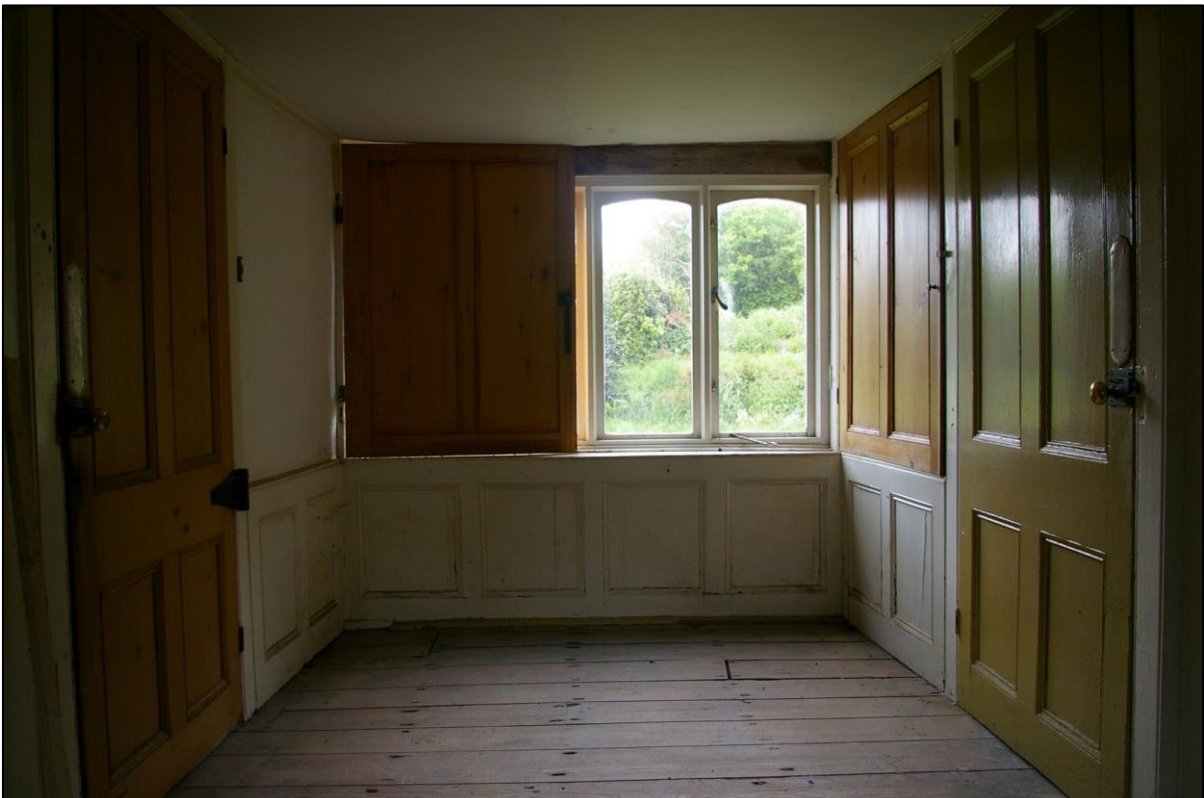
23. R2B, DETAIL OF THE PANELLING AND SHUTTERS; FROM THE NORTH.

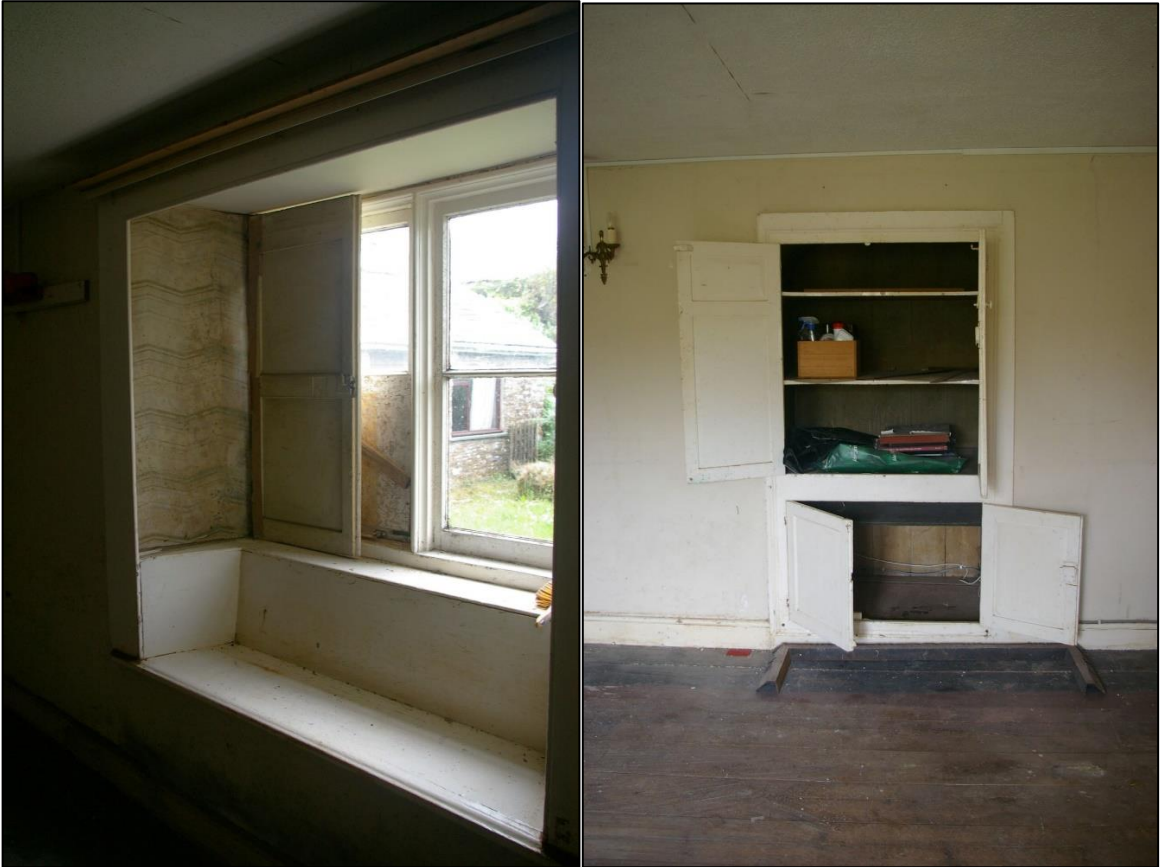
26. LEFT: THE WINDOW IN THE NORTH WALL OF R3, WITH GOOD PANELLED CASEMENT, WINDOW SEAT AND SHUTTERS; FROM THE EAST.
27. RIGHT: THE CUPBOARD IN R3, IN THE SOUTH WALL, IN A BLOCKED DOORWAY; FROM THE NORTH.

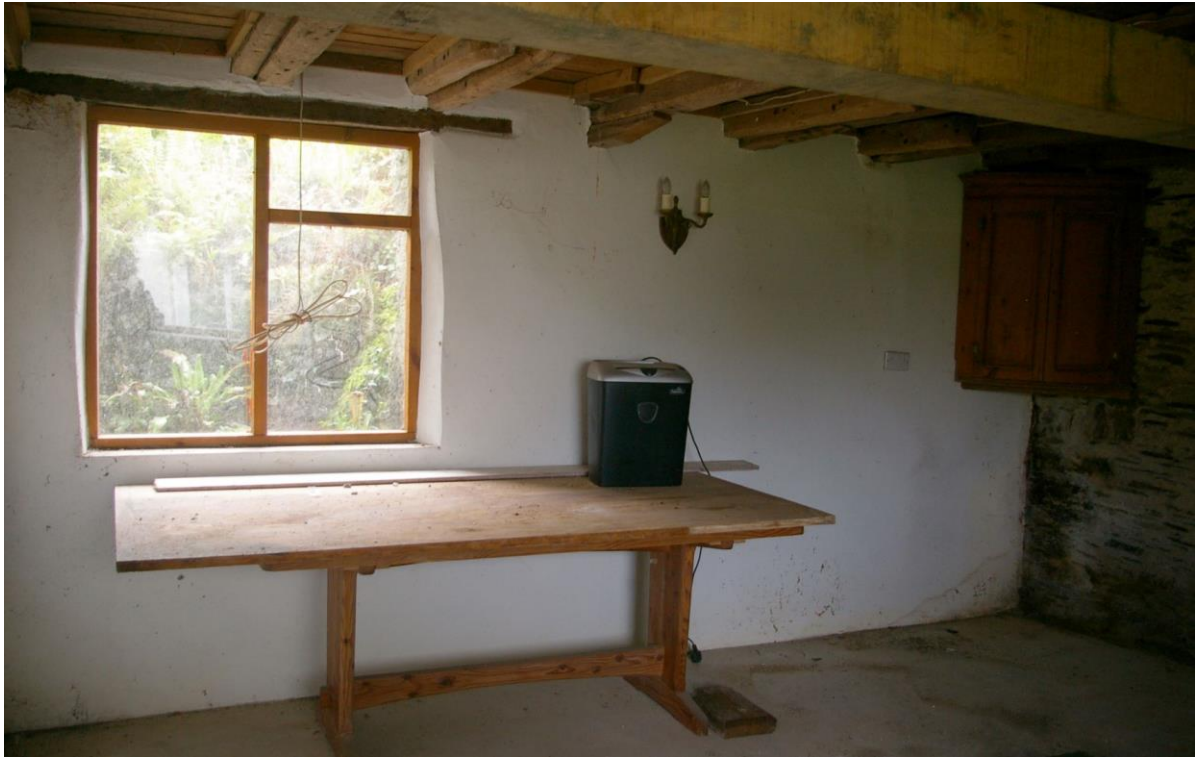
32. THE WEST WALL OF R5, WITH WINDOW IN THE BLOCKED DOORWAY; FROM THE SOUTH-EAST.

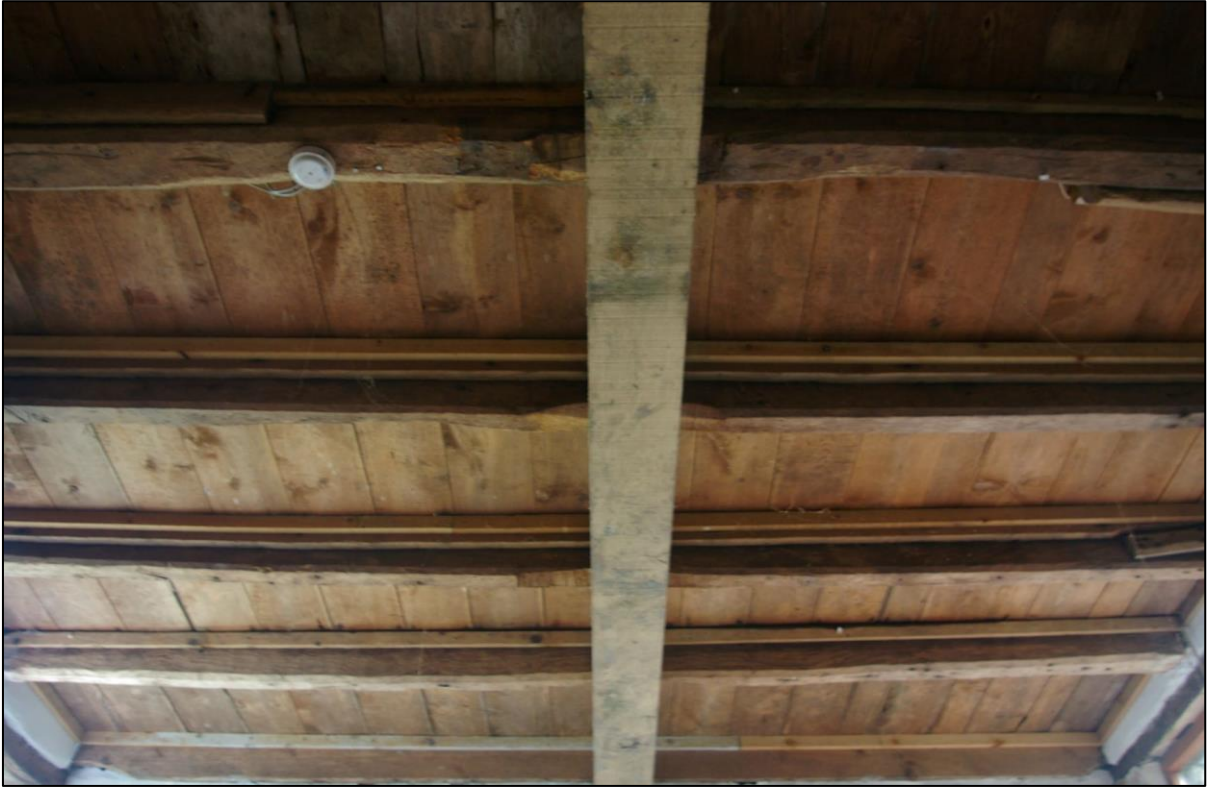
is the original floor level with very worn slate slabs. The ceiling is made from good 17th century square chamfered oak joists, reset here, which have had to be braced by thick pine timbers at each end, fixed with clenched nails and spikes, an 18th or early 19th century repair, seemingly due to the walls being altered or ceiling heights being raised and the building extended? There is a recent heavy central beam, which does not fill the massive beam socket on the north wall, suggesting a fair large beam once braced this space. There is a fine semi-circular panelled corner cupboard in the north-west corner. A massive beam with chamfer and cut stops, of 17th century character braces the east wall of this space, which was once clearly open at this south end of the wing, presumably an animal house or milking parlour.

34. THE CEILING OF R5; FROM THE NORTH.

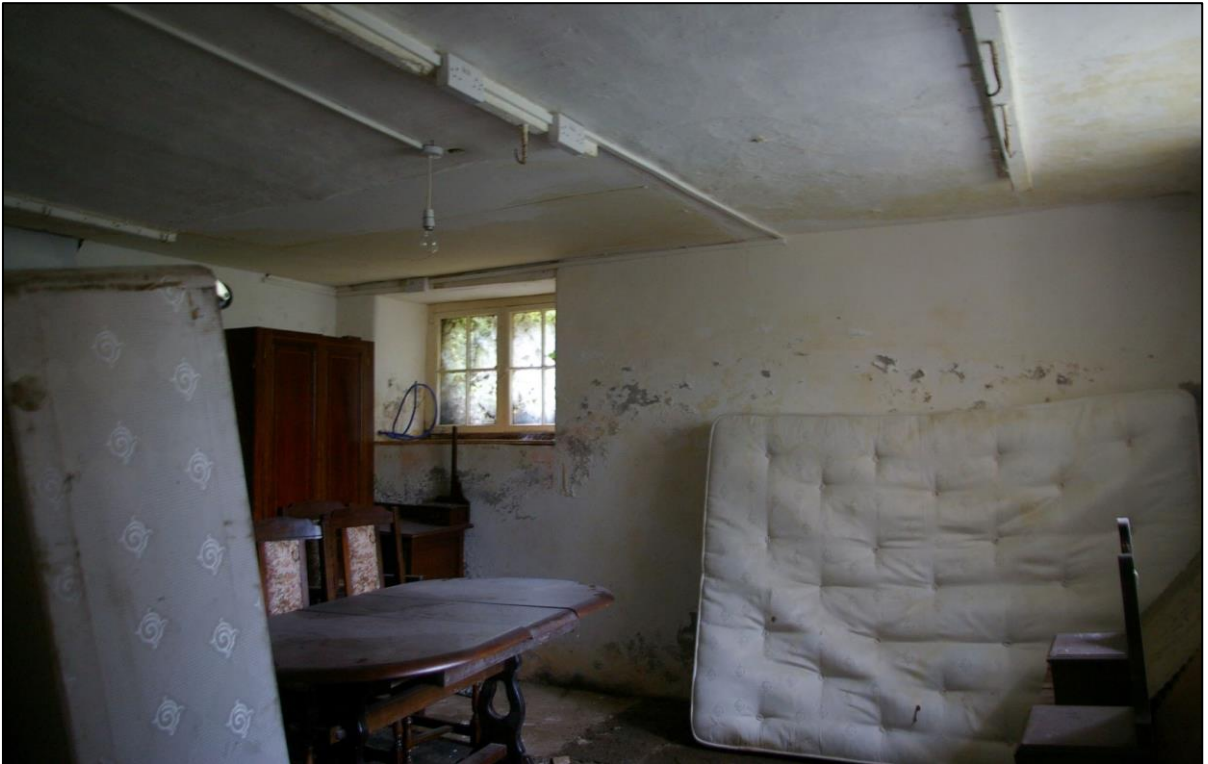
36. R6, WITH WINDOW TO WEST WALL, GOOD FLOOR AND BEAMS AND HOOKS TO CEILING; FROM THE NORTH-EAST.

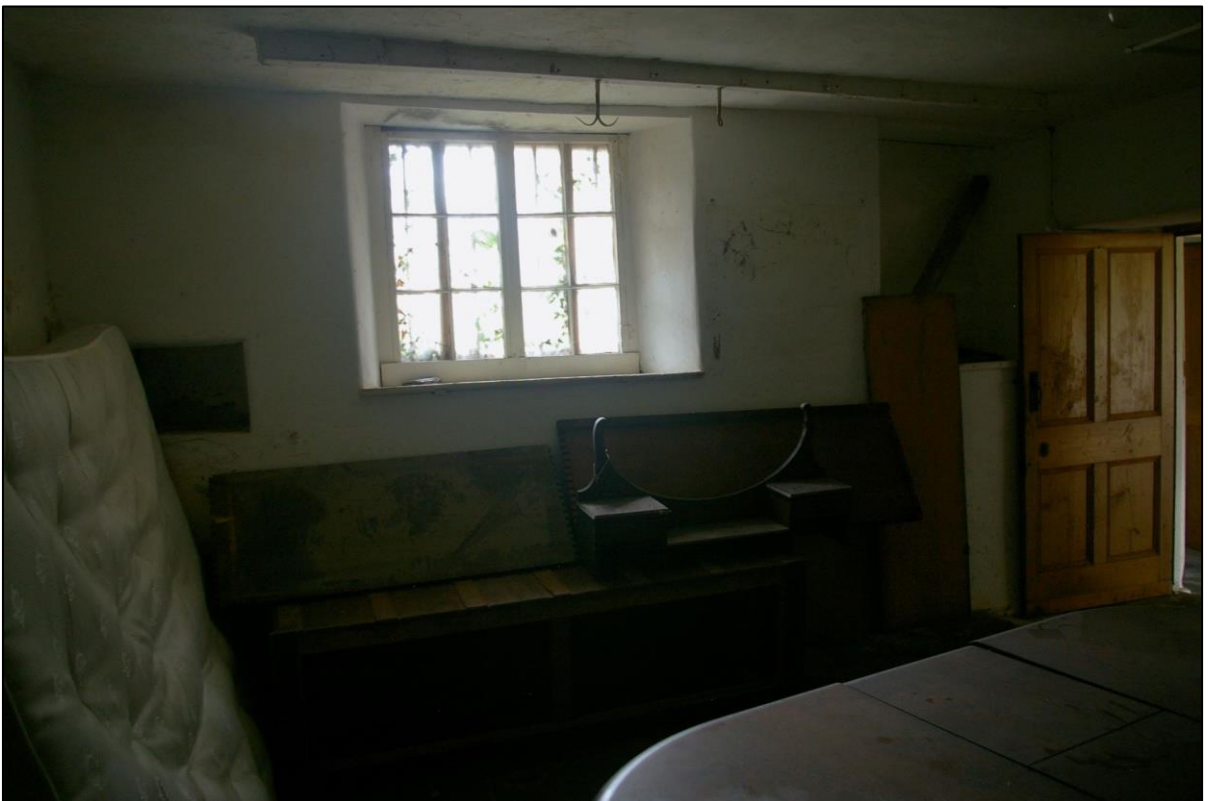
37. THE NORTH WALL OF R6, WITH EXTANT WINDOW AND WINDOW SEAT AND BLOCKED WINDOW; FROM THE SOUTH-WEST.

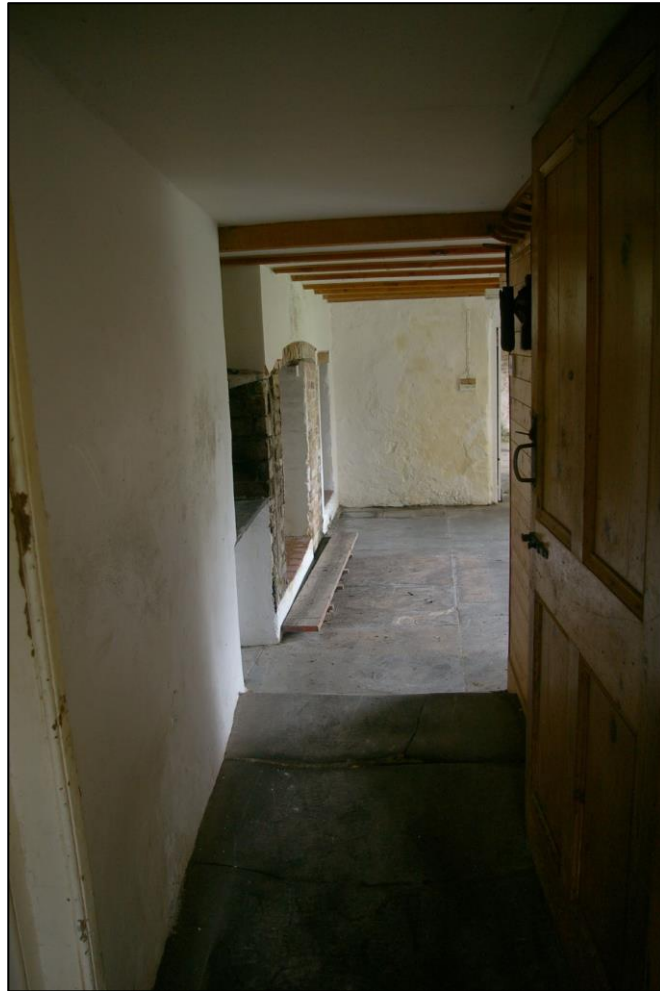
38. THE DOORWAY AND CORRIDOR INTO THE REAR SERVICE WING; FORM THE SOUTH.

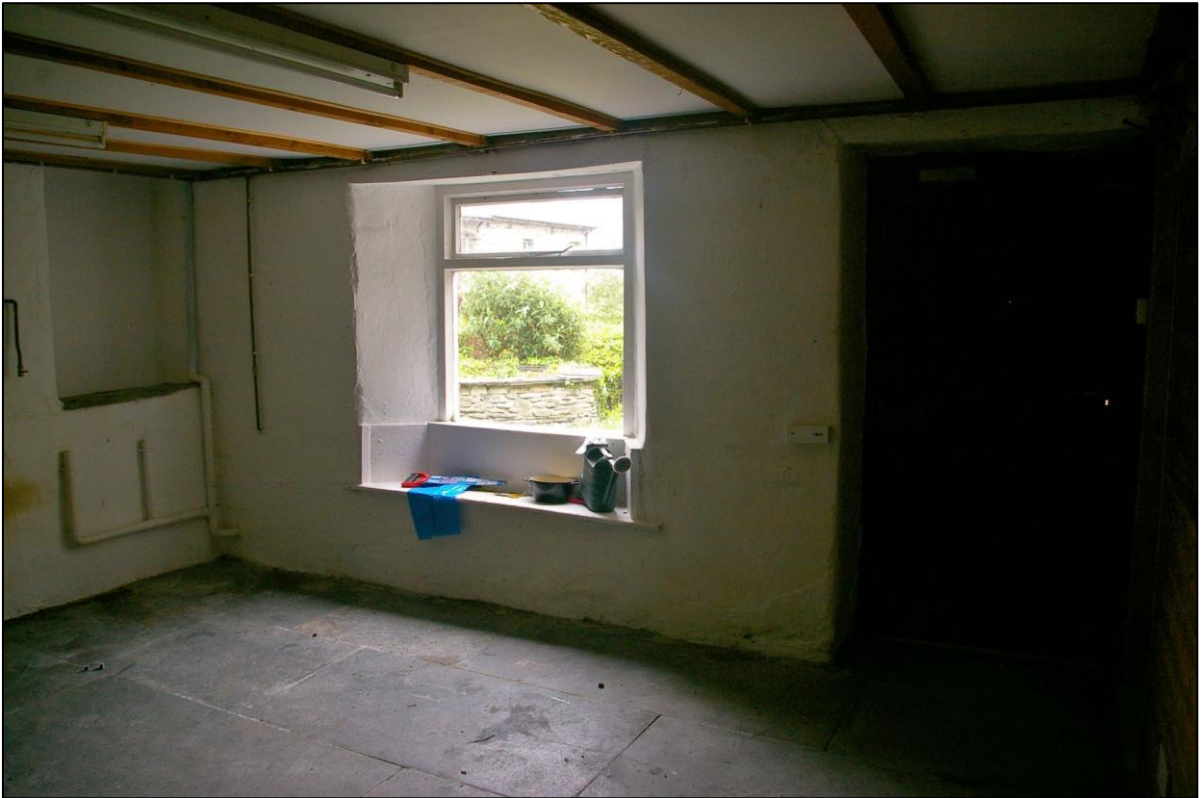
40. R7, THE EAST WALL WITH GOOD WINDOW SEAT AND EXTANT DOOR; FROM THE SOUTH-WEST.

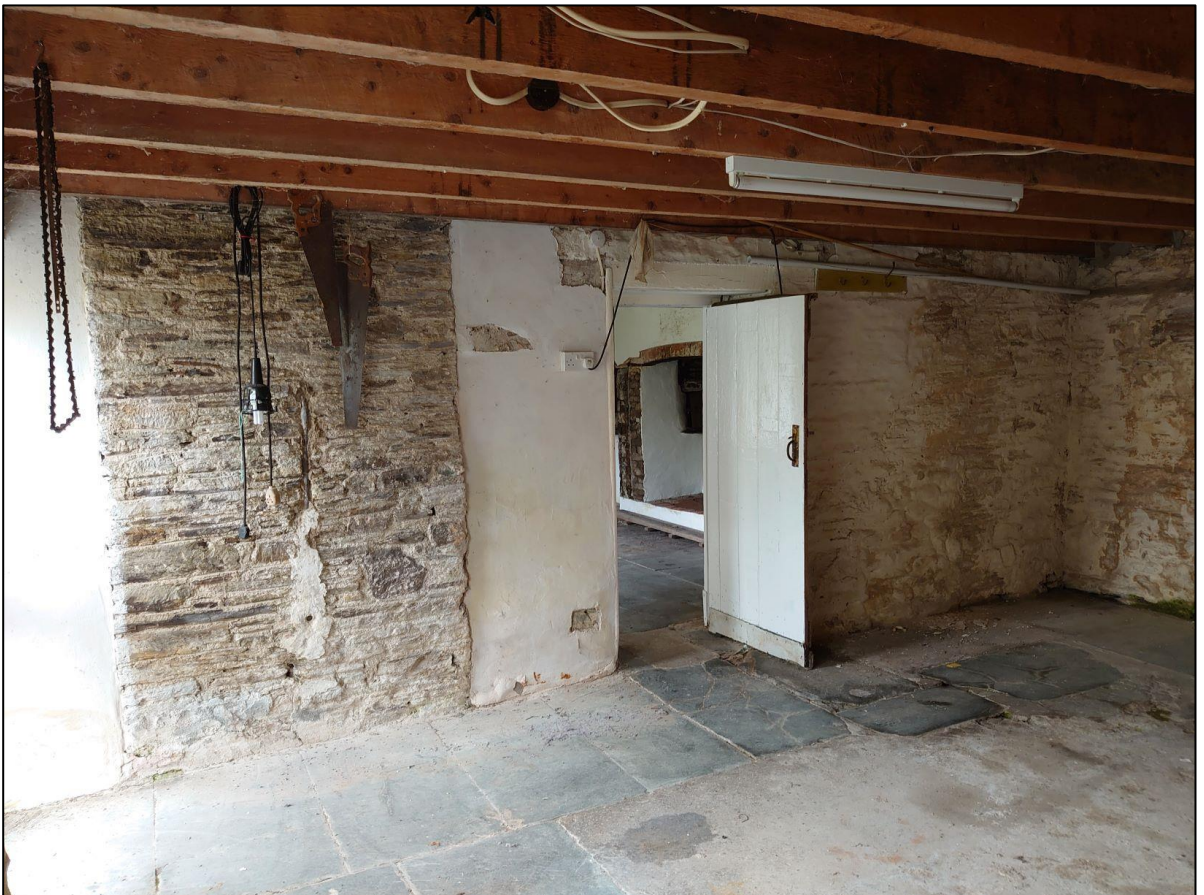
41. R8, THE SOUTH WALL, WITH DOOR LEADING BACK TO R7; FROM THE NORTH-EAST.

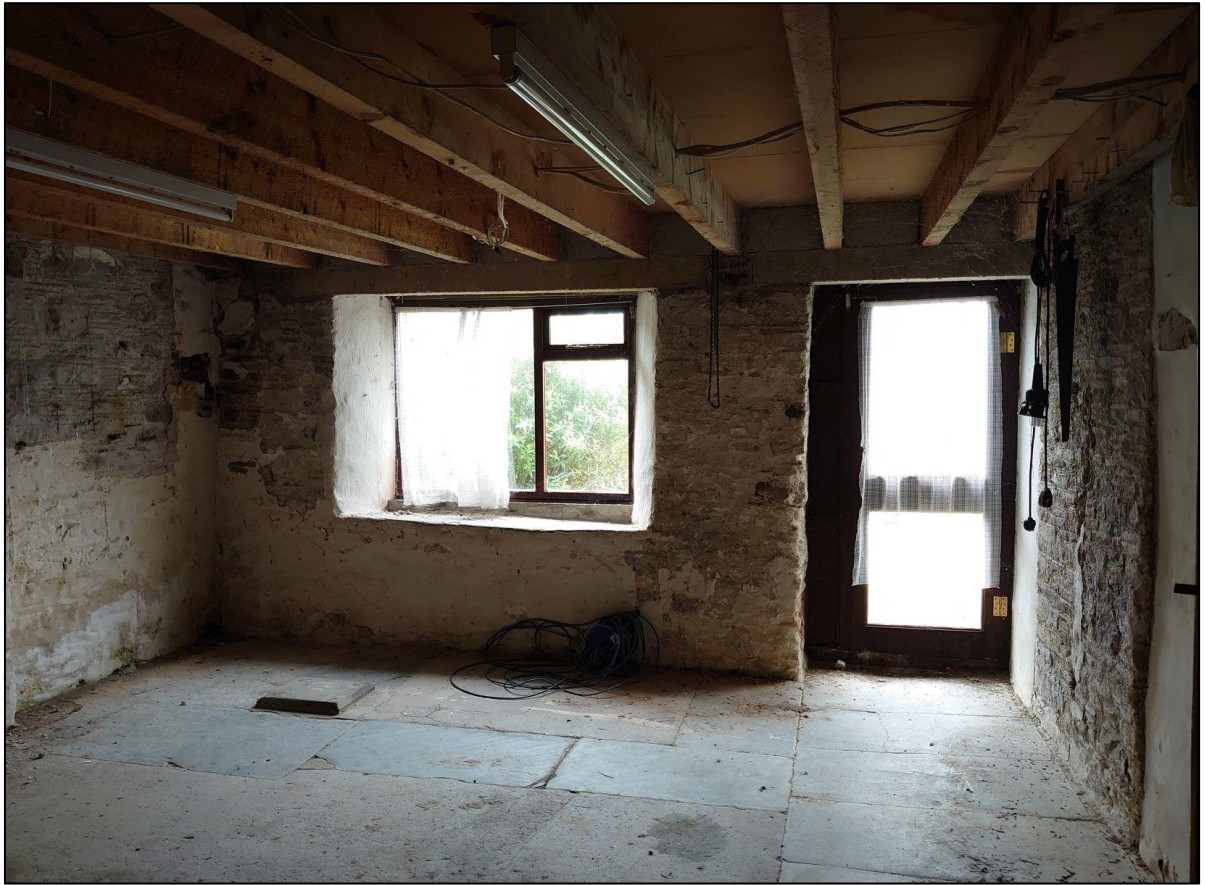
42. R8, WITH PARTS OF A GOOD FLAGSTONE FLOOR AND MODERN DOOR AND WINDOW TO THE EAST WALL; FROM THE SOUTH-WEST.

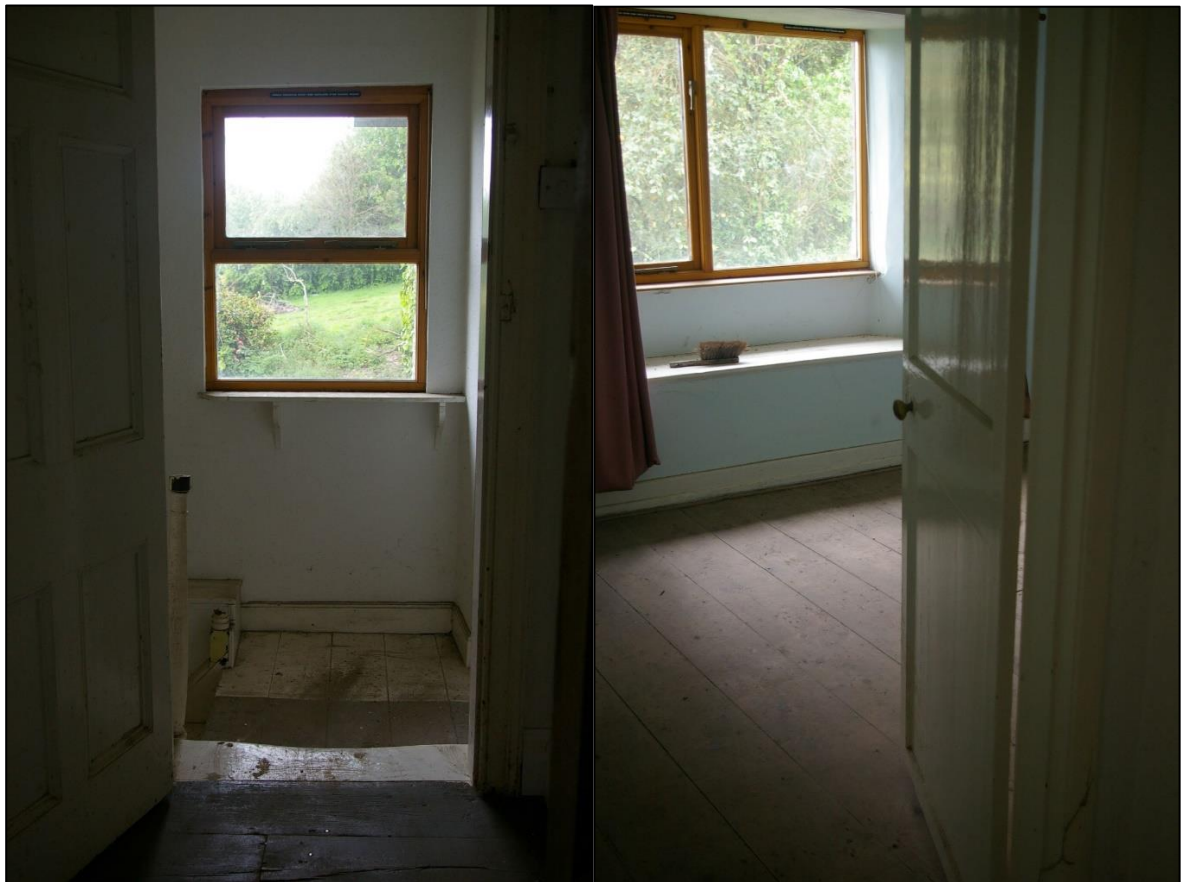
43. LEFT: ROOM 9, THE LANDING AT THE TOP OF THE WEST STAIRS; FROM THE NORTH.

44. RIGHT: ROOM 11, TO THE SOUTH OF THE CROSS-WING; FROM THE NORTH-EAST.

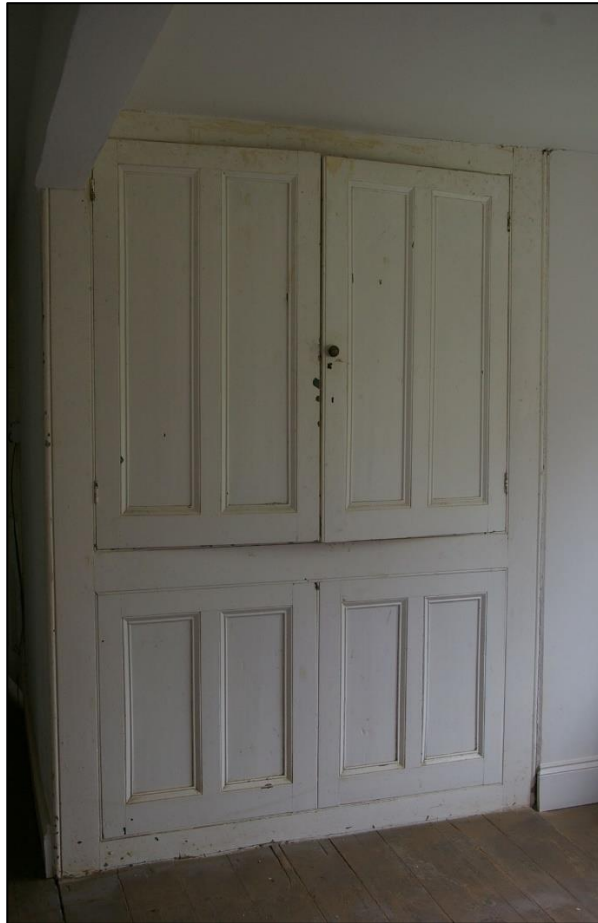
47. EXAMPLE OF THE GOOD PANELLED CUPBOARDS IN R13; FROM THE WEST.

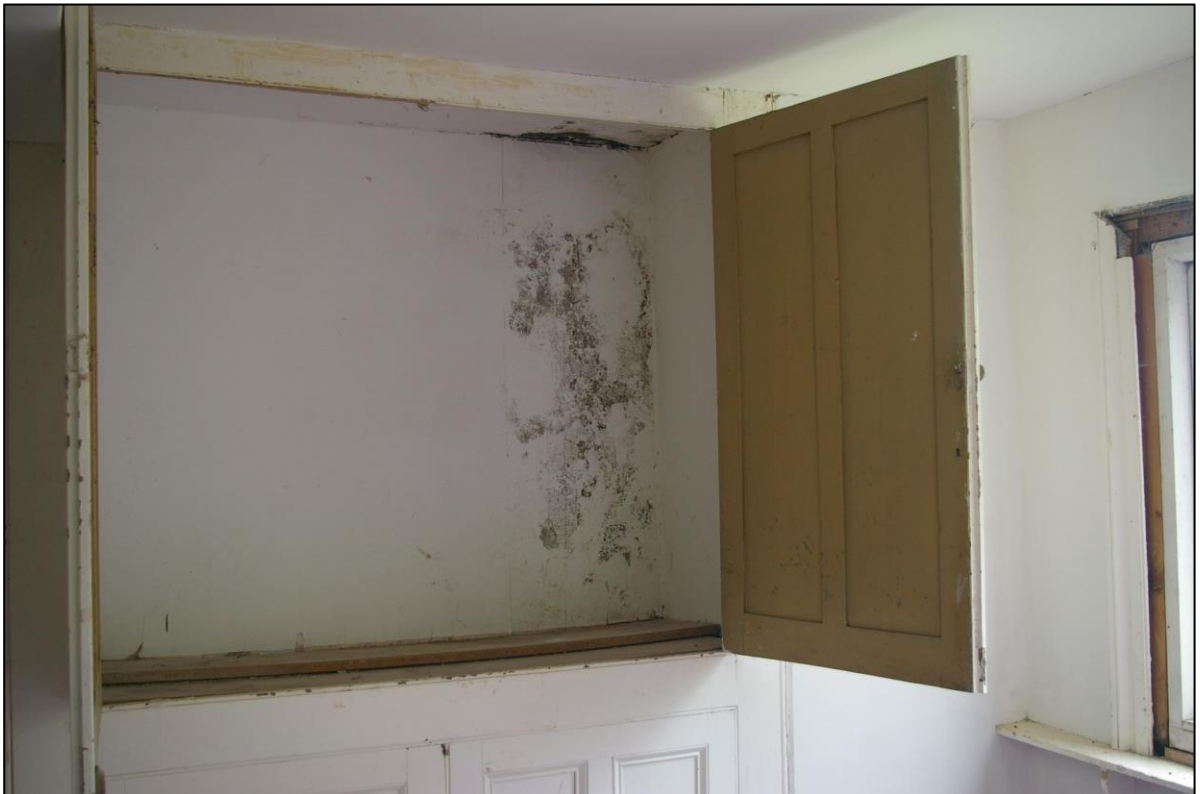
48. VIEW WITH THE DOORS OPEN, THE CUPBOARDS IN R13; FROM THE WEST.
