TREVEDDA FARM
LANTEGLOS HIGHWAY
FOWEY
CORNWALL

Heritage Assessment

South West Archaeology Ltd. report no. 200510

Draft issued: 29th May 2020
Finalised: 9th June 2020

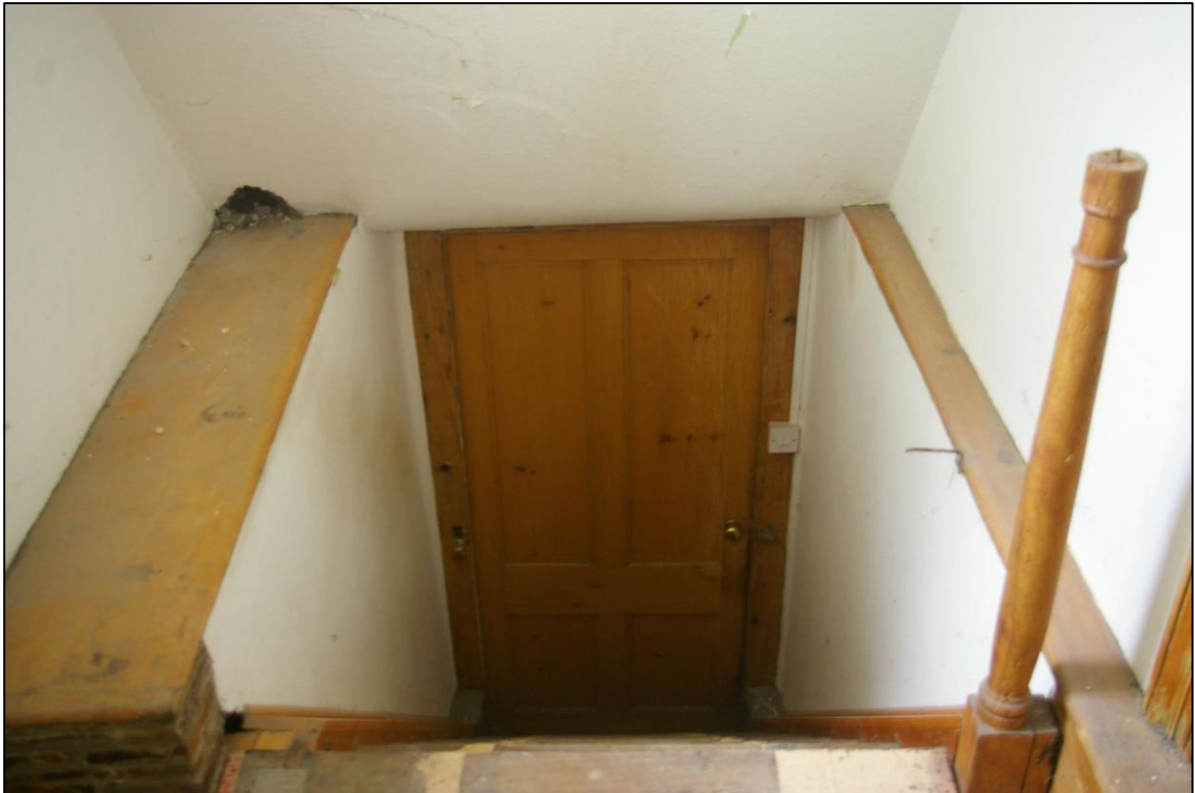
49. VIEW BACK DOWN THE EAST STAIRS, R14; FROM THE EAST.

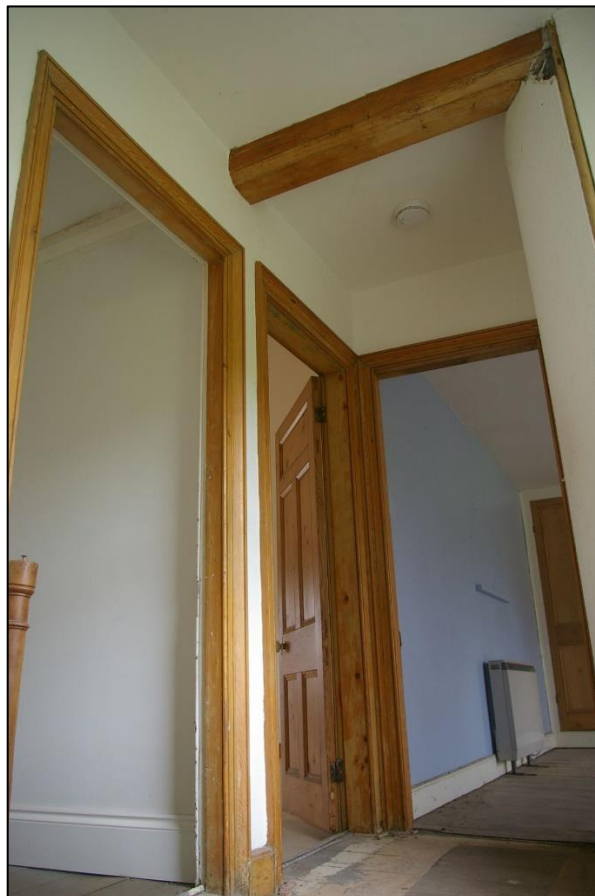
50. VIEW TO THE DOORS AND BEAM BRACING WHERE THE VARIOUS BLOCKS ADJOIN IN R14; FROM THE WEST.

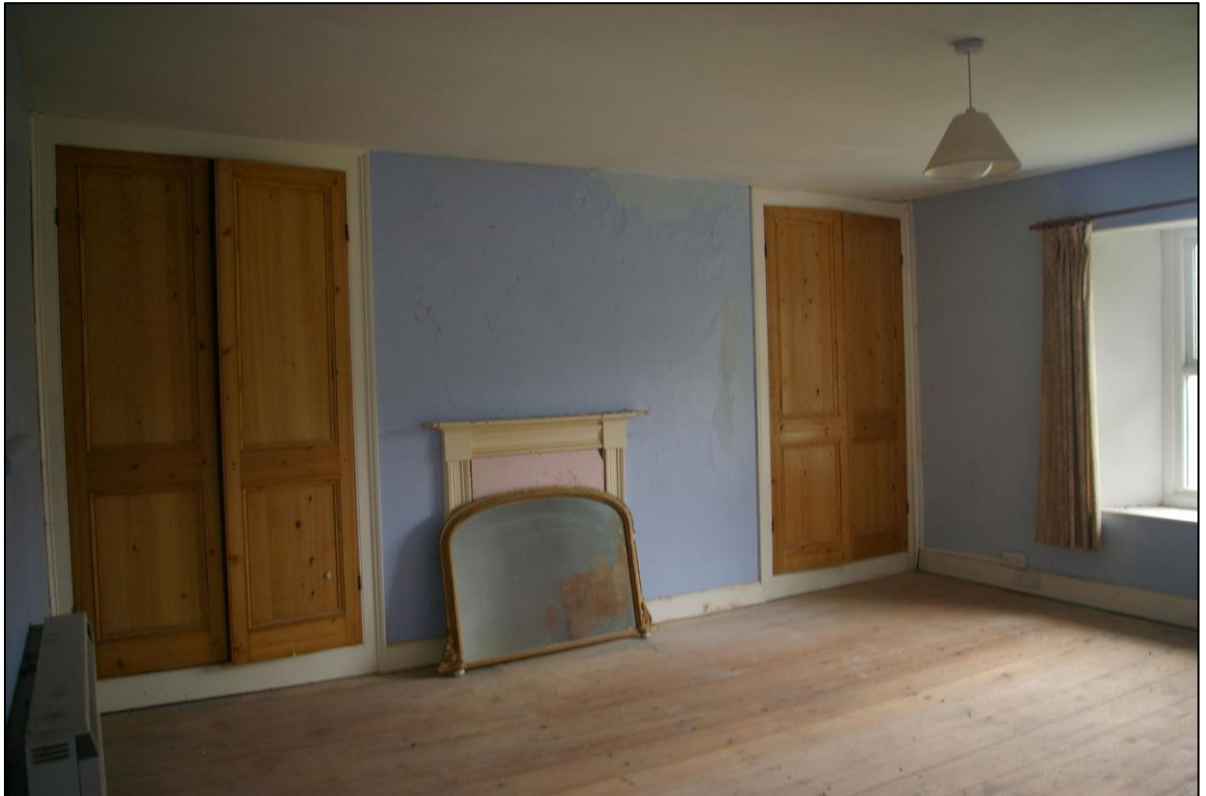
51. ROOM 15, IN THE EXTENSION, WITH GOOD FIREPLACE AND CUPBOARDS; FROM THE NORTH-WEST.

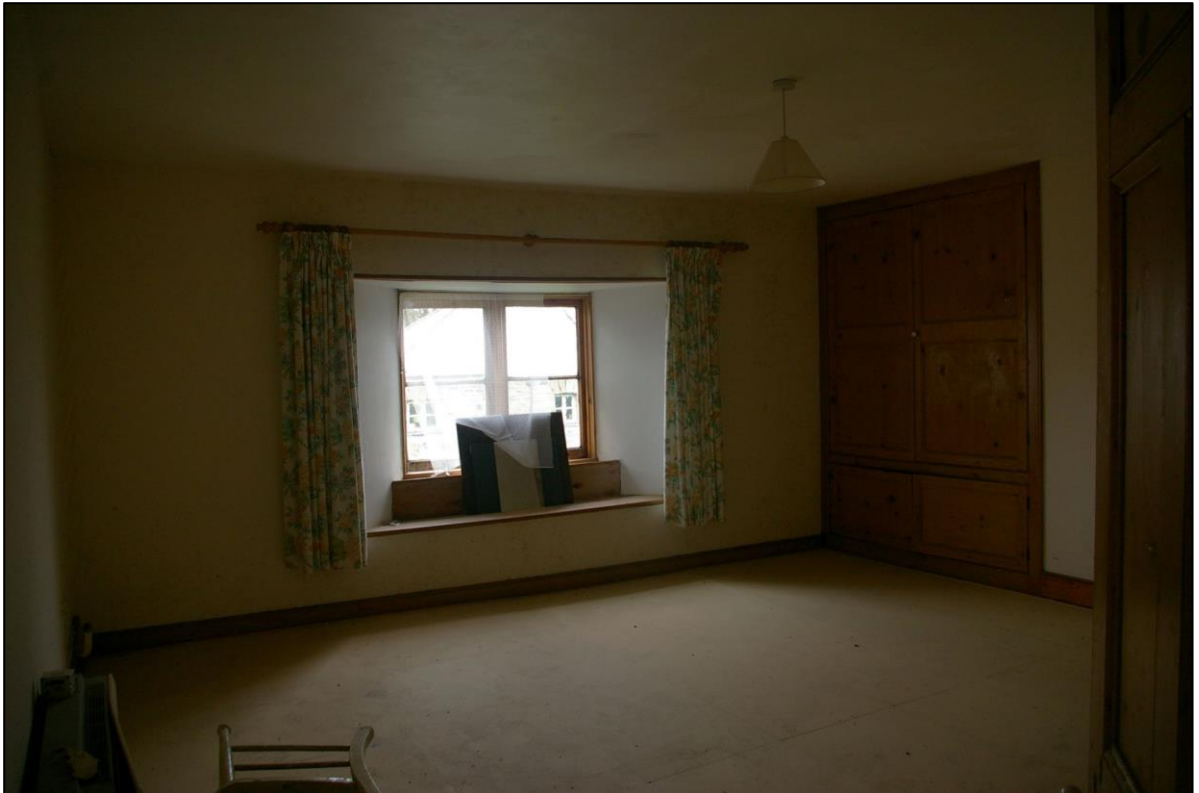
53. ROOM 16, WITH GOOD FIRST FLOOR WINDOW AND CUPBOARDS; FROM THE SOUTH-WEST.

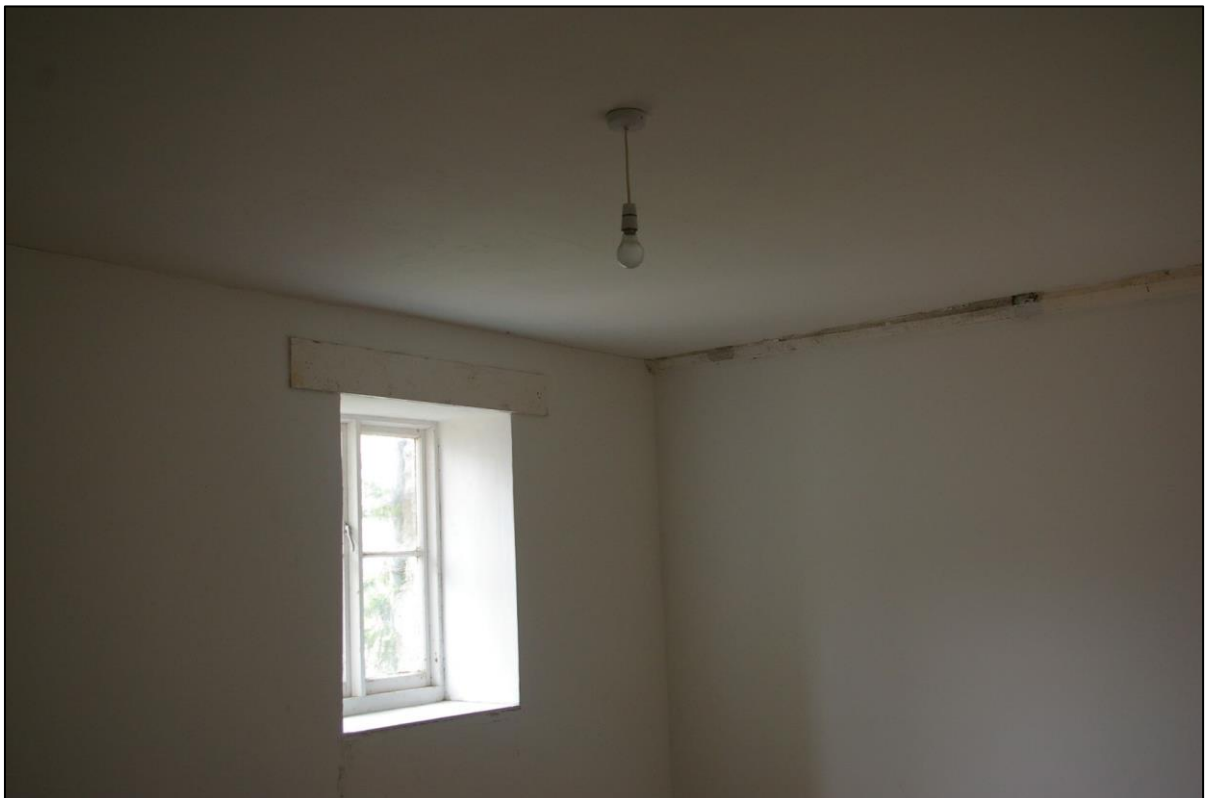
54. ROOM 17, WITH THE MORE RECENT WINDOW AND MOULDED BRACING BEAM; FROM THE SOUTH-WEST.

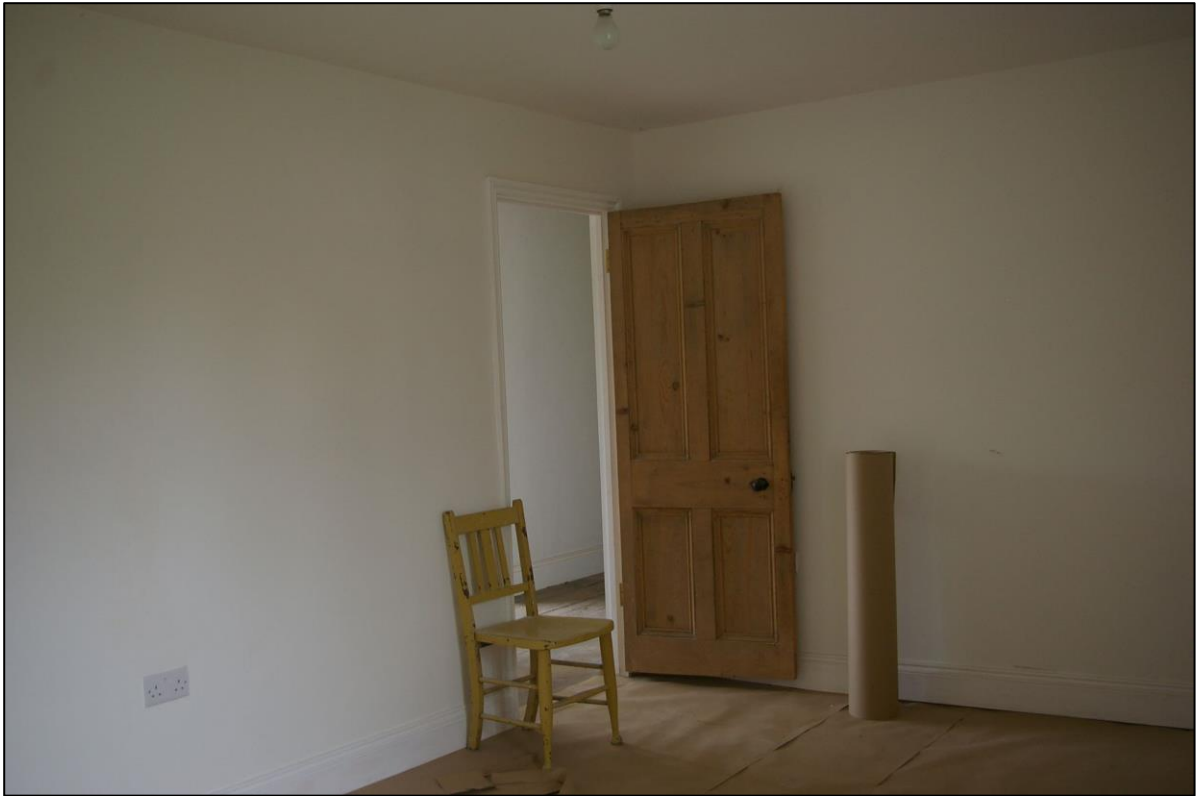
55. ROOM 17 WITH THE PANELLED DOOR TO R13; FROM THE NORTH-EAST.

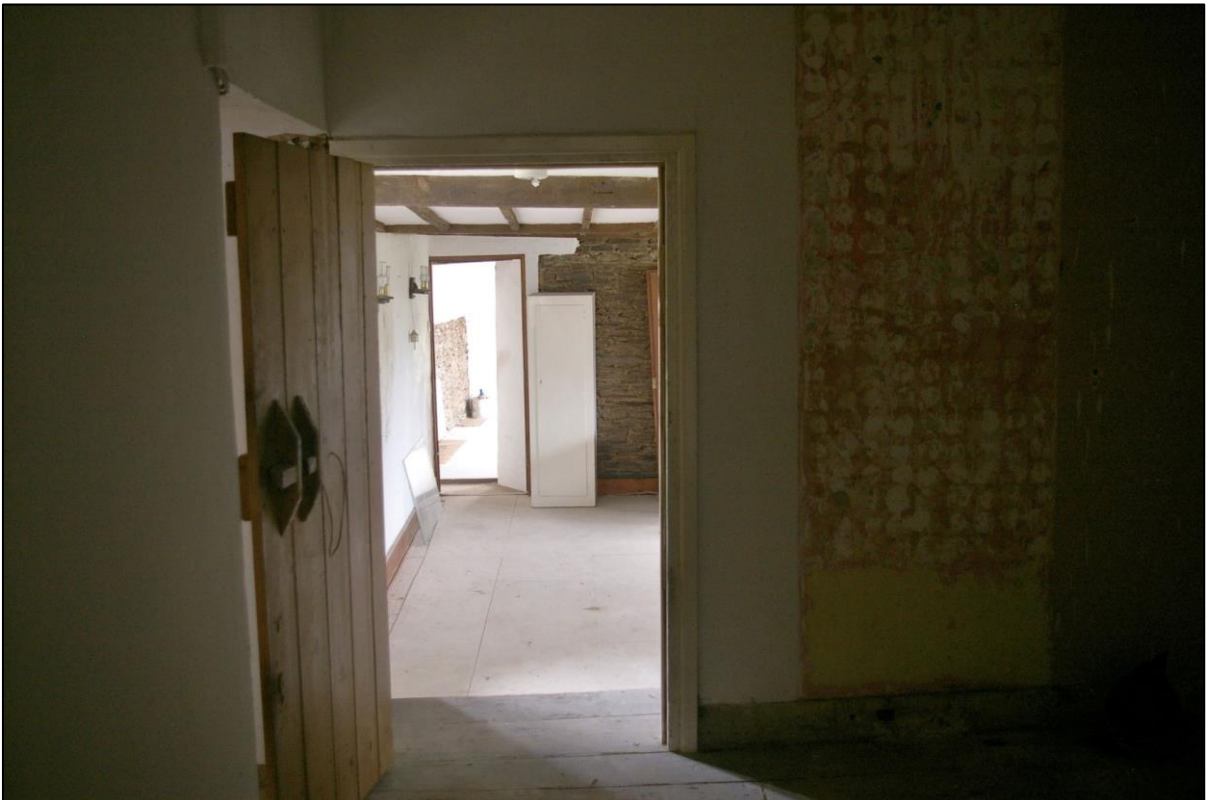
56. ROOM 18, NOW A WINDOWLESS LOBBY LINKING THE RANGES WITH TWO GOOD DOORS; FROM THE SOUTH.

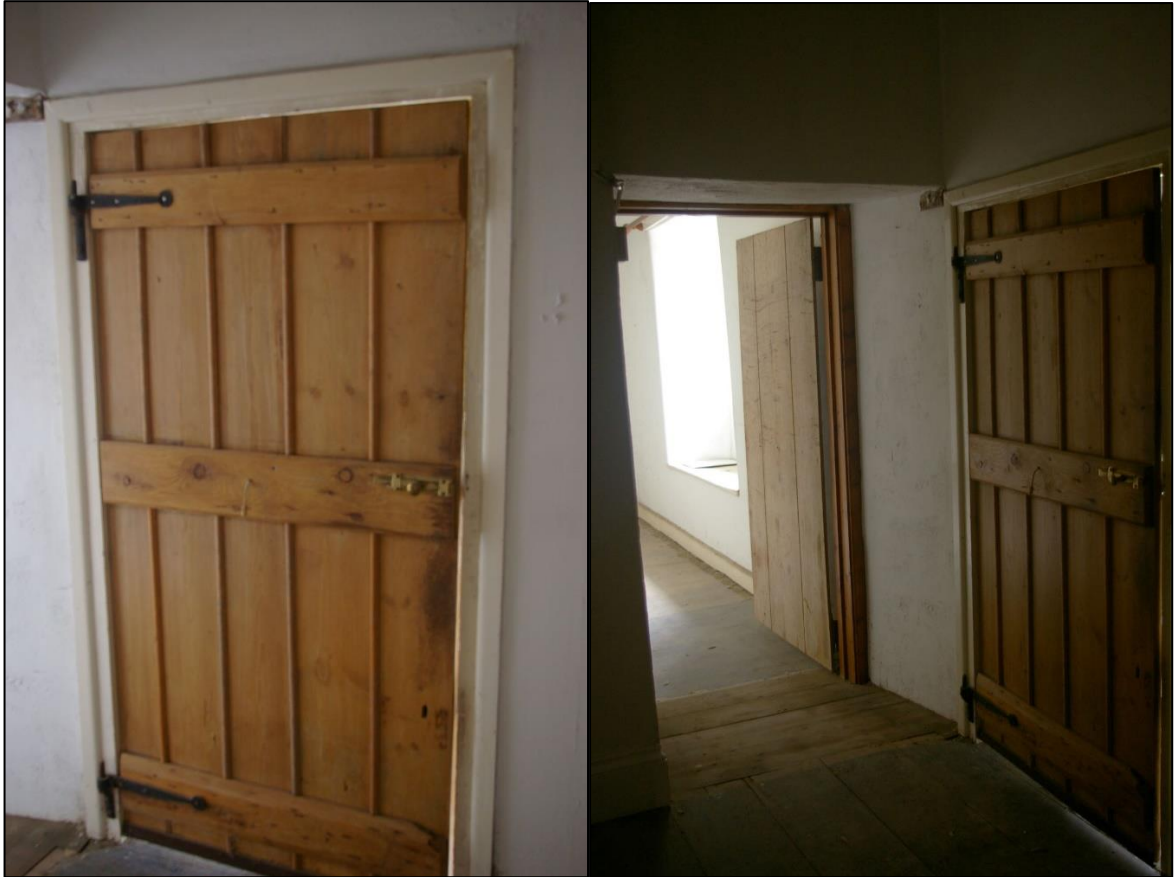
57. LEFT: THE GOOD PLANK DOOR TO THE REAR SERVICE RANGE; FROM THE SOUTH.

58. RIGHT: VIEW OF THE RELATIONSHIP BETWEEN DOORS AND OPENINGS BETWEEN THE SERVICE RANGE AND WEST CROSS-WING; FROM THE SOUTH-EAST.

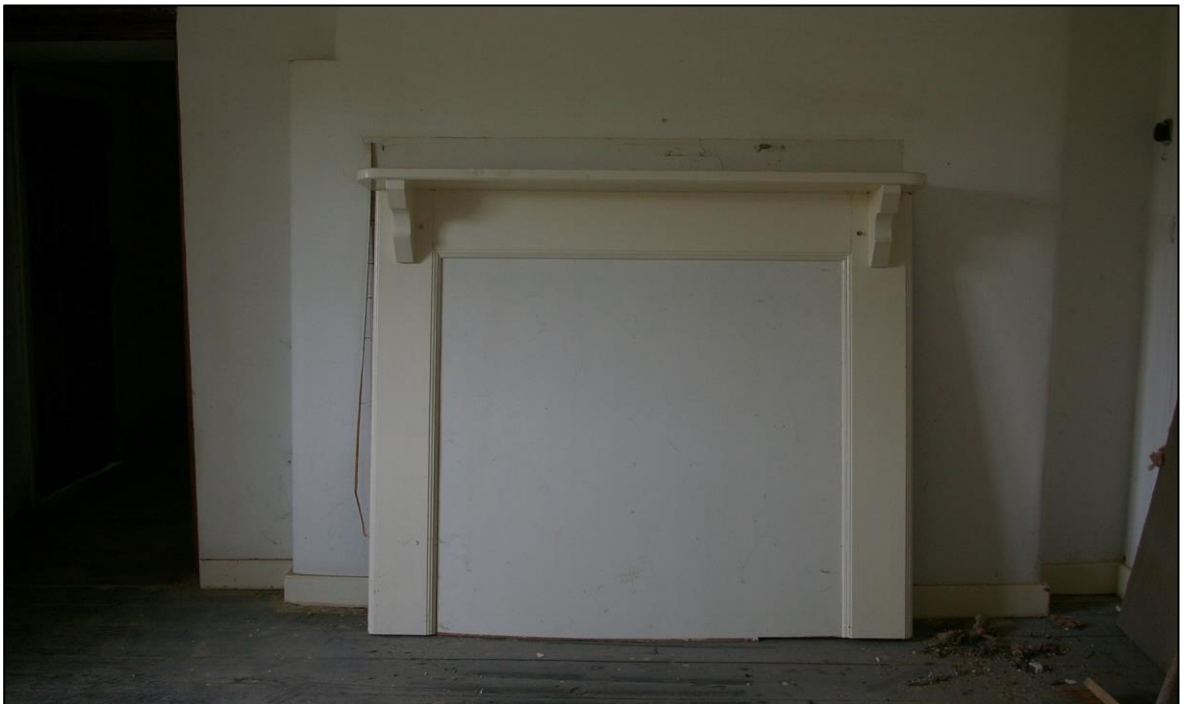
59. THE FIREPLACE SURROUND IN R19; FORM THE WEST.

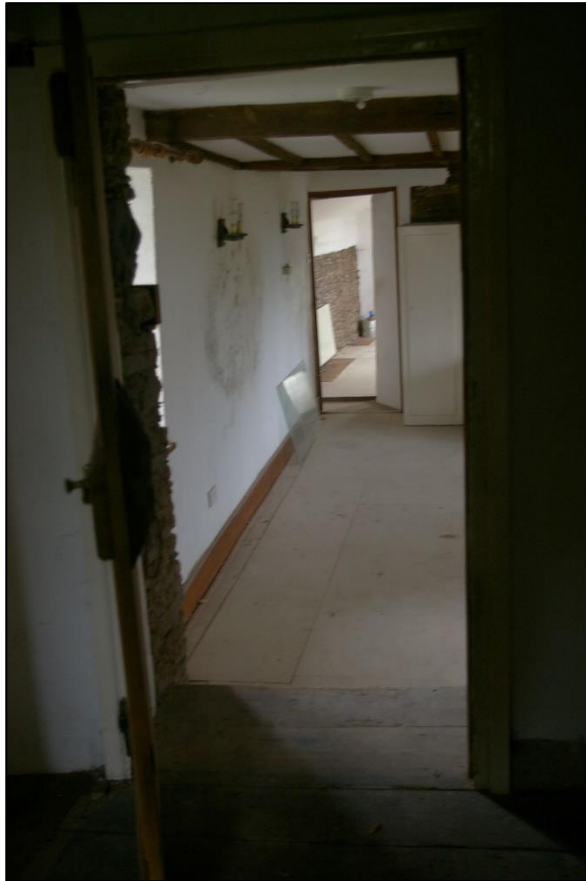
60. VIEW THROUGH THE DOORWAY INTO THE REAR SERVICE WING; FROM THE SOUTH.

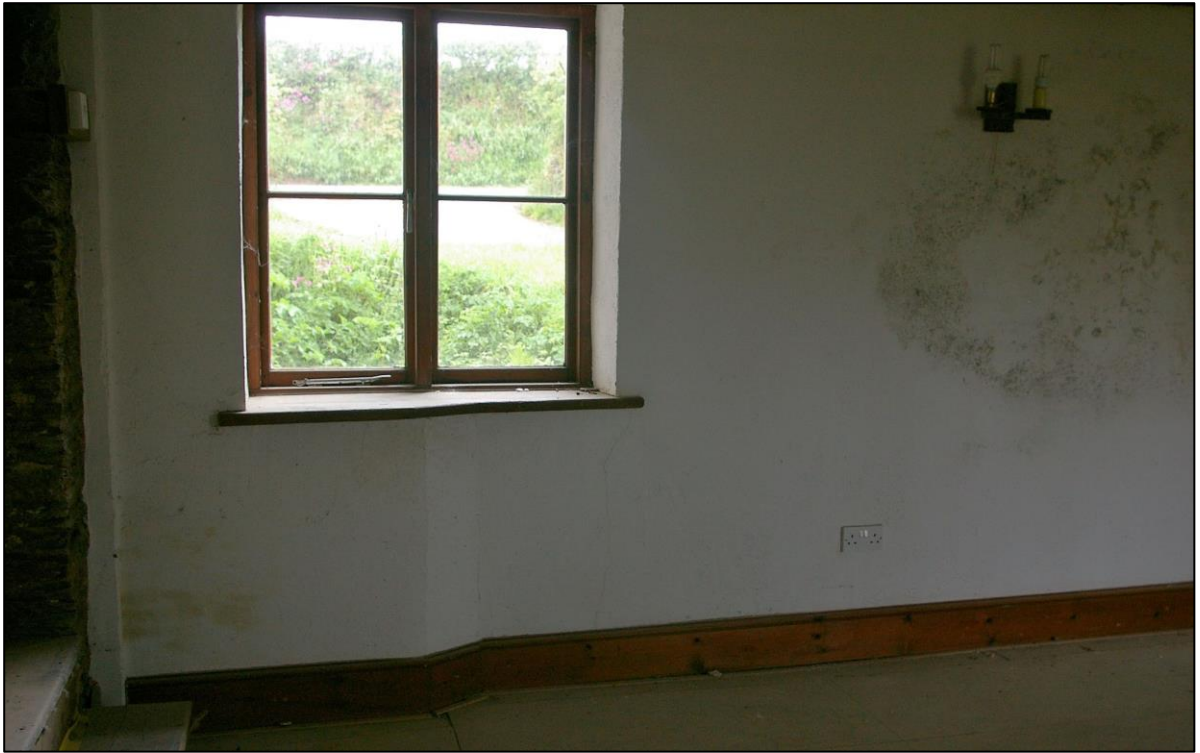
62. ROOM 20, THE WEST WALL WITH THICK SHORT SECTION, FORMERLY OF THE STAIR TURRET; FROM THE SOUTH-EAST.

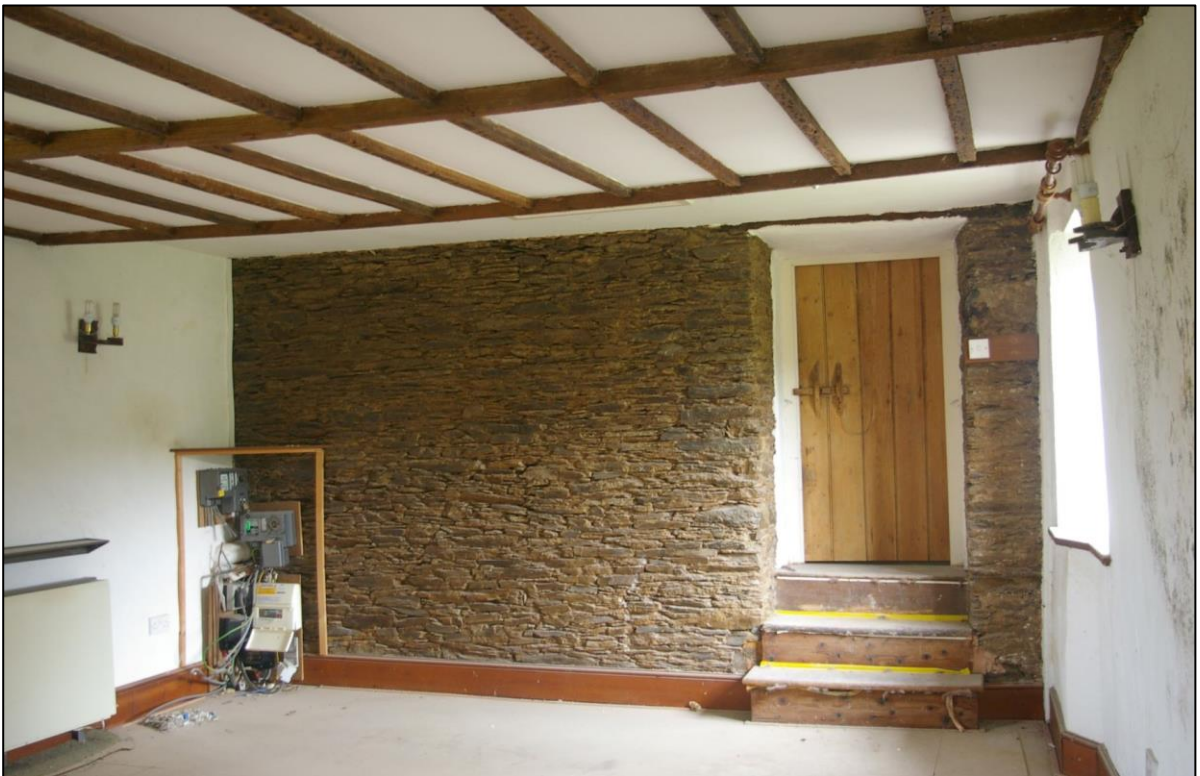
63. ROOM 20, VIEW BACK TO THE REAR WALL OF THE FORMER HALL; FROM THE NORTH-WEST CORNER.

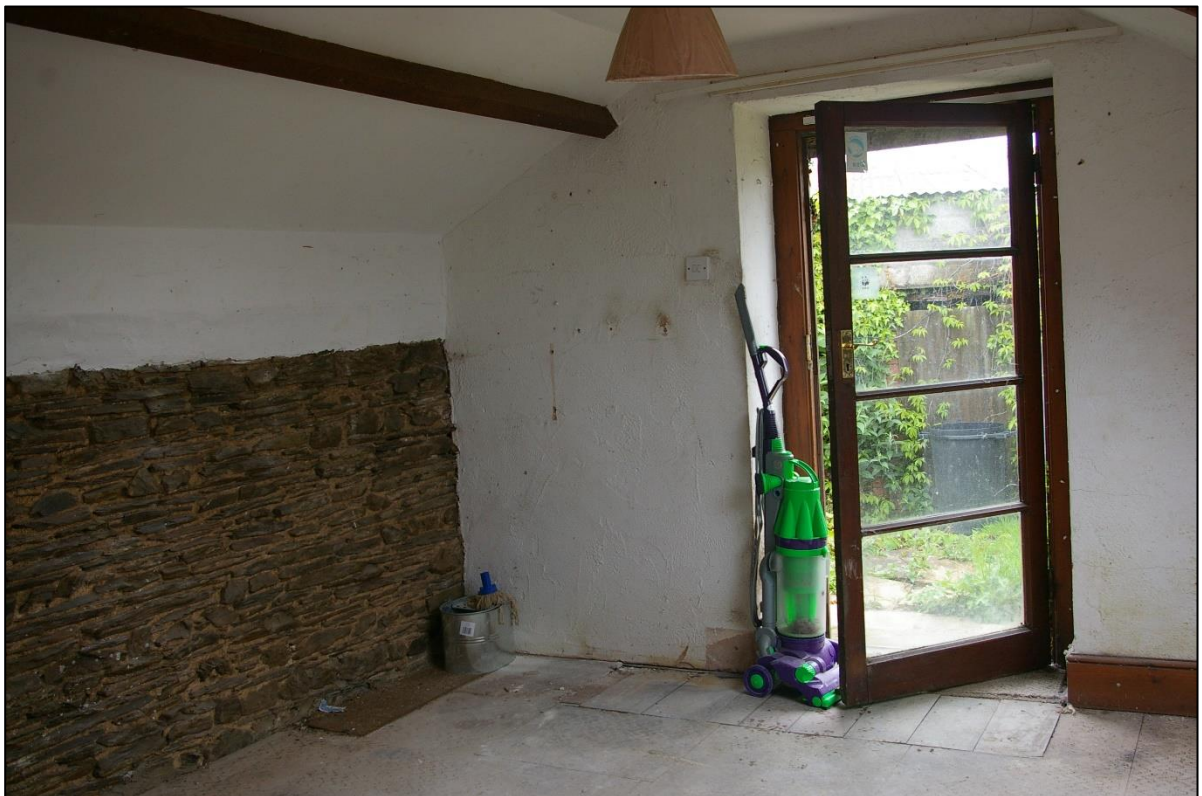
65. ROOM 21, A LOFT OVER AN AGRICULTURAL EXTENSION, NOW A STUDIO/ANNEXE WITH EXTERIOR DOOR, AS TERRACED DEEPLY INTO THE BANK; FORM THE SOUTH-EAST.
