# THE PACKHORSE INN FORE STREET ST BLAZEY CORNWALL

Results of a Desk-Based Assessment, Historic Building Recording, Walkover Survey and Heritage Impact Assessment

South West Archaeology Ltd. report no. 180124

By E. Wapshott & P. Webb  
Report Version: FINAL  
31<sup>st</sup> March 2020

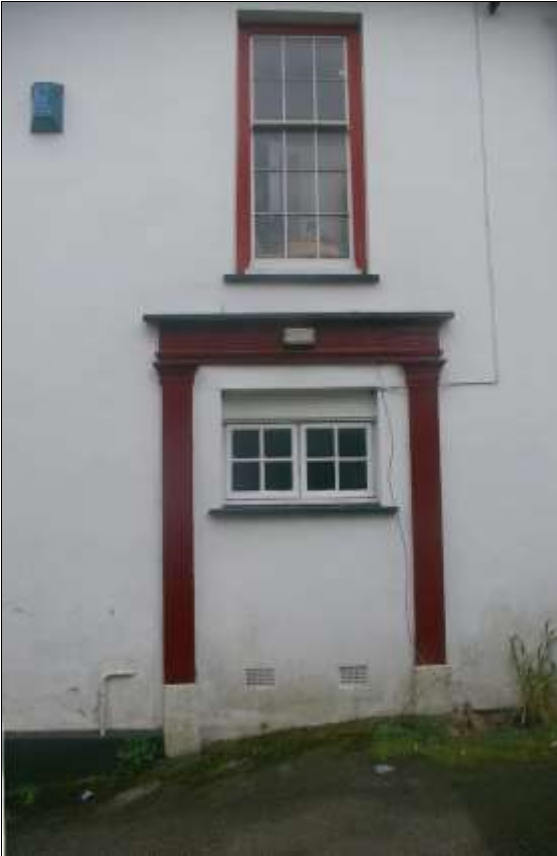
2. THE BLOCKED DOORWAY ON THE NORTH ELEVATION OF THE INN, WITH INSET WINDOW (W4); VIEWED FROM THE NORTH.

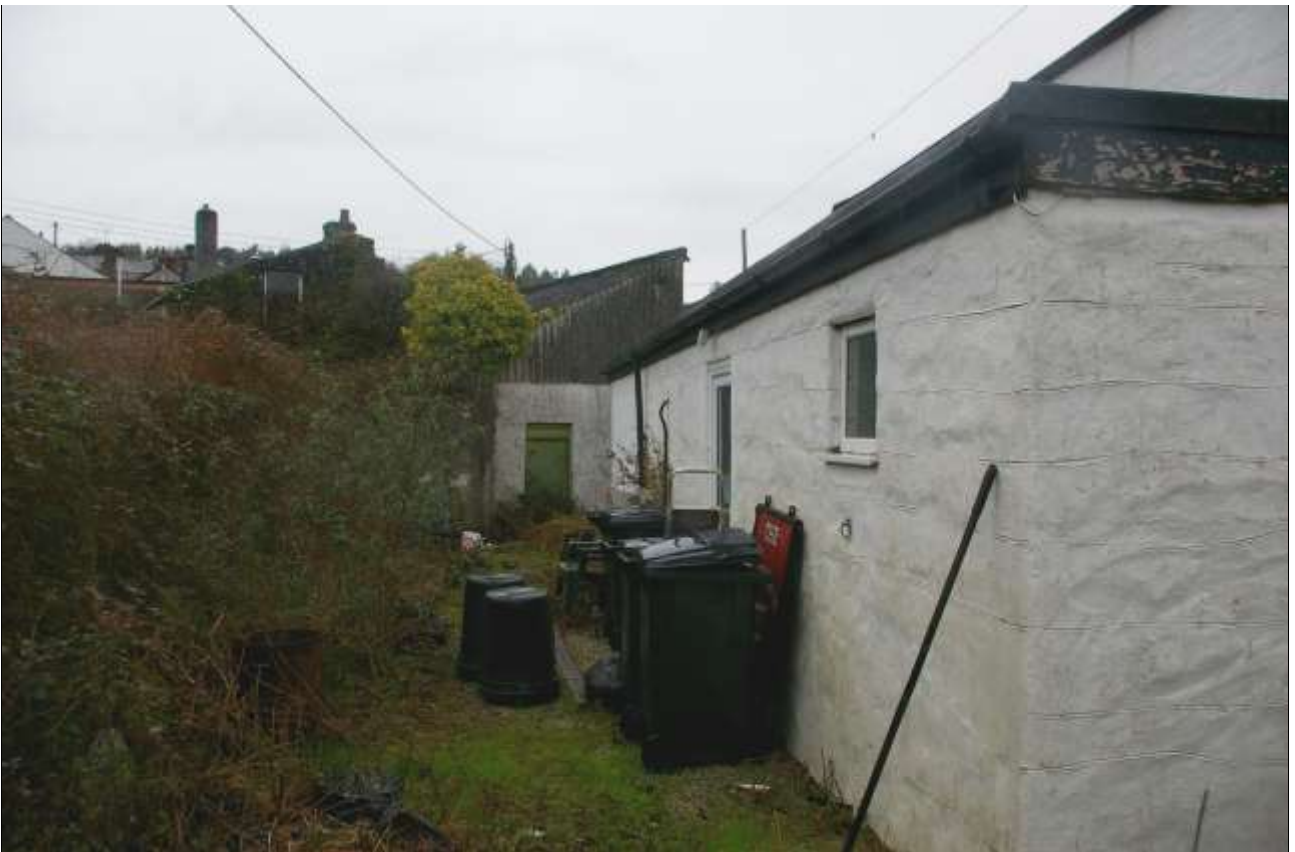
4. VIEW ALONG THE WESTERN ELEVATION OF THE EXTENSION AND THE THICK RETAINING STONE WALLS TO THE NORTH-WEST NOW INCORPORATED INTO THE GARAGE/STORE BUILDING; VIEWED FROM THE SOUTH.

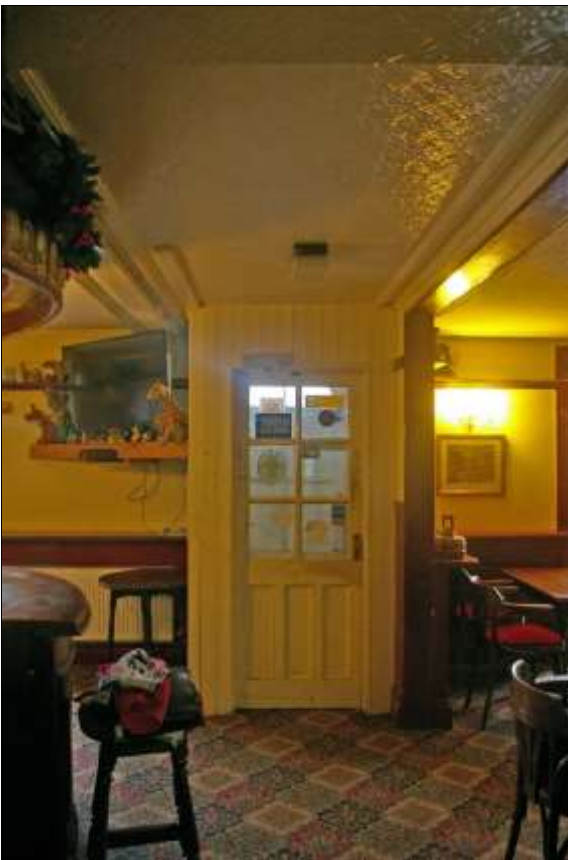
6. LEFT: R1, THE PLANK PARTITION WEATHER PORCH AROUND THE FRONT DOOR (D2) AND PRESENCE OF THE REEDED CORNICE, SHOWING THE LINE OF THE REMOVED PARTITION WALLS; VIEWED FROM THE WEST.  
7. RIGHT: R1, THE DOORWAY IN THE WEST WALL (D3), LEADING INTO THE REAR WEST BLOCK (R5), WITH DOORFRAME ETC. REMOVED; VIEWED FROM THE EAST.

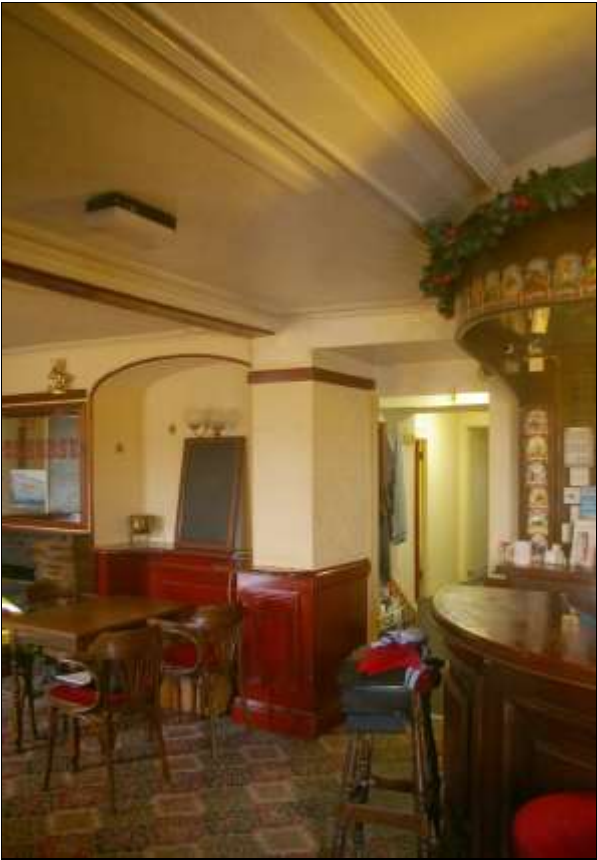
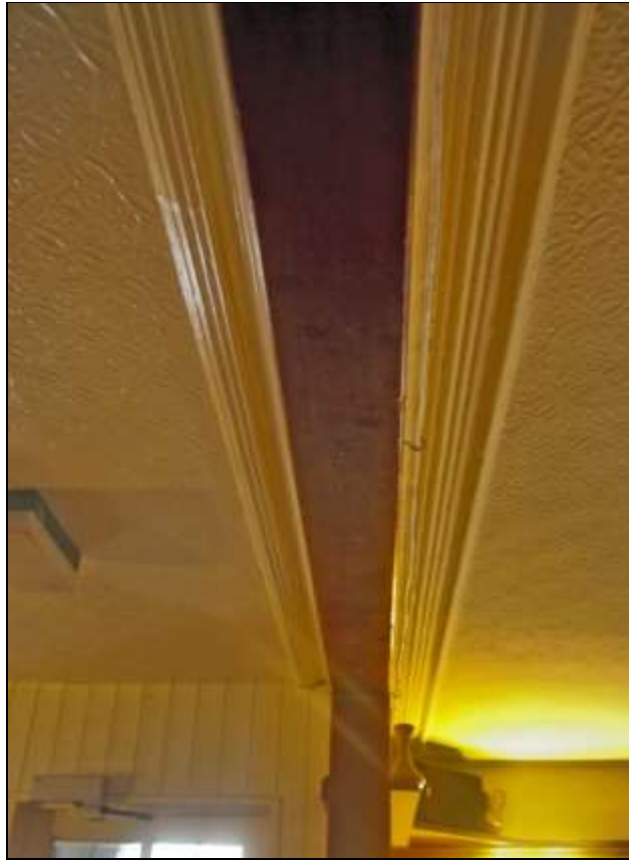
8. LEFT: R1/R2, OBLIQUE VIEW ACROSS THE NARROW ENTRANCE HALL, AGAIN SHOWING THE CORNICING SURVIVING, PROVIDING A 'GHOST' LAYOUT FOR THIS GROUND FLOOR SPACE; VIEWED FROM THE EAST-NORTH-EAST.
9. RIGHT: R1/R2, DETAIL OF THE CORNICING; VIEWED FROM THE WEST.

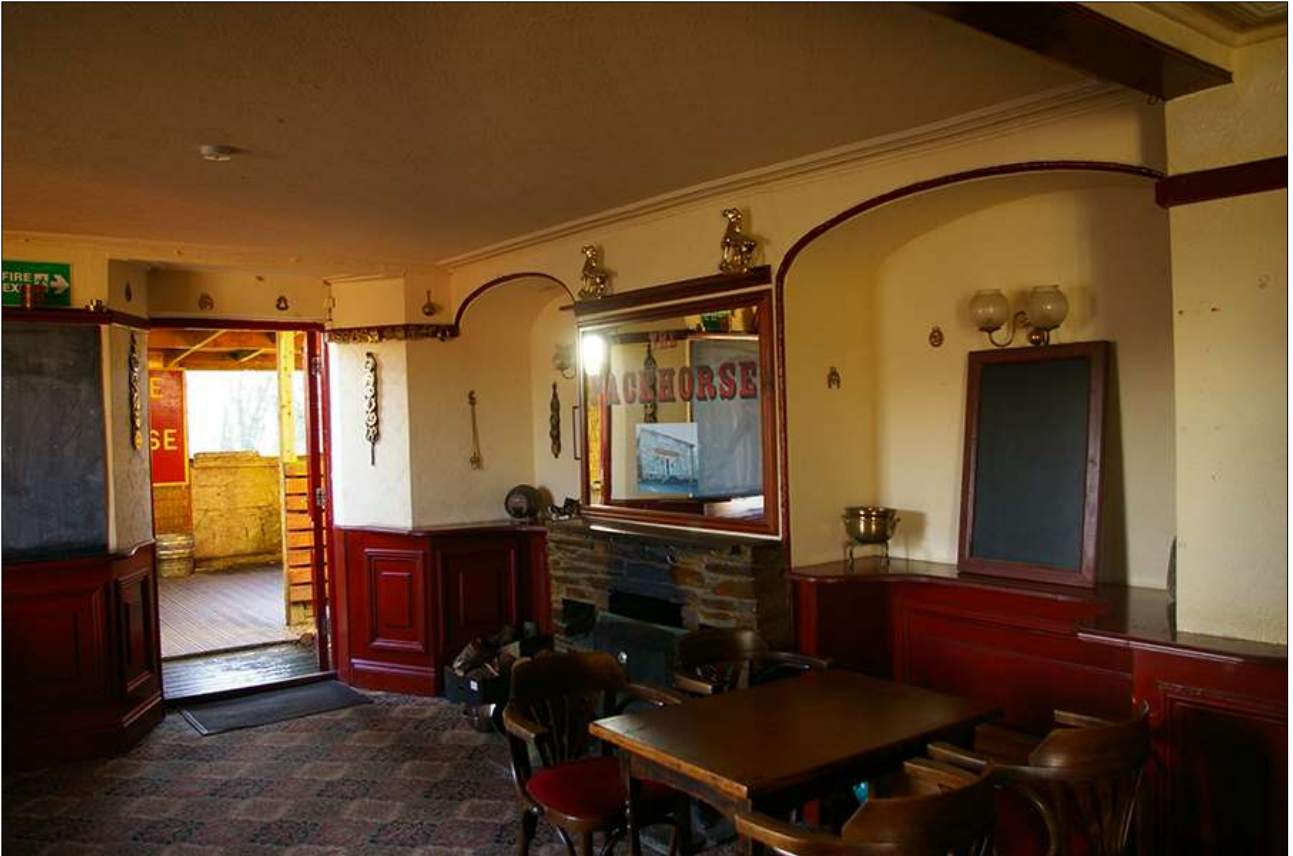
11. R2, DETAIL OF FP1 AND FLANKING ALCOVES WITH BASKET ARCHES; VIEWED FROM THE NORTH-EAST.

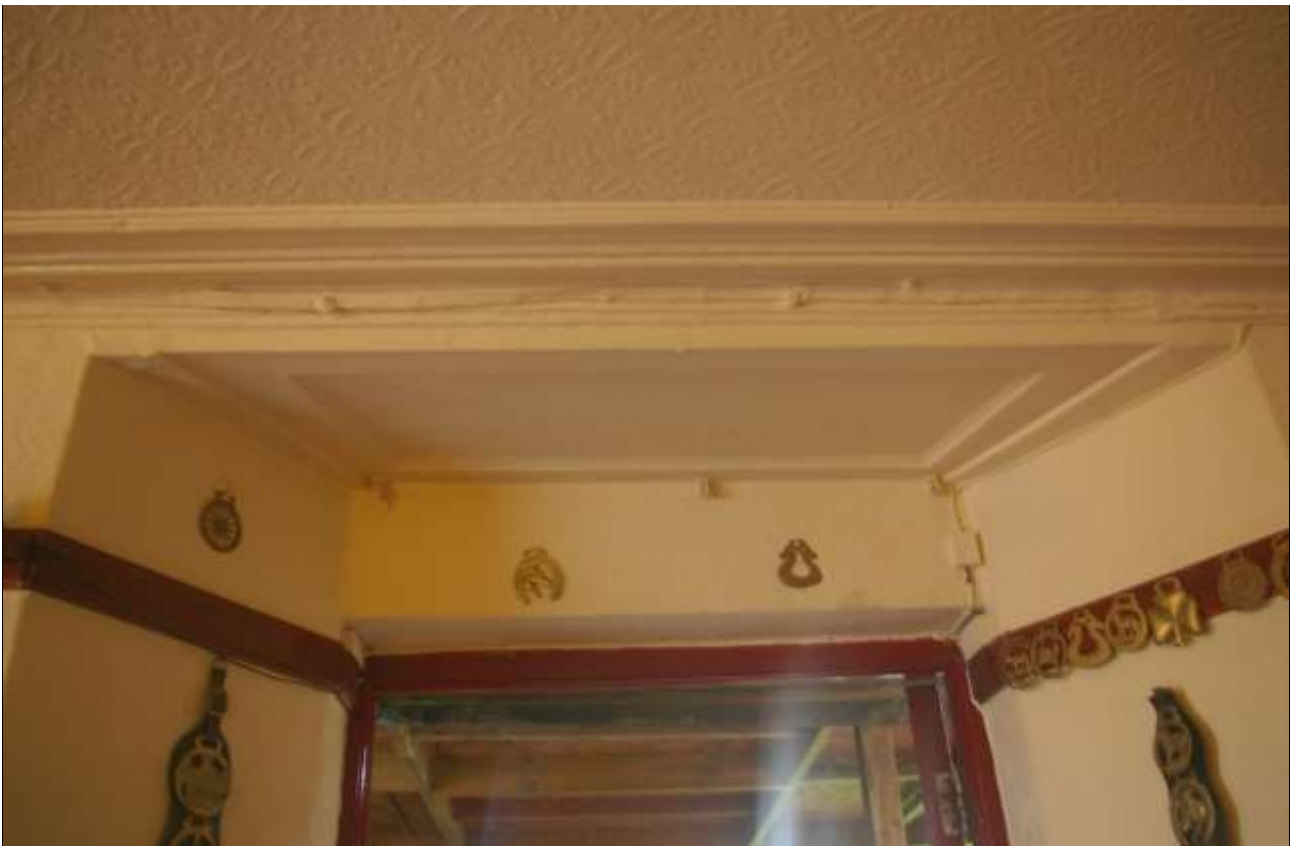
12. R2, THE PANELLED PLASTER DETAIL ABOVE A FORMER WINDOW IN THE SOUTH WALL (D4), WITH REEDED CORNICE TO CEILING; VIEWED FROM THE NORTH.

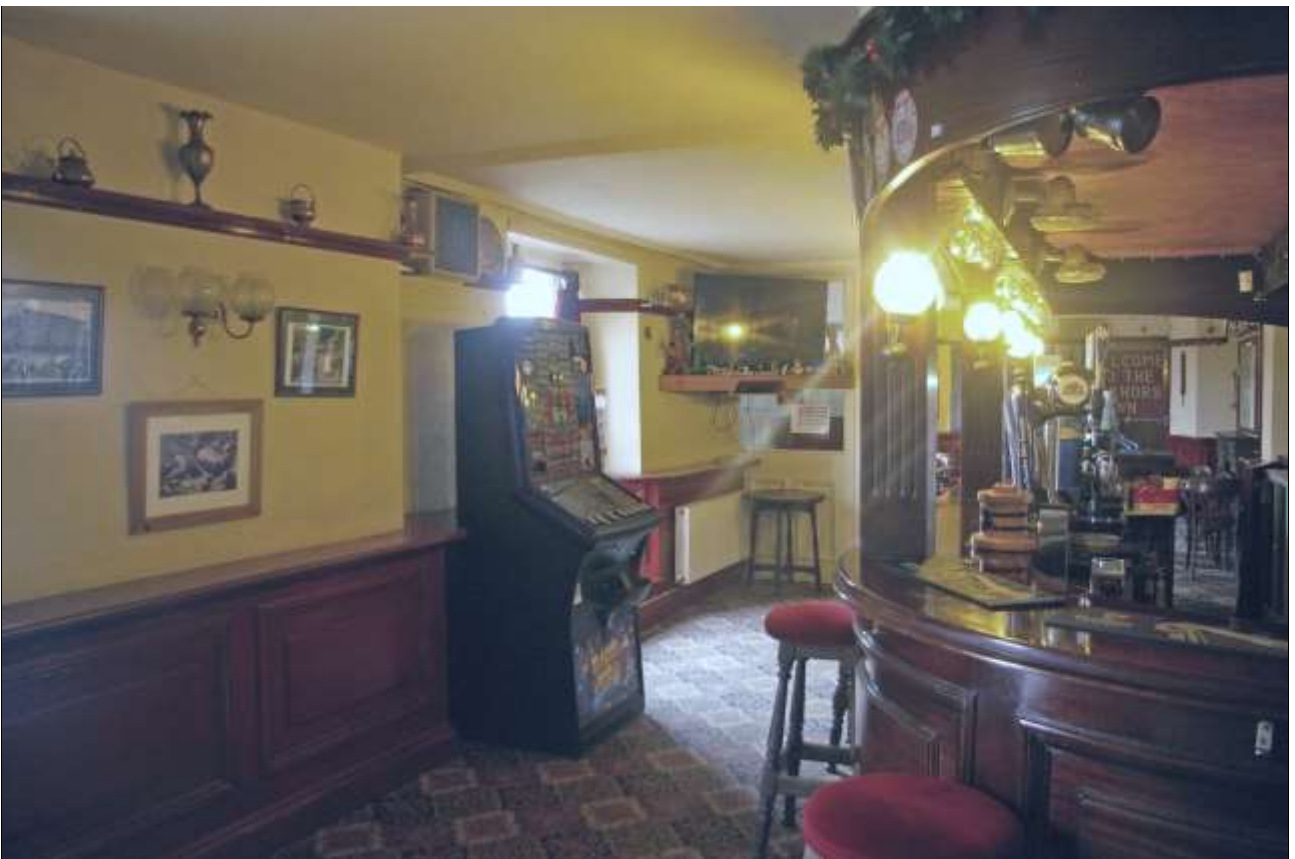
20. 3B/3A, SHOWING THE HISTORIC REEDED CORNICE CROSSING THE CEILING WHERE THE WALL BETWEEN THESE SPACES ONCE STOOD; VIEWED FROM THE NORTH-WEST.

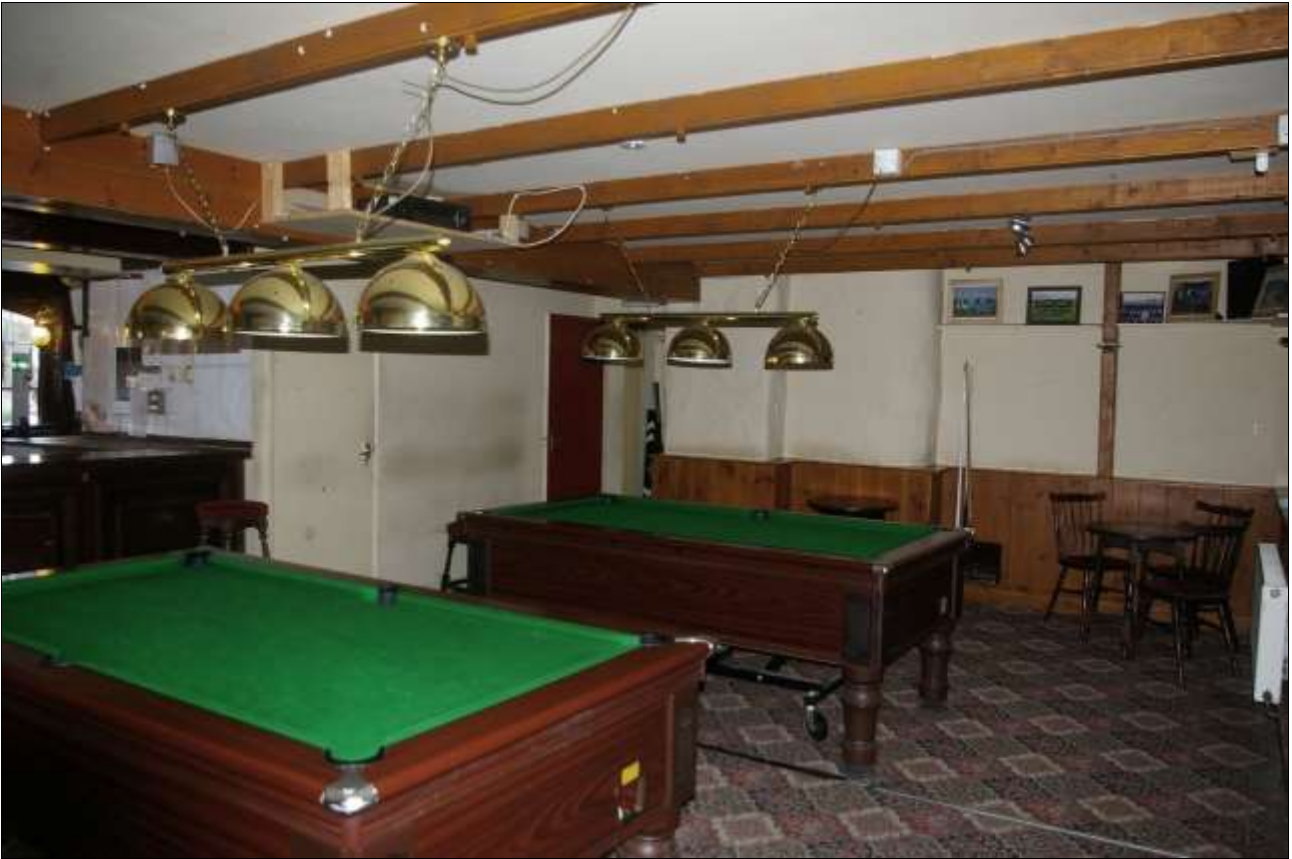
25. R4, SHOWING THE MODERN LOW CEILING WITH DECORATIVE APPLIED 'BEAMS'; VIEWED FROM THE NORTH-WEST.

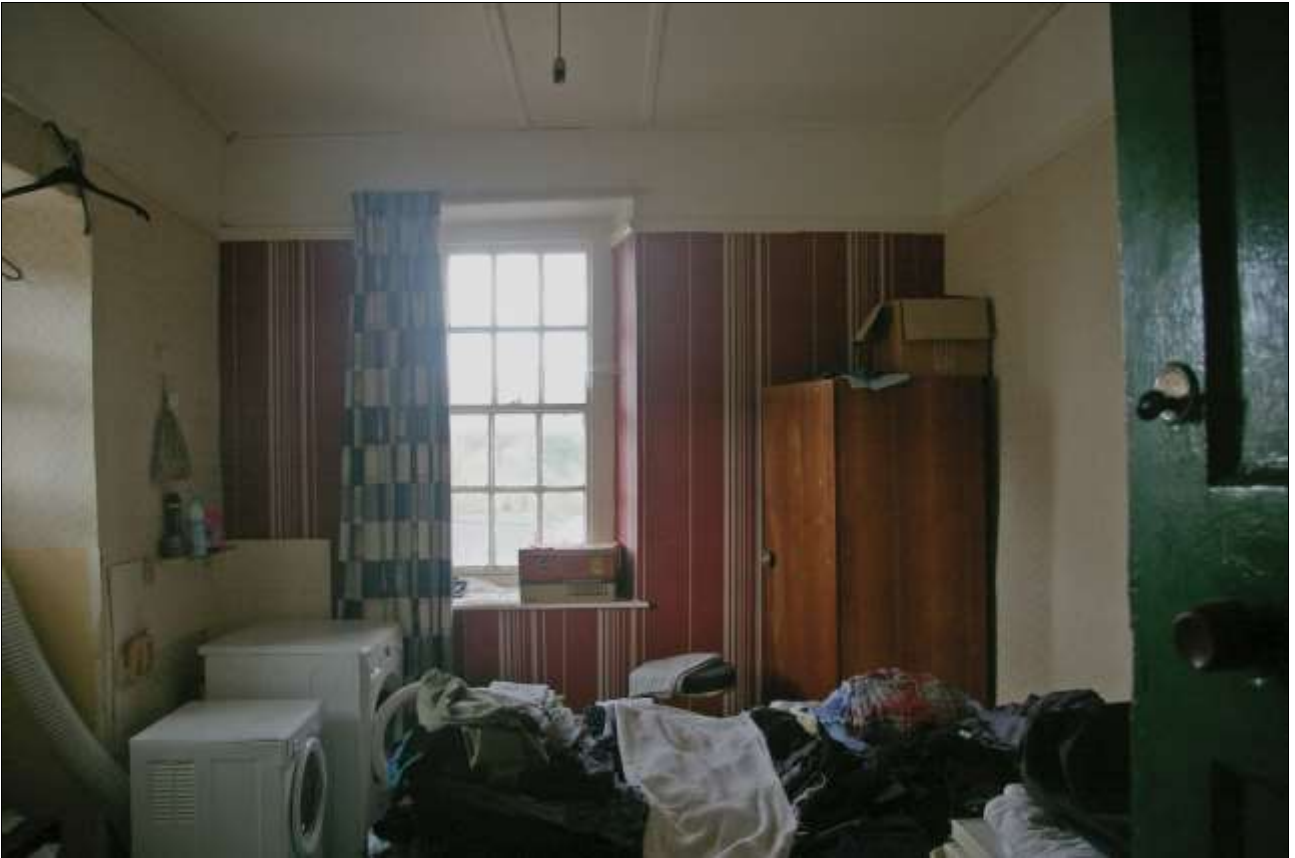
37. R8, THE WINDOW (W10) SET INTO A LOADING DOOR; VIEWED FROM THE WEST.

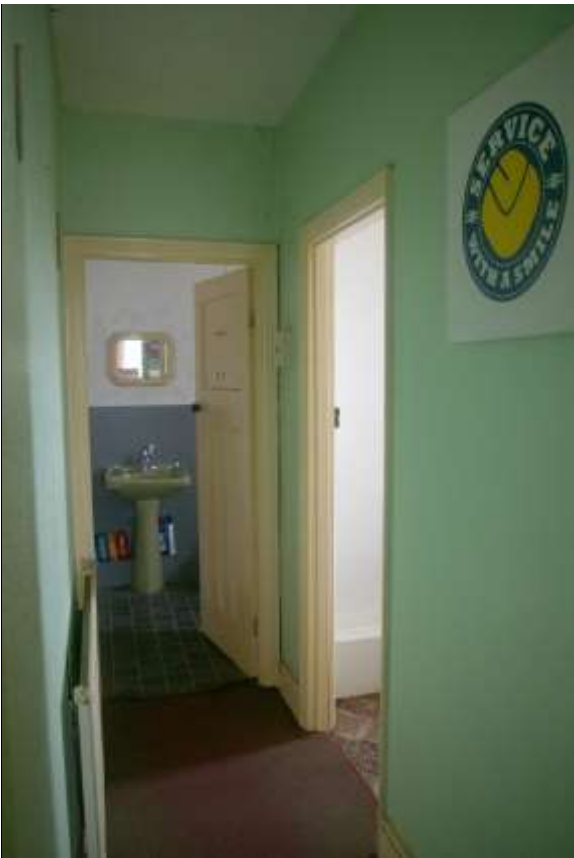
38. LEFT: VIEW TO R9 AND R10, A TOILET AND BATHROOM FORMED BY PARTITIONS FROM A LARGER BEDROOM; VIEWED FROM THE EAST.

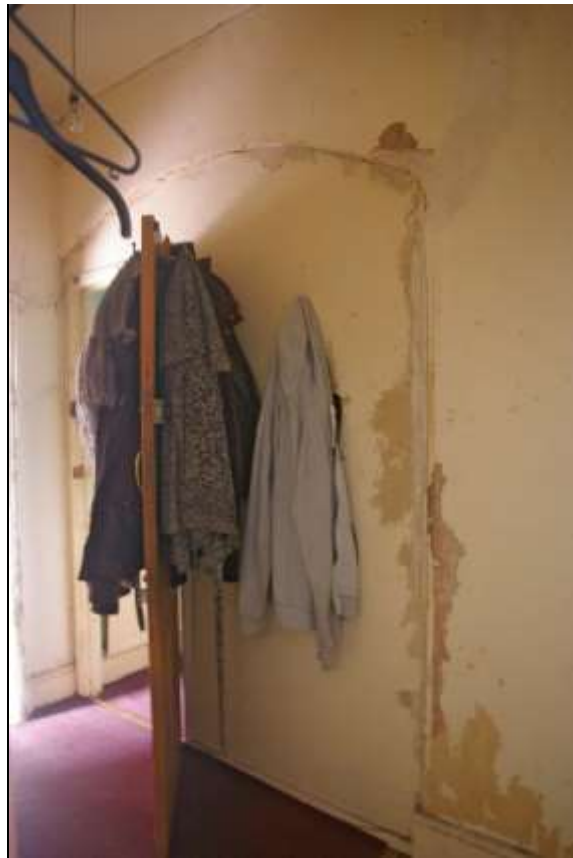
39. RIGHT: R13, THE SOUTH SIDE OF THE INFILLED BEADED BASKET-ARCHED OPENING OVER THE STAIRS; VIEWED FROM THE SOUTH-EAST.

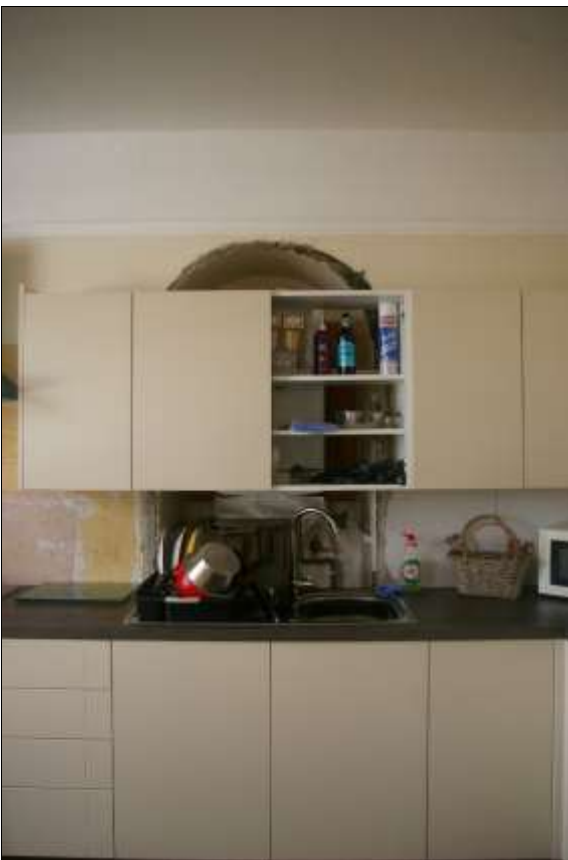
43. R15A, THE BLOCKED OPENING (BO4) IN THE SOUTH WALL; VIEWED FROM THE NORTH.
