**TREVEDDA FARM
LANTEGLOS HIGHWAY
FOWEY
CORNWALL**

Historic Building Recording

South West Archaeology Ltd. report no. 210120

Results of historic building recording

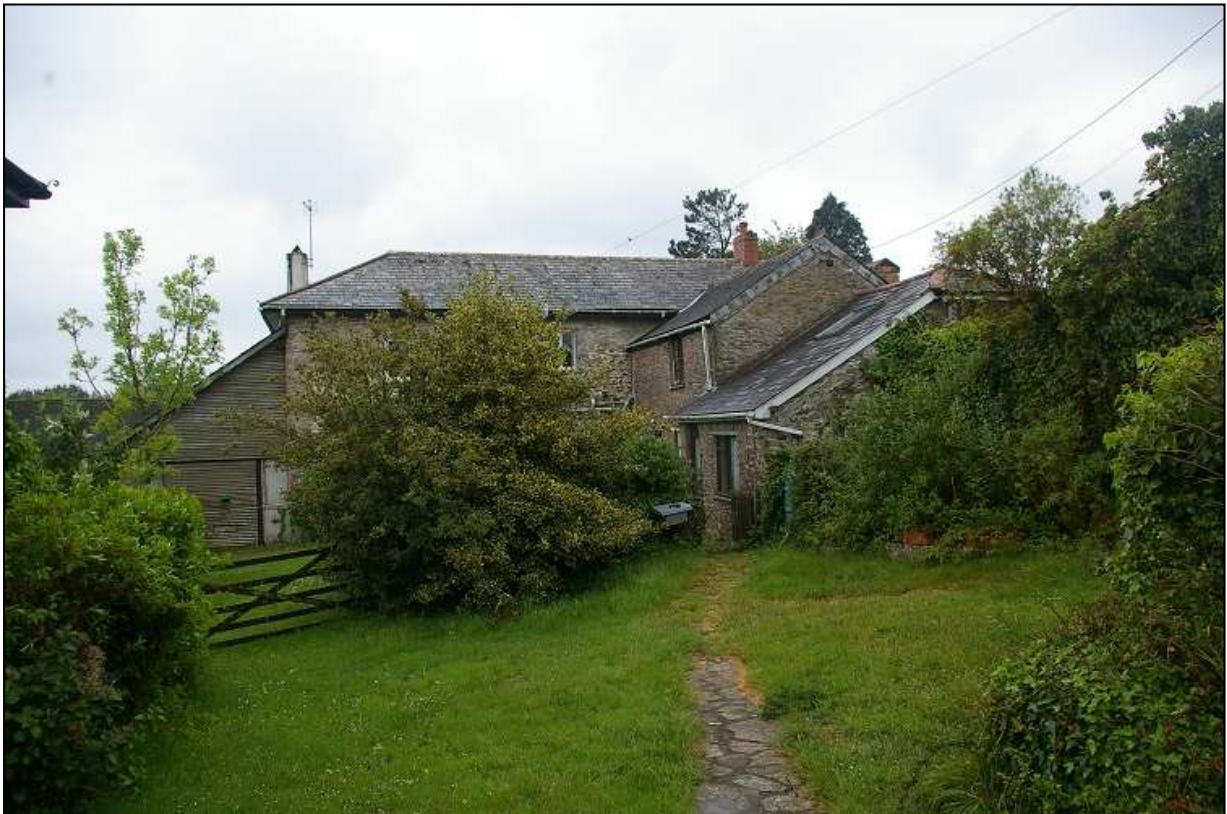
FIGURE 4: TREVEDDA, WITH THE SERIES OF SMALL WALLED YARDS TO THE REAR, NOW GRASS, OVER HISTORIC COBBLES; FROM THE NORTH.

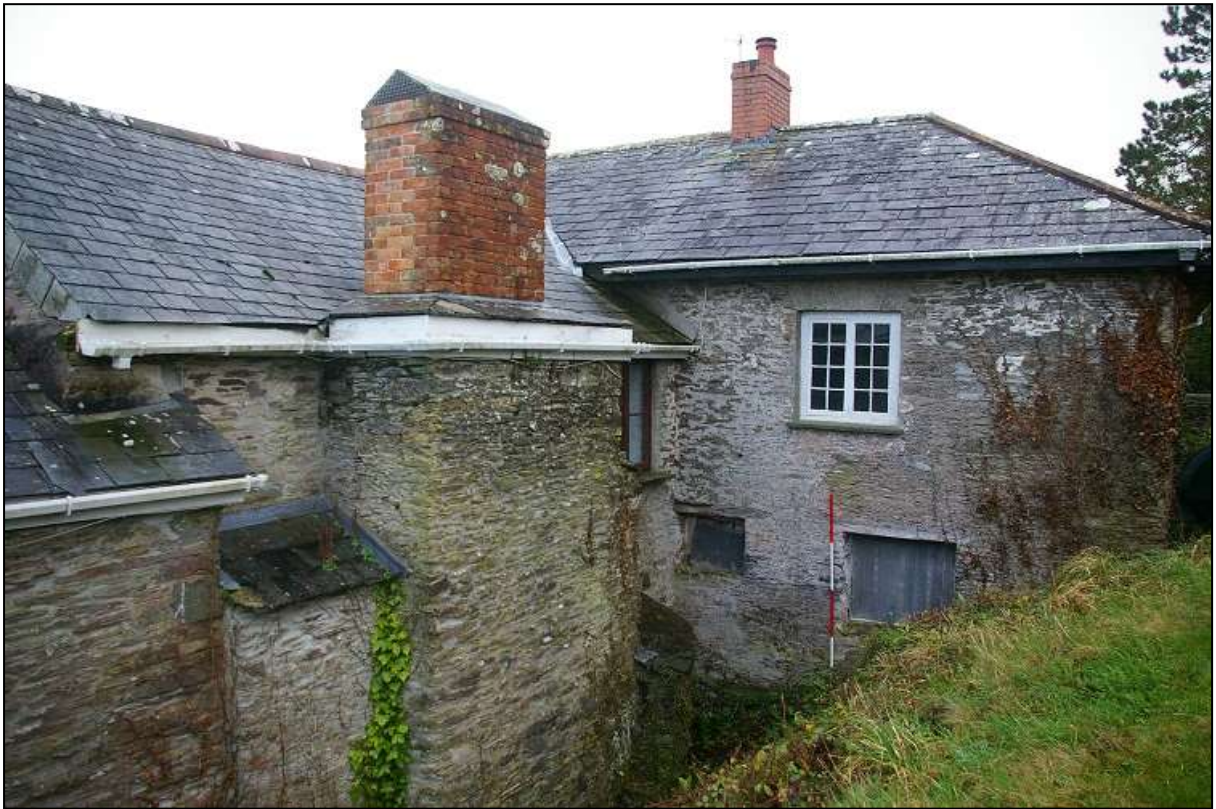
The west end of the main range, beyond the rear service wing, again displays clear structural phasing in its stonework, raised at the eaves, previously only one and a half storeys in height, as seen to the east end. This part of the elevation has had a significant amount of its north-west corner rebuilt and has been extensively re-pointed in both lime and cement mortars. It has three openings (Figure 8), one a narrow ground floor window in the angle with the rear service wing, which somewhat crowds it and blocks it, suggesting this window predates the adjoining wall. This opening has a good oak chamfered medieval or late medieval mullion window frame surviving, with pegged corners and a thick weathered oak lintel. There is then a central ground and first floor pair of windows; the ground floor window has a heavy oak lintel and a good later 17th or early 18th century window frame with chamfered central mullion and jambs with ferraments to open unglazed lights, plain top rail and base rail; to the inner side this window has been fitted with a later 18th, or early 19th century beaded casement. The first floor window is also of later 18th or early 19th century date, with beaded central mullion and jambs and plain top and base rail, set with later 19th century small-pane timber casements, probably originally having had leaded casements. This window has dressed voussoirs within the rebuilt raise and the timber window itself has been raised within an earlier opening, with loose rubble in-fill underneath the current sill, having been altered when the elevation was raised.

FIGURE 8: THE WEST END OF THE MAIN RANGE, WITH 2M SCALE; FROM THE NORTH-WEST.

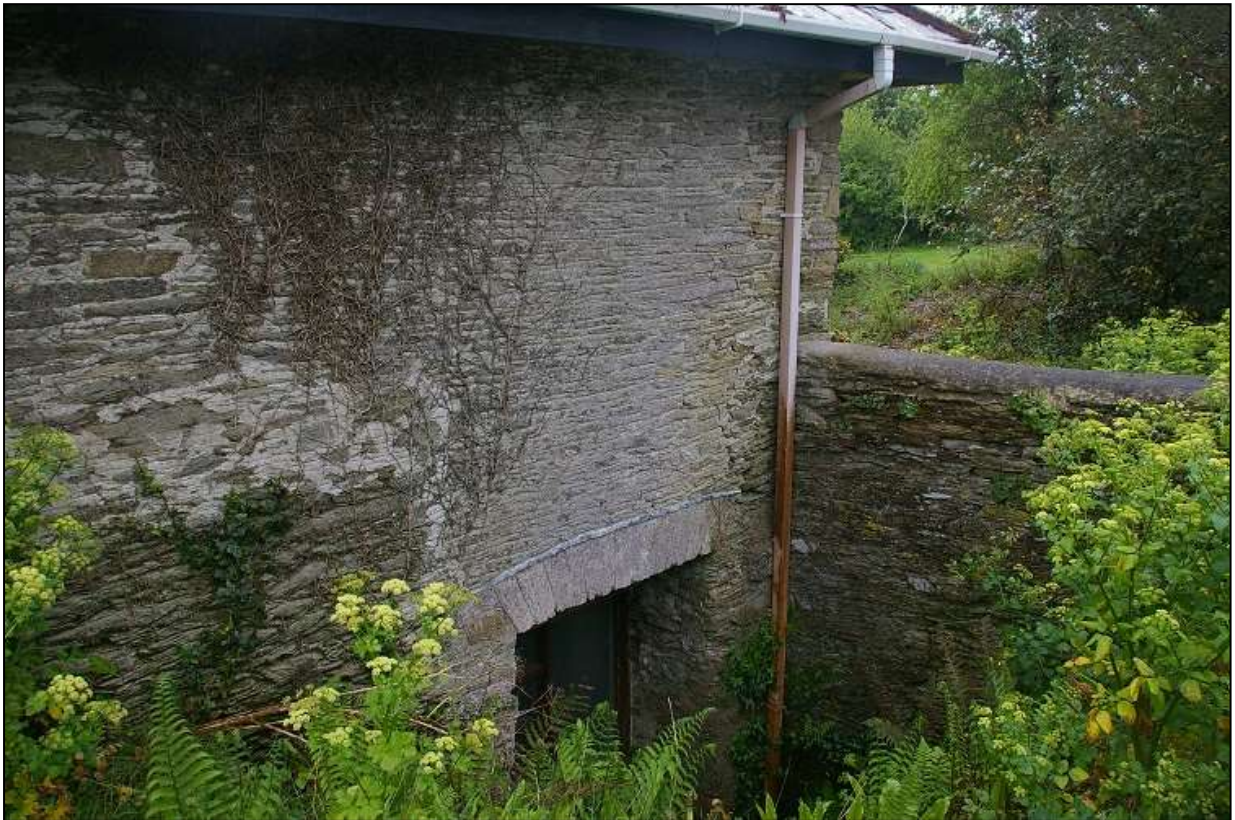
The west flank wall of the west wing is similar to the east elevation in that it has battered earlier stonework to the lower one and a half storeys, to the north end, with a raise at the eaves. It has three openings, with a small ground floor window offset north of centre, with heavy oak lintel and small later 18th or early 19th century casement window; it then has a central first floor window which has been forced into the older stonework, but is correct within the raise, with voussoirs and a 20th century casement. There is a clear build line in this wall, c.2m from the south end where the earlier stonework stops, and the south part of this elevation is an extension (Figure 9). At ground floor level within the post-medieval rubble extension stonework there is a large doorway, with very blocky voussoirs, which is now partly blocked with a crude modern fixed window frame inserted. The presence of the doorway would suggest levels have been significantly altered here as outside the ground level is at first floor height, blocking any sensible form of access. There is a thin bracing or retaining wall abutting the wall and running west from the south-west corner which has a gate between it and the current lean-to garage shed.

FIGURE 9: THE SOUTH END OF THE WEST ELEVATION, SHOWING THE TERMINUS OF THE OLDER STONEMWORK AND THE DOORWAY FORMED IN THE EXTENDED SOUTH END BLOCKED BY RAISED GROUND LEVELS; FROM THE NORTH-NORTH-WEST.

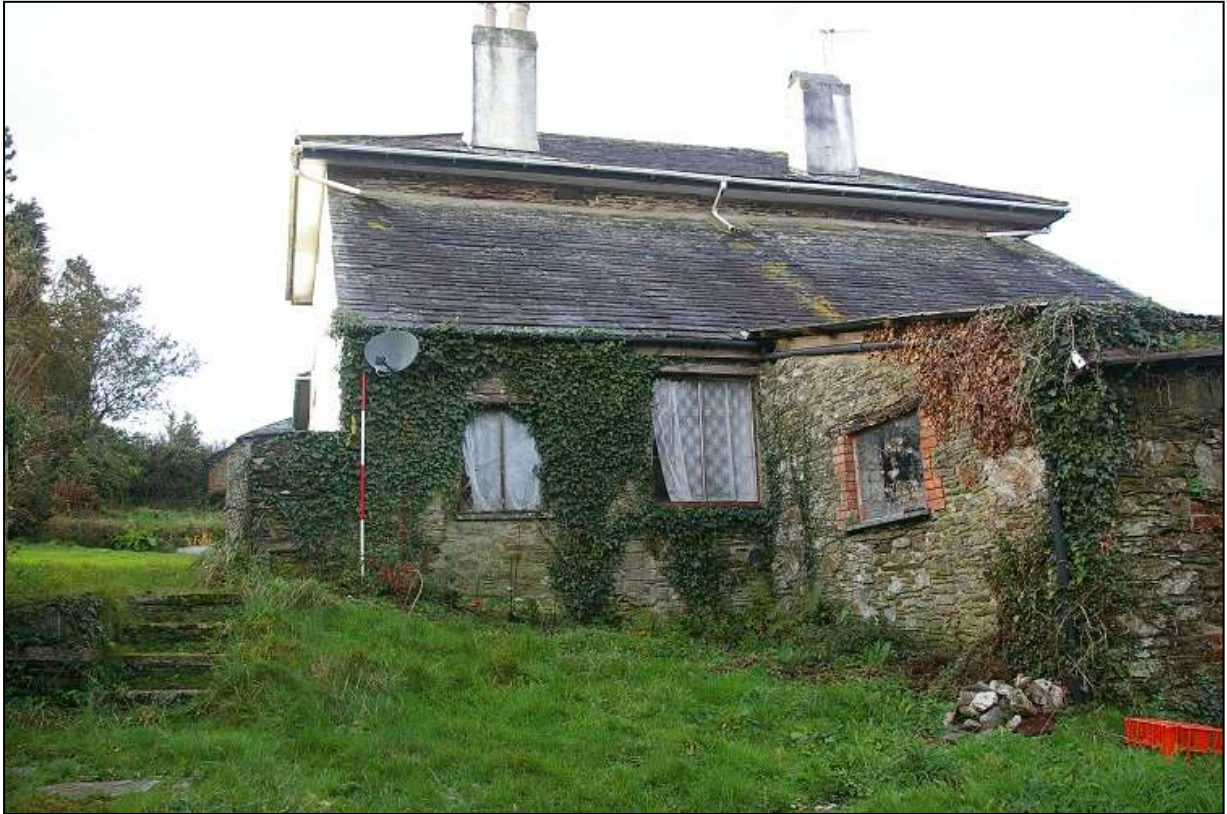
Attached to the east flank wall are two single storey lean-to outbuildings; OB1, the largest has a thick stonewall to the south and east and runs the full depth of the east wing. It has two irregularly sized windows to the south-east corner, with modern (20th century) timber frames, overlooking the stable yard. It has a concrete floor and heavy common rafter roof with struts, with a modern boarded loft, the building has been used as a workshop, having an open north front with timber boarding and a modern part-glazed boarded door. OB2, the smaller workshop is built up against OB1s east wall. It is small and square, with concrete floor and an old heavy-duty workbench against the south wall which has a large central window. The south wall exhibits a build line at the eaves, where the roof was once a shallower pitch and the east wall is of low single storey height and stops short of OB1, a modern timber boarded

FIGURE 22: THE STONE RUBBLE OUTBUILDINGS ON THE EAST FLANK OF TREVEDDA, WITH 2M SCALE; FROM THE EAST-SOUTH-EAST.

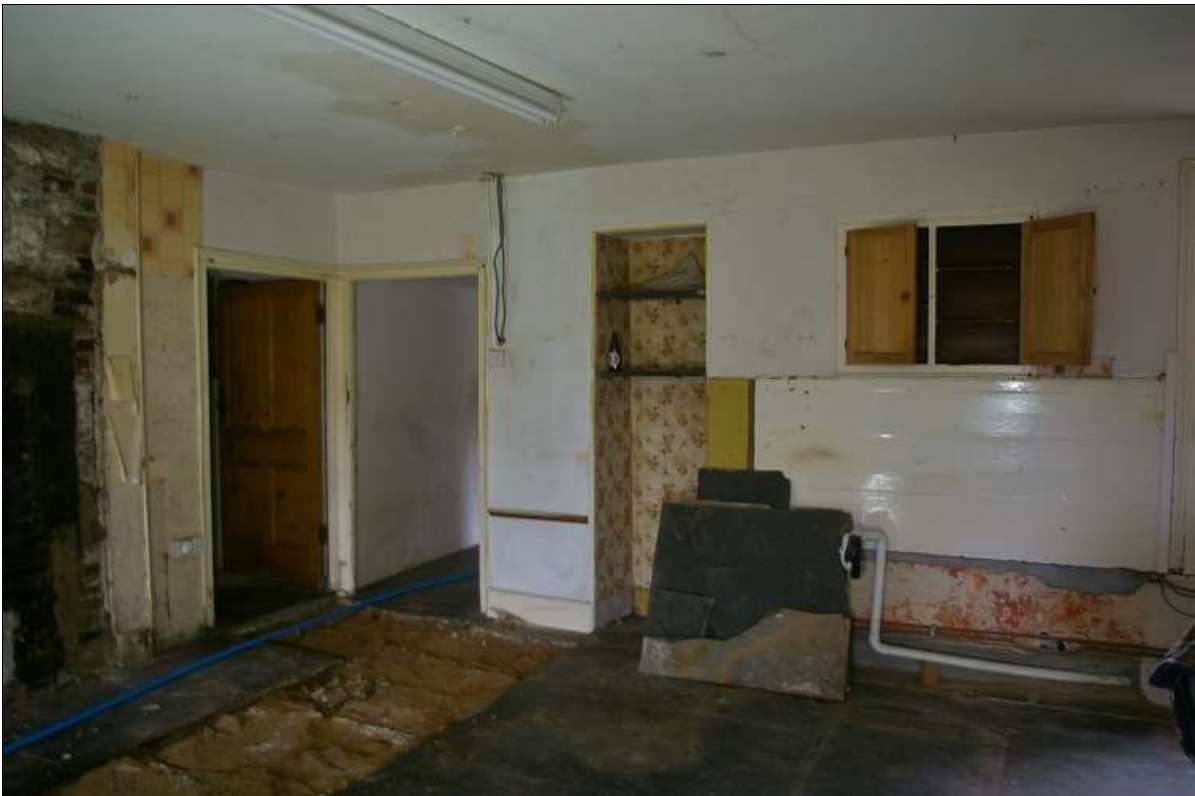
4. THE WEST END OF THE NORTH WALL, WITH A SERIES OF OPENINGS FOR CUPBOARDS SET INTO A POTENTIAL AREA OF BLOCKING, WITH DOORS TO SERVICE AND REAR SERVICE WING; FROM THE SOUTH-EAST.

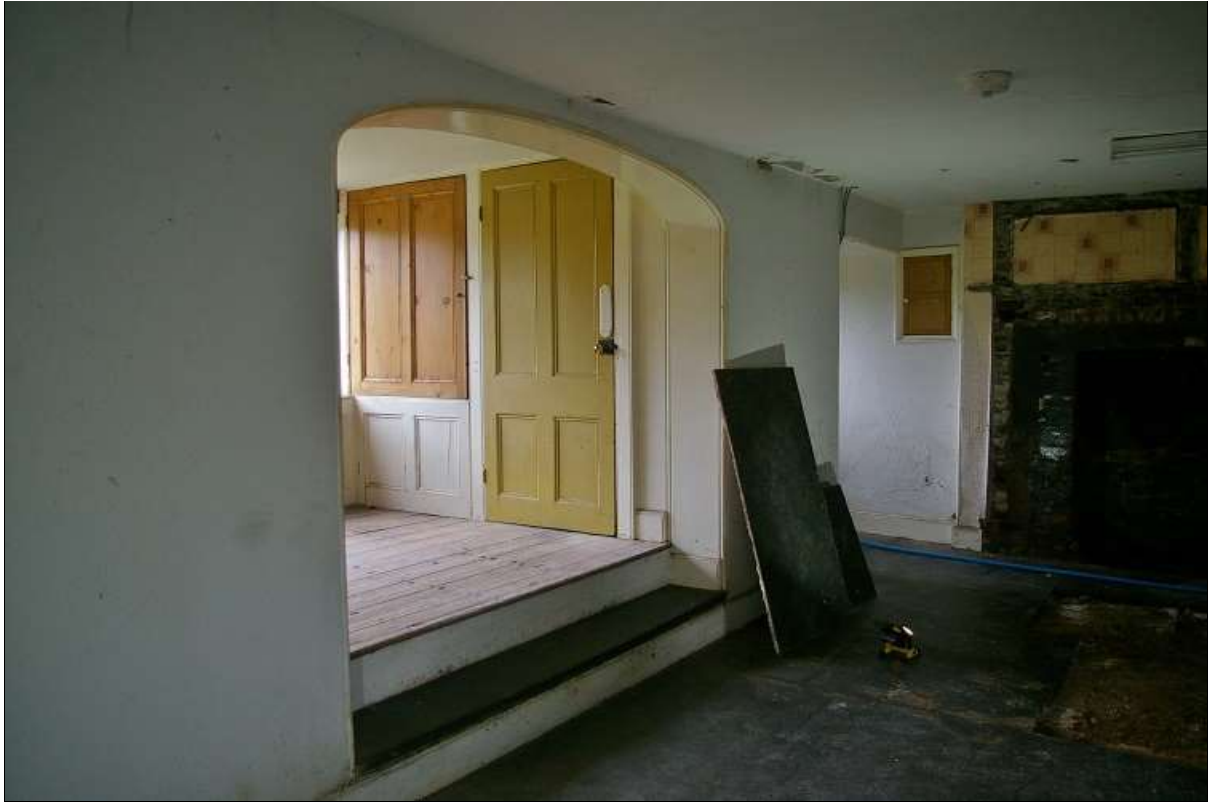
5. THE SOUTH WALL OF R2A, SHOWING THE ADDITION OF THE STAIR PROJECTION; FROM THE EAST-NORTH-EAST.

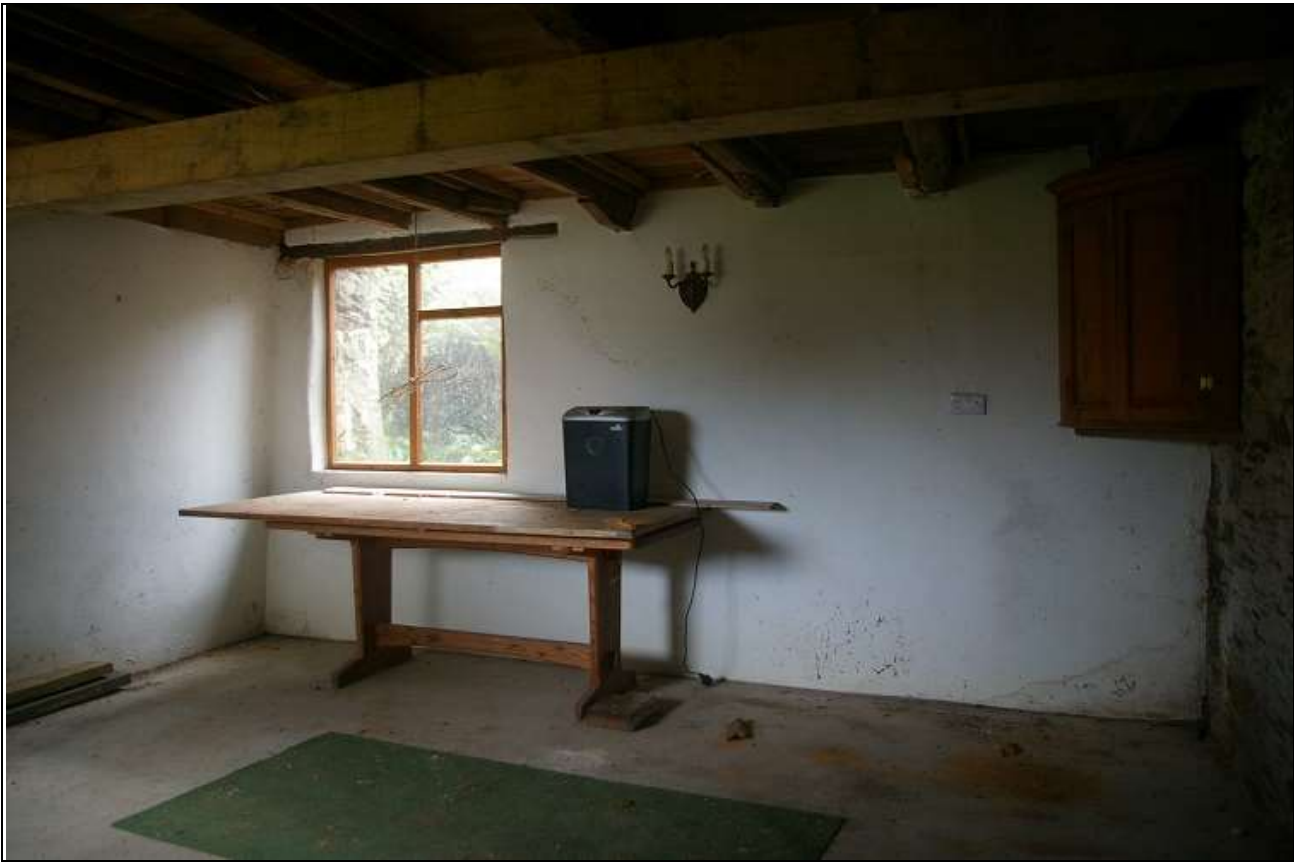
20. R5, A SPACE WITH BOTH A SERVICE AND AGRICULTURAL FUNCTION, WITHIN THE EXTENDED CROSS-WING TO THE WEST; FROM THE EAST-NORTH-EAST.

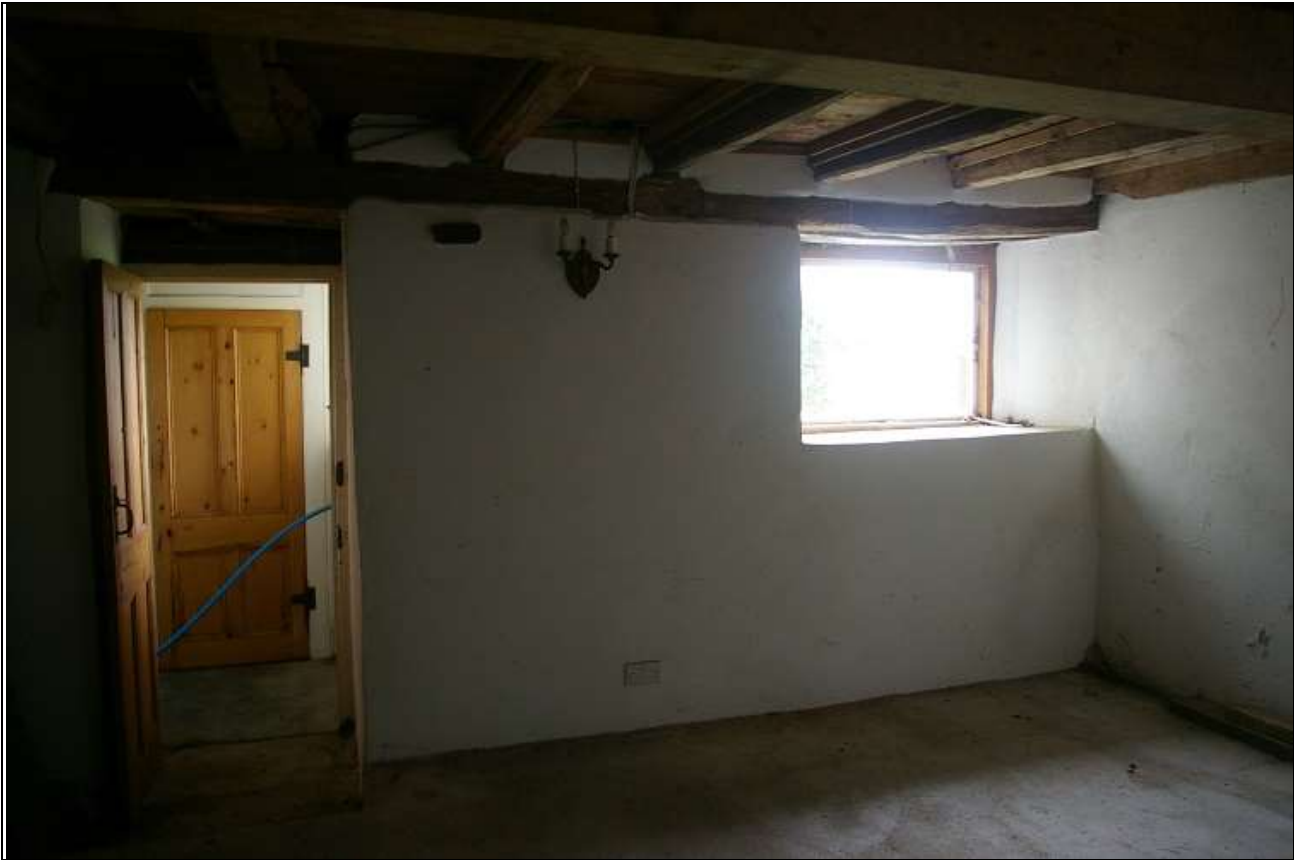
21. R5, THE DOOR TO R2A, WITH LOBBY AND SECOND UNDER STAIR CUPBOARD VISIBLE THROUGH THE DOOR, THE LONG BEAM IN THE EAST WALL OF THE WEST WING; FROM THE WEST-NORTH-WEST.

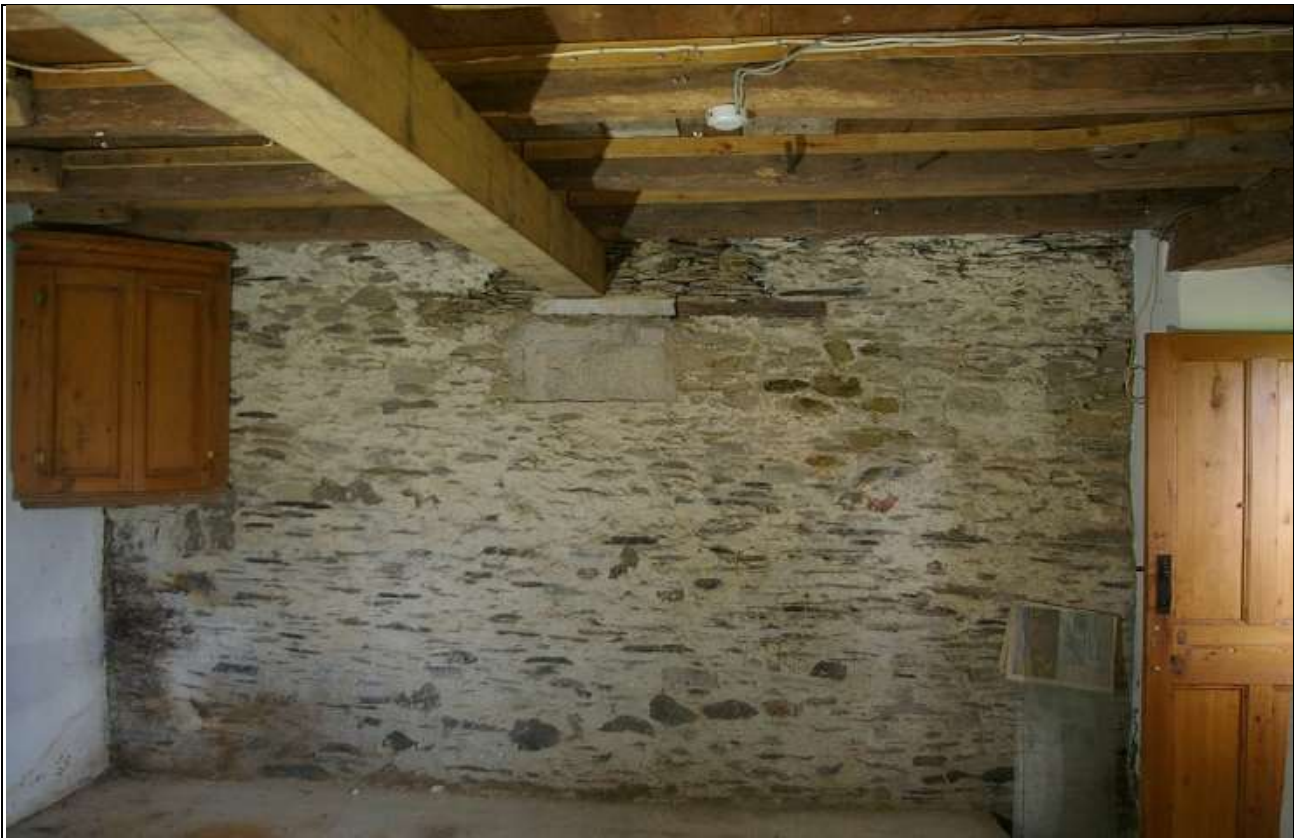
22. THE THICK STONE PARTITION WALL BETWEEN R5 AND R6 IN THE WEST WING; FROM THE SOUTH.

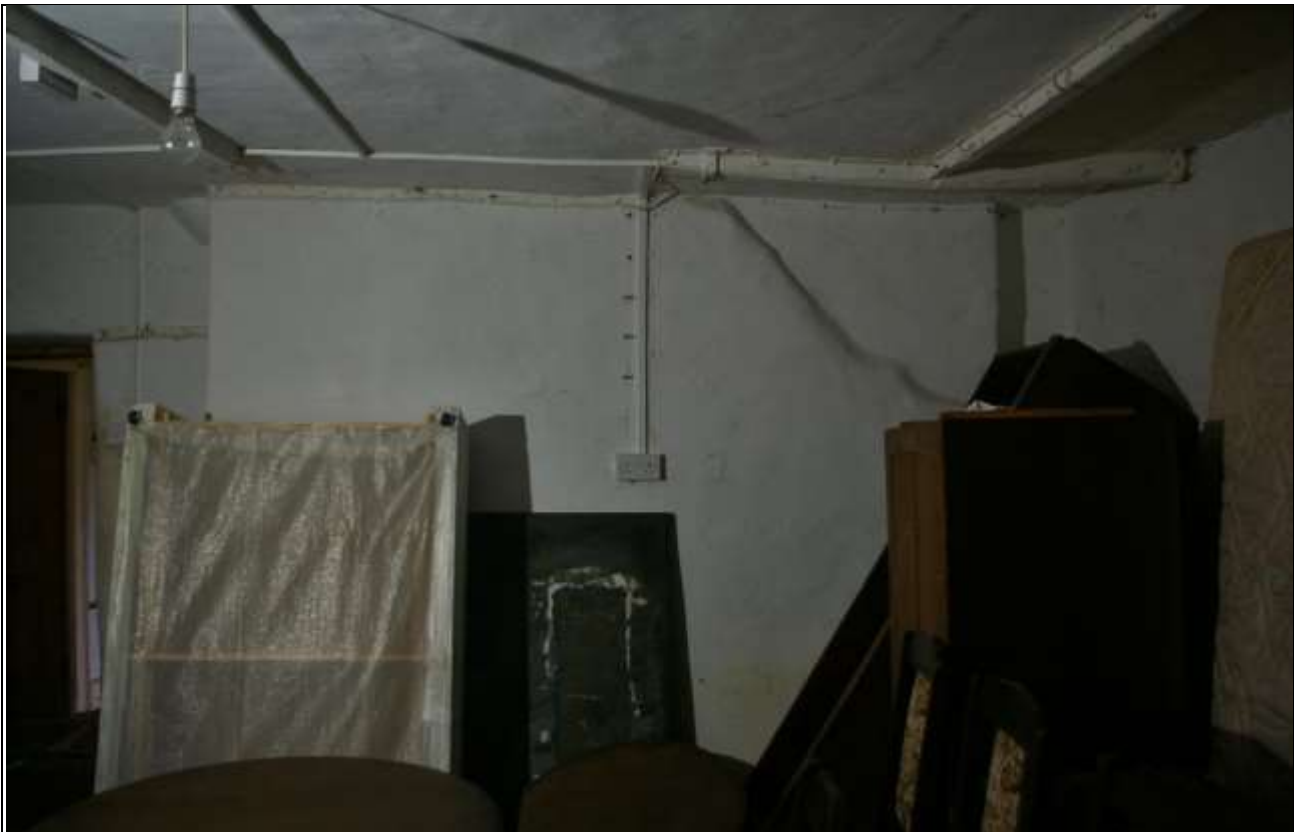
24. THE STACK IN R6, ALSO BEAMS AND TIMBERS WITH HOOKS AND LOOPS AT THE CEILING; FROM THE WEST.

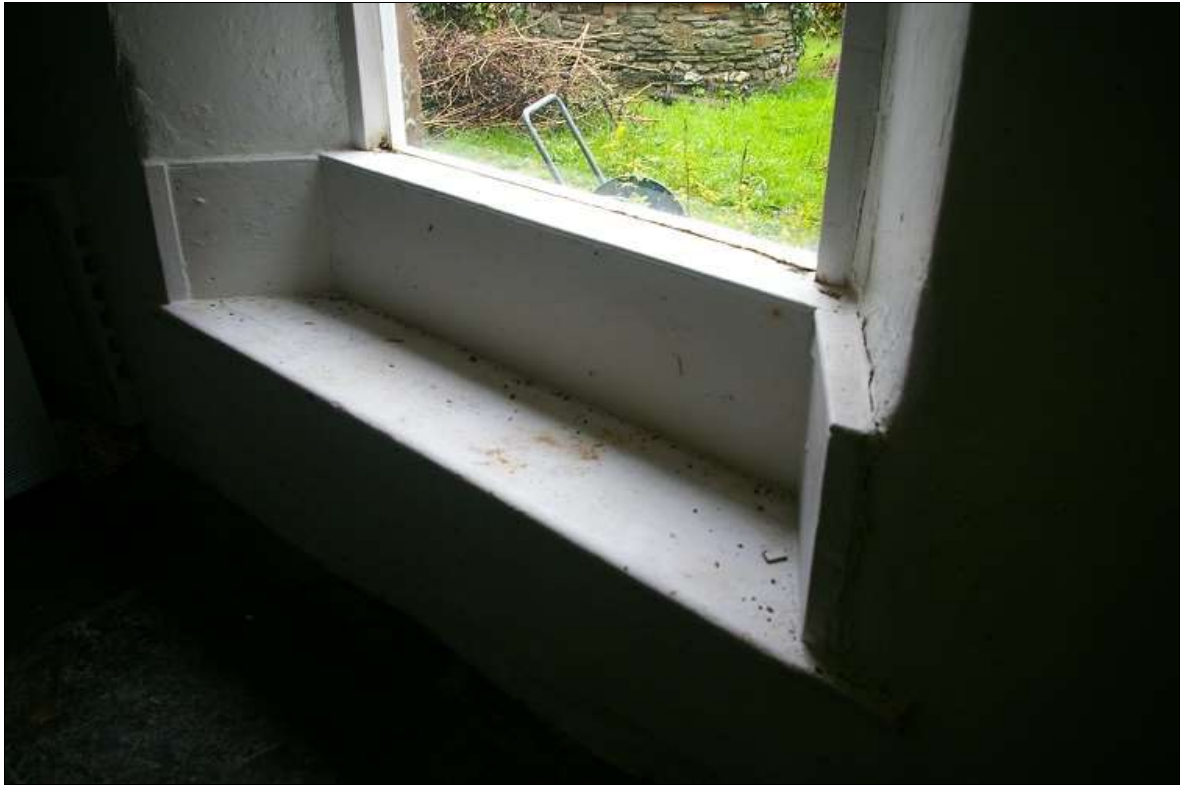
27. THE PLANK BEADED WINDOW SEAT IN R7A; FROM THE SOUTH-WEST.

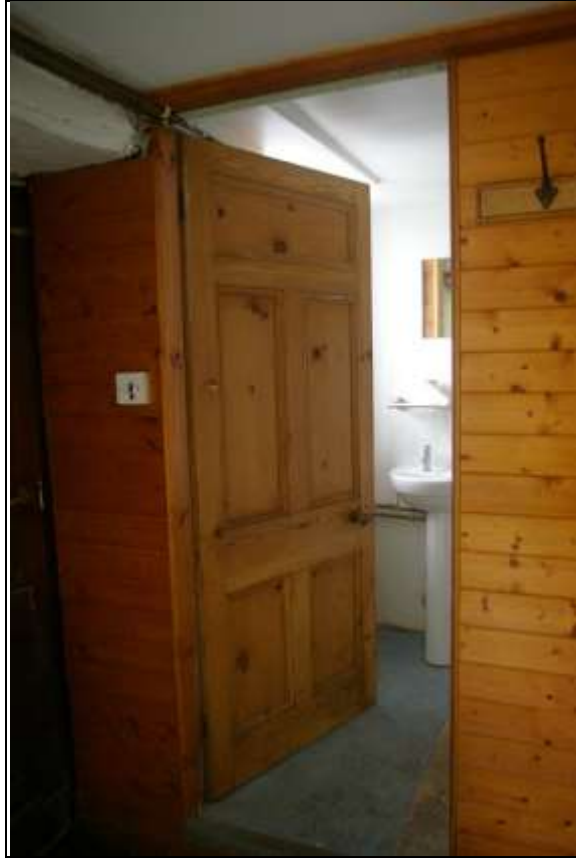
28. SMALL BOARDED PARTITIONS FORM A BATHROOM IN THE CORNER OF R7A, A SMALL ROOM, R7B; FROM THE NORTH-WEST.

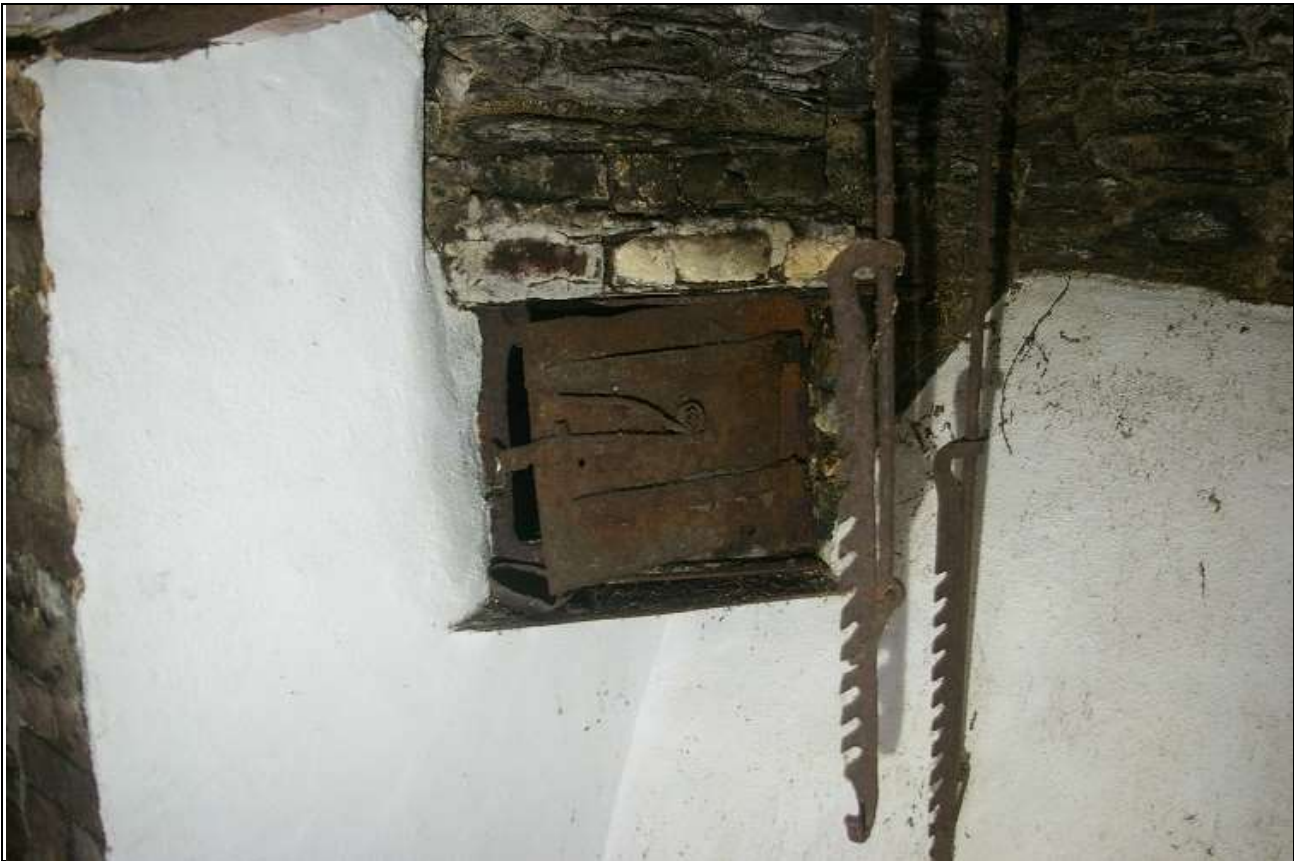
29. THE BREAD OVEN IN THE STACK IN R7A, ALSO POT HANGERS; FROM THE NORTH-EAST.

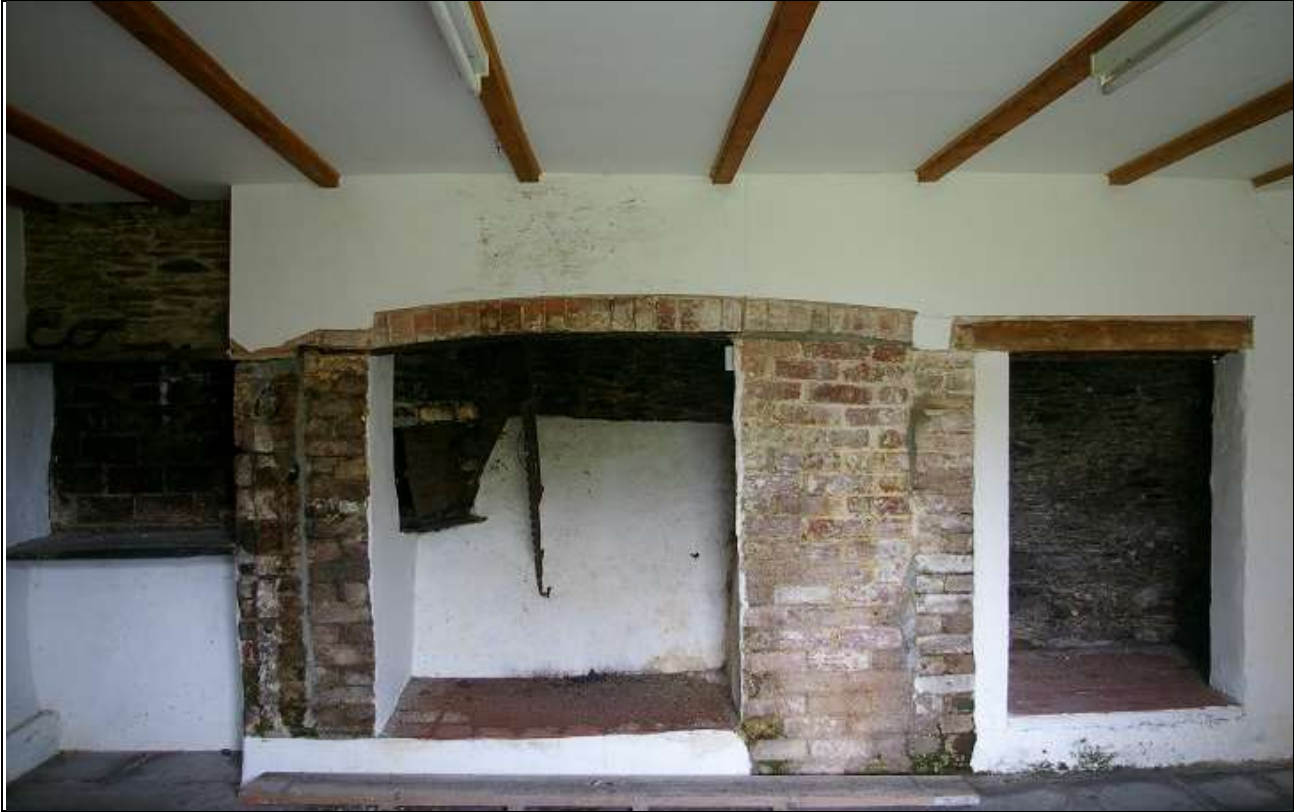
30. THE LATERAL STACK IN R7A; FROM THE EAST.

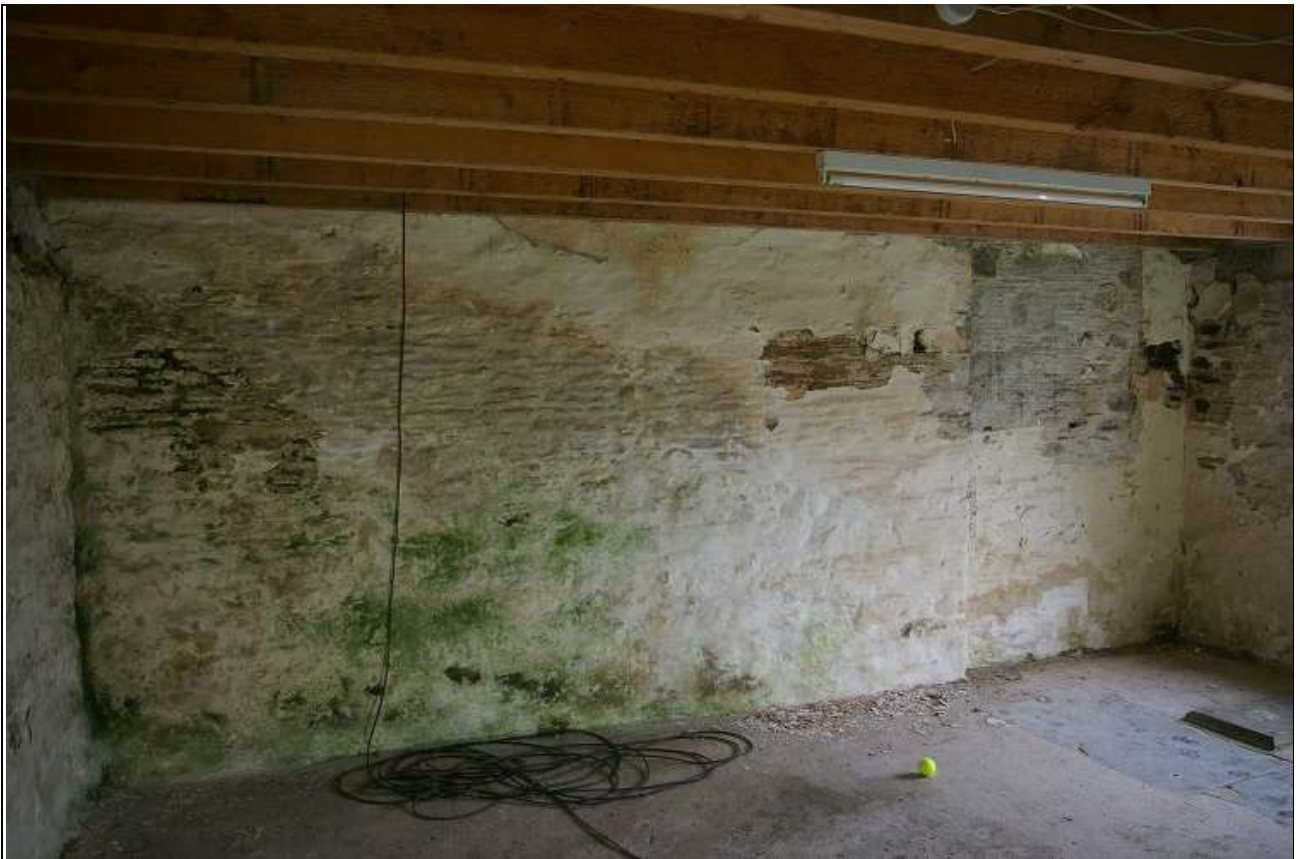
31. R8, AN SEMI AGRICULTURAL SPACE ADDED ONTO THE KITCHEN BLOCK, NORTH WALL, CLEARLY EXTENDED TO THE EAST; FROM THE SOUTH-WEST.

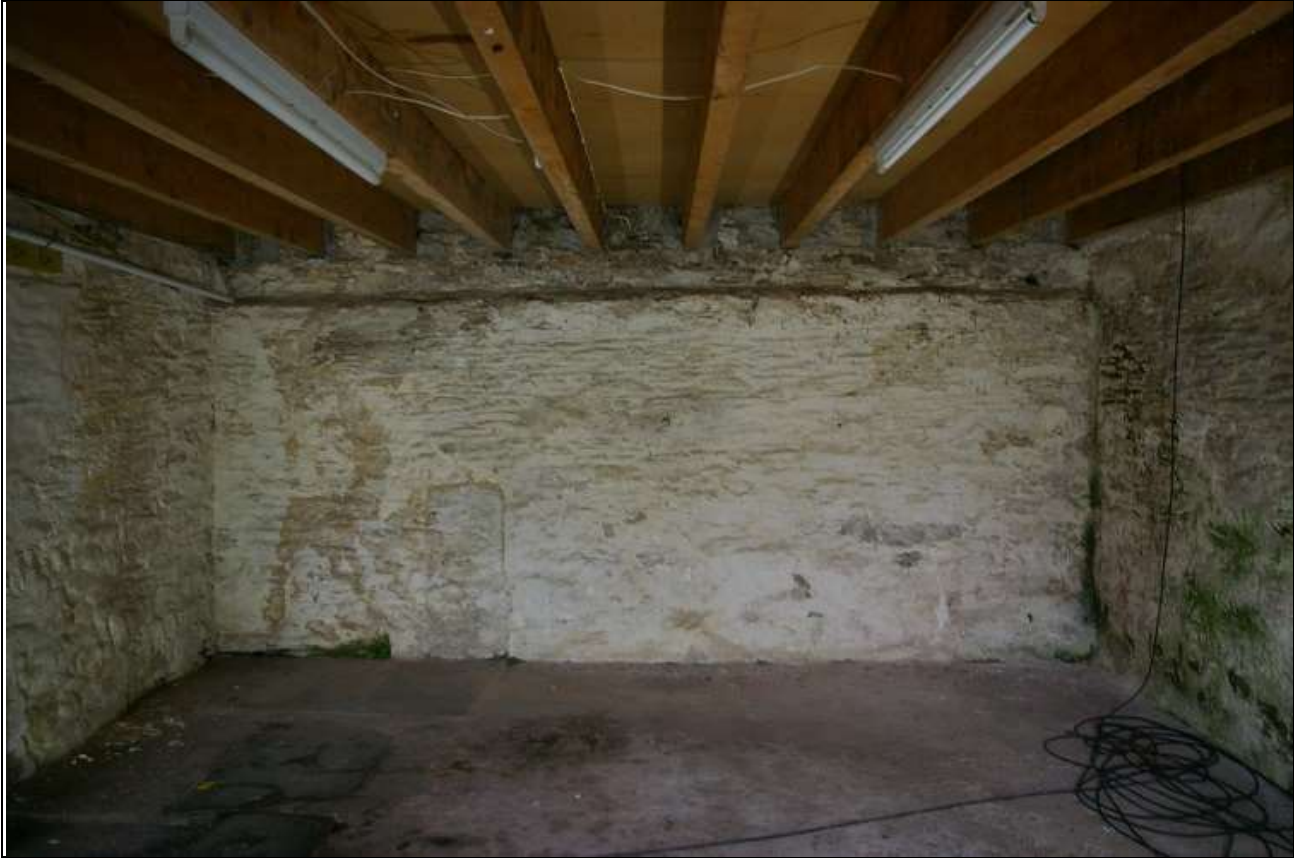
32. THE WEST WALL OF R8, WITH LEDGE FOR FORMER LOFT, MUCH LOWER THEN CURRENT FLOOR; FROM THE EAST.

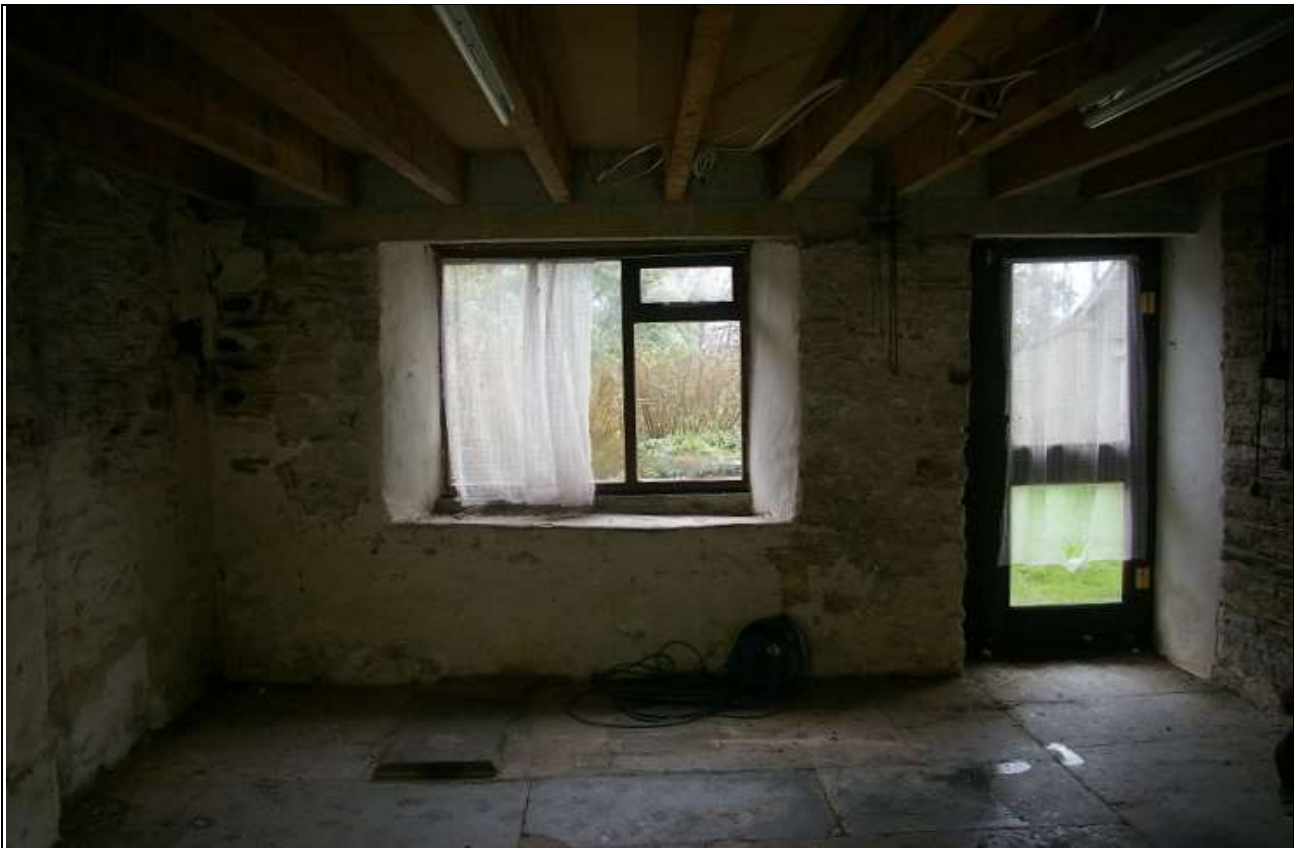
33. THE EAST WALL OF R8, EXTENDED TO THE EAST; FORM THE WEST.

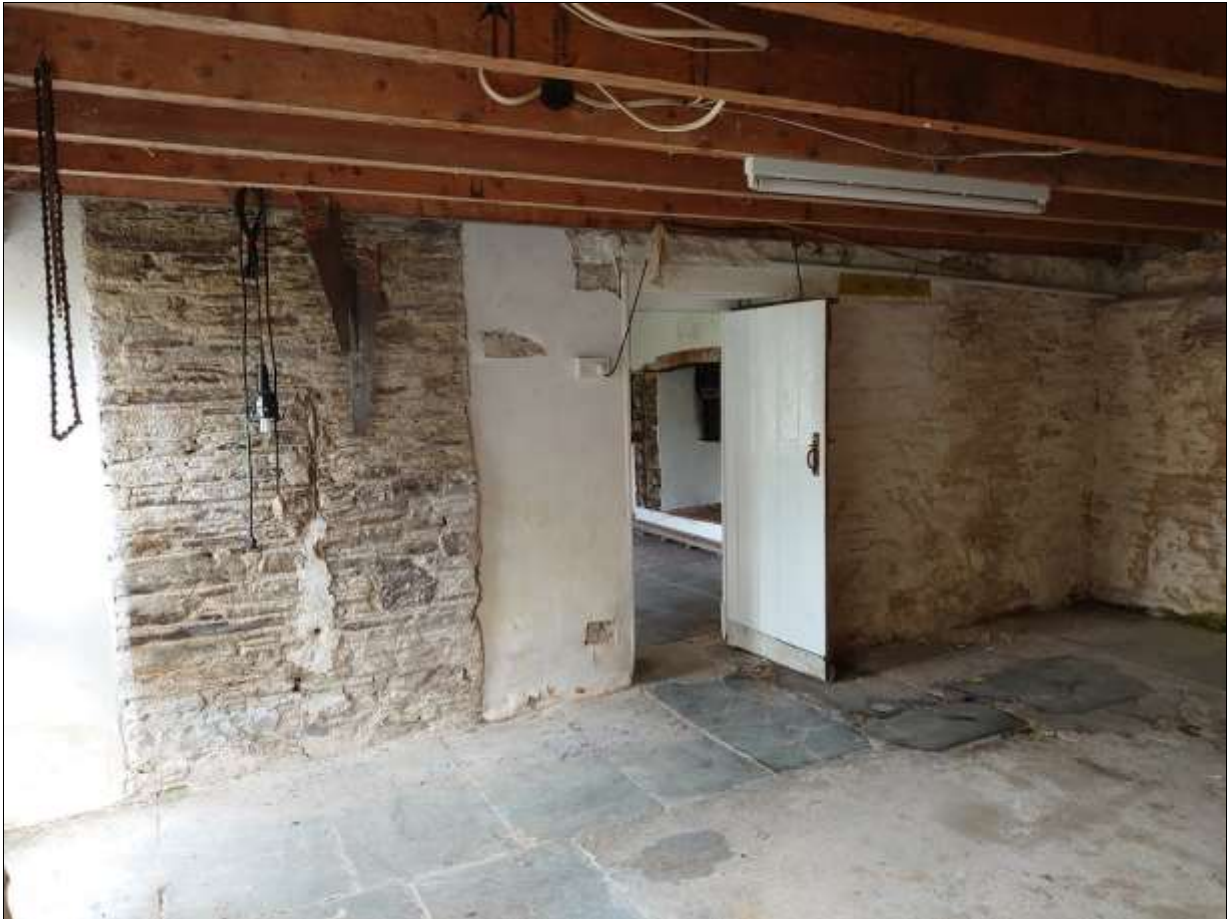
34. THE NORTH WALL OF THE ONE AND A HALF STOREY KITCHEN BLOCK, AS SEEN WITHIN R8; FROM THE NORTH-EAST.

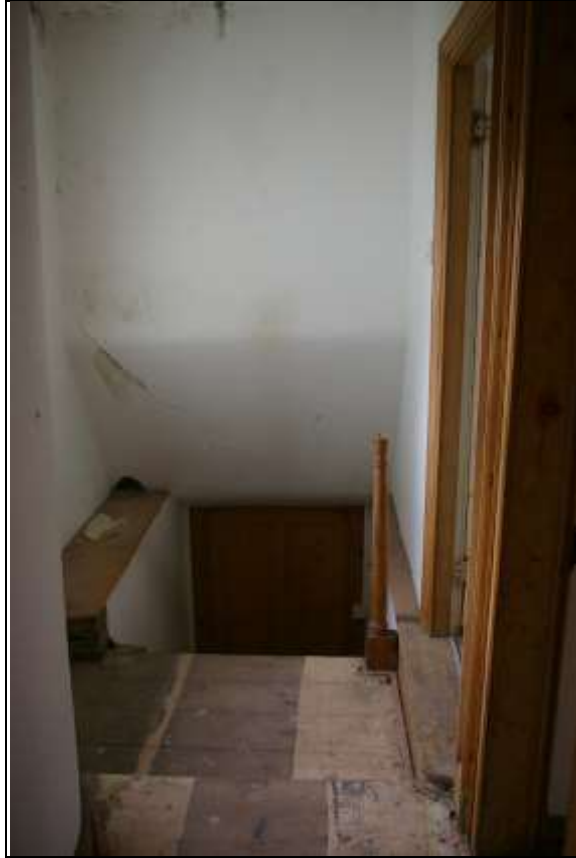
36. THE EASTERN STAIR LOBBY, R9A; FROM THE EAST.

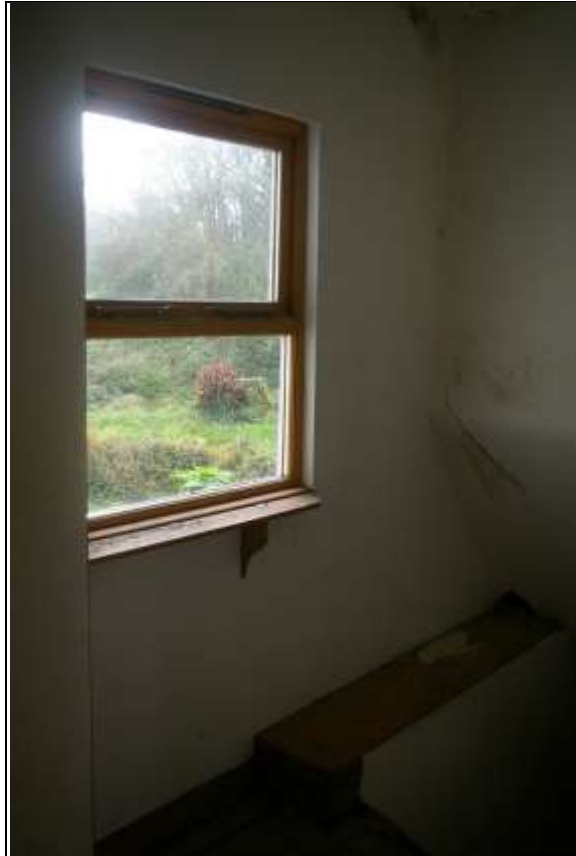
37. WINDOW WITH BRACKETED SHELF IN R9A; FROM THE EAST-NORTH-EAST.

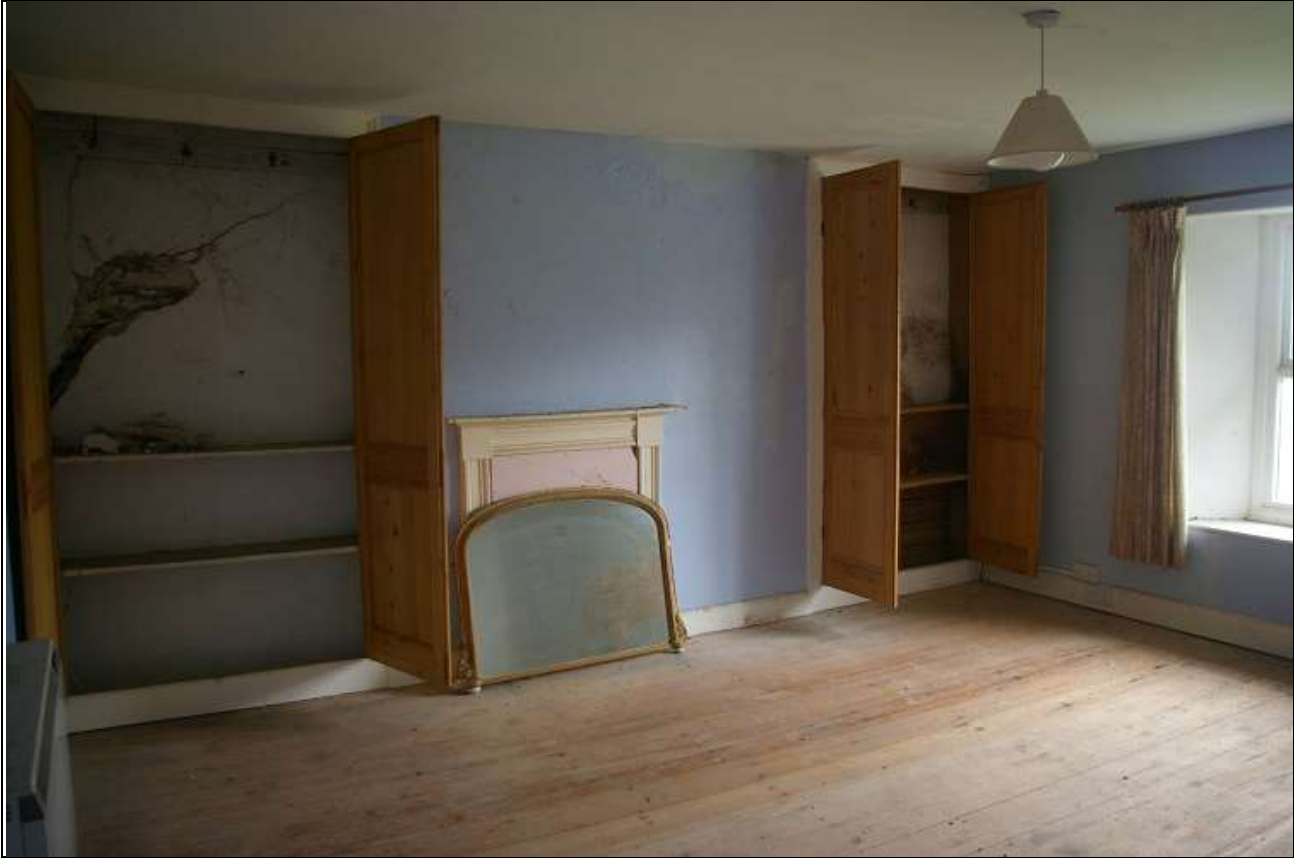
38. THE PAIR OF SHALLOW SHELVED CUPBOARDS IN R11, WITH BLOCKED FIREPLACE WITH MANTLED SURROUND; FROM THE NORTH-WEST.
