**TREVEDDA FARM
LANTEGLOS HIGHWAY
FOWEY
CORNWALL**

Historic Building Recording

South West Archaeology Ltd. report no. 210120

Results of historic building recording

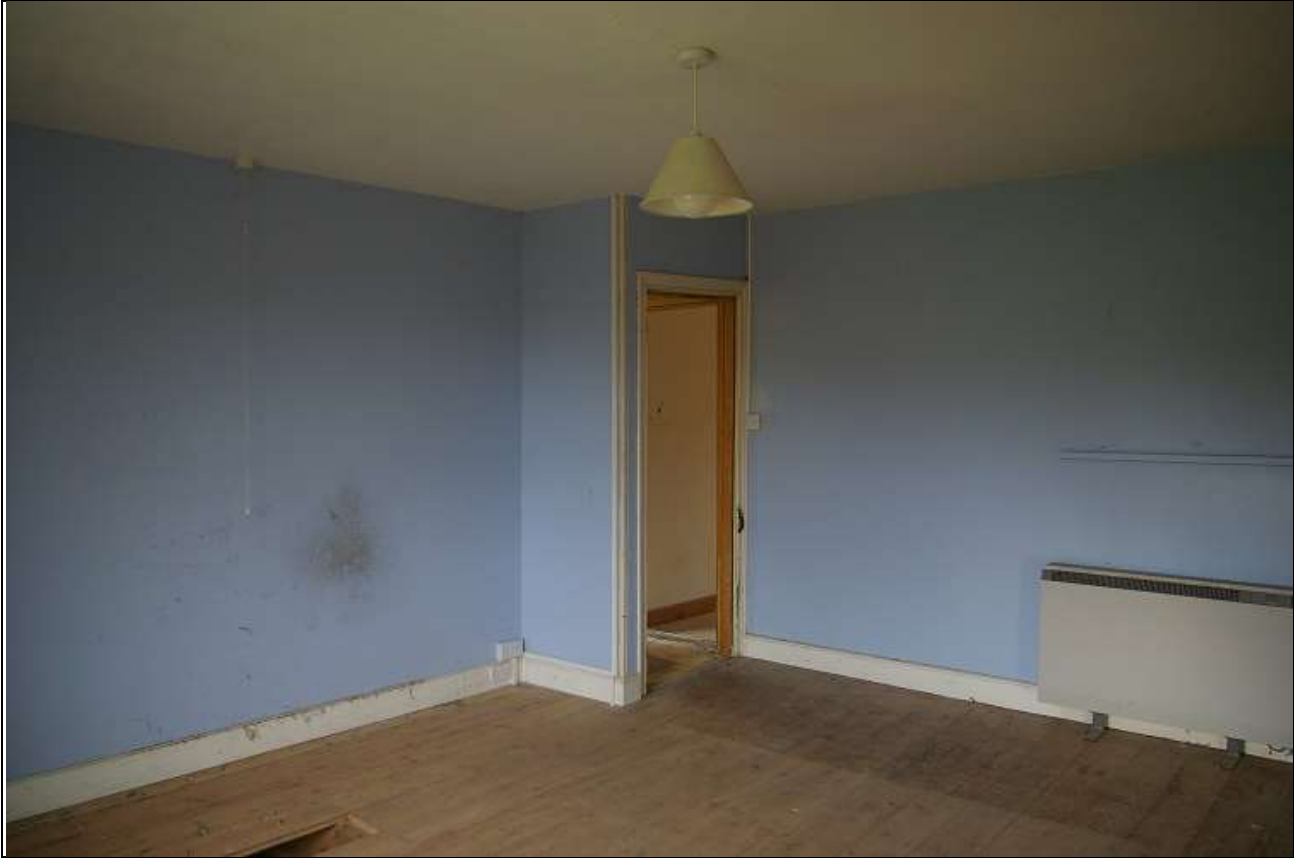
40. THE DOOR TO R9A, THE EAST STAIR LOBBY FROM R11; FROM THE SOUTH-EAST.

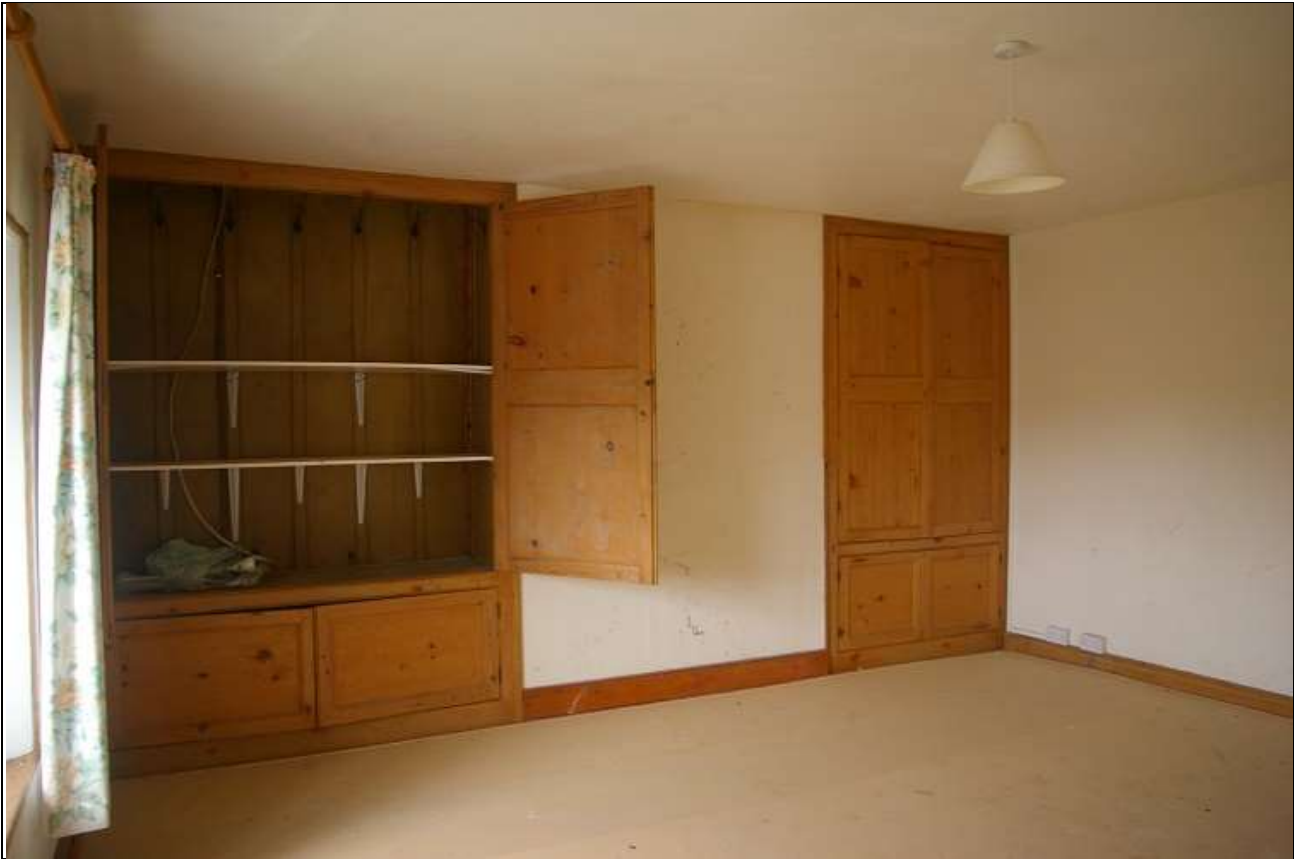
42. THE WIDE DEEP CUPBOARDS IN R12, LINED IN WOOD; FROM THE NORTH-WEST.

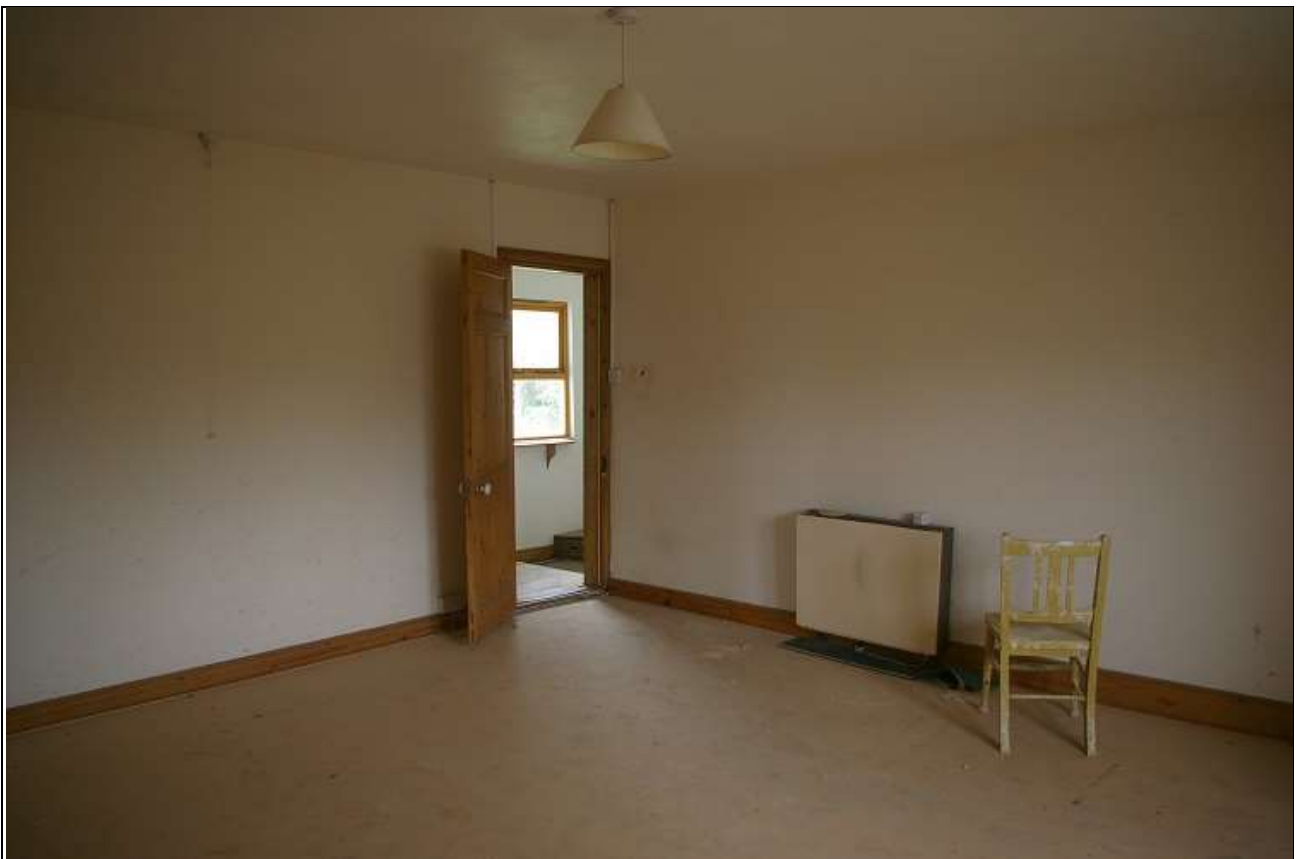
43. THE DOOR BACK TO R9A, THE EASTERN STAIR LOBBY FROM R12; FROM THE NORTH-EAST.

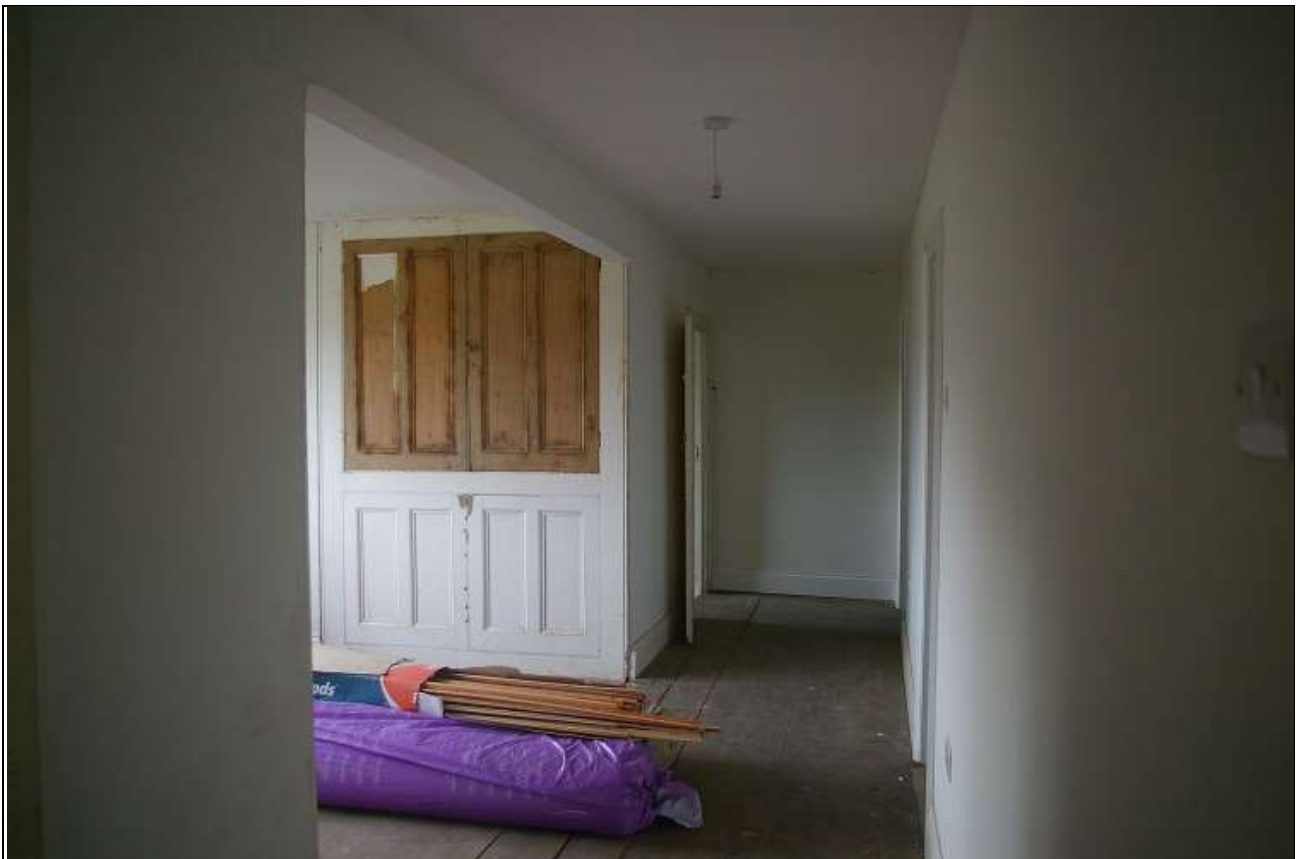
45. R10, THE LANDING WHICH LINKS THE EAST AND WEST WINGS AND REAR WING, CORRIDOR FORMED FROM LATH AND PLASTER PARTITIONS; FROM THE EAST.

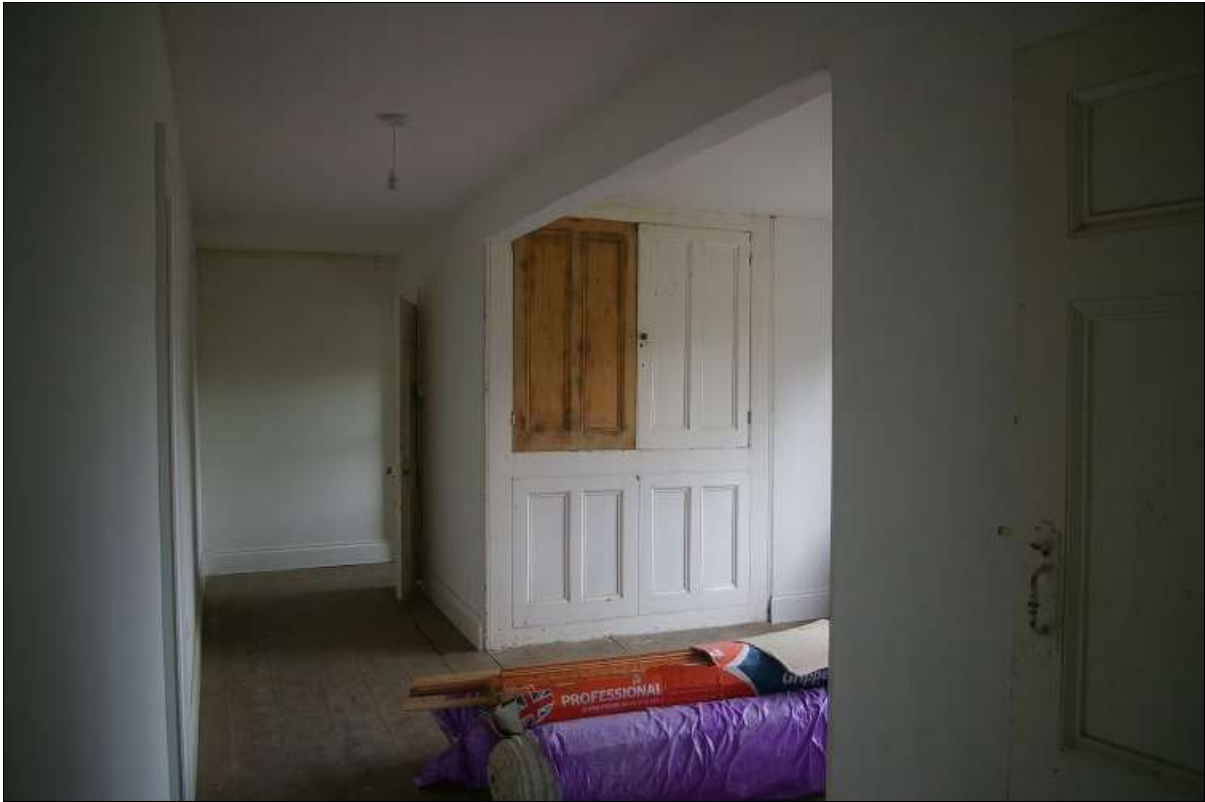
46. R10, THE LANDING WHICH LINKS THE EAST AND WEST WINGS AND REAR WING, CORRIDOR FORMED FROM LATH AND PLASTER PARTITIONS; FROM THE WEST-NORTH-WEST.

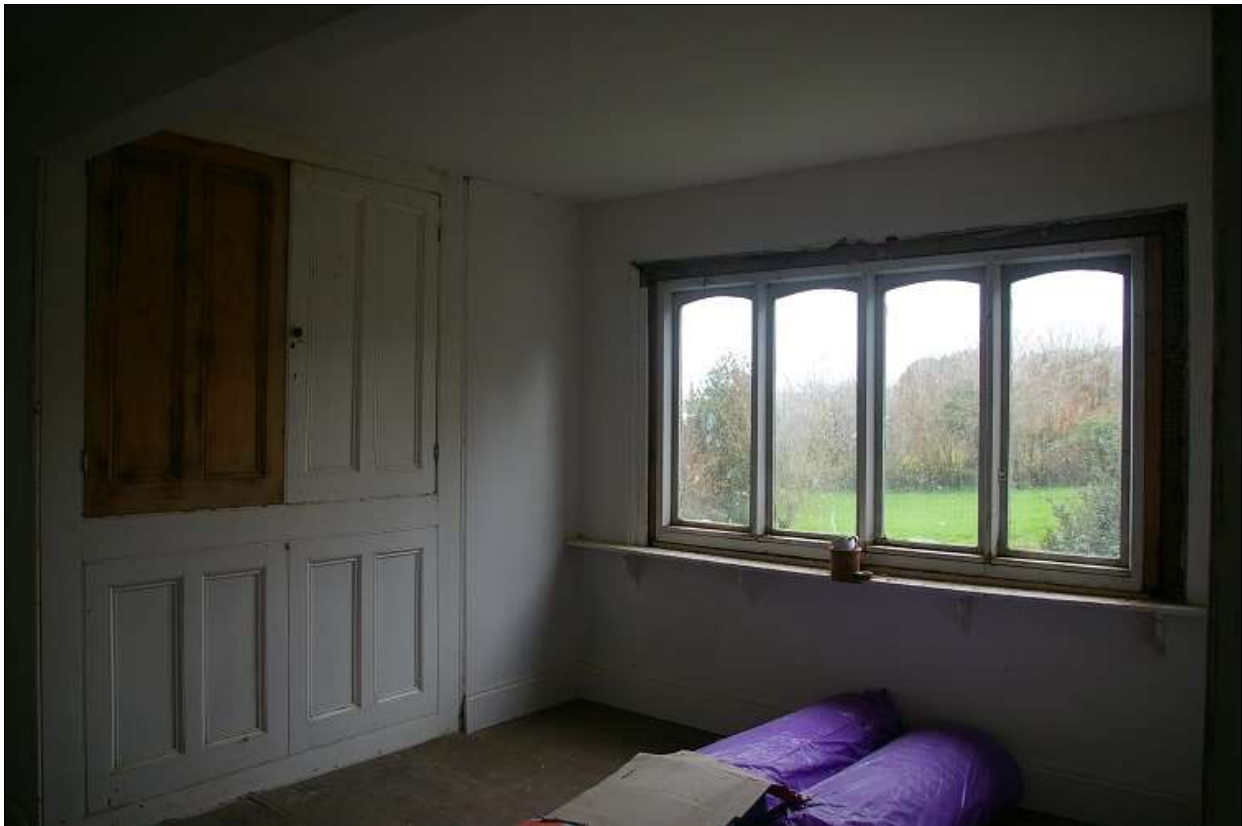
47. DETAIL OF THE PROJECTING STAIR PROJECTION, WITH PAIRS OF LINEN CUPBOARDS AND BRACKETED SHELF UNDER THE WINDOW; FROM THE NORTH-WEST.

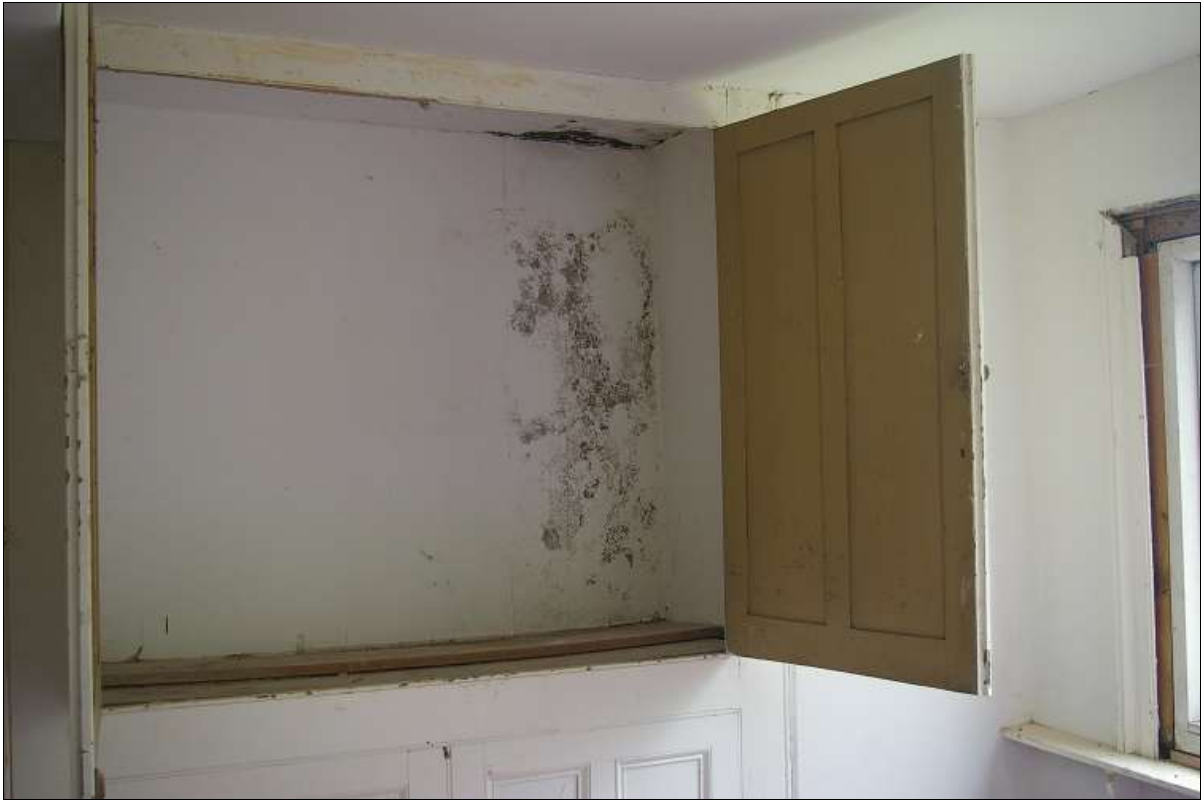
48. INTERIOR OF THE LINEN CUPBOARDS; FROM THE NORTH-WEST.

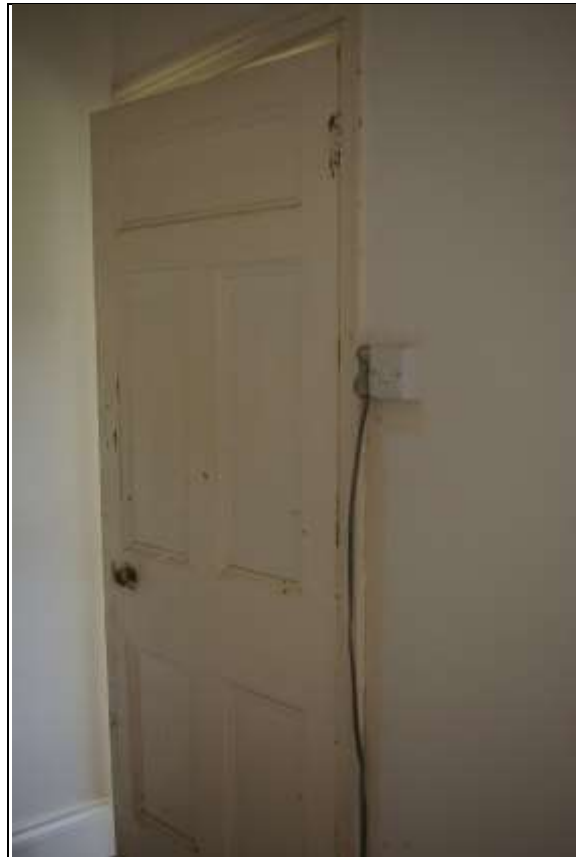
49. FIVE PANEL DOOR TO R9A, PART OF A MATCHING SET OF THREE WHICH SERVE THE LANDING R10; FROM THE NORTH-WEST.

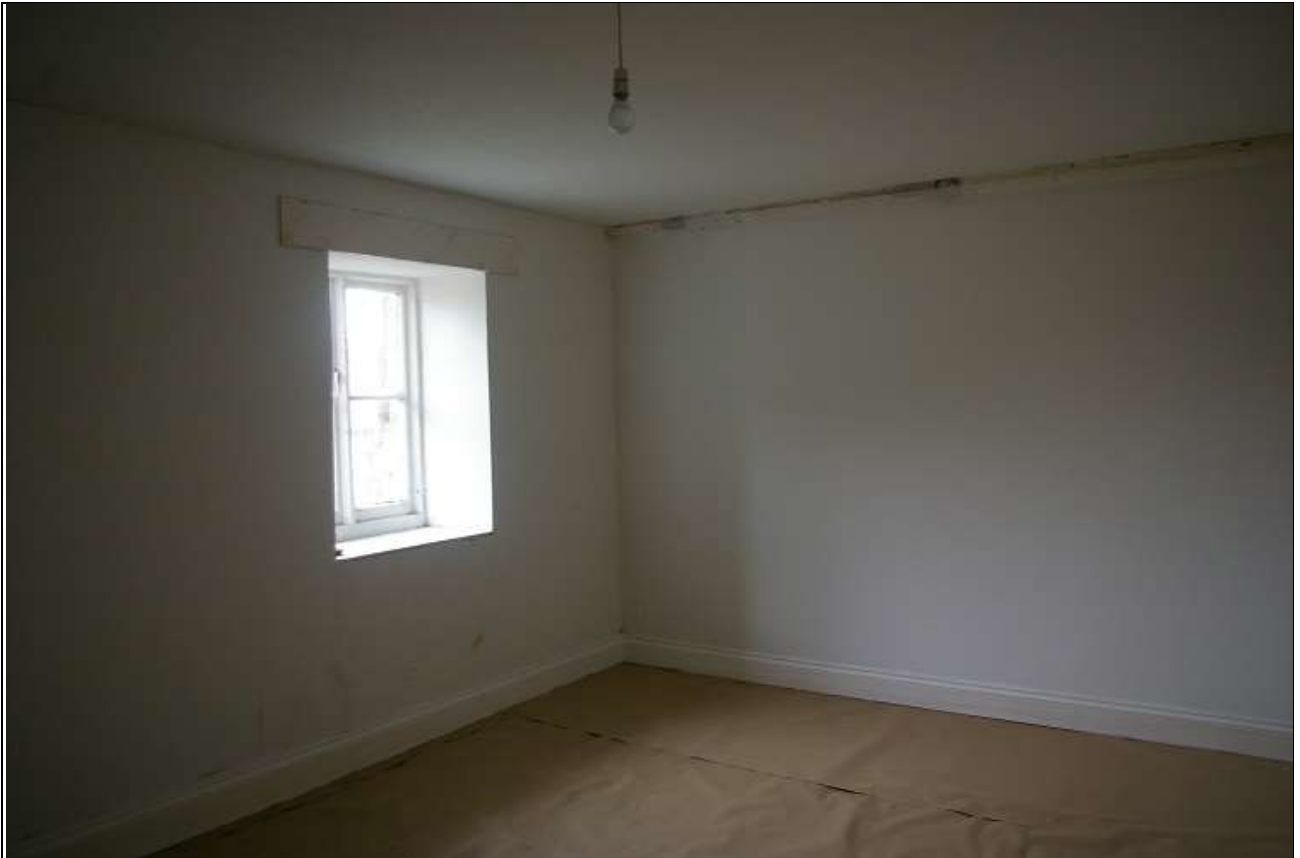
51. R13, CHAMBER OVER HALL, WITH LONG MOULDED BEAM WHICH SEEMS TO BRACE THE END OF THE FORMER HALL AND RUNS THROUGH TO THE EAST EXTENDED WING; FROM THE NORTH-EAST.

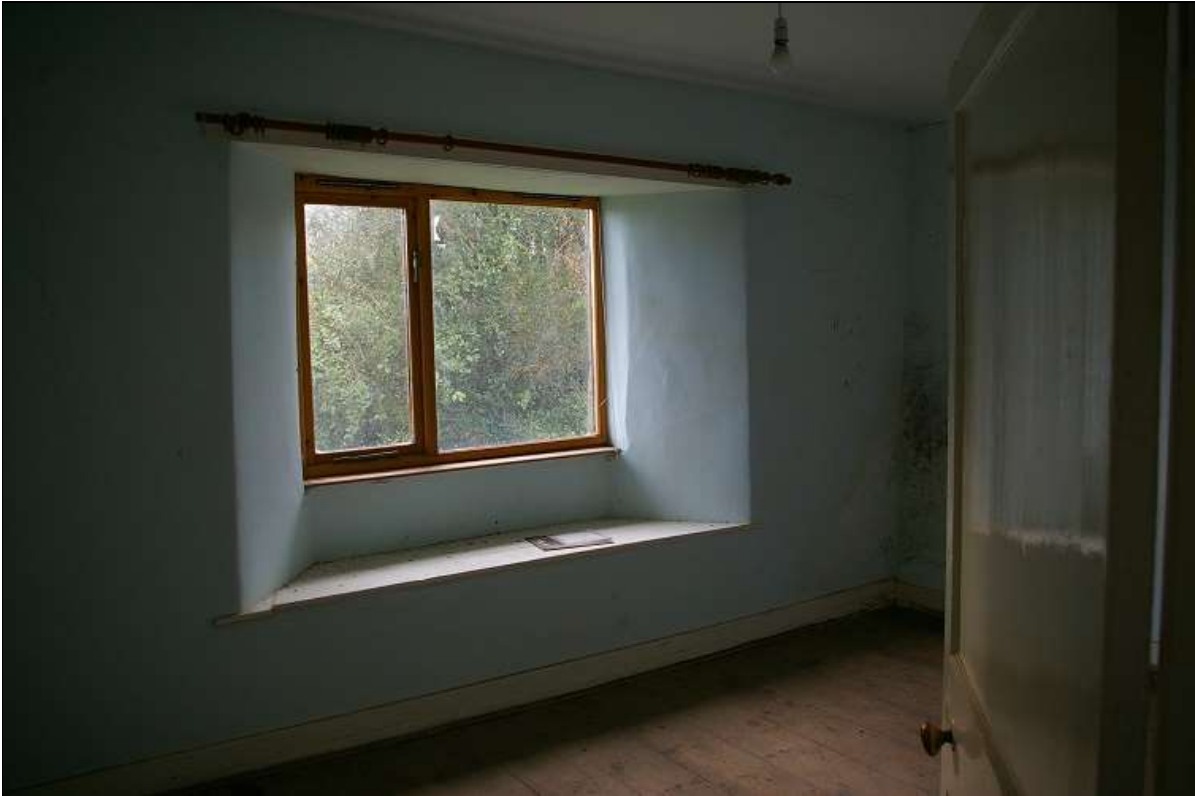
52. R15, WITH LARGE WINDOW IN SOUTH WALL, WITH PLANK WINDOW SEAT AND GOO TWO PANEL DOOR FORM THE LOBBY, R14; FROM THE NORTH-EAST.

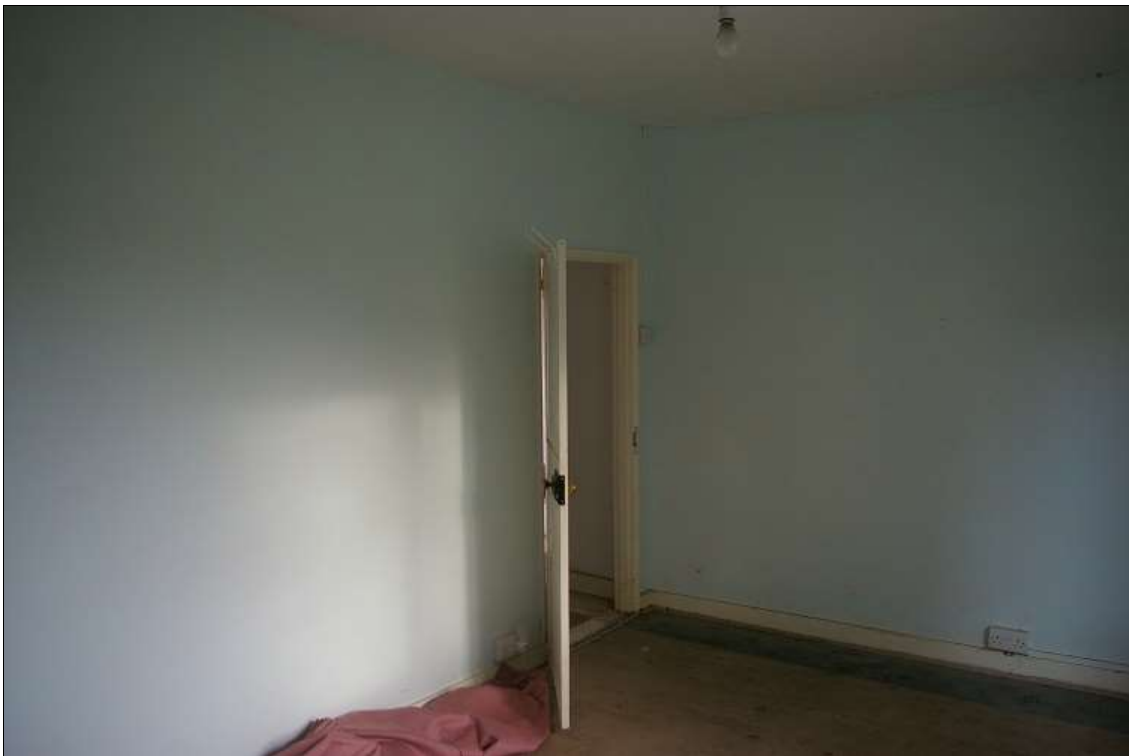
53. R15, DOOR TO LOBBY, R14; FORM THE SOUTH-WEST.

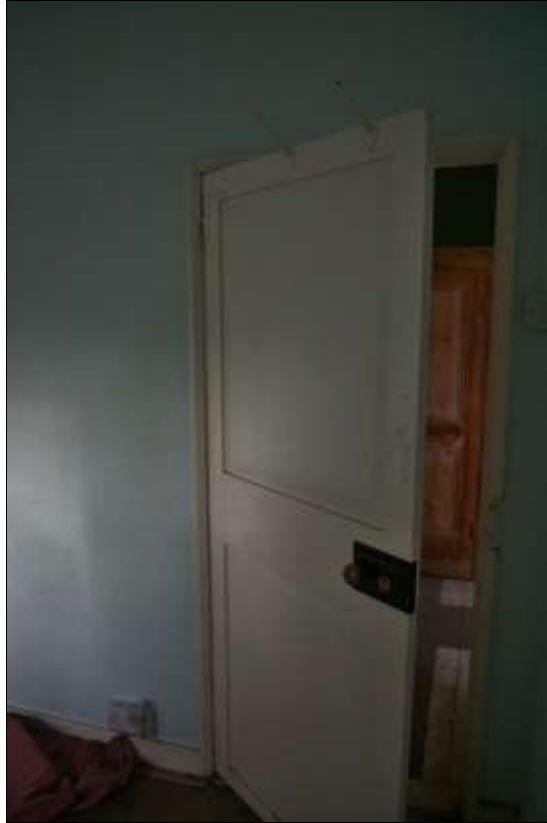
54. THE GOOD LATER 17TH OR EARLY 1700S TWO PANEL DOOR IN R15, GOOD L-H HINGES, BUT LIKELY RESET WITHIN THE BUILDING, ON A THIN BEADED FRAME; FROM THE SOUTH.

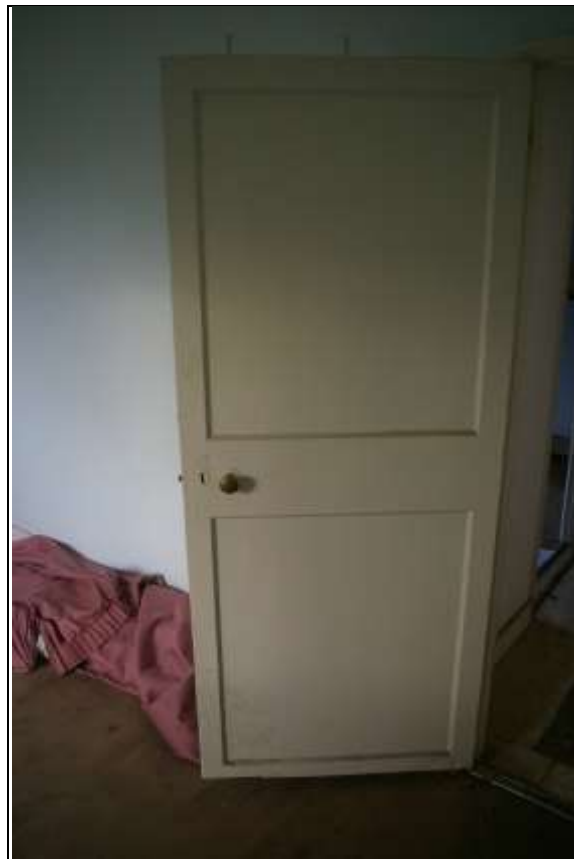
55. THE GOOD LATER 17TH OR EARLY 1700S TWO PANEL DOOR IN R15, GOOD L-H HINGES, BUT LIKELY RESET WITHIN THE BUILDING, ON A THIN BEADED FRAME; FROM THE SOUTH.

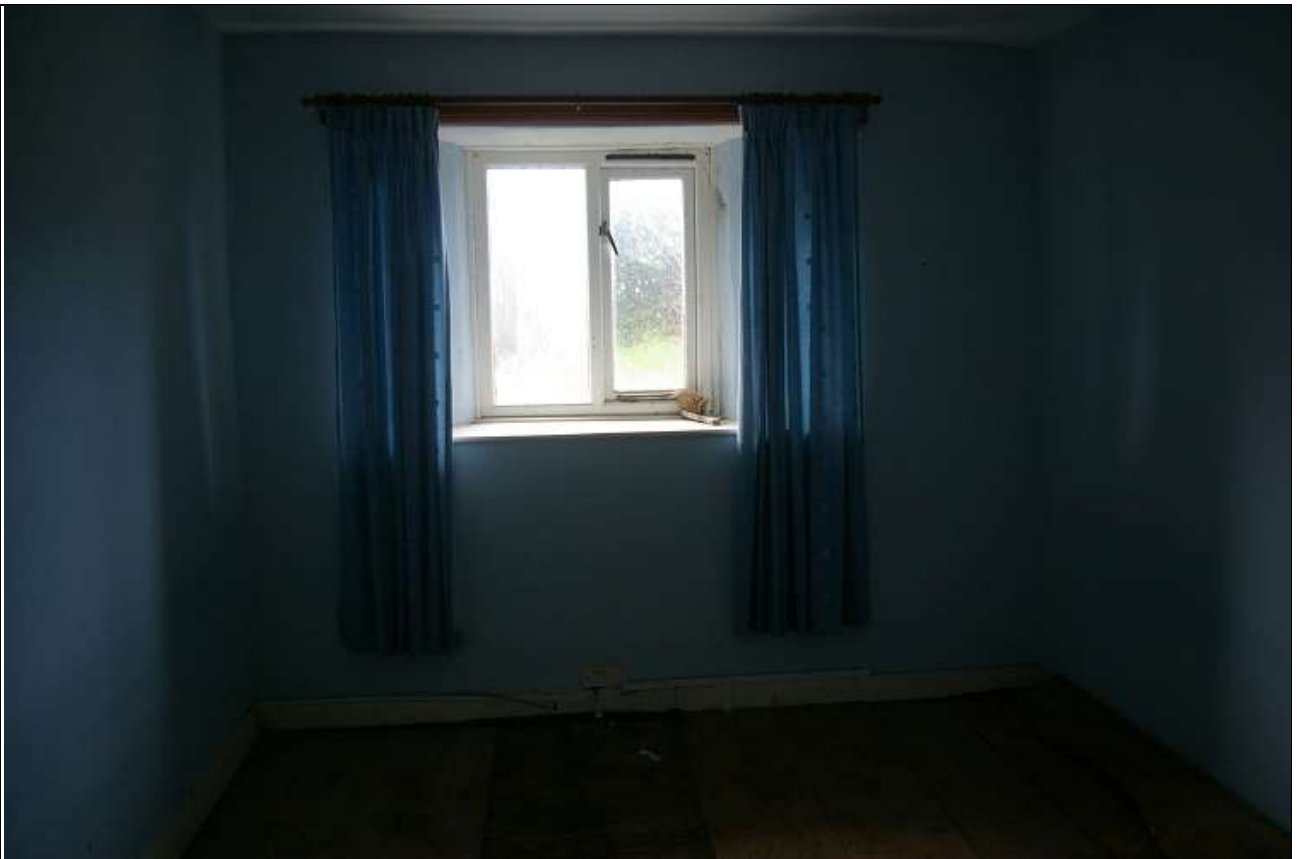
57. R16, A SMALL ROOM FORMED FROM LATH AND PLASTER PARTITIONS, LIT BY A SMALL WINDOW IN THE WEST WALL; FROM THE EAST.

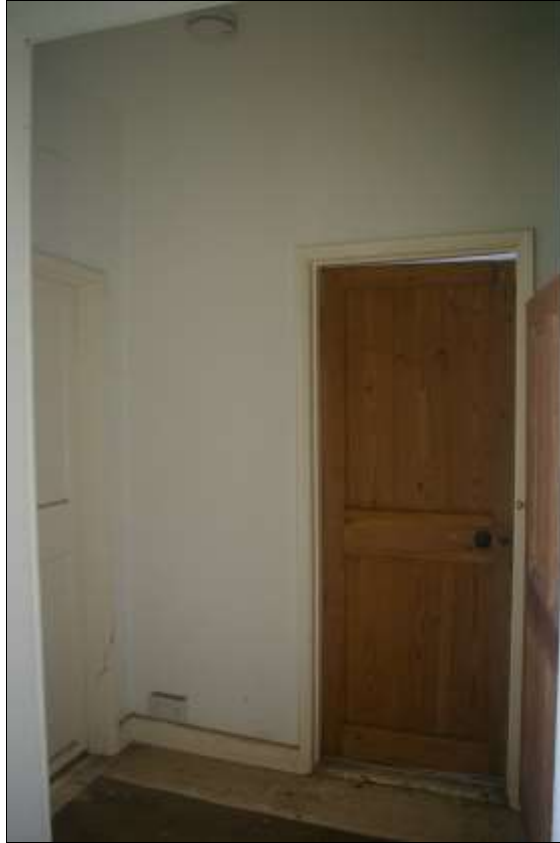
58. THE LOBBY R14; FROM THE EAST, SHOWING DOORS TO R15, R16 AND SMALL CUPBOARD FORMED AGAINST BLOCKED DOOR TO R18, TO THE NORTH.

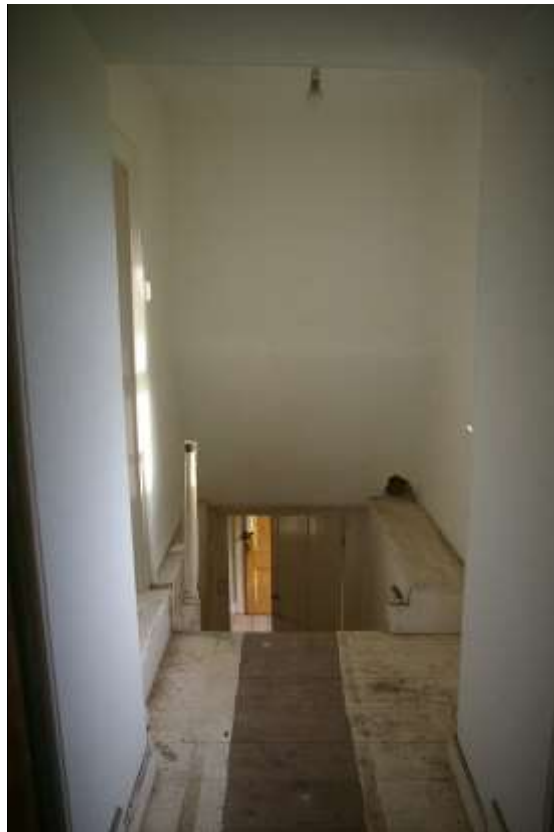
59. LOBBY INTO R9B THE WEST STAIRS; FROM THE WEST.

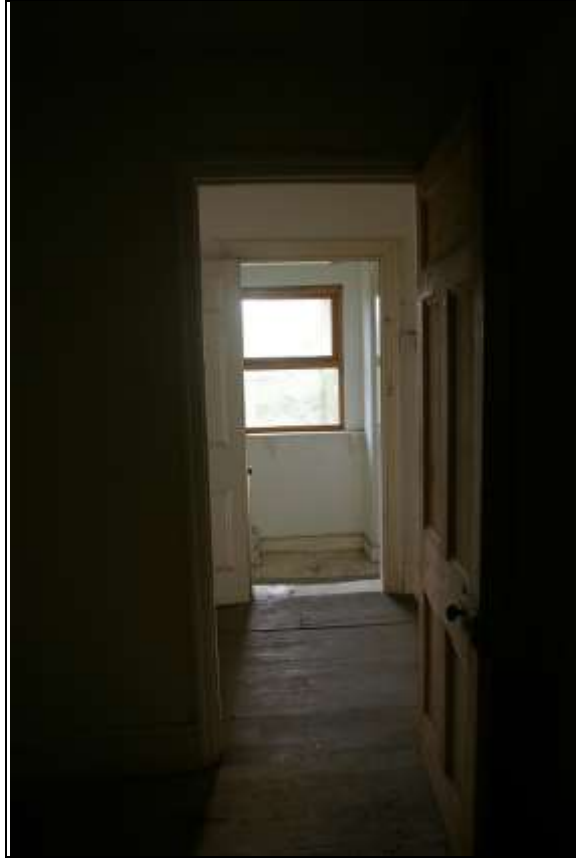
60. VIEW FROM R17, THROUGH R10 AND INTO R9B AT THE WEST END OF THE MAIN RANGE, SHOWING THE LINK BETWEEN MAIN RANGE AND WEST WING; FROM THE NORTH.

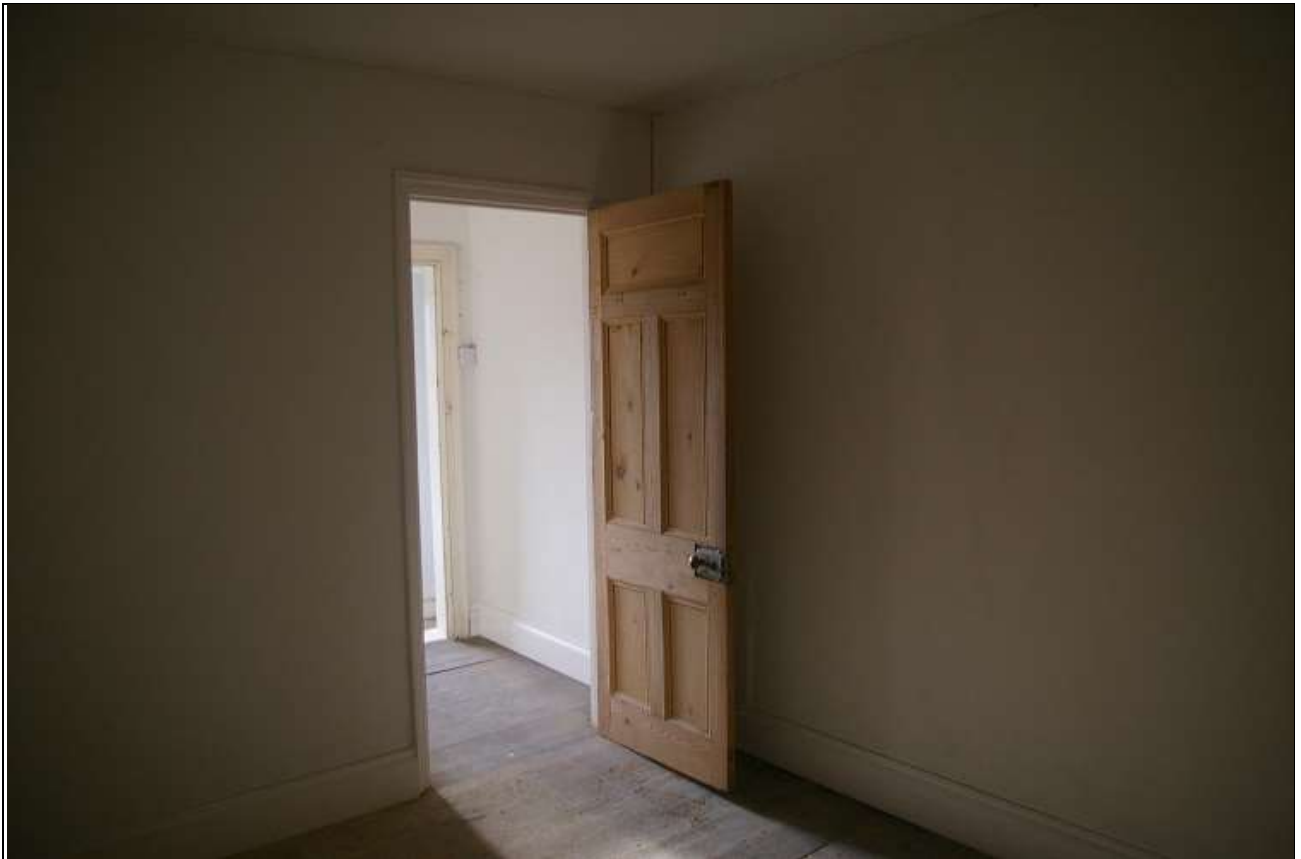
61. R17, A WINDOW LESS ROOM FORMED OVER THE WEST END OF THE HALL; FROM THE NORTH-EAST.

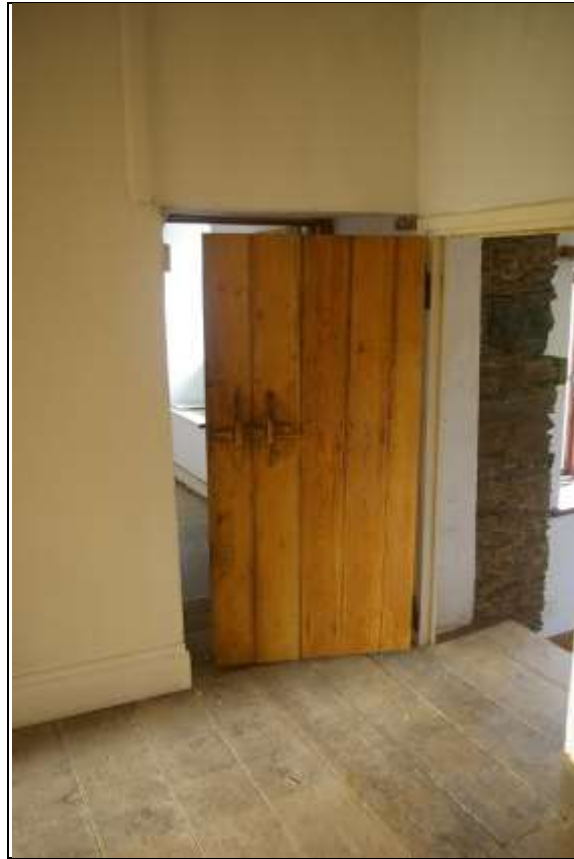
62. R17, FORCED OPENING IN WALL OF WEST WING TO R18 AND GOOD PLANK DOOR IN SMALL OPENING TO REAR SERVICE WING, THE SMALL LOW DOORWAY AND STEPS PART OF AN ORIGINAL STAIR TURRET; FROM THE SOUTH-EAST.

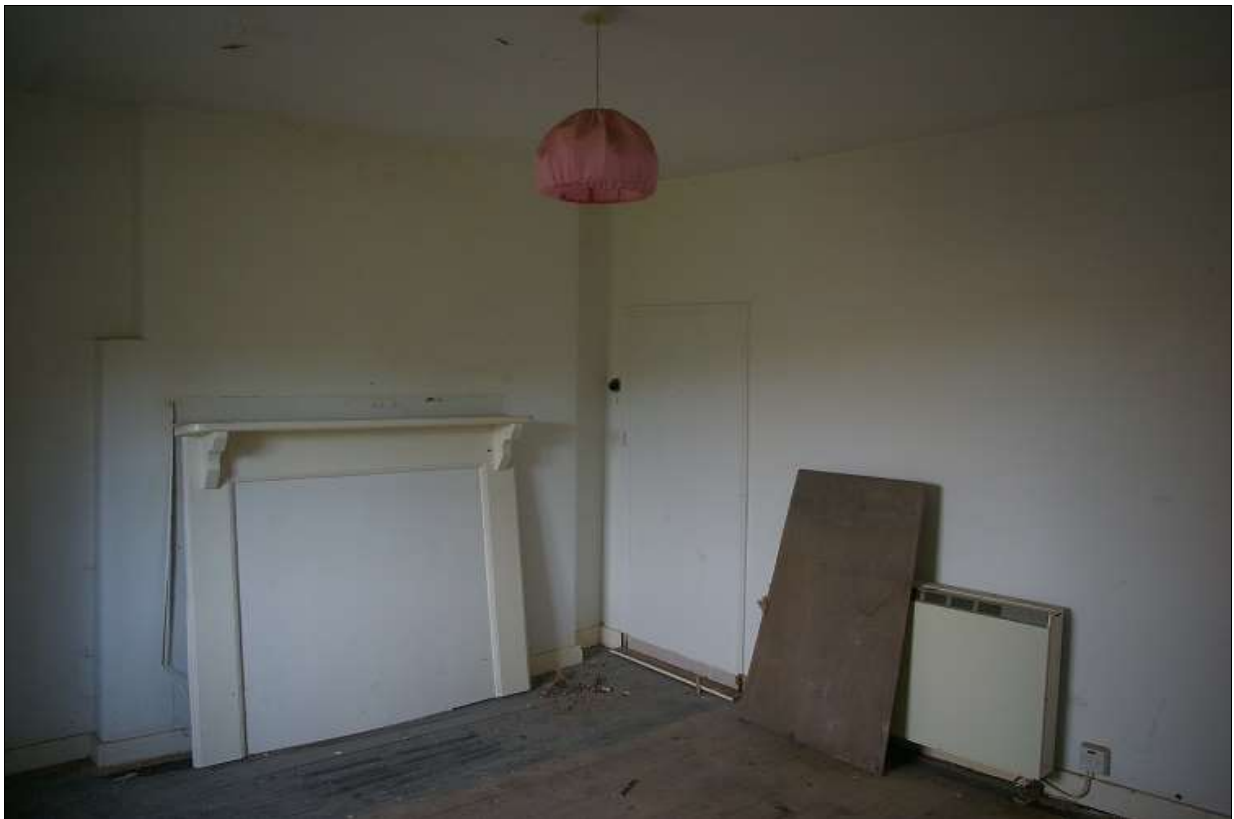
63. R18, WITH STACK WITH FIREPLACE AND BLOCKED DOOR TO THE LOBBY, R14; FROM THE NORTH-WEST.

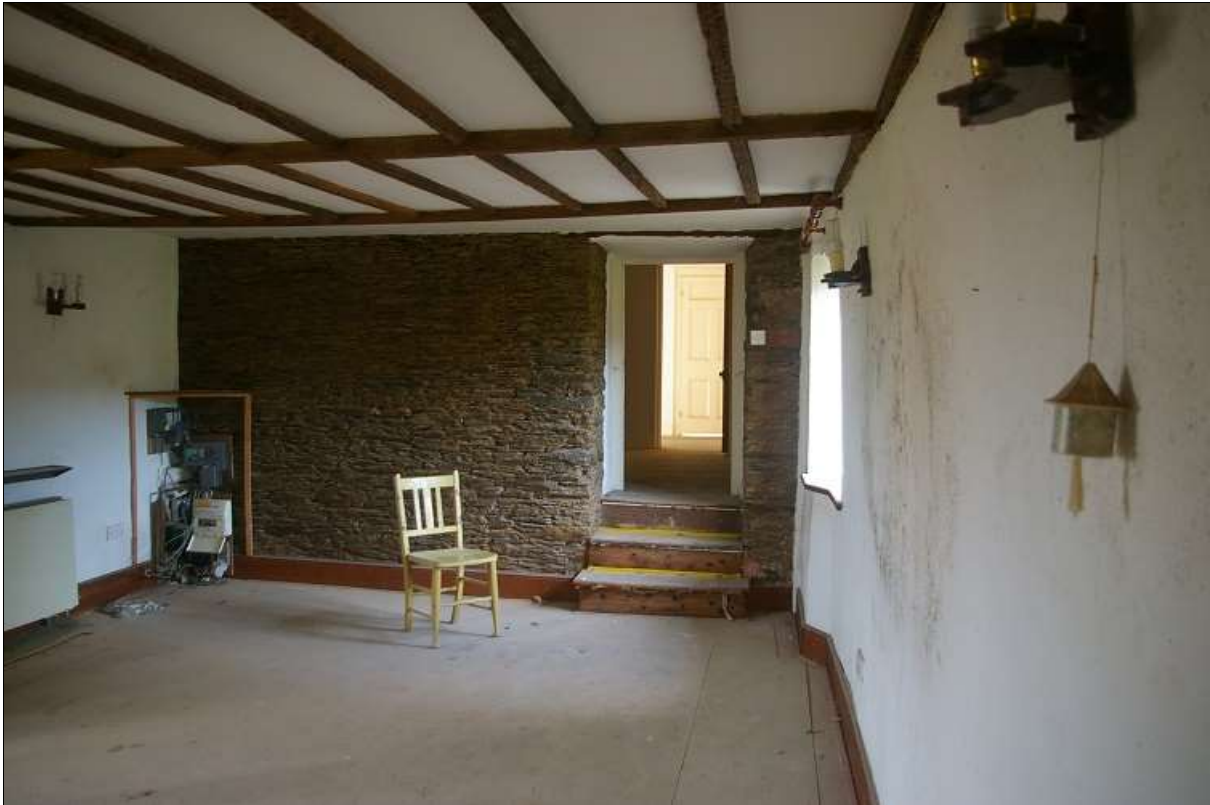
64. R19 OVER THE KITCHEN, INCORPORATING THE FORMER STAIR TURRET ETC AGAINST THE MAIN RANGE; FROM THE NORTH.

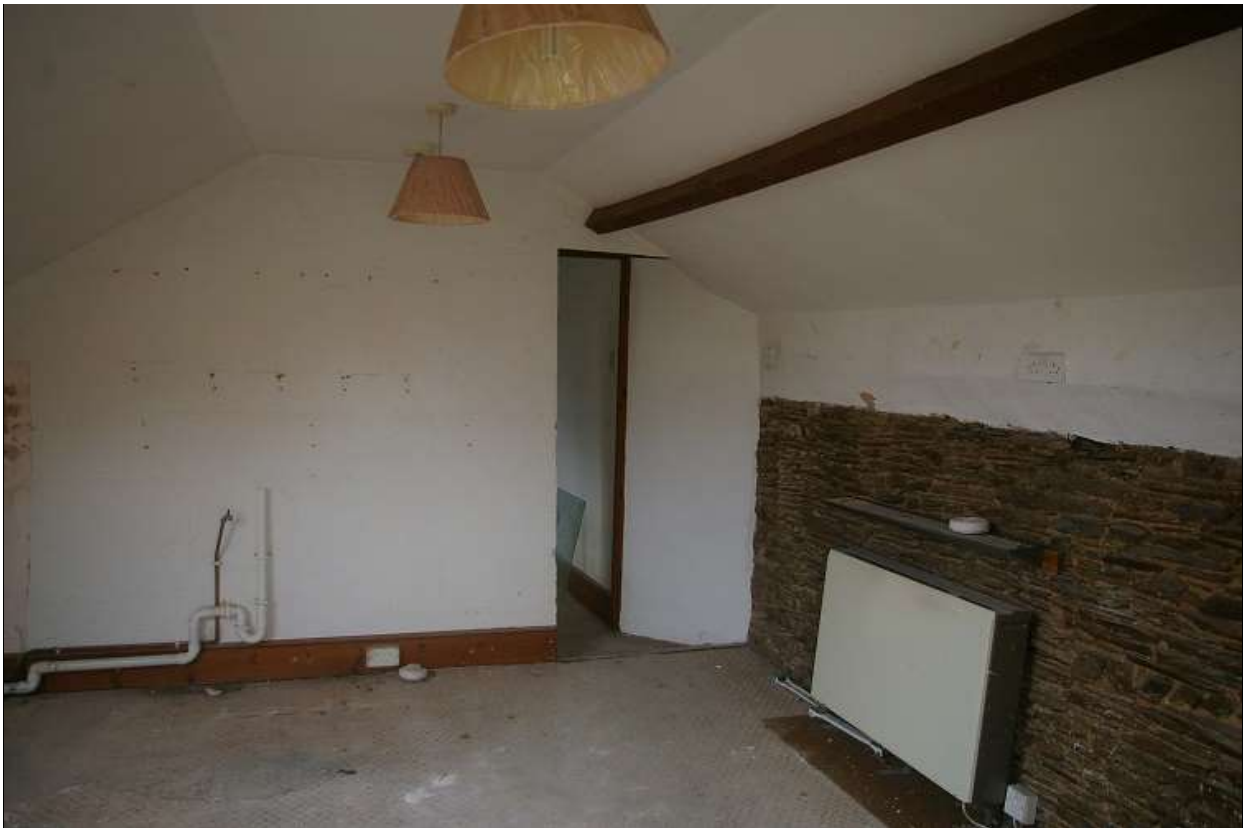
67. R20, THE LOFT OVER THE BARN/DAIRY AGRICULTURAL EXTENSION TO THE KITCHEN WING, CONVERTED INTO A BEDROOM/STUDIO; FORCED ACCESS ON THE CORNER TO R19; FROM THE NORTH-NORTH-EAST.

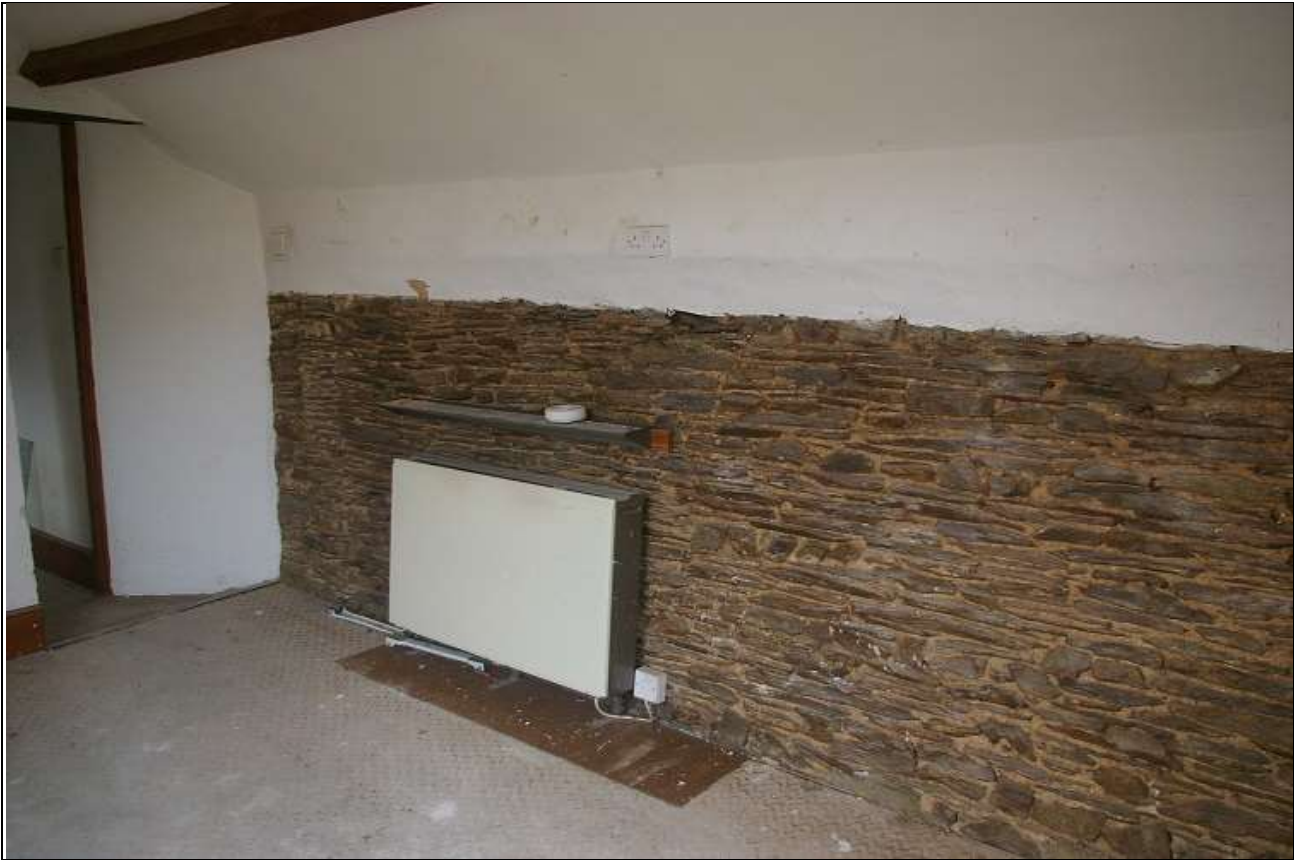
Doors:	D26	Door to R19, bedroom. Modern timber door.
	D27	Glazed modern door to exterior (building is terraced into slope).
Windows:		Glazed modern, deteriorating Velux.
Significant Details		Blocked slit vent, possibly connected to the ground floor dairy, used as ventilation?
Dating Evidence:		The room has been modernised fairly comprehensively.

68. EXPOSED STONE OF THE WEST WALL OF R20, SHOWING SMALL SLIT VENT AT SOUTH END; FROM THE NORTH-EAST.

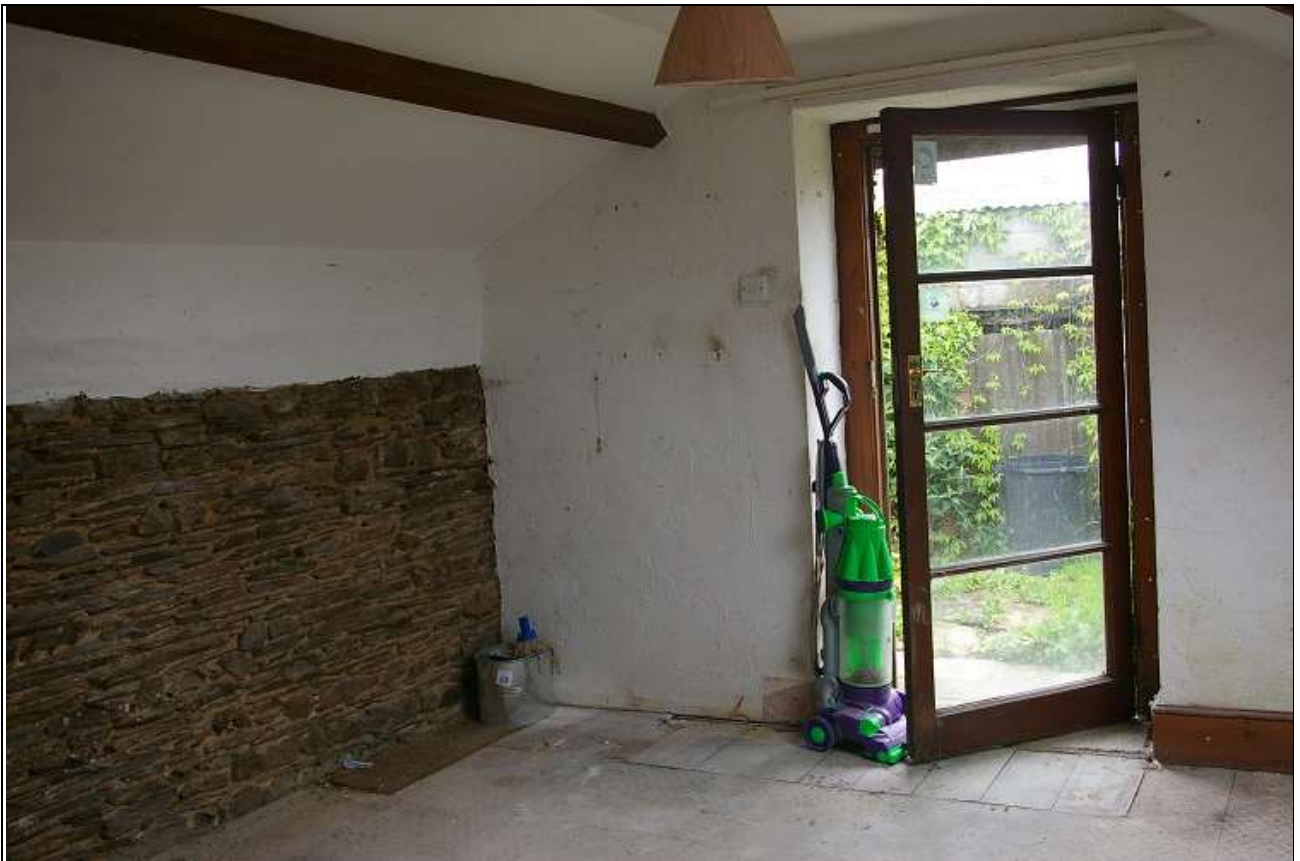
69. R20, THE NORTH WALL, WITH GLAZED DOOR OPENING ONTO THE TERRACED SLOPE OF THE BANK; FORM THE SOUTH-EAST.
