**TREVEDDA FARM
LANTEGLOS HIGHWAY
FOWEY
CORNWALL**

Historic Building Recording

South West Archaeology Ltd. report no. 210120

Results of historic building recording

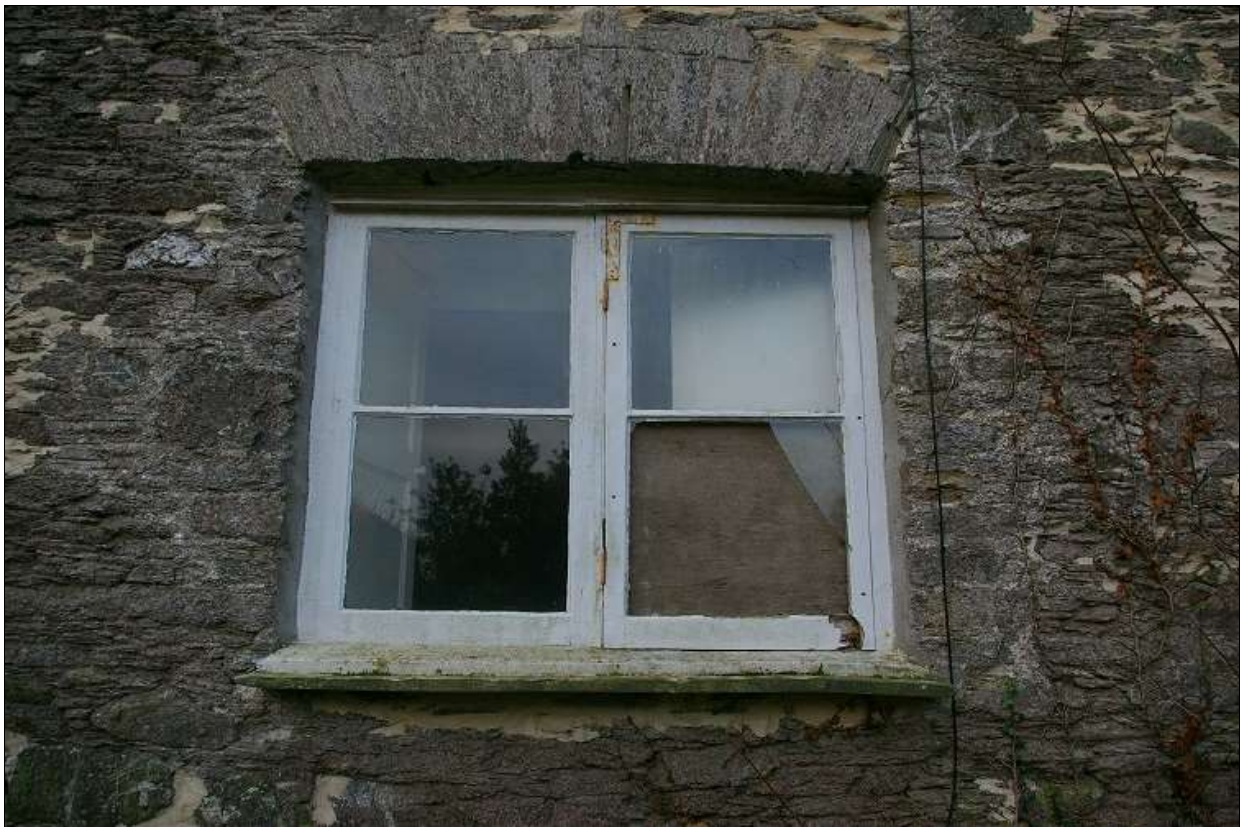
Floor:		Even width plank floor boards, 18 th or 19 th century, stained.
Windows	W10	Looking out onto back yard. Central window opening in wide stepped beaded ogee moulded casement, shutters with cavetto and ogee mouldings, beaded frame. Beaded plank window seat beneath. Ogee moulded strip beneath window seat. Shutters are of folding leaf form, two panels to each, the rear plain with raised panels, on strap hinges, tapering to round ends, bar closure and hook. Within the shutter boxes good historic wallpaper survives, hand painted or hand printed (flaws to pattern) this is of cream background with an arsenic green chevron pattern of foliage imagery. The woodwork within the shutter boxes also exhibits a salmon pink or pale terracotta colour historic paint. This is a good Regency or early Victorian decorative scheme.
Doors	D5	Door to R2A, kitchen/Hall. The door is four panelled with ogee and bead moulding, a brass knob and iron lock. Door frame is beaded with ogee moulded architrave.

75. W10 ON THE NORTH WALL OF TREVEDDA AN EXAMPLE OF ONE OF THE GOOD SET OF THREE 19TH CENTURY WINDOWS; FROM THE NORTH.

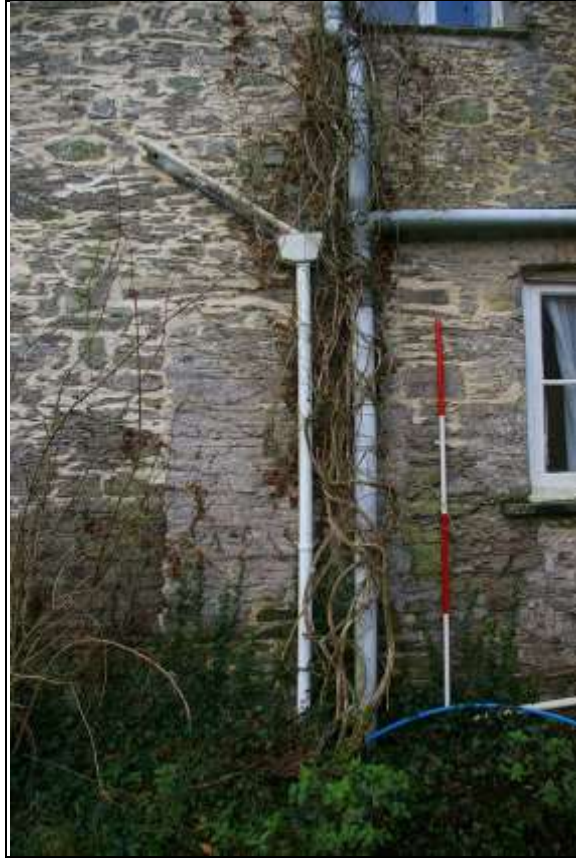
76. THE BLOCKED REAR CROSS PASSAGE DOOR IN THE NORTH WALL OF THE MAIN RANGE, WITH GOOD SLAB QUOINS AND CURVING OAK LINTEL, 2M SCALE; FROM THE NORTH.

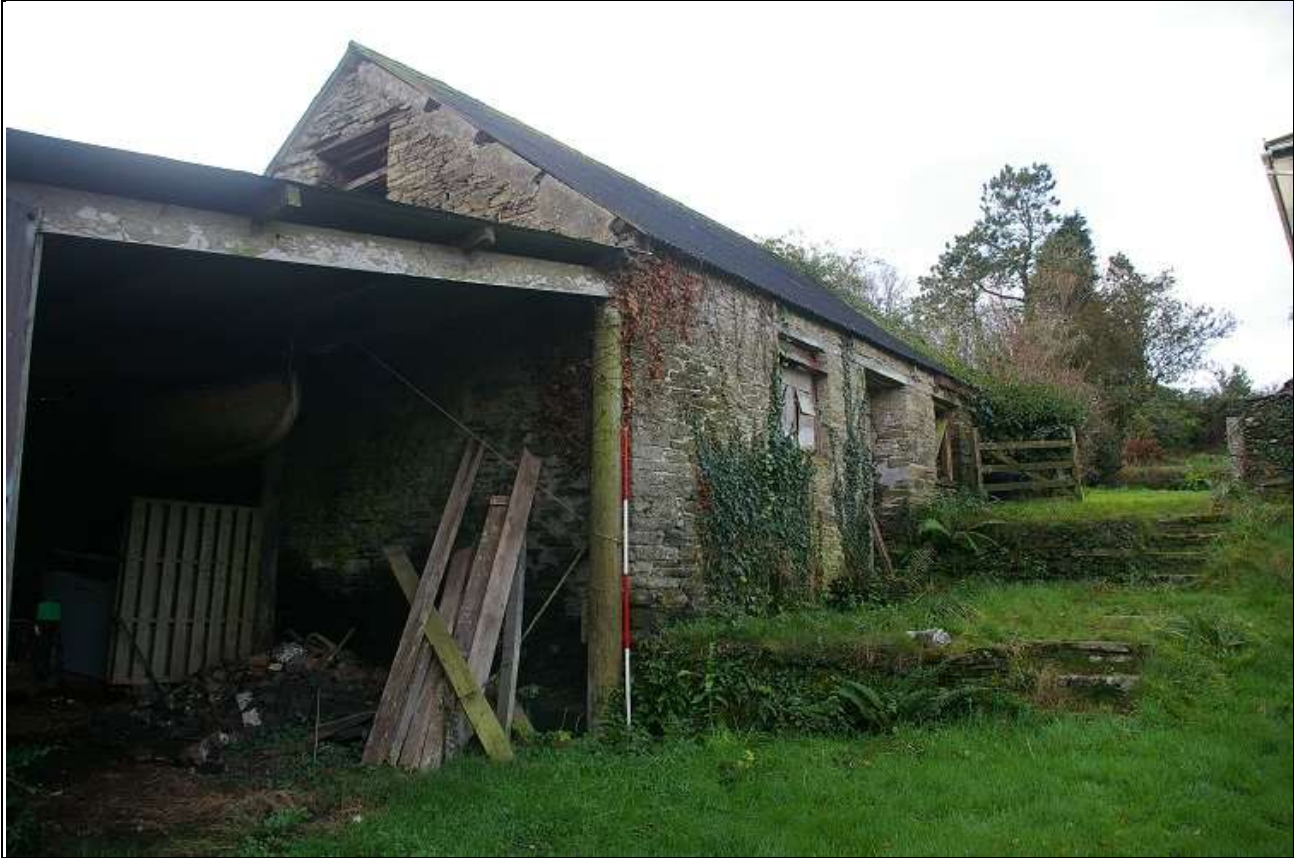
86. THE NORTH AND WEST WALLS OF THE STABLES, AS SEEN ABUTTED BY A TIMBER FRAMED CORRUGATED SHEETING LEAN-TO, WITH 2M SCALE; FROM THE NORTH-EAST.
