**THE BICKFORD CENTRE  
23 SOUTH STREET  
GREAT TORRINGTON  
DEVON**

HISTORIC BUILDING RECORDING & MONITORING

South West Archaeology Ltd. report no. 230519

Revised after archaeological monitoring of works: 19<sup>th</sup> May 2023

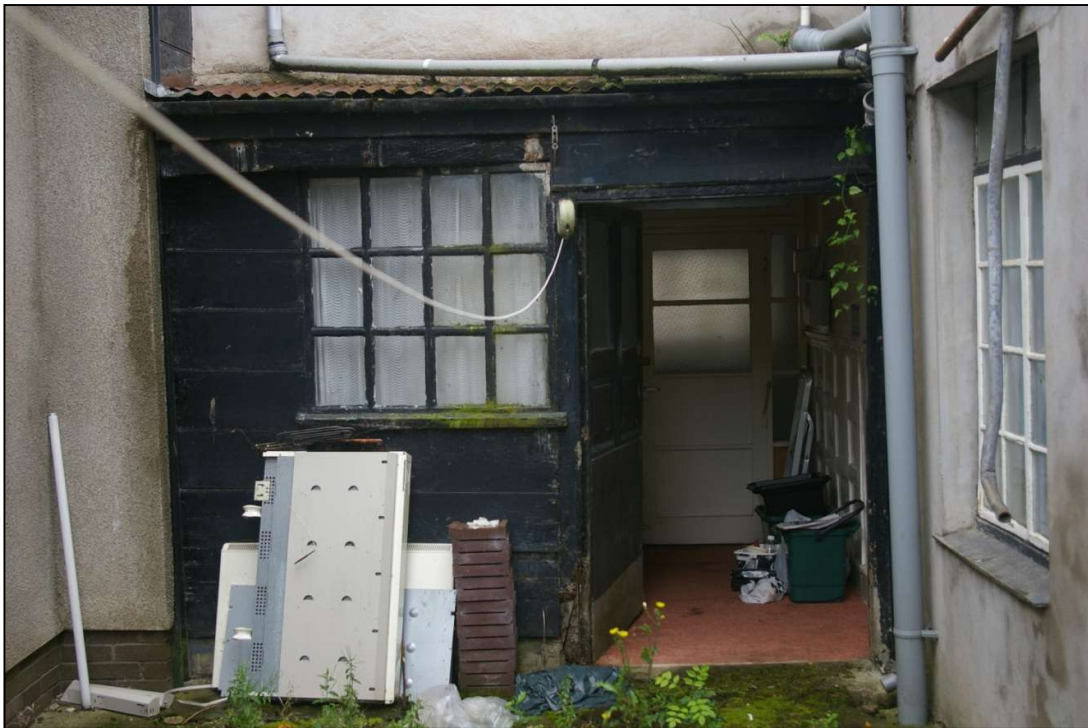
The rear elevation, facing the courtyard, is unpainted cement render over rubble stone of three storeys, two bay width. There is one chunky sash to first floor and a smaller casement to second floor. This elevation is obscured at ground floor level by a beaded plank timber structure, which forms a storeroom along the rear wall. Within this space, the rear wall can be seen to be obliquely angled and much thicker at ground floor level, containing a blocked opening. Access between the house and yard, as at the front, is via a pair of fine panelled doors, now strapped together, forming a matched set with those to the front, with a wide cross passage between. To the west side, the elevation is obscured by the back block (Building 2) and to the east is abutted by an attached, block of modern flats. This elevation lies at a slight oblique angle to the rest of the building and the street, an angle which is echoed in the back block (Building 2). It has a very well-preserved long drop toilet cantilevered above first floor level, a timber plank framed structure to the east side, with slate roof and lead pipe work.

FIGURE 3: THE BEADED PLANK TIMBER STRUCTURE WHICH ENCLOSES THE GROUND FLOOR OF THE REAR ELEVATION; FROM THE NORTH.

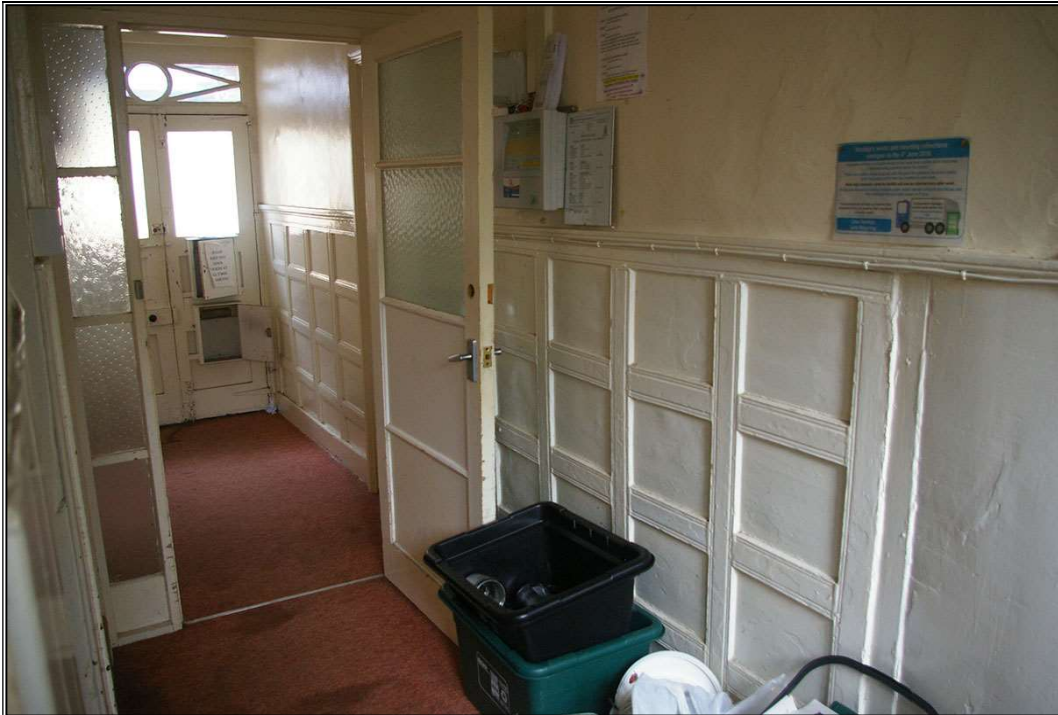
FIGURE 4: VIEW ALONG THE WEST WALL OF R1 AND R1A, SHOWING TWO PHASES OF PANELLING; FROM THE NORTH-EAST.

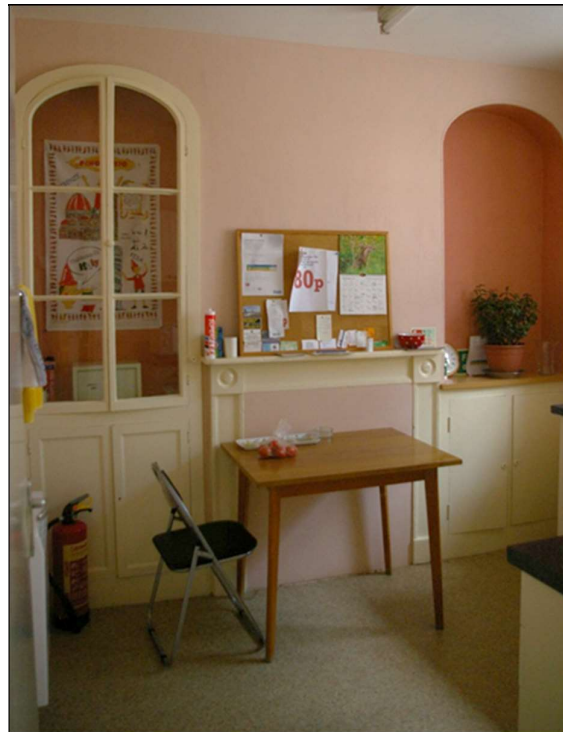
To the east of the cross passage is a small, heated room (Room 3), which is now used as a kitchen, with a set of modern fitted units fixed to the west partition wall and south wall. This room retains a strong early 19<sup>th</sup> century character, and it has some fine historic details; with panelled cupboards and a glazed display cabinet, flanking a fireplace in a shallow brick stack. It is likely, therefore, that this small room, directly accessible from shop and street was probably an office for the shopkeeper/tradesman. The small fireplace is blocked with boarding; it is not known if a grate remains behind, but the timber surround has moulded roundels to corners, sits on plain blocks plinths and has a round edged but plain mantle shelf. The arched alcoves are of very simple restrained style, with beaded plasterwork to the opening, set with beaded, glazed, cabinet arched doors to the north side, above an ogee moulded, panelled, double cupboard. To the north, the cupboard has survived, but its doors and the display cabinet have been lost. These decorative features show that this was a quality build, not fussy but with an eye to fashion and the style of 'new' polite interiors, very much of late Georgian or Regency type, cohesive with the character of the building's frontage.

FIGURE 5: THE EAST WALL OF R3, SHOWING CENTRAL FIREPLACE AND TWO BEADED ARCHED ALCOVES, ONE TO NORTH WITH SURVIVING CUPBOARD AND DISPLAY CABINET; FROM THE WEST-NORTH-WEST.

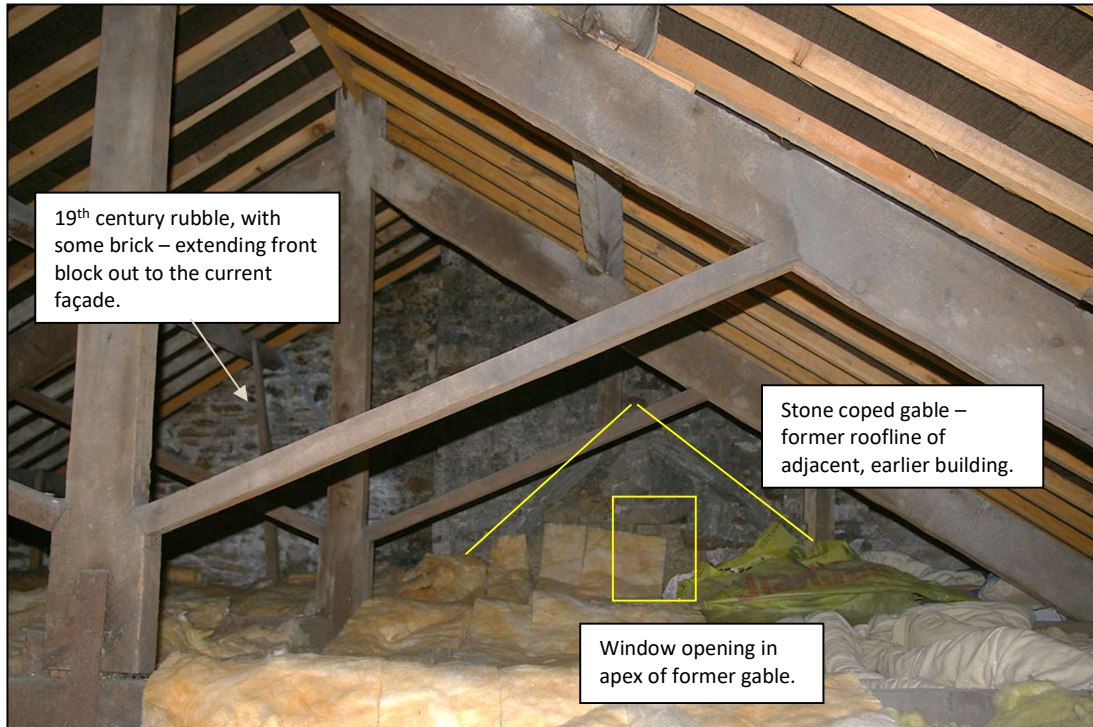
The roof space over the front block is accessed via the hallway, through a modern hatch. There are three large king-post trusses, where the blades clasp the post at the ridge, with pegged joints, but bolted joints to the tie beam, with additional later strap bracing. The struts are very lightweight and there are two purlins to each pitch, which loosely overlap, sitting directly on the backs of the blades. A narrow modern ridge plank has been cut into the historic king posts and modern rafters carry felt under the slates, the roof has been fairly recently overhauled. To the west end, in the roof space, there is clear visibility to the party wall; where a steep historic roofline with stone coping can clearly be seen, a small, stone-framed blocked opening (window) appears to sit right up into the apex of this roofline. This sits within very heavy stone walling, which stops short of the current frontage of the building by about 2m. The adjacent stack is of heavy stone build. This indicates that the next-door house had a lower three storey height roof and a small attic window originally looked out into a gap between buildings, rather than being attached. The front section of wall is 19<sup>th</sup> century rubble infill (some brick is present) and probably dates with this building. To the east end, the party wall is a looser mix of rubble stone, with a brick stack and flues forced into the centre at the apex and again, to the south end this wall is extended with looser rubble, probably 19<sup>th</sup> century, built up and around the earlier party wall, when this building was constructed.

FIGURE 7: VIEW TO THE WEST PARTY WALL OF THE BUILDING, AND 19<sup>TH</sup> CENTURY KING POST TRUSSES OF BUILDING 1; FROM THE EAST.

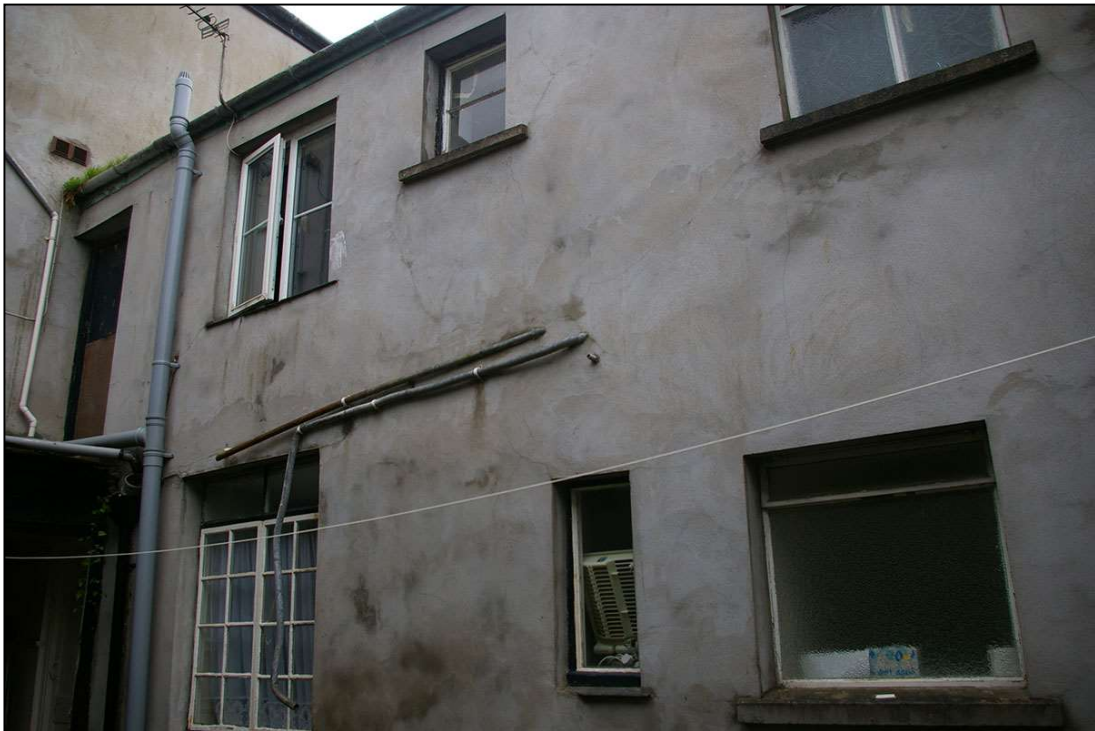
Two storey, four bay back block to the west of the plot, of which only the east wall is visible externally. The walls are of stone rubble; cement rendered externally to at least the north and east walls. The north, west and south walls are all blind, but exhibit blocked openings. Many of the windows in the east wall, facing into the yard, have been replaced in the 20<sup>th</sup> or 21<sup>st</sup> centuries and several of the openings may be wholly modern. There is one surviving single light, 19<sup>th</sup> century casement and frame to the first floor, set in a small square opening and there is one very narrow opening to the ground floor, with deep sloping sides, although set with a modern metal-framed window. These two central openings to ground and first floor are interesting, having a certain agricultural air to them and may in fact be enlarged slit vents, hinting at the possible earlier function of this range. There are also two door openings within this elevation, to the south end, directly above each other and both with 19<sup>th</sup> century doors. Generally, the inappropriate modernising of this building's exterior obscures its older origins.

FIGURE 8: THE EAST ELEVATION OF BUILDING 2, SHOWING THE MODERN CHARACTER; FROM THE NORTH-EAST

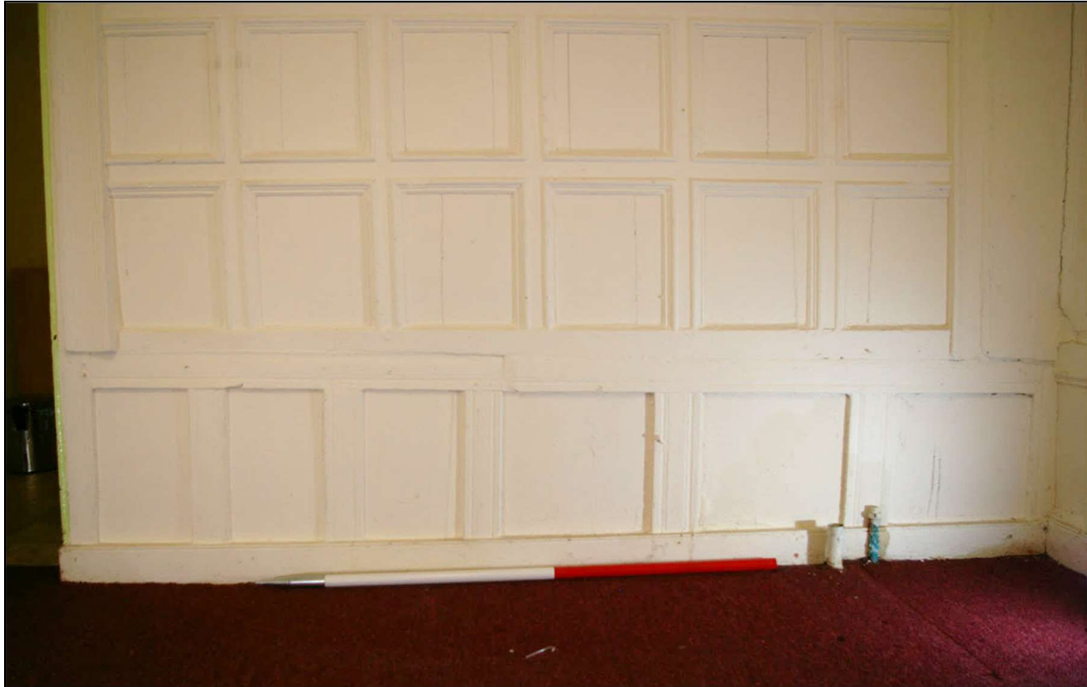
FIGURE 11: TWO PHASES OF PANELLING AT THE BASE OF THE NORTH WALL, TYPE 1 AND TYPE 2; FROM THE SOUTH (1M SCALE).

The earliest styles of panelling are the scratch moulded and ogee moulded sections found at the base of the north wall (Types 1 and 2). These small sections are identical to those in Rooms 1 and 1A, the entrance hall, and may be off cuts from larger panel pieces. It is particularly interesting that we see this reuse in both service areas of the house. Stylistically, the simple plank backing, and moulded uprights would identify a date range in the early 17<sup>th</sup> century, c.1600-1620s.

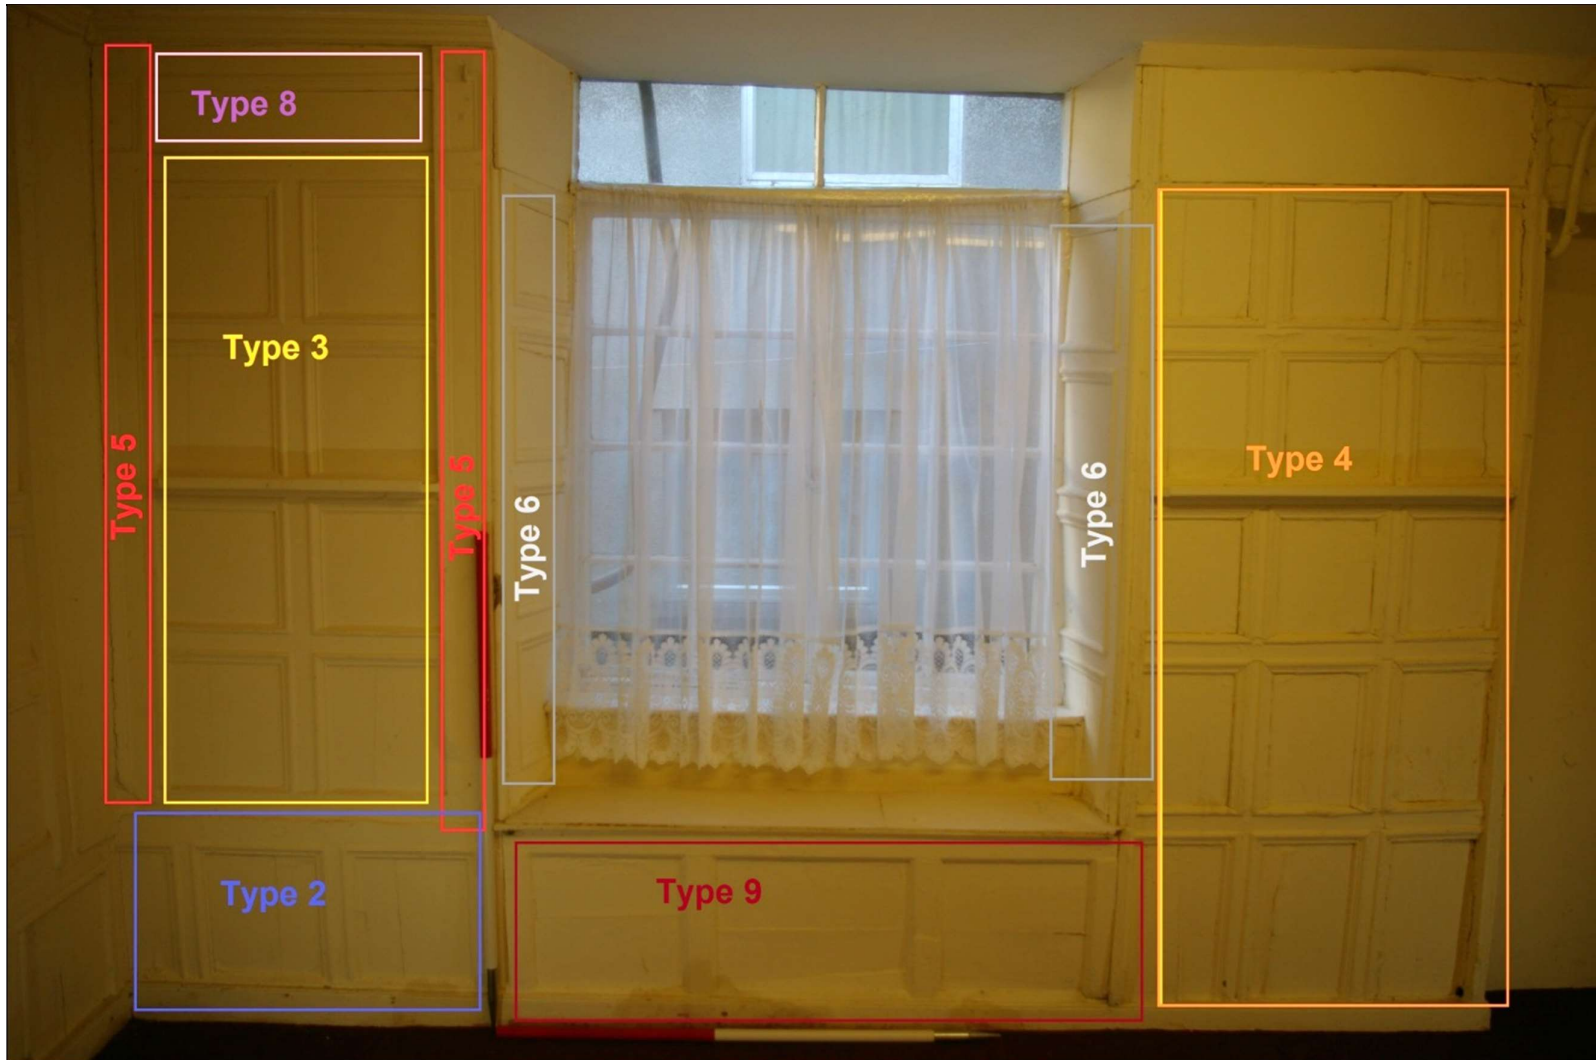
FIGURE 14: THE EAST WALL OF R17, WITH RESET PANELLING ANNOTATED, FROM THE WEST (1M SCALE).

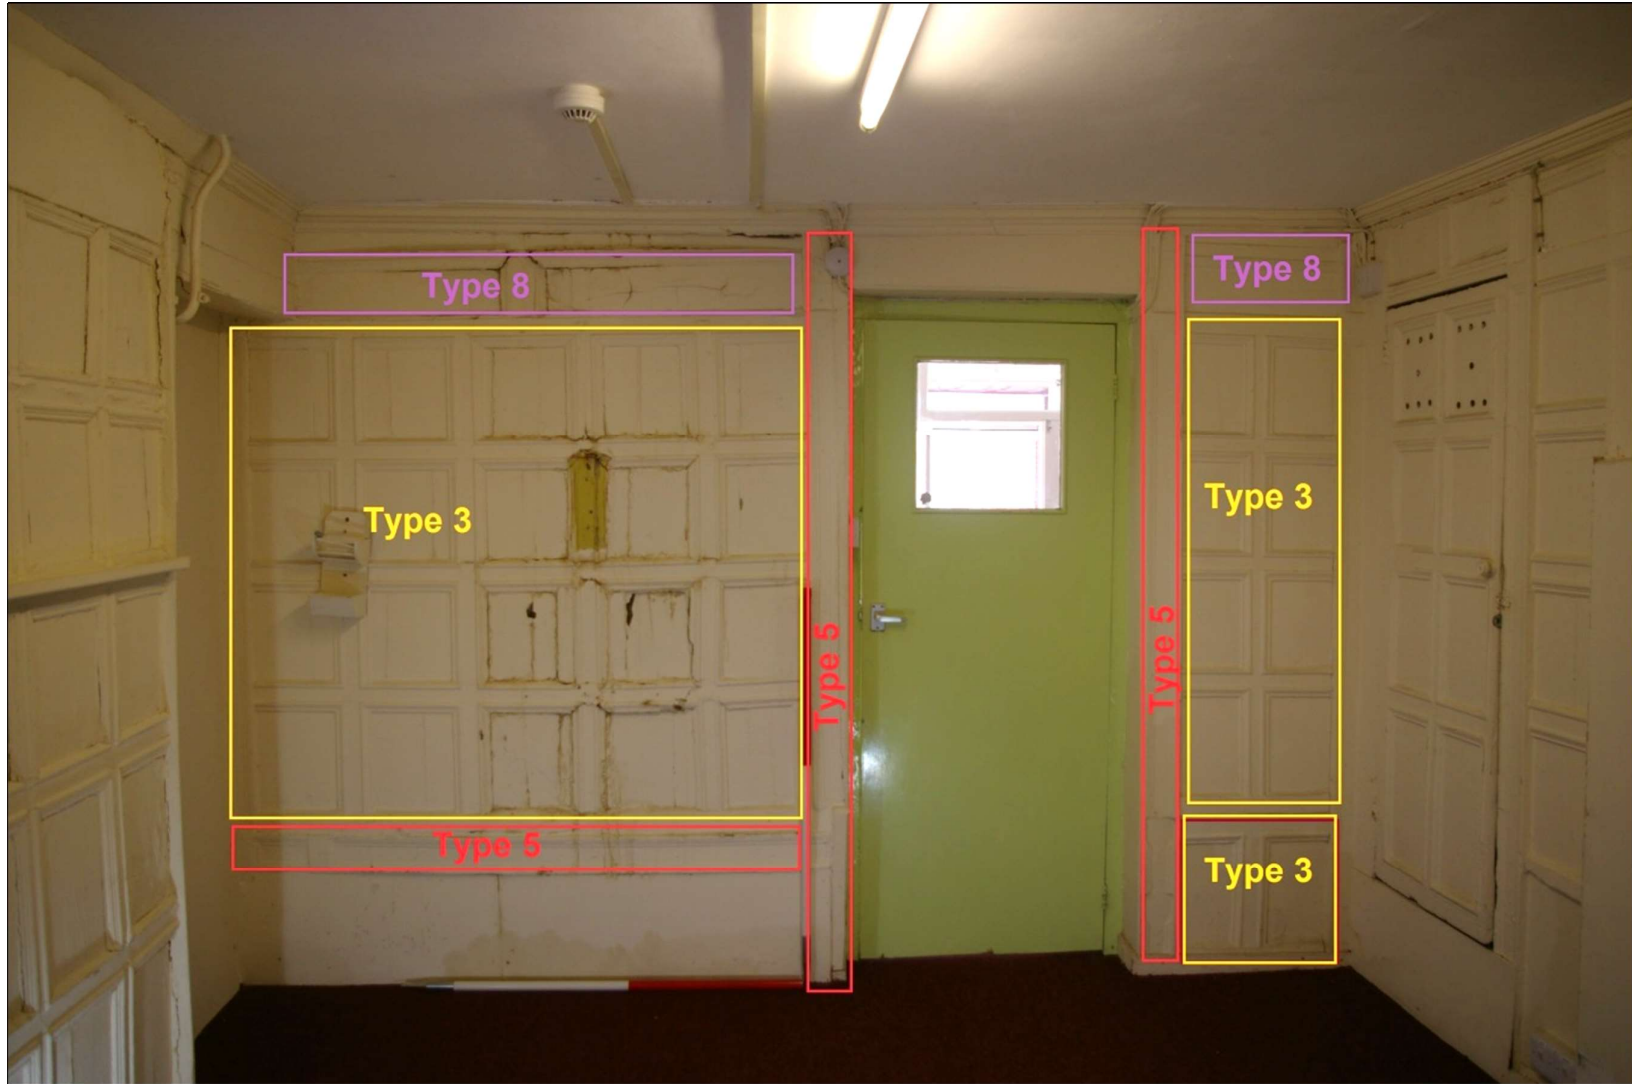
This wall has a door to the west end, opposite that in the north wall, but this is a forced opening, in the very thick, battered south wall. It is fitted with a modern, part-glazed door, D24. To the east end of the wall there is a large, contiguous panel of the same square bolection moulded panelling (Type 3) as the east and north walls. This runs into the opening of the blocked doorway. Below this, one of the pilasters (Type 5) has been used as a base rail, on its side and the section is framed by a pilaster edging the forced doorway. Above are two deeply moulded ogee long rectangular panels, the same as those used on the north wall (Type 8). Below, the base of the wall is infilled with plain plank and MDF sheeting. Beyond the door is another pilaster and beyond that, a short cut off section of the same bolection moulded panelling. At the base of the wall, in the south-west corner of the room, two panels of ogee moulding survive. The south wall has suffered in the past from damage and water ingress, damp having developed. The panelling is buckled and warped, very rotten in places.

FIGURE 15: THE SOUTH WALL OF R17, SHOWING ANNOTATED RESET PANELLING, FROM THE NORTH (2 X 1M SCALES).

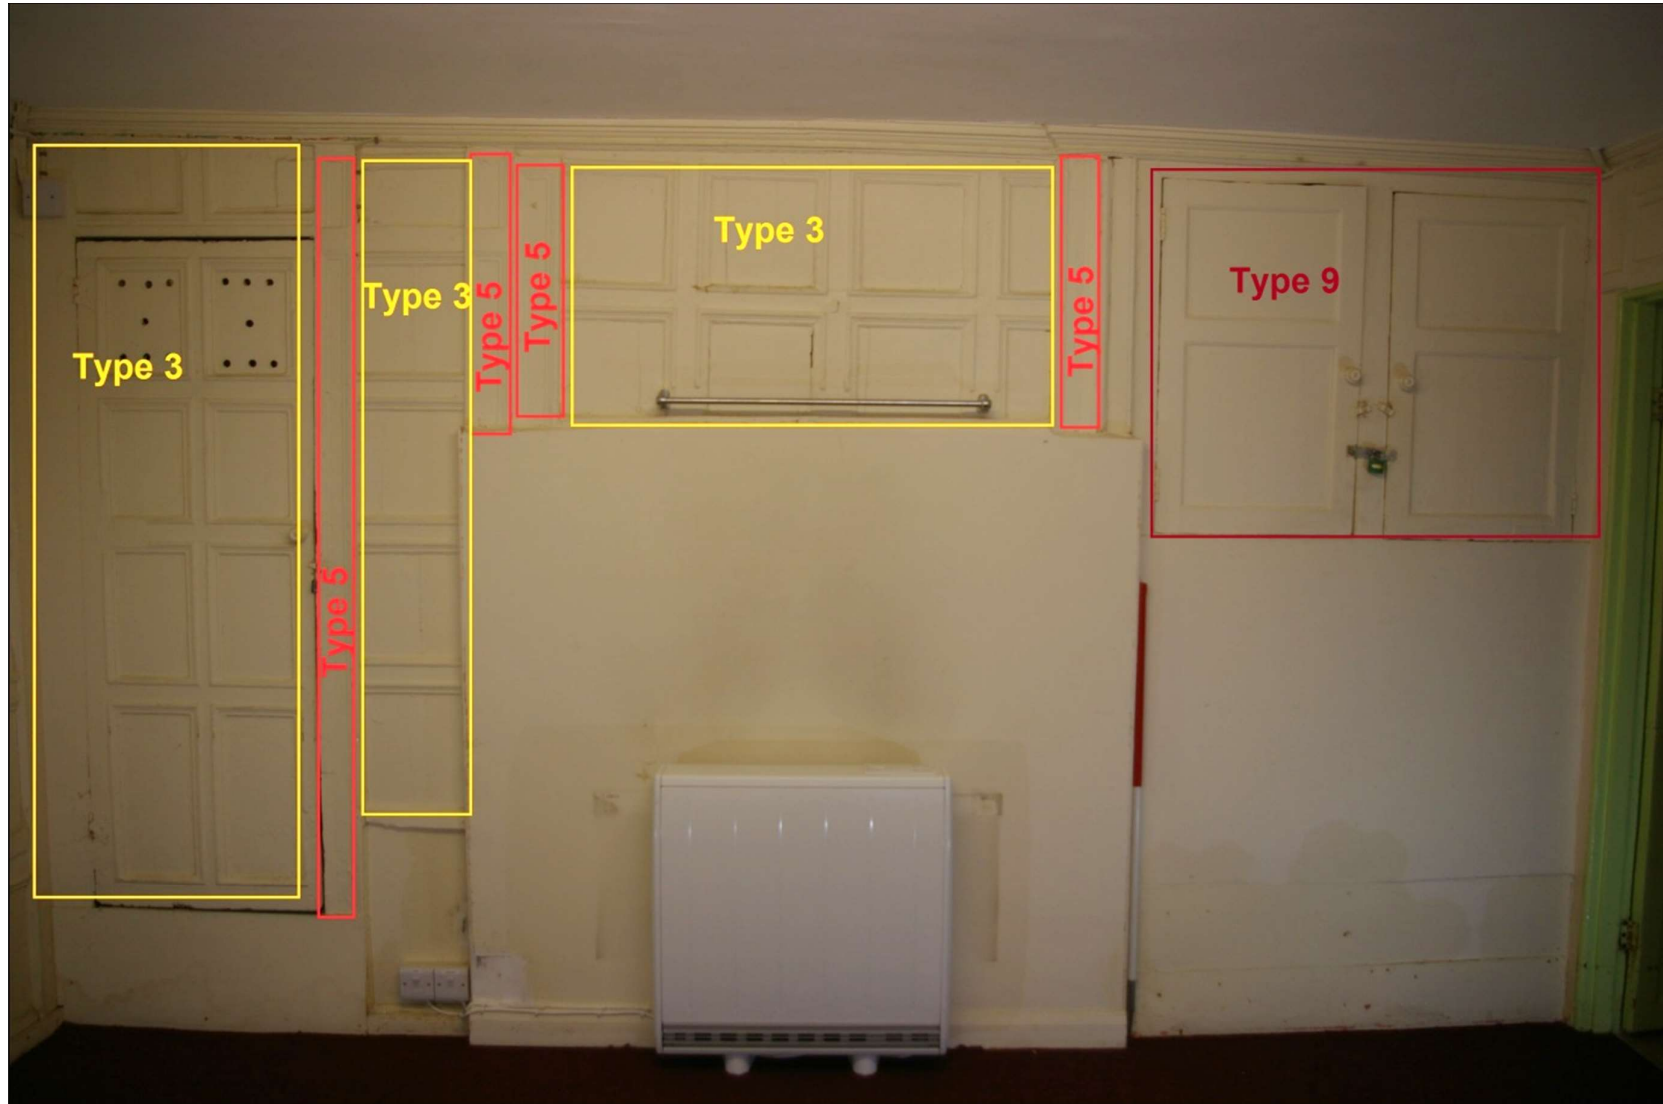
FIGURE 16: THE WEST WALL OF R17, SHOWING ANNOTATED PANELLING, FROM THE EAST (1M SCALE).

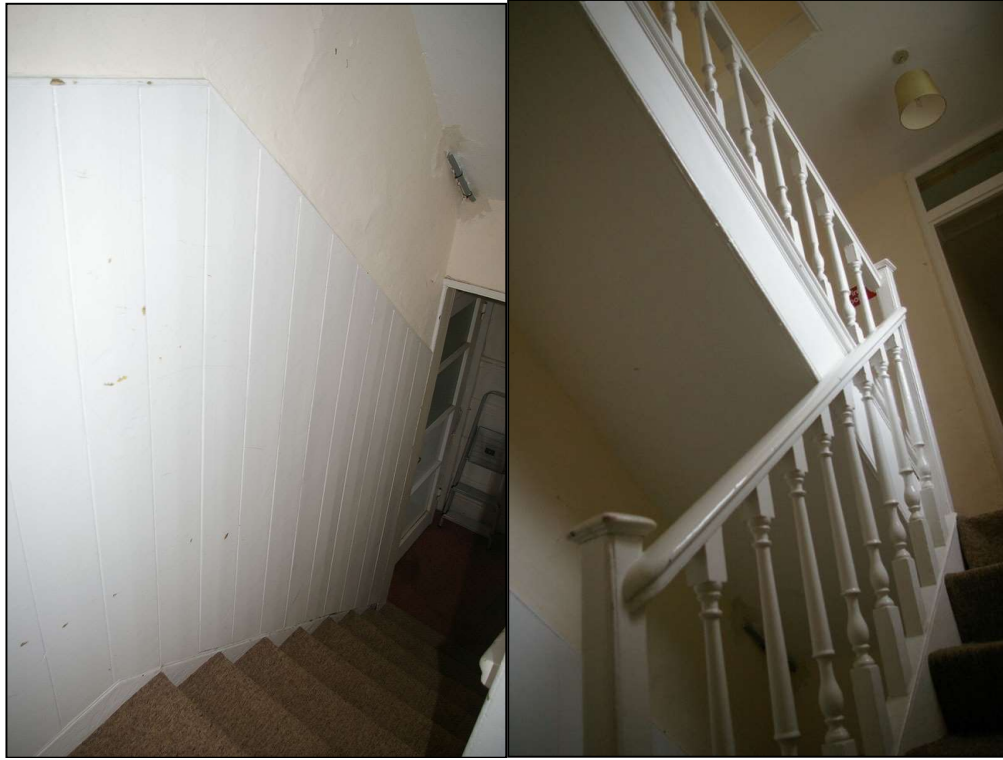
FIGURE 17 A & B: A (LEFT) THE BEADED PLANK PANELLING ON THE PARTITION WALL BETWEEN R5 AND R3; FROM THE NORTH-EAST. B (RIGHT) THE MOULDED HANDRAIL ATTACHED TO THE NEWEL POST, THE BANISTERS AND DETAILED VIEW OF THE TURNED BALUSTERS; FROM THE EAST-NORTH-EAST.

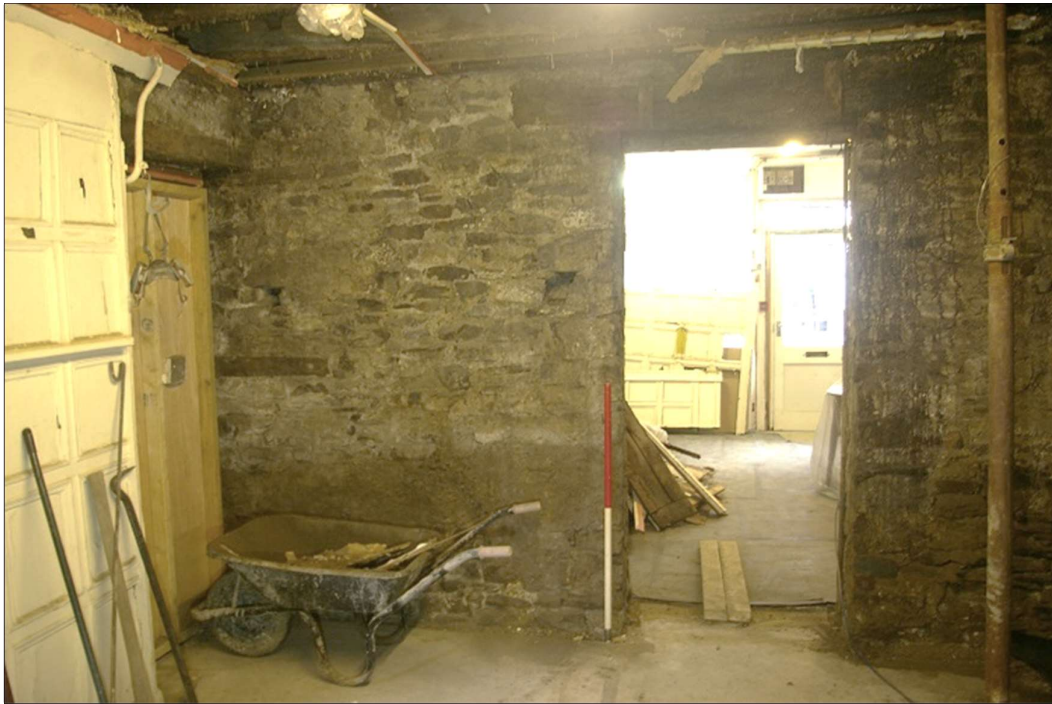
The south, north and west walls of R17 were stripped of panelling, for the renovations.

The south wall of R17, represents the north, rear wall of R2, part of the reconfigured block along the street. It was clear from the exposed stonework that to the west the wall is of battered, roughly coursed stone build, of graduated stonework with large stone slabs used at the base, likely of medieval of 16<sup>th</sup> century date. Further to the east this wall was rebuilt with closely packed semi-regularised rubble build, using platey slatestone – typical of 17<sup>th</sup> century buildings in and around Torrington and this region of North Devon. Between these two builds, where a door had been forced, or enlarged there was a large section of fairly loose 19<sup>th</sup> century rubble repair and several large, recycled pieces of timber have been inserted as lintels, propped up on timber blocks, possibly suggesting the alteration of an earlier, smaller opening.

FIGURE 20: THE REAR WALL OF THE FRONT BLOCK, WITH PANELLING REMOVED; FROM THE NORTH (1M SCALE).

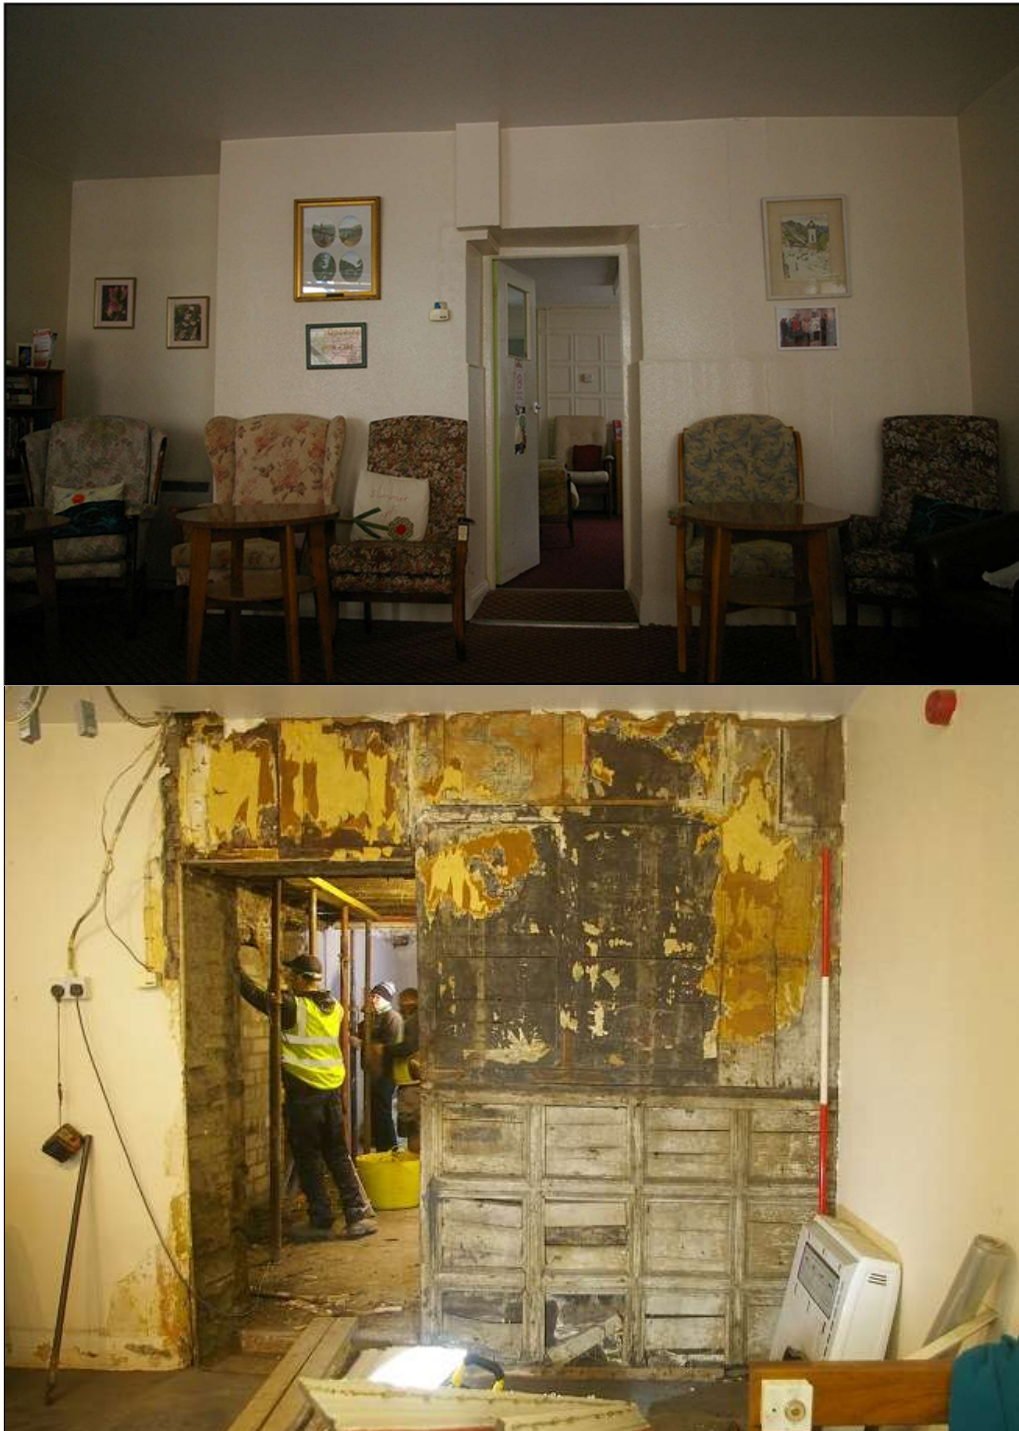
Within the current tearoom, coffee space, R2, the outer, visible wallcovering was of 20<sup>th</sup> century chipboard, covered by woodchip wallpaper, painted cream. This was laid over, and above later 19<sup>th</sup> century tongue and groove, vertical pine planking, of tall, dado height, with a simple beaded top rail (Figure 24).

When the wall coverings were removed a complex mix of reset wood panelling, shutters and planks was exposed. The Victorian panelling had been reset over later 17<sup>th</sup> or early 18<sup>th</sup> century panelling, to lower dado height, c.1.14m. This was of small even-sized rectangular panels, with outer flat face, raised to the rear, each individually shaped by adze, with the marks clear on the unfinished rear sides. The styles and crossbars are moulded with ogee and cavetto, or hollow-chamfered detail, showing the transition from vernacular to classical-inspired influence. This style was similar to Type 9, but not quite the same quality, with for example, the raised edges of the panels, tacked in place, instead of carved. The majority of the styles and crossbars, however, were pegged in place and the panels sit within grooves in the sides of the styles. Above this to the east was a section of reset vertical planks, nailed in place, presumably over some sort of crude frame, this had grey lime plaster over it, with a pale green and cream paint layers. To the west up and around the doorway are several cut sections, and one complete, boarded and framed panelled shutter – likely from the shop front, as it is noted to have dark red paint remains on the woodwork, covered by a bitumen paint. These fine shutters, with adze cut raised panels, exhibit numerous repairs, with T-braces and L-braces on the corners, tacked in place – 19<sup>th</sup> century repairs to an older structure to keep it functional. These planks and shutters were covered with several other layers, one of which is a wood-effect wallpaper – designed to look like walnut, laid over a layer of pasted newspaper remnants, including fragments of The Times, from the early 19<sup>th</sup>

FIGURE 24: THE NORTH WALL OF R2, WITH DOOR TO R17, BEFORE AND AFTER STRIPPING OF WALL COVERINGS; FROM THE SOUTH (2M SCALE BOTTOM PHOTOGRAPH).

The opening was only minimally enlarged, so much of this fabric was left in situ and the woodwork was carefully cut through to maximise survival. It has now been boarded over, within the new scheme. No other work in this space was monitored.

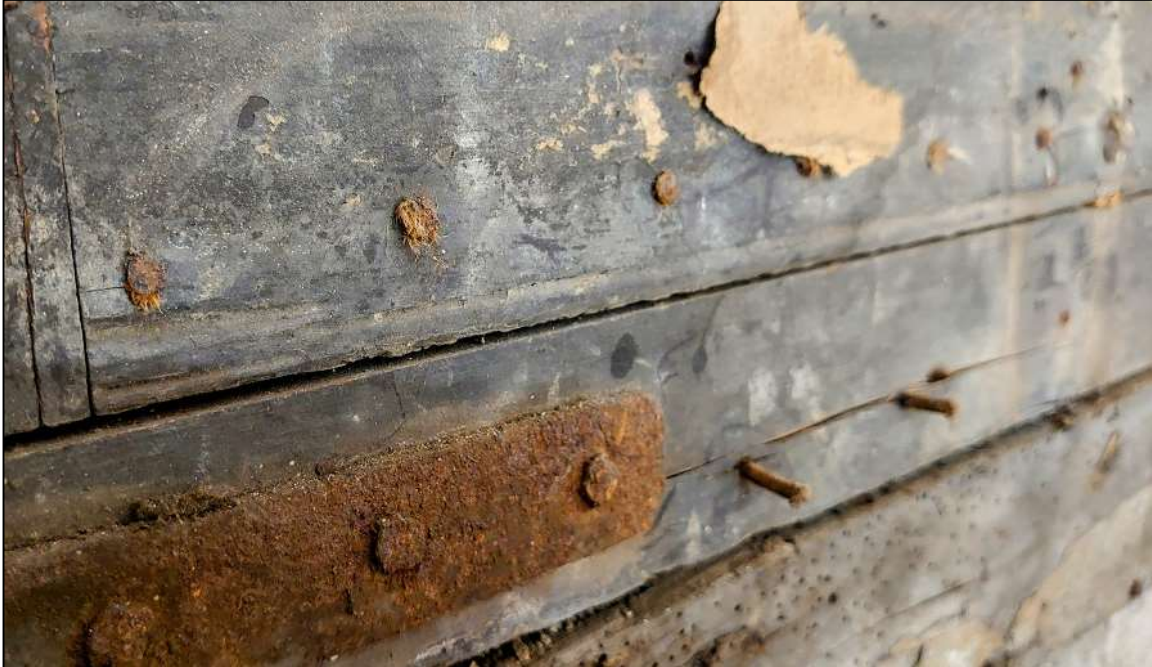
The extracts of the Times newspaper, photographed in situ, mention several politicians and events, so we can trace their dates quite accurately. Also of note are the rows of tacks over the panelling and boards, some of the tacks have hessian threads still attached; hessian was commonly used as a backing for fabric or fabric wallpapers, which could suggest fabric was stretched over these. The series of layers and their ascribed dates are laid out below in a table for ease of assessment.

FIGURE 26: ROW OF TACKS AND NAILS, SOME WITH HESSIAN FABRIC ON THEM, SUGGESTING THE BOARDING WAS LATER COVERED WITH FABRIC.

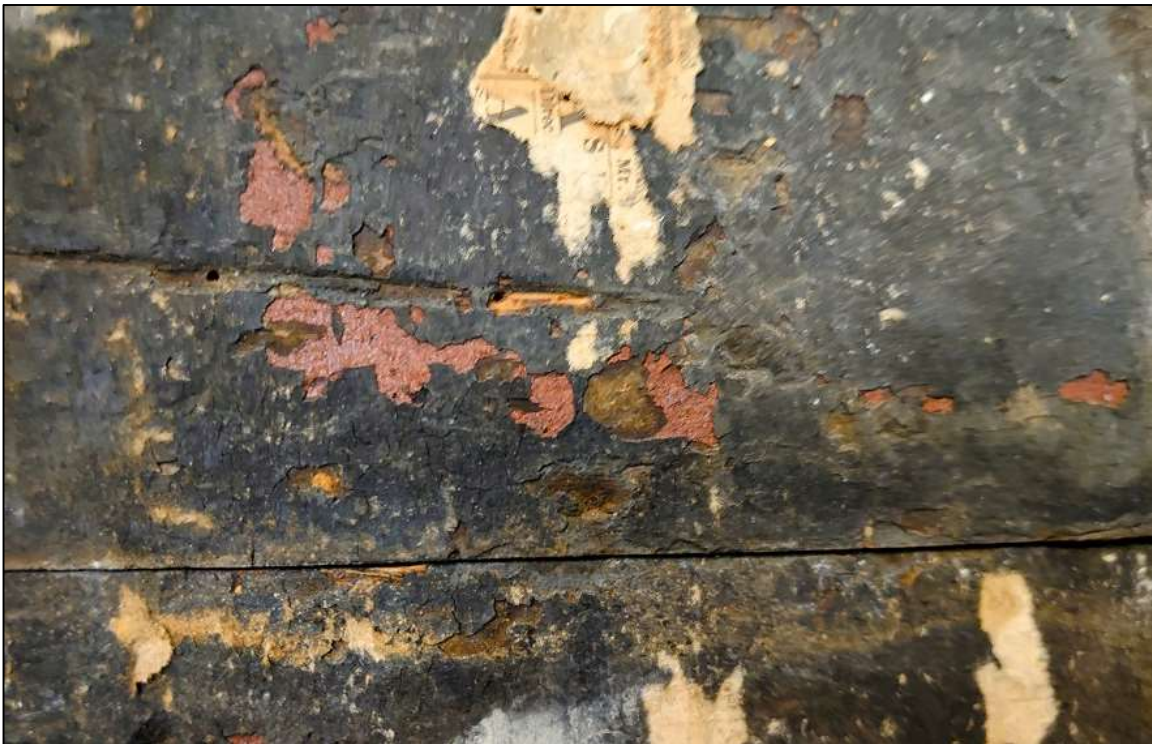
FIGURE 27: FRAGMENTS OF RED PAINT, UNDER A BITUMEN-LIKE BLACK TAR PAINT ON THE LARGEST OF THE SHUTTERS USED ON THE WALL OF R2.

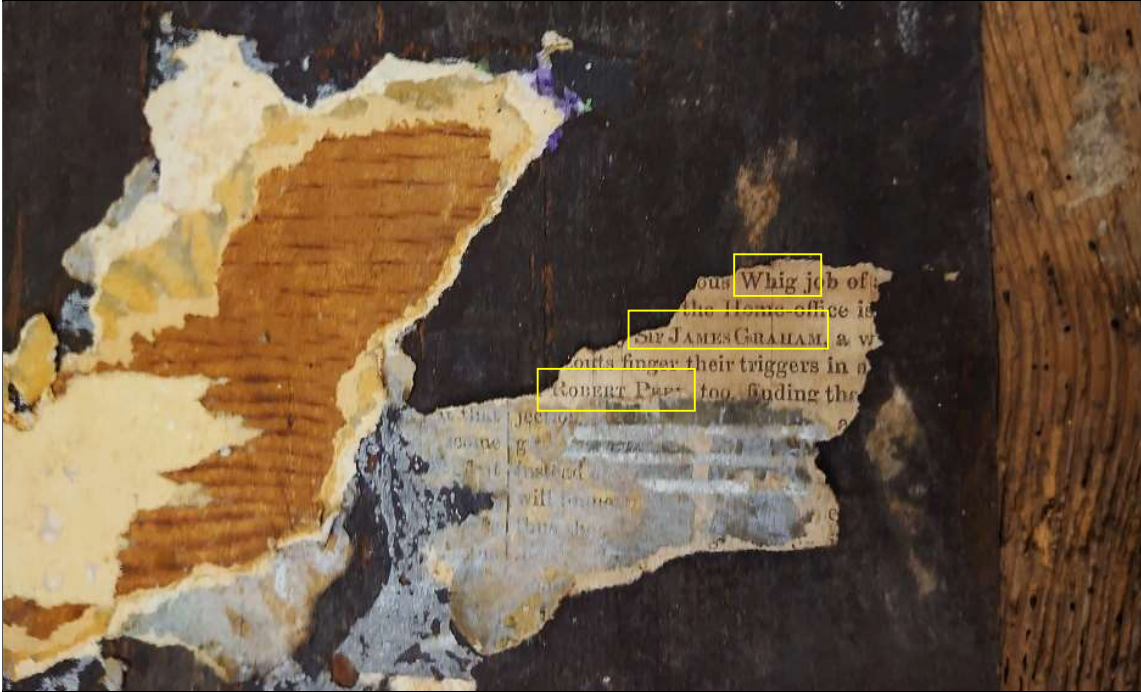
FIGURE 28: EXTRACT OF THE TIMES NEWSPAPER, MENTIONING SIR JAMES GRAHAM AND SIR ROBERT PEEL, AS WELL AS THE WHIG POLITICAL PARTY, LAID UNDER THE WOOD-EFFECT AND FLORAL WALL PAPERS.

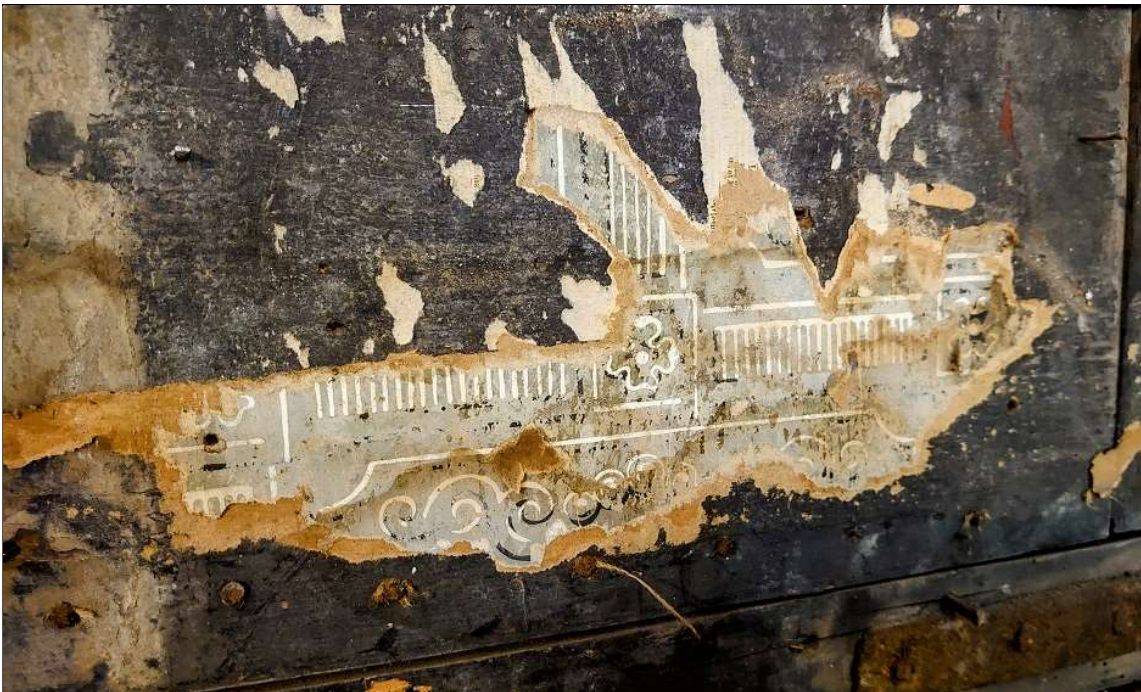
These historic layers are of interest as they potentially push the initial date of this building back slightly from the 1832 date, as inscribed on the gutter hoppers – meaning that may not relate to a phase of remodelling but an event, like a marriage, or a new owner, marking a purchase. Being in situ as they are with the detail of the multiple phases of decorative schemes, does appear to suggest this large upscale shop space has been in existence since possibly as early as the 1810s or 1820s. Obviously old newspaper can be used to line the walls – so the dating is not exact but gives us a *terminus post quem* date, for the lining of this wall, with the initial shutters and planks. The earliest block-printed wallpaper has a distinct *Regency* aesthetic (c.1811 – 1820).

FIGURE 29: THE EARLIEST LAYER OVER THE SHUTTERS, A REGENCY STYLE BLOCK-PRINTED WALLPAPER, OVERLAID BY FRAGMENTS OF NEWSPAPER.

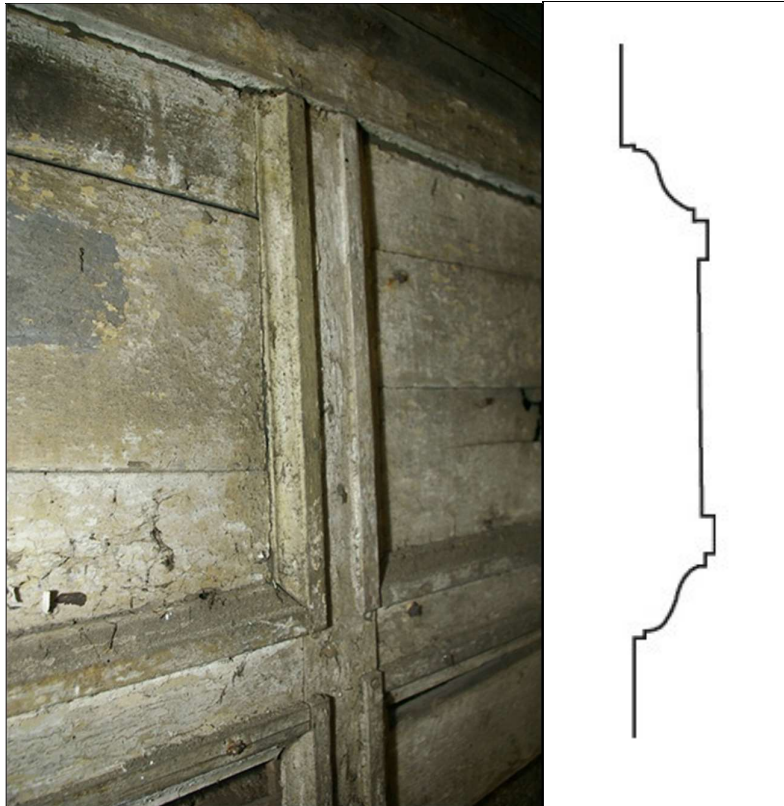
Stylistically this panelling has elements present from both Type 3 and Type 9, likely another late 17<sup>th</sup> or early 18<sup>th</sup> century style. It retains the small panels synonymous with 17<sup>th</sup> century form, but its mouldings are now distinctly classical and simple, almost restrained. The profile and a photograph are included below. The front faces of each panel have a very slight raise, with a more marked raise to the rear, the panels are formed of planks, or individual slices of wood, hand cut. The mouldings may be applied later, and this may have been plain, which could suggest an attempt by someone to modernise or aggrandise an existing wall covering.

FIGURE 30: PROFILE OF THE OGEE/CAVETTO MOULDINGS ON THE RECYCLED PANELLING IN R2, THE MOULDINGS MAY BE ADDED LATER TO PLAIN STYLES, HENCE WHY THEY ARE PROUD.

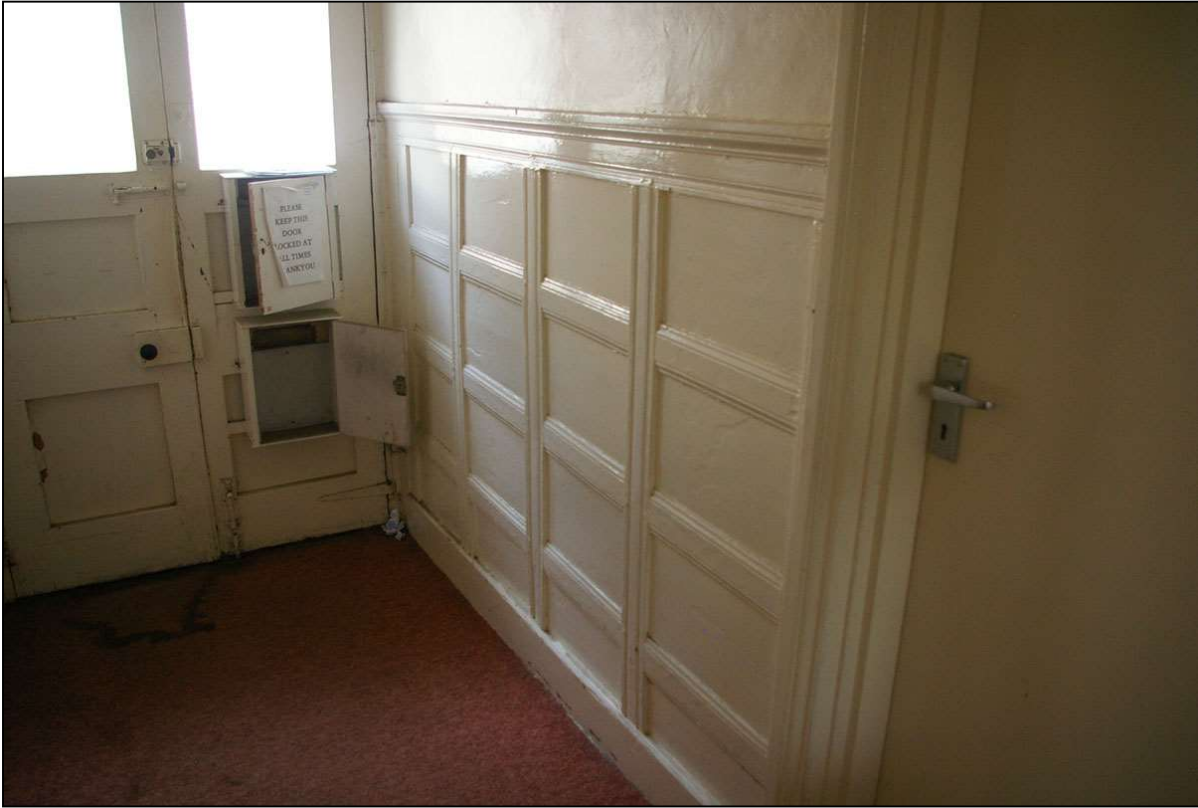
| Significant Details: | | Reset Late 17 <sup>th</sup> or very early 18 <sup>th</sup> century section of panelling to the west wall. This partition has been altered in some way, from its original position, now on a marked angle and awkwardly set with the front doorframe, clearly inserted. Did this replace an |

9. FINE 18<sup>TH</sup> CENTURY PANELLING, RESET HERE TO THE WEST WALL; FROM THE NORTH-EAST.

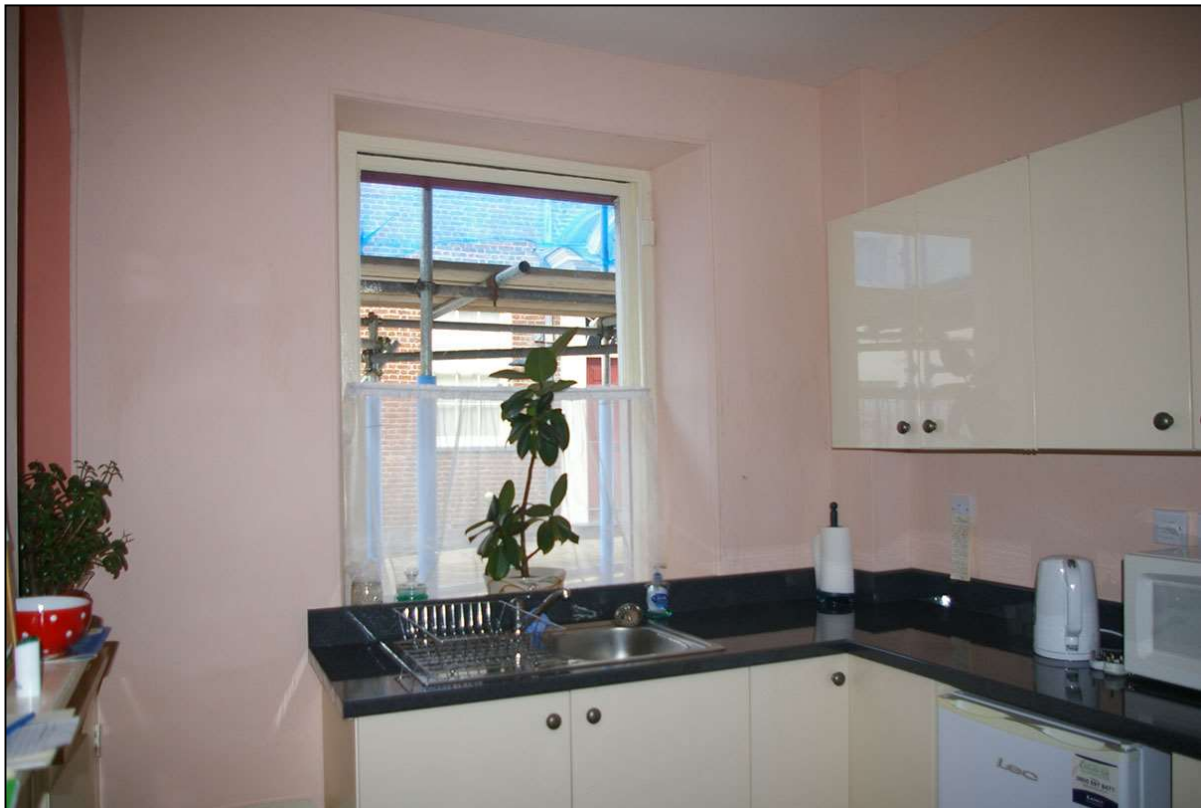
| <b>BUILDING 1</b> | | <b>General Description</b> |
|---|---|--|
| Opening – Windows: | 1 | W1 - Large sash window, hornless frame, moulded in narrow beaded frame but large single pane sashes to ground floor right.<br>Three windows on first floor, all identical – W4, 5 and 6. 6x6 hornless sashes in beaded frames.<br>Three windows on the second floor – W9 and 10 – horned squat 3x6 paned sashes, W11 a replacement white pvc double glazed window. |

13. THE SASH WINDOW IN THE SOUTH WALL, WITHIN BEADED OPENING; FROM THE NORTH-EAST.
