**THE BICKFORD CENTRE  
23 SOUTH STREET  
GREAT TORRINGTON  
DEVON**

HISTORIC BUILDING RECORDING & MONITORING

South West Archaeology Ltd. report no. 230519

Revised after archaeological monitoring of works: 19<sup>th</sup> May 2023

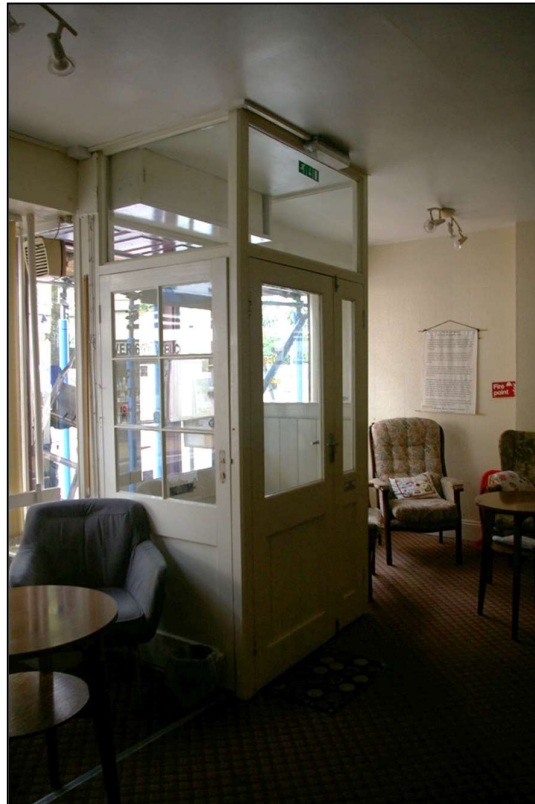
| Opening Windows: | – | SF - The modern plate glass fascia now replaces the historic small pane windows but sit within beaded frame with ovolo moulded glazing bars to side and Tuscan half-round pilasters to each end and framing the doorway. The windows are topped with a moulded wide timber hoarding, currently sign written as 'Bickford Centre'. |

15. THE MODERN PLATE GLASS FACIA OF R2, WITH A RECYCLED COMBINATION OF DOORS AND FRAMEWORK FORMING A SMALL LOBBY; FROM THE EAST-NORTH-EAST.

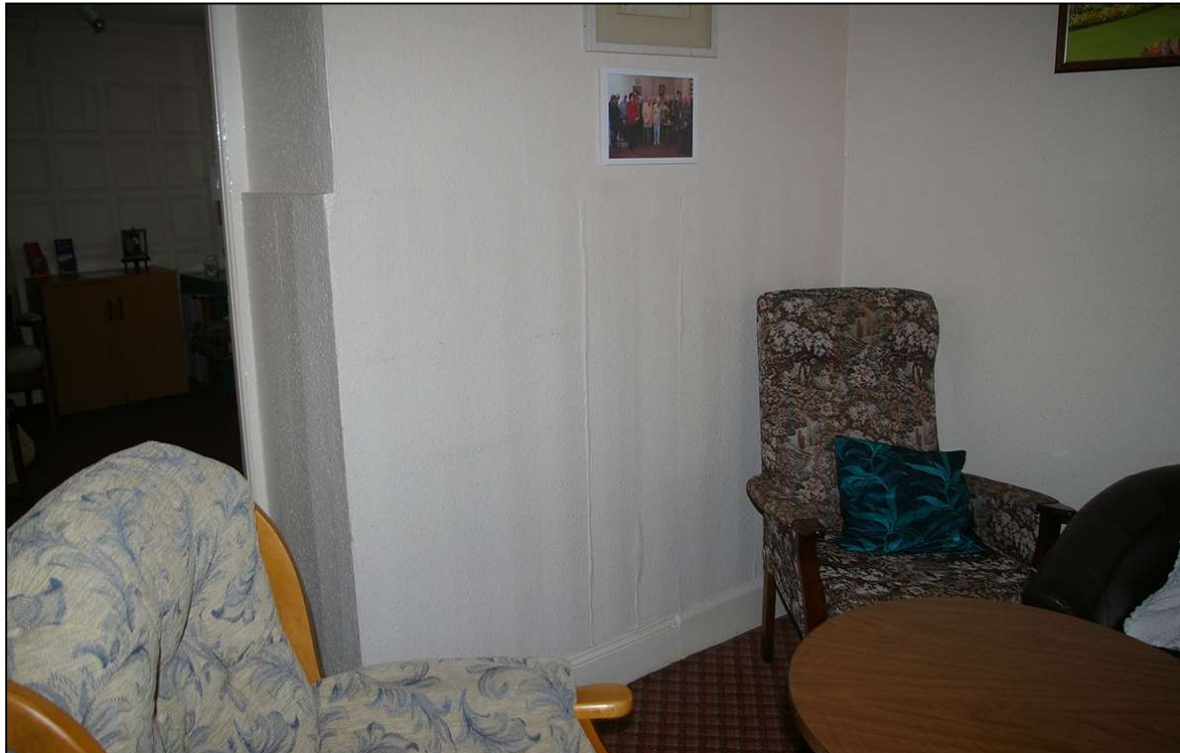
17. THE SURVIVING BEADED PLANK PANELLING IN THE NORTH-EAST CORNER OF R2, RUNNING INTO THE FORCED DOORWAY OPENING, PAPERED OVER WITH WOODCHIP WALLPAPER; FROM THE SOUTH-WEST.

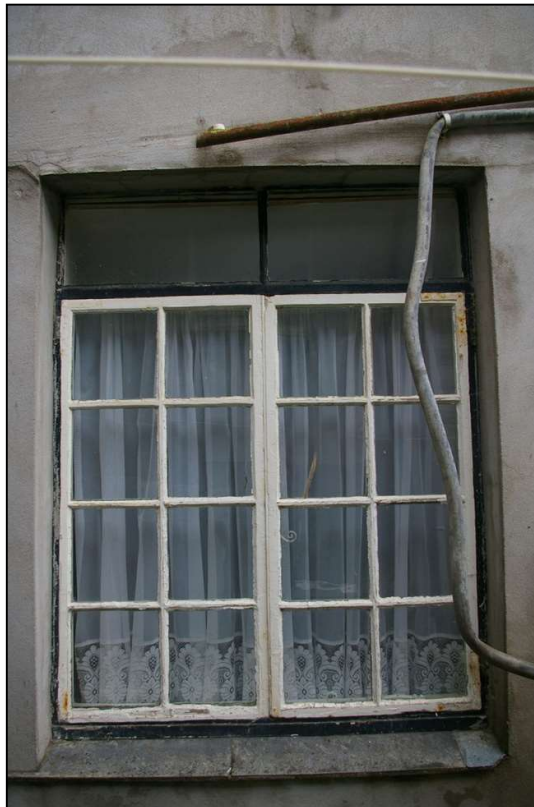
| | | <p>W13 - One large casement window, beaded glazing bars, coiled catches, narrow beaded frame, early 19<sup>th</sup> century.</p> <p>W14- One single pane metal framed window to centre.</p> <p>W15 and W16 - Two mid-20<sup>th</sup> century metal-framed toilet windows to north, large fixed frosted glass pane with small hopper casements above for ventilation.</p> <p>Three to the first floor:</p> <p>W17 - One modern two light white pvc casement window to south.</p> <p>W18 - One small 19<sup>th</sup> century single pane casement, bead moulded in beaded frame, with wooden turned knob to centre in small, raised opening.</p> <p>W19 - One large two light modern transom style timber window to north end, fixed panes below, small hopper casements above. 20<sup>th</sup> century.</p> |

29. W13, 19<sup>TH</sup> CENTURY CASEMENT WITH GLASS FILLET ABOVE, INFILLING AN ORIGINALLY TALLER OPENING; FROM THE EAST.

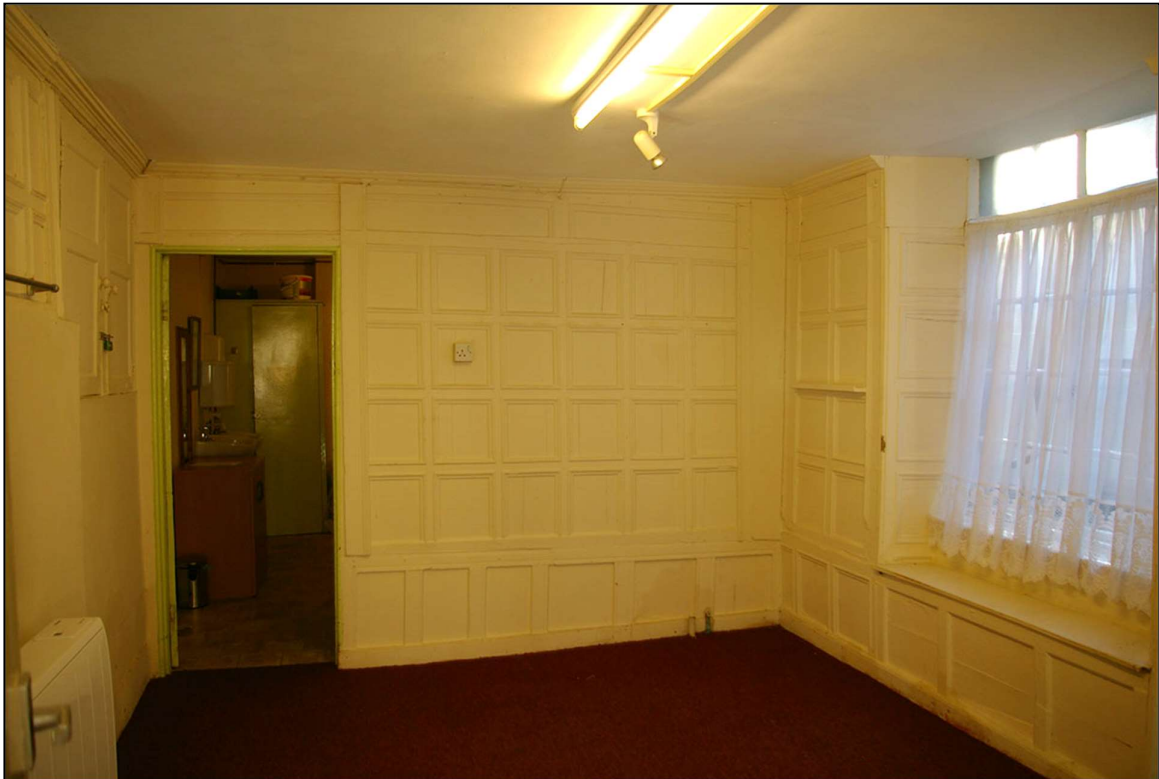
| Significant Details: | | Three large sections of recycled panelling have been set to the east, west and north walls. This panelling is later 17 <sup>th</sup> or early 18 <sup>th</sup> century in date, deeply raised and fielded, with chunky ovolo moulding to sides, very chunky and thick, likely oak planks. Damaged in places and re-pegged to corners, nailed and patched. Scarring beneath this panelling showing there was a timber box here, presumably covering some kind of toilet structure, later replaced by the early 20 <sup>th</sup> century high level cistern flush toilet, with chain flush pull. |

30. R17, SHOWING RESET 17<sup>TH</sup> CENTURY PANELLING SECTIONS ON THE WALLS; FROM THE SOUTH-WEST.

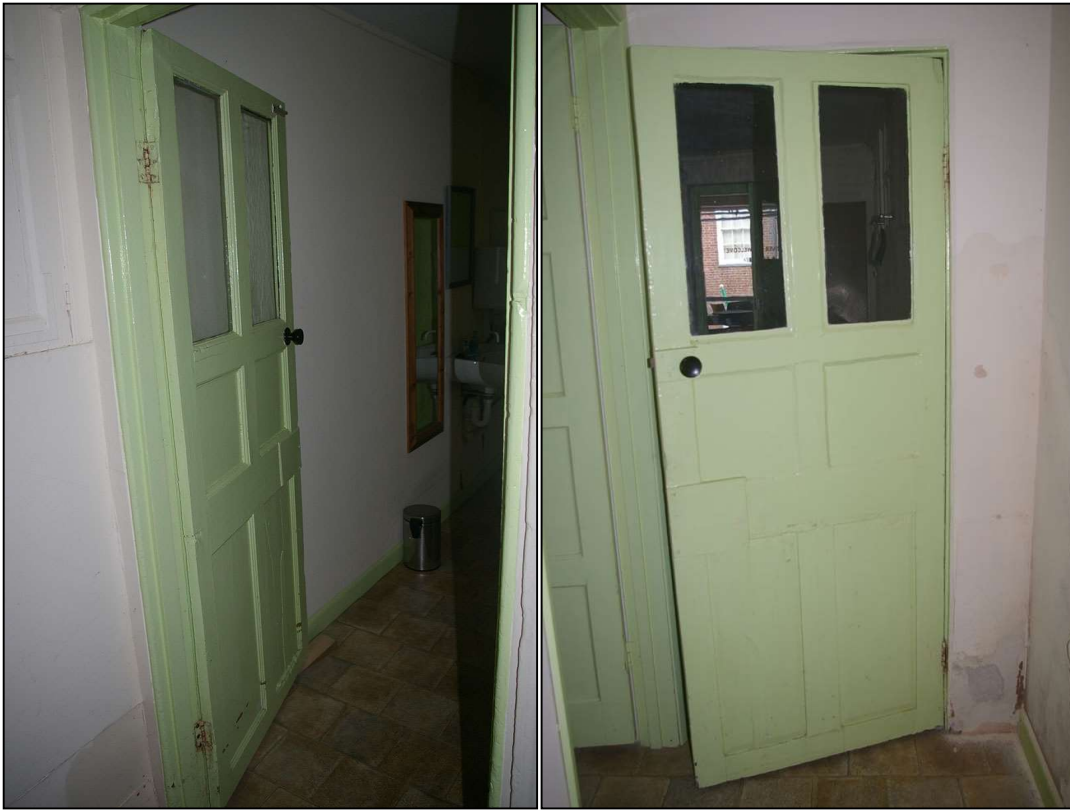
| <b>BUILDING 2</b> | | <b>General Description</b> |
|---|---|--|
| Openings – Doors: | 3 | <p>D24 – Modern flay boarded door with wired single glazed pane, chrome handle modern hinges, in modern narrow frame to south wall, in forced opening.</p> <p>D25 – Fine 18<sup>th</sup> century or early 19<sup>th</sup> century door. Ogee moulded six flat panels, the upper two cut out and frosted glass inserted. Reset on modern hinges, black Bakelite doorknob.</p> <p>(D7 – Boarded on room side but still in opening, leading formerly to Building 1. Later 19<sup>th</sup> century plain four panel doors.)</p> |

34. LEFT & RIGHT: D25, BETWEEN R17 AND R19, 18TH CENTURY STYLE DOOR WITH TWO GLASS PANES INSERTED; FROM THE SOUTH-EAST AND NORTH.

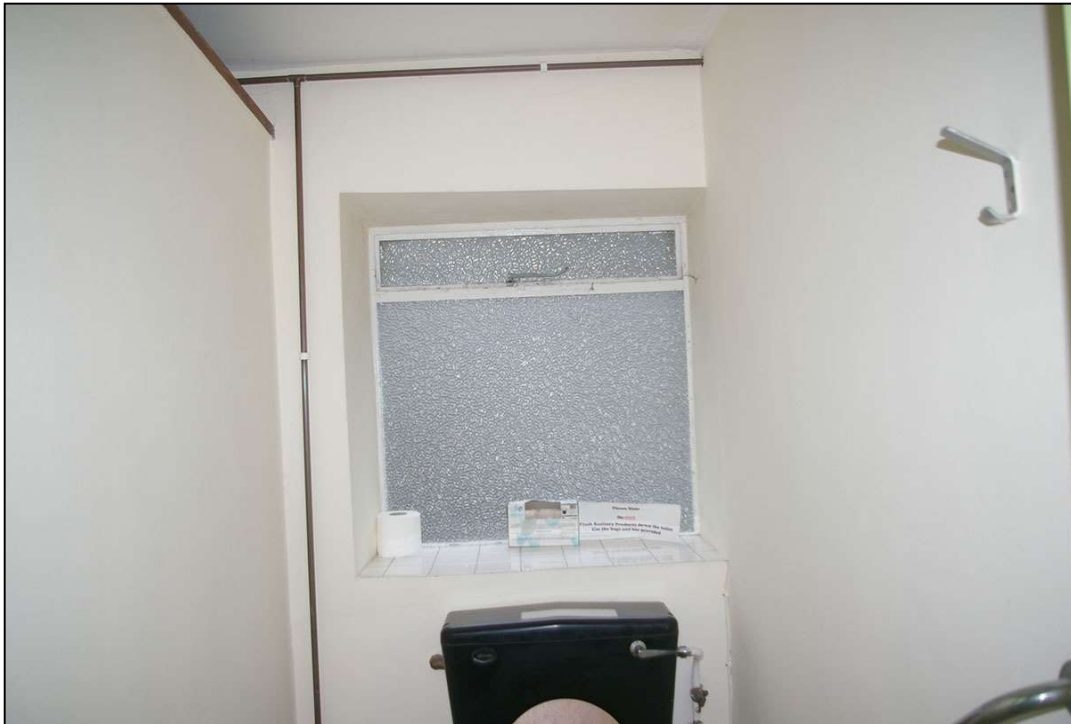
| Opening – Windows: | | W15 and W16 - Two mid-20 <sup>th</sup> century metal-framed toilet windows to north, large fixed frosted glass pane with small hopper casements above for ventilation. |

37. W15, ONE OF THE METAL FRAMED CRITTAL-STYLE WINDOWS IN ROOM 19; FROM THE WEST.

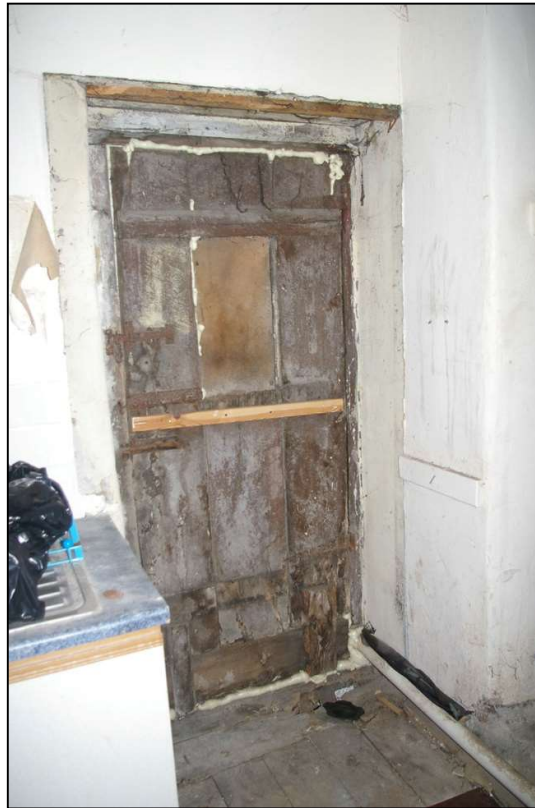
| Openings – Doors: | 2 | D29 – Modern unpainted boarded door in modern unmoulded frame.<br>D30 - One blocked but visible doorway to the first floor, slightly offset to that below. Good opening with neat quoins to side, very heavy oak timber lintels, one possibly reset with some ovolo moulded carving, but weathered and damaged. Set with early 19 <sup>th</sup> century door, uneven width planks, chunky ledging bars, small pane window cut into central plank. Strap hinges with spear-head shaped ends, replaced, iron pintles to chunky beaded frame. |

44. GOOD LATER 18<sup>TH</sup> OR EARLY 19<sup>TH</sup> CENTURY DOOR, D30, NAILED SHUT IN BOARDED OVER OPENING IN THE EAST WALL OF ROOM 20; FROM THE WEST-NORTH-WEST (WITH FLASH).

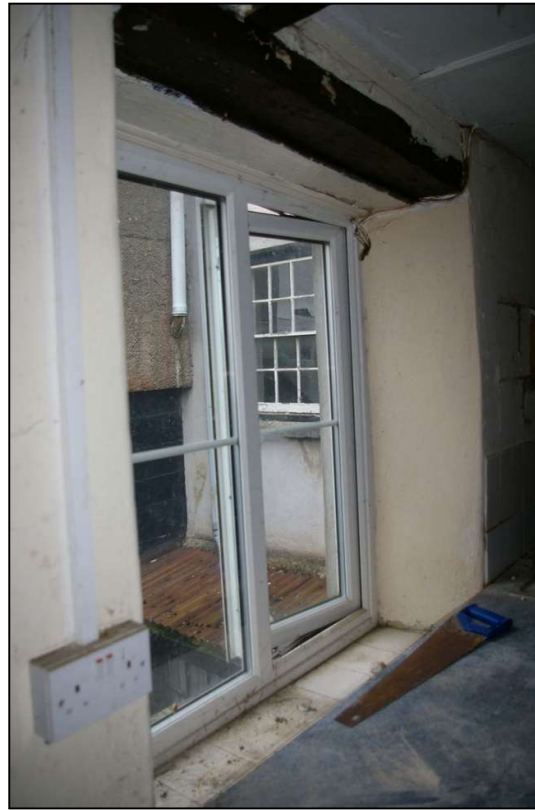
48. W17, SHOWING MODERN DOUBLE GLAZING IN DEEP OPENING, WITH WINDOW SEAT BELOW AND CHUNKY TIMBER LINTEL; FROM THE NORTH-WEST

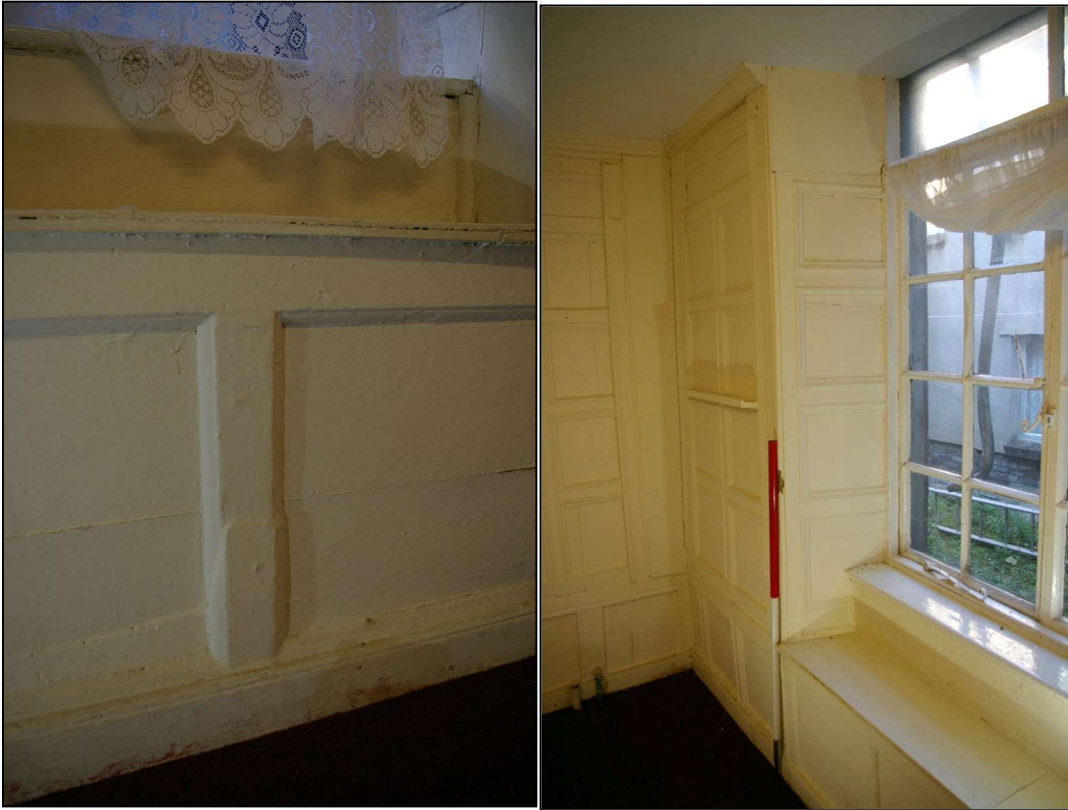
71. LEFT: THE CHUNKY BEAD MOULDING UNDER THE WINDOW SEAT, ON THE EAST WALL; FROM THE NORTH-WEST.

72. RIGHT: THE PANELLED SHUTTERS TO THE NORTH SIDE OF THE WINDOW, W13, WITH 1M SCALE; FROM THE SOUTH-SOUTH-WEST.

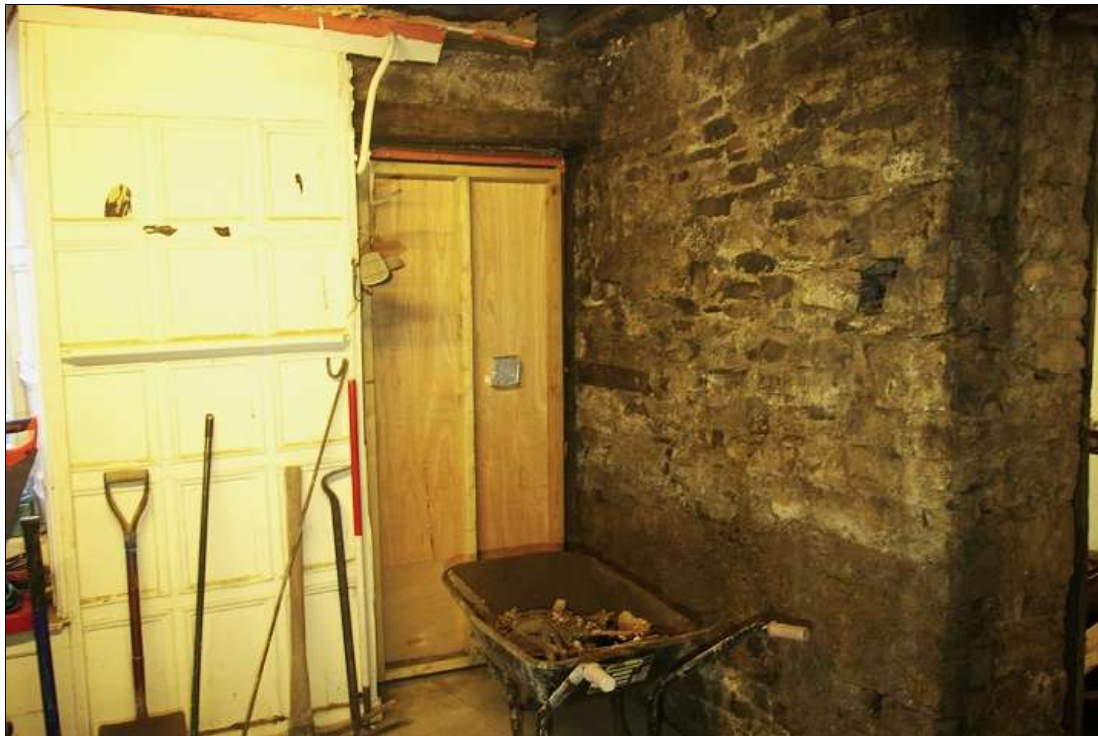
96. VIEW OF THE SOUTH-EAST CORNER OF R17, WHERE THE DOOR TO R1 IS BLOCKED, SHOWING THE EAST AND SOUTH WALL ARE COHESIVE HERE, THE DOOR HOWEVER IS FORCED; FROM THE WEST-NORTH-WEST (1M SCALE).

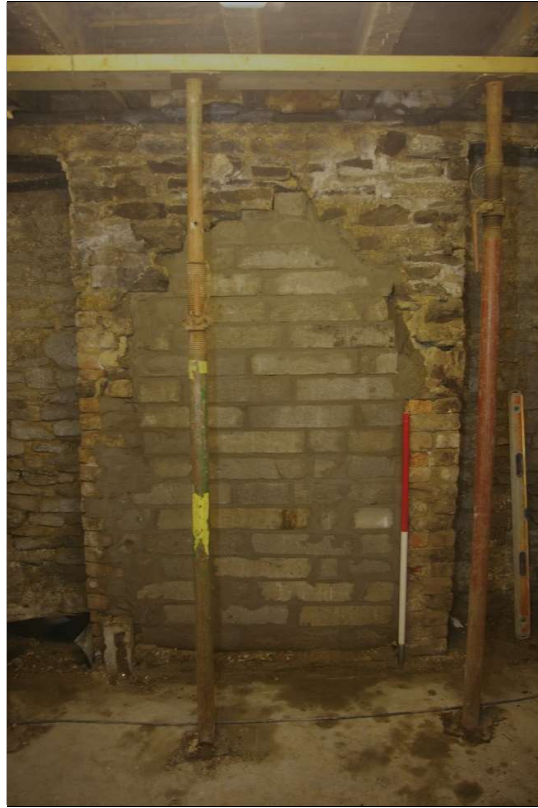
97. ALTERED STACK, SERVING NO.25, WITH FORCED AND NOW BLOCKED HEARTH SERVING NO.23; FROM THE EAST (1M SCALE).

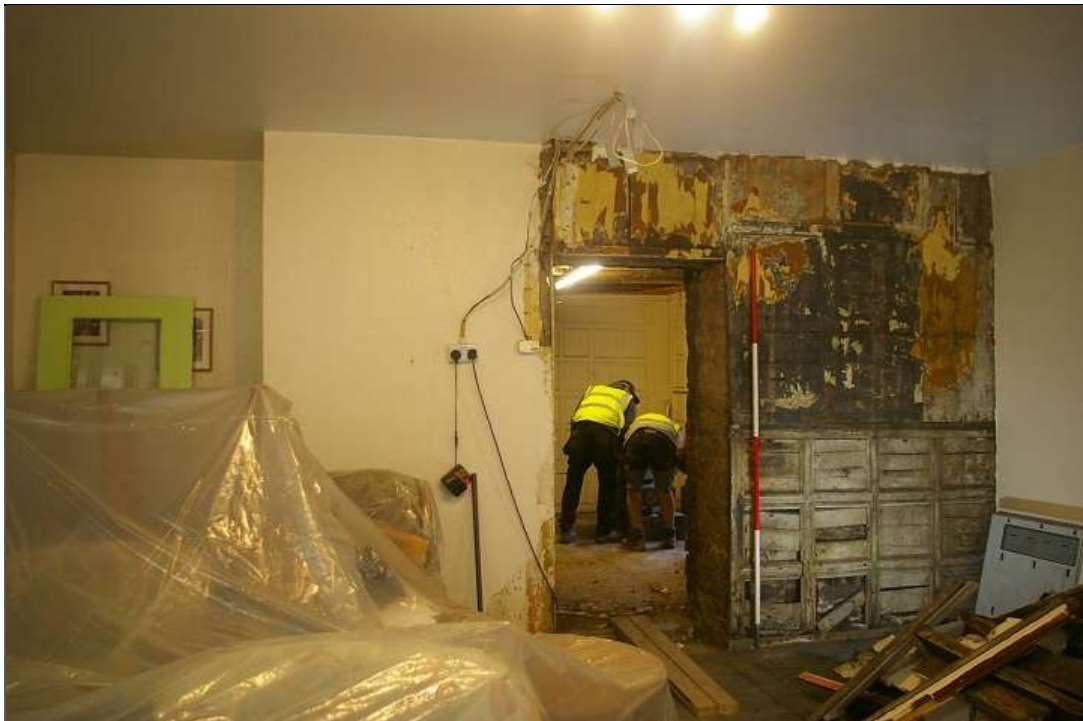
98. THE NORTH WALL OF R2, SHOWING PARTIALLY STRIPPED WALL COVERINGS, EXPOSING INTERESTING DECORATIVE SCHEMES AND RESET TIMBERWORK AND PANELLING; FROM THE SOUTH-WEST (2M SCALE).

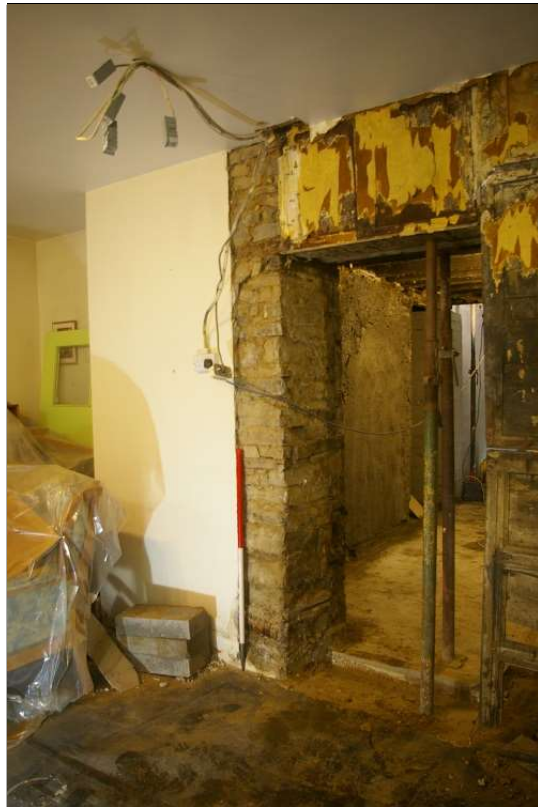
100. THE FRAGMENT OF GOOD HEAVY MEDIEVAL WALLING, WITH FORMAL LEVELLING COURSES — HACKED INTO TO CREATE OPENING, WITH TIMBER TIES INSERTED; FROM THE SOUTH-EAST (1M SCALE).
