**LAKE FARM  
WINGATE LANE  
HATHERLEIGH  
DEVON**

Historic Building Appraisal

South West Archaeology Ltd. report no. 221216

### Results of a historic building appraisal

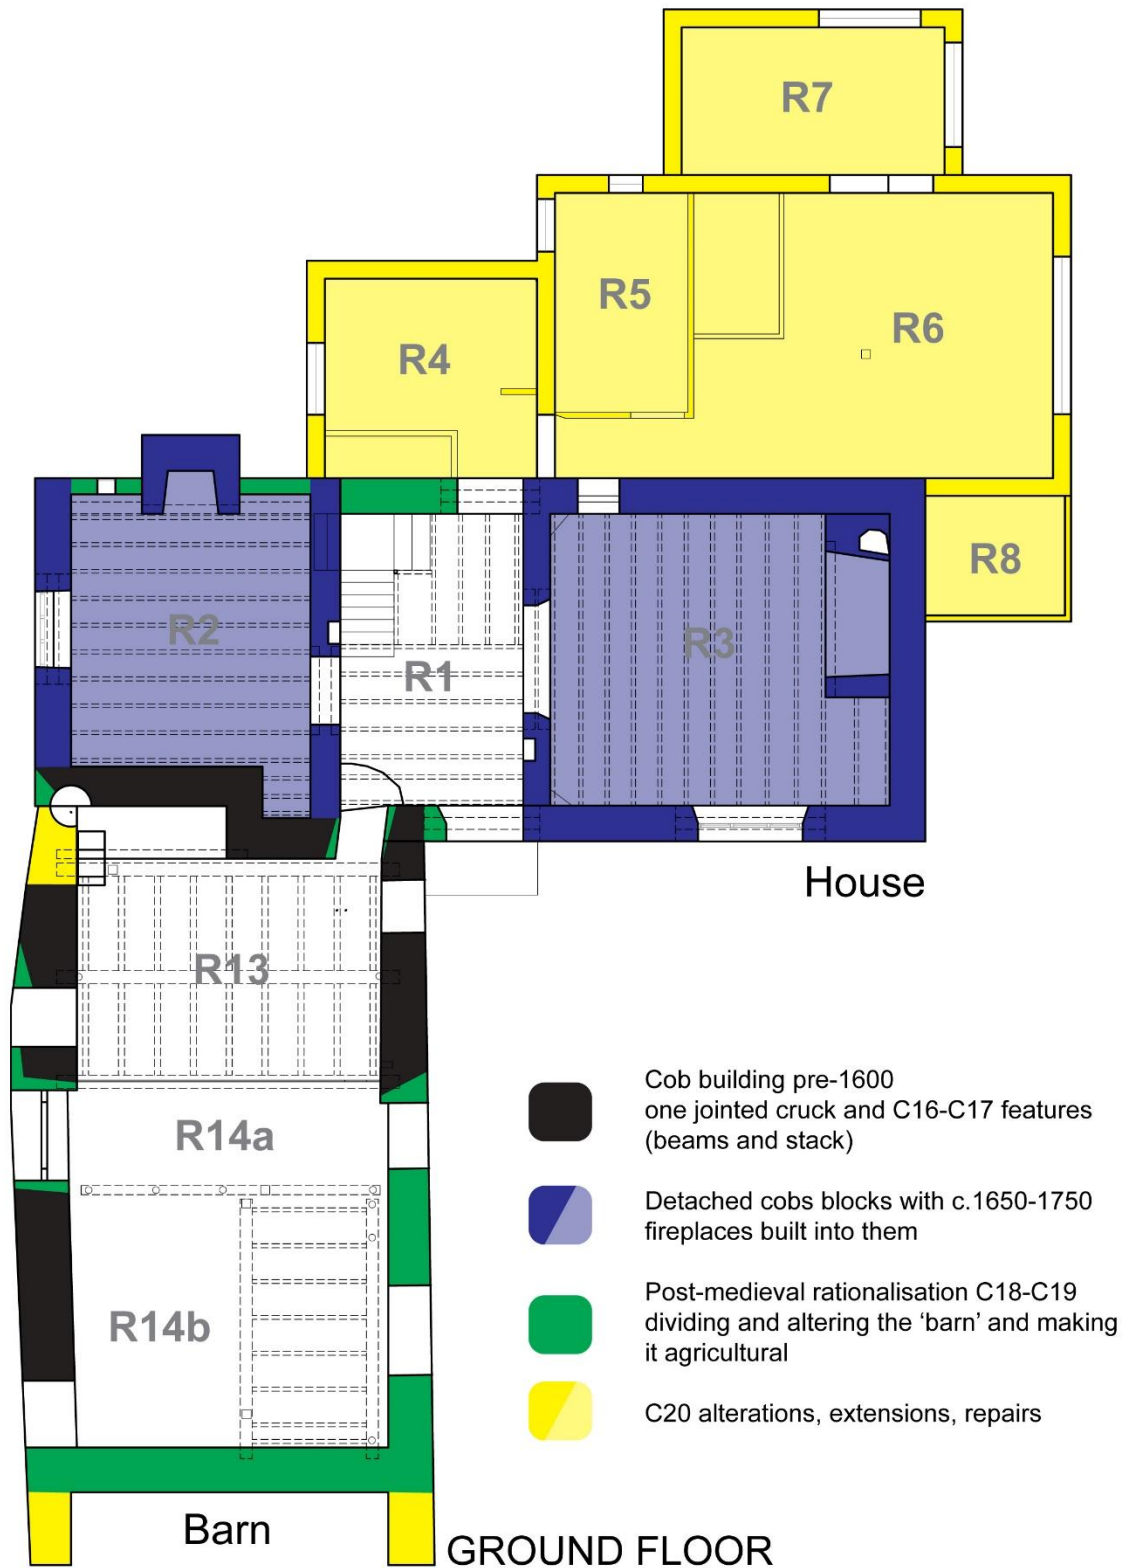
FIGURE 23: PROVISIONAL PHASE PLAN OF THE HOUSE AND BARN (BASE MAP PRODUCED BY CLIENT).

A draft phase drawing for the house and barn is presented in Figure 23 (below). This is a farmstead with its stylistic roots in the medieval period but probably dates to the last century of that period, the 16<sup>th</sup> century or perhaps the late 15<sup>th</sup> century. The key piece of evidence is the jointed cruck in the barn. Only one element survives but a dendrochronological date may be possible. The site may have evolved from a small, compact hall, into a larger courtyard range in the 17<sup>th</sup> century, as it appears there was considerable investment in this period, when the ‘barn’ was built, initially as two detached blocks, as well as the lost east and south ranges. The over-arching narrative of the site appears to be steady investment until the 1800s when challenging economic conditions for small farms were such that consolidation and demolition led to the only buildings standing being the L-shaped range and fragment of threshing barn.

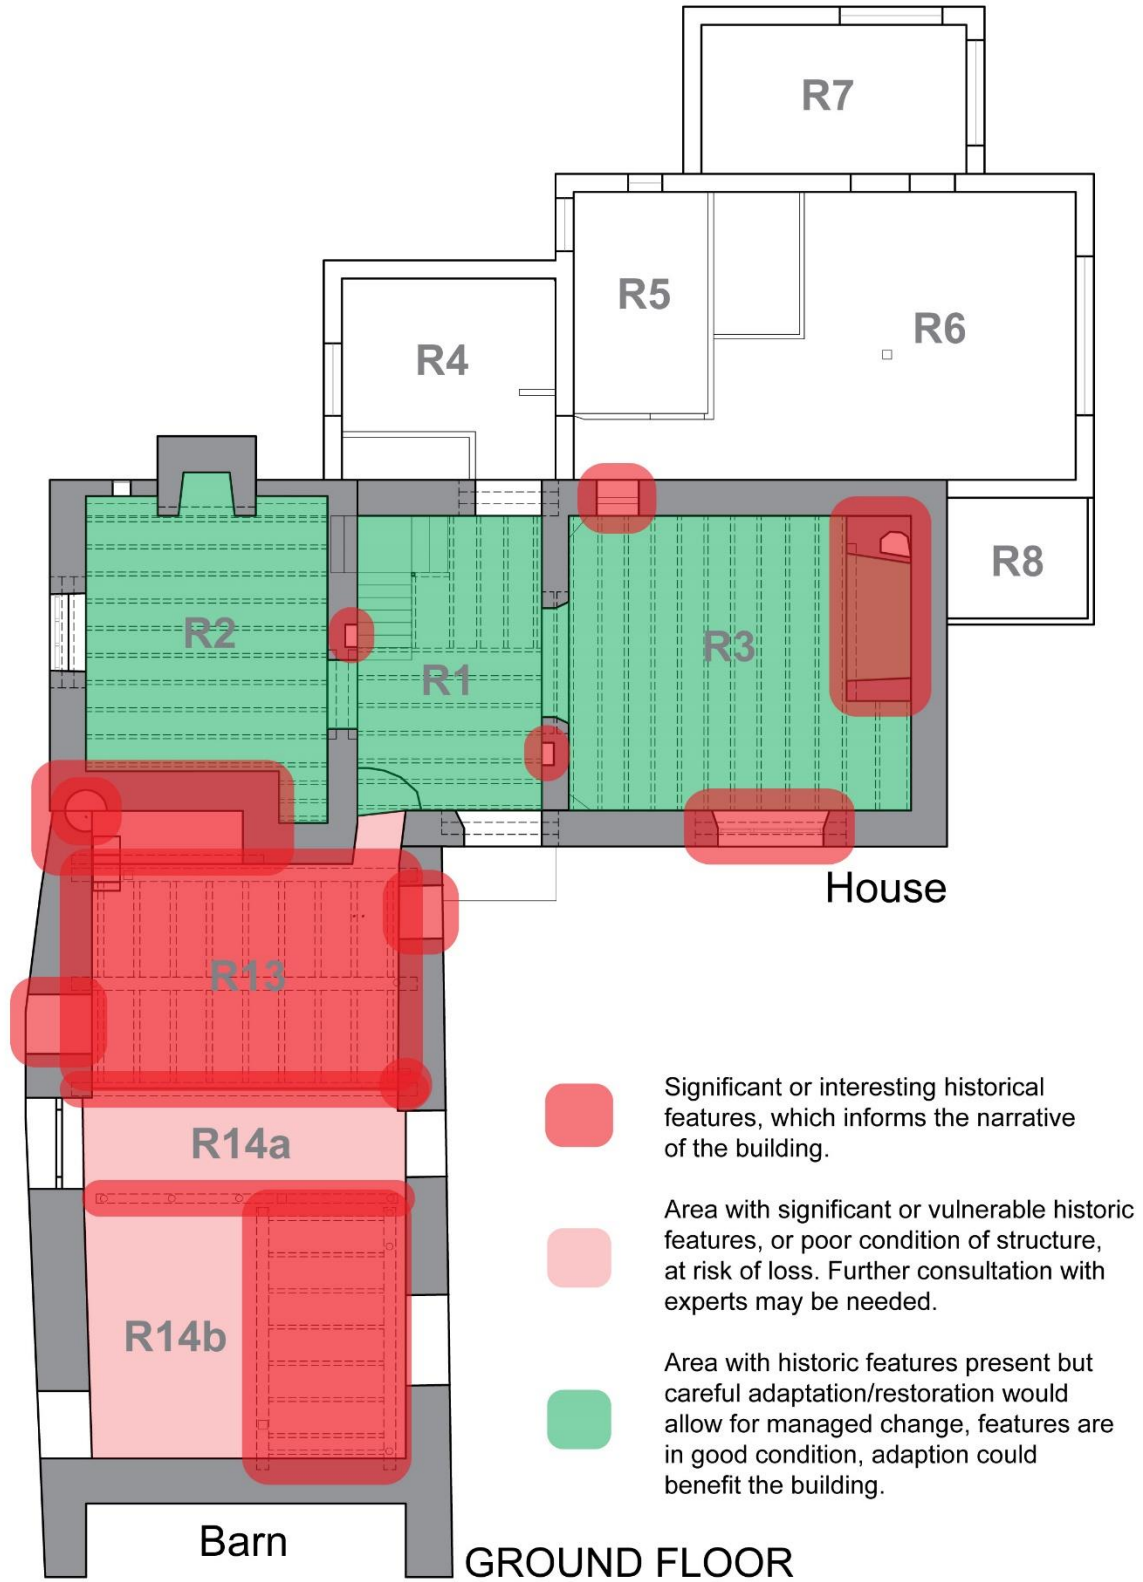
FIGURE 24: GROUND-FLOOR PLANS, SHOWING THE LOCATION OF SIGNIFICANT FEATURES AND SENSITIVITY OF SPACES (BASE PLAN PRODUCED BY THE CLIENT).

To simplify and clarify understanding of the building, Figures 24-25 identify the most significant features within the building and zones the spaces into red/green system for sensitivity. Areas tinted green show those areas where there is more flexibility for change; those tinted red identifies those areas where there is an increased risk of loss, poor condition or features of increased sensitivity or interest.

The current house (R1-R3, R9-R12) is a much-altered 17<sup>th</sup> century building, with significant phases of 18<sup>th</sup> and 19<sup>th</sup> century remodelling. This building has few early features left apart from its two stacks (three fireplaces). All its carpentry is now of 18<sup>th</sup> or 19<sup>th</sup> century date. However, the doors, floorboards, joists, and other later features are not without merit and inform on an interesting narrative, possibly including a devastating event which has led to the wholesale replacement of much if not all of the timber elements in the house, leaving only the stone and cob elements surviving.

Broad heritage principles apply here, as in all Listed buildings. Historic structural elements and fixtures and fittings must be retained unless express permission is given, via a scheme approved under planning permission from the LPA, including consultation with the Conservation Officer. Cosmetic changes are allowable, and maintenance can also be undertaken without consultation. The layout/plan of the house must also be maintained, and elevations should remain unaltered. That said, there is flexibility for managed change, within such a scheme, as so much of this house
