DERELICT COTTAGES OLD PORTREATH ROAD REDRUTH CORNWALL

Historic Building Recording

South West Archaeology Ltd. report no. 231020

Derelict Cottages, Old Portreath Road, Redruth, Cornwall

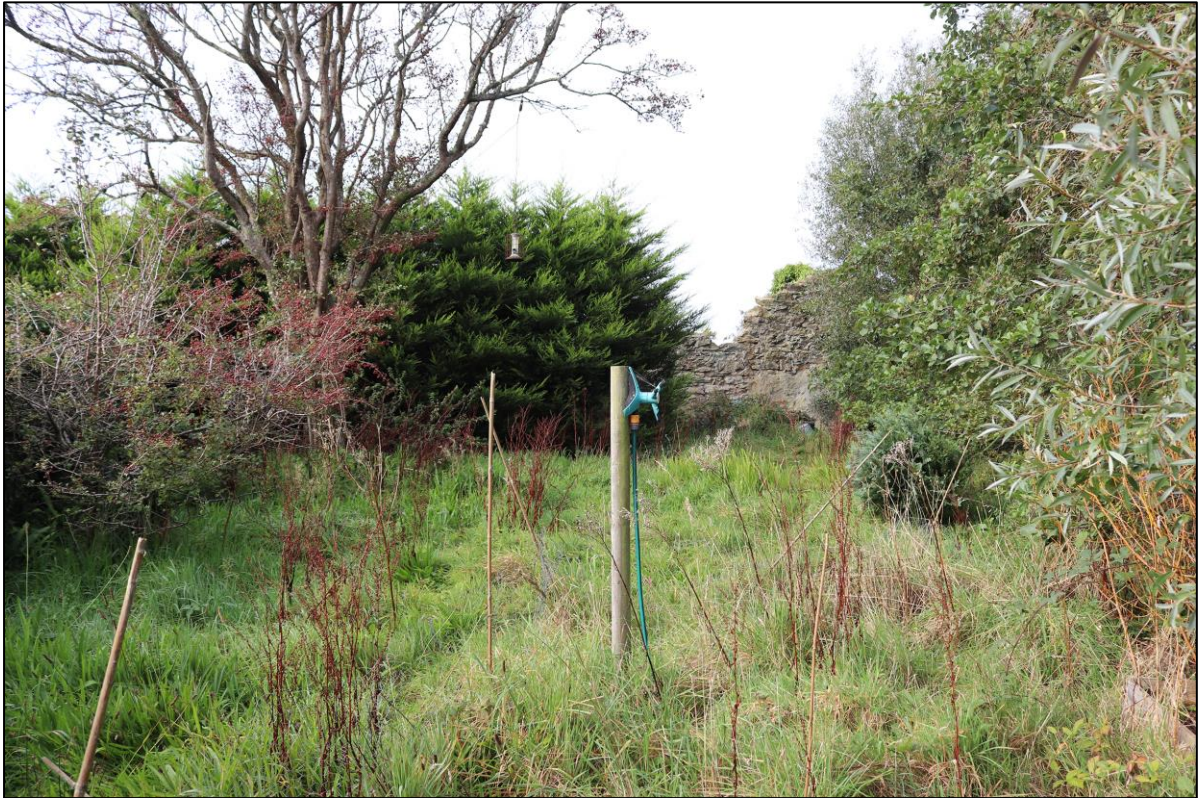
The south front garden had light earthworks for an earlier central footpath, and as Ratcliffe (2019) deduces, this space was likely used for small, later, vegetable plots for the dwellings. The grounds also include another small, triangular garden space to the east which was complete with rubble stone wall to the north and south elevations triangulating further east. The north boundary included mature shrubbery. A well was located to this garden to the north-west corner, now boarded over, and several smaller, more modern raised vegetable beds survives to the east end. The space is bounded to the west with killas rubble and granite rubble, accessed via two low granite posts with socket holes. The extended boundaries to the east include several mature apple trees of differing varieties, and the surrounding plot is undulating and uneven, with several areas of disturbance. There are good views over to Carn Brea and the Basset Monument to the south-west.

FIGURE 13: FROM THE GARDEN LOOKING BACK TO EAST ELEVATION OF MAIN RANGE.

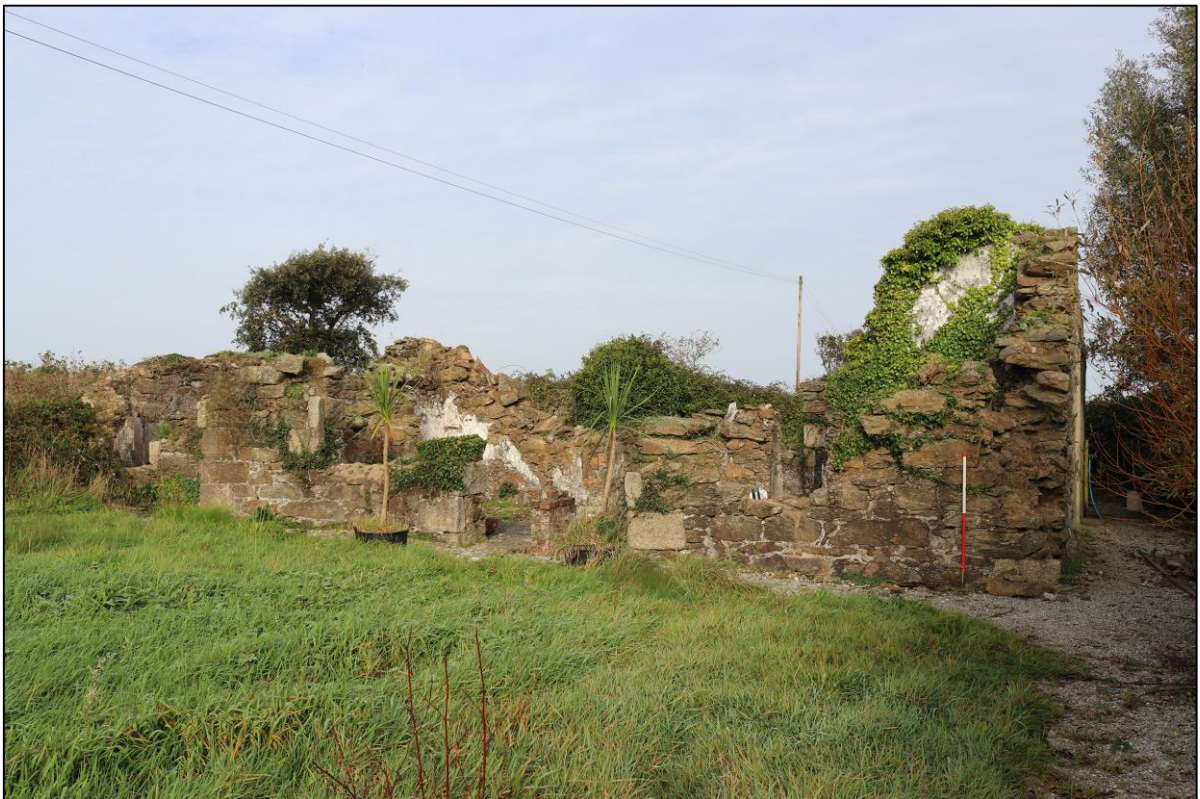
Elevation SOUTH	Description
Fabric Description:	South elevation is the main front for the cottages. The build does not survive above ground-floor level. Cornish killas rubble, large blocks packed with a red-brown, earth mortar, approximately 0.6m thick. Lime mortar repointing visible, and areas of later cement-based repair. This elevation likely never had the same level of external rendering, keeping its outward appearances and aesthetics intact, this may be why more areas of lime pointing are noted. The west block extension comprises of the same.
Roof Covering:	The build is ruinous, no roof survives. However, beneath some areas of internal

2. THE SOUTH FRONT; FROM THE SOUTH WITH 1M SCALE.

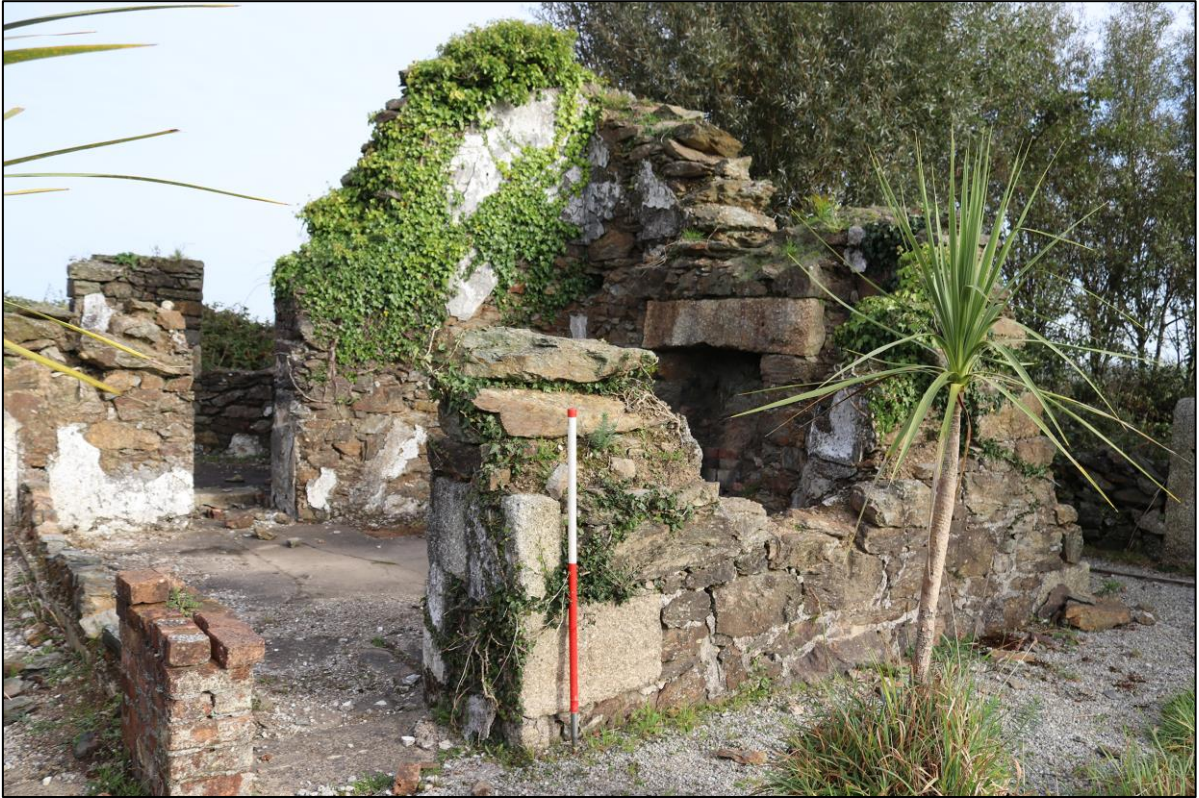
3. C1 EXTERIORS, BRICK PIER SHOWING DIVISION OF DOOR OPENING. FROM THE SOUTH-WEST WITH 1M SCALE.

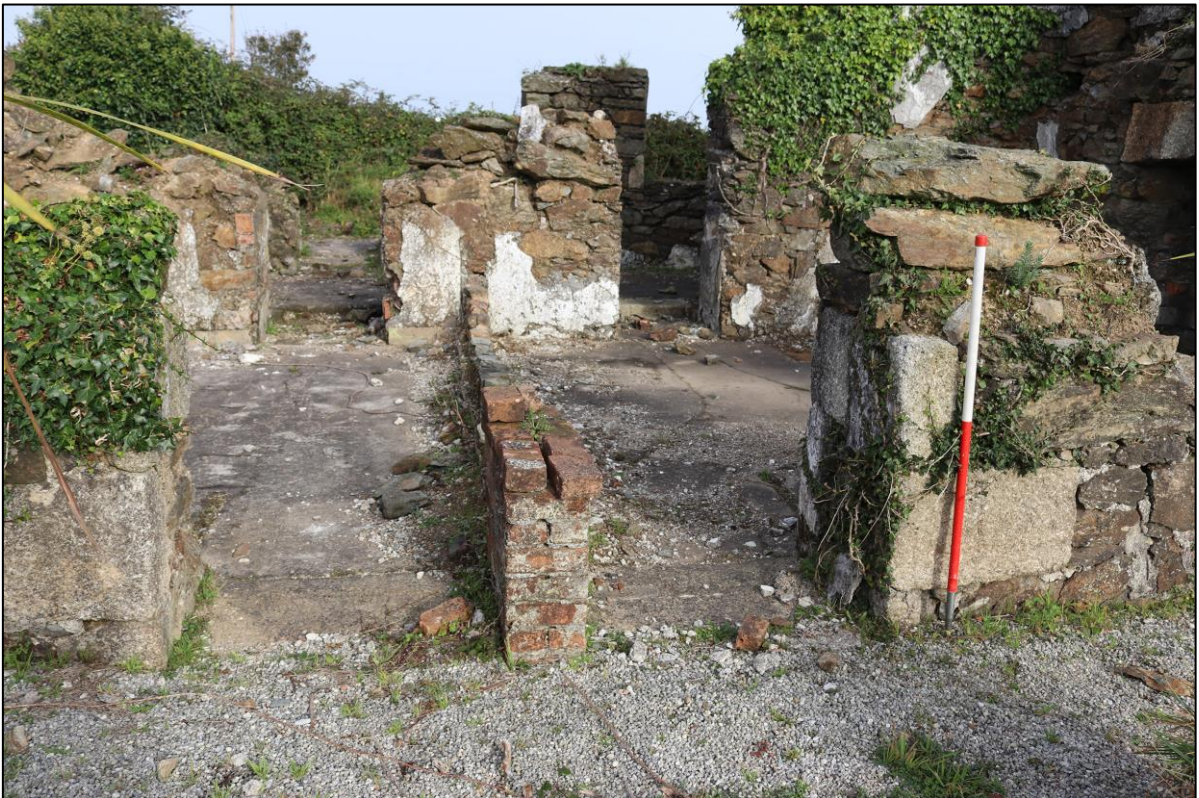
4. DETAIL OF THE SOUTH OPENINGS FOR BOTH COTTAGES, DIVIDED WHEN COTTAGE SPLIT TO TWO DWELLINGS C1843-1881. FROM THE SOUTH-WEST WITH 1M SCALE.

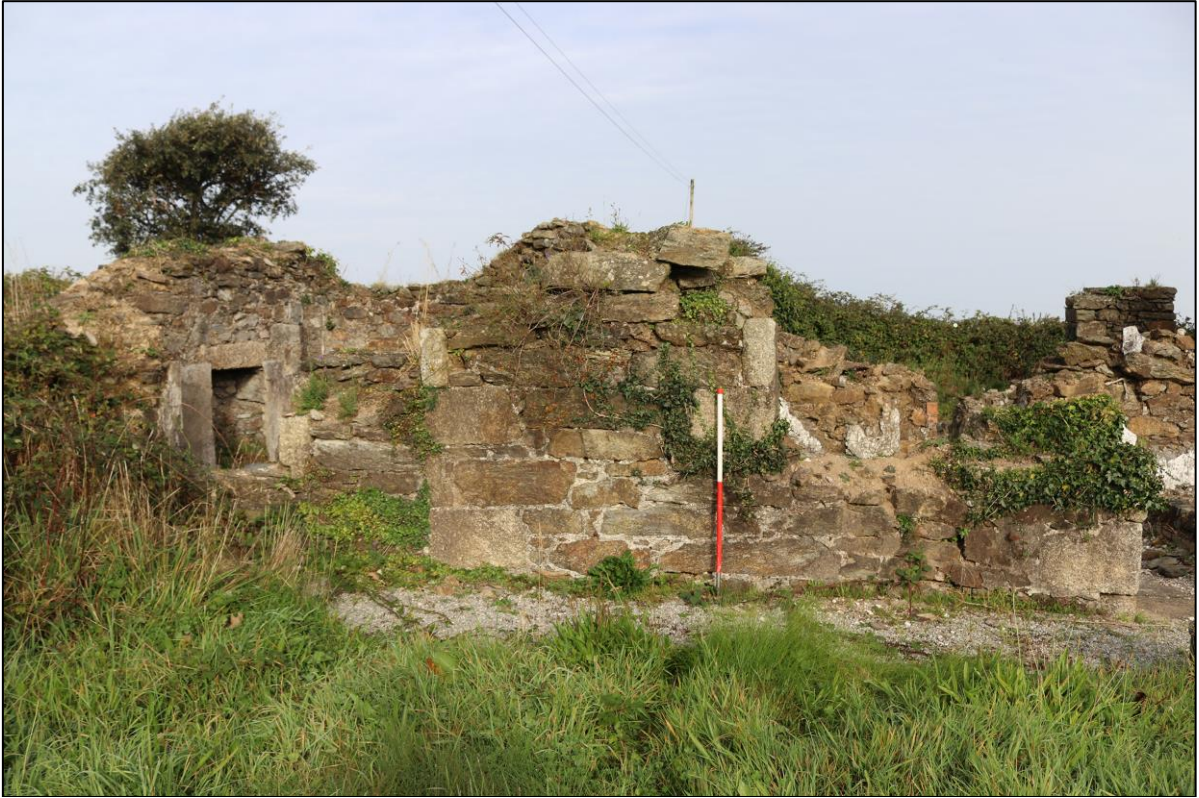
5. THE WEST EXTENSION BLOCK BUILT AGAINST QUOIN DETAILING OF THE MAIN RANGE; FROM THE SOUTH WITH 1M SCALE.

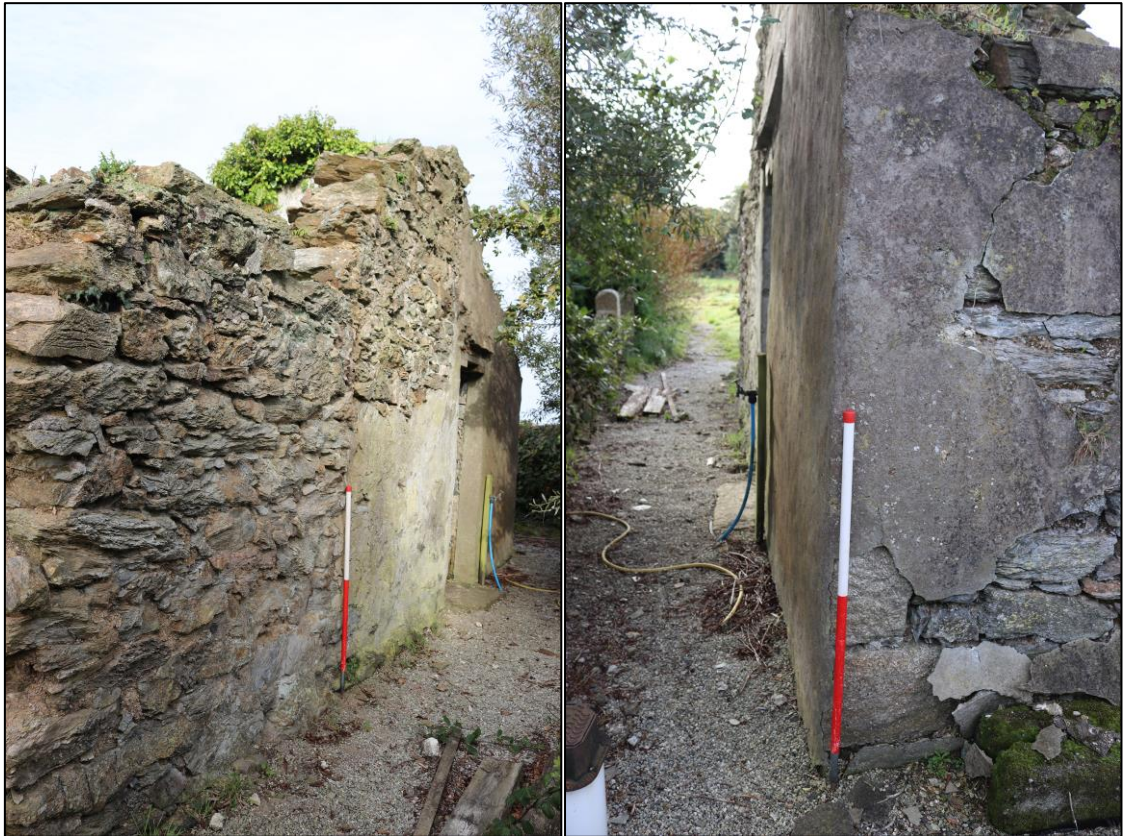
7. LEFT: EAST ELEVATION WITH CEMENT RENDER FROM SOUTH. RIGHT: EAST ELEVATION FROM NORTH CORNER. BOTH WITH 1M SCALE.

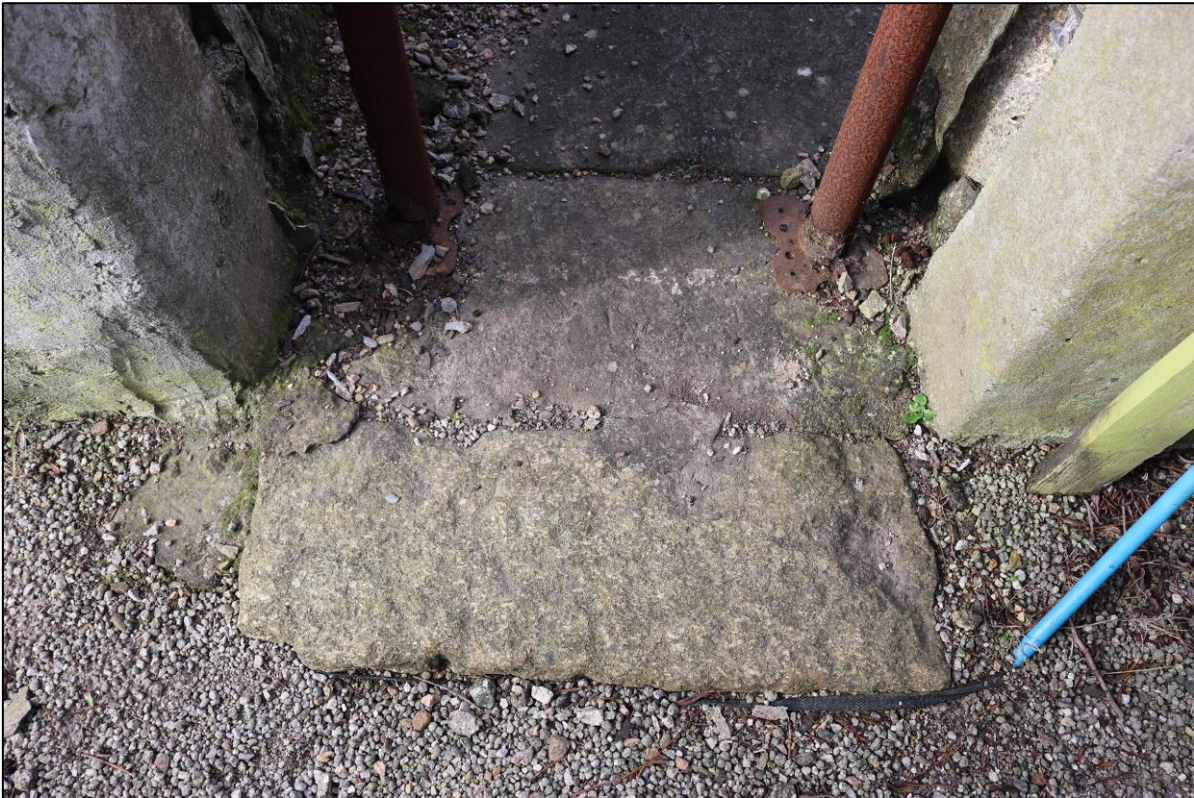
9. GRANITE THRESHOLD FOR ABOVE OPENING. MOUNTED WITHIN MODERN LANDSCAPING FABRIC AND LOOSE GRAVEL.

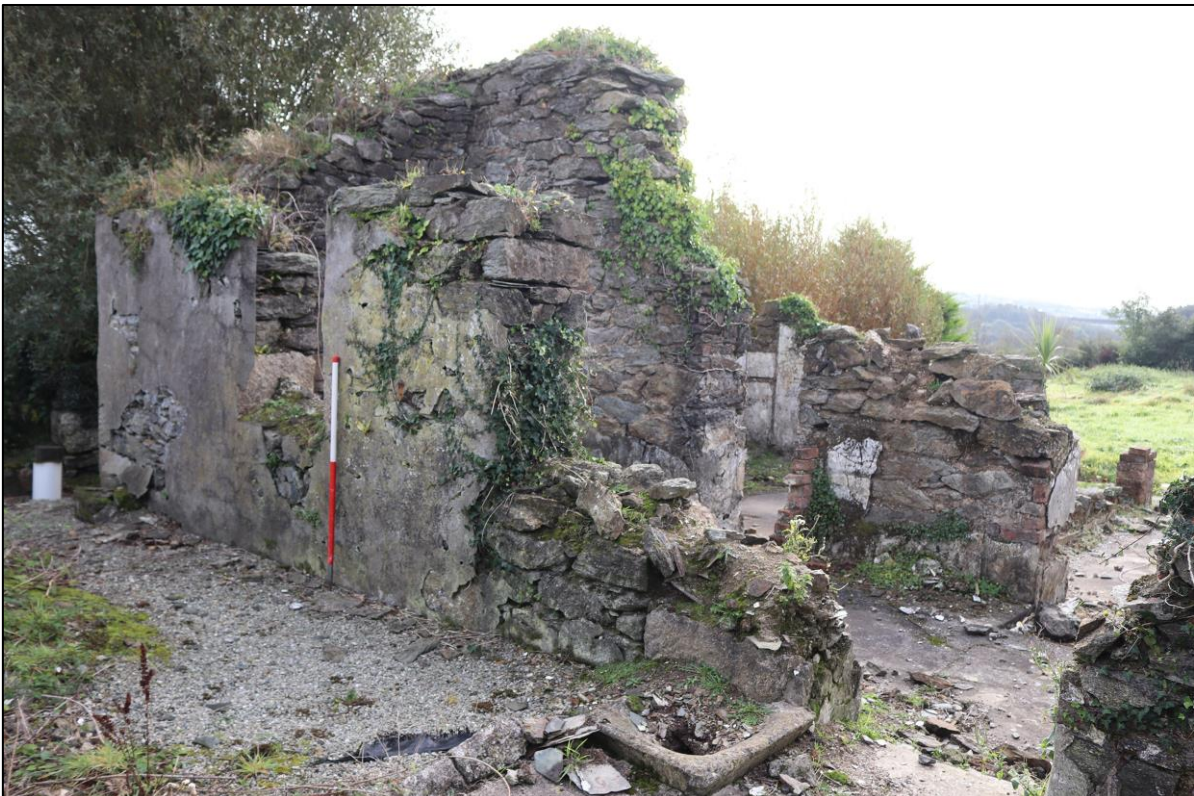
Roof Covering	No roof survives, though the pitch to the east side and evidence of socket holes for split basic a-frame would evidence a shallow mono-pitched roof to this addition supporting the main range.
Opening – Windows:	Definite window to east side, with some quoin detailing under render. Another possible later window, slim and rectangular to east side of rear door.
Openings - Doors	Rear door to small concrete courtyard. Narrow in width, reflects internal forced door for C2. Access for C1 to the east elevation.
Blocked openings:	West block extension: single blocked doorway with rustic timber lintel blocked with killas rubble. The opening to the west side has a few large grey-brown slate blocks acting as quoin detailing.
Drainage/Guttering	Small cement-sloped drain, over brick to the east side of doorway to C2.
Significant Details:	None.
Relationships:	<p>To the east end is a rear lean-to extension, likely initially built much smaller to support the main range. Evidence to the west end of this block suggests it may have been extended later with reused white bricks <i>St Day</i> to support the functions of both cottages. This theory is supported by a possible build line with quoin detailing to the centre of the elevation, just east of C2 courtyard door.</p> <p>This lean-to abuts the main range with forced socket holes to the north of main range and clear internal build lines. The main range has been extended to the west, again clear build lines to the north and south show the west end abuts main range. This west end has been extended again as a possible workshop space to the north, though this area is harder to quantify due to its overgrown present standing.</p>

12. THE NORTH ELEVATION OF LEAN-TO SHOWING SHALLOW MONO-PITCH; FROM THE NORTH-WEST WITH 1M SCALE.

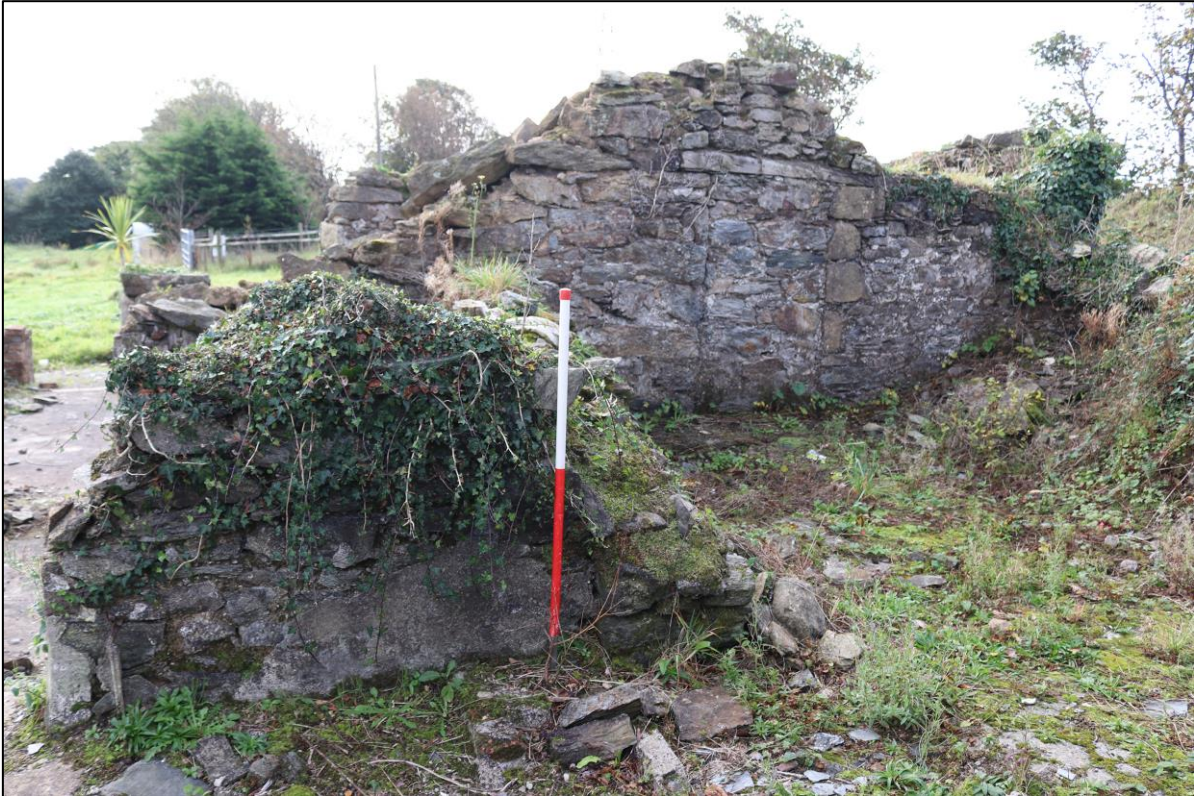
The north elevation of the extended western block included a central blocked doorway. This blocked opening still retained its rustic timber lintel and had been blocked with killas rubble and lime mortar. The opening did not exist with any distinct detailing, aside from a select few slate blocks, used for quoin dressing to the east side. This end of the elevation was much the same as the east lean to, built using killas rubble, though unrendered, and lime mortar repointing was clear above a dark red-brown earth mortar.

15. THE NORTH ELEVATION OF WEST BLOCK WITH BLOCKED DOORWAY; FROM THE NORTH WITH 1M SCALE.

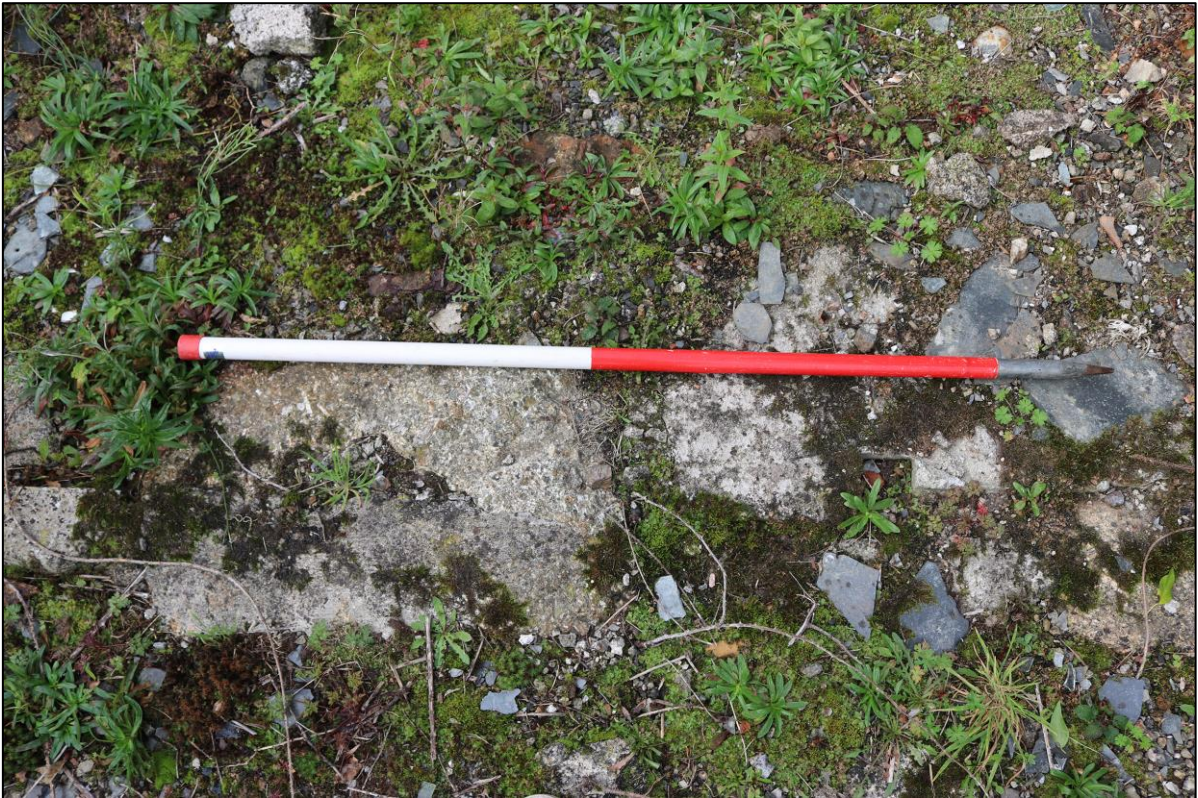
19. SCREED WRAPPING SOCKET TO THRESHOLD OF NORTH WEST EXTENSION.

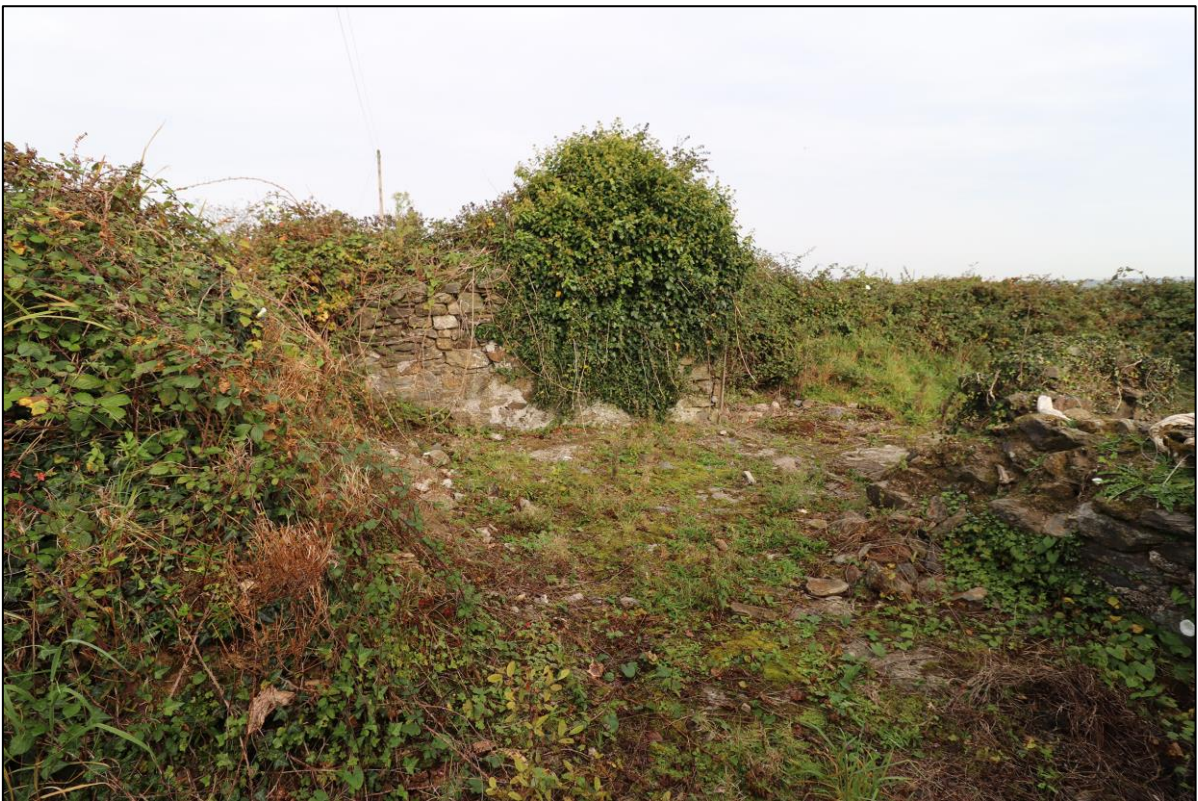
<p>GF space north extension to west end comment on fabric surviving:</p>	<p>This space is a little harder to make out. Wall to the far north is overgrown but had been heavily rendered. Floor very uneven with lots of disturbance, broken pottery and pipe found. Square socket holes to the threshold to the east showed a possible narrow opening/ or split door opening akin to those for garages. Blocked opening the the rear of the west extension block, complete with rustic timber lintel and a few large slate blocks mimicking quoin dressings the west side.</p>

20. THE NORTH WALL OF NORTH WEST BLOCK; FROM THE SOUTH TAKEN WITH WIDE-ANGLED LENS.

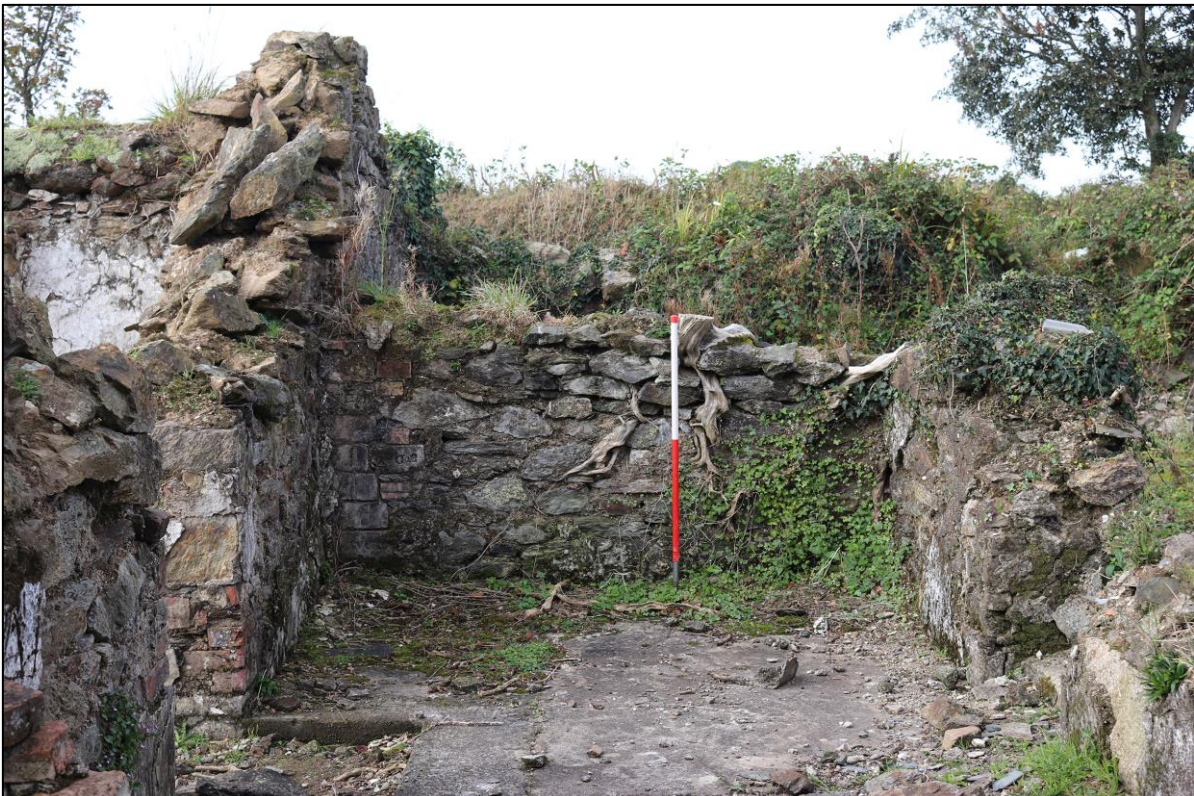
22. THE WEST OF THE LEAN-TO BUILT WITH BRICK TO THE CORNER NOT SEEN ELSEWHERE TO MASONRY, THICKNESS WALL TO THIS END DIFFERED FROM THE EAST. FROM THE EAST WITH 1M SCALE.

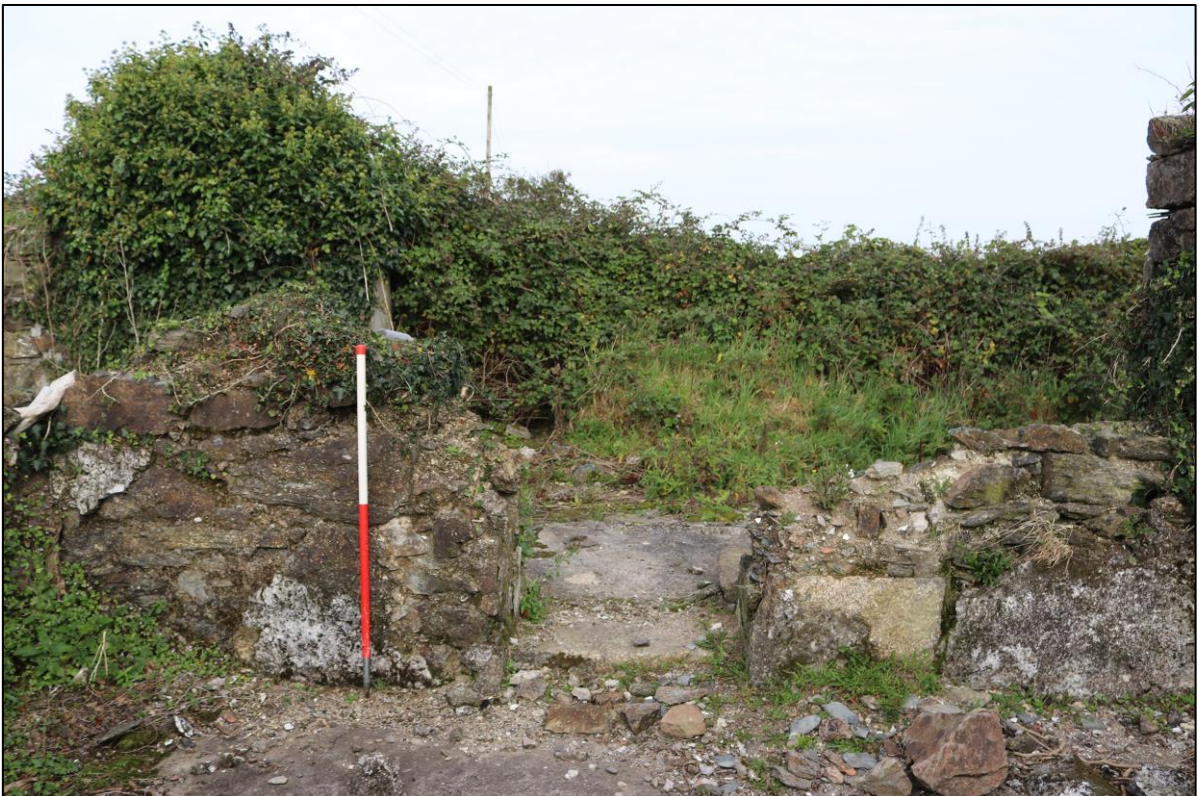
24. EXTERNAL OPENING FOR C2 IN NORTH WALL. FROM THE SOUTH WITH 1M SCALES.

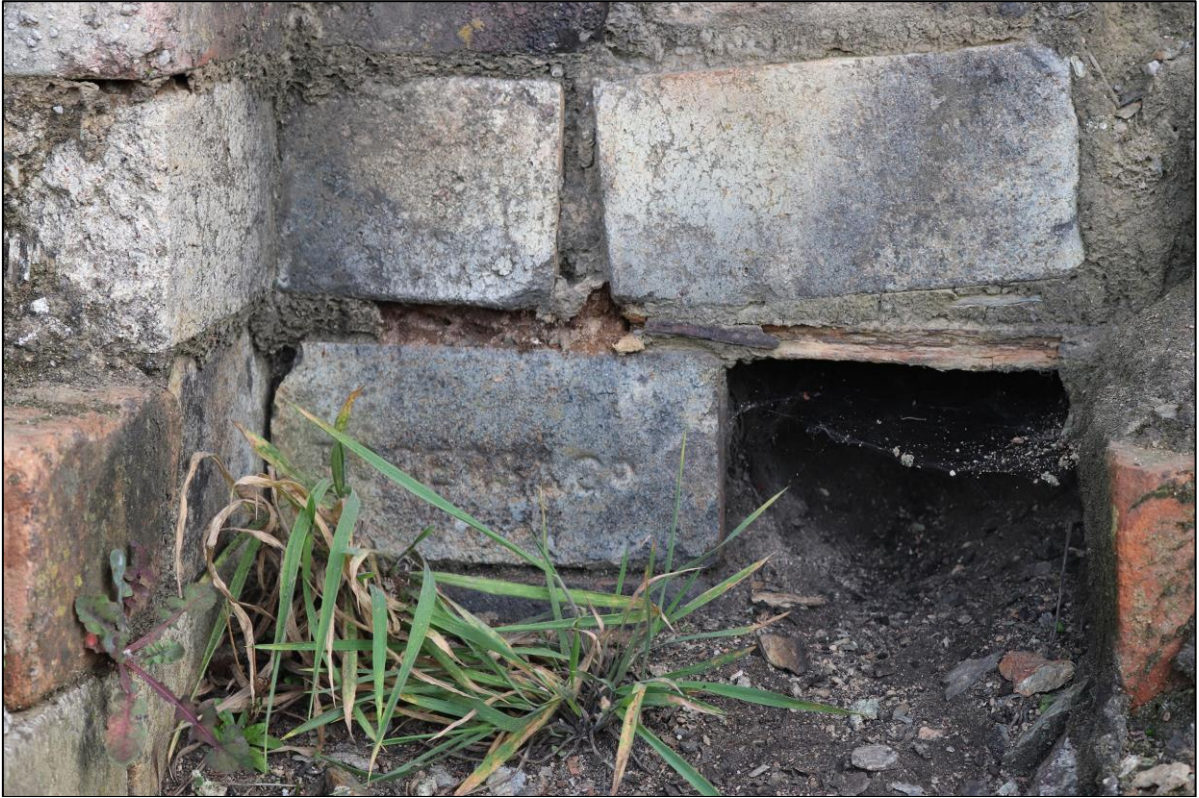
31. THE ROGER & CO BRICK SEEN TO ALTERATIONS MADE TO FIREPLACE. FROM WEST.

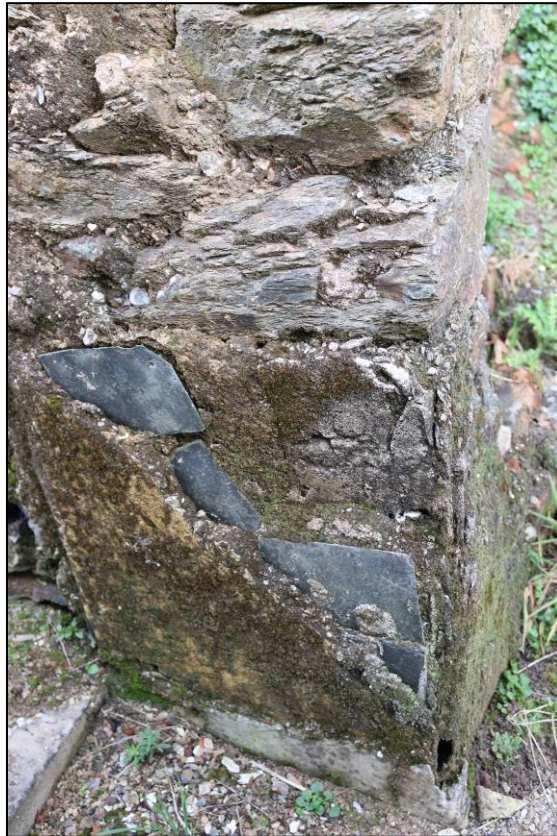
35. THE REUSED SLATES SEEN UNDER INTERNAL RENDERING.

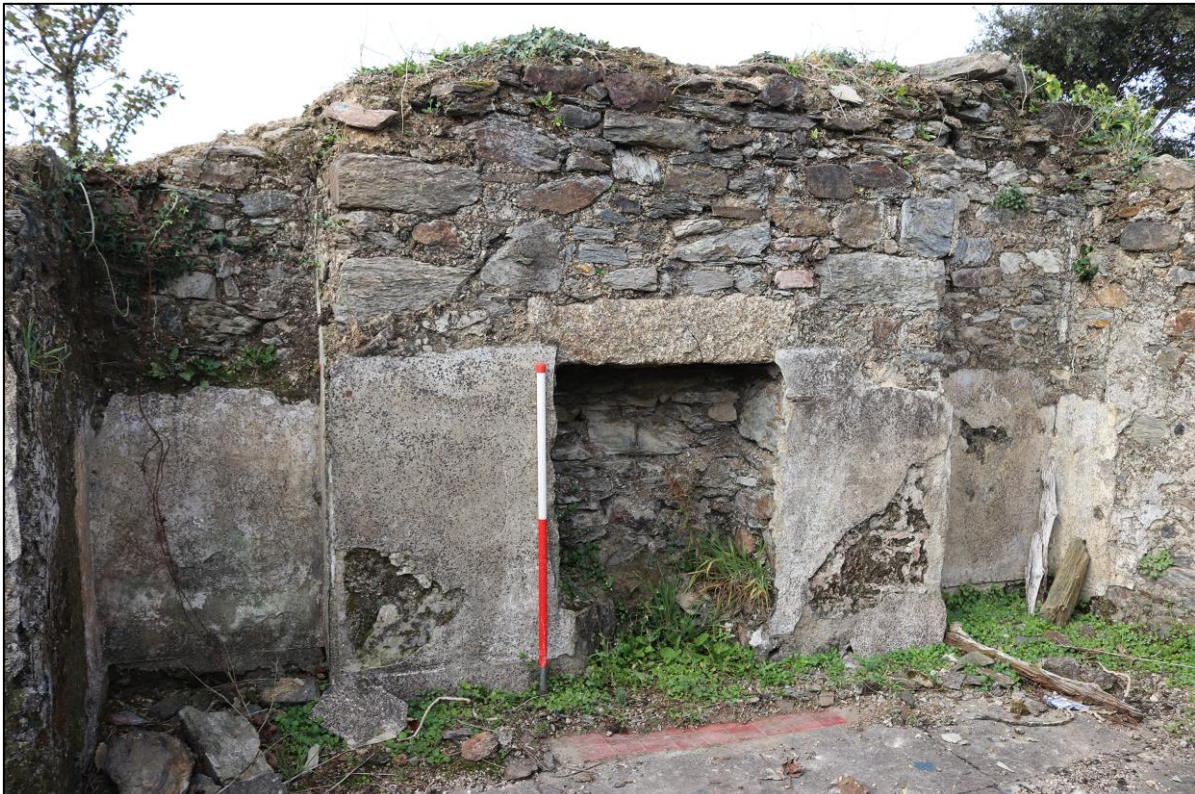
It is clear from the external south elevation this end of the building abuts the former main range. It is a single room space, and much smaller than that to C1/ C2, likely only built to extend C2. To the west elevation is a small, projecting stack, rendered to both sides, though a small granite lintel is exposed. The fireplace has been altered and reduced with angled cement splays to fit a small burner. This stack included small glazed red quarry tiles set into cement floor acting as a decorative threshold of mid-20th century design.

36. THE PROJECTING STACK TO WEST BLOCK; FROM THE EAST WITH 1M SCALE.

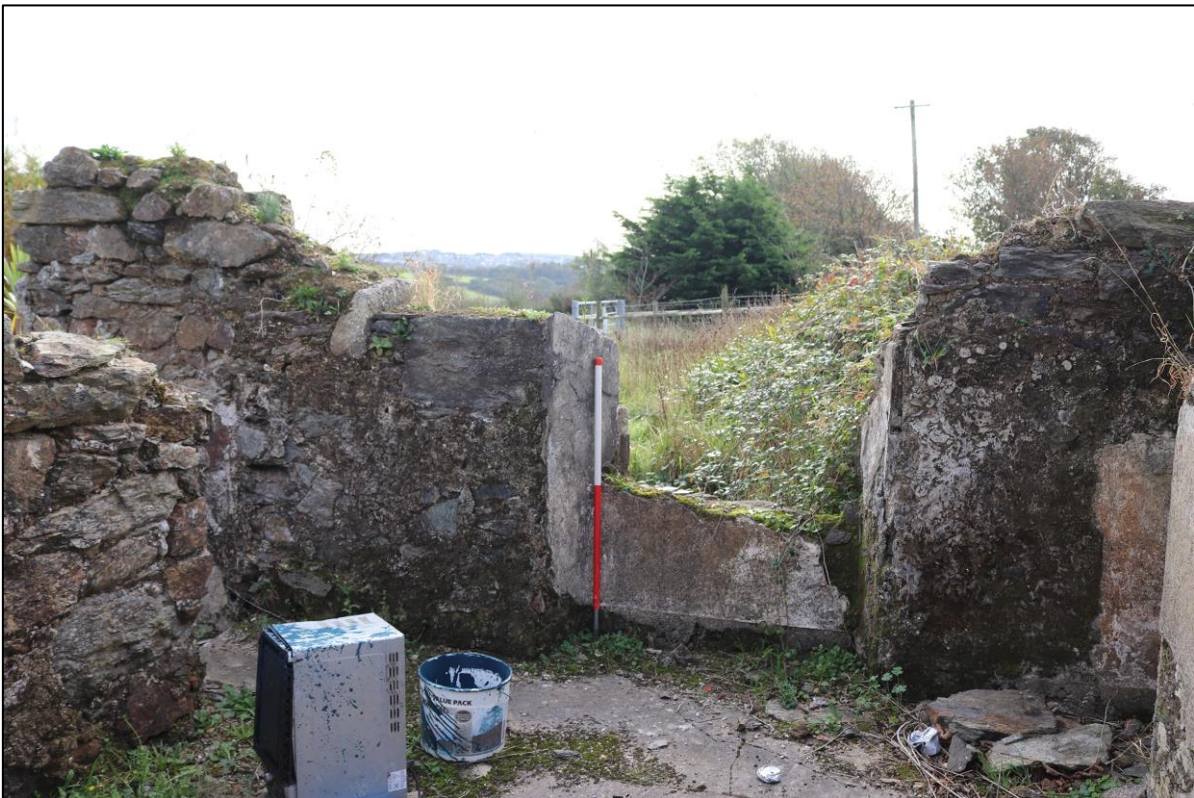
38. THE POSSIBLE BLOCKED DOOR NOW WINDOW TO SOUTH ELEVATION OF WEST BLOCK; FROM THE NORTH WITH 1M SCALE.

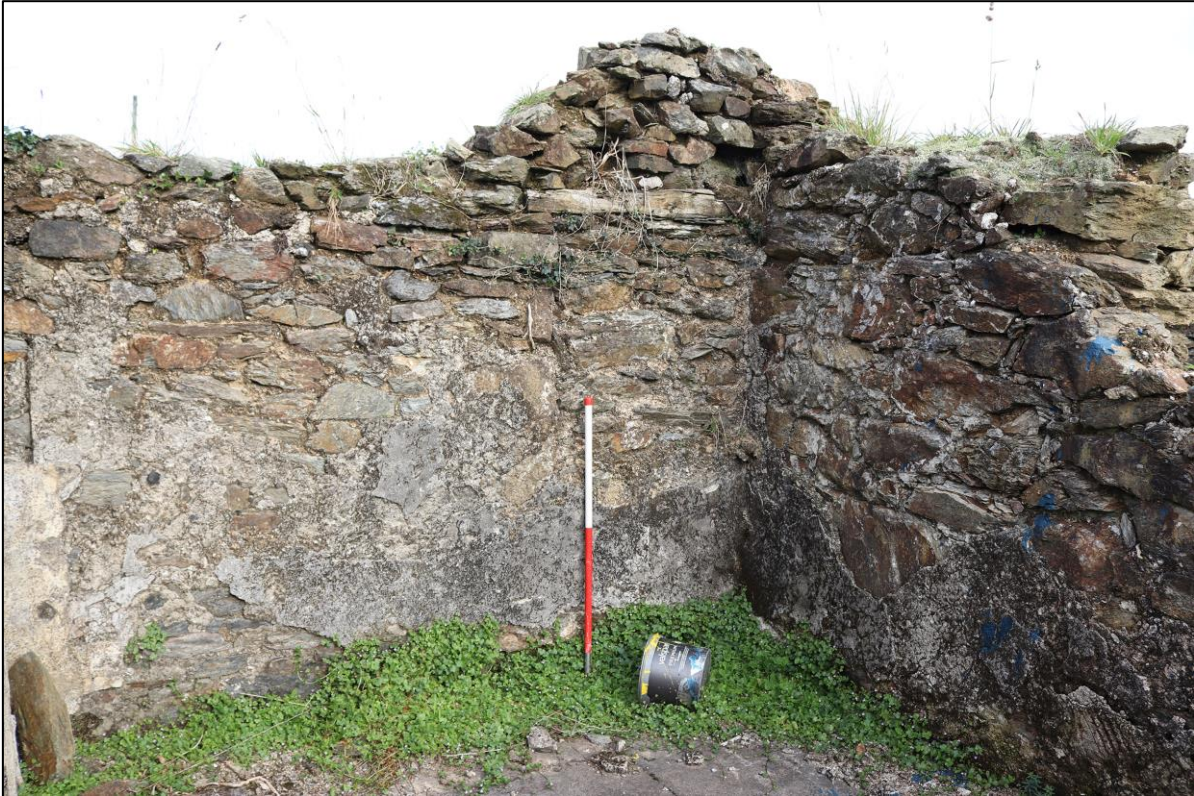
39. THE NORTH AND EAST ELEVATION OF WEST BLOCK SHOWING BLOCKED OPENING, FROM THE SOUTH-WEST WITH 1M SCALE.

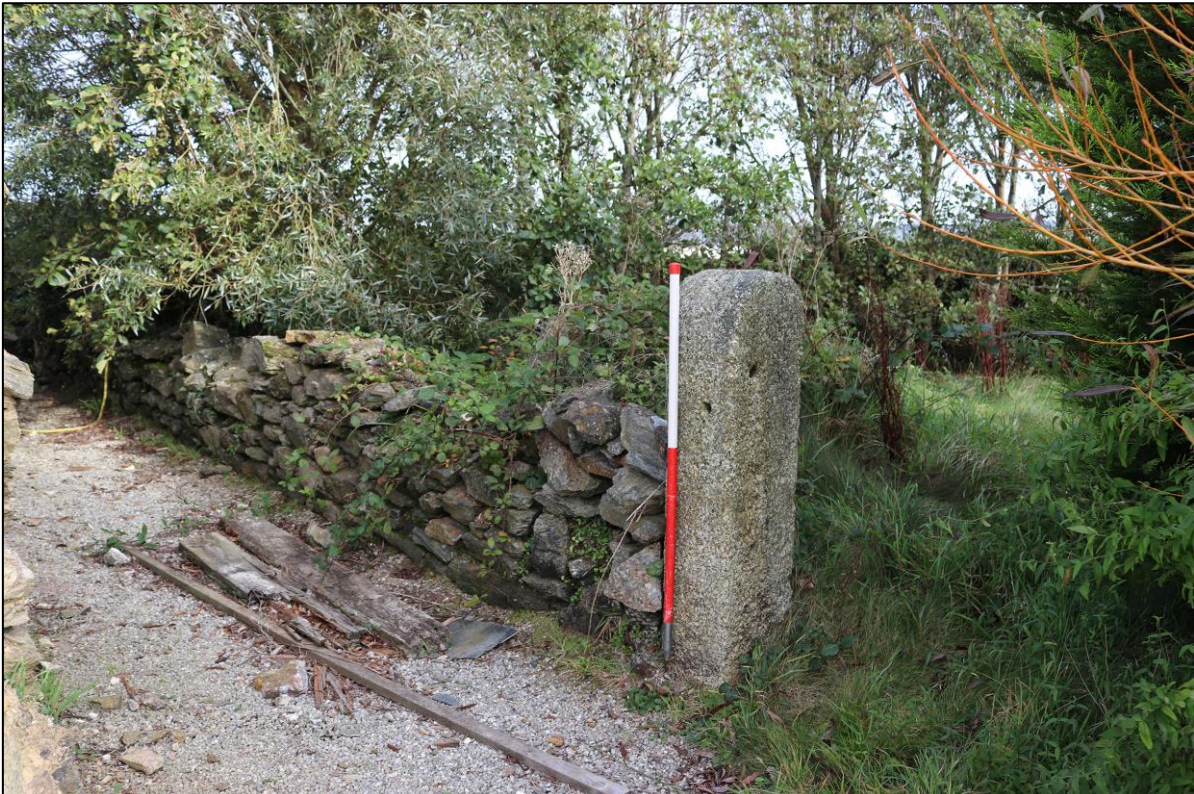
40. REUSED GRANITE POSTS FORMING ENTRANCE TO HOUSE GARDEN TO EAST, FROM THE SOUTH-WEST WITH 1M SCALE.

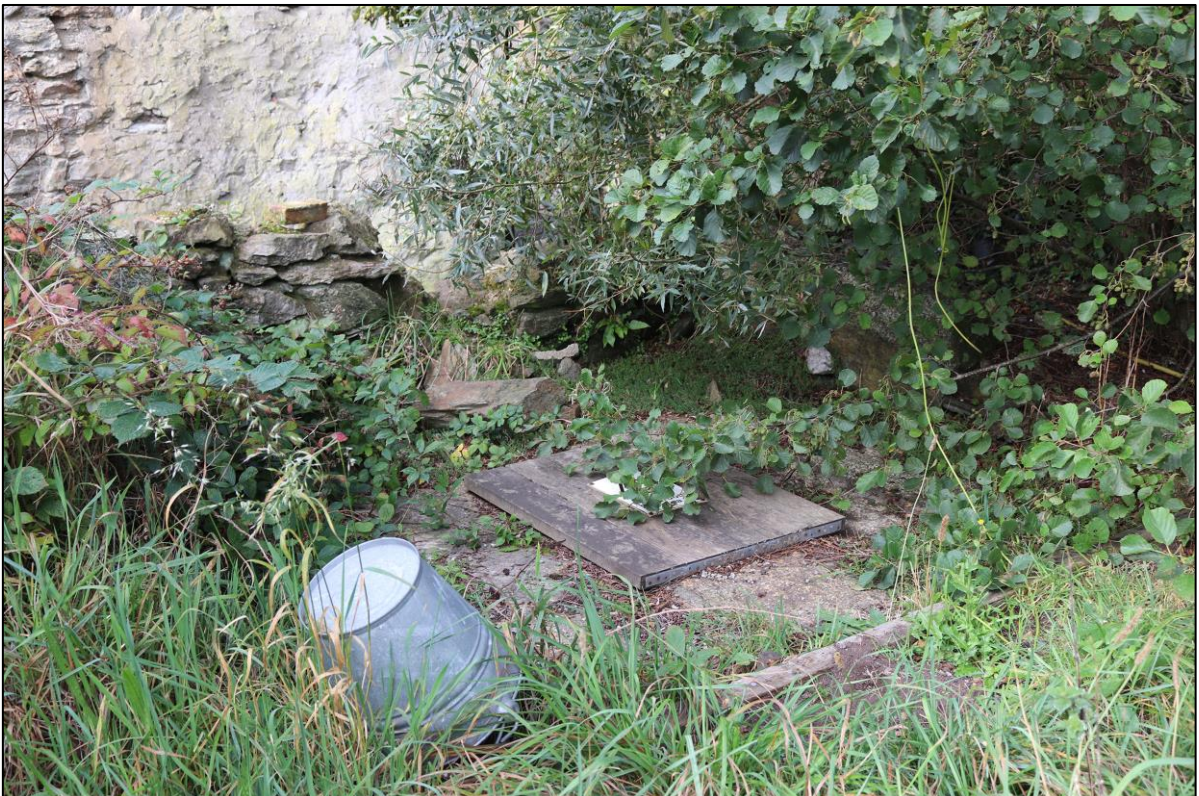
42. THE BOARDED UP WELL TO THE NORTH-WEST CORNER OF GARDEN; FROM THE SOUTH- EAST.

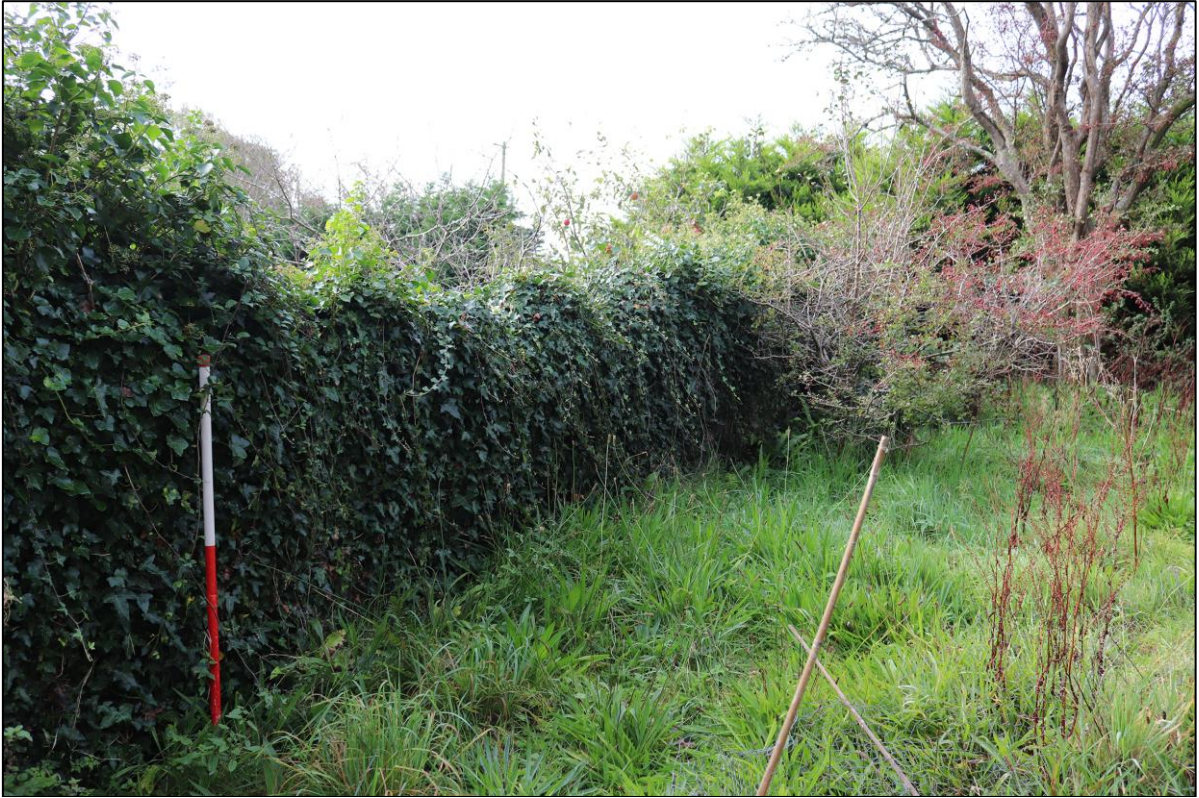
43. THE SOUTH RUBBLE WALL OF GARDEN OVERGROWN, FROM THE EAST WITH 1M SCALE.

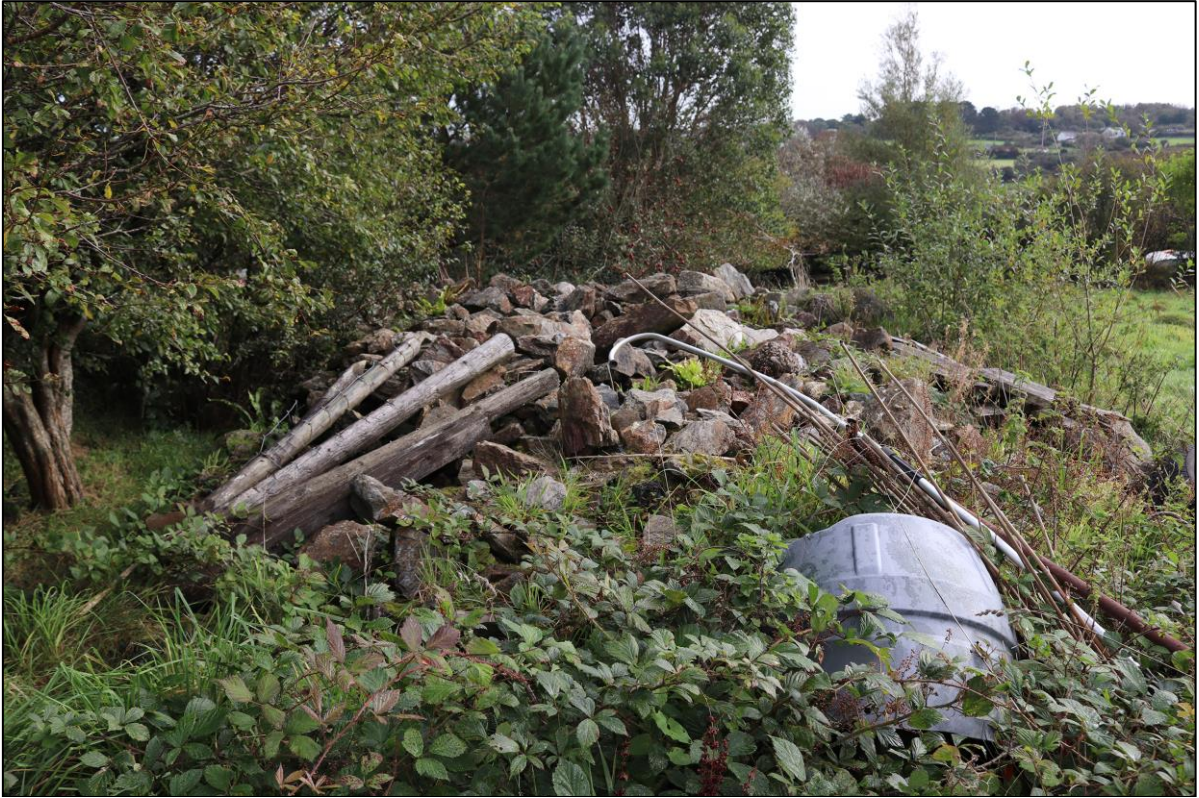
53. MOUND OF KILLAS AND GRANITE RUBBLE SEEN TO THE SOUTH-EAST CORNER OF THE GARDEN. FROM THE WEST.
