North Hooe Mine, Bere Alston, Devon

Historic Building Recording

Executive Summary

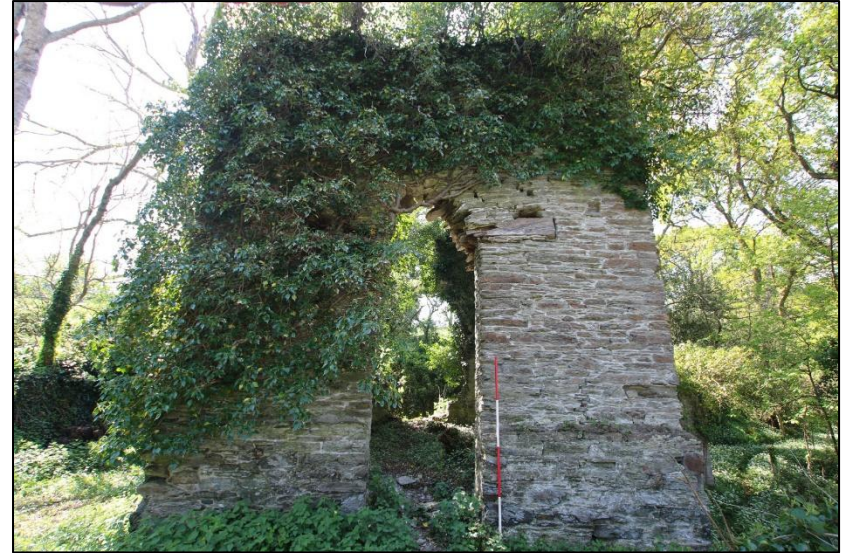
FIGURE 14: THE NORTH-EAST ELEVATION (BOB WALL); FROM THE NORTH-EAST (SCALE 2M).

The north-east facing elevation contains the central plug door; this was originally c.3.4m high, externally 1.3m wide, 1.85m wide to the splayed interior. The base has been broken down by c.0.15m. The heavy squared (0.3m) timber lintels, which extend 1.1m to the left and 0.95m to the right of the opening, have failed and the stonework above, to both external and internal face, has failed and dropped. To the right and slightly above the plug door is a shallow very shallow socket, cut back into the face of the stonework.

The engine house is in poor and declining condition. The principal issue is the failure of the timber lintels over the openings, which has led to the partial or complete collapse of the masonry above. It appears likely this has been aggravated by deliberate intervention (i.e. the loss of the walls above bob height, and steam pipe opening). The solution is fairly straightforward: the careful removal of vegetation, the replacement of lintels, and the consolidation and partial reinstatement of the stonework.

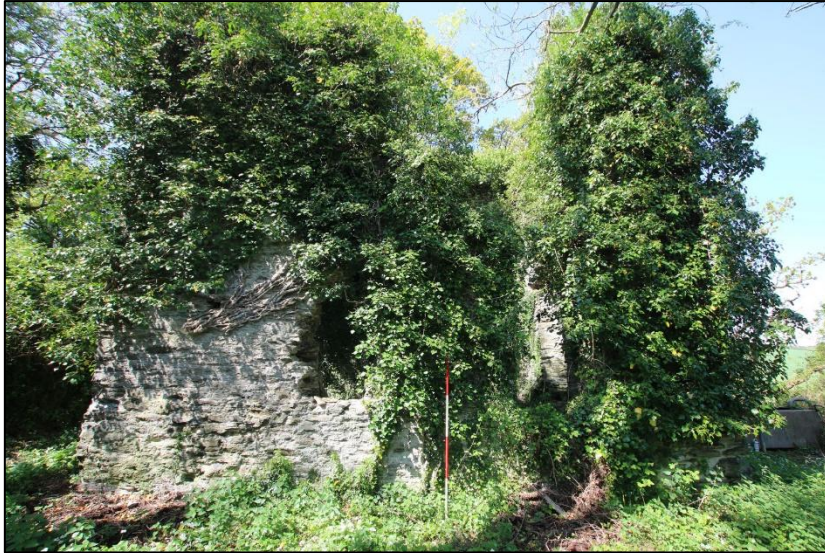
FIGURE 15: THE SOUTH-EAST ELEVATION; FROM THE SOUTH-EAST (SCALE 2M).

The south-east facing elevation adjoined the boiler house. The east end of the elevation is the boiler door, 1.12m wide and c.2.25m high, above which the stonework has been lost. The splay of one side of a window is just visible at first-floor level; the combination of a failed boiler house door with a window above explaining why this section of the wall has failed, and why the corresponding section in the north-west elevation has survived. There is a second ground-floor opening, originally c.0.5m square for the steam pipe, but this has been deliberately and crudely expanded, both above and below, perhaps in an abortive attempt to mimic the facing window opening in the north-west elevation; the opening is now 2.07m high and up to 1.28m wide. There are at least five sockets for joists in this elevation; the two larger sockets are at a level just below the window and carried the roof of the boiler house. To the west corner there are three iron pegs and a hinge driven into the stonework.

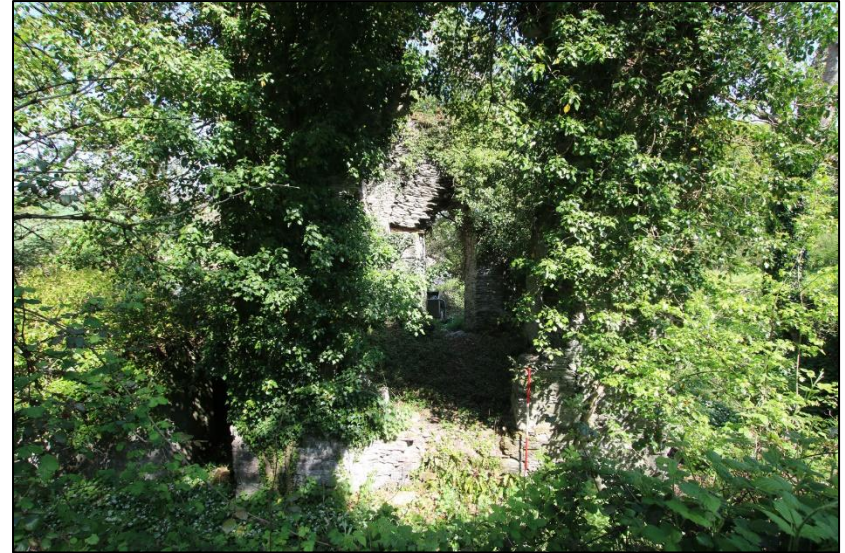
FIGURE 16: THE SOUTH-WEST ELEVATION (CYLINDER DOOR); FROM THE SOUTH-WEST (SCALE 2M).

The south-west facing elevation contained the cylinder door. It is likely this also had a flat timber lintel, as all the stonework above the opening has collapsed. The cylinder door was 1.95m wide with a base c.1m above the external ground level. The level of its threshold has since been reduced by c.0.25m. To the south side of the opening the slot for a short length of timber lacing is visible. At first-floor height, the west splay of a central window is visible in the surviving stonework.

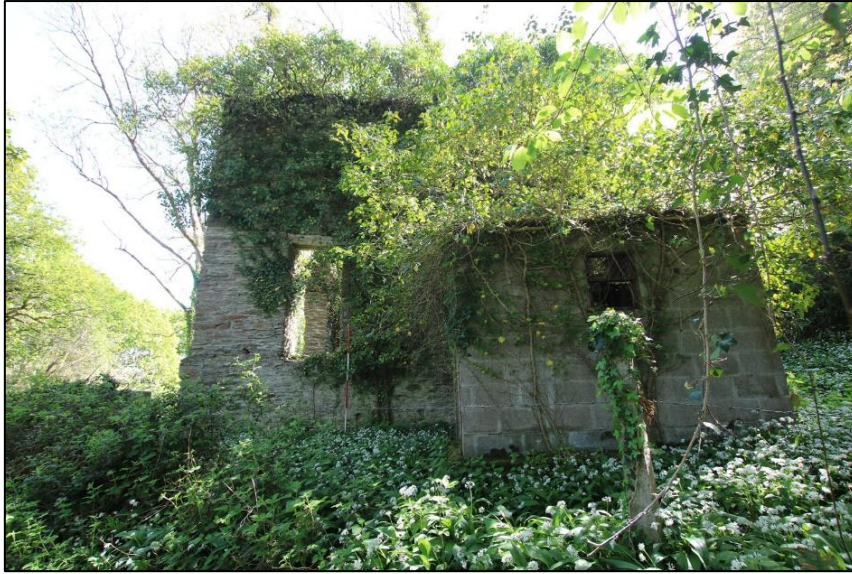
FIGURE 17: THE NORTH-WEST ELEVATION; FROM THE NORTH-WEST (SCALE 2M). THE BUILDING IN THE FOREGROUND IS THE C20 PUMP HOUSE.

The north-west facing elevation contains two openings at plinth level: a doorway 1.1m wide and 2.26m high, with surviving timber lintel, opposite the boiler house door; and a tall, narrow window 0.64m wide and 1.99m high, with a tight segmental slatestone arch. The lintel is failing and the stonework above the lintel is dropping. The window lacks an internal splay, so it is possible the doorway is actually a window, as the opening opposite the boiler house door tends to be (note the first-floor windows and the plug door *are* splayed to the interior). Otherwise, there are four joist sockets in a line just above the plinth, two with traces of decayed wood, and a fifth joist socket is visible at first-floor level at the southern end of the elevation.

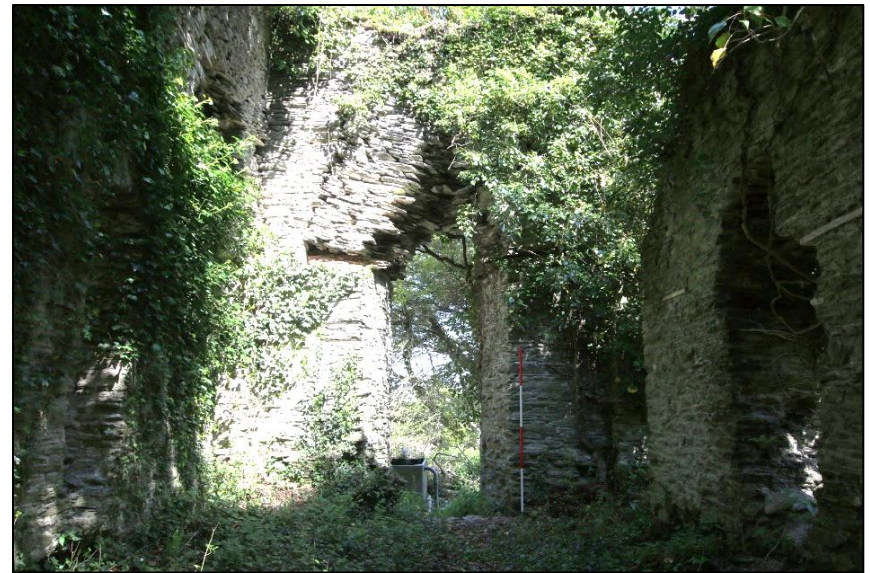
FIGURE 18: THE INTERNAL ELEVATION OF THE NORTH-EAST WALL; FROM THE SOUTH-WEST (SCALE 2M).

Unsurprisingly, the internal elevations reflect the layout of the exterior, with the following additional notes. In the north-east wall an extensive section of stonework around the plug door has dropped and partly fallen out. The south-east wall steps back slightly at first-floor level, with two large joist sockets to the south side. Some short lengths of timber lacing are visible. At the base of the wall, along most of its length and up to c.0.3m high, the stonework is rather ragged. The south-west elevation has two large joist sockets at first-floor height, abutting the joining walls. The north-west elevation again steps in slightly at first-floor level, with two large joist sockets to the southern end matching those in the opposing wall. There is again timber lacing, and the stonework over the doorway has lost its internal face. At the base of the wall, along most of its length and up to c.0.3m high, the stonework is rather ragged.

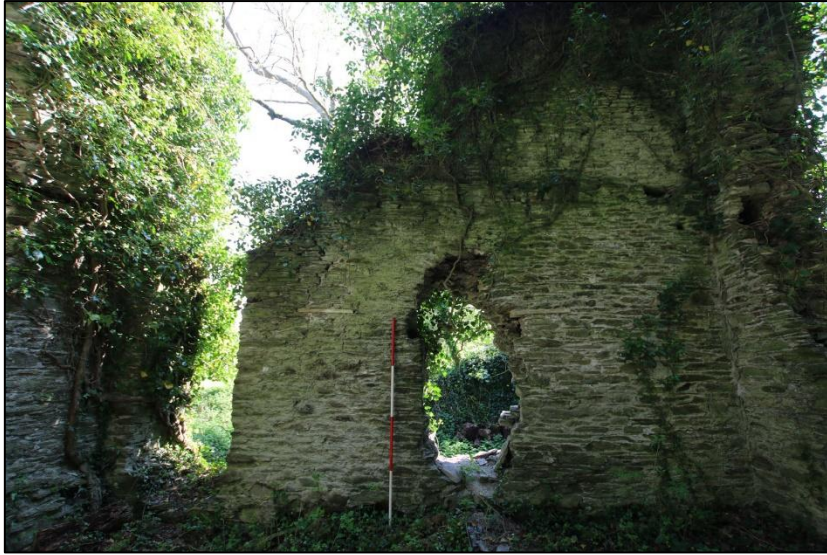
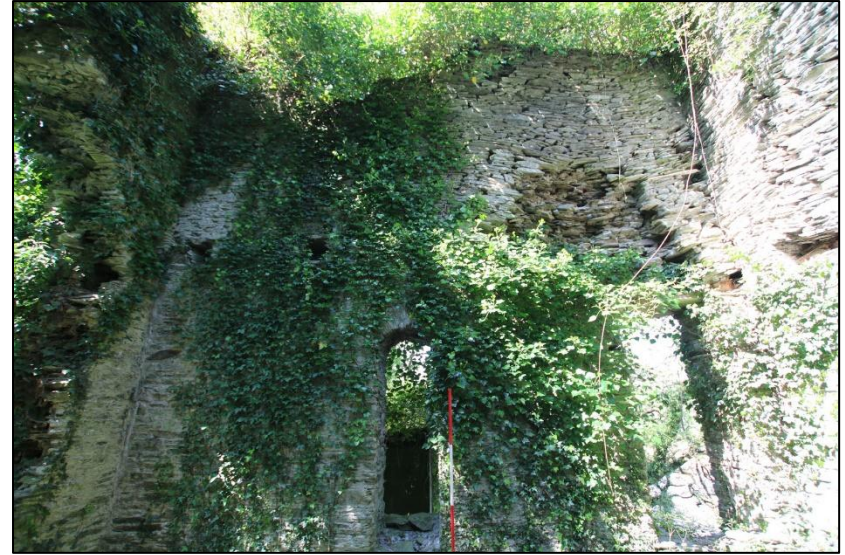
FIGURE 19: THE INTERNAL ELEVATION OF THE SOUTH-EAST WALL; FROM THE NORTH-WEST (SCALE 2M).

FIGURE 21: THE INTERNAL ELEVATION OF THE NORTH-WEST WALL; FROM THE SOUTH-EAST (SCALE 2M).

The cataract pit has been infilled and – if the ragged stonework to the base of the north-west and south-east walls is any guide, the driver's floor has been reduced in height by c.0.3m. The lack of rubble to the interior, despite the reduction in the height of the engine house and the evident loss of stonework, particularly to the south-east elevation, would suggest the interior has been cleared, perhaps more than once. (The rubble may have found its way into the balance-bob pit?)

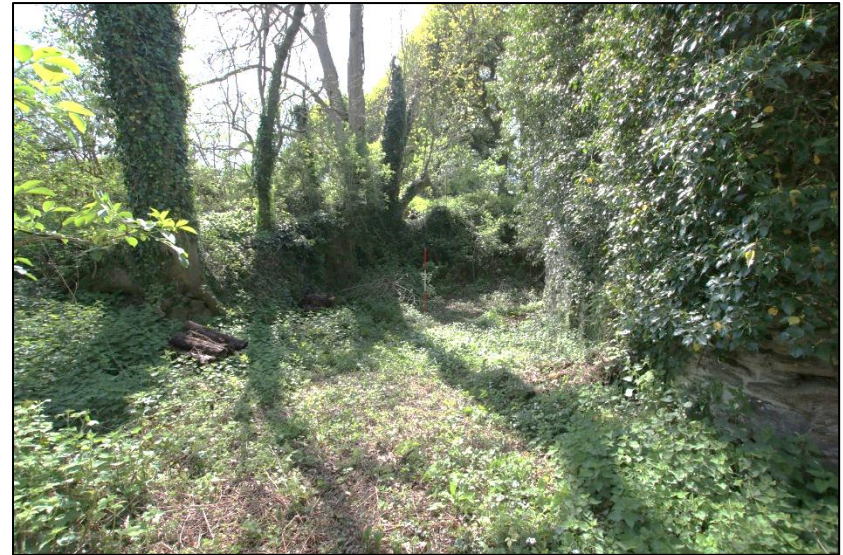
Not much remains of the boiler house; it is in poor but stable condition. Its surviving fragment of wall and the entrance to the flue should be cleared of ivy and consolidated.

FIGURE 25: THE ROCK-CUT TERRACE FOR THE BOILER HOUSE; FROM THE NORTH-EAST (SCALE 2M).

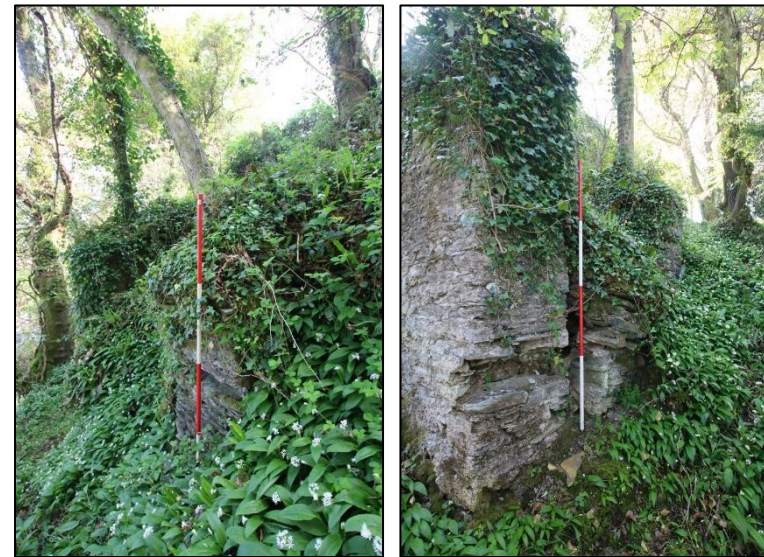
The walls of the balance bob pit are in fair and stable condition, though the loss of the timber lacing should be corrected. The battered fragment of wall abutting it to the east is in poor but stable condition. Again, these walls should be cleared of vegetation and consolidated.

LEFT FIGURE 28: THE WESTERN BALANCE BOB PIT WALL; FROM THE WEST (SCALE 2M).

RIGHT FIGURE 29: THE EASTERN BALANCE BOB PIT WALL; FROM THE NORTH (SCALE 2M).

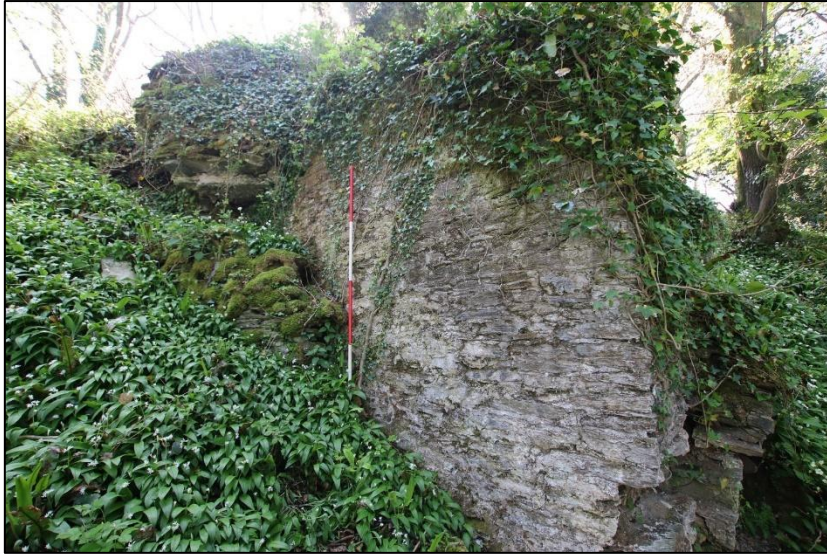
The eastern wall, due to the fall of the ground and the angle of the slope, is 3.1m tall, and its north-eastern face is visible running c.4.7m back into the hillside. 2.1m below the top of this wall is another horizontal slot running the width of the wall and 0.2×0.2m across. Built up against the north-east face of the eastern balance bob wall, and 2.3m back from the end of the wall, is a battered section of walling that abuts it at a c.45° angle. The lower face of this wall has been lost; the loss being either from erosion of the slope below it, or perhaps due to a missing timber element.

FIGURE 30: THE SIDE OF THE EASTERN BALANCE BOB PIT WALL; FROM THE NORTH (SCALE 2M).

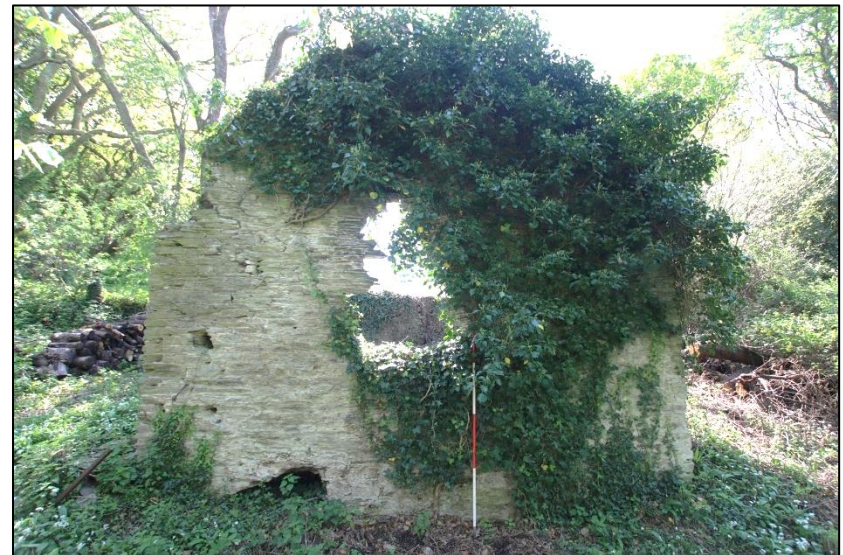
The south gable survives to first-floor height, and to the west side the internal face has been collapsed. The north gable survives to full height, though swathed in ivy. There is a central window with missing timber lintel, what survives presenting as a ragged hole c.1m across and c.1.8m high. The loss of both reveals and the sill would imply this was deliberately – and crudely – widened. To the east of the window are two sockets (putlogs?), the upper one blocked. Below, and below the internal floor level, there is another irregular forced opening c.1.0m wide and c.0.45m high, of unknown purpose (for bringing something – pipework? – into the building?).

FIGURE 33: THE NORTH GABLE; FROM THE NORTH (SCALE 2M).

The walls of the smithy are in poor and declining condition, again partly, it would seem, through deliberate intervention (in the 1900s?). The walls should be cleared of vegetation and consolidated.

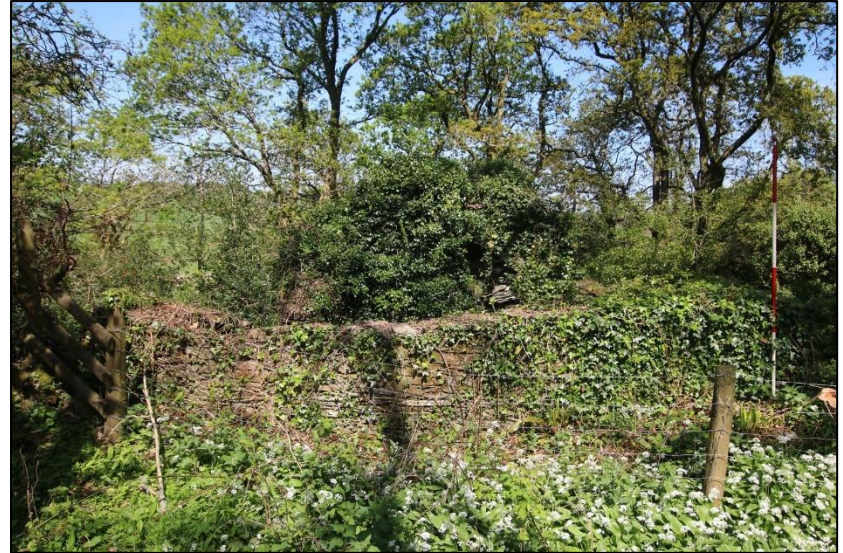
FIGURE 36: THE SOUTH GABLE WALL; FROM THE SOUTH (SCALE 2M).

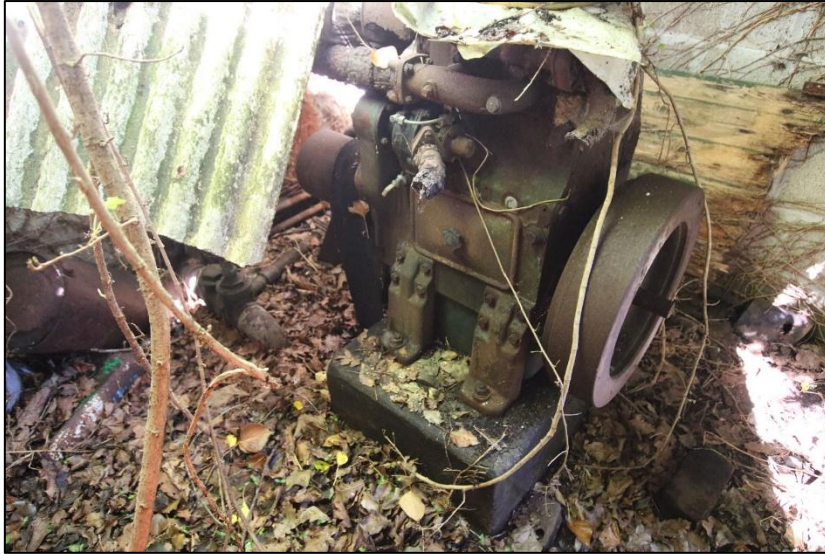
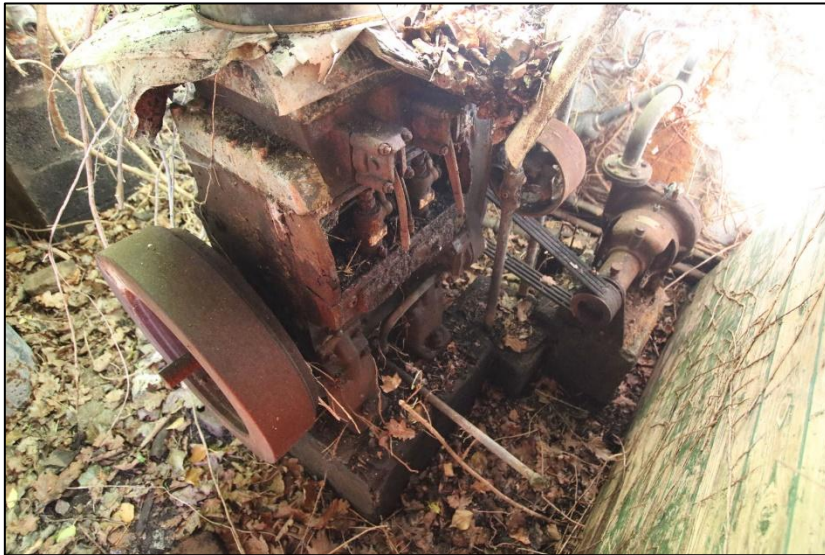
FIGURE 47: THE LISTER ENGINE; FROM THE SOUTH (NO SCALE).

FIGURE 48: THE LISTER ENGINE AND WORTHINGTON-SIMPSON PUMP; FROM THE SSE.

The walls of the structure are sound, but the roof has collapsed into the building, affecting the machinery inside. As and when the roof is made sound, the building could be considered in fair and stable condition.

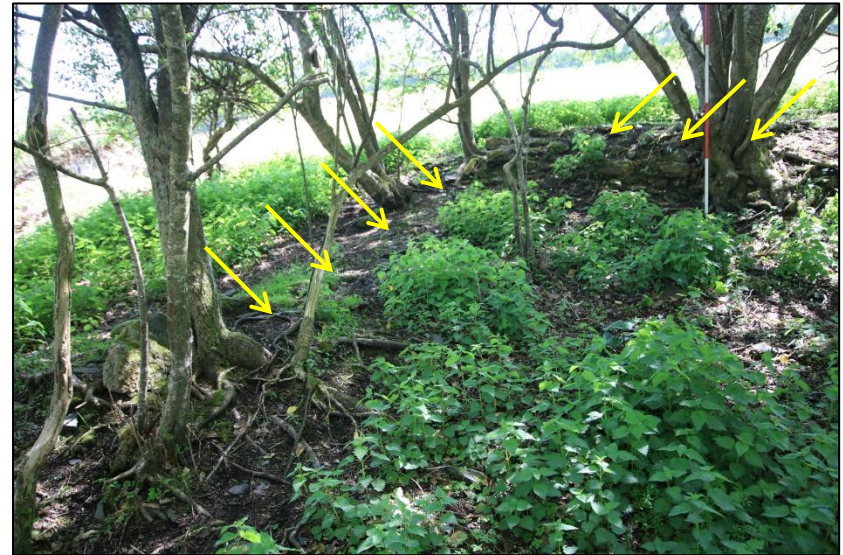
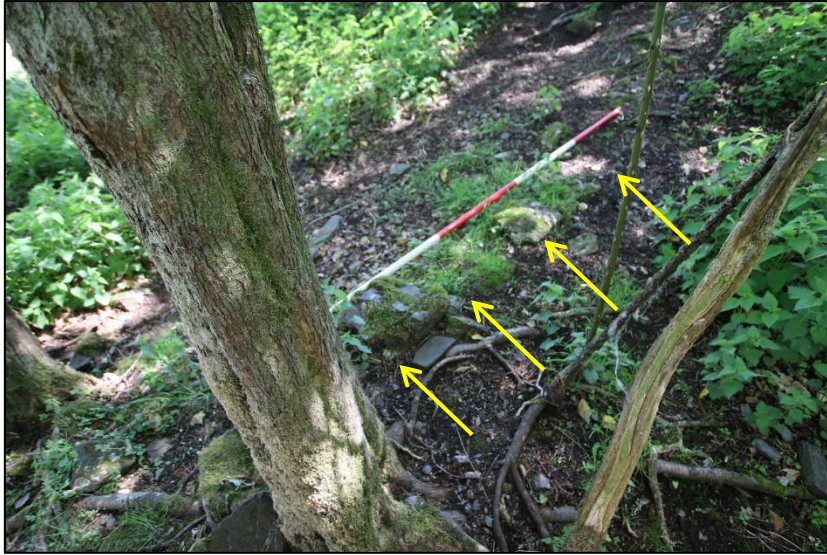
The crusher house has been almost totally lost; only its terrace and a short section of wall survive, the rest as a buried archaeological feature. The surviving visible fragments of wall are in poor condition, but can be considered to be stable, assuming the shrubs/roots are not removed. No interventions are required.

FIGURE 53: THE EAST SIDE OF THE TERRACE, INDICATING THE WALLS; FROM THE NORTH-WEST (SCALE 2M).

FIGURE 54: THE FRAGMENT OF WALL FACING (INDICATED); FROM THE NORTH-WEST (SCALE 2M).

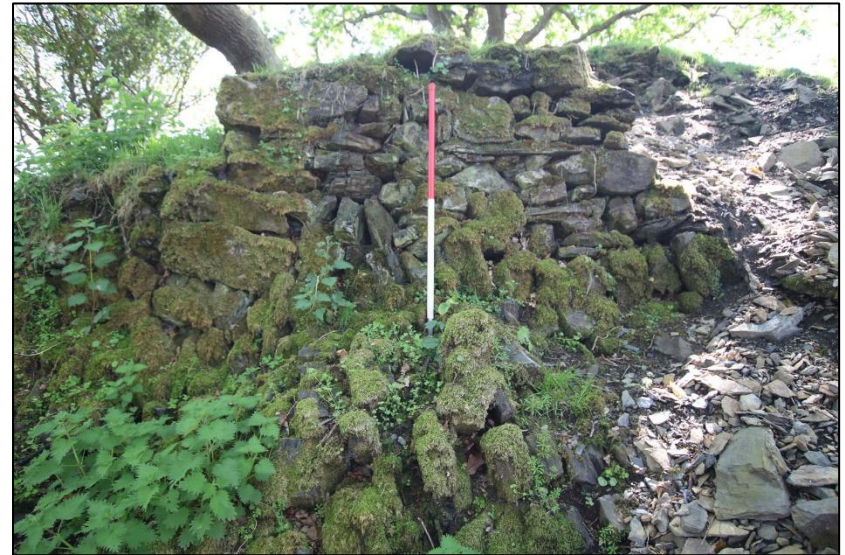
The retaining wall to the north-west has suffered a partial collapse fairly recently and can be considered to be in a poor and declining condition. That structure would benefit from partial rebuilding.

FIGURE 55: THE RETAINING WALL BELOW THE CRUSHER HOUSE; FROM THE NORTH-EAST (SCALE 2M).

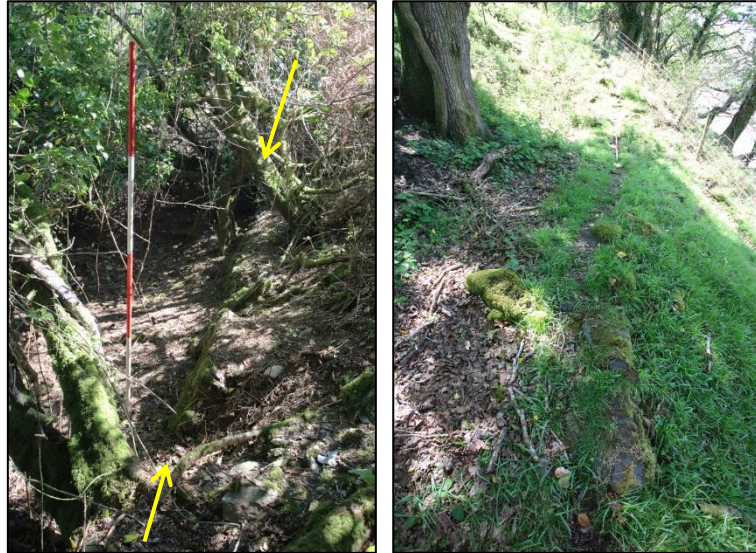
The 1st edition OS map (surveyed 1882) shows a straight boundary (a wall?) and a small rectangular structure to the east of the crusher house. In this approximate location a short length of battered stone wall was identified within the scrub/undergrowth, but it is unclear whether it belonged to the structure, or to the boundary.

LEFT FIGURE 58: THE WALL EAST OF THE CRUSHER HOUSE; FROM THE WNW (SCALE 2M).

This unidentified structure survives as a low retaining wall within an area of scrub. It appears to be in poor but stable condition. No interventions are required.

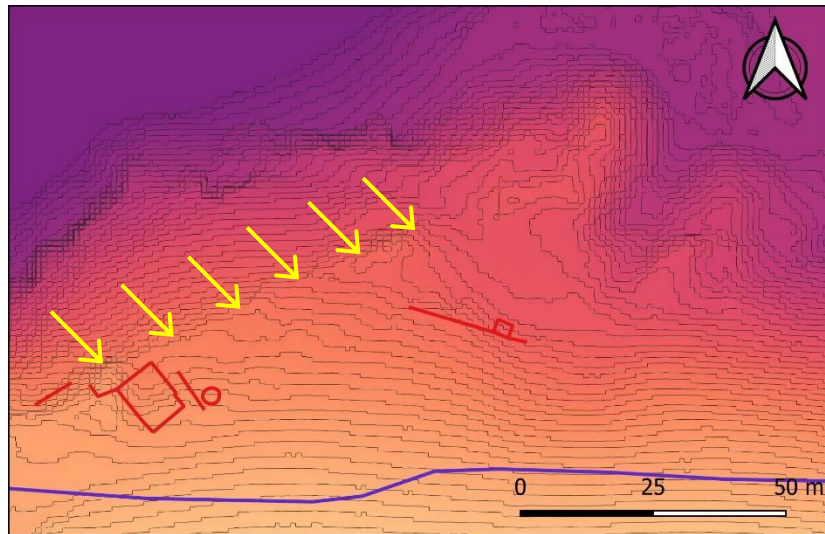
The tramway survives as a linear earthwork with some elements of stonework visible. It can be considered to be in a poor but stable condition. No interventions are required.

FIGURE 61: IMAGE BASED ON 1M DTM LIDAR DATA, SHOWING THE POSSIBLE LINE OF THE FORMER TRAMWAY (DATA USED UNDER THE OGL V3.0). CONTOURS EVERY 0.5M.

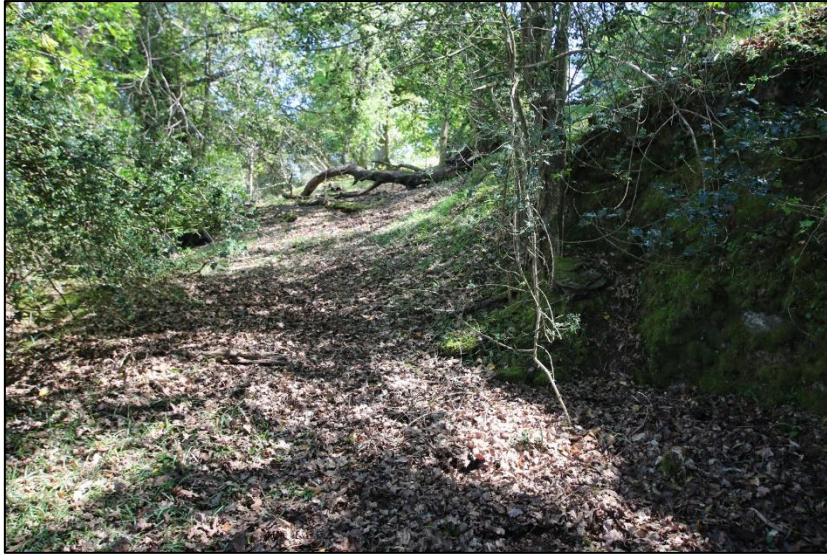
The ramp survives as a linear earthwork with some elements of stonework visible. It can be considered to be in a fair and stable condition. No interventions are required.

FIGURE 63: AS ABOVE; FROM THE WEST, LOOKING BACK UP THE RAMP.

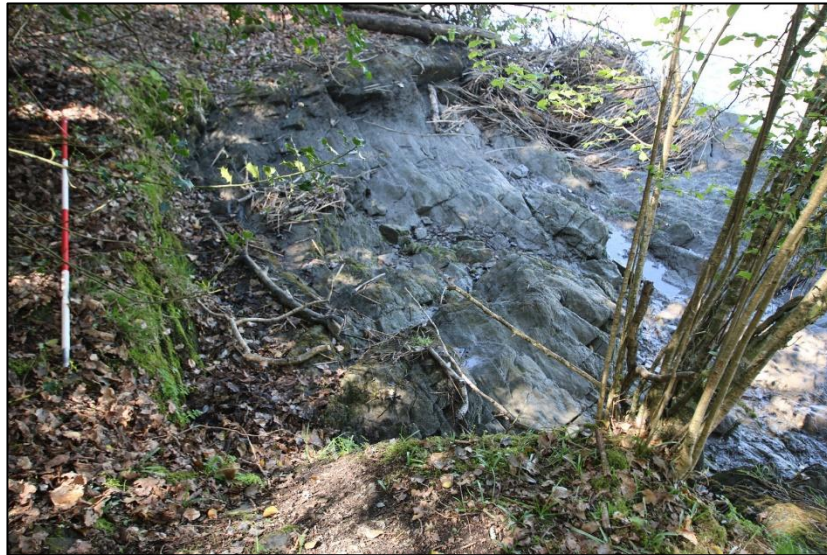
FIGURE 64: THE SUB-RECTANGULAR HOLLOW CUT INTO THE ROCK AT THE BASE OF THE RAMP; FROM THE EAST (SCALE 2M).

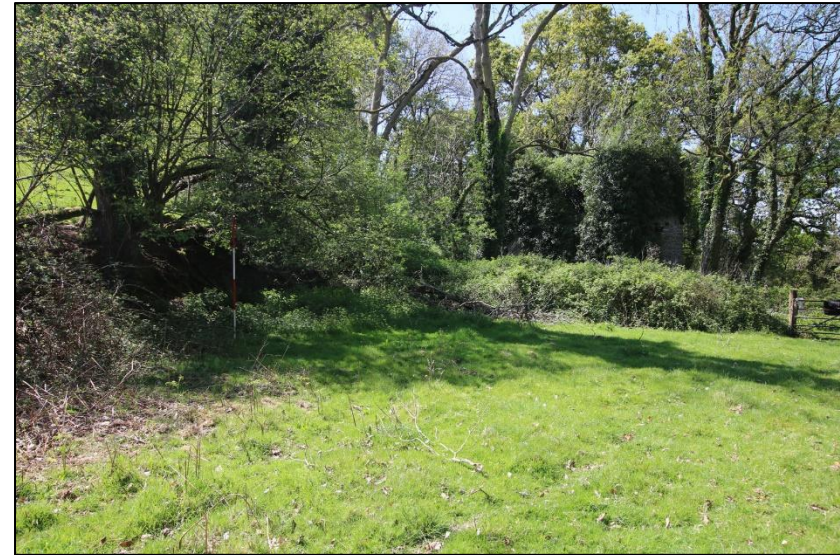
The dressing floors survive as a broad, level spaces cut back into the hillside. They can be considered to be in a good and stable condition. No interventions are required.

FIGURE 66: THE DRESSING FLOOR TO THE EAST OF THE BOILER HOUSE; FROM THE EAST.

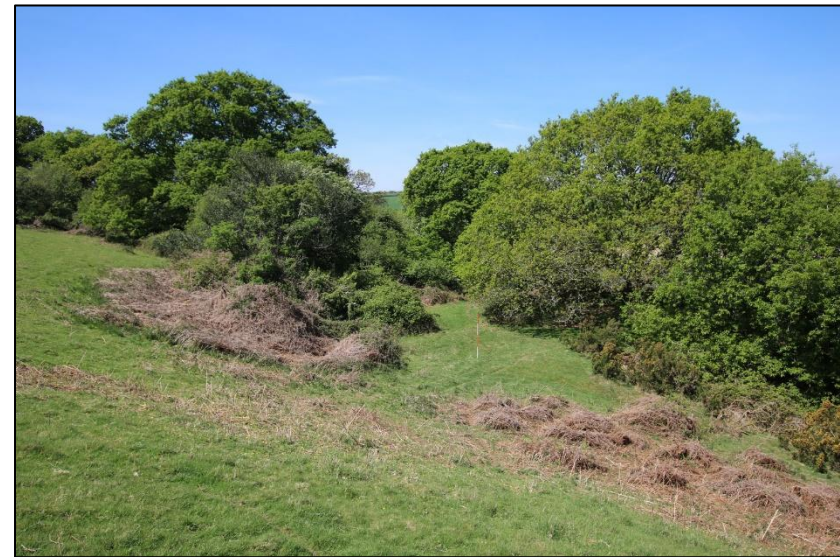
The second main candidate is at the eastern end of the site, above the spoil heaps. This area is more irregular (more opportunistic? or perhaps more damaged?), sub-oval and 18×20m across. The 1949 RAF aerial photographs show this, and the adjacent spoil heap, as devoid of vegetation, so perhaps its current appearance is owed to a later phase of reworking?

FIGURE 67: THE POSSIBLE DRESSING FLOOR ABOVE THE SPOIL HEAPS TO THE EAST; VIEWED FROM THE EAST (SCALE 2M).

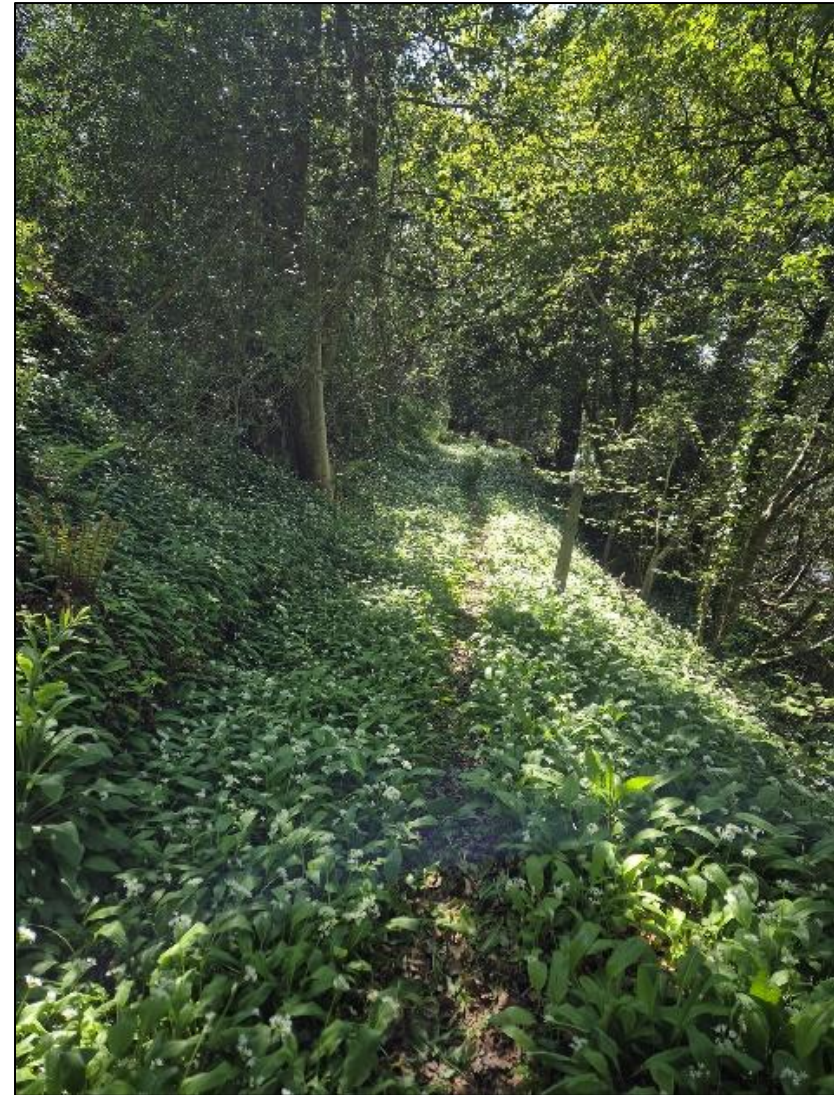
There is now no trace of the leat in the field. To the west of the engine house the course of the leat has been superseded by the access track leading to the mine site. The track is very well defined, c.2.5m wide, and a greater part runs along the line of the contour. Along the southern (upslope) side of the track there are several small quarries (or possibly mineral prospecting? or both?), which presumably provide some of the material needed to build up the trackway.

FIGURE 69: THE ACCESS TRACKWAY; FROM THE EAST (NO SCALE).

The leat (now track) appears to be in good and stable conditions. No interventions are required

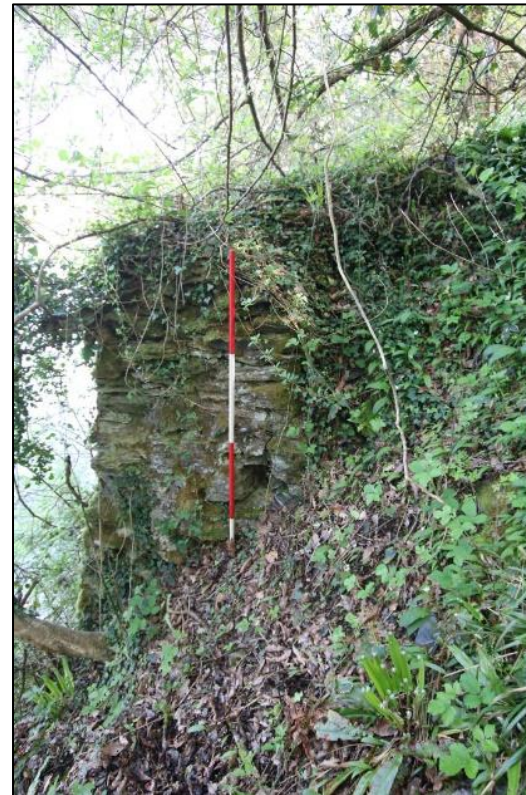
The structure appears to be in a fair and stable condition. There remains some uncertainty here, as the structure was difficult to access and its downslope side was not readily visible. If it does mark the entrance to the adit, the interplay between the waters of the river, and the water in the mine, may become an issue.

FIGURE 71: DETAIL OF THE SW CORNER OF THE STRUCTURE; FROM THE SOUTH (SCALE 2M).

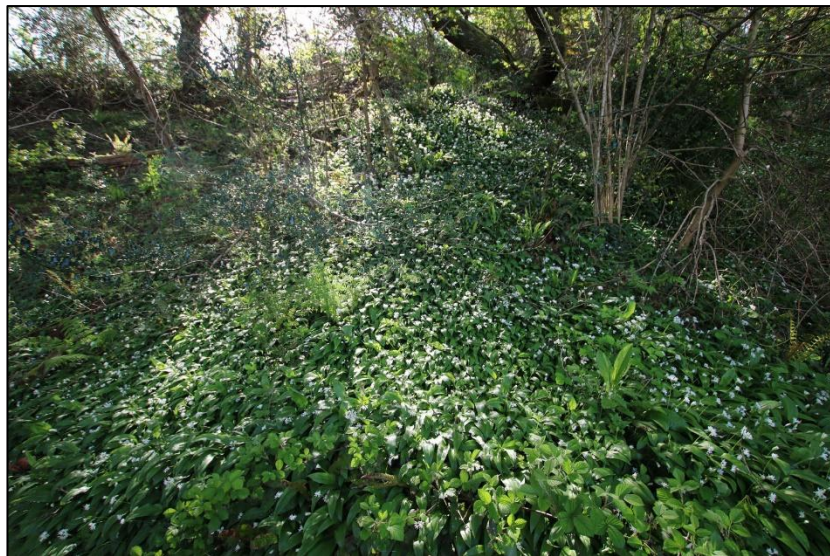
FIGURE 72: THE BANK OF RAMSONS RUNNING BACK UP THE SLOPE BEHIND THE STRUCTURE; FROM THE NORTH-EAST (NO SCALES).
