**BEAFORD MILL**

Historic Building Appraisal of Mill Building

# Beaford Mill, Beaford, Torridge, Devon

## Results of a historic building appraisal of the Mill building

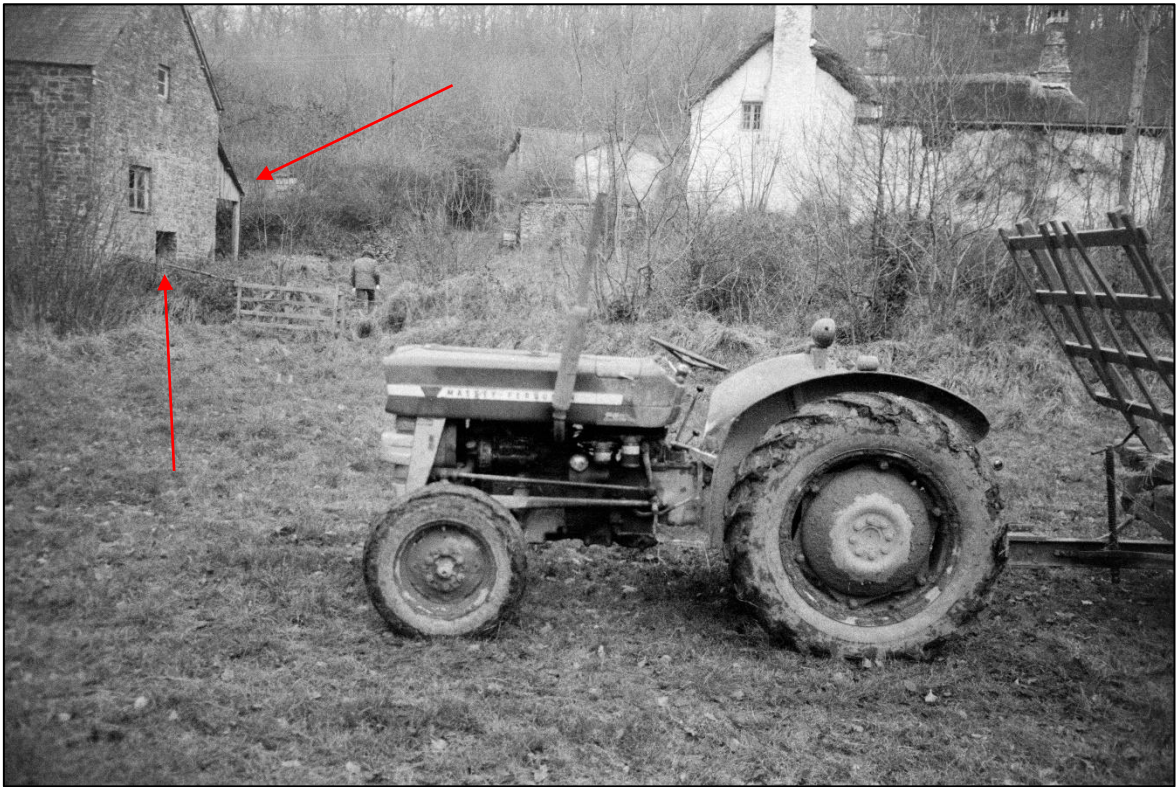
FIGURE 3: A PHOTO OF THE BEAFORD MILL SITE, TAKEN BY ROGER DEAKINS IN 1972, WE CAN SEE SOME TIMBER OUTSHUTS SURVIVE AT THIS POINT ALONG THE 'NORTH' SIDE OF THE MILL AND THERE IS A DOOR TO THE MACHINE ROOM IN THE EAST ELEVATION, THE BRIDGE IS GATED OFF AND THE LEAT AND BANKS ARE OVERGROWN; BEAFORD ARCHIVE (DEA/01/179/30).

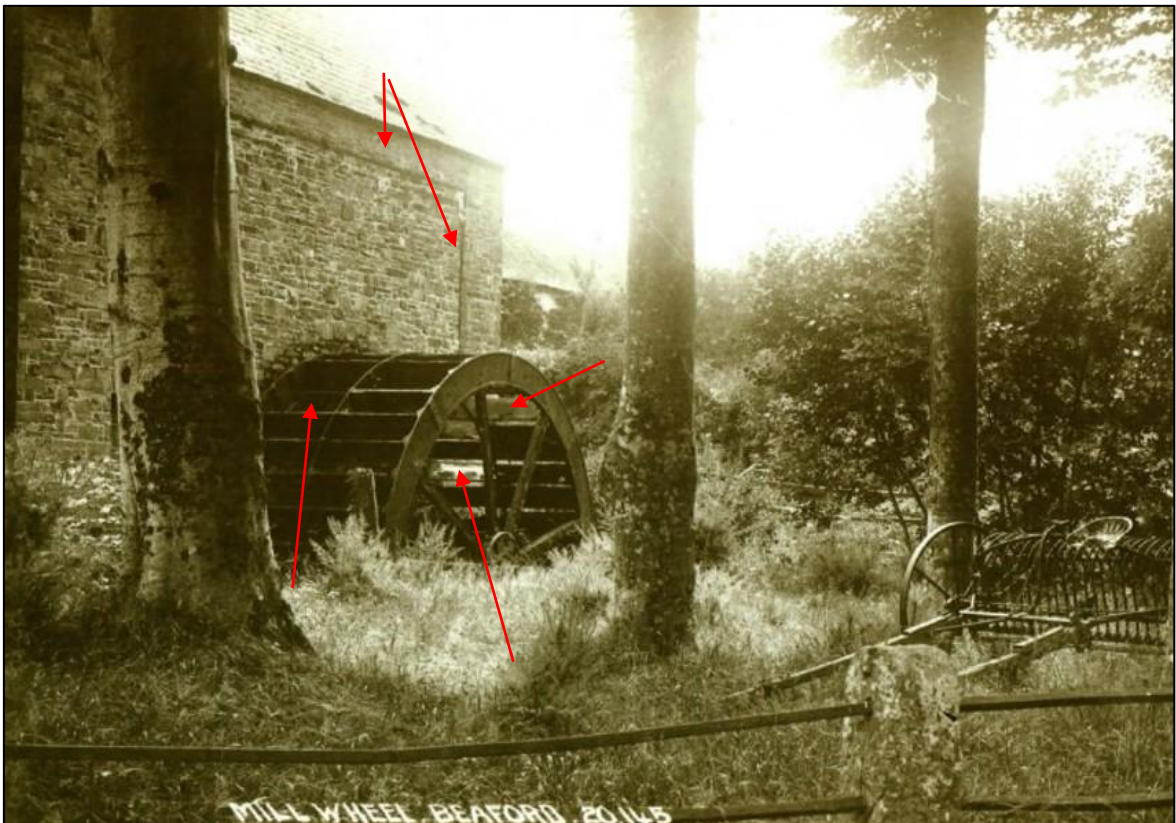
FIGURE 4: ANOTHER EARLY-MID 20<sup>TH</sup> CENTURY PHOTOGRAPH OF THE MILL WHEEL IN SITU, THE SITE AGAIN LOOKS OVERGROWN. THE PHOTOGRAPH IS SHOWING A TYPICAL UNDERSHOT FED WHEEL USING TIMBER FLOATS AND IRON RINGS AND BARS OF DOUBLE-WIDTH FORM, SOME OF THE FLOATS CAN BE SEEN TO BE MISSING ON THE WHEEL AND THE HOUSING CHAMBER OVER THE WHEEL HAS ALREADY BEEN REMOVED, THE FLASHINGS CAN CLEARLY BE SEEN. (PROVIDED BY CLIENT).

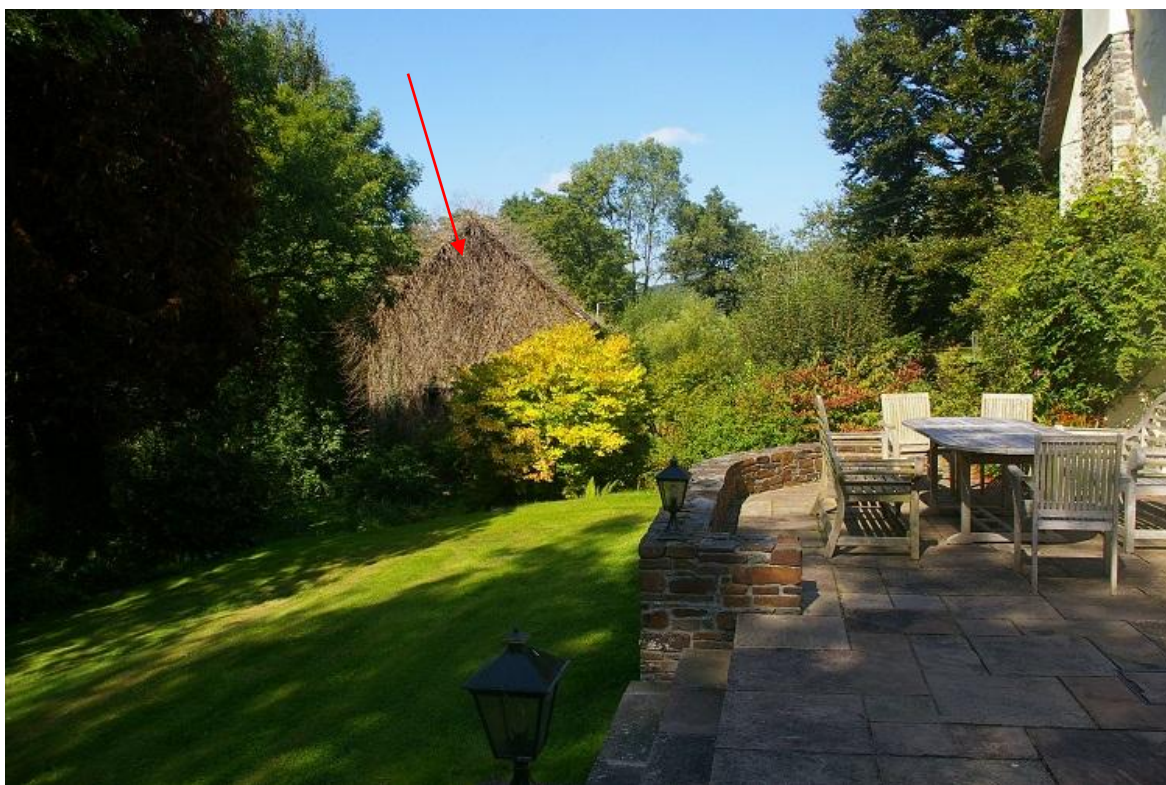
The Mill stands at the base of the west-south-west facing slope, surviving as a long linear range parallel to a leat, adjacent is a flattish meadow, with the river beyond. Between the mill and the road is a small rough stoney area, with direct access to the lane. Immediately to the 'north' is an overgrown strip of grass and slumped spoil/soil which may obscure ruins of the malthouse, with a tall bank and path rising to the hedge banks of a small traditional orchard to the north. To the north-east is the mill house with access track and a yard between the Mill and House; the yard is currently being cleared and restored, the track is believed to be of surviving cobbles beneath a thin grass sward. To the east of the house is a large gravel courtyard, formerly the farmyard, with one surviving stone barn and cart shed. A third barn has been attached to the house as an annex. Enclosing the site are beautifully landscaped gardens alongside the millrace. There is a patio on the west side of the house adjacent to a conservatory, which currently overlooks the Mill building. The Mill now presents as a 'romantic ruin', aesthetically pleasing but not authentic to its working character. The setting is generally very rural, quiet, and peaceful, it is now however, of upscale residential character; but this site was once a busy working Corn Mill and the later polite aesthetics somewhat obscure the wider narrative and the collective value and relationships of the Listed assets onsite – there is potential to improve these historic relationships with landscape restoration. The mill was once covered with ivy and obscured by planting, the owners are now carefully clearing back much of the vegetation, with a view to conserving the building for the future.

FIGURE 9: THE MILL (INDICATED) WITHIN THE LUSH GARDENS OF THE SITE (SEPTEMBER 2021).
