**SURVEY OF BUILDINGS AT  
MANOR FARM,  
NORTH STREET,  
DIGBY,  
LINCOLNSHIRE  
(DINS11)**

Work Undertaken For  
Stonewell Homes Ltd

April 2011

A.P.S. Report No. **48/11**

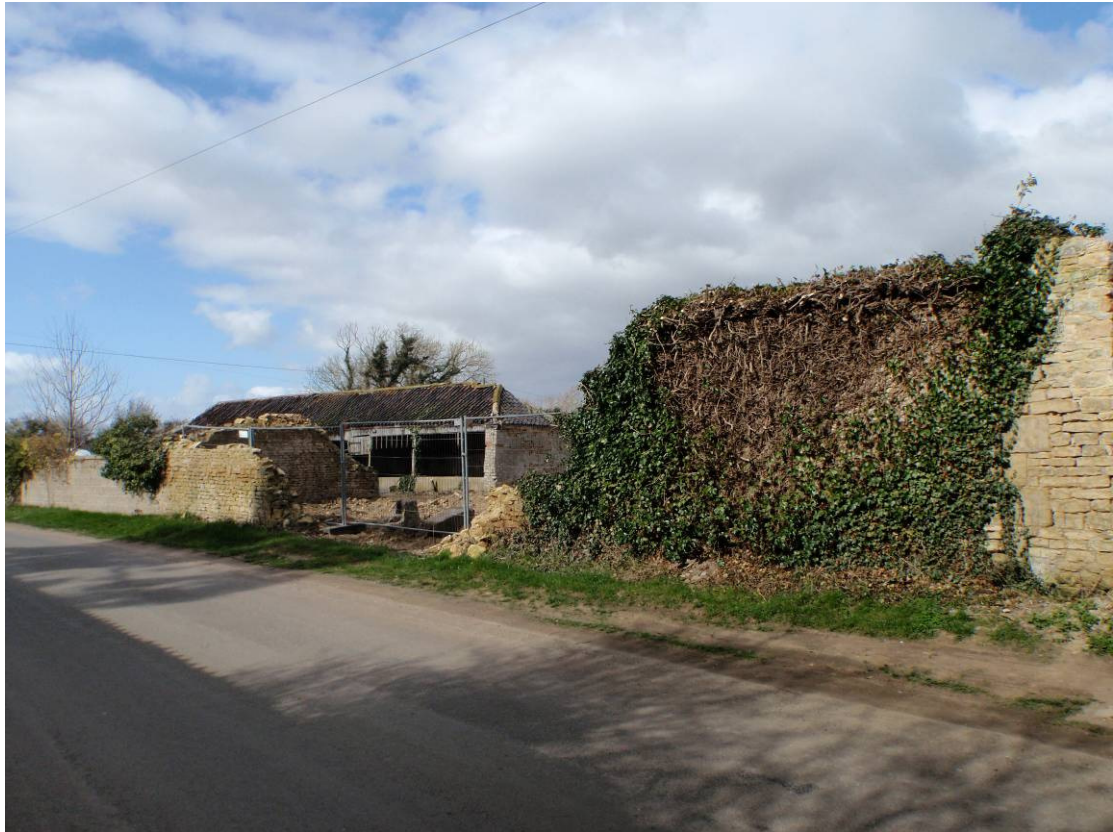
The fragmentary remains of Building 2 (see Figure 6) are located in the angle between North Street and the western boundary of grounds associated with the adjacent Manor House (Plate 15). From the available evidence the building would appear to have been open to the north indicating probable use as a cartshed and/or implement store. Constructed in coursed limestone rubble, the walls survive to their full height of around 3.15m only on the east side of the building (Plate 16), having collapsed to ground level over much of the southern side (Plate 17), and standing to approximately half of their original height to the west (Plate 18). A pantile roof (probably hipped) is indicated by fragmentary, *in situ* remains, on walls at the southeast corner of the building, and loose pantiles are spread across the internal area (Plate 16 & 19).

Plate 16 – Building 2 - Interior of collapsed building, eastern end, looking southeast

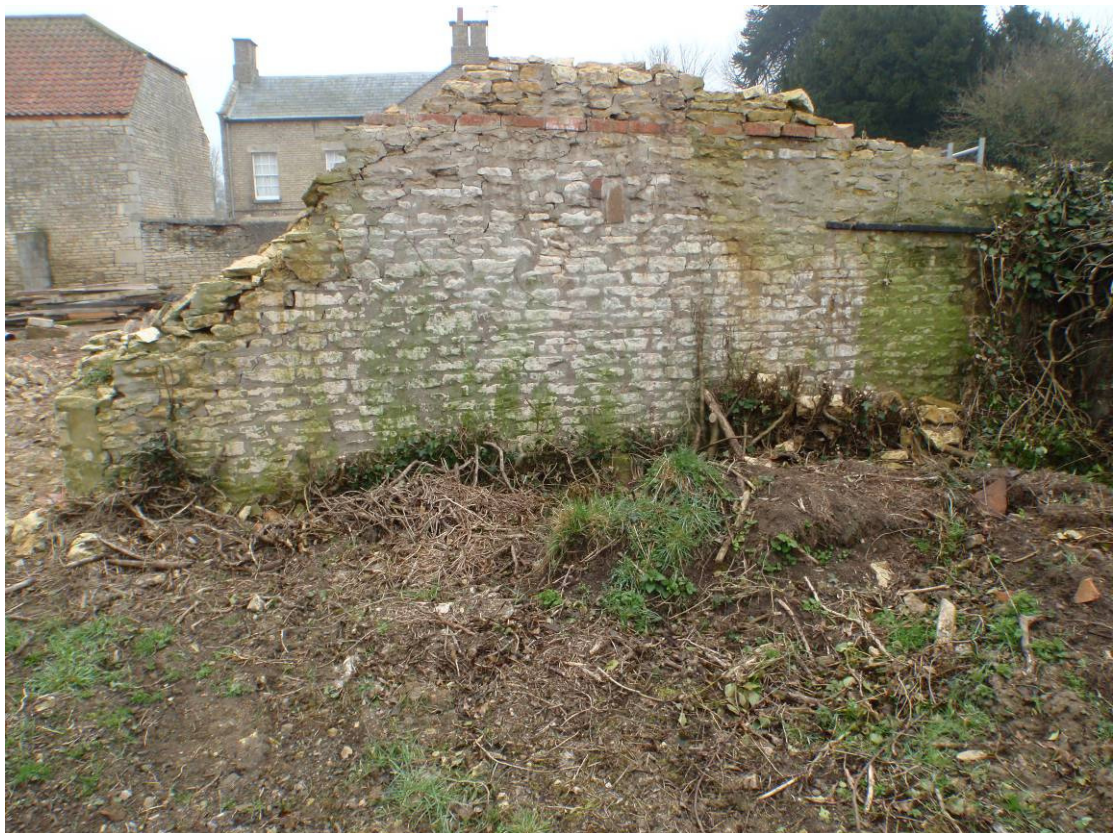
Plate 17 – Building 2 - Collapsed building, south side, looking northwest

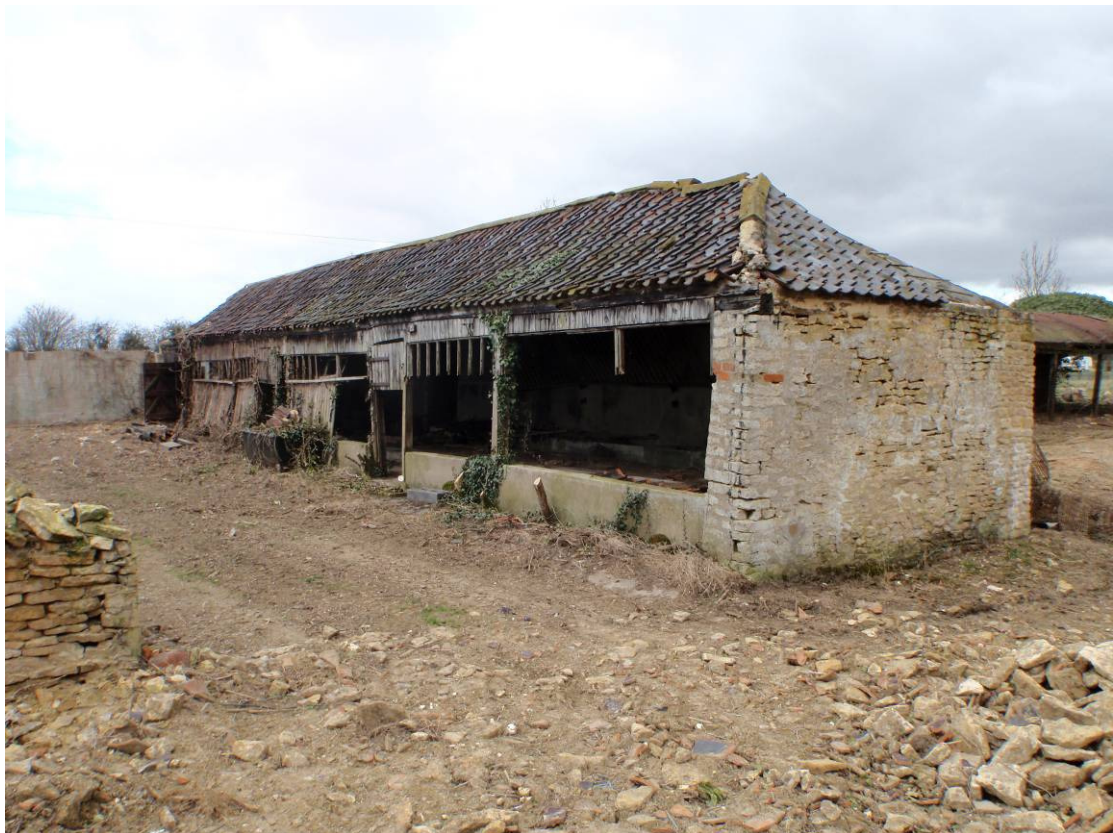
The original part of the structure comprises walls of coursed limestone rubble on three sides (west, north and east), which presumably functioned as a shelter shed for cattle, opening into a yard to the south (Plates 21, 22 & 23). The only feature in this part of the structure is a doorway in the north wall (slightly offset to the west), edged with brick and containing a timber planked door (the northeast corner and north wall, extending to the door, have been repointed) (Plate 24). A hipped roof covered by glazed (apparently modern) pantiles (Plates 20 & 22) is carried upon timber wall plates and another plate on the south side, running longitudinally upon five timber uprights measuring 130mm x 160mm in section. Tie-beams run between the uprights and the rear wall, with common rafters above and single purlins to either side (Plate 25). The purlins are clasped at regular intervals to the rafters. All of the roof components, with the exception of the main tie-beams are straight cut. Partial collapses in the roof structure have occurred at the northeast and southeast corners of the building.

Plate 25 – Building 3 - Interior of cowhouse, roof, looking east

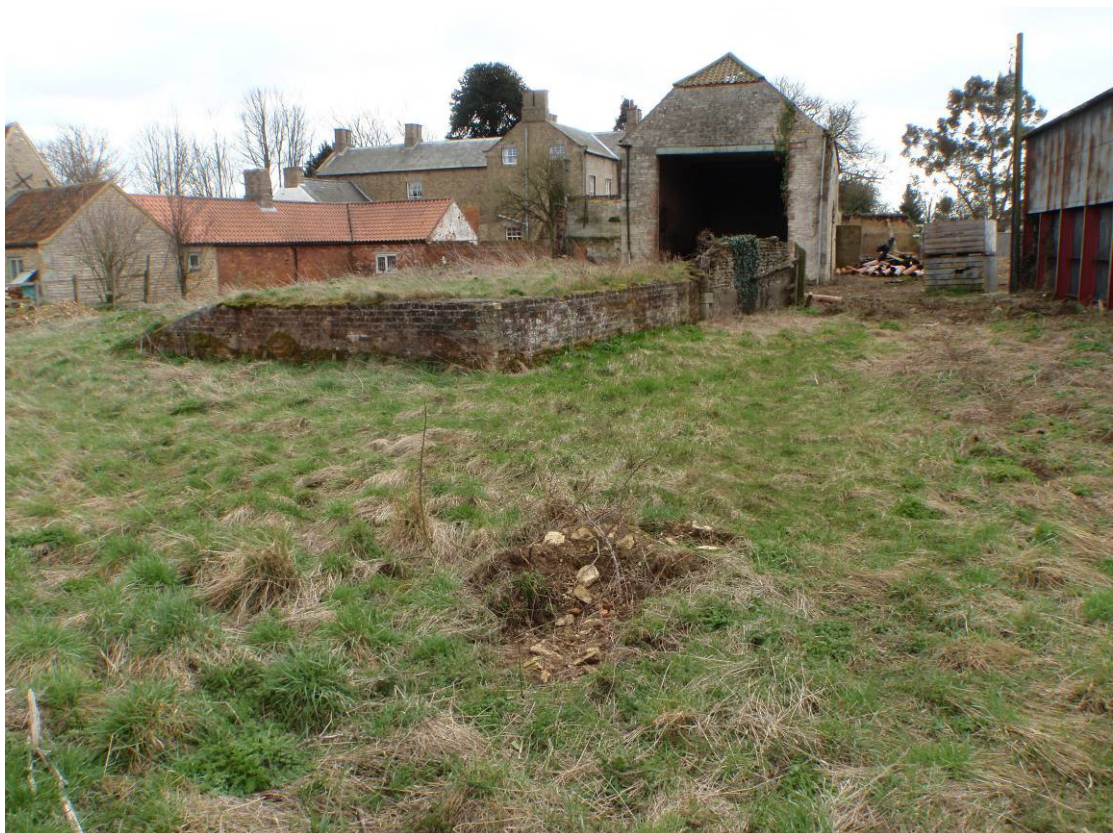
There is a collapsed stone structure (Plate 34) immediately north of the barn adjacent to a raised structure denoted on the survey (see Figure 4) as a loading dock (Plate 35).

Plate 34 – Other buildings - Collapsed structure north of barn, looking north
