**HISTORIC BUILDING RECORDING
THE ELMS FARMHOUSE
GUNBY ESTATE
BRATOFT
LINCOLNSHIRE
(GUTE16)**

Work Undertaken For
The National Trust

April 2016

APS Report No. **29/16**

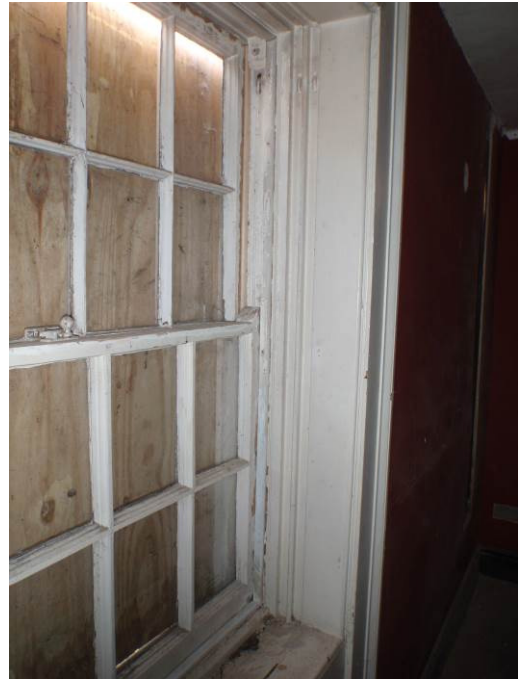
On the west wall, butting up to the chimney breast is a six over six Victorian sash window which is described above as a later insert to the original wall. The window in the south wall is and eight over eight Victorian sash set within a Georgian surround. The sash runners for the original window are visible within the frame, set closer into the room (Plate 17).

Plate 17 (above). Detail of the Victorian sash window within the Georgian Frame. The runners for the previous sash cords are visible just inset from the present window

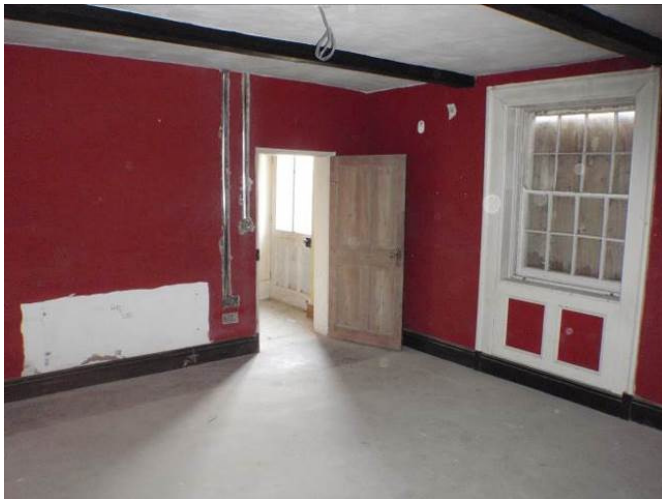
Plate 18 (left). A general view of Room 1 looking toward the vestibule/hall showing the Georgian window surround and the ceiling beams

There are two ceiling beams that cross the room from north to south. Both are chamfered with run-out stops. It is possible that they are original but this sort of beam is un-dateable from visual inspection. The four panel wooden door to the vestibule probably dates to *circa* 1900.

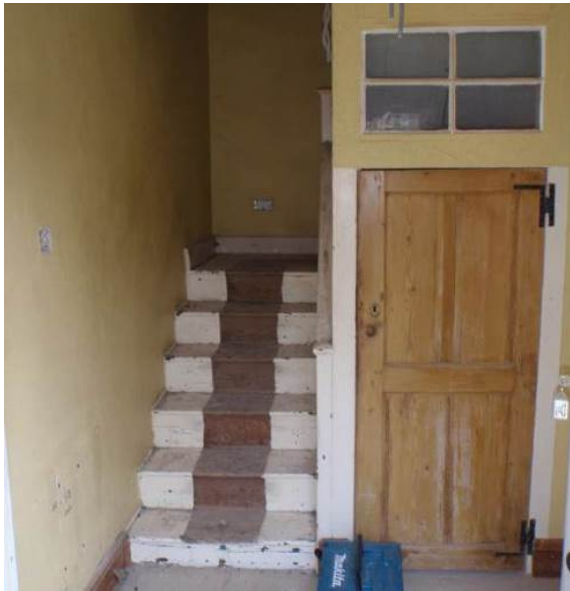
Immediately within the main entrance to the East-West Range, in the south elevation, the vestibule/hall has a concrete floor and provides access to Rooms 1 and 2 to the left and right respectively. The stairs are offset slightly to the west and there is an under-stairs cupboard with an early 20th century door. The under-stairs area has been fitted with shelves.

Plate 19
General view of the vestibule/hallway

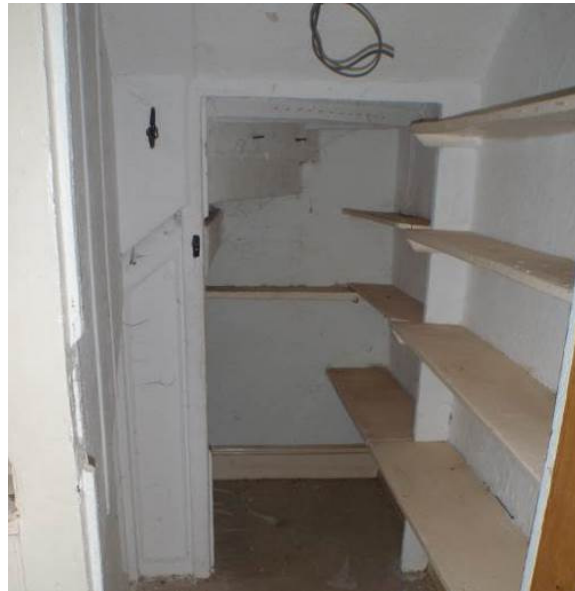
Plate 20
The under-stairs cupboard with the fitted shelves

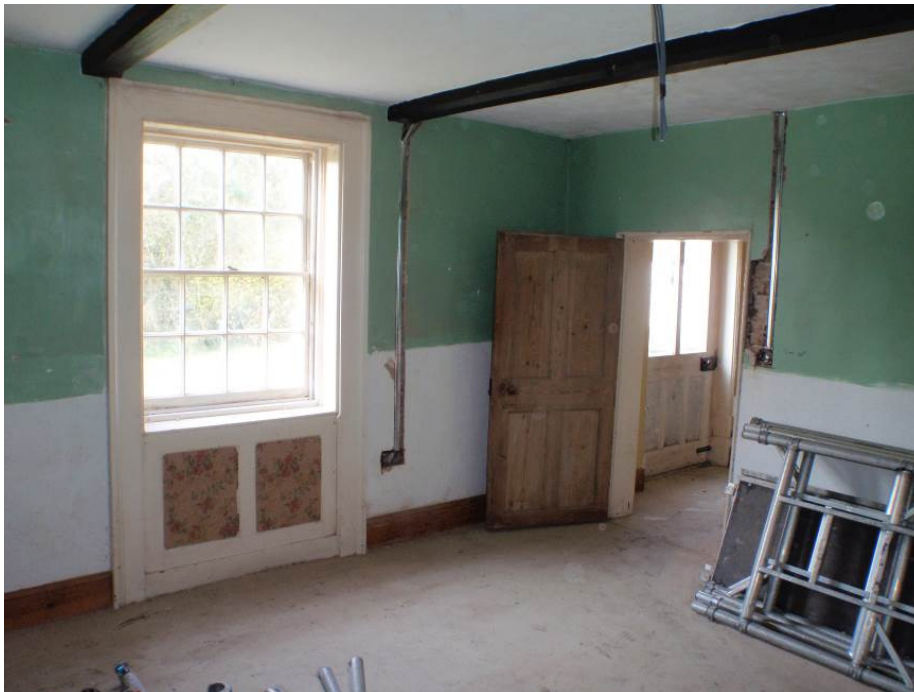
This room, located in the East-West Range, has many similarities with Room 1 in that it has a concrete floor, two north-south aligned chamfered beams with run-out stops and a door dating to approximately 1900. The window is also a Victorian replacement in a Georgian surround that displays the original sash runners.

Plate 21. General view of Room 2 looking toward the vestibule/hall and showing the eight over eight Victorian sash window in the Georgian window surround, and the ceiling beams

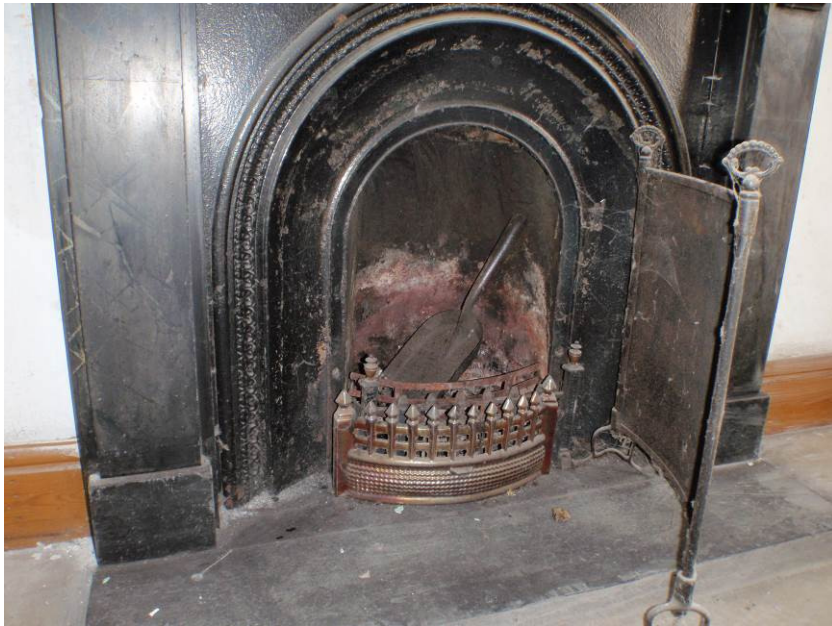
The fireplace in this room is Victorian with its cast iron surround in the form of decorative arches. To the north of the chimney breast there is a cupboard divided into an upper and lower section with a shelf in the upper.

Plate 22. The decorative, cast iron Victorian fireplace in Room 2

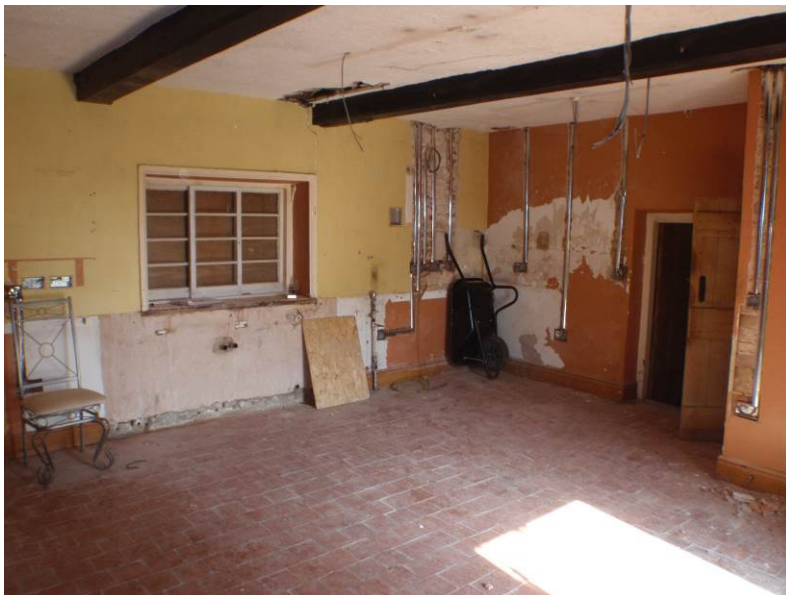
Plate 23. A general view of Room 3 looking toward the pantry area from the entrance from Room 2

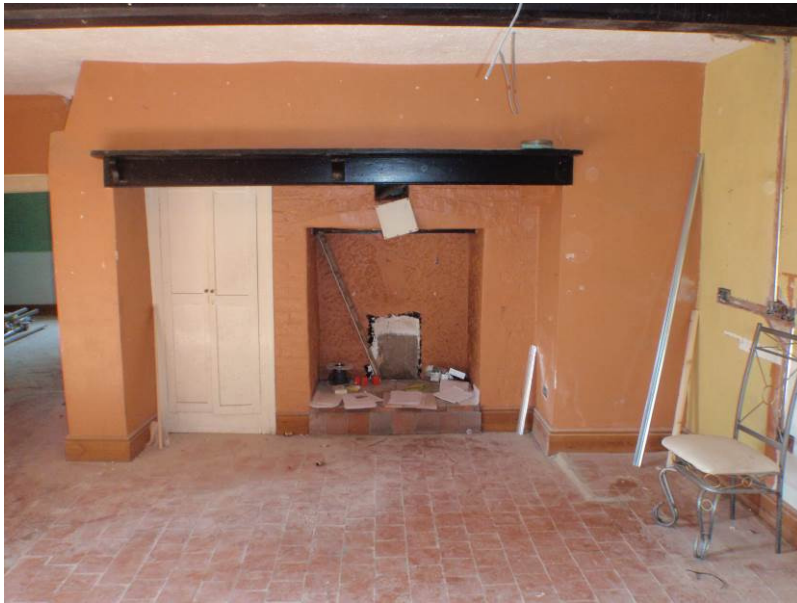
Room 3 has a very large inglenook fireplace on the south wall. The projection of the chimney breast and surround extends to the west wall (to the area of the possible projecting oven noted externally). The fireplace has a gentle segmental arch of brick that appears to have been infilled below to create a horizontal opening. There is a cupboard to the east of the fireplace. This and the adjacent covered part of the chimney breast has a barrel vaulted top. The fireplace, at some time, appears to have contained a range and back boiler as evidenced by the filled in scarring for pipework at the back of the fireplace.

Plate 24. The large inglenook fireplace in the south wall of Room 3

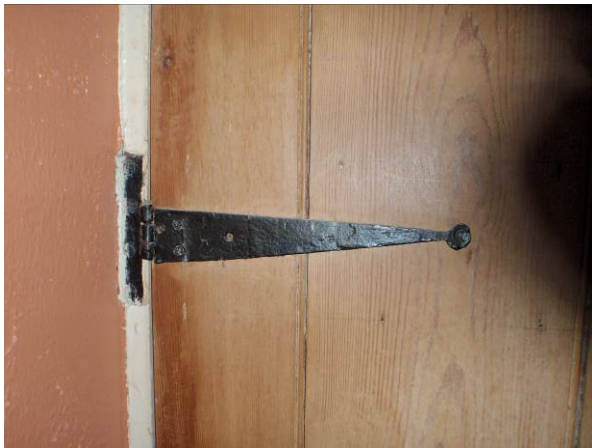
In the northeast corner are a set of stairs leading to the upper floor. These are straight flight with a winder. Under the stairs is a cupboard. The door to the cupboard is likely mid-20th century in date but the hinges and latch are either earlier and re-used or fashioned to look older than they are.

Plate 25. Detail of door hinge on the under stairs cupboard in Room 3, possibly an early hinge on a later door

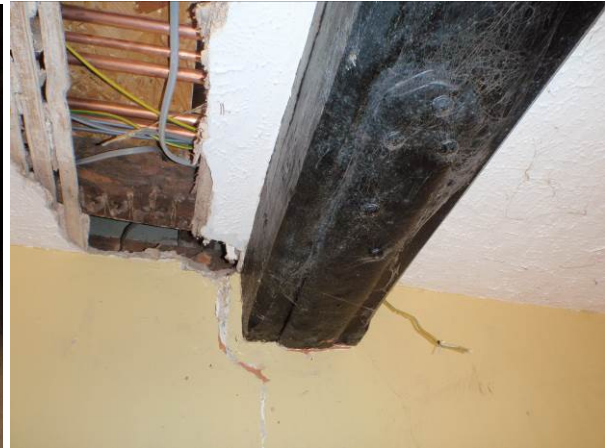
In common with Rooms 1 and 2, Room 3 is crossed by two ceiling beams that are chamfered with run-out stops. There are substantial iron ties at the ends of the beams.

Plate 26. A substantial iron tie on the ceiling beam in Room 3

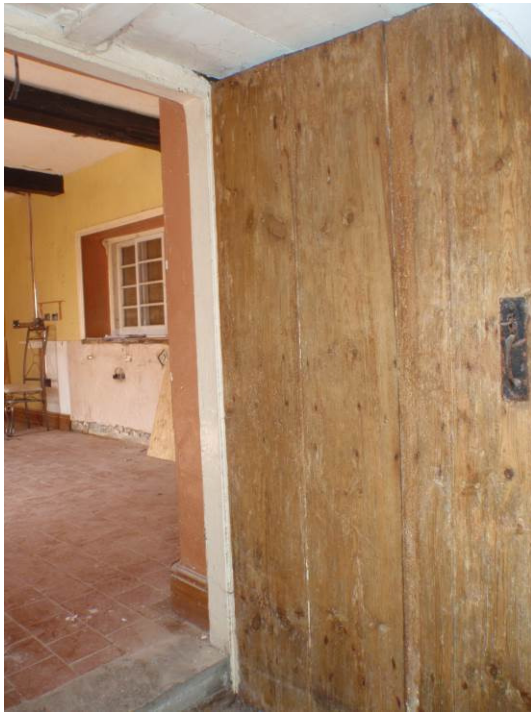
The door leading from Room 3 to the Pantry Area (Plate 27) may be original to the construction of either the original extension or the initial phase of the present northern extension (see exterior North Elevation and Room 10) as it appears to be of late 18th or early 19th century date.

Plate 27 (left). The late 18th or early 19th century door from Room 3 to the Pantry Area

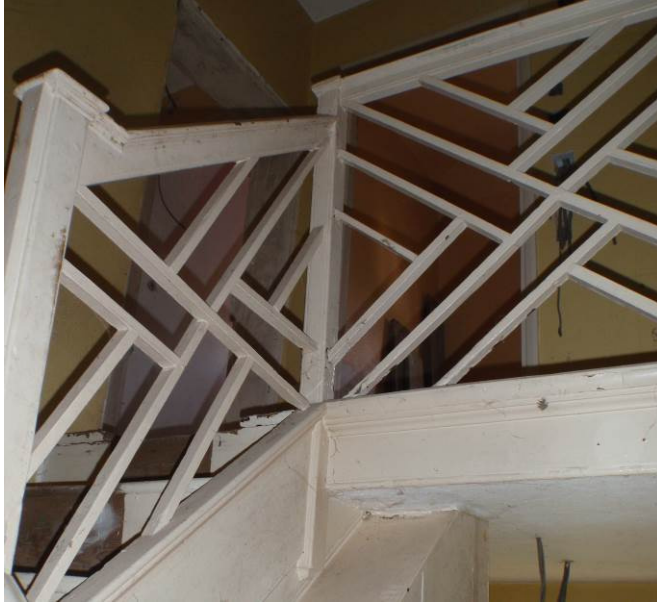
The front stairs are slightly offset to the west of the door in the south elevation. The staircase is closed string and doglegged with a half landing. Viewed from below, the carriage and bearers appear to be original and the risers and treads may also be contemporary. The decorative balustrade panels are made from angled laths and are in the Art Deco style.

Plate 30. The decorative balustrade panels in the Art Deco style on the Front Stairs

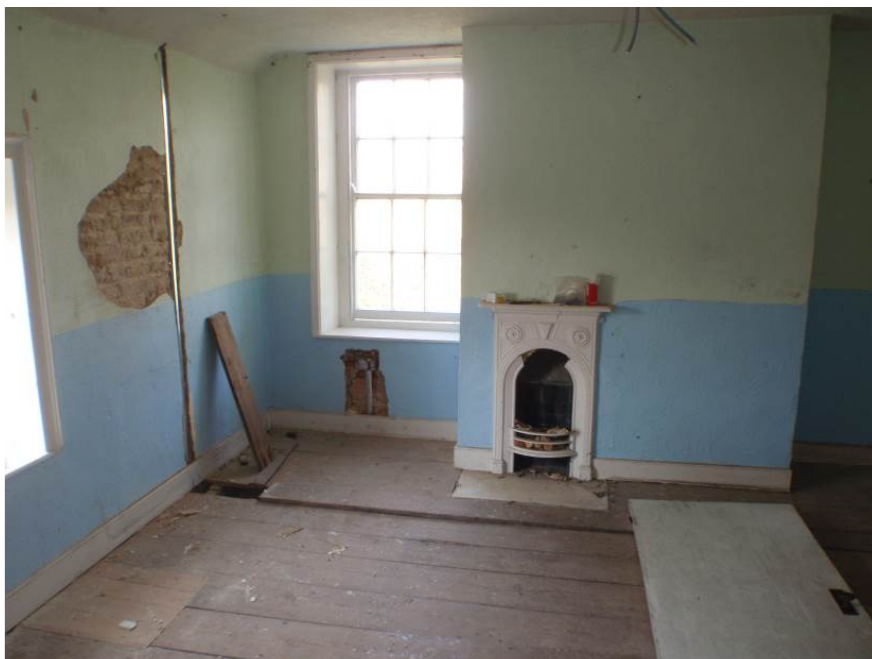
Plate 31. Room 4 with the offset fireplace and the 19th century surround. The hearth is supported from below in Room 1

The fireplace, on the west wall, sits off-set to the south within the chimney breast. The surround is cast iron and dates to the 19th century. The concrete hearth in front appears to be the reason for the support seen in the ceiling of Room 3 immediately below.

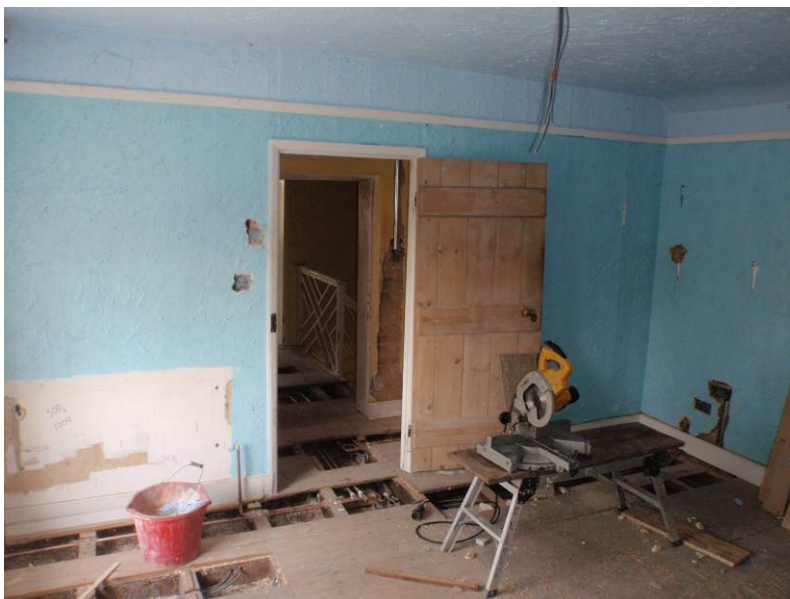
Located on the eastern end of the East-West Range, the west wall of Room 7 is a wooden partition added in the mid-20th century. The door into the room is also of the same date. Similarly to the doors on the lower floor, the door furniture is iron and is either re-used and older than the doors or is designed to look that way.

Plate 35. The mid-20th century partition wall on the west side of Room 7, looking toward the stairway

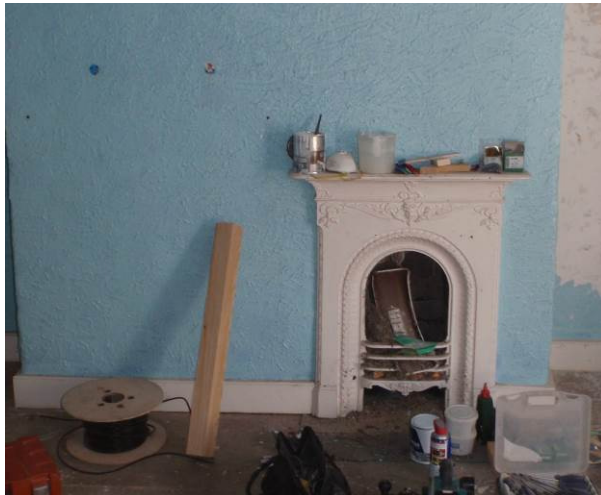
There is a planked floor and, similarly to Room 4, there is a 19th century cast iron fireplace set in the southern portion of the chimney breast in the west wall. Unlike the fireplace in Room 4, there is no obvious support for the hearth on the ceiling of the floor below.

Plate 36 (below). The fireplace set into the southern portion of the chimney in Room 7

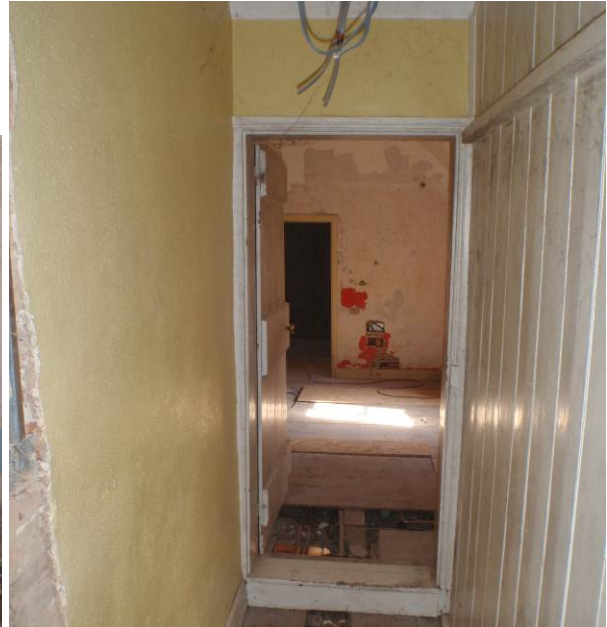
Plate 37 (right). The partition wall on the west side of Room 7 that forms the secondary landing that leads to the North-South Range

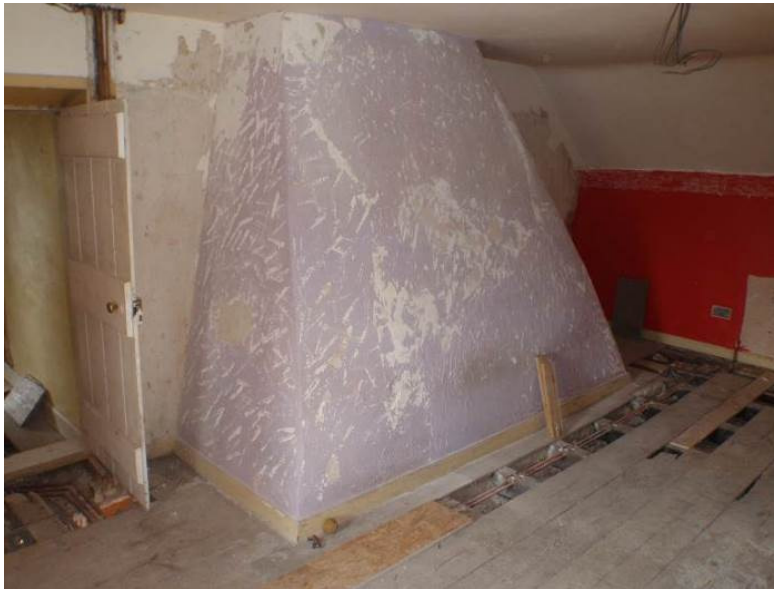
On the south wall is a large and cambered chimney breast that covers the span of the inglenook below. On the west and east sides of this, the ceiling cants in where the walls join the roof.

Plate 38. The large, cambered chimney breast in Room 8 above the inglenook fireplace on the floor below

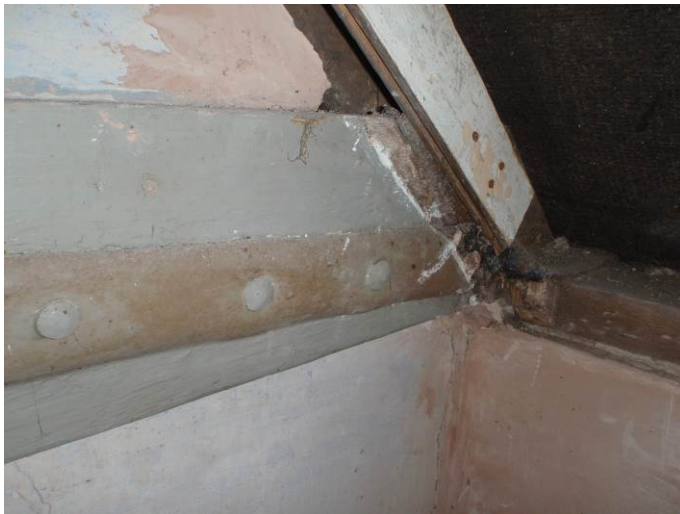
Plate 39. Detail of the iron bracers trip on the tie beam. It is twisted to fold over the wall plate on the west wall

Recent work to the ceiling had exposed some of the structure. Rafters with roof felt were visible on the east and west sides with joists resting on a wall plate. The tie beam for the south wall rests on the wall plates of the east and west walls with large iron bracing strips at each end of the beam (Plate 39).

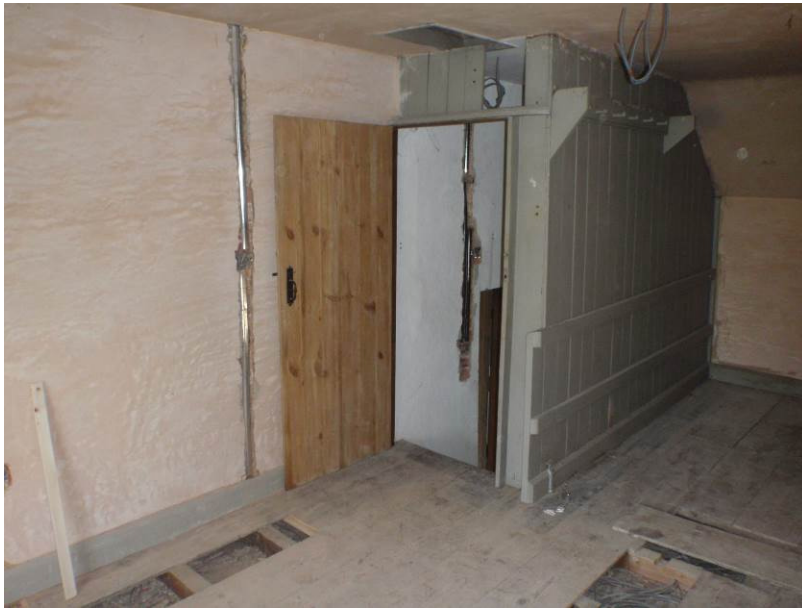
In the northeast corner of the room is the surround to enclose the back stairs. There is a row of coat pegs on the south side of this partition (in the room). This suggests that the room was meant as separate occupancy in this range and may have, at some time, acted as servants' quarters.

Plate 40. The northeast corner of Room 9 with the wooden surround for the back stairs. The row of coat pegs suggests this was used as separate living quarters

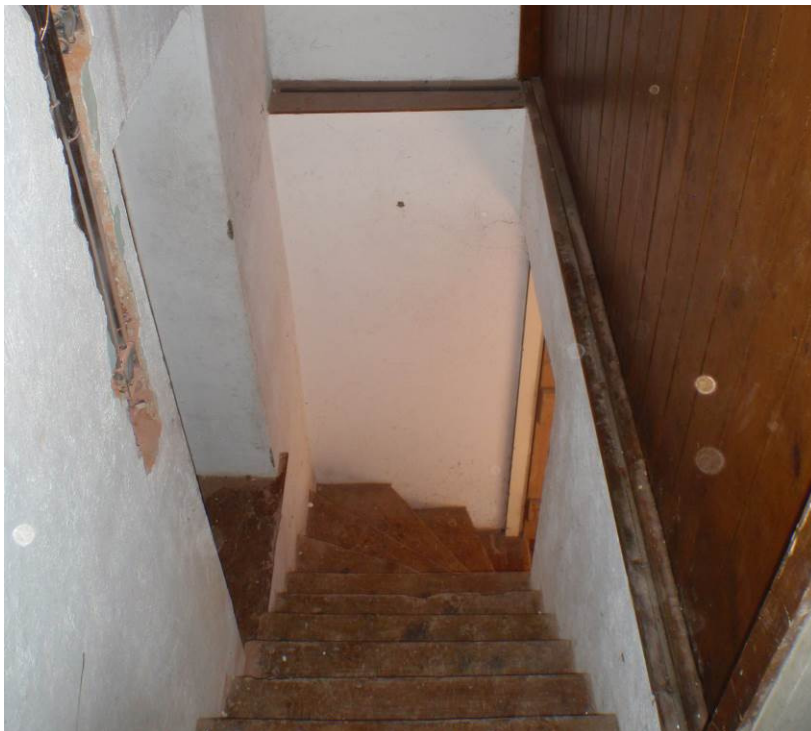
As discussed previously, the back stairs are straight flight with a winder and lead to the mezzanine Room 10 in the northern extension. The stairs are completely enclosed by brickwork and wood panelling with a doorway to Room 10 at the head of the winder.

Plate 41. The Back Stairs leading to the mezzanine Room 10 on the left of the picture and Room 3 at the foot of the stairs

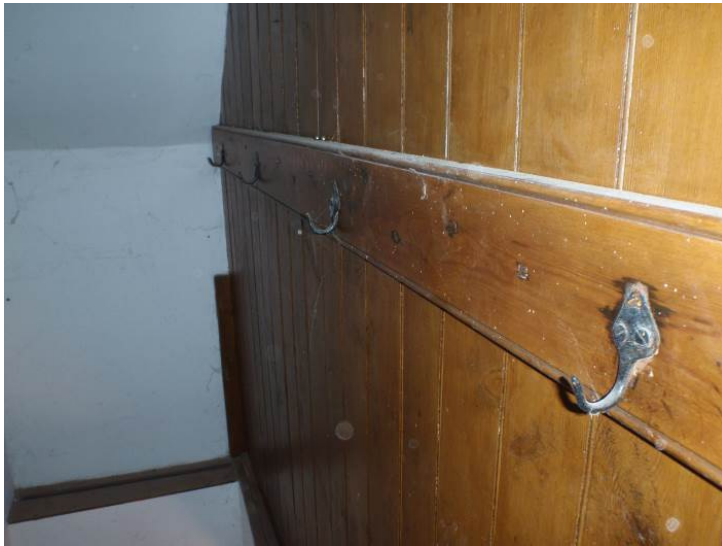
On the south side of the stairs, toward the top of the wooden panelling, is a double row of iron hooks. Although these look like coat hooks, they are completely inaccessible and it is more likely that they are to carry cables or perhaps servant's bells.

Plate 42. Detail of the metal hooks on the wooden panelling of the 'back stairs' possibly for servant's bells

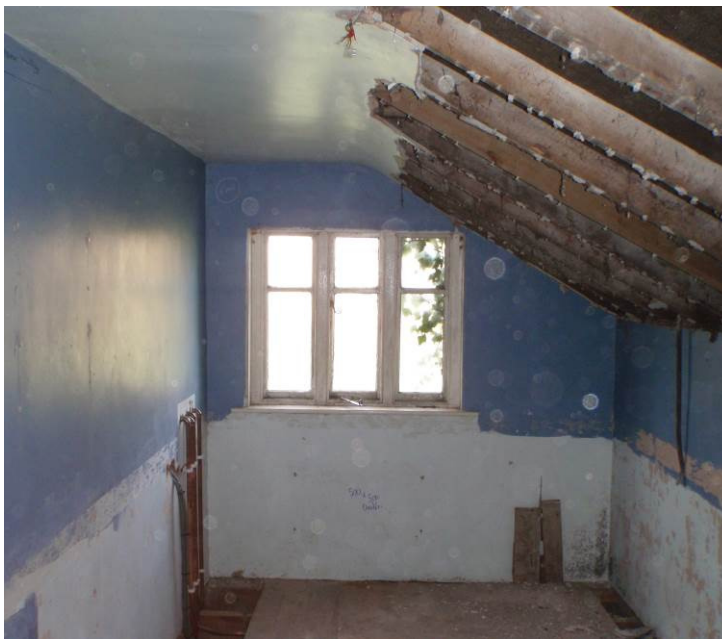
The smallest room on the upper floor, Room 10 is also the latest part of construction of the farmhouse. Internal examination of the window showed it to be a three light window with a central opening panel and cockspur catches.

Plate 43. Room 10, showing the exposed rafters and the three light window on the west wall

During the investigation an inserted 20th century ceiling was removed exposing both the rafters of the mono-pitched roof at the north end of the extension and the brickwork of the covered end gable of the North-South Range.
