**HISTORIC BUILDING RECORDING
ON SAWPIT AND DUTCH BARN
AT THE WOODYARD,
BELTON HOUSE,
LINCOLNSHIRE**

Work Undertaken For The
National Trust

May 2018

APS Report No. **36/18**

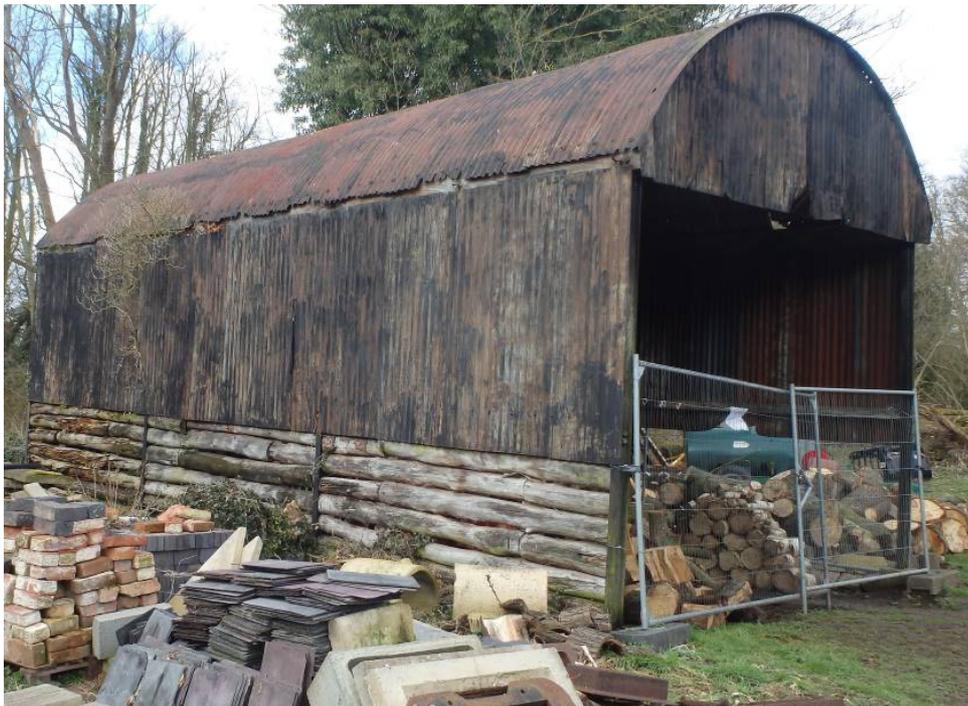
Plate 2 General view of the Dutch barn from southeast

The Dutch barn's condition is also poor, although it is still in use, unlike the sawpit. There is a large amount of rust visible on the corrugated iron sheeting which covers the barn. In places this sheeting has corroded to expose the substructure and allow water ingress through the roof.

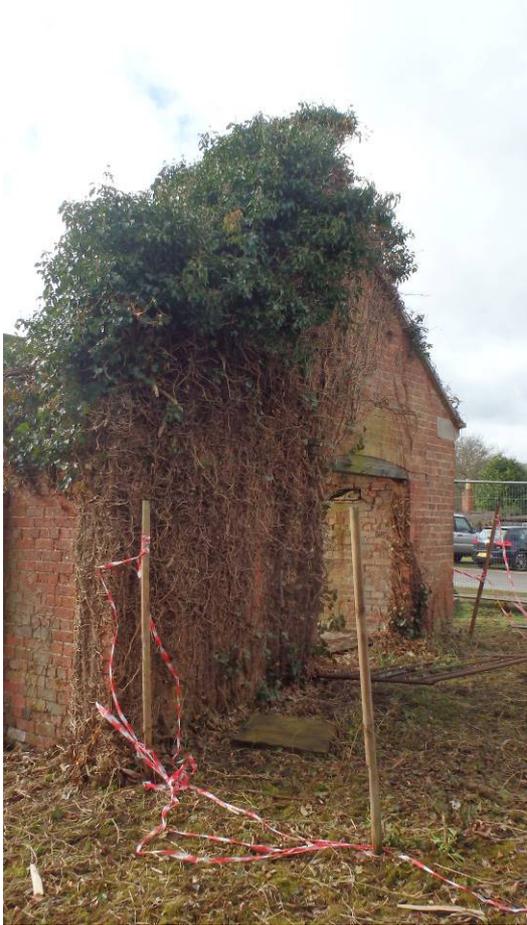
Plate 13 North gable of sawpit, looking west

The north gable is brick and survives to its full height (Plates 13 & 14). This elevation

features stone kneelers matching those of the south gable, and here they support the projecting coping stones at the roofline, forming a kneelered-gable. Presumably matching coping stones have been lost from the south gable.

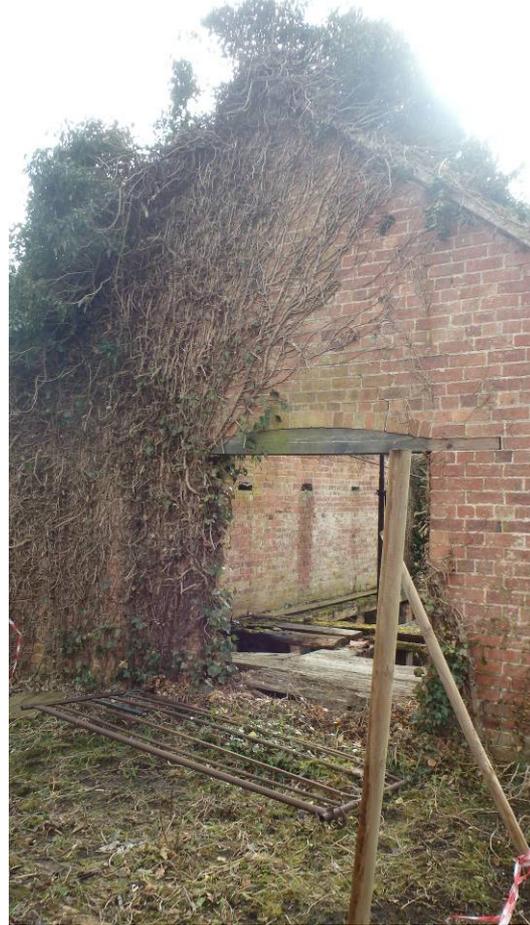
Plate 14 North gable of sawpit, looking southeast

The opening for a double doorway, off centre and opposing that of the south gable, was recorded. This opening has a segmental arch of a single course of rowlock bricks and a wood lintel keyed in to the brickwork surrounding the door (Plate 14). A timber purlin is visible in an aperture cut through the brickwork at the west side, although the east side of this elevation is largely obscured by ivy (Plate 14). The slightly plainer arch and surround to the north door may reflect its position, facing away from the estate yard entrance.

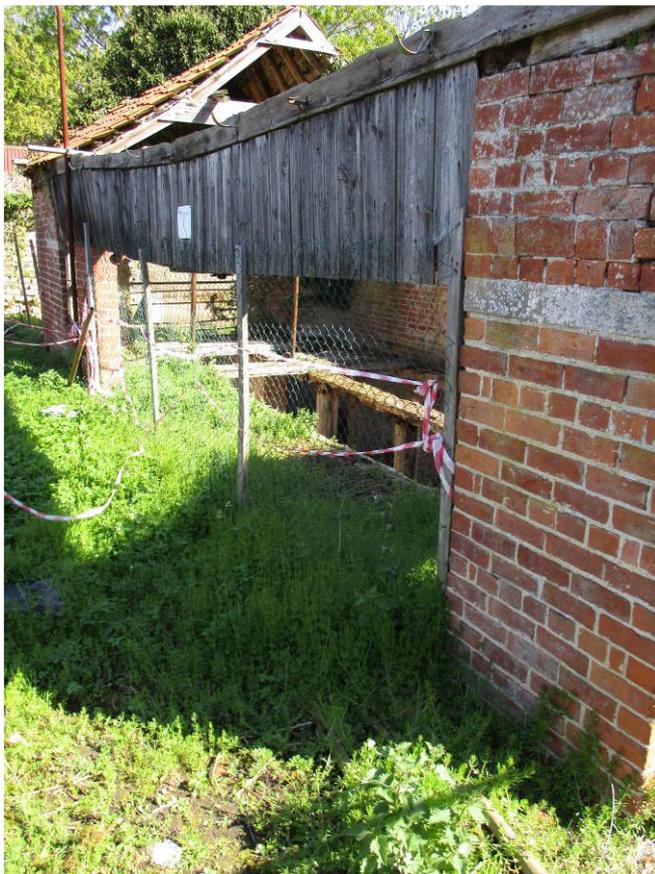
Plate 16 West elevation of sawpit showing weatherboard, opening beneath and masonry course in brickwork

Areas of original brickwork at either end of this elevation include a masonry course, above which timbers in turn support a weatherboard covering to the upper third of the wall (Plates 15 & 16). A variety of gutter brackets are fixed to the timber at the top of the west elevation, and include iron examples (Plates 4 & 16).

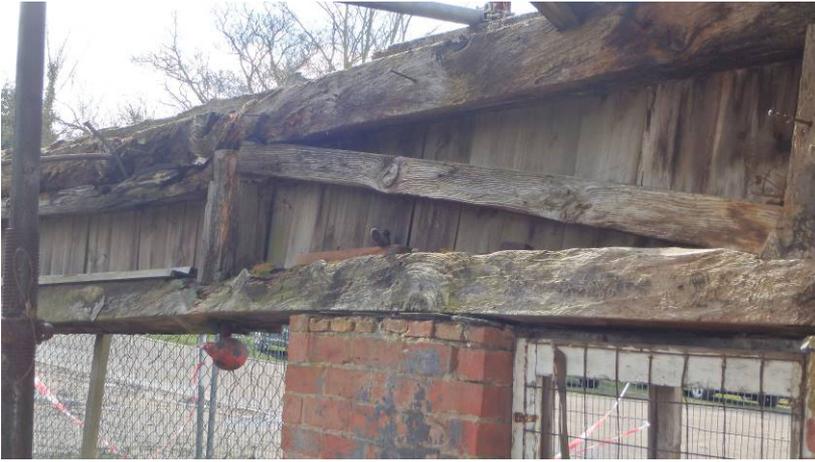
Plate 19 Timber structure of west wall of sawpit viewed internally

The hand-sawn timbers of the upper third of the west elevation are clearly visible internally (Plate 19). A horizontal beam supports vertical struts, which along with angled timbers support a further horizontal beam at the roofline (Plates 19-21). The two horizontal beams are tied together by iron pins which pass through the length of the struts (Plate 21).

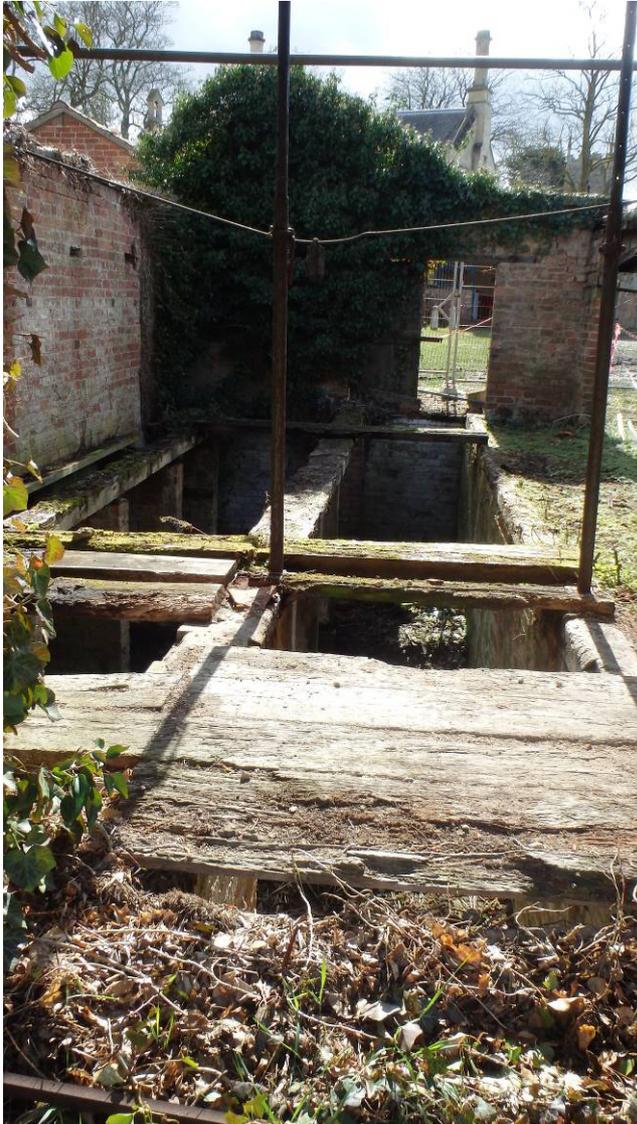
Plate 22 General view of sawpit interior from north

The sawpit interior comprises a single open space, much of which is occupied by a large brick-lined pit, internally measuring 9.75m x 3.47m x 1.97m deep (Plate 22). At the north, east and south the walls of the pit are continuous with the walls above at ground level. At the west side the pit is stepped in slightly in from the west wall (Plate 22). Due to the condition of the building the pit was not entered during the survey, and as a result the flooring material within the pit is not known.

An iron bar spanning the Belton sawpit may have been used to reposition the timber once inside, and although slightly uncertain, an iron and timber object hanging from this may have served as part of a device similar to a chain block or gantry crane (Plate 27). The sawpit itself is divided into two longitudinal bays, possibly allowing two halves of a tree to be worked together, and probably helping to maintain access and egress to the pit while a timber was in place. The iron bar and attached device are lower in the centre of the room, above the divide in the pit, and this may have allowed the top sawyer to work on top of either the west or east bay without banging his head on the hoist (Plate 22).

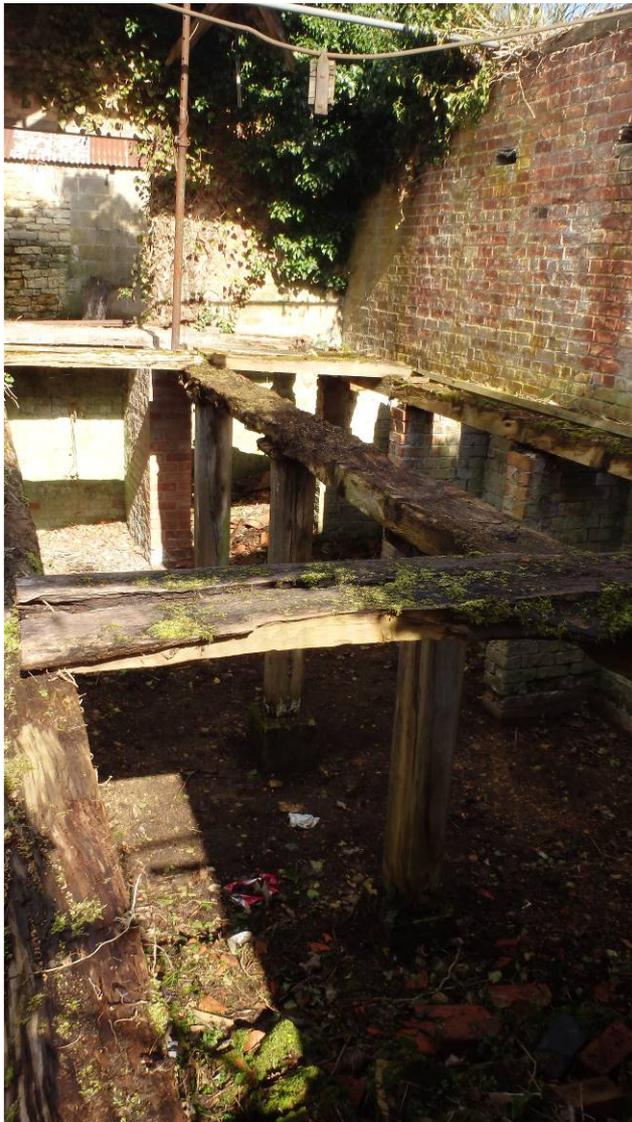
Plate 24 Sawpit, looking north

Five brick plinths provide buttressing along the east wall of the pit and also form supports for a hand-sawn timber joist along the length of the building (Plates 23 & 24). A single brick plinth is located at each of the north and south walls of the building, to the east side of each doorway. A further joist is supported on these two plinths and three timber posts along the length of the joist. Each timber post rests on a dressed stone pad (Plates 23 & 24). The west brick wall of the pit is topped by a further joist along its length (Plate 22). Further planks at the west of this form wooden flooring at the northwest corner of the building (Plate 26).

The three parallel joists provided support for substantial hand-sawn timber planks set in notches in the joists at the north and south of the sawpit (Plates 24-26). Notches in joists which are not currently occupied by planks may indicate the position of lost timbers but could equally indicate that the planks could be repositioned as required for sawing. Although the joists are very weathered in places, it does not appear that they ever had notches along their entire length.

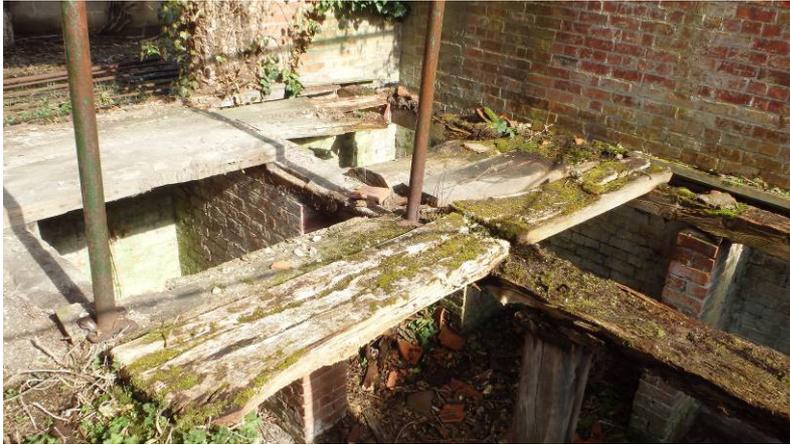
Plate 25 Timber planks and joists of sawpit, looking northeast

The timber would have been positioned longitudinally over the pit at Belton, perhaps using iron 'dogs' to position it on the boards which cross the pit, as in Sturt's account. The weight of the timber would be supported on the thick wooden planks which survive between the joists of the sawpit (Plate 25). The saw would be operated by two sawyers, one in the pit and the other standing on the timber (Figures 4 & 9). The top-sawyer was the senior, and the bottom sawyer would often wear a brimmed hat to help keep some of the sawdust from his eyes (Bailey 1994, 11). Several parallel cuts would be made in the timber before it was moved to minimise repositioning of the hefty timber. When the parallel cuts had been made the bottom handles of the saw were detached and it was lifted out. Rollers beneath the timber would be moved, the saw reinserted and the cuts continued.

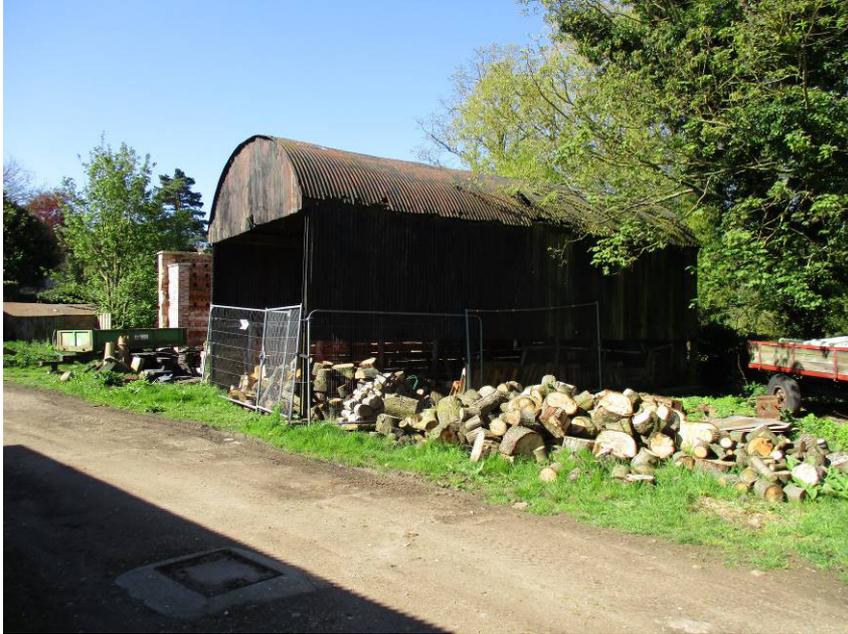
Plate 30 General view of Dutch barn from northeast

The Dutch barn comprises a rectangular east-southeast-west-northwest building with a steel and timber frame which is clad in corrugated iron with some timber walling (Plate 30). The building comprises a single space open to the roof, and is currently in use as a timber store.

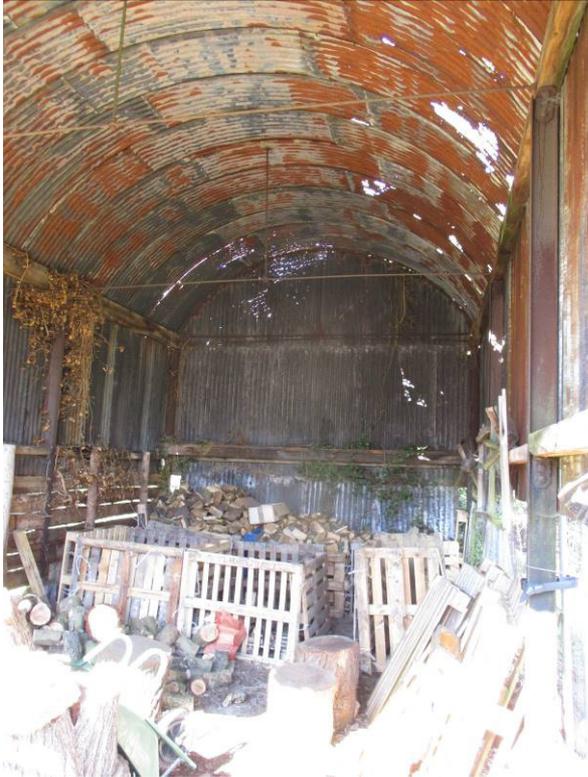
Plate 36 General view of Dutch barn interior

The structure of the barn is evident internally and comprises four vertical steel girders along each of the long sides of the building which support a horizontal timber wall plate along the length of the building (Plates 36 & 39). Each of the iron girders is set in a concrete plinth (Plate 37). The girders are also joined by horizontal timbers just above the one-third height base of the corrugated sheet walling (Plate 36).

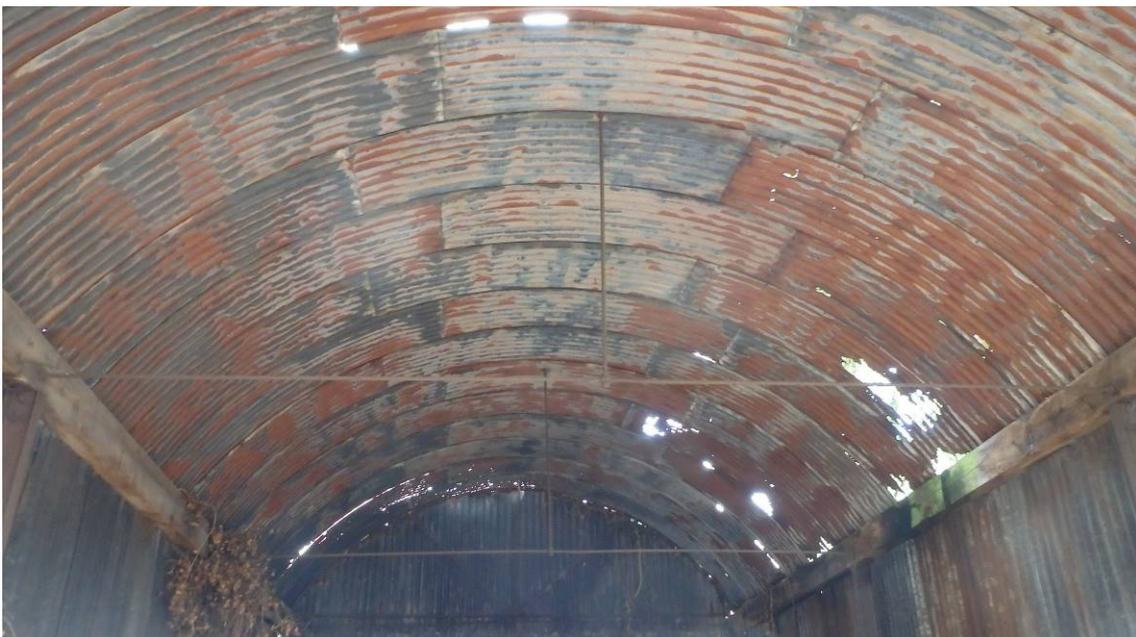
Plate 38 Roof structure of Dutch barn

Iron ties span the width of the barn, joining the longitudinal timbers above each girder (Plate 38). Each of these ties also has a central vertical member, linking the horizontal tie with the roof. The ties at the gable ends of the building also include additional angled braces (Plate 38).
