**HISTORIC BUILDING RECORDING ON
FARM BUILDINGS AT
117 STATION ROAD
SNETTISHAM
NORFOLK
(51884)**

Work Undertaken For
D.H. Williams,
Architectural Consultant to
Mr and Mrs South

November 2008

A.P.S. Report No. **123/08**

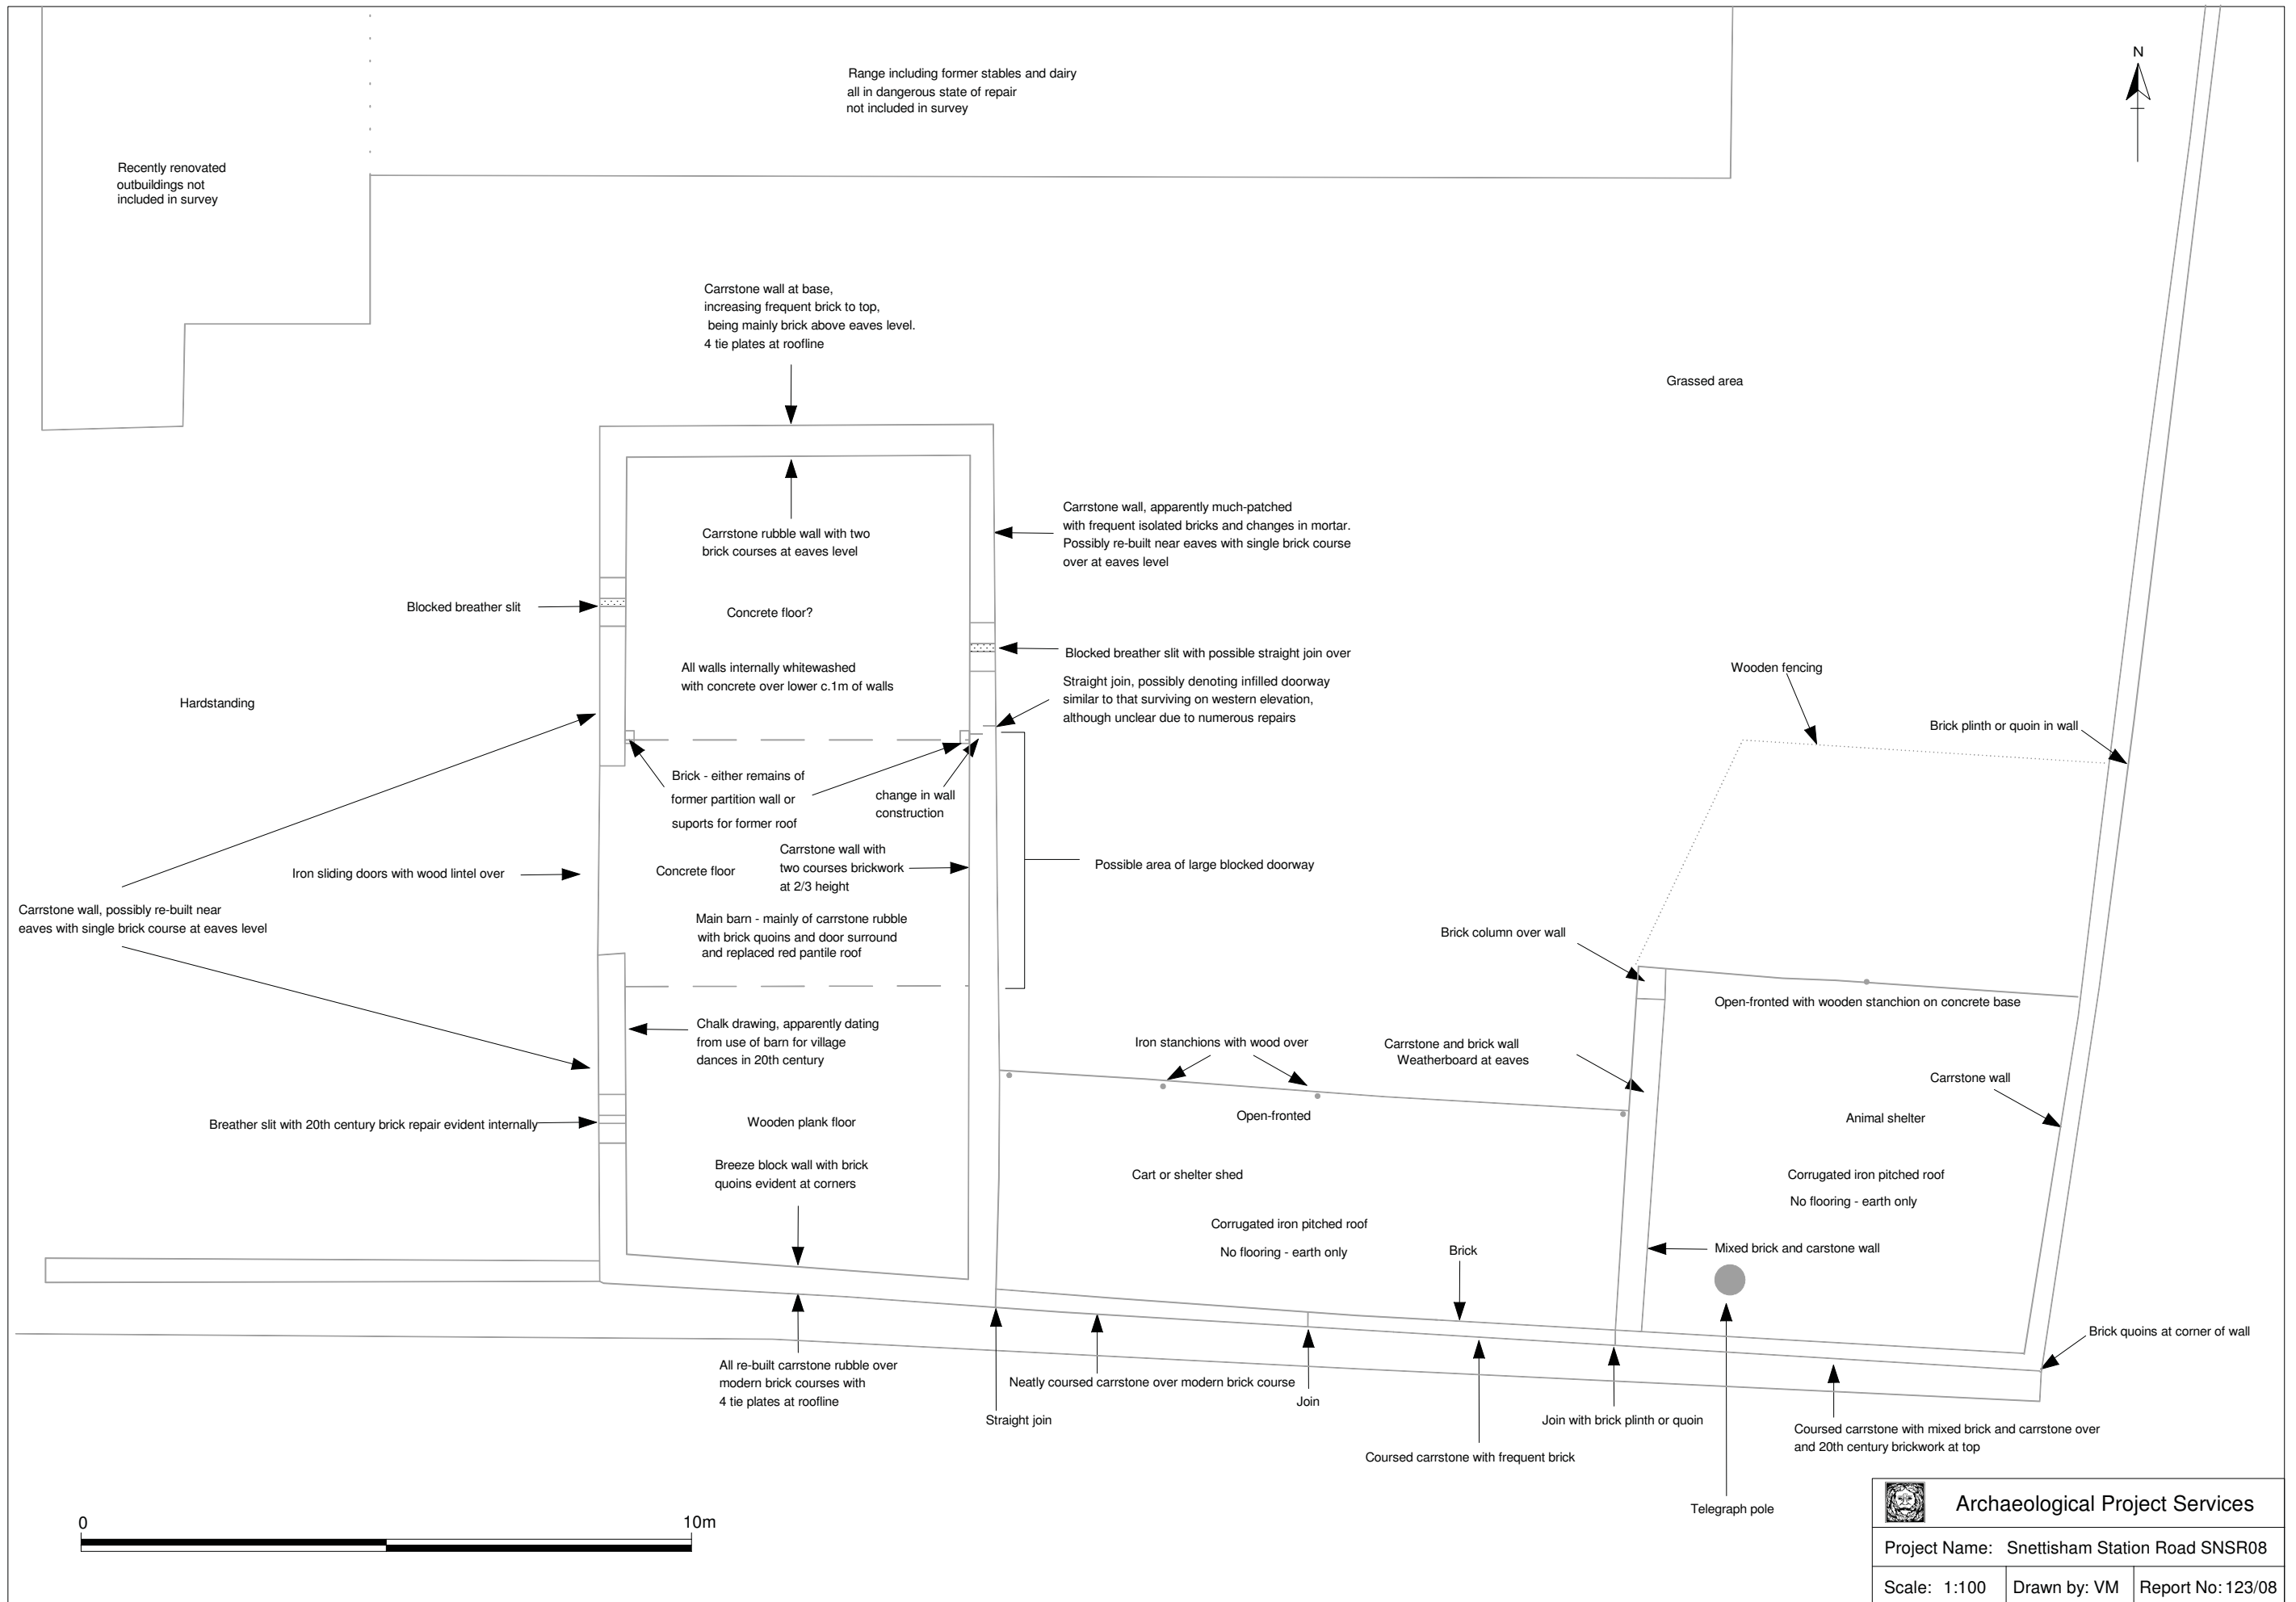
Figure 3 Plan of surveyed buildings

(Figure 3, Plates 5 & 9). Overall, this building was approximately 10.2m long by 3.8m wide.

formed part of the boundary wall of the neighbouring property and was of carrstone rubble construction (Plates 9 & 10). Brick quoins formed the southeast corner of this building. Further brick pillars or quoins were identified in the eastern wall, beyond the northern extent of the surveyed building, level with the wooden fencing (Figure 3, Plate 10). This quoining may be an indicator of the former extent of buildings in this area.

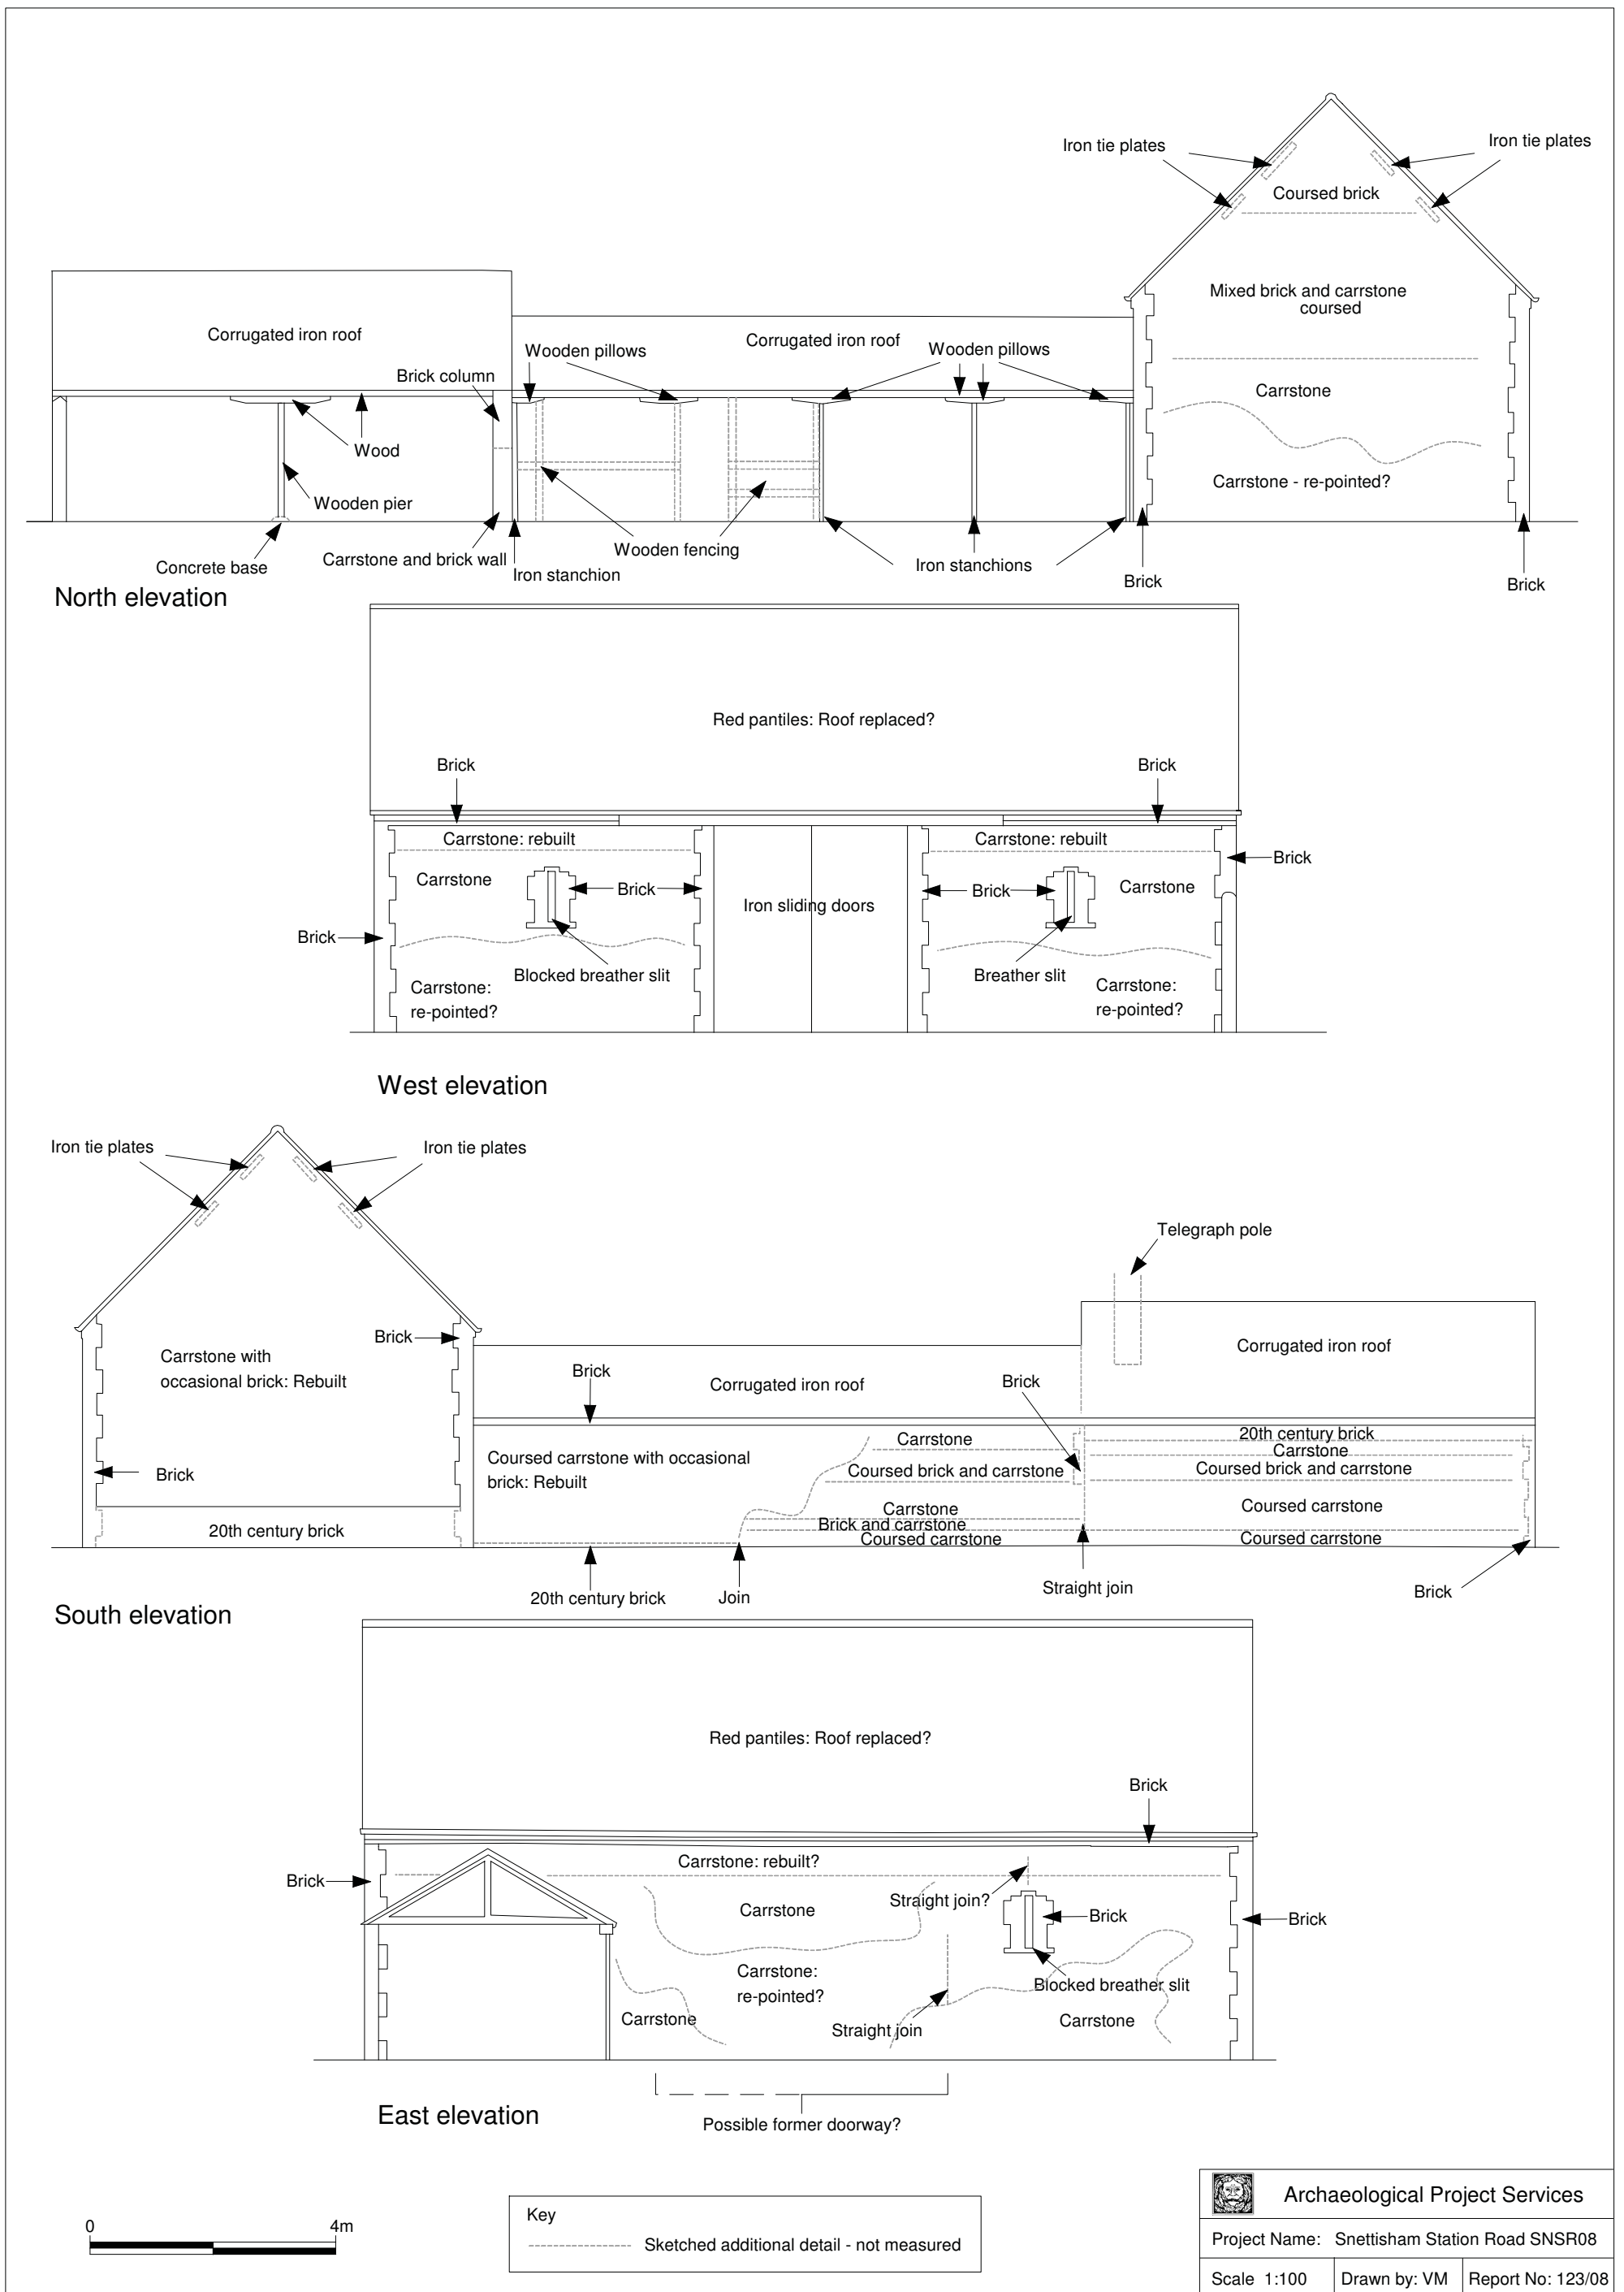
Figure 4 Elevations of surveyed buildings

The northern side of the building was open-fronted, being supported on four iron stanchions and wooden fencing (Figure 4, Plate 5). The stanchions were positioned beneath four of five wooden pillars, which may have originally topped wooden piers.

The northern side of the building was open, with the roof supported by a wooden pier on a concrete base, and the east and west walls (Figure 4, Plates 5, 10 & 11)
