**HISTORIC BUILDING RECORDING ON  
FARM BUILDINGS AT  
WARREN FARM  
SANDY LANE  
SOUTH WOOTTON  
NORFOLK  
(52880)**

July 2009

A.P.S. Report No: **66/09**

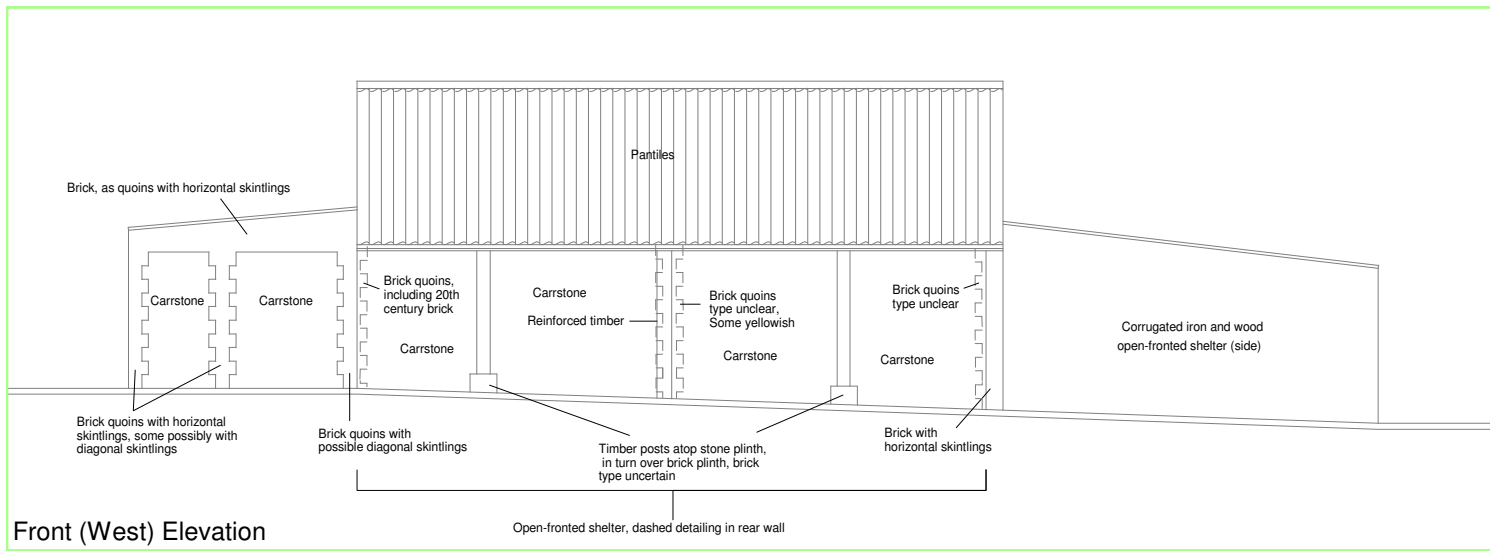
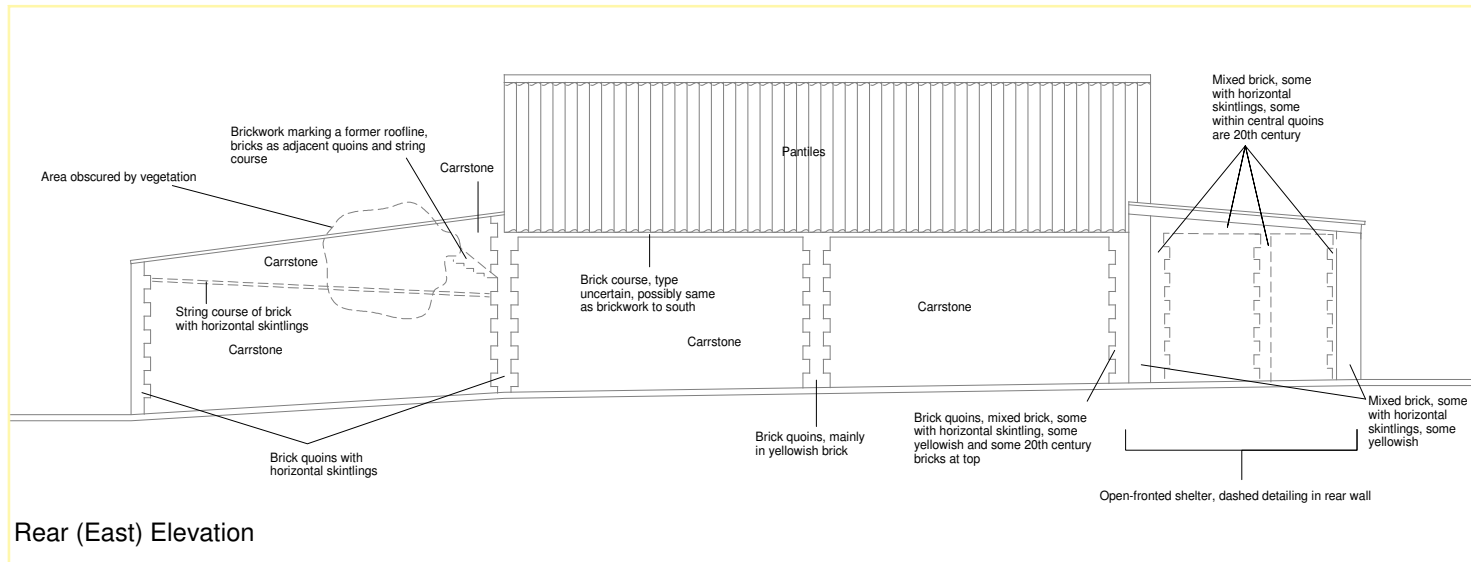
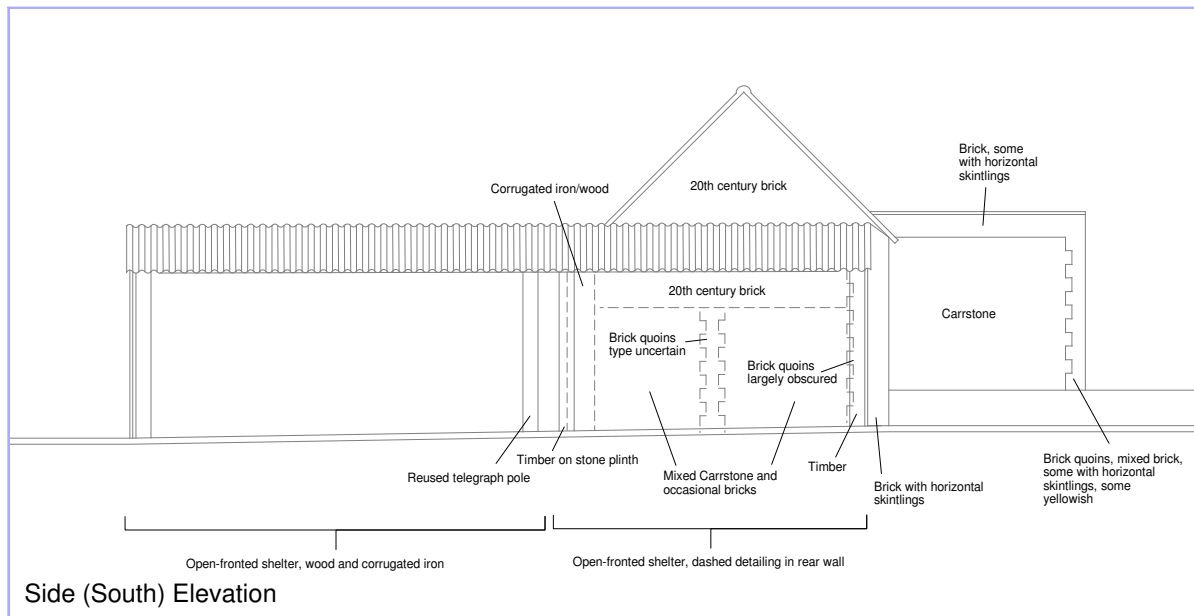
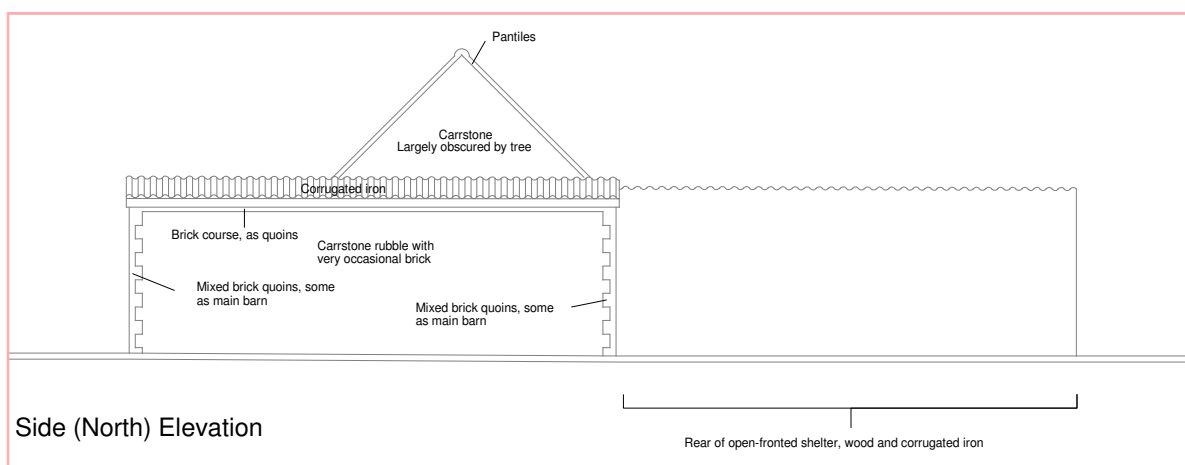
Figure 7 Elevations, eastern range

has been altered to form the modern mono-pitched roof, and may have originally been built with a gabled roof (Figure 7). The quoins at the southern end appeared unaltered, and this may be an indication of an original opening at this point in the southern elevation.

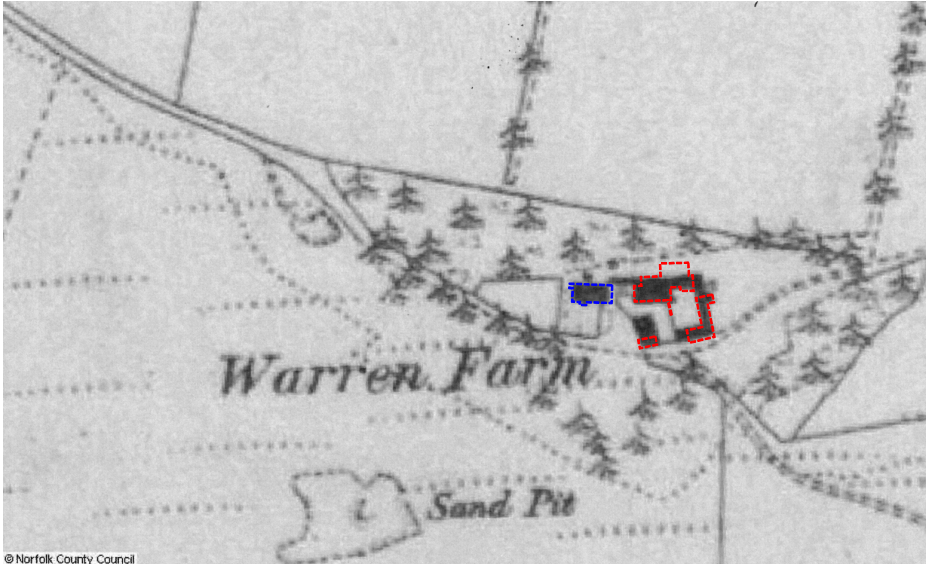
Extract from Ordnance Survey  
 England - Norfolk 033/NE  
 1:10,560 Epoch 1 (1888)  
 Source: Norfolk County Council  
 e-map explorer

A range of farm buildings is depicted on an Ordnance Survey map of 1888 (Figure 9), and comparison of the survey results to this map indicates that parts of each of the three recorded ranges were extant by this time.

A building matching the size and location of the main barn, barn porch and animal accommodation appears on the Ordnance Survey map of 1888, indicating it was extant by this time (Figure 9). A tack room, identified through its location and harness hooks, was a later addition to the

The 1888 map shows buildings bridging the north and east ranges, although no trace of any such buildings was observed during the survey, much of this area being the site of modern tractor stores.

A cartshed in the eastern range matches the location of a building recorded in the 1888 Ordnance Survey map (Figure 9). The predominant brick of the cartshed quoins was similar to that of the main barn, although the brickwork was rather more mixed. This included yellowish bricks similar to those noted in the tack room in the northern range, and it may be that the cartshed similarly post-dates the main barn. In south Lincolnshire farmsteads, the majority of such cartsheds date from the third quarter of the 19<sup>th</sup> century (Barnwell and Giles 1997, 57). This trend in the Lincolnshire examples indicates a possible date within this range for the construction of the Warren Farm cartshed, although this remains uncertain.

gabled end of an east-west range, and it is likely that this is the range depicted on the 1888 Ordnance Survey map (Figure 9).

A prominent eaves scar was evident on the northern wall of the east building, apparently part of a former building extending further to the north than the present range. The 1888 Ordnance Survey map shows a range of buildings in this location (Figure 9), and these also seem to be visible on a 1946 aerial photograph of the site (Figure 9).

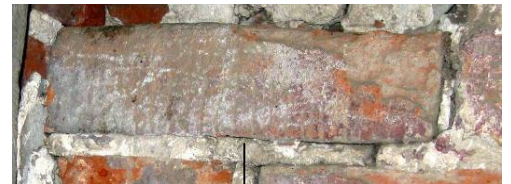
Plate 20 Detail of quoin inside barn porch, at west side of wooden doors showing vertical scratches on brick, possibly relating to number of sacks loaded or similar. Also further graffiti including initials, looking southwest.

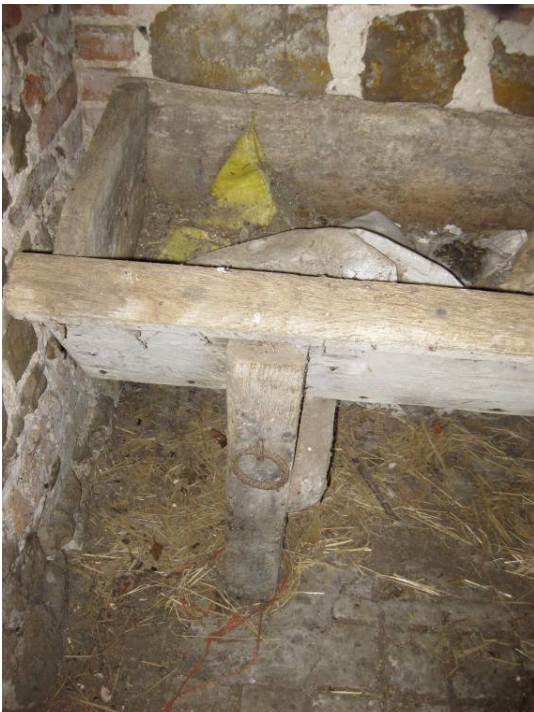
Plate 23 Interior of stable/loose box 2, detail showing wooden manger, possibly original to building, looking north

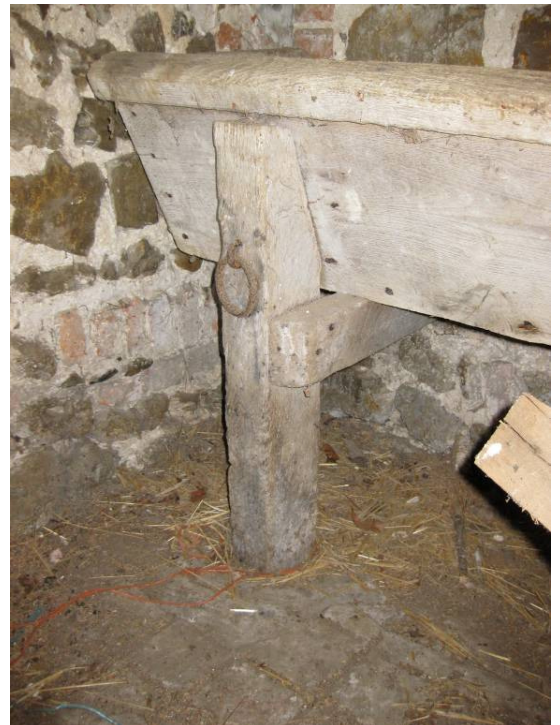
Plate 24 Interior of stable/loose box 2, detail showing wooden manger, possibly original to building and flag/tile flooring, looking northwest.

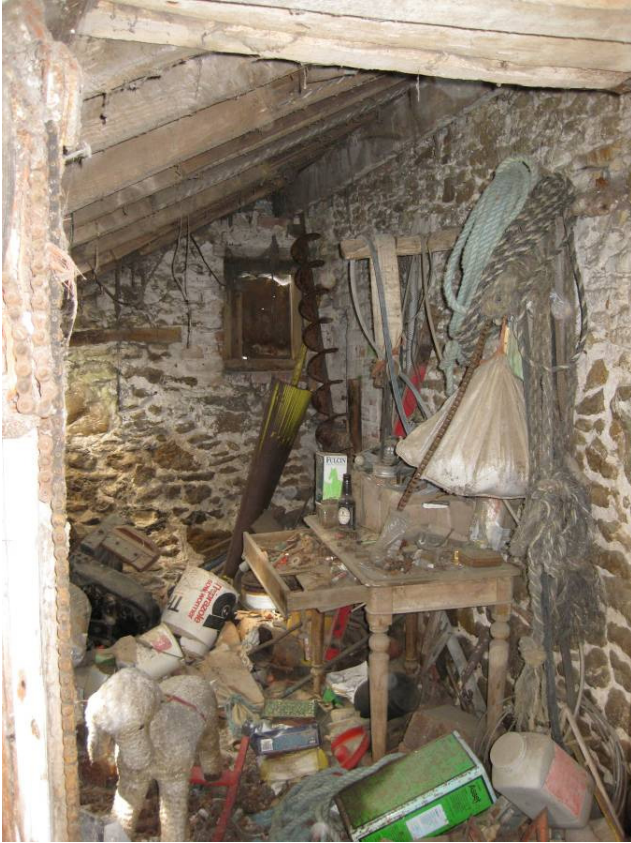
Three wooden pegs protruded from the north wall of the room, and were probably tack pegs (Plates 27 & 28).

Plate 27 General view of tack room from entrance, looking west.

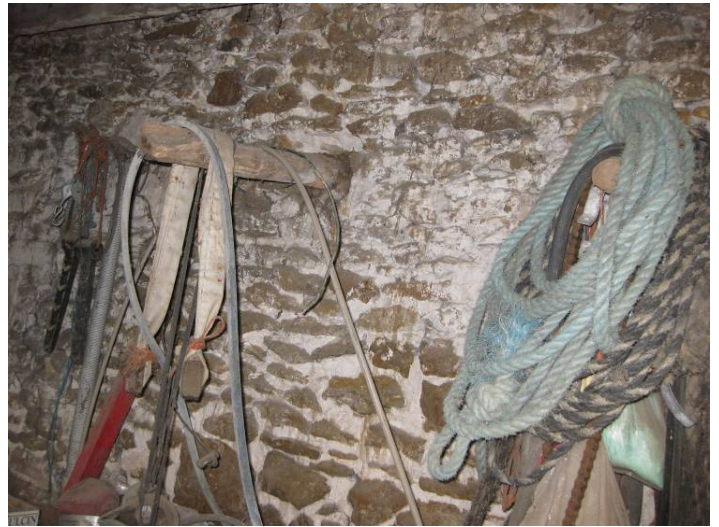
Plate 28 Detail of wooden tack pegs in north wall of tack room, looking northwest

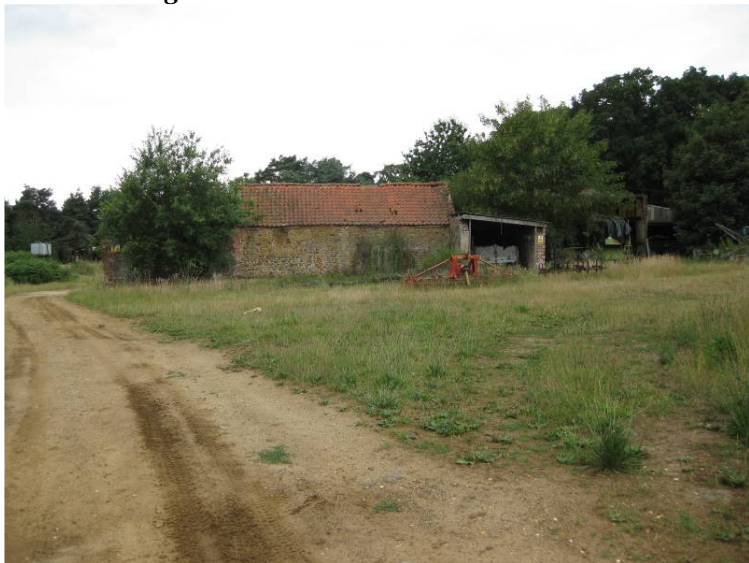
A carrstone store with brick quoins joined the northern end of the cartshed (Plates 31 & 34). This had a mono-pitched corrugated iron roof.

Plate 31 General view of eastern range, rear of cart shed at centre, looking west

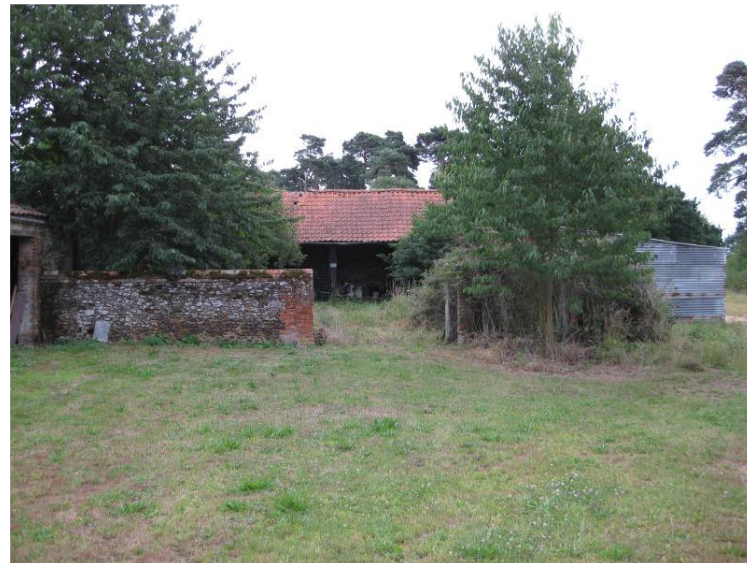
The building shared its roof with a further adjacent store to the west, the latter being entirely of modern materials (Plates 32 & 33).

Plate 33 General view of eastern range, front of cart shed at centre, looking east

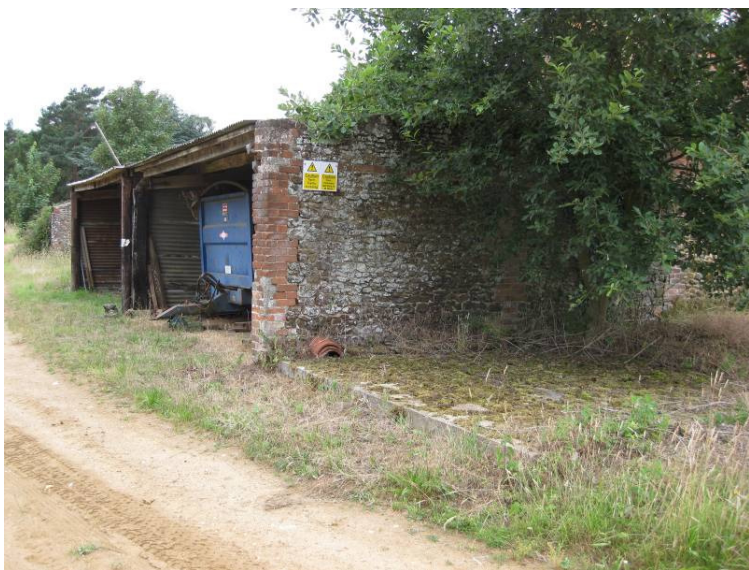
A further carrstone wall adjoined the southeast corner of the cartshed, with brick quoins between the cartshed and store walls (Plate 37). This wall formed the eastern side of a building currently used as a store, the northern side of this room being formed by the southern gable end of the cartshed (Plate 32).

At the base, this east wall may be contemporary with the cart shed, as no joins were apparent where these met (Plate 37). Above this however, some alterations to the wall were evident. A single string course of brick, similar to the bricks of the main barn, extended along the length of the wall (Plates 32 & 37). Above this, at the north end of the wall, traces of a former roofline were evident in brickwork adjacent to the end quoins (Plate 37). It seems likely that the upper part of this wall

Plate 32 Stores 2 & 3, looking northwest

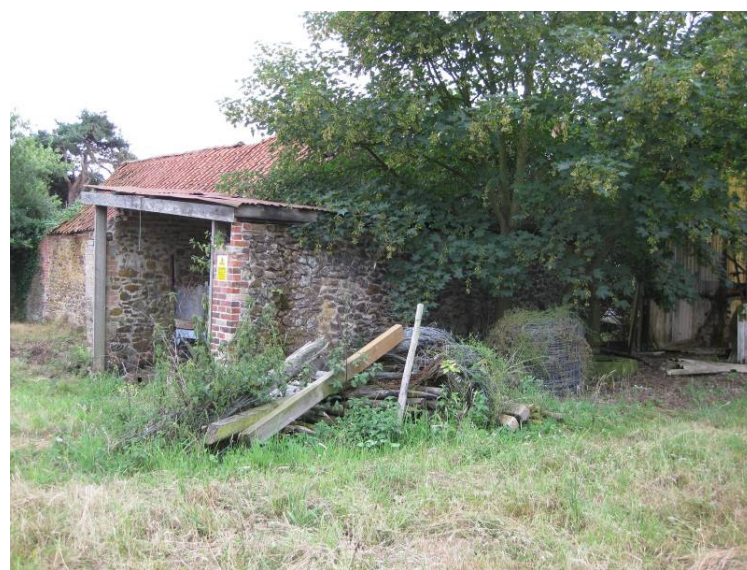
Store 1, to the north of the cartshed, had been much altered or repaired in the 20<sup>th</sup> century, but its carrstone walls suggest an earlier origin. Again a building is depicted in this position on the 1888 map, although little more can be discerned as to its original function or date.

Plate 34 Store 1, cart shed to rear, looking southwest

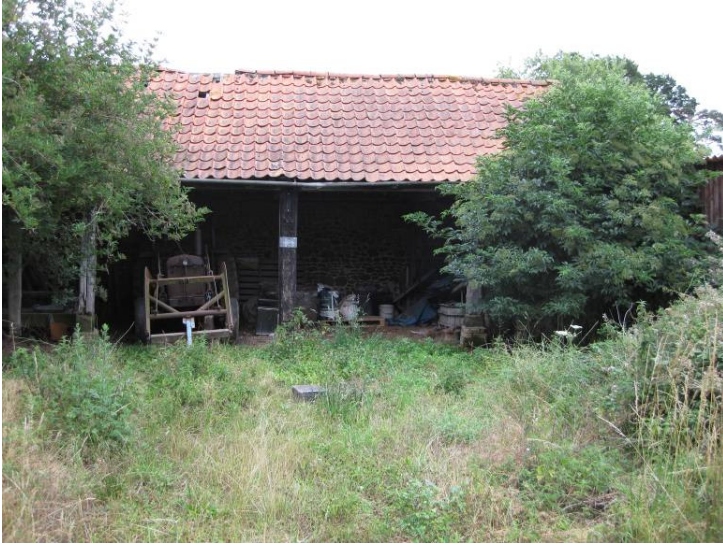
Plate 38 Cart shed frontage, looking west.

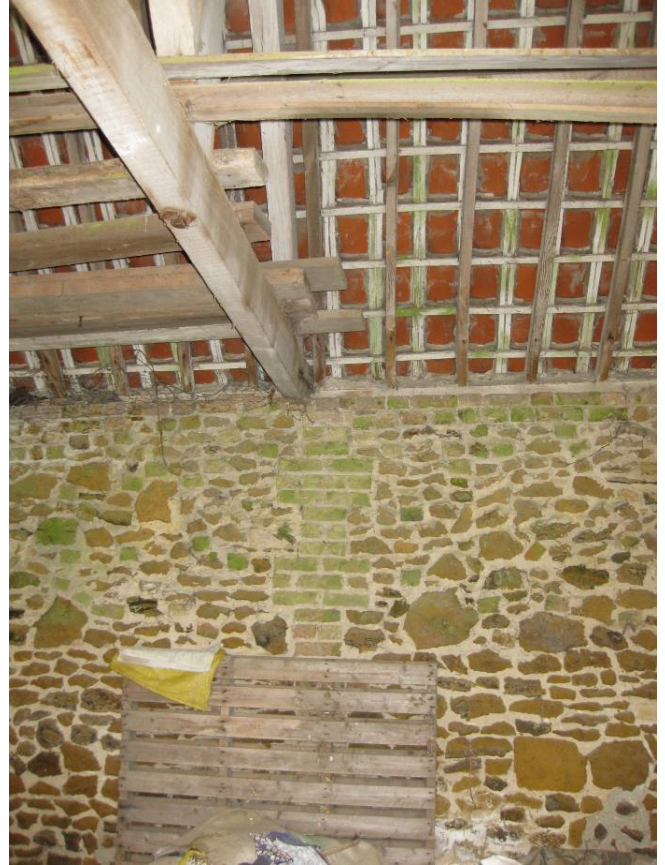
Brick quoins were recorded at each corner of the building, and near the centre of the east wall (Plates 40 & 42). The bricks used in this detailing varied, many being apparently similar to those of the main barn with horizontal skintlings being noted at the southwest corner. At the northwest corner were similar bricks, but here these had some possible diagonal skintlings (Plate 42). Occasional yellowish and irregular bricks were included in several of the quoins, whilst some 20<sup>th</sup> century bricks were noted at the northeast corner and in the southern wall. The upper half of the southern wall was entirely of 20<sup>th</sup> century brick (Plate 39).

Plate 40 Detail of east wall construction in interior of cartshed, looking east.

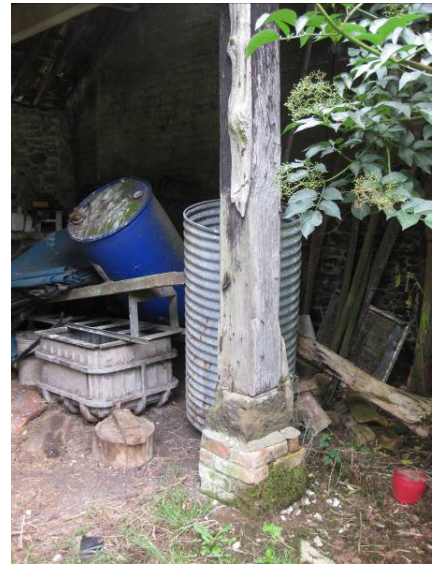
Plate 41 Detail of cartshed frontage, timber post over brick and stone plinth, looking southeast.

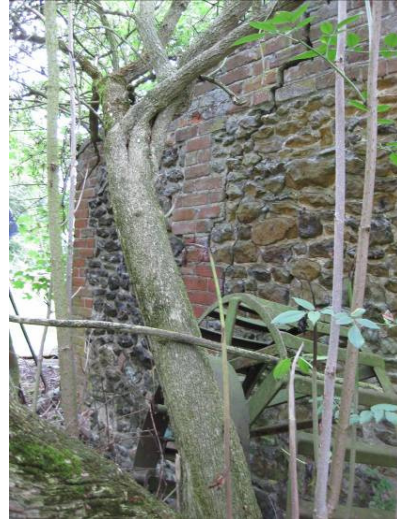
Plate 43 West wall of store 1, looking northeast

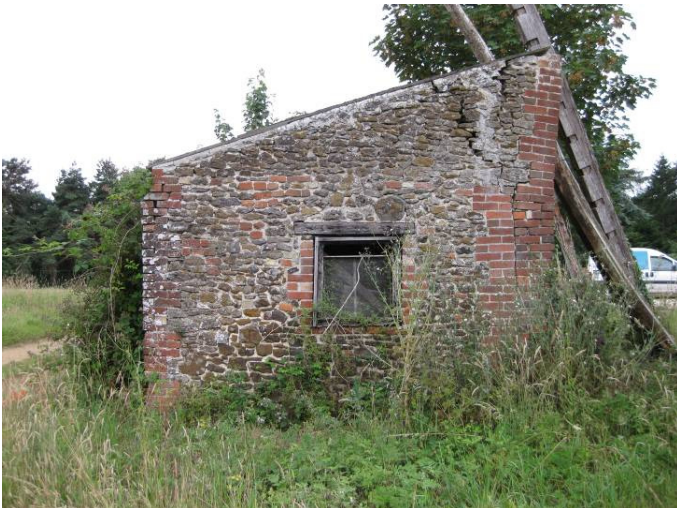
The east and south walls of the east building were predominantly of carrstone, with occasional brick fragments, and with brick quoins at the corners (Plates 44 & 45).

Two bullnose bricks near the top of the southeast quoin may indicate that the building originally had a gabled roof. The carrstone walling above this level in the east wall is apparently re-built, perhaps a further indication of this alteration (Plate 44). At the northern end of the east wall large cracks were noted, and a secondary set of brick quoins at the northeast corner may reflect an attempt to stabilise this corner of the building, or possibly to slightly extend it (Plate 44). A single window was located in the east wall, this having a timber lintel and brick surround.

Plate 44 East end of southern building, looking west.

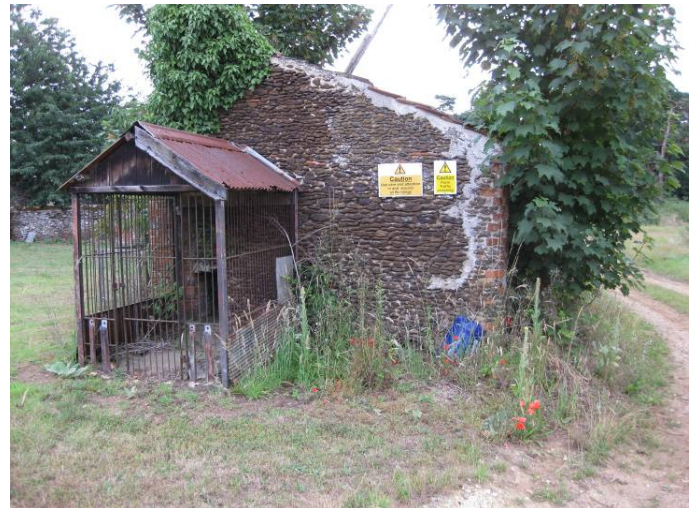
The west building was of varied construction, the southern and western walls being of carrstone rubble with brick quoins at the southeast and northwest corners (Plates 45 & 46). At the southwest corner an increased number of bricks were included in the walling, but did not form clear quoins (Plate 46).

This building had a single doorway in the southern wall, although this was overgrown and inaccessible during the survey (Plate 45). The west end had a single small opening at ground level, sufficient for an animal such as a small to medium sized dog to pass through, which led to a modern iron cage/kennel at the west (Plate 46). The west building was roofed in pantiles.

Plate 46 West end of southern building, looking east.

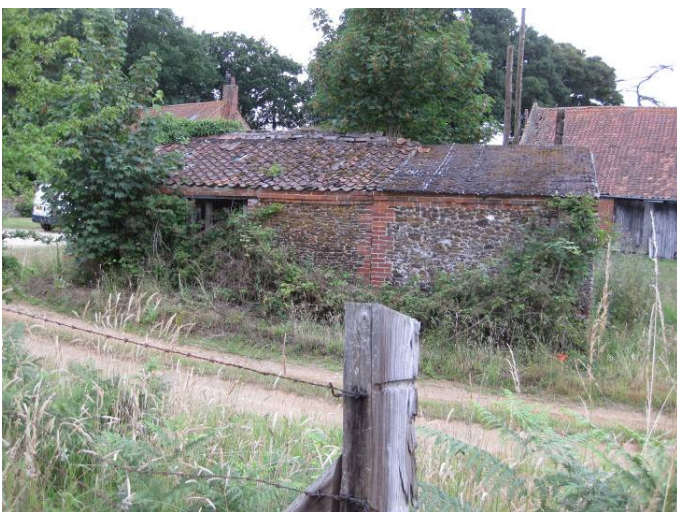
Plate 45 South wall of southern building, looking north.

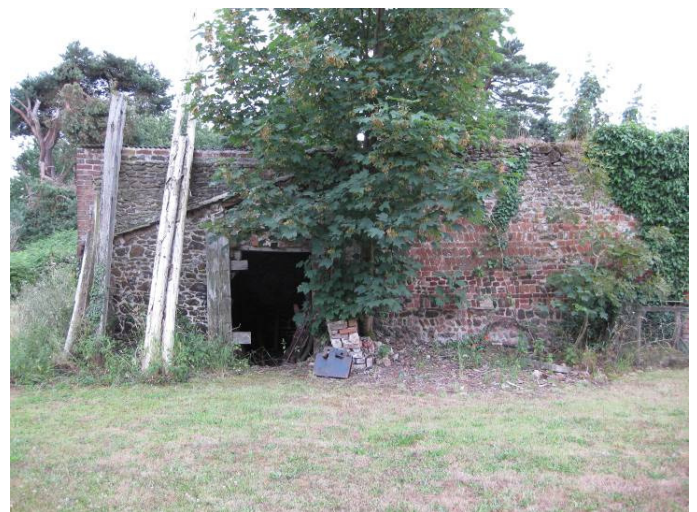
The northern wall of the west building was of rather different construction, largely comprising bricks laid in a rather haphazard manner, being in a rough herringbone arrangement (Plate 47). The upper part of this wall was predominantly of carrstone rubble.

The northern wall of the building was of uncoursed carrstone and included a doorway with a timber lintel (Plate 47). Above this carrstone walling was a prominent mono-pitched eaves scar, visible both externally and internally (Plate 47). Above the eaves scar the carrstone wall continued, and this part of the wall appeared to be an addition, possibly contemporary with the additional quoins of the northeast corner (Plates 47 & 44).

Plate 47 North wall of southern building, looking south.
