**HISTORIC BUILDING RECORDING AT
MANOR FARM
SHOULDHAM THORPE
NORFOLK
(29980)**

August 2009

A.P.S. Report No: **84/09**

**ARCHAEOLOGICAL
PROJECT
SERVICES**

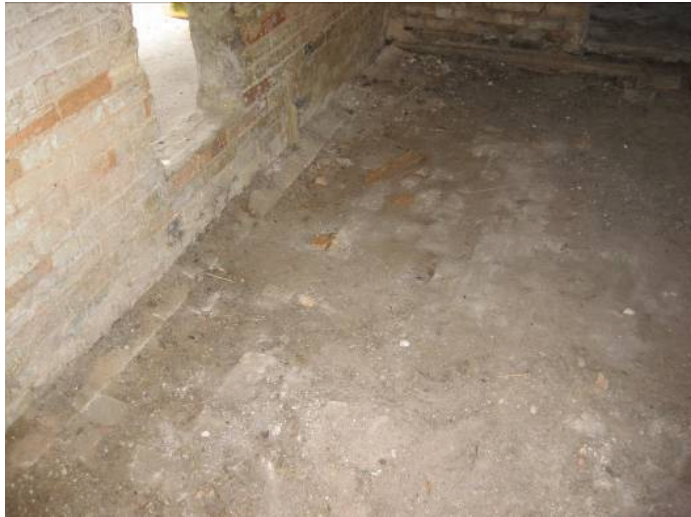
Plate 7 - Detail of brick flooring inside Room B, looking southwest

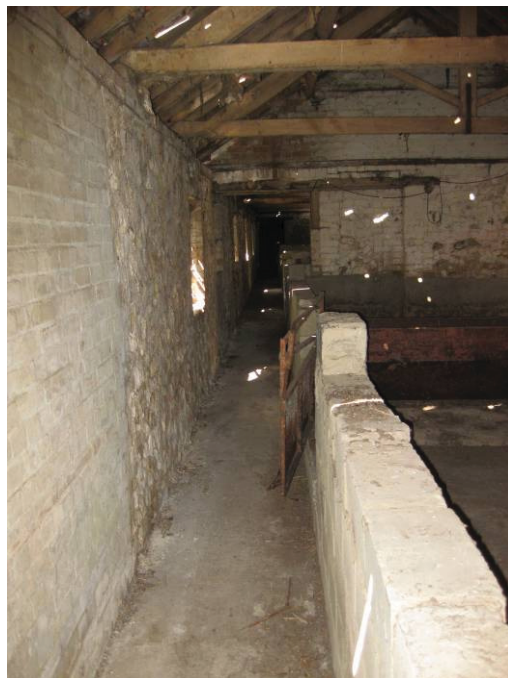
Plate 12 - Interior of Room E from southern doorway along probable original 19th century corridor route, showing modern breeze block animal pens to right, looking north

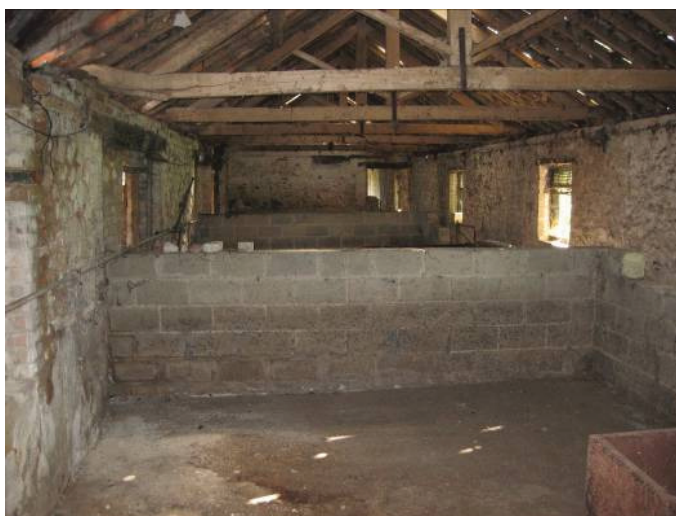
Plate 15 - Interior of Room G, showing modern breeze block pens and 19th century doors, windows, walling and roofing, looking south

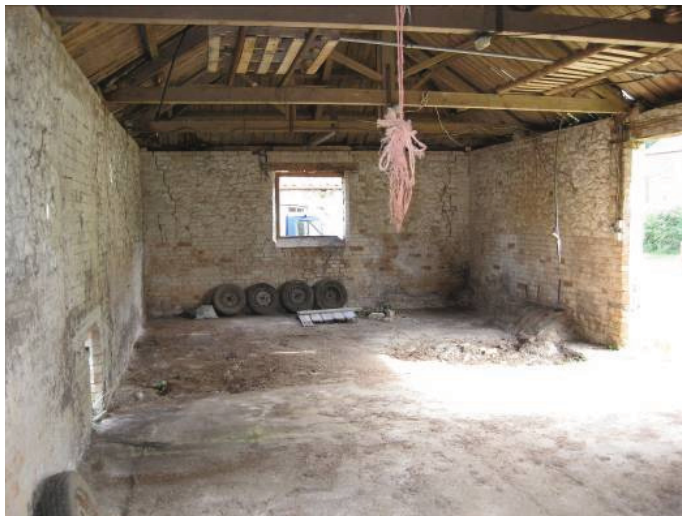
Plate 21 - Interior of Room J, looking northeast

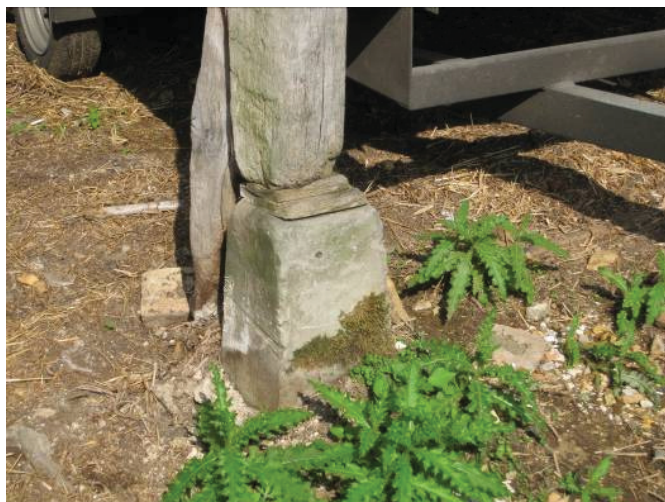
Plate 24 - Detail of 19th century stone stanchion base and timber stanchion of Shelter K, looking northwest

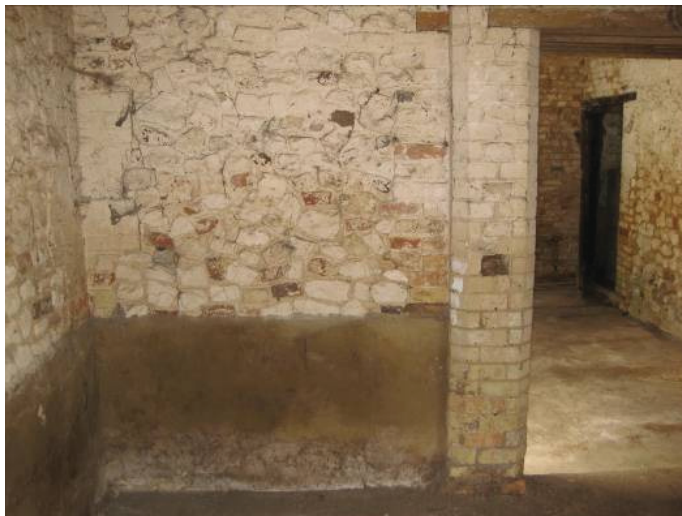
Two small holes in the walling to the east of the southern door of the room might potentially mark the position of original stalls, feed troughs or similar, although this is not clear (Plate 33).

Plate 33 - Detail of notches adjacent to doorway and near corner of Room P, possibly being traces of former structures such as feed troughs or partitions, looking south

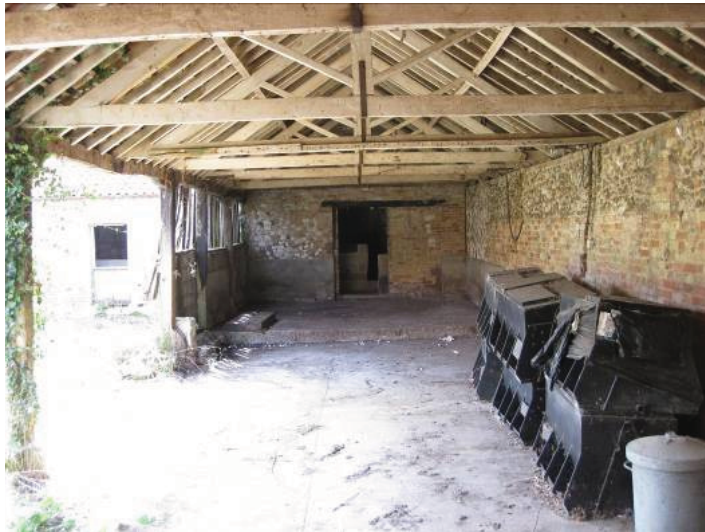
This open-sided shelter fronted onto Yard 4 (Plate 37), and included many original timber stanchions and pillows, in addition to some original stone plinths (Plates 38 & 41). The centremost stanchion had apparently been removed and a faint scar was evident in the concrete floor in line with this, indicating a former east-west partition along the centre of the shed. The stanchion may have been removed to allow parking of farm vehicles in the 20th century, or may have perished.

Plate 38 - Interior of open-fronted shelter T, showing doorway for sliding door at south, looking south

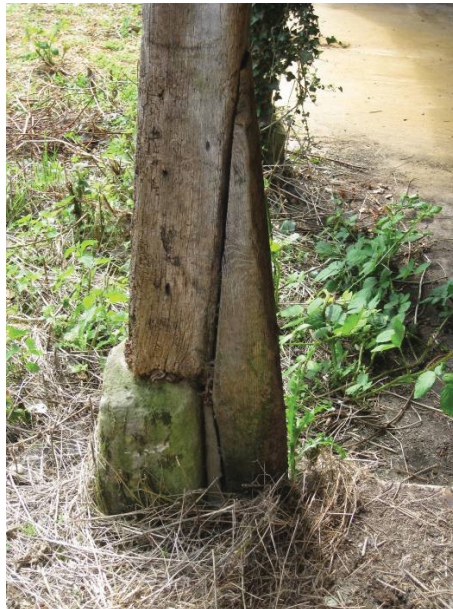
Plate 41 - Detail of original 19th century timber stanchion and stone stanchion base of open-fronted shelter T, looking southwest

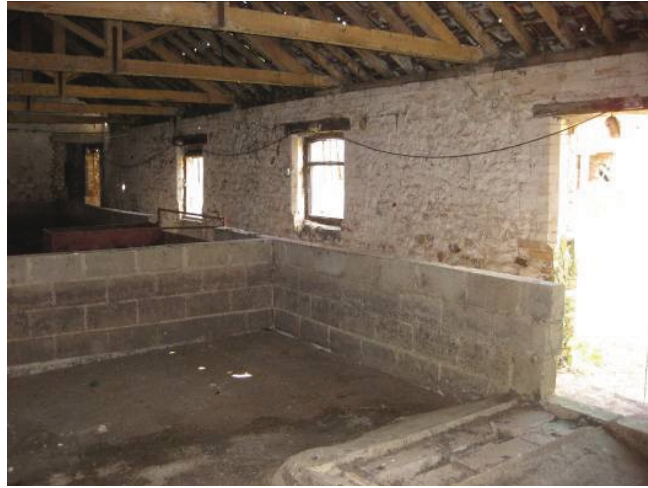
Two apparently original doorways in the northern wall did not appear to be of sliding type, although a single window in this wall was half-glazed and similar to those elsewhere (Plates 43 & 42).

Plate 43 - Interior of Room L showing original doorways and windows and modern breeze block animal pens, looking northwest

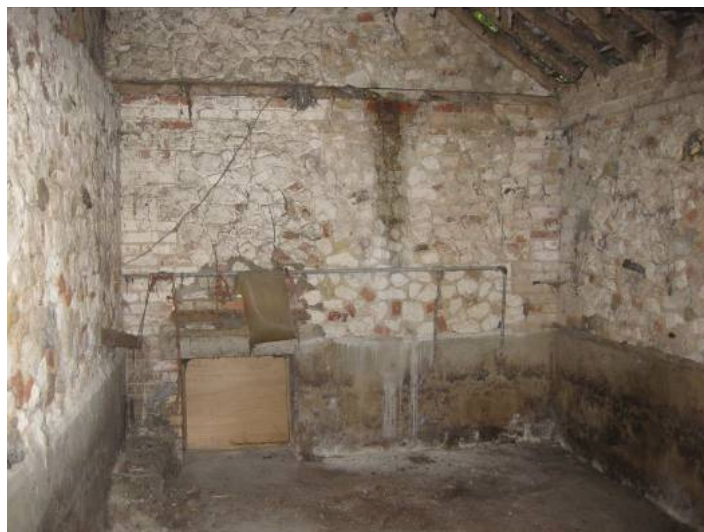
Few features were evident in this room, although it had been recently used as animal accommodation, as evidenced by a breeze block pen and low door inserted into the southern wall (Plate 45).

Plate 45 - Interior of room M, looking south

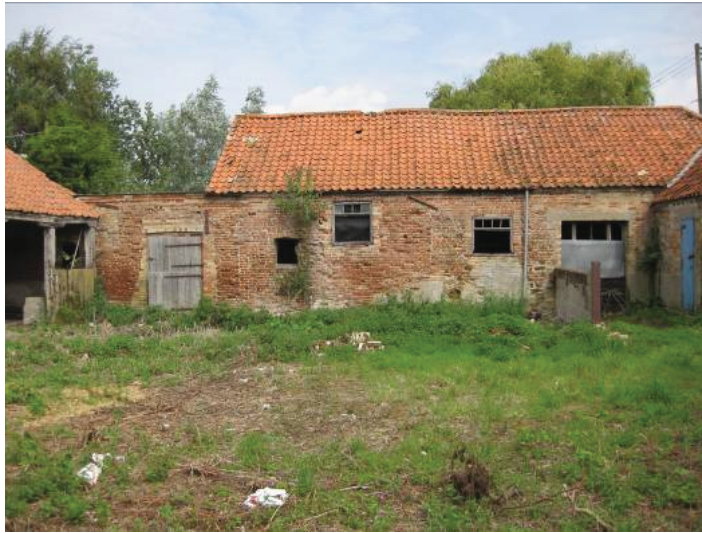
The southern wall of this room was rather complex, with several joins being apparent. Again, much of this wall was of earlier brick, with diagonal skintlings (Plates 46 & 48). At the western edge, inside shelter T, several features were evident in this wall. A small opening was a probable later insertion, but a blocked opening just above and to one side of this may be a window original to the building

At the eastern end of the southern wall of the room was a door with modern repairs, but which shared similarities with sliding doors identified elsewhere, and may have originally been one such (Plates 50 & 46). This wall includes many 19th century and modern alterations and repairs (Plates 46 & 51). These include two straight joins visible externally, the southernmost of which seems to align with the easterly internal dividing wall (Figure 4). This does not however appear to align with the straight join evident in the northern wall. A further straight join in the southern wall seems to indicate a blocked doorway, close to the westerly internal wall (Plate 51). Three windows in this wall were of uncertain age due to the use of various material and numerous repairs, although they might possibly be of 19th century date (Plate 46). This range probably initially served as animal accommodation, and this function was maintained in later phases of construction and use, with a half-glazed ventilator window inserted in the west wall.

Plate 46 - Western wall of Room S viewed from Yard 4, showing various walling, features and joins of late 18th century or earlier, 19th century date and modern dates, looking north

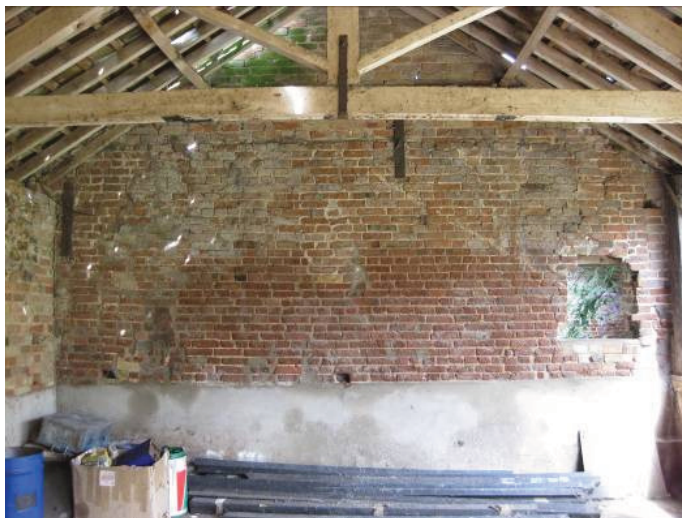
(Plate 54). A pitched eaves scar on the south of this wall attests to the former presence of a north-south building in this position, pre-dating Room T and therefore earlier than the 19th century range (Plate 48).

Plate 48 - Western wall of Room S as viewed from interior of open-fronted shelter T, including late 18th century or earlier brickwork, looking north

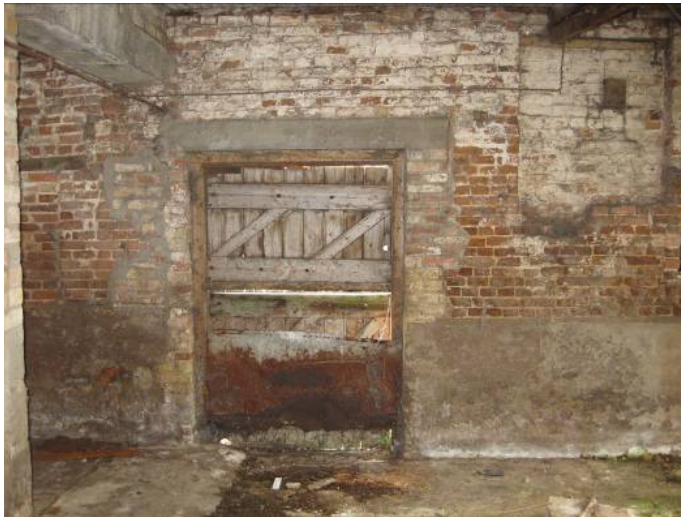
Plate 53 - Detail of southern wall of Room S showing elements of late 18th century or earlier walling and stable door of possible 19th century date

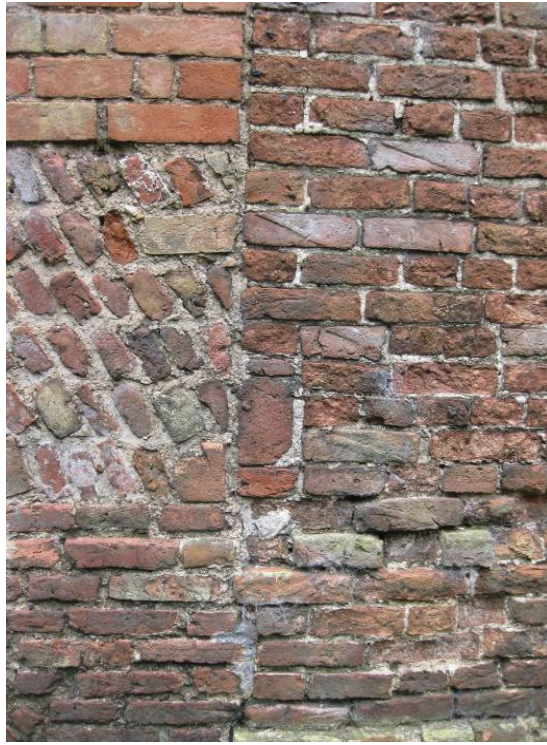
The eastern end of the room meets, in a straight join, the bulk of the remainder of the building. This greater part of the room was substantially earlier in date than the eastern section, with much of the brickwork comprising dark red bricks with clear diagonal skintlings (Plate 57).

Externally, the northern wall comprised various phases of brickwork, largely of early type but with several 20th century repairs. A clear join was evident approximately half way along the northern wall, with a distinct change in brick coursing (Plate 57). This indicates some phasing within the early building, although the sequence is unknown. Internally the northern wall of the room comprised a mix of cobble, early and later brickwork, and was somewhat confused (Plate 55).

Plate 57 - Detail of northern wall of Room S showing join in walling, 19th century bricks evident at top left, and late 18th century or earlier bricks below and to right, some with clear diagonal skintling marks, looking south
