**HISTORIC BUILDING RECORDING AT
THE OLD RECTORY
RECTORY ROAD
OUTWELL
NORFOLK
(46871)**

Work Undertaken For
Brand Associates
On behalf of
Dr G Cowley, EDC Holdings Ltd

September 2009

A.P.S. Report No: **104/09**

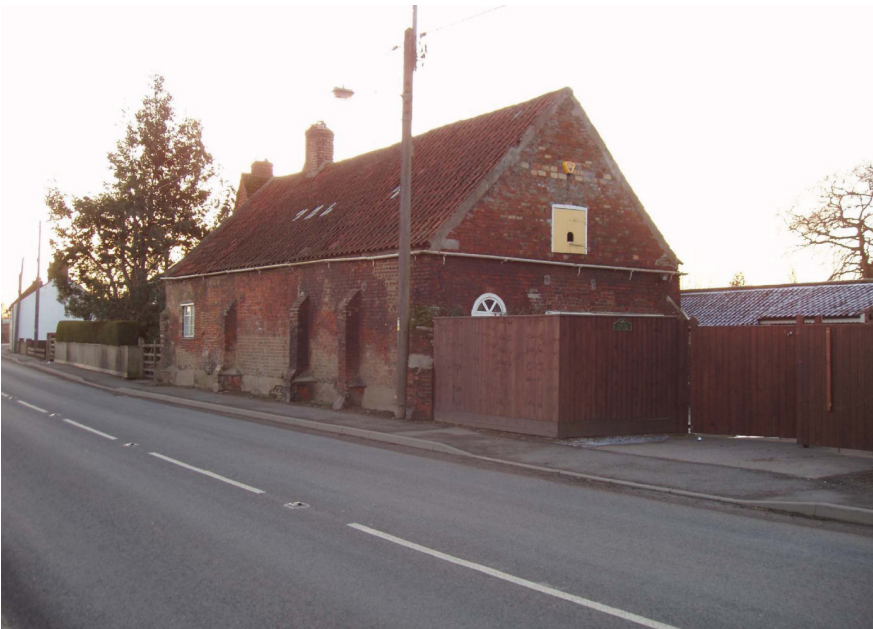
The eastern, street-side, elevation has two corner buttress and three others in between (Plates 5 and 8). All of them bond with the wall. There are inclined triangular flagstones set low in the corners between the buttresses and wall. The outer sides of the second and third buttresses from the south end are square to the elevation but their inner sides are angled to the wall. On the south side of the central buttress is a possible straight join (Plate 6). The top of this buttress overlaps a circular tie plate.

Plate 5 North and east elevations, looking southwest

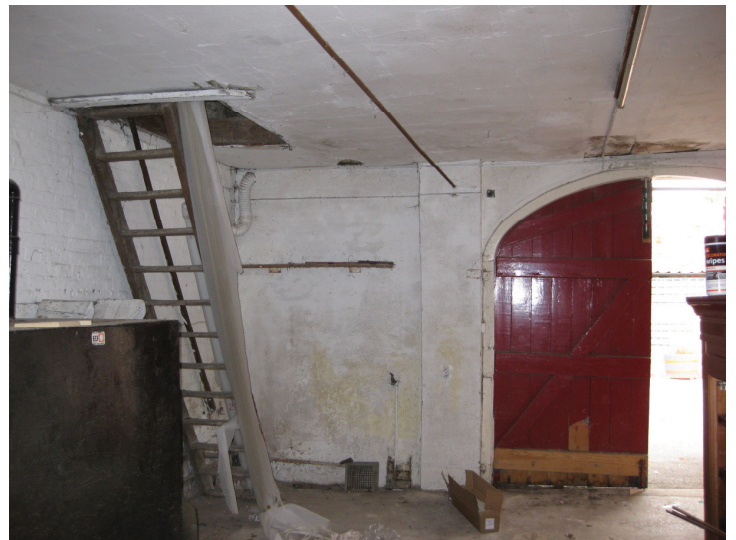
Entered by the double doors on the west side (Plate 10), the southern (accessible) ground floor room has a concrete floor and a modern lath and plaster ceiling. All the walls are rendered except the southern, which is of late handmade brick of probable late 19th century date. The northern wall has a central door to the northern room and, above and either side of this, the ends of two sawn-off timber beams (Plate 11). To the west of the doorway is a rack of wooden pegs for coats or horse trappings (Plate 12). On the opposite, south wall, are two wooden triangular projecting supports (Plate 13), perhaps to carry horse collars or other pieces of harness. Wooden steps to the upper storey are located towards the southwestern corner of the room.

The upper floor is accessed from the stairs up from the southern ground floor room (Plate 10). As with the ground floor, the most southerly room on the first floor is incorporated in the house and inaccessible.

Plate 10 Interior of southern surveyed room, ground floor, showing main doorway and stairs, looking west

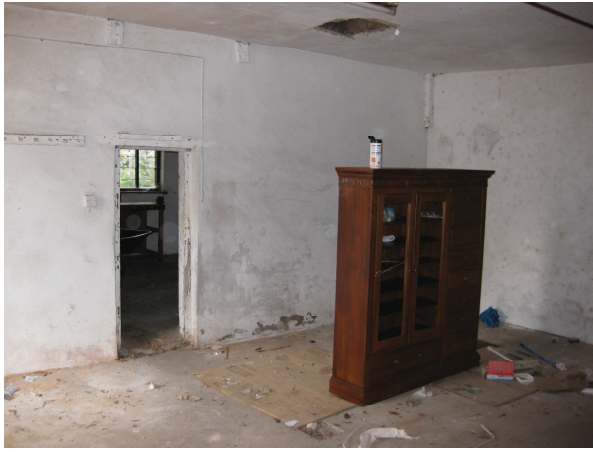
Plate 11 Interior of southern surveyed room, ground floor, showing door to north room, looking northeast

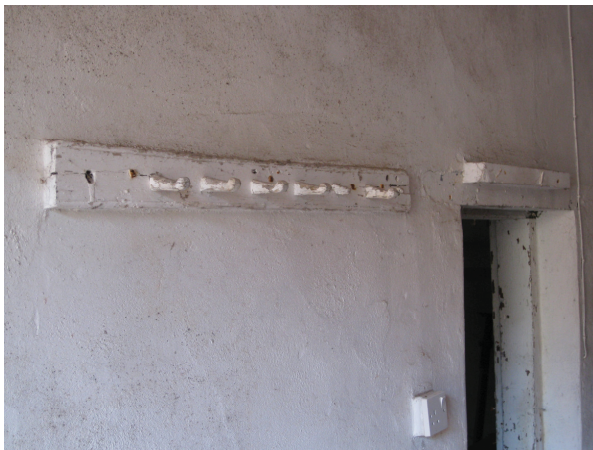
Plate 12 Ground floor, southern room, showing peg rack on north wall, looking northeast

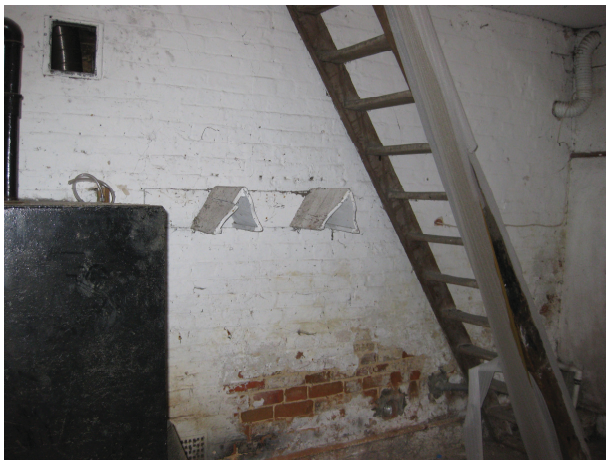
Plate 13 Ground floor, southern room, showing timber horse collar supports and stairs looking southwest

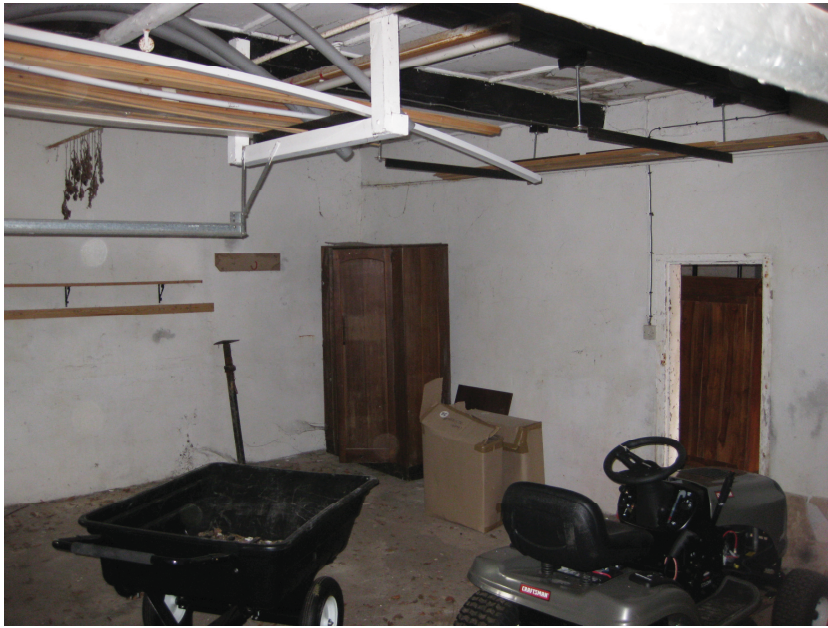
The northern ground floor room also has a concrete floor and all the walls are rendered. The north wall contains the window and garage door evident on the exterior (Plate 14). Two beams cross the room north-south at ceiling height and flank the southern doorway (Plate 15). The ceiling appears to be a 20th century replacement or refurbishment but contains a trapdoor at the junction of the western beam and south wall (Plate 16).

Plate 15 Ground floor, north room, showing beams and door to south room, looking south

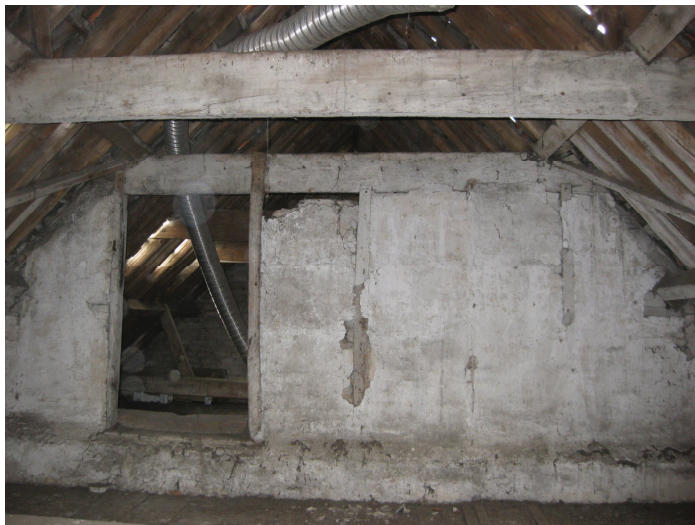
Both the north and south walls of this room are covered in render or thick whitewash (Plate 19). The north wall reduces in thickness and is set back above the level of the upper purlins (Plate 18).

Plate 19 Upper storey,
northern room, showing
partition wall between
rooms, looking south
