**HISTORIC BUILDING RECORDING
AND ARCHAEOLOGICAL WATCHING BRIEF
ON AND AROUND FARM BUILDINGS AT
ABBAY FARM
OLD BUCKENHAM
NORFOLK
ENF 125186**

Planning Application: 3PL/2007/1445/F
National Grid Reference: TM 0703 9252
OASIS Reference Number: archaeo11-95351

A.P.S. Report No: **24/11**

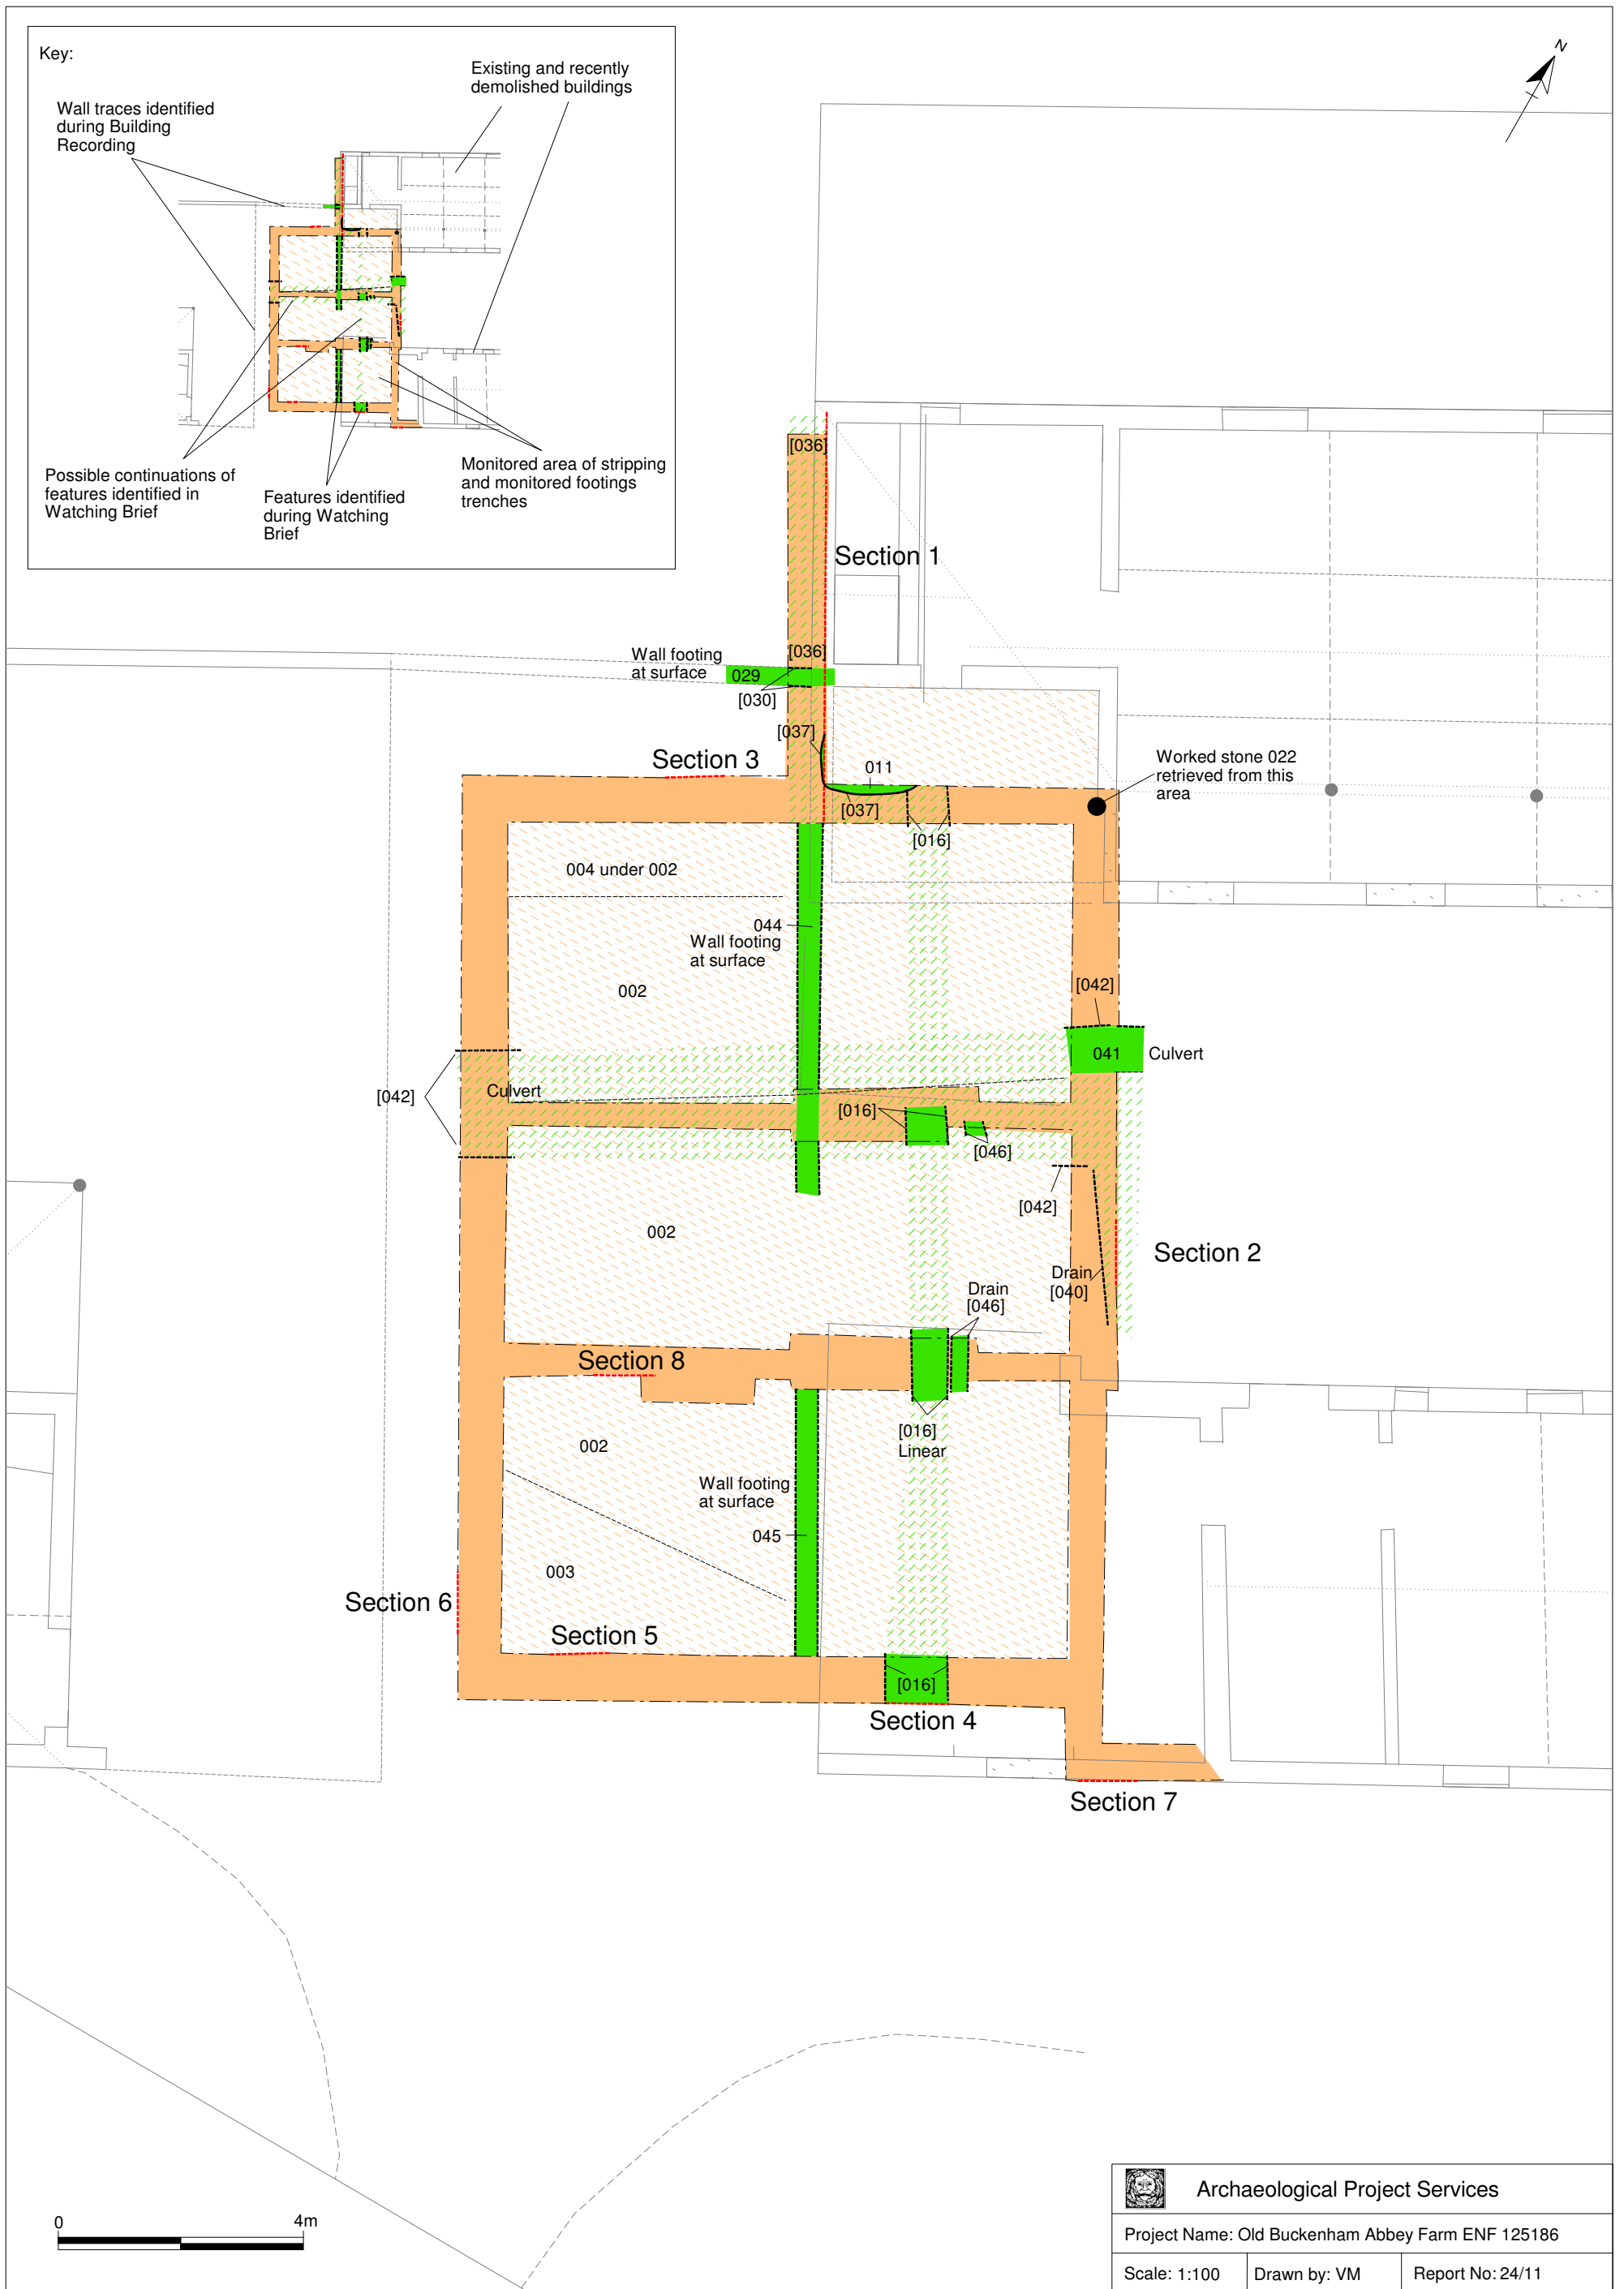
Figure 8 Plan of area monitored in Watching Brief

A pit [037] was recorded near the northern edge of the footings trenches (Figure 8, Figure 9: Section 1, Plate 45). This possibly sub-circular feature was more than 4.00m by 1.50m in area and up to 0.80m deep, with steep sides and a flattish base. The earliest fill of pit [037] was (011), a 0.31m thick deposit of soft black silty clay which appeared to have formed by natural silting, probably in standing water conditions. Sealing this was fill (035), a 0.66m thick firm mid grey, clayey silt with moderately frequent small fragments of mid red fired clay.

Possibly truncating pit [037] at its northwest side was a further feature, perhaps a ditch [036], which was over 1.80m wide and over 0.95m deep with moderately steep sides (Figure 8, Figure 9: Section 1, Plate 45). This apparently linear feature was on an approximately southwest-northeast orientation and

A northwest-southeast drain [040] was recorded, apparently draining into this manhole (Figure 8, Plate 48). This drain trench was recorded obliquely in Section 2 (Figure 9, Plate 46). Fragments of this 18th to 20th century drain were retained (Appendix 3).

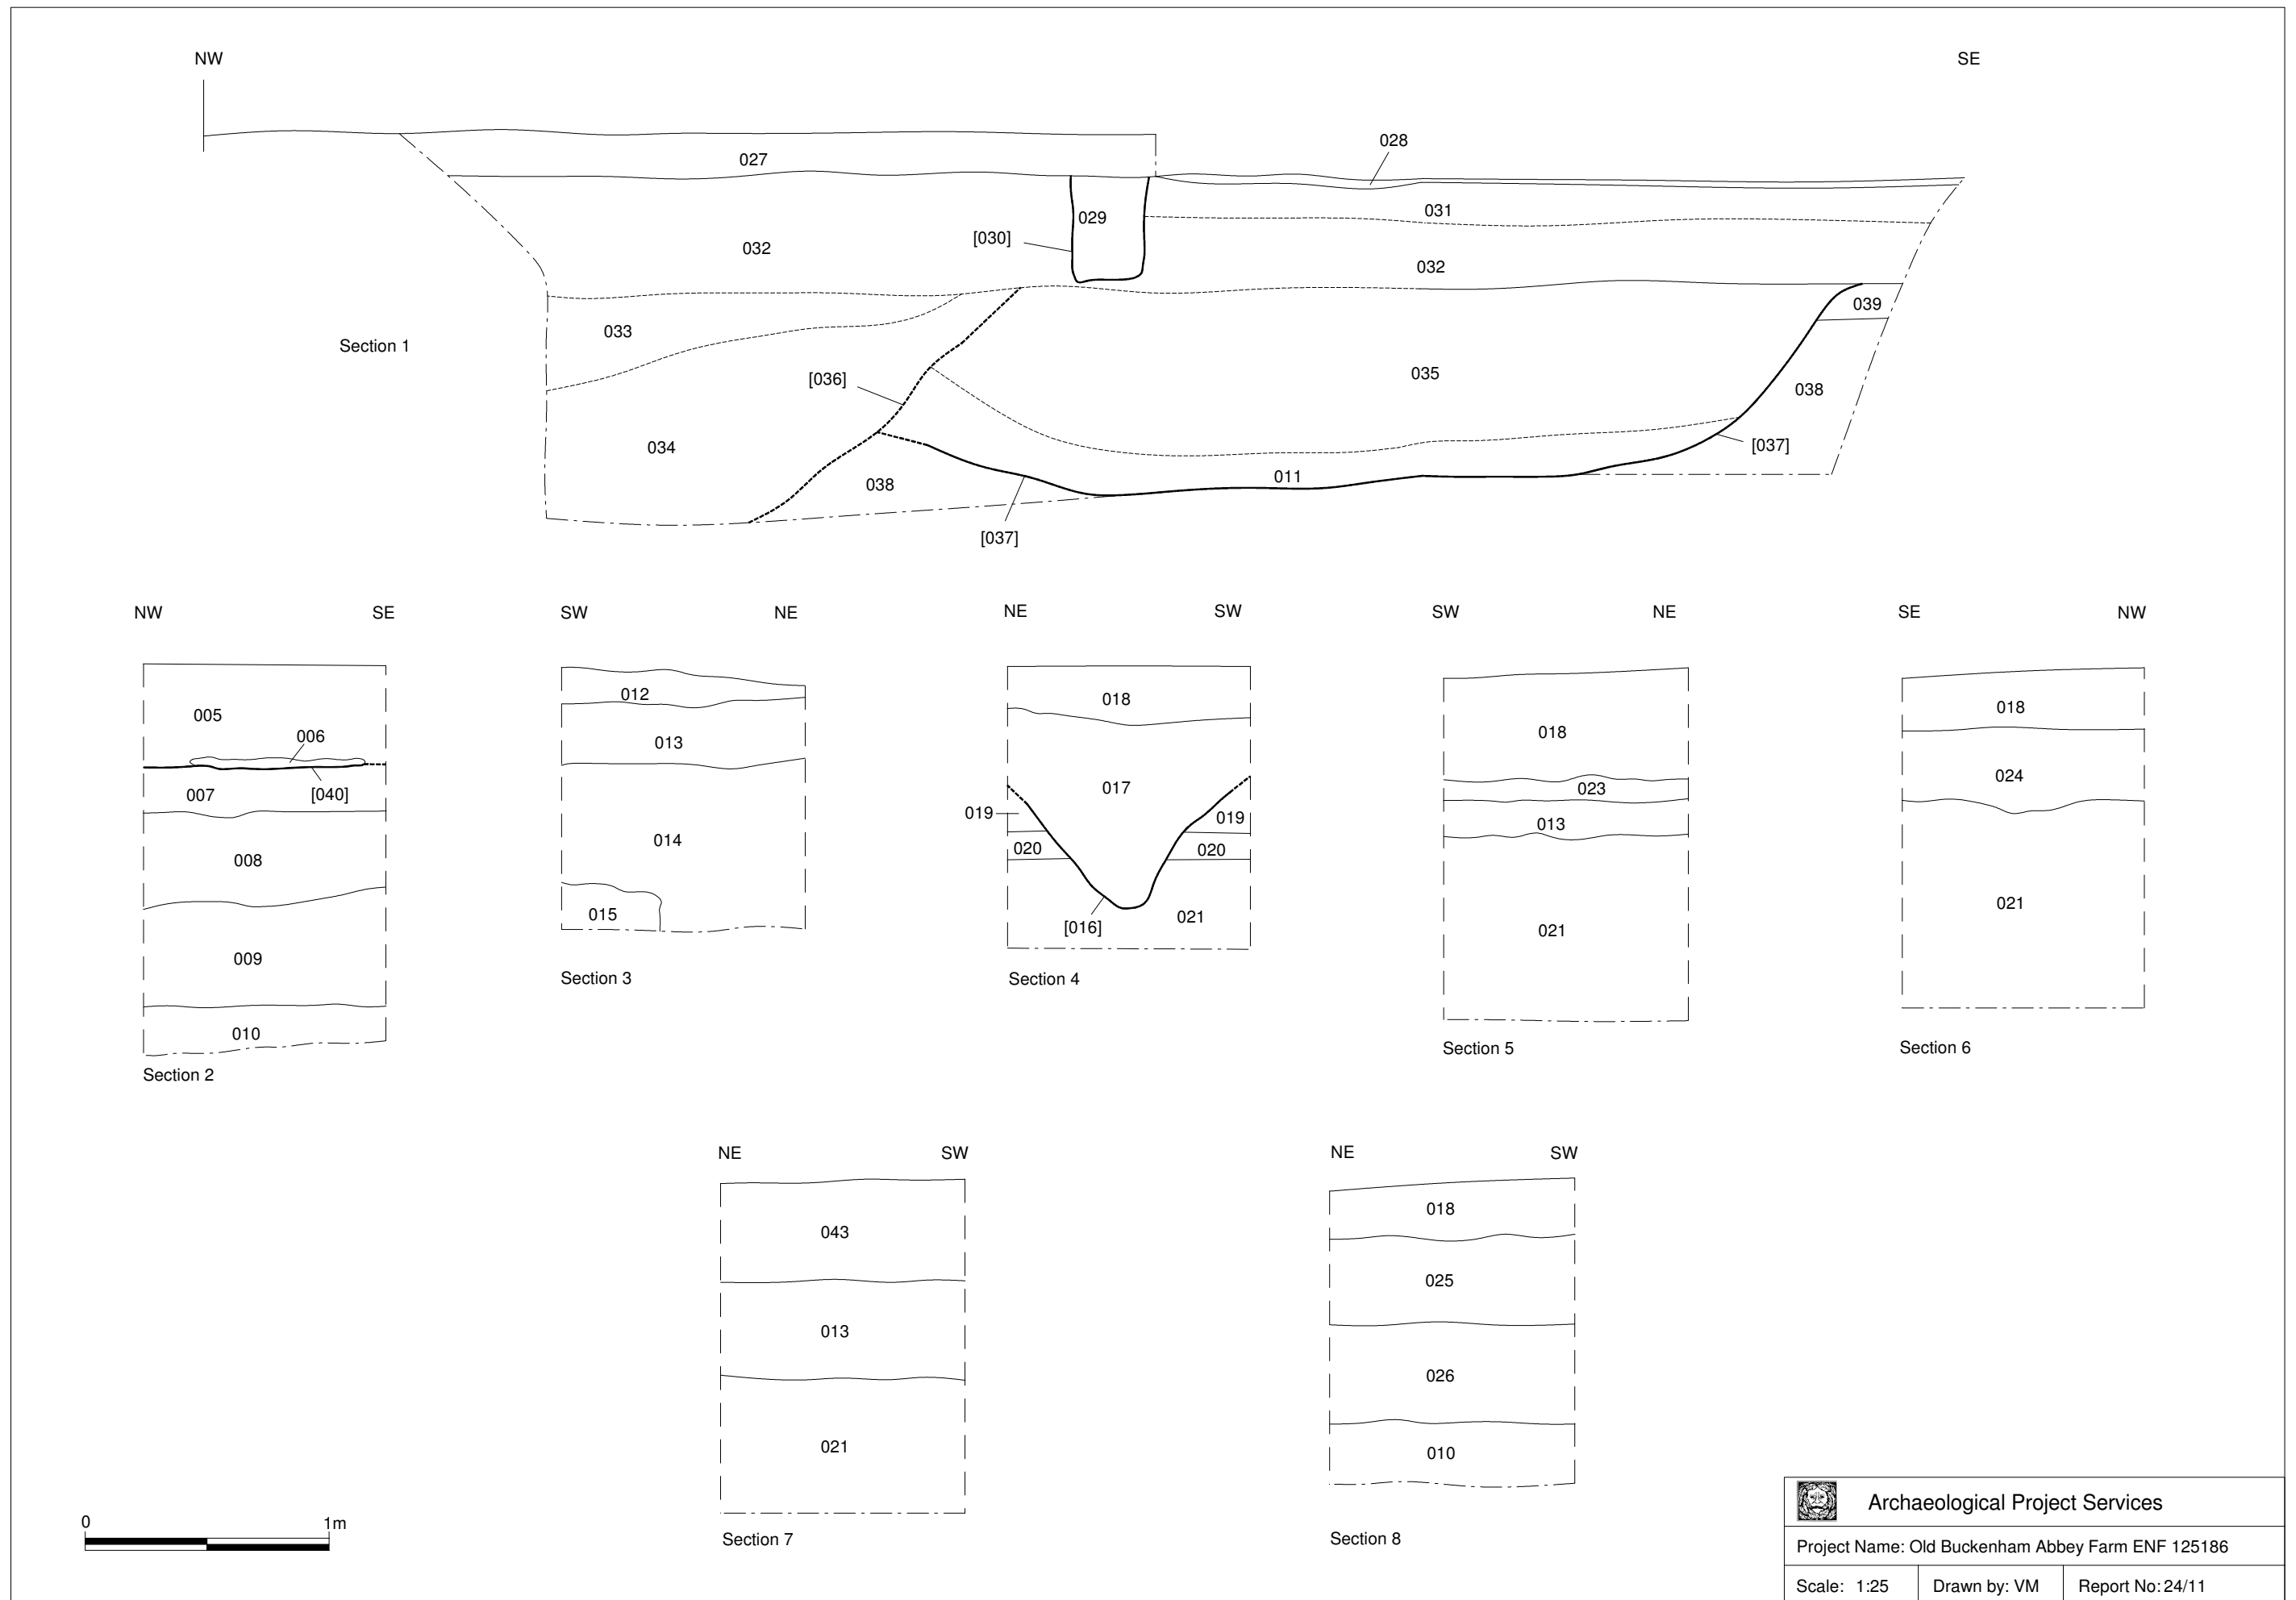
Figure 9 Sections recorded in Watching Brief

Buried soil layers were recorded sealing natural clay layers in various parts of the footings trenches. Deposit (013) was recorded in several sections (Figure 9) and comprised a 0.22m thick firm dark brown clayey silt with occasional fragments of ceramic building material and occasional chalk. Buried soil layer (039) was recorded at the north of the footings, and comprised a 0.15m thick moderately firm dark brown clayey silt.

A northeast-southwest aligned linear feature [042] was recorded crossing the footings trenches (Figure 9). This was over 1.80m wide and contained a brick culvert with a gothic arch (041) (Plates 47, 48 & 53). This culvert appeared to align with the brick arched culvert recorded in the building survey at the southwest side of Range 3 (Figure 5), and was probably a continuation of this feature. This may have continued to the northeast, close to the farmhouse itself. A brick-built manhole was identified providing access to this culvert within the footings (Plate 47).

The internal brick floor of the southeastern room of Range 1 was recorded at the north of the footings, in Section 1 (Figure 8, Figure 9, Plate 45 & 35). At the southeast end of Section 1, within a separate room of the existing buildings, was layer (028), a 40mm thick white compacted crushed chalk layer. This may have formed either a floor or a base layer, perhaps for a further brick floor (Figure 9). Chalk (028) sealed (031), a 140mm thick layer of firm to stiff mid to light olive clay. This dumped layer may have been levelling or formed a base under chalk layer (028).

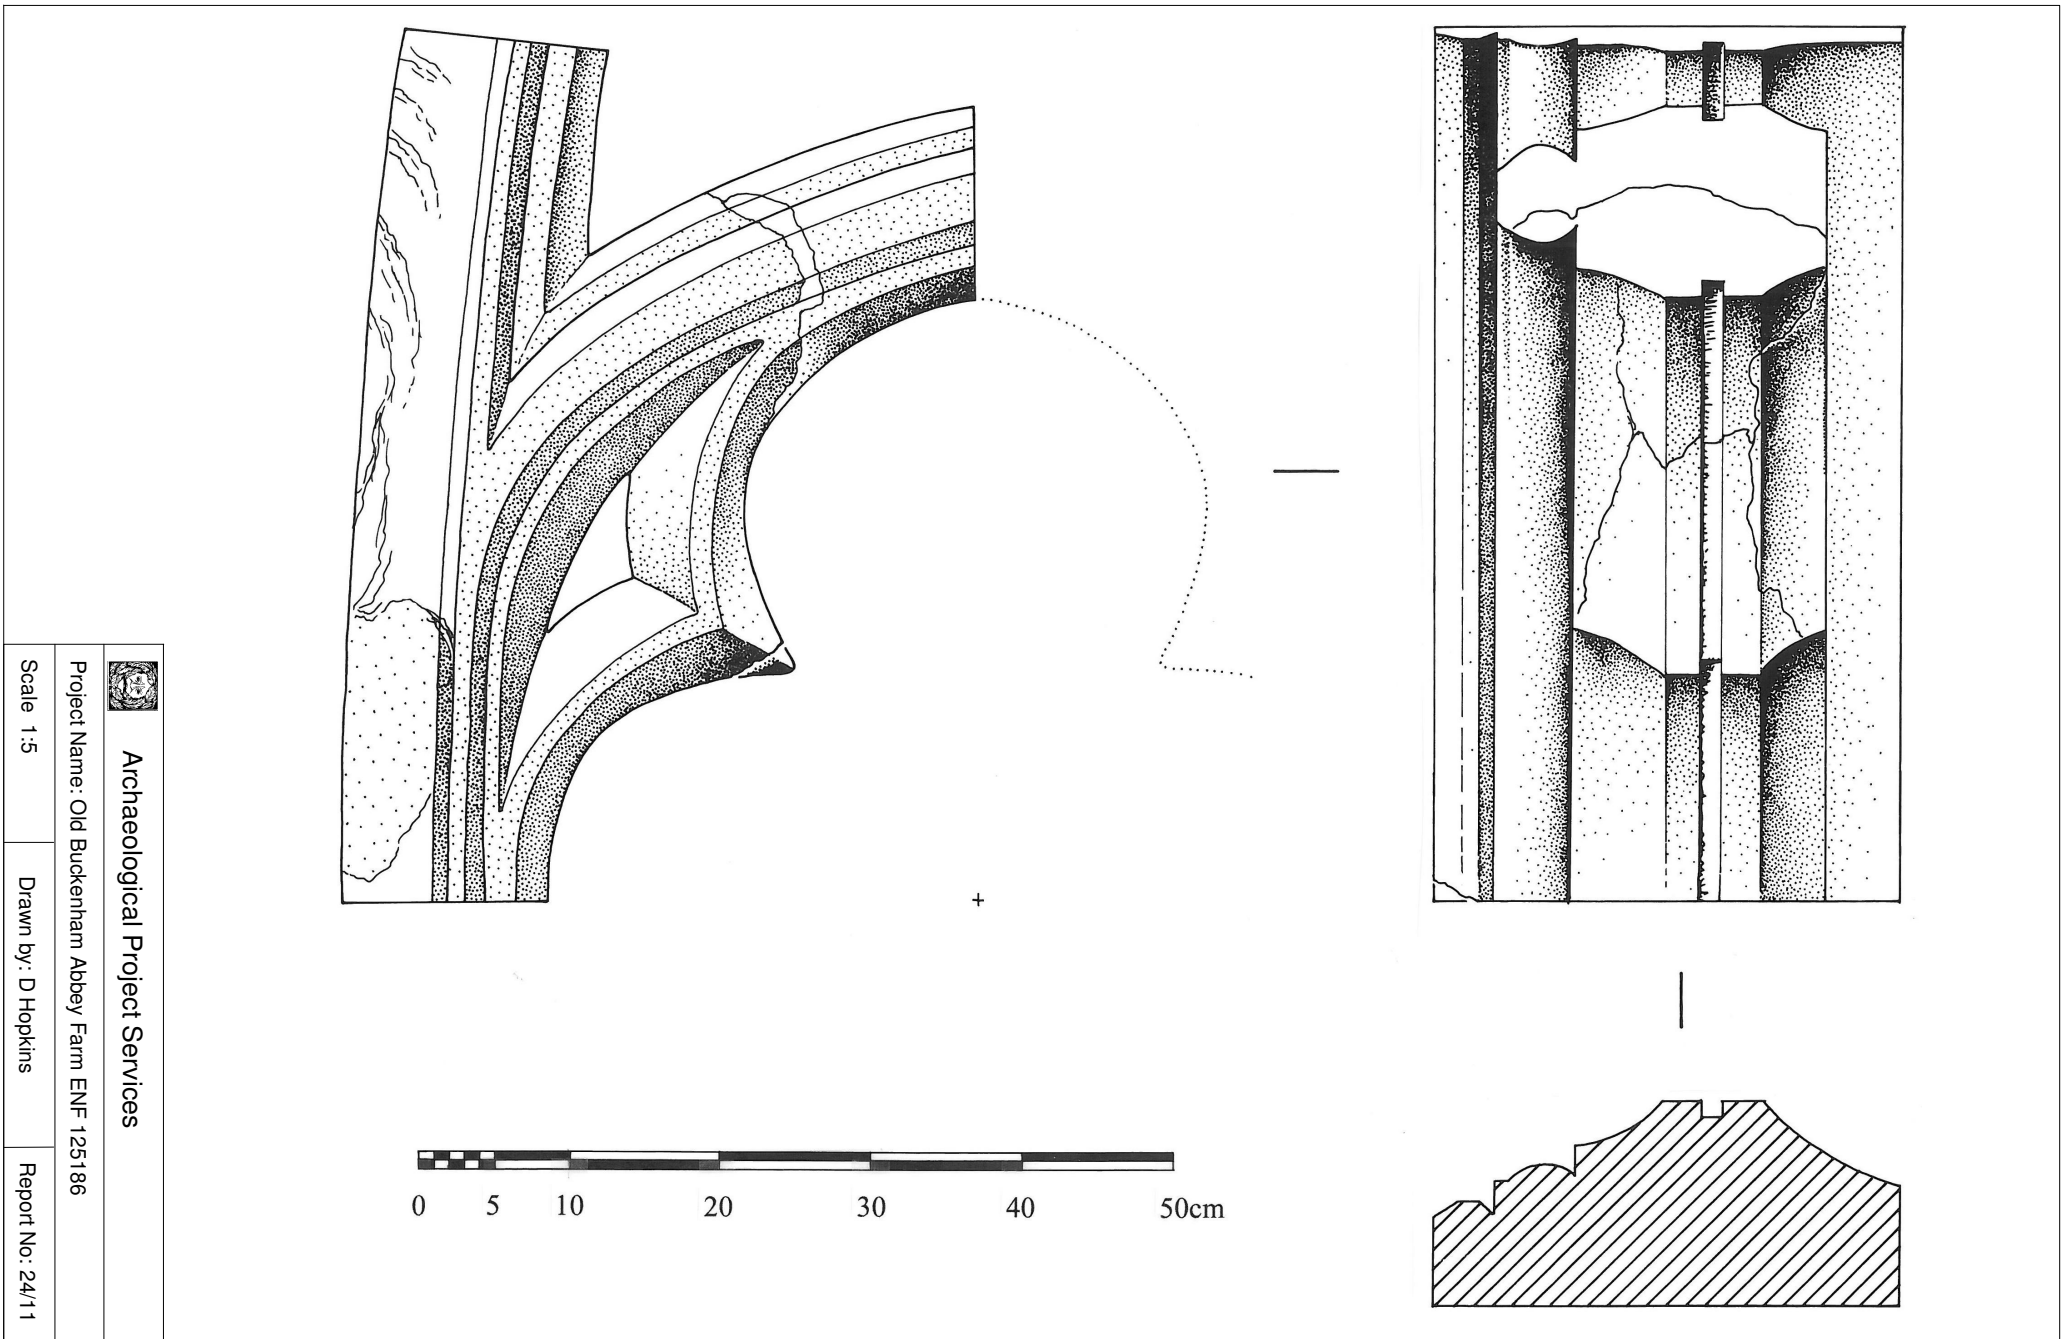
Figure 10 Illustrated arch head from traceried window (022) retrieved during groundworks

The first piece is a section of arch head from a large traceried window, and is a Late Decorated piece, likely to date to 1280-1320 (Figure 10). The second piece

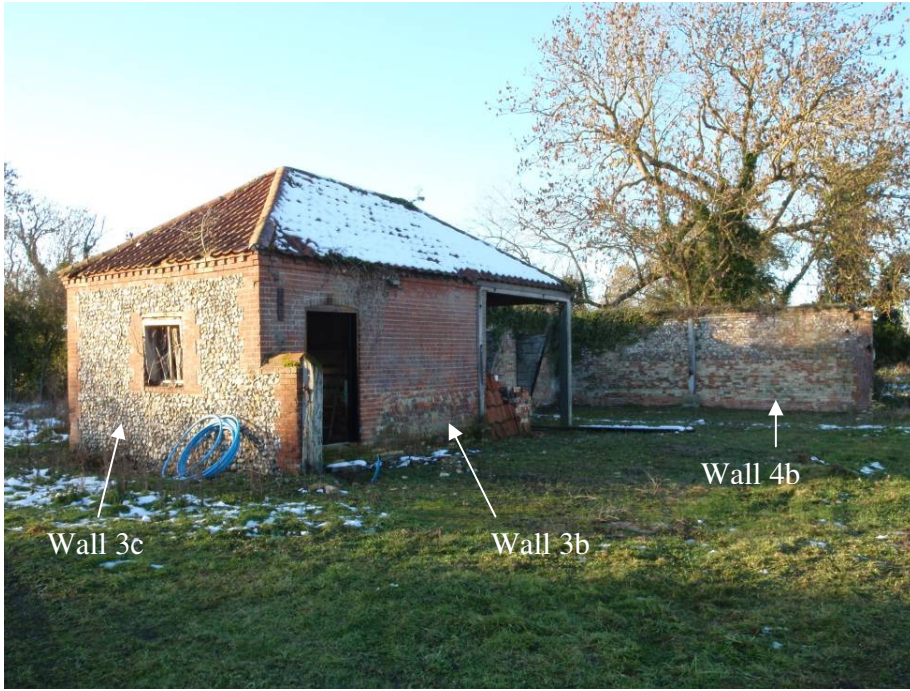
Somewhat different construction was employed for the northeastern wall (3b), much of the external elevation being of neatly-coursed Flemish bond brickwork (Plate 3). The quoin, cornice and dentil detailing recorded elsewhere was repeated

Plate 3 General view of Range 3 and Range 4 (background), walls 3c, 3b & 4b, looking northwest

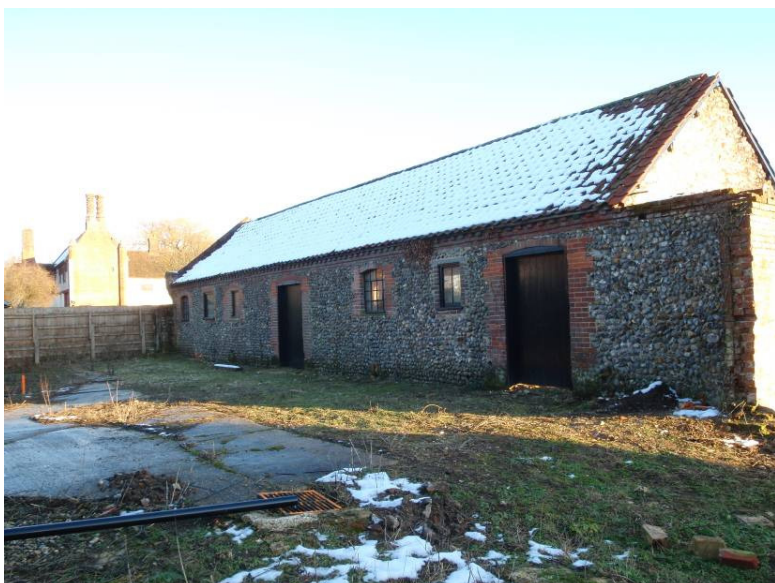
Plate 14 Exterior of northwest wall of Range 2, wall 2a, Abbey Farmhouse in background, looking east

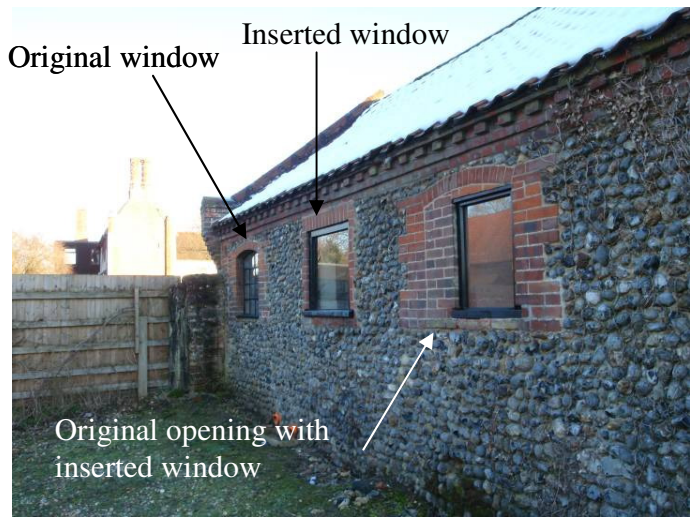
Plate 15 Exterior of northwest wall of Range 2, wall 2a, detail of original and inserted windows and original window opening with inserted window, looking east

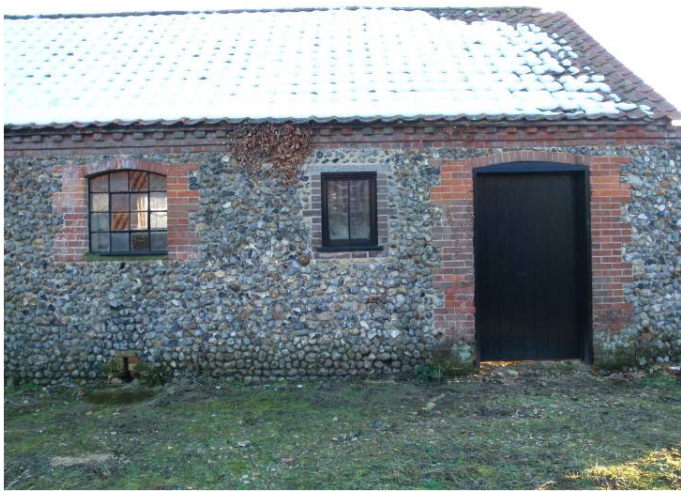
Plate 16 Exterior of northwest wall of Range 2, wall 2a, detail of original and inserted windows, and original doorway, looking southeast

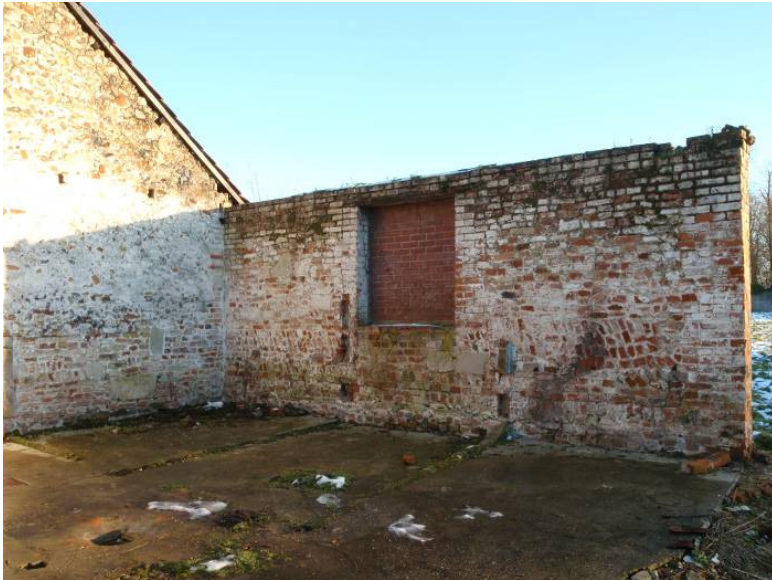
Plate 18 Range 2 showing former room at southwest end of range, walls 2d and 2c, showing blocked window, looking southeast

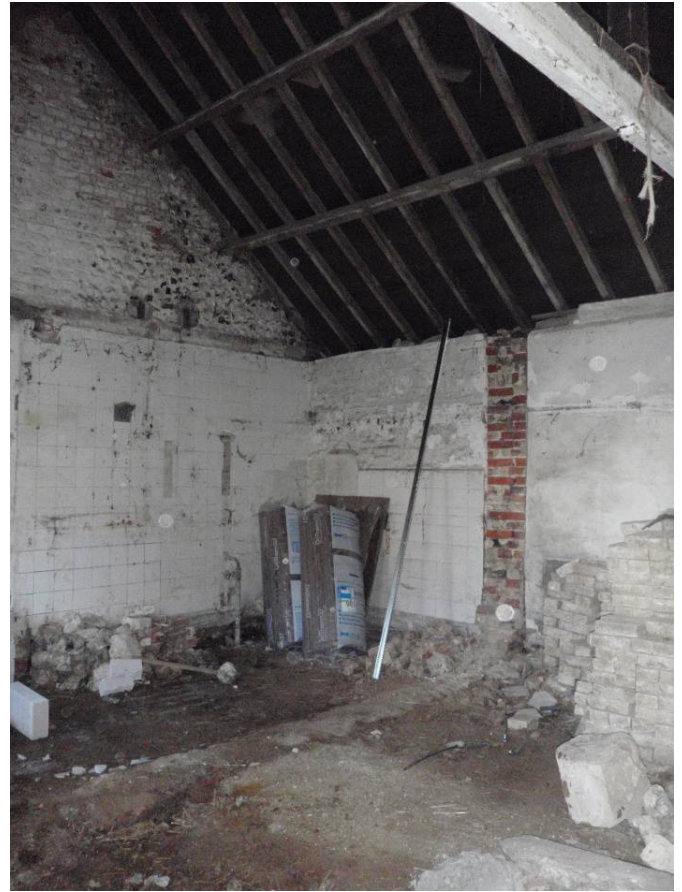
Plate 24 Interior of Range 2, northeasterly room, walls 2b and 2c, showing wall scar across room, looking east

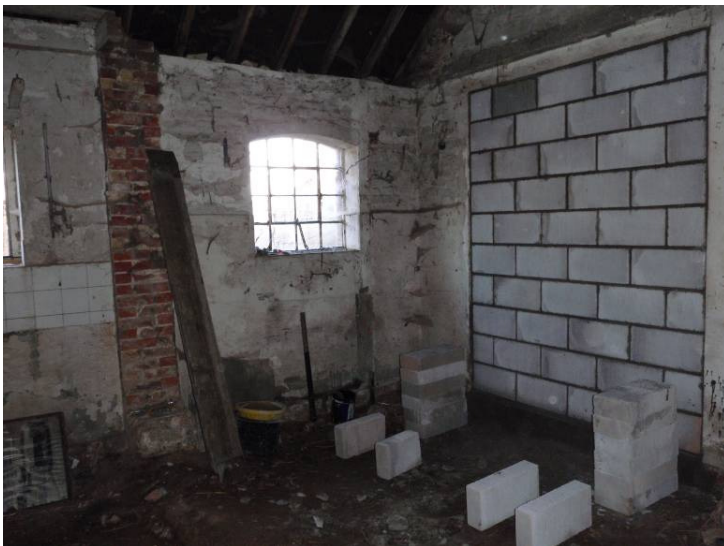
Plate 25 Interior of Range 2, northeasterly room, wall 2b showing blocked doorway and wall 2a showing original window and wall scar, looking north

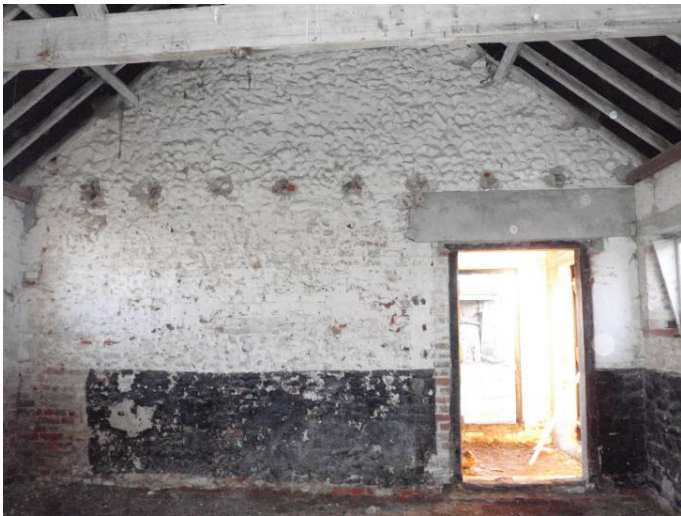
Plate 28 Interior of Range 2, central room, wall 2e,
showing joist holes, looking southwest

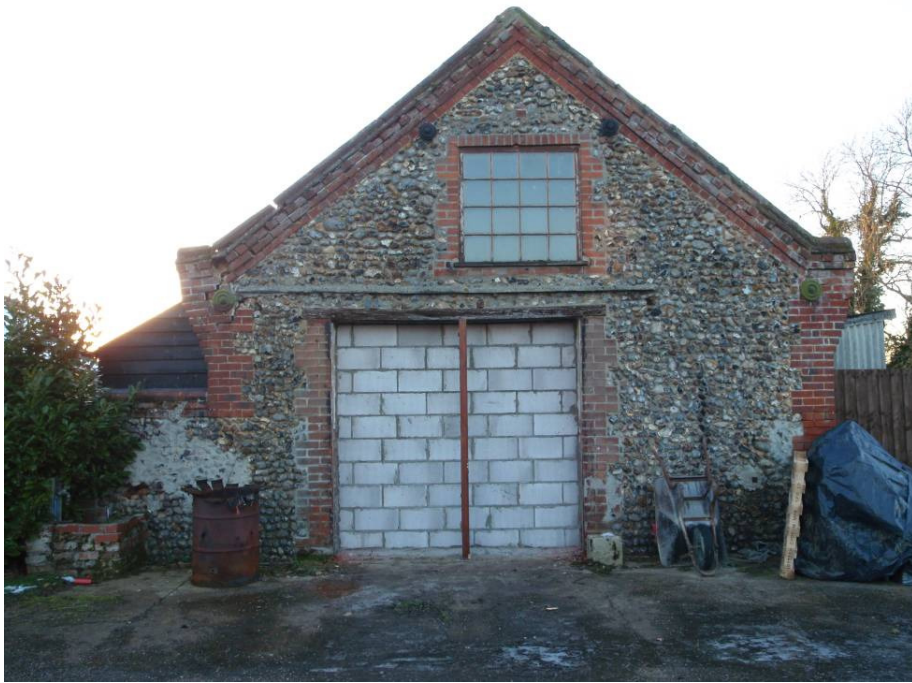
Plate 30 Northeast gable end of Range 1, wall 1b, showing blocked doorway, looking southwest

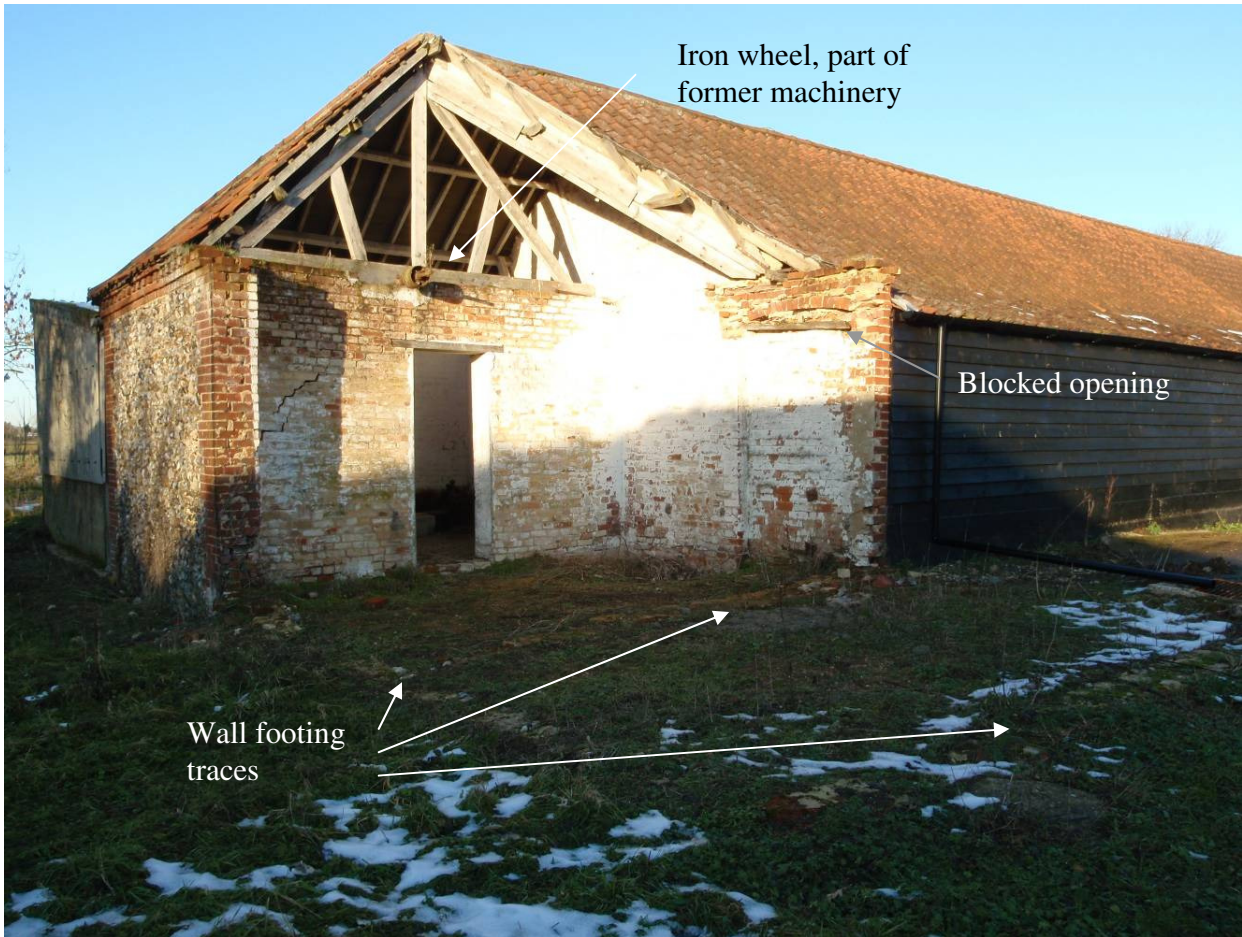
Iron wheel, part of former machinery

Blocked opening

Wall footing traces

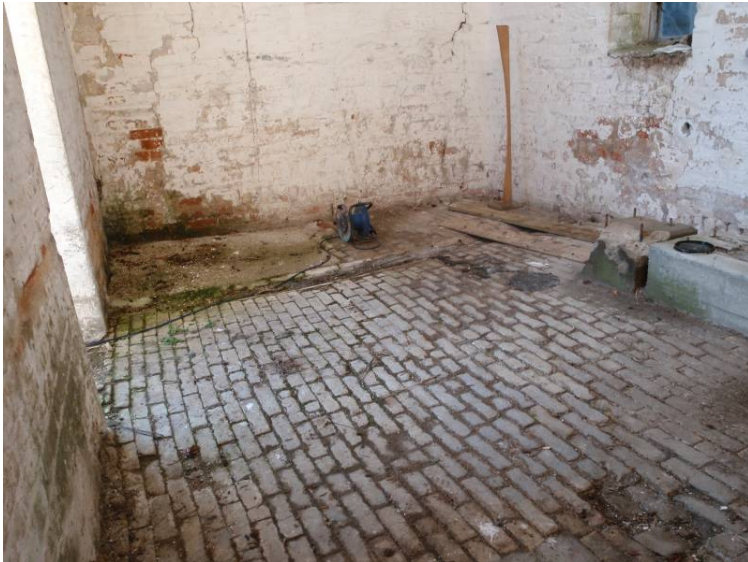
The small western room was c.4.3m by c.3.9m wide and had a brick floor (Plates 35 & 36). This floor included guttering near its western edge (Plate 35, Figure 5).

Blocks for former machinery were recorded in the northeast corner of this room (Plate 35). An iron shaft was recorded across the eaves of the room, with a cast iron wheel or pulley attached to each end. One of these pulleys was positioned close to the machinery blocks inside the room, whilst the other was located on the opposite side of the southeast wall (1f), within a now-demolished further room (Figures 5 & 6, Plates 36 & 33). It seems probable that an engine, located on the south side of wall 1f, transferred energy via belts and the iron shaft into the more northerly room where machinery such as a threshing machine, chaff cutter or other fodder preparation machine might be powered. The brick flooring of this room would have made for easy sweeping and reduce wastage of grain or other crops.

Plate 35
Interior of Range 1,
southwestern room,
showing brick
flooring, looking
west

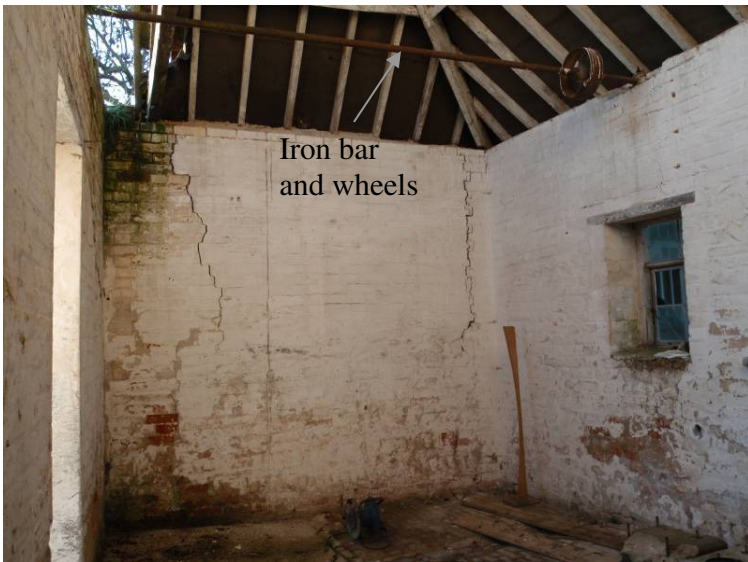
Plate 36
Interior of Range 1,
southwestern room,
showing iron bar and
wheels, part of
former machinery,
walls 1a and 1d,
looking west

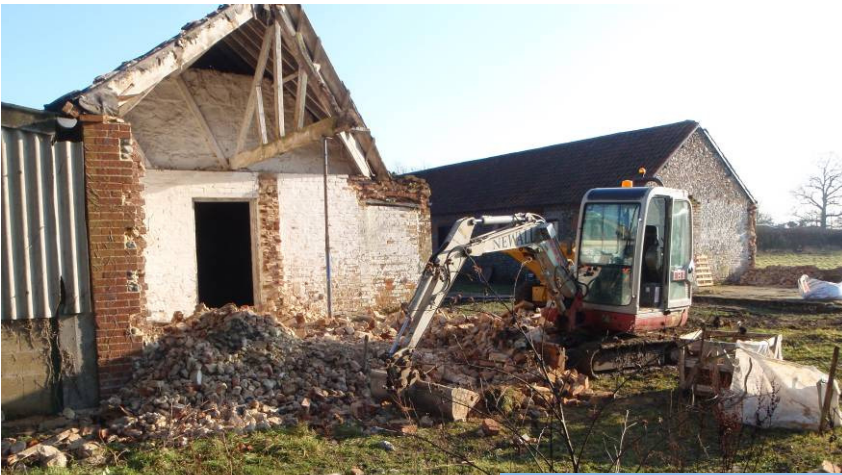
Plate 41 General view showing partial demolition of Range 1 in progress, looking southeast

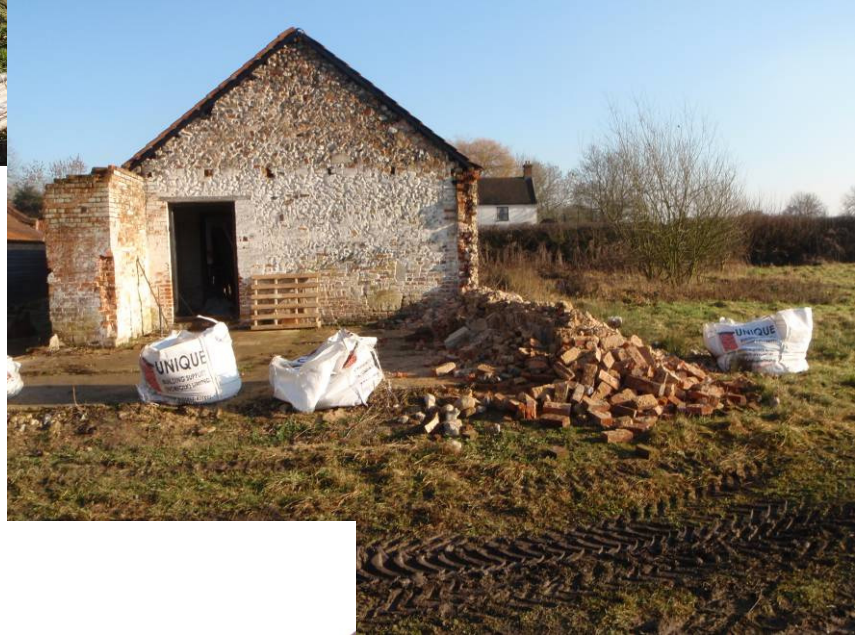
Plate 42 General view showing Range 2, partially demolished, looking northeast

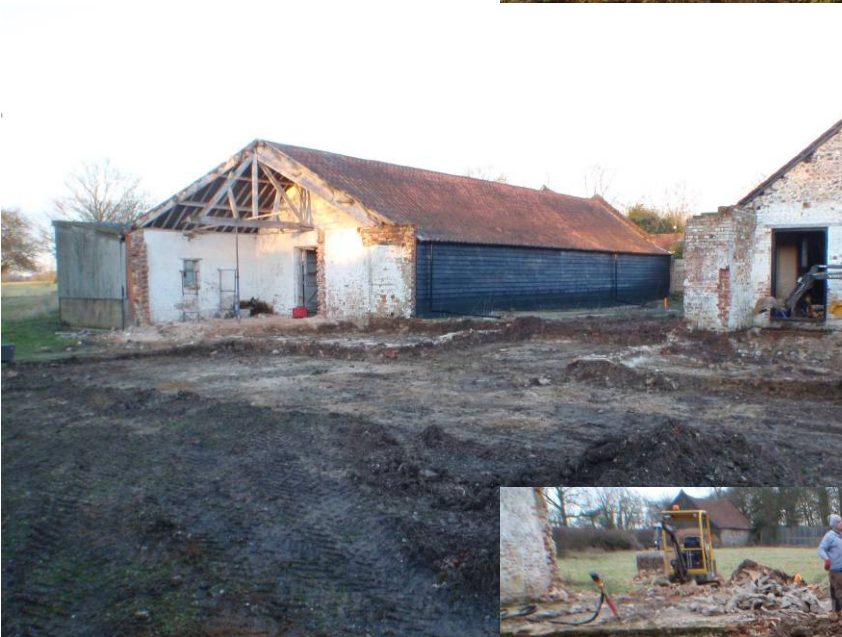
A layer (001) of firm mid olive-brown sandy clay with frequent fragments of ceramic building material and flint fragments was removed from the footings area in the initial topsoil stripping. This 0.23m thick layer appeared to be material gradually accumulated in former farmyard. Beneath layer (001) was (002), a layer of softish light brownish-yellow to whitish powdered sandy lime mortar with occasional ceramic building material and flint fragments. This extended over the majority of the area of the new footings, and may have resulted from the construction of farm buildings or formed an internal floor surface (Figure 8, Plates 43 & 44).

Plate 43 General view of stripped area prior to excavation of wall footings, looking north

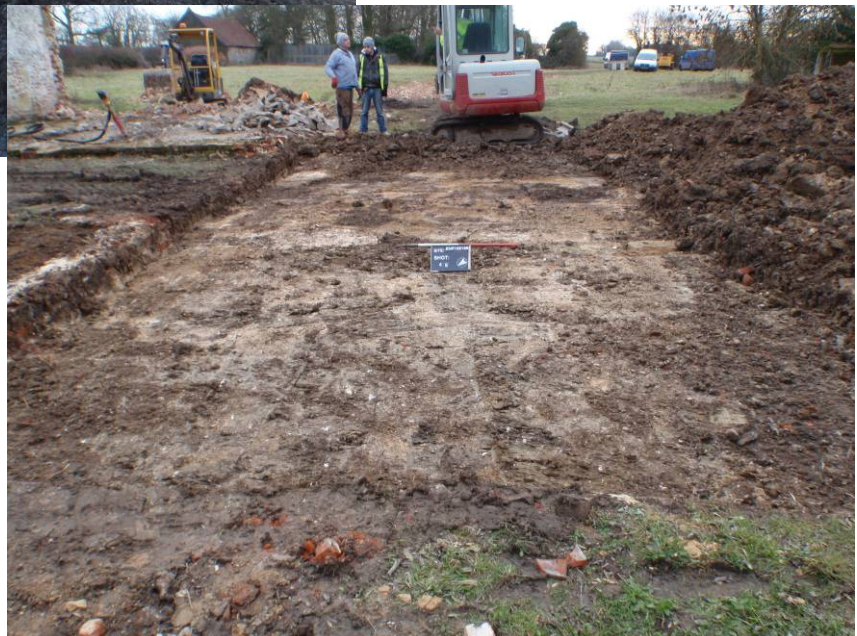
Plate 44 General view during stripping, looking southeast

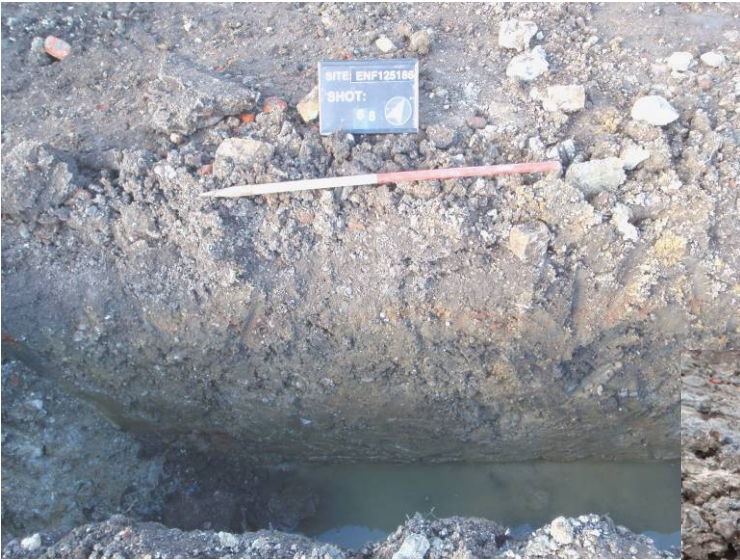
Natural clay deposits (010), (026), (021), (014), (015) and (038) were identified in the footings trenches. These were over 0.85m thick and comprised firm to plastic mid brown, mid olivey-yellowish brown, light olive and orangey-brown mottled clays to slightly silty or sandy clays with frequent chalk flecks and fragments and flints (Plates 52 & 49).

Plate 49 Representative Section 5, looking northeast

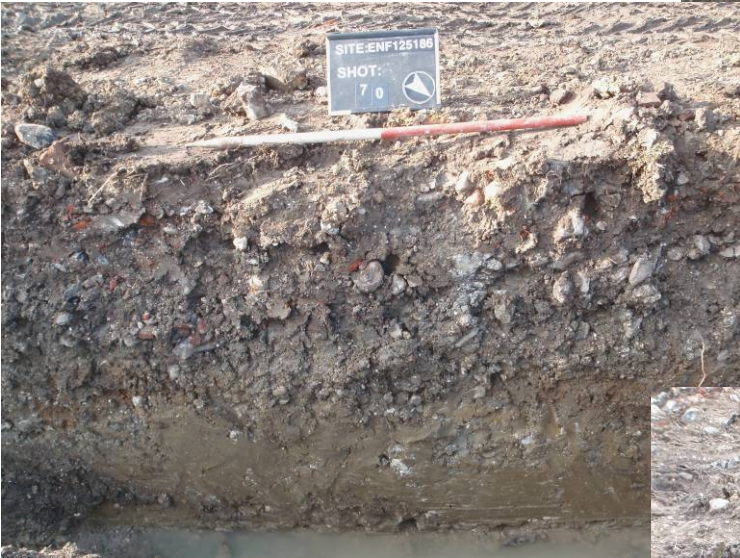
Layer (007) was a 0.20m thick layer of firm to plastic dark greyish-brown silty clay with occasional brick fragments and moderately frequent flints. This may have represented a further buried soil layer incorporating some construction and/or demolition debris. Similarly, deposit (024) was a mixed deposit containing flint cobbles and brick fragments, this perhaps being material associated with construction of farm buildings mixed with former soil (Plate 51).

Plate 51 Representative Section 6, looking northwest

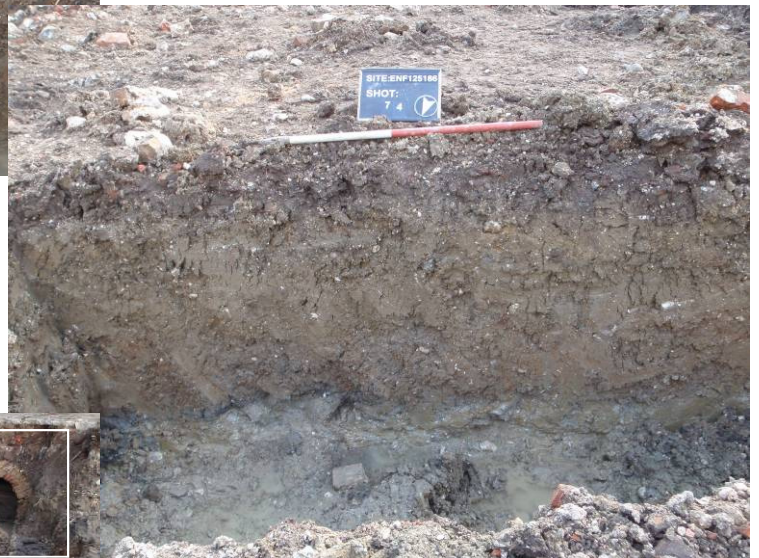
Plate 52 Representative Section 8, looking southwest

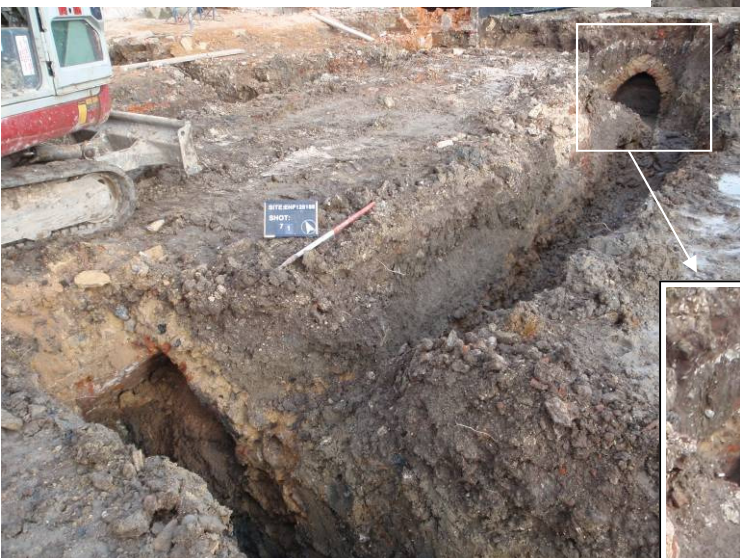
Plate 53 General view of footings trenches showing brick culvert 041, looking southeast
