**HISTORIC BUILDING RECORDING & BUILDING WATCHING BRIEF:  
PATCHETTS GREEN FARMHOUSE (THE COACH HOUSE)**

**PATCHETTS EQUESTRIAN CENTRE**

**DRAFT REPORT**

May 2012

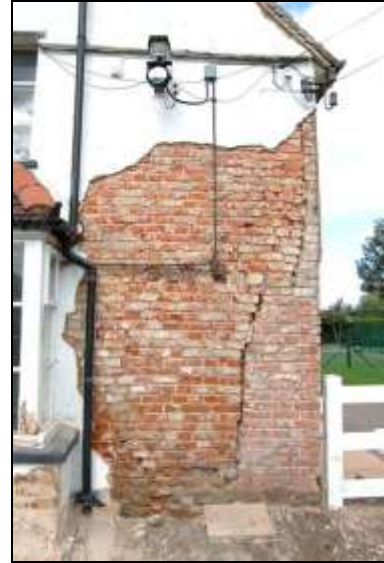
**Plate 49:** South wall during works

**Plate 50:** Structural fault in the south wall

The cellar, which may have caused the fault line to occur, also appears to have been built in the early 19<sup>th</sup> century. The interior of the building was again remodelled at this time. The fireplace in Room G1 was made smaller and a cupboard built to the left of it. The fireplace was installed in Room F2, the chimney stack for which was merely supported by the transverse beam in Room G1. The fireplace itself is in a style in keeping with the time, ie Regency, but does not appear to be original.

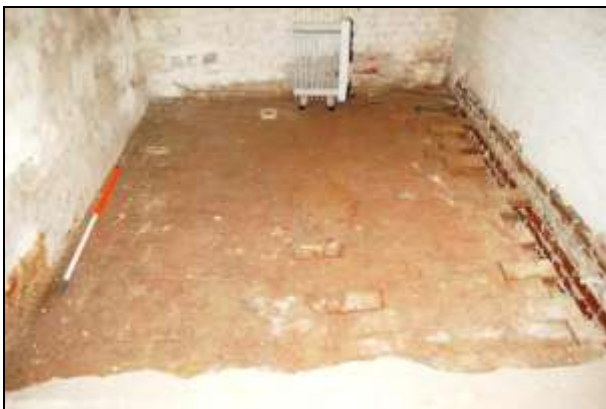
**Plate 65:** Room G6: brick floor

A brick floor with a worn walkway in the centre was exposed beneath the concrete during the watching brief. The bricks were well puddled, red and measured 22.5 x 11.5 x 4.5cm. A square hole set in mortar and measuring 7.5cm north-south and 5cm wide east-west, and was located at the northern end of the room.

The brick floor in Room G6 suggests that this may have functioned as a kitchen, dairy or scullery. Although the application and subsequent removal of concrete on the floor has caused some damage, the hollow walkway running down the centre of the room indicates long term and heavy use. This room appears to have been unheated, despite the remains of a possible chimney stack on the west wall. This appears to have been associated with a now demolished structure that is suggested by the roofline on the adjoining building and the timber above the chimney remains. The complete chimney stack on the north wall is also 19<sup>th</sup> century, but the brickwork suggests that it postdates the construction of the wall by a few decades.

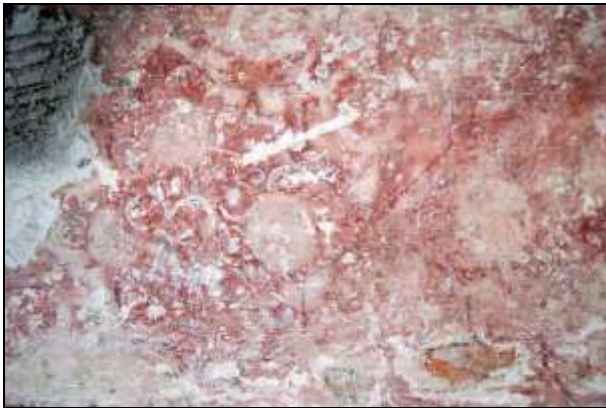
Painted plaster was revealed on the south wall, which consisted of white curlicues within a lozenge shaped border on a red background (App. 3). The wall painting appeared to be of early 17<sup>th</sup> century date and following specialist advice was stabilised to minimise further degradation.

**Plate 75:** Room F4: detail of painted plaster

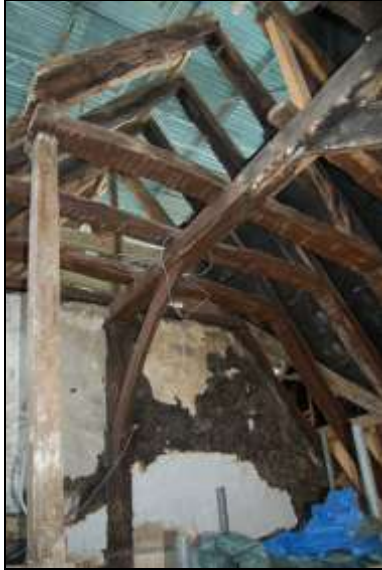
**Plate 79:** Room F3: crown post & collar purlin

The crown posts are fairly simple; cross quadrate posts with slender braces. The southern crown post retains a single foot brace but there are none to the north, where only the lateral collar braces survive. This type of crown post found favour in the later 14<sup>th</sup> century (Stenning 2011: 33).

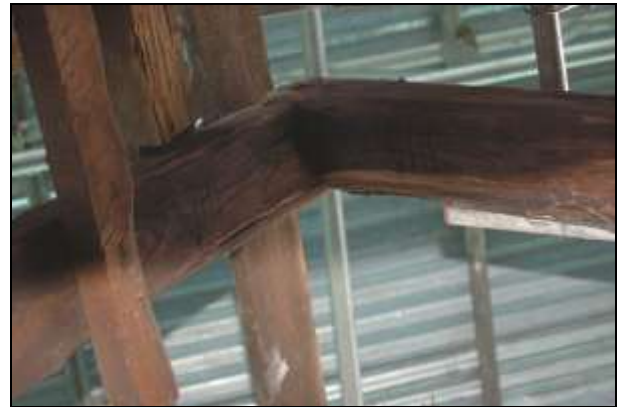
The crown posts are cross quadrate in form with no decorative moulding. Some of the rafters have carpenters assembly marks at the apex and just above the junction with the collar purlin. The numbers start with IIII at the northern end but this end has clearly been truncated and the first full height rafter is marked IX. It should be noted that the numbers that could be seen were not fully sequential. A few of the original rafters were supplemented by waney edged timbers, as was evident in Room F3 during the watching brief.

**Plate 86:** Carpenter's assembly marks
