**HISTORIC BUILDING RECORDING AND WATCHING BRIEF:
EAST BARN AND STABLES
THROCKING HALL
THROCKING
HERTFORDSHIRE**

NGR: TL 33835 30055

November 2012

ASC: 1522/TTH/2

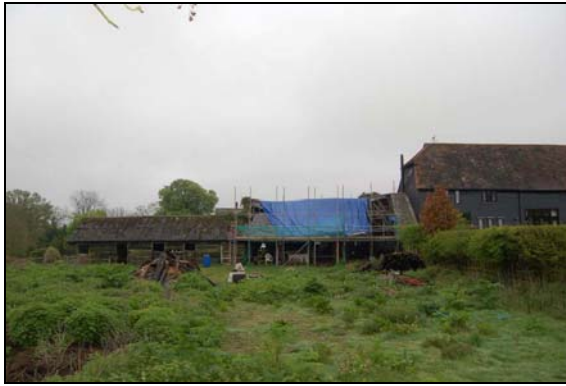
East Barn and the stables are located at the eastern end of a series of timber framed converted farm buildings, which formerly constituted the southern range of a large complex belonging to Throcking Hall Farm (Plate 1). East Barn is a 4-bay, open fronted structure under a slate roof (Plate 2). It is currently being supported by scaffolding, the west wall and much of the roof having collapsed. The stables, which consist of a tack room, three individual stalls and two separately accessed rooms in the western bay, are in far better condition (Plates 3-5).

Plate 1: East Barn & the stables from the north

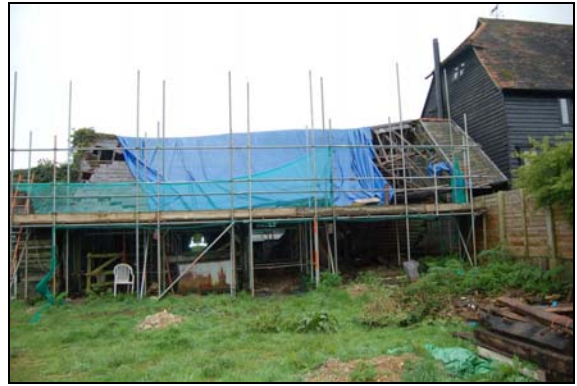
Plate 2: The barn: north elevation

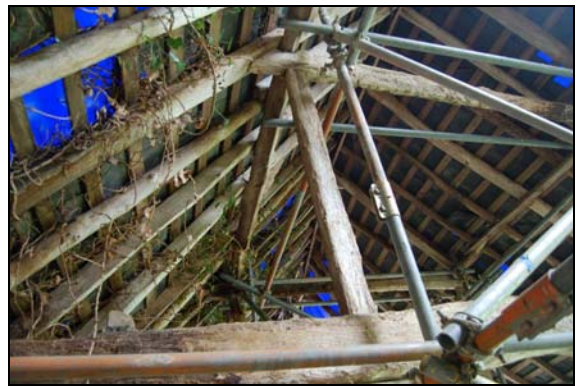
The building has a queen post roof with carpenters' assembly marks on the braces, which are in numerical order from east to west (Plates 16-17). However, some aberrations occur, such as the figure II on the eastern side of Truss 1. There is an edge halved bridled scarf joint in southern wallplate of Bay 2 and another on the northern wallplate (Plate 18). Some rafters have been replaced, others have bark on them. The ridgeboard is intact.

Plate 16: East Barn: queen post & clasped purlin

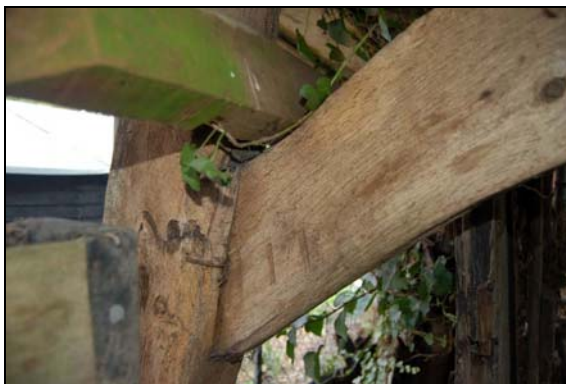
Plate 17: East Barn: carpenters' assembly marks

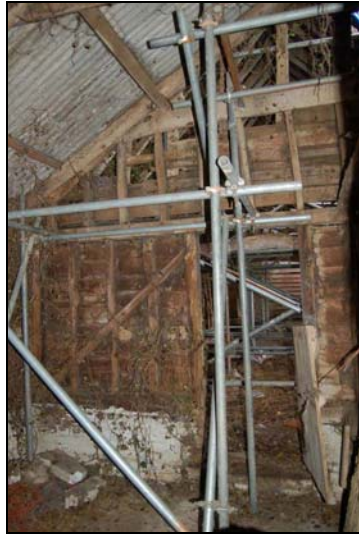
This is divided into two store rooms (Plates 29-32). The northern room is accessible by a ledged and braced door in the north wall (Plate 31). Access to the southern room is via the East Barn. The wall between the two store rooms comprises a boarded timber frame with primary bracing above a brick dwarf wall (Plate 32).

Plate 31: Northern store room: west wall

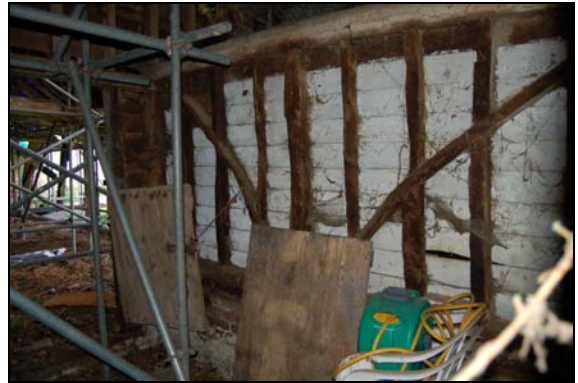
Plate 32: Northern store room: north wall

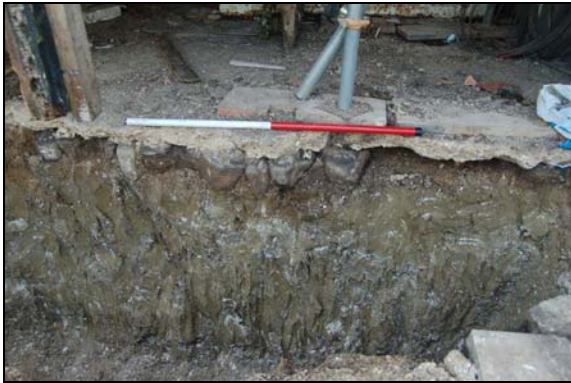
Plate 45: Cobbled surface in the north facing section of northern stable trench

A foundation trench approximately 0.65m wide and 1.20m deep was excavated beneath the north wall of the stables. There was little or no subsoil on the northern side of the trench. Most of the concrete floor had been removed in the stables, but where it survived, the cobbled surface that it covered was revealed (Plate 45). The base of the cross walls and an area of water staining within the clay below the door to Stable 2 were the only other features observed (Plates 46-47). The natural comprised very stiff olive brown clay with chalk.

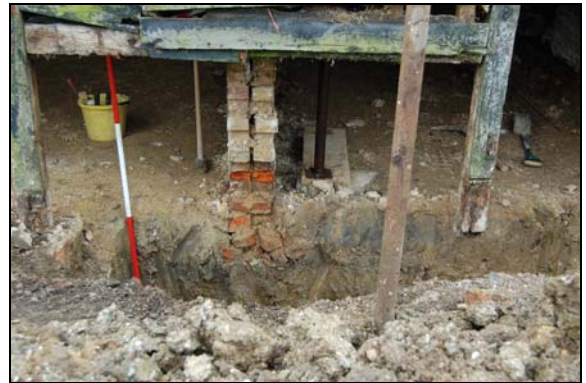
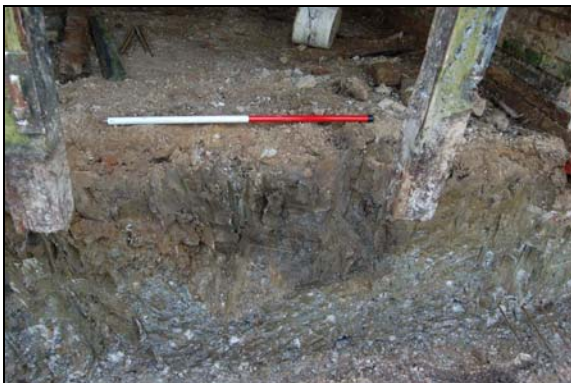
Plate 46: North facing section of northern stable trench

Plate 47: Staining in the north facing section of northern stable trench

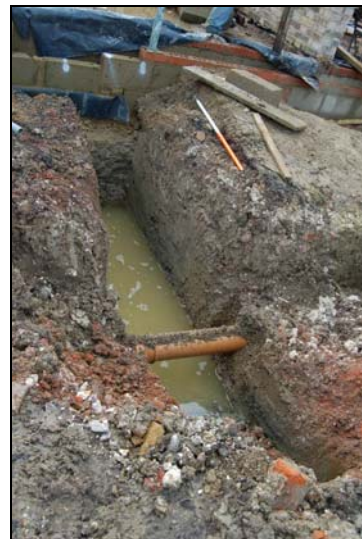
Plate 48: Western trench north of stables from NE

Two foundation trenches orientated north to south and measuring approximately 1.20 (l) x 0.75m (w) x 1.20m (d) were excavated for a new structure to the north of the stables (Plate 48). The stratigraphy comprised 0.20-0.30m of mixed overburden above olive brown clay. A possible yard surface was exposed at the very northern end of the eastern trench, which consisted of 0.30m layer of rubble, flint and ceramic building material (Plate 49). A small area to the west of the trench was then scraped back, which confirmed that this was a yard surface extending at least part way along the northern front of the building. As the ground surface between the two trenches was only 10cm above the finished floor level, nothing further was excavated at this point.

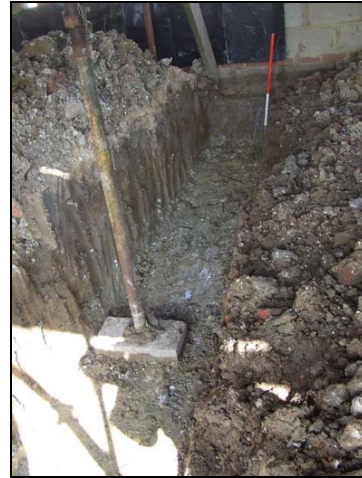
Plate 50: Footing trench in the stable

Two foundation trenches were excavated within the former stables to a depth of 0.70m (Plate 50). No topsoil or former floor surface was recorded within the stable area, and the trenches appeared to be cut straight into the natural soil. No archaeological finds or features were observed within the foundation trenches.

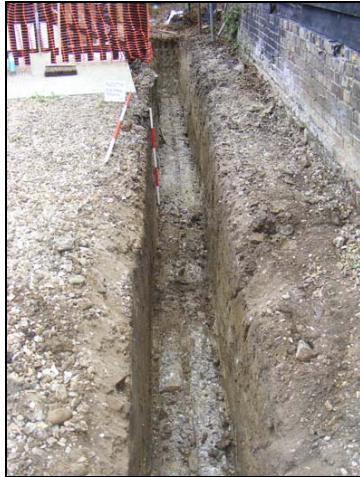
Plate 51: Trench to the rear of the stable

The trenches to the south of the barn were of a similar width and depth to those described in section 5.1 and displayed the same natural stratigraphy (Pl. 51). However, no features or finds were observed.
