**HISTORIC BUILDING RECORDING & WATCHING BRIEF:
THE MANOR HOUSE
THE GREEN
CULWORTH
NORTHAMPTONSHIRE**

NGR: SP 5425 4708

December 2012

ASC: 1566/CMH/1

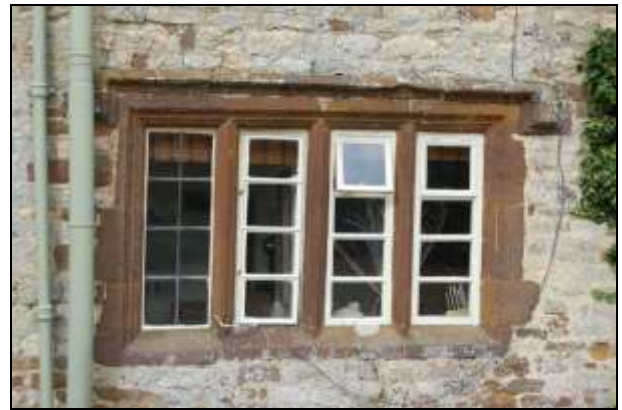
Plate 2: South elevation: stone window

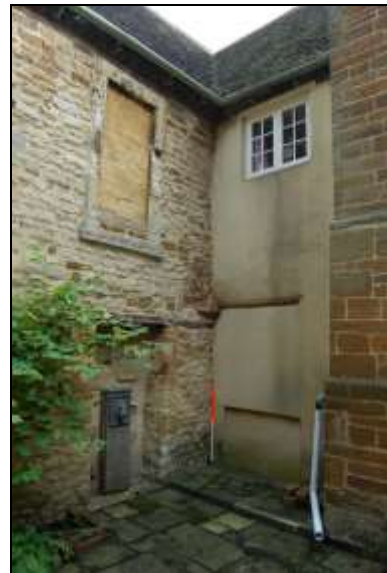
Plate 4: Internal courtyard: southeast corner

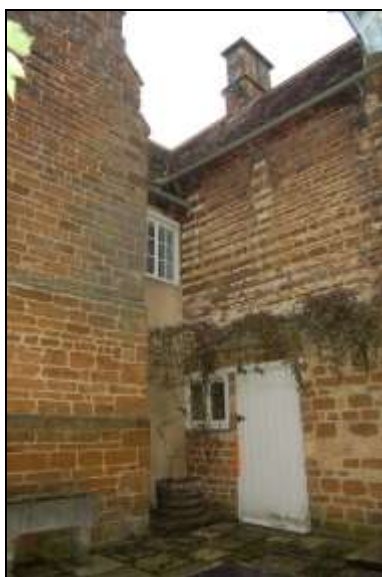
Plate 5: Internal courtyard: southwest corner

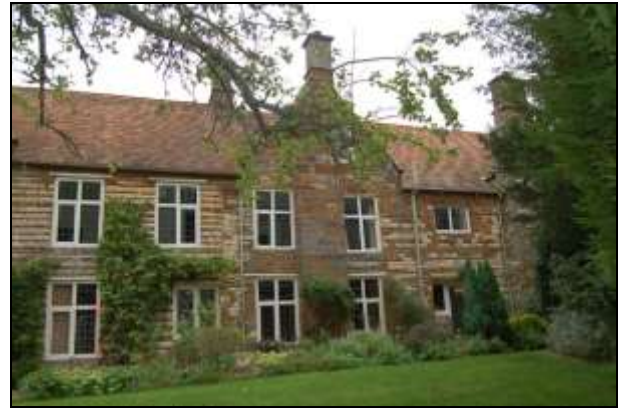
Plate 8: West elevation: central section

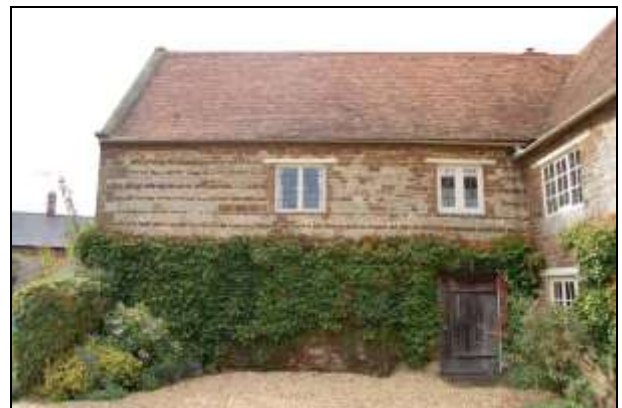
Plate 12: West Range: east elevation

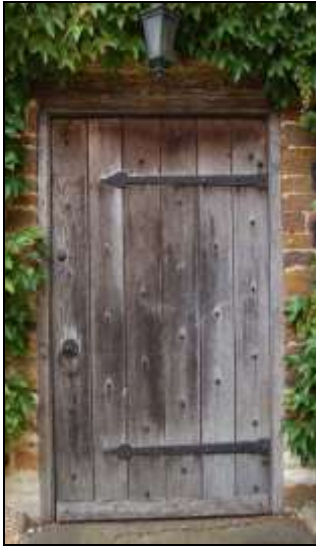
Plate 13: West Range: door detail

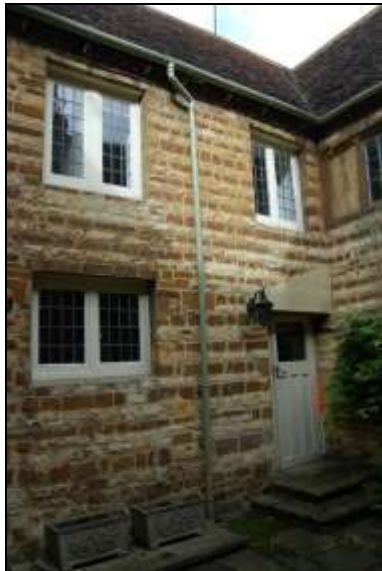
Plate 15: Internal courtyard: north wall

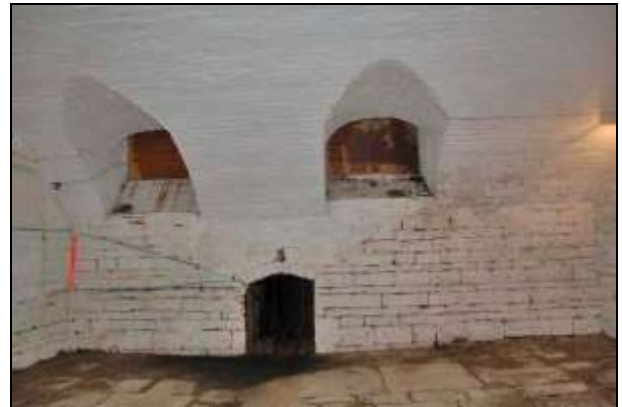
Plate 16: Cellar 1: north wall

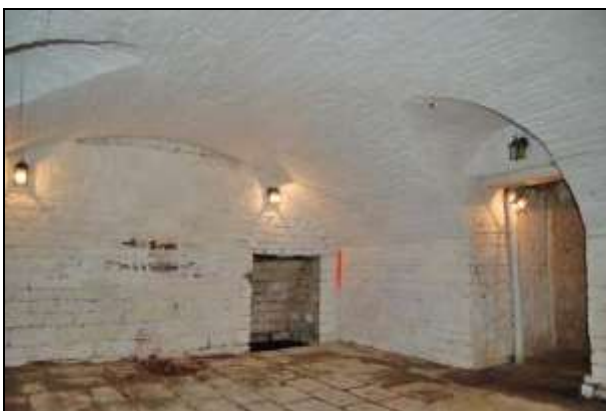
Plate 17: Cellar 1: southeast corner

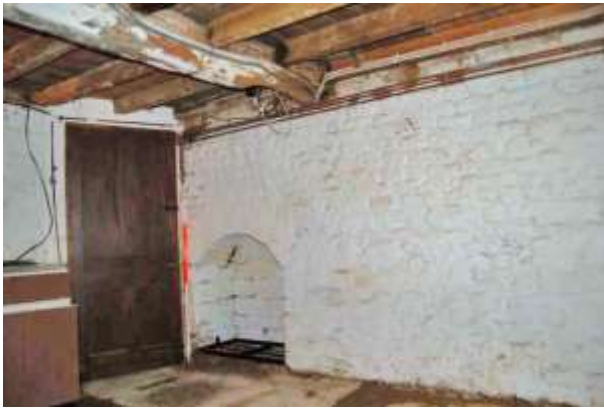
Plate 19: Cellar 2: southeast corner

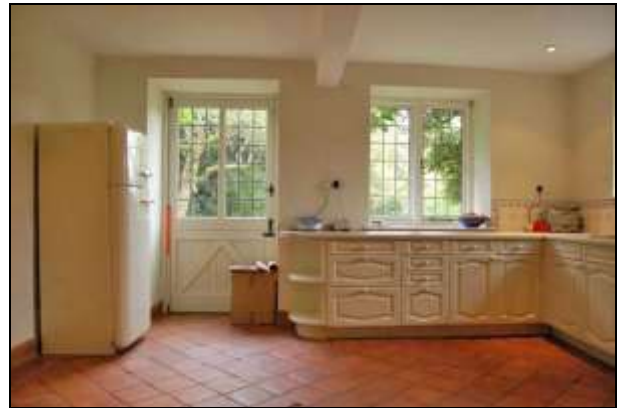
Plate 20: Room G1: west wall

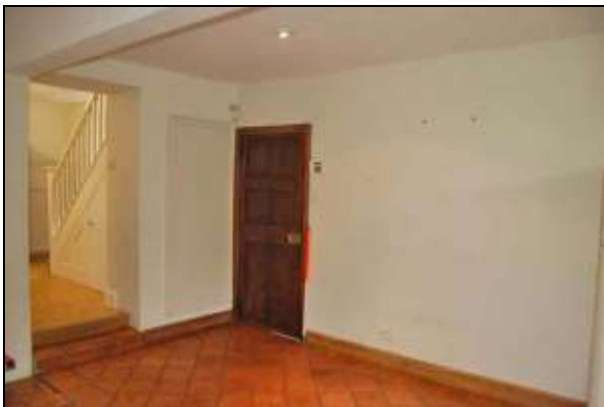
Plate 21: Room G1: southeast corner

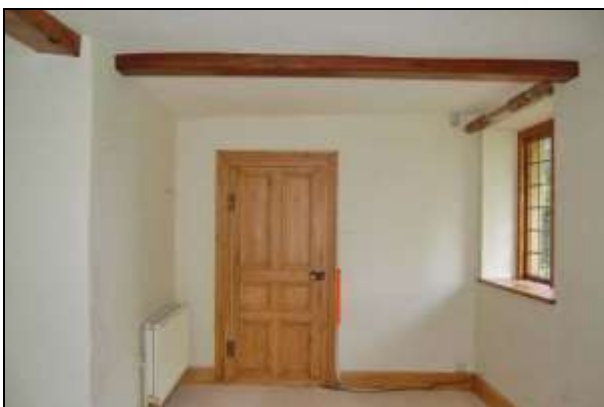
Plate 23: Room G2: south wall

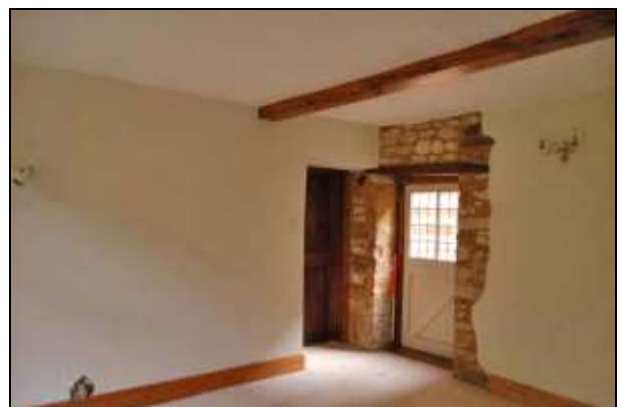
Plate 24: Room G2: northeast corner

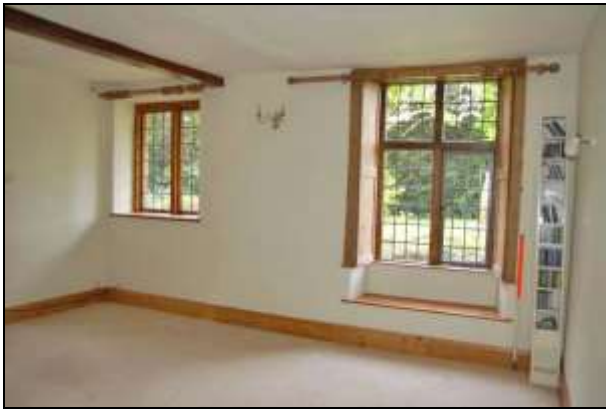
Plate 25: Room G2: west wall

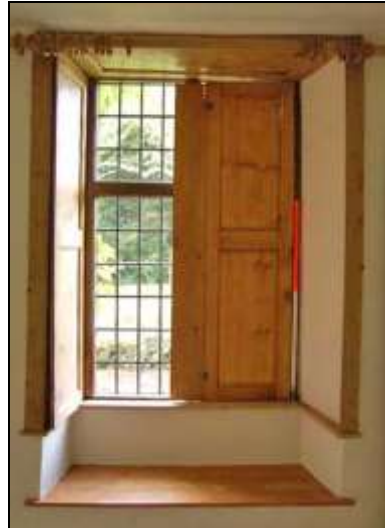
Plate 26: Room G2: window detail

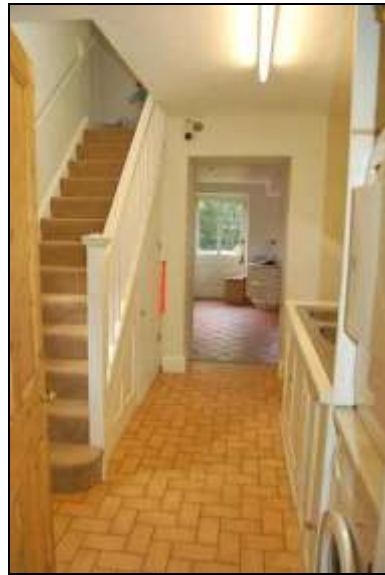
Plate 28: Room G3: looking west

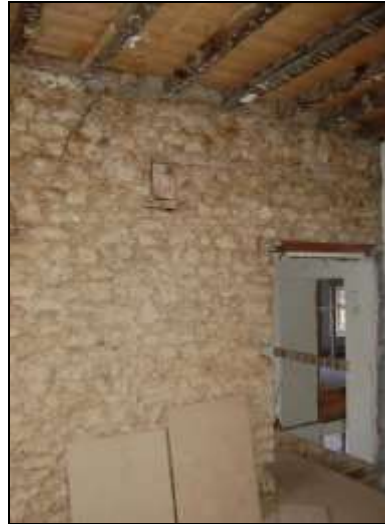
Plate 106: Room F5: bonding and end of ceiling beam in north wall
