**HISTORIC BUILDING RECORDING
ST. DENIS' CHURCH
EAST HATLEY
CAMBRIDGESHIRE**

on behalf of South Cambridgeshire District Council

December 2005

ASC: 717/EHC/1

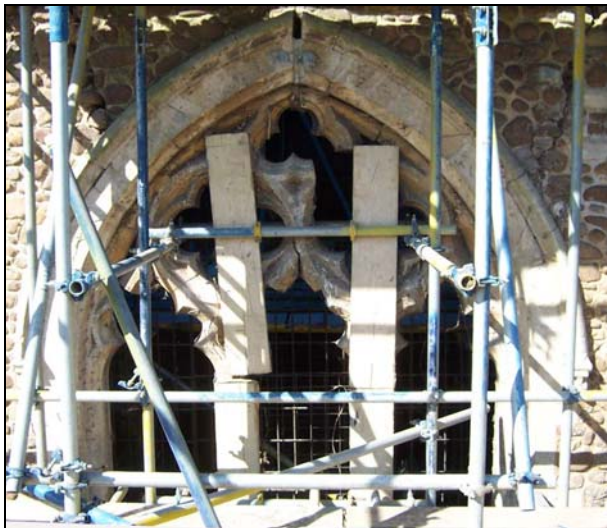
Plate 9: Hood mould over the East window

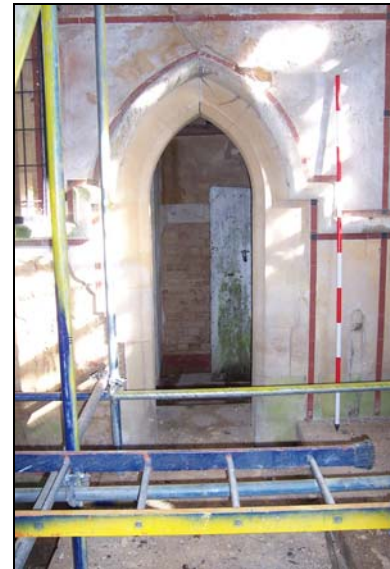
The wall decorations in the chancel lie largely above a stone dado and primarily consist of parallel, horizontal lines with red lozenges above and a border to the vestry door and windows (Plate 16). These are created using red and black tiles, presumably the Minton tiles mentioned in the Specification of Works. The clunch-built reredos, which deviates somewhat from Butterfield's original design, consists of a central crucifix within a trefoiled arch flanked by two orders of quatrefoils, all of which is set against a red tile background (Plate 17). There are three geometric, quatrefoil based tiled areas on either side of the altar, bordered by red and black tiles. The tiles used to decorate the altar steps and risers are plain red and black as well as decorated with medieval motifs, primarily floral in concept (Plate 18). The floor elsewhere is plain.

Plate 16: Wall decoration around the vestry door

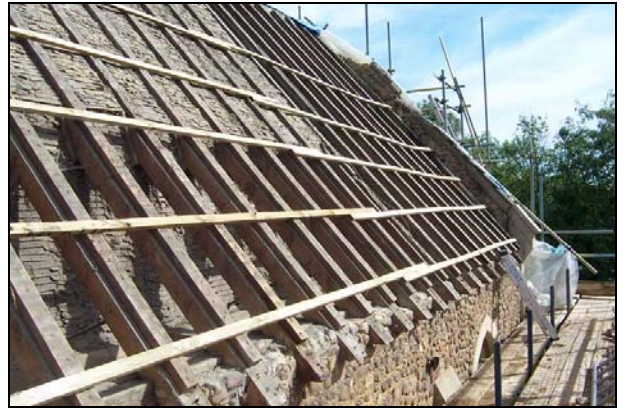
Plate 20: Stripped chancel roof, south side

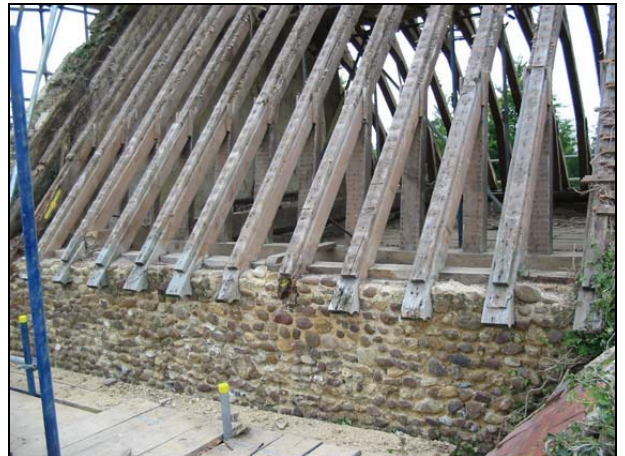
Plate 22: Stripped nave roof west of the porch
