**HISTORIC BUILDING RECORDING & WATCHING BRIEF:
NEWTON BARN
LAVENDON MILL
OLNEY
MILTON KEYNES**

on behalf of Mrs Alicia Cavanagh

January 2007

ASC: 696/ONB/2

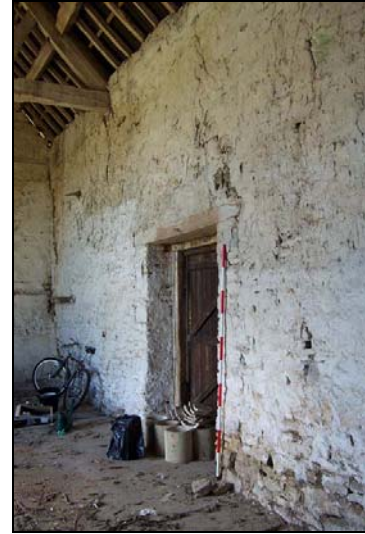
Plate 8: West wall

No alterations appear to have been undertaken to the west wall apart from a replacement lintel over the door.

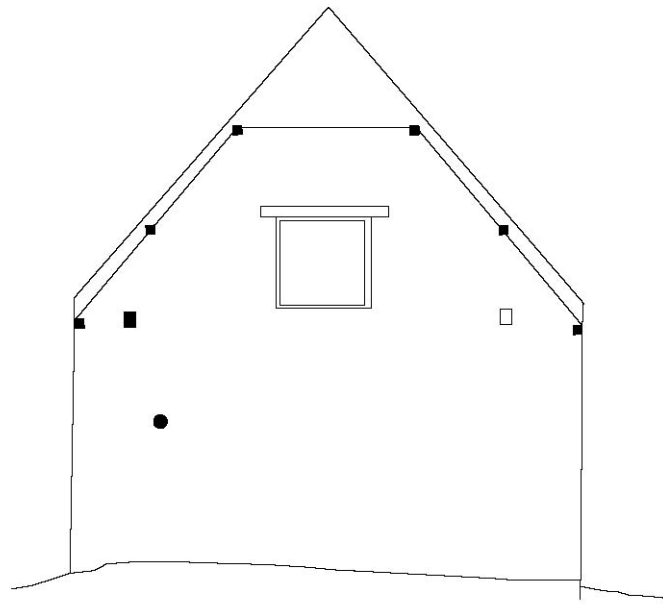
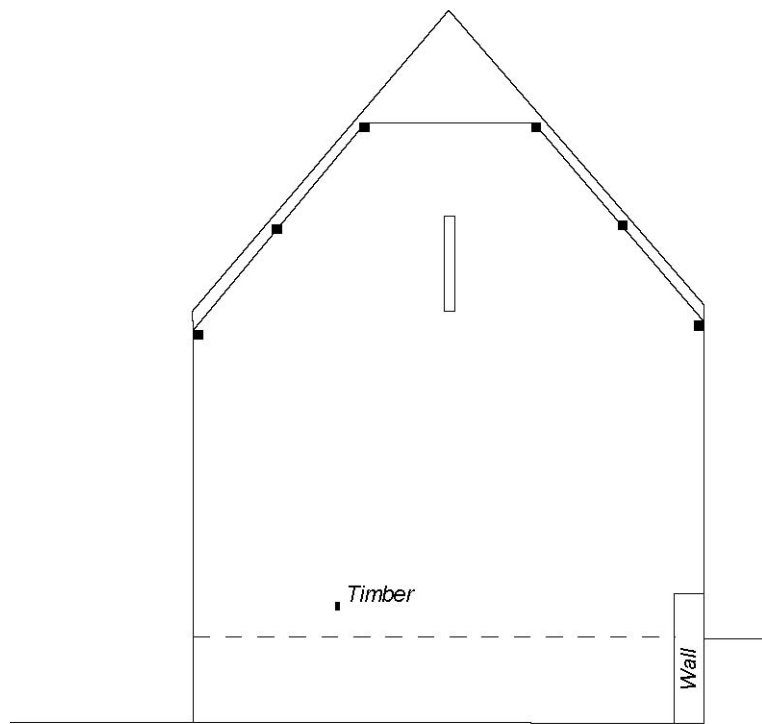
Figure 8: North & south elevations (scale 1:100)

The window in the south elevation appears to be an original single splayed opening with a wooden lintel and sill. In contrast, the window in the north elevation is a large, rectangular opening with a wooden lintel above. The window truncates one of the bonding timbers, and, as such would appear to be a later addition. Although it could have replaced an earlier splayed window, there is no remaining evidence to support this.

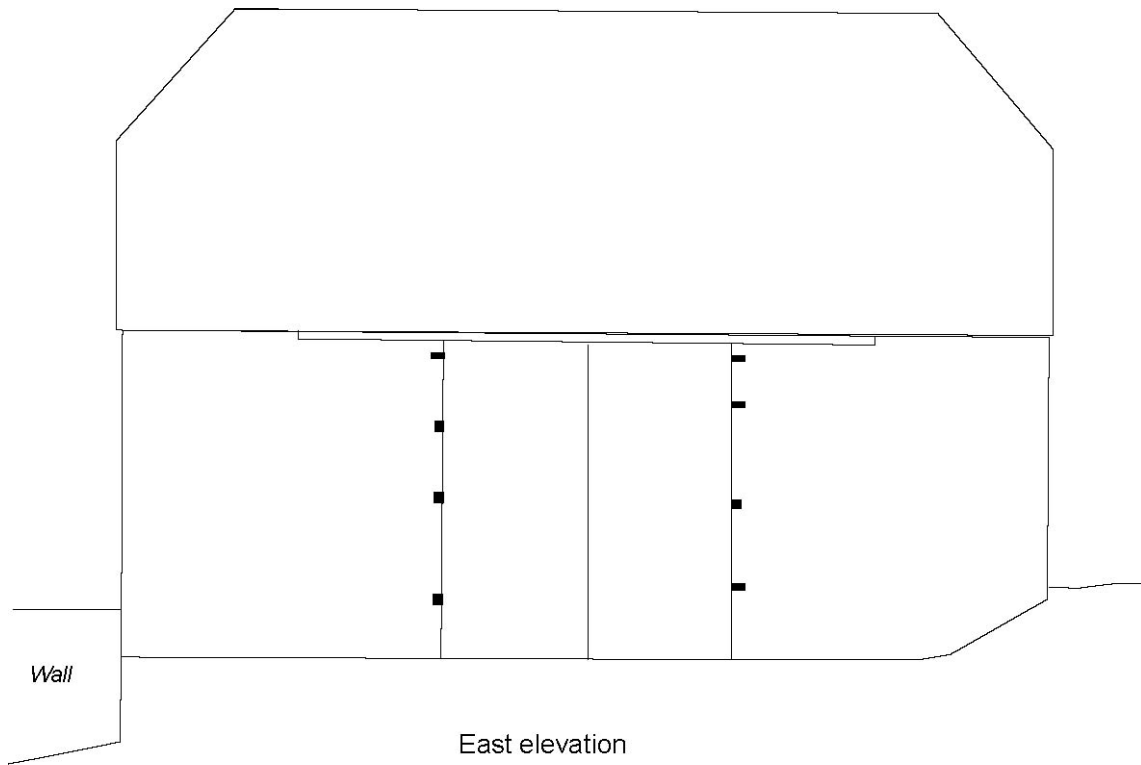
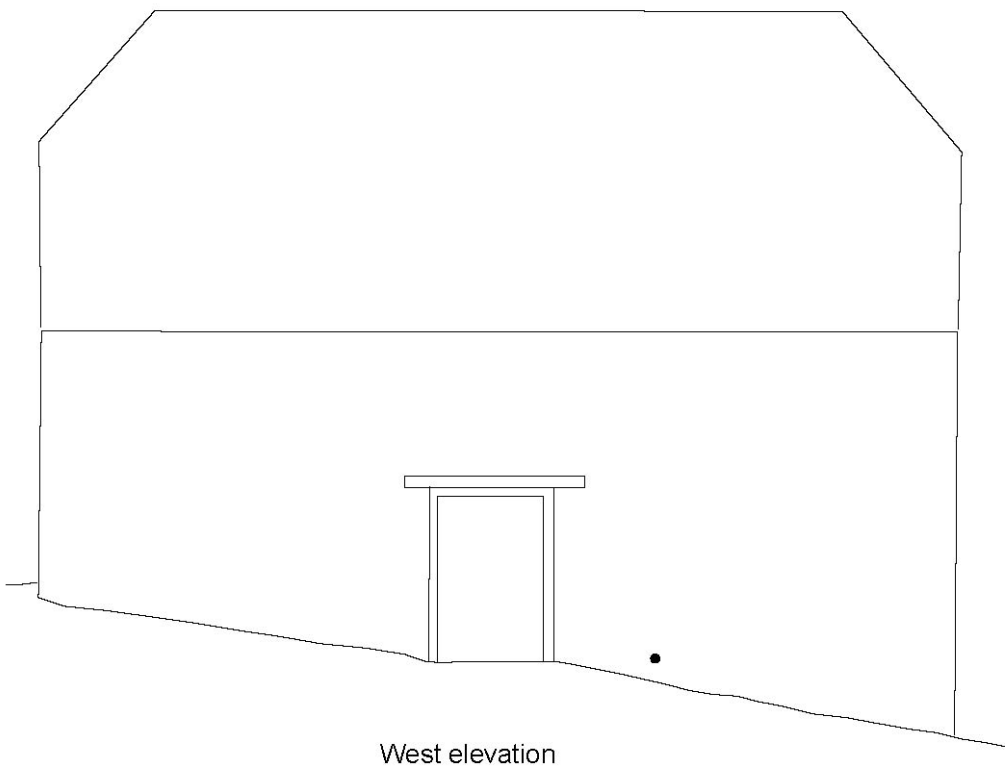
Figure 9: East & west elevations (scale 1:100)

Although the double barn doors have been replaced by sliding doors, the original doorframe is still in place. There are four bonding timbers measuring between 12 x 13cm and 8 x 17cm running through the wall on either side of the door.
