Archaeological Services & Consultancy Ltd

WATCHING BRIEF: GLEBE HOUSE, LEIRE LEICESTERSHIRE

By
David Fell BA MA MIFA
September 2004

ASC: 599/LGH/2

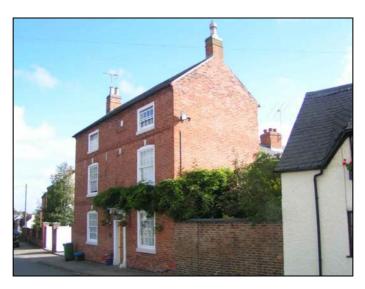
Glebe House was probably constructed during the late 18th century and a plaque bearing the inscription "WB TSS 1793" is centrally located at the top of the façade. It is a typical small Georgian red brick constructed townhouse on three storeys (Plate 1). The layout in 1889-91 is shown on the Ordnance Survey map (Fig. 4) and shows the house on the street frontage, set within a rectangular plot. A number of buildings are shown to the rear of the house, including one on the site of the present garage. A variety of outbuildings stood in the garden until the mid 20th century, when they were demolished and the existing garden laid out (C. Everard, *pers com*).

Plate 1: View of the façade of Glebe House

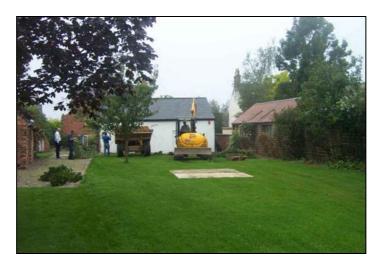
Plate 2: View of the site, prior to the development
