Merryhill Farm, Haywood, Herefordshire:  
archaeological monitoring and building recording

Dan Lewis  
2004

Client: Mr M Mitchell, Merryhill Farm owner

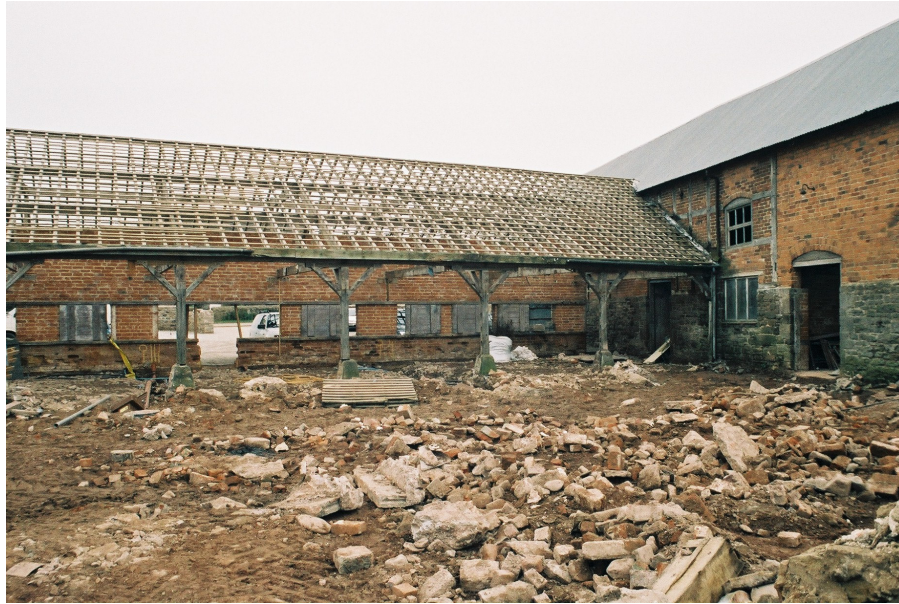
**Plate 1: The west (back) yard and the Barn and Cattle Shed. The make up of the front yard had a similar concrete surface and rubble make up.**

Trench two cut through a concrete yard surface and its rubble makeup (3) and what appeared to be natural reddish brown clay (2) that was relatively undisturbed. The two south-east running trenches were of a similar makeup.

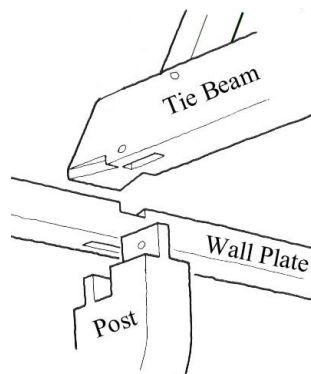
**Figure 11: Tie beam lap dovetail assembly. Construction detail of the tie beam, post and wall plate from section K-L.**

The stable had 12 simple A-frame trusses similar to section K—L. The trusses had no scars, such as empty mortice joints or peg holes, suggesting that they are all original timbers.

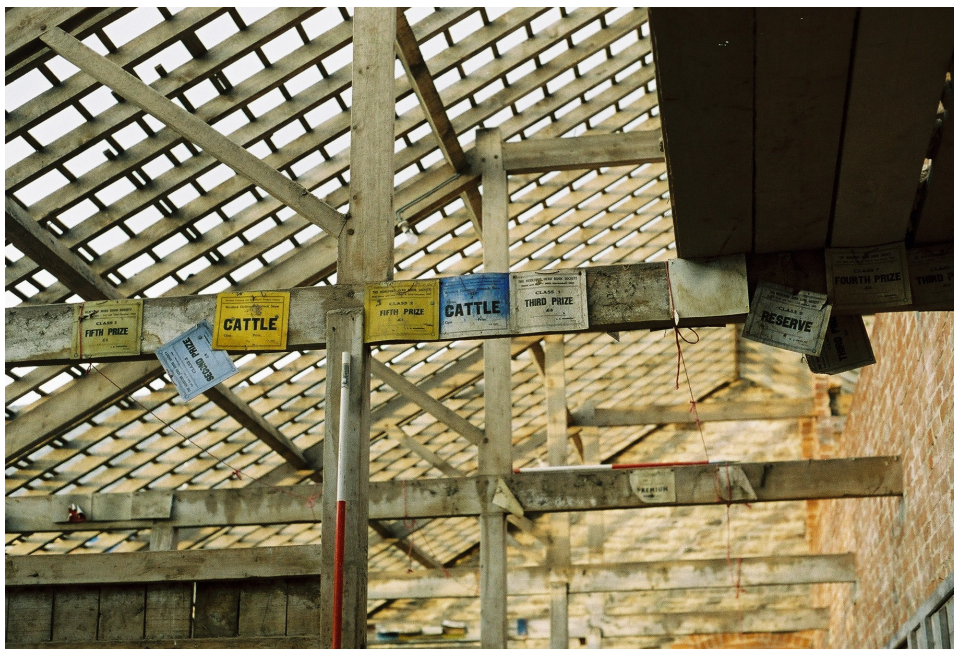
Plate 5: The east side of the cattle shed

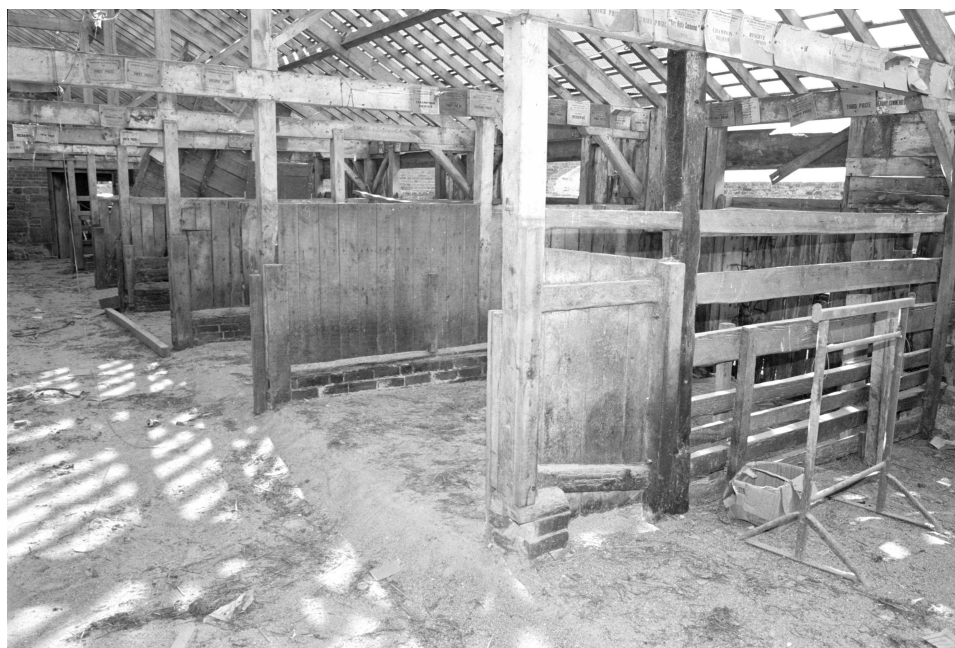
Plate 6: Cattle pens in the west side of the shed

The west side of the cattle shed (plate 6 and drawing 21) was occupied by 6 pens with doors that opened west into a yard. The pens were constructed of

wood on a small brick foundation wall and ran east-west. A feeding passage ran north-south down the central brick wall, with an inserted door (tied-in with brick) in the north gable end of the building (plate 7).

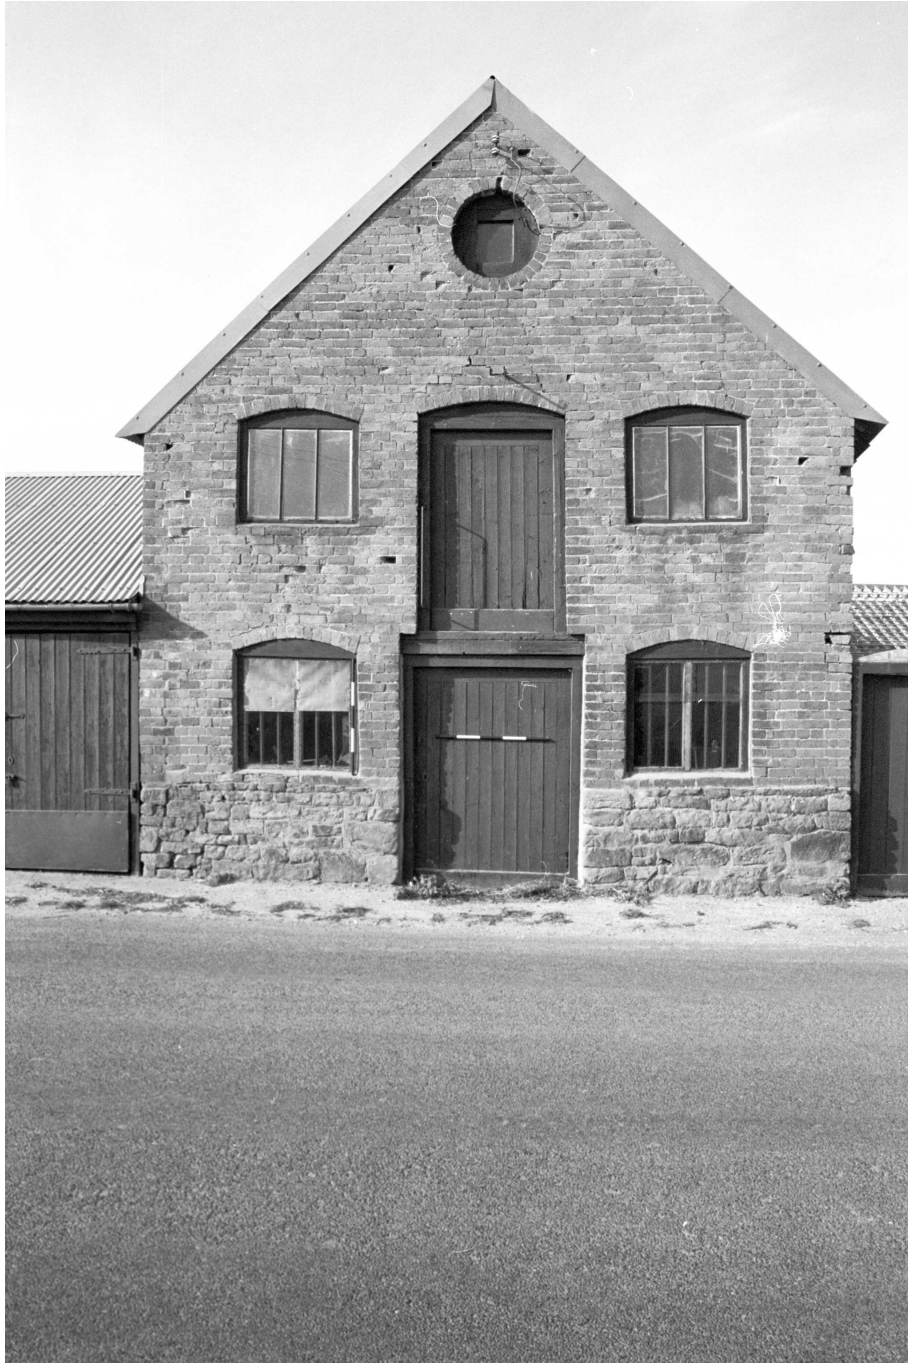
**Plate 9: The east end gable of the barn**

The east gable end of the barn (plate 9 and drawings 13 and 14) had four windows that were timber framed and either side of two timber doorways. The

ground floor door opened into what was, at the time of the survey, a store room for tools. The floor of this building was stone flagged. The second door opened immediately above the ground floor door and was probably used for loading.

Above the windows and the upper door was a circular 'Owl hole'. This would have allowed easy access and nesting opportunities for birds acting as pest control within the barn.

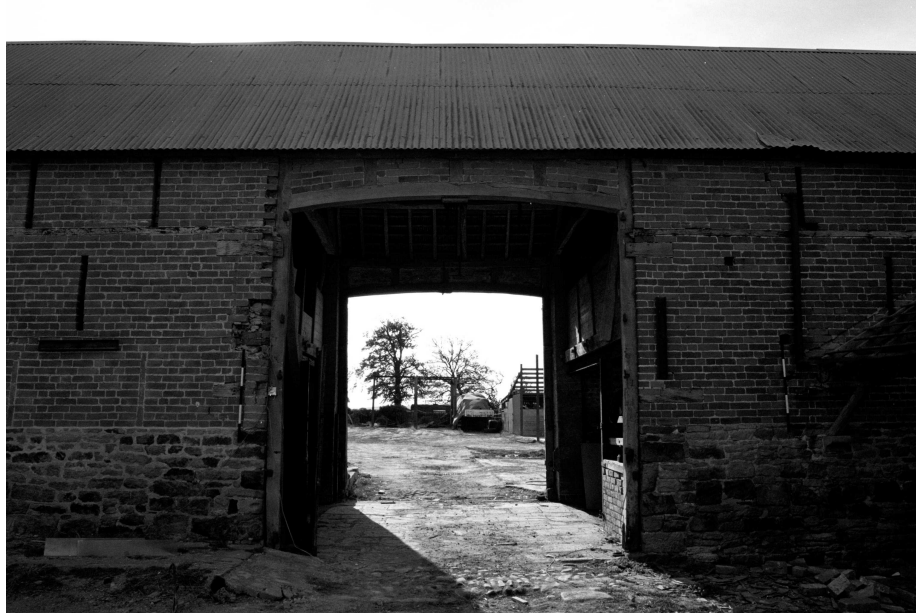
**Plate 10: The through-way (from the yard) of the barn**

The largest building in most farmyards was the barn and was mainly used for the process and storage of corn. The entrance needed to be large enough to admit a high loaded wagon that was usually unloaded into bays either side of the door. These bays, to prevent the crop from becoming mouldy, or from overheating, needed good ventilation. Ventilation holes are a common feature of stone and brick barns and come in a variety of forms. Plate 10 (above) and drawings 9 to 12 show vertical slots in the original barn that would have allowed air to circulate within the storage bays.

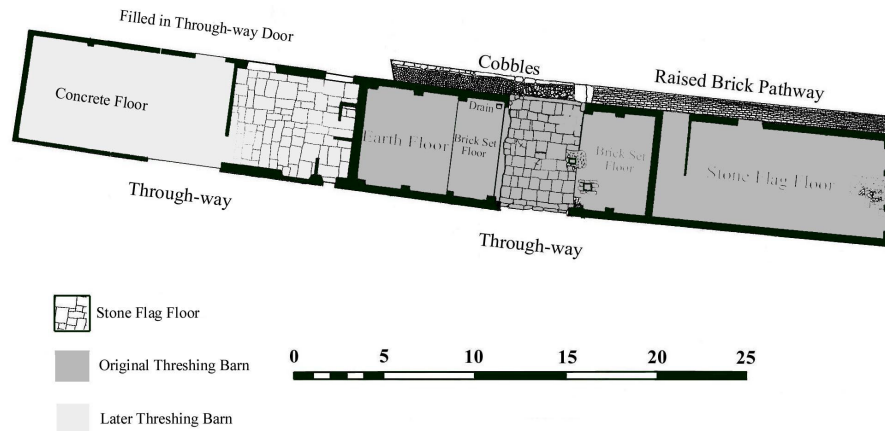
**Figure 12: The floor materials from the barn**

Floor surfaces of stone, brick and earth were recorded in the barn. The through-entry was of stone flags with rooms either side having brick sets. The west end of the original barn building had, at the east end, approx. 5m. of brick set flooring while the room to the east had a compact earth floor. On the north wall of the building was a hayrack and manger for the feeding of animals.

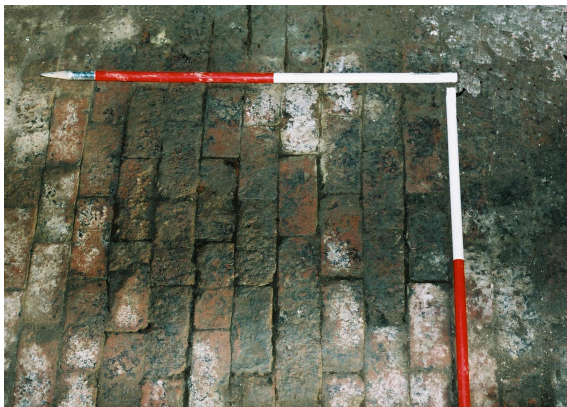
**Plate 11: Brick set flooring within the barn**

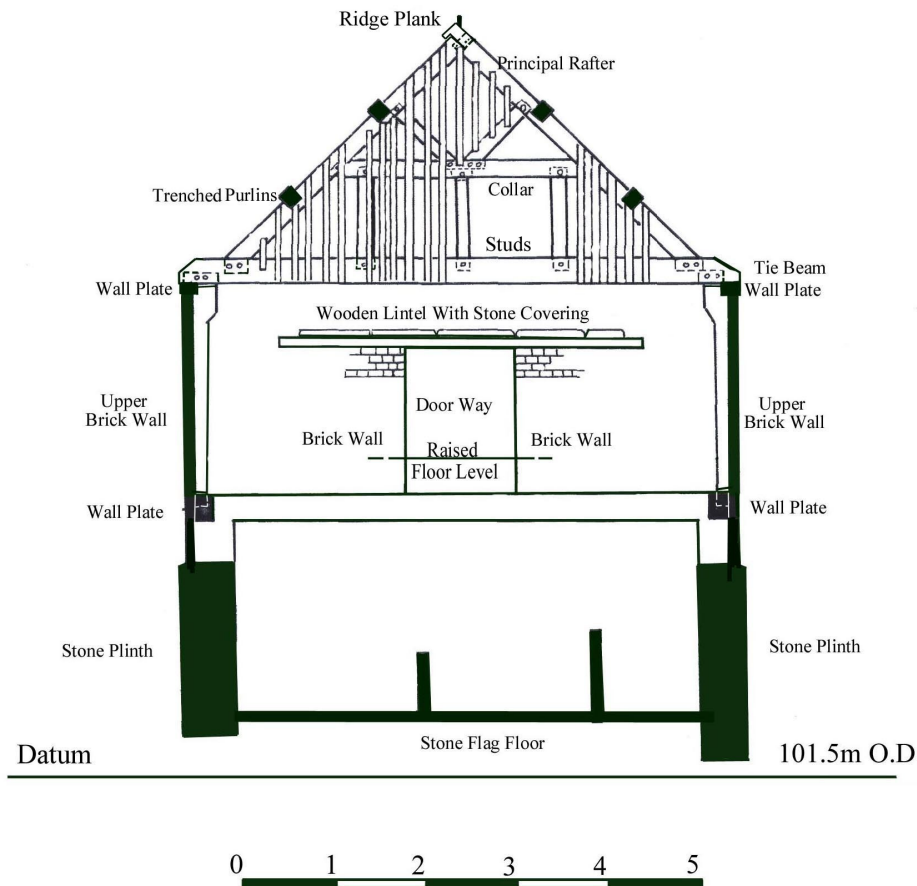
**Figure 13: Section (G-H) of the exterior west gable end of the original threshing barn. The elevation was recorded from within the later west barn (see plate 12). The inserted floor in the original threshing barn can be seen through the doorway.**

The A-frame truss has three studs between the tie-beam and the collar and two struts above the collar that are jointed to the rafters by mortice and tenon. Four purlins are trenched into the rafters and a thin central plank runs down the ridge. Planks have been added to the west of the frame, probably when the later barn was added. The two main posts have been partly covered by brick infill. The top of the tie-beam was grooved and stave holes were in the rafters and the underside of the collar.

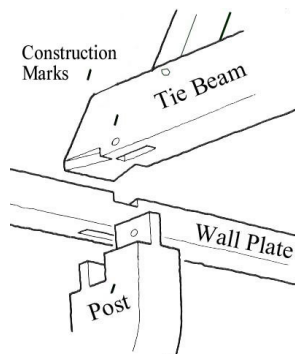
Builder's construction marks were present on the timbers in Roman Numerals. The north tie-beam and principle rafter was marked I, and the south tie-beam and rafter, II. The three post and tie-beam were also marked, from north to south, I, II and III.

**Figure 14: Tie beam lap dovetail assembly. Construction detail of the tie beam, post and wall plate**

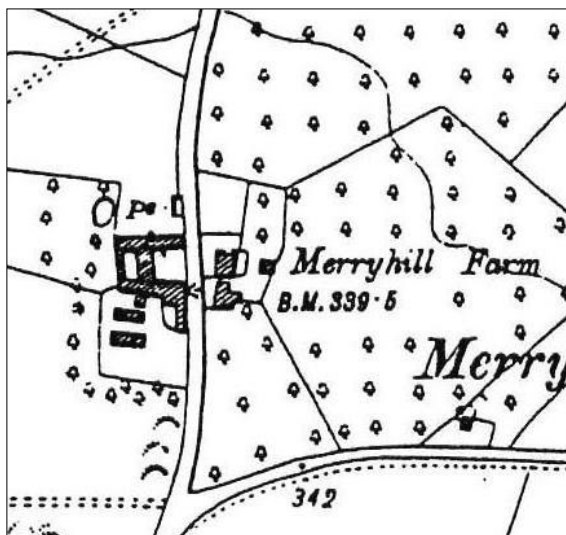
**Figure 15: 1930 OS map of Merryhill Farm showing a standing building attached to the south and north of the barn.**

Two out lying buildings are also shown on the 1930 OS map. These two buildings are aligned east-west are to the south of the barn, and were not standing at the time of the survey.

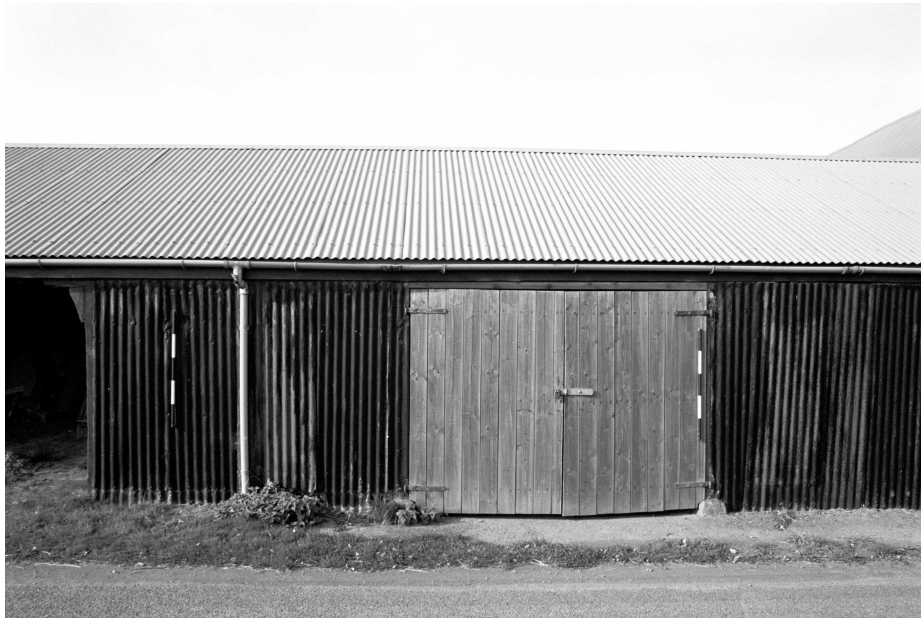
The front garage is attached to the east end of the barn, and fronts onto the road. Its walls are stone built on the west and south ends. The front of the building (see drawings 13 and 14) is mostly open, supported on eight wooden piers buried into the ground. The northern most end of the building had two double doors.

**Plate 16: The garage doors on the east (road) side**

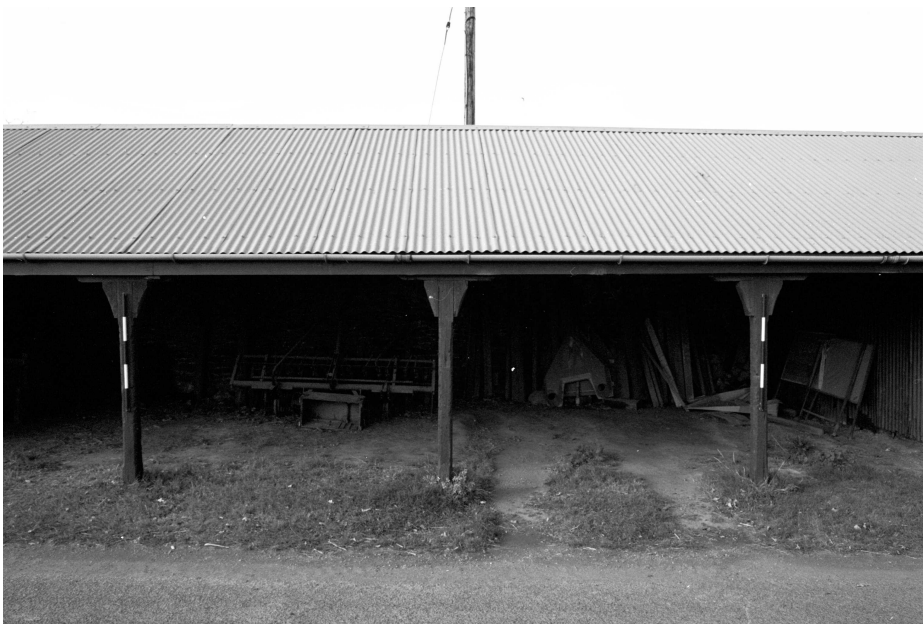
**Plate 17: The wooden piers that support the front of the garage and the roof trusses**

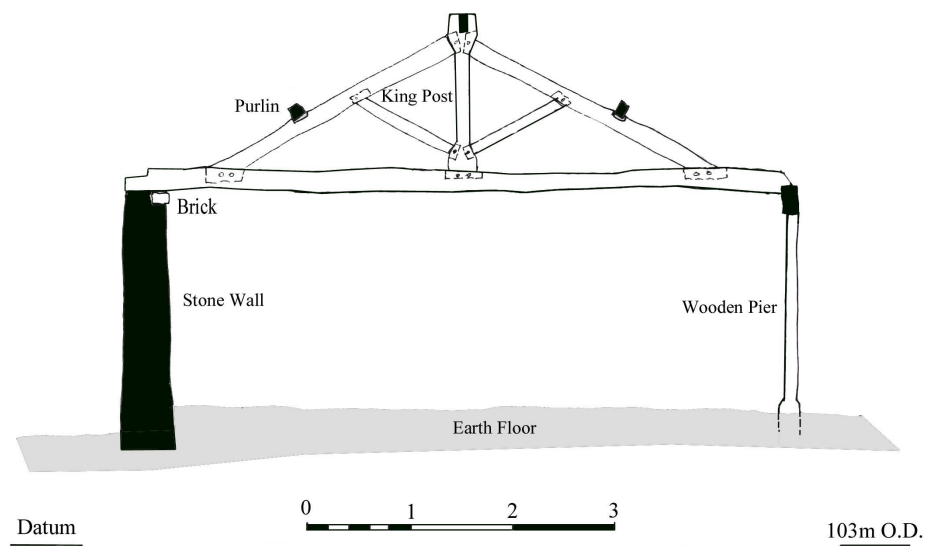
**Figure 16: Cross section through the garage. The truss consists of a king post with struts from the tie-beam to the principle rafters. The king post truss dates from the late 18<sup>th</sup>/19<sup>th</sup> century.**
