**HISTORIC BUILDING SURVEY REPORT:
MANOR FARM, WEST WINCH, NORFOLK**

Planning Reference: 10/01911/EXF

By
Allen Archaeology Limited
Report Number 2012099

October 2012

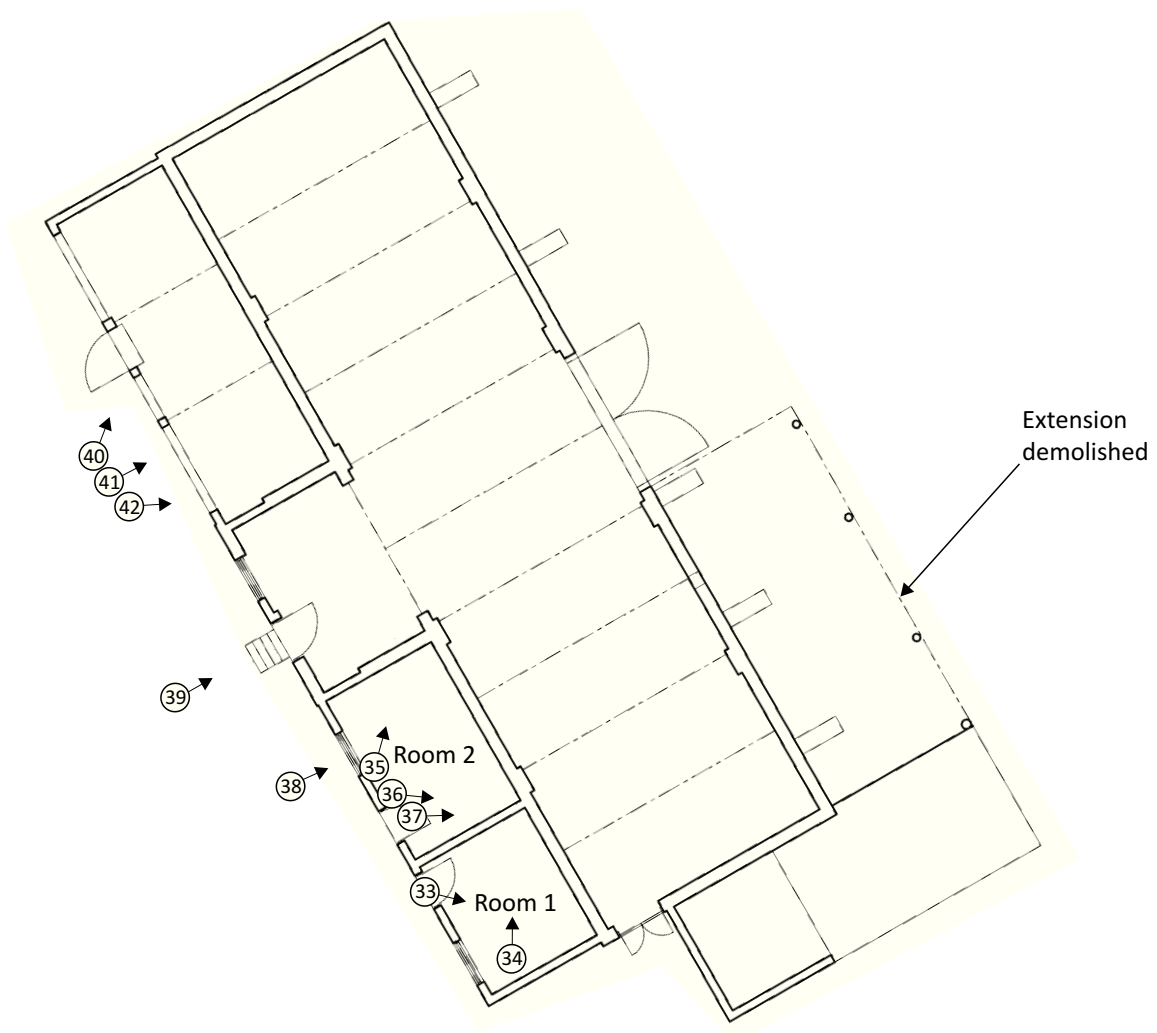
Figure 3: Plan of Barn 1 at Manor Farm. Numbered arrows indicate location and orientation of photographs (base plan provided by Bidwells Property Consultants)

Extension demolished
