**HISTORIC BUILDING SURVEY AND EVALUATION BY TRIAL TRENCHING:
CHURCH FARM, YELLING, CAMBRIDGESHIRE**

Planning Applications: 11/02080/FUL and 11/02081/LBC

By
Allen Archaeology Limited
AAL Report Number 2013146

December 2013

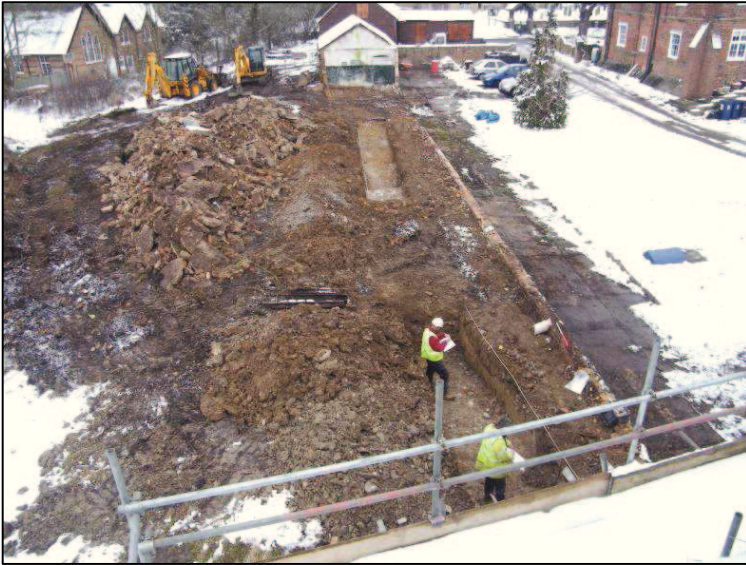
Plate 1: General view of the site with Trench 1 in the foreground and Trench 2 in the background, looking north

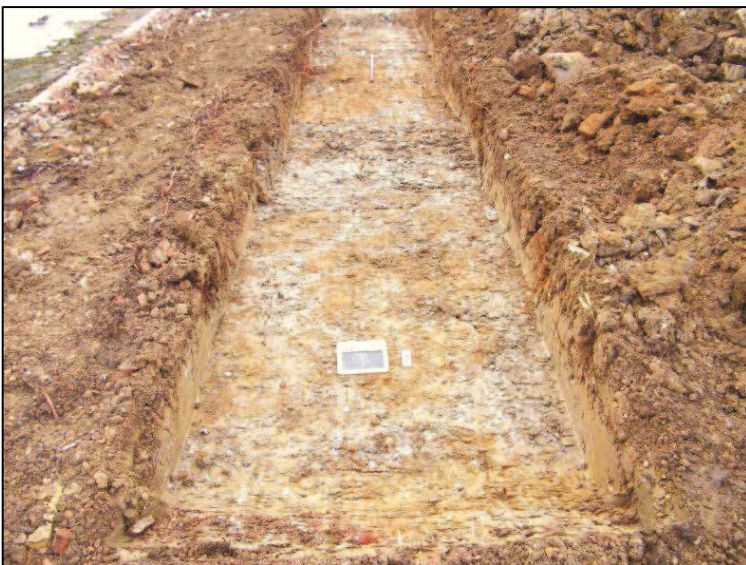
Plate 3: General view of Trench 2, looking south

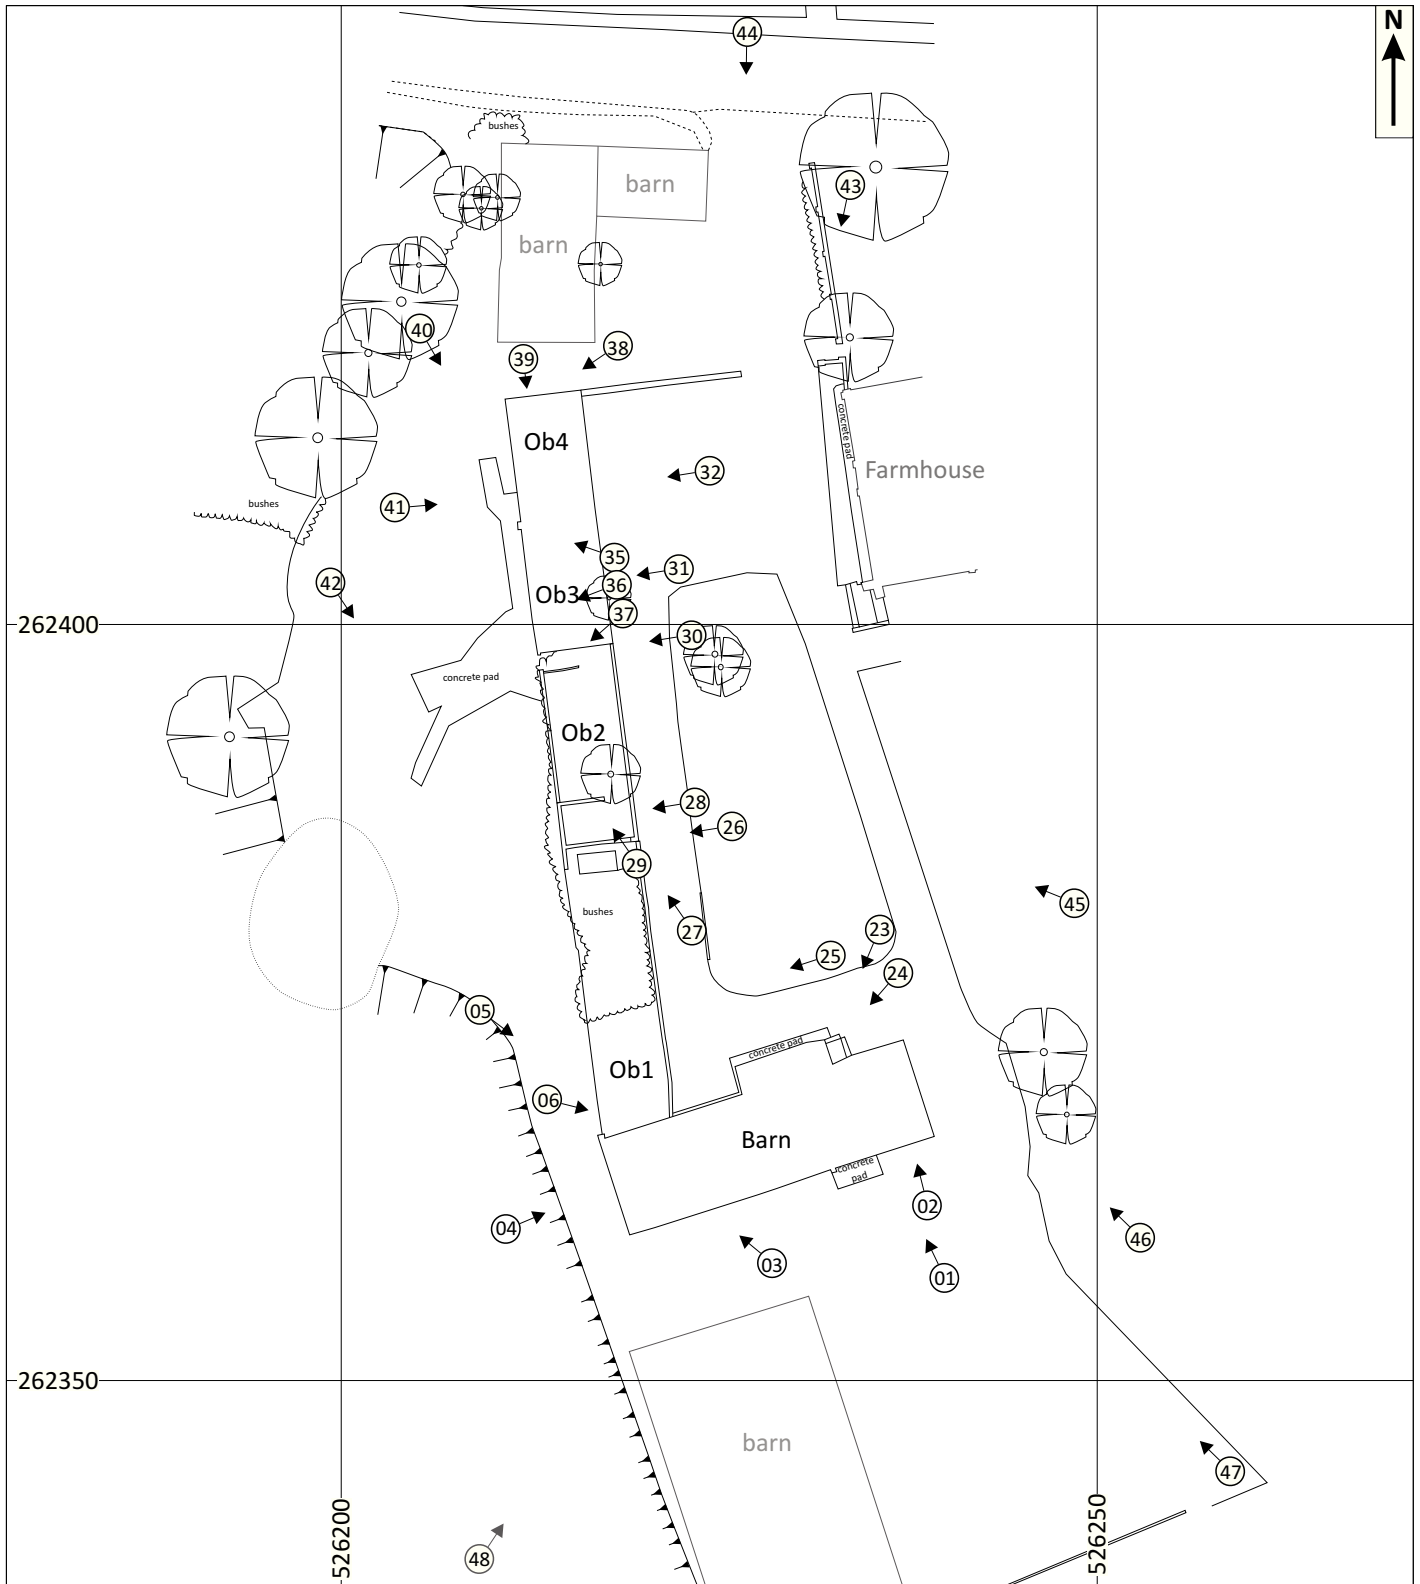
Figure 3: Location plan at scale 1:500. Numbered arrows indicate location and direction of photographs taken during the building survey. Internal photographs of the barn shown on Figure 4. (Baseplan provided by the client)

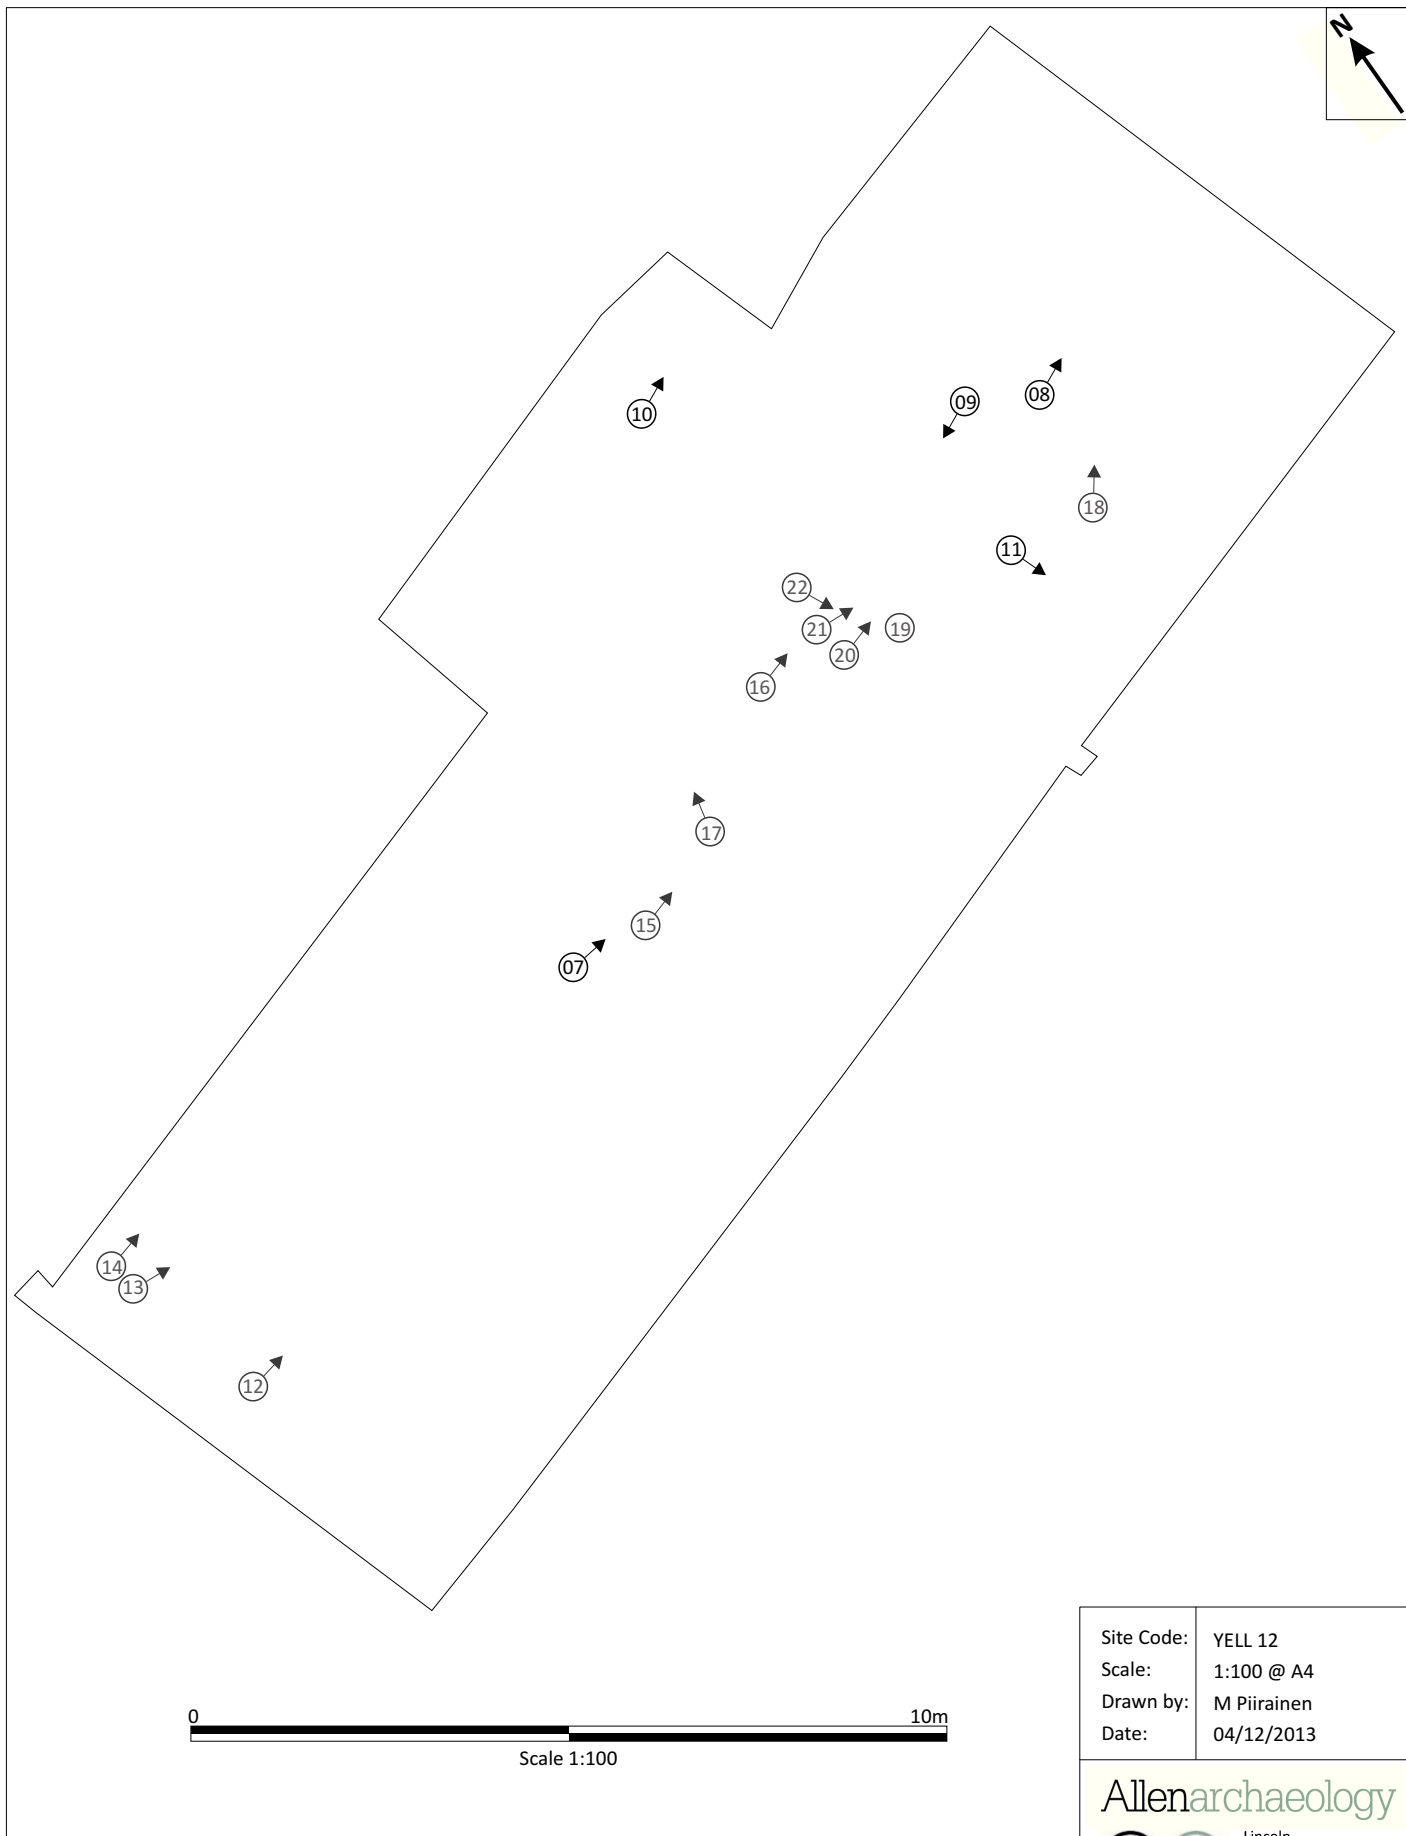
Figure 4: Plan of the barn at scale 1:100. Numbered arrows indicate location and direction of internal photographs taken during the building survey. Arrows and numbers in grey relate to photographs taken from the temporary work floor situated above ground floor. For exterior photographs see Figure 3. (Baseplan provided by the client)
