HISTORIC BUILDING SURVEY REPORT:

BRUMBY RESOURCE CENTRE, BRUMBY, SCUNTHORPE, NORTH LINCOLNSHIRE

By
Allen Archaeology Limited
Report Number AAL2016006

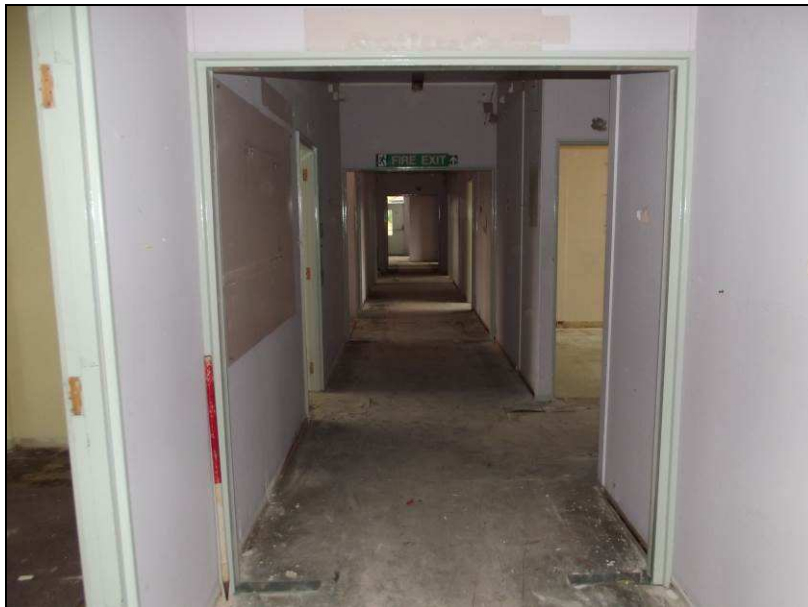
- 6.4 The building is centred on a small courtyard (Plate 5) with a corridor running along the south of the courtyard of the building aligned east-west. A second corridor is linked to the building on the eastern side and runs north-south (Plate 6).

Plate 6 (shot 354): Eastern corridor of Ashby House, looking south

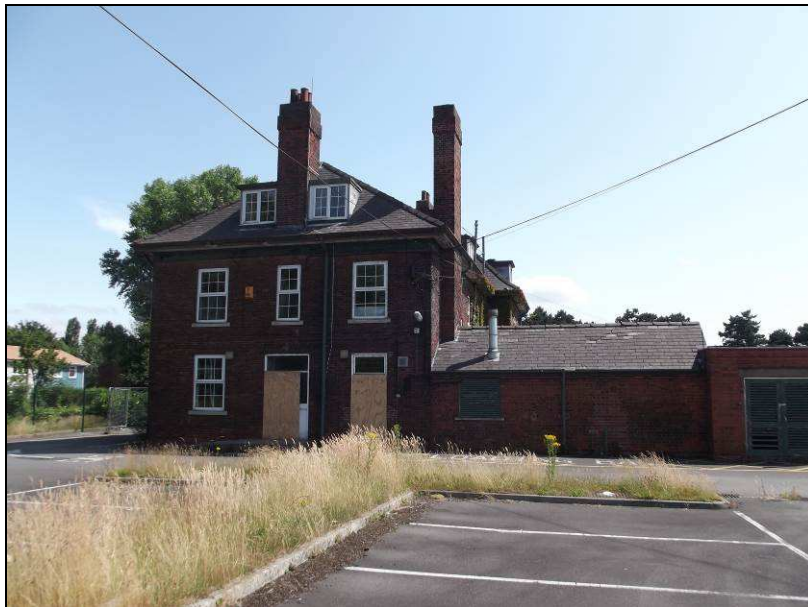
- 6.6 The main building and the eastern extension are in stretcher bond brickwork, the western extensions are in English Bond.
- 6.7 The third floor windows occupy large flat roofed dormers with wood panelled sides (Plate 8). The remaining windows are generally below flat brick arches with stone sills. All the windows are modern uPVC replacement casements.
- 6.8 A drainpipe on the north-facing elevation bears the date 1929 (Plate 10), all of the drainpipes are of this style, with others bearing patterns of flowers.

Plate 8 (shot 293): The western extension of Barton House, taken from the west looking east

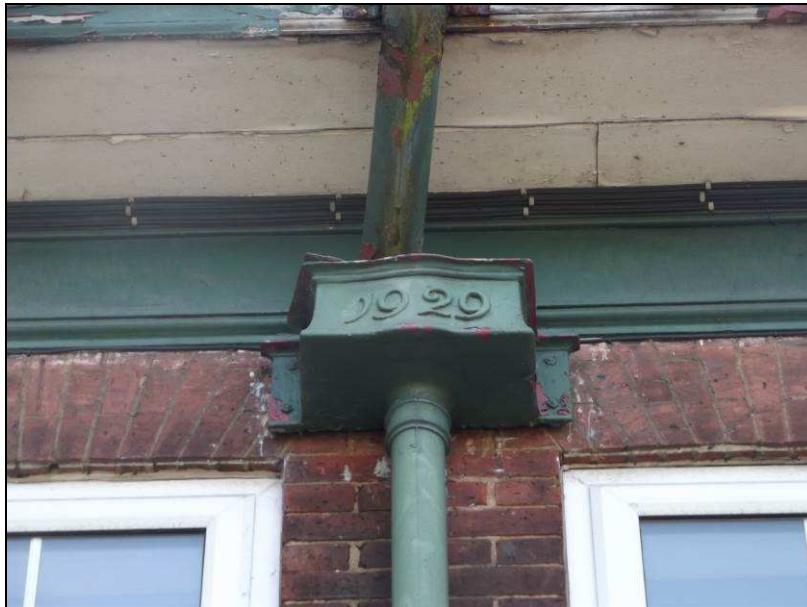
Plate 10 (shot 302): Inscribed pipe on the northern face of Barton House, looking south

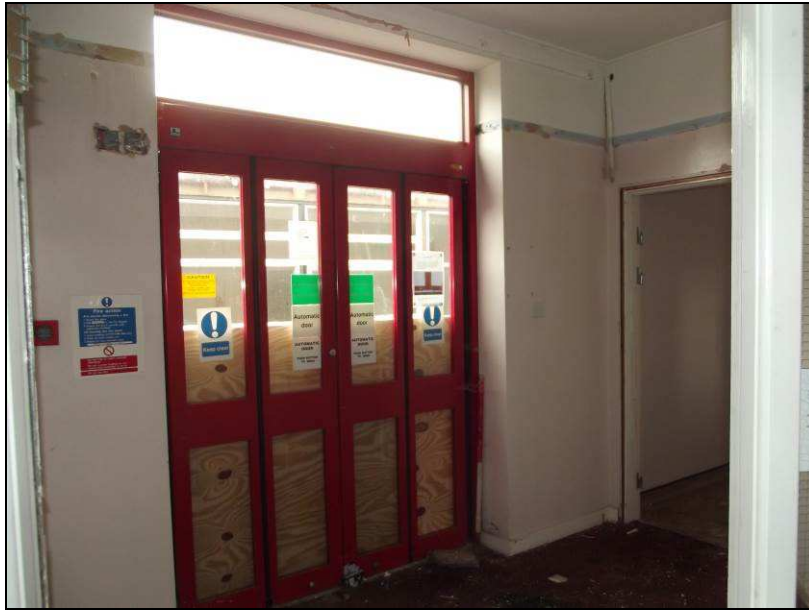
- 6.10 Area B1 is the eastern extension and has been used as an entrance into the building which has now been blocked (Plate 13). The space provides access to the upper floors (Plate 14) and the eastern extent of the building (Plate 15), two lavatories are also present on either side of the entrance.

Plate 13 (shot 96): Eastern extension to Barton House, entrance, looking southwest

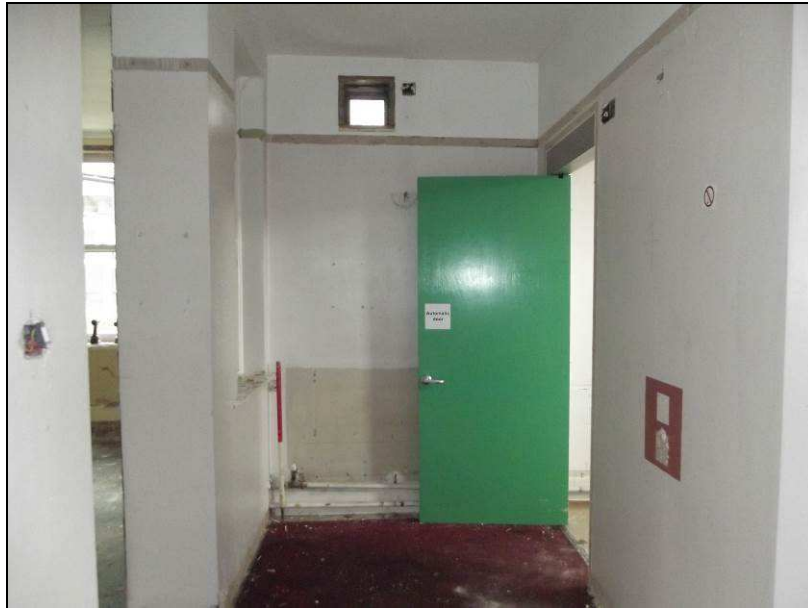
Plate 15 (shot 98): Buildings main entrance is to the left and entrance to the rest of the building to the right. Looking west

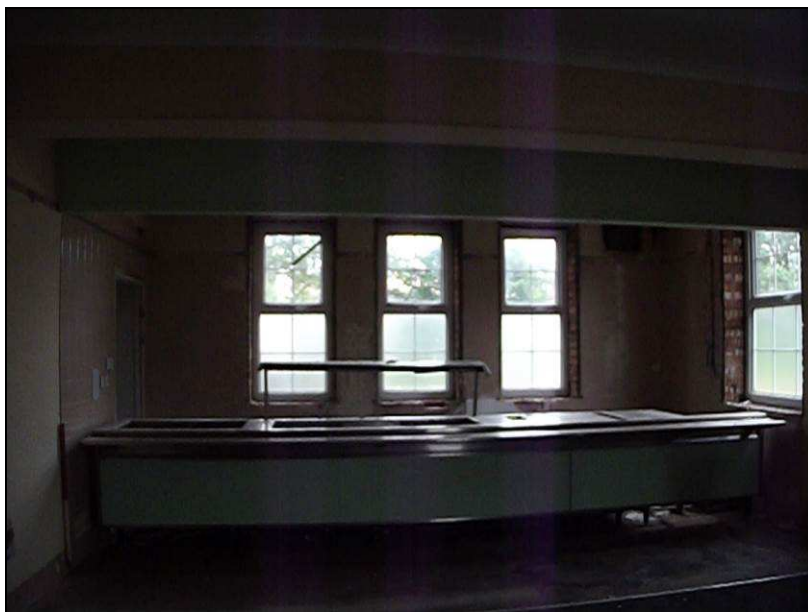
- 6.11 There are a series of rooms associated with a canteen, B2 is the first of these spaces (Plate 16). It consists of an open space with a concrete floor and a serving area, the space behind which has a tiled floor.

Plate 16 (shot 100): Ground floor of Barton House which was in use as a canteen (B2). Looking north

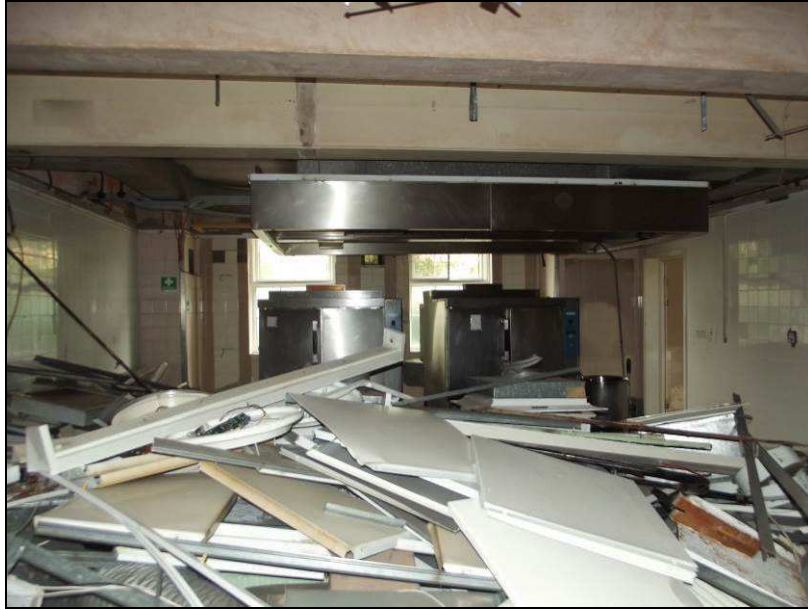
- 6.12 B3 is a continuation of B2 and consists of two conjoined spaces, filled with demolition material at the time of the survey (Plate 17). The space is tiled throughout which can be seen clearly at the southern extent of this space (Plate 18). To the west is an entrance with double doors, now boarded up (Plate 19).

Plate 17 (shot 103): View of catering units in B3, looking north

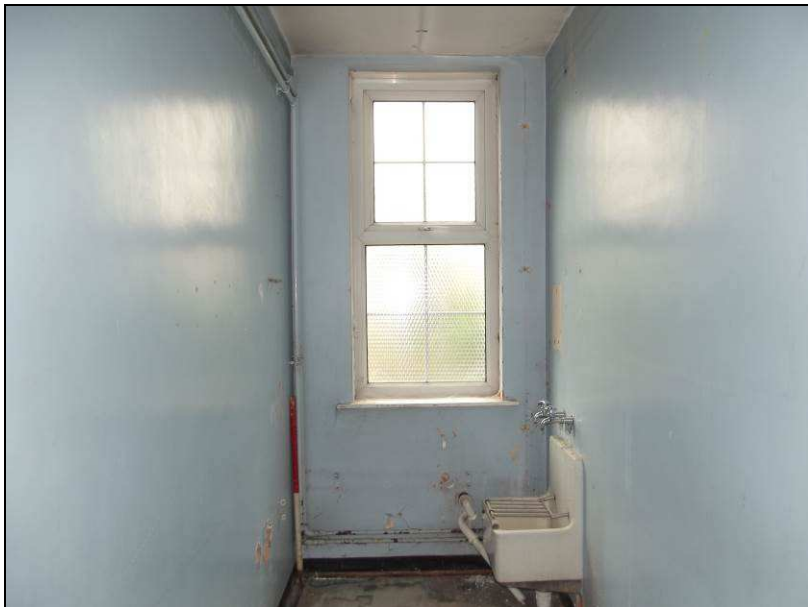
Plate 22 (shot 120): Photo of one of the wash rooms in B6, looking north

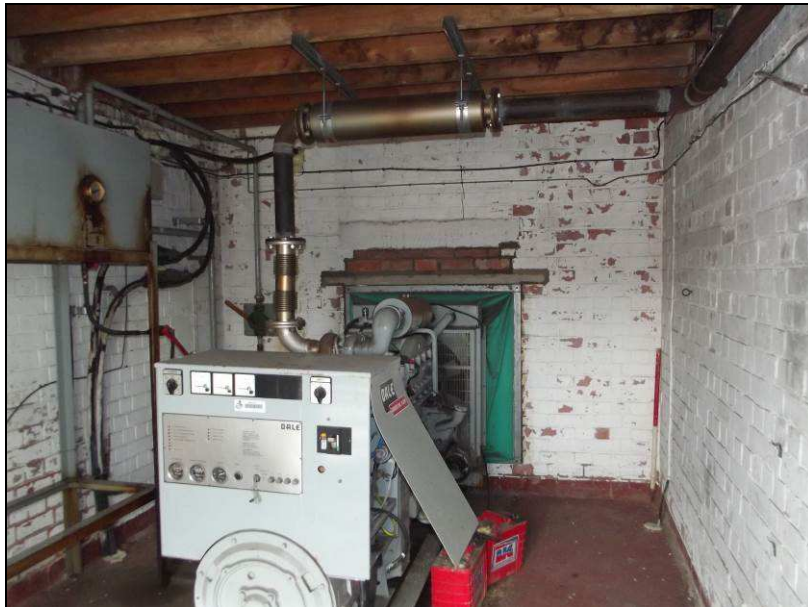
Plate 24 (shot 89): Barton House western extension housing the services for the main building, looking northeast

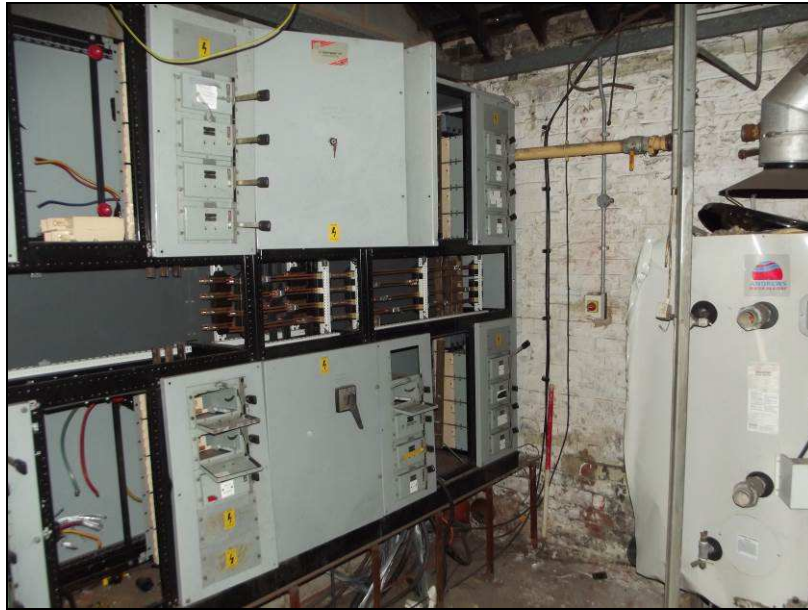
Plate 25 (shot 135): Extension of Barton House containing services for the main building, looking southwest

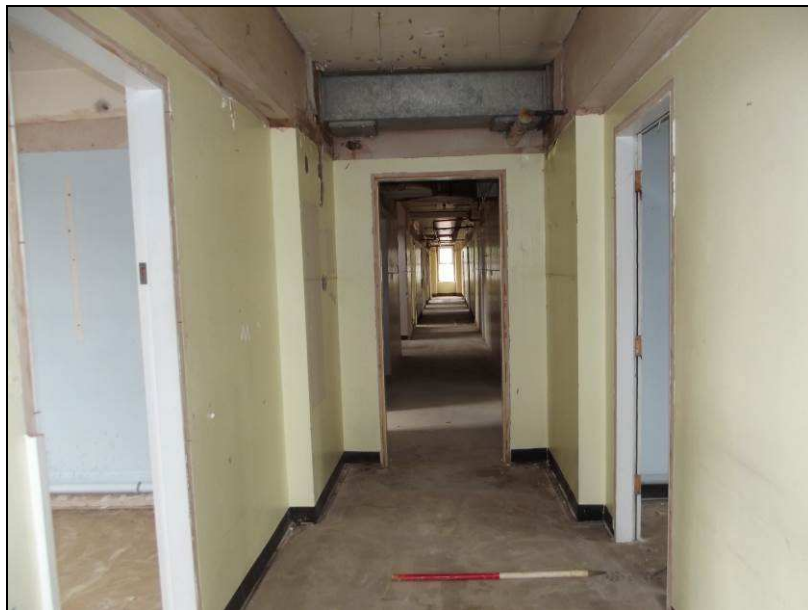
Plate 26 (shot 195): Corridor on the first floor of Barton House, looking west

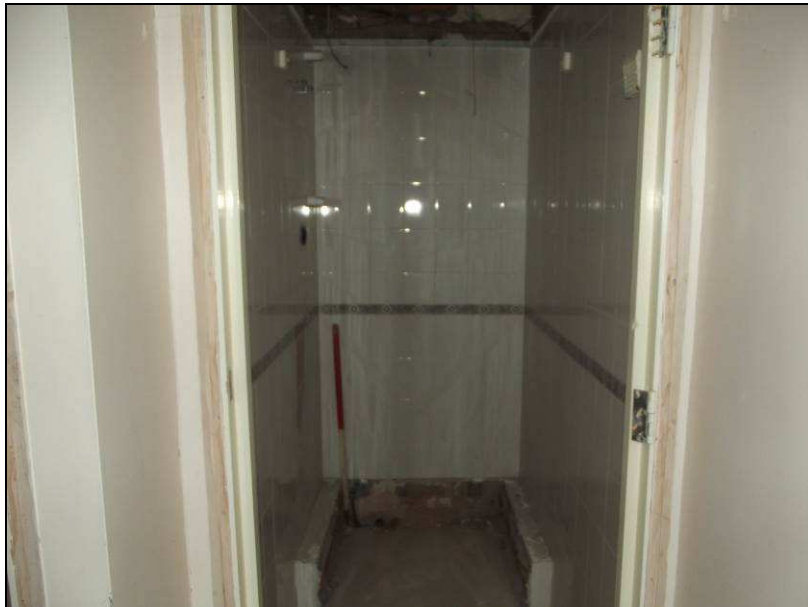
Plate 28 (shot 181): Example of a wash room in B9, looking north

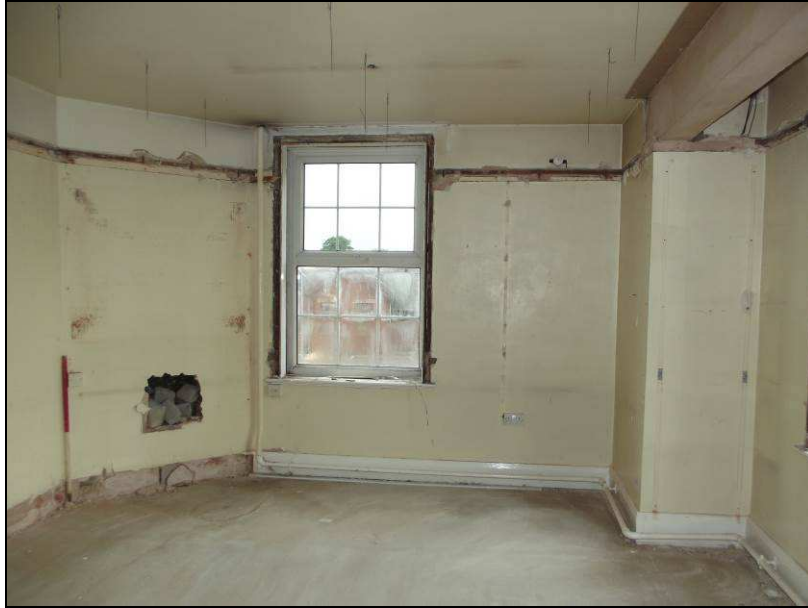
Plate 29 (shot 159): One of the larger rooms on the first floor of Barton House (B11), looking west

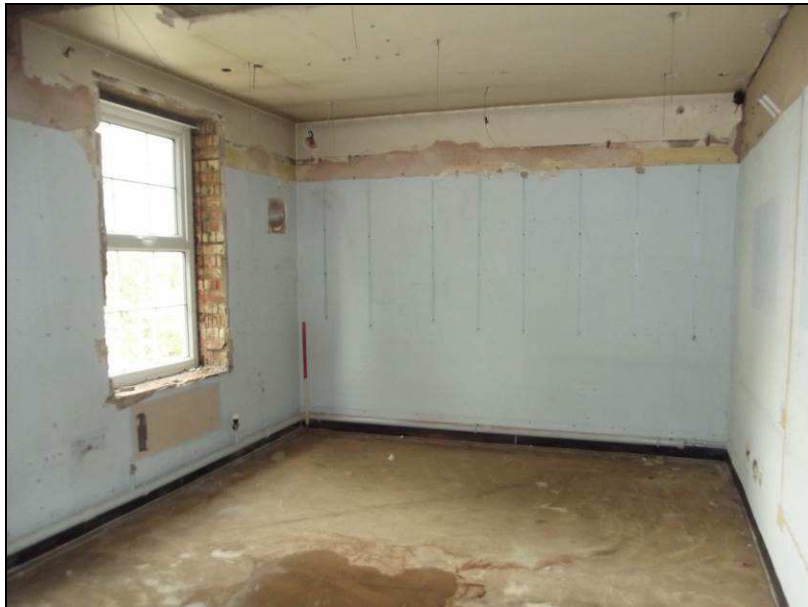
Plate 30 (shot 190): One of the larger rooms on the first floor of Barton House (B12), looking northeast

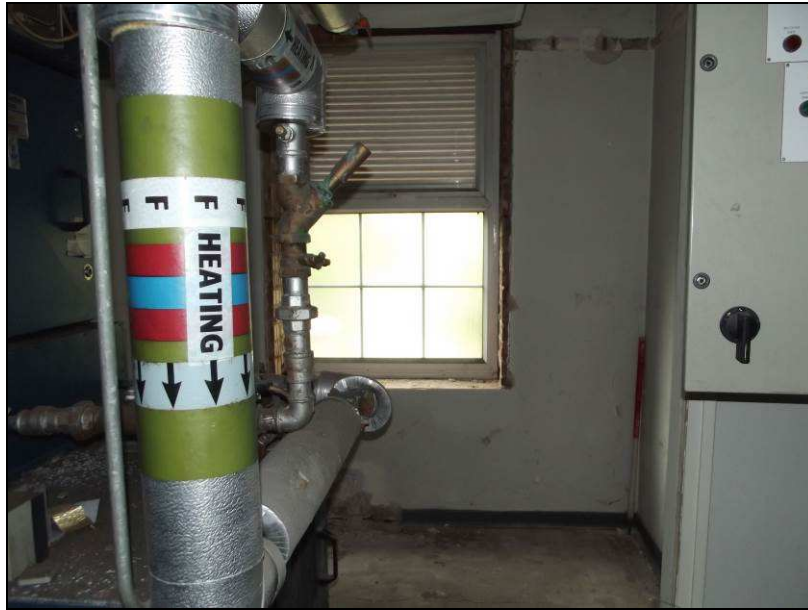
Plate 31 (shot 185): Supply of services to the first floor of Barton House, in B13, looking north

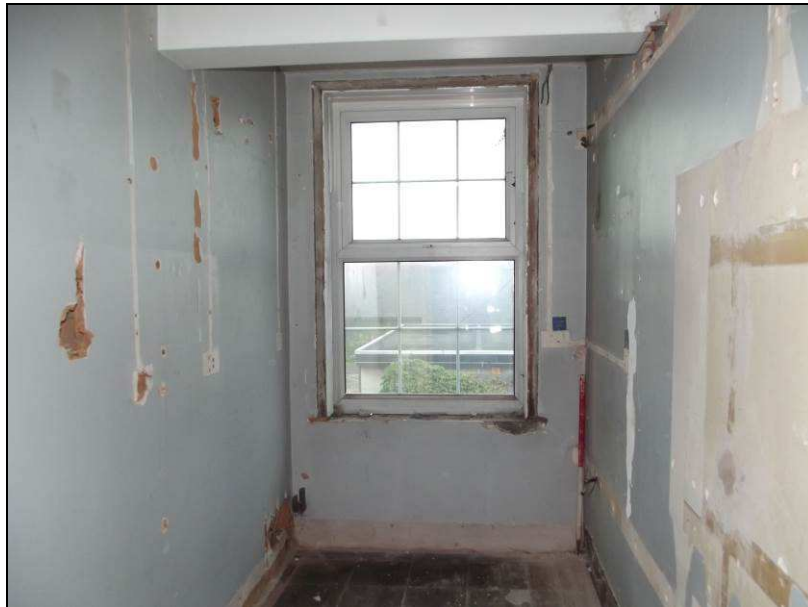
Plate 32 (Shot 170): Small room in B10, possibly used for storage on account of its dimensions, looking south

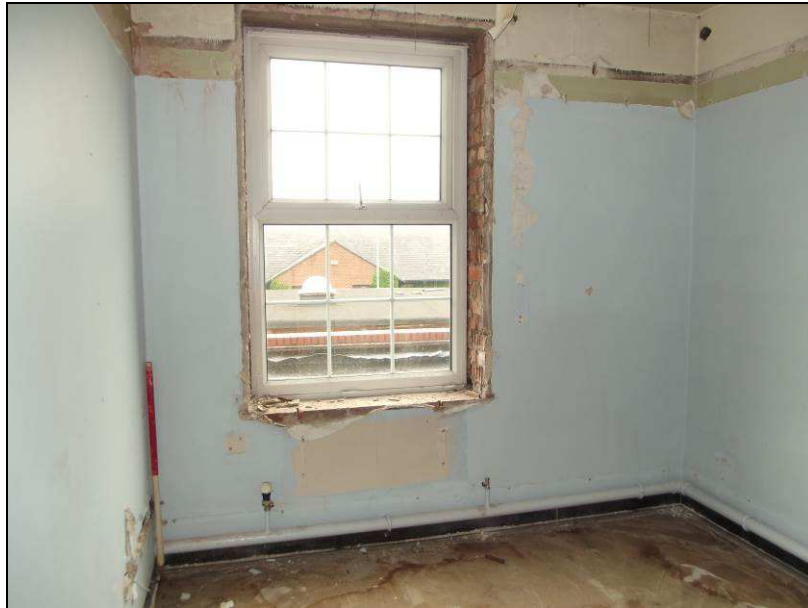
Plate 33 (shot 193): A room from B15, an example of a smaller room from the first floor, looking southwest

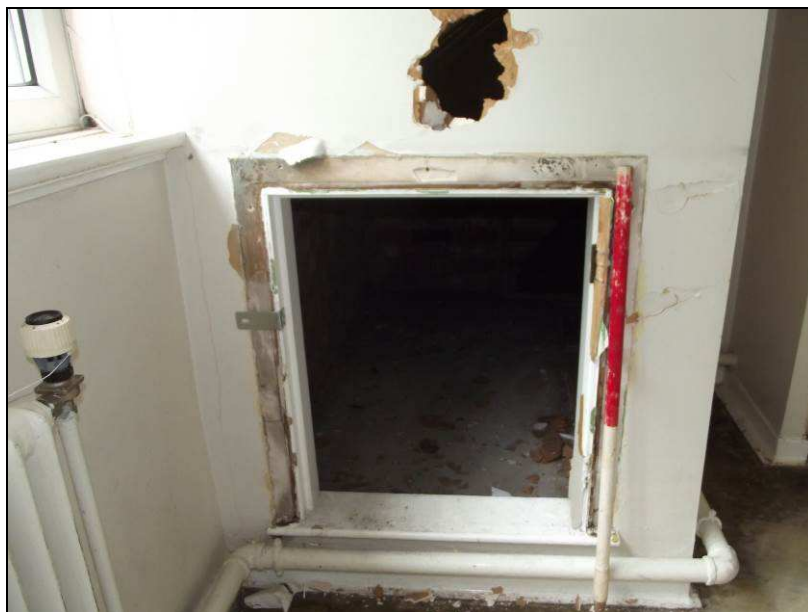
Plate 34 (shot 198): Access point to crawl space behind the outer walls of the second floor of Barton House, looking northeast

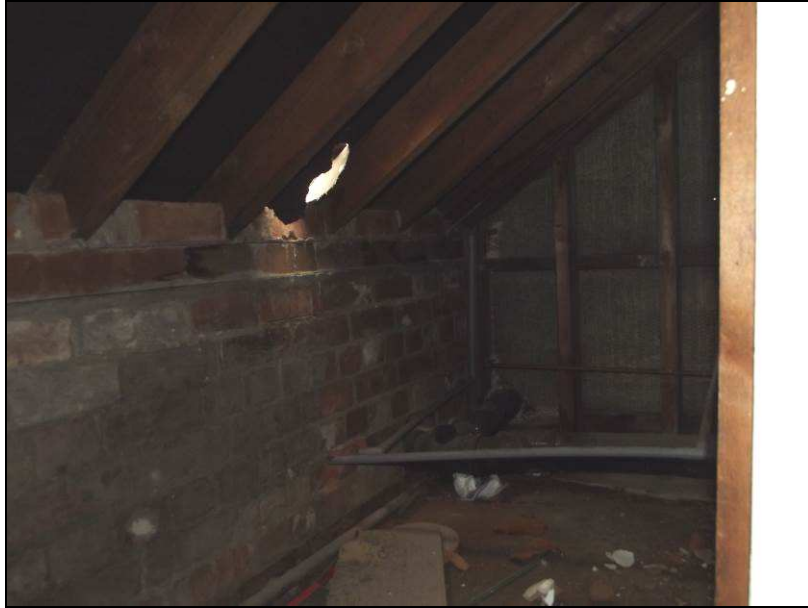
Plate 35 (shot 208): Timber framed roof visible through crawl space, looking southwest

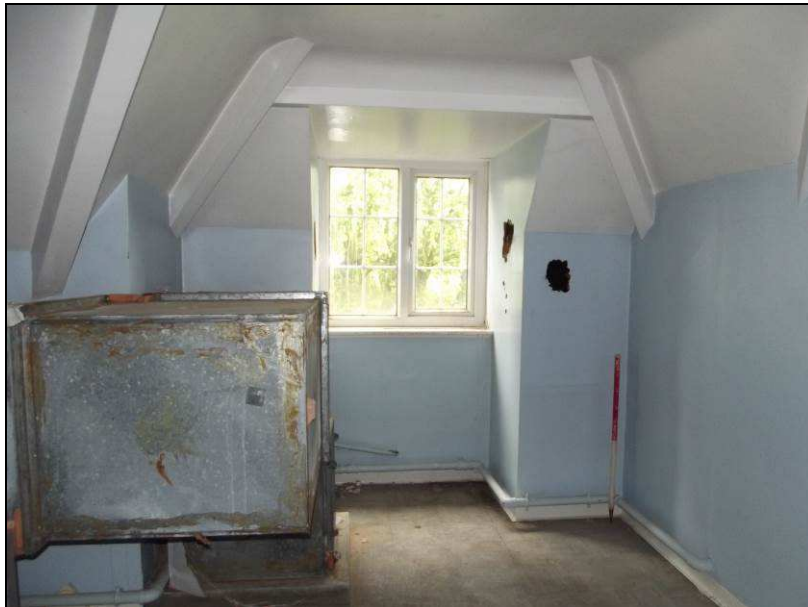
Plate 36 (shot 206): Water tank in one of the rooms on the second floor of Barton House, looking north

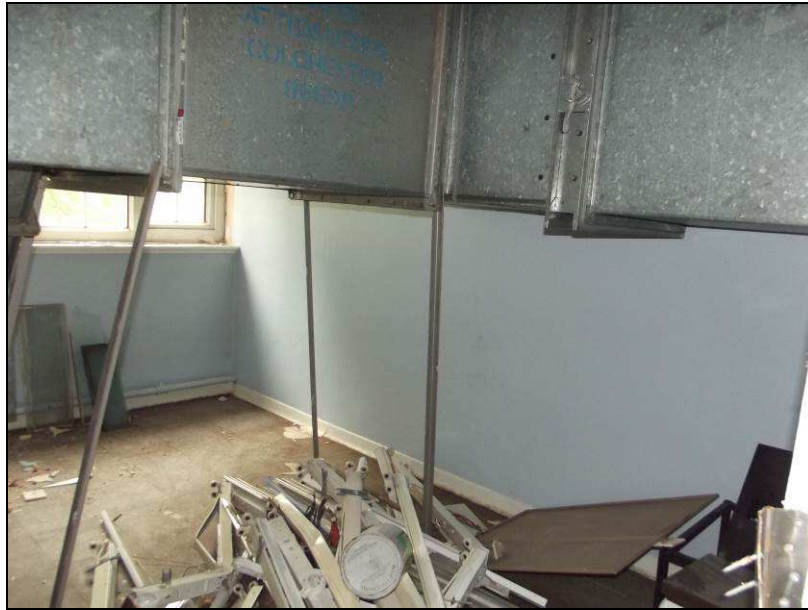
Plate 37 (shot 204): Metal extractors from the lower floors of Barton House found on the second floor, looking northeast

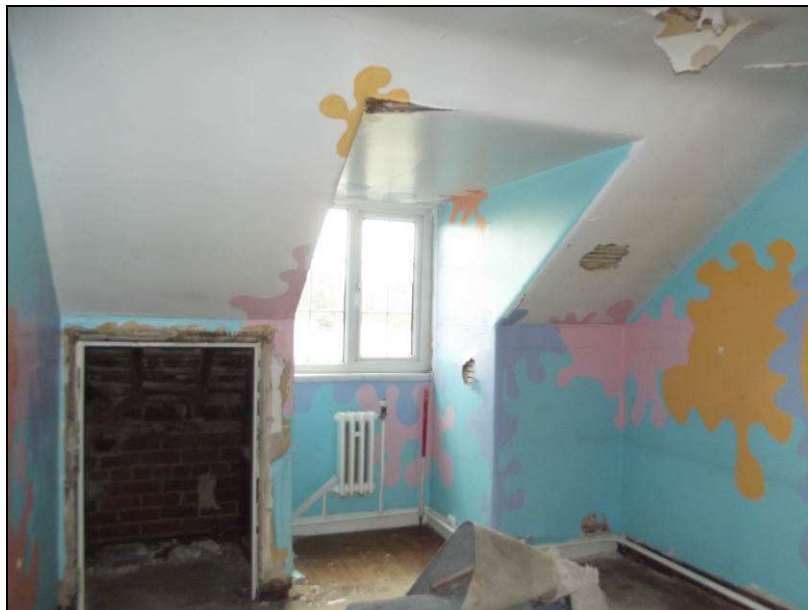
Plate 38 (shot 222): Room on second floor of Barton House with a dormer window, looking northeast

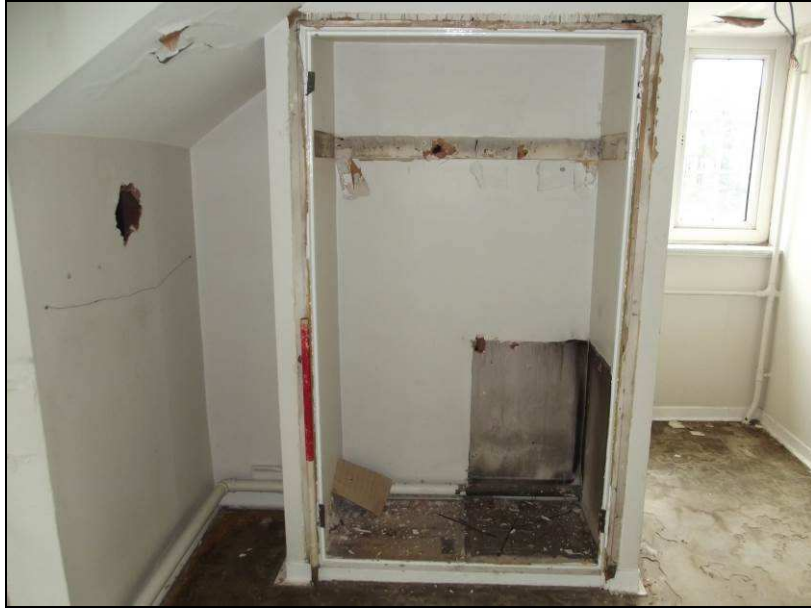
Plate 39 (shot 199): Built in wardrobe on second floor of Barton House, looking east

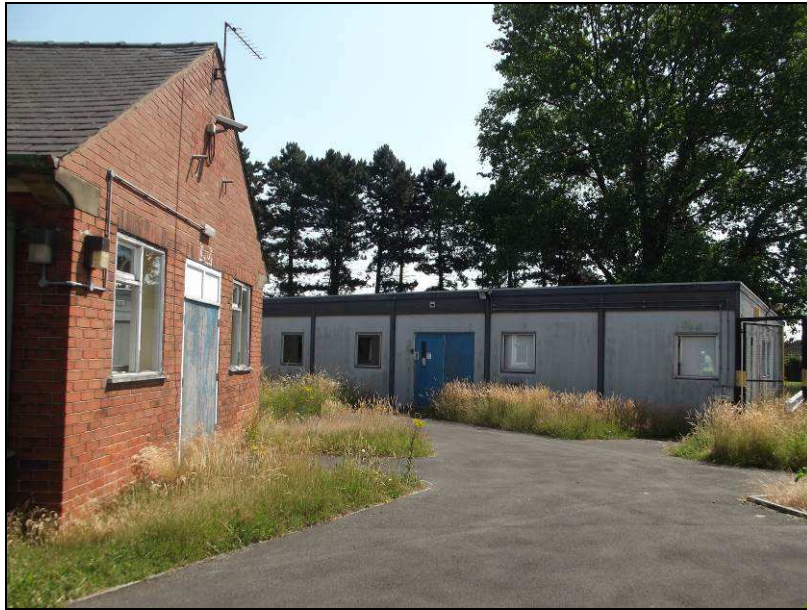
Plate 41 (shot 278): Prefabricated extension to the rear of Crosby House, looking east

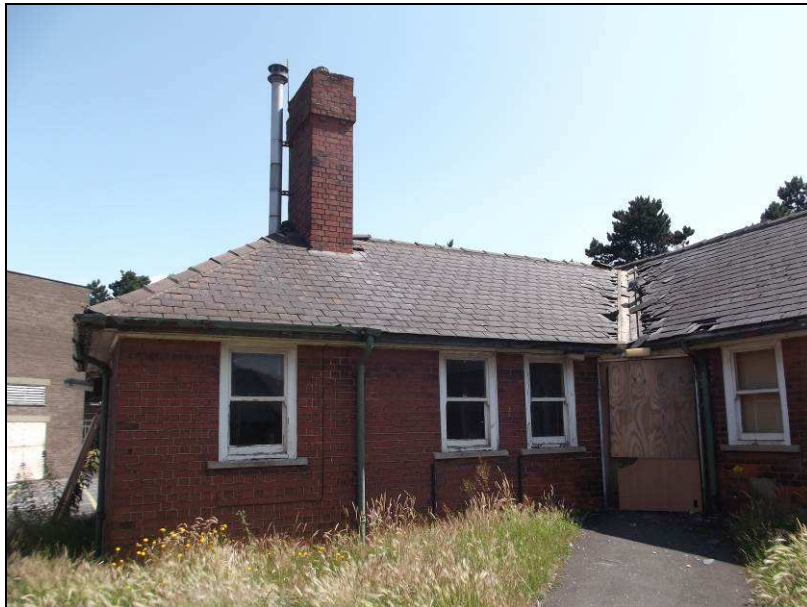
Plate 42 (shot 276): Porch of Crosby House, note the change from stretcher bonding to English bonding either side of the downpipe, looking east

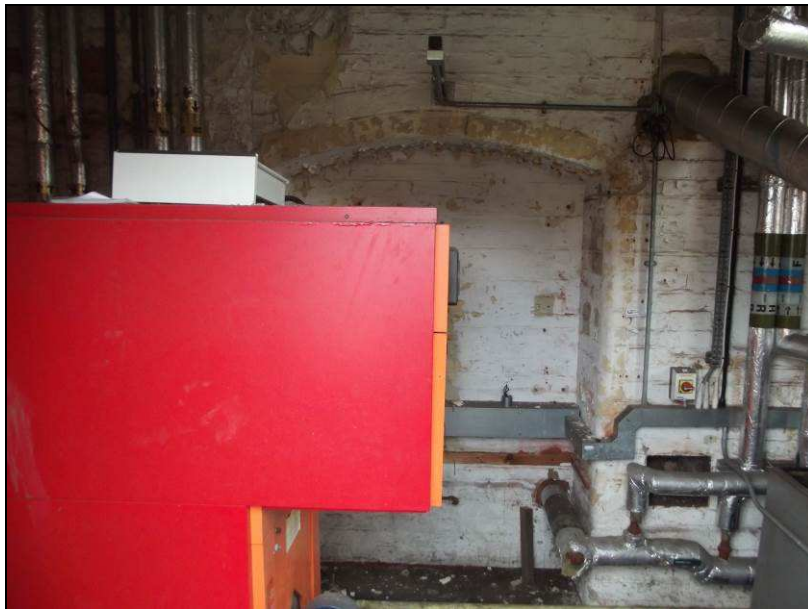
Plate 44 (shot 262): Plant room in Crosby House, looking southeast

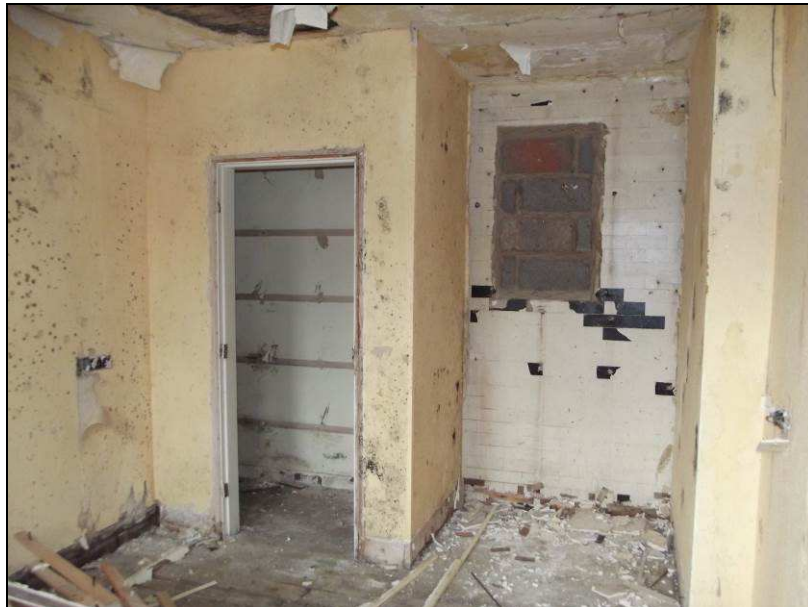
Plate 46 (shot 260): Crosby Building front office space with built in cupboards, looking northeast
