- 1.1 Allen Archaeological Associates was commissioned by Christopher Press Architect, on behalf of their clients, Mr and Mrs Smith, to undertake a building survey of two ranges of barns that are being converted into self contained holiday accommodation at The Grange, Yarburgh Road, Alvingham, Lincolnshire.
- 1.2 The methodology conforms to a specification prepared by this company (Allen 2007), and the English Heritage guidelines in *Understanding Historic Buildings: A Guide to Good Recording Practice* (English Heritage 2006).
- 1.3 A copy of the building survey report and the full project archive will be submitted to The Collection, Lincoln, for long-term storage, and will be stored under the Museum Accession Number 2007.97.

- 2.1 Alvingham is situated in the administrative district of East Lindsey, approximately 5km north-east of the centre of Louth. The Grange is to the north-west of the village, on the east side of Yarburgh Road. The barns that are the subject of the building survey form part of a complex of agricultural buildings, to the south of the farmhouse. The site centres on NGR TF 3596 9153.

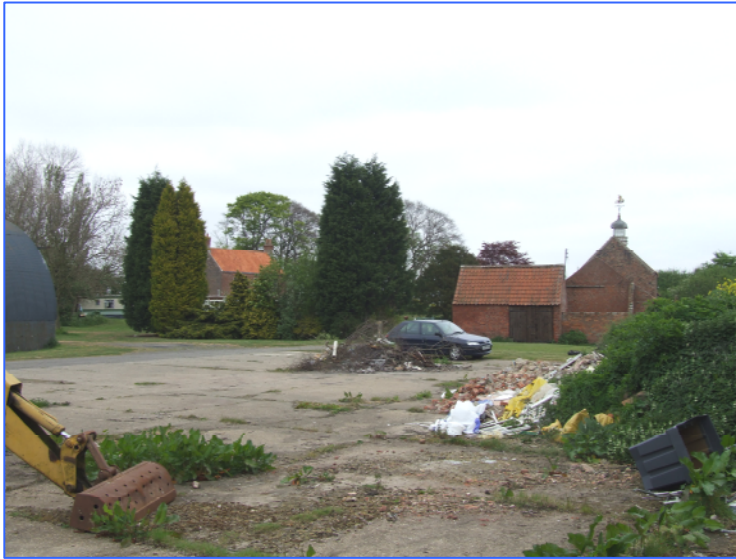
**Plate 1:** General view of the site, with the barns to the right of the shot and the farmhouse in the background. Looking north-west.

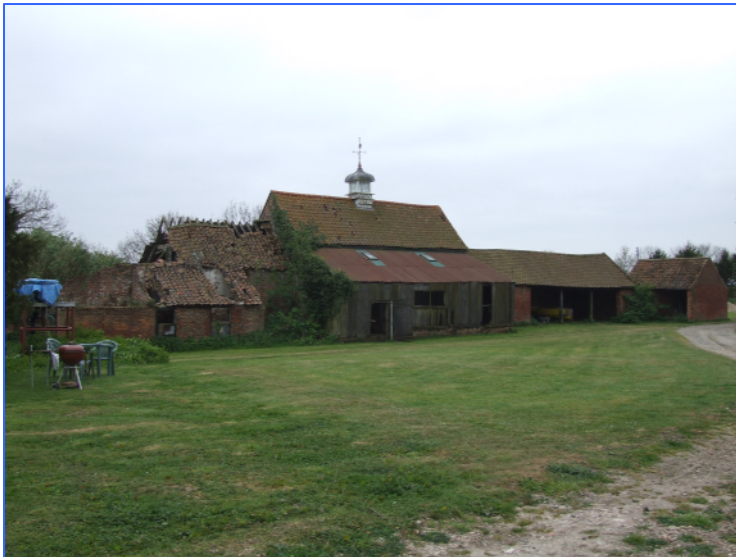
**Plate 2:** The north elevation of the north range, looking south.

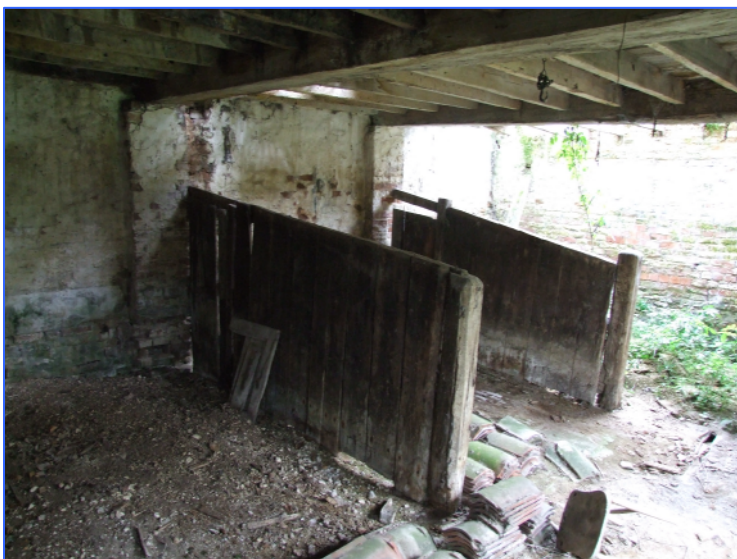
**Plate 6:** Interior of the stable block, showing the wooden partitions. Looking north-north-east.

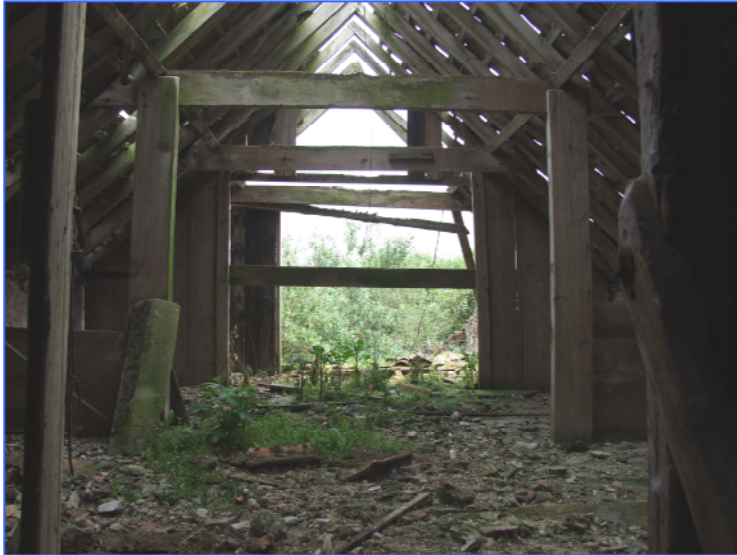
**Plate 7:** Hayloft above the stable block. Note the wooden partitions dividing the room into bays. Looking east-north-east.

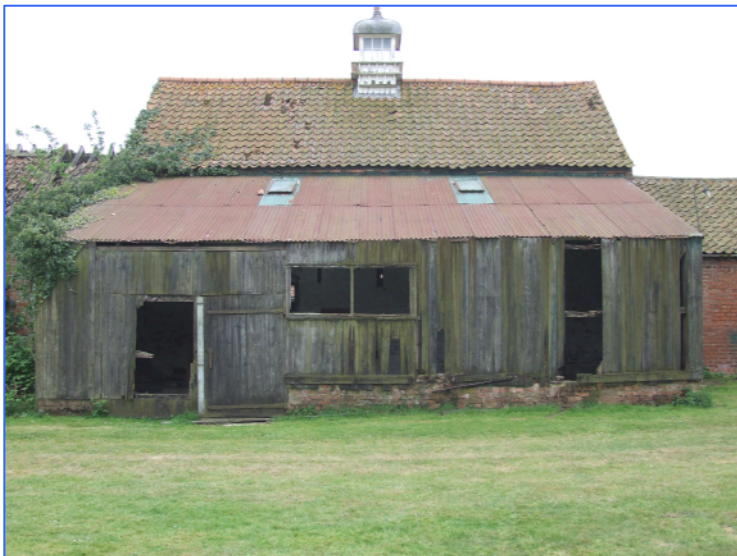
- 5.1.8 The barn has a large lean-to of probable 20<sup>th</sup> century date attached to its north elevation (Building 6), measuring 11m by 4.5m and constructed of a brick dwarf wall supporting vertical timber boarding and a mono pitched corrugated steel roof, with two skylights. The east elevation of the lean-to incorporates the west wall of the derelict stable block.

**Plate 9:** Lean-to on the north elevation of the north range. Looking south-south-east.

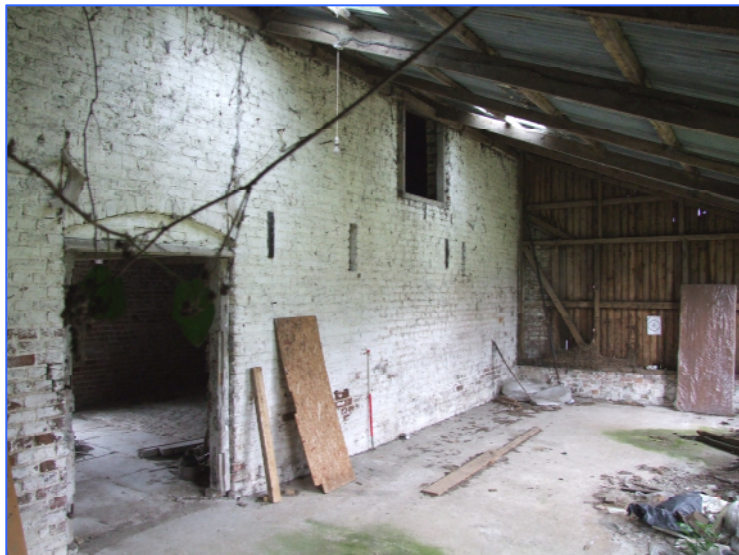
**Plate 10:** Interior of lean-to on north elevation of north range, showing the door and pitching hole in the north elevation of the barn.

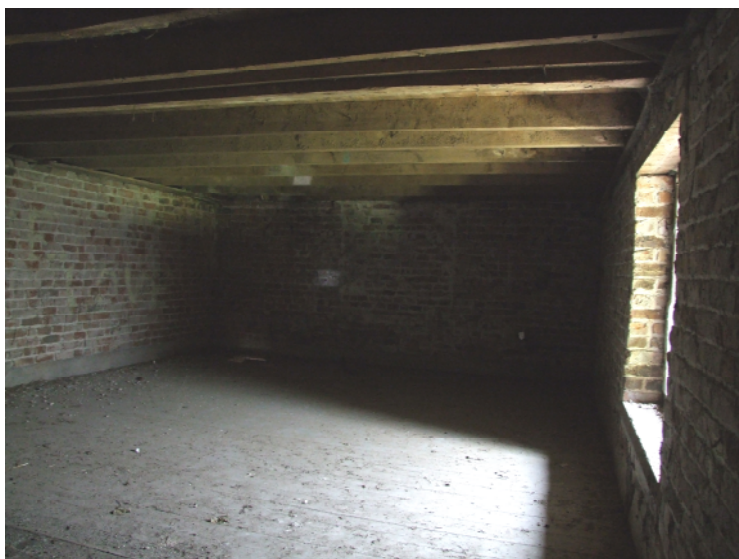
**Plate 12:** First floor of the threshing barn, looking west.

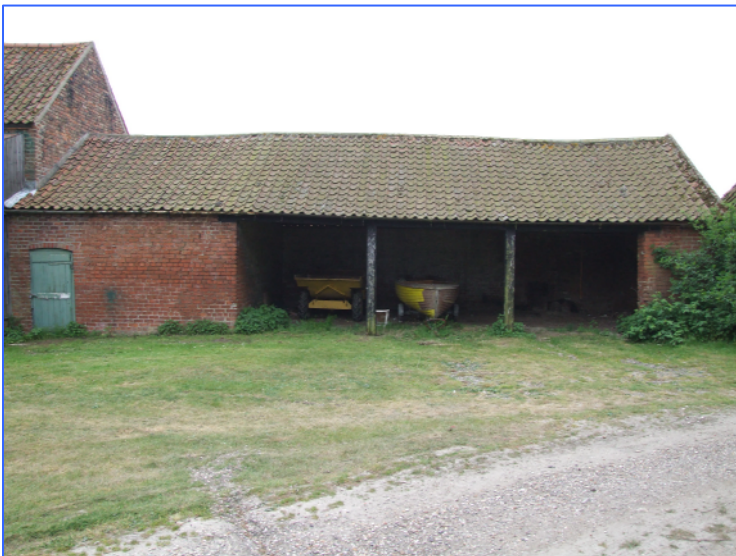
**Plate 15:** Cartshed and store towards the west end of the north range. Looking south-south-east.

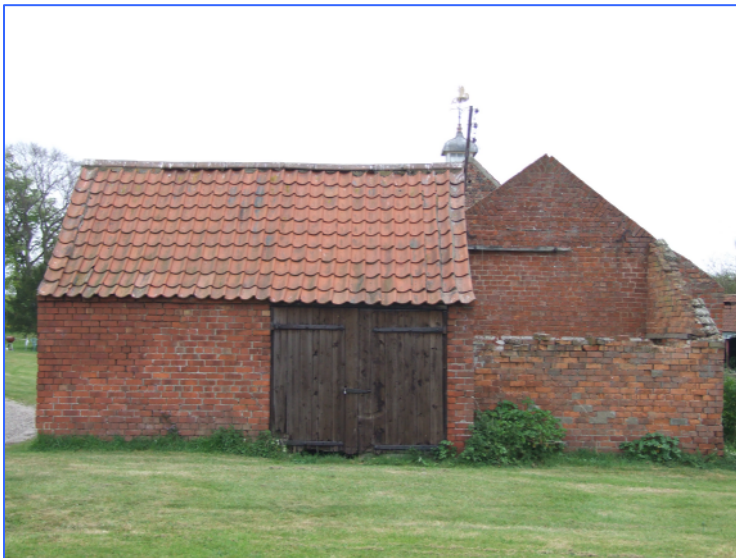
- 5.1.2 At the east end of the range there is a derelict outbuilding (Building 1), the roof of which has collapsed. Much of the brickwork above the wall plate on the south, east and west elevations has also collapsed. The east elevation has a set of double doors with a wooden lintel, and the north elevation bows out to the north with a large crack running top to bottom across the centre of the wall. The position of the double doors, pointing away from the crew yard, suggests that it served as a cart shed allowing access directly to the fields; a common architectural addition during the 19<sup>th</sup> century (Pickles and Lake 2006).

**Plate 17:** Outbuildings at the east end of the north range, looking east-north-east.

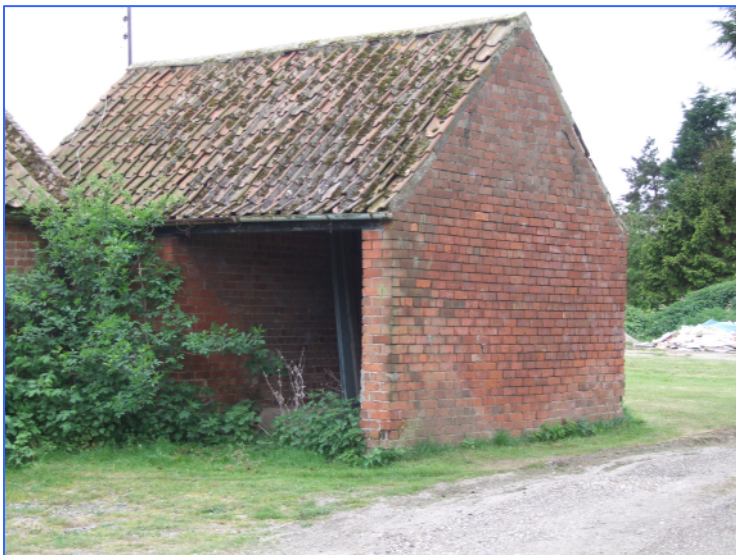
**Plate 18:** Outbuilding at the east end of the north range, showing the compartment probably used as a cartshed. Looking south-west.

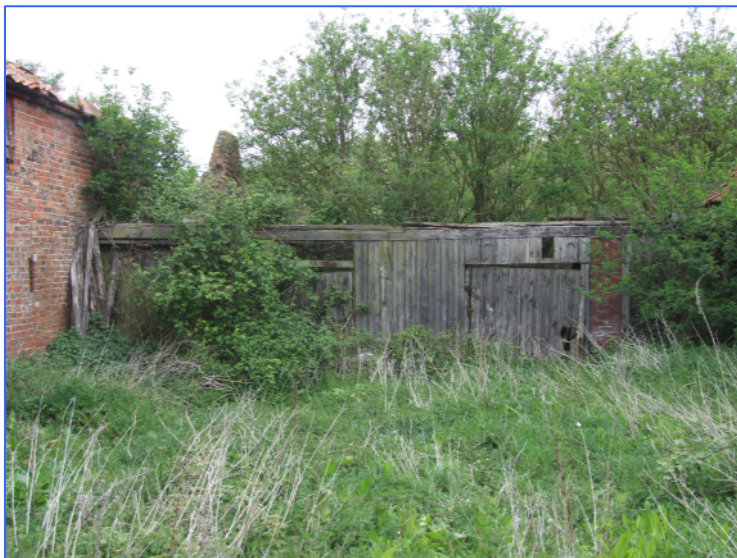
**Plate 20:** West elevation of the barn at the east end of the crew yard. Looking east-north-east.

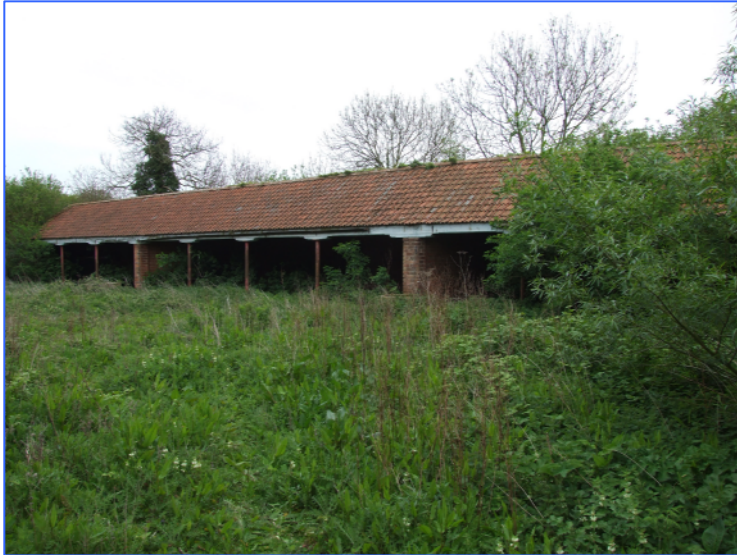
**Plate 22:** North elevation of the south range, looking east.

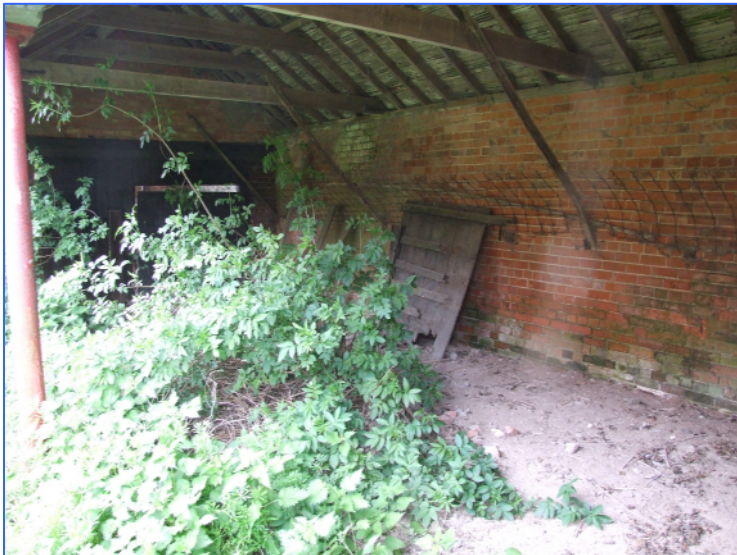
- 5.2.6 In the eastern bay, there is a steel mesh feeding tray along the south wall, similar to the wooden one in Building 10 to the east. The central bay has a door in the south elevation, with a row of brick feeding troughs and a water trough at its east end. To the west of the door the brick foundations for another row of feeding troughs are visible.

**Plate 23:** Interior of the eastern bay in the south range, with the feeding rack along the south wall. Looking east

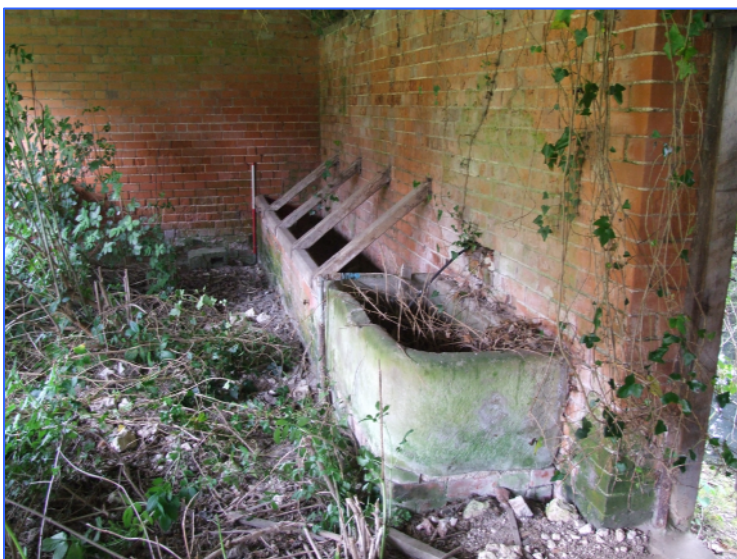
**Plate 24:** Feed trough and water trough at the east end of the south wall in the middle bay of the south range. Looking east.

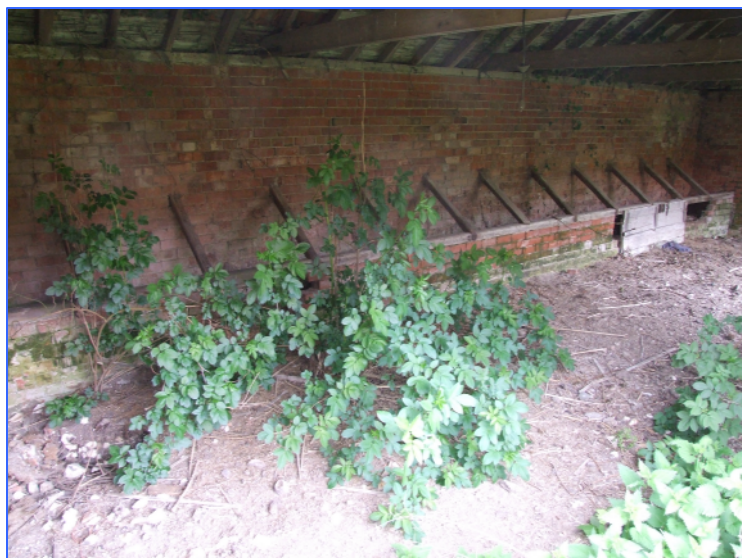
**Plate 26:** Feed troughs along the south wall of the western bay of the south range. Looking south.

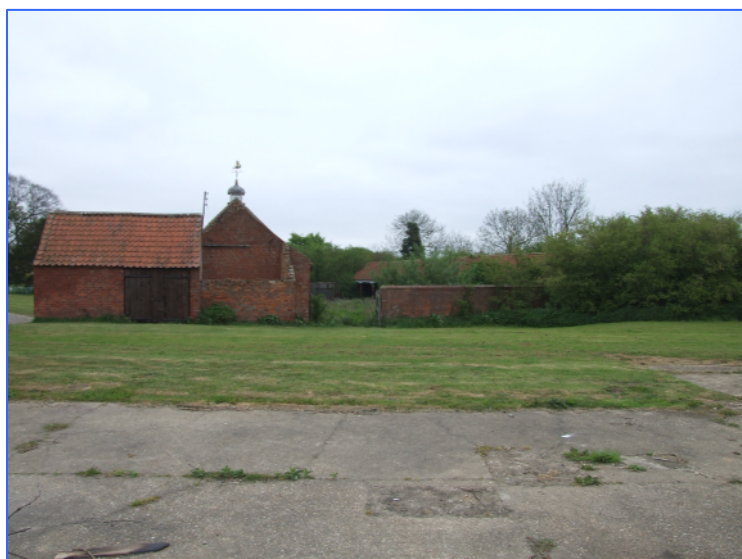
**Plate 27:** West elevation of the barns, showing the outbuildings at the end of the north range and the boundary wall attached to the south range, with the gates between. Looking east-north-east
