- An archaeological scheme of works was undertaken in advance of the conversion of an existing building, and the construction of a new block of retirement flats, on land at the Old Cornmill, South Street in Bourne, Lincolnshire.
- The existing cornmill was subject to a programme of building survey prior to conversion, detailing all external elevations and internal shots of original features, fixtures and fittings.
- A programme of archaeological trial trenching was also carried out, in advance of the construction of a new block of flats adjacent to the existing building. Two trenches were excavated, exposing a late medieval, several undated linear features, and a large late medieval pit.

- 1.1 Allen Archaeological Associates was commissioned by Quadrant Surveying Limited on behalf of their client, Mill Developments (UK) Limited., to undertake a programme of building survey and archaeological trial trenching in advance of development at The Old Cornmill, South Street in Bourne, Lincolnshire.

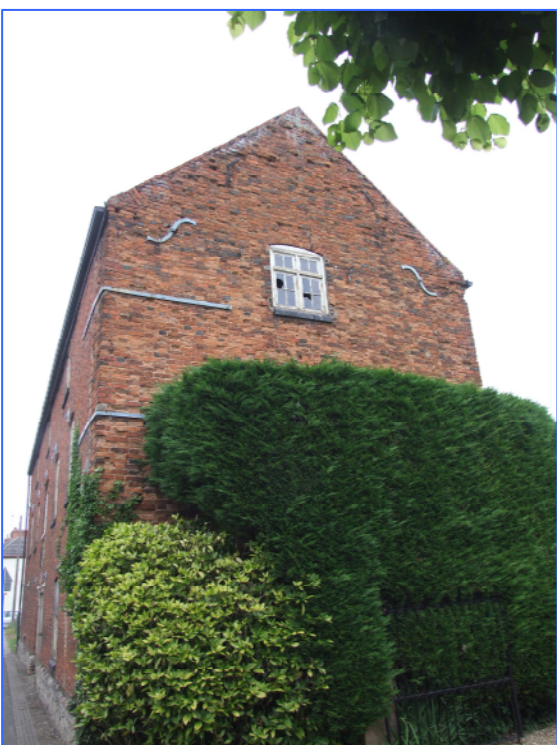
- 7.10 The brickwork in the south wall is in a poor state, with a number of cracks evident. The opening for the window is recessed into the wall and supported by a wooden beam with a wooden lintel over. To the west of the window is a blocked doorway, the wooden frame of which has been left in situ.

**Plate 3:** South elevation, looking north-north-east

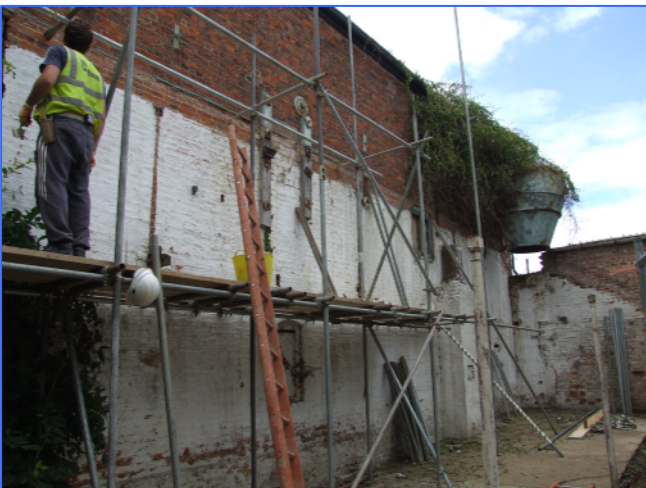
**Plate 6:** East elevation, looking north-north-west. Note the small chimney and the metal funnel at the north end of the elevation.

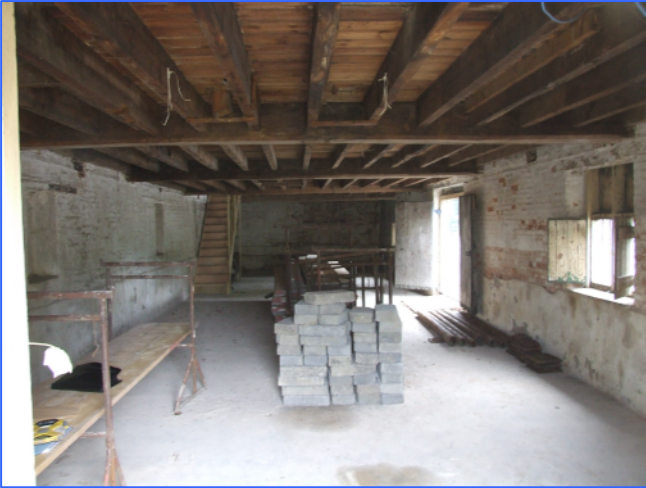
- 7.7 The interior of the building is divided into three storeys, each comprising a single room. The ground floor has few architectural features of note. The walls have been whitewashed, and are plastered to the height of the window sills. The windows along the west elevation all have double wooden shutters, while the east elevation has three recessed windows, all of which have been blocked. Only one of these windows was visible outside. The floor is concrete and appears to be a relatively new repair, and there is a new wooden flight of stairs to the first storey against the east wall, with a further set of stairs from the first floor to the second.

**Plate 7:** Ground floor of the building, looking south.

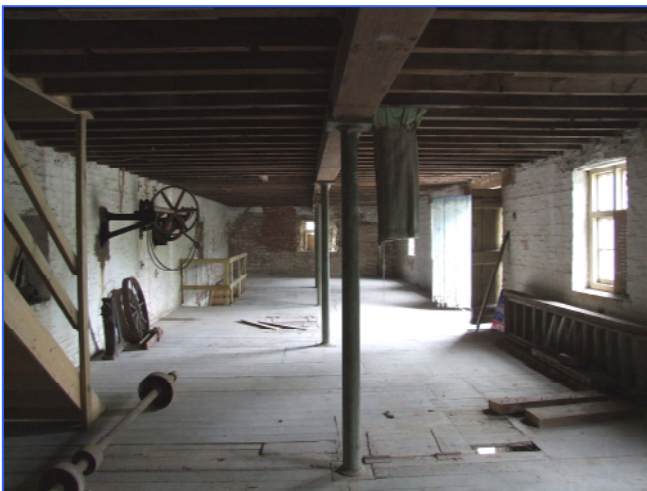
**Plate 8:** First floor, looking south. The in situ mill machinery is visible to the left of the shot, with the cloth grain chute over a hatch in the foreground.

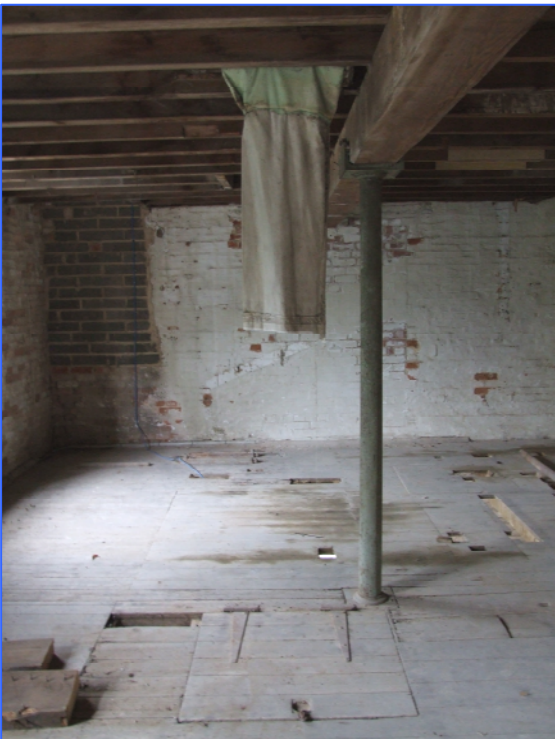
**Plate 9:** Grain chute on the first floor, over a hatch into the ground floor. Looking north.

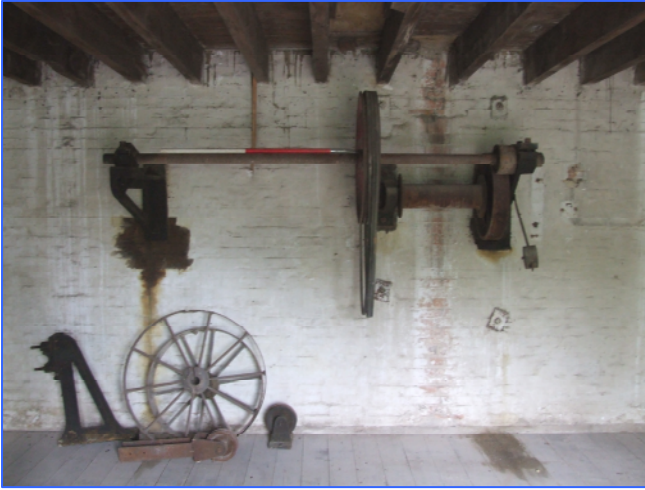
- 7.9 The first floor also has some surviving components of the machinery used to run the mill. A large metal flywheel and associated gearing was attached to an axle against the east wall. Further brackets to support this machinery were noted to its north, and there was a further piece of axle and gearing laid on the floor. There were also a large number of holes of varying shapes and sizes in the floor at this end of the room, which may have been related to the numerous belts, chains and pulleys that ran through the building to operate the machinery of the mill.

**Plate 10:** Machinery in situ on the east wall of the first floor, looking east.

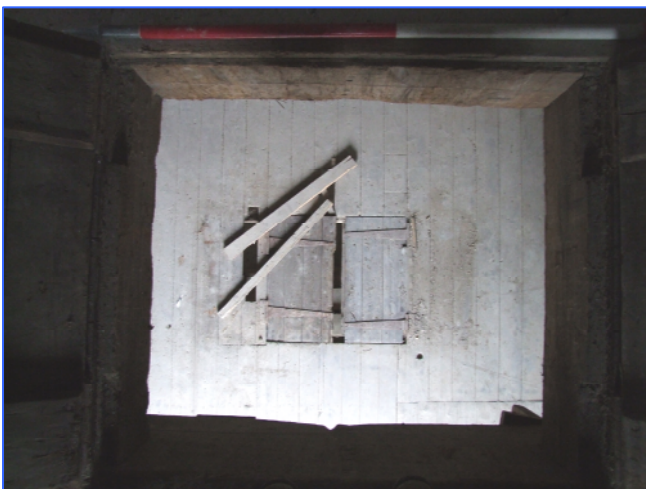
- 7.14 As noted above, there is a hatch in the second storey directly above that in the floor below. On the second storey, a wooden frame has been built over this hatch, to which there are still attached two small metal flywheels for a pulley system.

**Plate 15:** View through hatch on second floor, showing the hatch on the first floor below.
