HISTORIC BUILDING SURVEY REPORT:

NOS 113 AND 115 HIGH STREET AND DOBB'S YARD, CHATTERIS, CAMBRIDGESHIRE

Planning Reference: F/YR16/0247/F
NGR: TL 3909 8660
AAL Site Code: CHHD 17
CHET Event Number: ECB5436
OASIS Reference Number: allenarc1-324532

By
Allen Archaeology Limited
Report Number AAL 2018135

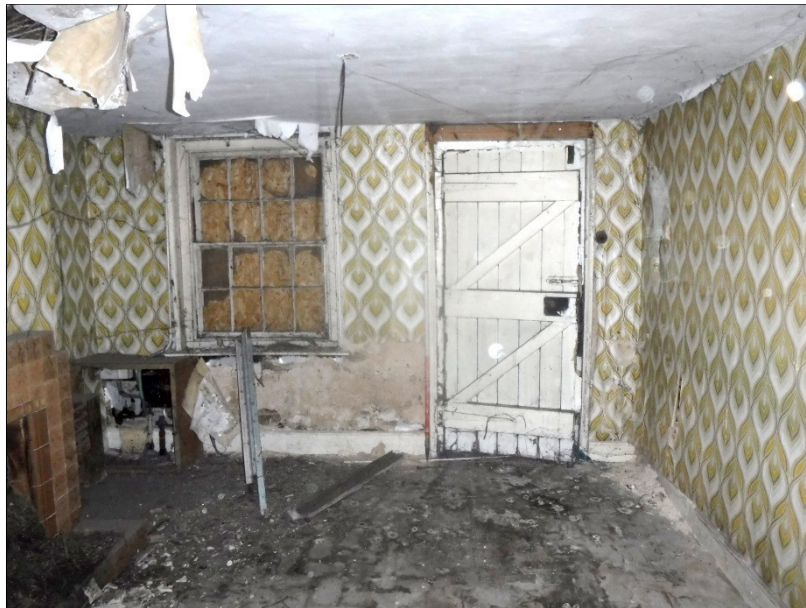
Plate 6 (shot 57): View of front window and door of No 113. Looking southwest, 1m scale

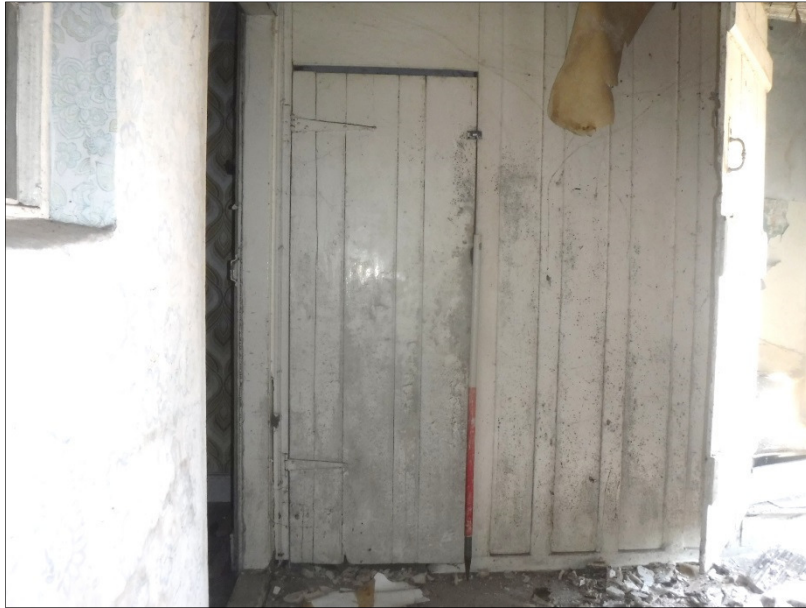
- 7.7 The kitchen, originally the living room, contains a fireplace with cream coloured tile surround on the southeast elevation. A later Belfast sink has been fitted on the northeast elevation and there appears to have been room for an electric cooker (Plate 7). A hole in the ceiling reveals the same reed construction as that in the living room. The staircase is encased by white painted wooden plank panelling with an under stairs cupboard, a plank and batten door is fitted in the access to the stairs (Plate 8).

Plate 8 (shot 53): Panelling and under stairs cupboard in 113. Looking northwest, 1m scale

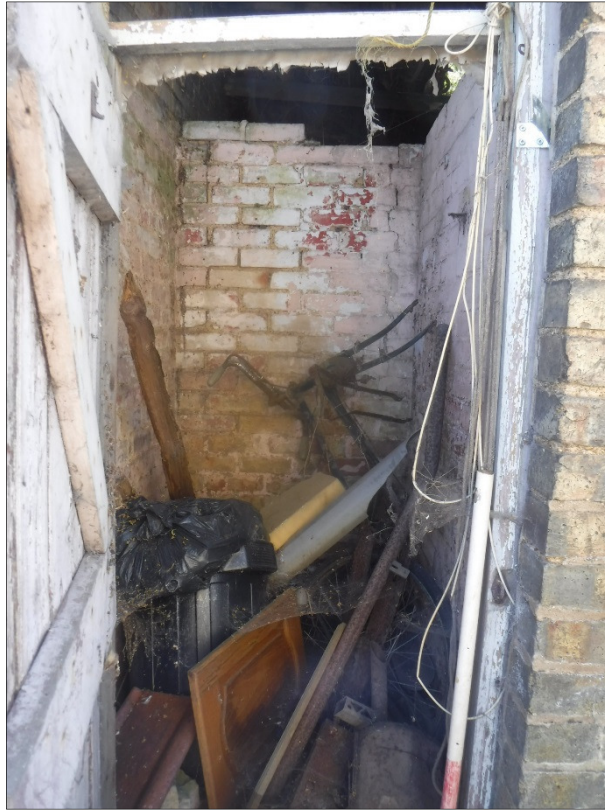
- 7.19 The northwest elevation has six wooden doors allowing access to the various internal spaces. The door furthest to the northeast leads into a small storage space. It is heavily cluttered and inaccessible (Plate 21).
- 7.20 The adjacent entrance allows access to an L-shaped room to the side and rear of the small store. It has of late also been used for storage of various paraphernalia and is largely inaccessible although on the rear wall it was possible to distinguish a monk bond with each vertical row of headers being separated by four horizontal stretchers (Plate 22). A strap hinge protrudes from the partition corner abutting the southeast elevation, a change in brickwork suggests a bricked up window (Plate 23). Plans provided by the client suggest the presence of a back-to-back fireplace, but only part of the chimneybreast was visible during the survey.

Plate 21 (shot 8): Small store to the northeast. Looking southeast

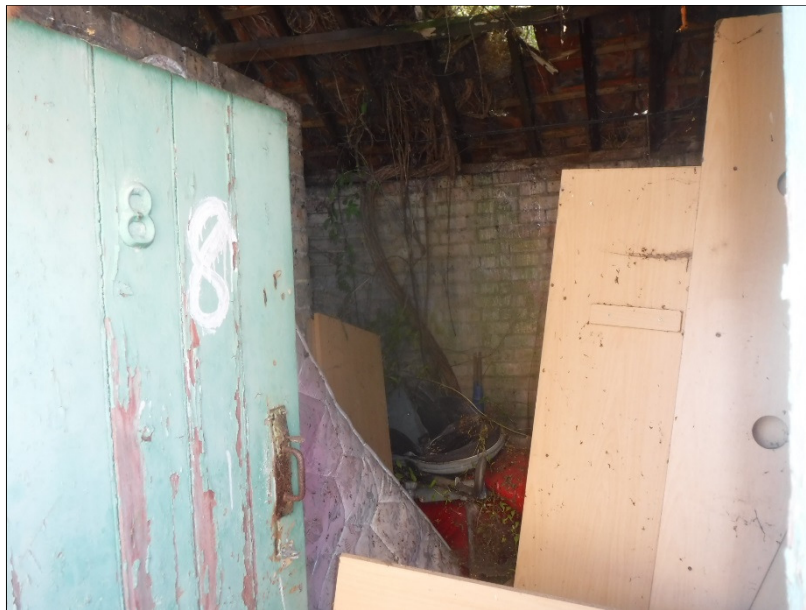
Plate 22 (shot 10): General view of the L-shaped store. Looking southeast

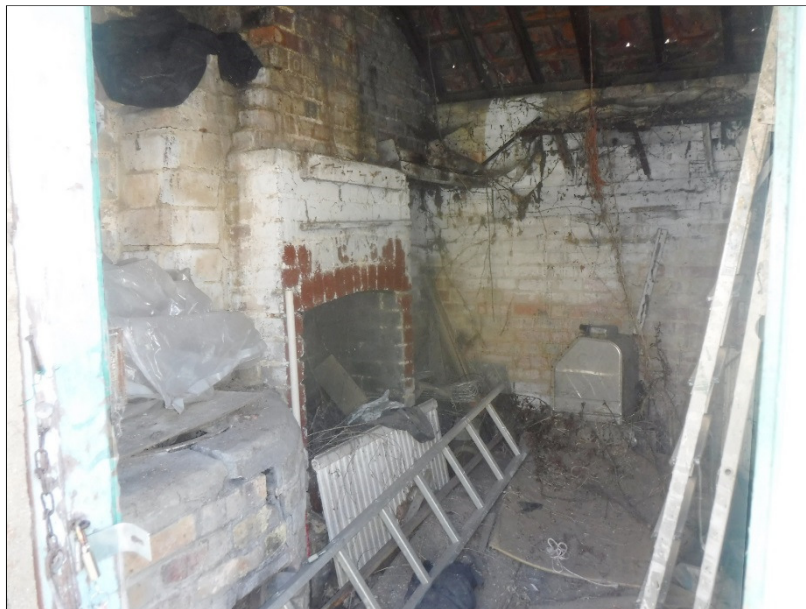
- 7.21 A better view is offered of the fireplace in the adjacent room. It has a double brick segmental arch over a large open hearth. Situated in the northwest corner of the room adjacent to the fireplace is a copper, the round cauldron was probably made of zinc and encased by brick, confirming that this was a former washhouse (Plate 24 and Plate 25). The narrow flue of the copper has been built against the chimneybreast with shiners facing outwards. The southeast wall once again displays a monk bond whilst the partition wall to the southwest is built in stretcher bond. The roof structure comprises common rafters resting on a wall plate.

Plate 24 (shot 12): General view of the washhouse. Looking east

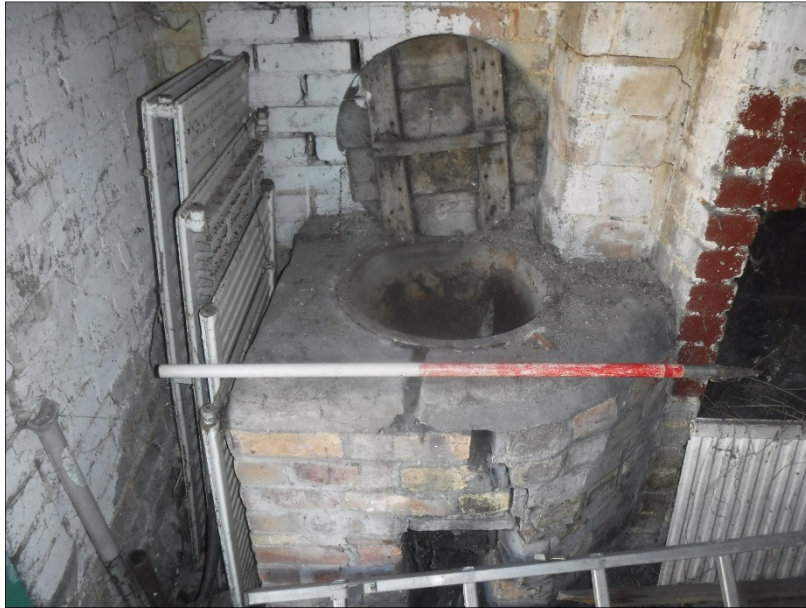
Plate 25 (shot 15): Copper with wooden lid near the fireplace. Looking northeast, 1m scale

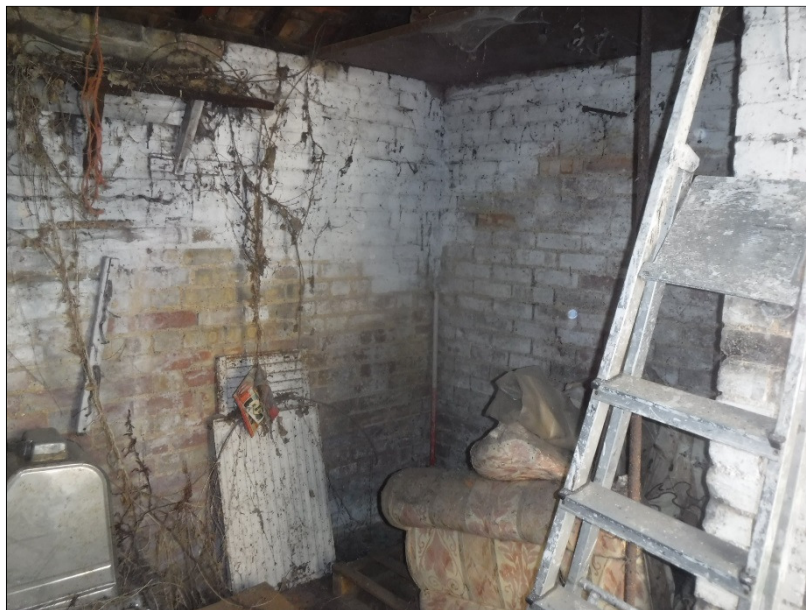
Plate 26 (shot 13): General view of the washhouse. Looking south, 1m scale

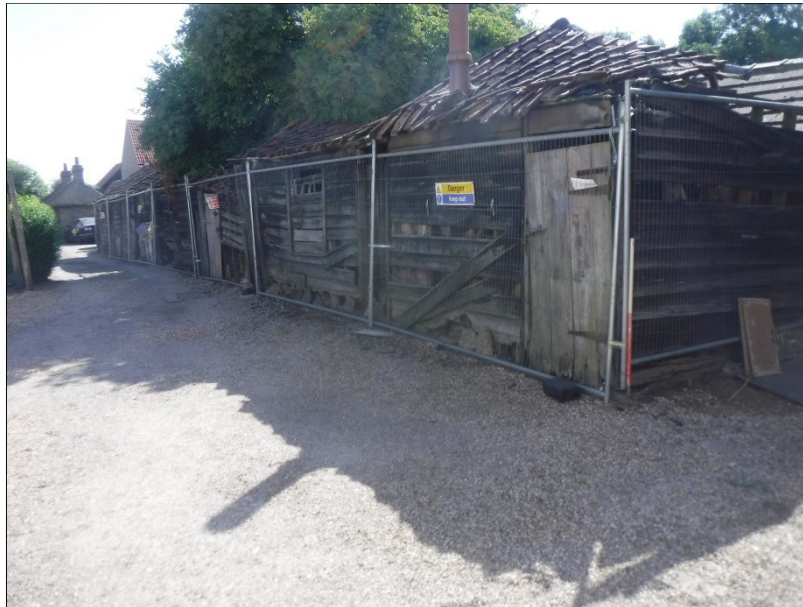
- 7.24 A long range of single storey, weather-boarded sheds, with attached brick outbuilding, runs along the southeast site boundary, between the cottages on the road frontage and the brick outbuilding at the eastern end of the site (Plate 29). Access is not possible so interior photographs were limited to images taken through gaps in the boarding and doorways.

Plate 29 (shot 20): General view of the sheds. The southwest shed has a chimney through the roof. Looking east, 1m scale

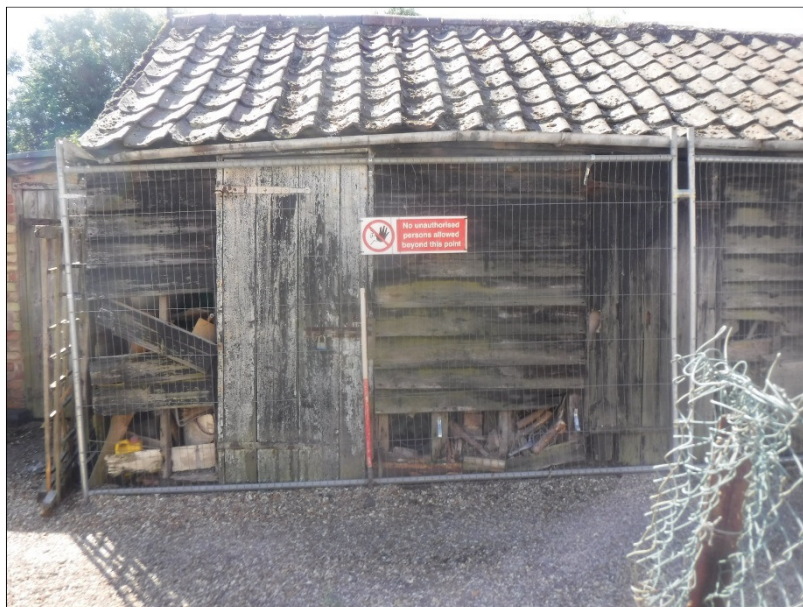
7.25 The wooden buildings are divided into ten compartments by internal wooden partitions with a series of plank and batten doors on strap hinges along the northwest elevation (Plate 30 and Plate 32), although an area roughly central to the elevation has completely collapsed (Plate 31 and Plate 32). The roofs are largely double pitched, hipped to the southwest and covered in s-shaped ceramic tiles, with several areas of collapse. Towards the southwest end of the building a ceramic flue extends through the roof, presumably a later feature and suggestive of a fireplace.

Plate 30 (shot 25): Northeast end of wooden outbuildings. Looking southeast, 1m scale

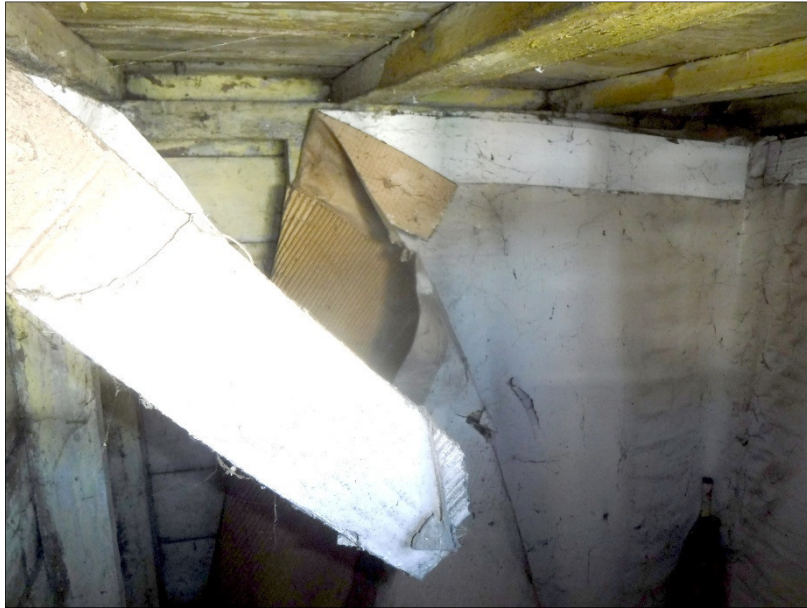
- 7.26 The middle and the southwest end appear to have been used as stores, the middle part is the only room revealing a boarded ceiling supported by main beams (Plate 33).

Plate 33 (shot 32): General internal view towards southwest end of shed. Looking south

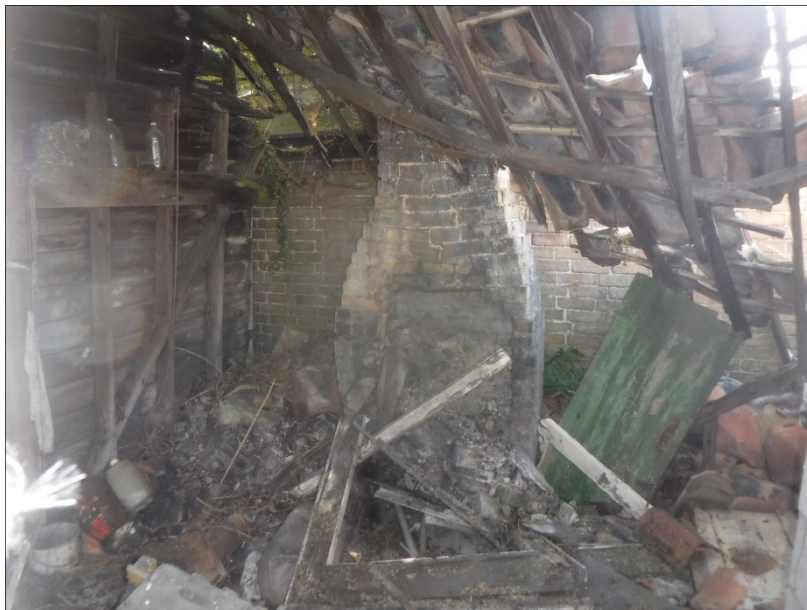
- 7.27 The southwest part of the shed is built up against a boundary wall in stretcher bond (Plate 34), with a brick fireplace and chimney stack in one of the rooms. The roof in this area has partially caved in and debris covers the floor, but where visible the roof consists of common rafters with laths above, the rafters have the added support of purlins. The stud wall to the northeast is braced for better support.

Plate 34 (shot 33): Fireplace within southwest shed, northeast part. Looking southeast

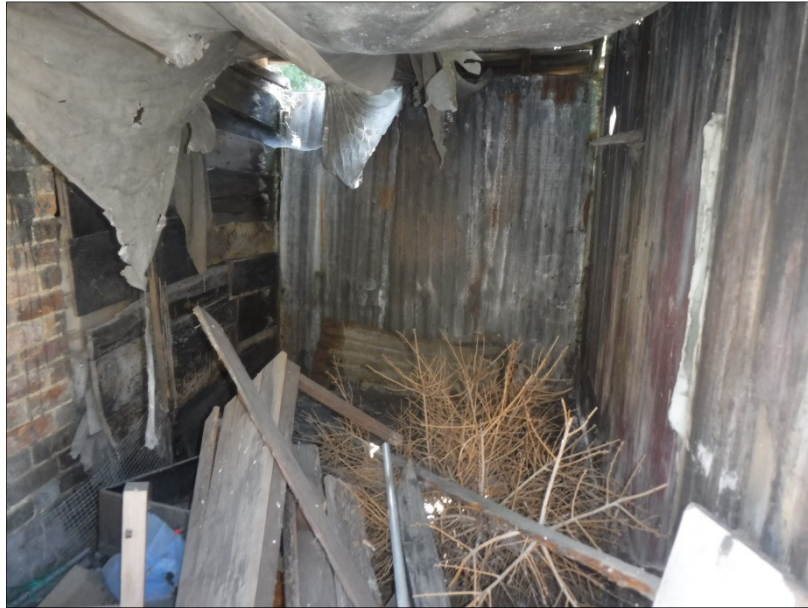
- 7.28 It is uncertain whether the brick boundary wall continues beyond this area of the building. The shed to the northeast has corrugated sheets to the rear with brick and weather-boarded partitions internally (Plate 35).

Plate 35 (shot 37): Internal view showing corrugated steel on rear wall and brick partition. Looking southeast

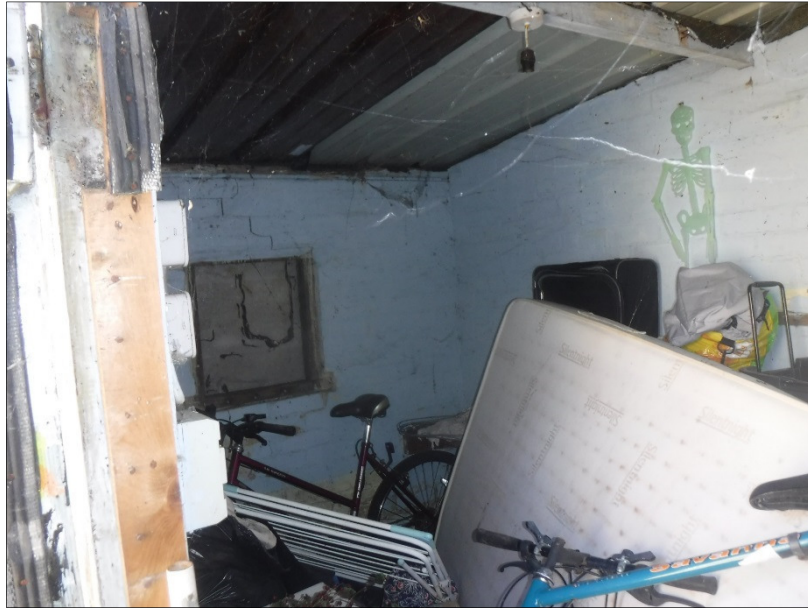
- 7.29 A small brick lean-to in stretcher bond is attached to the northeast end of the wooden sheds, it too is full of assorted rubbish and was not fully accessible (Plate 36 and Plate 37). The lean-to structure has a mono-pitched roof covered in corrugated sheets. A window facing northeast is boarded from the outside. A plank and batten door on strap hinges on the northwest elevation provides the only access. The interior walls are painted, the amount of items stacked in the store offer limited views of the interior.

Plate 37 (shot 24): General view of brick lean-to store. Looking east
